Nicodemus National Historic Site

Nicodemus, Kansas

Historic Structures Report Update

May 2010

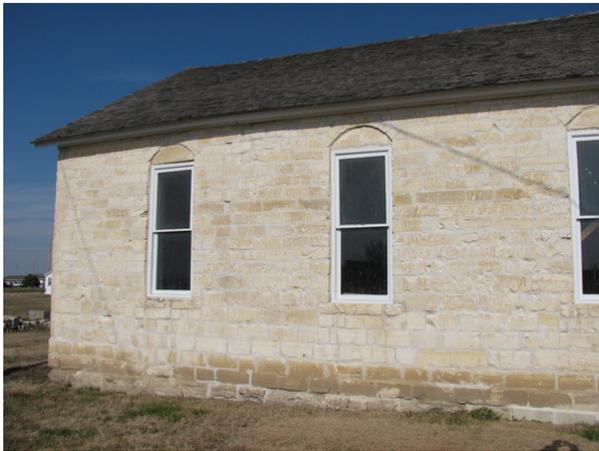
53 In September to December 2005, four new
54 wood-framed double hung windows were
55 fabricated and installed by a contractor engaged
56 by NPS to replace the existing ventilated board-
57 ups and windows at the south elevation
58 (Figure 2). The original windows were
59 considered to be deteriorated to be repaired. It is
60 not known if the original window sash were
61 salvaged for storage. The new window units are
62 wood, one-over-one double hung, single glazed
63 units, primed with two coats of Porter Paints
64 #513 (an oil-modified acrylic bonding primer)
65 and painted with one coat of Porter Paints #631
66 (100 percent acrylic gloss paint), color Brilliant
67 White. The design of the new units matched the
68 profiles and construction of the original
69 windows, based on surviving fragments of the
70 original windows.⁵

5
6 *Figure 2. New windows at the south elevation. Photo by*
7 *WJE, 2009.*

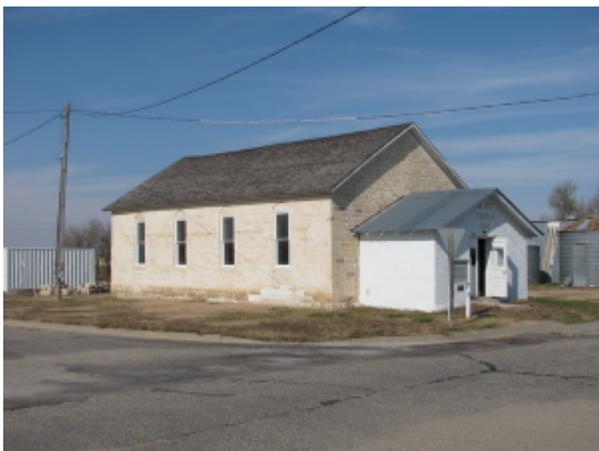
38 stucco remains in place on the exterior walls of
39 the vestibule (Figure 3).

8
9 *Figure 3. Overview from the southeast showing the*
10 *removal of stucco from the main sanctuary and the*
11 *recoating of the stucco at the vestibule. Photo by WJE,*
12 *2009.*

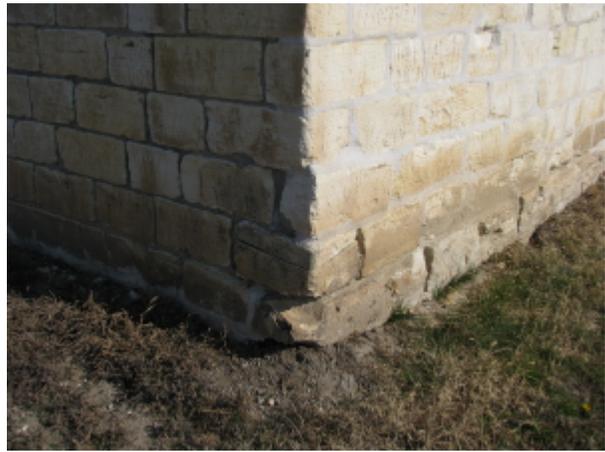
13
14 *Figure 4. Detail at the southwest corner of the church,*
15 *showing two types of repointing mortar, with joints*
16 *struck back on the west elevation (left) or tooled to a*
17 *concave profile on the south elevation (right). Photo by*
18 *WJE, 2009.*

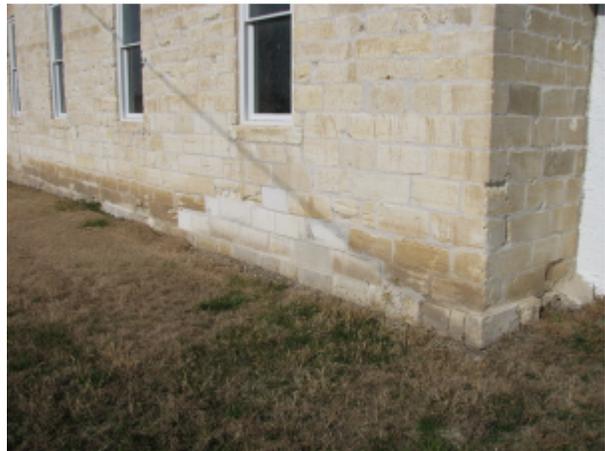
23 New limestone for use in repairing the A.M.E.
24 church was purchased in 2003 and delivered to
25 the site on September 26, 2003.³ Subsequently,
26 several stone units near grade on the south
27 elevation were replaced (Figure 5). Some stone
28 units were installed in 2009, however the extent
29 of that work is not documented. The original
30 stone units were observed to be severely
31 deteriorated when inspected during the 2001
32 HSR field work. Additional new limestone
33 material is stored on wooden pallets to the north
34 of the building. The new stone material is not
35 covered or secured.

19
20 *Figure 5. New stone units were installed near grade on*
21 *the south elevation. Compare to Photo A-20 in the 2002*
22 *HSR. Photo by WJE, 2009.*

- The new replacement stone units on the south elevation near grade are intact, although these units are not a good aesthetic match to the adjacent original stone (refer to Figure 5 above). The new stone units may better blend visually once they have weathered.

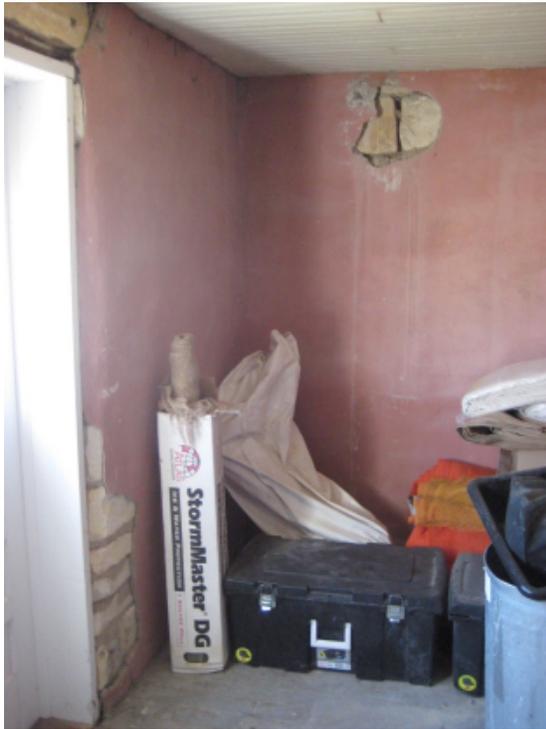
1
2 *Figure 6. View of south east corner of Anteroom. Note*
3 *tools and equipment stored. Photo by BVH, 2009.*

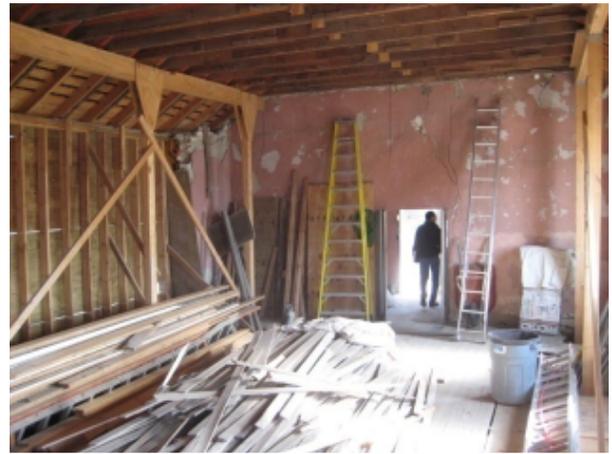
7
8 *Figure 8. View looking towards north east corner of*
9 *Sanctuary. Note that all ceiling boards have been*
10 *removed since 2002 HSR. Photo by BVH, 2009.*

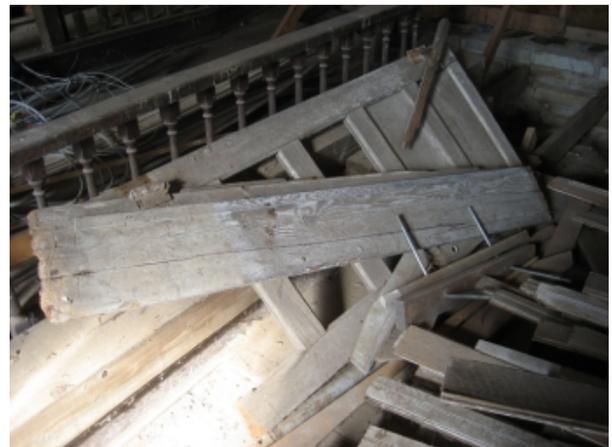
14
15 *Figure 10. Detail of items removed and piled near*
16 *Chancel. Note that materials include door, frame, wall*
17 *and floor boards. Photo by BVH, 2009.*

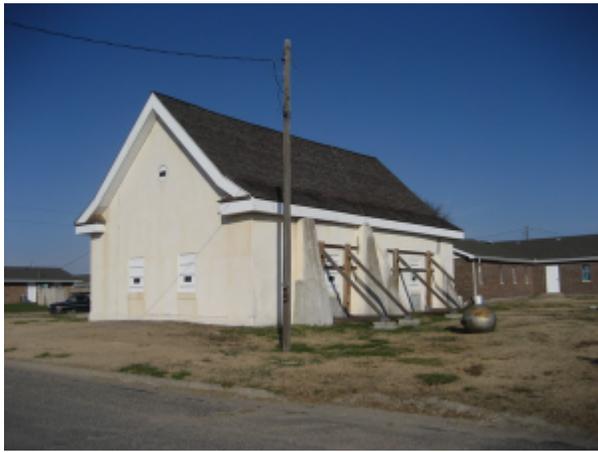
1
2 *Figure 11. Overview from the southeast showing east*
3 *wall shoring. Photo by BVH, 2009.*

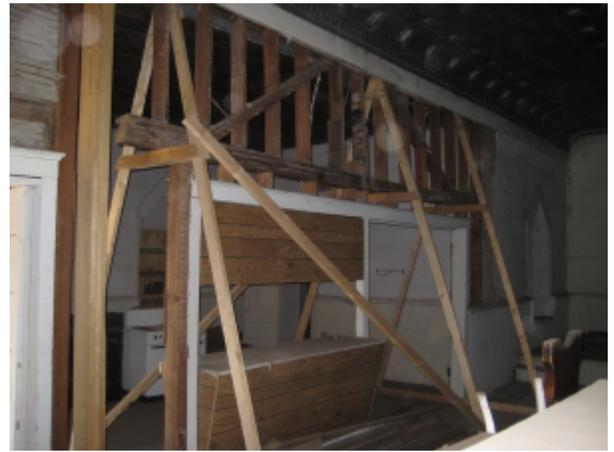
10
11 *Figure 14. Interior shoring and removal of finishes at*
12 *the interior partition wall between the sanctuary and*
13 *kitchen. Photo by BVH, 2009.*

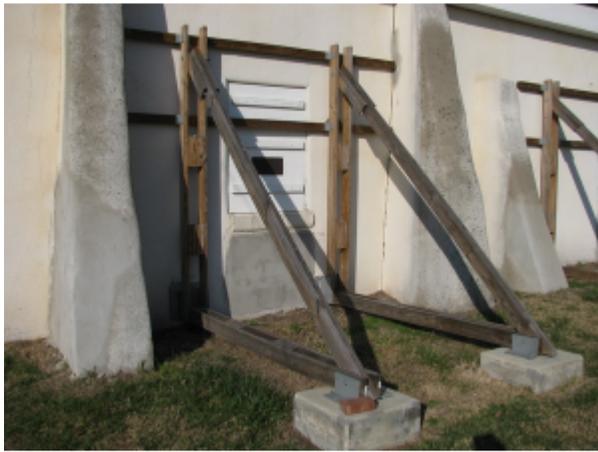
4
5 *Figure 12. Wood shoring at the east wall. Photo by*
6 *WJE, 2009.*

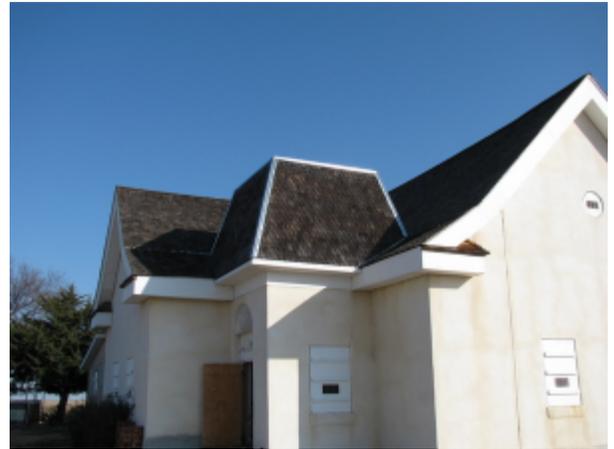
14
15 *Figure 15. Reconstructed vestibule mansard roof.*
16 *Photo by WJE, 2009.*

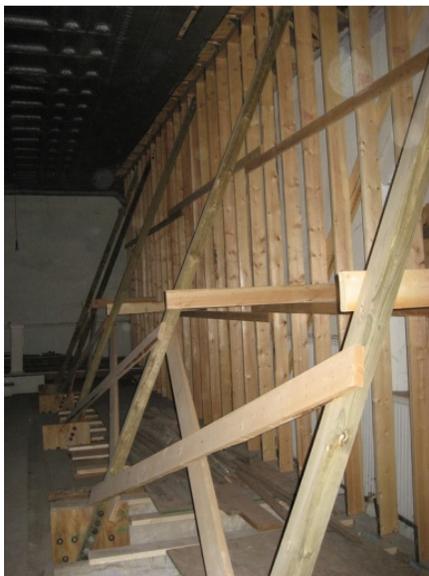
7
8 *Figure 13.. Interior shoring to support the roof*
9 *structure near the east wall. Photo by BVH, 2009.*

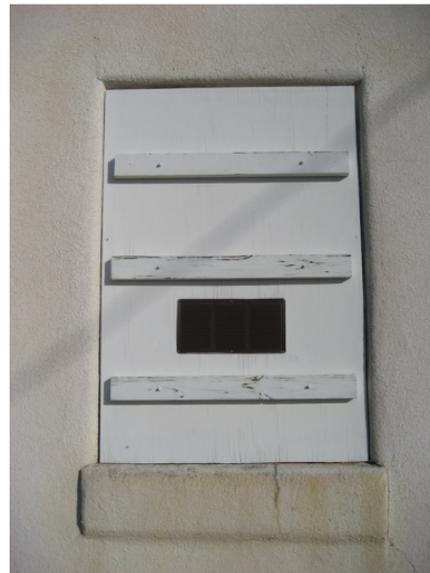
17
18 *Figure 16. Typical window board-up. Photo by BVH,*
19 *2009.*

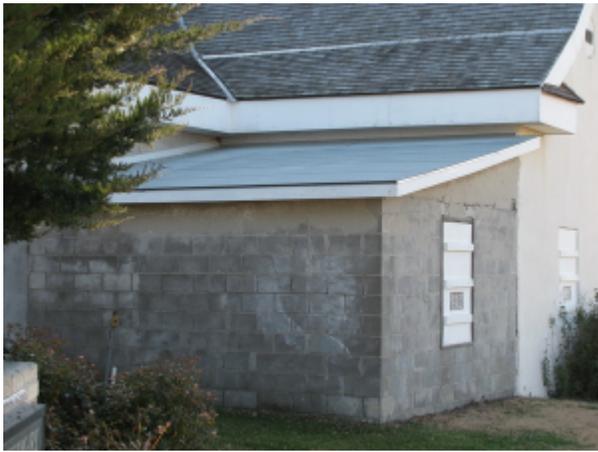
1
2 *Figure 17.. Reconstructed northwest addition roof.*
3 *Photo by WJE, 2009.*

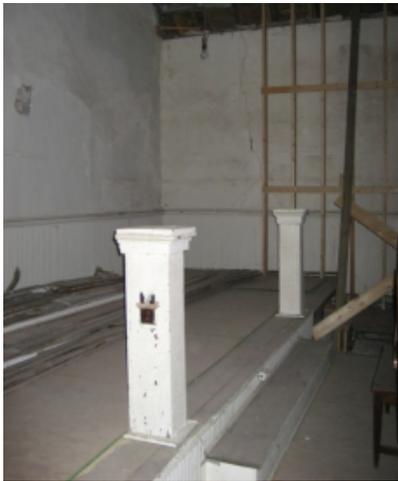
47 interior of the sanctuary (Figures 18 and 19). At
48 the west wall dividing the kitchen from the
49 sanctuary, most of the existing wall over the
50 kitchen pass-through window was dismantled,
51 including the brick chimney and plaster finishes.
52 Additional structural wood framing and shoring
53 was installed, leaving the pass-through window
54 and door opening intact (Figure 14). The
55 structural improvements and the need to insert
56 additional beams and framing also necessitated
57 the removal of the tin ceiling panels at the
58 kitchen. The appliances in the kitchen have been
59 cleaned, disconnected, and are stored within the
60 room. The propane gas space heater originally
61 located in the sanctuary has also been
62 disconnected and is stored within the interior of
63 the church (Figure 21 and 24). The study and the
64 two toilets remain in much the same condition
65 and configuration as observed in 2002. The

4
5 *Figure 18.. View of chancel. Note new shoring at east*
6 *wall beyond. Photo by BVH, 2009.*

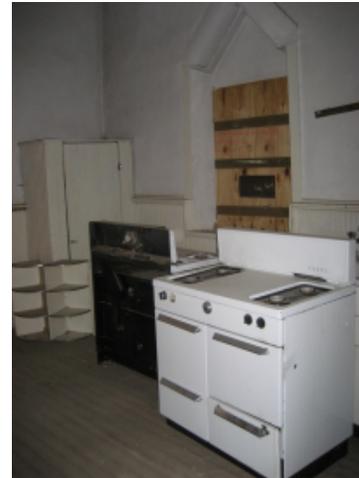
20
21 *Figure 21. Detail view in kitchen. Note that appliances*
22 *have been disconnected from power/propane, cleaned,*
23 *and stored. Photo by BVH, 2009.*

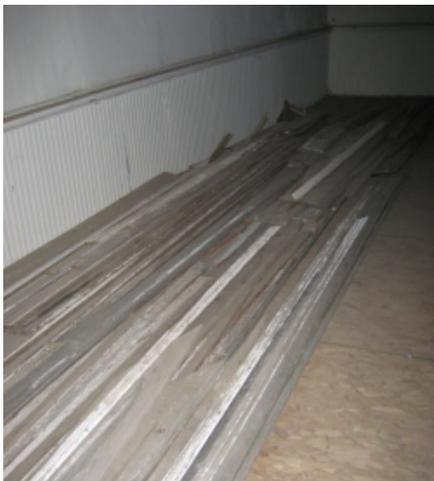
7
8 *Figure 19. Detail view of stored flooring boards in the*
9 *chancel. Also note protective layer of OSB applied*
10 *over historic flooring remaining in place. Photo by*
11 *BVH, 2009.*

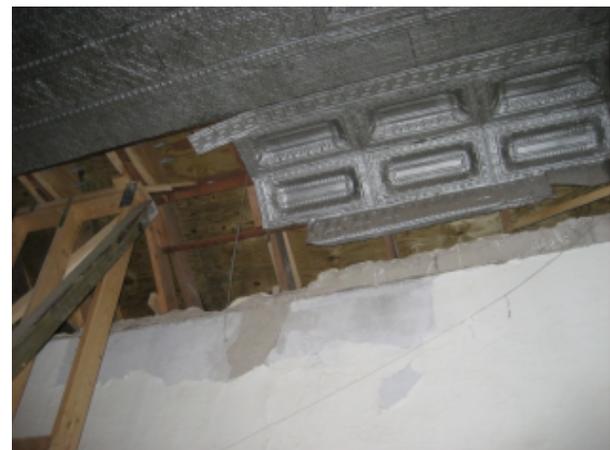
22 While much of the interior fabric observed and
23 documented in the 2002 HSR remains, the
24 stabilization project caused several changes and
25 modifications to some of the interior finishes
26 and systems. Prior to the stabilization, a clean-
27 up of the interior was performed, including
28 mitigation of vermin and mold growth.⁸ As part
29 of the stabilization, carpet and vinyl sheet floor
30 coverings were removed and a protective layer
31 of 4 foot by 8 foot sheets of oriented strand
32 board (OSB) was laid over the majority of the
33 floor area. Since much of the stabilization work
34 was focused on the east wall, tower, and west
35 interior/chimney bearing walls, these areas of
36 the interior were the most affected by the work.
37 At the east wall ceiling, a narrow section of the
38 stamped tin ceiling running north to south over
39 the entire length of the wall was been removed
40 (Figures 22 and 23). Correspondingly, a narrow

24
25 *Figure 22. Detail view of ceiling/wall junction at east*
26 *wall showing strip of ornate tin ceiling material*
27 *removed for shoring installation. Photo by BVH, 2009.*

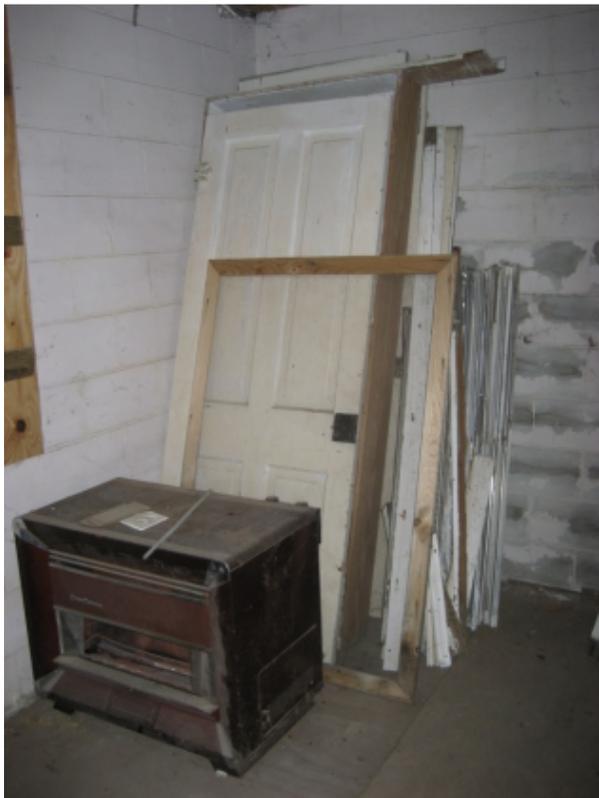
6
 7 *Figure 24. Detail at study noting stored gas space*
 8 *heater and materials removed from kitchen area. Photo*
 9 *by BVH, 2009.*

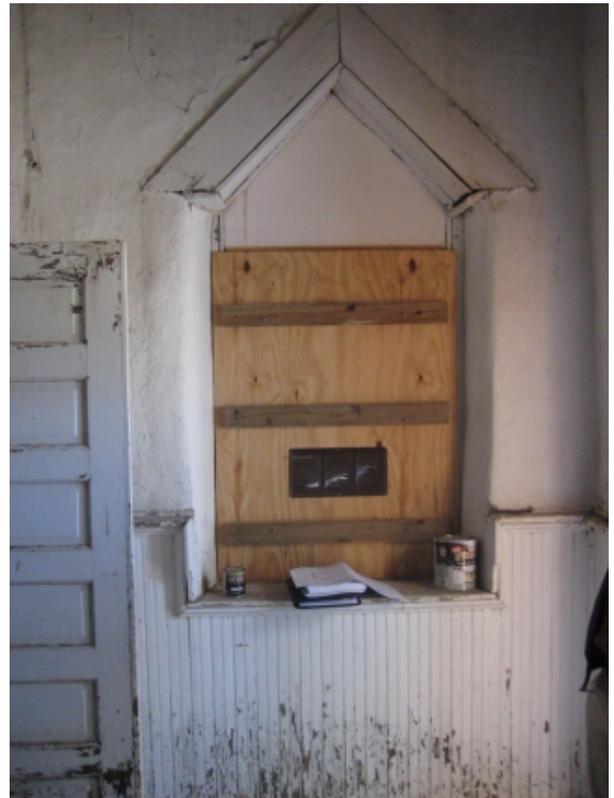
10
 11 *Figure 25. Interior view of typical window that has had*
 12 *a protective plywood cover installed. Photo by BVH,*
 13 *2009.*

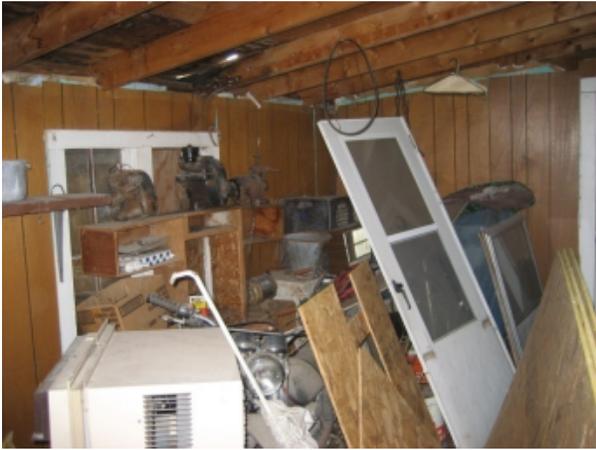
1
2 *Figure 29. View stored materials at rear south porch.*
3 *Photo by BVH, 2009.*

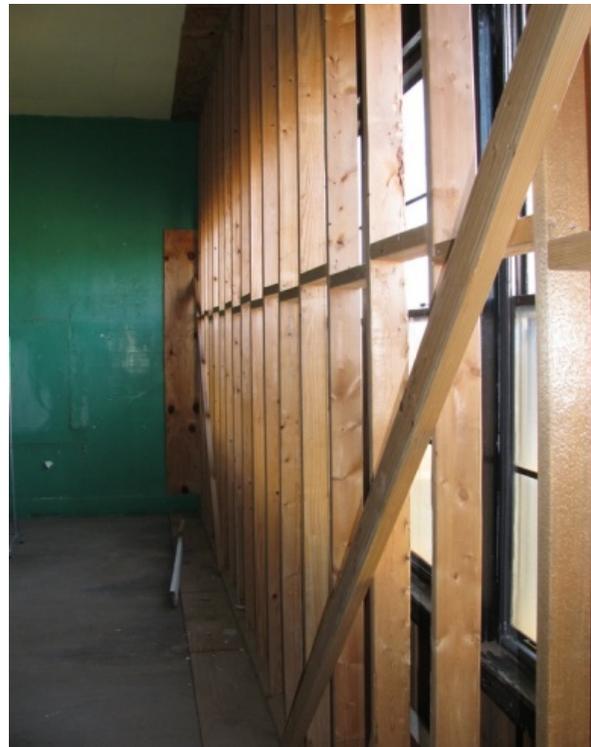
22 It appears that some of the intended work was
23 not completed. The interior wood-framed
24 shoring wall remains in place (Figure 32). Some
25 components of the original exterior wood
26 window trim had been removed and not
27 replaced (Figure 33). Matching pieces of wood
28 trim were observed, in a partially repaired
29 condition, stored in the interior of the building.

46
47 *Figure 32. Interior shoring remains in place at the*
48 *north wall. Photo by WJE, 2009.*

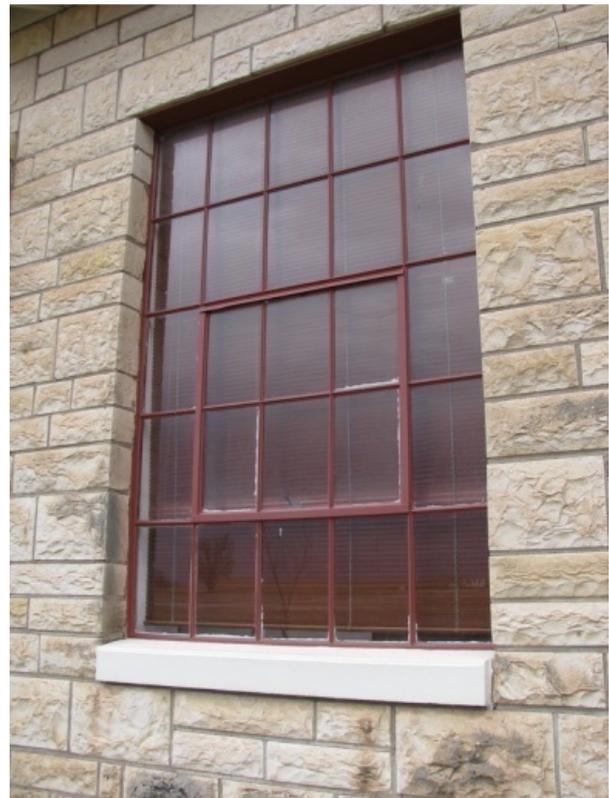
23 The exterior steel window sash and adjacent
24 steel lintels were repainted. The concrete
25 window sills were also painted (Figure 39).

51
52 *Figure 39. Newly repainted steel window and concrete*
53 *sill. Photo by WJE, 2009.*

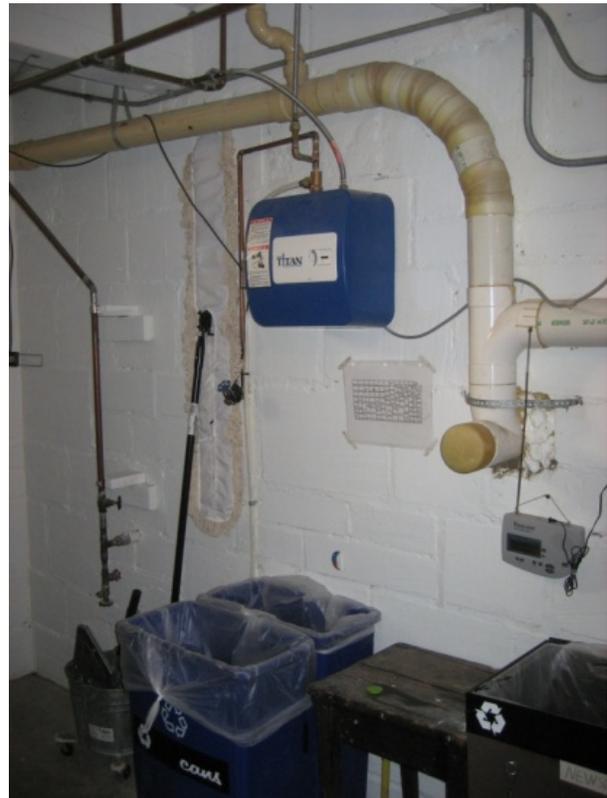
10
11 *Figure 43. Detail view in basement. Note installation of*
12 *instantaneous water heater and new plumbing lines.*
13 *Photo by BVH, 2009.*

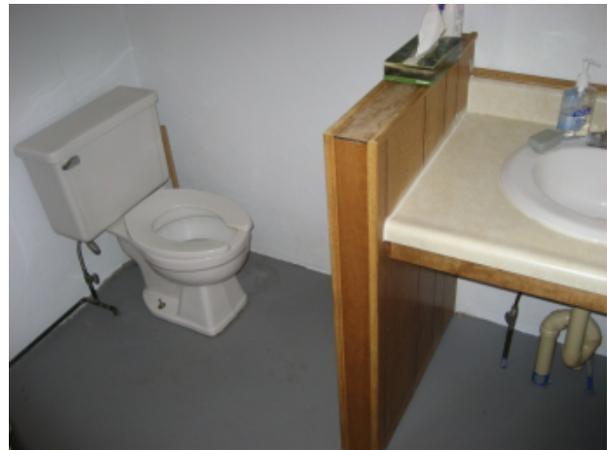
14
15 *Figure 44. Detail view in men's restroom. Note new*
16 *toilet fixtures, plumbing and new paint finishes. Photo*
17 *by BVH, 2009.*

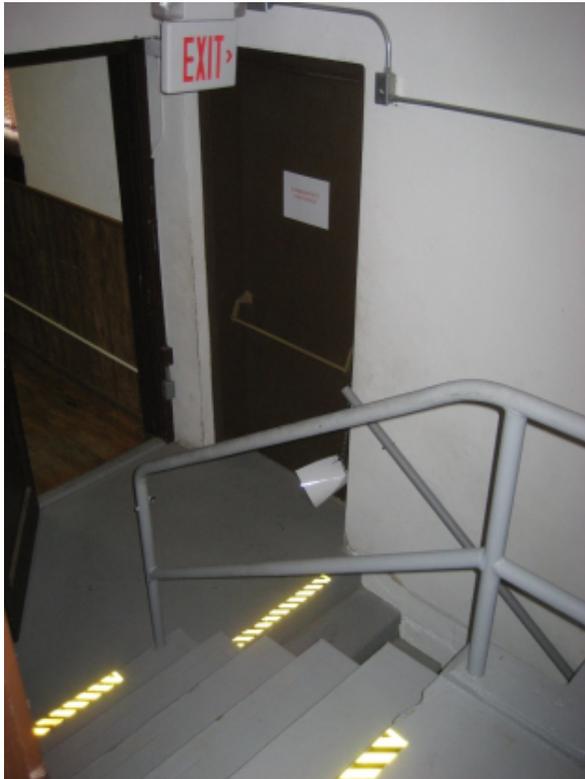
- 2 *Figure 45. Detail view in west side room/stair. Note*
- 3 *new exit door, panic hardware, exit lighting, handrail*
- 4 *improvements, and paint finishes. Photo by BVH, 2009.*

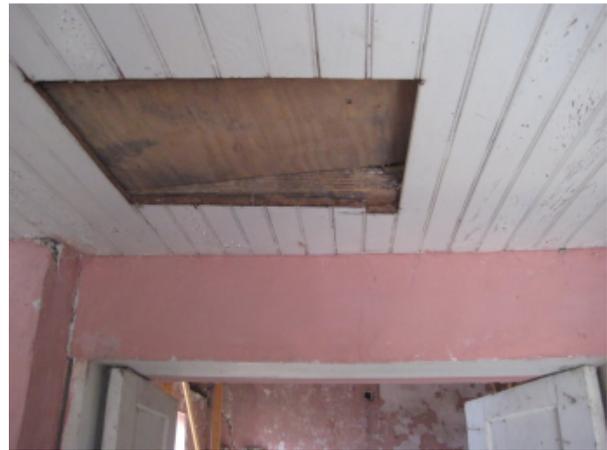
- The ceiling is composed of bead board tongue and groove planks attached directly to the underside of the bottom chord of the roof truss, and is in fair condition. An access hatch has been cut into the bead board ceiling and covered with a piece of plywood (Figure 50). The paint finish on the bead board ceiling is not excessively built up and the beading detail is still evident. The paint, however, is in poor condition with localized failure and general chalking.

Figure 50. Access to attic space above cut into bead board ceiling of vestibule. Photo by BVH, 2009.

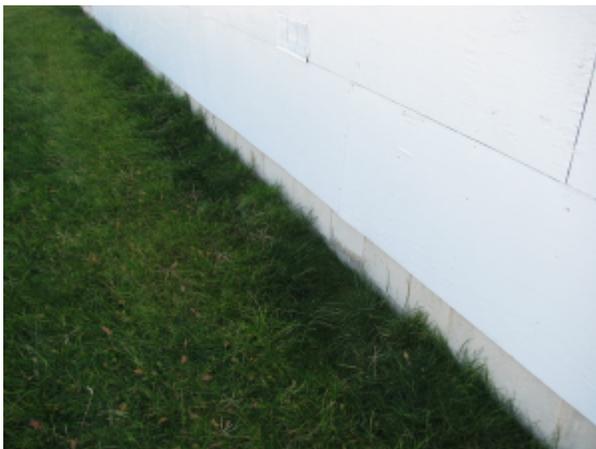
- The building roof does not have gutters. On the south side, grade slopes away from the building and the soil appears to drain well. Sunlight also helps to dry this side of the building. On the north side, grade slopes toward the building. The turf grass near the building wall was observed to be saturated with water (Figure 48).

Figure 48. Saturated turf grass along the north elevation. Photo by WJE, 2009.

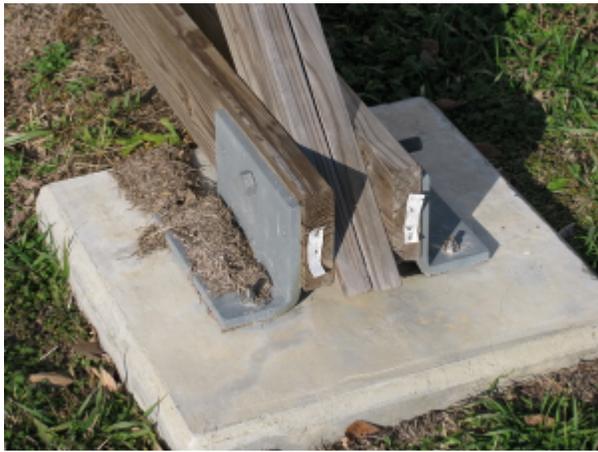
- Although treated lumber was used for the exterior east wall shoring, the wood elements are starting to weather (Figure 53).
- The paint coating on the wood trim enclosures has begun to weather (Figure 54).

Figure 53. The treated wood shoring at the east wall has begun to weather. Photo by WJE, 2009.

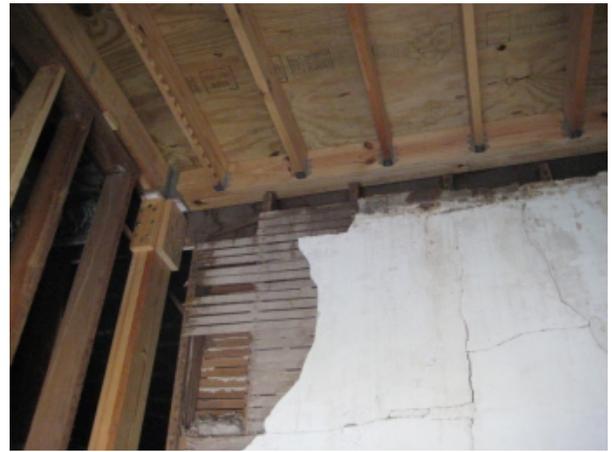
- The plaster walls have water damage and are cracked. The plaster is in fair condition. The wood wainscot is deteriorated with severe water damage and is in poor condition.
- Some plaster has been removed to allow for the new tower framing, exposing the lath beneath (Figure 56).
- The ceiling of the foyer has been removed to accommodate new joist framing for the tower above (Figure 56).
- The exterior doors and frames have been removed and replaced with a temporary plywood door and side panel, painted on the exterior only. The transom has also been in-filled with plywood (Figure 57).

Figure 56. Wall plaster and ceiling plaster removed in foyer for tower stabilization effort. Photo by BVH, 2009.

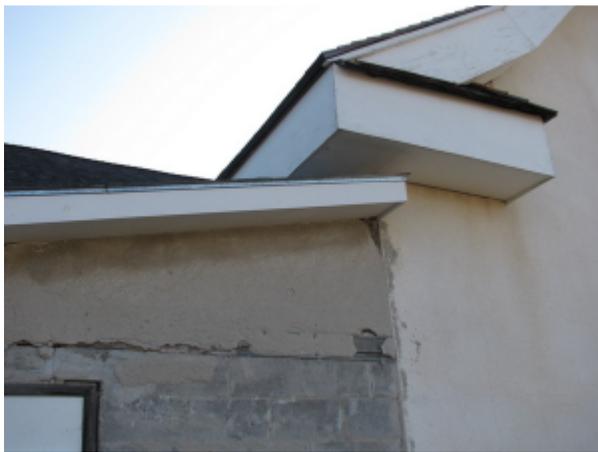
Figure 54. The painted wood trim board-ups have begun to weather. Photo by WJE, 2009.

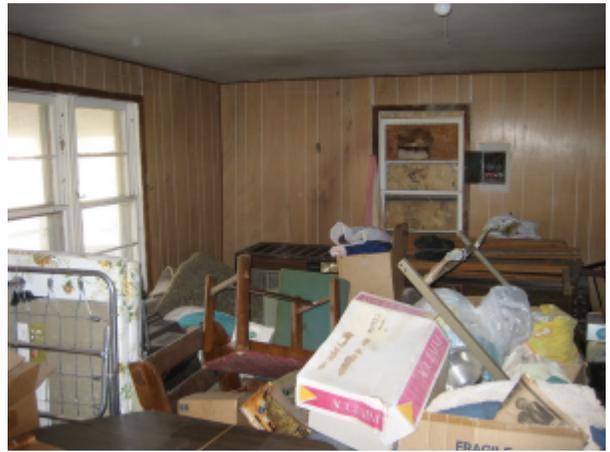
Figure 63. A large quantity of furniture and other items is stored in the building. Photo by BVH, 2009.

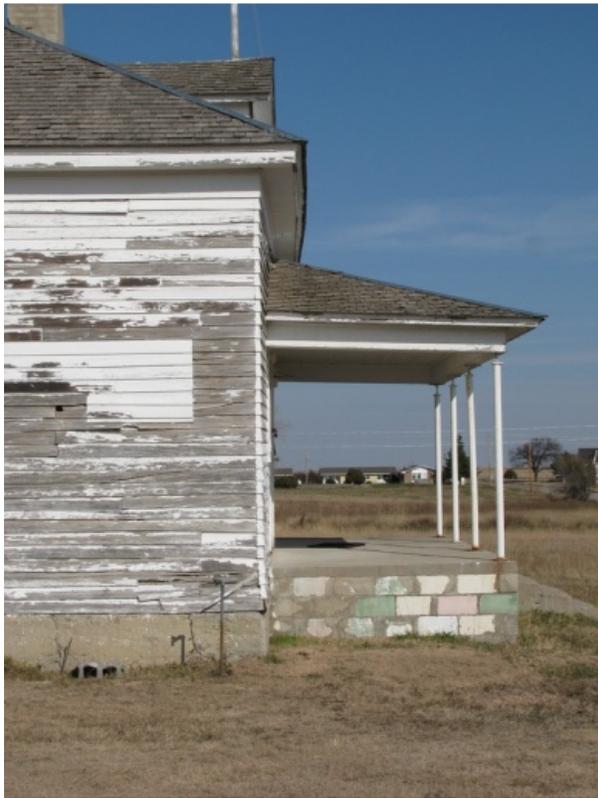
- The structural stability of the building roof requires further study. The east wall of the building has bulged outward (Figure 72), likely due to irregular forces imparted by the configuration of the hip roof and the presence of vertical ties from the ceiling joists to one rafter at the centerline of the building. These conditions are unchanged since the 2002 HSR.

Figure 72. The east wall of the building has bulged outward; note the curve of the roof eave line. Photo by WJE, 2009.

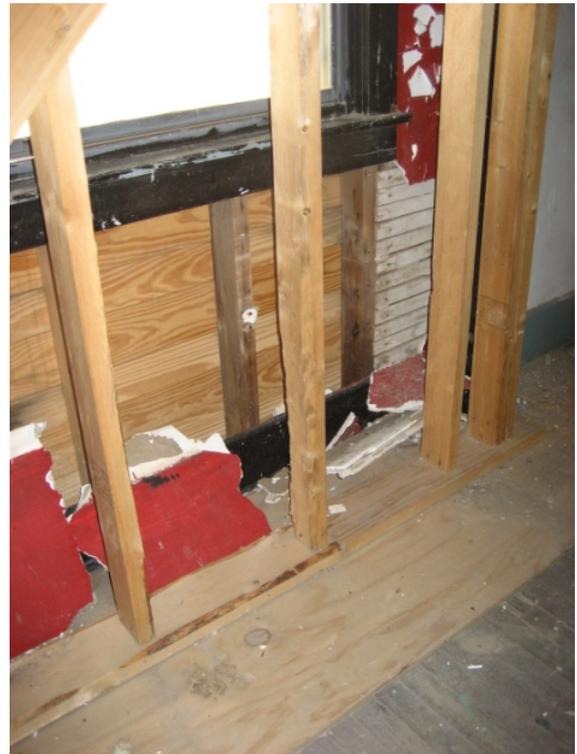
Figure 73. Plaster and gypsum wall board removed for stabilization effort. Photo by BVH, 2009.

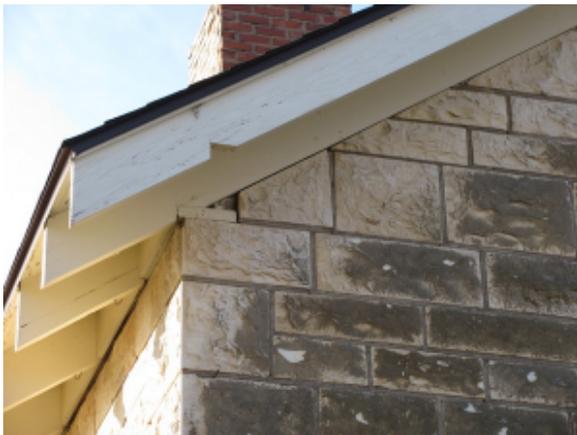
- Water leakage is occurring at the top of the walls. A possible source for the observed leakage is the unsealed gap between the masonry and wood roof eave trim (Figure 74).

Figure 74. Open joint where the stone masonry meets the wood roof trim at the eave and gable. Photo by WJE, 2009.

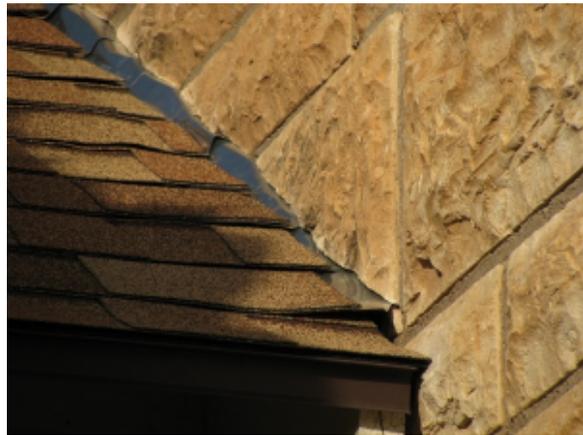
- During the recent roof replacement, new flashing was installed into a new reglet at the joint between the vestibule roof and the main building south wall (Figure 75). The reglet joint and the lap joints within the flashing are unsealed.

Figure 75. New flashing and reglet where the vestibule roof meets the south gable wall. Photo by WJE, 2009.

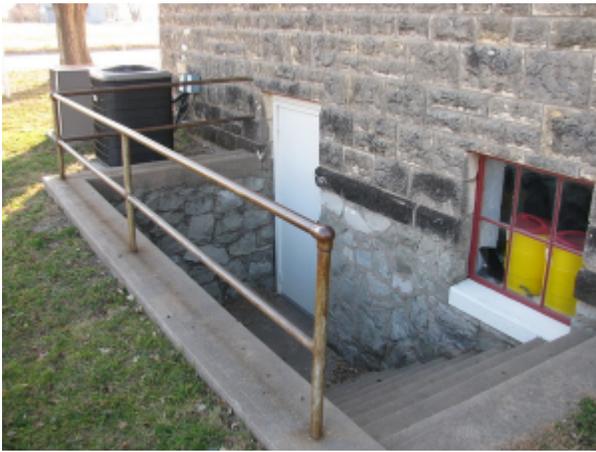
- Perimeter drainage at the base of the building is problematic. There are no gutters at the roof. On the east side of the building, there is a concrete walk installed in 1971 along the entire length of the building (Figure 76). On the west side of the building, there is a concrete terrace along the north half (Figure 77). These concrete paved areas slope toward the building, exacerbating stone spalling and staining at the base of the wall. At the north side area well, the exterior basement steps have an area drain that does not seem to be connected to piping (Figure 78). This area reportedly ponds water during rain.

Figure 78. Exterior stairs at the north side of the building. Photo by WJE, 2009.

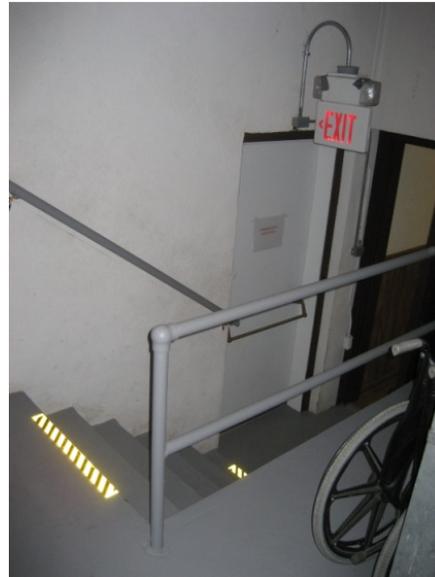
Figure 88. Painted concrete floor with reflective caution tape at stairs. Photo by BVH, 2009.
