Submerged Cultural Resources Site Report

NOQUEBAY

APOSTLE ISLANDS NATIONAL LAKESHORE

**SUBMERGED CULTURAL RESOURCES SITE REPORT:
NOQUEBAY**

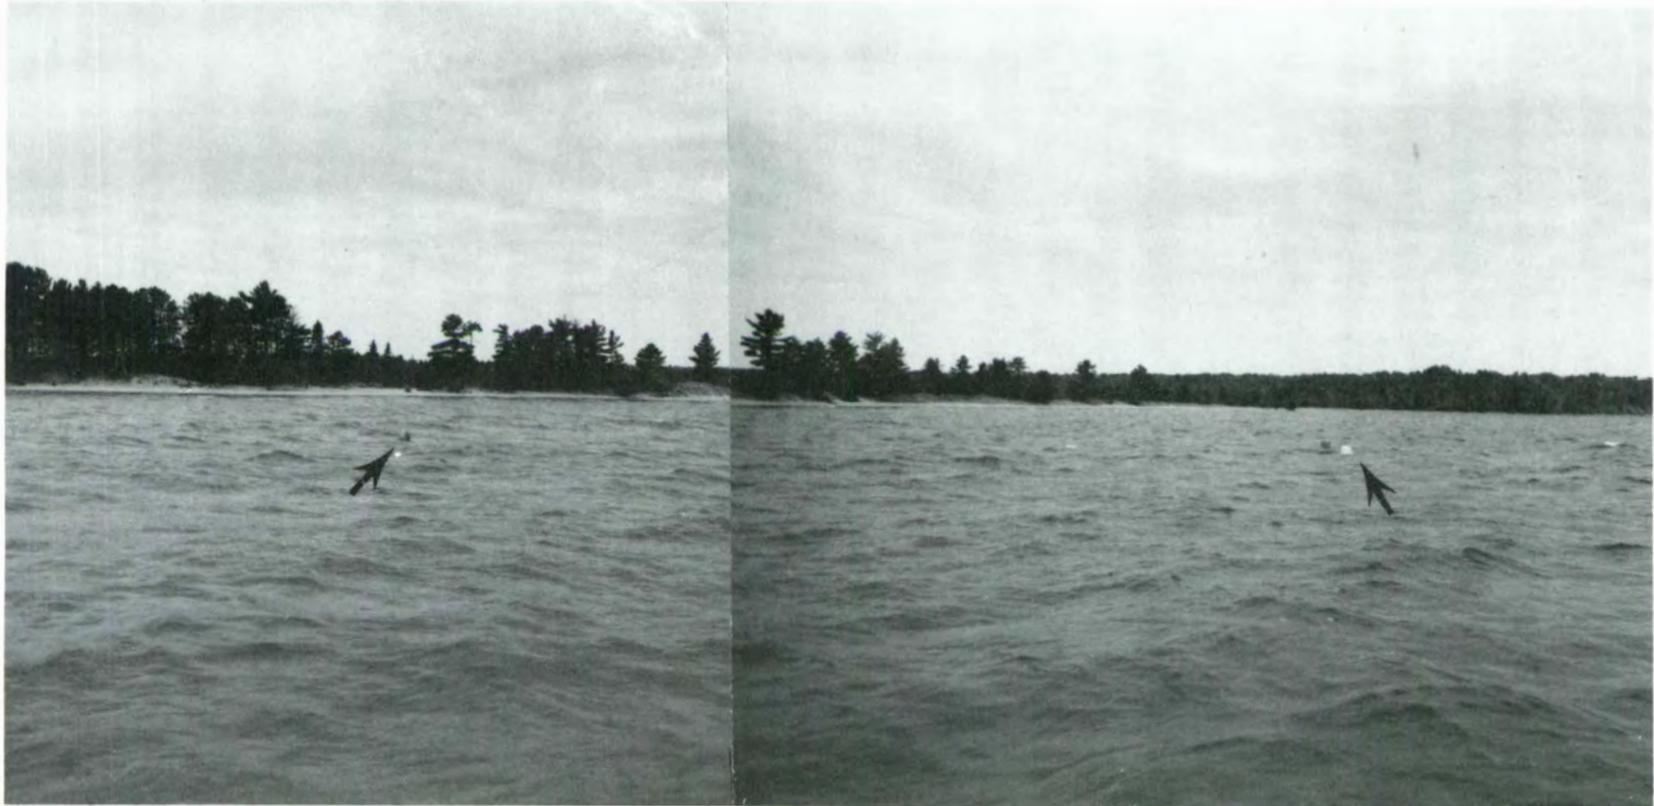
Plate 5: View of Julian Bay, looking west, toward Stockton Island. The remains of the historic wooden vessel, NOQUEBAY, are buoyed at the donkey boiler (right) and at the stern deadwood (left).

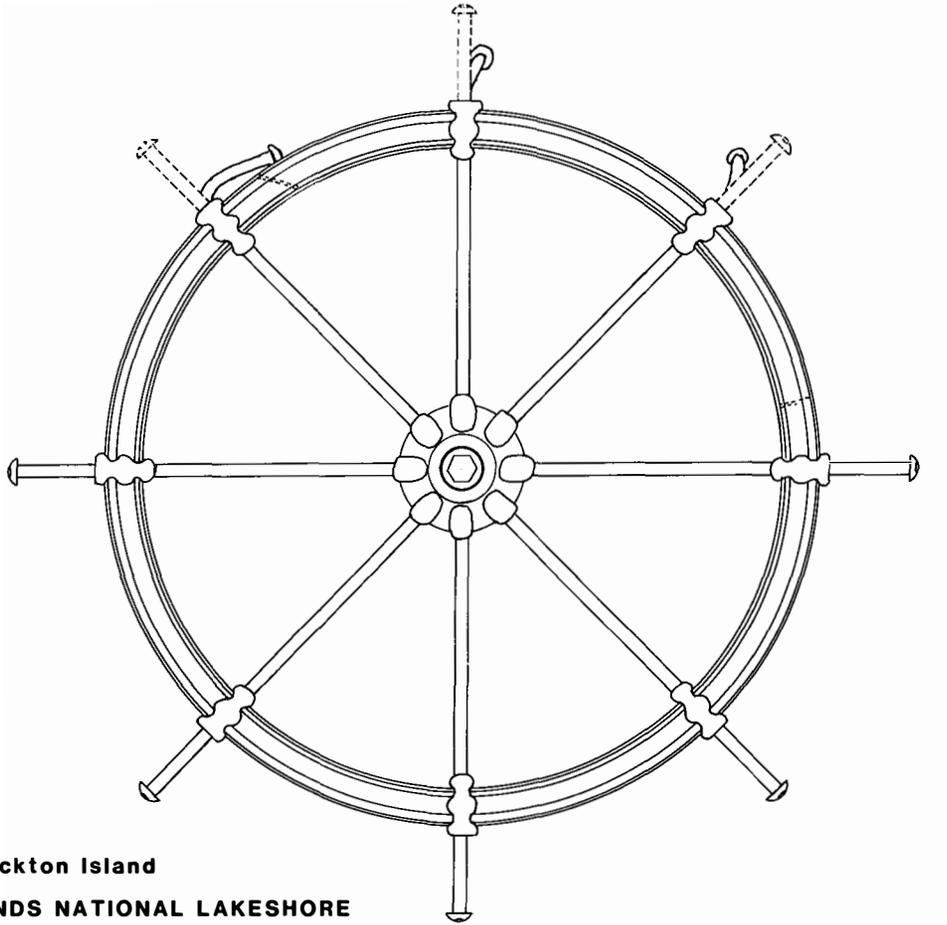
Figure 7: Ship's Wheel

Several artifacts were discovered during excavation of the wheel and steering mechanism, they included: a length of wire cable 1 inch in diameter, not attached to the wheel; 9 square spikes varying in size from 5 to 9 inches long by 7/16 inch in cross-section; 6 round nails varying in size from 8 to 14 inches and 3/4 inch in diameter; and a 1-by-4-inch piece of tongue and groove board, painted beige, with a small segment of canvas attached via small nails. These items were identified, measured, and left in place under the wheel and steering assembly.

Following the mapping, photo, and video documentation of this feature, it was reburied. This was done to protect the wheel from winter storms, ice action, and possible vandalism.

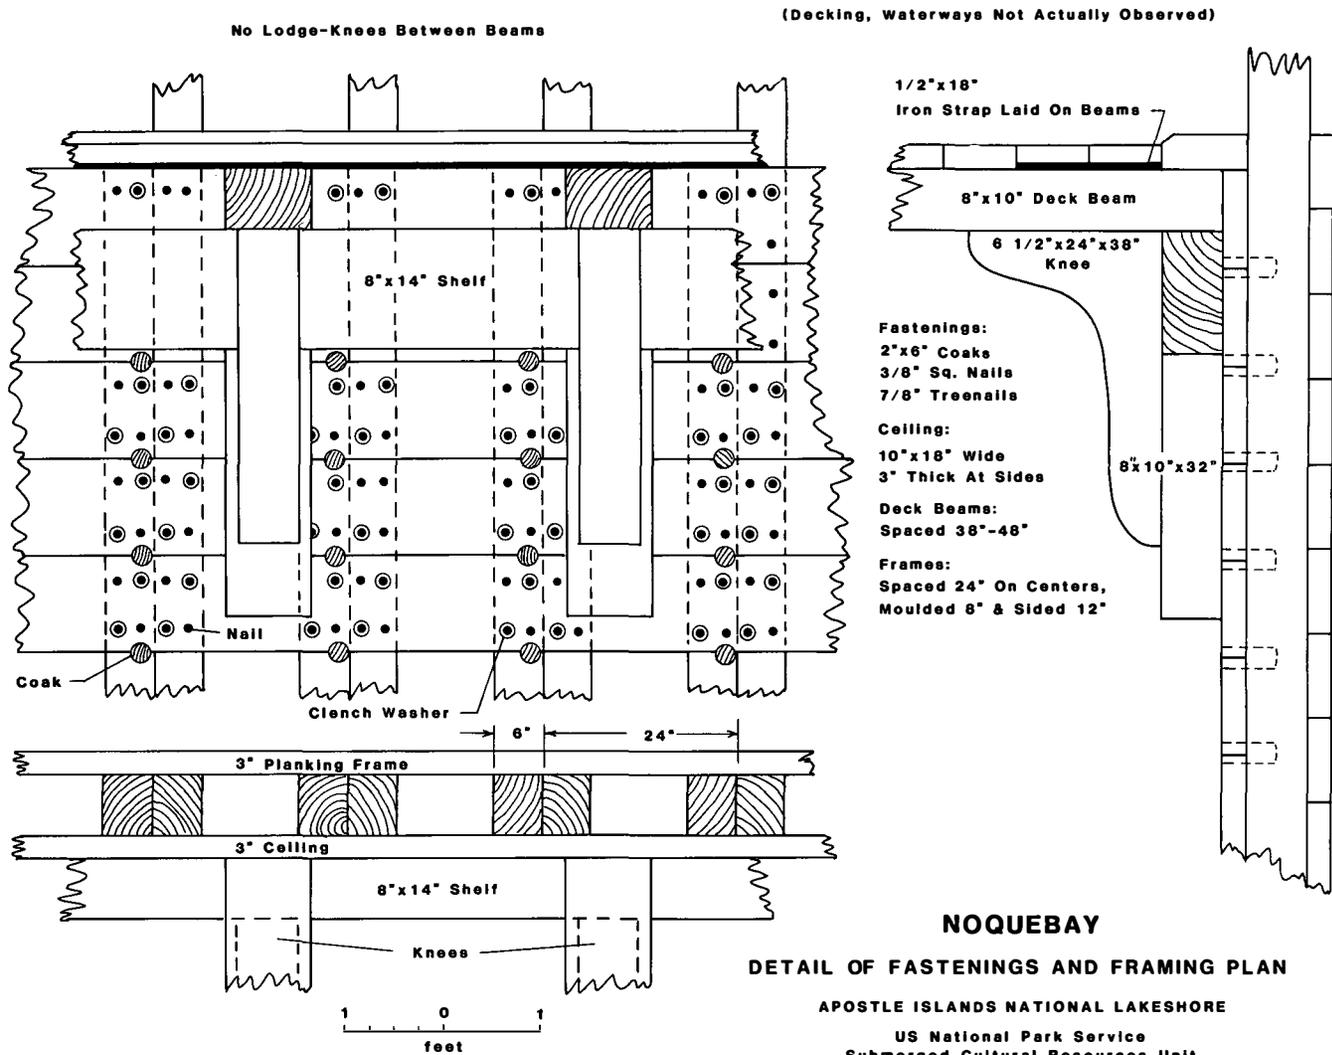
Figure 11: Detail of Fastenings and Framing Plan

the bilge ceiling. These are wooden "dowels" which are laid into the surface of two adjoining timbers to prevent slipping or sliding endways, i.e., longitudinally. The bilge ceiling has 2-inch coaks, spaced on 24-inch centers, falling between frames. The bilge ceiling fasteners differ from the ceiling on the bottom only in that the double fasteners alternately have 1-inch diameter clench washers (Figure 11). This fastening pattern begins at the turn of the bilge and continues to the main deck.

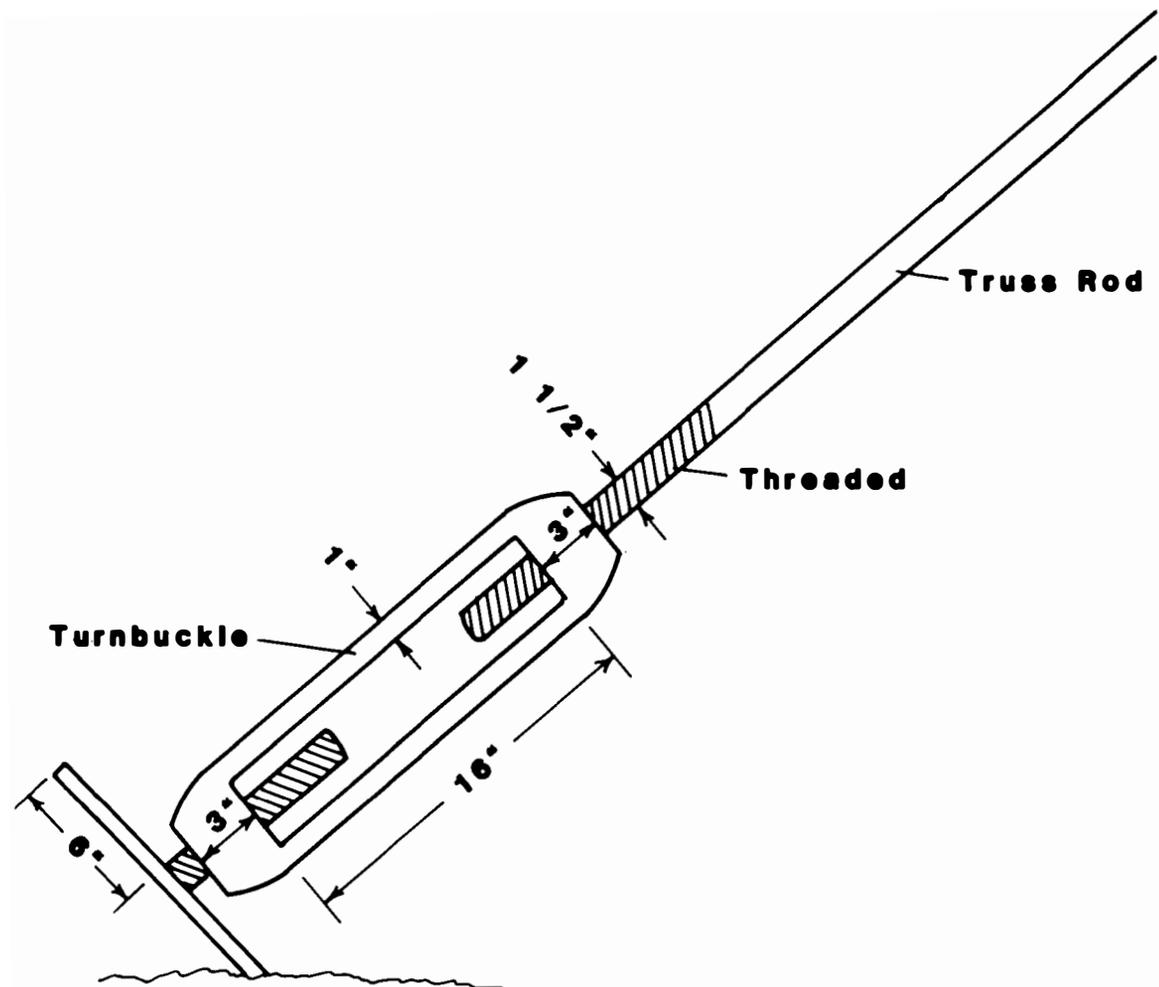
Figure 12: Detail of Turnbuckles

At base line point 160, adjacent to the starboard sister keelson, a 25-foot section of truss rod begins. This section of rod, with a 22-by-4-inch turnbuckle, is one of several represented on the site. The rod is uniformly 1-1/2 inches in diameter; where it articulates with the turnbuckle it is threaded to facilitate connecting and adjustment. There are 5 articulated turnbuckles exposed on the site that are either 22 inches or 24 inches long. Two of the turnbuckles are 24 inches by 4-1/2 inches and three are 22 inches by 5-1/2 inches. It is probable that at least one additional turnbuckle would have been used on this vessel, making a total of six.

In some of the cases the rod and turnbuckles also had flat plates in association. The turnbuckle on the starboard side near base line point 165 has such a plate. It is 4 feet from the end of the turnbuckle and is 6 by 5-1/2 by 1 inch. The plate is not perpendicular to the rod, rather it is at a slight angle to the rod. Two other similar plates were found on sections of rod, one of which is in association with a turnbuckle. The plate and turnbuckle, located on the starboard sister keelson near base line point 202, is reproduced in Figure 12. The plate with this turnbuckle is the same size as the plate at base line point 165, however this plate is only 1 inch from the turnbuckle and is perpendicular to it. One additional plate

The truss rod was designed to reduce longitudinal hogging of the hull. The turnbuckles were used to tighten sections of rod, pulling the vessel bow and stern up. It appears that the rod passed up through the deck near the bow, similar to truss rod found on another Great Lakes schooner WILLIE LOUTIT (Plate 11), ran down the deck to the stern and then below again. The plates found on rod were probably for deck reinforcement and protection at the points where the rod passed through the deck planking. Internal strengthening was particularly important on NOQUEBAY, since she had no mainmast and no forestays connecting the remaining masts (see historic photo, Plate 3). If NOQUEBAY had continuous forestays they would have provided some additional longitudinal strength to the hull, perhaps without the necessity for a truss rod. Further, the relatively light planking on this vessel's hull also contributed to the need for longitudinal strengthening (C. P. Labadie, personal communication).

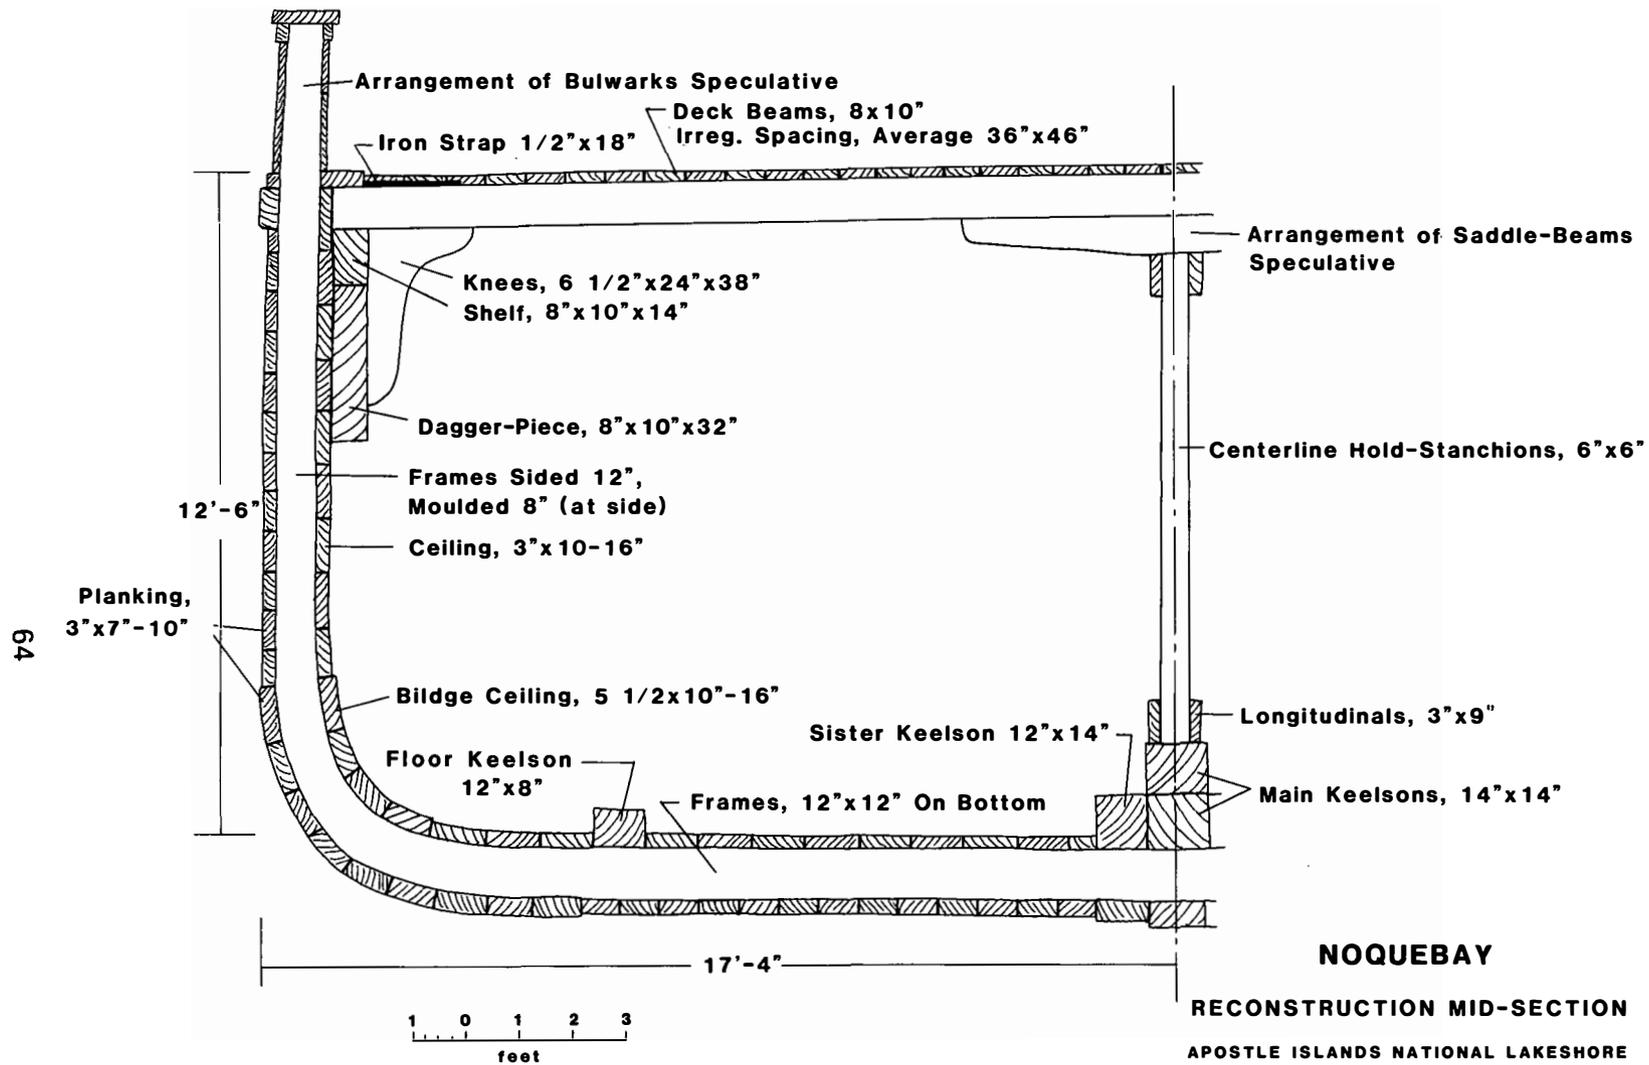
Figure 13: Hull Cross Section

Transverse strains cause the sides of a vessel to bow out or in. Transverse strains are much greater than longitudinal strains and as soon as a vessel moves, inclines, or pitches and rolls, transverse water pressure works to alter the shape of the vessel. If the framing, especially at connections between deck beams and side framing, is not strong enough or properly fastened, the knees, as well as the framing of the decks and bilges, will begin to loosen (Desmond 1919:35). In an effort to deal with this problem, the builders used a wide strap (Plate 13), running longitudinally at the level of the main deck. The strap was probably placed directly over the deck beams, at the level of the decking, and tied into the deck beams and knees by fasteners (Figure 13).

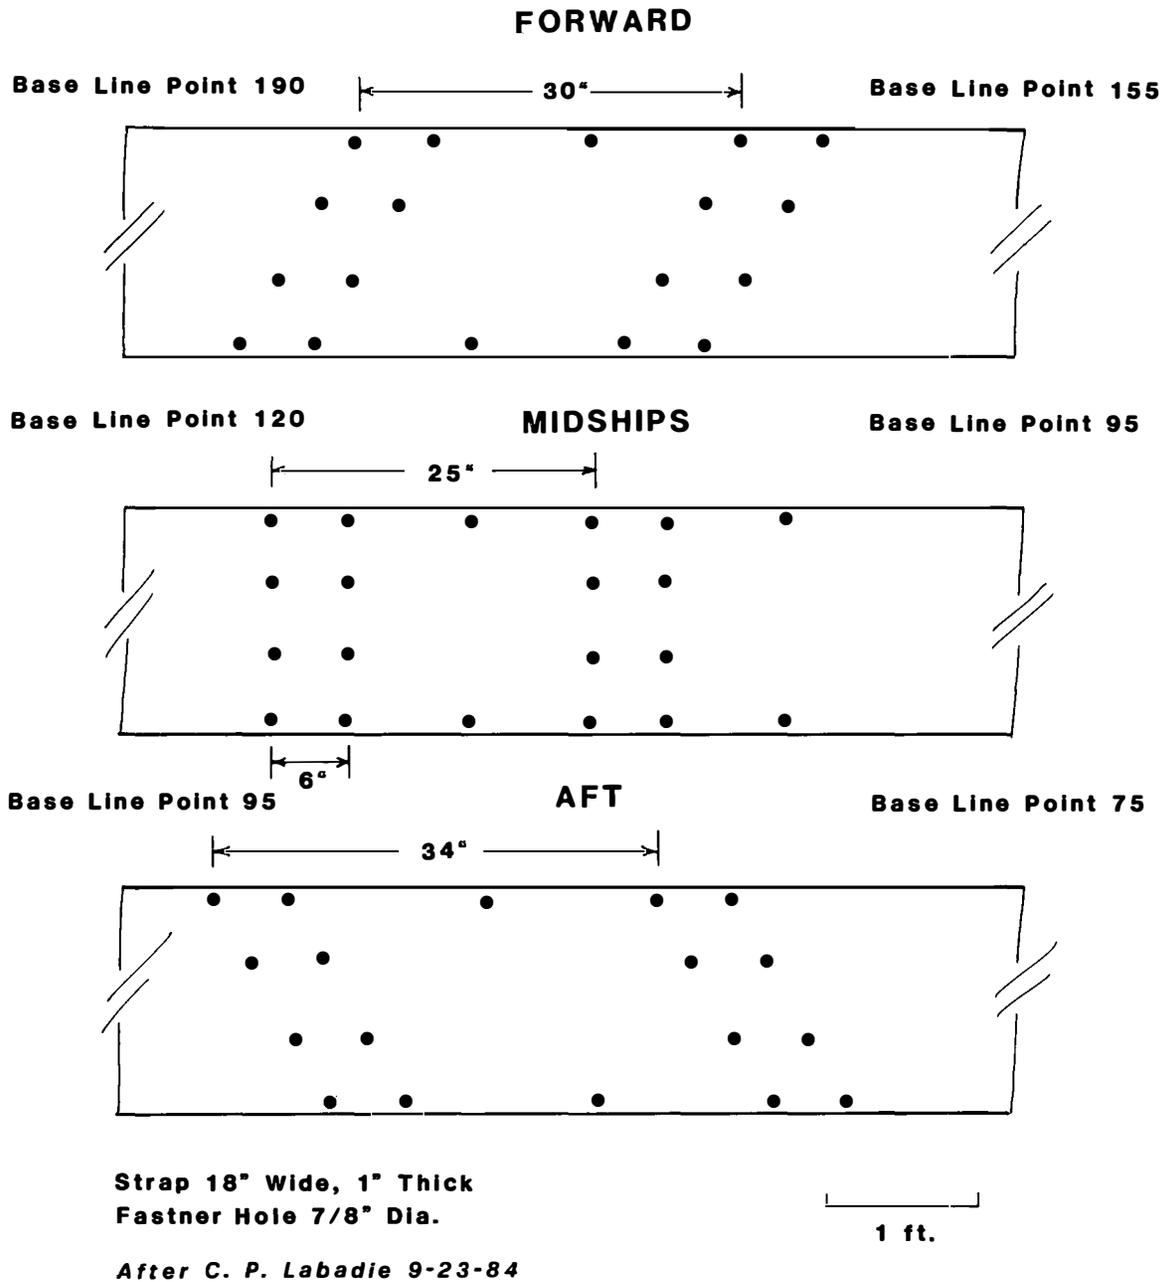
Figure 14: Hogging Strap Detail

the ceiling thickness is reduced from 5 inches to 3 inches. A 29-foot piece of hogging strap is near the frames of this piece.
