# Submerged Cultural Resources Study

USS ARIZONA MEMORIAL  
and

PEARL HARBOR NATIONAL HISTORIC LANDMARK

Southwest Cultural Resources Center Professional Papers  
No. 23

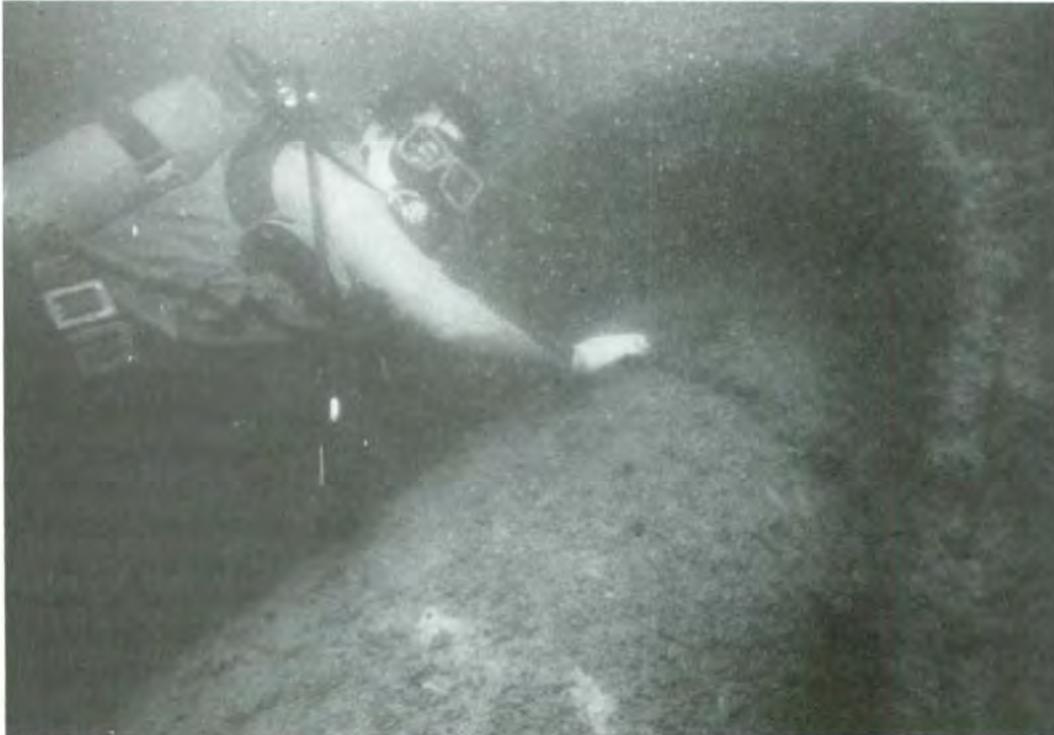
*Figure 1.1. Gary Cummins, Superintendent of ARIZONA Memorial inspects embasures of No. 1 turret. It was not known that the 14-inch guns were still in place on the ship until the underwater survey. (NPS photo by Larry Murphy)*

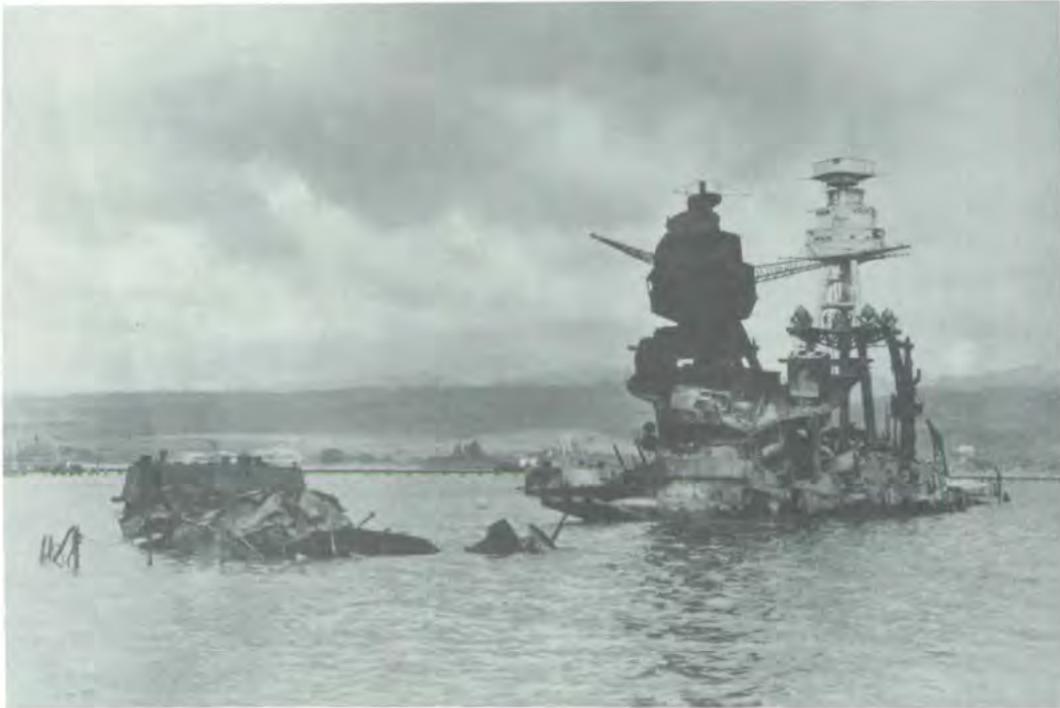
Figure 2.22. *Aftermath: December 1941, the USS ARIZONA from port bow looking aft.* (NPS: USAR collection)

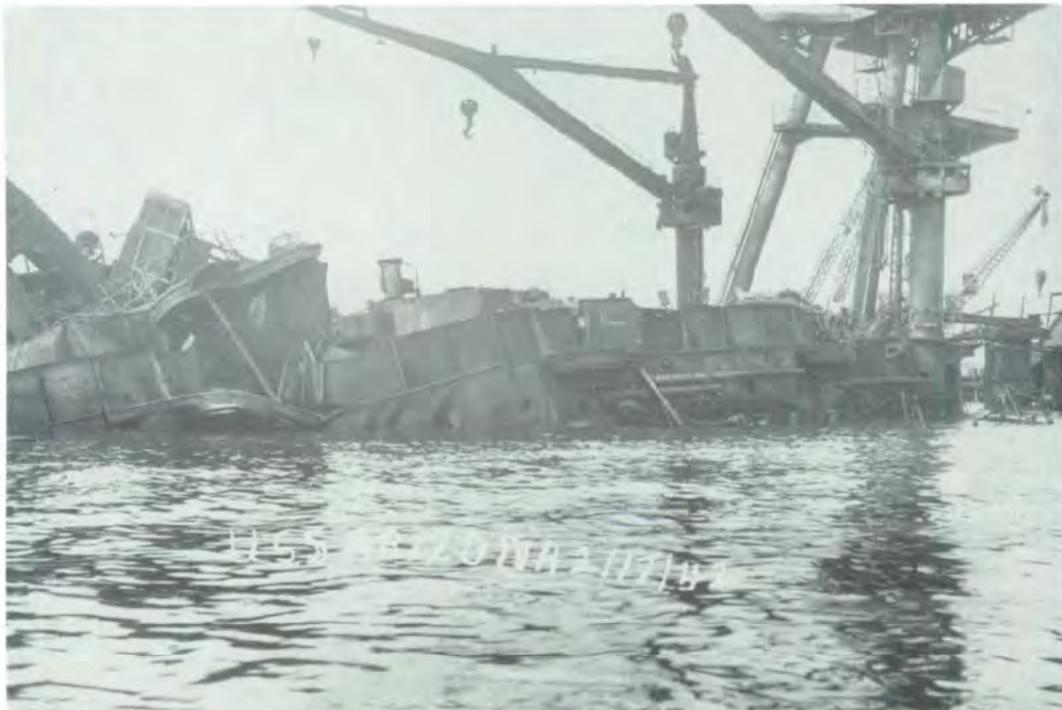
Figure 2.23. *Aftermath: The USS ARIZONA midships area near boat cranes February 17, 1942. Note V for victory placed on splinter shield (center).* (NPS: USAR collection)

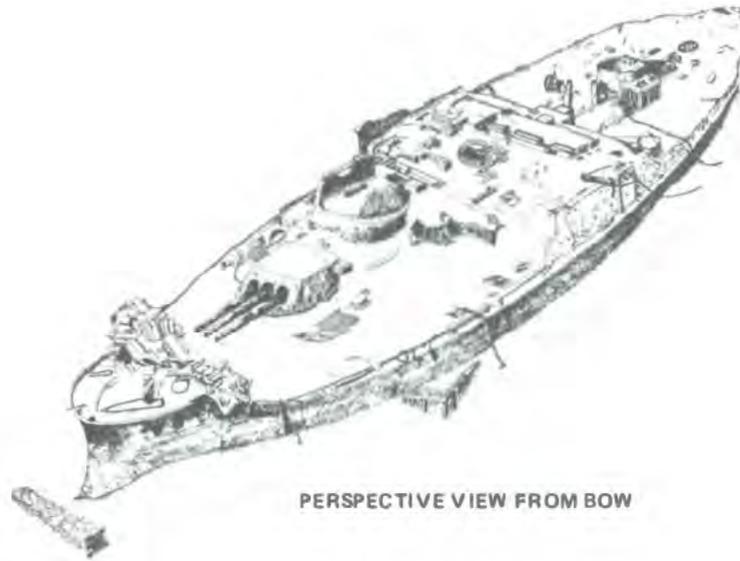
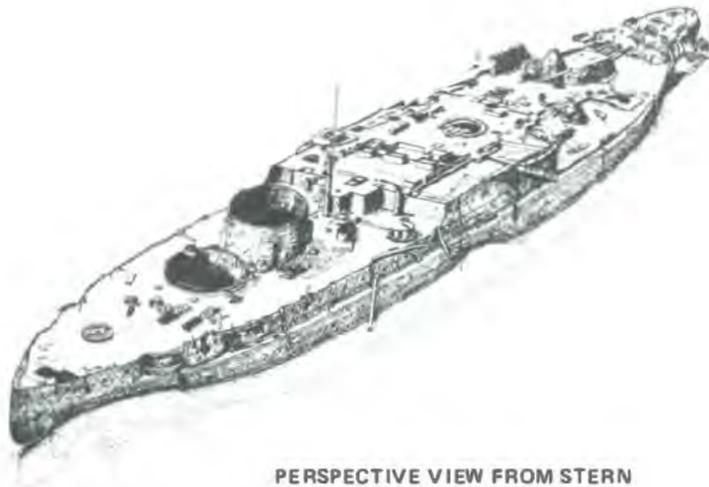
Extensive salvage operations are recorded in the bow area. The remains of the fore-castle deck and main deck were cut away and removed, and mud was pumped out of the area. The salvage log records much cutting on the second and third decks and the forward bulkheads. The magazine explosion clearly damaged the lower deck areas aft as far as the No. 2 turret. Navy salvage divers were unable to enter sections of No. 2 because passageways were blocked with wreckage. The explosion apparently collapsed bulkheads supporting the No. 1 turret, which still remains onsite, and the turret rests 15 feet lower than its original position.

On the port side approximately 80 feet and 112 feet aft of the stem, open cracks visible in the torpedo blister continue below the silt line. These cracks in the sides above the silt probably indicate a major structural failure associated with the magazine explosion. In all probability the inner hull and armor belt are also cracked.

*Figure 3.7. These artistic renderings by Jerry Livingston portray the ship remains from different oblique angles.*

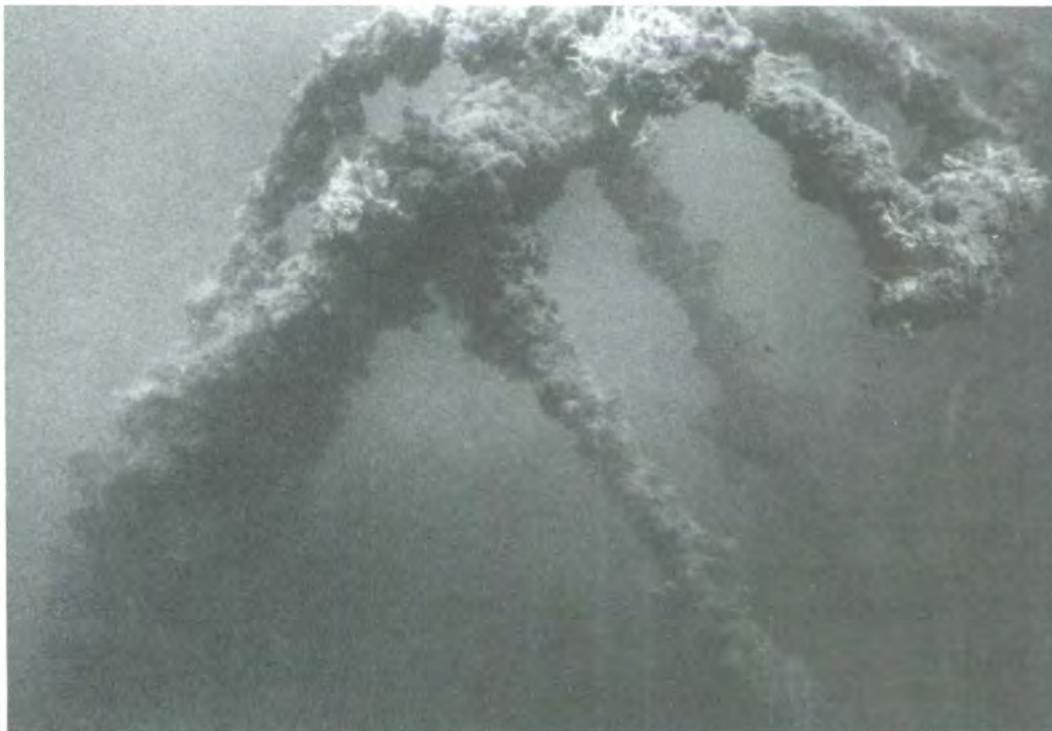
*Figure 3.12. Awning cover for a hatch on aft port side of No. 1 turret. (NPS photo by Larry Murphy)*

Along the sides of turret No. 1 below the range finders, teak decking -- the forward remains of the forecastle deck -- is visible after light fanning of the silt. A few feet farther aft on the port side is a hatch that has been propped open for access below decks, probably by the salvage teams (Figure 3.12). The tropical awning support is in place.

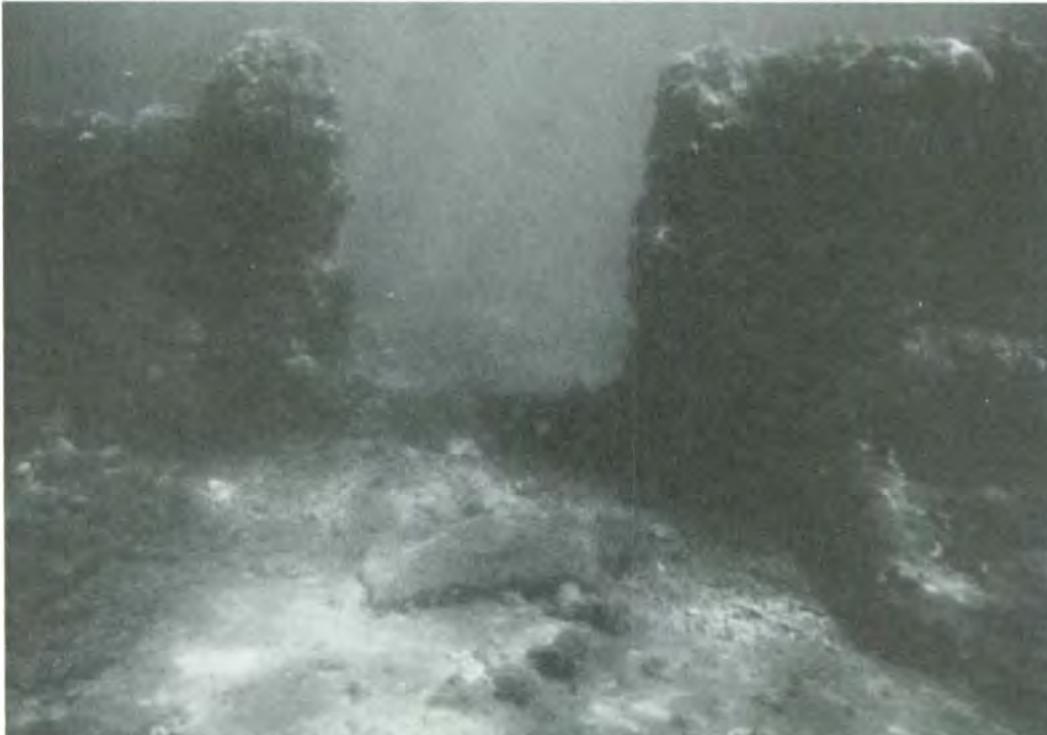
*Figure 3.15. Entryway to galley and mess area , with bulkheads partially removed . (NPS photo by Larry Murphy)*

The remains of bulkheads and other features unmistakably define the galley area (Figure 3.15). Doorways, oven bases and what appear to be table legs are visible. The floor was covered with 2-inch hexagonal tile, much of which remains beneath the thin layer of silt. Many artifacts can be found, including coffee cups, plates and silverware (Figure 3.16). The stumps of the main mast tripod legs are discernible, as are the bases of boat cranes.

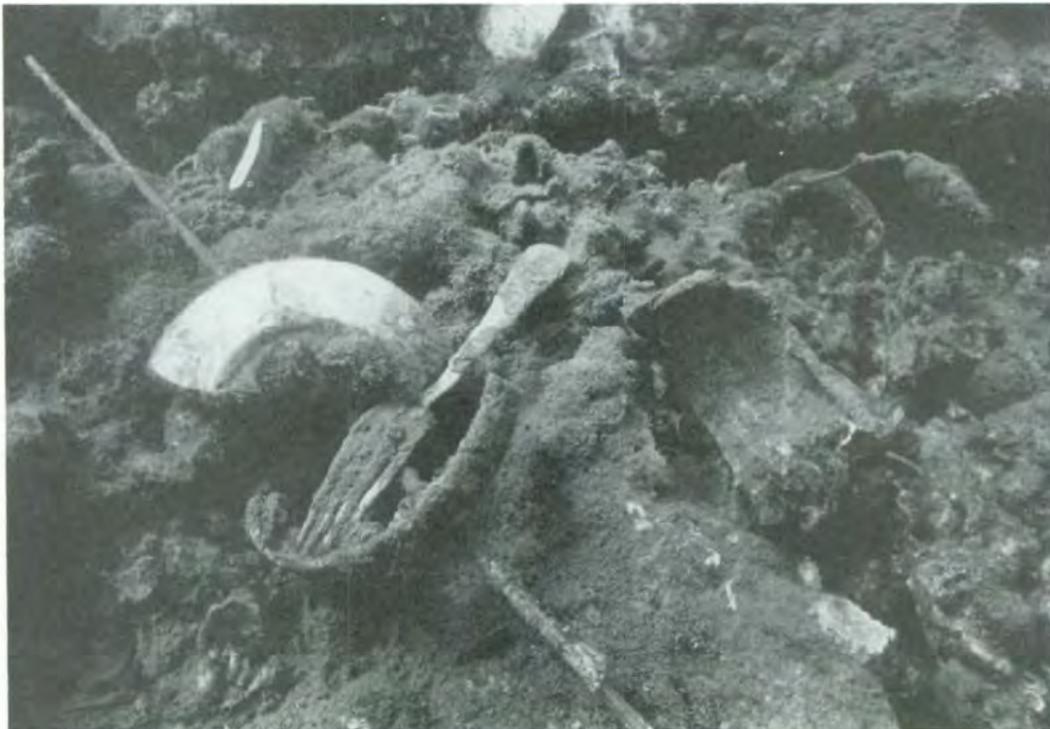
*Figure 3.16. Artifacts in ship's galley area, USS ARIZONA. (NPS photo by Larry Murphy)*

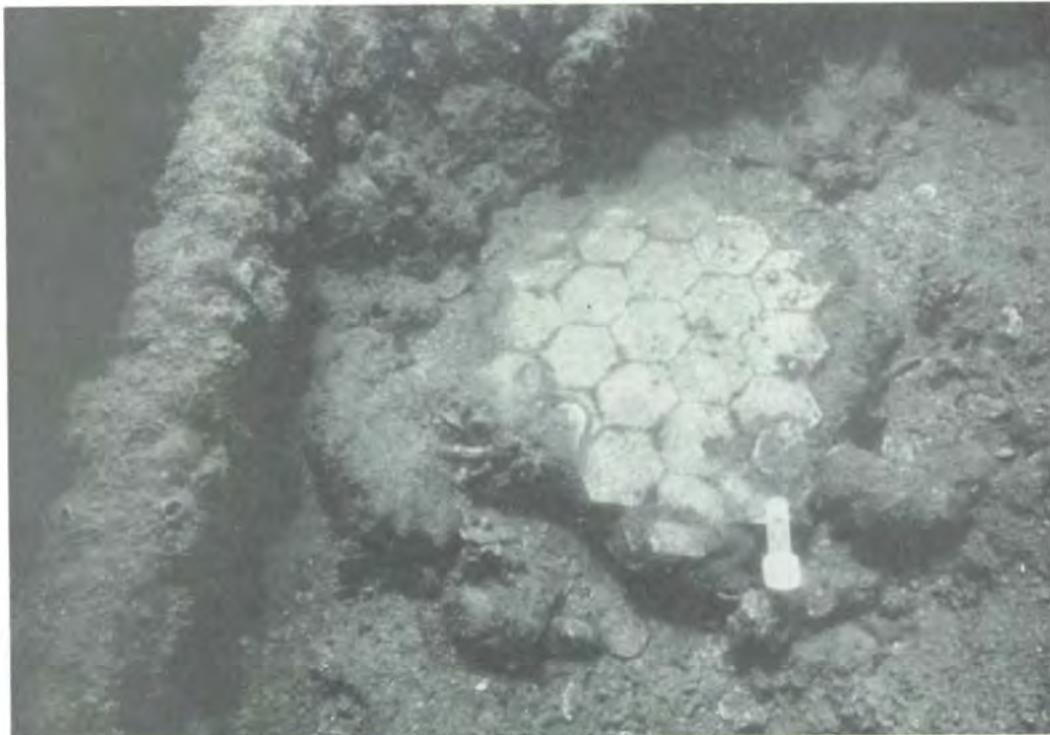
*Figure 3.18. Tile floor in galley area of USS ARIZONA. (NPS photo by Larry Murphy)*

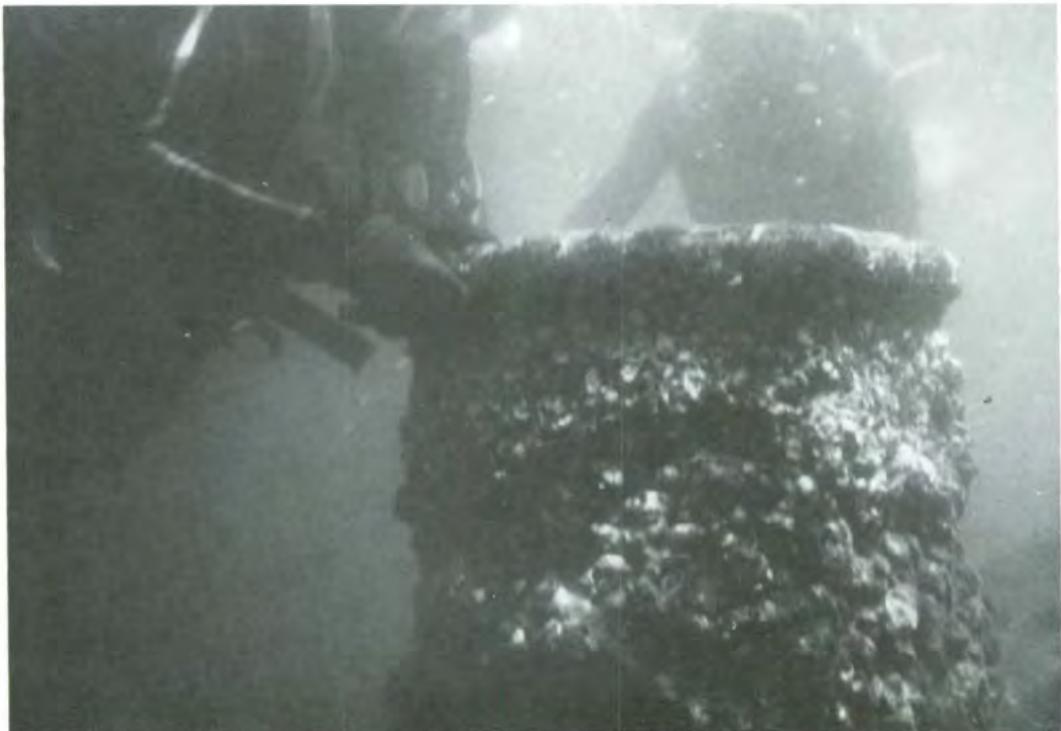
*Figure 3.20. Ventilator on deck of USS ARIZONA. (NPS photo by Larry Murphy)*

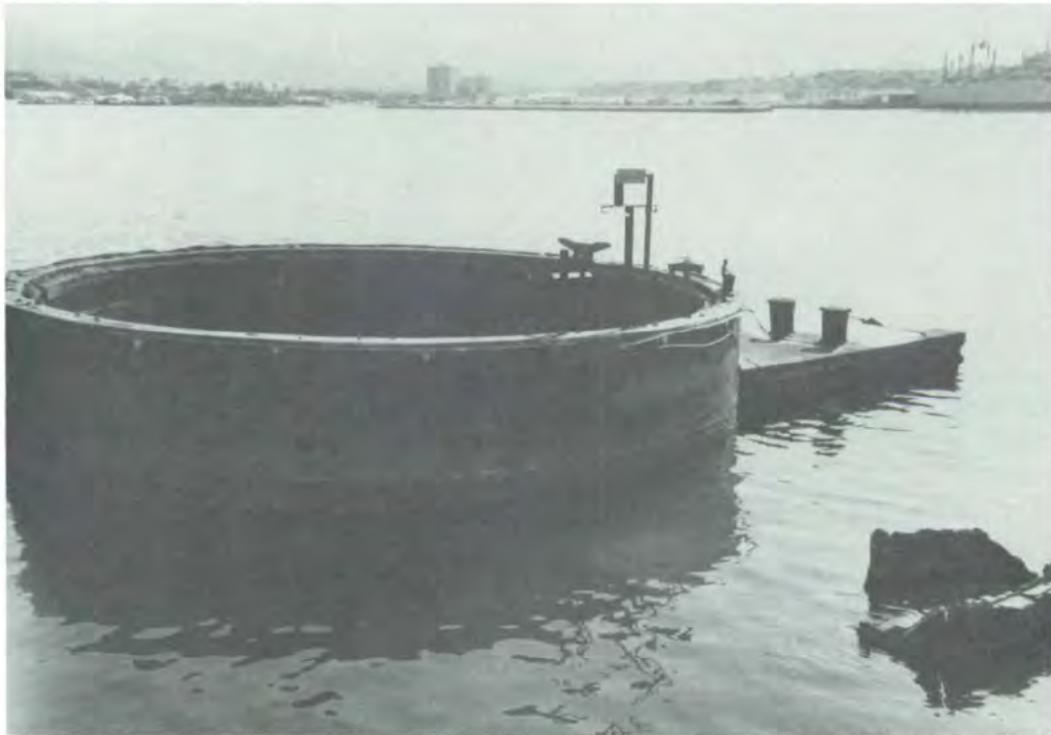
*Figure 3.22. No. 3 barbette protrudes higher than any other feature of the ship. (NPS photo by Larry Murphy)*

guns have been removed from turrets 3 and 4. An old concrete mooring platform is attached to the No. 3 barbette, which is the largest ship feature above the water (Figure 3.22). Mooring bits still remain atop the platform.

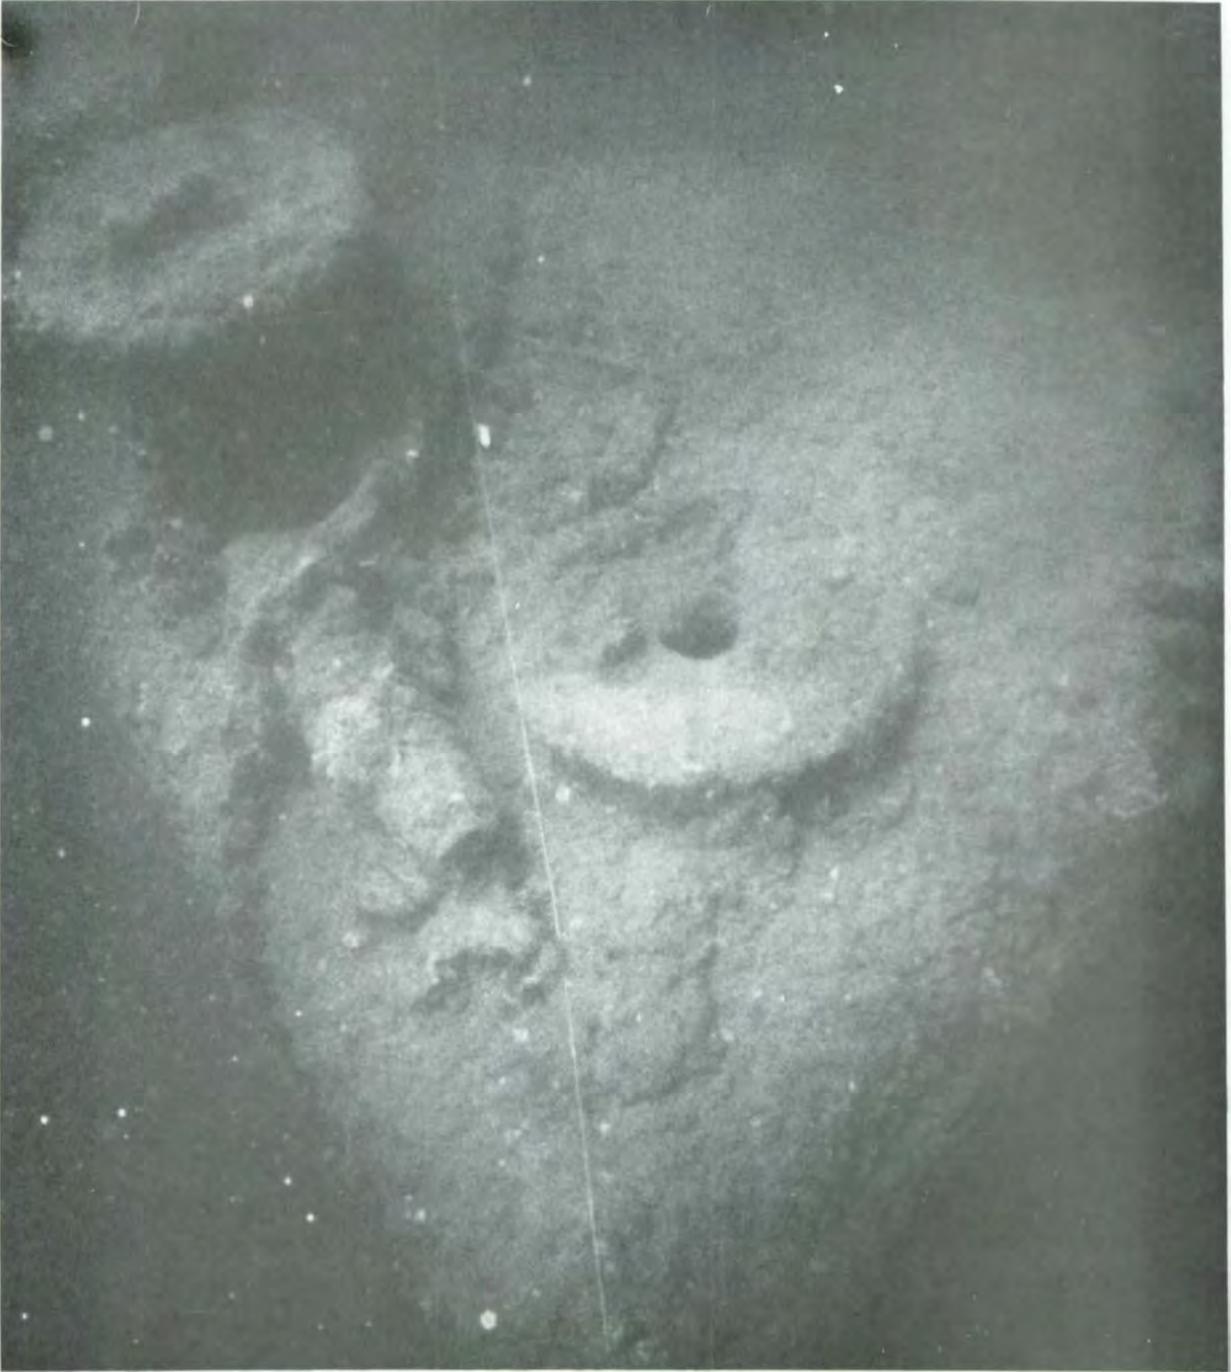
*Figure 3.23. Flagstaff hole at stern of USS ARIZONA. Mooring bitts visible to left. (NPS photo by Larry Murphy)*

A 12-inch-diameter cable of bundled wire strands can be seen running along the inside of both gunnels in the stern. The function of these cables is unknown, although our original guess that they had something to do with degaussing was not confirmed by military personnel familiar with degaussing technology. The airplane catapult base is visible on the stern. There is a hole in the starboard stern extending to amidships left from the salvage of the airplane recovery crane. On the port stern hull are some portholes that still hold trapped air between the blackout covers and the glass (Figure 3.21); this is the area of the admiral's cabin. The jackstaff hole at the stern is intact, although empty (Figure 3.23).

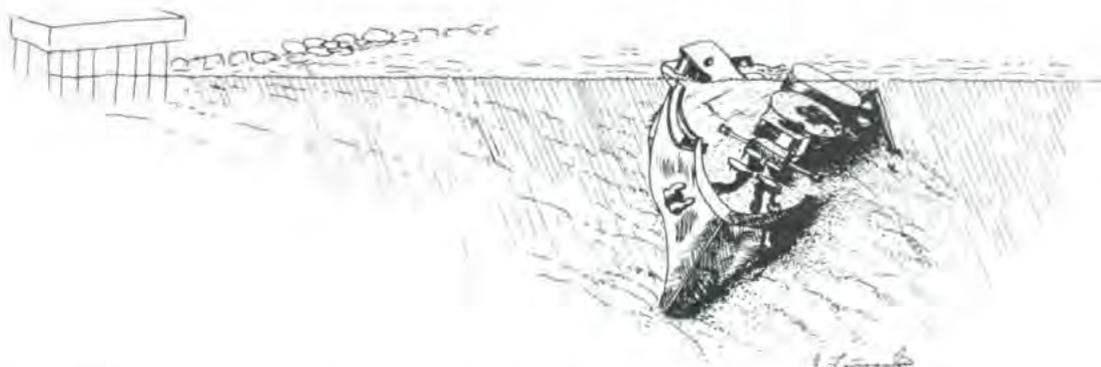
Figure 3.27. Perspective of Utah from bow by Jerry Livingston.

As is evident from the site map (Figure 3.27), the UTAH is lying on its port side and partially buried in the silt. A portion of the starboard side area protrudes from the water amidships and is visible from the memorial. It is interesting that some plants have been able to establish themselves on the hulk, and greenery protrudes from unlikely places on the exposed hull portions.

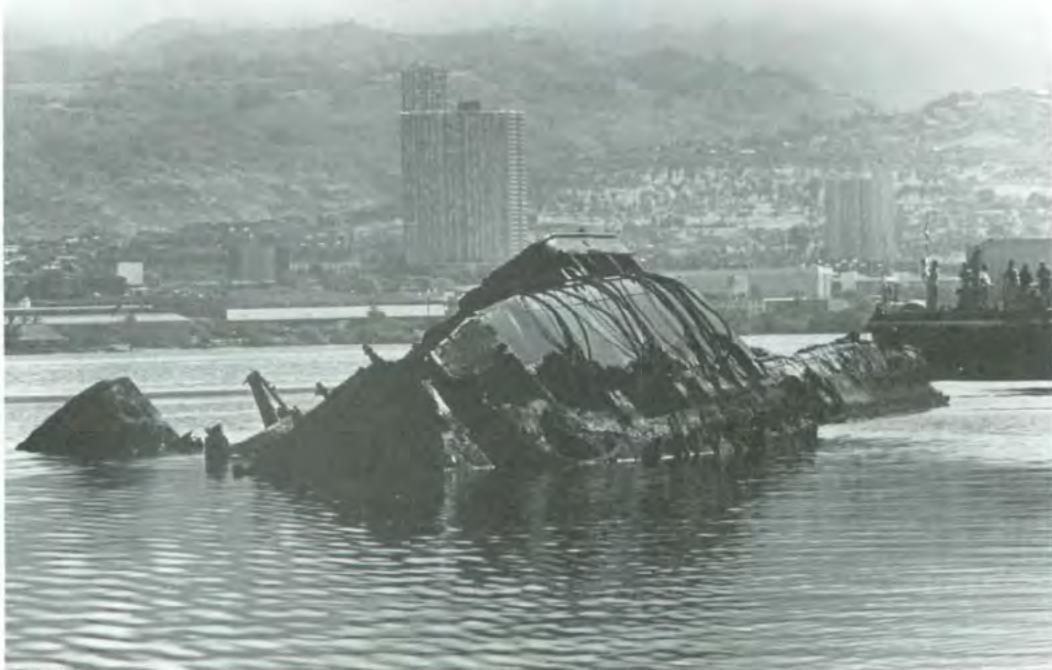
Figure 3.28. USS UTAH looking forward from stern. (NPS photo)

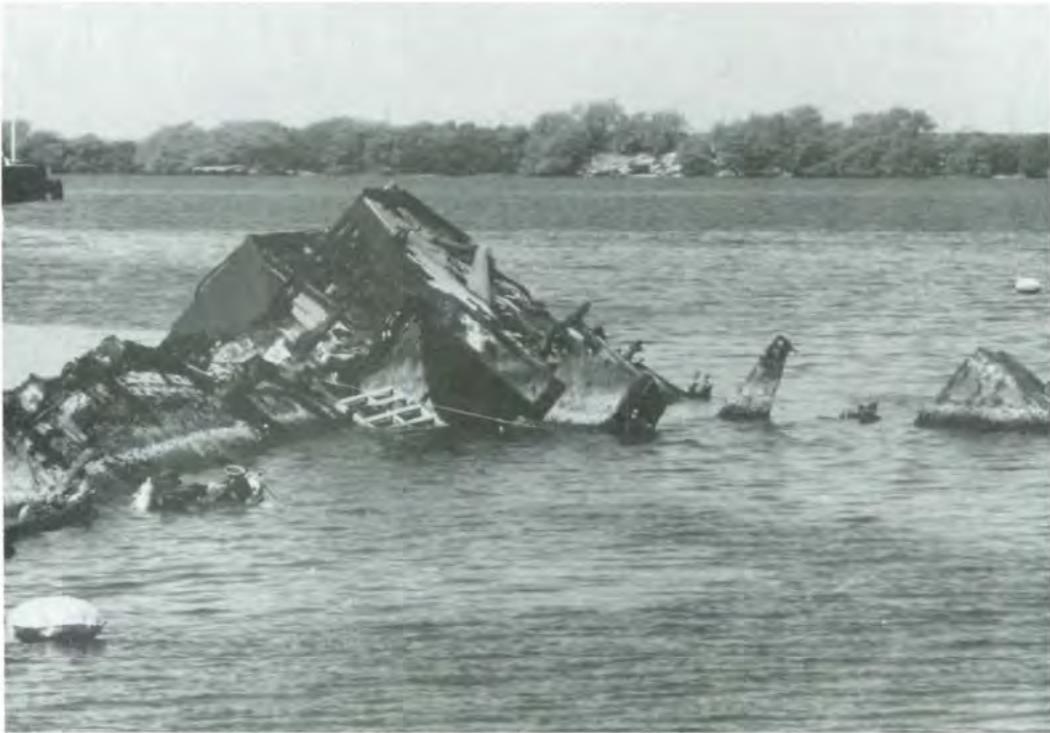
Figure 3.29. USS UTAH looking aft from the bow. (NPS photo)

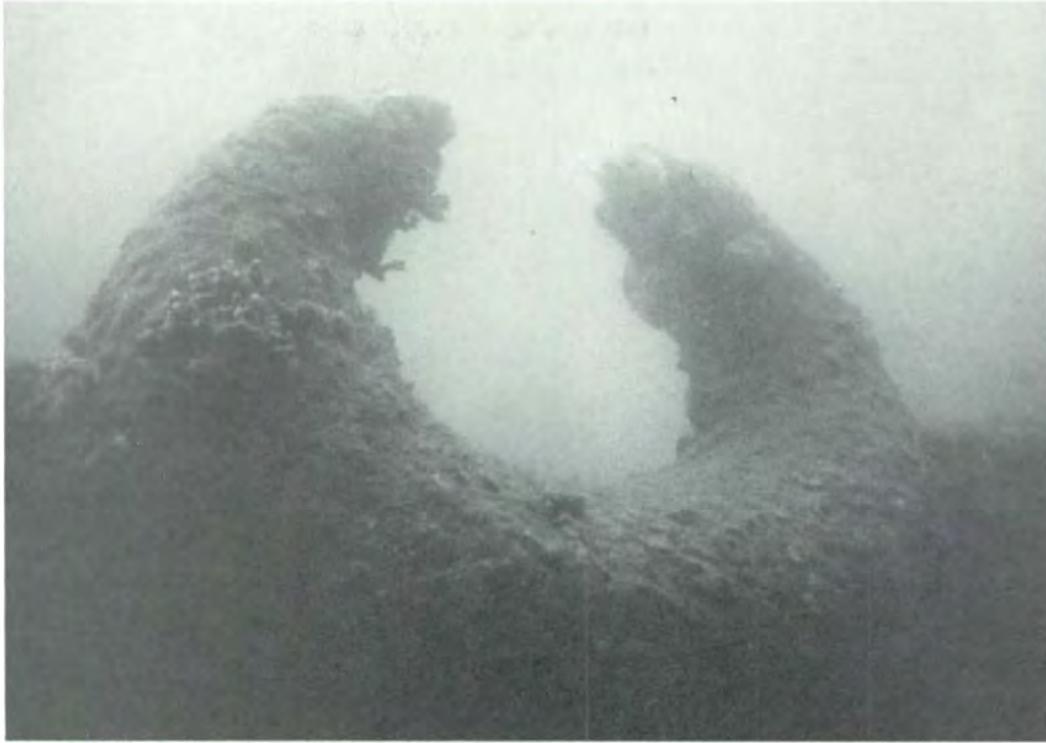
*Figure 3.30. Chock on gunnel of starboard bow of USS UTAH. (NPS photo by Larry Murphy)*

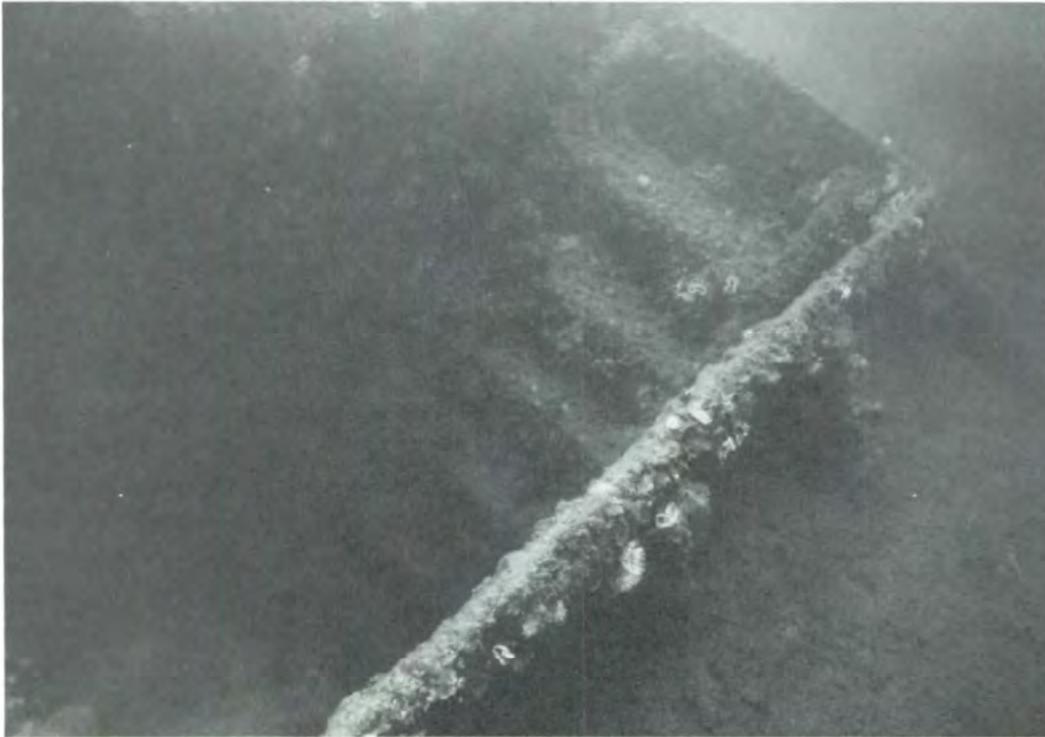
*Figure 3.31. Stairs lead down into interior of USS UTAH. (NPS photo by Larry Murphy)*

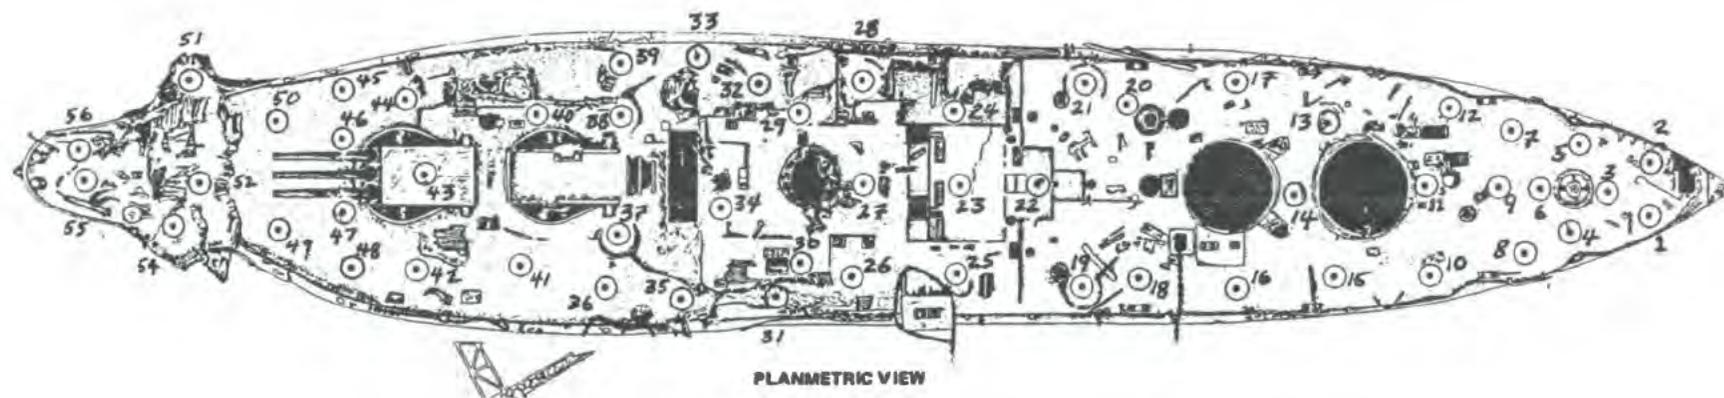
Figure 4.7. Locations of horizontal surface monitoring stations on the USS ARIZONA.

Fifty-five locations on horizontal surfaces of the ship were marked for examination of sediment type and depth (Figure 4.7). Because most of the ship's superstructure had been removed in the salvage operations, most of the study stations had to be situated over main deck surfaces, primarily of teak wood. Station depths ranged from 5 to 18 feet.

Aft area, about 40 percent of ship length (Stations 1 through 22). This area lies in an average depth of 8 to 10 feet. Sediment is generally 1 to 6 inches deep and is characteristically about 50 percent sand, 20 percent rubble, and 10 percent mud/silt. The sediment is held together in a spongy mat by pervading growth of colonial feather-duster worms (*Branchiommata cingulata*) and sponges. Large feather-duster worms (*Sabellastarte sanctijosephi*) inhabit the sediment in densities of about 1 to 5 per square meter. Encrusting and erect spon-

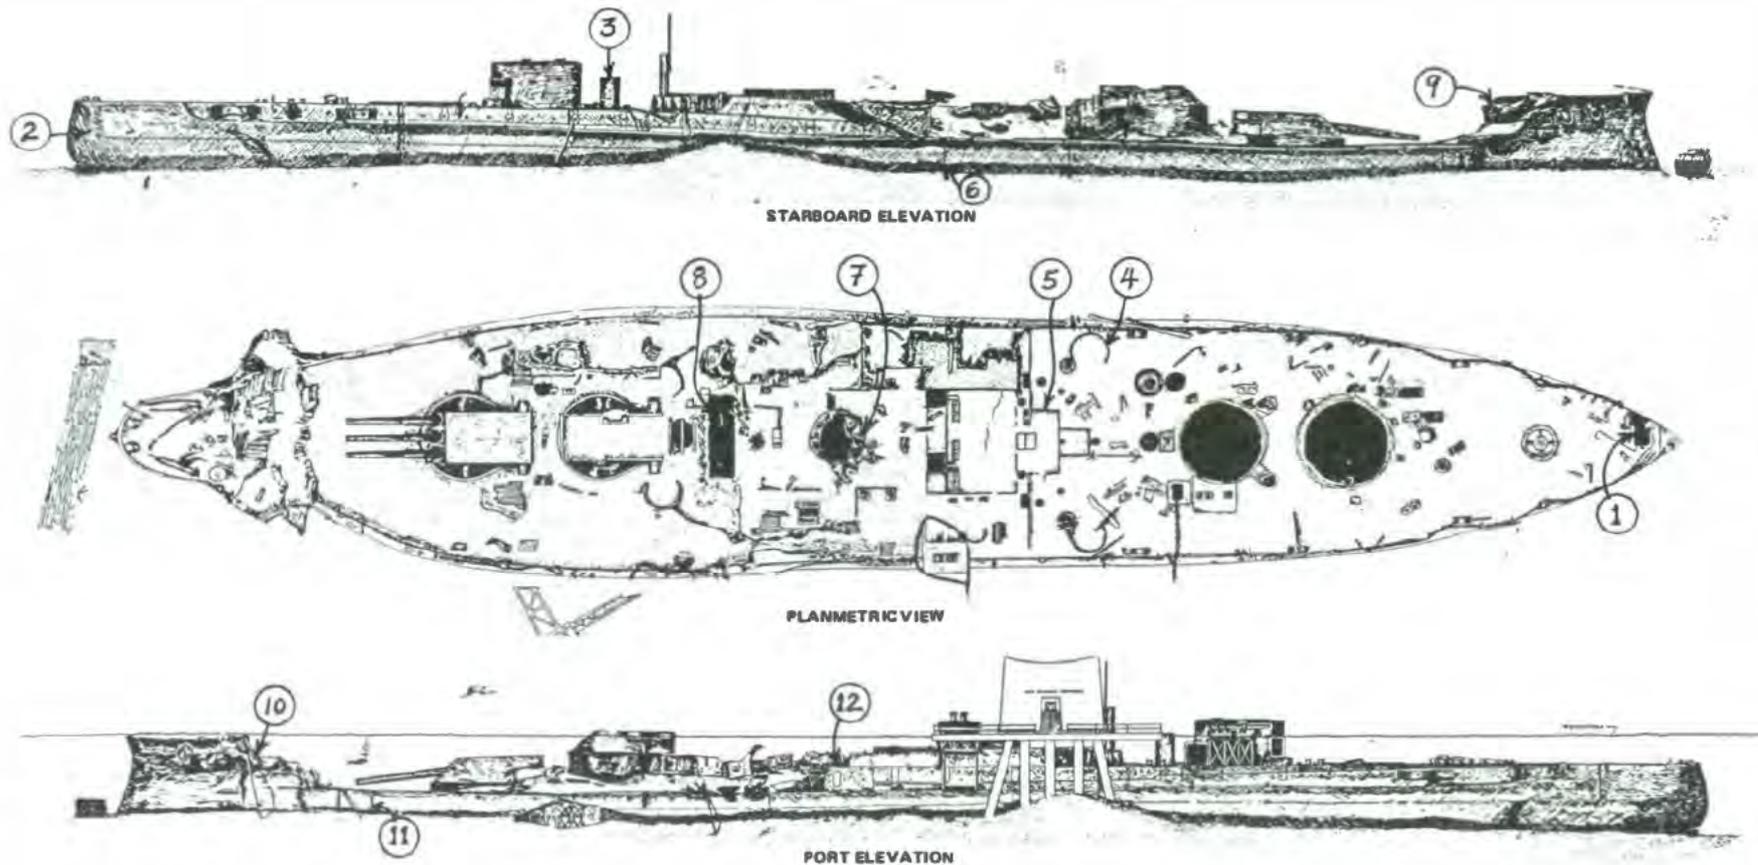
Figure 4.8. Locations where measurements were made of thickness of corrosion products and underlying shiny steel on edge sections of hull and superstructure fabric on the USS ARIZONA.

Twelve stations were selected on hull and superstructure surfaces that had access to metal edges (Figure 4.4). At each station, divers used a claw hammer to chip away a few square inches of fouling growth and corrosion from both sides of the metal edge to expose shiny metal. Observations were then made of the thicknesses of dense fouling, black and grey oxides, and shiny steel that were visible in the exposed end sections.

It is recognized that surfaces on or near exposed edges might be affected by edge events that could alter measurements of corrosion, in other words, yielding higher corrosion rates than would occur on large-area flat surfaces. However, since sampling removal of metal pieces from flat areas was not allowed, it was decided to examine the edge corrosion to allow at least a worst-case estimation of corrosion rates.
