ABRAHAM LINCOLN BIRTHPLACE
MEMORIAL BUILDING

HISTORIC STRUCTURE
REPORT

2001
Historic Structure Report
Abraham Lincoln Birthplace Memorial Building
Hodgenville, Kentucky
LCS#: 00002

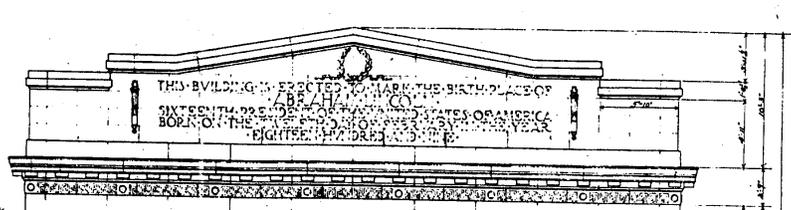
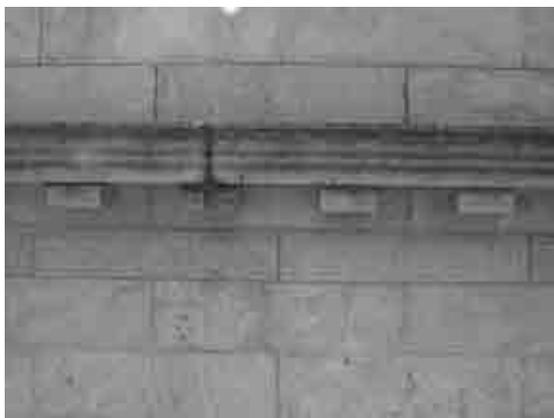
large granite, denticulated cornice with patterned frieze, 27' above grade (above)

Smooth granite base course 24" high and projects 2" from stone wall above (below)

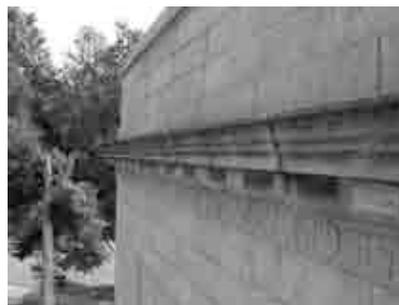
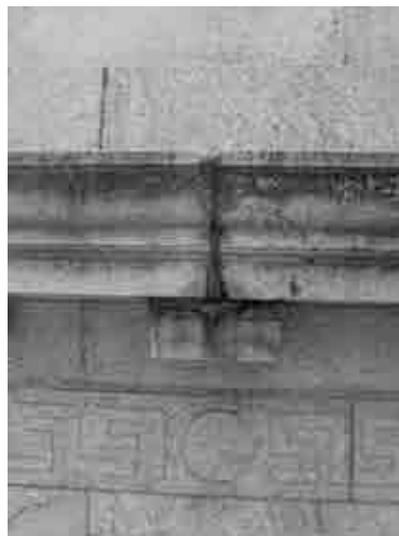
Dirt and mildew buildup on cornice at north elevation (above and below)

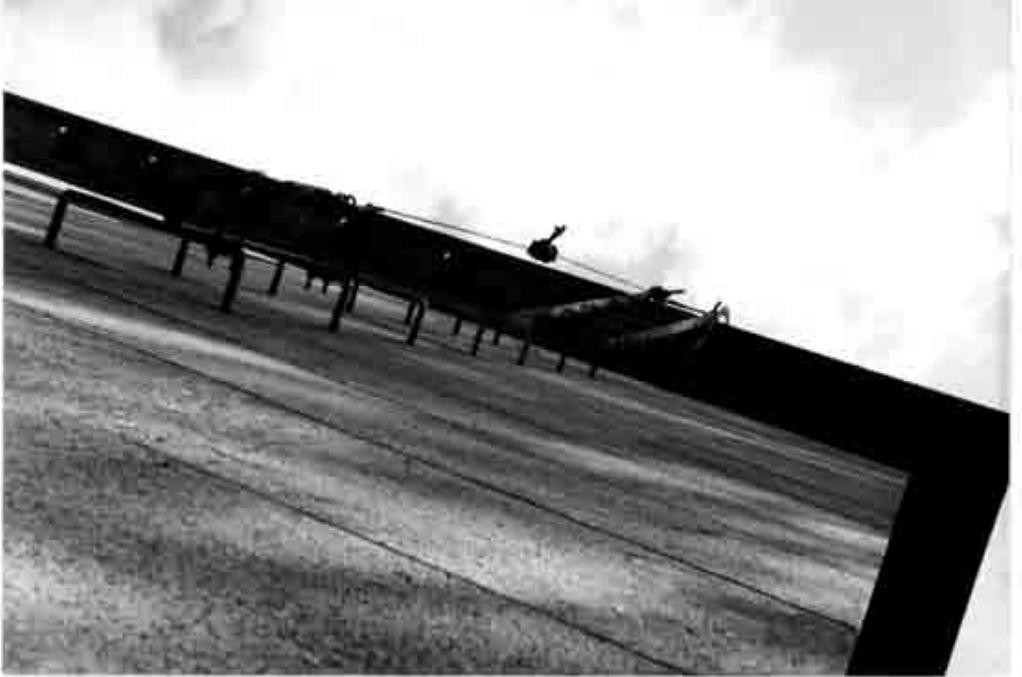
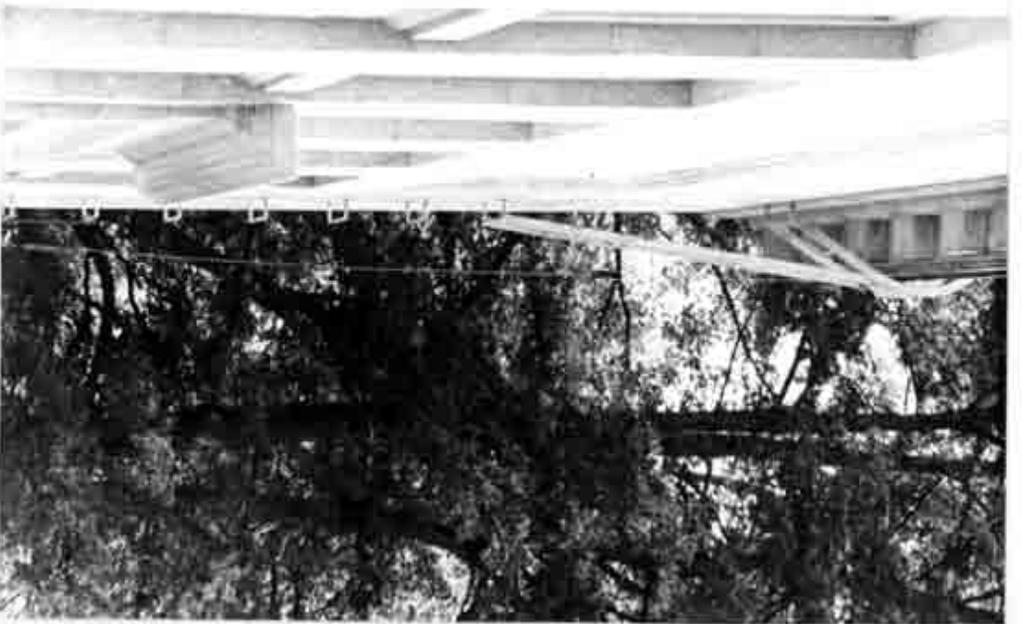
Steel rungs appear to be rusting. Extent of deterioration has not been determined. There is some outward movement in at least one rung.

A portion of this 7' section extends from the building to provide access over the ledge extending from the building.

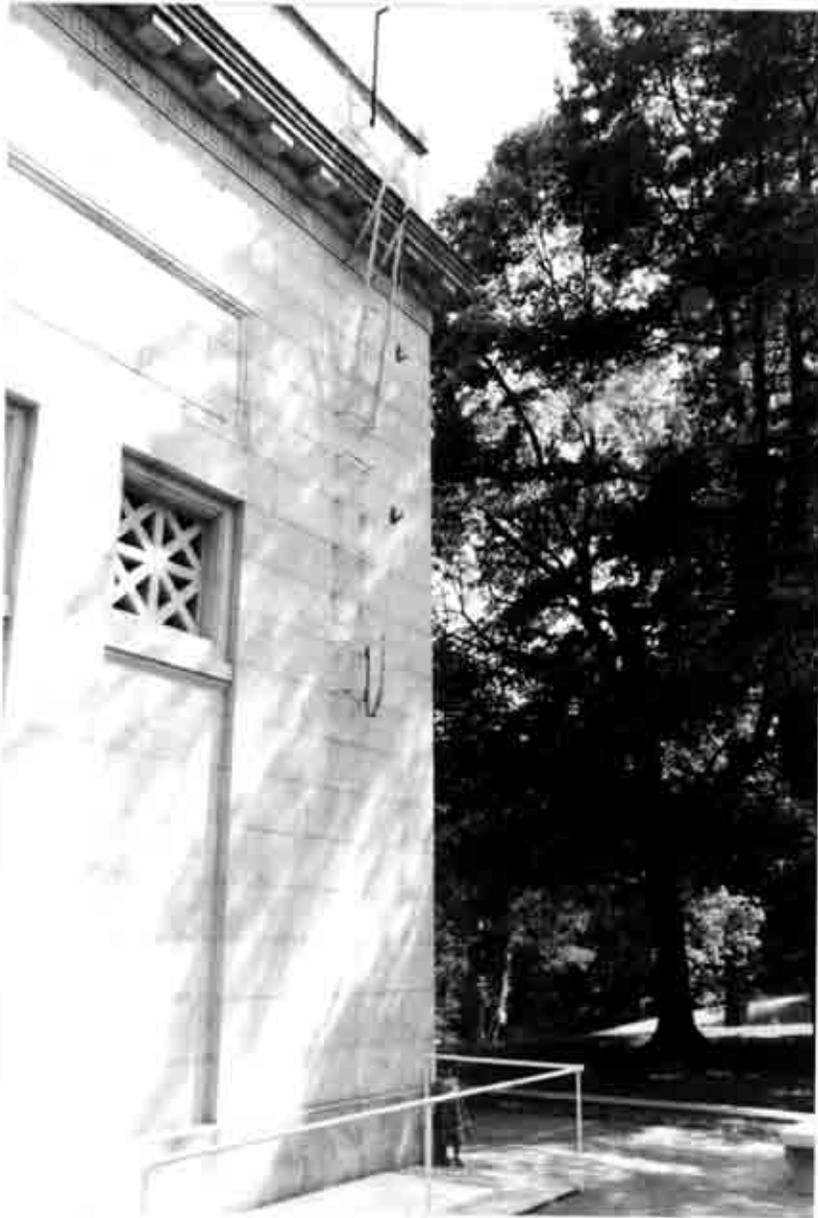
Ladder attached to rear wall of Memorial Building.
Not pictured is a 10' wooden ladder which attaches
to the bottom rung.

Approximately 45' from ground to top of building.

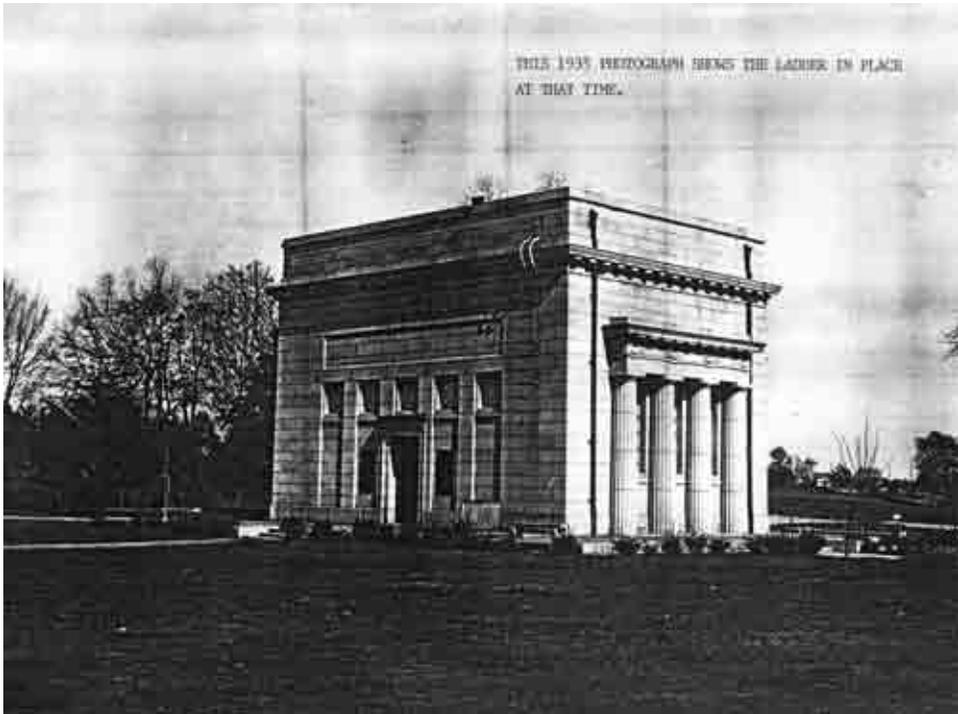
THIS 1935 PHOTOGRAPH SHOWS THE LADDER IN PLACE
AT THAT TIME.

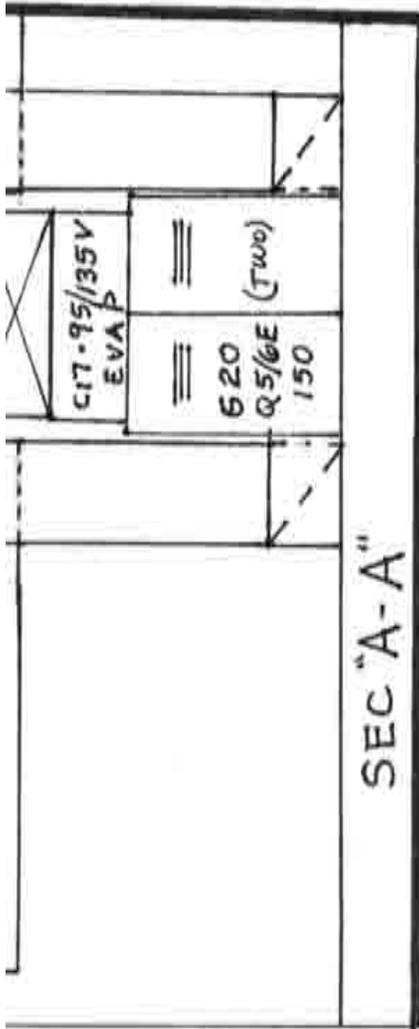
SEC "A-A"

1 1/2" PVC (UG)
CONDUIT
MAY BE
REUSED.
PULL NEW
WIRE.

NOTE:
REPLACE
ALL ELEC-
TRICAL
EQUIPMENT
IN BASE-
MENT AND
OUTSIDE
EXCEPT
WHERE
ALLOWED
BY SPECS.
