Historic Structure Report for

**BUILDING 125 (PAINT SHOP)
CHARLESTOWN NAVY YARD**

Boston National Historical Park
Boston, Massachusetts

December 2003

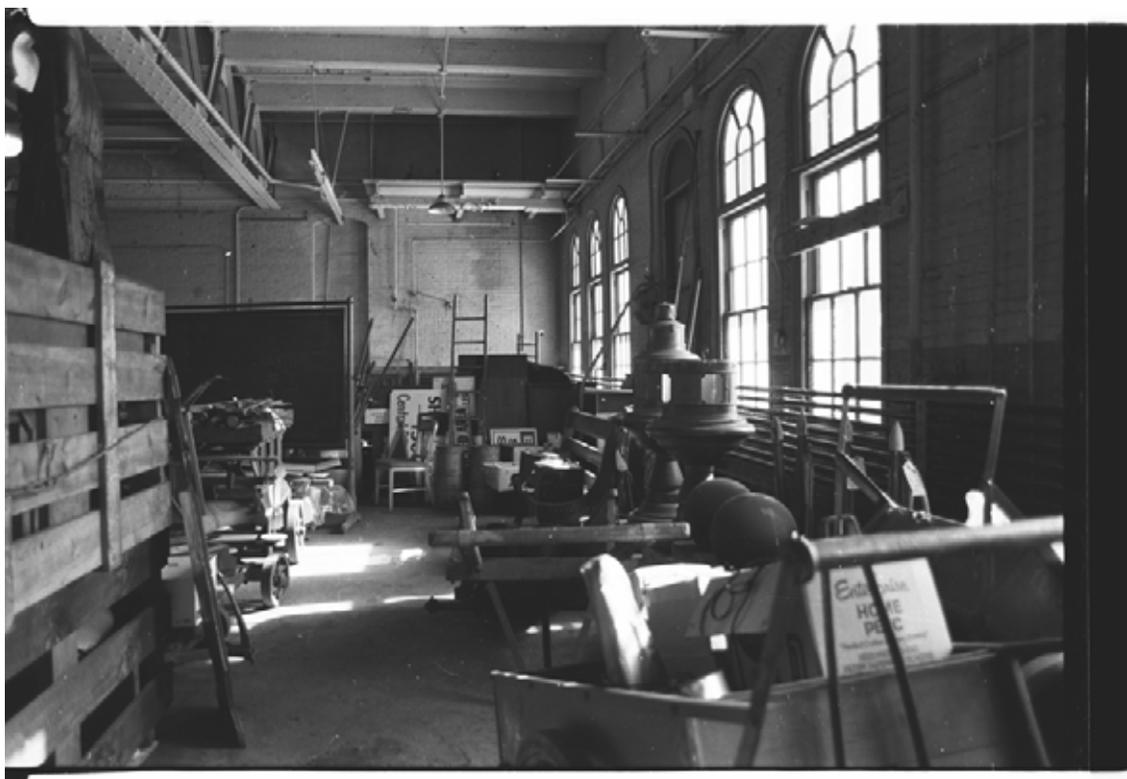
Figure 22: The main first floor space when initially used for general curatorial storage by the Park Service. View is looking south along the west wall. (02/1978)

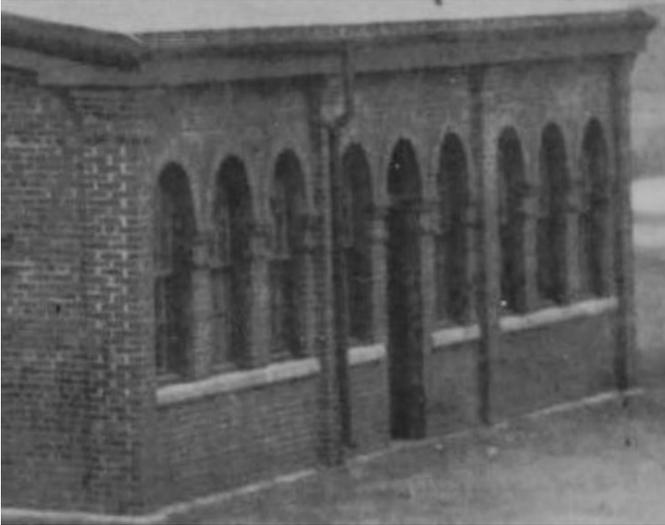
Figure 27: This ca. 1917 photograph of the north wall shows the original exterior single door opening within a typical brick arch.

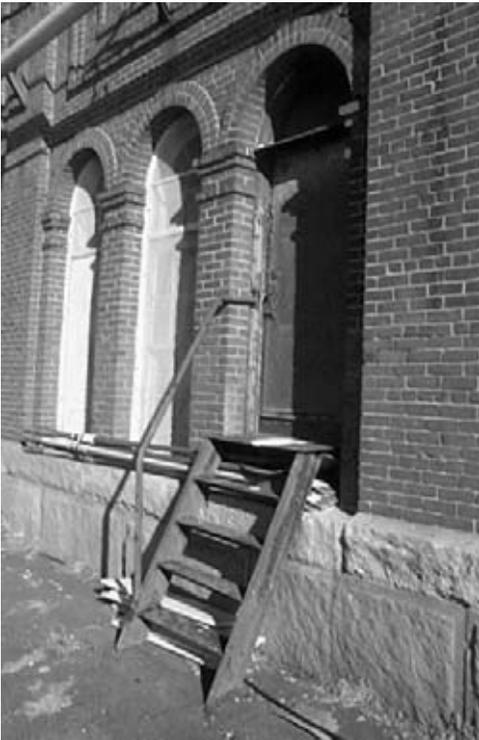
The original windows have been lost at five locations on the first floor. An egress door through the west wall of the first floor main space replaced one window without affecting the original masonry opening (figure 32). But new door openings through the north and east walls of the north wing altered the original arch-topped window openings, which were partially filled (figures 27 and 28).

Figure 32: Fire door and stair through an original window opening in the west wall of the main space. (1/15/03)

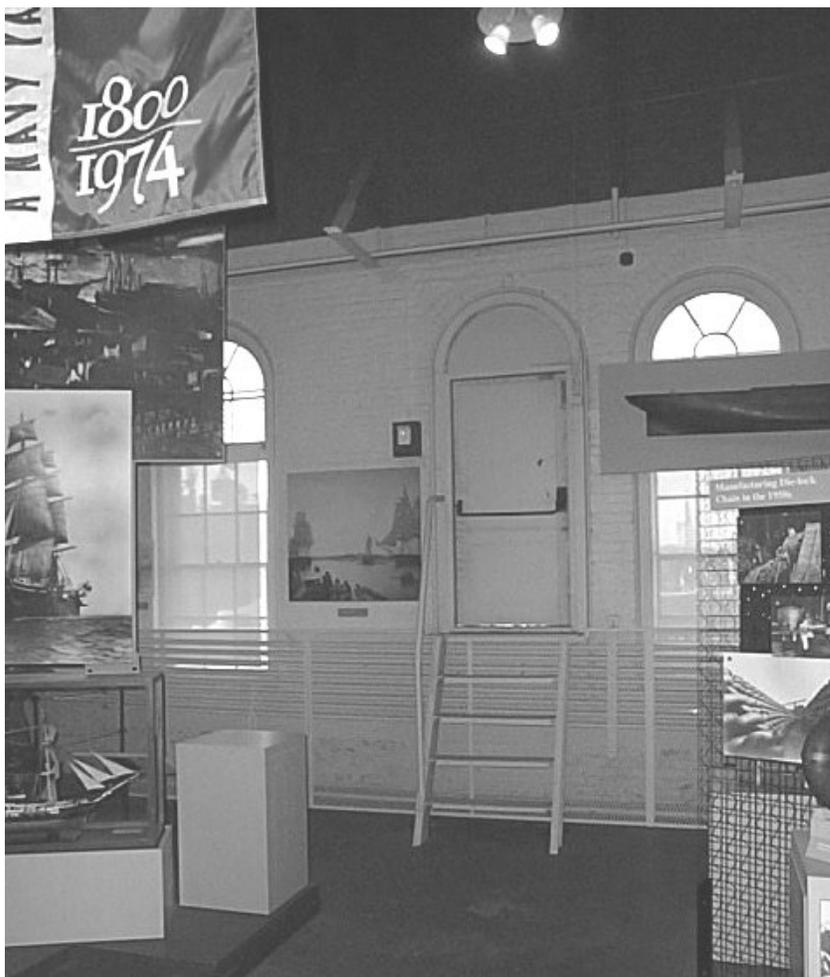
Figure 38: View to egress door in west wall of main space, Rm. 104. (1/15/03)

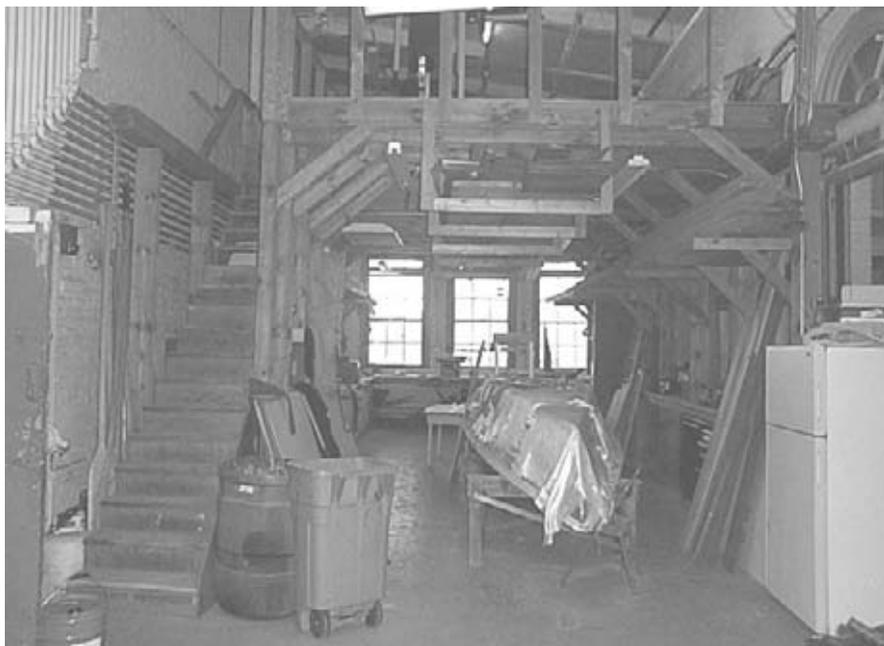
Figure 39: View looking west in north wing Room 105 showing existing wood framed loft. (1/15/03)

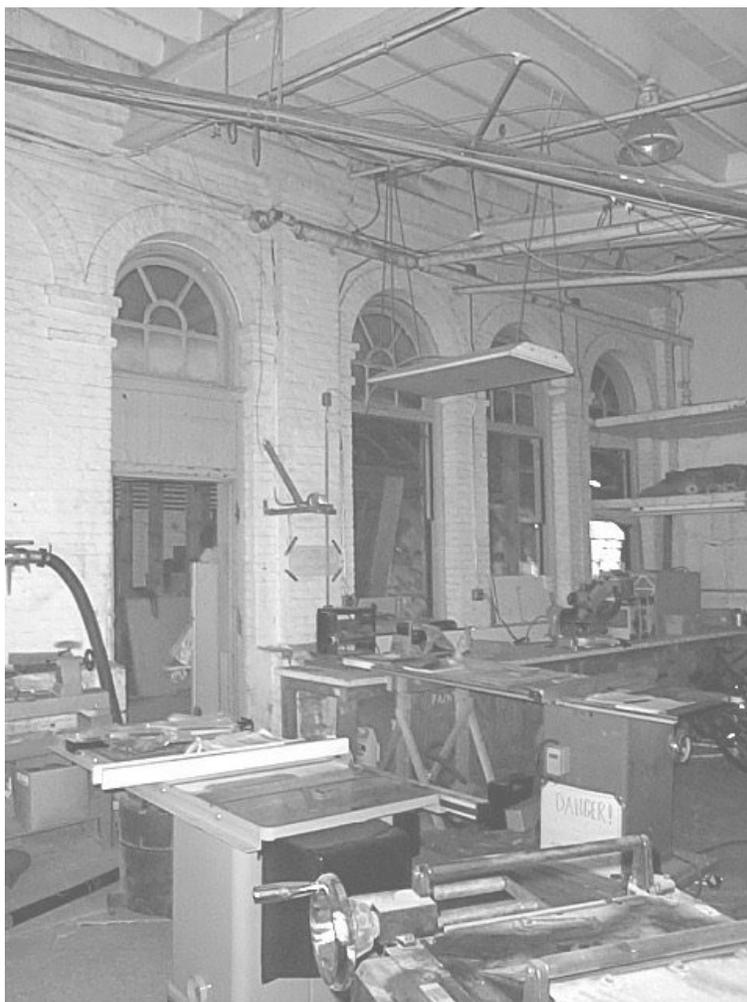
Figure 40: View of Room 106 looking south to wall that was originally the north exterior wall prior to the construction of the north extension. Note that the roof in this space is framed with wood. (1/15/03)

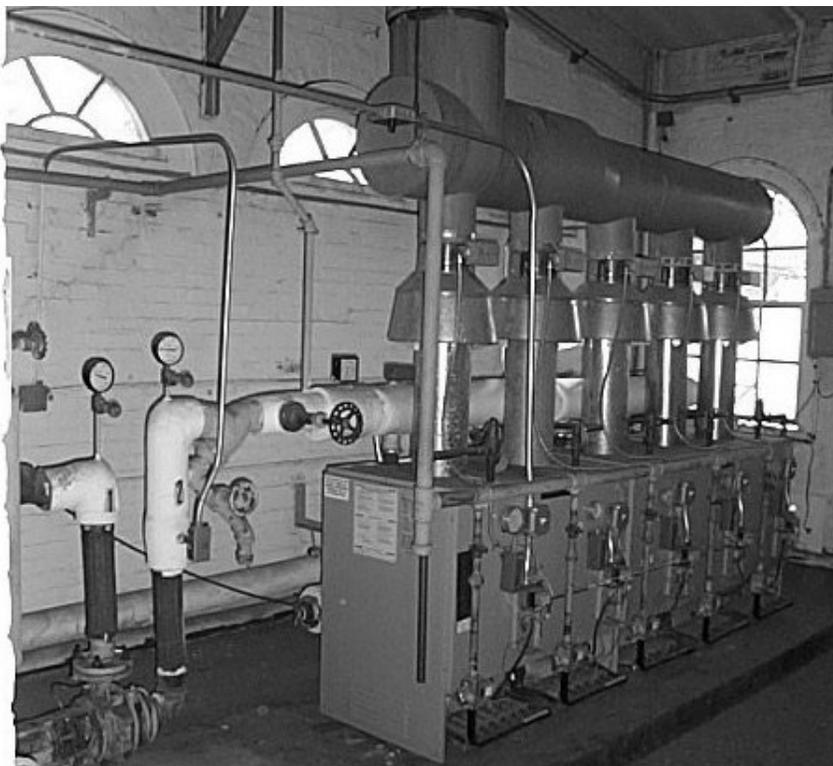
Figure 41: View to northwest in Room 107, the boiler room. Since this space was originally constructed as a shower room, the west wall windows were built as shown with fixed transoms only. (1/15/03)

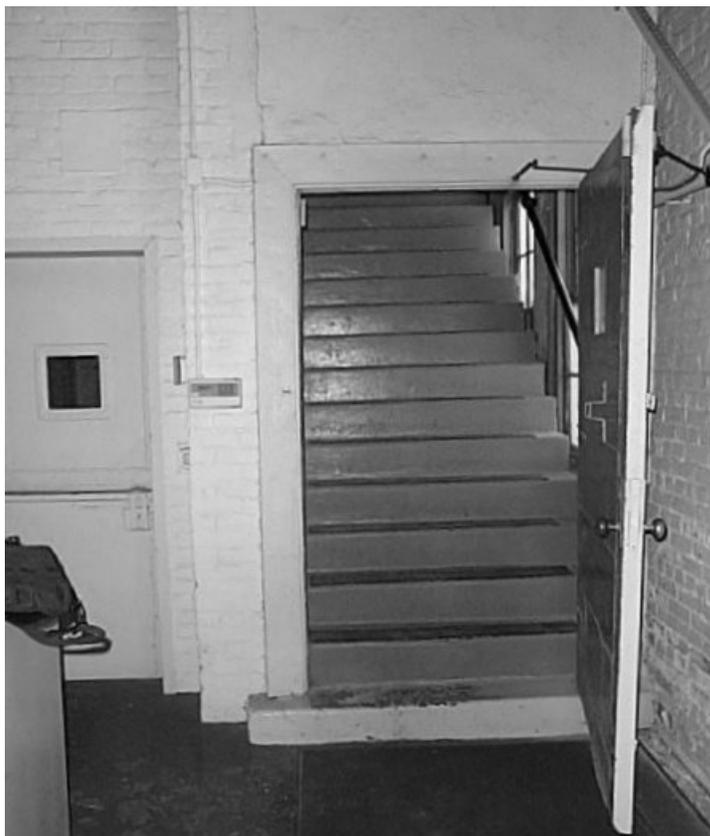
The painted, cast-in-place concrete stair in the northeast corner of the center mass is original. With 7-3/4 in. risers and 9-1/2 in. treads, it does not meet current egress code requirements.

Figure 42: Stair to second floor from Room 104. The stair is original, but the freight elevator (left) replaced the original in 1939. (1/15/03)

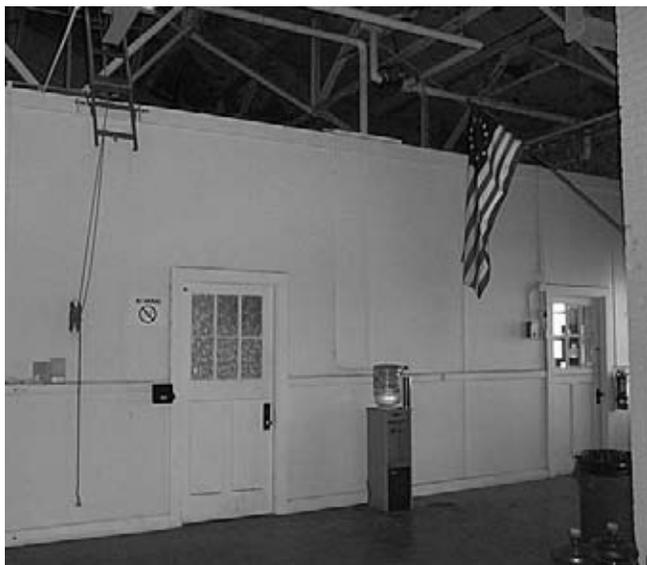
Figure 43: View of second floor corridor. The existing offices were constructed in the 1950's, enclosed by 12' high GWB partitions with suspended ceilings. The corridor is open to the steel trusses of the roof structure above the offices. (1/15/03)

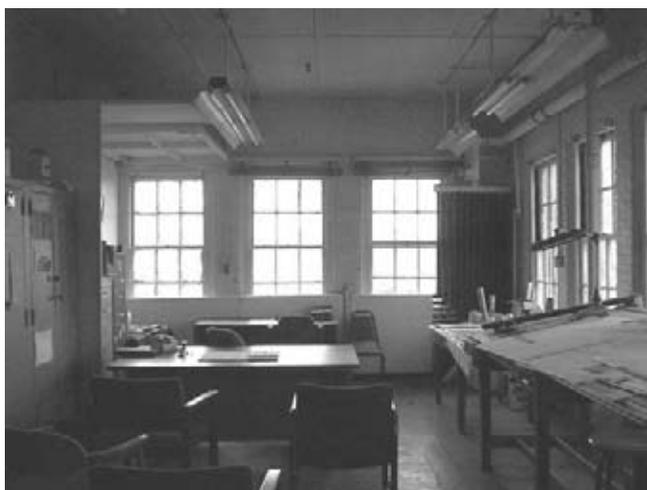
Figure 44: Typical second floor office interior. Exterior brick walls are exposed. (1/15/03)
