historic structure report building 198

october 1982

BOSTON
CHARLESTOWN NAVY YARD

HISTORIC STRUCTURE REPORT
BUILDING 198
CHARLESTOWN NAVY YARD
BOSTON NATIONAL HISTORICAL PARK
MASSACHUSETTS

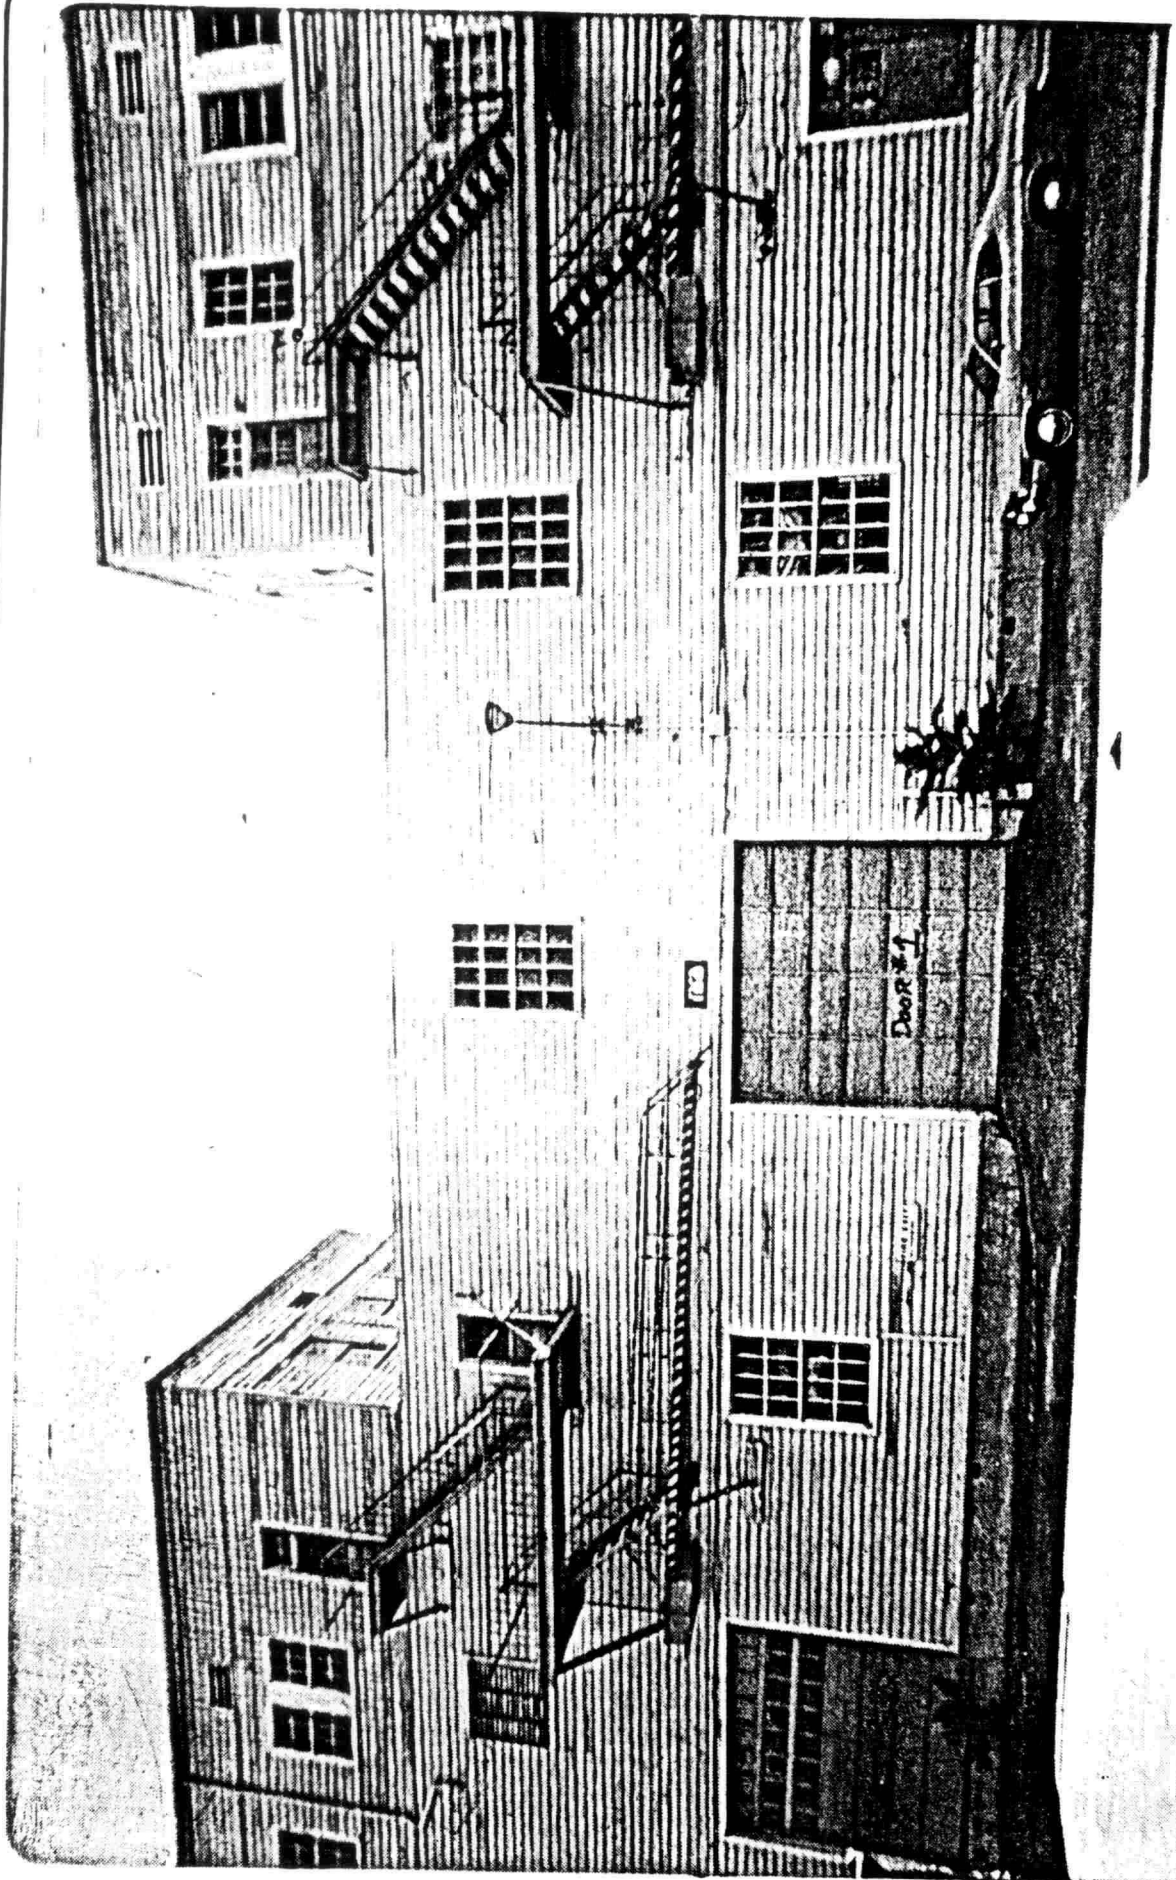
Boston Naval Shipyard - Building 198
Plate 2
Exterior North Elevation - wood siding
deterioration, roof drain and overhead
doors.

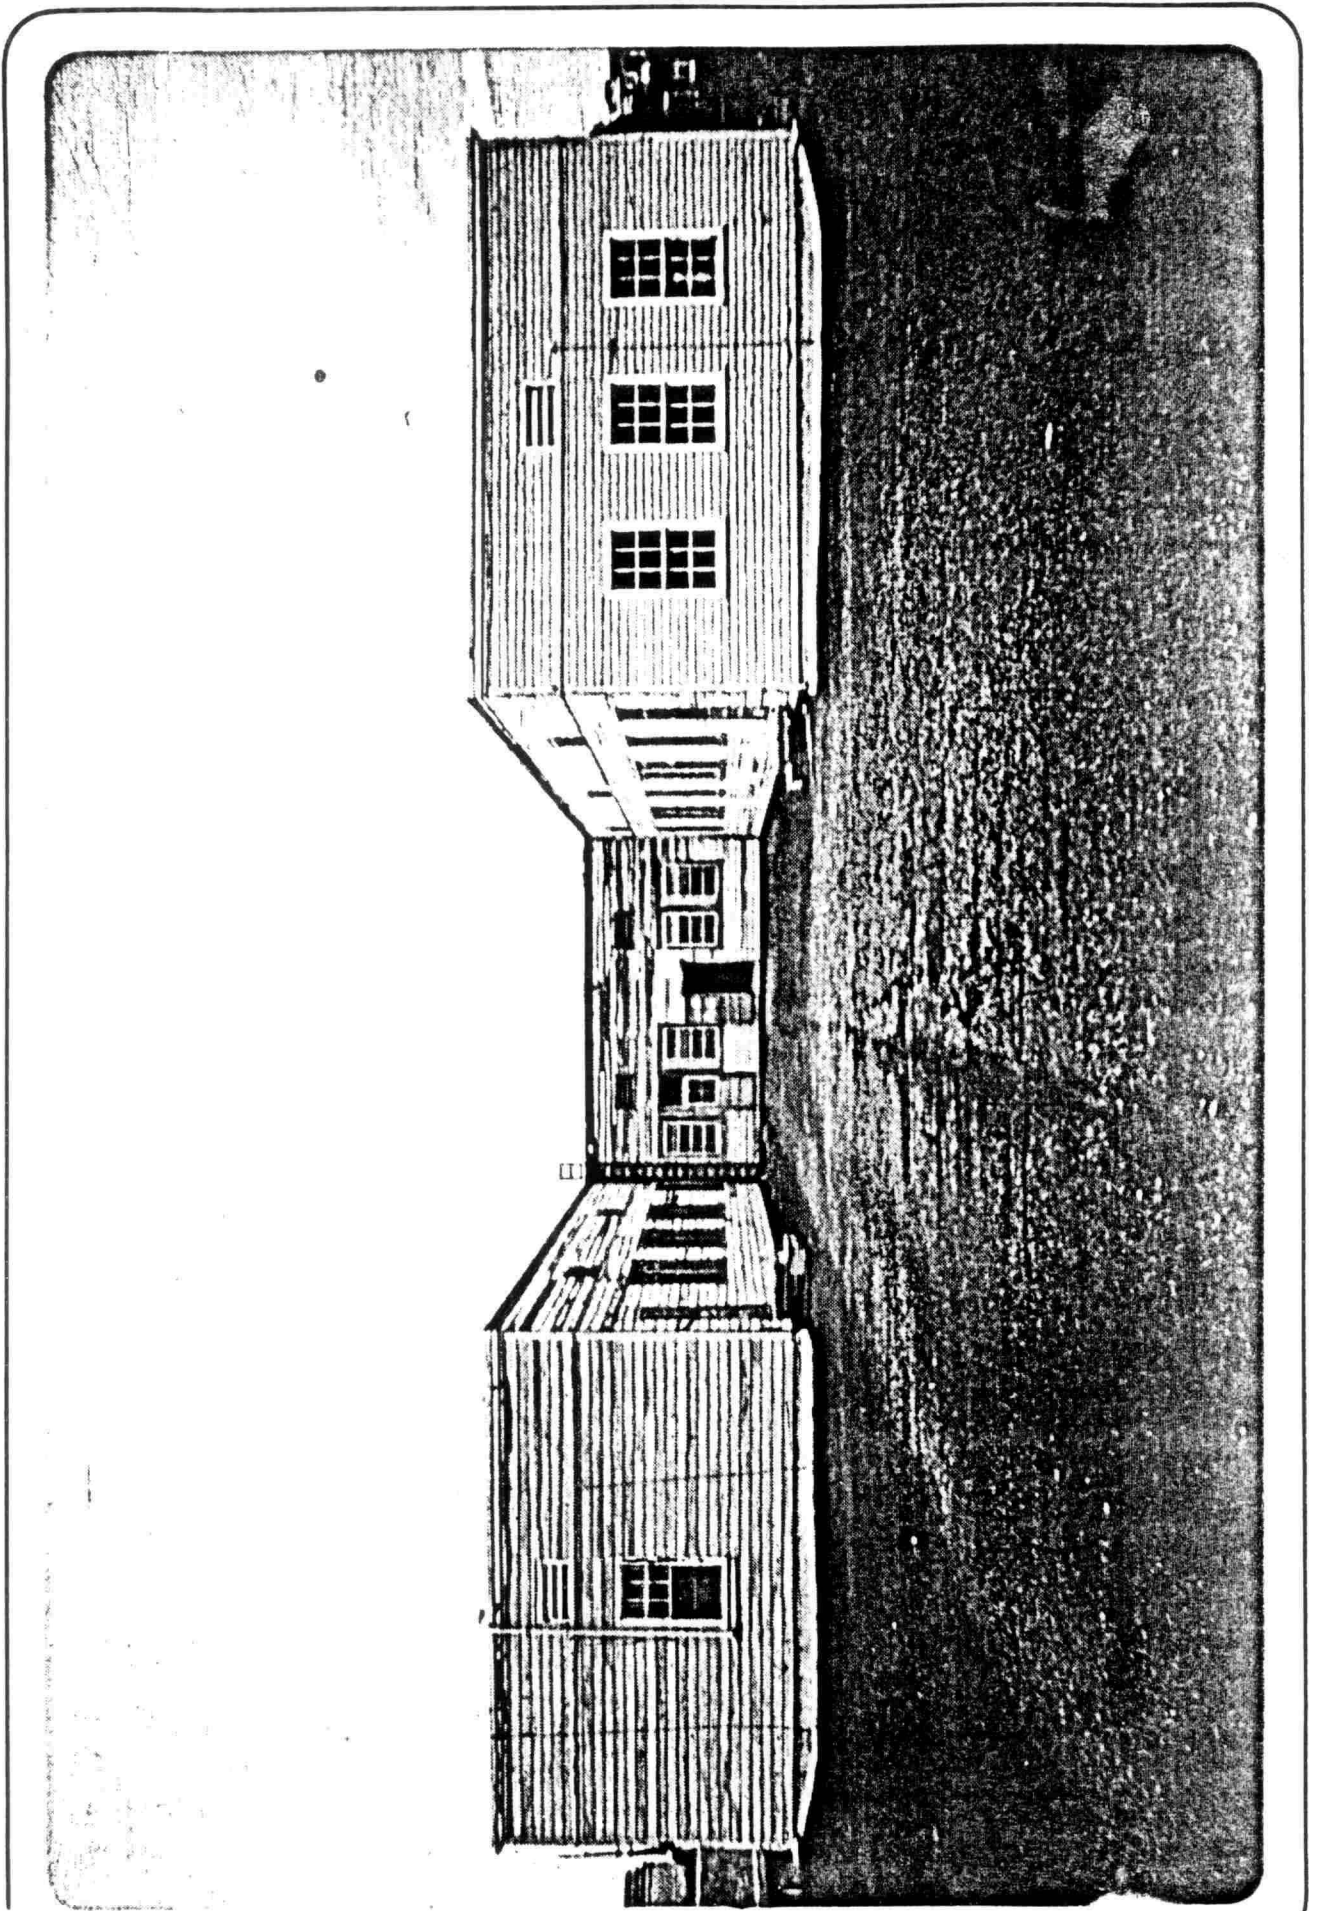
Boston Naval Shipyard - Building 198
Plate 6

Exterior elevation of west wing 3rd level. Window, siding, screen, and roof flashing deterioration.

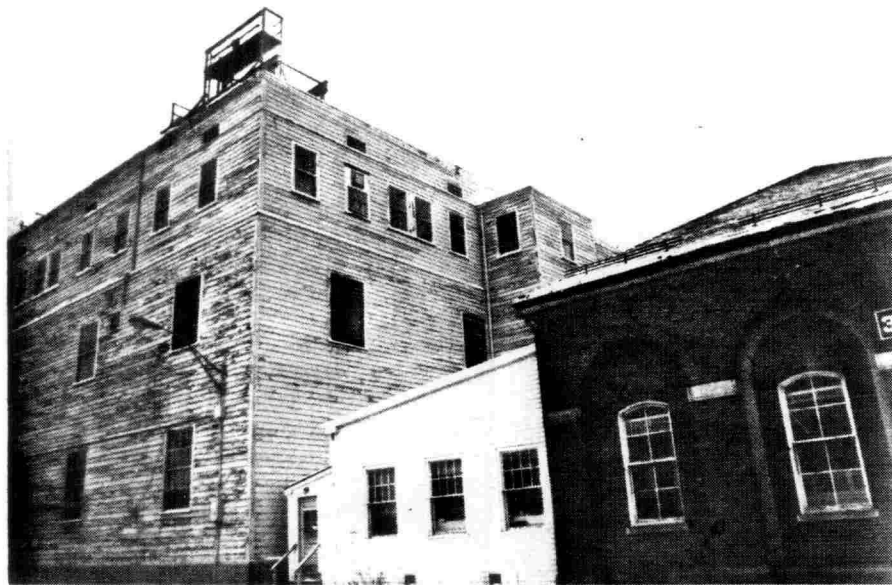
Illustration 13. Southeast corner showing missing sash at second floor, structure on roof for lights, relationship to adjacent Building 32. Note also one added vent replacing a window sash at the third-floor level.

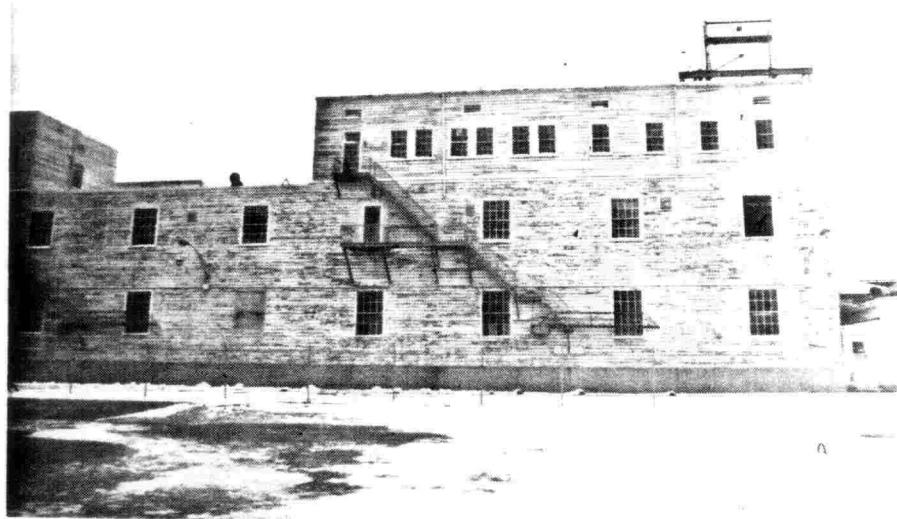
Illustration 15. Eastern half of the south facade. Note the fire escape and the second-floor new door to the landing. Note also the blocked-in window at the first floor.

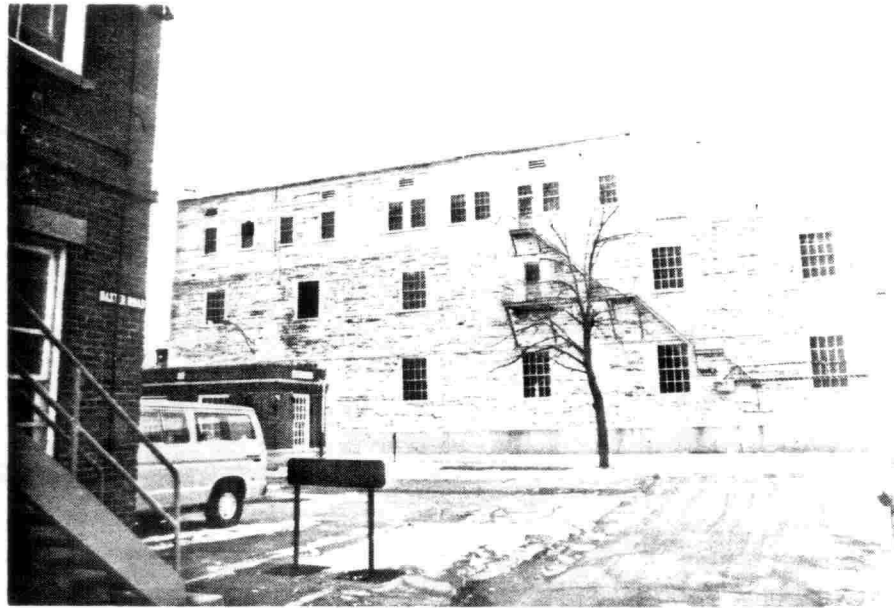
Illustration 17. Western portion of the south facade.
Note the missing sash at second and third floors.

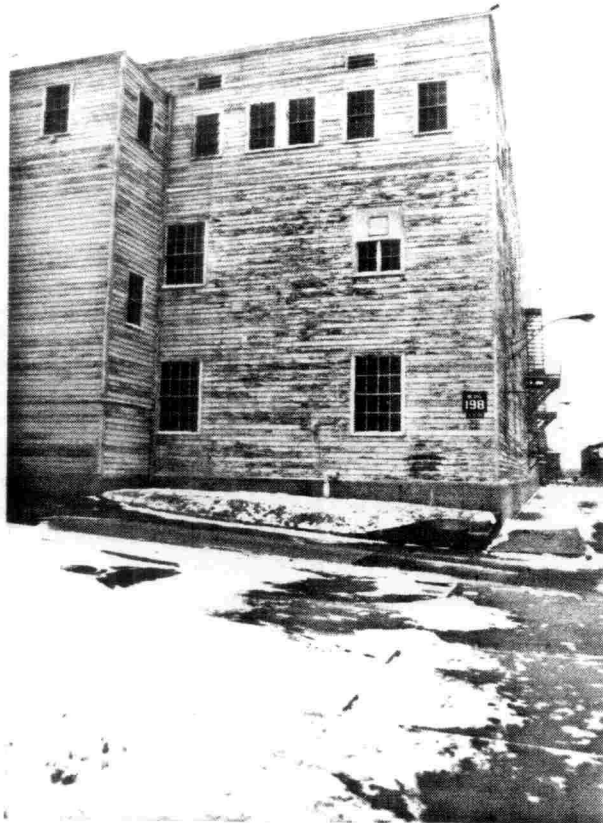
Illustration 19. West facade, southern portion. Note the difference in heights of the main building and the stair tower. Also note the vent and replaced sash in one window on the second floor.

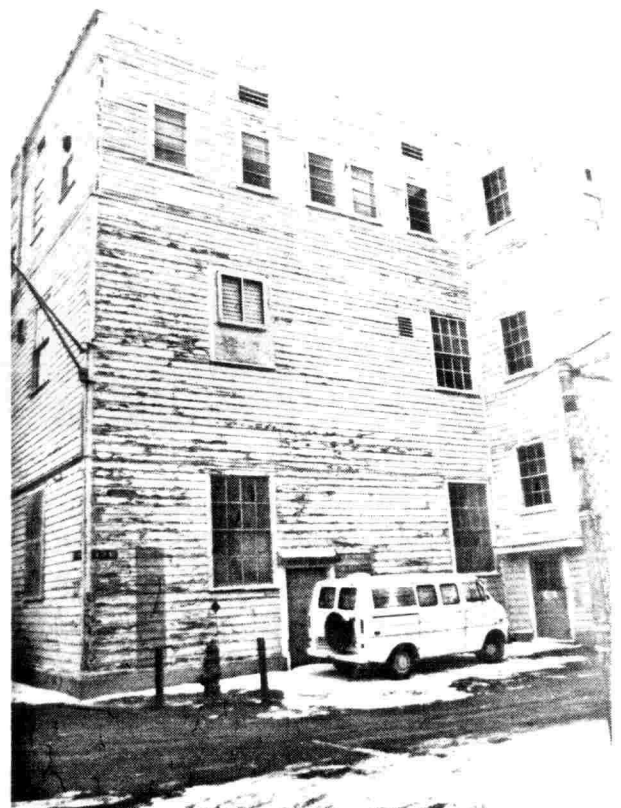
Illustration 20. West facade, northern portion. Note the added door on the first floor, the vent and blocked-in window on the second, the replaced sash on the third.

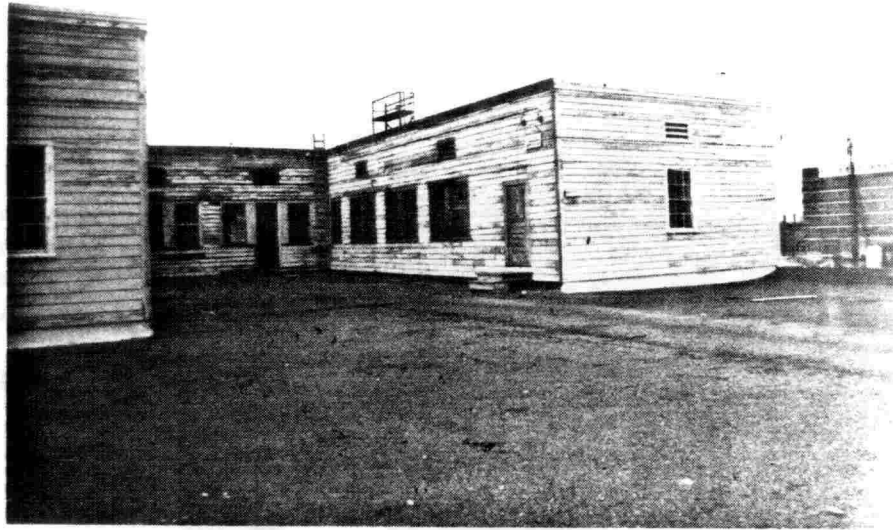
Illustration 21. Eastern third-floor addition looking southeast. Note built-up roofing at edges.

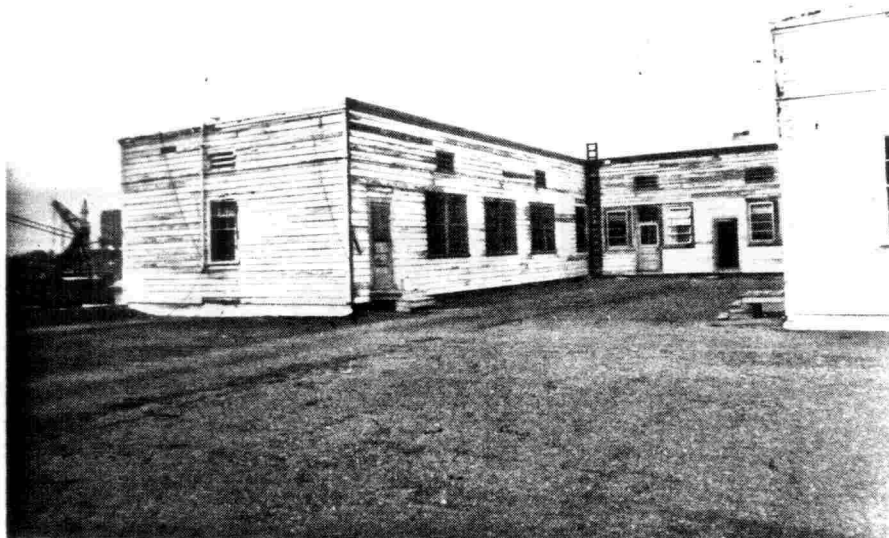
Illustration 23. Western third-floor addition looking southwest.

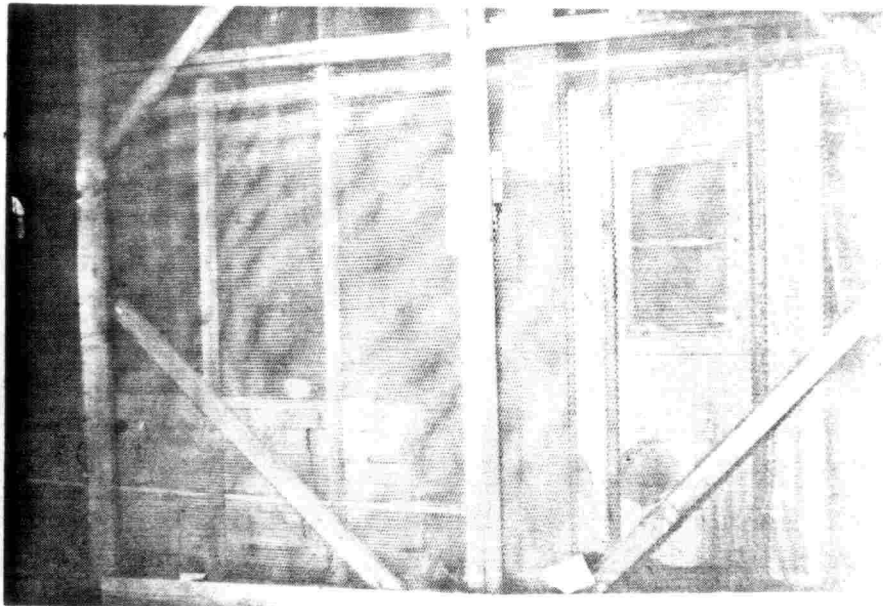
Illustration 26. Wire mesh and stud partition in Room 102-security storage area.

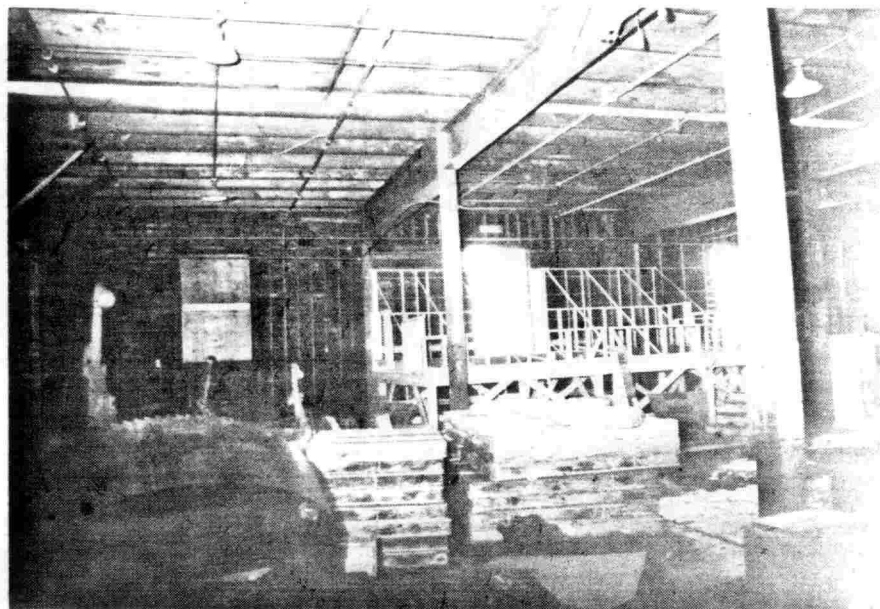
Illustration 27. Room 102 - looking south. Note blocked-in windows. Room used as main storage area for materials and equipment.

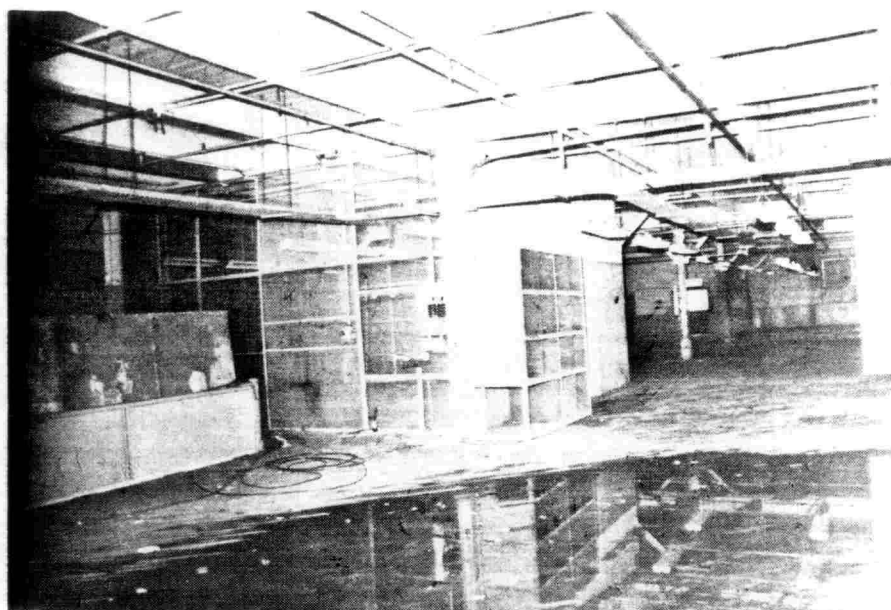
Illustration 37. Room 201 looking west at caged area. Note the standing water on the diagonal floor boards. Also note the exposed framing ceiling.

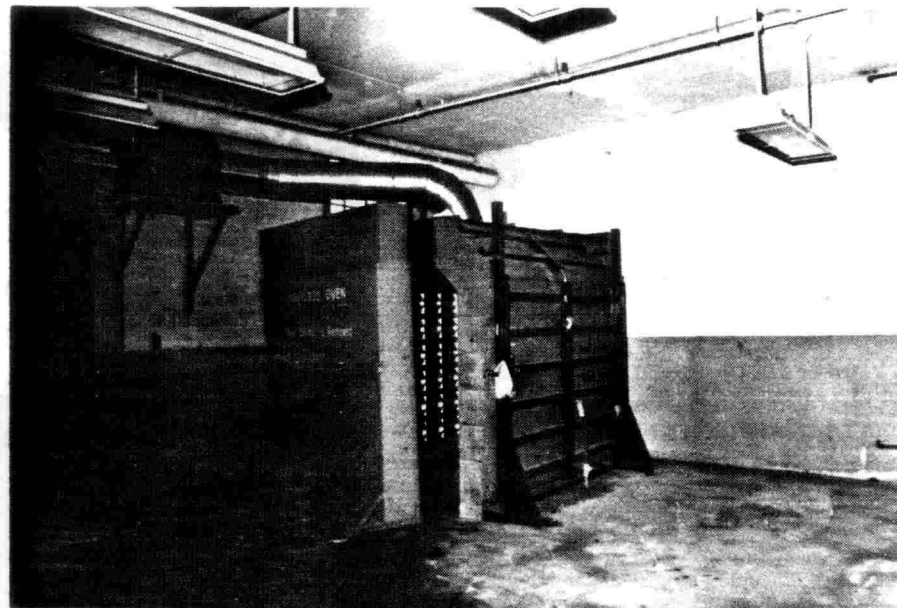
Illustration 44. Room 212 - Infra-red oven, probably used for paint drying as this room also contains a ventilated painting booth.

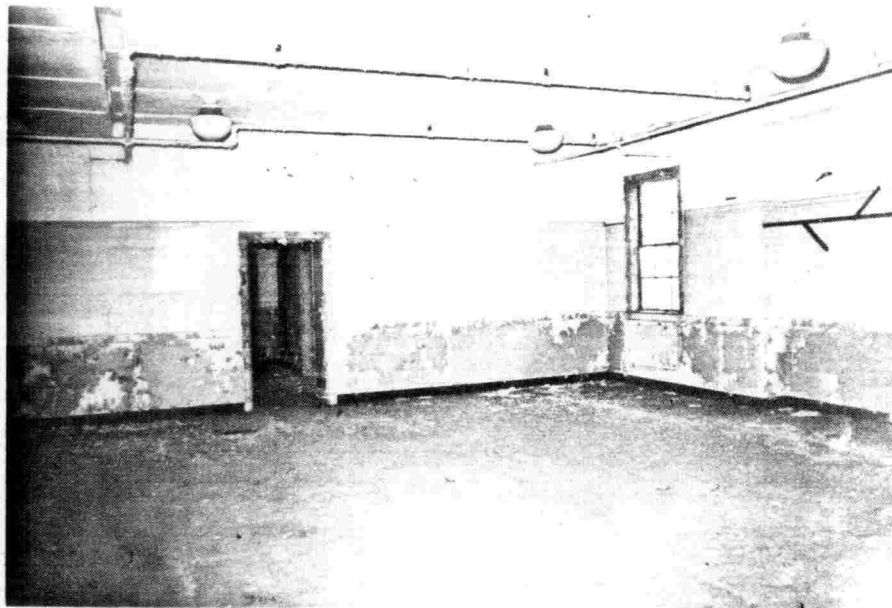
Illustration 54. Room 336 - Door to east stair tower to
immediate right of photograph. Door on left leads to
Room 334, hallway.

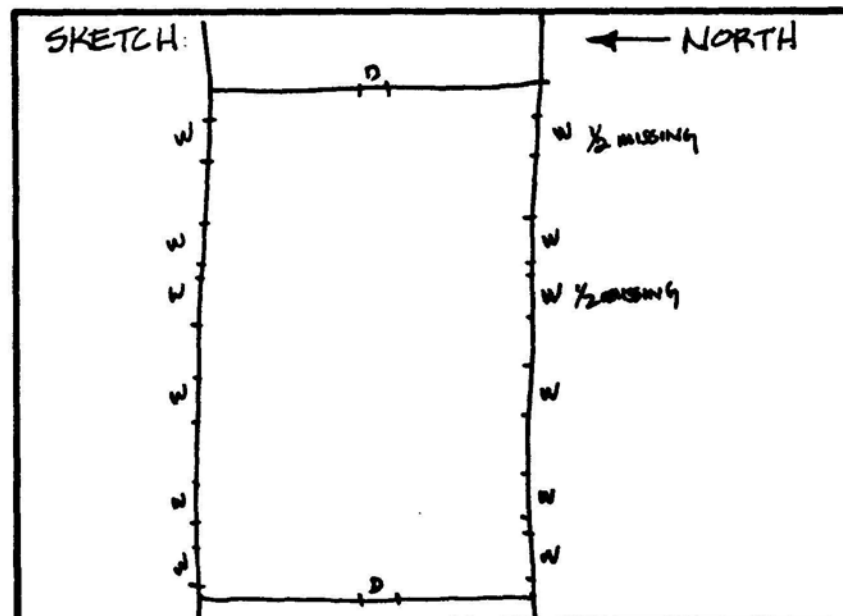
ROOM 327 SCHEDULE

DOORS	WINDOWS
INTERIOR:	INTERIOR:
MISSING	NONE
EXTERIOR:	EXTERIOR:
NONE	TWELVE 6/6 LIGHTS. SOME MISSING 1/3 SASH

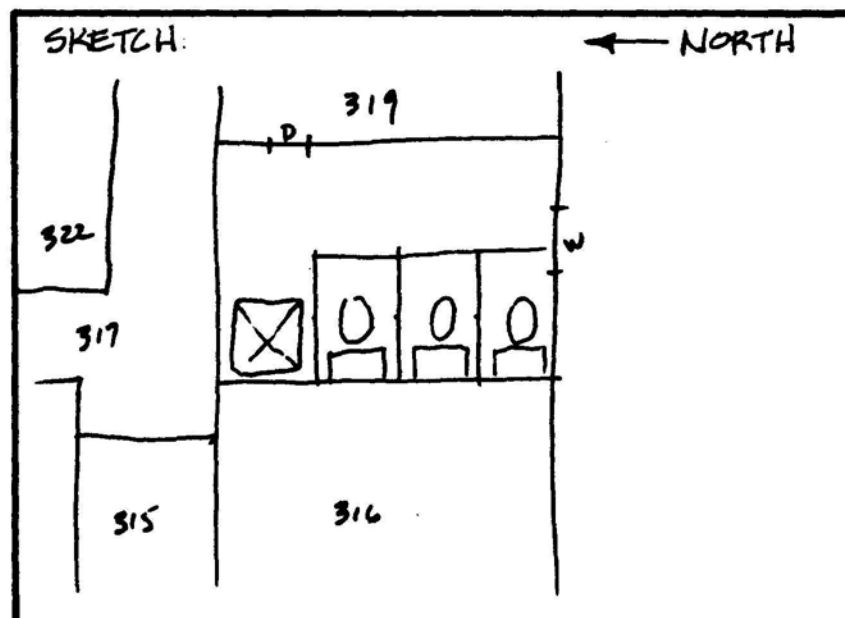
ROOM 317 SCHEDULE

DOORS	WINDOWS
INTERIOR:	INTERIOR:
MISSING	NONE
EXTERIOR:	EXTERIOR:
NONE	ONE: MISSING TOP SASH 6/6 LIGHTS ORIGINALLY

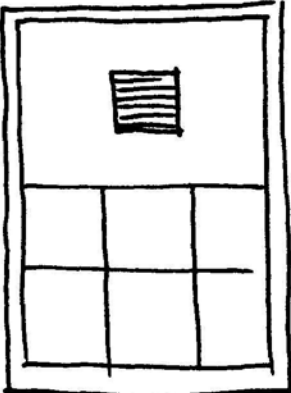
DOORS	WINDOWS
INTERIOR:	INTERIOR:
MISSING	NONE
EXTERIOR:	EXTERIOR:
NONE	ONE VENT / 6 LIGHTS (SEE SKETCH) ONE 6/6

MISCELLANEOUS
VENTED WINDOW:

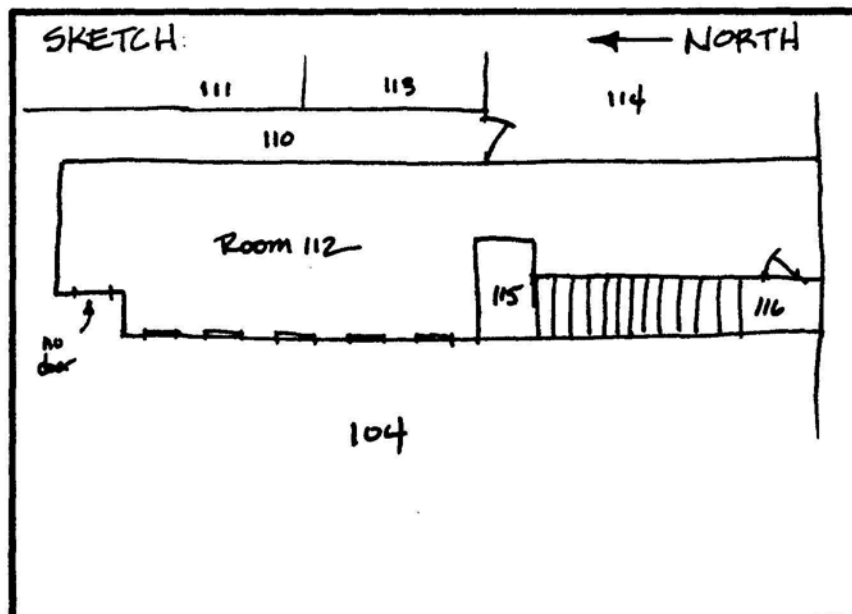
BUILDING 198

MISCELLANEOUS
STANDING WATER CAUSING DAMAGE TO FLOOR, WALLS.

WALLS		FLOORS		CEILINGS	
	2x4 WOOD STUD		CONCRETE		EXPOSED FRAMING
	WIRE MESH		2x4 T & G 45° ANGLE		WOOD T & G
X	PARTICLE BOARD TOP		ROLLED VINYL		PARTICLE BOARD
X	PLYWOOD BOTTOM 4'	X	VINYL ASBESTOS TILE	X	GYP SUM BOARD
	GYP SUM BOARD		MASONITE		PLYWOOD
	MASONITE		OTHER:		OTHER:
	2x6 T & G	COMMENTS:		COMMENTS:	
	CEDAR SIDING	GRAY - BADLY DETERIORATED FROM WATER DAMAGE.		DROPPED CEILING	
	OTHER:

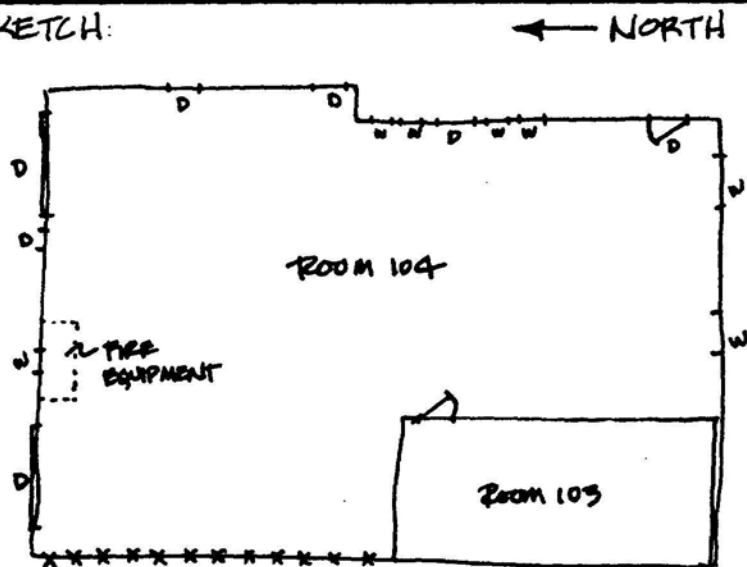
ROOM 103 SCHEDULE

EXTERIOR:
 NORTH: ONE, MISSING TOP SASH.
 SOUTH: TWO, ONE COMPLETELY
 BOARDED IN.

STANDING WATER ON FLOOR -
 MUCH WATER DAMAGE TO
 EAST WALL

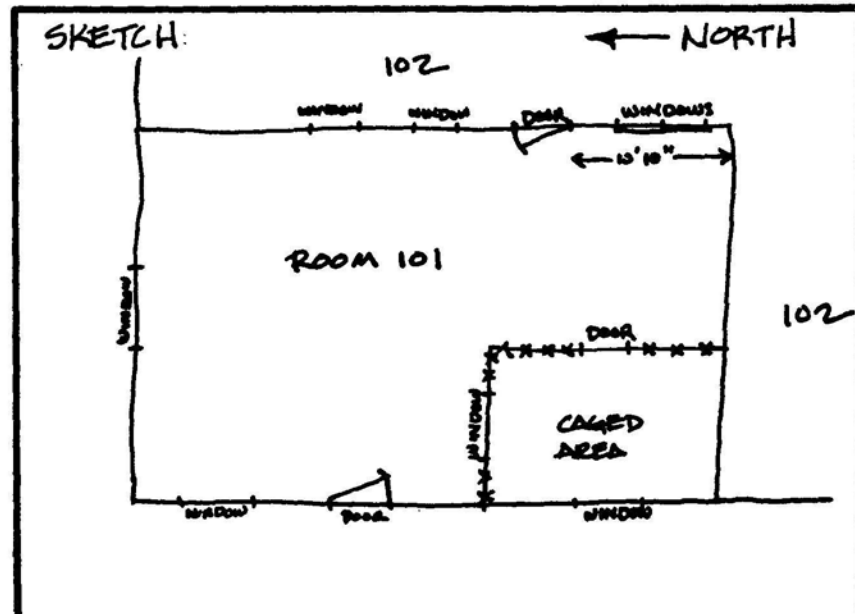
WALLS		FLOORS		CEILINGS	
<input checked="" type="checkbox"/>	2x4 WOOD STUD	<input checked="" type="checkbox"/>	CONCRETE		EXPOSED FRAMING
	WIRE MESH		2x4 T & G 45° ANGLE		WOOD T & G
<input checked="" type="checkbox"/>	PARTICLE BOARD		ROLLED VINYL	<input checked="" type="checkbox"/>	PARTICLE BOARD
	PLYWOOD		VINYL ASBESTOS TILE		GYP SUM BOARD
	GYP SUM BOARD		MASONITE		PLYWOOD
	MASONITE		OTHER:		OTHER:
	2x6 T & G	COMMENTS:		COMMENTS: WATER DAMAGED - SOME FRAMING EXPOSED	
	CEDAR SIDING				
	OTHER:
