HISTORIC STRUCTURE REPORT

THE OLD POINT LOMA LIGHTHOUSE  
CABRILLO NATIONAL MONUMENT  
SAN DIEGO, CALIFORNIA

by  
F. Ross Holland, Jr.  
Historian

March 1981

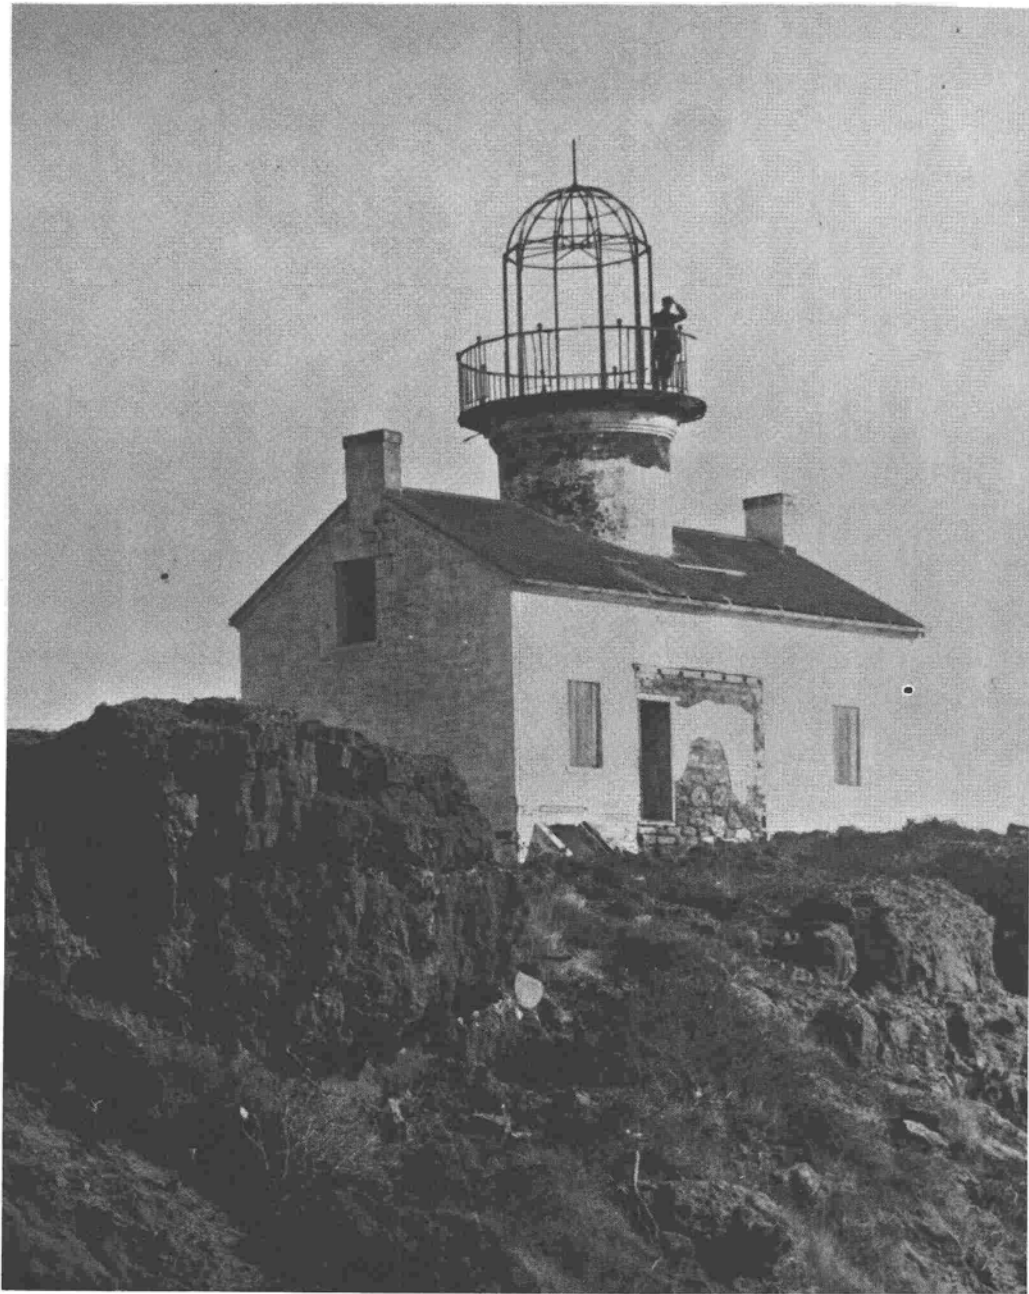
There is practically no information about the construction of the lean-to. The foundation was undoubtedly of stone, and perhaps sandstone was used since by 1880 the foundation was in poor condition and had to be rebuilt. After the lighthouse was abandoned the attachment deteriorated again and in time sheared away from the stone dwelling. The doorway which had connected the dwelling to the lean-to was sealed up, and all that remained were marks and stains on the west wall of the structure outlining where the attachment had been.

ABANDONED POINT LOMA LIGHTHOUSE, ABOUT 1915. NOTE  
WHERE LEAN-TO HAD BEEN. From historical collection  
Title Insurance and Trust Company, San Diego, California

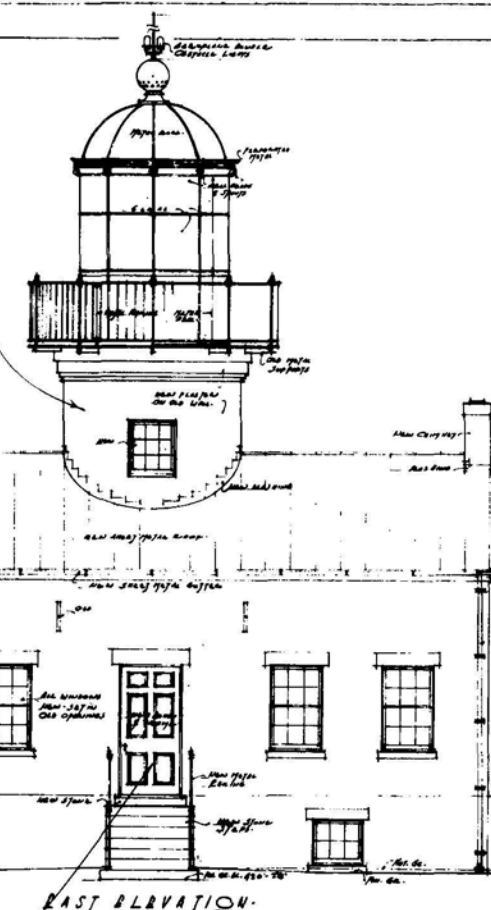
EAST ELEVATION

DAMAGED FLASHING  
HOLES IN RIDGE

MOISTURE DAMAGED PLASTER  
STANDING WATER

CONDUIT CLAMPS CORRODED

ELEC. OUTLET CLOSE TO STANDING WATER

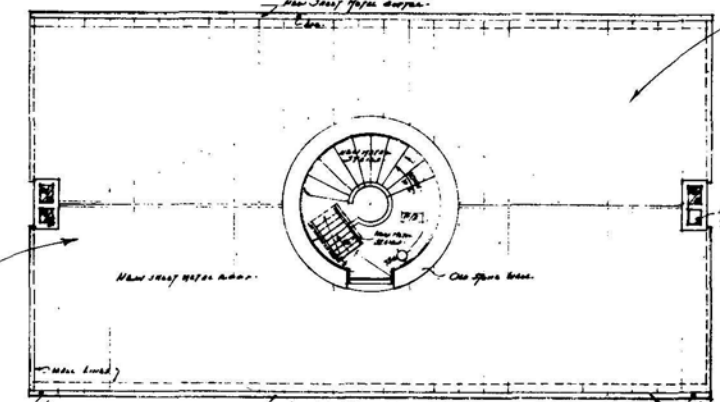
ROOF & TOWER PLAN

CRACKS IN STANDING SEAMS & NUMEROUS HOLES WHERE NAILS ARE MISSING

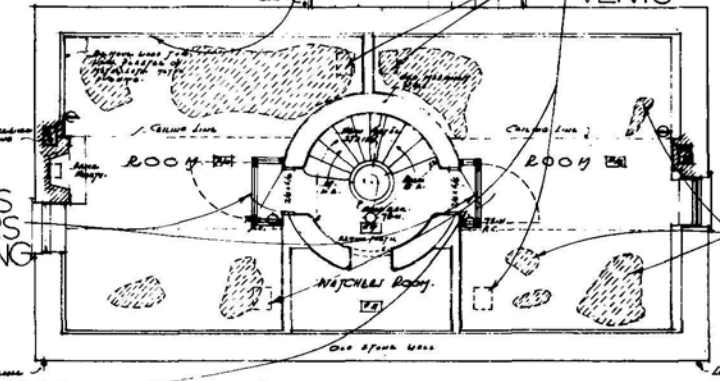
SECOND FLOOR PLAN

DAMAGED PLASTER

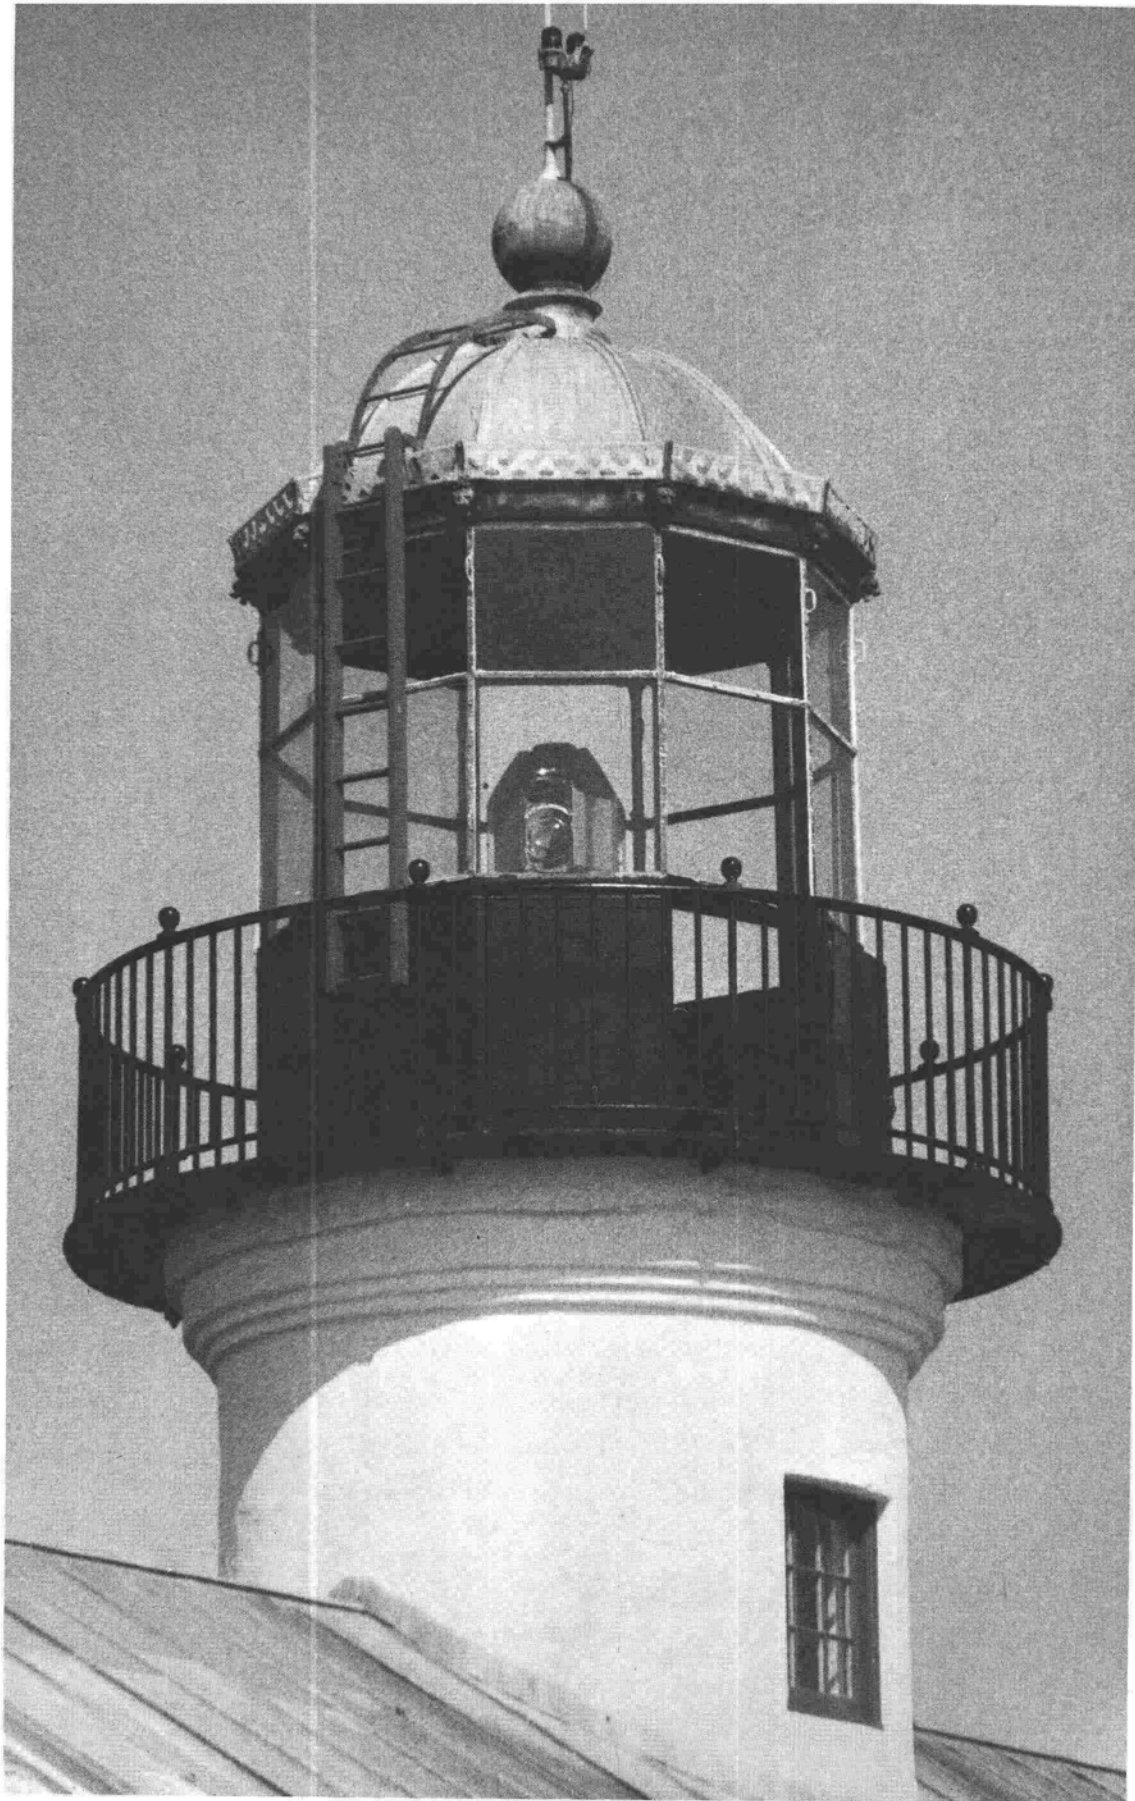
OLD POINT LOMA LIGHTHOUSE TOWER AND LANTERN, 1977. National Park Service photograph by H. G. Law.

There exists a large crack in the concrete floor of the lantern, as well as vertical and horizontal cracks on the exterior of the tower. These exterior cracks are not visible at this time due to recent repainting. There is a vertical crack through the masonry cornice of the tower at each gallery bracket. The horizontal cracking is located approximately at the level where the segmental dome springs from the wall. These cracks appear in several photographs taken earlier and have been the concern of other professionals evaluating the structure. A photograph of the building taken circa 1915 shows a major horizontal crack in the tower, which appears to be the same as the one existing most recently (see photo 89).

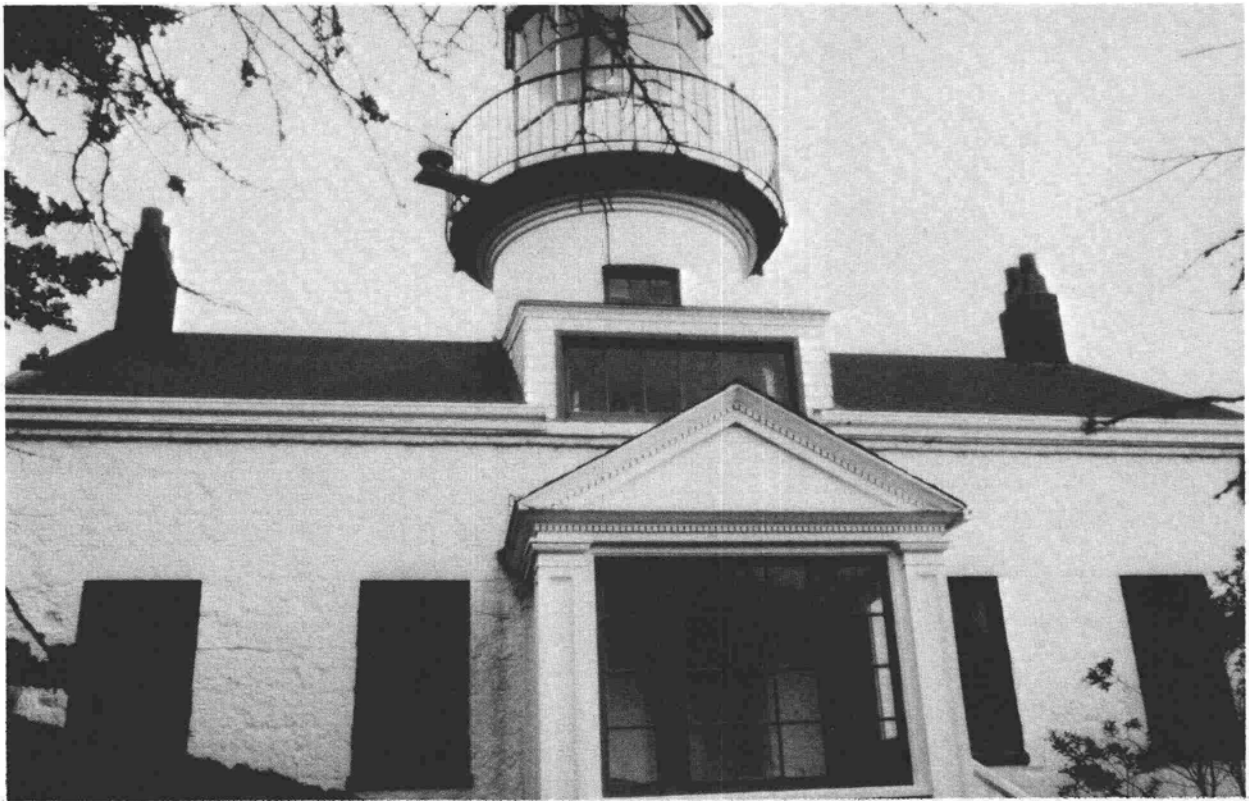
POINT PINOS LIGHTHOUSE, WEST ELEVATION, 1979. National Park Service photograph by H. G. Law.

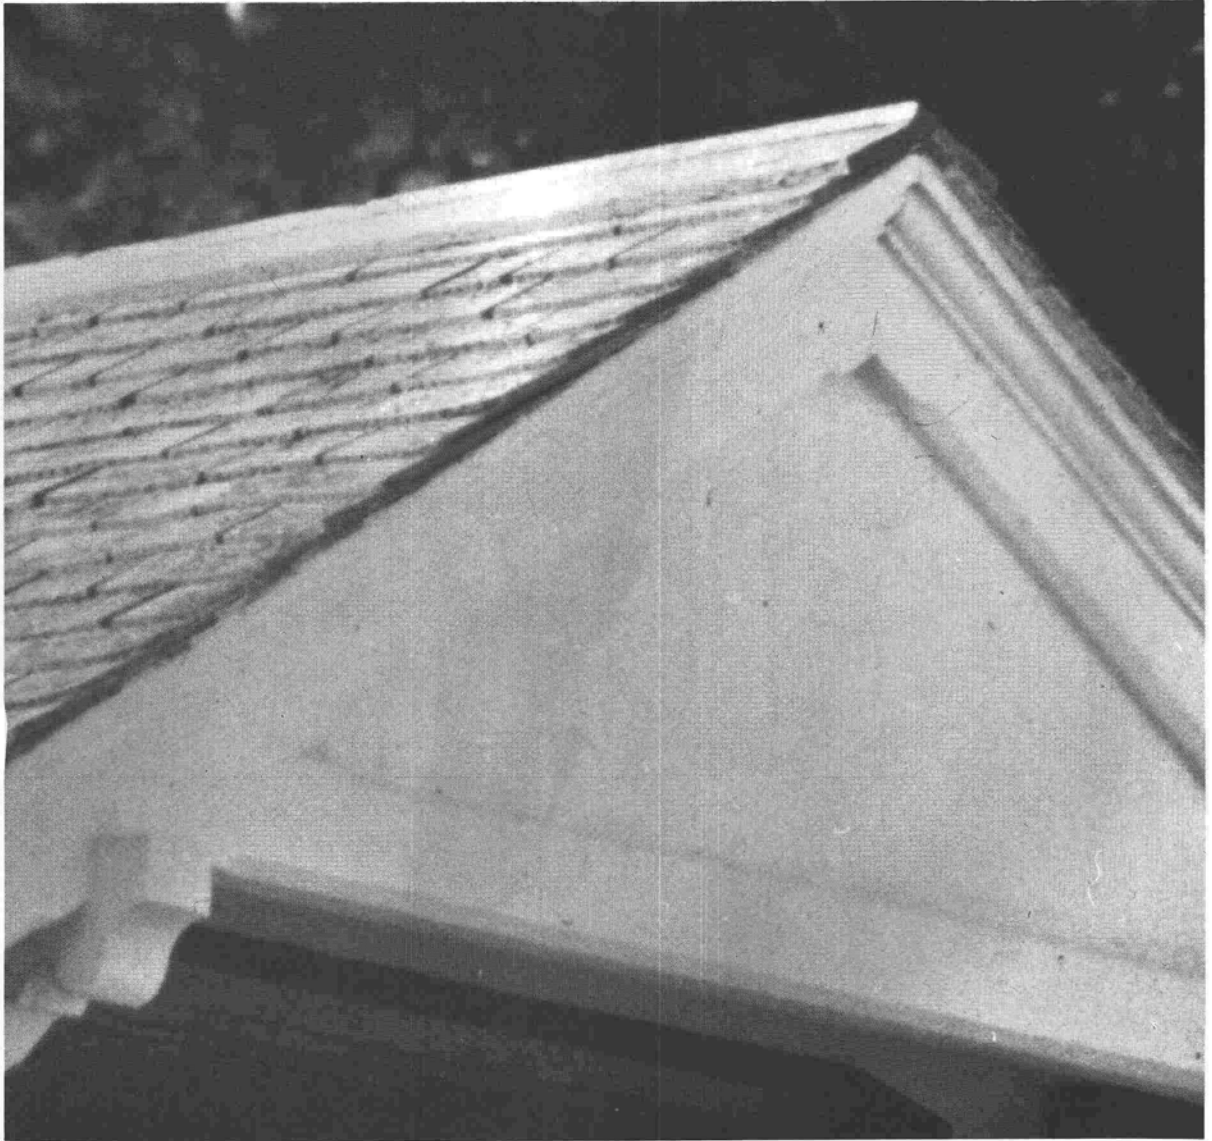
RIDGE DETAIL ON ROOF OF ONE OF THE DWELLINGS AT THE NEW  
POINT LOMA LIGHTHOUSE, 1979. National Park Service  
photograph by H. G. Law.

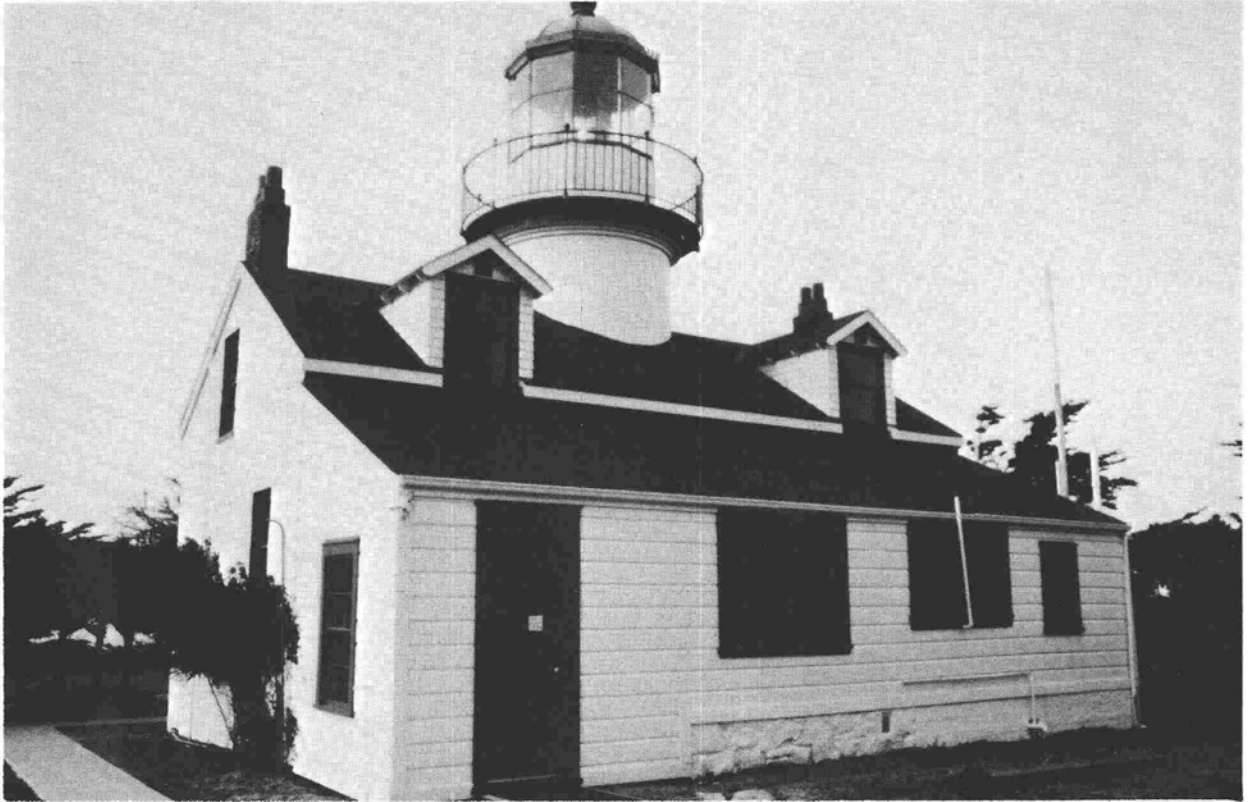
POINT PINOS LIGHTHOUSE, EAST (REAR) ELEVATION, 1979. NOTE  
STONE FOUNDATION WHERE ORIGINAL LEAN-TO WOULD HAVE BEEN.  
THE EARLY SHINGLE ROOF OF THE LEAN-TO EXISTS INTACT UNDER THE  
LARGER EXISTING LEAN-TO ROOF. National Park Service photograph  
by H. G. Law
