CAPE HATTERAS NATIONAL SEASHORE

BODIE ISLAND
LIGHTHOUSE & OIL HOUSE

HISTORIC STRUCTURE REPORT

**Cultural Resources Division
Southeast Regional Office
National Park Service
December 2004**

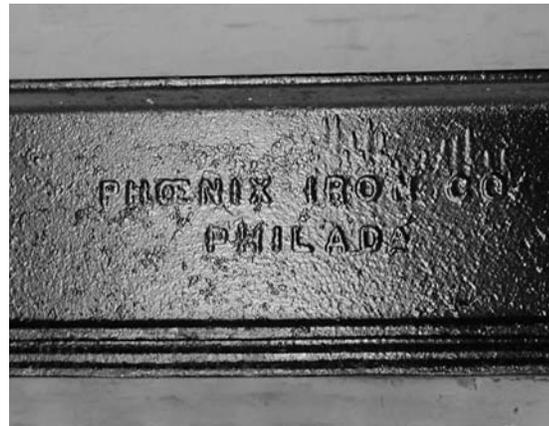
Figure 4 Landing support beams in Tower. Beams were actually installed with manufacturer's stamp upside down. Photo courtesy of Jack McCombs.

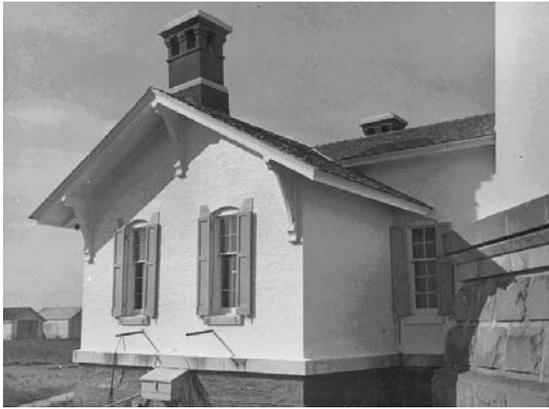
South Elevation: The south elevation is a mirror of the north elevation in composition. Like the north elevation, the south elevation exhibits a dormant and repaired crack from the west corner of the east window downward and to the east. In addition, there appear to be several patches in the elevation that have repaired brick damage, likely spalling. One patch is over the head of the east window, and one is at the east side and below the sill of the west window. Evidence of spalled brick can be seen on the lower east corner of the elevation below the water table.

Figure 19 Photo of south elevation by U.S. Coast Guard, 1948.

There are two patched holes in the center of the elevation below the water table and above the inset in the wall. Earlier photos suggest these patches mark the location of what appear to be drain outfalls from the Oil Room. Mid-20th century photos also indicate the location of a box mounted to the south wall below the water table. The brick shelf defining the inset brick panel below the water table was partly removed to accommodate the box sometime between 1930 and 1948. A portion of a bracket, likely part of the anchorage system for the box, remains attached to the wall. The windows on this elevation are 4/6 like those on the north elevation. However, the east window on the south elevation has a metal screen on a wood frame attached to the window frame. Also present are five brackets for shutters that no longer exist.

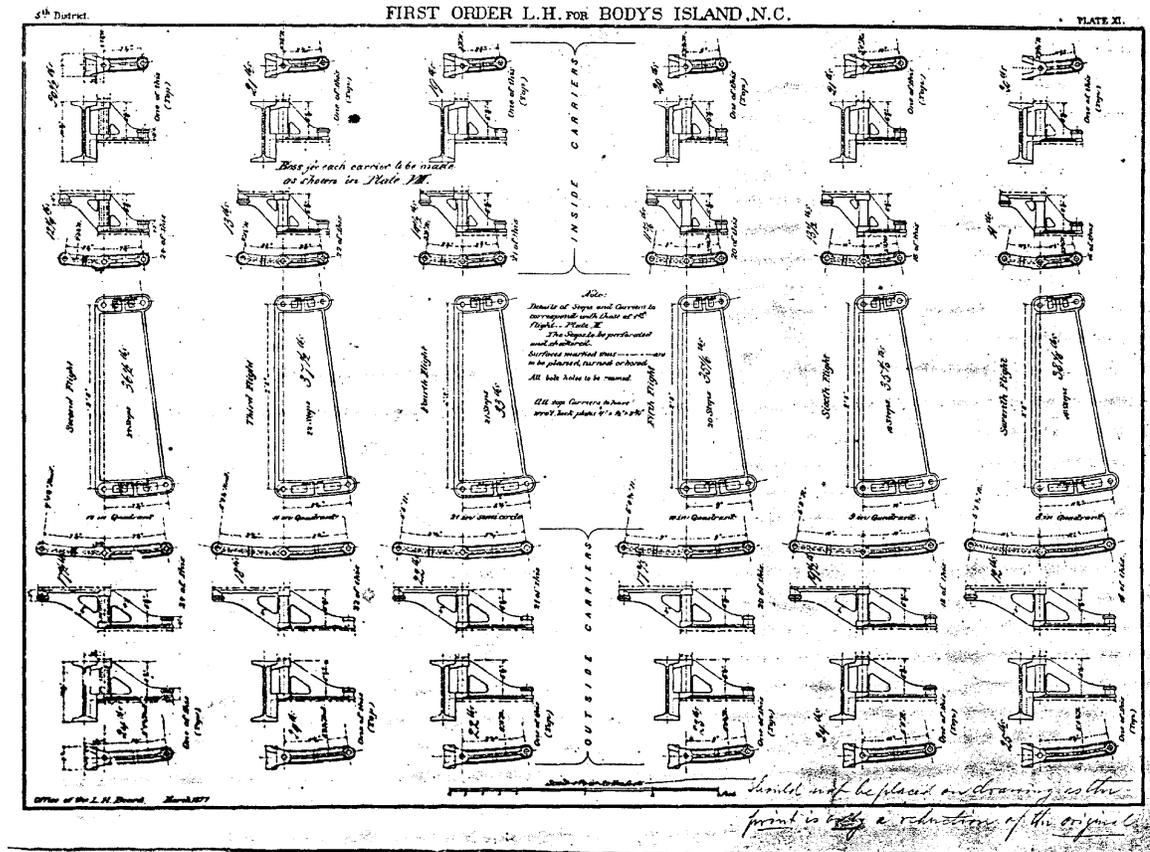
Figure 22 Plate XI, 1871 Drawings.

Stairs: Since the stairs are common to all levels of the Tower, they are addressed here to best present their condition and characteristics. The original drawings document the characteristics of the stairs in great detail. The Tower stairs and landings (except for the first level which is on fill with marble and stone flooring) are cast iron. There are five cast iron components associated with each tread (see Plate XI. of the 1871 construction documents), which are cast iron with an open-checked plate walking surface.

The landings are cast iron plate with diamond pattern on the walking surface and an integral reinforcing grid on the underside and are supported by a cast iron I- beam at the diameter edge of the landing.

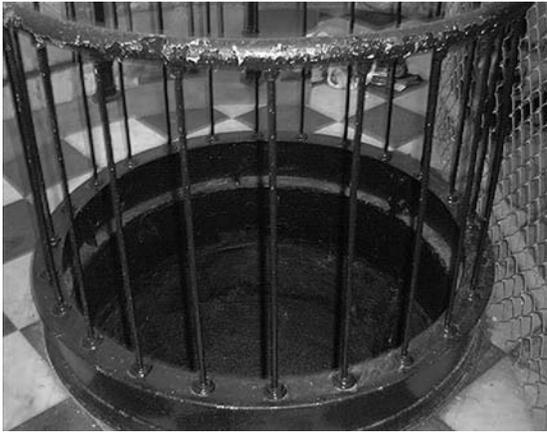
Well: In the center of the ground level is a depressed well approximately 30" deep protected by an original cast iron railing 38" high. The well is constructed of cast iron, with a cast iron wall and cast iron floor, the entire assembly being painted black. The well and railing are in sound condition. The well was reportedly constructed to receive weights used in the operation of a mechanism that would allow the

Figure 23 Well.

light to “flash.” However, the mechanism was never installed, and, thus, the well was never used as intended in the original design.

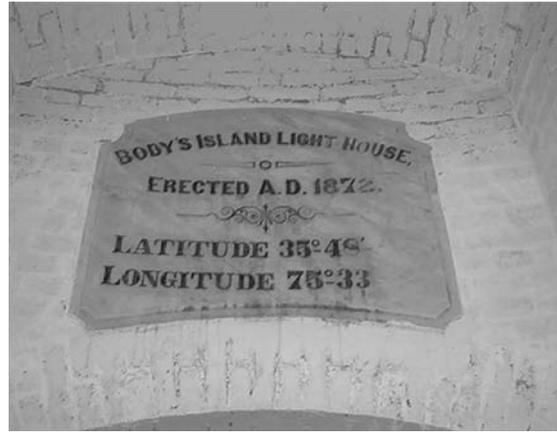
Dedication Plaque: A marble dedication plaque is mounted on the archway facing the center of the Tower (see picture). There are three points of note regarding this plaque. First, the spelling of “Body” is an early spelling of the name, thus suggesting an early fabrication and installation

Figure 24 Dedication Plaque.

of the plaque. The second point of note is that the 1871 construction documents do not show a plaque, suggesting one was designed, fabricated, and installed in an exercise separate from the original construction. Thirdly, this is not the first plaque erected. The original plaque listed the members of the Lighthouse Board and the date at the time the construction of the Bodie Island Lighthouse was begun. An image of the drawing for the original plaque is found in the Chronology of Development and Use portion of this report. The drawing indicates that the location of this plaque is also the location of the installation of the first plaque. The current plaque is in excellent condition, but has some overpainting of white, the result of applications of paint to the wall to which it is affixed, that should be removed.

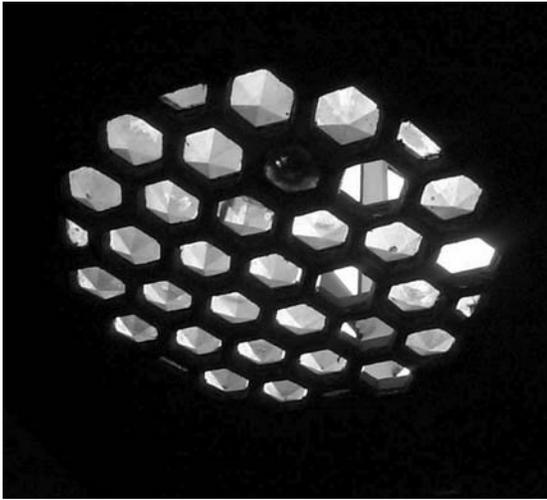
Figure 25 Watch Room ceiling insert made of prismatic glass.

Watch Room level below the lantern, much like the deck prisms of ships. A number of the glass prisms are missing. The cast iron grating and lens pedestal appear in sound condition. On the southwest side of the Watch Room is a penetration in the ceiling for a vent for earlier coal heat at that level. This source of heat has been abandoned.

The grating that serves as both the ceiling of the Watch Room and the floor of the lamp level is missing several of the glass prisms installed in the inserts to provide light to the Watch Room below. This grating and the interior of the muntins in the lamp should be stripped of paint, inspected for defects, and repaired as necessary. Replacement prisms should be fabricated and securely installed in the grating. (It is entirely possible that some of them have been removed in the past as souvenirs.) The grating and the muntins should be repainted as appropriate, consulting the 2002 paint analysis for guidance on paint colors.

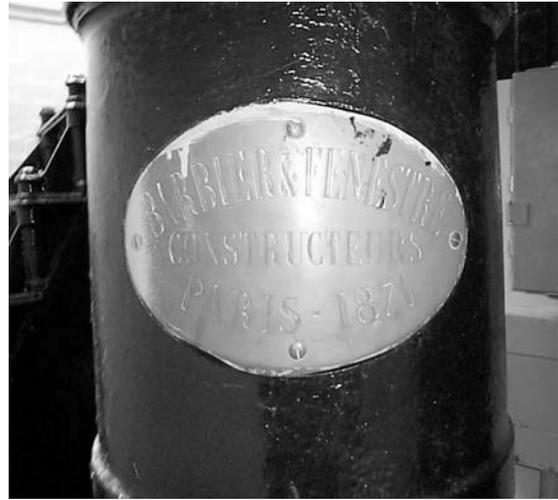
Figure 26 Lens pedestal, original manufacturer's brass plaque.

of the pedestal. The pedestal is in good condition.

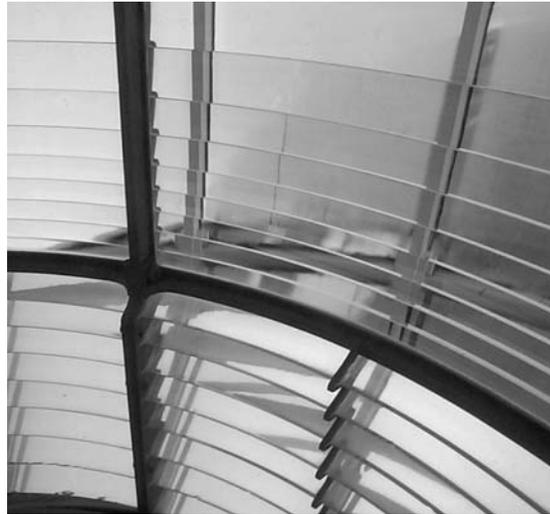
Lens: The lens is a first order Fresnel lens held in position by a brass and iron frame. There are five distinct sections of the lens defined by the position and configuration of the prisms. Except for a few chipped prisms and one missing prism in the second tier from the top of the southeast quadrant of the lens, the lens appears

Figure 27 First order Fresnel lens.

in sound condition. The frame exhibits a limited amount of oxidation in some parts of the cast iron frame. The bronze components of the lens frame appear in good condition.

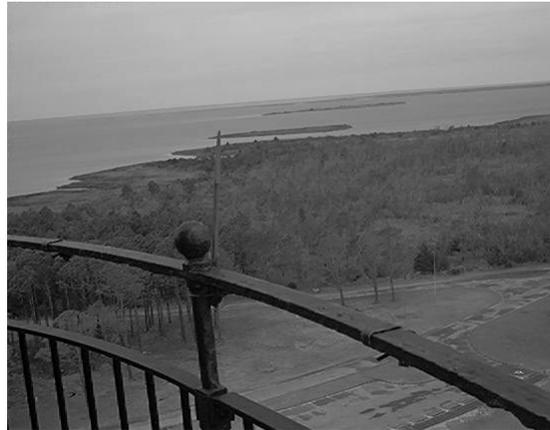
Figure 34 View from Lantern Gallery.

load mandated by current building codes. The top side of the floor plate shows some rusting but is adequate to support a man, though probably not the 100 pounds per square foot mandated by current building codes for public access areas. The brackets which support the gallery could not be closely inspected, due to lack of access, but at least a portion of one of the brackets has fallen to the ground. The condition of the gallery railing, installed in the 1960s, which is severely corroded, can give some indication of the condition of the support metal below the gallery, installed in 1872. It should be noted that these conditions have been in evidence since at least the 1989 structural evaluation performed by the U.S. Corps of Engineers for the Coast Guard, and have been repeatedly mentioned in subsequent reports. These reports and the warnings contained therein should be taken very seriously. Recommendations regarding these components may be found in the “Ultimate Treatment and Use” portion of this report.

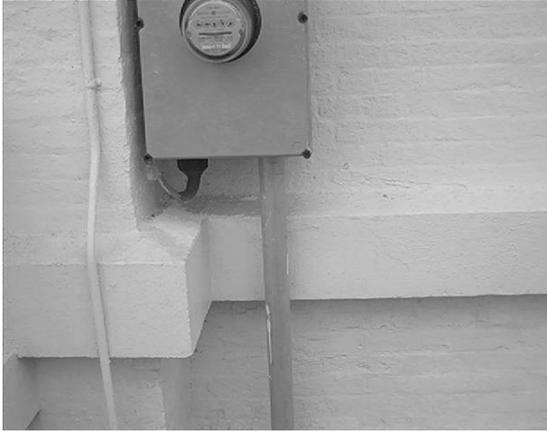
The electrical service entrance for the Bodie Island Lighthouse is provided via underground service. The utility meter is mounted on the west side of the entrance to the Oil House, and the meter indicates 120/240 V service (see Figure 36).

Figure 36 Detail of utility meter.

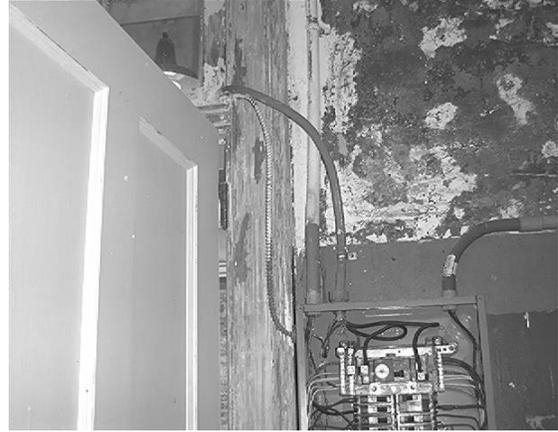
The routing of the service conductors and grounding cable runs from the utility meter to above the door of the Oil House entrance (see Figure 37), penetrates the door (Figure 38), is routed across the south wall of the Hall to above the Oil Room door, and penetrates the door to the distribution panel (see Figure 39).

Figure 39 Detail of electrical wiring access to distribution panel.

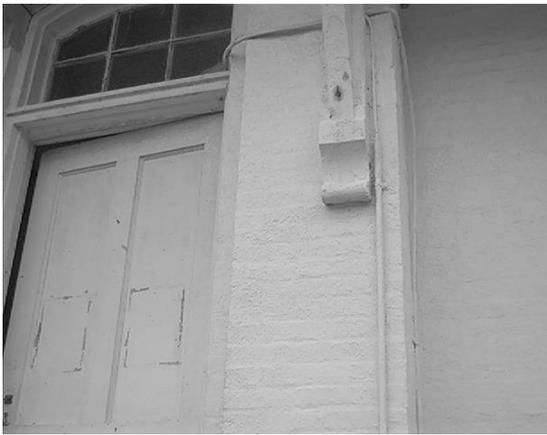
Figure 37 Detail of utility routing through door frame

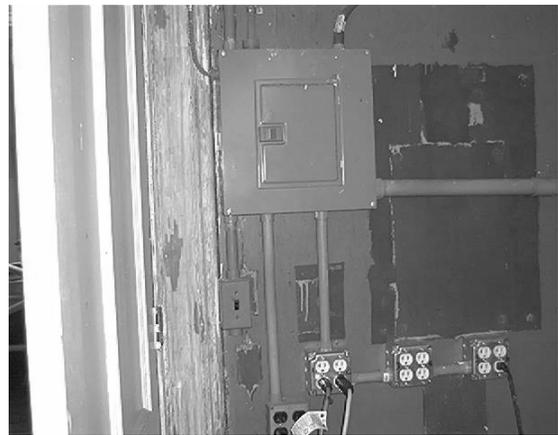
The distribution panel is a 12-circuit panel with a 100A main circuit breaker located in the north wall of the Oil Room (see Figure 40).

Figure 40 Detail of distribution panel.

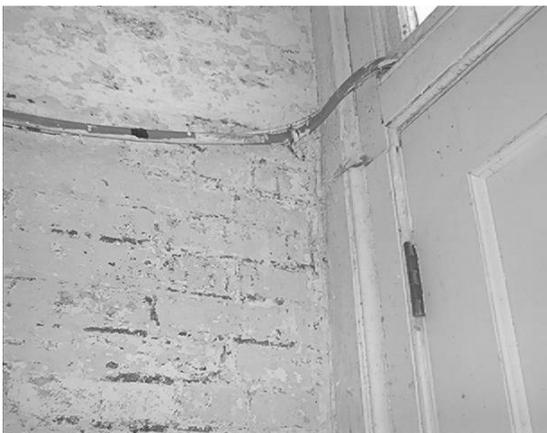
Figure 38 Detail of electrical line.

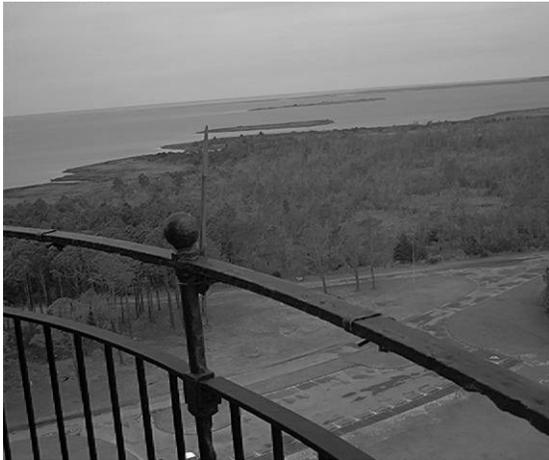
Figure 41 Lightning rod installed on gallery handrail.

There are number of lightning rods installed on the handrail of the gallery and supported by the handrail (see Figure 40) with two opposite down conductors (2/0) on the north and south side of the Lighthouse. The two down conductors are bare copper and are routed exposed to approximately 14' above ground, then routed to a 1/2" schedule 40 PVC conduit to the earth (see Figure 41). There was no indication of what the down conductors were connected to underground (ground rods, ground ring, or both). The original lightning rod at the top of the ventilator ball is no longer connected to any down conductors. However, a bare copper cable runs from a newel post at the base of the Tower stairs, along the perimeter of the ground floor of the Tower, through the window on the north side of the Hall Connection (H/100), and down the wall on the exterior into the ground. This

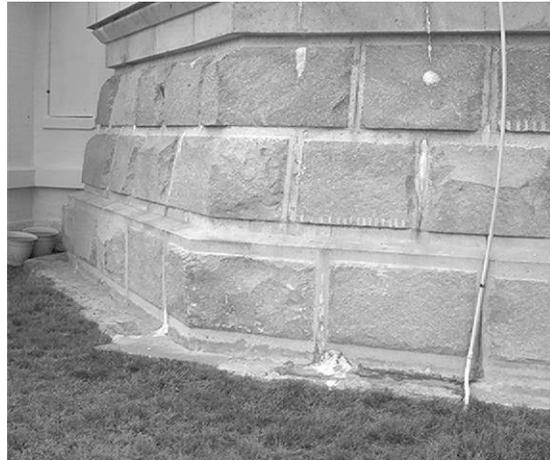
Cables to the main light (circuits number 2 and 4) are in good condition and appear to have been installed recently. The cables are routed through a PVC conduit with fittings from the ground level to the main lights. Conduit and

Figure 42 Conduit for lightning protection, located at tower base.

fittings are in good condition. Conduit continues to the control box in the Watch Room level and then to the main light.

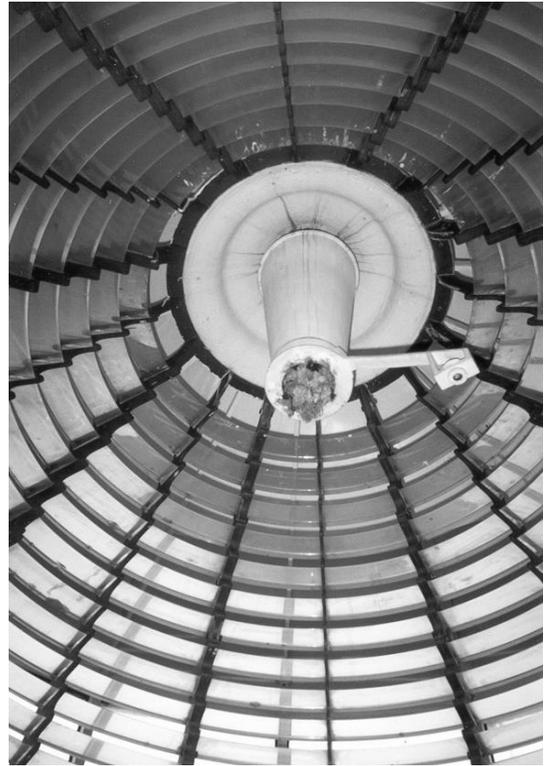
Figure 45 Detail of Fresnel lens.

The Fresnel lens and the light within are the property of the United States Coast Guard. It is not recommended that the Park Service undertake any repair activities on these features. The hood above the lens and the ventilation tube that connects to the ventilator ball are, however, features belonging to the Lighthouse structure. These should be cleaned, repaired if necessary, and painted if required. The ventilation tube is stopped up with some sort of fabric or paper. This should be removed. However, it is desirable to prevent insects, rain, or birds from accessing the interior of the Fresnel lens, so the tube should be stopped with caulk or other waterproof material at a distance inside
