CAPE LOOKOUT NATIONAL SEASHORE
Coast Guard Station Boat House
**HISTORIC STRUCTURE
REPORT**

2004
Historic Structure Report
Coast Guard Station Boat House
Cape Lookout National Seashore
Cape Lookout Village
LCS#: 09t830

Historic Structure Report

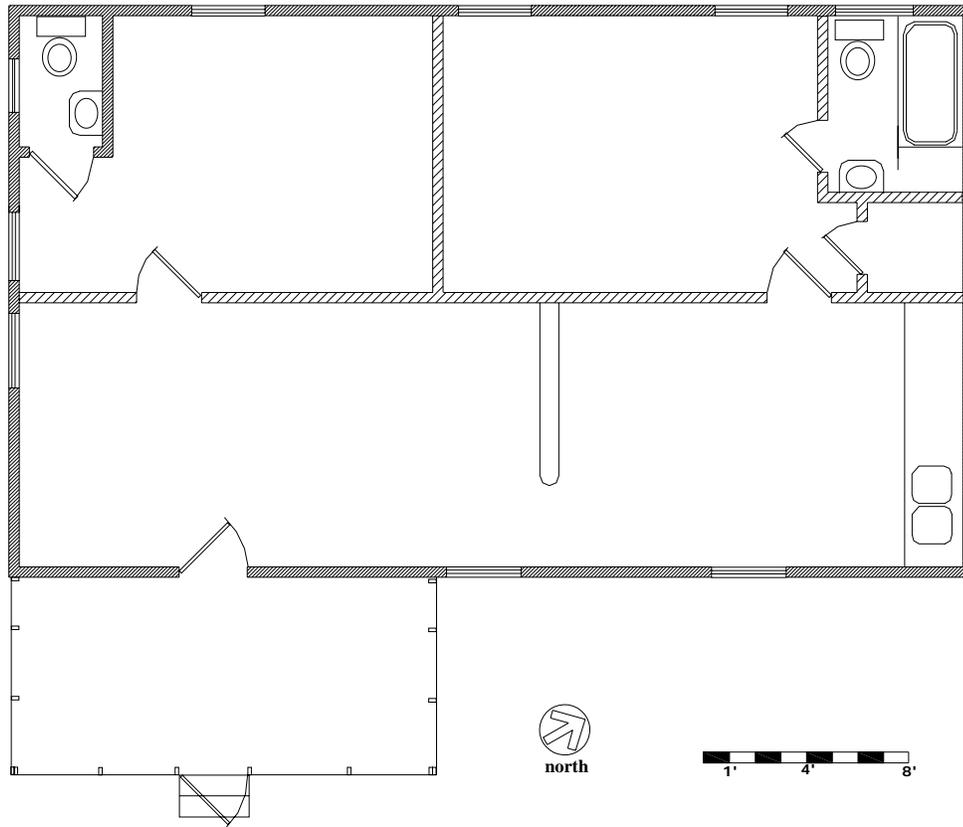
Alterations to the doors was the first major change. The single door on the southeast side of the building was removed and the opening closed by a wall and a conventional front door. The exterior of the wall was sided with drop

Figure 22 Plan of Boat House showing alterations in the 1960s. (T. Jones, NPS-SERO-CR, 2003)

siding that matched the original siding, but it is not clear if the existing front door was installed at that time or if it is a later replacement. At the northeast end of the building, the old double doors were simply fixed in place and the exterior covered with drop siding. The roof was also shingled with wood at the same time.

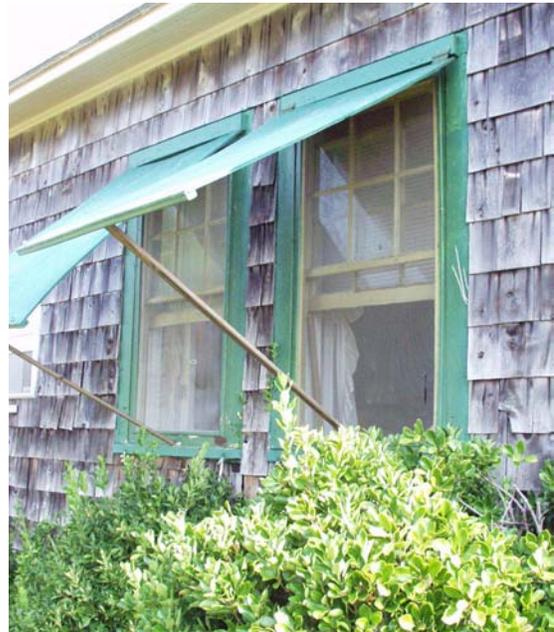
Figure 28 View of historic windows on northwest side of house with modern awning shutters. (NPS-SERO-CR, 2002)

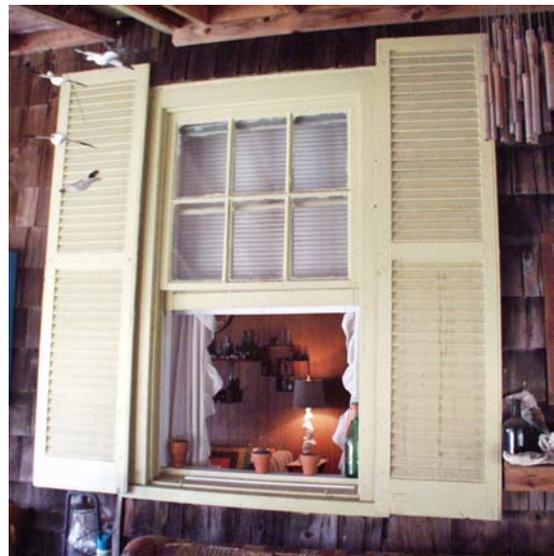
Figure 29 View of historic window on front porch with salvaged shutters added by present owner. (NPS-SERO-CR, 2002)

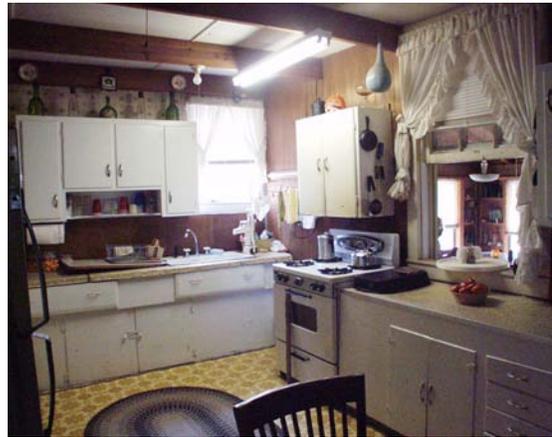
Miscellaneous: A wooden base cabinet approximately 27" wide runs the width of the northeast end of the room. According to the house's present occupant, who moved the building in 1958, this cabinet was part of a somewhat longer workbench that was originally located on the northwest (rear) wall of Room 102. Dimensions of wood used in its construction suggests that the cabinet dates to the building's original construction. The base cabinet door openings may not be original but the two drawers appear to be so. Both have faces 8-1/2" by 33", with broadly chamfered edges. Beneath the cabinet, part of the original boat doors at that end of the building are visible. The door was constructed with double-V-joint, tongue-and-groove, similar to that used on the building's soffit.

Wall cabinets on the northeast and northwest walls and the base cabinet on the northeast wall are wood and date to the building's remodeling after 1958. The top of the work bench is a board that is unusually wide, 22", and 1-3/4" thick.

Figure 32 View to east in Room 101. Base counter at center left is part of a work bench that was originally in the space now occupied by Room 102. (NPS-SERO-CR, 2002)

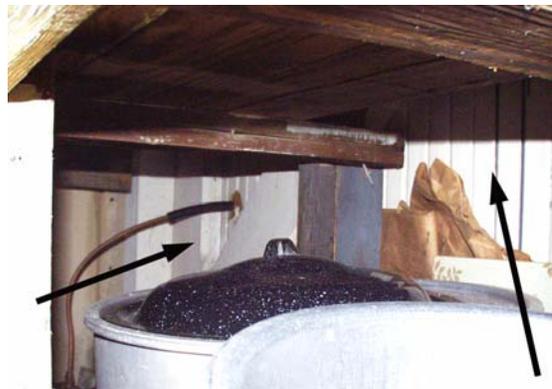
Figure 33 View of part of original boat doors under kitchen counter. Arrows indicate chamfered framing of door, left, and V-joint paneling used to finish doors, right. (NPS-SERO-CR, 2002)

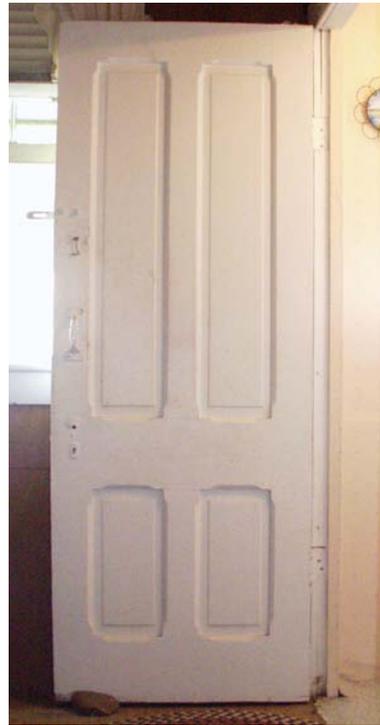
Figure 36 View of door to Room 102, believed salvaged from Life- Saving Station when it was remodeled in 1924. (NPS-SERO-CR, 2002)
