CAPE LOOKOUT NATIONAL SEASHORE
Cape Lookout Lighthouse
Keeper's Dwelling (1907)
**HISTORIC STRUCTURE
REPORT**

**Historical Architecture, Cultural Resources Division
Southeast Regional Office
National Park Service**

2002
Historic Structure Report
Cape Lookout Lighthouse Keeper's Dwelling
(1907)
Cape Lookout National Seashore
LCS#: 091838

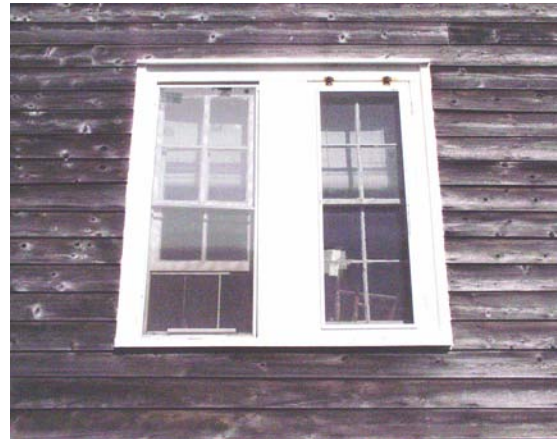
All of the present window and door openings on the house are historic, with all but two of those being a part of original construction. However, a number of the original sash have been replaced, although the original muntin pattern was maintained. Double windows are used on both stories of the three gable ends of the house, with single windows present elsewhere. Double window sash are four-over-four, 2'-1" by 5'-2" on the first floor and 2'-1" by 4'-6" on the second floor. Single window sash are six-over-six, 2'-10" by 5'-2", on the first floor and 2'-10" by 4'-6" on the second floor. Most of the sash are in generally good condition, except for paint, which is beginning to fail.

Figure 9 View of typical double windows. (NPS-SERO-CR, 2002)

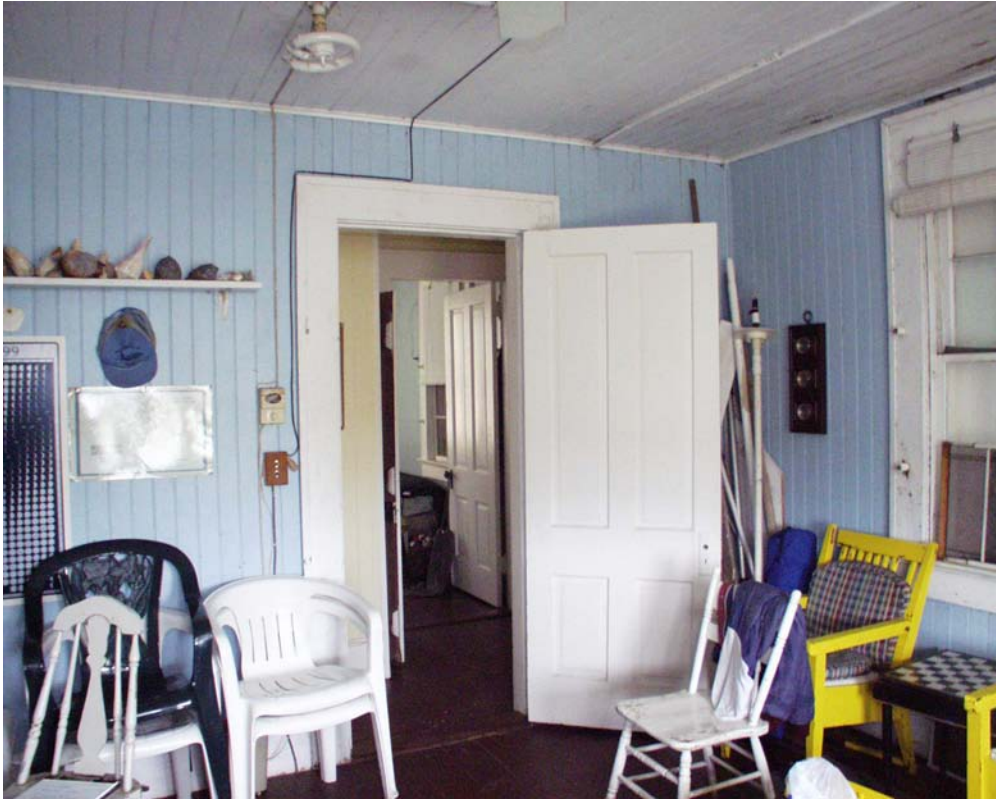
Doors: The door from the hall is 2'-6" by 7'-0" by 1-3/8" with four vertical panels. A mortise lock is present but the knob is missing. In addi-

Figure 23 View to west in Room 102. (NPS-SERO-CR, 2002)

tion, the door has been damaged and the hinges bent, with the damage only partially repaired.

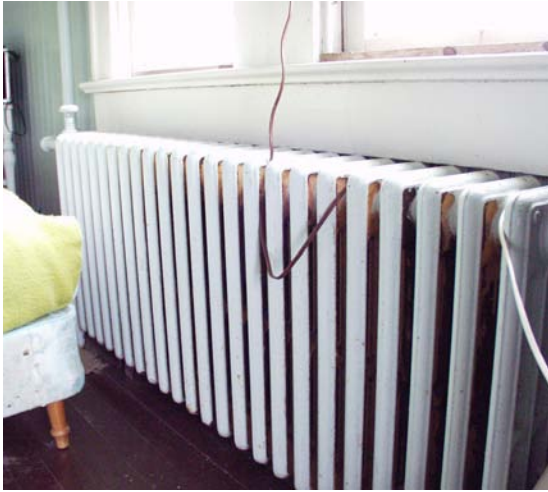
Figure 35 View of radiator in Room 203, which was typical of those installed in the 1930s. (NPS-SERO-CR, 2002)

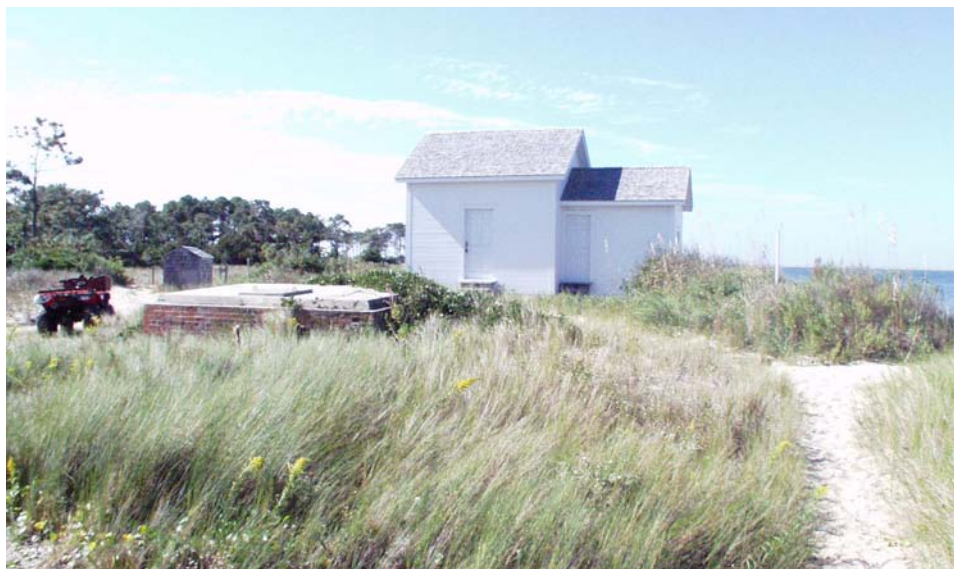
Figure 37 View to southwest of original site of Barden House, showing brick cistern and summer kitchen constructed along with the house in 1907. (NPS-SERO-CR, 2002)

Treatment: The building should be returned to its original location at the light station, which is very well documented and so should require a minimum of conjecture in reconstructing its brick foundation on the original site. In addition to reconstructing the building's foundation, the exterior of the building should be restored to its appearance just prior to 1950 by

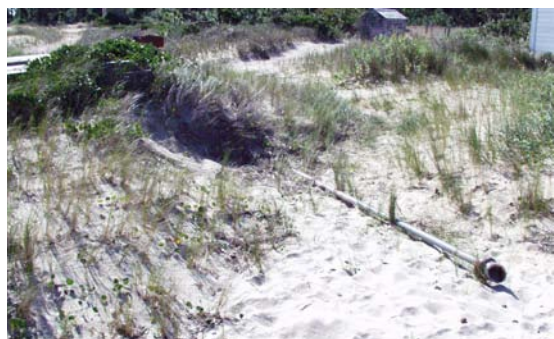
Figure 38 Waste line from kitchen at original site. (NPS-SERO-CR, 2002)

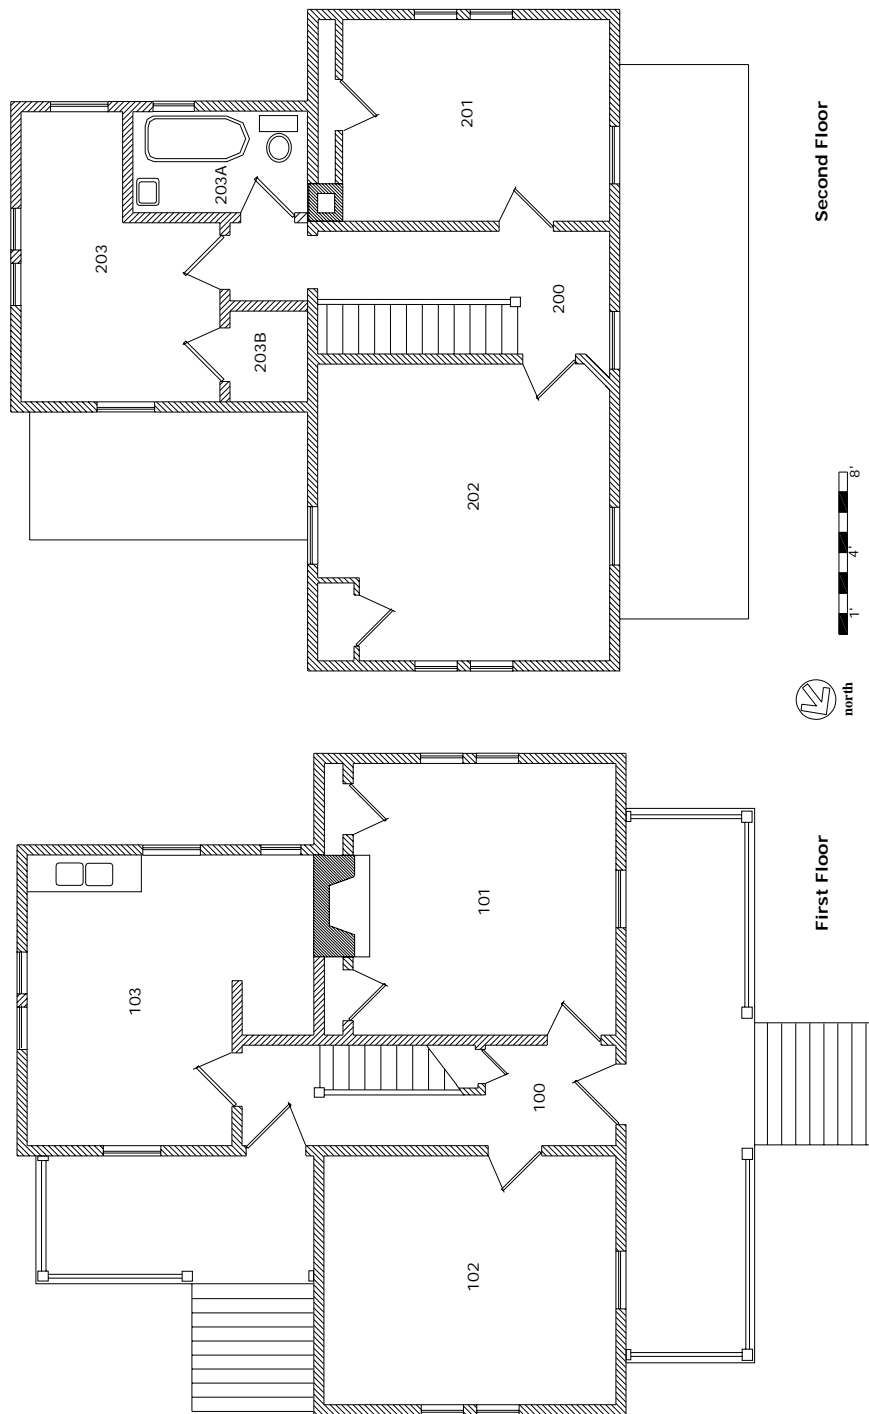
Figure 40 Plans of 1907 Keeper's Dwelling at it exists today. (T. Jones, NPS-SERO-CR, 2002)
