Cape Lookout National Seashore

**Cape Lookout**  
**Life-Saving Station**  
**HISTORIC STRUCTURE REPORT**

Historical Architecture, Cultural Resources Division

2004

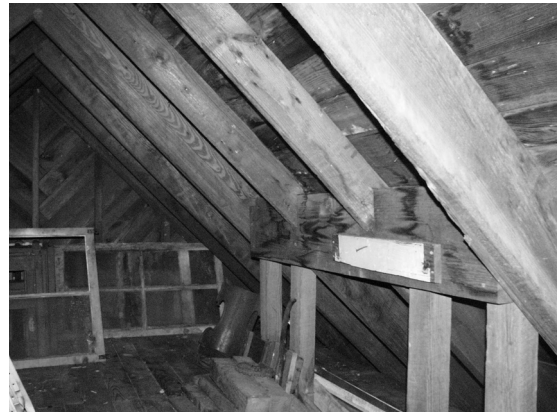
**Figure 48** View of roof framing at northeastern end of the building. Rafter at upper right is original; the next two, which are smaller, infill the original opening for the lookout. (NPS-SERO-CRS, 2002)

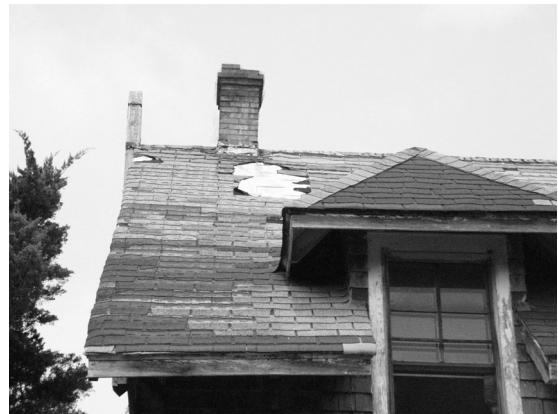
metal roof. Probably when the building was moved in 1958, asphalt “hurricane” shingles were installed over the metal roofing, except on the dormers. The entire roof, including the dormers, was overlaid with the present, three-tab, asphalt shingles in a variety of colors around 1970. These shingles are missing in several areas and in poor condition over the entire surface of the roof.

**Figure 49** View of existing roofing. White “hurricane” asphalt shingles installed in early 1950s are exposed just below the chimney. (NPS-SERO-CRS, 2002)

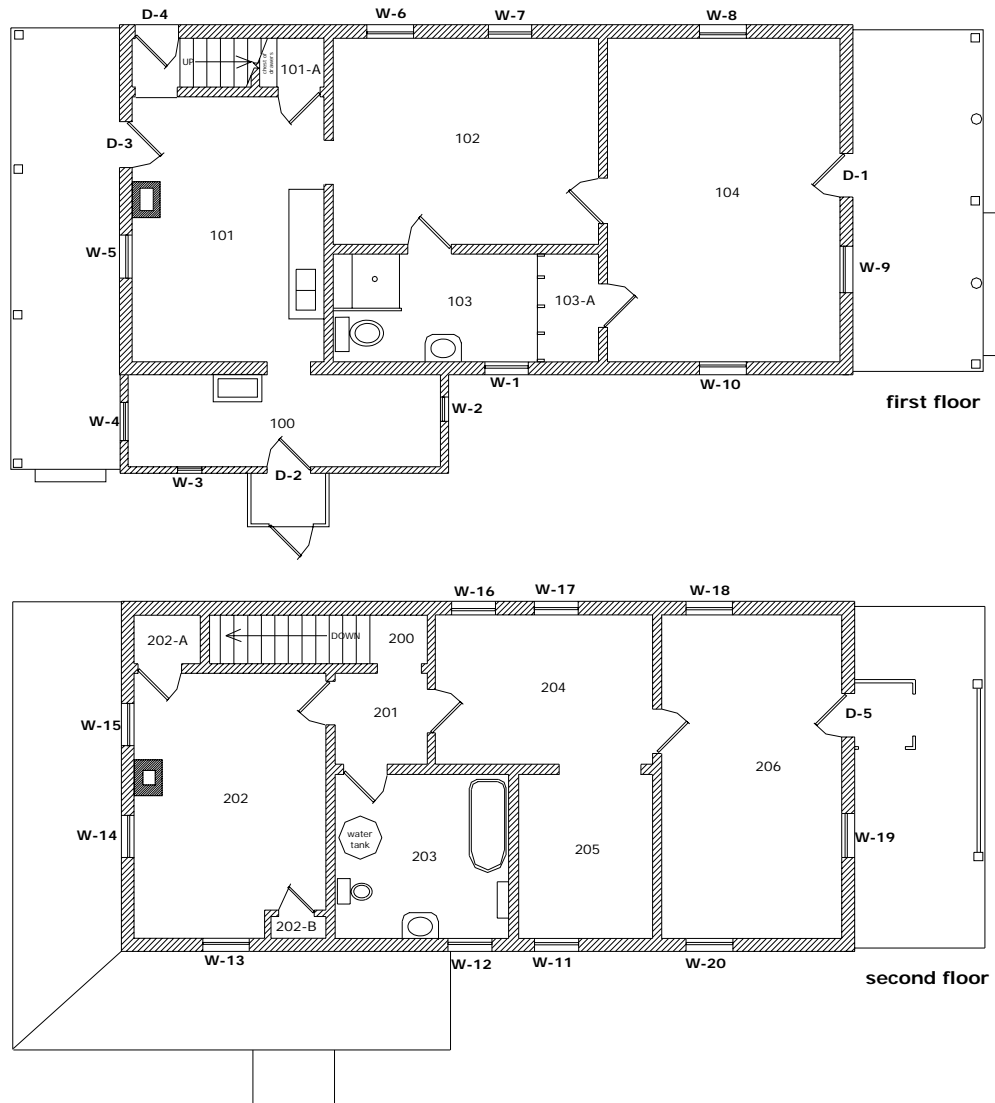
*W- 3:* Opening created when chimney was removed in 1958; opening 1'-6" by 2'-11"; fixed, two- light sash; typical sill, casing, drip cap, and wood- framed screen; poor condition.

*W- 4:* Opening is part of enclosure of original entry porch, c. 1920; opening 2'-4" by 4'-2", double- hung, wood sash, 4/4, probably relocated from east wall at D- 2; poor condition.

**Figure 50** .Plan of windows and doors. (T. Jones, NPS-SERO-CRS, 2002)

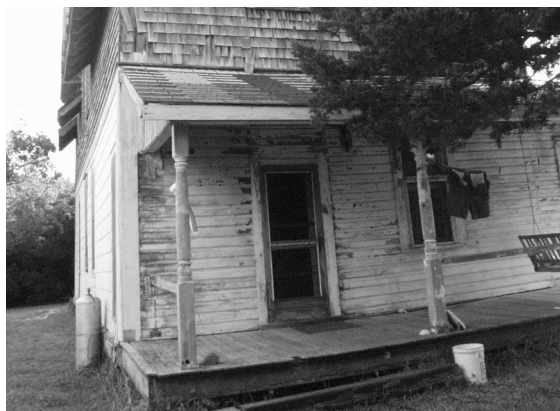
**Figure 57** View of back or south porch, added before 1905. The door was not present until the renovations in the 1920s. (NPS-SERO-CRS, 2002)

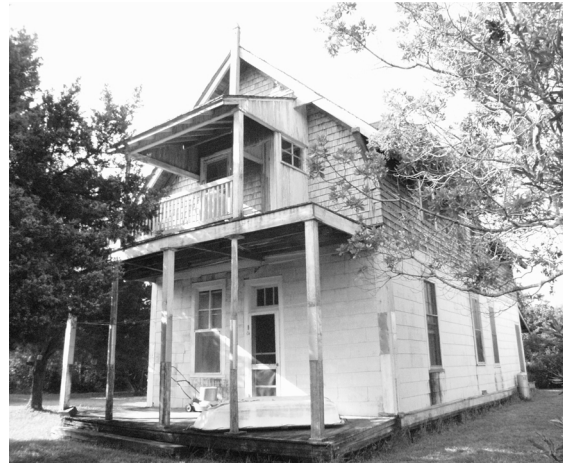
*Front Porch:* The front porch, located on the northeast end of the house, was added before World War II, but unlike the back porch, which is considerably older, is badly deteriorated and in unstable condition. Floor framing at the first floor level was inaccessible but the condition of the floor deck indicates serious problems with the underlying framing. Flooring, which appears to be mostly original, is 7/8" by 2-1/2", tongue- and groove.

Deterioration, especially of the sills and floor framing at the first floor level, has allowed the roof of the upper porch to pull away from the building as much as 2", and the framing for the second floor is in very poor condition.

**Figure 59** View of front porches, added in 1920s. (NPS-SERO-CRS, 2002)

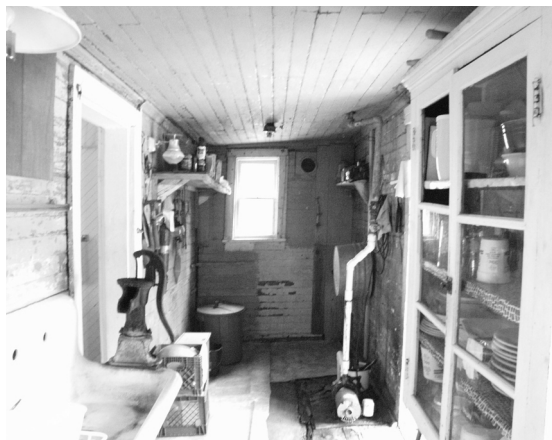
**Figure 63** View to north in Room 100, showing location of original pantry. (NPS-SERO-CRS, 2002)

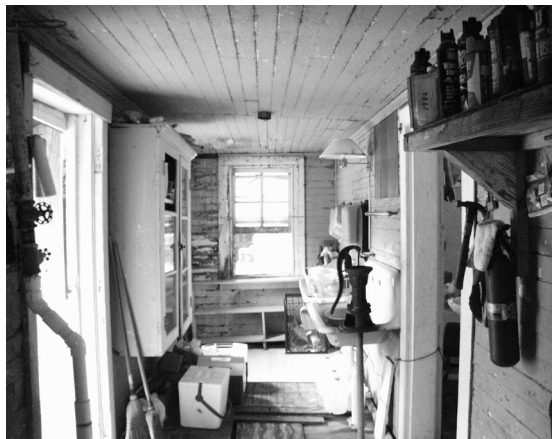
**Figure 64** View south in Room 100, showing location of original entry porch. Door opening at left replaced a window in the original configuration of the space. (NPS-SERO-CRS, 2002)

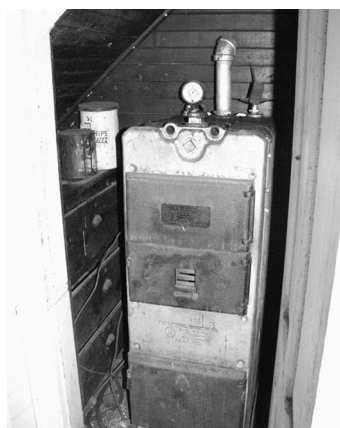
**Figure 67** View of original closet on west side of kitchen and defunct boiler now stored in the space. (NPS-SERO-CRS, 2002)

*Closet (Room 101-A):* Located on the west side of the room, beneath the stairs, this space was part of the building's original configuration. It features an original, built-in chest with three drawers on its southwest wall. Also in this space is a boiler that was part of the building's steam-

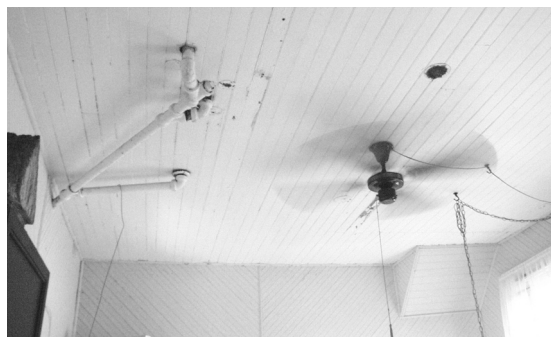
**Figure 70** View of ceiling in Room 102, showing cast-iron waste lines (c. 1920) from upstairs bathroom. (NPS-SERO-CRS, 2002)

Cast-iron waste and vent lines from the bathroom in Room 202 are exposed on the ceiling along the east side of the room. Because the upstairs sink was relocated, only the vent stacks are still in use. Other holes in the ceiling above the windows indicate the location of risers for the building's historic heating system.

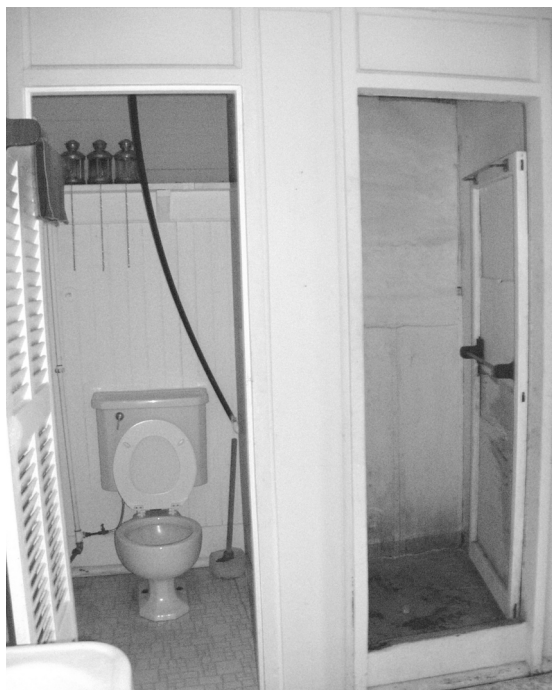
**Figure 72** View of toilet and shower in Room 103. Note original wainscot on rear wall of toilet room. (NPS-SERO-CRS, 2002)

south corner of the room is a toilet room, 3'-2" wide and 4'-2" deep, closed by a louvered door, 2'-8" by 6'-8". The American Standard toilet tank is stamped with a date of 3/28/38 and the tank lid with a date of 3/22/38. Adjacent to the toilet room is a metal shower enclosure, 3'-1" by 3'-2". The walls surrounding both of these spaces rise to about 8', with the area above an unenclosed storage area.

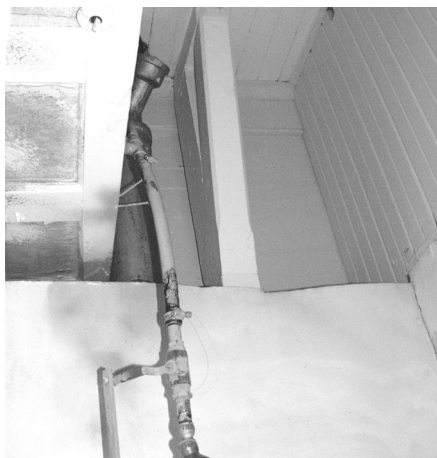
**Figure 73** View of large bracket behind and above shower, installed to support water tank at second floor. Note original cornice on rear wall. (NPS-SERO-CRS, 2002)

*Miscellaneous:* Next to the toilet is a large, cast- iron water tank set on wooden blocks and supported from below by a large bracket mounted against the ceiling below in Room 103. It was installed after 1969 to replace the original 1920s tank, which was moved but remains in the room after an unsuccessful attempt to saw it up and remove it.

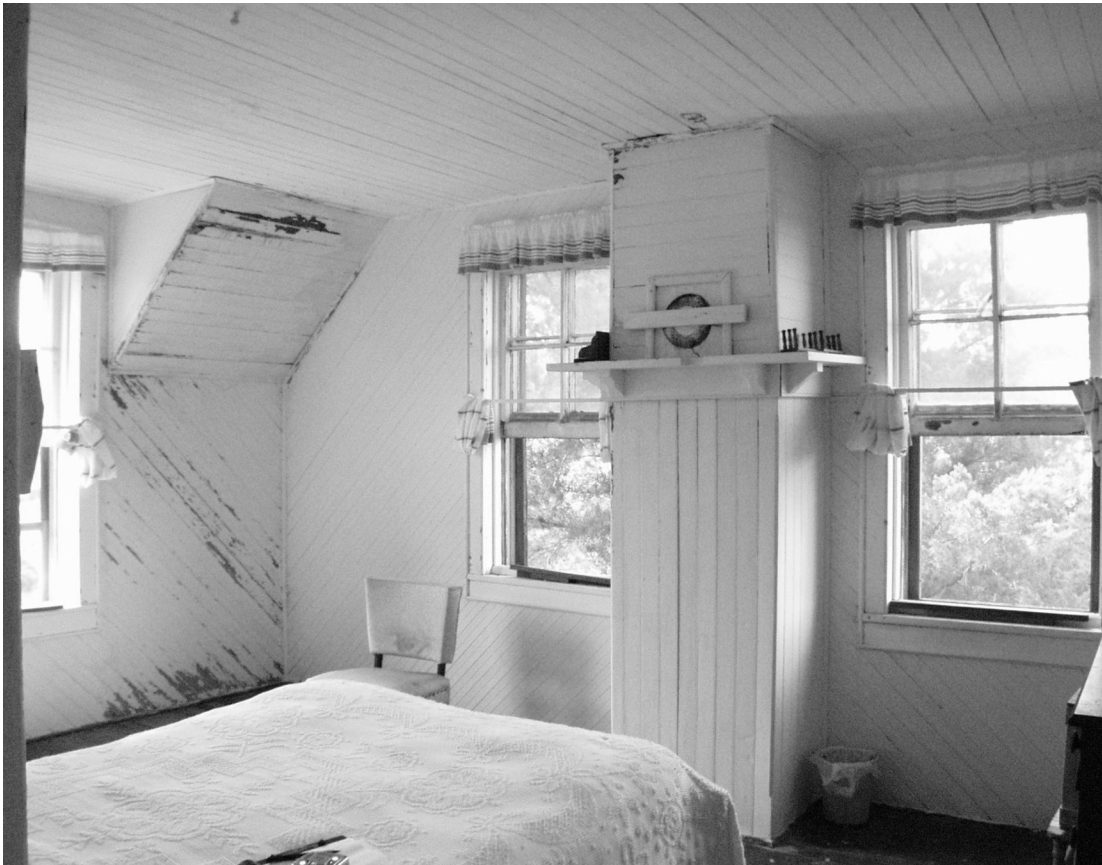
**Figure 76** View to south in old keeper's room (Room 202). Note original paneling and plate rail around chimney rising between the two windows on the south wall. (NPS-SERO-CRS, 2002)

paneling. Original paneling with plate rail remains in place around the chimney which rises between the two windows on the southwest wall.

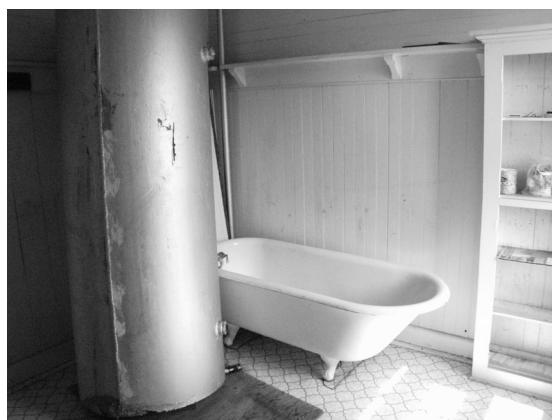
**Figure 81** View to north in Room 203, showing tub and original 1920s water tank. (NPS-SERO-CRS, 2002)

*Fixtures:* Along the northeast wall is a footed, enameled, cast- iron tub, 5' long, in excellent condition with its original fittings intact. On the southeast wall is a wall- hung, enameled cast- iron sink, recently moved from its original location on the northwest wall, where the original brass waste line and "O" trap remains intact. A "Standard Trenton" porcelain toilet with a wall- mounted tank is installed against the southwest wall. The tank lid bears a date of December 3, 1943.

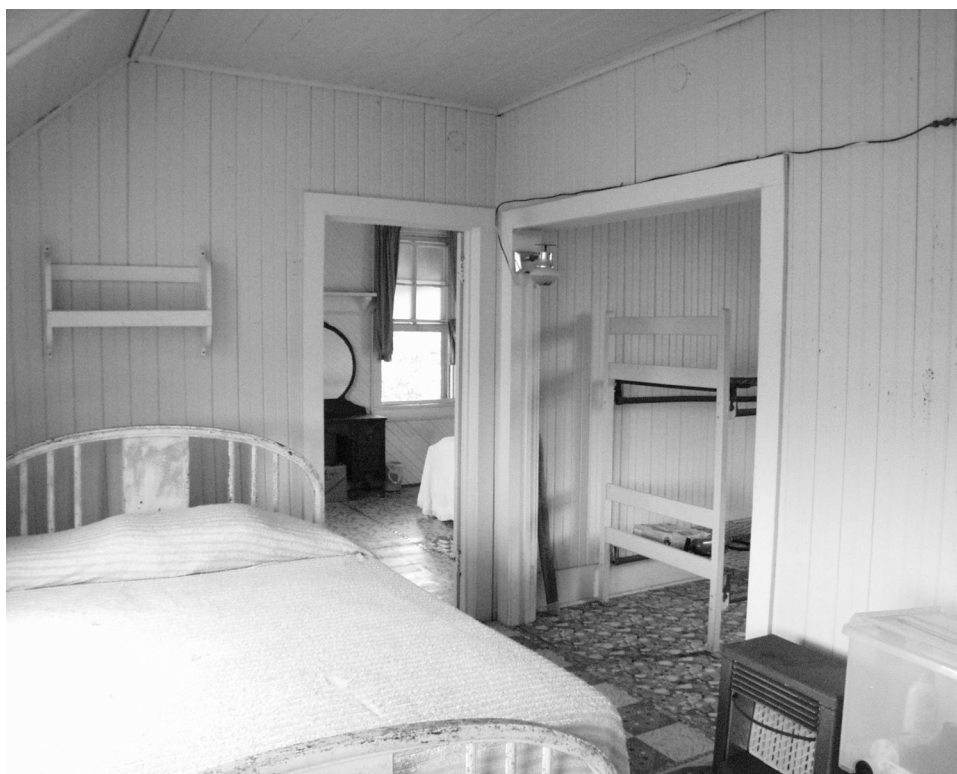
**Figure 83** View to northeast in Room 204. Large cased opening at right was created after the partitioning of the crews' quarters, probably after the building was moved. (NPS-SERO-CRS, 2002)

On the southeast wall a large cased opening, 5'- 2" by 6'- 7", opens into Room 205. About six feet of this wall was removed in the 1960s, but the ghost of an earlier header indicates that there was a door, which was presumably five- panel, at the northern end of this opening.

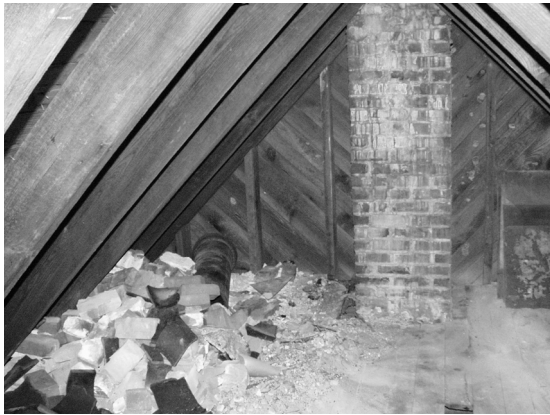
**Figure 87** View to south in attic showing chimney stack and unidentified brick rubble. (NPS-SERO-CRS, 2002)
