Cape Lookout National Seashore  
GASKILL - GUTHRIE HOUSE  
**HISTORIC STRUCTURE  
REPORT**

**Historical Architecture, Cultural Resources Division  
Southeast Regional Office  
National Park Service**

2004

2004  
Historic Structure Report  
Gaskill- Guthrie House  
Cape Lookout Village  
CAPE LOOKOUT NATIONAL SEASHORE  
Harker's Island, NC  
LCS#: 272049

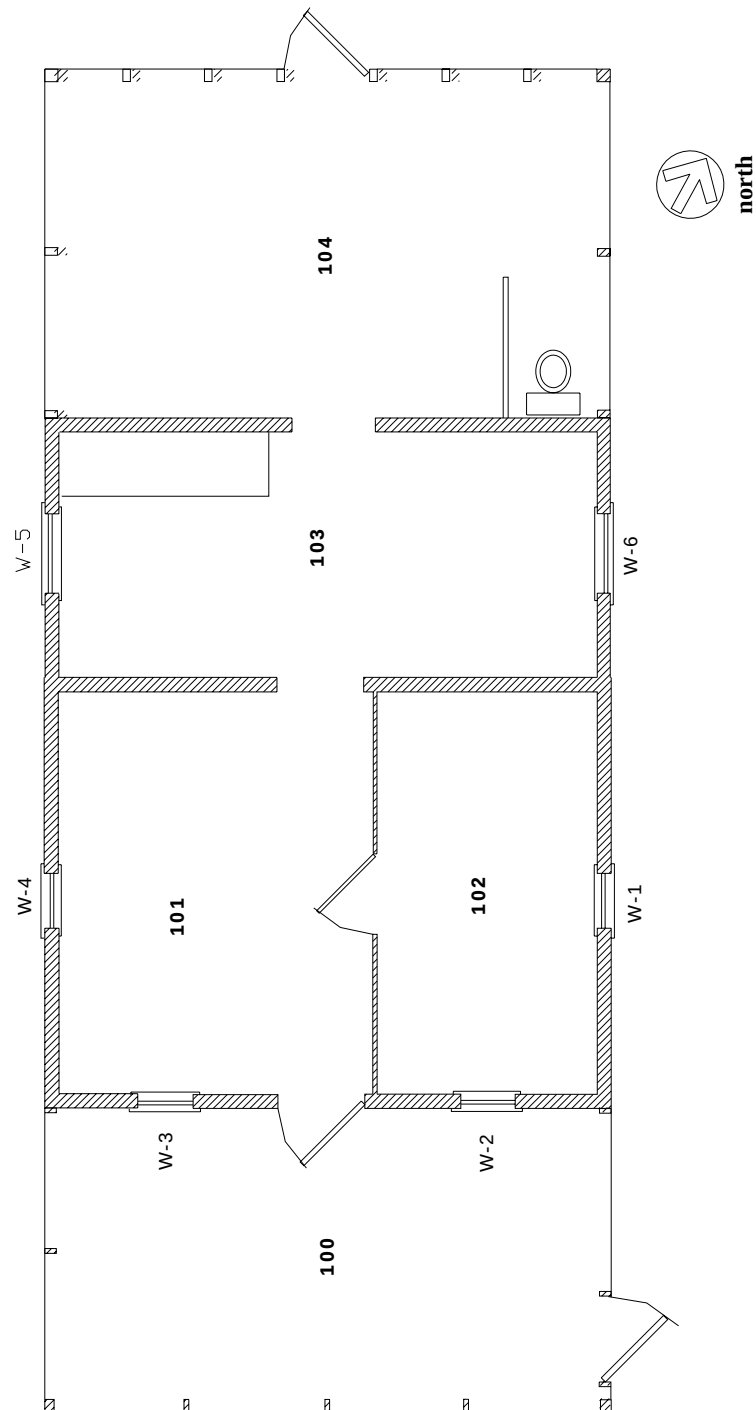
*Electricity:* The house has been wired for electricity, but the system is haphazardly installed and does not meet modern codes.

*Plumbing:* Historically, the house did not have an indoor bathroom. A toilet has been added on the back porch since 1976. Off the north corner of the house, a concrete slab, 2' - 10" by 3' - 3" marks the location of a septic tank, which may only consist of a wooden box or metal barrel buried in the ground and a drain field that appears to be no longer than about eleven feet.

**Figure 30** Plan of existing Gaskill-Guthrie House. (NPS-SERO-CRS, 2002)

In addition, continued residential use requires rehabilitation, especially replacement of the building's electrical and plumbing systems. The Lighthouse Keeper's Quarters (or Barden House), the Life- Saving Station, and other
