Cape Lookout National Seashore
Portsmouth
GEORGE DIXON HOUSE
**HISTORIC STRUCTURE
REPORT**

2004
Historic Structure Report
George Dixon House
Cape Lookout National Seashore (CALO)
Portsmouth, NC
LCS#: 12519

Historic Structure Report

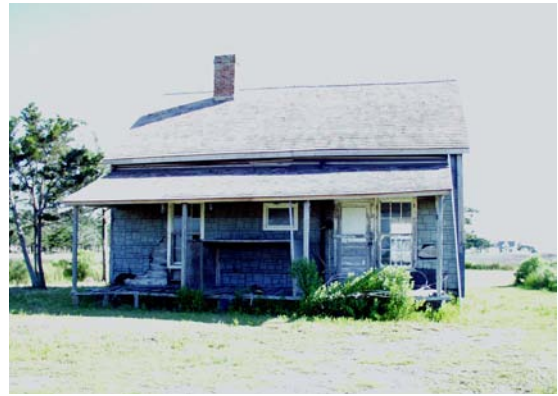
Figure 10 View of rear or southwest side of Dixon House. (NPS-SERO-CRS, 2002)

The original back door was closed when the bathroom was created and a small window installed in its place. At that time, a new door opening, 2'- 8" by 6'- 8", was created from the back porch into Room 104. The door is identical in design to the front door but in much poorer condition with the lights in the upper part of the door missing and replaced by plywood.

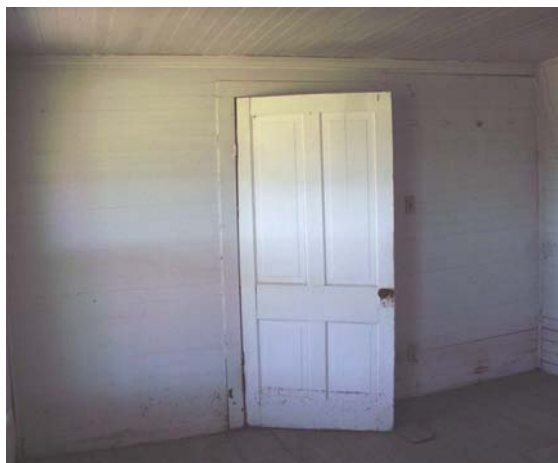
Figure 17 View of south wall of Room 101, showing typical door in house. (NPS-SERO-CRS, 2002)

Floors: Flooring is 5"- wide, painted, tongue-and- groove boards. The collapsing sill that runs through the center of the house has

caused major deflection of the floor around the middle of the hall.

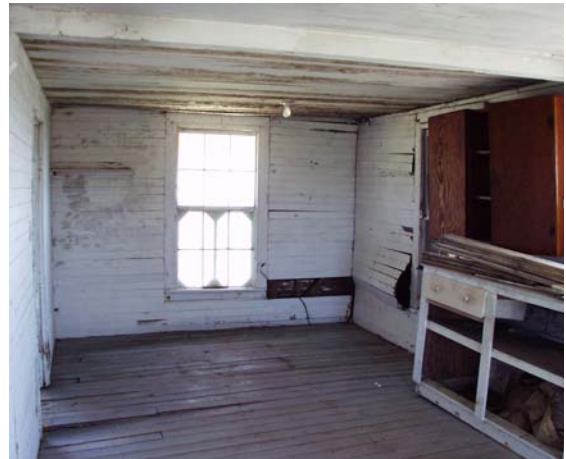
Figure 22 View east showing Room 104, now combined with Room 103. (NPS-SERO-CRS, 2002)

Walls: The wall that was constructed to partition this space from the central hall is composed of plain, 3- 1/4”- wide, tongue- and- groove boards attached at the floor and the ceiling without an internal frame.

Ceiling: The ceiling is finished with the same 3” tongue- and- groove boards used on the hall ceiling.

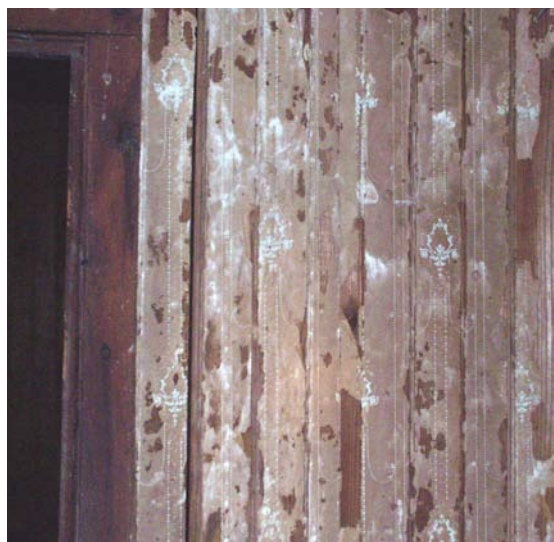
double- beaded, tongue- and- groove boards, thus creating Rooms 201 and 202 with a hall (Room 200) between the two. The layers of wallpaper on the walls in Room 201 indicate that this occurred as early as the 1890s or early 1900s.

Figure 25 View of wallpaper-covered paneling on north wall of Room 201. (NPS-SERO-CRS, 2002)

- Install new bathroom in Room 202, avoiding alterations to the ceiling in Room 102.
- Install modern kitchen in Room 102.
- Rebuild wall between Rooms 103 and 104.
- Reconstruct ceiling in Room 202.
- Reconstruct missing walls and ceiling at front (east) end of center hall.
- Repair finishes in Room 201, preserving as much of the historic wallpaper as possible.
- Install modern electrical and plumbing systems.

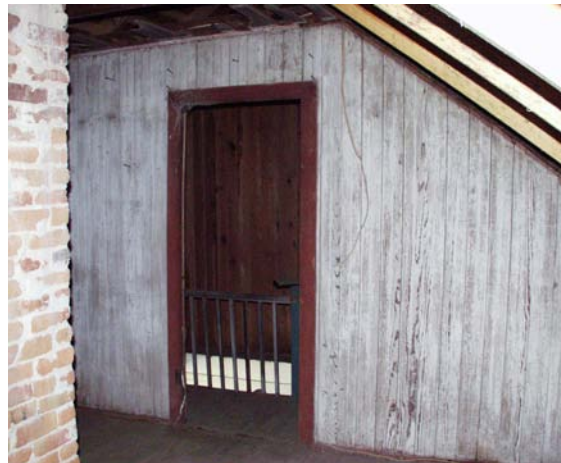
Figure 27 View south in Room 202. (NPS-SERO-CRS, 2002)

Windows: There are two window openings on the south wall. Both are 2'- 4" by 3'- 10", originally fitted with six-over-six sash. The upper sash in the east window is missing.
