Cape Lookout Lighthouse

Historic Structure Report

December 2008

Joseph K. Oppermann - Architect, P.A.

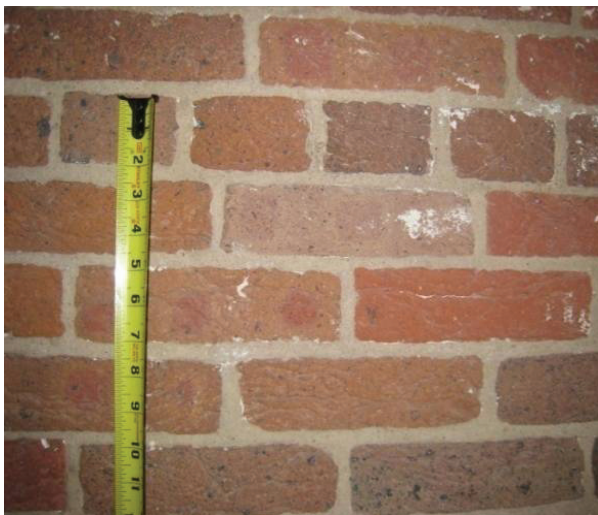
Figure C-9 Brickwork of interior face of core wall.

The mortar joints of both the outside and inside walls have a width of about ½" and are struck flush. However, on the core wall interior face, it is clearly evident that portions of the brickwork have been re-pointed with a hard, Portland cement-rich mortar. The re-pointing mortar is also fairly impermeable as evidenced by the re-pointed joints sitting proud, hard and rigid, while the adjoining bricks have spalled well back from the face of the mortar. Similar spalling has not occurred on bricks adjoining the earlier mortar.

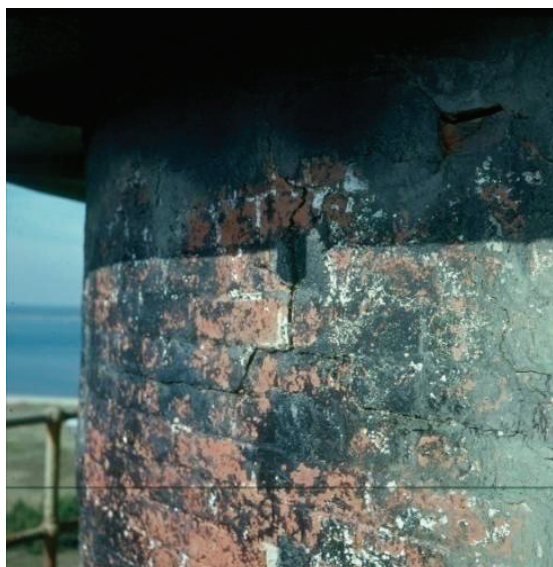
In addition, the condition of the bricks of the exterior wall is not known. These bricks have been water-blasted and subsequently covered with the current, thick, non-breathable coating. These actions are likely to have damaged the brick by removing portions of the fireskin and also trapping moisture, conditions that may affect their overall water absorption and possibly their compressive strength properties. Additional testing of the exterior brick is recommended to confirm actual performance characteristics. (See *Appendix D: Materials Analysis* for further discussion.)

Figure C-12 A 1976-1981-era photograph of exterior masonry at Observaton Deck.

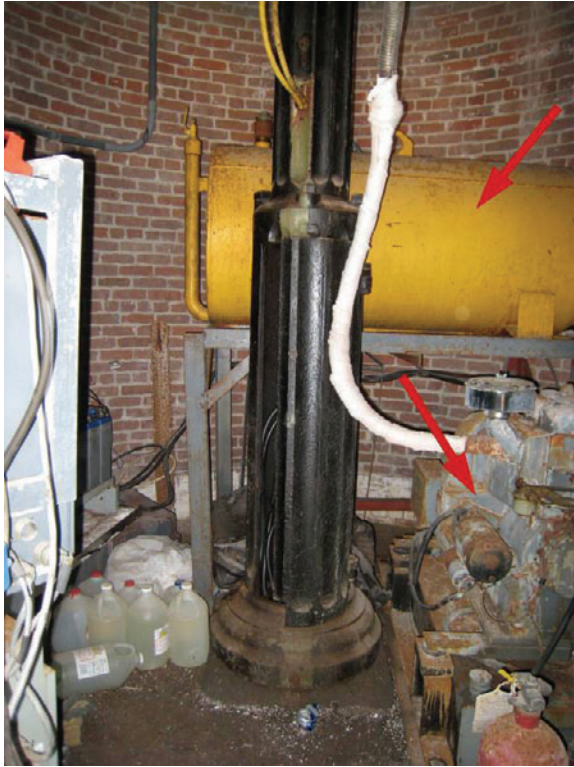
Figure C-13 Center column on sandstone pedestal, abandoned emergency generator and fuel tank nearby.

together in sections and extends from the masonry floor of the First Floor to the Ninth Floor Lantern platform for the beacon. At all levels the column appears to be sound.

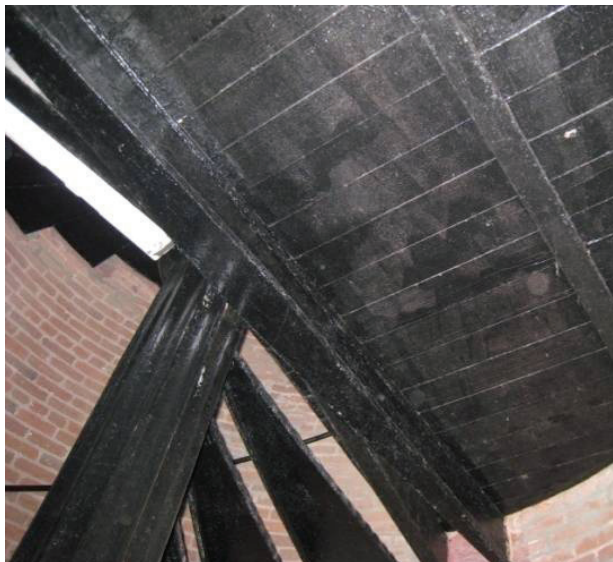
Figure C-15 Wood deck and floor joists of rebuilt 1867 Third Floor landing.

At the Third Floor, a level damaged by the Confederate explosion, the landing was rebuilt in the 1867 repair effort and is comprised of wood plank flooring (3/4" x 5") atop two wooden joists (2 7/8" x 8") in addition to the original I-beam.

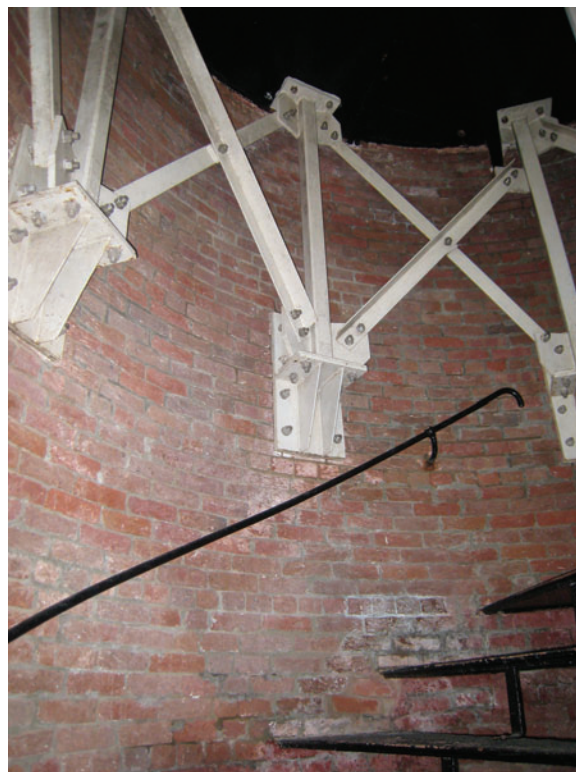
Figure C-16 1989 steel framing at Seventh Floor.

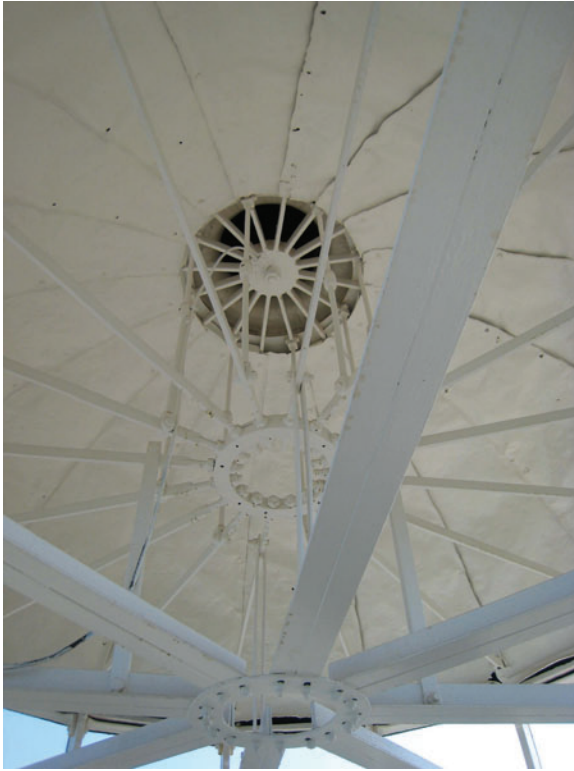
Figure C-17 Structural supports and central ventilator of dome.

- *Roof Framing:* The sheet metal dome is supported with cast-iron ribs and interconnecting 7/8" diameter iron rods, and rests on a cast-iron wall plate. Seventeen vertical iron-framing members hold glass panels to create a sixteen-sided wall enclosure (Lantern) and to support the wall plate. This iron framing sits on an iron floor plate atop the masonry tower. The cross bracing is copper-based, probably brass. Corrosion is extensive among the supporting iron elements.

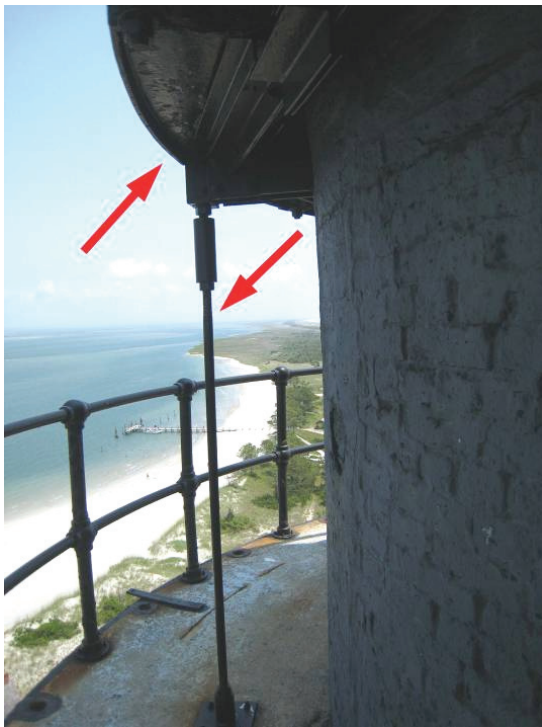
Figure C-18 1989 steel reinforcement of Gallery deck and connecting rod.

Outside, steel angles were added to the underside of the Lantern Gallery. Stainless steel, 1" diameter rods were added as connectors between the Lantern Gallery and Observation Deck. (See *Appendix B: Structural Assessment & Carrying Capacity Analysis.*)

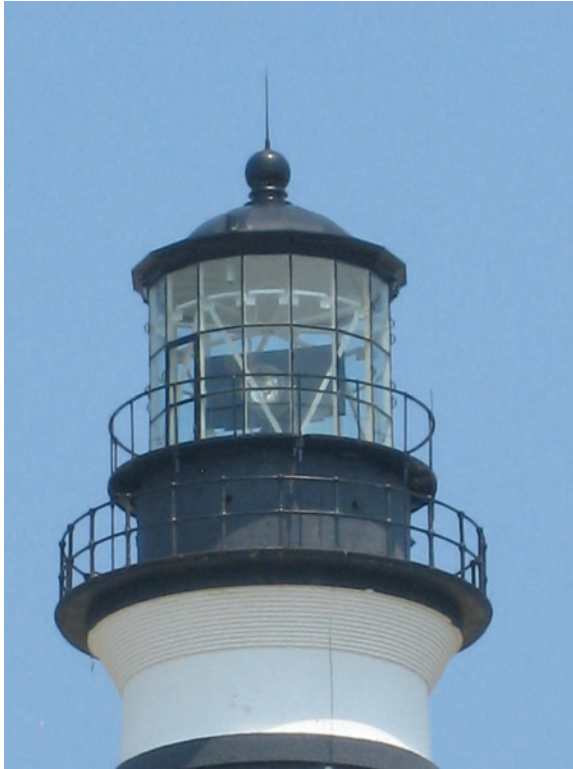
Figure C-21 *Lantern, Lantern Gallery and Watch Level Observation Deck.*

cast-iron framing members and horizontal cross-bracing of a copper-based material, perhaps brass. An iron sill plate attaches the Lantern atop the masonry tower. There are extensive amounts of corrosion at the iron elements.

Four presumably original iron rods, each 7/8" in diameter, connect the sill plate of the Lantern to the floor at Watch Level. These rods have extensive corrosion with at least one severely compromised.

Along the outside perimeter of the Lantern is the narrow Lantern Balcony. This Balcony has sixteen cast-iron floor plates, probably the original. These plates are in very poor condition with extensive corrosion, numerous breaks and some loss of material. Stainless steel angles were added in 1989 for support beneath the floor plates. During those same repairs, the current stainless steel railing system was installed. This railing consists of 1½" round stanchions with a flat 1" x 2" handrail 38" above floor level.

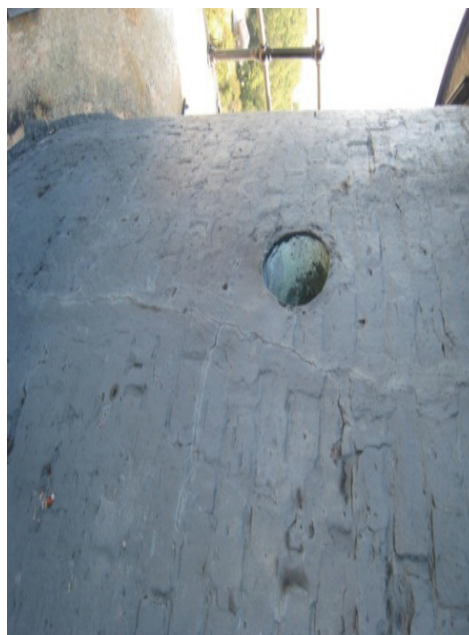
Figure C-26 Exterior view of one of four Watch Room air vents.

- **Air Vents:** Four round 8"-diameter vents constructed of sheet copper are equally spaced in the perimeter wall at the Watch Level. Apparently original, each vent is Z-shaped with the exterior opening approximately 12" below the interior opening where a manually-operated, five-point, cast-brass closer adjusts airflow.

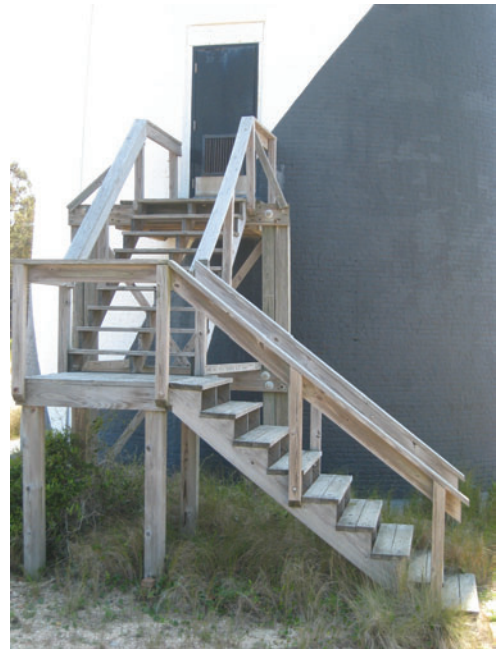
Figure C-29 Modern entrance stair to Second Floor.

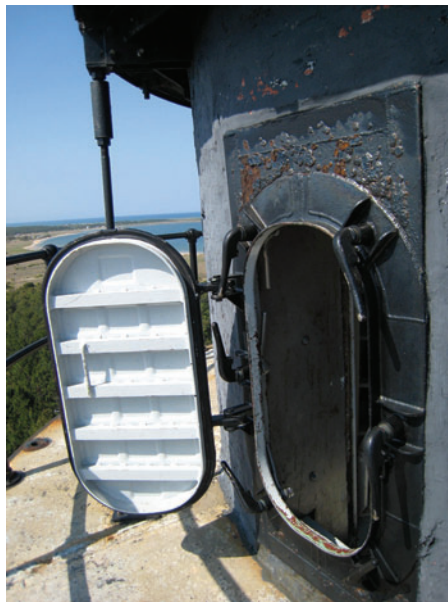
Figure C-30 Ship's Hatch at Observation Deck

The exterior door plate is steel and has extensive wear and corrosion suggesting that it may date to a much earlier period with a steel door of similar design to the current aluminum one.

The brick jambs of this masonry opening are reinforced flush, stainless-steel panels. The time of installation is not known but the lack of wear suggests a recent date perhaps 1996 the date of door replacement. The bottom of this masonry opening is accessed from the interior by a 10" tall, painted masonry step, and the base of the hatch door opening is another 9" above the masonry.

The original masonry opening is sound and the hatch door is in good condition and operational.

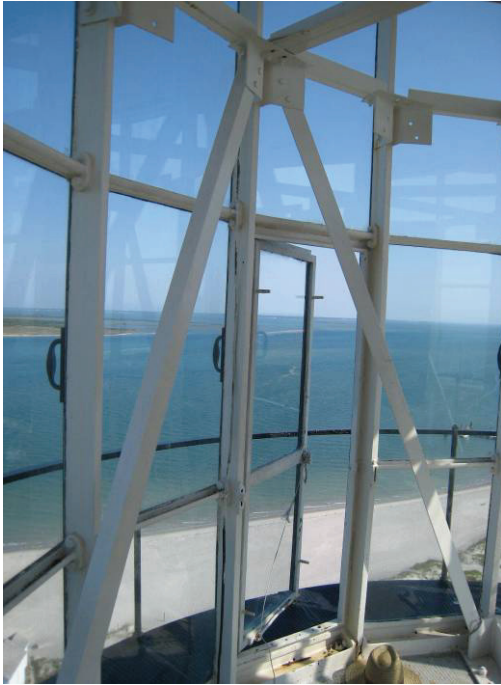
Figure C-31 Doorway to Lantern Gallery.

A fourth doorway is at the Lantern. Apparently an original feature, it is made of brass framing with two, glass panels, designed to conform to the framing configuration of the Lantern. This door permits passage between the Lantern and the Lantern Gallery. The door metal is heavily encrusted with paint and difficult to operate.

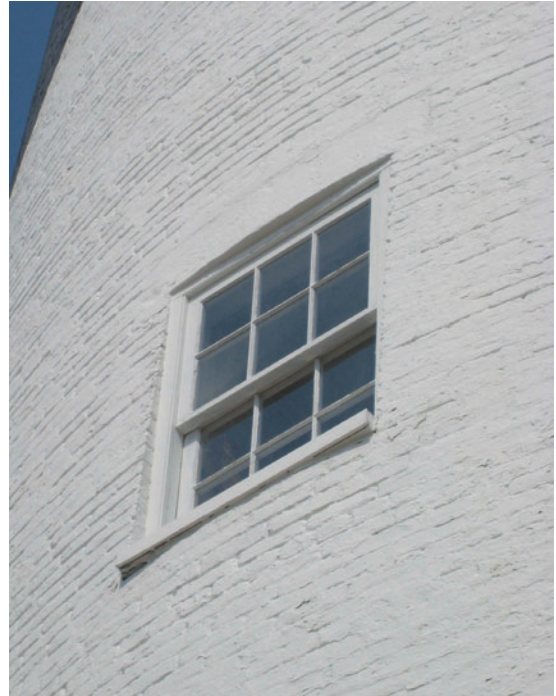
- **Windows:** Apart from the glass expanses of the Lantern, there are ten windows in the Tower. All ten of the current window units are replacements, fabricated and installed in 1999 by the NPS Historic Preservation Training Center of Shepardstown, West Virginia. Each window is an operable, double-hung, sash design made of wood.

Figure C-32 Typical replacement window unit.

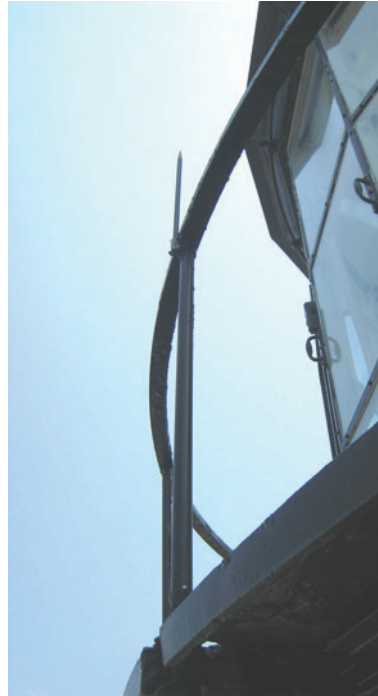
Figure C-36 Modern lightning rod at Gallery railing.

- **Lightning Protection:** The prototype drawings indicate a lightning rod atop the roof finial. Today, a group of modern lightning rods include one atop the dome and four at the Lantern Balcony rail. Two grounding cables connect to this rail, one at the north side and one at the south, and then run down the face of the masonry to grade. The south ground cable is disconnected at the Eighth Floor.

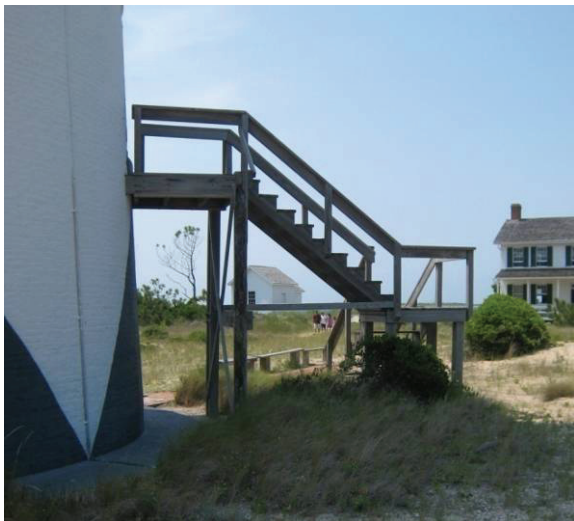
Figure C-35 Stairs for Main Entrance.

- *Entrance Stairs:* According to park personnel, the current L-shaped configuration of stairs and landings was installed in the 1980s. The wood members are treated pine, unpainted, and cut to modern dimensions. They were constructed adjacent to and connected with remnants of a previous stairs.

3/8" posts that support the entrance landing. These two early posts have extensive rot. The 1980s elements remain in good condition though the entrance landing posts would benefit from additional support as the earlier, now supplemental, posts continue to deteriorate.

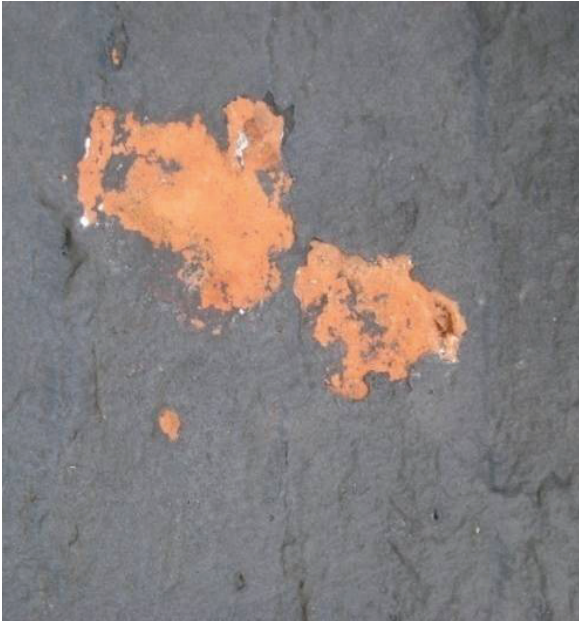
Figure C-37 Physical evidence of red limewash on tower's exterior masonry.

- **Finishes:** According to the testing of exterior finishes prepared for this report, the brick masonry contains two campaigns of a red limewash followed by six campaigns of

black and white paint (in a harlequin pattern.) This finding apparently confirms the application of a coating as opposed to the simple exposure of the brickwork to give the red appearance noted in the 1859 *Notice to Mariners*.

The later black and white paints apparently post date the 1873 decision of the federal Light House Board to implement the current distinctive diamond pattern. The recent paints applied to the masonry are synthetic based, very rubbery and non-breathable. Probably applied for their waterproofing

capability and durability, they belong to a category of paint that has proven to be harmful to soft, handmade bricks, especially in combination with the use of hard, non-permeable repointing mortars as are found at this lighthouse.

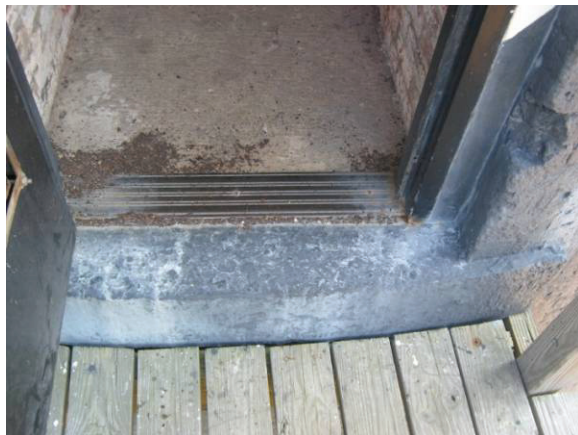
Figure C-40 Granite doors sill at Second Floor entrance. Note modern infill, door frame, and door.

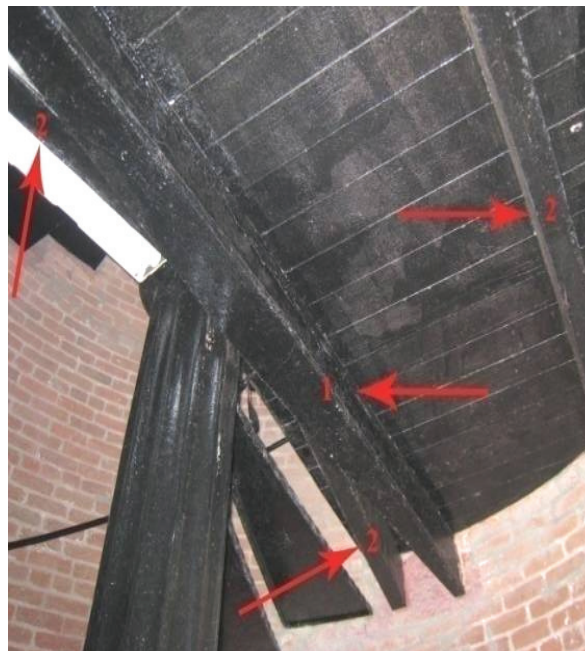
The third exception is also a mystery. Unlike all the landings above grade, the deck of the Third Floor landing is made of wood, not cast-iron. In the 1864 Union drawing of the temporary repairs, both the Second Floor and Third Floor original landing are absent, victims of the Confederate explosion. The makeshift runs of temporary wood stairs bypass the original locations of these two landings. In addition, the Union assessment calls for nine replacement floor plates, a number appropriate for the six needed at the full landing at the Second Floor and three for the intermediate half-landing of the Third Floor.

Figure C-45 Third Floor Landing with reused 1859 cast-iron I-beam (1) and 1867 wood framing (2).

The Second Floor landing apparently was rebuilt with replacement iron floor plates, but the Third Floor landing is instead made of wood. The original cast-iron beam apparently was reused, but there are two

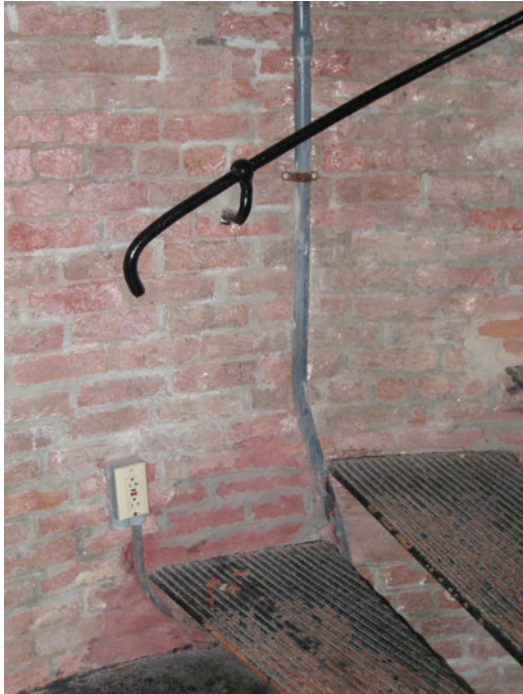
Figure C-46 Original iron handrail of 1-inch diameter.

painted, round, iron handrail, 1" in diameter, apparently the original. The handrail is in good condition except for the masonry anchors, several of which are corroded and one has rusted through.

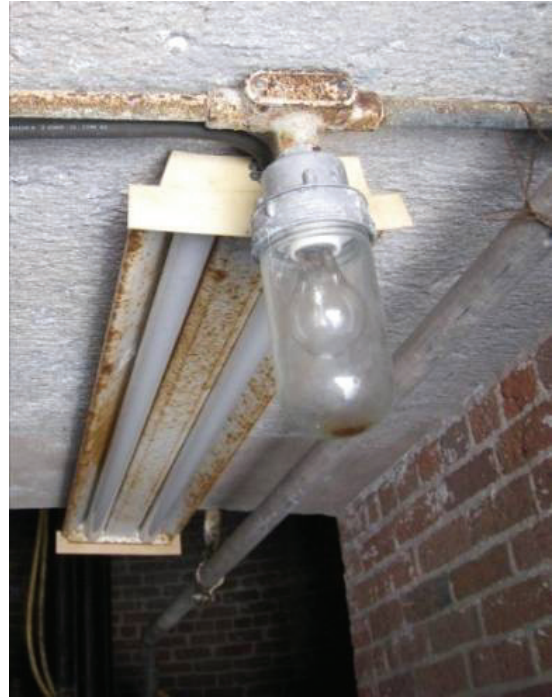
Figure C-57 Metal electrical conduit with incandescent and fluorescent light fixtures.

- **Electrical Systems:** Most of the active components of the electrical system date to 1996-97. The wiring is contained in surface mounted metal conduit.

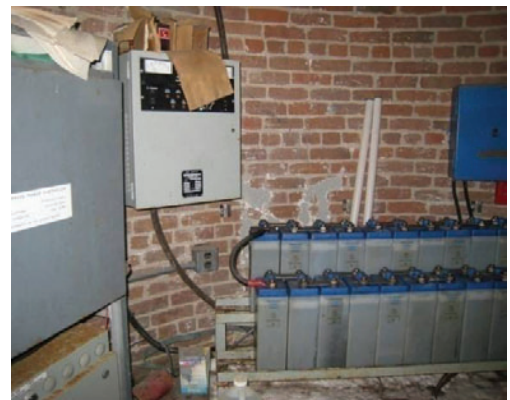
Figure C-58 Abandoned power controller and fuel cells.

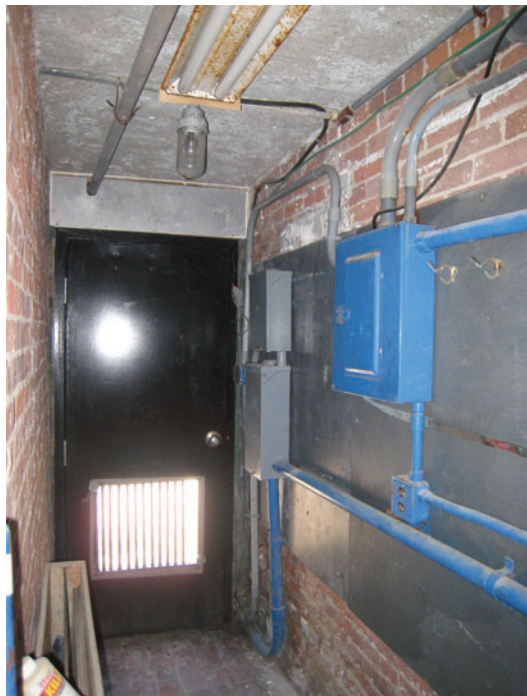
Figure C-59 Currently operational electrical panels on west wall of entrance passage.

There are two electrical panel boxes on the west wall of the passageway. The circuit breaker is identified as 100 amp 600 v I Phase. The non-operational emergency generator is just east of the center column. Its fuel tank is just north of the column.

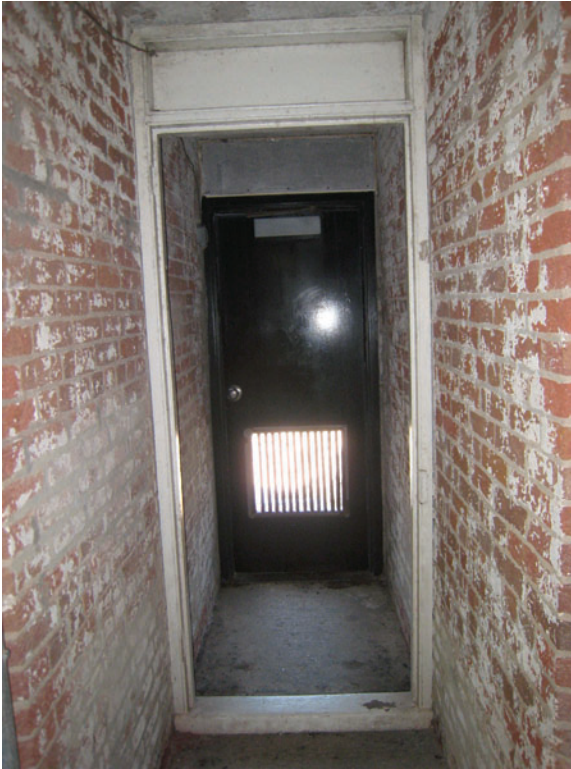
Figure C-61 Modified original exterior doorway and c.1914 interior door/transom framing in foreground.

Partway down the passageway are the framing remnants of a wood doorway and transom framing. The door and transom sash are missing. Although associated documentary evidence has not been found, the construction is similar to the 1914 work at the Service Room and may be remnants of another air lock, part of the effort of that

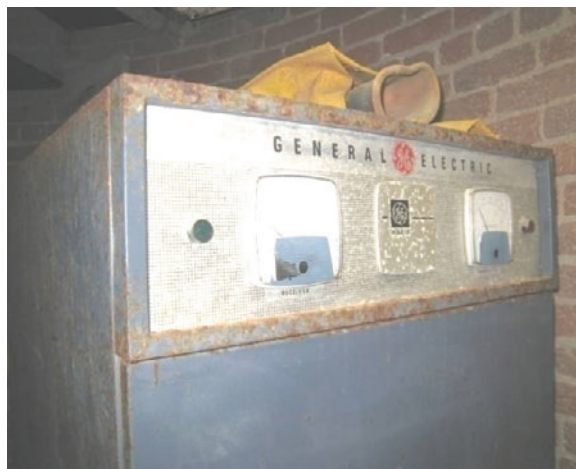
Figure C-63 Abandoned GE transmitter/receiver.

Abandoned electronic equipment includes a General Electric Master Transmitter/Receiver.

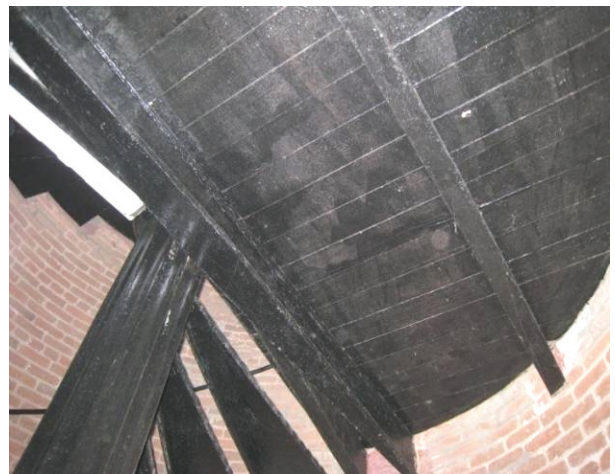
Third Floor: Although the Union forces submitted an assessment indicating the need for cast-iron floor panels to replace those that had been damaged by the Confederate explosion, this landing was not rebuilt accordingly. The reason is not clear from the documentary records.

The original I-beam was apparently reused. However, two wood joists measuring 2 7/8" x 8" were added and a new flooring of boards measuring 1 3/4" x 5" was installed in place of iron floor plates.

Figure C-66 Third Floor wood Landing.

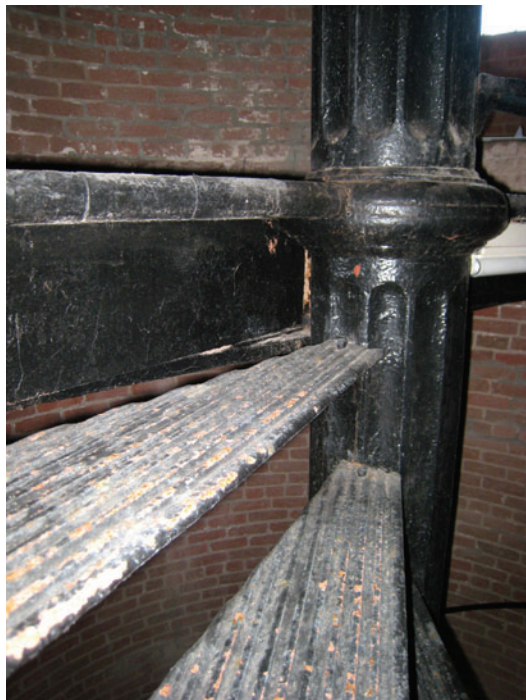
Figure C-67 Detail of bull nose edging of Third Floor landing.

- **Flooring:** The landing was rebuilt in the same location and configuration as shown in the prototype design. However, the landing is made of wood instead of cast-iron. The plank floor boards, each measuring $1\frac{3}{4}$ " x 5", are laid running northwest to southeast with a bull nose edge.

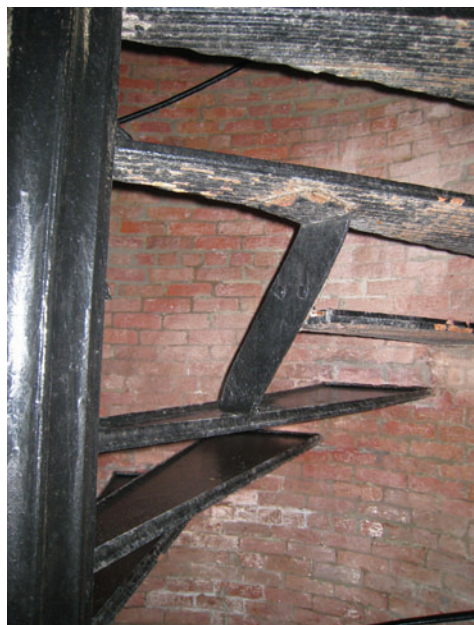
Figure C-73 1914 tread modification to accommodate the weight for occulting mechanism.

One step is missing half of its tread and is supported by an added vertical brace. This modification was made in 1914 to two treads in order to accommodate the chains for the new oscillating device.

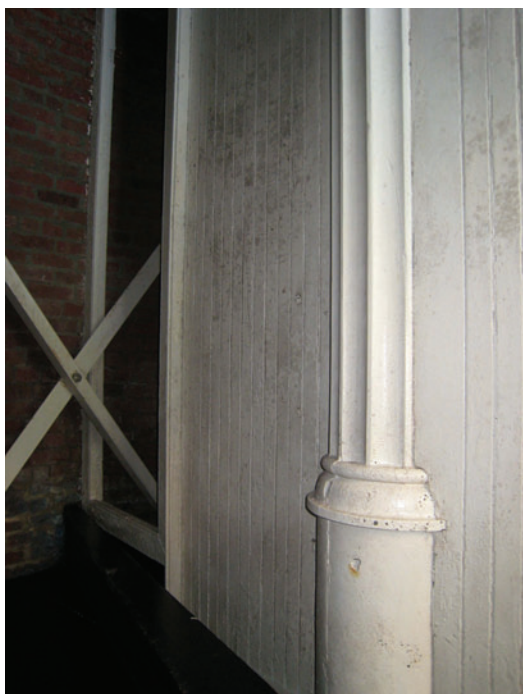
Figure C-77 1914 board wall and doorway at Seventh Floor landing. Note 1989 steel reinforcement added at masonry perimeter.

board wall at the lighthouse in types of material, methods of construction and paint finishes. The Museum's board wall and doorway appears to be part of the missing air lock. In addition, it appears that in situ wall was not repaired as called for on the 1913 plans but was rebuilt. Both the wall in situ and the air lock were constructed in 1914.

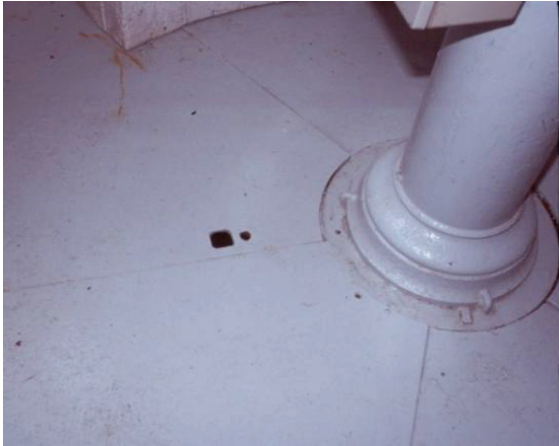
Figure C-84 Floor cuts for 1914 drive chain for occulting mechanism.

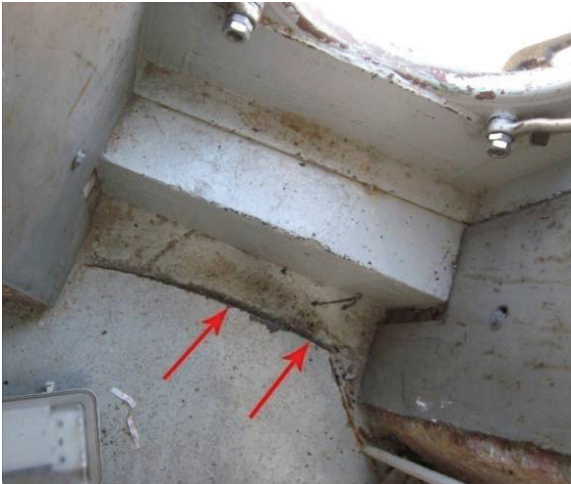
Figure C-85 Jacking of iron floor plate at doorway to Observation Deck.

At the hatch to the Observation Deck, there is jacking of the iron floor plate with one section of broken plate sitting proud of the floor about 1¾".

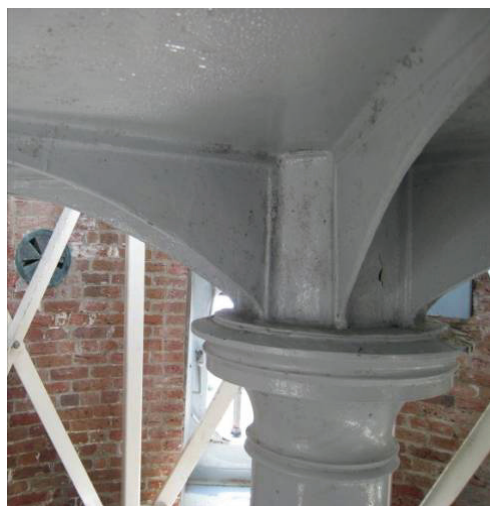
Figure C-88 Column and underside of cast-iron platform for beacon.

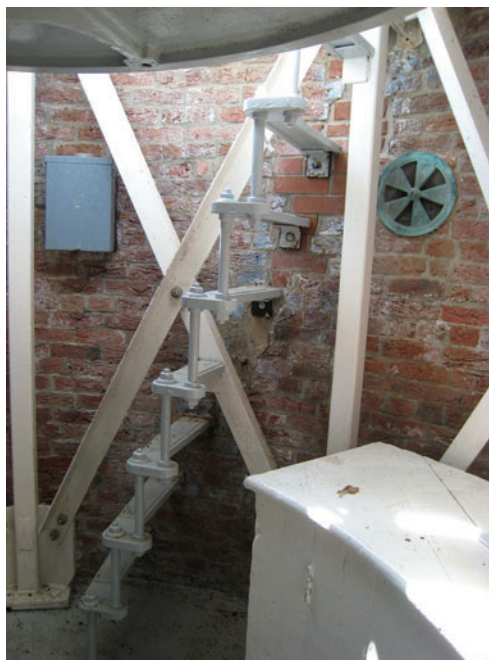
Figure C-89 Original cast-iron ship's ladder to Lantern.

- **Stairs:** The original cast-iron ladder stairs provide the access to the Lantern. These steps are also in the shape of a boot like those at the level below, but narrower and with a greater rise between treads. The steps begin along the southeast exterior wall (whereas the prototype plan has the steps beginning along the northeast wall.) Each tread measures 1'-9 ½" wide x 3½ to 4½" deep and 1" thick. The wider flange of each tread is connected to the masonry wall, while the narrow end is connected by two, separate 1" diameter rods with both the step above and the step below. The riser height is 9½". Portions of two of the eight treads have been removed to accommodate the steel reinforcement framing installed in 1989. Otherwise, this original ladder stair is intact and in good condition.

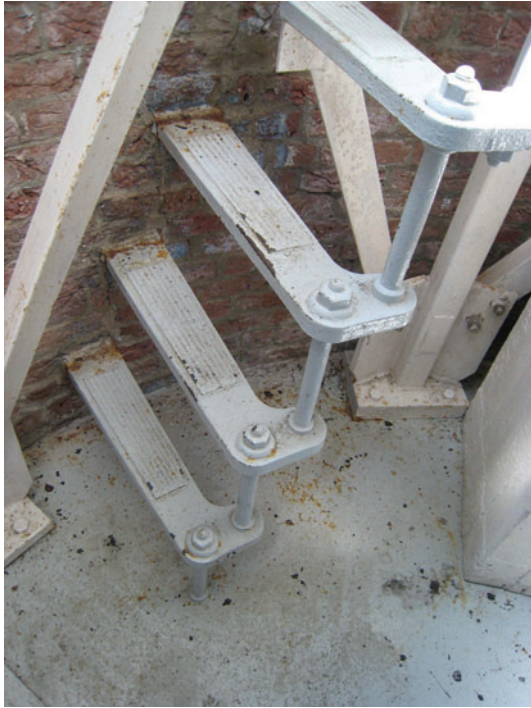
Figure C-90 Close-up view of ship's ladder to Lantern.

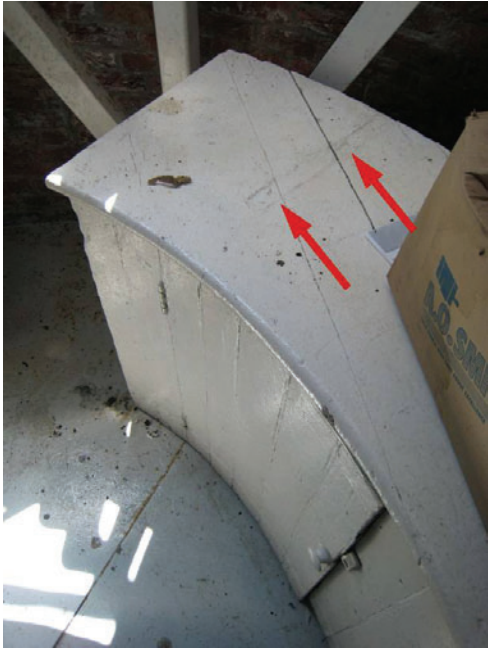
Figure C-93 Ghost marks of missing shelving supports.

wood door pull. The cabinet's counter surface has a 5/8" radius bull nose at the forward and side edges. Towards the back of this counter top are paint ridges indicating three vertical supports for bookshelves, now missing.

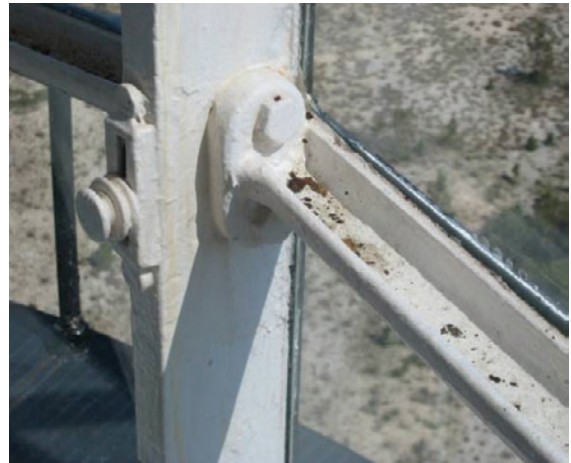
Figure C-99 Close-up view of horizontal framing of a cast copper-based metal.

refined details. There is much corrosion and surface loss of the cast iron, especially at the floor plate and at some connection points with the brass. A few of the glass panels are damaged.

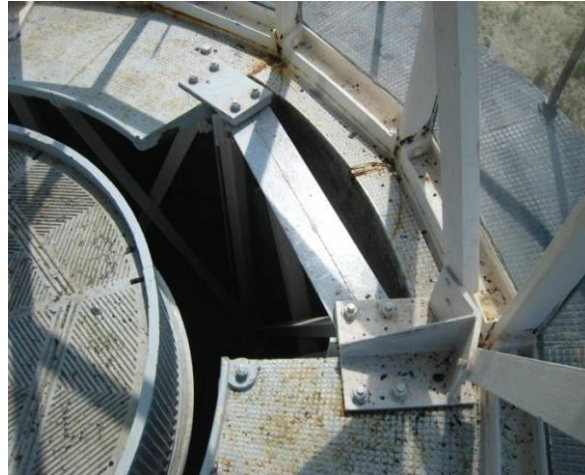
Figure C-102 Access to stairs to Watch Level partially blocked by 1989 reinforcing steel.

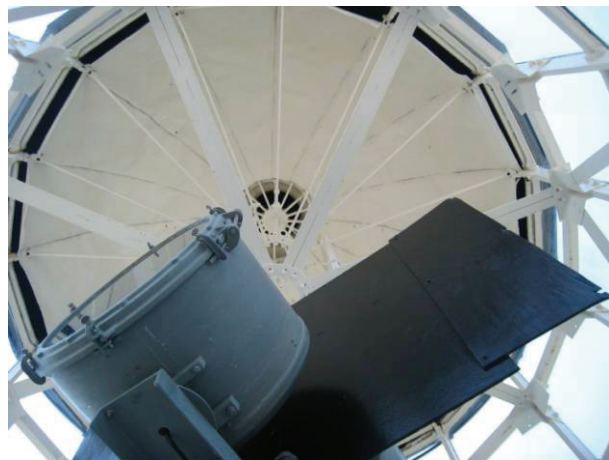
Figure C-103 Beacon.

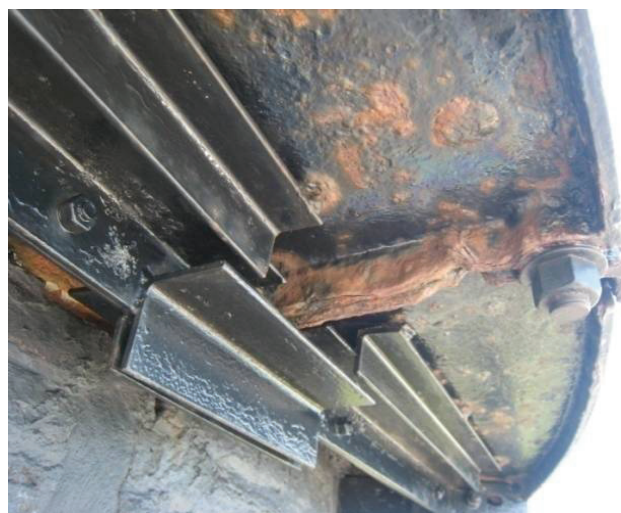
The iron elements of the Lantern including wall plate, framing struts, and Gallery walkway plates have extensive advanced deterioration. In addition to the damages to these elements, the expansion caused by the deterioration process is not only damaging

Figure C-106 *Underside of Lantern Gallery reinforced in 1989.*

adjoining material, most notably the top of the masonry Tower, but also allowing moisture to freely enter, causing yet more damage. The prime example of suspected collateral damage is imbedded in the upper masonry at Watch Level, a tension ring presumably made of iron as was typical of the period and indicated on the prototype

drawings. The long, vertical cracks in the masonry from top of the Tower down to the Seventh Floor area is likely the result of the expansion from a deteriorating tension ring.

The 1989 installation of steel supplemental framing and tie rods provides much-needed reinforcement, but it does not address the cause of the problems. The damaged iron will continue to deteriorate and weaken, and in expanding it will continue to cause collateral damages as well. The only long-term solution and ultimately the most cost-effective, is to make repair to the damaged iron.

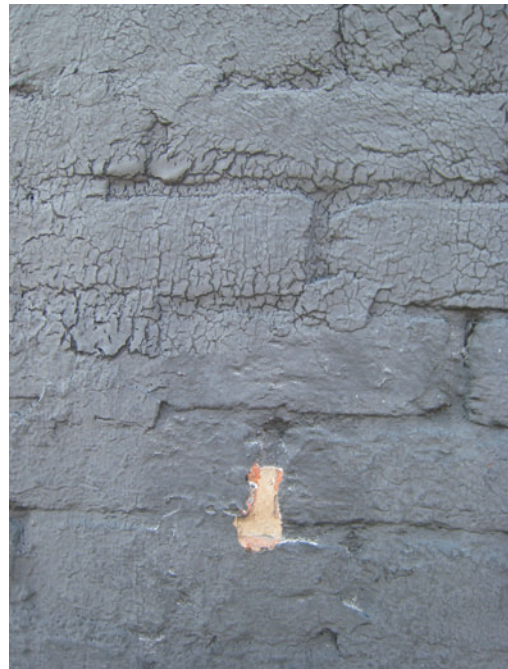
Unfortunately, both the interior surface of the core wall and the exterior surface of the exterior wall have been water blasted. The effect as seen on the interior of the lighthouse, is that the protective outer surfaces of the bricks have been damaged, exposing the less-durable interior material.

Figure C-108 Non-breathable coating on exterior masonry.

brickwork, removal of incompatible mortars/reapplication of suitable mortar, and removal of the non-breathable exterior coating/replacement with a compatible coating.

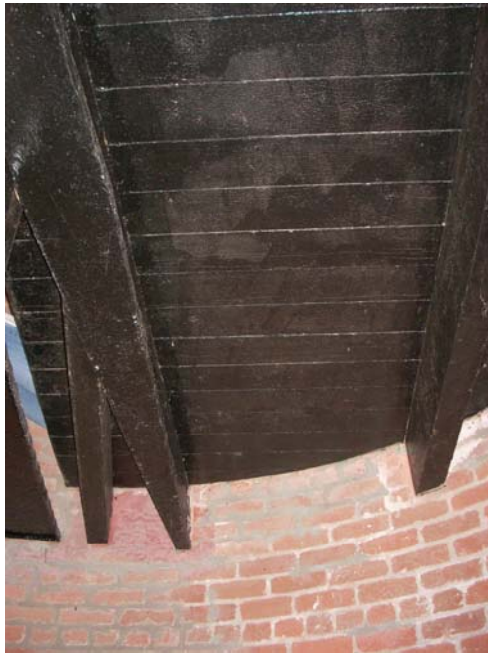
One landing differs in construction from the remainder of the other landings. The third floor landing is of wood construction with wood support beams (see Figure 4). Analyses were also performed on this landing to determine if it may provide adequate capacities to support the traffic which will occur. In addition, since this is the first landing that visitors will reach it is more likely that it will receive the most traffic and impact. Interest was expressed by both the park service staff, and the architect to preserve this landing during the May 2008 site visit. In an earlier report “Engineering Study of Cape Lookout Lighthouse” issued on May 12, 2005, issues concerning the fire resistivity of this landing were expressed. Recommendations for these concerns may be found in the recommendations section below. The flexural and shear capacities used in analysis were that of visually graded sawn Southern Pine No. 2. It is known that the lumber present during the construction of the lighthouse had a greater available capacity, but the decrease in allowable values ensure that the actual landing capacities are conservative.

Analysis has shown that the presence of the bracing ribs (at the steel landings) increases the allowable stress by 25 percent to 3.75 ksi for the landing plates. Using the minimum code recommended live load of 100 psf, the maximum stress of the landing plates as originally designed was calculated to be 5.4 ksi, giving a safety factor of 9.3 based on the additional 25 percent of allowable stress. Although that value is lower than the recommended safety factor for cast iron, it is still a comfortable safety factor since the landing plate showed no apparent signs of cracks. The maximum calculated deflection of 0.42 inch exceeds the allowable deflection of 0.23 inch. In its existing condition, an analysis of the steel plate landing produced stress and deflection results of 6.5 ksi and 0.56 inch. With the additional 25 percent allowable stress, the safety factor for the existing landing plate is 7.7, much lower than the recommended safety factor of 13.3 and exceeding the “comfort zone” for safety. Since analysis of the landing plate produces

results that exceed the safety “comfort zone,” there is a possibility of failure if the landing is fully loaded to the maximum code-mandated load of 100 psf; 16 people weighing 250 pounds per person would have to stand on the landing. It would be physically impossible for 16 people to stand on the landing simultaneously. A more realistic assumption would be 6 people on the landing at the same time (one person per 7 square feet), reducing the load to approximately 40 psf and the stress to 3.2 ksi. The resulting stress would be within the recommended range for cast iron.

Figure 4 – Wood Landing

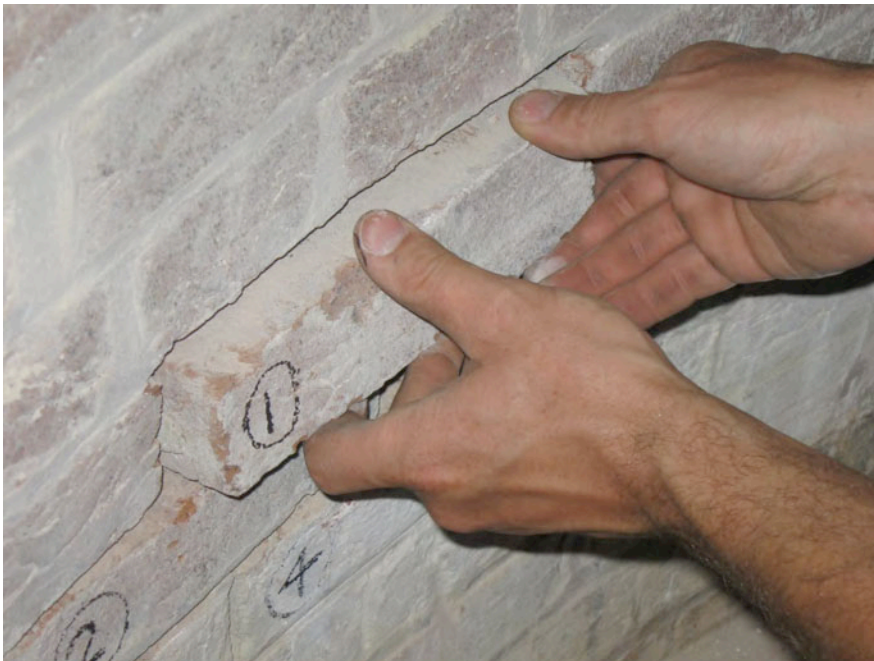
Figure 4. Cape Lookout Lighthouse, October 2008. Removal of a brick for laboratory testing. A total of five bricks were removed from the building. Photograph by author.

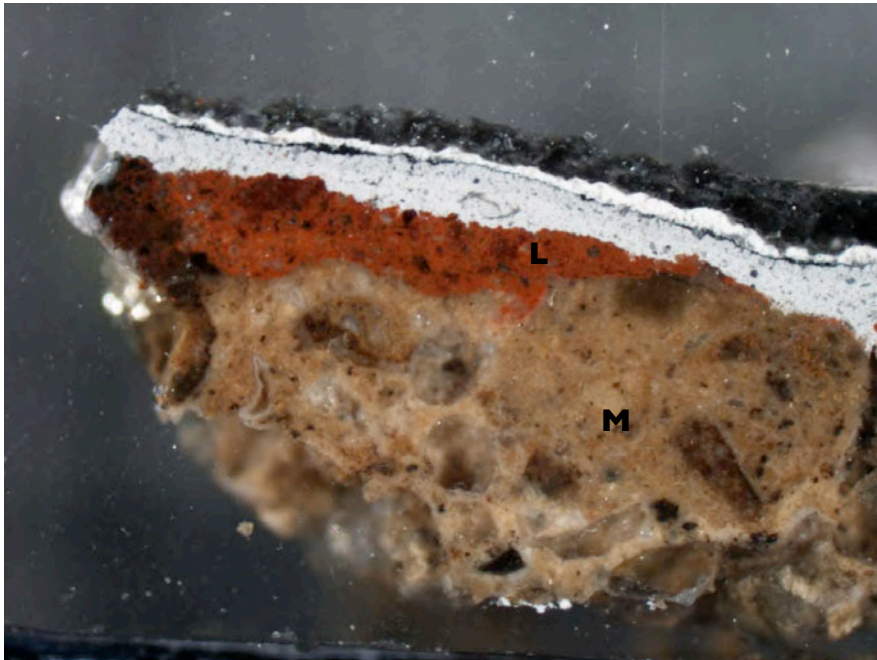
Analysis of paint samples indicates that the exterior brick masonry of the lighthouse contains two early campaigns of red limewash followed by four to six campaigns of black and white paint (always applied in a checkered pattern). The red limewash is also visible under the existing exterior paint coatings, on the surface of both the brick and mortar, in numerous locations. Archival research, performed by Joseph K. Oppermann Architect, P.A. as part of the HSR, revealed that the lighthouse was historically red in color. An 1859 *Notice to Mariners* states that: “The color of the tower is red.”⁶ Until now, the source of the red color was unknown. The color could have been achieved through the application of an oil paint or the description could have simply referred to the color of the brick masonry construction. The current research, however, provides proof that the first finish applied to the lighthouse’s exterior masonry was in fact a pigmented red limewash. While it is possible that the exterior brickwork of the lighthouse was originally unpainted and that the red-colored limewash was applied subsequently in order to refresh its red brick appearance, the lack of a distinct dirt layer between the surface of the brick and the first pigmented limewash suggests that the first red limewash layer is original. (Figures 5 and 6)

Figure 5. Cape Lookout Lighthouse. Photomicrograph of Sample CALO.E.11, removed from the exterior of the lighthouse shows the original red limewash (L) applied over brick mortar (M), followed by layers of modern black and white paint coatings. Photograph by author, 40x magnification.

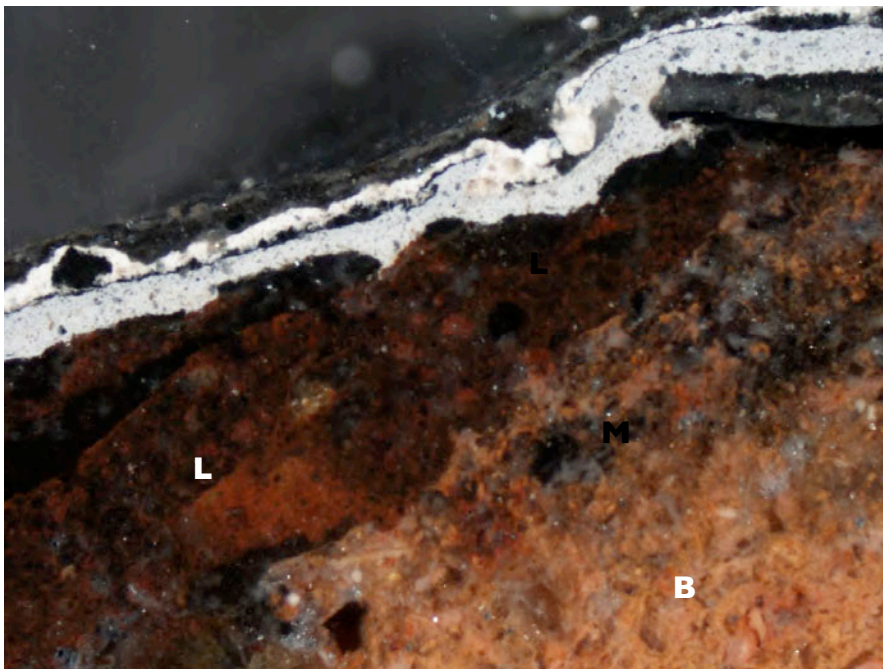
Figure 6. Cape Lookout Lighthouse. Photomicrograph of Sample CALO.E.10, removed from the exterior of the lighthouse shows the original red limewash (L) applied over brick substrate (B). Subsequent layers of black and white paint coatings are also visible. Photograph by author, 40x magnification.

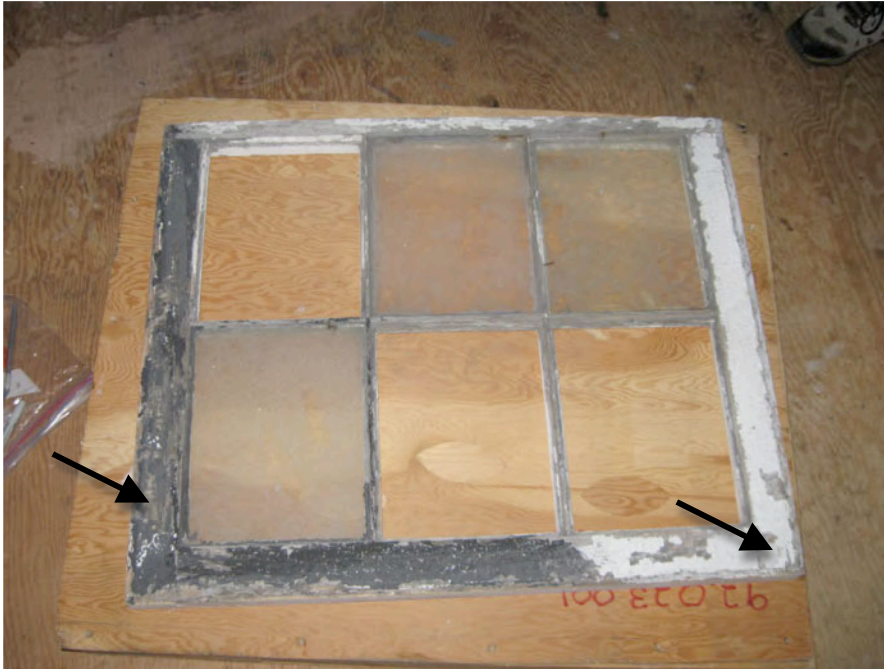
As previously mentioned, the majority of the exterior woodwork on the lighthouse was damaged by Hurricane Fran and replaced in 1996. However, the historic (presumably original) window sash were salvaged and are in storage at the North Carolina Maritime Museum in Beaufort, North Carolina. These sash were examined as part of this study and were found to retain much of their paint history. Unfortunately, the original exterior doors were not located. (*Figure 9*)

Figure 9. Cape Lookout Lighthouse, October 2008. A salvaged window sash currently located at the North Carolina Maritime Museum. Two samples were removed from the exterior face of the sash (arrows). Photograph by author.

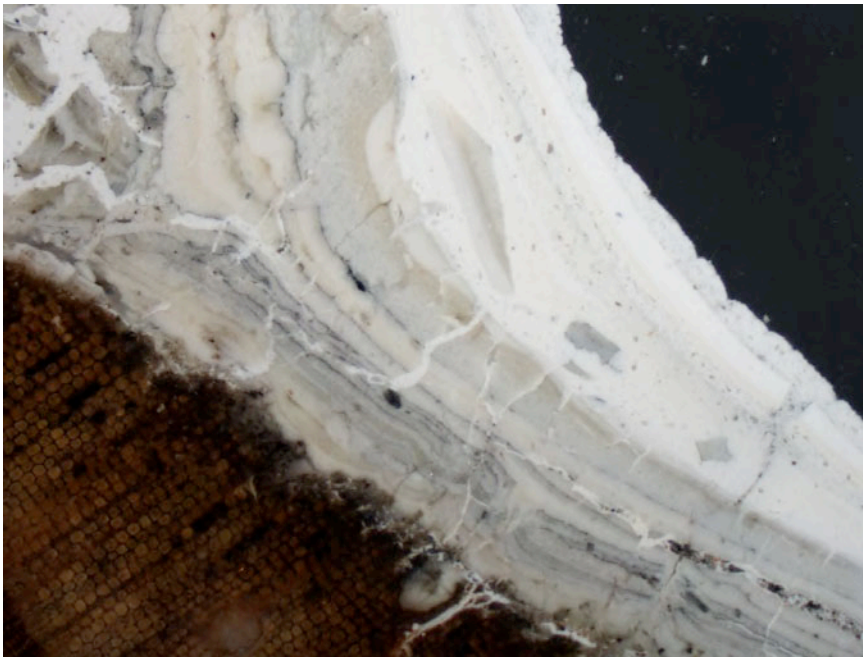
The current paint scheme of the salvaged window sash examined for this study, which must have been located at the diagonal seam between black and white sections of the lighthouse exterior, is half black and half white. A paint sample was removed from the black portion of the sash and revealed approximately 15-20 layers of paint, the majority of which were white or off-white. Therefore, it appears that the exterior face of the sash was historically painted solid off-white, even when the black and white checkered pattern was applied to the lighthouse masonry. In fact, the historic photograph from the early 20th century, visible in *Figure 8*, shows a light-colored sash in one of the window openings within the black-painted area. It seems that the bi-color paint scheme on the sash is not original and that it is a fairly recent treatment. (*Figure 10*)

Figure 10. Cape Lookout Lighthouse. Photomicrograph of Sample CALO. SALV.3, which was removed from the exterior face of the salvaged window sash. Between 12 and 18 paint layers were found on the exterior face of the sash and the majority of the layers were off-white, even in the area currently painted black. This evidence suggests that the sash were painted off-white for the majority of the lighthouse's history. Photograph by author, 40x magnification.
