Cape Lookout Lighthouse

Historic Structure Report

December 2008

Joseph K. Oppermann - Architect, P.A.

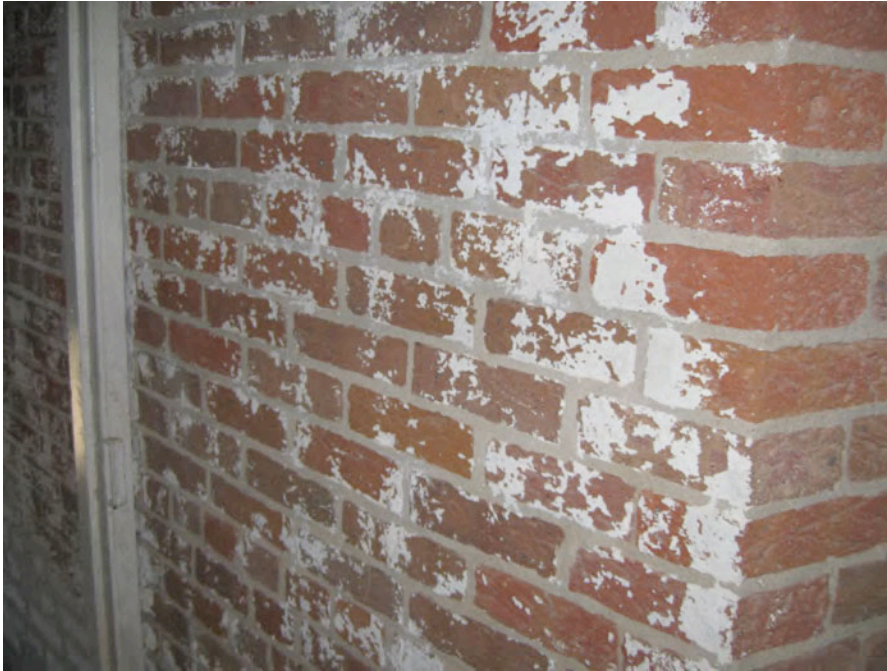
The interior brick walls, which were blasted in 1996, currently contain minimal evidence of paint finishes. The entry vestibule walls and the floors of window wells contain some evidence of limewashes, but all other walls throughout the lighthouse are exposed brick. Historical accounts of other lighthouse in the same region, namely the Bodie Island Lighthouse to the north, indicate that the interior was typically whitewashed on a regular basis.¹² This would certainly be in keeping with nineteenth century practices of maintenance and hygiene. White limewash was found on the entry vestibule walls and also on the bottom four courses of brick in the boiler room (in a location that would have been under a wood platform and therefore protected), suggesting that historically a white limewash treatment may have been applied to the interior of the lighthouse. Unfortunately, the lack of physical evidence prevents this from being documented with any degree of certainty. (*Figures 11 and 12*)

Figure 11. Cape Lookout Lighthouse, September 2008. Evidence of white limewash on the entry vestibule walls. All other finishes have been removed from the interior brick walls. Photograph by author.

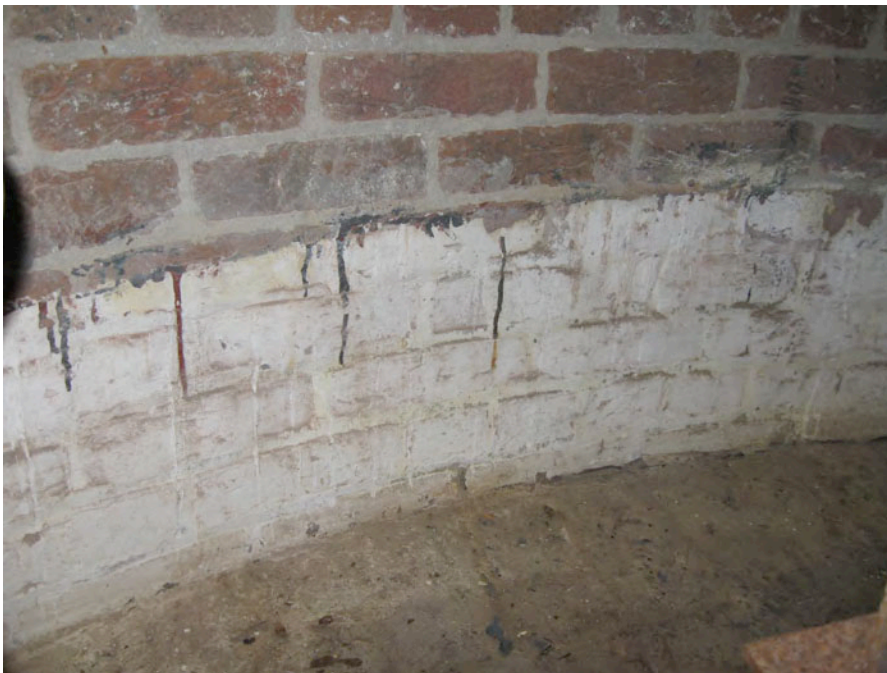
Figure 12. Cape Lookout Lighthouse, September 2008. Additional evidence of limewash was found in the boiler room, in an area previously covered by a wood platform. Photograph by author.

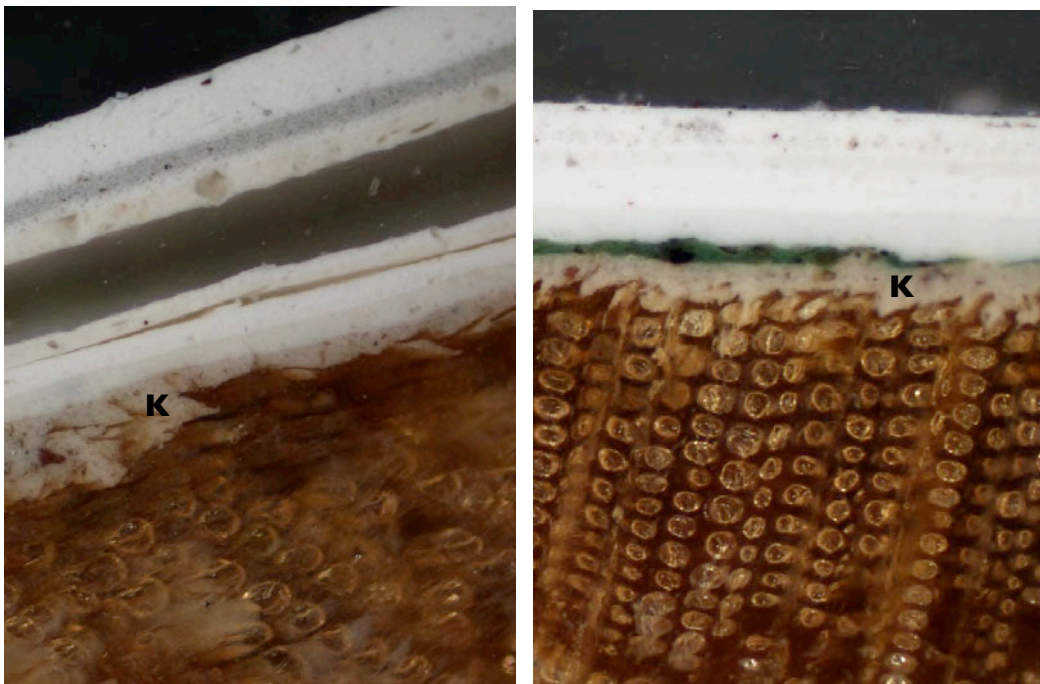
The interior woodwork of the Cape Lookout Lighthouse has a richer finishes history. In general, there is consistency between the paint evidence found on the salvaged woodwork and the pieces that remain in situ. On several pieces of interior woodwork, the earliest existing paint color is khaki. This color was found on a section of salvaged beadboard wall and associated interior door and frame, as well as on an in situ section of beadboard wall located on the service level of the lighthouse. These components of the lighthouse are believed to be contemporaneous, dating from a 1914 period of modification for the lighthouse.¹³ On the salvaged interior door, the khaki color was documented on rails and stiles but the panels were picked out in a dark green. (*Figures 13 and 14*)

Figure 14. Cape Lookout Lighthouse. A comparison of two paint samples, CALO.SALV.4 (left) and CALO.SALV.5 (right), removed from the stile (left) and the recessed panel (right) of a salvaged interior door. Note the layer of dark green applied over the original khaki (K) paint only on the sample removed from the panel. This evidence suggests polychromy. Photograph by author, 100x magnification.

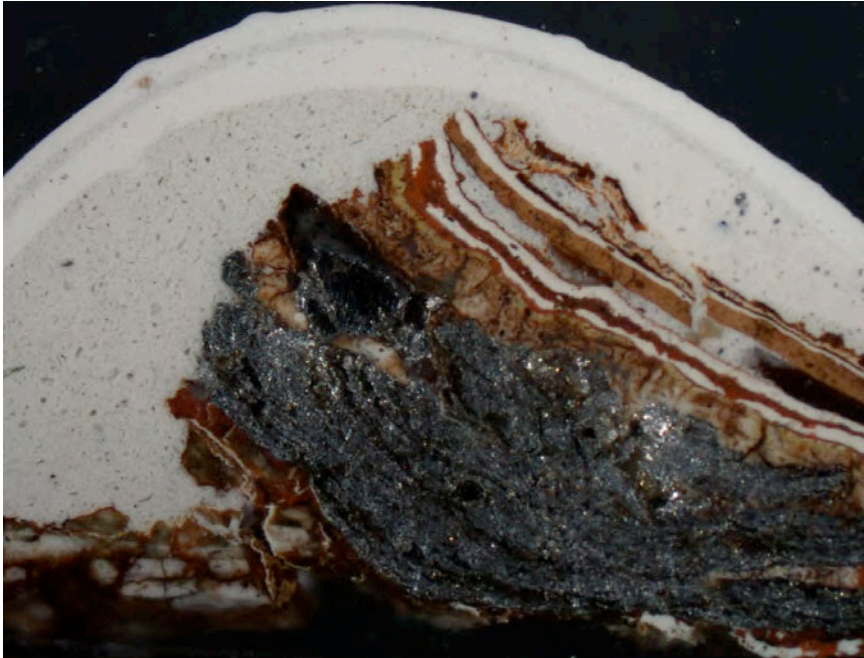
The one metal component of the interior that contains numerous layers of paint, the earliest of which may be original, is the glazed lantern frame. Although the frame is composed of two different types of metal (ferrous vertical pieces and copper alloy horizontal pieces), they both appear to have always been painted some version of white. One area of the copper alloy component was sampled and was found to contain twelve layers of cream or white paint, sometimes applied over a red primer. A similar stratigraphy was found on the iron-based component. This light color for the interior of the lantern would have been important for reflecting the light from the lens. (*Figures 15 and 16*)

Figure 15. Cape Lookout Lighthouse. Photomicrograph of Sample CALO. 1.22, removed from one of the copper alloy components of the glazed lantern frame. Numerous layers of off-white (as well as primer red) are visible. There is also a thick metallic paint layer that was applied to the lantern interior fairly early in its history but is not original. Photograph by author, 40x magnification.

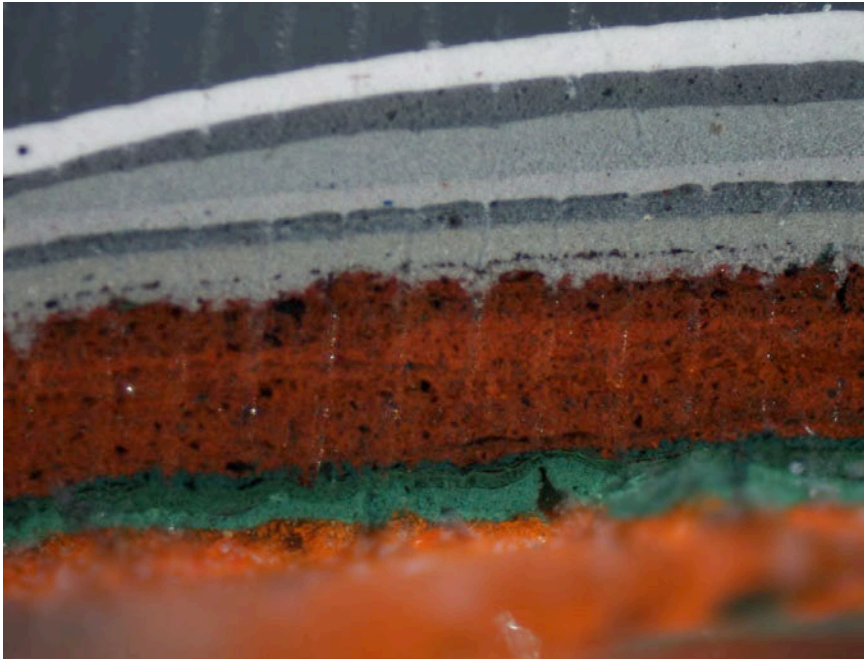
Other metal components of the interior were painted differently. The earliest paint color on the central cast iron column was dark green (two layers), followed by numerous red-browns and grays. The dark green was applied directly over a red primer on the metal, indicating it may have been original. In total, however, there were twelve layers of paint applied to the column. The earliest color on the cast iron stair treads was dark gray, followed by several red-browns and dark grays. This area also contained approximately twelve layers of paint. Although there are a fair number of paint layers on both of these interior elements, the lighthouse would have been well maintained and one would expect to find evidence of even more paint layers. There is unfortunately no way to determine whether or not the early dark green and gray paint colors on these metal components are original. (*Figures 17 and 18*)

Figure 17. Cape Lookout Lighthouse. Photomicrograph of Sample CALO. I.3, removed from the astragal of the center cast iron column (at the Watch Level). Note the early red-orange primer followed by a dark green paint finish at bottom of photograph. This campaign may be original. Photograph by author, 100x magnification.

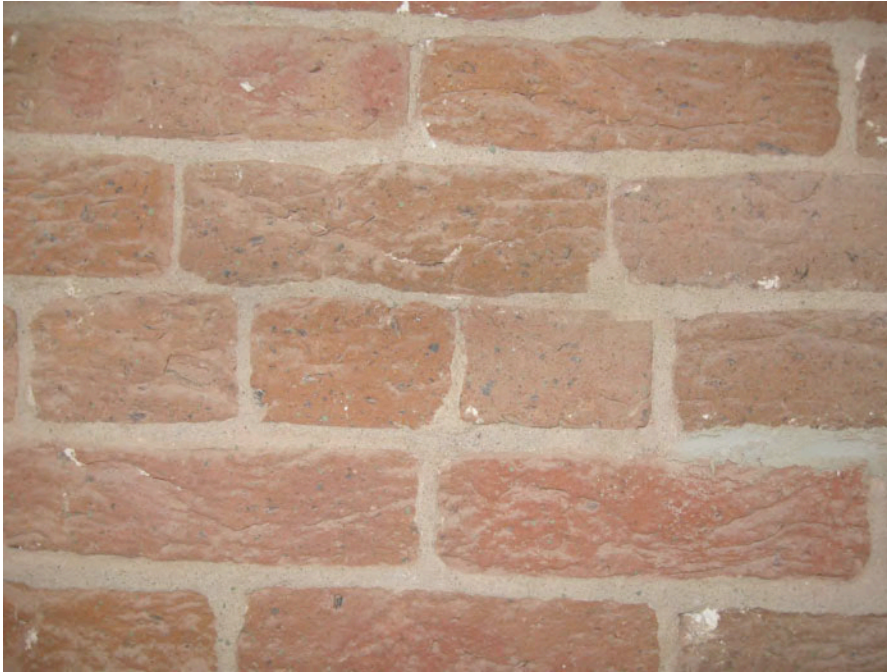
Figure 19. Cape Lookout Lighthouse, September 2008. Area of typical interior brickwork showing the brick's hand-pressed, low-fired quality and appearance. Photograph by author.

The bricks that the Cape Lookout Lighthouse is constructed of are low-fired and handmade, with subtle variations in color and texture due to the low temperature firing process. There are also numerous visible inclusions of aggregate and clay, as well as evidence micro-cracks from the forming process. Although much of the brickwork on the exterior of the building is obscured by paint, the interior brick is currently exposed. (*Figured 19 and 20*)

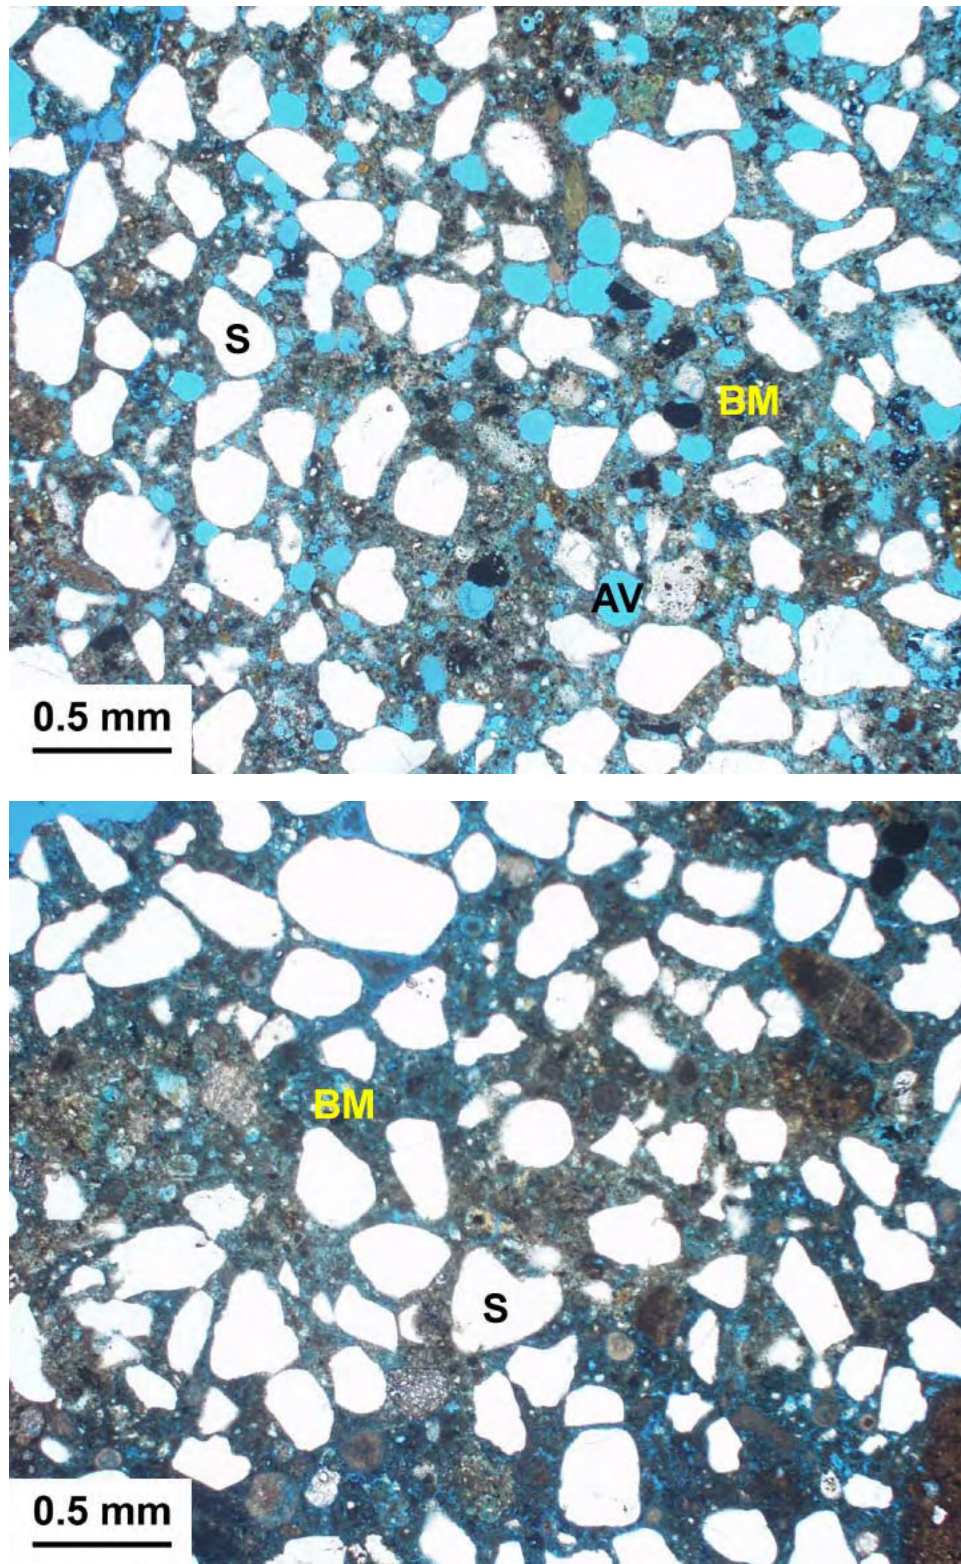
Figure 2: PPL photomicrographs illustrating the microtexture of mortar samples CALO.Mortar.1 (top) and CALO.Mortar.2 (bottom). Relatively rounded and narrowly graded sand grains (S) are well distributed throughout the binder matrix (BM). The cementitious matrix has a moderate capillary porosity as indicated by the blue-dyed epoxy used in the sample preparation. Air-voids (AV) are shown for sample CALO.Mortar.1 and these are abundant. Voids are nearly as abundant in sample CALO.Mortar.2 but are mostly filled with secondary calcium carbonate rendering them nearly invisible at this scale (see Figure 6).

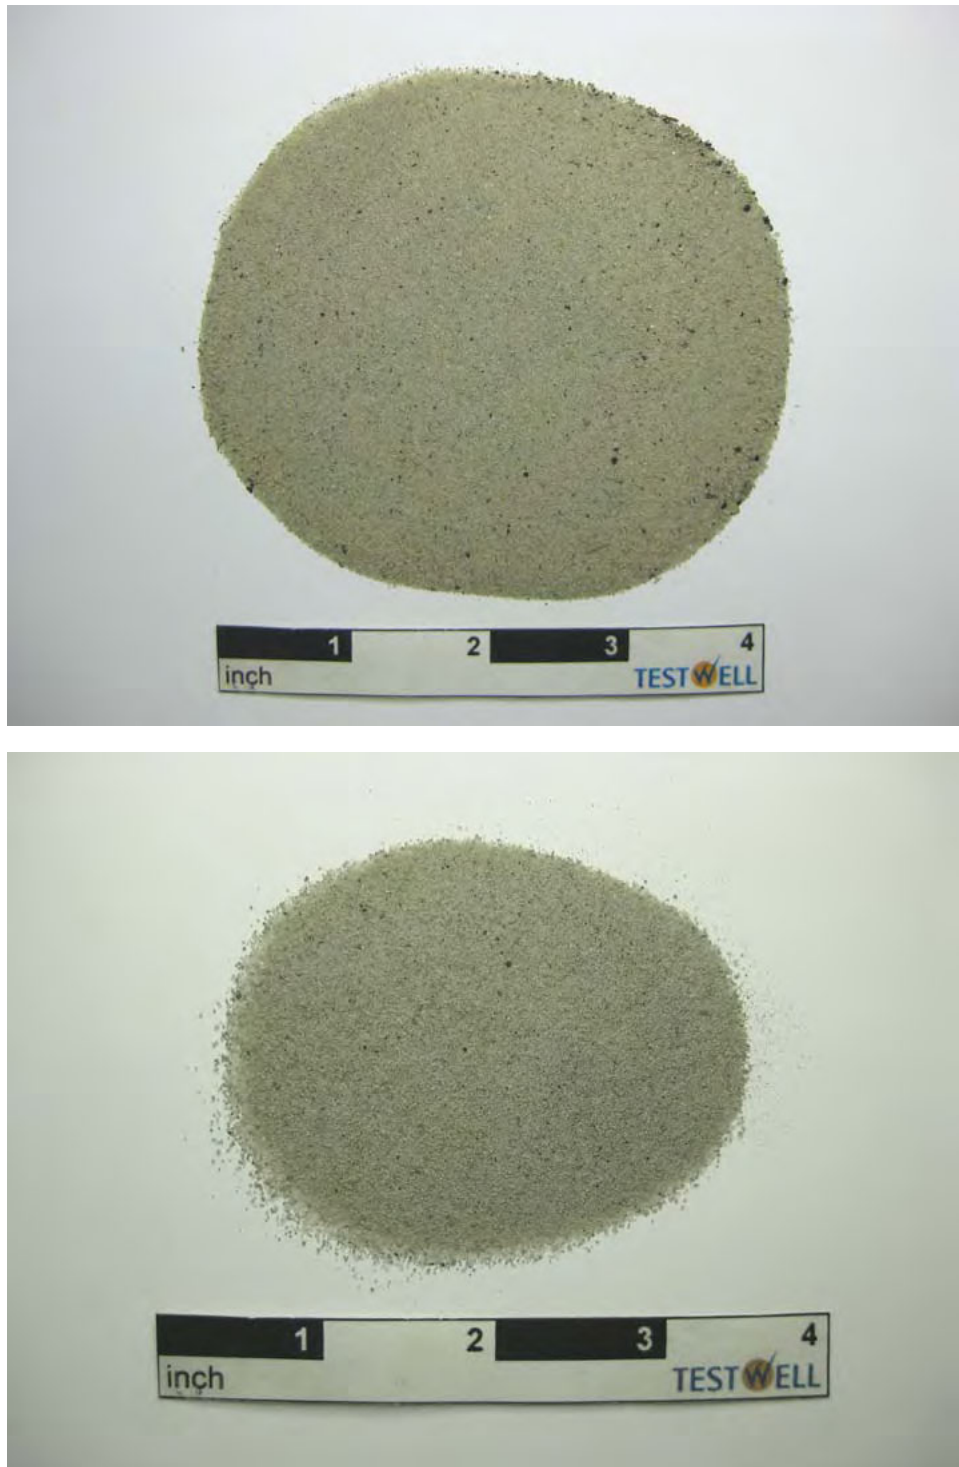
Figure 3: Photographs of sand separated from mortar samples CALO.Mortar.1 (top) and CALO.Mortar.2 (bottom). The sands are virtually identical appearing as uniform, fine-grained, and light-colored sands. The trace dark grains are identified as coal dust that likely represent a minor contaminant from the cement.

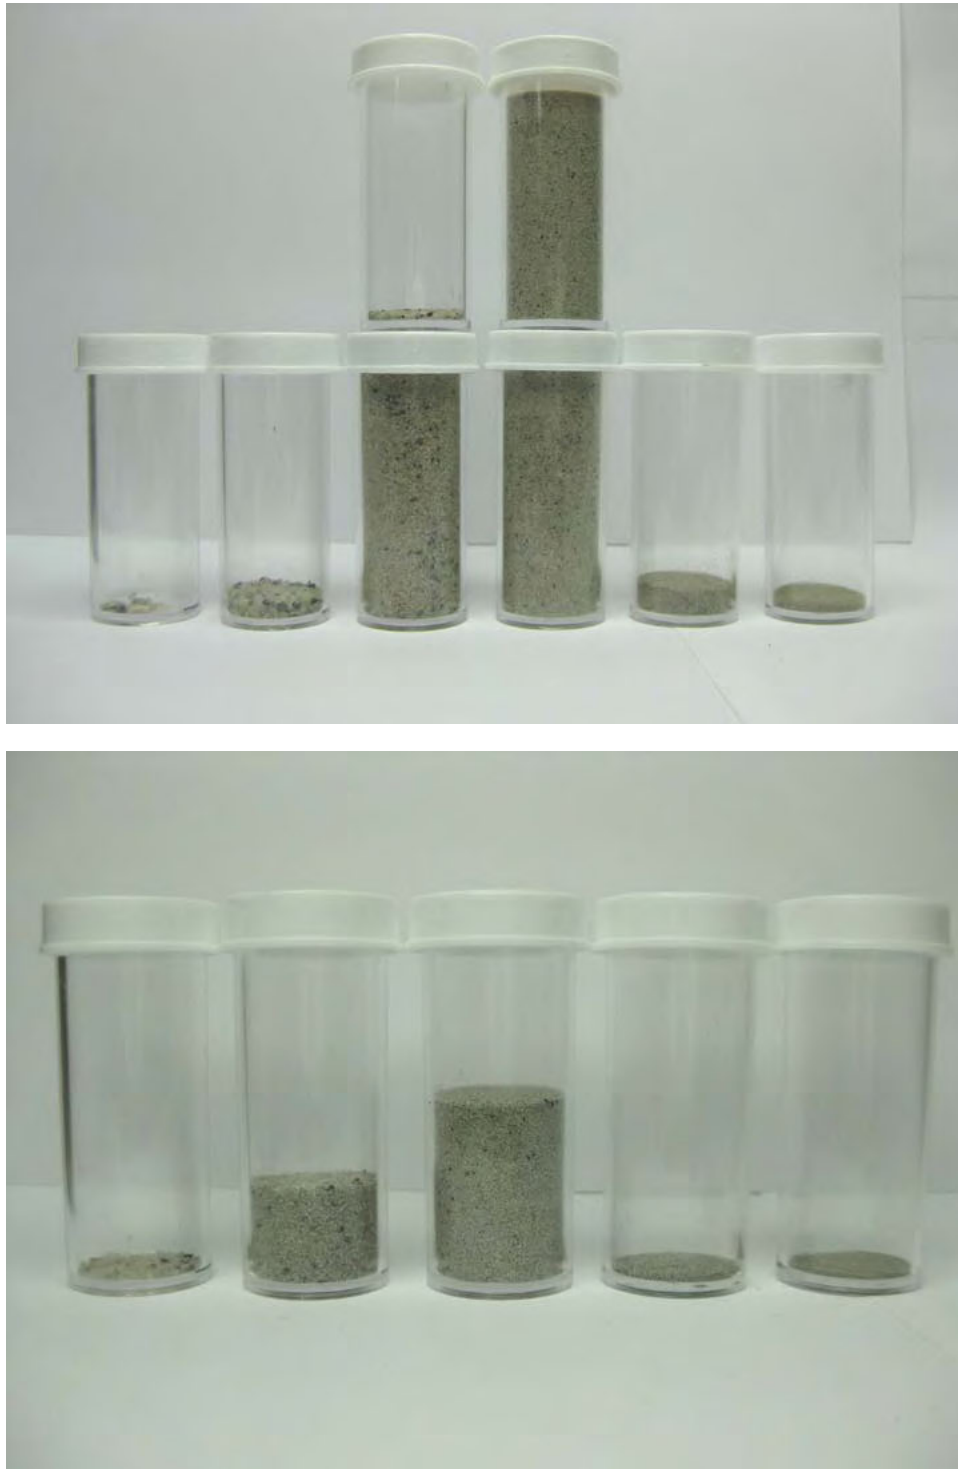
Figure 4: Photographs of the graded sand separated from mortar samples CALO.Mortar.1 (top) and CALO.Mortar.2 (bottom). The sands are both narrowly graded with a vast majority of material found between the No. 30 and No. 100 sieves.

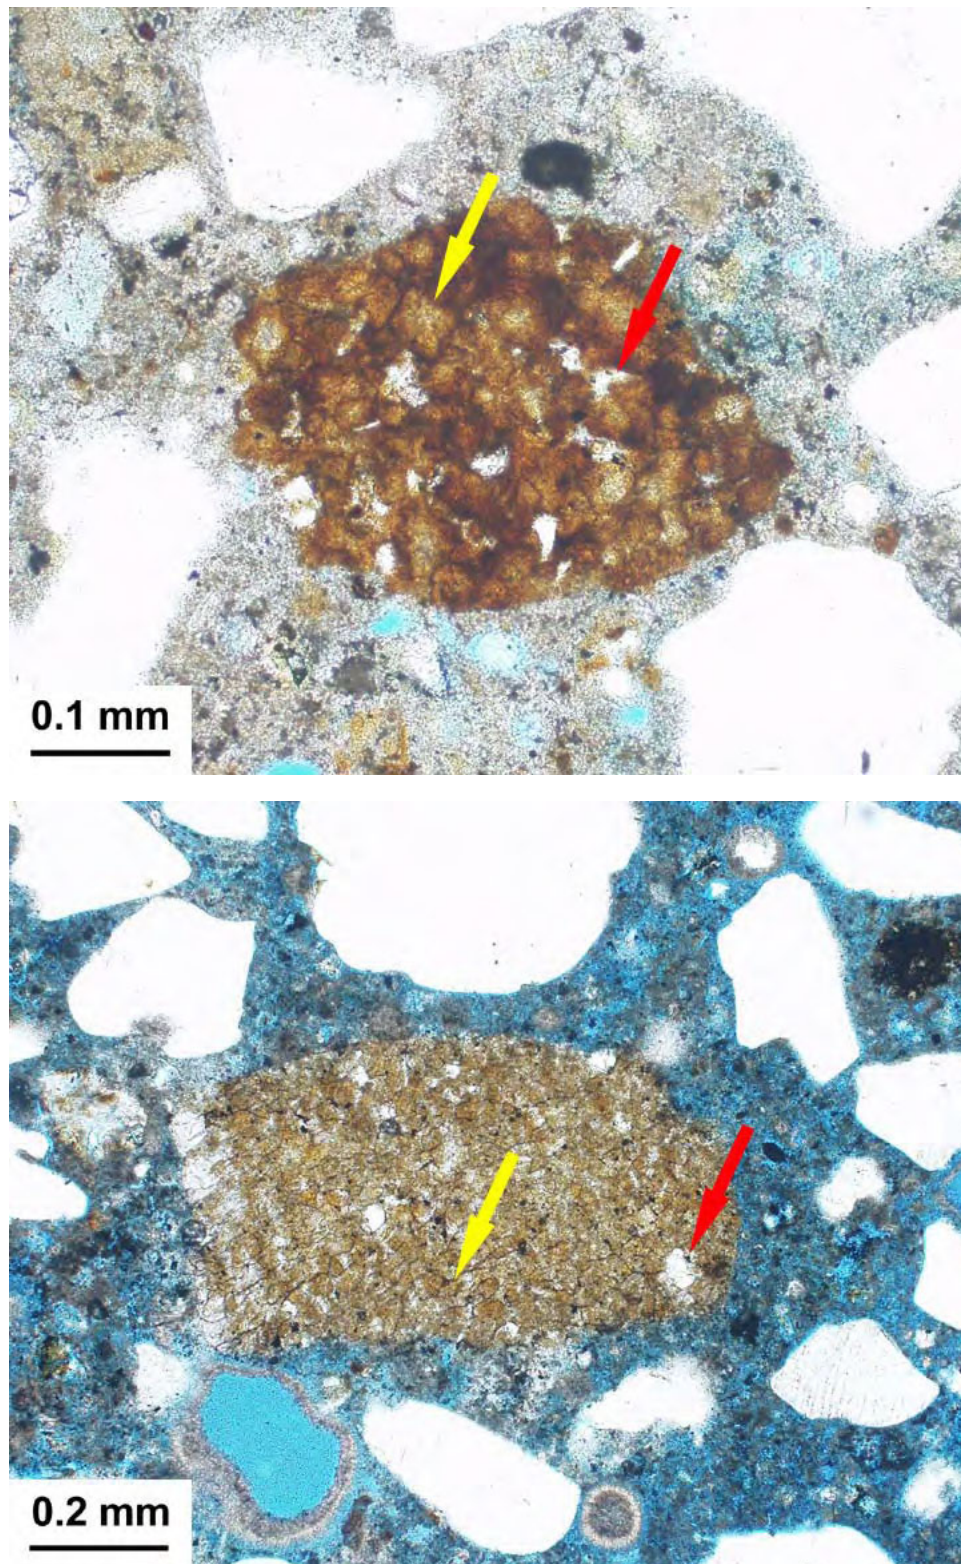
Figure 5: PPL photomicrographs illustrating natural cement grains in mortar samples CALO.Mortar.1 (top) and CALO.Mortar.2 (bottom). The yellow arrows indicate original dolomite crystals now lined with iron-bearing cement phases. The red arrows represent quartz silt grains that have not combined during cement calcination. These textures are typical of nineteenth century American natural cements. No residual lime binder is detected petrographically in either sample.

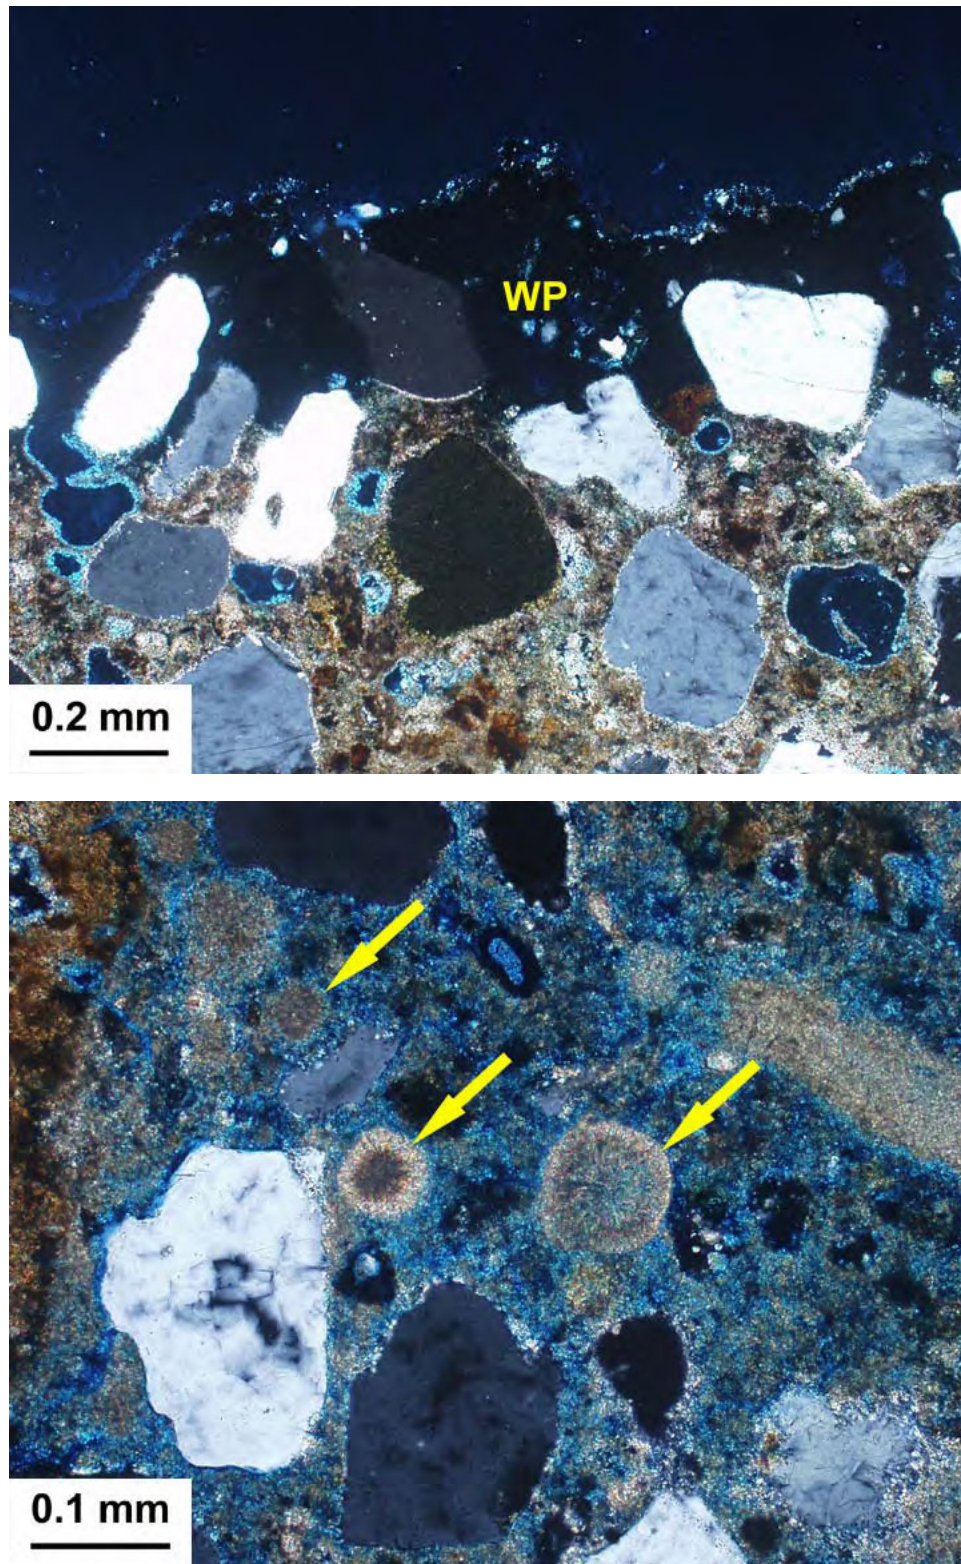
Figure 6: XPL photomicrographs illustrating minor secondary chemical reactions. (Top) Sample CALO.Mortar.1 exhibits a rind of weathered paste (WP). The golden color of the paste below is due to normal carbonation. The dark color within the rind indicates dissolution of this secondary carbonate along with other acid-soluble phases. The weathered paste is consistent in texture with that affected by acidic solution. (Bottom) The arrows indicate air-voids in Sample CALO.Mortar.2 that are filled with secondary calcium carbonate. These are visible in hand sample as fine white spots that should not be confused with lime inclusions.
