Cape Lookout National Seashore

Portsmouth Life- Saving Station

# Historic Structure Report

2006

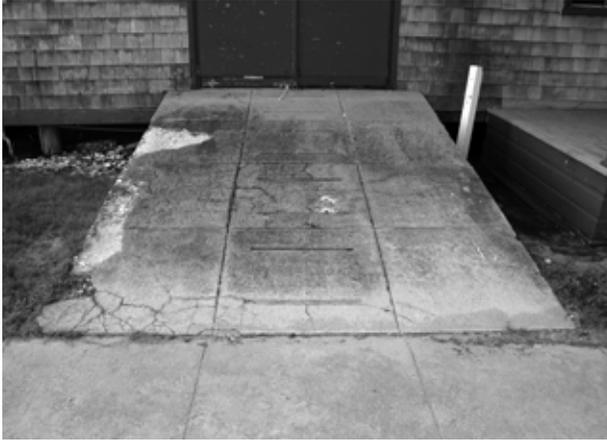
FIGURE 55. View of ramp to smaller boat room door on northwest side of building. (T. Jones, NPS, 2005)

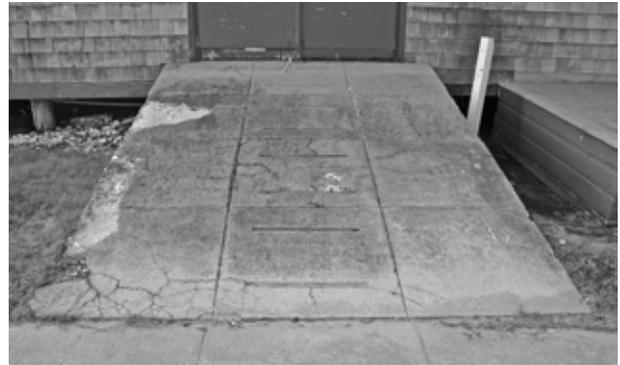
FIGURE 59. View of ramp to Boat Rooms doors D-5. (T. Jones, NPS, 2005)

*Condition:* The ramp from the easternmost door on the northwest side of the building is basically sound, but the finish layer of concrete on the other two ramps is spalling away from the base along part of the edges of the ramps.

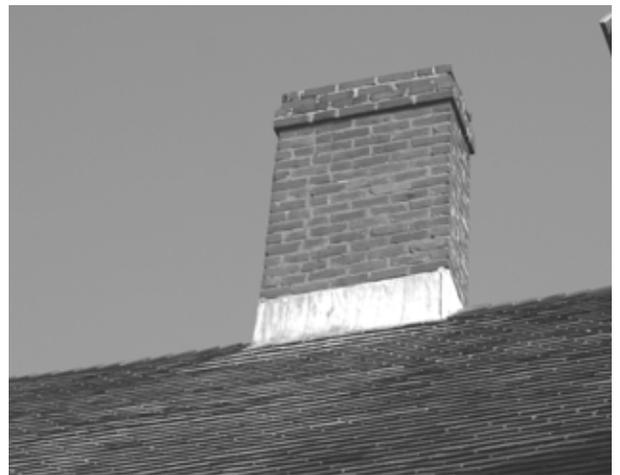
FIGURE 60. View of southeast side of chimney. (T. Jones, NPS, 2005)

*Condition:* The chimney stack is only visible in the attic and above the roof. In the attic, the brick has been stuccoed, and the stucco remains mostly intact and in good condition. Above the roof, the original chimney stack appears to remain intact, although the original stepped flashing has been replaced.

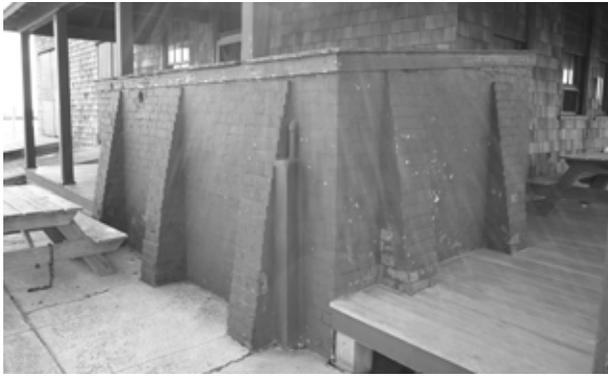
FIGURE 61. View east of cistern. (T. Jones, NPS,

*Condition:* The cistern appears to be in sound condition, but downspouts from the gutters no longer

keep it filled. The wooden cover is in fair condition. The hatch that provides access to the interior of the cistern is nailed shut, and the condition of the interior of the cistern was not inspected.

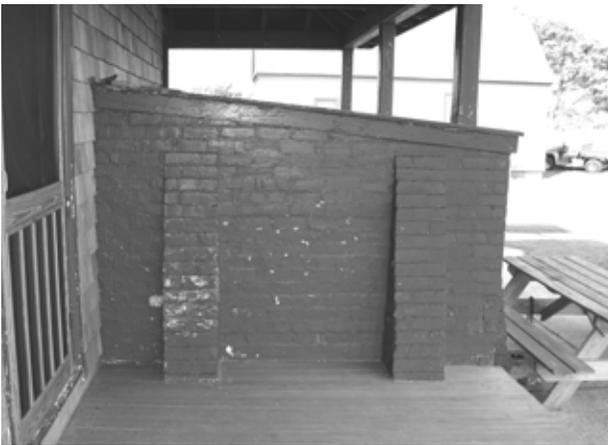
FIGURE 62. View southwest of cistern. (T. Jones, NPS, 2005)

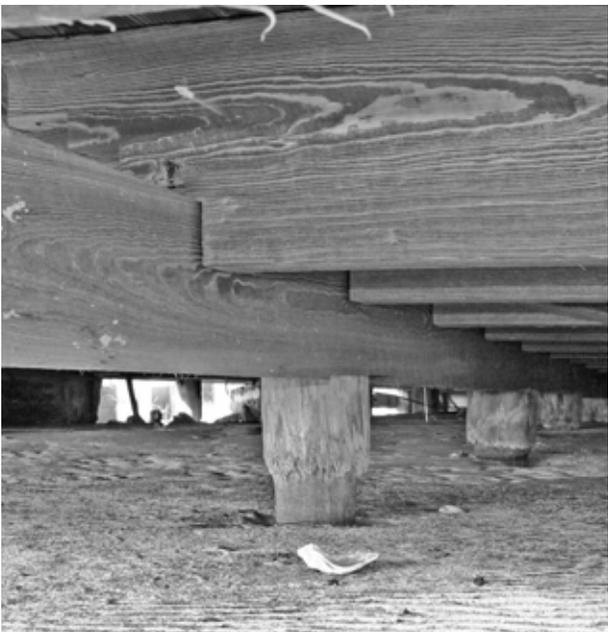
FIGURE 63. View west under boat room. (T. Jones, NPS, 2005)

*Condition:* There is no indication that the pilings are not original to the building, and many of them have lost a considerable amount of wood, mostly due to erosion from sand- laden water that periodically sweeps the site.

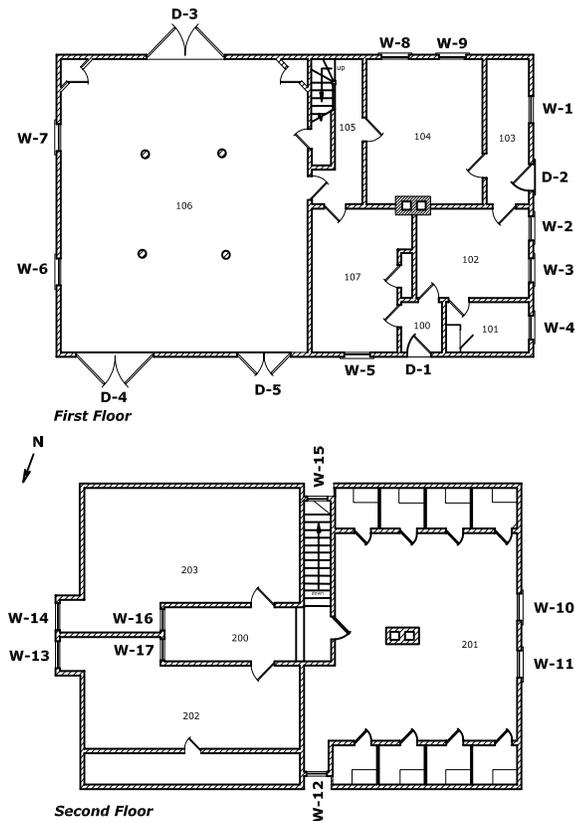
FIGURE 73. Plan showing numbering of windows and doors. (T. Jones, NPS, 2005)

W-1	3'-4" by 2'-9", single sash, nine lights, originally top hinged
W-2	2'-10" by 5'-8", nine over two, double hung, one light broken
W-3	2'-10" by 5'-8", nine over two, double hung, one light broken
W-4	2'-10" by 5'-8", nine over two, double hung, two lights broken
W-5	3'-4" by 5'-10", nine over two, double hung
W-6	3'-4" by 5'-10", nine over two, double hung, sash and frame out of opening
W-7	3'-4" by 5'-10", nine over two, double hung
W-8	3'-4" by 5'-8", nine over two, double hung, ropes broken
W-9	3'-4" by 5'-8", nine over two, double hung, ropes broken
W-10	3'-0" by 4'-4", six over two, double hung
W-11	3'-0" by 4'-4", six over two, double hung
W-12	2'-10" by 4'-4", six over two, double hung
W-13	3'-0" by 4'-4", six over two, double hung, ropes broken
W-14	3'-0" by 4'-4", six over two, double hung, ropes broken
W-15	2'-10" by 4'-4", six over two, double hung
W-16	2'-6" by 2'-7", single sash, four light, top hinged, all glass missing

W-17	2'-6" by 2'-7", single sash, four light, top hinged, all glass missing
attic	2'-4" by 3'-5", two over two, double hung
tower	seven openings, 1'-8" by 2'-4", single sash, three lights, top hinged

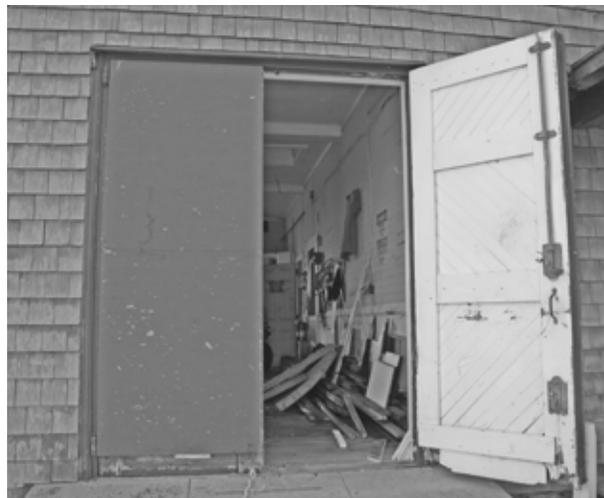
FIGURE 80. View of Door D-5. (T. Jones, NPS, 2005)

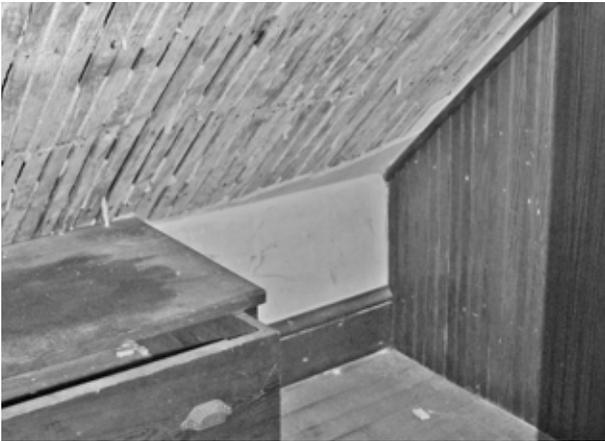
FIGURE 88. View of original plaster on wood lath in one of the closets in Room 201. (T. Jones, NPS, 2005)

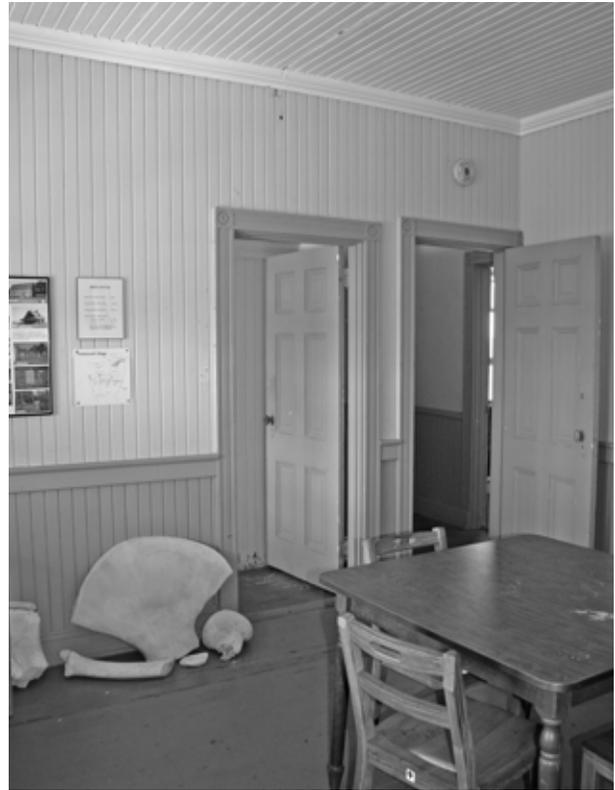
FIGURE 100. View north in Room 102. (T. Jones, NPS, 2005)

two, and are 2'-10" by 5'-8". One of the large panes in each of the lower sash is broken.

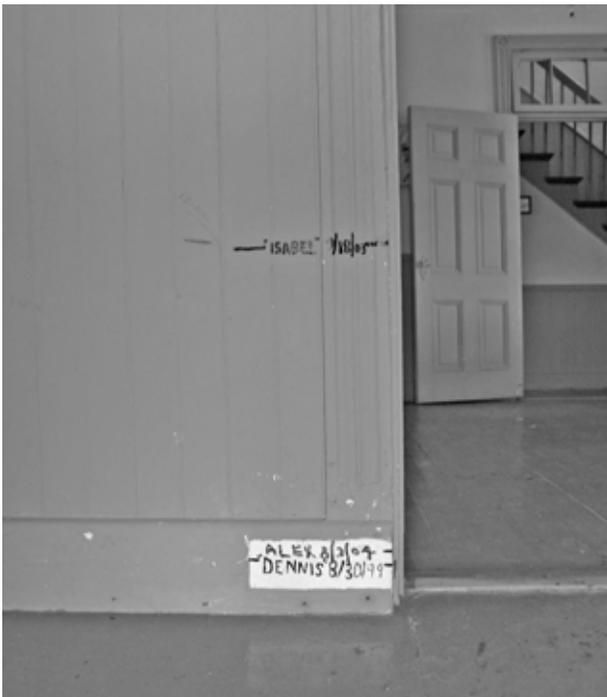
*Condition:* The lower two or so feet of the plaster walls on the first floor have been severely damaged by the recent flooding, when water rose as high as 22” inside the station. Above the water line, the upper walls and ceilings are in fair condition and can be easily repaired. In the closets, where the original plaster on wood lath was not replaced, much of the plaster is missing, although the wood

FIGURE 103. View of marks showing high-water marks for recent hurricanes. (T. Jones, NPS, 2005)

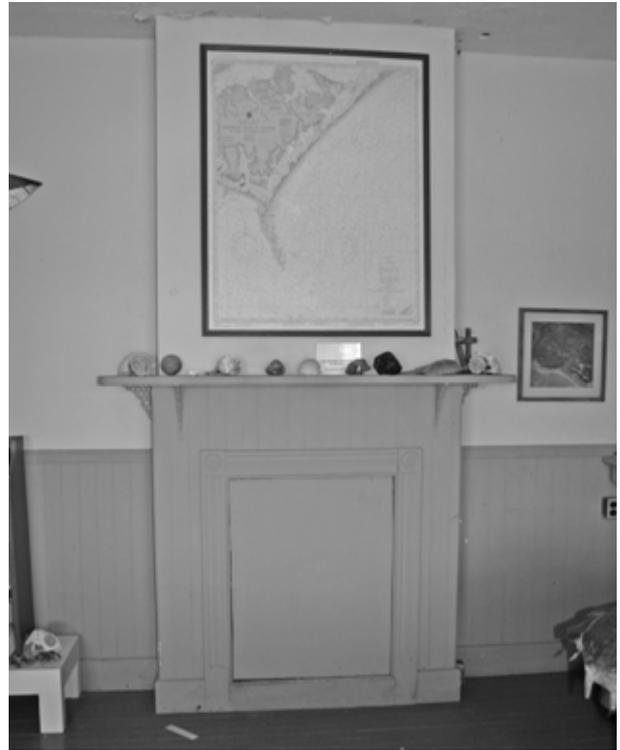
FIGURE 105. View north in Room 104. (T. Jones, NPS, 2005)

*Flooring:* The entire floor is laid with painted, 2- 1/2" wide, tongue- and- groove flooring, the only floor in the building laid entirely with the narrower flooring. As a result of storm flooding, flooring is severely buckled on the northwest side of the room.

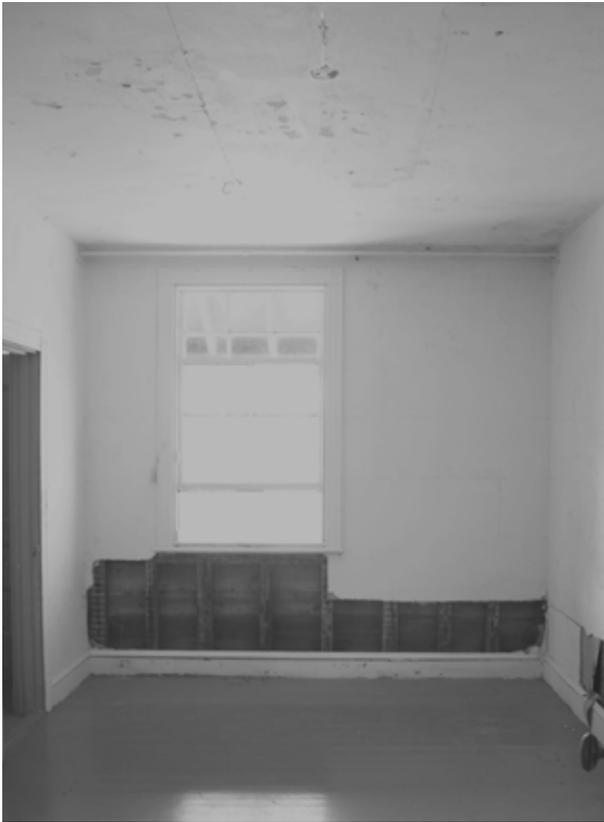
FIGURE 116. View northwest in Room 106. (T. Jones, NPS, 2005)

*Walls and Ceilings:* Walls and ceiling are finished with plaster on plaster board. Recent flooding badly damaged the lower portions of the walls, and some of the plaster board has been removed. Residue from the original plaster on wood-lath walls is visible on exposed studs.

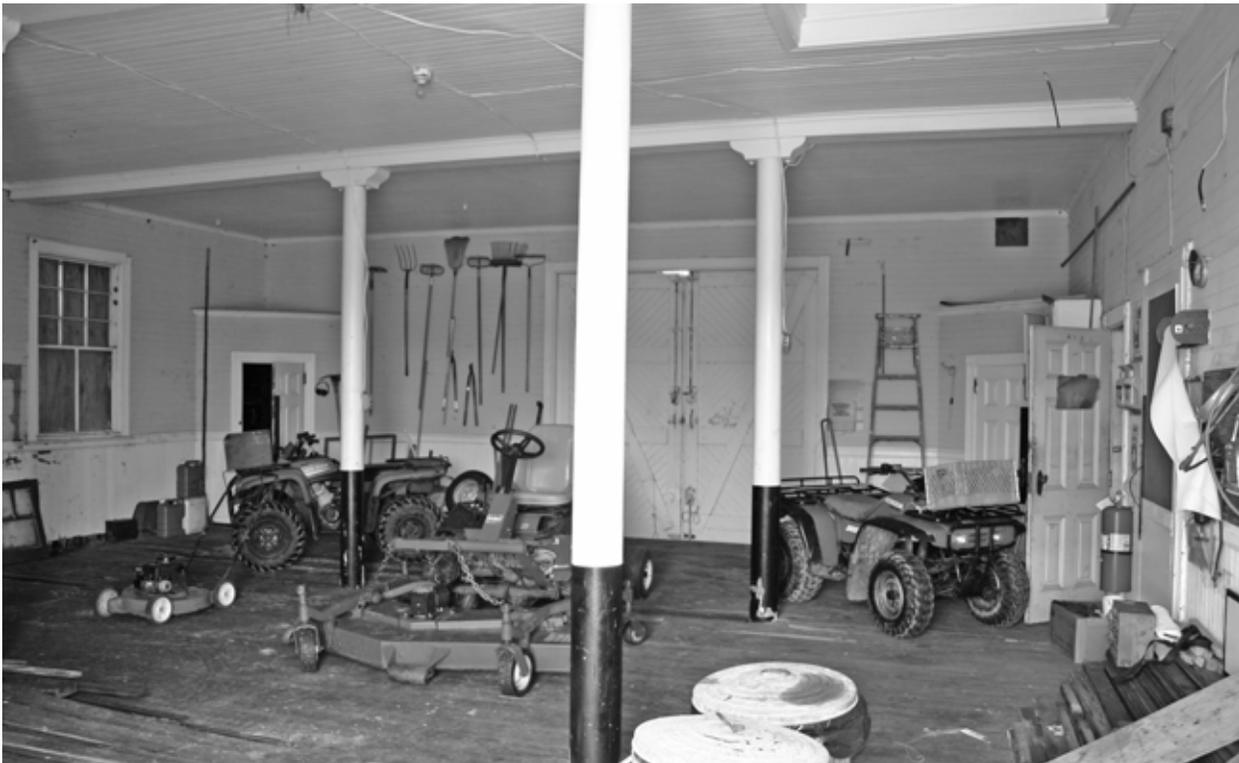
FIGURE 122. View southeast in Room 107. (T. Jones, NPS, 2005)

*Flooring:* Flooring is a typical mixture of 2- 1/2" and 3"- wide tongue- and- groove flooring. The storm surge that accompanied Hurricane Isabel in 1993 did severe damage to the north corner of the room, including dislodging sub- flooring and flooring from the floor joists, although the flooring itself was not destroyed.

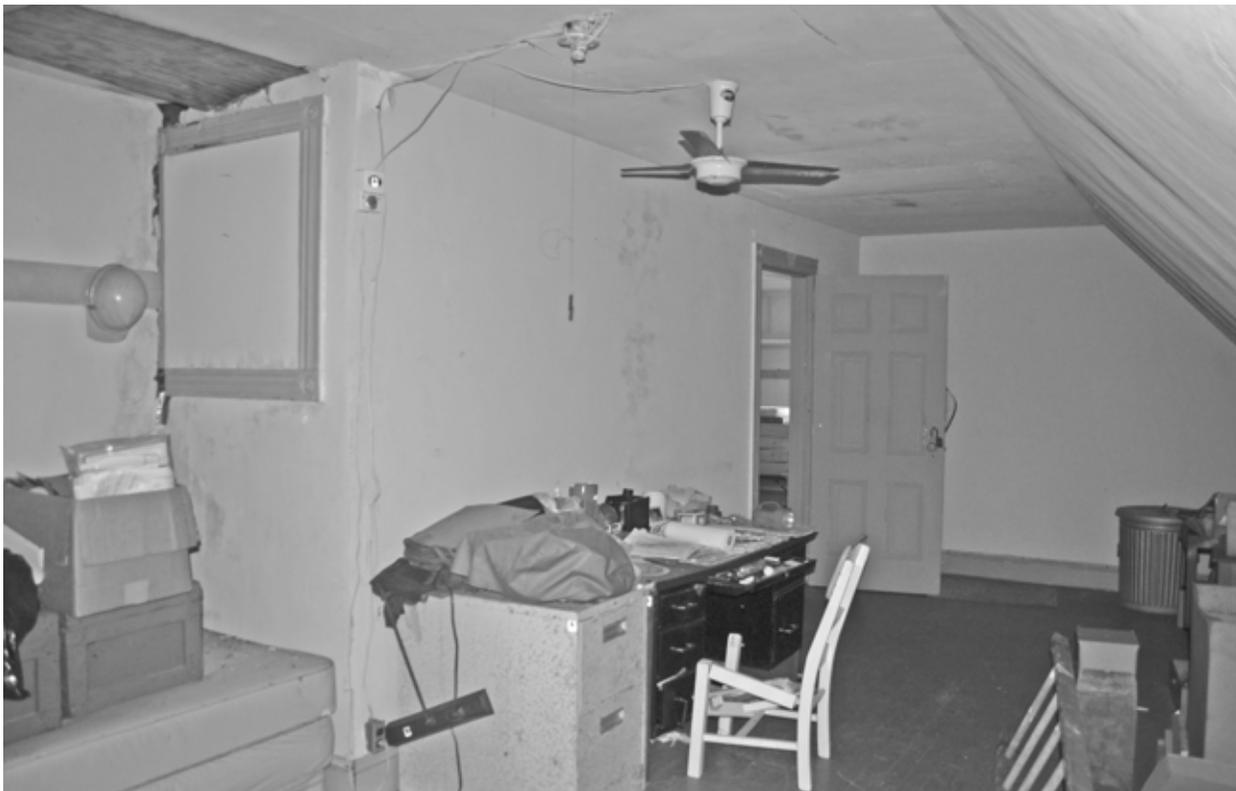
*Miscellaneous:* The wall below the dormer window has been severely damaged, apparently due to water penetration.

FIGURE 140. View southwest in Room 202. (T. Jones, NPS, 2005)
