Cane River Creole National Historical Park
Magnolia Plantation
Overseer's House
Historic Structure Report

Hartrampf, Inc.

The Office of Jack Pyburn, Architect, Inc.

2004
Historic Structure Report
Overseer's House
Magnolia Plantation
Cane River Creole National Historical Park
Natchez, LA
LCS#: 091558

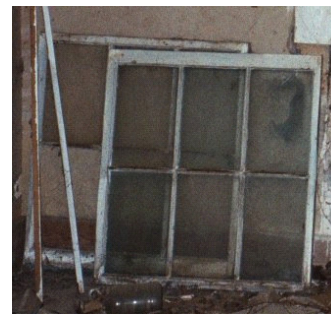
Sashes stored in Room 111,
possibly from Window 15

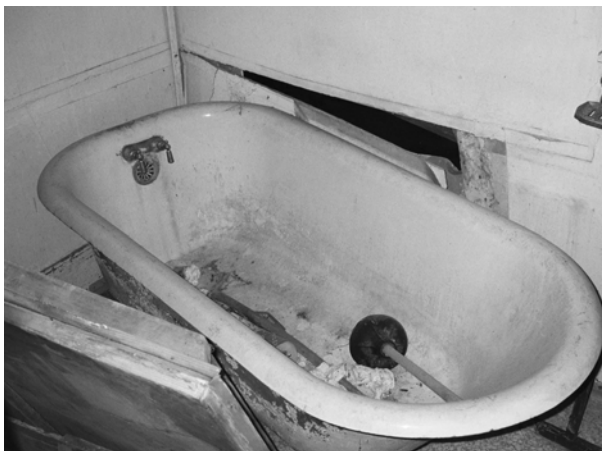
FIGURE 63. Room 109, bath tub.

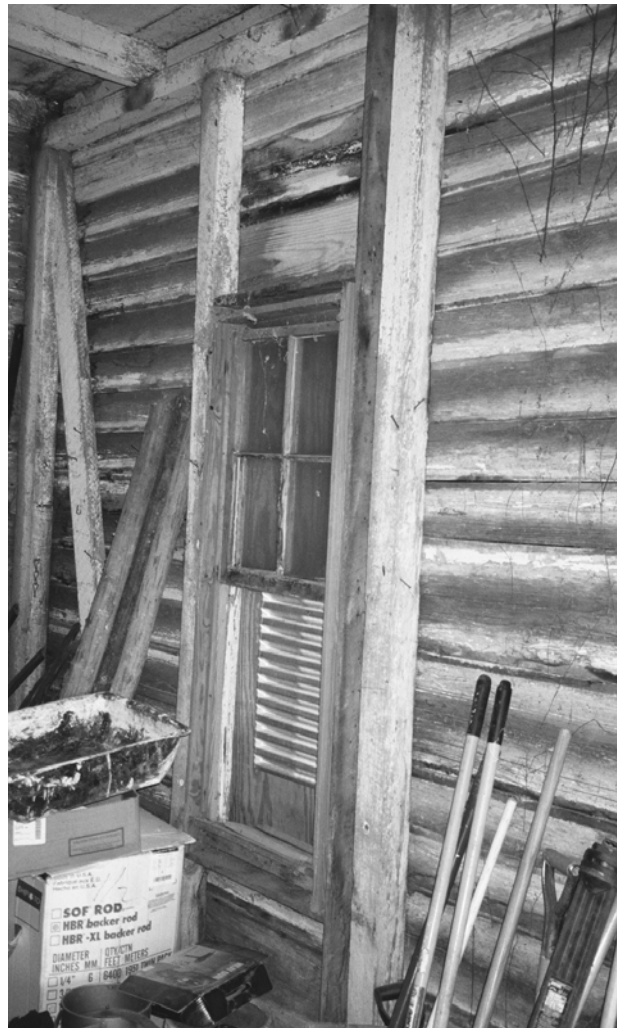
FIGURE 65. Northwest wall, Room 110.

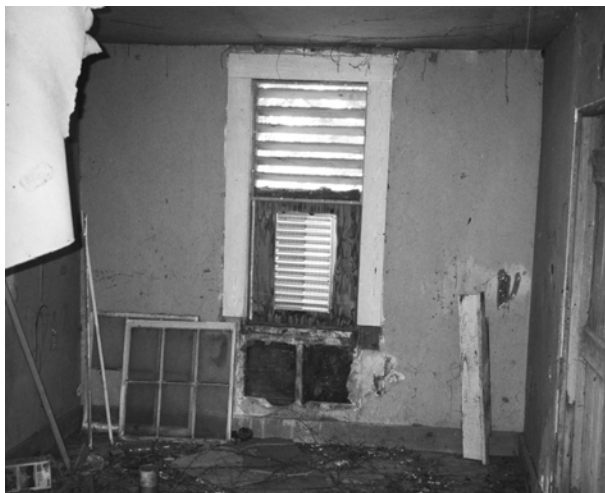
FIGURE 67. Northeast wall, Room 111.
