Dry Tortugas Light Station

Keeper's Residence Historic Structure Report

by Lord, Aeck & Sargent Architecture

2009

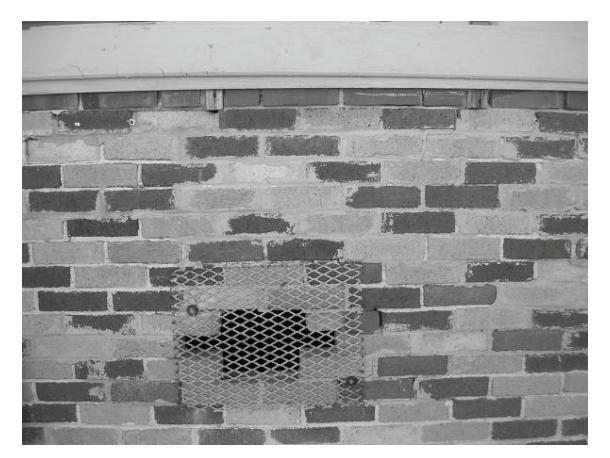
Figure 49: Typical past repointing efforts at the exterior face of foundation walls.

Existing Condition: The foundation walls of the main house appear sound with no signs of past or active settlement or movement of the foundation walls. Localized mortar loss and evidence of repointed masonry joints indicate previous mortar loss due to weathering at all foundation walls. (Figure 49)

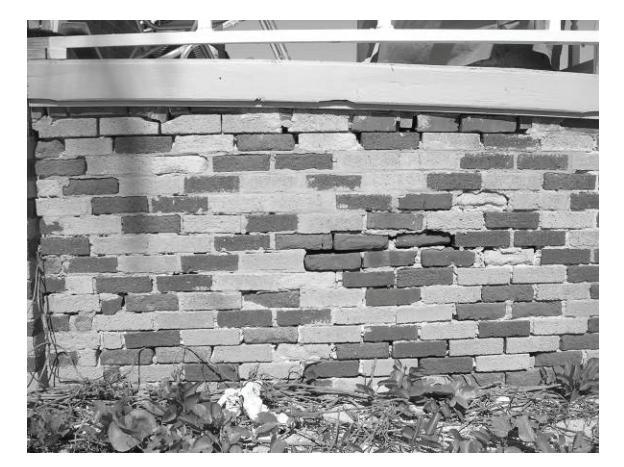
Figure 50: Loss of mortar in horizontal and vertical masonry joints at southwest front porch wall.

- Southwest wall of front porch exhibits loss of mortar in horizontal and vertical masonry joints. (Figure 50)
- Left side of the porch foundation wall on the southeast elevation (when facing the residence) (Figure 51)

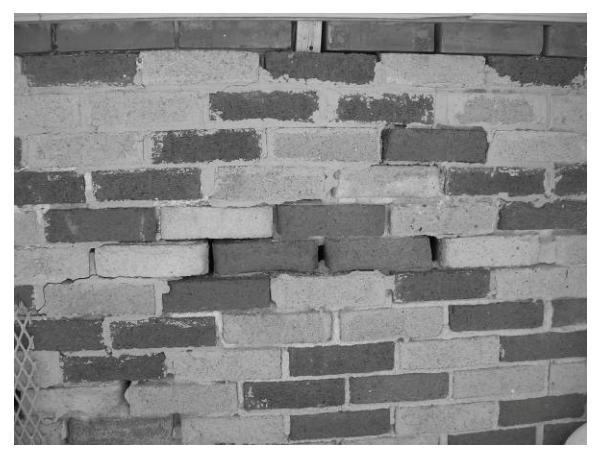
Figure 52: Loss of mortar in masonry joints and evidence of past repointing efforts at right side of front porch foundation wall on southeast elevation.

• Right side of the porch foundation wall on the southeast elevation (when facing the residence) (Figure 52)

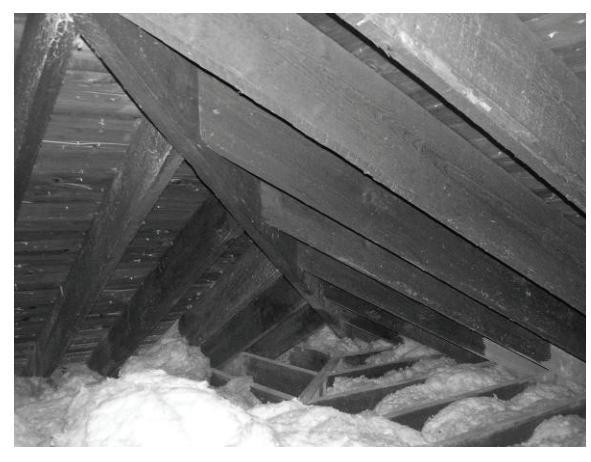
Figure 57: Roof framing at hip ridges.

signs of corrosion but generally appeared in good condition. No signs of failed fasteners was observed and all joinery appeared tight (Figure 57).

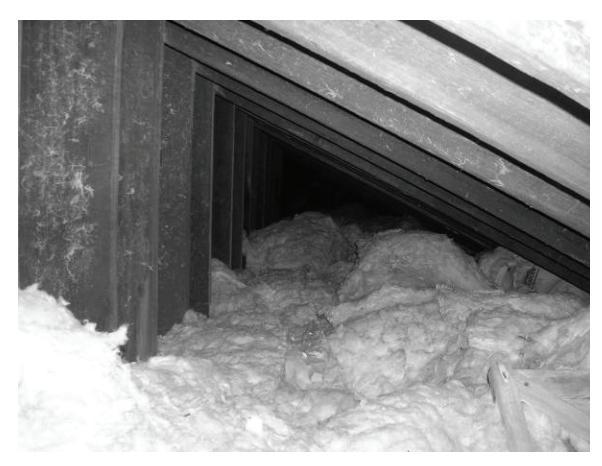
Figure 60: Vertical struts of roof truss extending from mid-span of the rafters to joists.

Two rows of vertical 2" x 8" struts extend from the ceiling joists to the rafters at mid-span, with one row of struts on each side of the V-shaped struts. The roof framing members are attached with round-headed common nails that are exhibiting some corrosion but generally appear in good condition. This roof framing was designed to resist wind loads. (Figure 60)

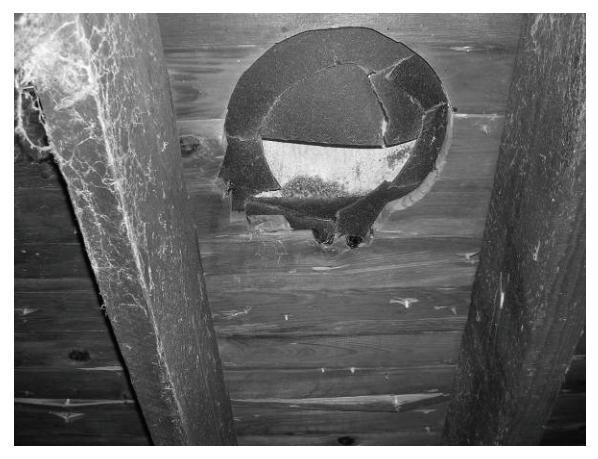
Figure 62. Attic vent open though the roof.

Existing Condition: The attic space was dry at the time of inspection and no evidence of active or past leaks was observed. A circular opening, most likely for an attic vent, is open through the roof framing and roofing and does not have a cover or screening. This opening could allow moisture to infiltrate the roof and attic of the residence (Figure 62). The fasteners used to secure structural roofing members appear to be in relatively good condition. Some fasteners are exhibiting signs of surface corrosion while others have not corrosion at all. All of the structural roofing members appeared well secured.

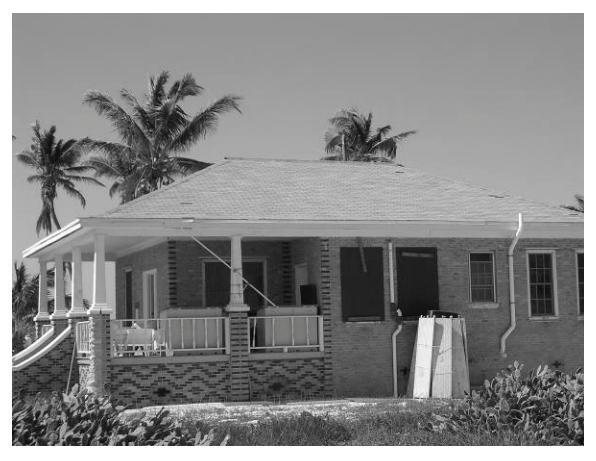
Figure 68: View of single PVC downspout at north elevation

Gutters and Downspouts: The original construction drawings indicate that the building was intended to have gutters and downspouts. Historic photographs dating from the period of construction also indicate that the house originally had fascia-hung gutters and downspouts. Architectural drawings from 1989 indicate that new PVC gutters were installed at that time. The Keeper's Residence currently has no gutters, and a single PVC downspout remains on the northeast elevation. (Figure 68)

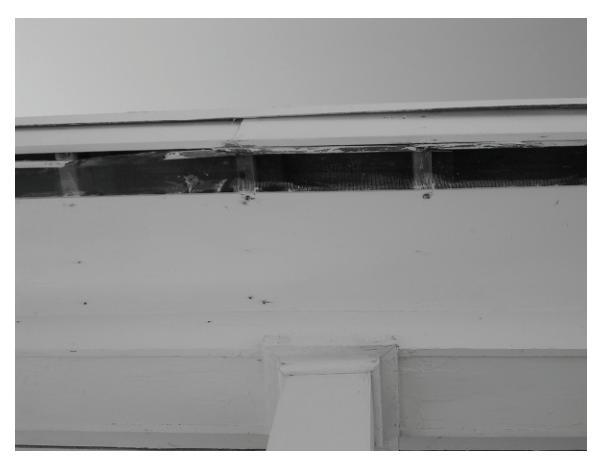
Figure 69: Weather paint finish, rusted nail heads, and torn/missing quarter-round and screening at the eave soffit.

deteriorating. The metal flashing and nails are rusted. The quarter-round wood molding and screening at the eave soffit is torn and missing in select locations. (Figure 69)

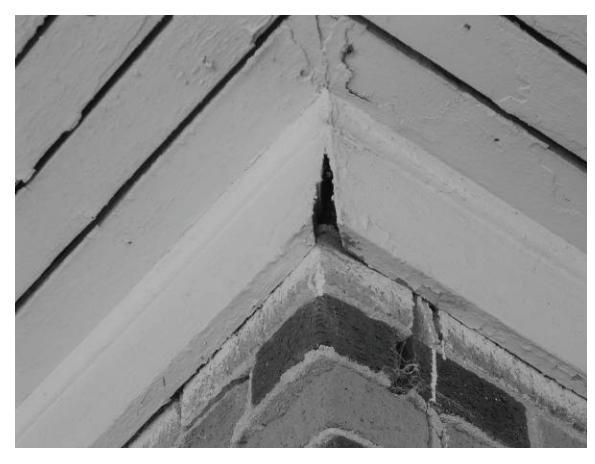
Figure 70: Separation of frieze board at east corner of building.

The sheet metal flashing is pulling away from the eave at the southeast (front) elevation and east corner of the residence. The cornice at the east corner of the building is separating with an approximate $\frac{1}{2}$ " gap at the mitered corner. (Figure 70)

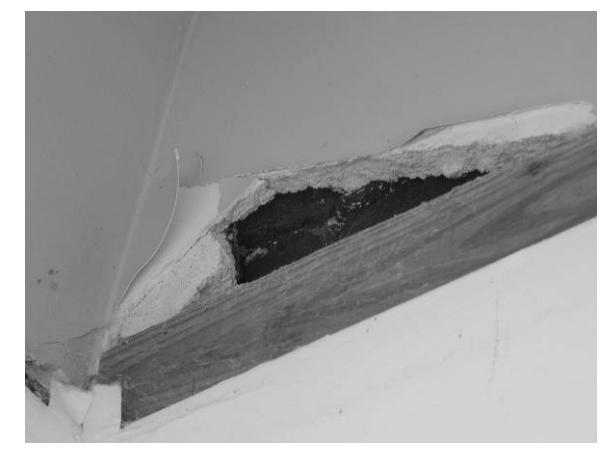
Figure 71: View of tar coating the interior face of the exterior brick viewed through hole in the bathroom wall.

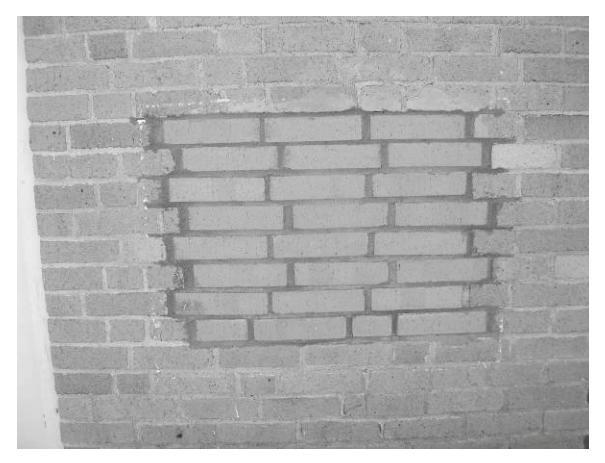
Figure 72: Replacement brick and mortar not matching historic materials located to the right of the main door on the east elevation

Existing Condition: The exterior walls have experienced moderate erosion of mortar and face brick due to weathering caused by the extreme weather conditions of heat, wind, water, and sand. Evidence of past repointing with mortar not matching the historic mortar indicates that these conditions have existed for some period of time. For example, portions of brick located to the right of the main door on the east elevation and at the northwest elevation have been replaced with brick and mortar that does not match historic brick and mortar. The new brick is 9" long with a smoother texture than the original 8" brick with a rougher texture. The mortar joints are wider than the historic joints; the mortar is dark grey in color rather than the lighter gray of the historic mortar; and the new mortar has a smooth consistency rather than the more textured consistency of the historic mortar, indicating that the later mortar does not contain the local carbonate sand as the historic mortar. (Figure 72)

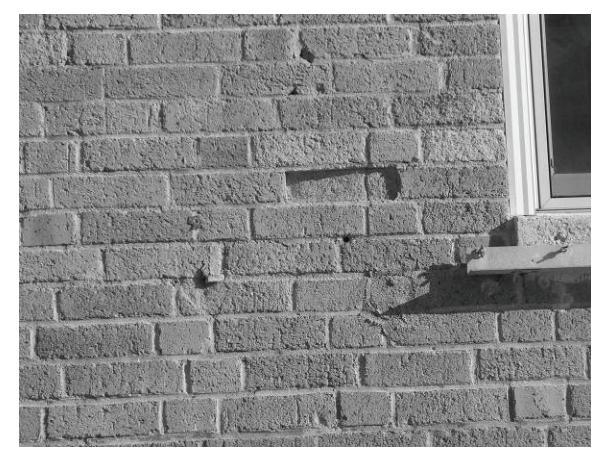
Figure 74. Spalling brick at west elevation.

- Loss of mortar and spalling brick at lower portion of wall on north elevation (Figure 73)
- Spalling brick and inappropriate repointing on west elevation (Figure 74)
- Spalling brick at west elevation (Figure 75)
- Infill of crawlspace vent for hose bib on west elevation (Figure 76)
- Cracking in mortar joint on northwest elevation
- Spalling brick to right of Window 15 at south corner on southwest elevation
- Loss of mortar at lower wall section below Window 15 on south elevation

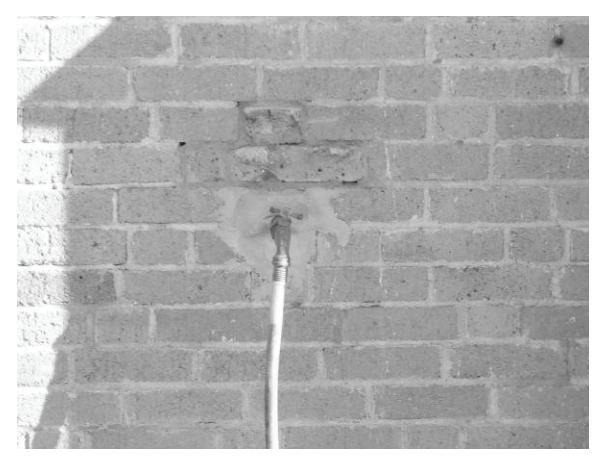
Figure 76. Vent opening infilled for hose bib at west elevation.

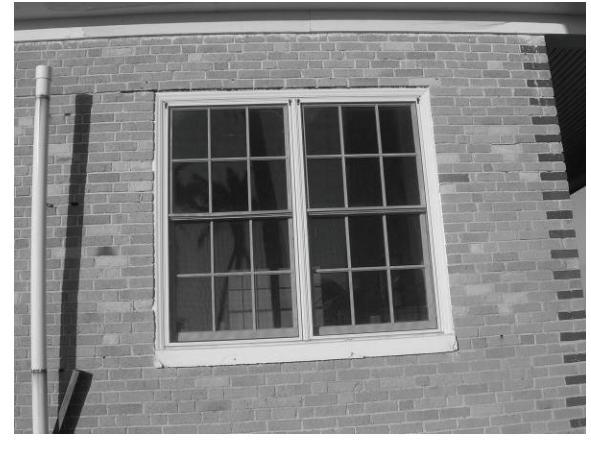
Figure 77: Mortar joint cracking due to oxide jacking.

walls. These conditions are caused by jacking from oxidation and associated expansion of the steel lintels embedded in the masonry walls. This

Above and between Windows 14 and 15 (Figure 77)

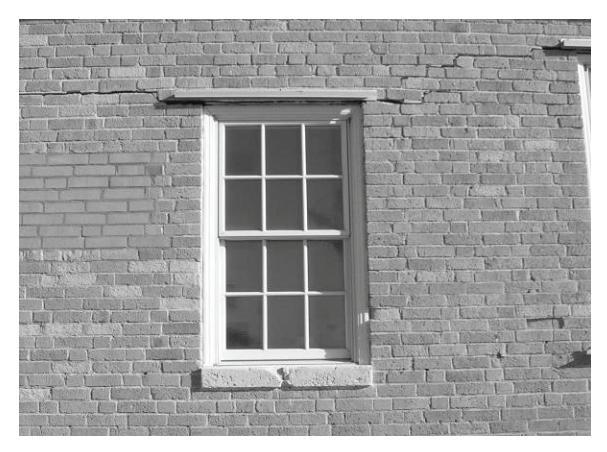
Figure 78: Mortar joint cracking due to oxide jacking.

Above and between Windows 8, 9 and 10 (Figure 78)

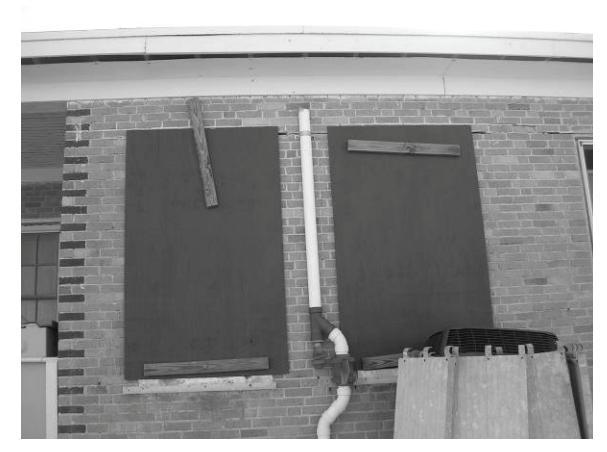
Figure 79: Mortar joint cracking due to oxide jacking between windows 3 and 4.

- Above and between Windows 3 and 4 (Figure 79)
- Above and between Windows 4 and 5 (Figure 80)

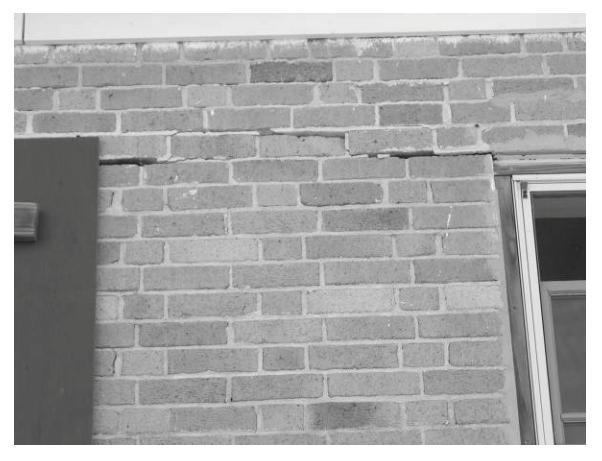
Figure 80: Mortar joint cracking due to oxide jacking between windows 4 and 5.

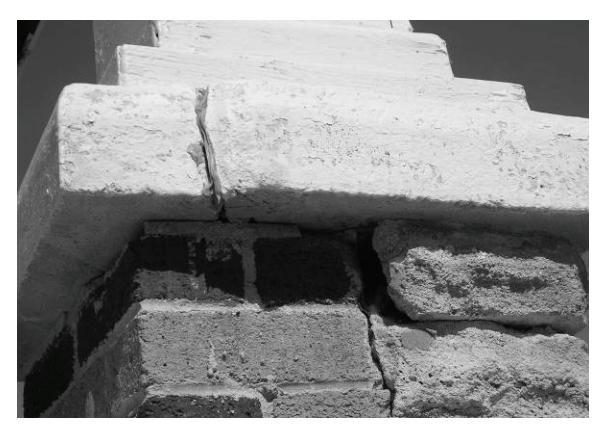
Existing Condition: There is masonry damage in multiple locations at the front porch piers. There are multiple cracks in the mortar joints, bricks, and concrete caps of the porch piers. This damage is almost certainly related to the corrosion and expansion of tie rods and anchor plates embedded in the piers to secure the porch roof. There is also evidence of past cracks that have been filled with epoxy filler. The specific areas of masonry damage to the porch piers are identified below.

No 1: Crack in the southwest side of the plinth on the far left porch pier on the southeast elevation (facing residence) (Figure 83)

Figure 83: Crack in the concrete plinth on the far left porch pier on the southeast elevation.

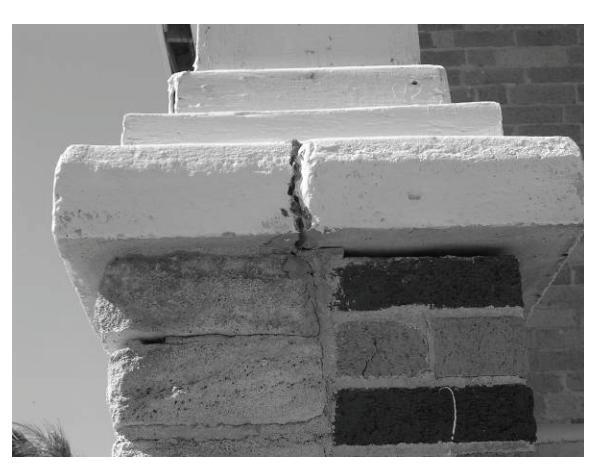
No. 2: Crack in the east side of the plinth on the far left porch pier on the east elevation (facing residence) (Figure 84)

Figure 84: Crack in east side of plinth on the far left porch pier at east elevation.

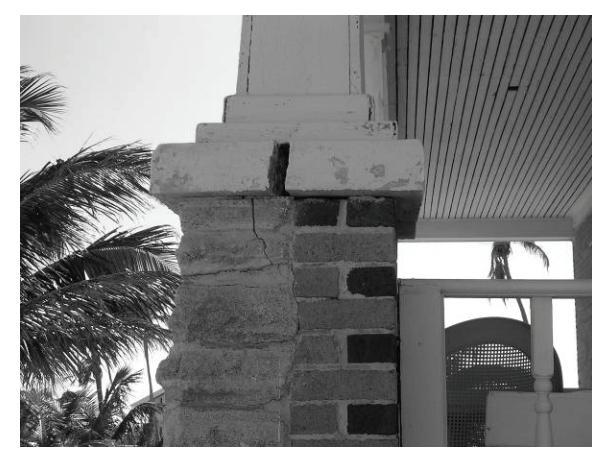
No. 5: Cracks in the brick and mortar joints at the top of the far right pier on the north elevation (facing residence) (Figure 86)

Figure 86: Cracks in brick and mortar joints at the top of the far right pier on the north elevation.

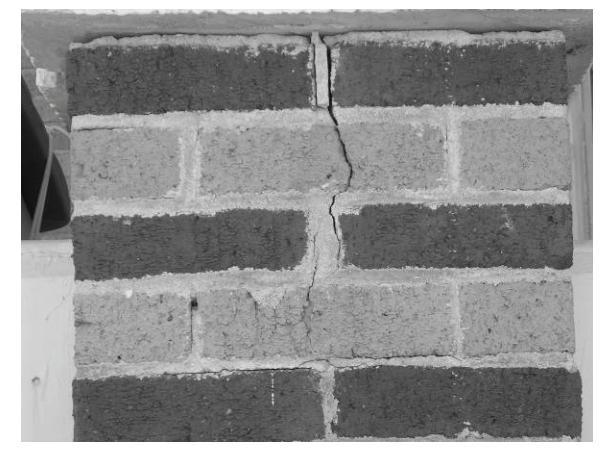
No. 6: Crack in the west side of plinth and top three courses of the second pier from the left on the south elevation (facing residence) (Figure 87)

Figure 87: Crack in the west side of plinth and top three courses of the second pier from the left on the south elevation.

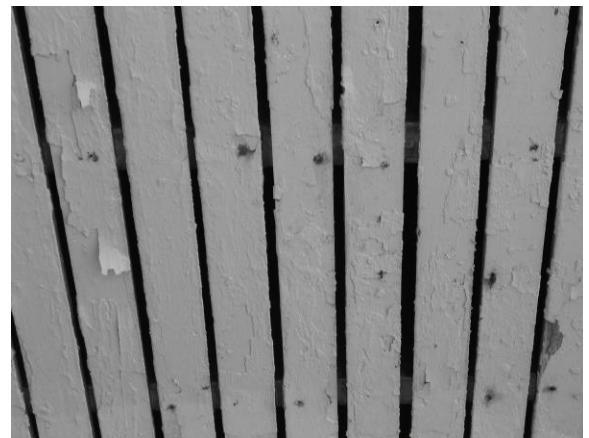
Existing Condition: The front porch ceiling has multiple layers of paint. The outer layers are chipping and flaking. The heads of the nails used to secure the ceiling boards are corroded due to exposure to salt. (Figure 90)

Figure 90: Deteriorating paint finish of the front porch ceiling.

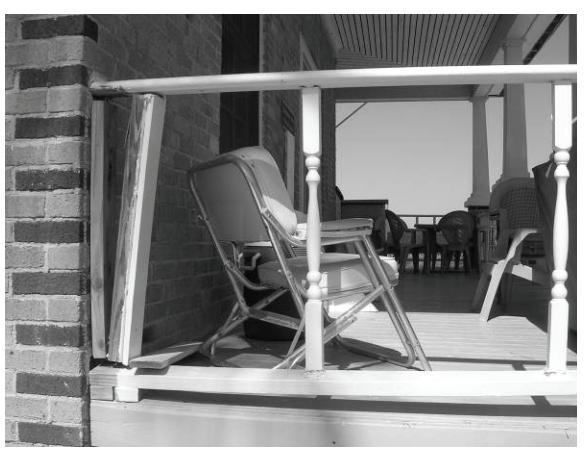
Existing Condition: Generally, the wood is sound and nails are secure. The baluster post at the south corner of the house on the southwest elevation is separating and the face board is detached. (Figure 92)

Figure 92: Damage to baluster post at the south corner of the porch.

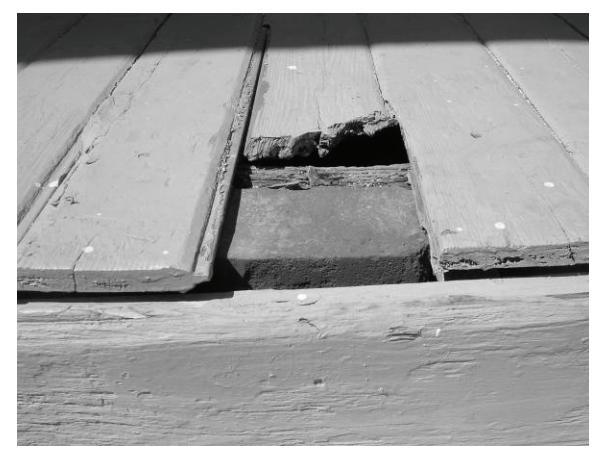
- Boards 8 & 9 -- broken ends
- Board 12 -- joint separating on left side
- Board 42 -- broken end (Figure 93)
- Board 47 -- joint separating
- Board 62 -- joint separating
- Board 68 -- split and cracked
- Board 71 -- split and joint separating at right side

Figure 93: Broken tongue and groove flooring of front porch.

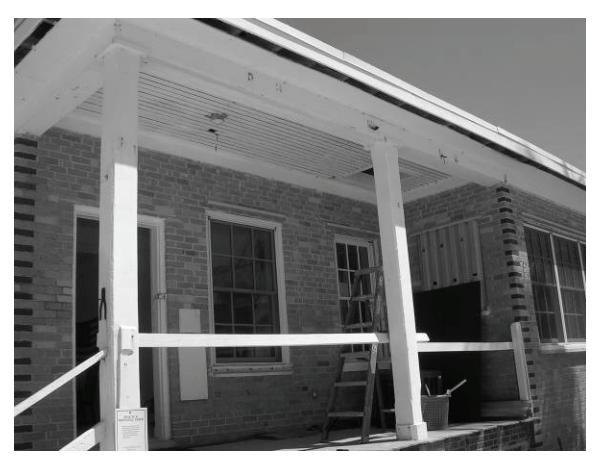
Existing Condition: The wood elements of the roof, eave, cornice and posts are sound. The screening of the eave soffit is torn and missing in sections. In numerous locations along the side porch cornice, metal anchors and brackets are attached to the exterior of the cornice. These items are corroding and staining the exterior paint. (Figure 98)

Figure 98: View of side porch – eave screening is torn and missing; metal anchors and brackets are corroding and staining the exterior paint.

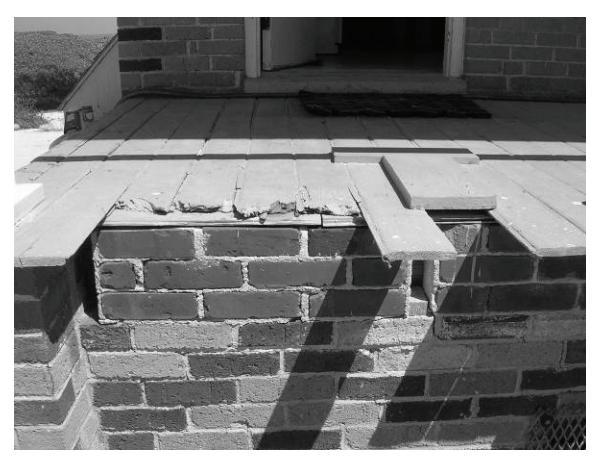
- Boards 5, 6, 7, 8, 10, and 20 (Figure 103)
- Boards 35 and 39 (Figure 104)

Figure 103: Damage to outside ends of side porch flooring – boards 5, 6, 7, 8 and 10.

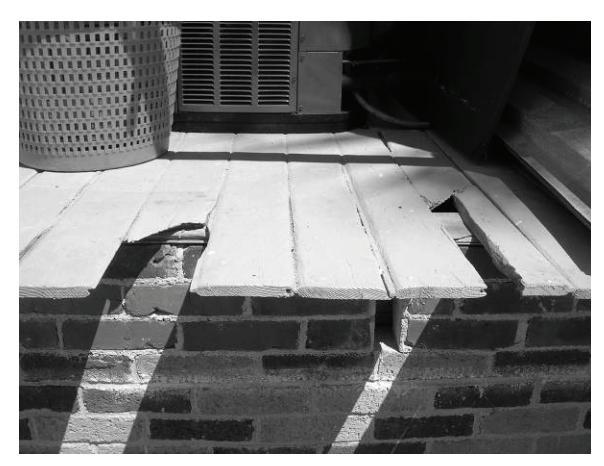
Figure 104: Damage to outside ends of side porch flooring – boards 35 and 39.

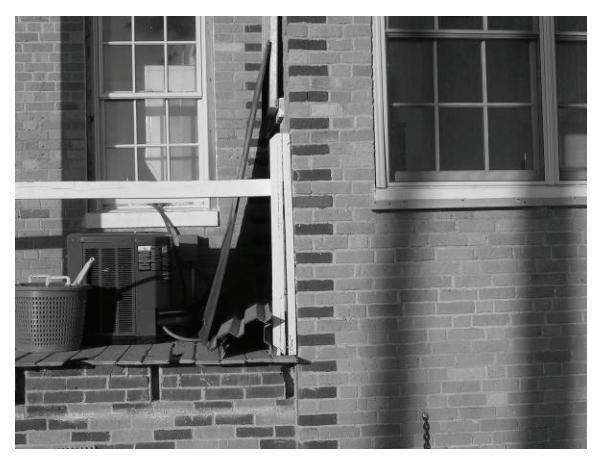
Figure 106: Separation between the wood porch rail post at northwest wall.

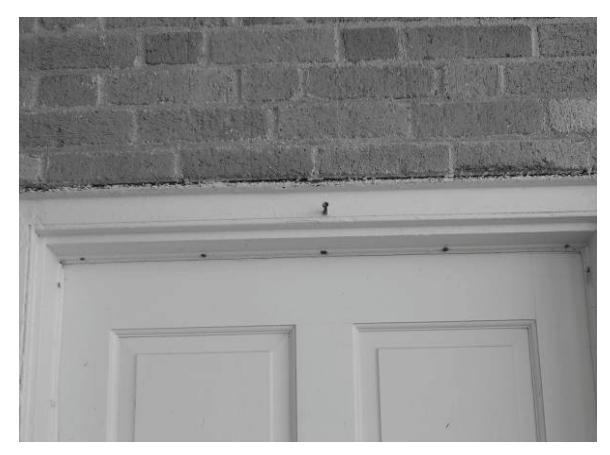
The paint finish on the threshold at the secondary front door (D-2) is chipped and cracked in select locations. Heads of nails used to fasten weather stripping to the secondary front door are rusted. (Figure 116)

Figure 116: Rusted lintel and nail heads at secondary front door (D-2).

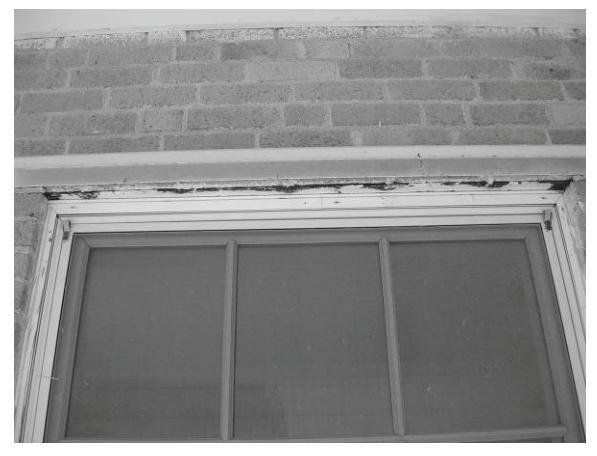
Existing Condition: While the window units themselves are in sound condition, the steel lintels and coral concrete sills are in a deteriorating condition. As described above in the *Exterior Wall* section of this report, the steel window lintels over the windows are severely rusted causing extensive jacking of brick along the window heads and extending between windows. (Figure 118)

Figure 118: Rusted steel lintel above the opening for Window 2.

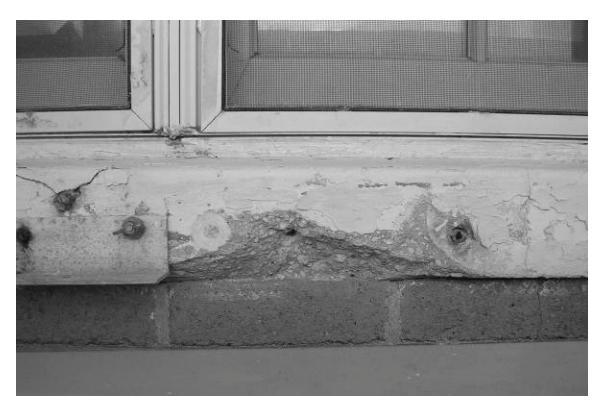
Figure 119: Damage to concrete sill of Window 2 from the metal shutter track.

Window 2 – chipping and cracking of the concrete sill (Figure 119)

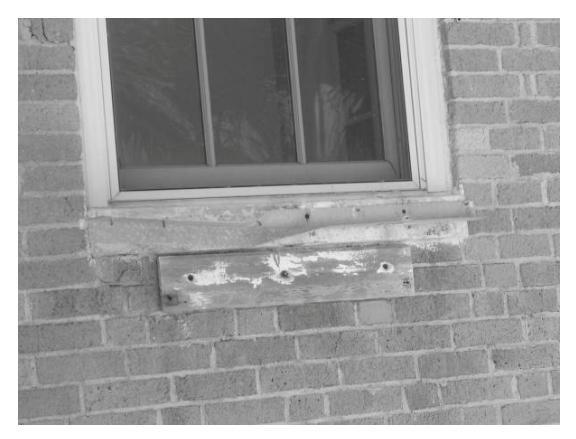
Figure 120: Cracks in the masonry and mortar joints below Window 7.

Window 7 – cracking of bricks and along mortar joints below window sill (Figure 120)

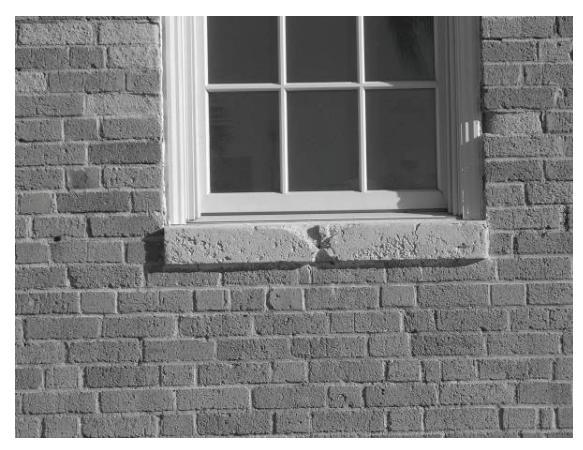
Figure 121: Damage to concrete sill of Window 9.

Window 9 – chipping of concrete sill (Figure 121)

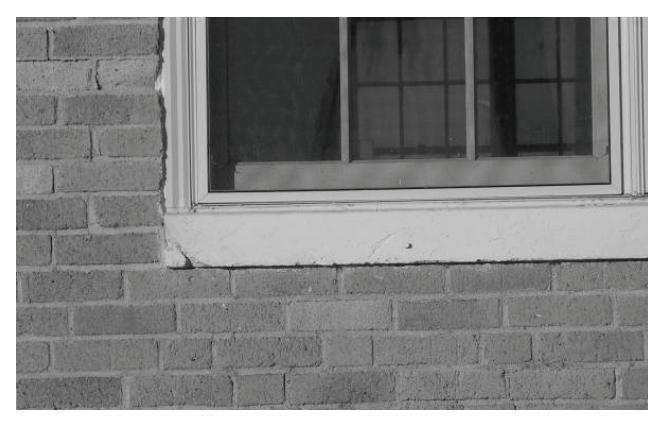
Figure 122. Cracked concreted sill of Window 15.

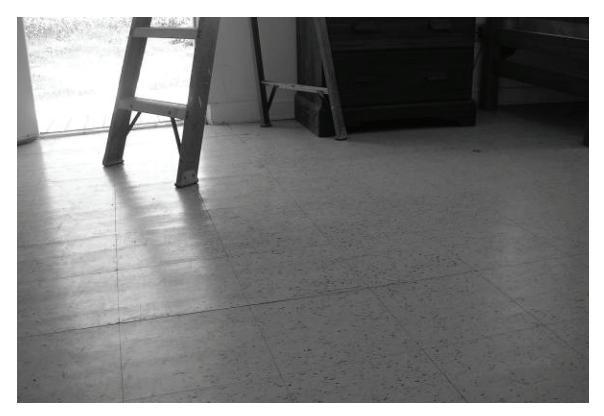
Figure 126: Uneven vinyl tile in living room.

- The tile is uneven just inside the front door. This is most likely due to poor underlayment and/or moisture infiltration from below (Figure 128)
- There is a narrow hairline crack in the visible portion of the plaster wall at the east corner of this room. The diagonal crack begins at the corner and runs northwest down the length of the visible portion of the plaster wall. (Figure 129)

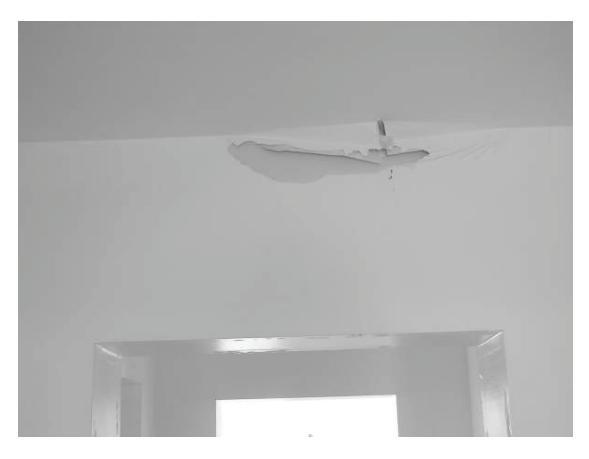
Figure 128: Peeling paint at the southeast wall just below the ceiling.

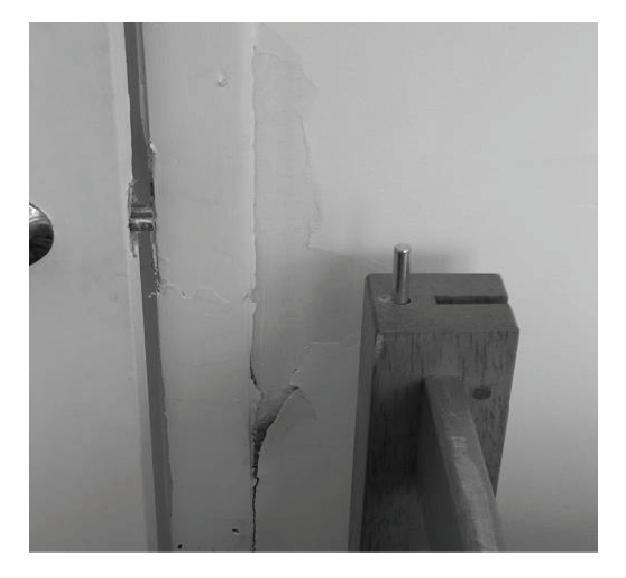
Figure 132: Peeling paint on the southwest wall along the door frame.

Existing Condition: The condition of the finishes in Room KR103 is generally sound. Items of concern regarding condition include peeling paint on the southwest wall along the door frame. (Figure 134)

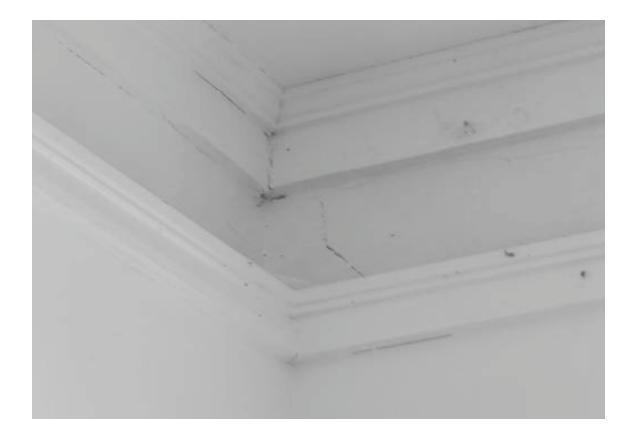
There is a narrow crack in the visible portion of the plaster wall above the drywall at the south corner of the bedroom. The diagonal crack begins just below the historic crown molding and runs down the visible portion of the plaster wall. (Figure 135)

Figure 133: Hairline crack in the plaster wall at the south corner.

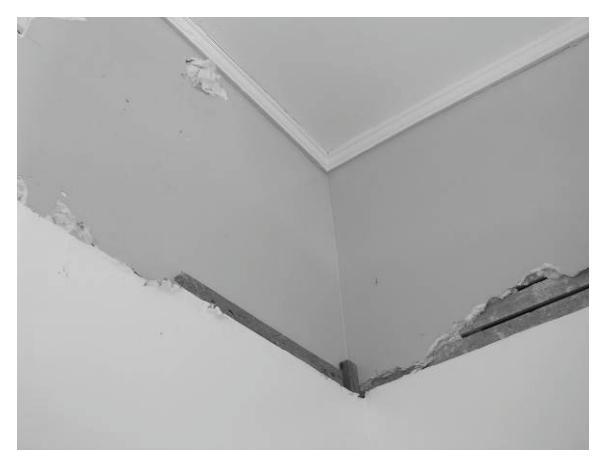
Figure 137: Plaster damage at west corner of bathroom.

- Torn and missing drywall at east corner of bathroom
- Missing plaster and holes in plaster at west corner (Figure 139)
- Missing plaster and holes in plaster at north corner
- Cracked and missing plaster at east corner
- Missing plaster and peeling paint at northwest wall (Figure 140)

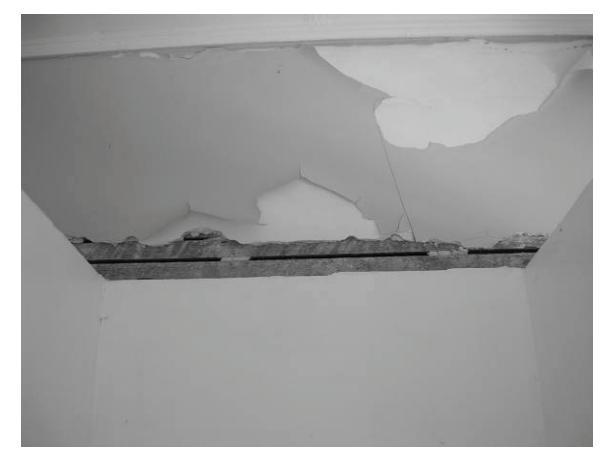
Figure 138: Plaster damage and peeling paint at northwest wall or bathroom.

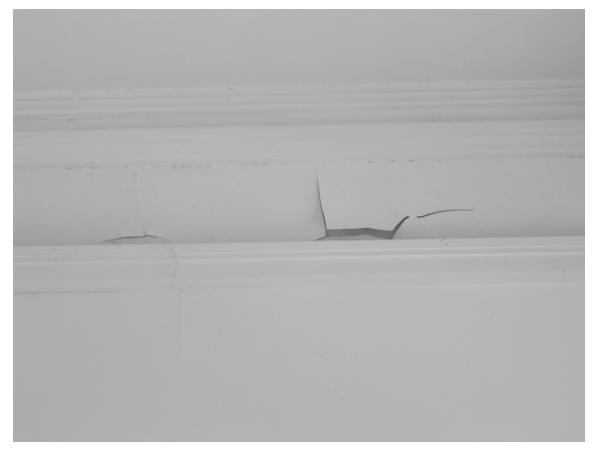
Figure 139: Peeling and flaking paint from southwest wall above Window 12.

- Peeling and flaking paint from plaster in kitchen section at southwest wall above Window 12 (Figure 141)
- Peeling and flaking paint from plaster in dining section at southeast wall above Window 8 (Figure 142)
- Cracked plaster in dining section at southwest wall between Windows 6 and 7

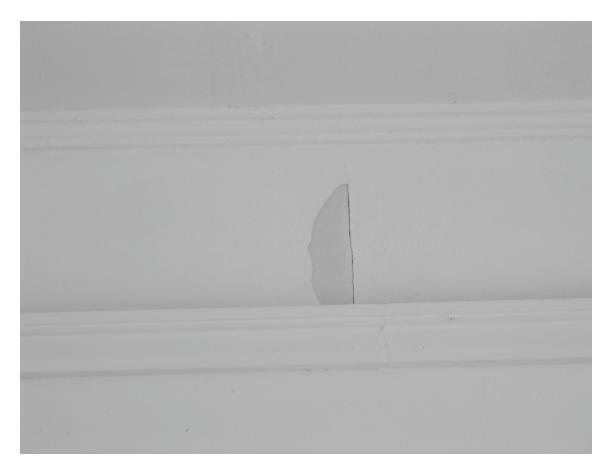
Figure 140: Peeling and flaking paint from plaster at southeast wall above Window 8.

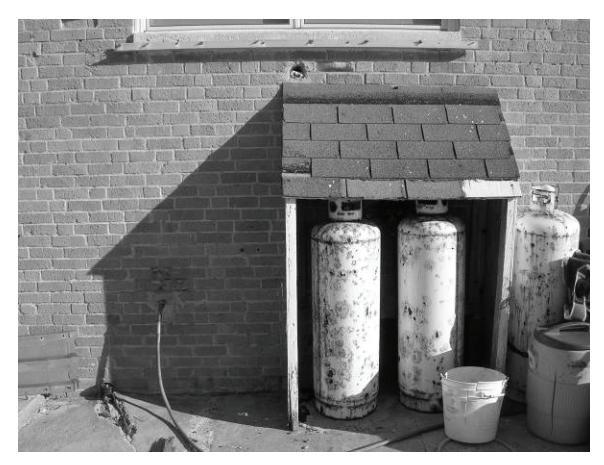
Existing Condition: The gas system is in operable condition, however, the gas tanks themselves exhibit rust and corrosion. The roof of the shed covering the tanks is also deteriorated, with missing roofing shingles. (Figure 149)

Figure 146: Two steel gas supply tanks located at the west elevation.

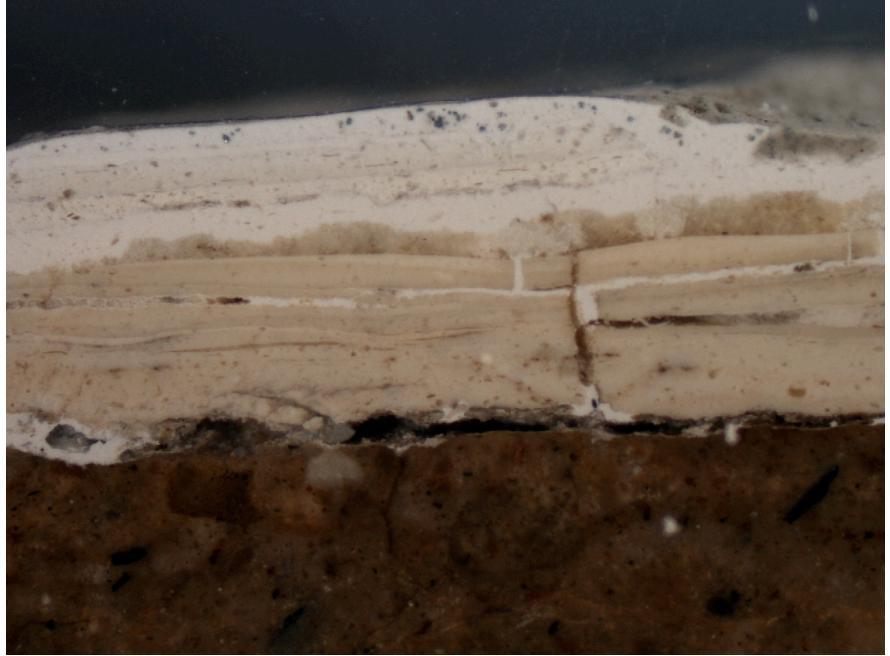
Physical evidence confirms the historical documentation. The surface of the brick in samples removed from these buildings appears somewhat weathered and uneven, suggesting it was worn by exposure to the elements before being painted. The only structure that may have always been painted was the south brick cistern. As evidenced in Figure 9 the sample removed from the brickwork of the cistern shows a relatively clean brick surface, suggesting it has always been protected from the weather. (*Figures 8-9*)

Figure 8. Oil house. Photomicrograph of painted exterior brick showing numerous layers of cream and white-colored paint. (40x magnification, visible light).

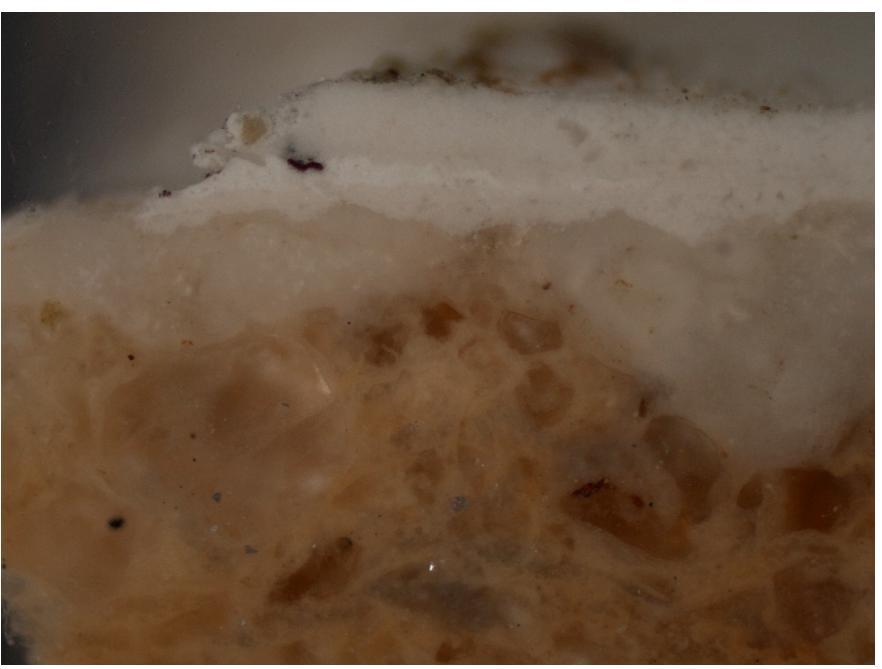
Figure 9. South brick cistern. Photomicrograph of earliest finish applied to brick wall of cistern. Note first layer is more translucent than the others and appears to be a limewash. Also, the surface of the brick is relatively unsoiled. (100x magnification, visible light).

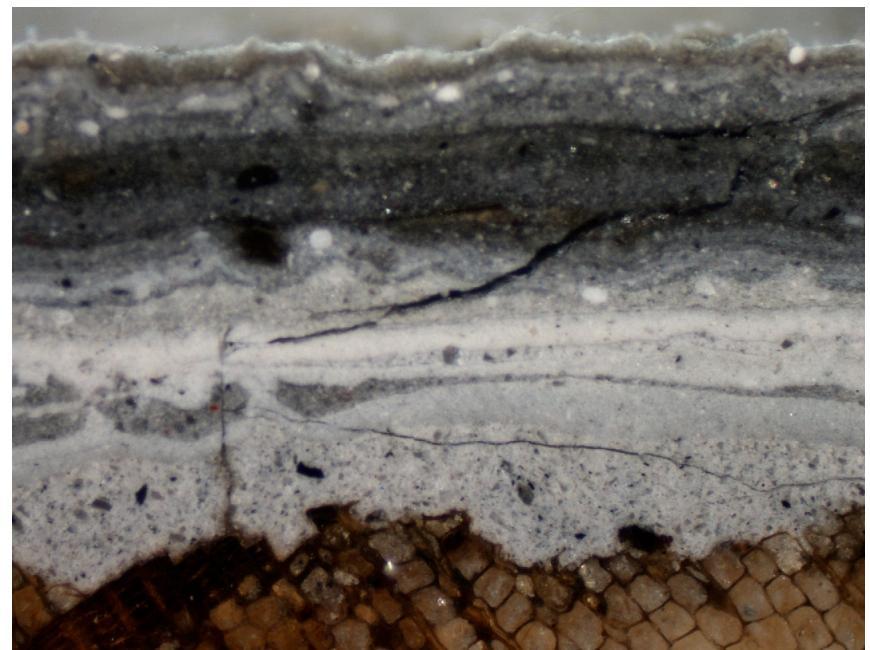
Figure 10. Oil house. Photomicrograph of a paint sample removed from the exterior door of the oil house showing numerous layers of gray paint applied to the frame over time. (100x magnification, visible light).

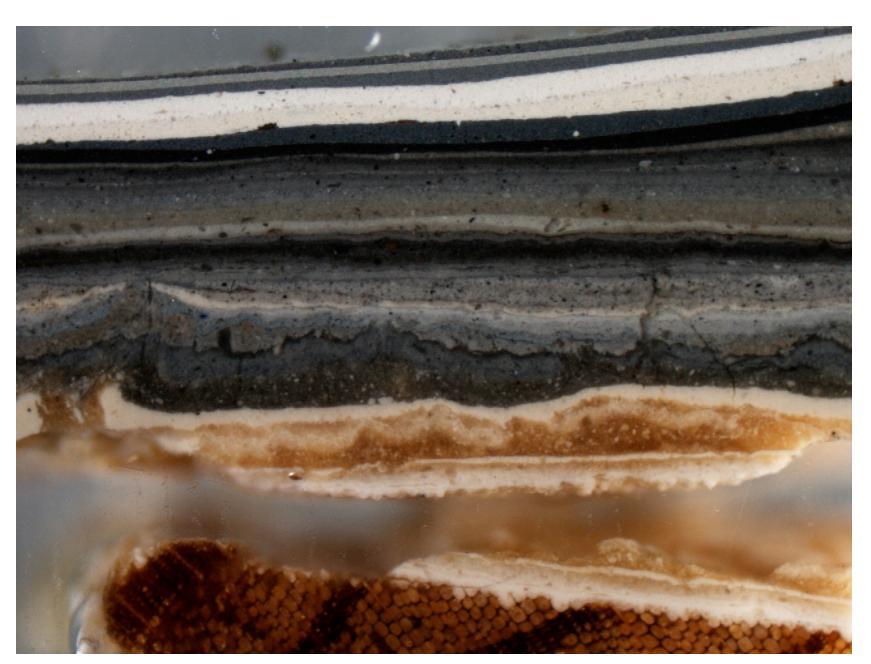
Figure 11. Lighthouse. Photomicrograph of a paint sample removed from the exterior door frame of the lighthouse showing a similar range of gray paint colors as the sample above, although the earliest paint color was cream. (40x magnification, visible light).

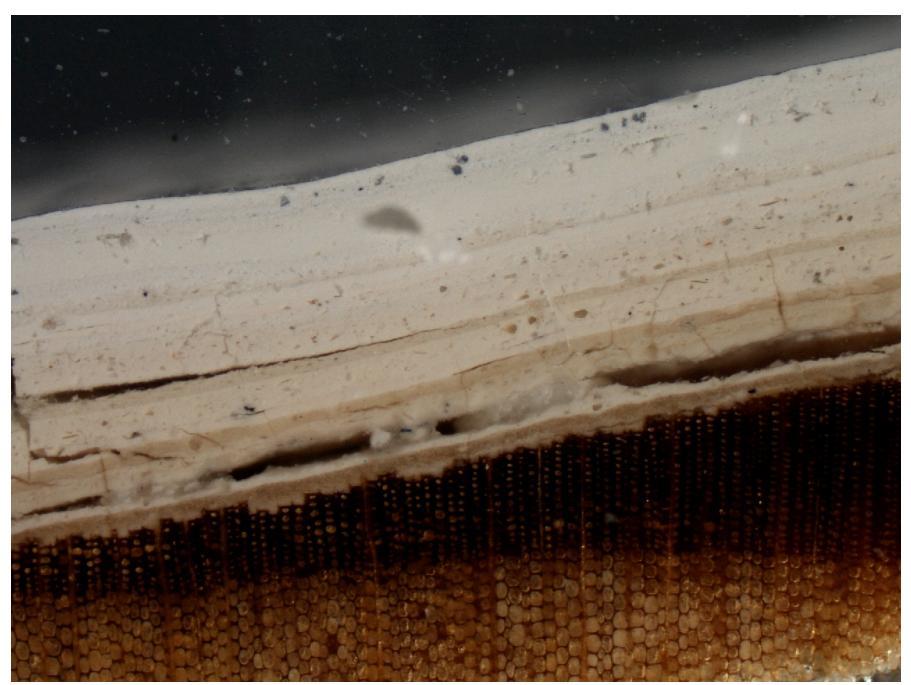
The exterior woodwork of the keeper's residence was originally painted white, a conclusion based on both physical and archival documentation. Samples removed from the front porch trim show 11 layers of white and cream paint. In addition, historic photographs of the house show white-colored trim and the preliminary specifications for the building that date to 1917 state that all woodwork was to be painted white. (*Figure 12*) The original hurricane blinds, which appear a dark color in the historic photographs, do not remain on the building and could therefore not be sampled to confirm

Figure 13. Keeper's residence. Photomicrograph of a paint sample removed from the exterior porch trim contains only cream and white-colored paint. (100x magnification, visible light).

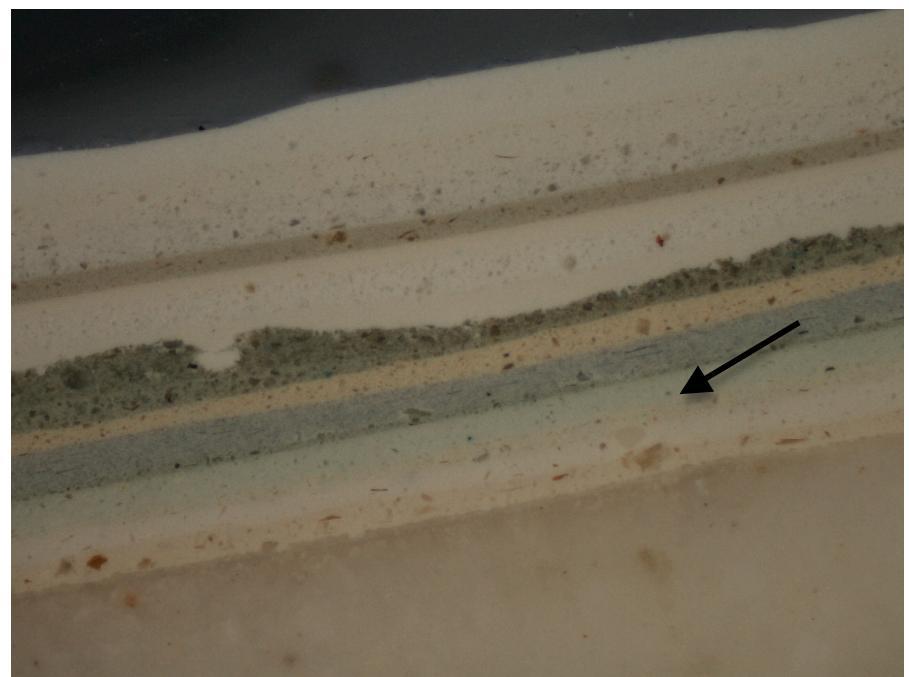
Select interior finishes of the keeper's residence were also examined. Samples were removed from the plaster walls of the hallway and bathroom and the wood cornice of the hallway. The walls of both the hall and bathroom were painted a pale gray-green originally and the cornice was painted white, after having been sealed with a clear coat. The preliminary specifications call for the wood to be sealed with shellac and for a three-coat paint system (I primer and 2 finish coats), all white in color. While the sealer layer and three-coat system seems to have been employed, the color varied from that included in the specification. (*Figure 14*)

Figure 14. Keeper's residence. Photomicrograph of a sample of paint removed from the plaster wall's of the bathroom. Note original three-layer paint system of two primers topped by a pale gray-green. (100x magnification, visible light).

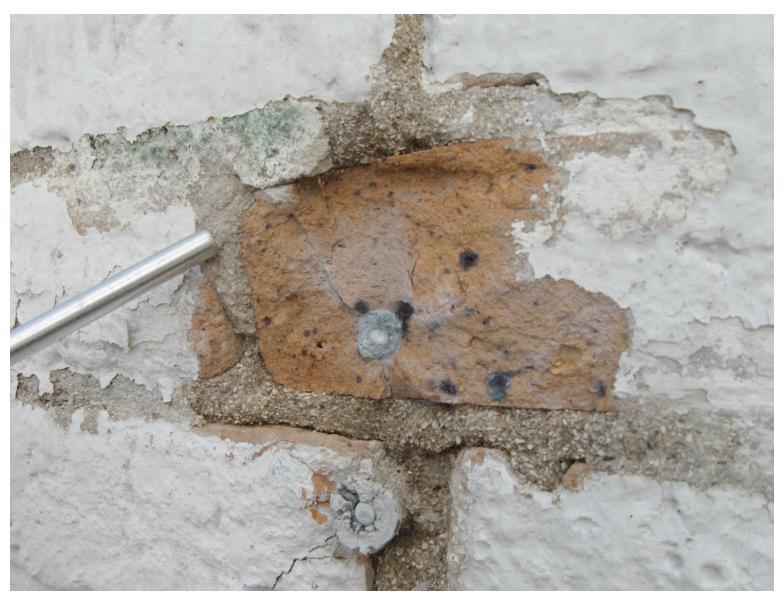
Laboratory analysis indicates that the majority of mortars used historically at the Dry Tortugas Light Station are composed of natural cement and local carbonate sand. Lime, which would have been added to the mortars as a gauging material to improve workability, was not documented in any of the historic mortars analyzed as part of this study. The natural cement and sand mortars were found at the lighthouse, the oil house, the original kitchen building and the south brick cistern. In addition, samples of mortar removed from four different locations within the lighthouse, including the portion of brick masonry directly below the watch room floor plate, were as natural cement and carbonate sand mortars that ware virtually indistinguishable from one another. The similarity of these mortars makes it difficult to draw any conclusions about the date of installation or type of mortars used for the numerous repair campaigns made to the lighthouse, which were documented in extensive written material. However, the physical evidence suggests that, although there were numerous repairs campaigns, the same mortar mix and ingredients were used consistently for the majority of the re-pointing campaigns in the 19th century. (*Figure 15*)

Figure 15. Lighthouse. Area of historic mortar removed for analysis. Note characteristic carbonate sand inclusions.

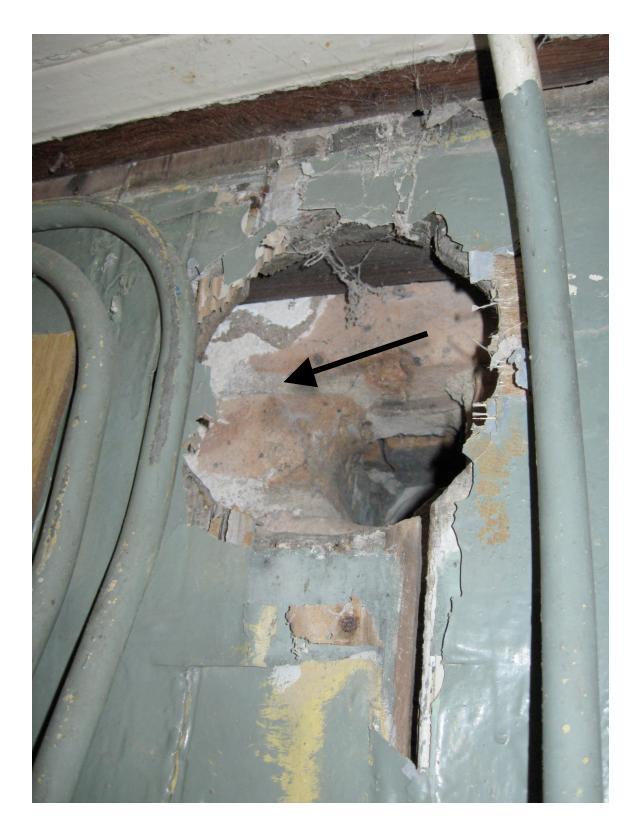
Figure 16. Oil house. Area of early plaster, discovered behind later wall finishes, removed for analysis.

Interior plaster of two of the historic buildings was also examined. In the oil house, a sample of a three-coat plaster system, discovered behind a layer of modern wood paneling and a bead board wall, was removed for analysis. The plaster is composed of: a lime and carbonate sand scratch coat gauged with natural cement, a natural cement and carbonate sand brown coat, and a lime-based finish coat that is gauged with gypsum (no sand). Although it is unclear when this plaster dates from, it is possible that it is original to the building and dates to the 1850s. The sand used in the scratch and brown coats is the same as that used in the brick mortar of the same building, a local carbonate sand. (*Figure 16*)

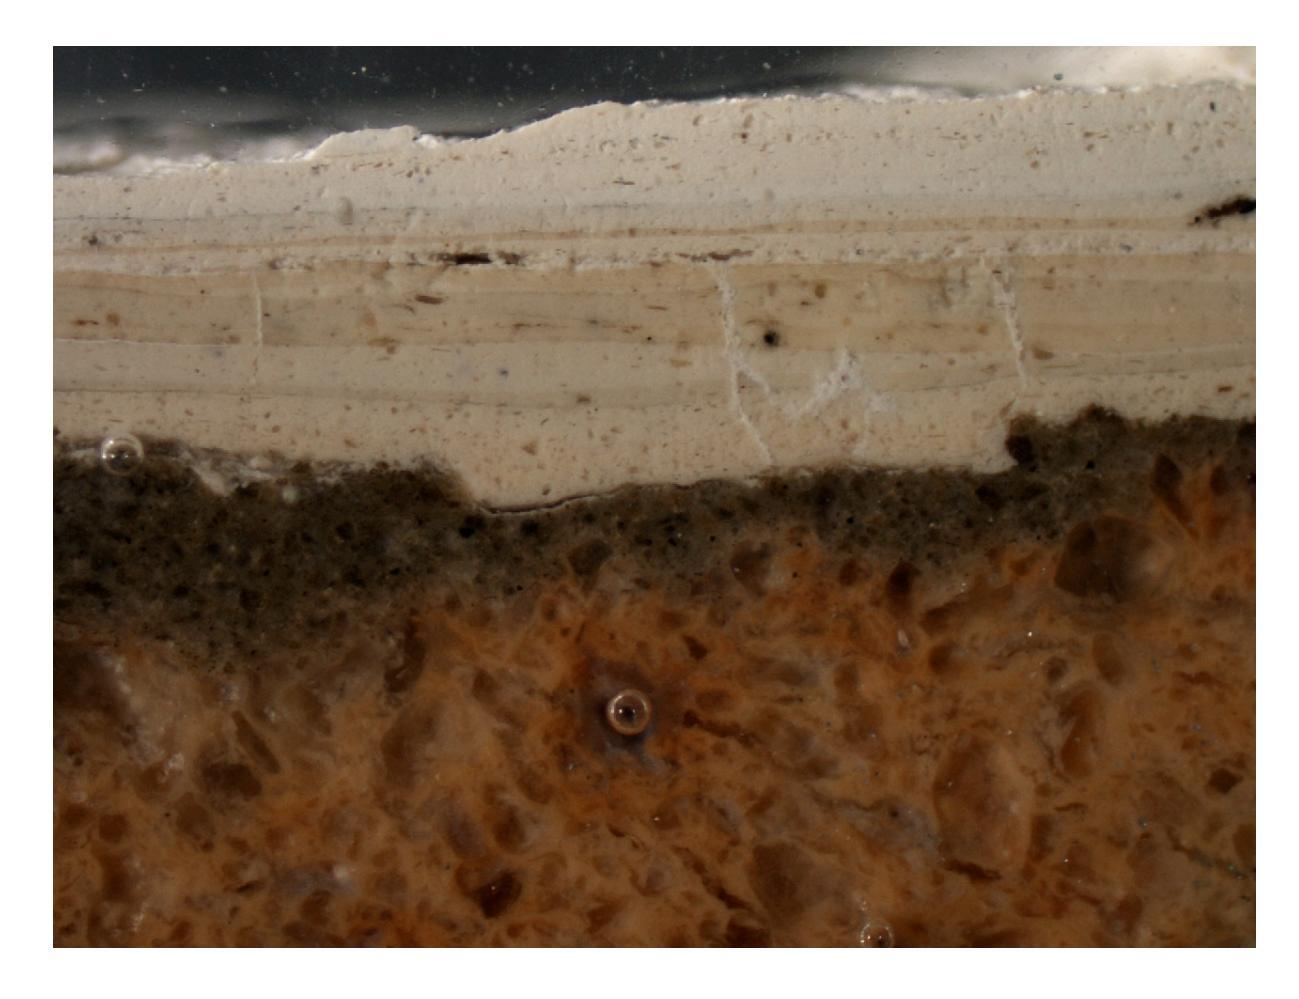
SAMPLE NO:	LOKE.F.I (40x, Visible Light)
LOCATION:	Oil House, exterior, east elevation now enclosed, finishes on brick.

LAYER*	COLOR	NOTES
Substrate	Brick	Surface looks weathered and soiled, suggests exposure
		prior to painting
I	Cream	All finishes look like paint, missing early limewash layer
		visible in LOKE.F.9
2	Off-white	
3	Off-white	
4	Cream	
5	Cream	
6	Cream	
7	Off-white	
8	Cream	
9	Off-white	
10	Off-white	
11	Off-white	Current finish
