Dry Tortugas Light Station

Keeper's Residence Historic Structure Report

by Lord, Aeck & Sargent Architecture

2009

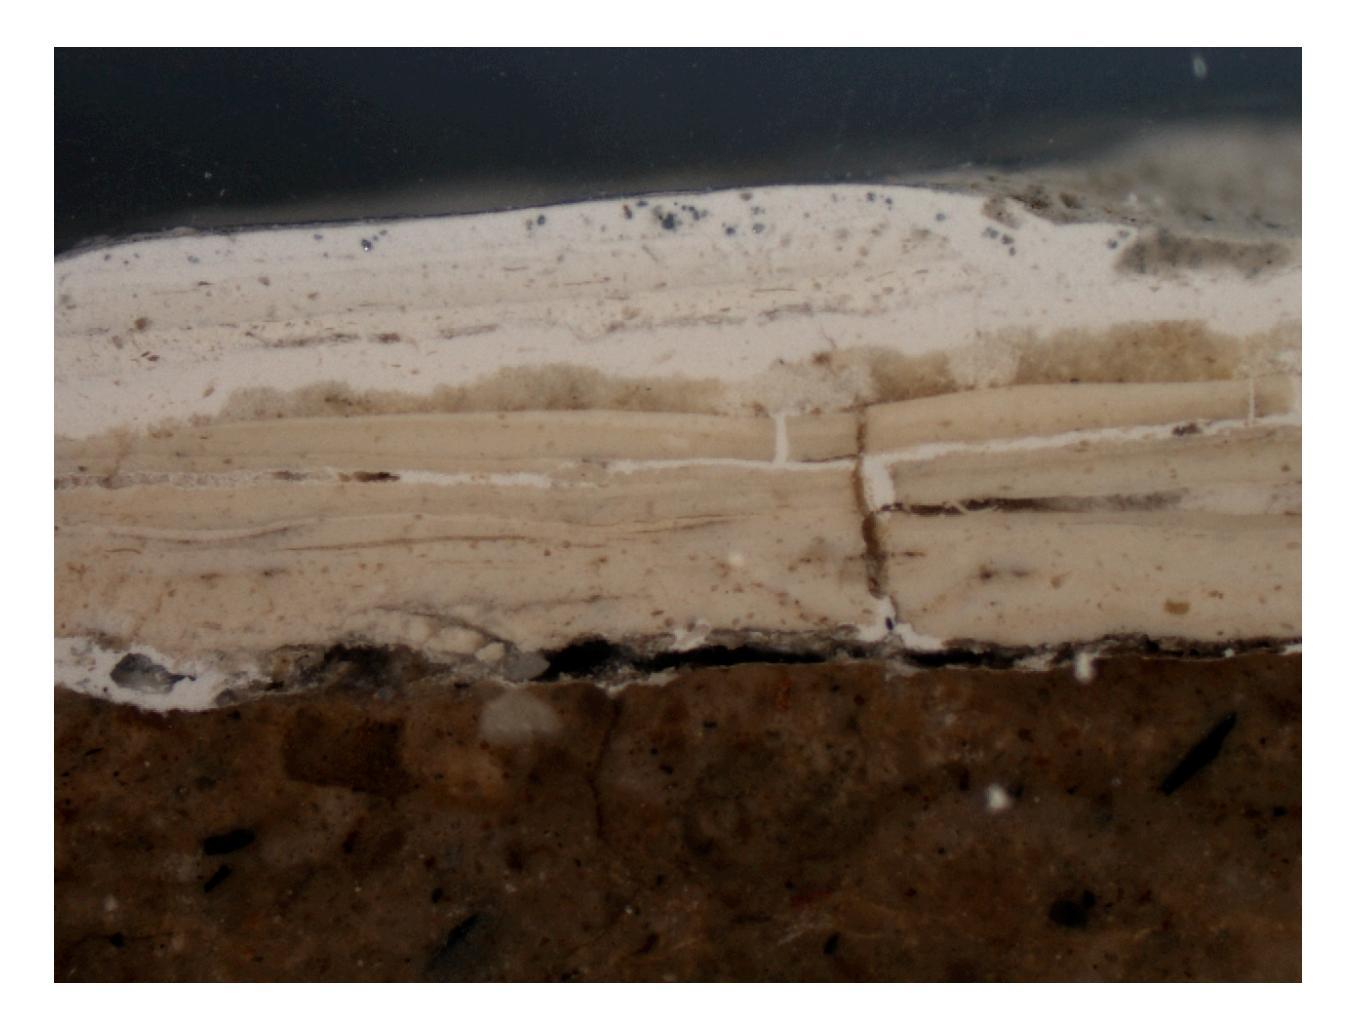
SAMPLE NO:	LOKE.F.3 (40x, Visible Light)	
LOCATION:	CATION: Oil House, exterior, east elevationl, finishes on brick.

LAYER*	COLOR	NOTES
Substrate	Brick	Fracture at surface suggests weathering prior to painting
I	Cream	
2	Cream	
3	Cream	
4	Cream	
5	Cream	
6	Cream	
7	Cream	
8	Cream	
9	Cream	
10	Cream/tan	Translucent
11	White	
12	Off-white	
13	Off-white	
14	Off-white	
15	White	Current finish

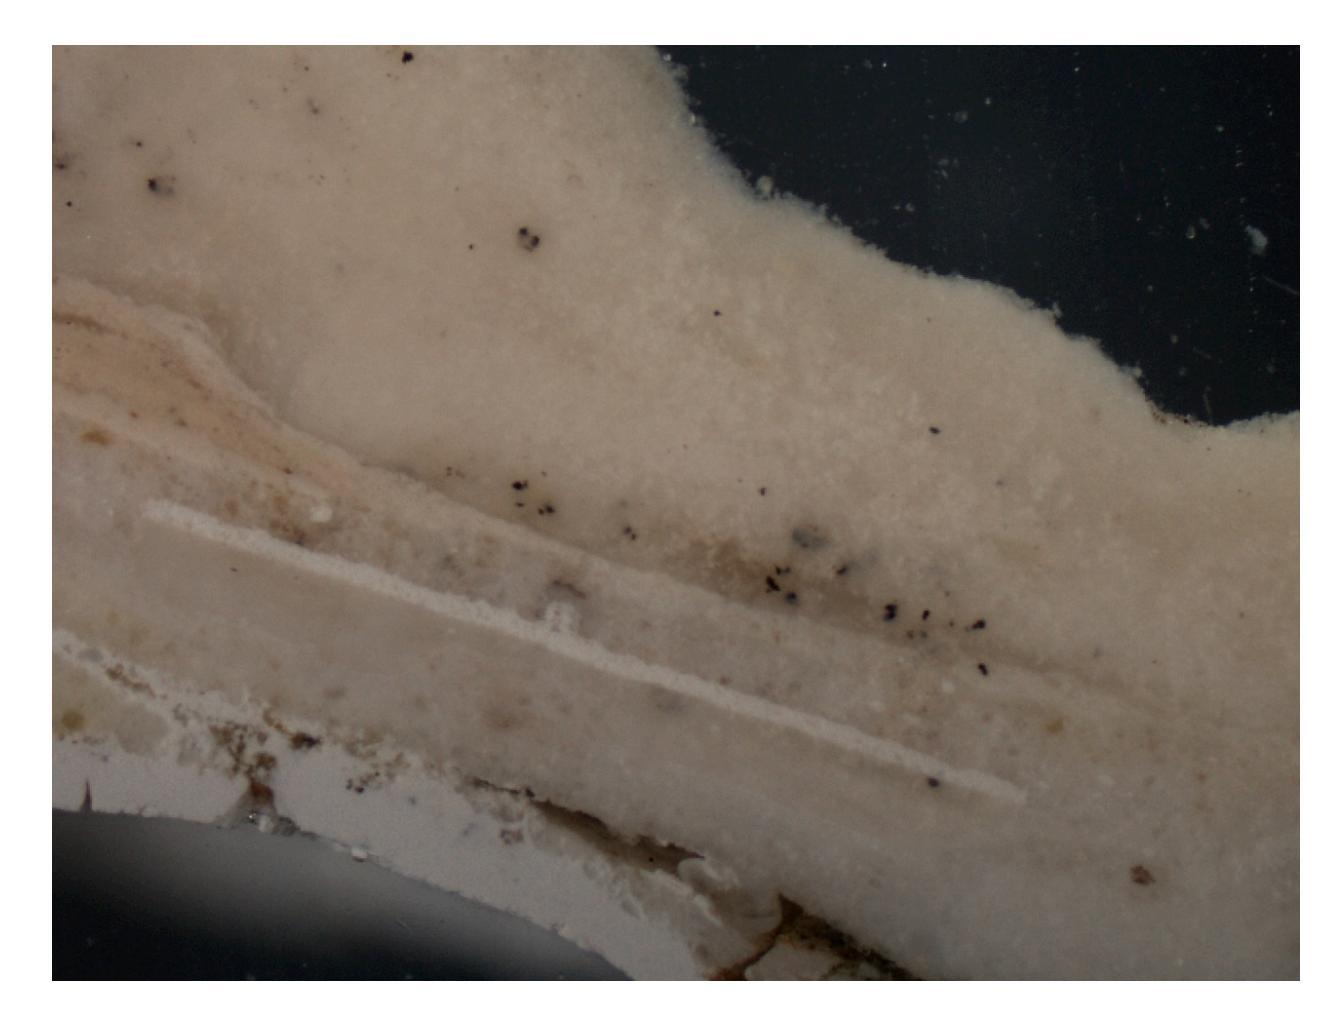
SAMPLE NO:	LOKE.F.5 (100x, Visible Light)
LOCATION: Cistern, west elevation, finishes on brick.

LAYER*	COLOR	NOTES
Substrate	Brick (missing in photo)	No sign of weathering of brick surface, suggests brick was always finished
I	Off-white	Translucent, white wash
2	Off-white	Translucent, white wash
3	Off-white	
4	Off-white	Modern paint
5	White	
6	White	Current finish

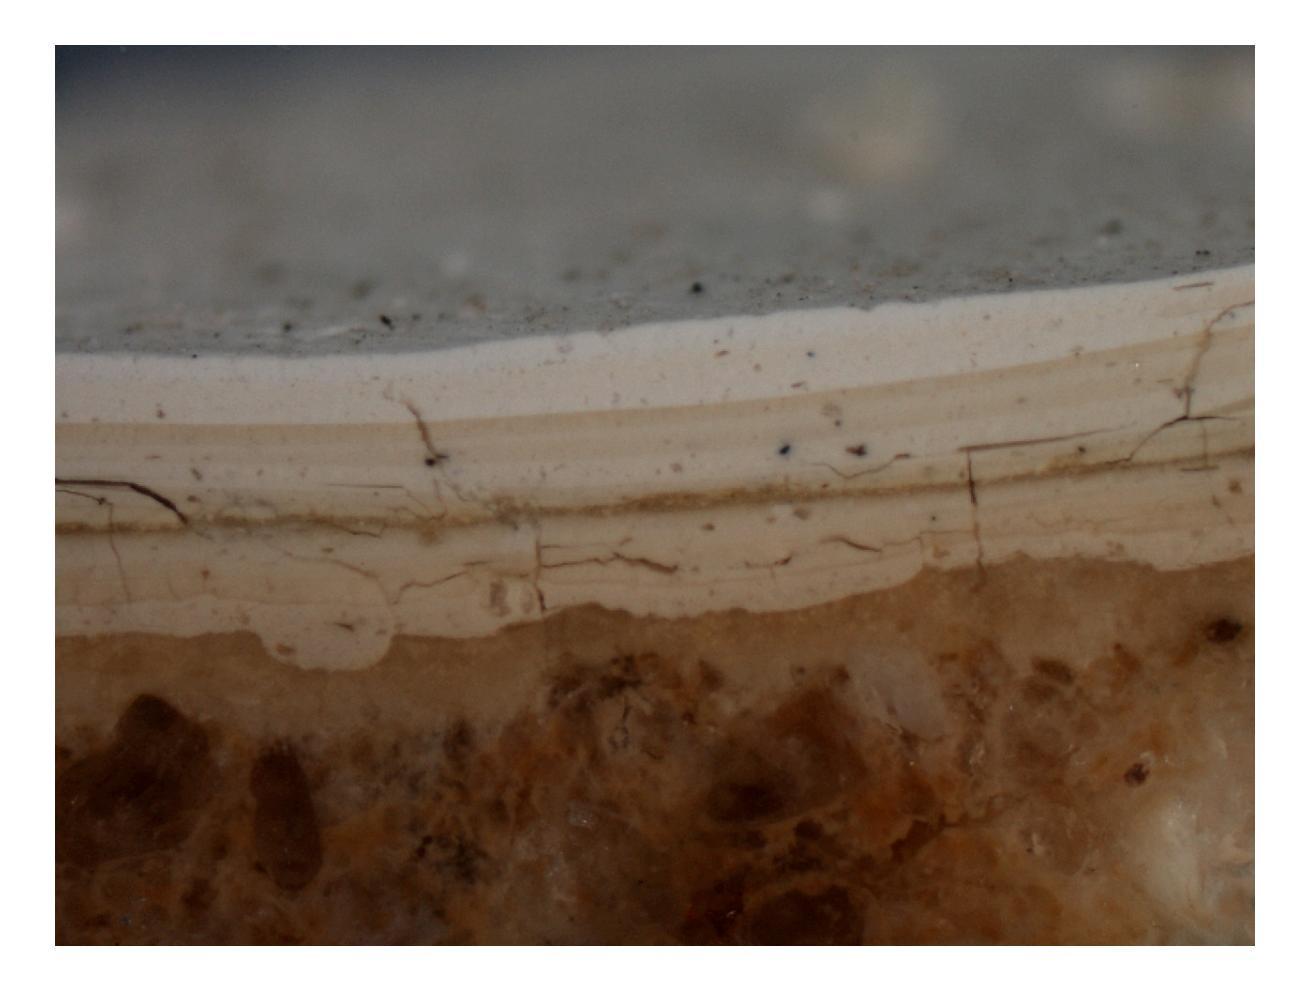
SAMPLE NO:	LOKE.F.9 (40x, Visible Light)	
LOCATION:	Oil House, exterior, east wall, finishes on brick.

LAYER*	COLOR	NOTES
Substrate	Brick	Surface looks weathered
I	Cream	Translucent, limewash
2	Cream	Remaining layers look like paint
3	Cream	
4	Cream	Translucent material at surface
5	Cream	
6	Off-white	
7	Cream	
8	Cream	
9	Cream	
10	White	Translucent
	Cream	
12	White	Current Finish

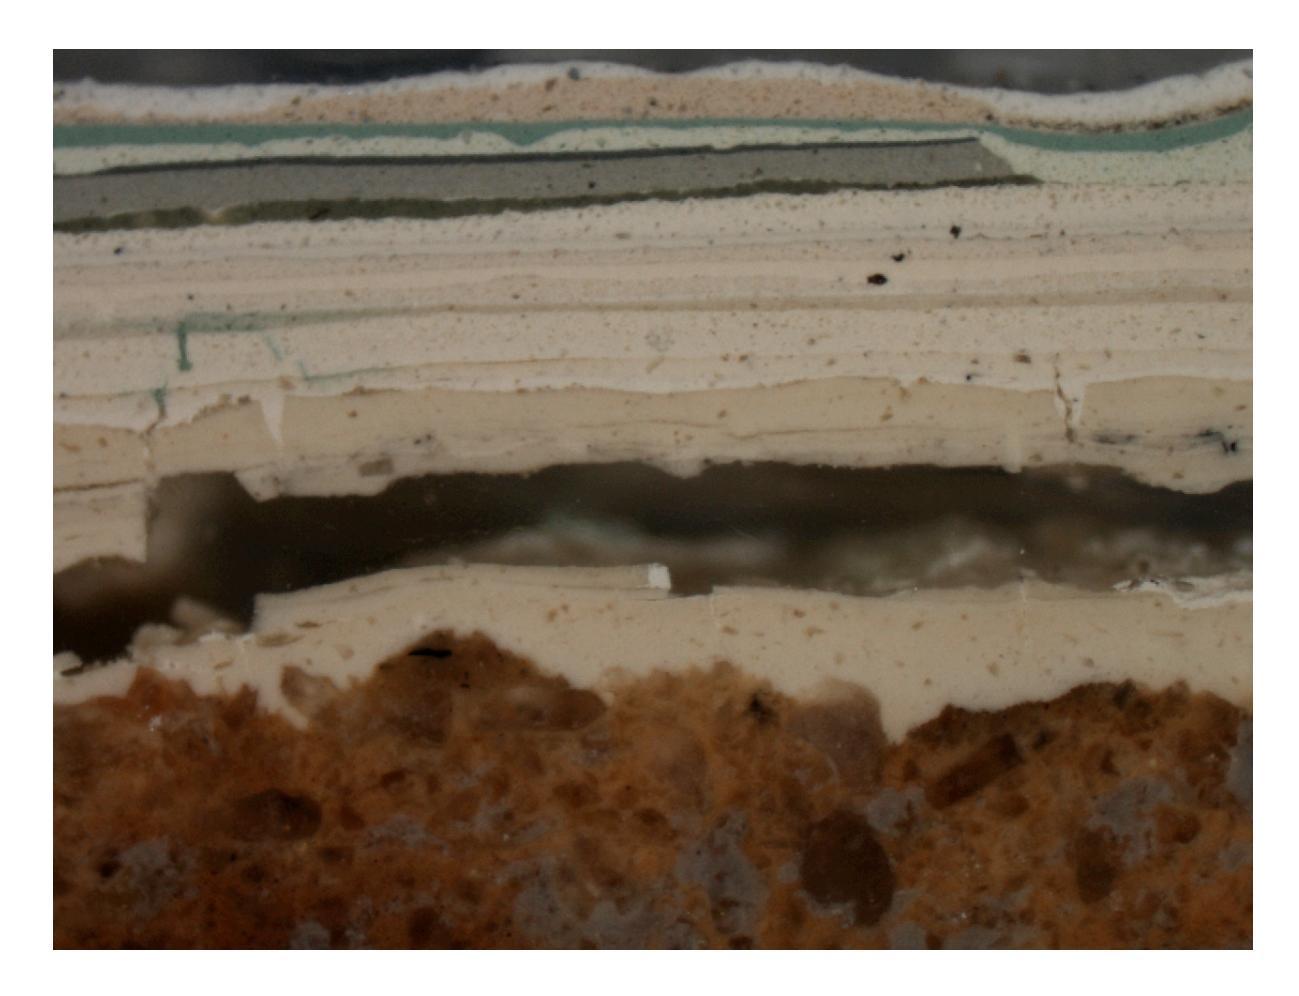
SAMPLE NO:	LOKE.F.11 (40x, Visible Light)	
LOCATION:	Oil House, exterior, south elevation now enclosed, finishes on brick.

LAYER*	COLOR	NOTES
Substrate	Brick	Surface is weathered, suggests exposure
I	Cream/tan	Translucent, lime wash (partial layer)
2	Cream	
3	Cream	
4	Cream	
5	Light cream	
6	Cream	
7	Cream	
8	Cream	
9	Cream	
10	Cream	
11	Cream	
12	Cream	
13	White	
14	Off-white	
15	White	
16	Gray	
17	Light gray	
18	Light gray/off-white

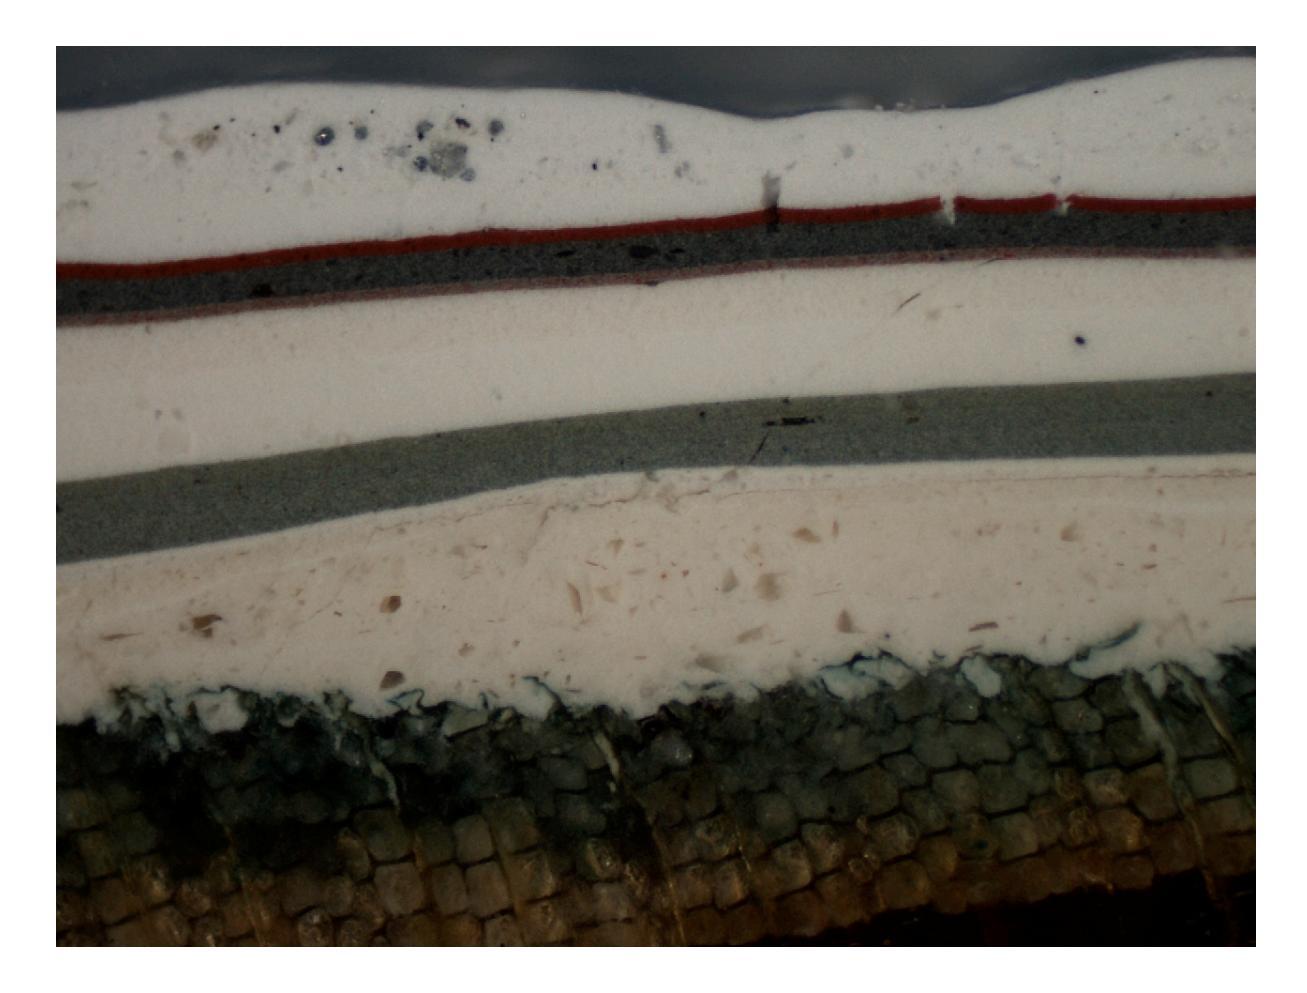
SAMPLE NO:	LOKE.F.15 (100x, Visible Light)
LOCATION:	Keeper's Dwelling, exterior, east elevation, front door surround, finishes on wood.

LAYER*	COLOR	NOTES
Substrate	Wood	Surface distressed, looks stripped, missing earliest finish?
I	Dark green	Soaked into pores of wood at surface
2	Cream	
3	White	Thin
4	Gray-green	
5	White	
6	Dark red	Thin
7	Dark gray	
8	Dark red	Disrupted, weathered
9	White	
10	White	Current finish

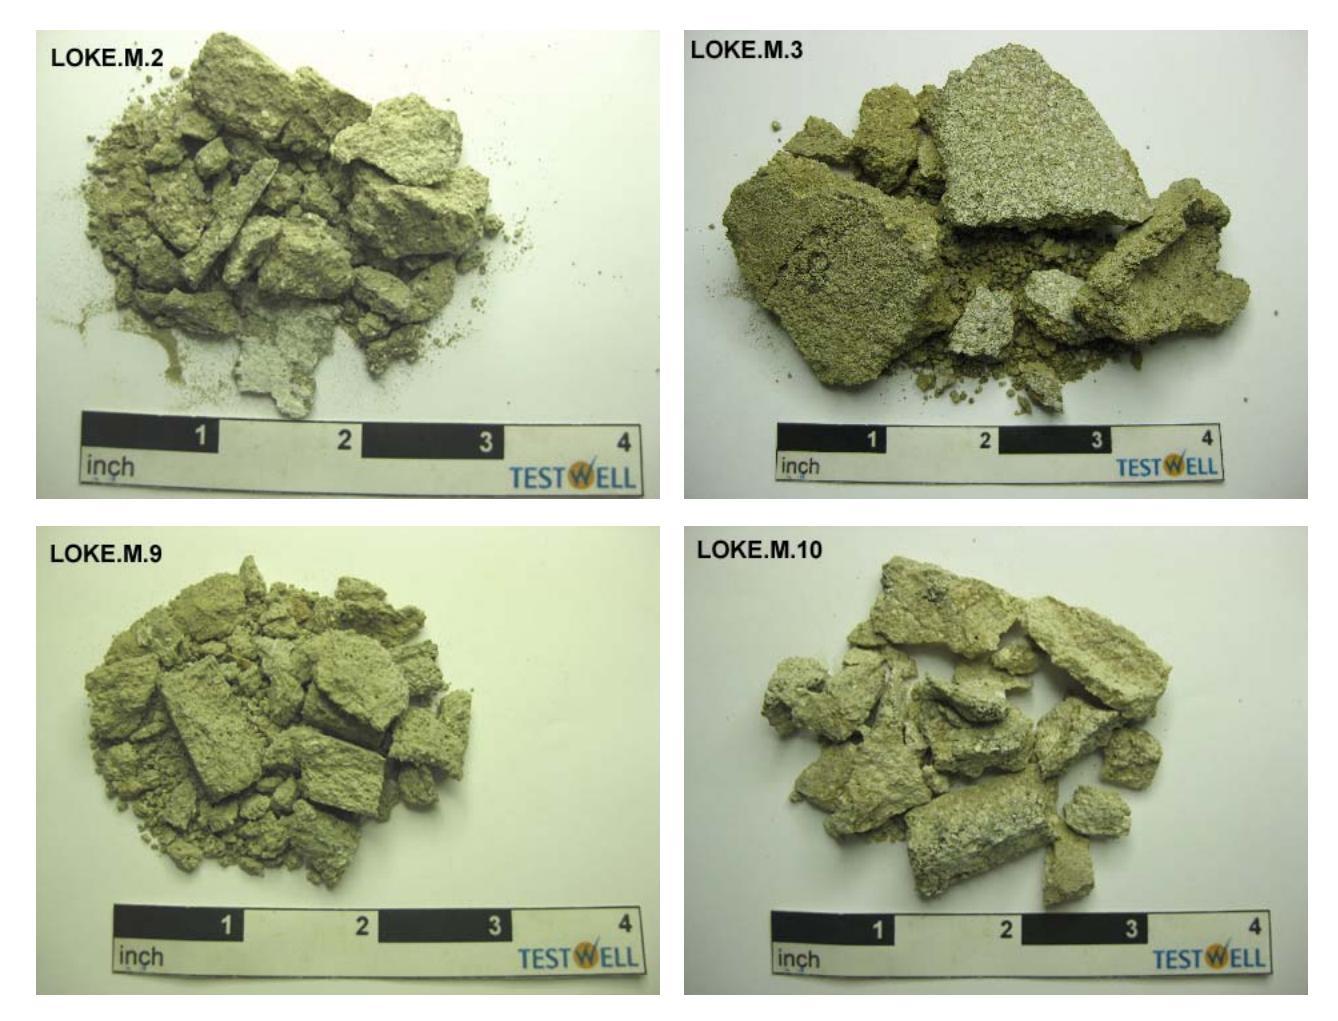
Figure 2: Photographs of mortar samples from the cistern, Kitchen Building and Keeper's Dwelling as received by Testwell for examination.

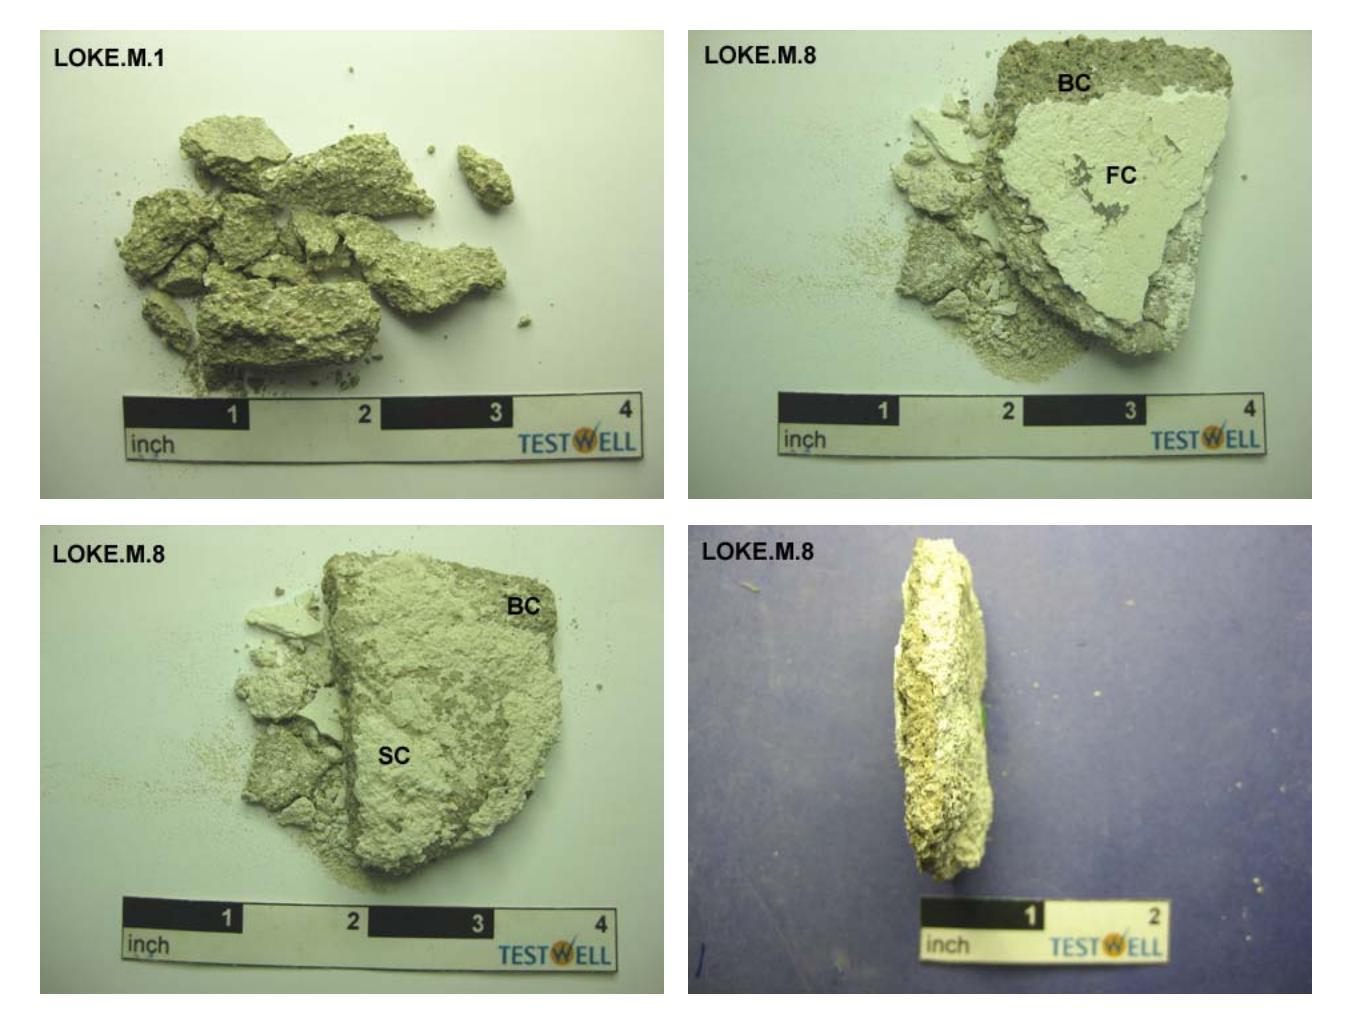
LOKE.M.8 is reported to represent an Oil House plaster sample and consists of a three-coat plaster system (Figs 16 through 20). Substrate is not included with the sample. The sample includes a relatively soft and porous scratch coat identified as a sanded, lime-based plaster gauged with natural cement, a relatively hard and dense brown coat identified as a sanded, pure natural cement plaster, and a fine-textured, unsanded finish coat consisting of lime gauged with gypsum. Generally speaking, these materials are considered consistent with a mid-nineteenth century vintage and certainly are inconsistent with twentieth century practice. The use of gypsum-based plaster as a gauging material is less well understood. While the use of calcined gypsum as a binder has a long history, the author is unaware of any American references to its use in the States prior to approximately 1880.

Figure 3: Photographs of the samples from the Oil House as received by Testwell for examination. Sample LOKE.M.8 is a plaster sample. A top view (top right) and rear view (bottom left) show the scratch coat (SC), brown coat (BC), and finish coat (FC) in this three-coat plaster. The last photograph presents a side view.

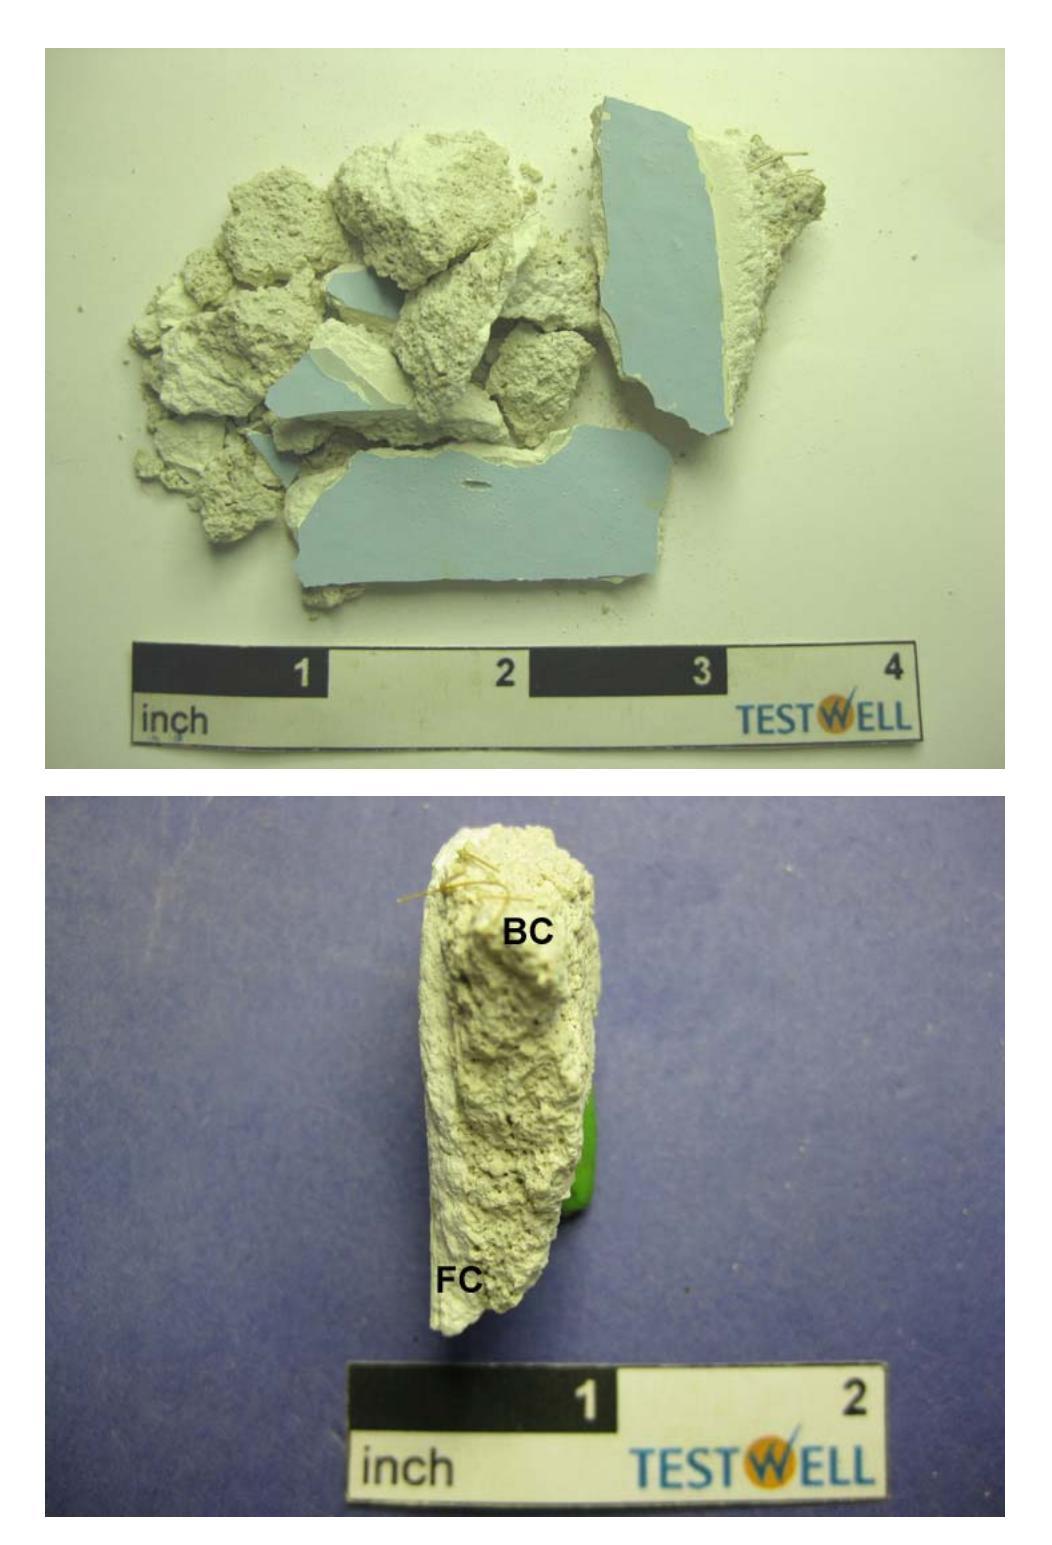
LOKE.M.11 is reported to represent an Keeper's Dwelling plaster sample and consists of a two-coat plaster system (Figs. 21 through 24). Substrate is not included with the sample. The sample includes a relatively hard but porous brown coat identified as a sanded, gypsum-based plaster and a relatively hard but porous, unsanded finish coat consisting of a fine-textured gypsum gauged with lime. The use of gypsum materials rather than lime for interior plastering is considered consistent with the 1920's vintage reported by the client.

Figure 4: Photographs of the plaster sample from the Keeper's Dwelling as received by Testwell for examination. The bottom photograph presents a side view of the two-coat plaster with brown coat (BC) and finish coat (FC) visible.

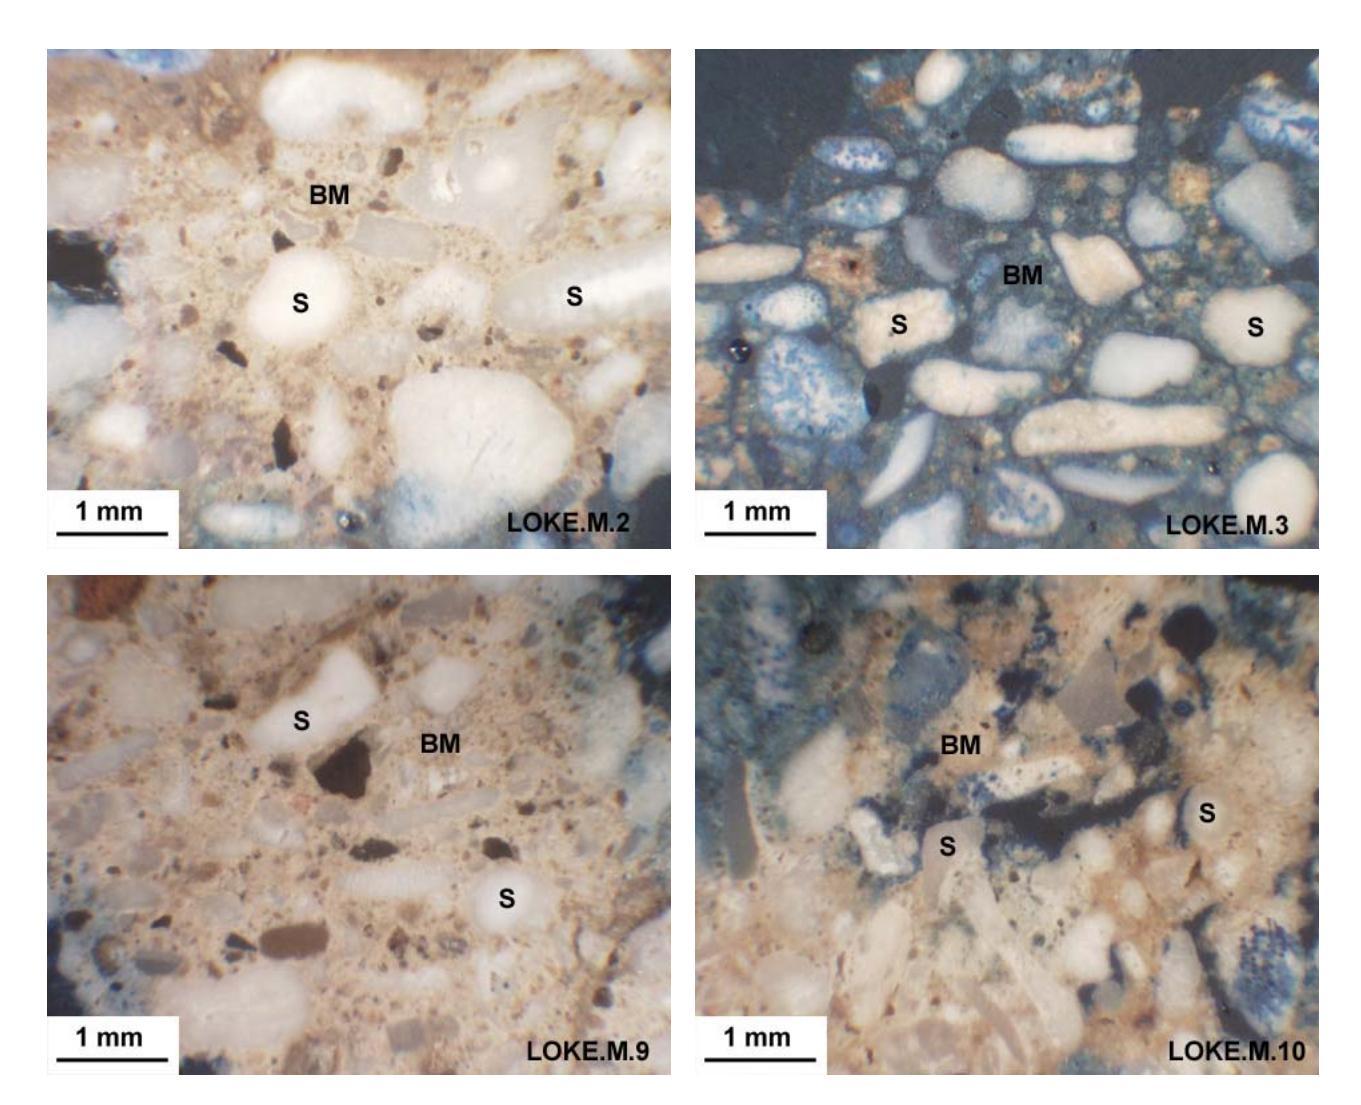
The sand in this sample is identical in composition and only slightly different in gradation as that observed in the natural cement mortars discussed above. As with these, the sand is a natural carbonate sand consistent with the local source (Figs. 6 and 10). The appearance of the sand is also homogenous and light-colored ranging from nearly white to pale yellow. The grains are rounded due to natural weathering processes but tend to be somewhat elongate due to the original shapes of the organisms. The gradation is still narrow with a nominal top size estimated at the No. 16 sieve but the peak abundance is estimated to be spread more evenly between the No. 16 and No. 50 sieves as compared to other samples in the suite. Still, there are relatively few fines in the sand estimated to pass the No. 50 sieve size. As with the other samples, this relatively narrow gradation is considered geologically consistent with the local sediment.

Figure 6: Reflected light photomicrographs of honed cross sections of mortar samples from the cistern, Kitchen Building and Keeper's Dwelling. Binder matrix is well compacted and consolidated around sand grains (S). The sand is light-colored and homogeneous and the same type of sand component is found in all samples. Gradations tend to be relatively narrow with all material estimated to pass a No. 8 sieve and little material found below the No. 50 sieve. Blue coloration in some of the samples is due to the impregnation of a low-viscosity blue dyed epoxy. Several of the honed sections were prepared directly from residual thin section billets where total sample size is small.

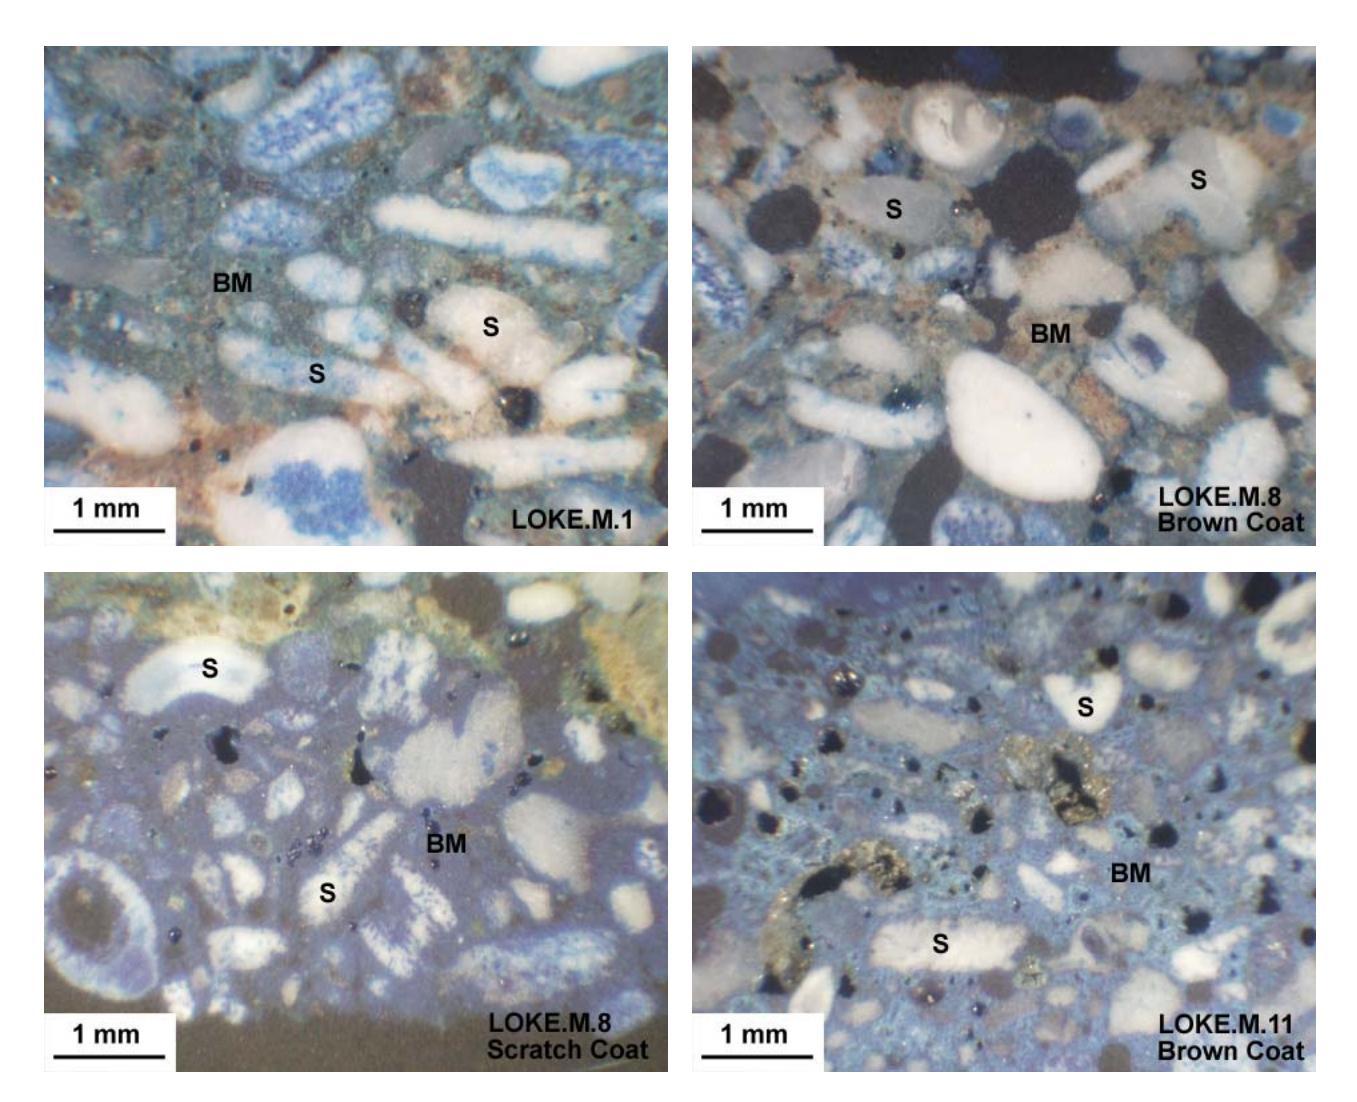
The sand in the scratch and brown coats is more or less identical (Fig. 7). As discussed earlier for the brown coat, the aggregate is identified as a natural carbonate sand containing coral and shell fragments similar to that making up the sediment of the Dry Tortugas. Visual examination indicates a homogeneous color ranging from nearly white to pale yellow with no significant variegation. Grains are rounded due to natural weathering processes but tend to be somewhat elongate due to the original shapes of the organisms. The gradation is quite narrow with a nominal top size estimated at the No. 8 sieve with all material estimated to pass. A strong peak abundance is estimated between the No. 16 and No. 30 sieves with only a moderately low abundance of material estimated to pass the No. 30 sieve.

Figure 7: Reflected light photomicrographs of honed cross sections of samples from the Oil House and sanded plaster coats. Binder matrix is well compacted and consolidated around sand grains (S). The sand is light-colored and homogeneous and the same type of sand component is found in all samples. Gradations tend to be relatively narrow with all material estimated to pass a No. 8 sieve and little material found below the No. 50 sieve. Blue coloration in some of the samples is due to the impregnation of a low-viscosity blue dyed epoxy. Several of the honed sections were prepared directly from residual thin section billets where total sample size is small.

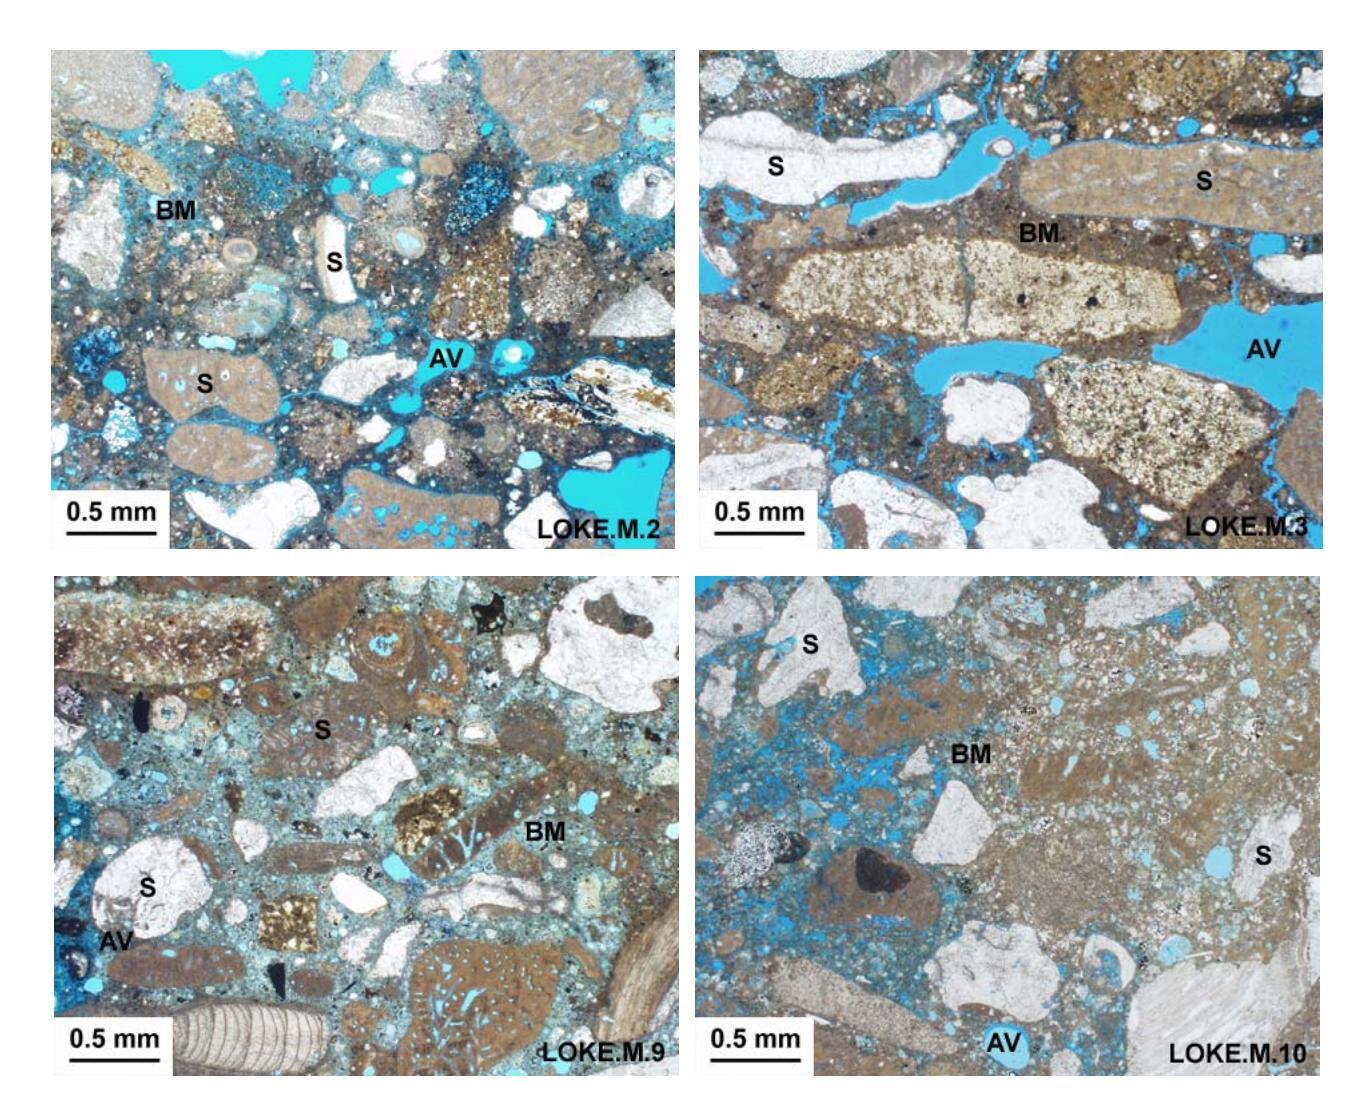
LOKE.M.10 exhibits cement and sand components that are well mixed and distributed. Air contents tend to be low and the mortar well consolidated. Hydration qualities of the cement are virtually complete with a homogeneous distribution of cementitious product. The original water to cement ratio is estimated to be moderate based on the observed capillary porosity and the mortar appears to have been mixed without an excess of water or significant retempering (Fig. 10).

Figure 10: PPL photomicrographs illustrating the overall microstructure of mortar samples from the cistern, Kitchen Building and Keeper's Dwelling. The hydraulic binder matrix (BM) is well developed. Porosities tend to be moderate to moderately high for these samples and this is demonstrated by the moderate absorption of blue-dyed epoxy used in the sample preparation. Sample LOKE.M.9 has a high porosity in some areas of the sample. The sand (S) is well coated with binder and is identified as a soft, natural carbonate sand composed of a variety of coral and shell fragments. Air-voids (AV) are not abundant.

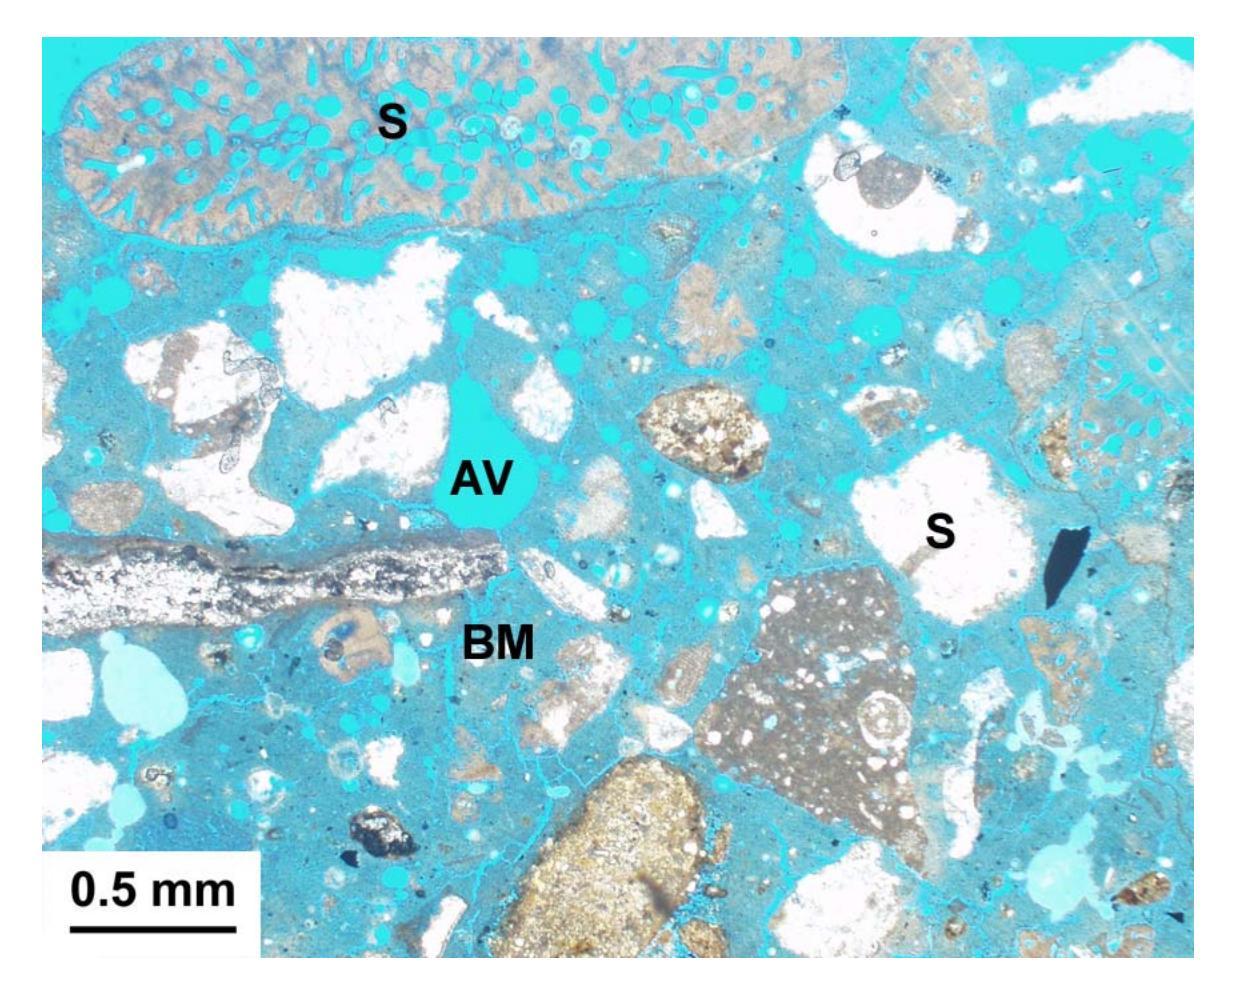
The binder matrix in the scratch coat is characterized by a highly porous, carbonated paste, with a moderate abundance of microscopic shrinkage cracks. The paste matrix is typical of a high lime binder (Fig. 16). Larger relict lime grains are observed in low abundance and these exhibit homogeneous internal textures. Given the limited sample available for the scratch coat, it is not possible to speculate on the source of the lime. Furthermore, a chemical analysis could not be performed and no information is available for the lime chemistry. Natural cement grains identical to those of the brown coat are found in very low abundance (Fig. 17). The cement is estimated to represent a minor gauging affording only minimal hydraulic property to the scratch coat. While no quantitative estimate is offered, it is unlikely that the cement represents more than one tenth part of the lime by volume. The sanding is interpreted to be relatively low based on petrographic observations and the binder to sand ratio is probably less than 1 : 2 by volume.

Figure 16: PPL photomicrograph illustrating the overall microstructure of the scratch coat in sample LOKE.M.8. The binder matrix (BM) has a high capillary porosity as indicated by the high absorption of blue-dyed epoxy used in the sample preparation. Fine shrinkage cracks are also detected within the matrix and these two features are characteristics of high-lime binder matrices. The sand (S) is the same soft, natural carbonate sand found in the mortar samples. Air-voids (AV) are moderately abundant.

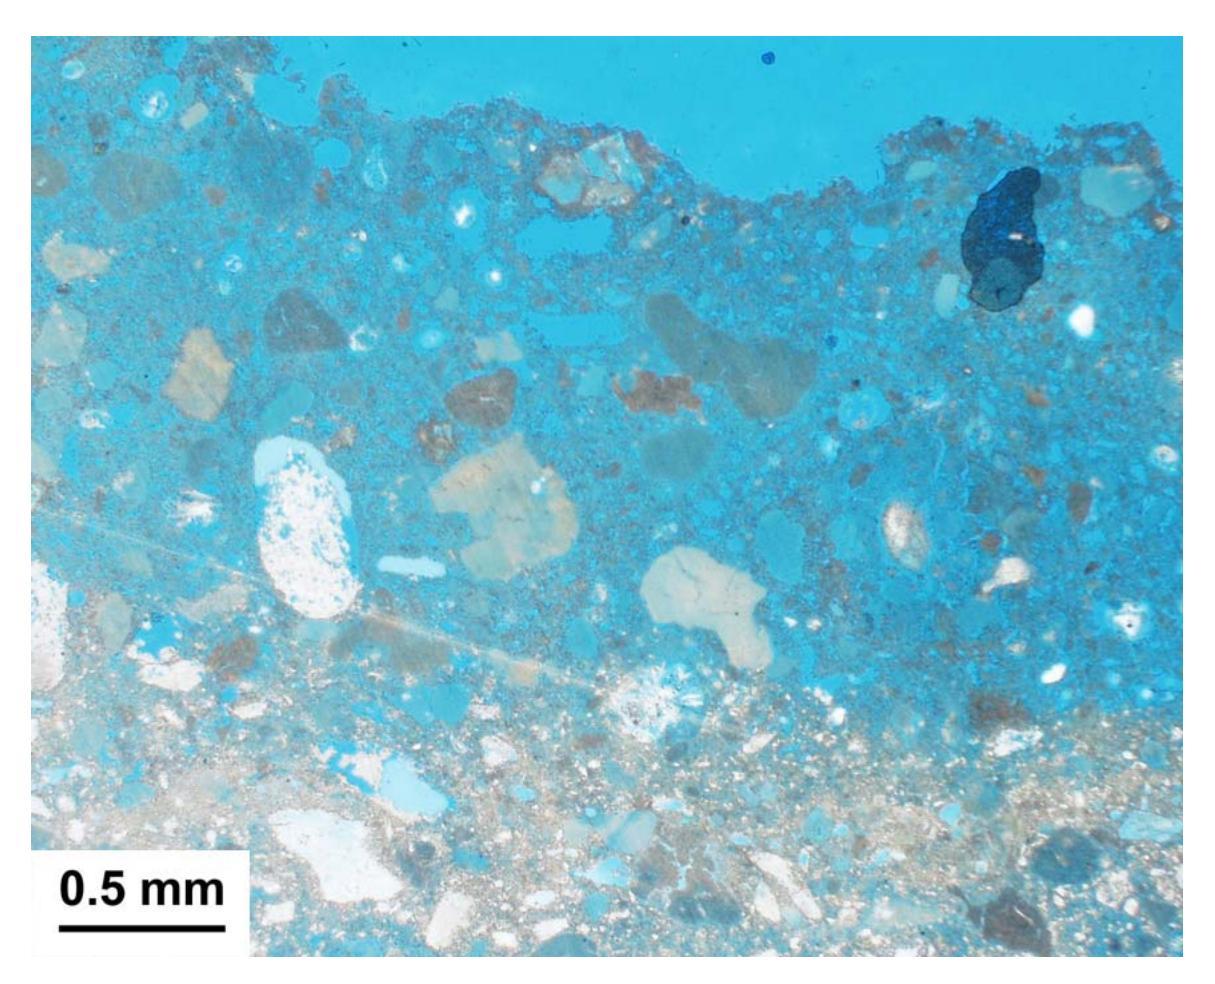
The finish coat matrix is fine-textured and porous (Fig. 19). An abundance of fine residual lime grains indicates the layer is mostly lime based. Chemical analysis was performed on this layer. Even assuming that all magnesium is contained in the lime, a CaO/MgO weight ratio of 10 (an order of magnitude higher than an ideal dolomitic ratio of 1.4) suggests a high calcium rather than dolomitic lime. Traces of calcined silicate contaminants suggest a rock lime source but not enough material is observed petrographically to offer a definitive statement. Gypsum plaster is identified as a gauging material (Fig. 20). Very few unhydrated gypsum relicts are identified. The rare abundance of coarser hemihydrate or finer dead-burned anhydrite suggests that the plaster was not a cement plaster or Keene's cement but rather a fine finishing plaster such as Plaster-of-Paris.

Figure 19: PPL photomicrograph illustrating the overall microstructure of the finish coat in sample LOKE.M.8. The binder matrix (BM) has a high capillary porosity as indicated by the high absorption of blue-dyed epoxy used in the sample preparation. The layer is unsanded and all grains observed here are part of the binder.
