Dry Tortugas Light Station

Keeper's Residence Historic Structure Report

by Lord, Aeck & Sargent Architecture

2009

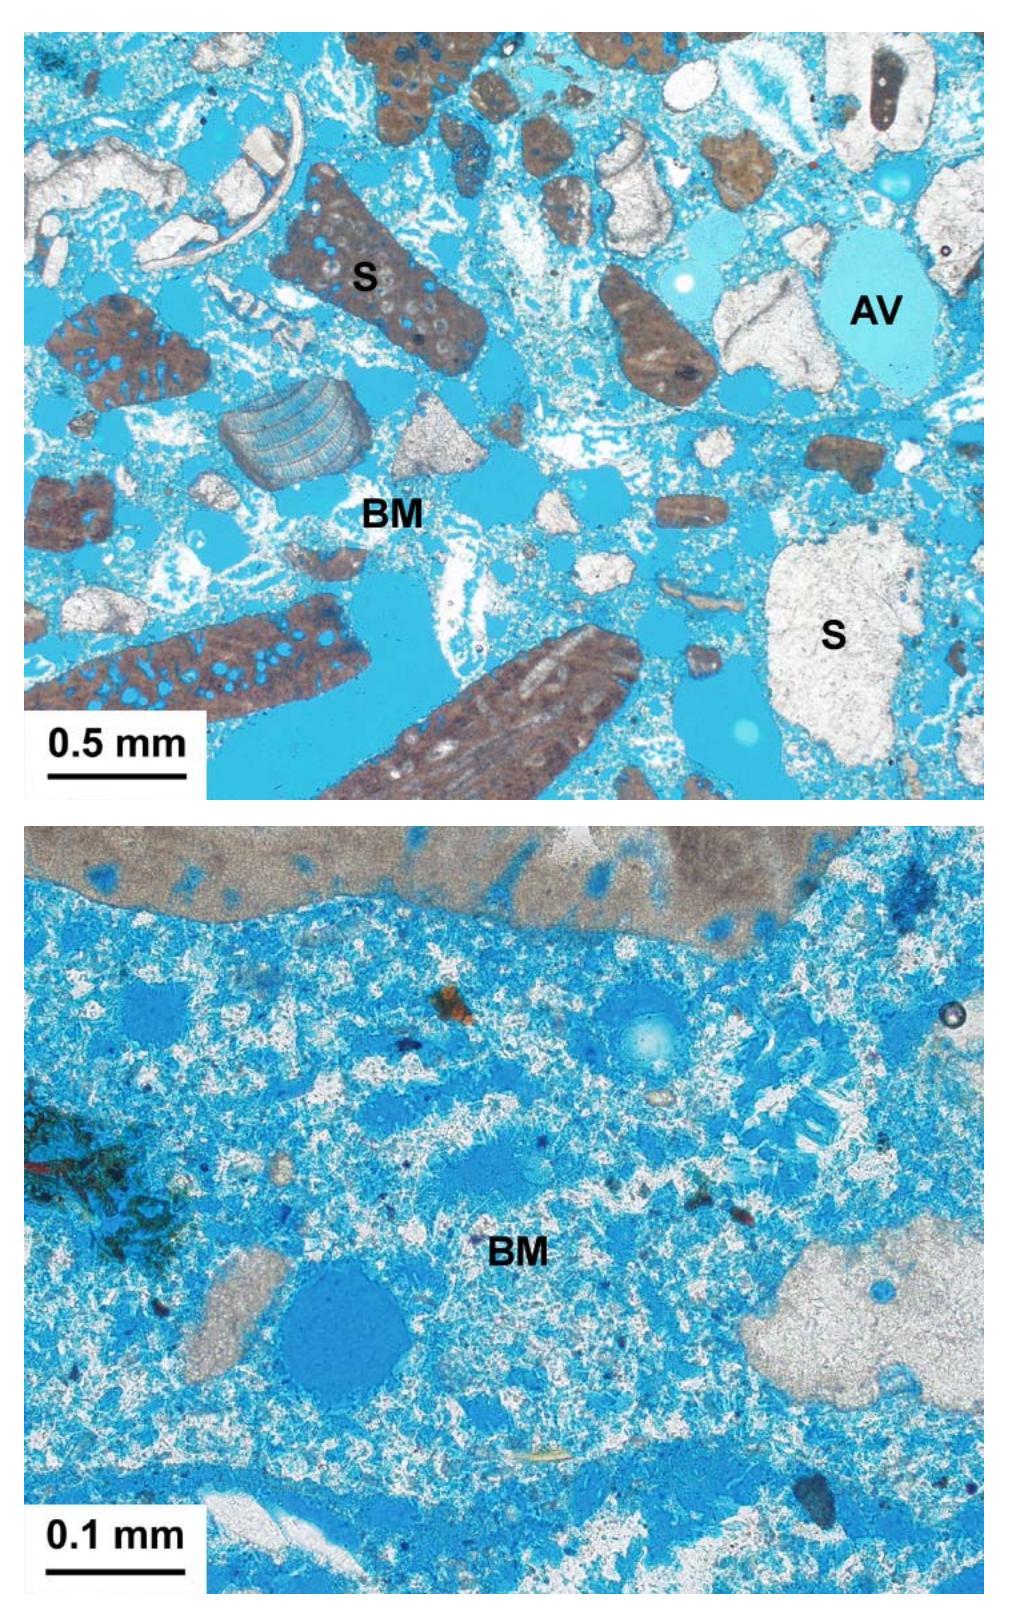
The brown coat contains a relatively coarse-textured and porous binder matrix composed of a network of fine-grained gypsum hydrate (Fig. 21). Coarser hydrated residuals are relatively common and unhydrated hemihydrate and fine-grained, dead-burned anhydrite are also present though in lower abundance (Fig. 22). A chemical analysis was not requested for this sample and further information regarding the plaster provenance cannot be provided. However, the microtexture of the coat clearly discounts a refined finishing plaster and the presence of the dead-burned gypsum (anhydrite) suggests that the plaster may have been a Keene's cement. It should be noted that the term "cement" here does not refer to hydraulic calcium silicates and Keene's cement represents a relatively pure calcium sulfate product.

The sand in the brown coat is identical to that of the other samples in the suite and is most similar to the other Keeper's Dwelling sample (LOKE.M.10) in gradation (Figs. 7 and 21). The aggregate is identified as a natural carbonate sand containing coral and shell fragments similar to that making up the local sediment. Visual examination indicates a homogeneous color ranging from nearly white to pale yellow with no significant variegation. Grains are rounded due to natural weathering processes but tend to be somewhat elongate due to the original shapes of the organisms. The gradation is

Figure 21: PPL photomicrographs illustrating the overall microstructure of the brown coat in sample LOKE.M.11. (Top) The binder matrix (BM) has a high capillary porosity as indicated by the high absorption of blue-dyed epoxy used in the sample preparation. The sand (S) is the same soft, natural carbonate sand found in the mortar samples. Air-voids (AV) are moderately abundant. (Bottom) The matrix is defined by a network of fine hydrated gypsum crystals. Still, the texture is somewhat coarse when compared to the finish coat (Fig. 23 below) and the plaster in this coat may have been a Keene's cement.

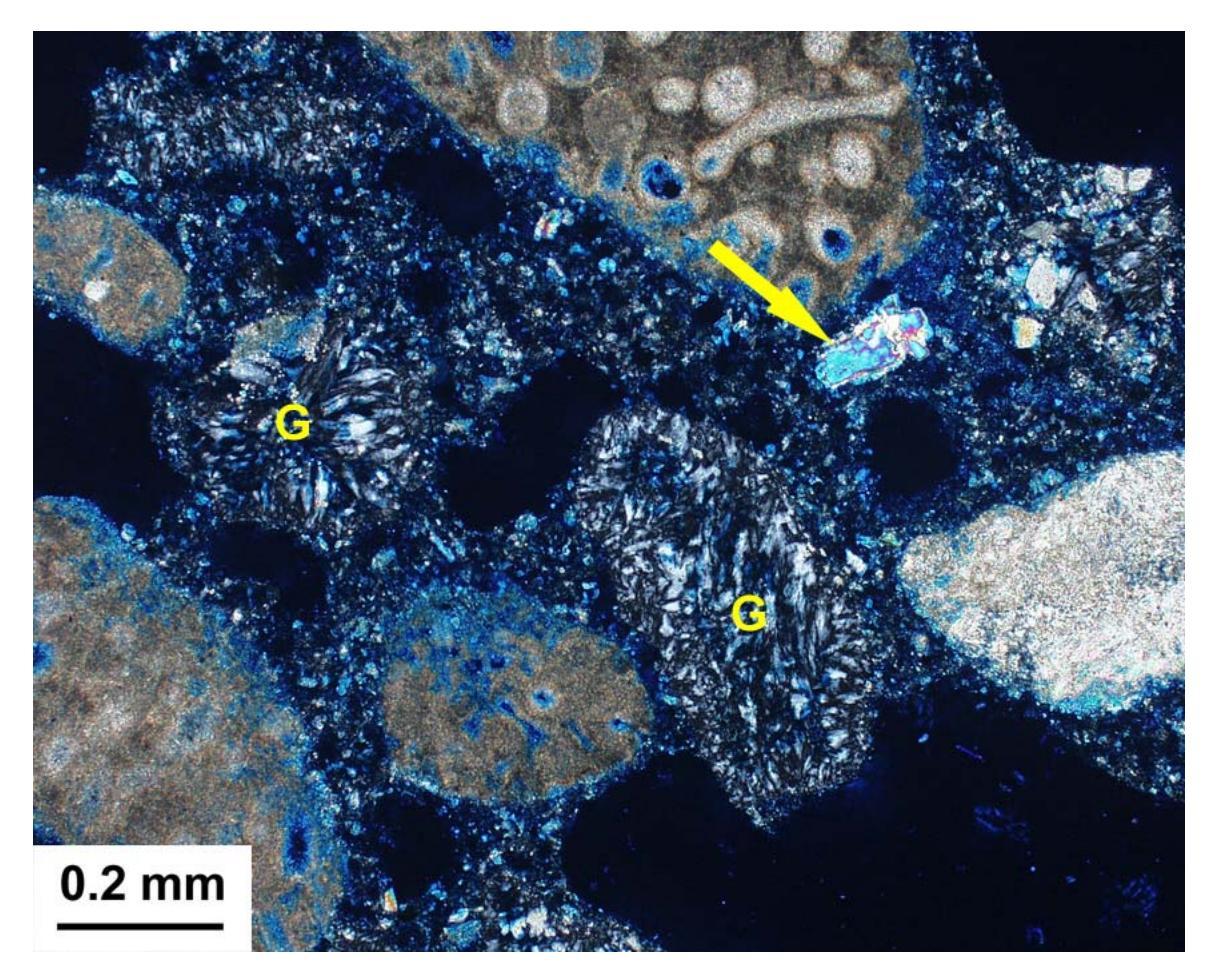
Figure 22: XPL photomicrographs illustrating binder residuals in the brown coat of sample LOKE.M.11. Gypsum residuals (G) represent grains of originally unhydrated hemihydrate that has hydrated to coarser grained gypsum. The arrow indicates a fine crystal of deadburned anhydrite. This type of inclusion is typical of Keene's cement and would not be abundant in a Plaster-of-Paris. **TESTWELL, INC.** Building Conservation Associates, Inc.; Loggerhead Key Light Station Report #: OPCL011/PGE-001 Page 50 of 53

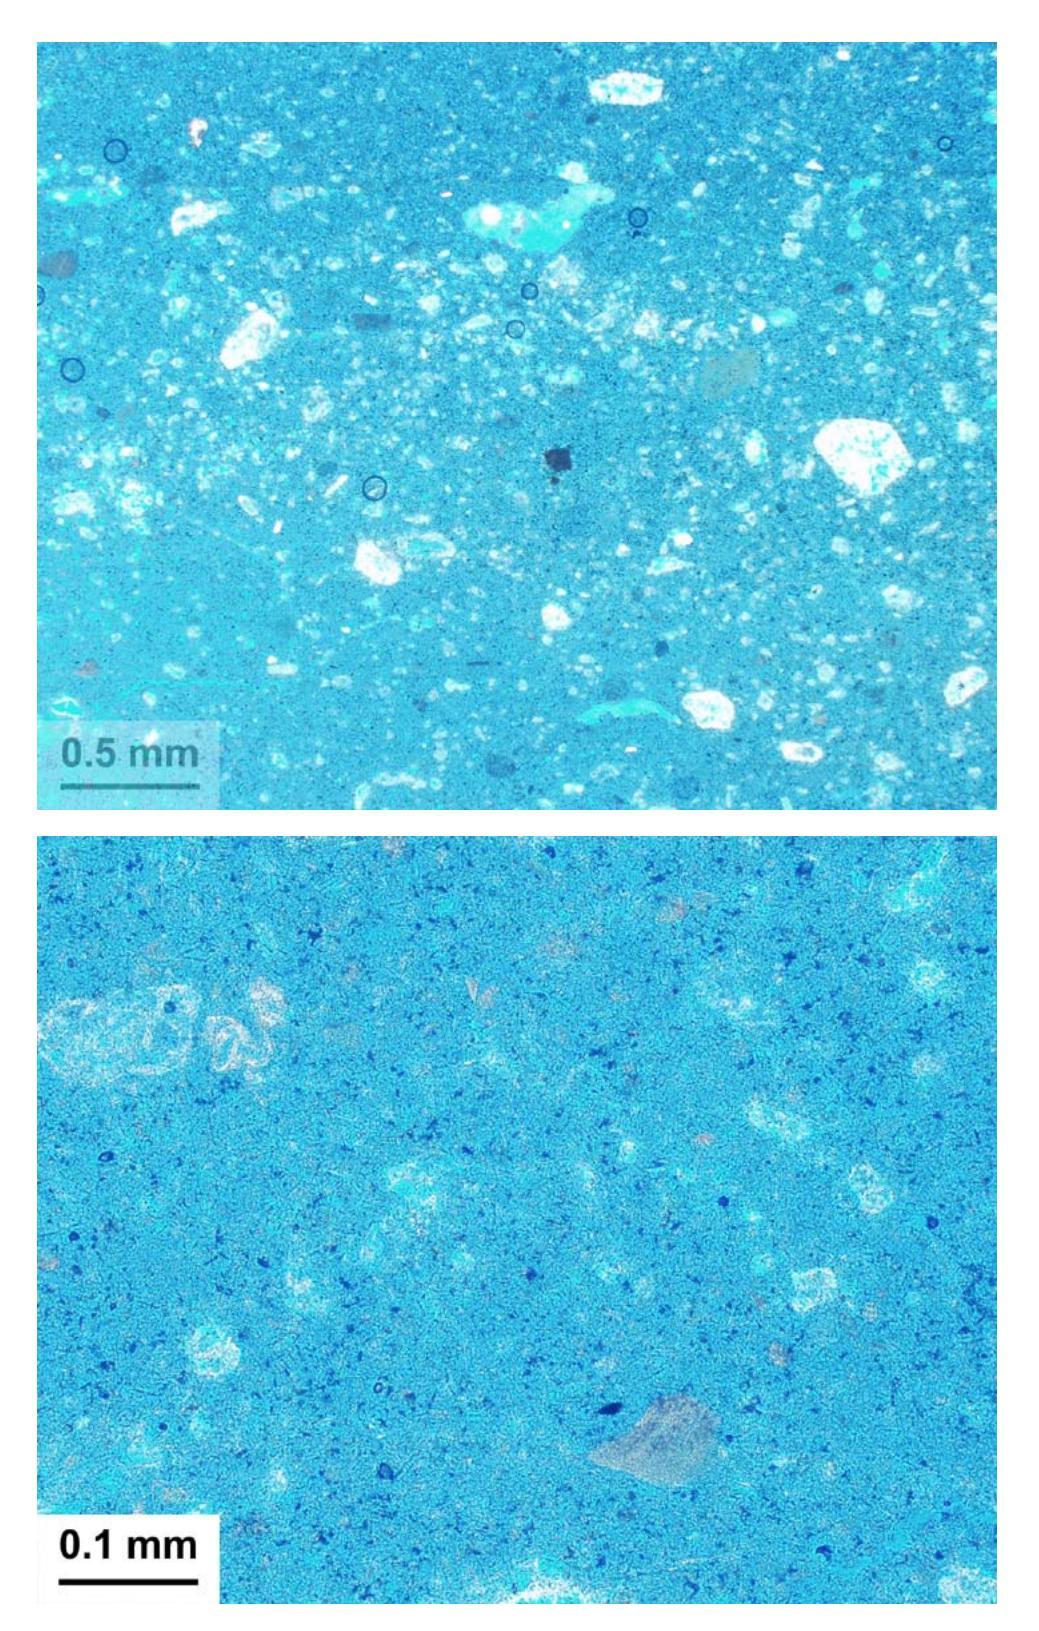
The finish coat matrix is fine-textured and moderately porous. The paste matrix is dominated by a network of very-fine grained hydrated gypsum crystallites (Fig. 23). Very few unhydrated gypsum relicts are identified. The rare abundance of coarser hemihydrate or finer dead-burned anhydrite suggests that the plaster was not a cement plaster or Keene's cement but rather a fine finishing plaster such as Plaster-of-Paris (Fig. 24). A very low abundance of carbonated lime grains are dispersed throughout the largely gypsum-based matrix. While a chemical analysis was not performed for this sample, the lime is interpreted to represent a minor gauging rather than a major component of the finish plaster.

Figure 23: PPL photomicrographs illustrating the overall microstructure of the finish coat in sample LOKE.M.11. (Top) The binder matrix (BM) has a high capillary porosity as indicated by the high absorption of blue-dyed epoxy used in the sample preparation. The layer is unsanded and all grains observed here are part of the binder. (Bottom) The matrix is defined by a network of fine hydrated gypsum crystals. Even in this higher magnification image, the texture is difficult to see and the finish coat plaster is much finer textured.
