Dry Tortugas Light Station

Lighthouse and Oil House

Historic Structure Report

2009

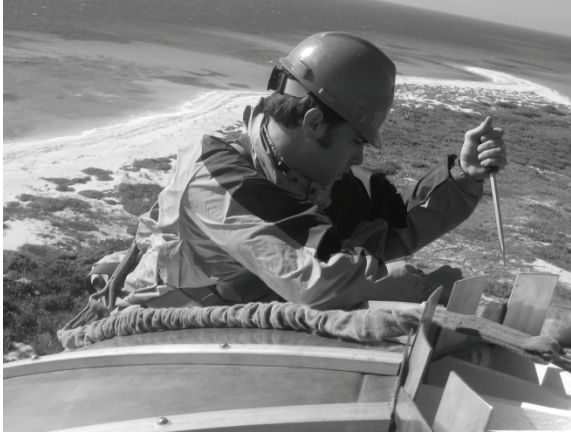
Figure 30. Image taken in early 2009 during repair of the Lantern roof.

The project began with removal of the deteriorated roof panels followed by removal of the vent ball and lightning rod which were placed in storage at the Everglades National Park collections facility. Due to the limited funding available only a partial restoration of the roof could be accomplished. The dome of the roof was replaced, but reconstruction of the integral gutter system and replication of the vent ball and reinstallation of the lighting rod could not be completed. The new copper panels were attached to the existing iron skeleton with stainless steel clips and a roof access hatch was added. The Lantern glass was replaced with 7/16" tempered hurricane glazing and the iron frame was scaled and painted. The project was completed in early 2009.

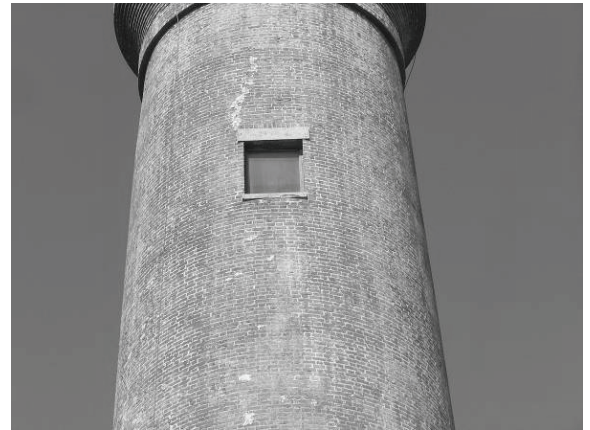
The central portion of the upper zone is experiencing moderate to severe mortar deterioration requiring repointing. There is evidence of a vertical crack in the lower half of the zone. The crack appears to have been

Figure 37. Vertical crack extending from head of fifth-level window.

repointed in the past with non-matching mortar. The area of mortar deterioration extends into the corbelling at the top of the zone. Degradation of the head joints is most prevalent in this area.

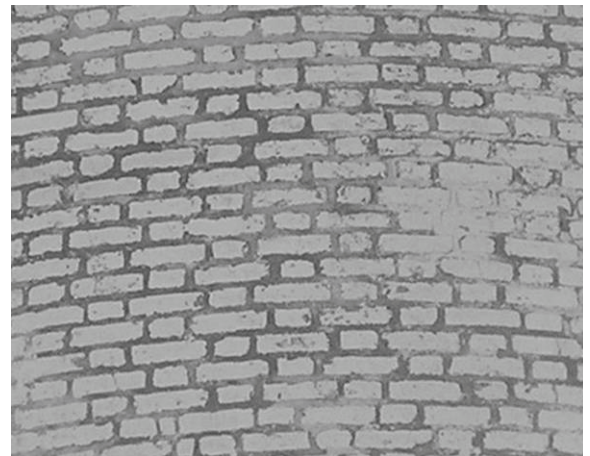
Figure 38. Close-up view of paint deterioration on exterior wall.

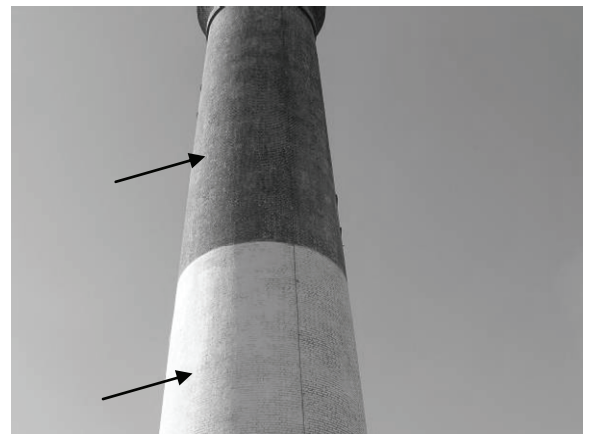
Figure 39. Middle zone of north elevation. There is a perceptible seam or strip on this elevation that may be attributed to the 1967 sand blasting project.

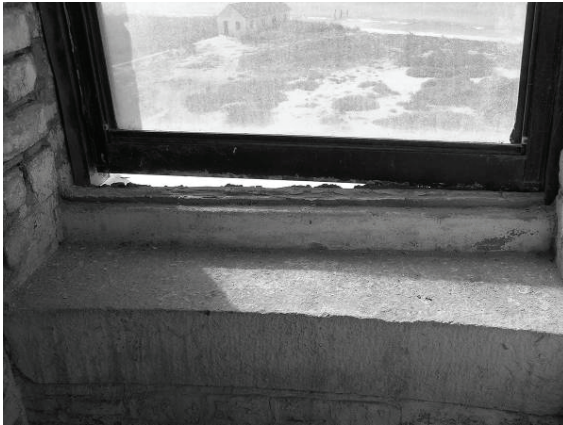
The tower windows were also replaced at this time with three-pane, aluminum, awning windows. Because the new windows would not completely fill the original rough opening, a two-inch concrete sill was fashioned to make up the difference.

Figure 42. A concrete sill has been formed on top of the original granite sill at each window location to accommodate the installation of the modern aluminum sash.

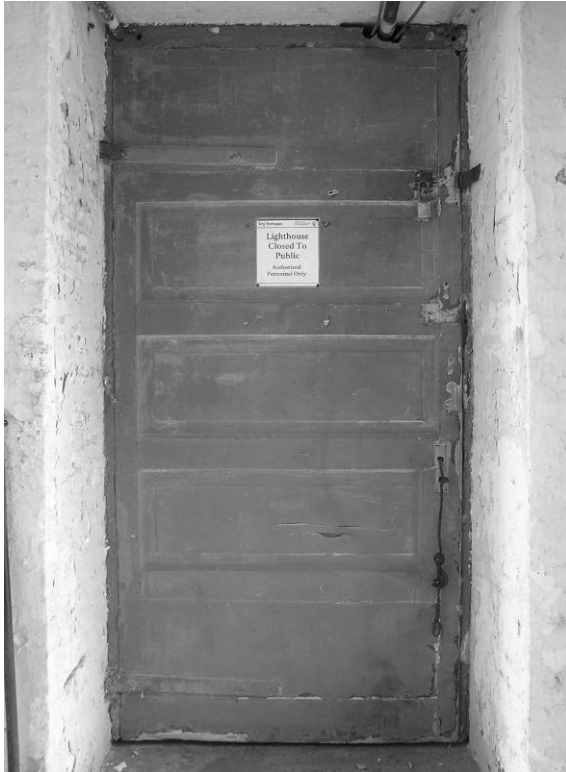
Figure 43. Five-panel wood entry door to tower.

Existing Condition: The existing tower door is in fair to poor condition. The door appears to be structurally intact, but many of its original hardware components are missing or have been modified.

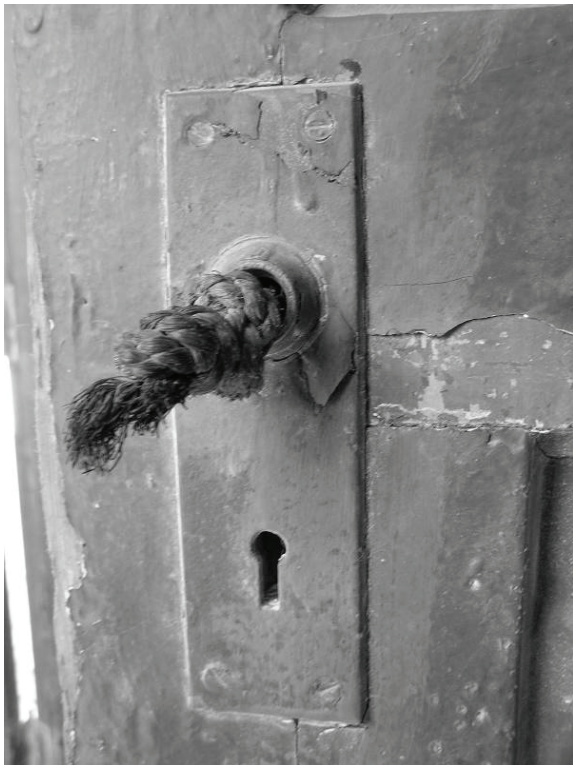
Figure 44. This escutcheon plate and the mortise lockset are the only remaining hardware components.

The knobs and exterior key escutcheon have been removed. A mortise lockset is set within the door. The lockset was not removed to try and determine a date of manufacture. A rope threaded through the door provides a pull and the unit is secured by a modern hasp and padlock.

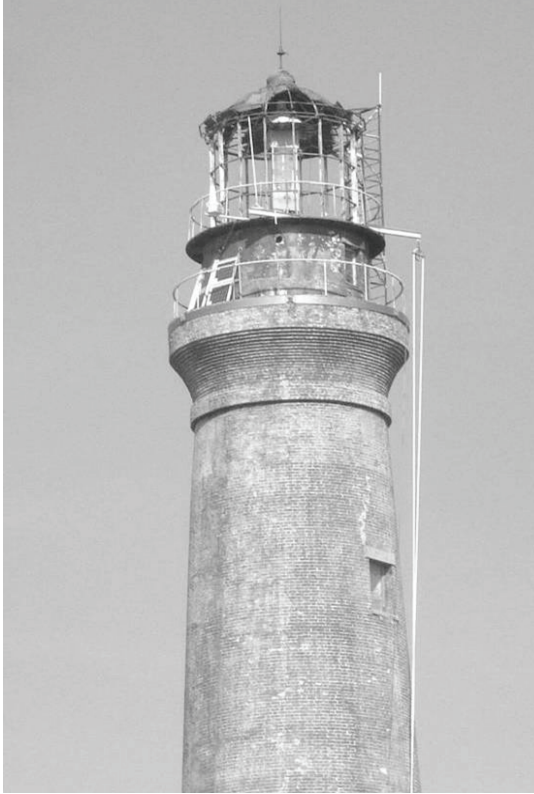
During the approximately 25 years between 1985 and 2009 the Lighthouse Lantern structure and roof had deteriorated significantly to the point that the structure was open to the weather for an extended period of time. This prompted a recent emergency stabilization effort by the National Park Service to replace the copper roof and Lantern glazing, and scale and paint the iron elements of the Lantern structure.

Figure 45. 2008 image showing condition of Lantern prior to recent repairs.

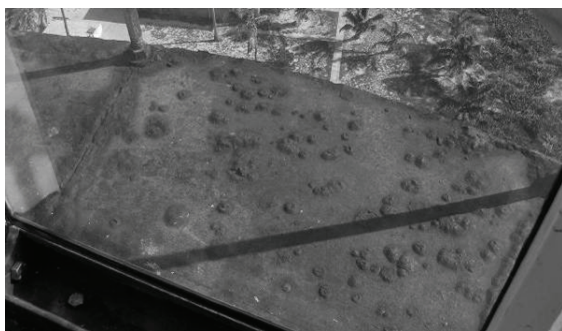
Figure 49. Image showing pitting corrosion on Lantern gallery floor plates.

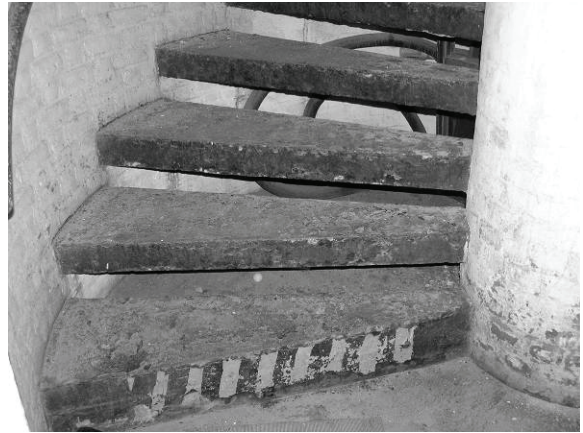
Existing Condition: The stone stair slabs appear to be in good condition. No signs of cracking of the slabs or failure at the connection to the masonry walls were noted. The underside of some of the slabs appears eroded or pitted, but it was unclear if this was the original condition of the slabs or the result of some kind of deteriorative process. Two treads, the fifteenth tread of the fourth flight and second tread of the fifth flight, have experienced cracking and therefore have been stabilized by sandwiching the slab between plywood boards.

Figure 52. View of first four treads at base of tower.

The existing hand rail is broken and loose in several areas.

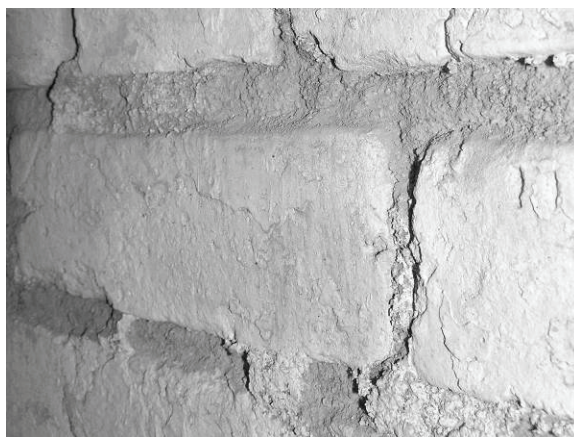
Figure 54. Close-up view of deteriorated mortar joints of stair tower walls. Almost universally the surface of the mortar has become friable, falling from the wall as powder.

Existing Condition: The primary condition problem noted on the interior walls of the tower is the deterioration of the cement mortar and the associated painted finish. These condition problems were observed universally at all levels

of the tower, but the severity of the condition varied significantly from location to location. No discernable patterns of deterioration could be identified that would lead one to a specific cause for this condition. In general, the outer $\frac{1}{8}$ " to in some cases 1" of the mortar has become friable. In some areas, the friable mortar remains

trapped behind the painted finish. However in most cases the painted finish has also failed and the deteriorated mortar has fallen from the wall as fine sand. The head joints of the wall seem to be affected more severely than the bed joints. This condition was observed on the walls and the central column. The processes that are causing this condition are not entirely clear, but the migration of moisture through the wall assembly is thought to be at the root of the problem.

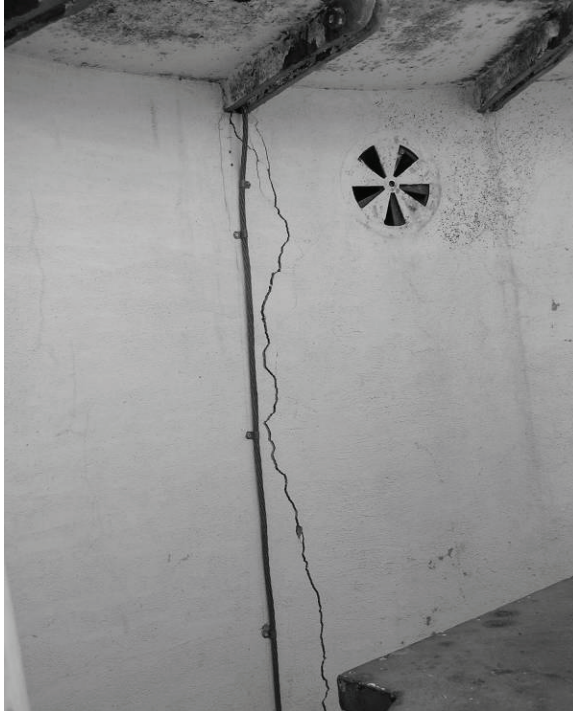
Several vertical cracks were noted above the fifth level landing. The cracks extend down from the iron ring embedded in the masonry wall as part of the structure of the Watch Room level floor plate. These cracks may be associated with corrosion and expansion of anchor rods placed within the walls to secure the Watch Room floor plate to the masonry tower.

Figure 59. Vertical crack in watch room wall extending down from Lantern level floor plate.

The underside of the iron floor plates are experiencing moderate to severe corrosion. The corrosion appears to extend into the masonry wall where it may be exerting pressure on the masonry and causing cracking of the walls below.

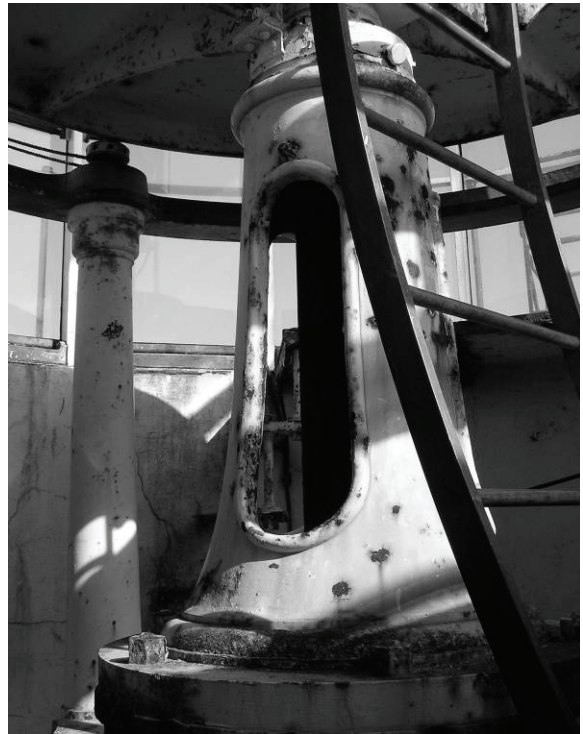
The iron components of the lens pedestal as well as the diamond-plate floor panels, brackets, and iron stair to the Lantern room are experiencing moderate surface corrosion.

Figure 61. Portion of lens pedestal and support structure.

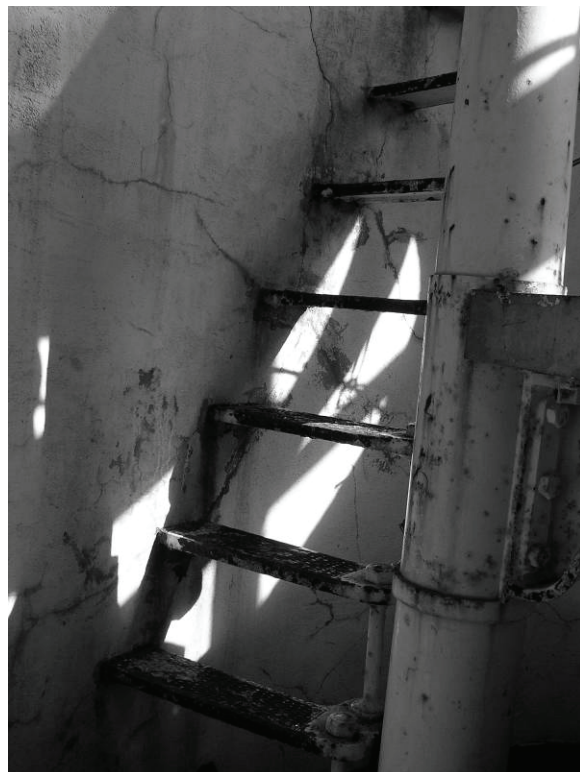
Figure 62. Iron stair between Watch Room and Lantern.

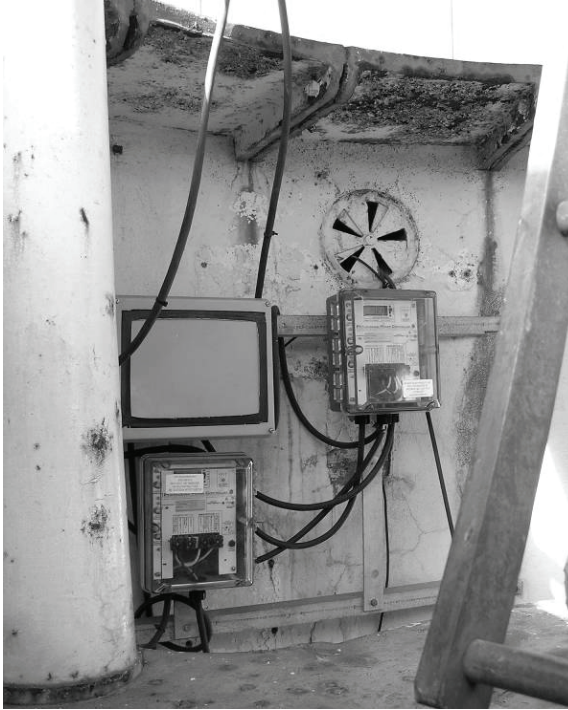
Figure 65. Equipment mounted to the Watch Room wall associated with the solar collection system that provides power to the primary and secondary beacons.

- Modern conversion and distribution panels for the solar collection system installed on the Watch Room walls.
- Second-order bivalve lens was removed in 1986 and replaced with the VRB-25 rotating beacon changing the character of the Lantern Room.
- Corrosion of iron floor plates and their potential impacts on masonry.
- General surface corrosion of lens pedestal components.

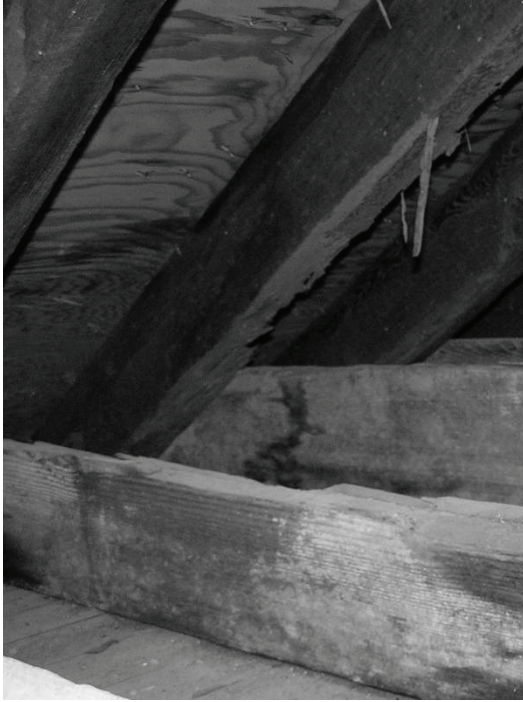
Figure 71. Image of roof framing members taken in attic of Oil House. Note evidence of moisture, minor termite damage and the different patina of the members.

Existing Condition: The attic space was dry at the time of inspection. No evidence of active leaks was observed, but some moisture staining was noted on the ceiling joists. In addition minor termite damage was observed on several rafters. No active termites were observed.

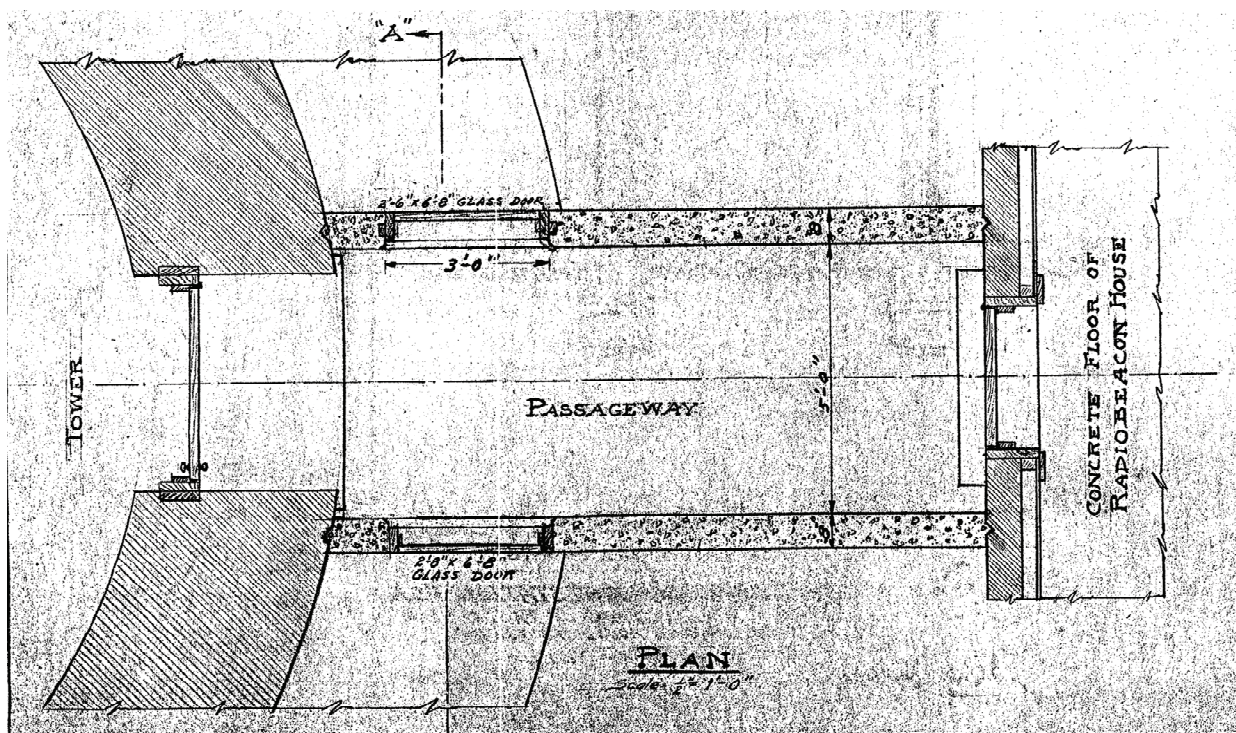
Figure 82. Original 1926 drawing of the reinforced concrete passageway connecting the Radio Beacon House (former Oil House) to the Lighthouse.

“Notwithstanding the distance it is to be located from the surface the reinforcing will eventually result in extensive repairs from time to time and the ultimate destruction of the walls and roof. In the opinion of this office it is unnecessary and detrimental rather than beneficial. As a matter of information it might be stated that this office does not know of a single piece of reinforced concrete in this district, similarly situated, that has been in service 10 years but what is now seriously affected and in some instances replacements are only a question of a short time.”³

The reinforcing was ultimately installed in the walls. The original architectural drawings call for the reinforcing to be “thoroughly covered with a thin coating of Portland cement,” presumably in an effort to prevent moisture from attacking the metal.

Existing Conditions: Isolated areas of concrete spalling on the interior walls and ceiling of the passageway were noted during the review of conditions. In addition, identical patterns of horizontal and vertical cracking are present on the exterior of the north and south elevations and around the through-wall galvanized roof drain pipes. Both the spalling and the cracking can be attributed to corrosion and expansion or “jacking” of the internal reinforcing and drain pipes. Given that segments of the reinforcing have now been exposed and the cracking that has formed is providing a pathway for water to infiltrate the walls, it is expected that this condition will continue to worsen in the short term.

- Corrosion and expansion of internal reinforcing has caused spalling in several areas.
- The interior and exterior painted finish of the passageway is deteriorated and requires repainting.

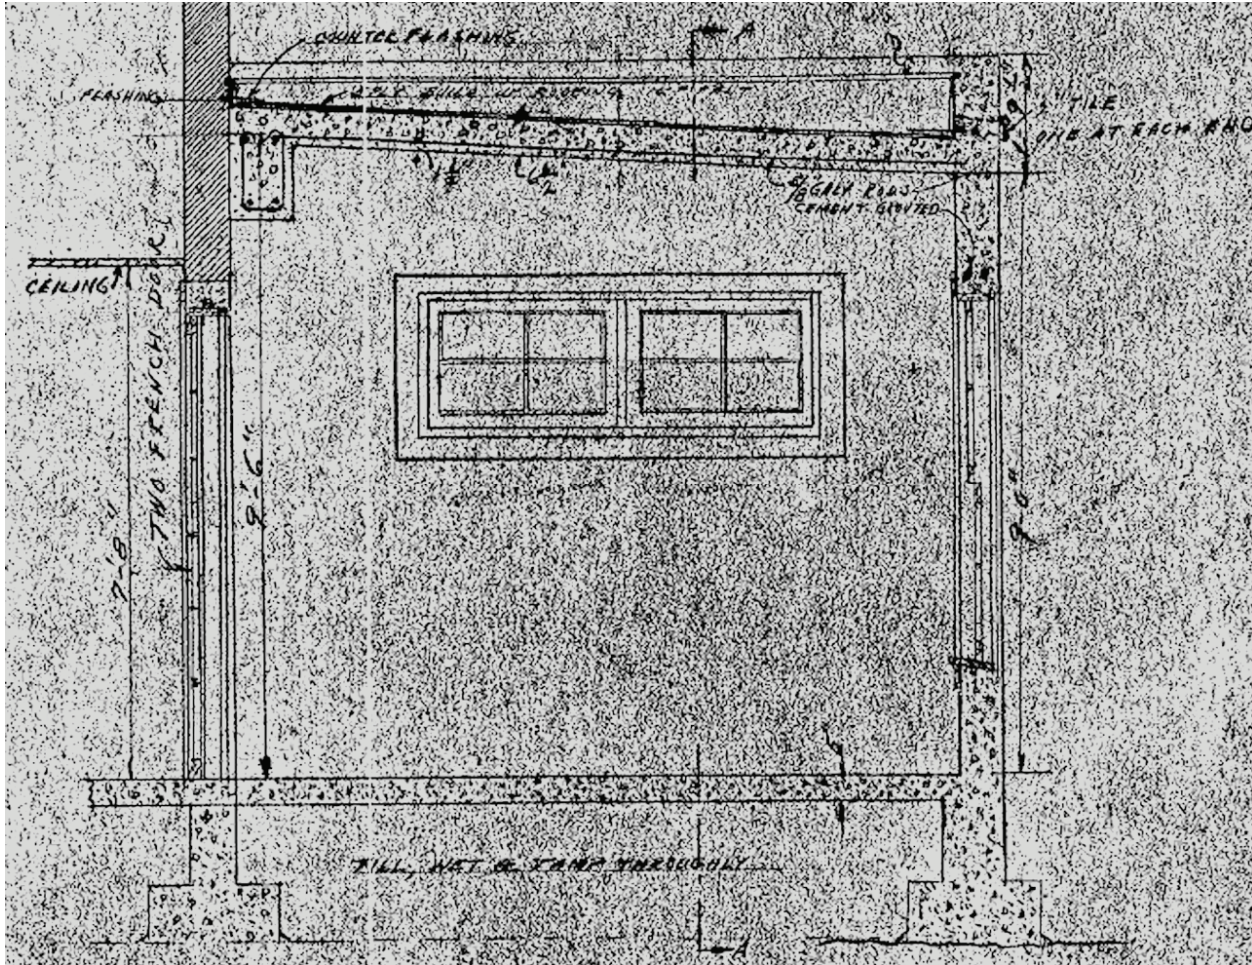
Figure 84. Section through West Addition to Oil House (Battery Room).

Existing Conditions: The addition to the Oil House is in relatively good condition with no significant signs of component failure or deterioration. A horizontal crack was noted on the interior extending from the middle of the window on the west elevation to the bottom corner of the window on the north elevation. The interior painted finish is experiencing localized flaking. The west window has been removed.

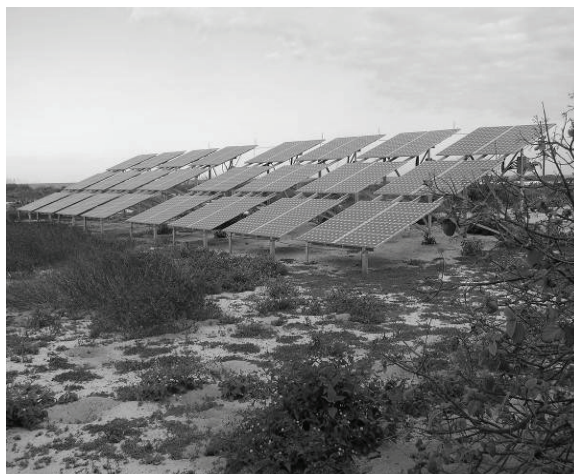
Figure 86. View of photovoltaic array located west of the Lighthouse and Oil House.

Existing Conditions: The photovoltaic array has an anticipated useful life of 20 years, which leaves a minimum of 13 years before it will need to be replaced. However, the lifespan of the individual components of the system, and the batteries range from one to three years. Regular maintenance of the system is required primarily due to the effects of the environment on individual system components.

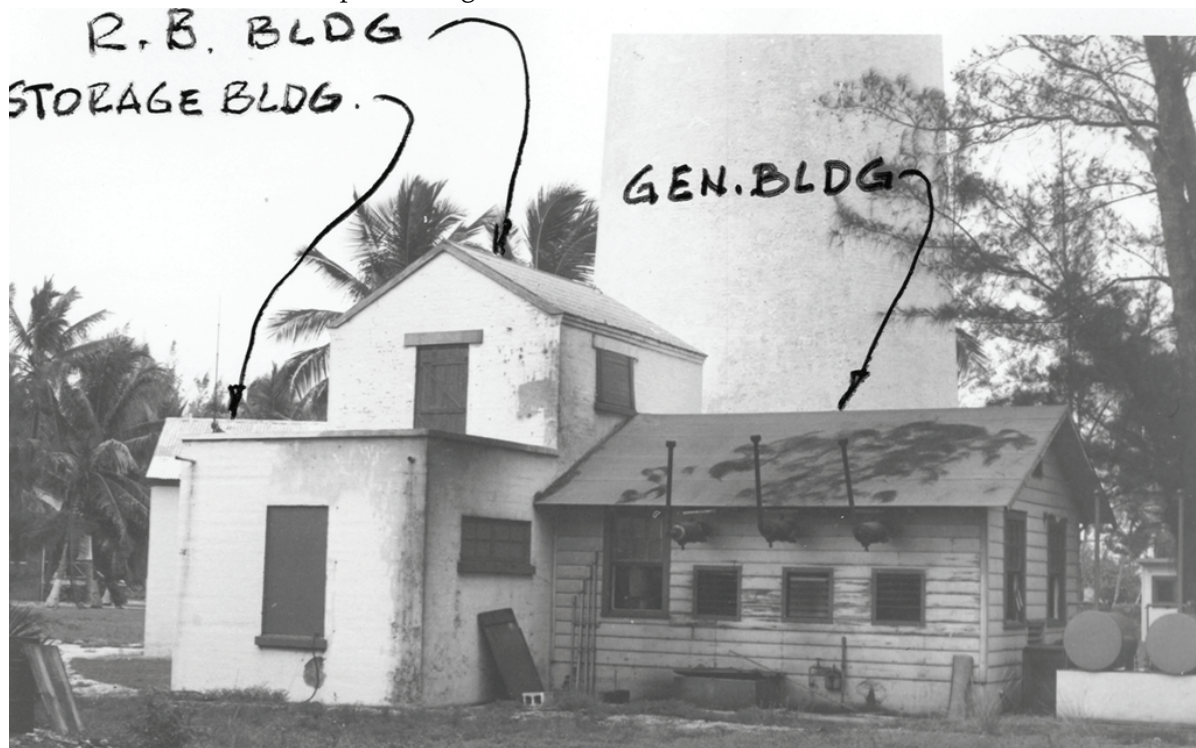
Figure 93. Pre-1969 image of Oil House showing wood-frame addition and shutters on the Oil House windows.

Like the Lighthouse, the Oil House received new windows in 1967 and 1982. A single awning window remains from the 1967 installation and the remainder of the windows are bronze aluminum awning units similar to those installed in the Lighthouse. The hardware on all of the existing windows is deteriorated or damaged and in most cases the windows are no longer operable. We recommend that the windows be replaced in the short term.

Available documentation from the 1920s conversion of the Oil House shows four-over-four, double-hung windows installed at the time (see Figure 26). Consistent with the proposed ultimate treatment, we recommend that existing aluminum units be removed and four-over-four, fluoropolymer coated

aluminum double-hung units be installed similar to the treatment prescribed for the Lighthouse. We also recommend that the vertical board shutters with “Z-bracing” that were present on the Oil House be replicated and installed as part of the window replacement (see Figure 93).

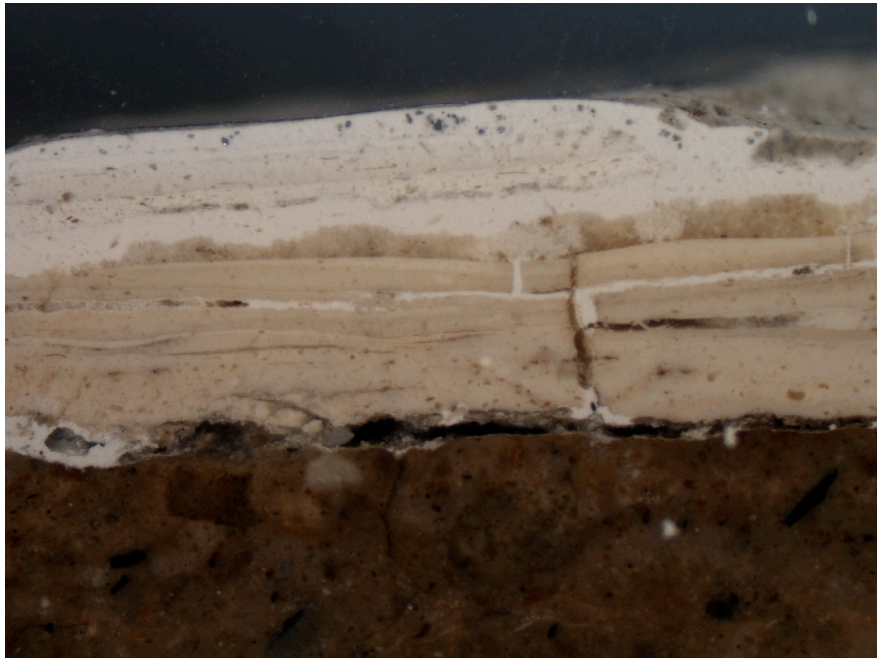
Physical evidence confirms the historical documentation. The surface of the brick in samples removed from these buildings appears somewhat weathered and uneven, suggesting it was worn by exposure to the elements before being painted. The only structure that may have always been painted was the south brick cistern. As evidenced in *Figure 9* the sample removed from the brickwork of the cistern shows a relatively clean brick surface, suggesting it has always been protected from the weather. (*Figures 8-9*)

Figure 8. Oil house. Photomicrograph of painted exterior brick showing numerous layers of cream and white-colored paint. (40x magnification, visible light).

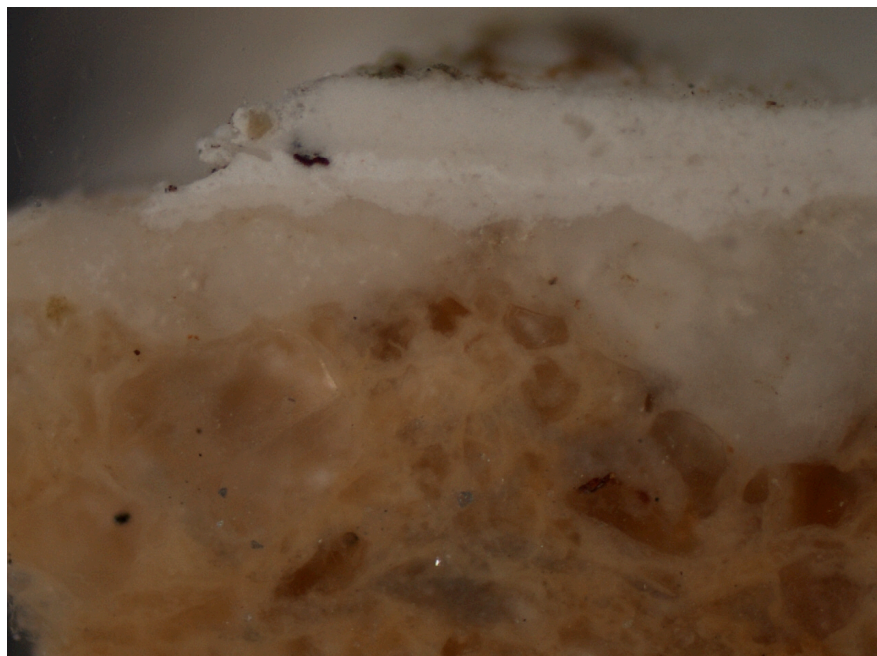
Figure 9. South brick cistern. Photomicrograph of earliest finish applied to brick wall of cistern. Note first layer is more translucent than the others and appears to be a limewash. Also, the surface of the brick is relatively unsoiled. (100x magnification, visible light).

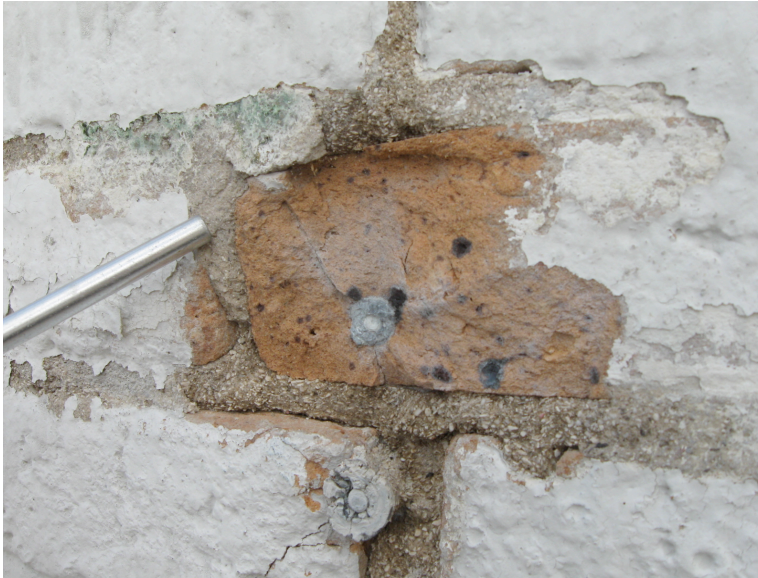
Laboratory analysis indicates that the majority of mortars used historically at the Dry Tortugas Light Station are composed of natural cement and local carbonate sand. Lime, which would have been added to the mortars as a gauging material to improve workability, was not documented in any of the historic mortars analyzed as part of this study. The natural cement and sand mortars were found at the lighthouse, the oil house, the original kitchen building and the south brick cistern. In addition, samples of mortar removed from four different locations within the lighthouse, including the portion of brick masonry directly below the watch room floor plate, were as natural cement and carbonate sand mortars that were virtually indistinguishable from one another. The similarity of these mortars makes it difficult to draw any conclusions about the date of installation or type of mortars used for the numerous repair campaigns made to the lighthouse, which were documented in extensive written material. However, the physical evidence suggests that, although there were numerous repairs campaigns, the same mortar mix and ingredients were used consistently for the majority of the re-pointing campaigns in the 19th century. (*Figure 15*)

Figure 15. Lighthouse. Area of historic mortar removed for analysis. Note characteristic carbonate sand inclusions.

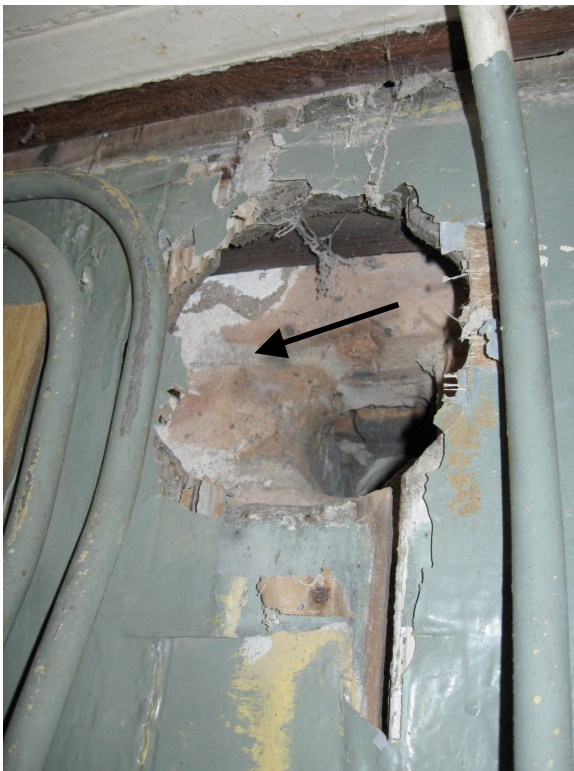
Figure 16. Oil house. Area of early plaster, discovered behind later wall finishes, removed for analysis.

Interior plaster of two of the historic buildings was also examined. In the oil house, a sample of a three-coat plaster system, discovered behind a layer of modern wood paneling and a bead board wall, was removed for analysis. The plaster is composed of: a lime and carbonate sand scratch coat gauged with natural cement, a natural cement and carbonate sand brown coat, and a lime-based finish coat that is gauged with gypsum (no sand). Although it is unclear when this plaster dates from, it is possible that it is original to the building and dates to the 1850s. The sand used in the scratch and brown coats is the same as that used in the brick mortar of the same building, a local carbonate sand. (Figure 16)

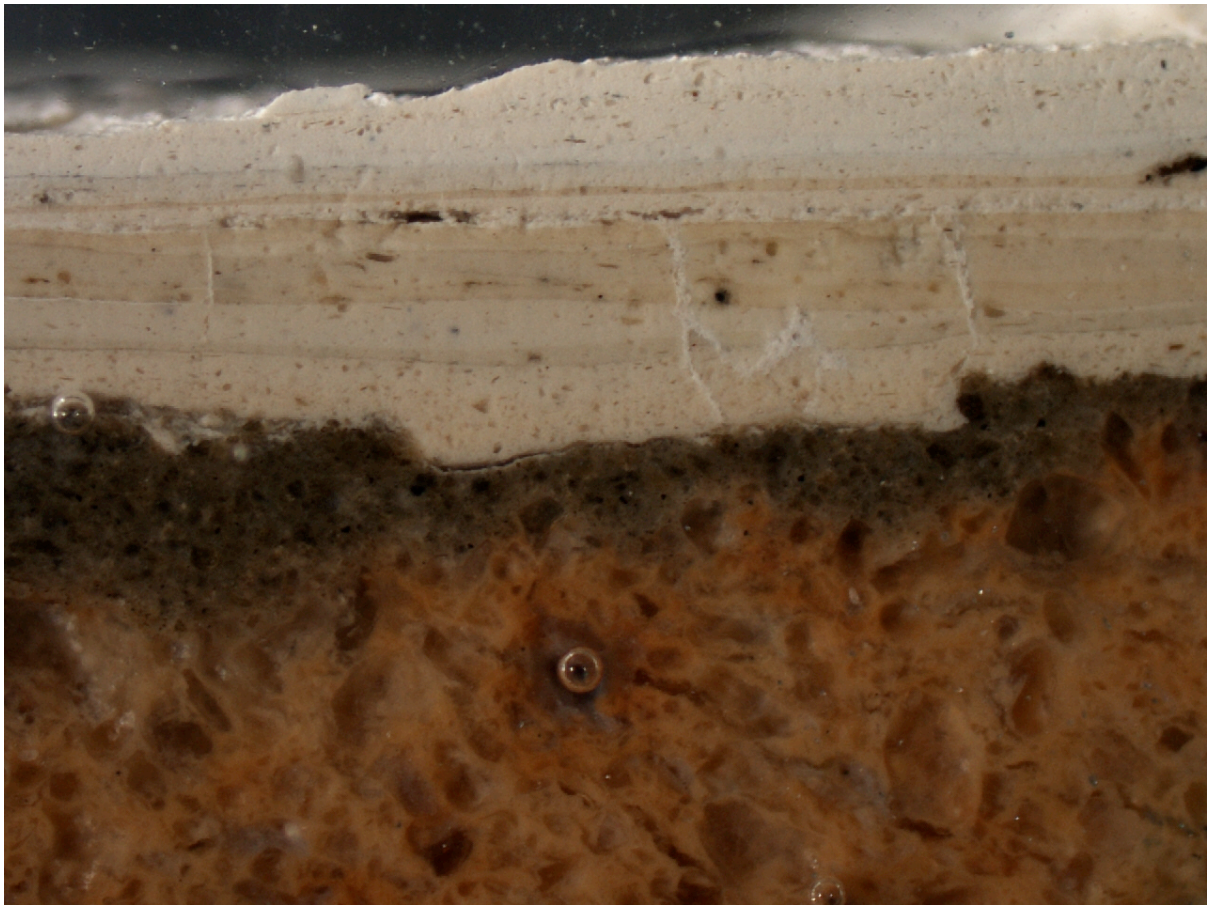
SAMPLE NO:	LOKE.F.1 (40x, Visible Light)
LOCATION:	Oil House, exterior, east elevation now enclosed, finishes on brick.

LAYER*	COLOR	NOTES
Substrate	Brick	Surface looks weathered and soiled, suggests exposure prior to painting
1	Cream	All finishes look like paint, missing early limewash layer visible in LOKE.F.9
2	Off-white	
3	Off-white	
4	Cream	
5	Cream	
6	Cream	
7	Off-white	
8	Cream	
9	Off-white	
10	Off-white	
11	Off-white	Current finish

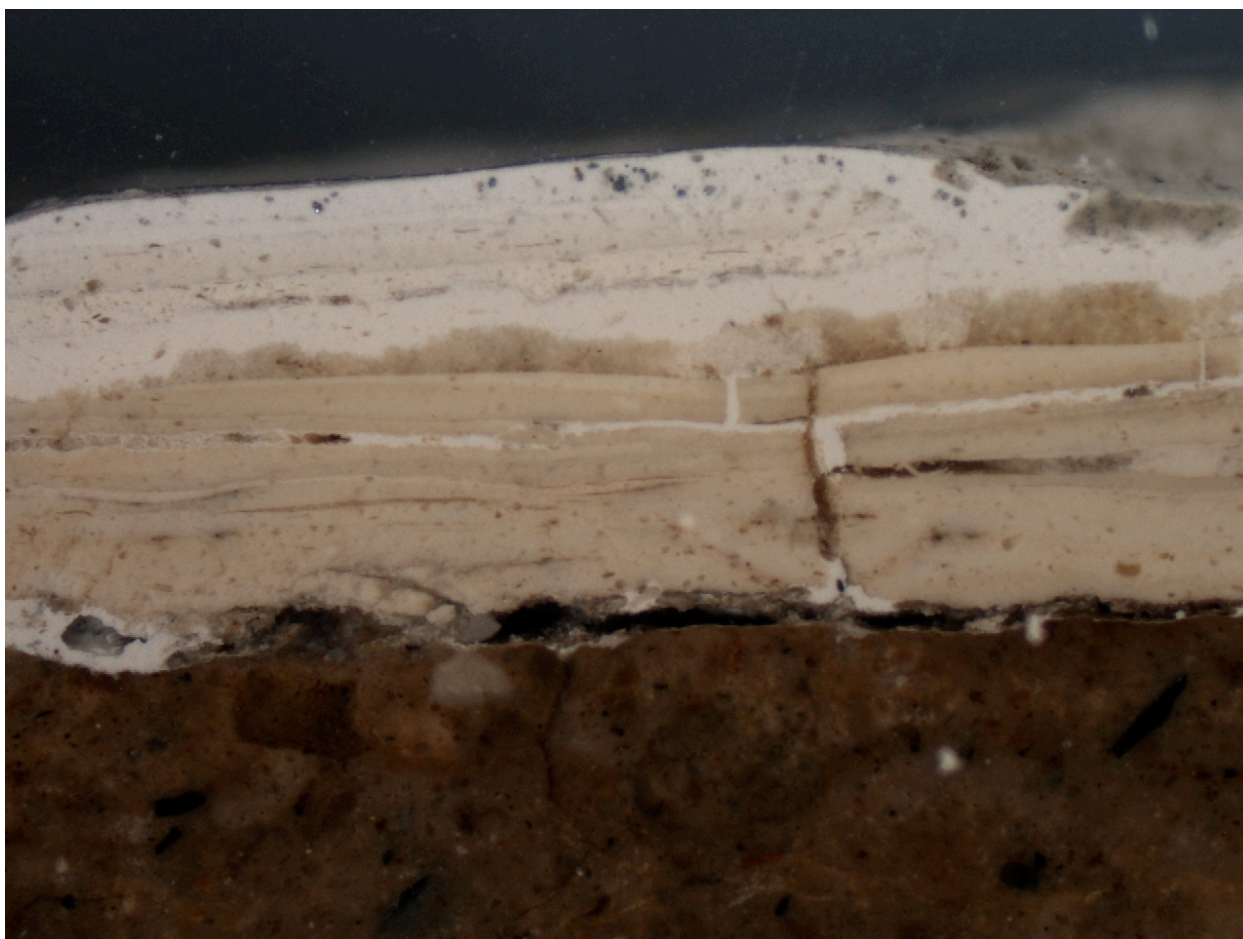
SAMPLE NO:	LOKE.F.3 (40x, Visible Light)
LOCATION:	Oil House, exterior, east elevationl, finishes on brick.

LAYER*	COLOR	NOTES
Substrate	Brick	Fracture at surface suggests weathering prior to painting
1	Cream	
2	Cream	
3	Cream	
4	Cream	
5	Cream	
6	Cream	
7	Cream	
8	Cream	
9	Cream	
10	Cream/tan	Translucent
11	White	
12	Off-white	
13	Off-white	
14	Off-white	
15	White	Current finish

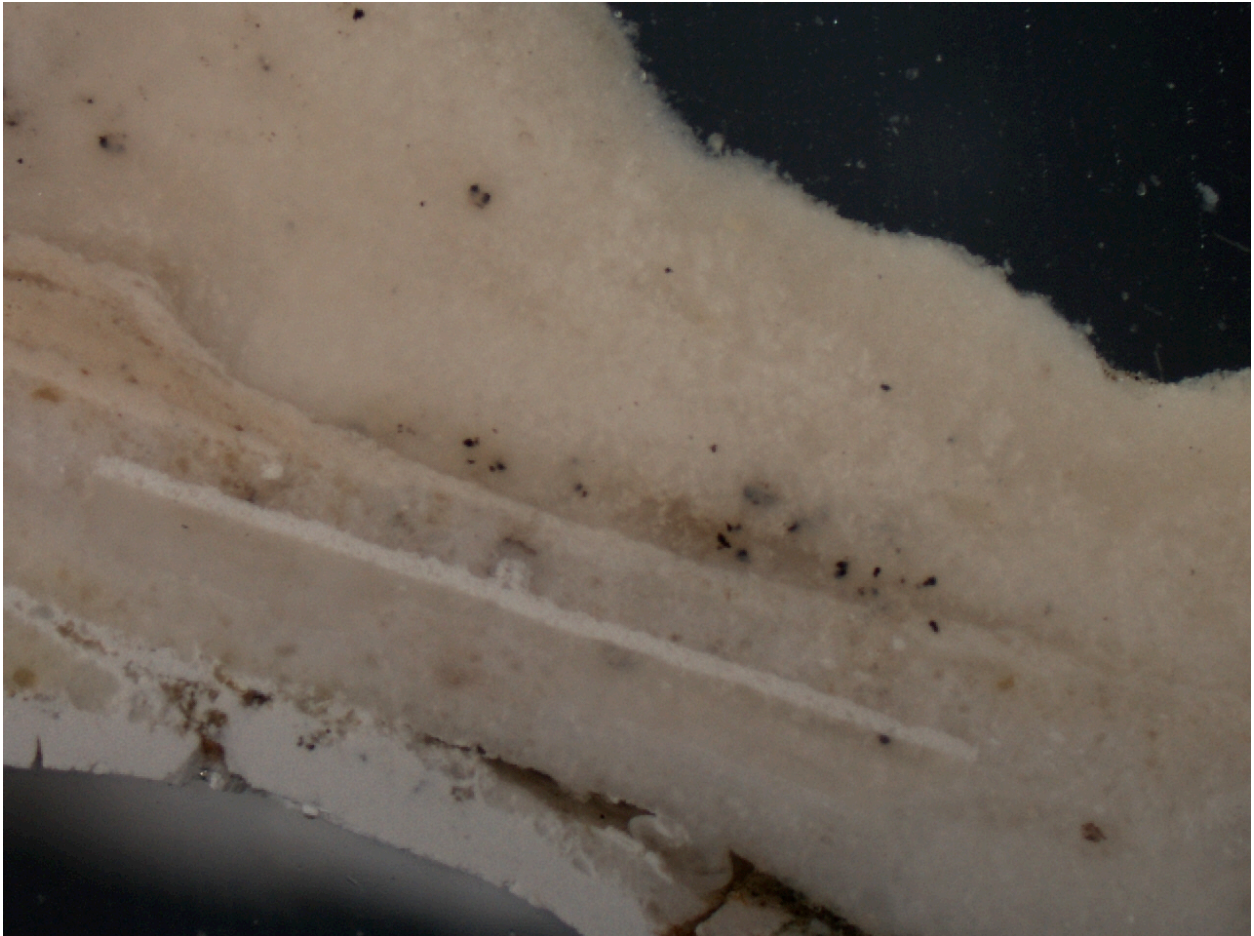
SAMPLE NO:	LOKE.F.5 (100x, Visible Light)
LOCATION:	Cistern, west elevation, finishes on brick.

LAYER*	COLOR	NOTES
Substrate	Brick (missing in photo)	No sign of weathering of brick surface, suggests brick was always finished
1	Off-white	Translucent, white wash
2	Off-white	Translucent, white wash
3	Off-white	
4	Off-white	Modern paint
5	White	
6	White	Current finish

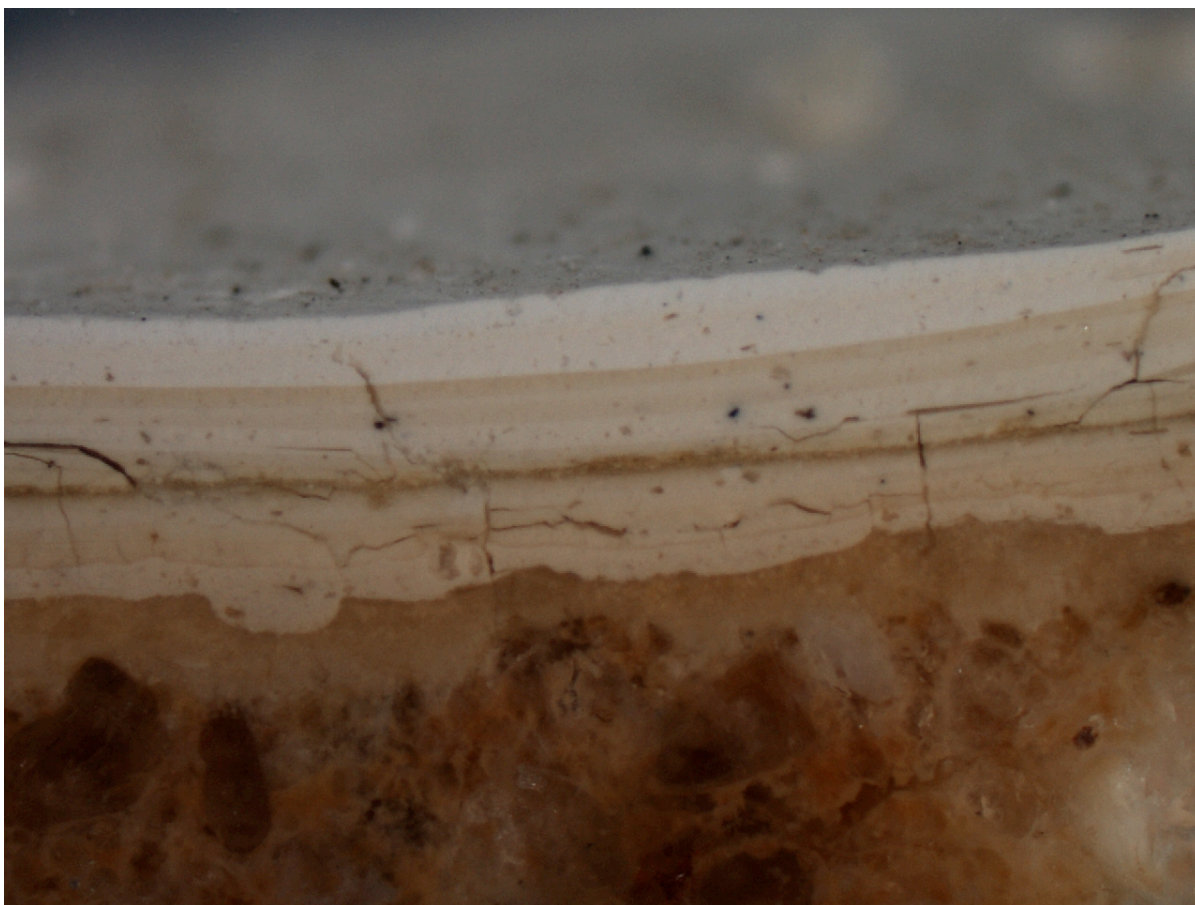
SAMPLE NO:	LOKE.F.9 (40x, Visible Light)
LOCATION:	Oil House, exterior, east wall, finishes on brick.

LAYER*	COLOR	NOTES
Substrate	Brick	Surface looks weathered
1	Cream	Translucent, limewash
2	Cream	Remaining layers look like paint
3	Cream	
4	Cream	Translucent material at surface
5	Cream	
6	Off-white	
7	Cream	
8	Cream	
9	Cream	
10	White	Translucent
11	Cream	
12	White	Current Finish

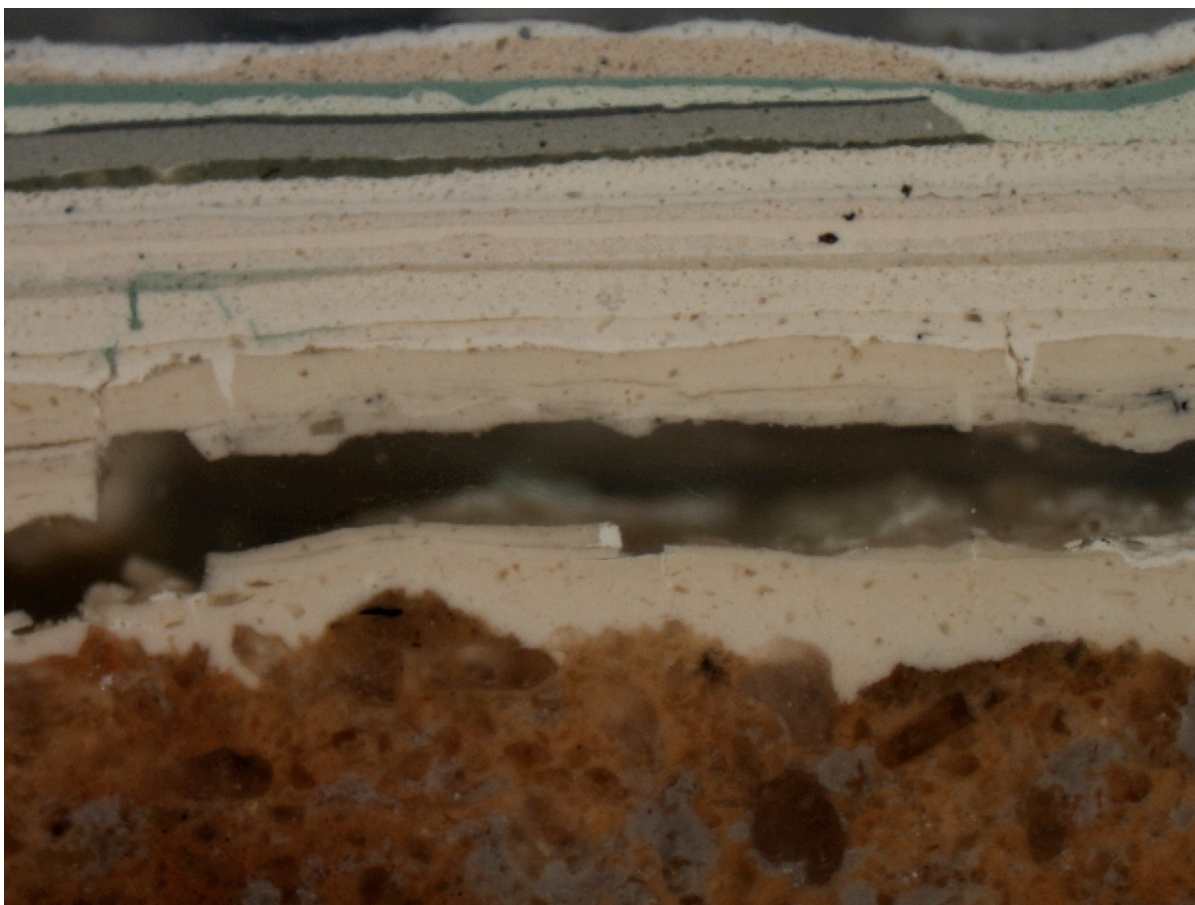
SAMPLE NO:	LOKE.F.11 (40x, Visible Light)
LOCATION:	Oil House, exterior, south elevation now enclosed, finishes on brick.

LAYER*	COLOR	NOTES
Substrate	Brick	Surface is weathered, suggests exposure
1	Cream/tan	Translucent, lime wash (partial layer)
2	Cream	
3	Cream	
4	Cream	
5	Light cream	
6	Cream	
7	Cream	
8	Cream	
9	Cream	
10	Cream	
11	Cream	
12	Cream	
13	White	
14	Off-white	
15	White	
16	Gray	
17	Light gray	
18	Light gray/off-white

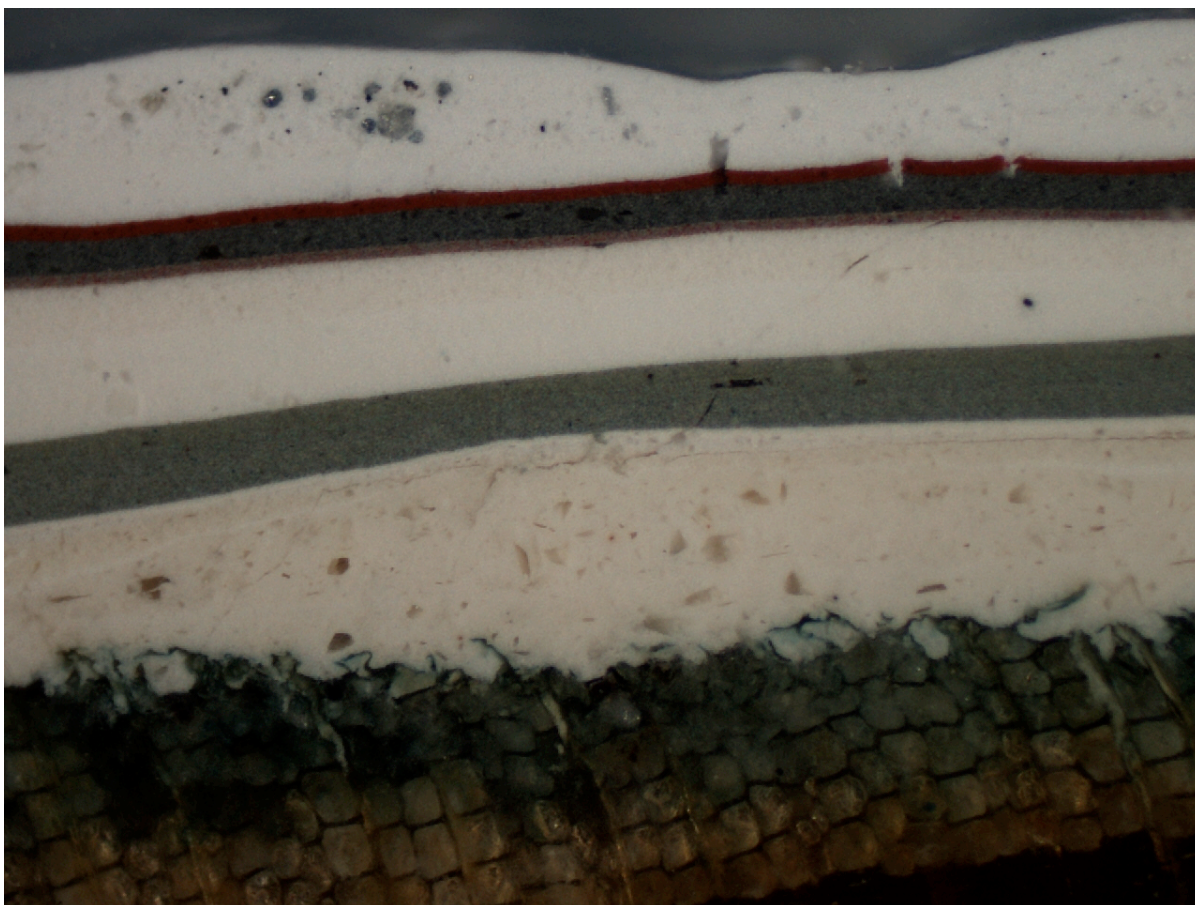
SAMPLE NO:	LOKE.F.15 (100x, Visible Light)
LOCATION:	Keeper's Dwelling, exterior, east elevation, front door surround, finishes on wood.

LAYER*	COLOR	NOTES
Substrate	Wood	Surface distressed, looks stripped, missing earliest finish?
1	Dark green	Soaked into pores of wood at surface
2	Cream	
3	White	Thin
4	Gray-green	
5	White	
6	Dark red	Thin
7	Dark gray	
8	Dark red	Disrupted, weathered
9	White	
10	White	Current finish
