Dry Tortugas Light Station

Lighthouse and Oil House

Historic Structure Report

2009

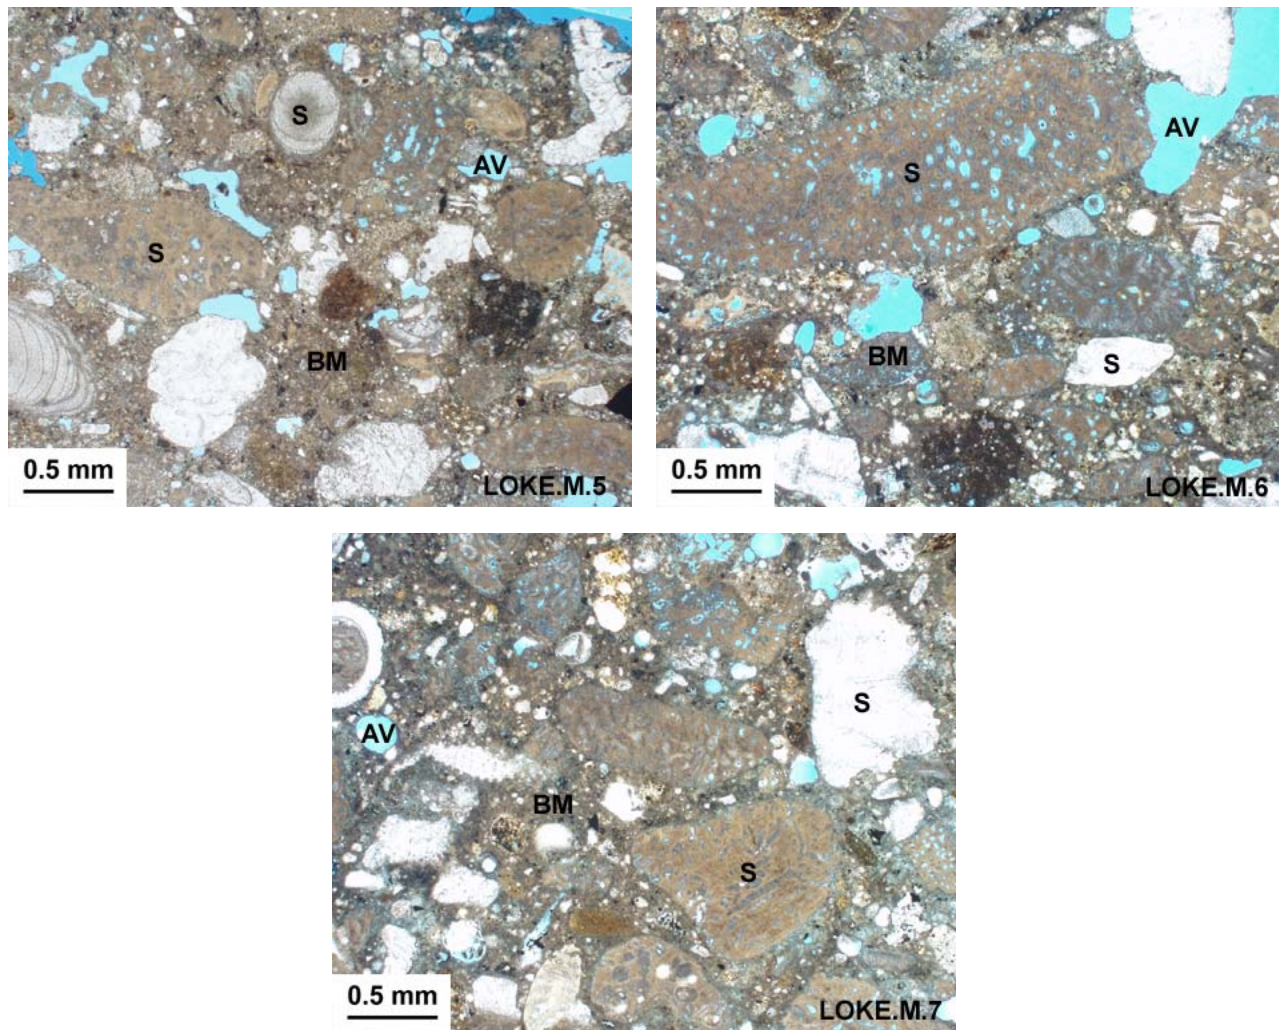
Generally speaking, all samples discussed in this section exhibit cement and sand components that are well mixed and distributed. Air contents tend to be low and the mortars are well consolidated. Hydration qualities of the cement are adequate with a homogeneous distribution of cementitious product. While some variation in original water to cement ratios are suggested by minor variations in capillary porosity (Figs. 8 through 11), all appear to have been mixed without an excess of water or significant retempering.

Figure 8: PPL photomicrographs illustrating the overall microstructure of the Lighthouse mortar samples. Sample LOKE.M.4 is not shown here and is presented in the next figure. The hydraulic binder matrix (BM) is well developed. Porosities tend to be moderate for the Lighthouse samples and this is demonstrated by the relatively low absorption of blue-dyed epoxy used in the sample preparation. The sand (S) is well coated with binder and is identified as a soft, natural carbonate sand composed of a variety of coral and shell fragments. Air-voids (AV) are not abundant.

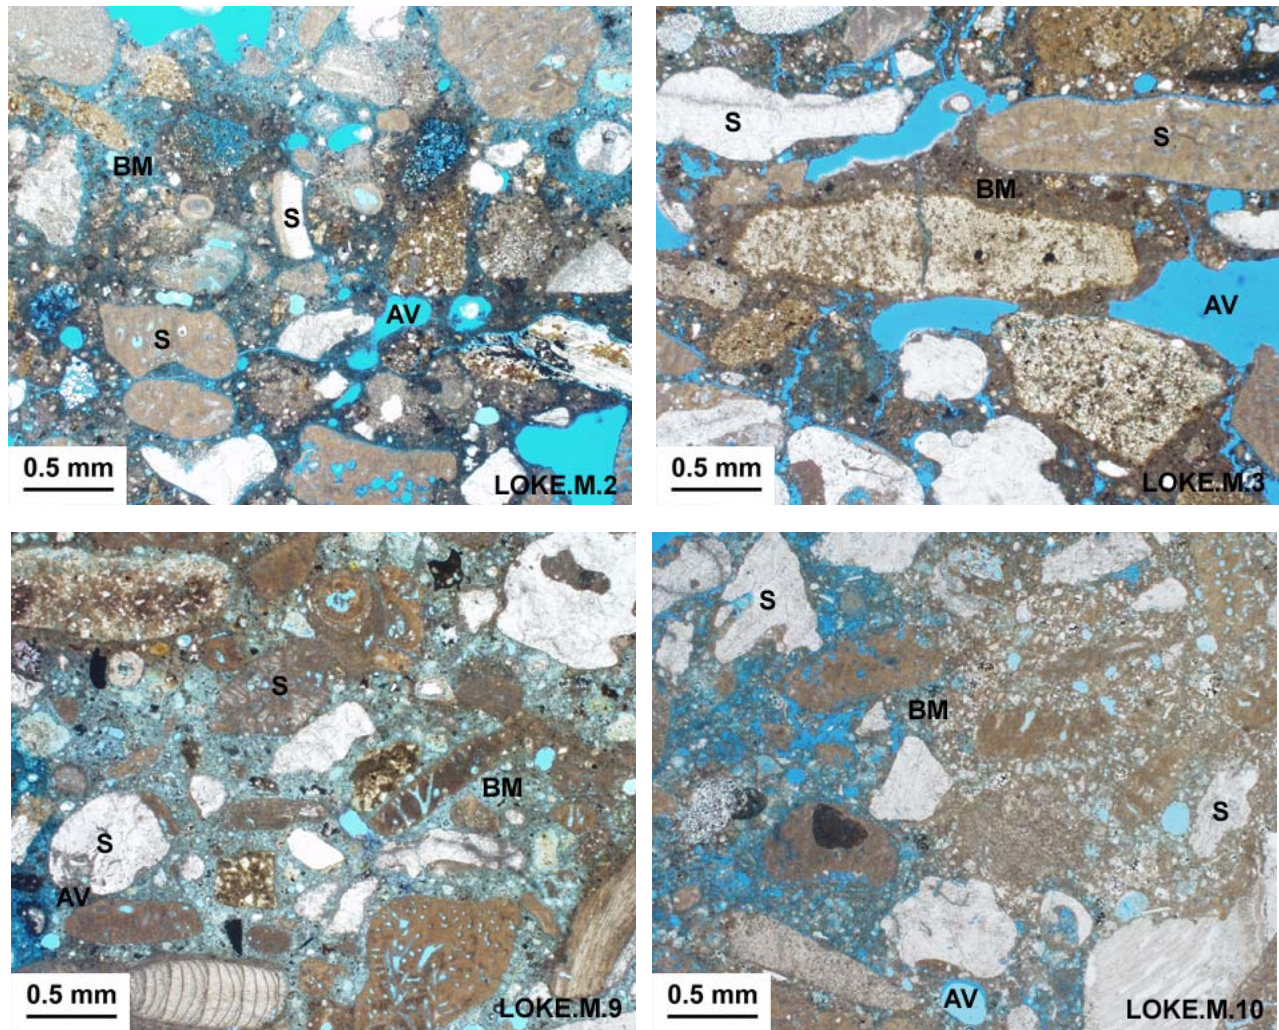
LOKE.M.10 exhibits cement and sand components that are well mixed and distributed. Air contents tend to be low and the mortar well consolidated. Hydration qualities of the cement are virtually complete with a homogeneous distribution of cementitious product. The original water to cement ratio is estimated to be moderate based on the observed capillary porosity and the mortar appears to have been mixed without an excess of water or significant retempering (Fig. 10).

Figure 10: PPL photomicrographs illustrating the overall microstructure of mortar samples from the cistern, Kitchen Building and Keeper's Dwelling. The hydraulic binder matrix (BM) is well developed. Porosities tend to be moderate to moderately high for these samples and this is demonstrated by the moderate absorption of blue-dyed epoxy used in the sample preparation. Sample LOKE.M.9 has a high porosity in some areas of the sample. The sand (S) is well coated with binder and is identified as a soft, natural carbonate sand composed of a variety of coral and shell fragments. Air-voids (AV) are not abundant.

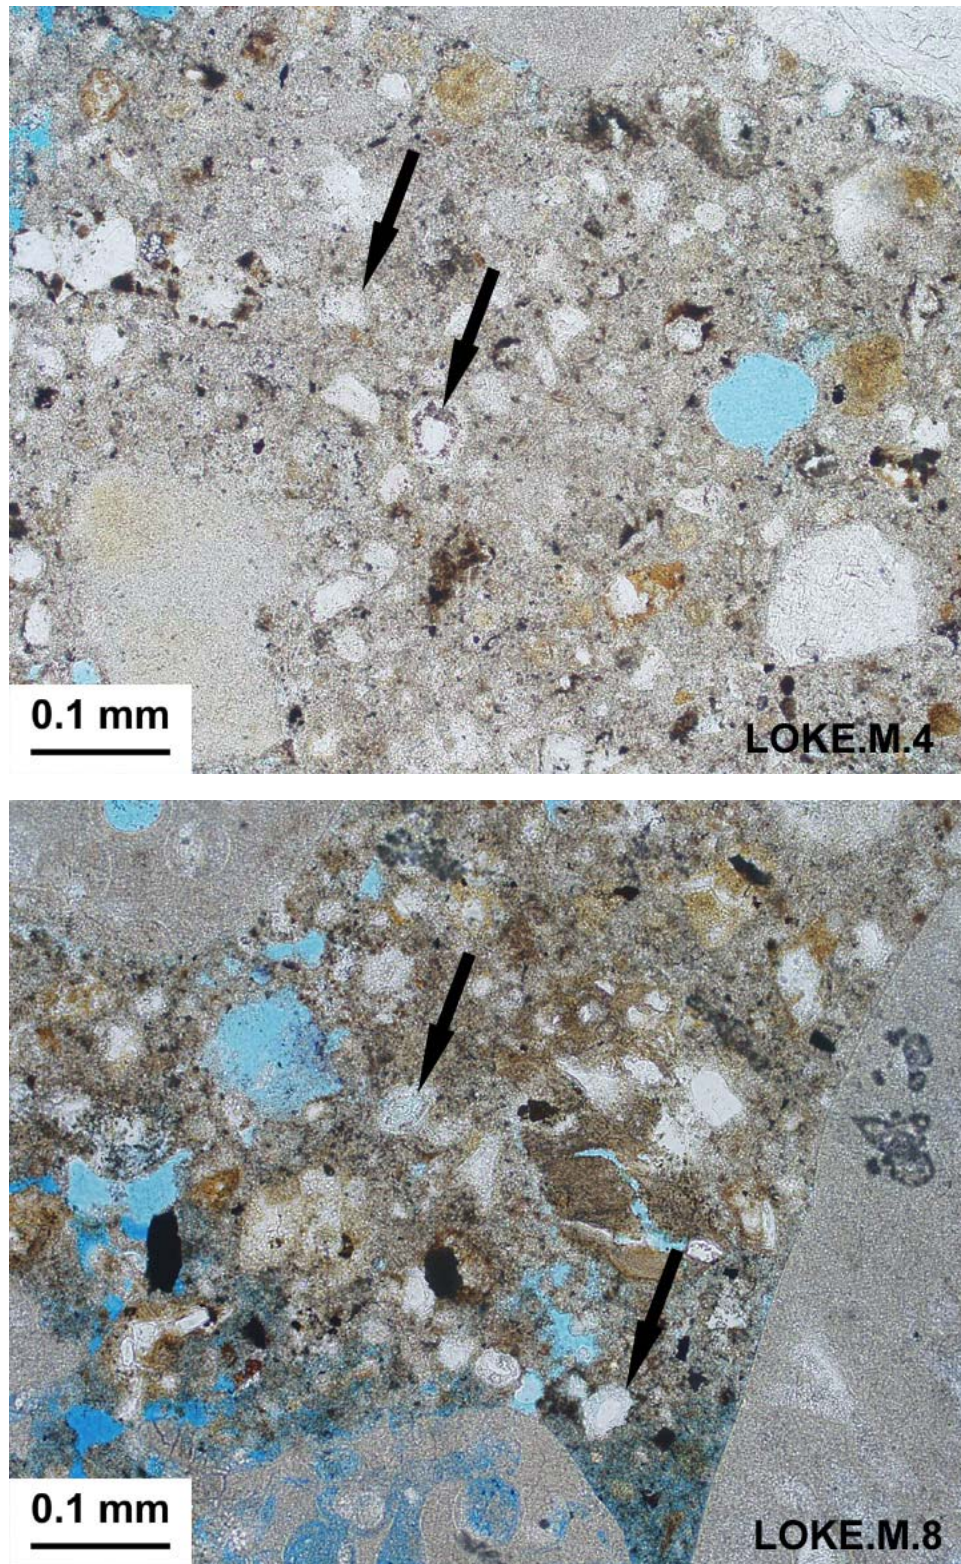
While difficult to ascertain different placement vintages based on cement characteristics, there are some subtle variations observed both petrographically and chemically that appear to group cements into similar batches or sources. Three of the four lighthouse samples (all but LOKE.M.5) exhibit a greater variation in the grind of the cement. All other samples exhibit a fine to medium grind but these three contain unhydrated cement relicts that are found as large as several hundred microns in dimension (Fig. 12). It is tempting to interpret this coarseness as representative of an earlier vintage but this would be purely speculative. The very slight difference in the sand gradation in LOKE.M.5 (discussed below) in addition to slightly different cement characteristics could suggest that this sample is not contemporaneous with the other lighthouse samples. It is also noted that some variation exists within the fragments of sample LOKE.M.4 (Fig. 9). Some portions of this sample exhibit cement characteristics more similar to those of the Oil House plaster brown coat (LOKE.M.8) rather than those of the other lighthouse samples. The distinctive texture here is a much greater abundance of very fine-grained, partially calcined quartz silt grains dispersed as isolated cement residuals throughout the paste (Fig. 13). The acid-insoluble residues measured chemically for both samples is also the highest in these two samples and this is consistent with the petrographic observation. The cement in these two samples is clearly of a different quality than the others and this has implications in the estimation of sand to binder ratios as discussed below. What is not clear based on examination of the fragments is the reason that LOKE.M.4 appears to contain two different types of cement within one sample.

Figure 13: PPL photomicrographs illustrating distinctive cement microtextures in portions of LOKE.M.4 and all of the brown coat in LOKE.M.8. The arrows exhibit isolated fine silt grains dispersed throughout the paste matrix. These are not a component of the sand as closer inspection reveals fine calcination rims around these grains. Such calcined quartz silt is a common component of natural cements and in fact, these are found in all the natural cement mortars examined for this report. However, the abundance is distinctively high in these two samples suggesting a different cement batch or source.

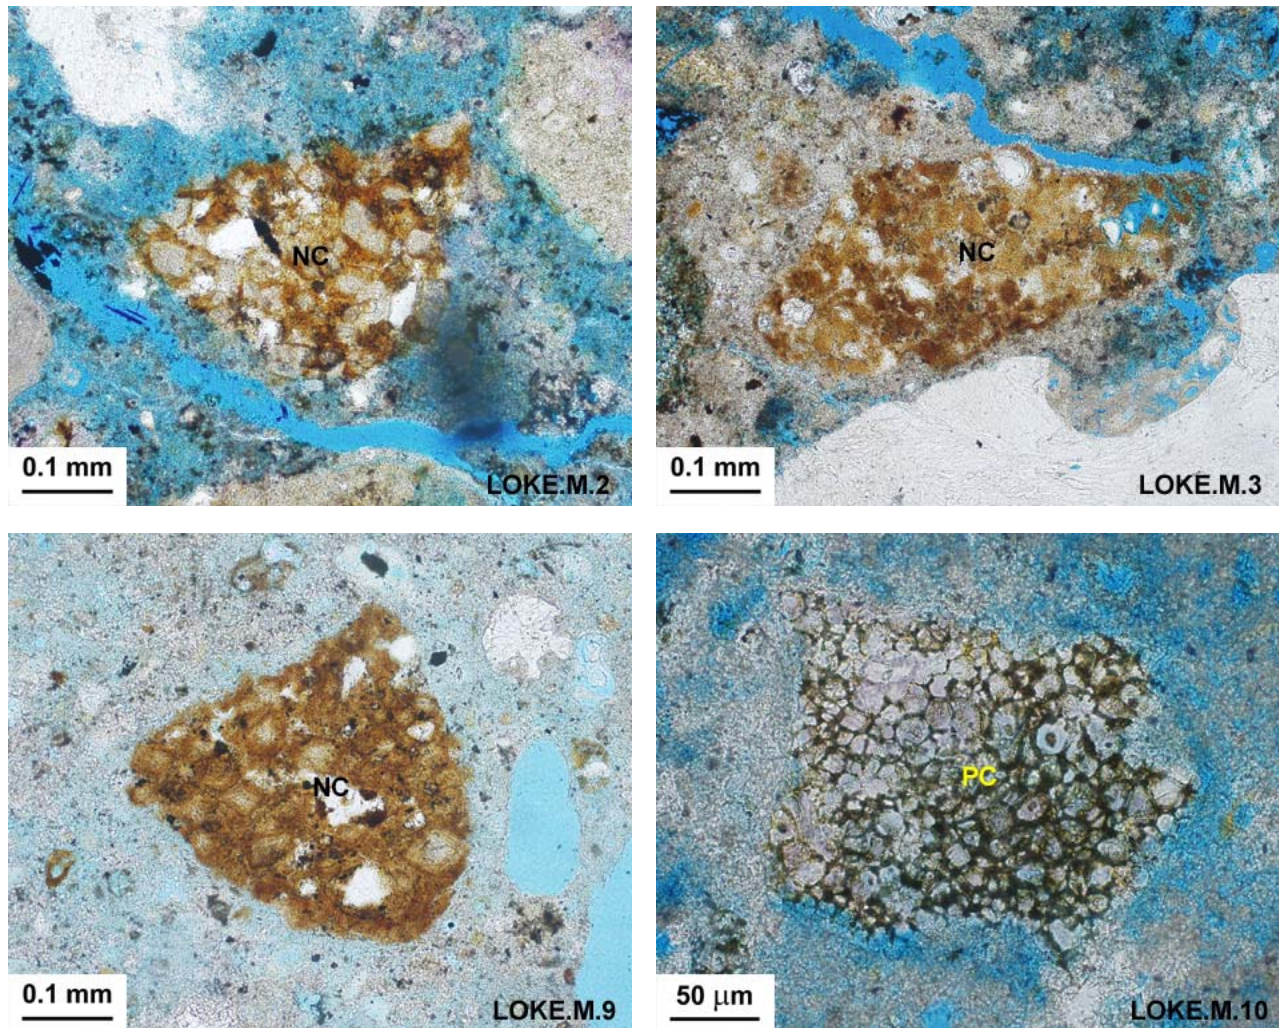
The exterior mortar of the Keeper's dwelling (LOKE.M.10) appears identical to the other mortars based on visual characteristics and is also identified as a pure cement mortar (Figs. 6 and 10). However, the binder is identified as a pure portland cement with no lime additions identified. The distinctive low-magnesium, low insoluble residue values measured chemically are consistent with this qualitative identification. Cement relicts are identified petrographically as medium-sized agglomerates of well-hydrated calcium silicates with interstitial ferrite (Fig. 14). The iron-bearing ferrite identifies the binder as an ordinary gray portland cement. The medium grind and homogeneity of calcium silicate size is consistent with cements produced in the early twentieth century and is considered consistent with the early 1920's vintage reported by the client.

Figure 14: PPL photomicrographs illustrating binder residuals in mortar samples from the cistern, Kitchen Building and Keeper's Dwelling. All but those in LOKE.M.10 (Keeper's Dwelling) are identified as natural cement relicts (NC). Typical textures within these grains include calcined dolomite rhombs surrounded by an iron-rich hydraulic product and partially burned quartz silt grains evenly dispersed throughout the particles. These textures are characteristic of magnesium-rich American cements of the nineteenth century. Residual cement tends to fine- to medium-grained. The residual binder in LOKE.M.10 is identified as an ordinary gray portland cement (PC). The grain shown here contains rounded "ghosts" of fully hydrated calcium silicate with interstitial iron-bearing cement phases. The grind and consistency of the cement is characteristic of early twentieth century portlands.

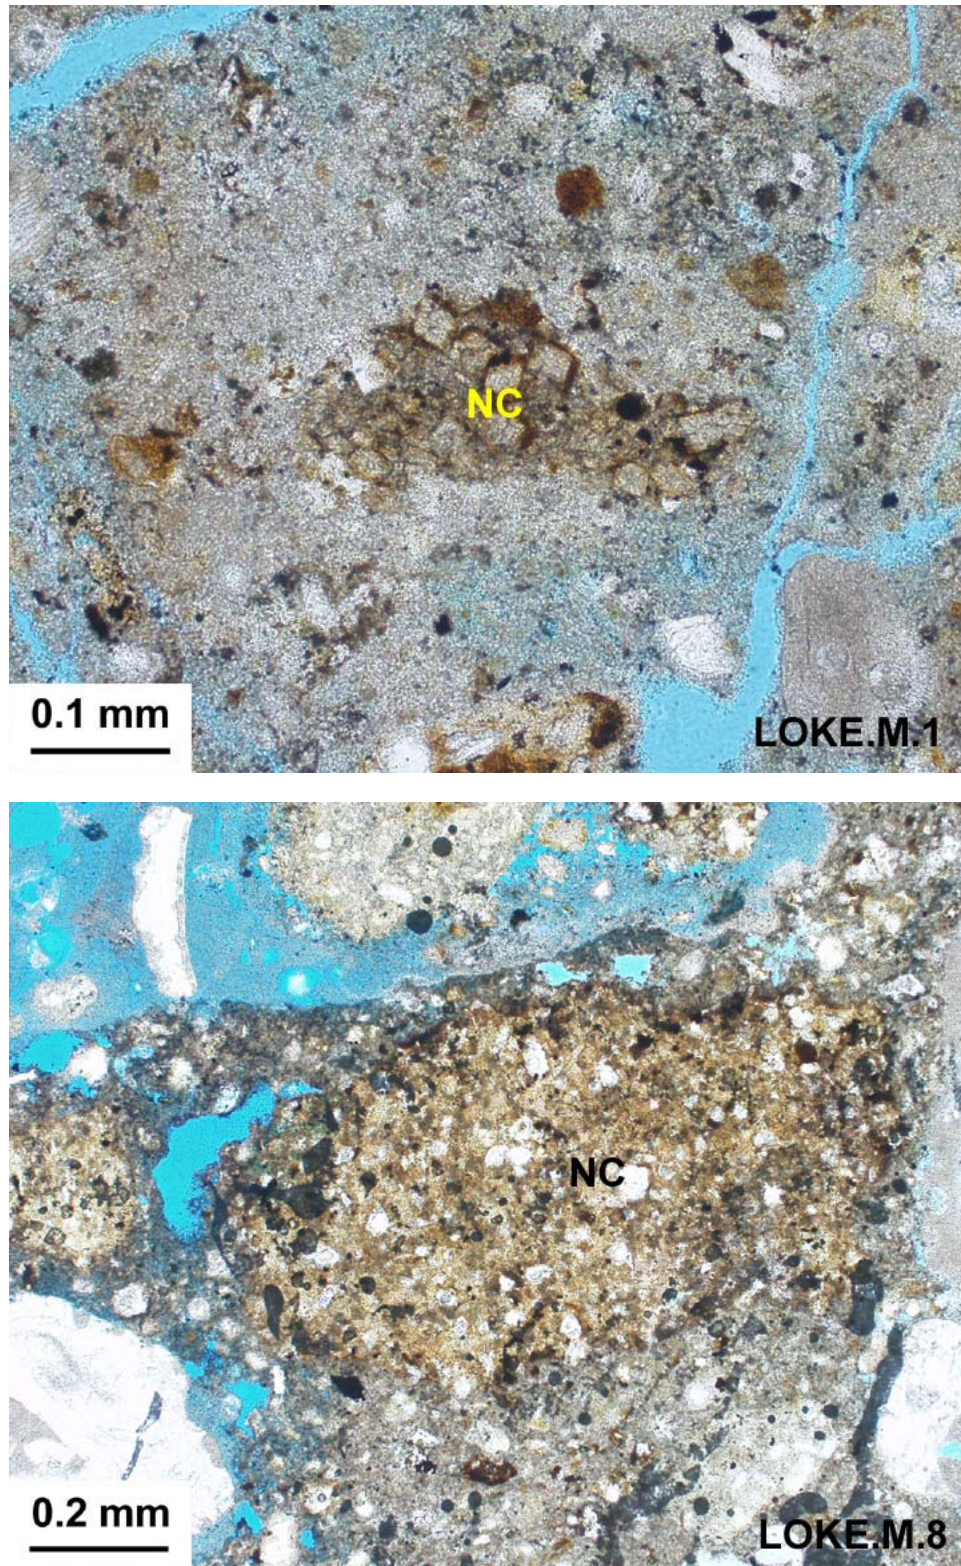
Figure 15: PPL photomicrographs illustrating binder residuals in some of the Oil House samples. The brown coat is shown for LOKE.M.8 as this material is more or less identical to that of the masonry mortar samples. All are identified as natural cement relicts (NC). Typical textures within these grains include calcined dolomite rhombs surrounded by an iron-rich hydraulic product and partially burned quartz silt grains evenly dispersed throughout the particles. These textures are characteristic of magnesium-rich American cements of the nineteenth century. Residual cement tends to fine- to medium-grained.

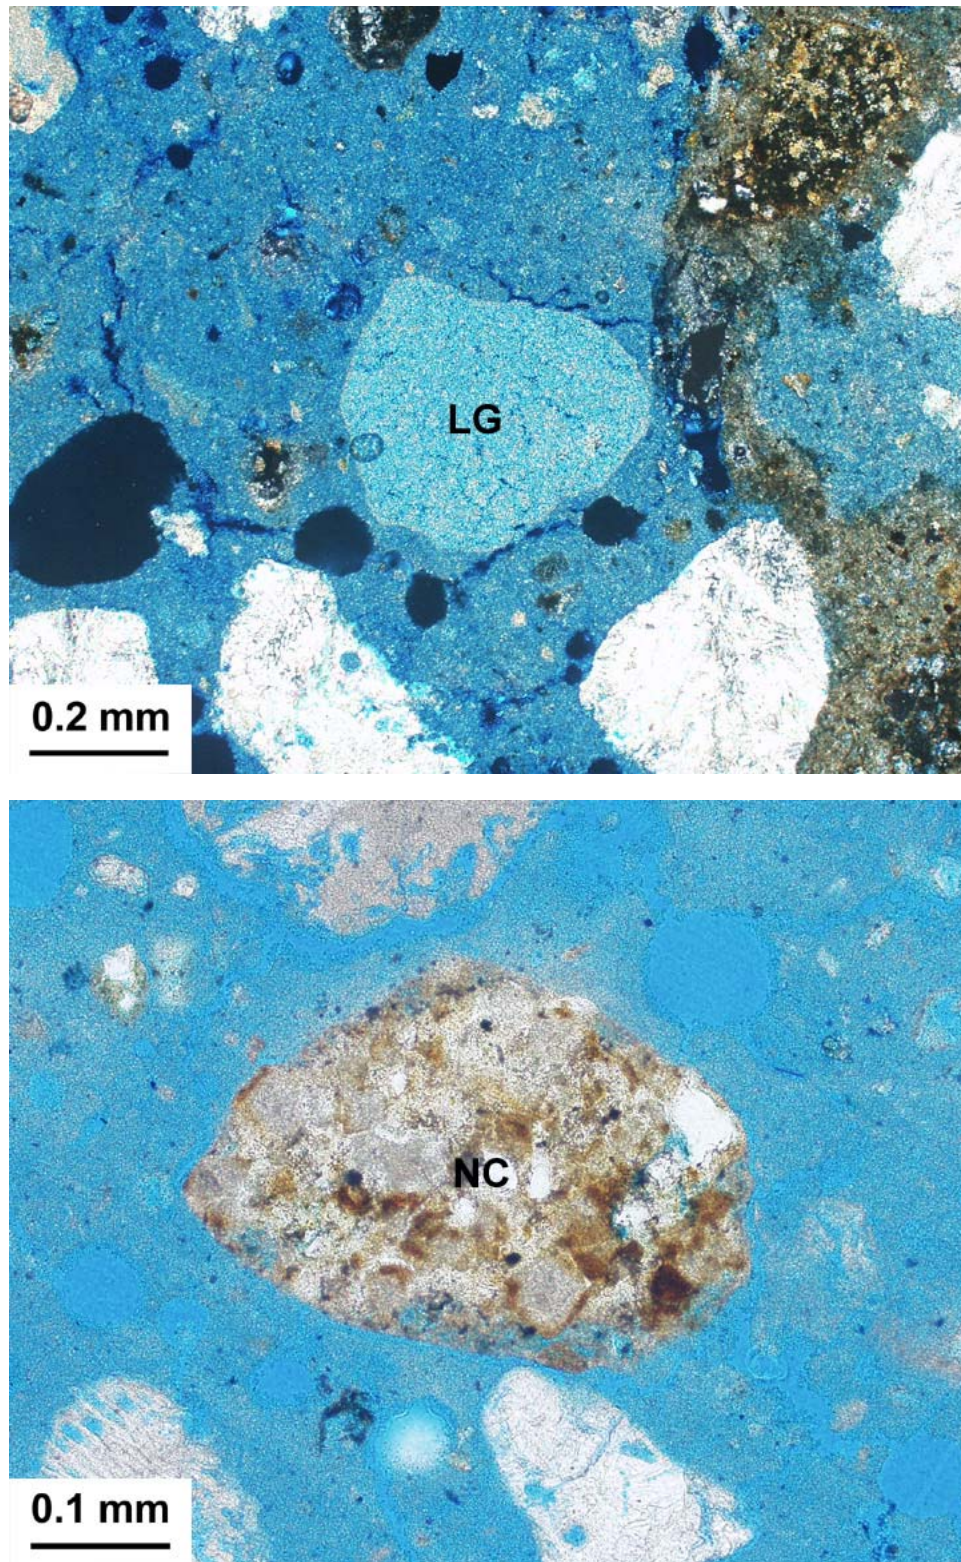
Figure 17: Photomicrographs illustrating binder residuals in the scratch coat in sample LOKE.M.8. (Top) XPL image. A lime grain (LG) is shown. The internal texture of the lime is homogeneous and little evidence is provided that might suggest the provenance of the lime. (Bottom) PPL image. A natural cement relict is shown (NC). These have the same characteristics as other cements in the sample suite. The cement is present in low abundance and is estimated to represent a minor gauging of an otherwise non-hydraulic lime plaster.

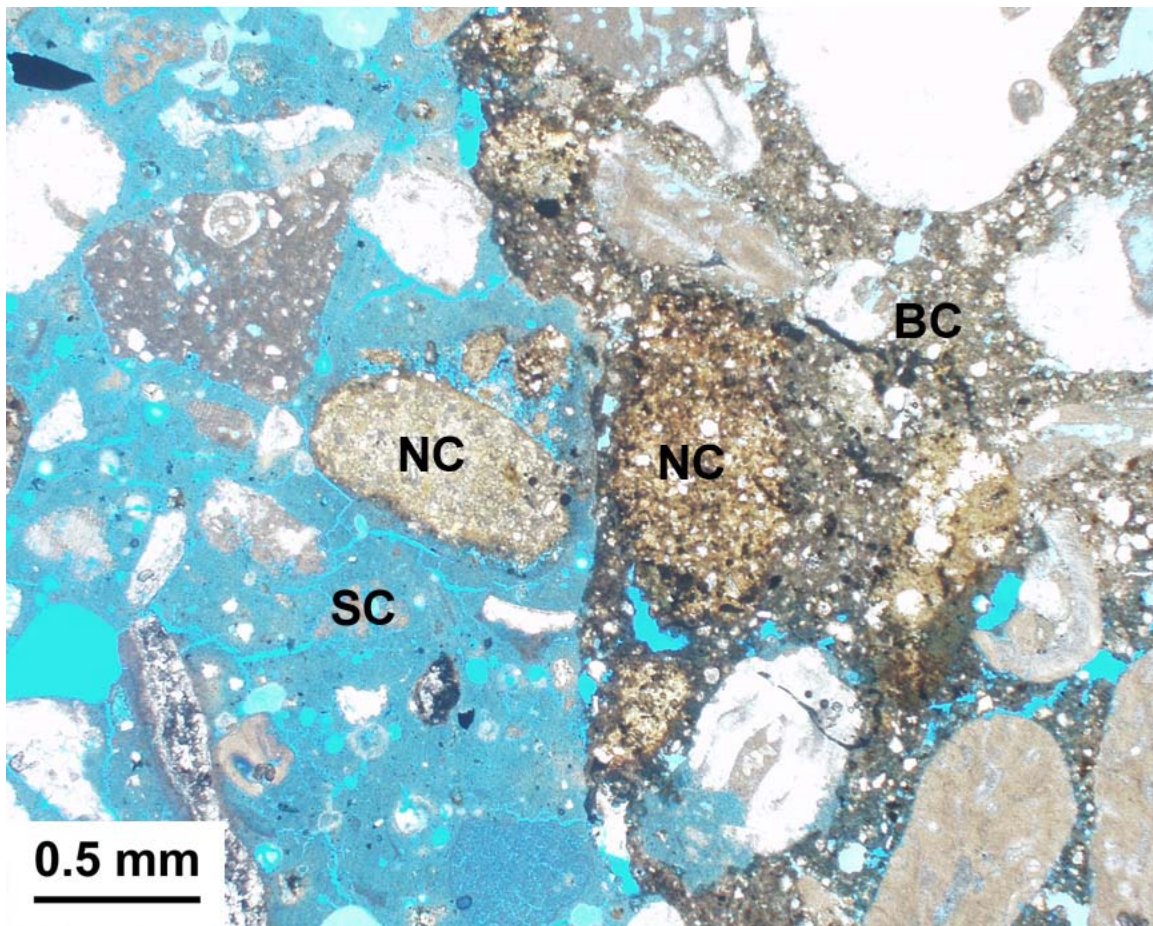
Figure 18: PPL photomicrograph illustrating the contact between the scratch coat (SC) and brown coat (BC) in LOKE.M.8. While natural cement (NC) is present in both, the difference in binder texture between a lime plaster gauged with cement (left) and a pure cement plaster (right) is quite apparent and difficult to mistake. Other details of the brown coat are presented above and are not repeated here.

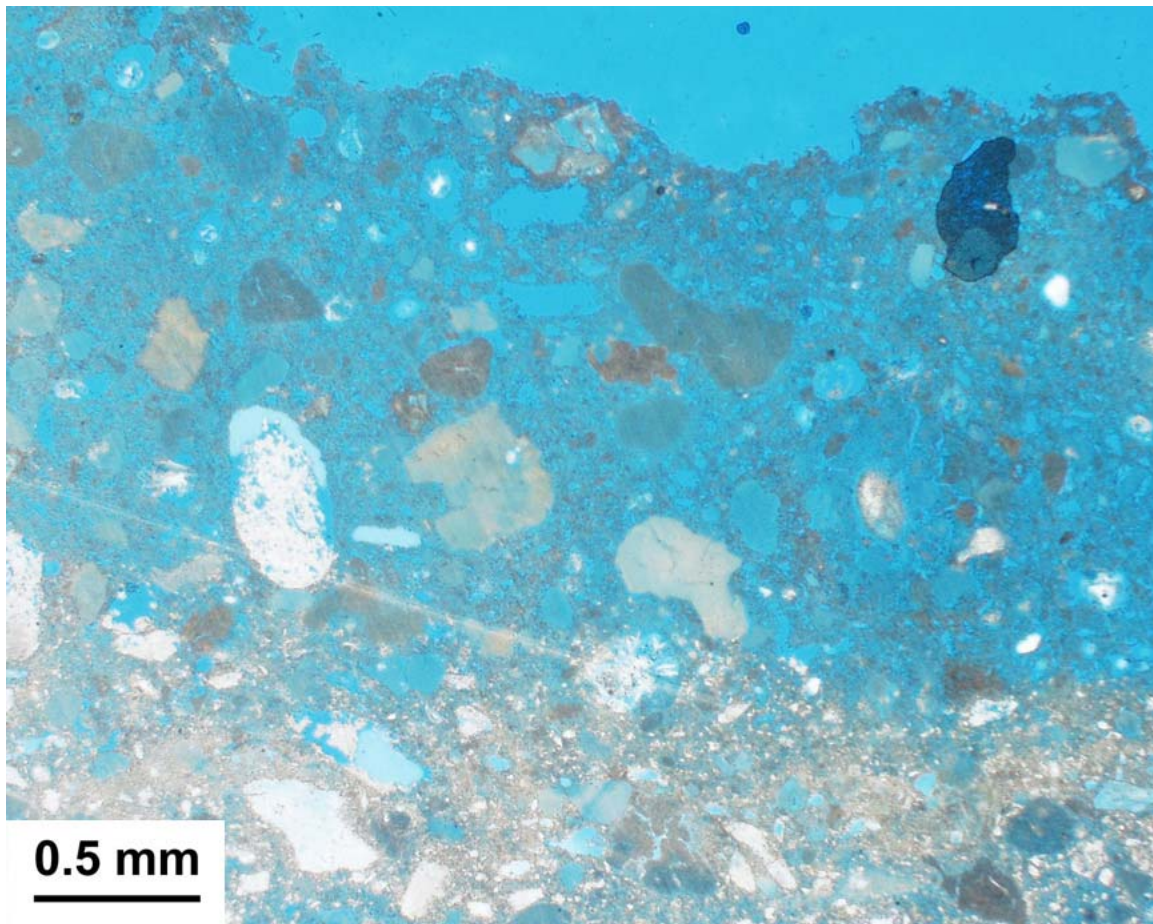
The finish coat matrix is fine-textured and porous (Fig. 19). An abundance of fine residual lime grains indicates the layer is mostly lime based. Chemical analysis was performed on this layer. Even assuming that all magnesium is contained in the lime, a CaO/MgO weight ratio of 10 (an order of magnitude higher than an ideal dolomitic ratio of 1.4) suggests a high calcium rather than dolomitic lime. Traces of calcined silicate contaminants suggest a rock lime source but not enough material is observed petrographically to offer a definitive statement. Gypsum plaster is identified as a gauging material (Fig. 20). Very few unhydrated gypsum relicts are identified. The rare abundance of coarser hemihydrate or finer dead-burned anhydrite suggests that the plaster was not a cement plaster or Keene's cement but rather a fine finishing plaster such as Plaster-of-Paris.

Figure 19: PPL photomicrograph illustrating the overall microstructure of the finish coat in sample LOKE.M.8. The binder matrix (BM) has a high capillary porosity as indicated by the high absorption of blue-dyed epoxy used in the sample preparation. The layer is unsanded and all grains observed here are part of the binder.

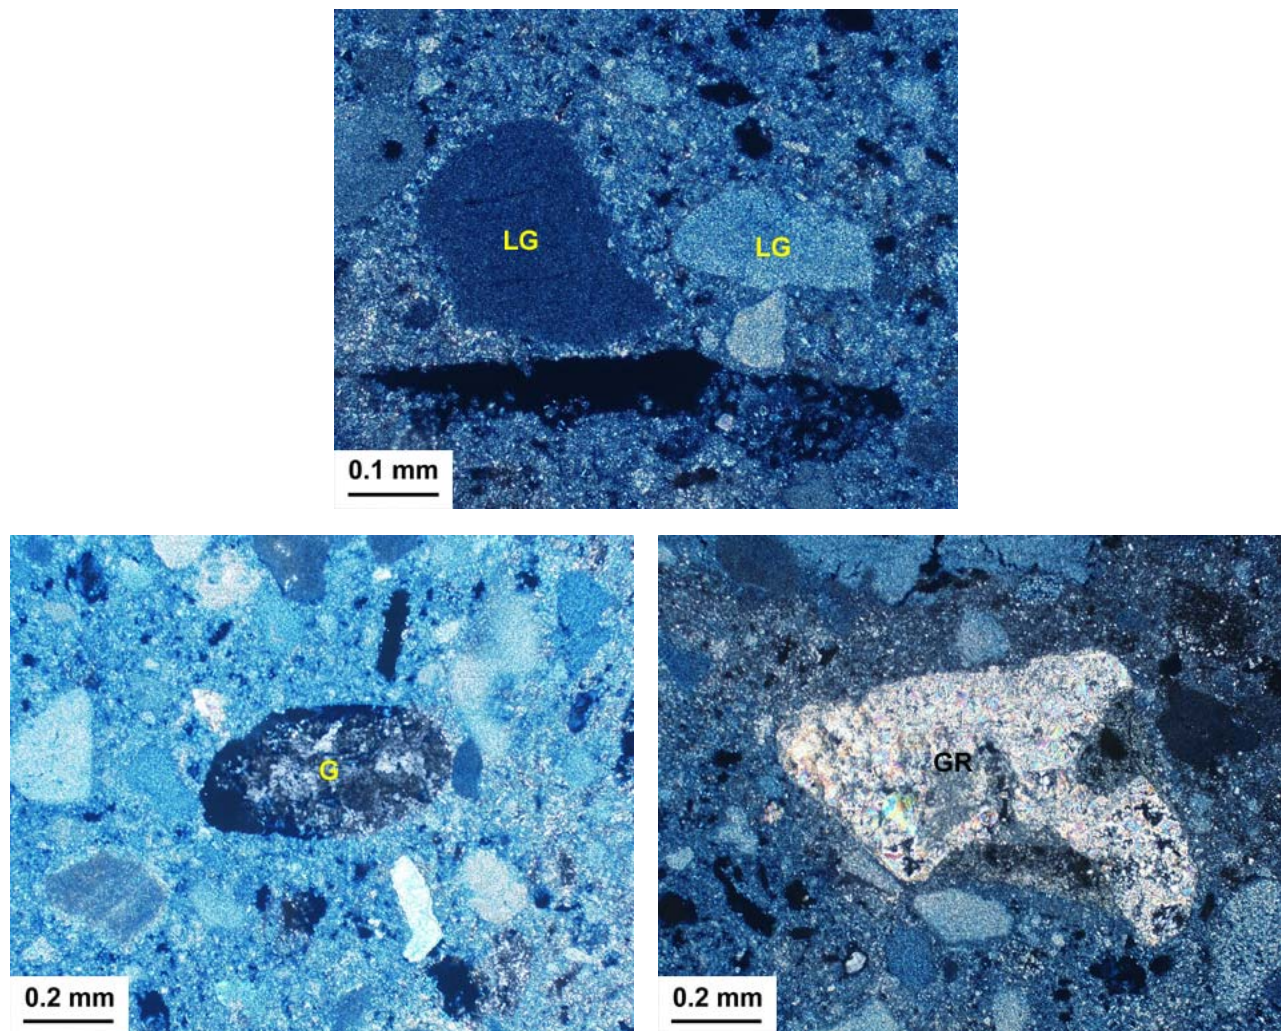
Figure 20: Photomicrographs illustrating binder residuals in the finish coat in sample LOKE.M.8. (Top) XPL image. Lime grains (LG) are found in high abundance. Chemical analysis indicates that the finish is principally a lime plaster with a moderate gypsum gauging. The darker appearance of the grain at left indicates that it has not carbonated. The brighter grain at right is carbonated as are most observed residuals. (Bottom left) A gypsum residual (G) represents a grain of originally unhydrated hemihydrate that has hydrated to coarser grained gypsum. (Bottom right) This gypsum residual (GR) contains residual unhydrated hemihydrate. Both types of residual are relatively rare in this fine-textured plaster coat.

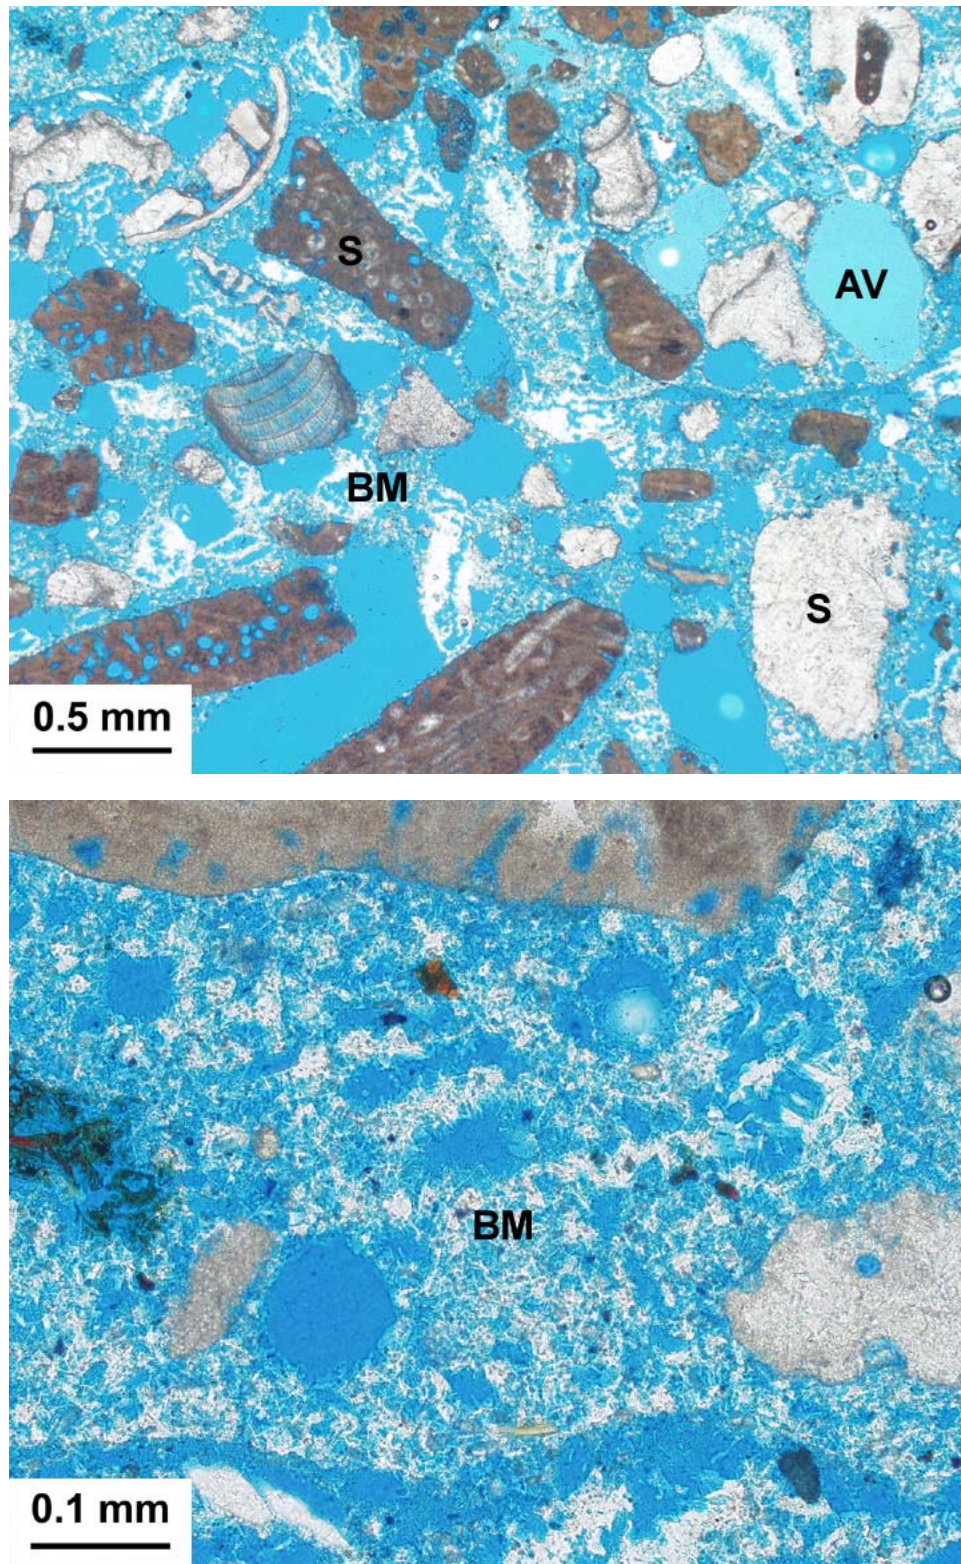
The brown coat contains a relatively coarse-textured and porous binder matrix composed of a network of fine-grained gypsum hydrate (Fig. 21). Coarser hydrated residuals are relatively common and unhydrated hemihydrate and fine-grained, dead-burned anhydrite are also present though in lower abundance (Fig. 22). A chemical analysis was not requested for this sample and further information regarding the plaster provenance cannot be provided. However, the microtexture of the coat clearly discounts a refined finishing plaster and the presence of the dead-burned gypsum (anhydrite) suggests that the plaster may have been a Keene's cement. It should be noted that the term "cement" here does not refer to hydraulic calcium silicates and Keene's cement represents a relatively pure calcium sulfate product.

Figure 21: PPL photomicrographs illustrating the overall microstructure of the brown coat in sample LOKE.M.11. (Top) The binder matrix (BM) has a high capillary porosity as indicated by the high absorption of blue-dyed epoxy used in the sample preparation. The sand (S) is the same soft, natural carbonate sand found in the mortar samples. Air-voids (AV) are moderately abundant. (Bottom) The matrix is defined by a network of fine hydrated gypsum crystals. Still, the texture is somewhat coarse when compared to the finish coat (Fig. 23 below) and the plaster in this coat may have been a Keene's cement.

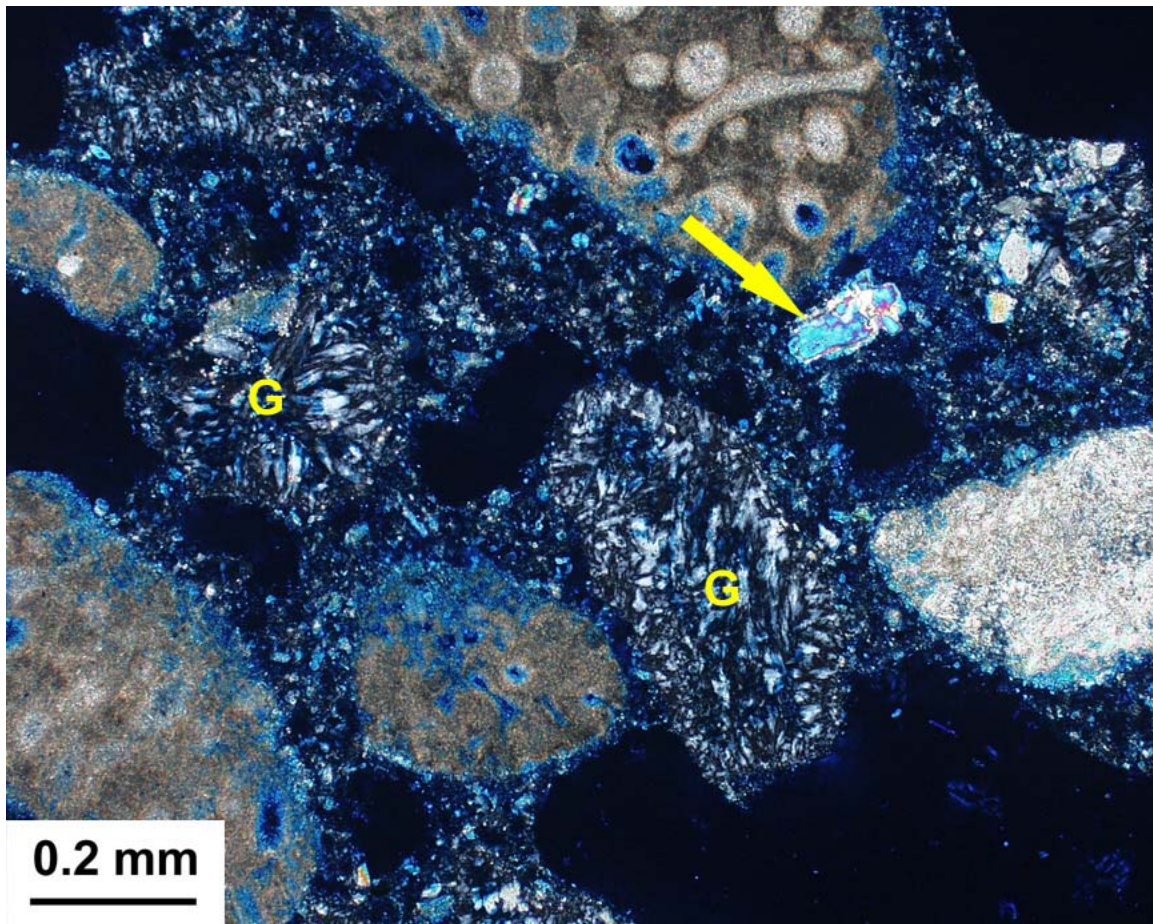
Figure 22: XPL photomicrographs illustrating binder residuals in the brown coat of sample LOKE.M.11. Gypsum residuals (G) represent grains of originally unhydrated hemihydrate that has hydrated to coarser grained gypsum. The arrow indicates a fine crystal of dead-burned anhydrite. This type of inclusion is typical of Keene's cement and would not be abundant in a Plaster-of-Paris.

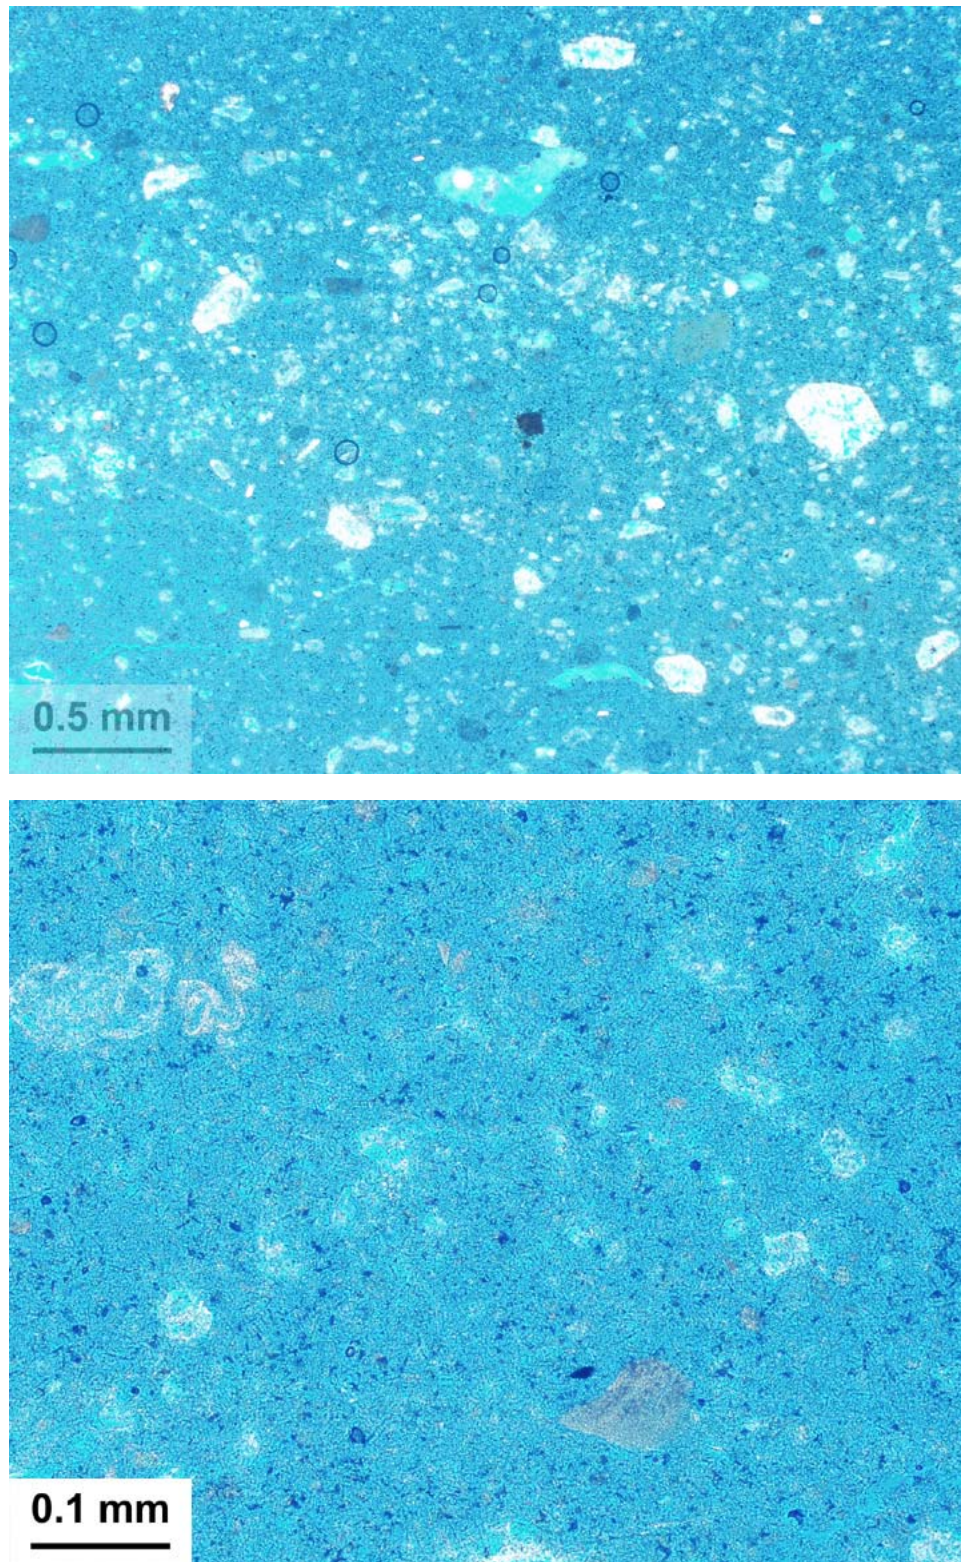
The finish coat matrix is fine-textured and moderately porous. The paste matrix is dominated by a network of very-fine grained hydrated gypsum crystallites (Fig. 23). Very few unhydrated gypsum relicts are identified. The rare abundance of coarser hemihydrate or finer dead-burned anhydrite suggests that the plaster was not a cement plaster or Keene's cement but rather a fine finishing plaster such as Plaster-of-Paris (Fig. 24). A very low abundance of carbonated lime grains are dispersed throughout the largely gypsum-based matrix. While a chemical analysis was not performed for this sample, the lime is interpreted to represent a minor gauging rather than a major component of the finish plaster.

Figure 23: PPL photomicrographs illustrating the overall microstructure of the finish coat in sample LOKE.M.11. (Top) The binder matrix (BM) has a high capillary porosity as indicated by the high absorption of blue-dyed epoxy used in the sample preparation. The layer is unsanded and all grains observed here are part of the binder. (Bottom) The matrix is defined by a network of fine hydrated gypsum crystals. Even in this higher magnification image, the texture is difficult to see and the finish coat plaster is much finer textured.

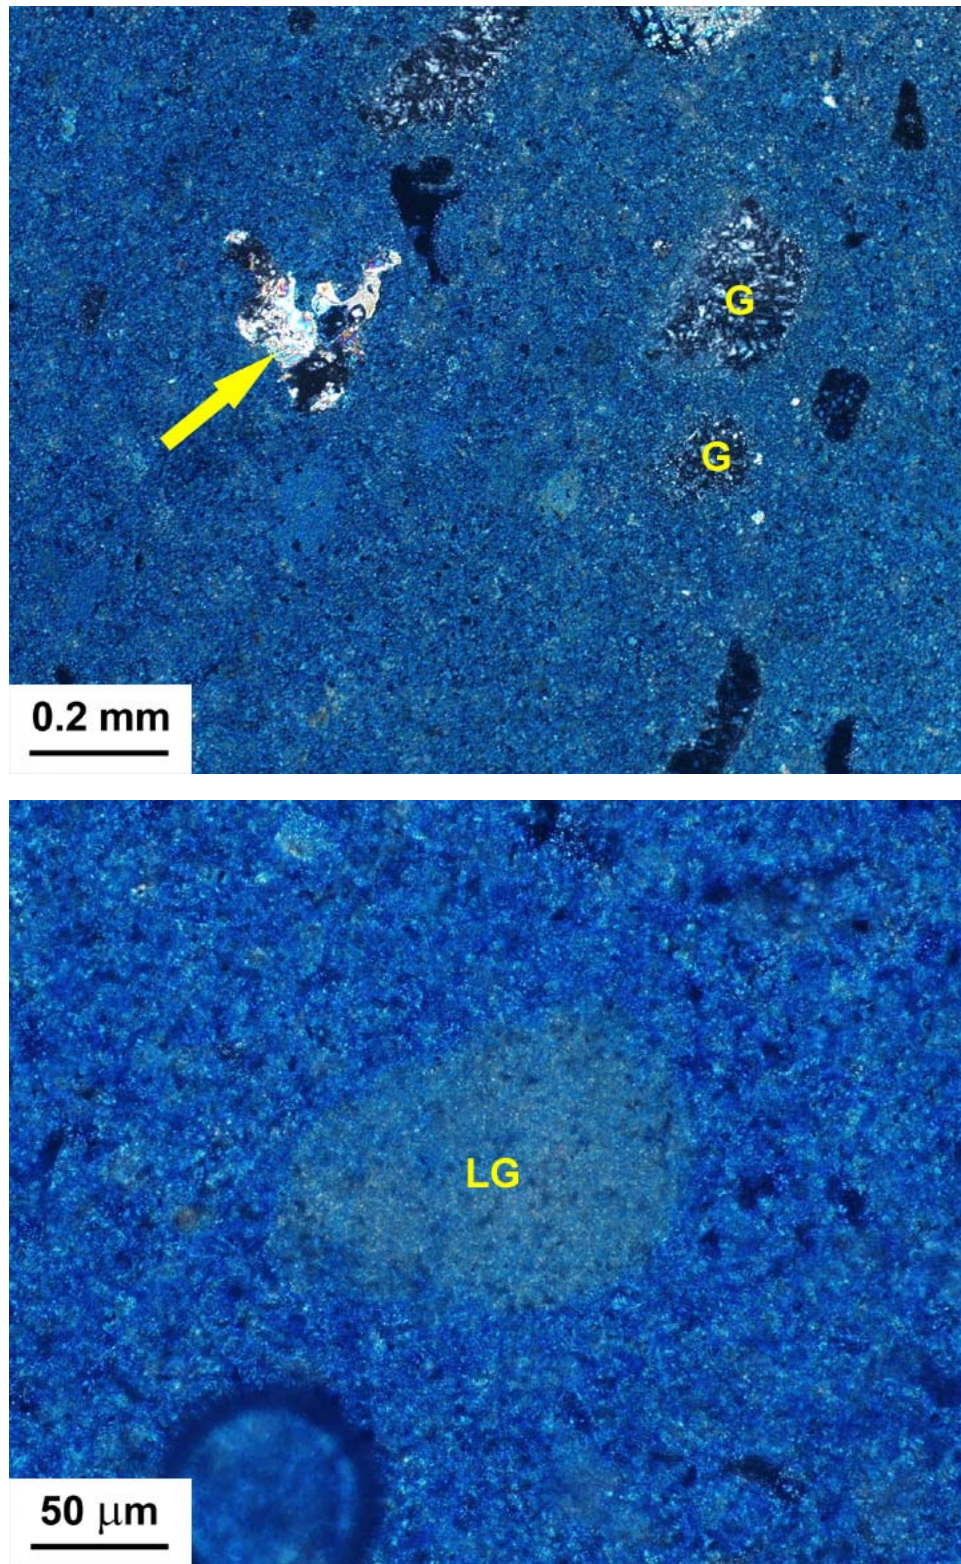
Figure 24: Photomicrographs illustrating binder residuals in the finish coat in sample LOKE.M.11. (Top) XPL image. Gypsum residuals (G) represent grains of originally unhydrated hemihydrate that have hydrated to coarser grained gypsum. The arrow indicates an unhydrated hemihydrate residual. Both types of residual are relatively rare in this fine-textured plaster coat. (Bottom) A carbonated lime grain is shown (LG). While chemical analysis was not performed on this sample, the lime is interpreted to represent a very minor gauging based on its observed abundance.

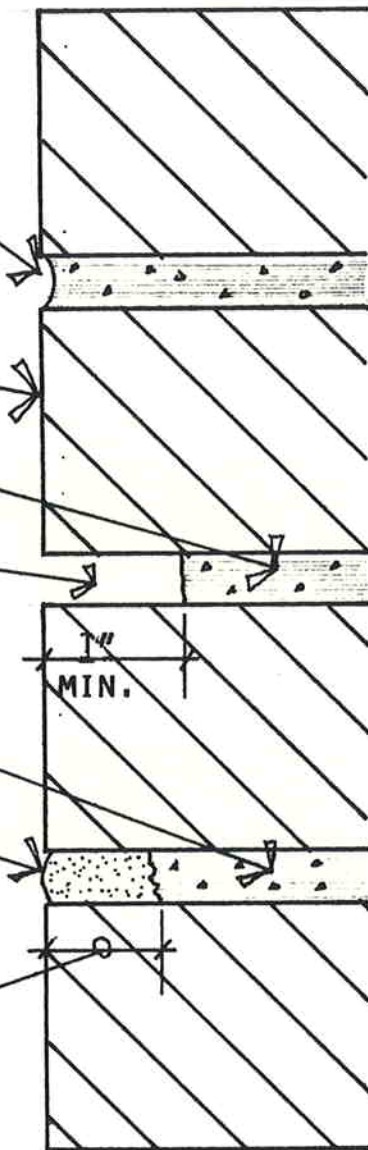
1.) RANDOM BREAKDOWN OF MORTAR JOINTS IS OCCURRING AT THE WALL'S SURFACE ON BOTH THE INTERIOR AND EXTERIOR OF THE TOWER. APPROXIMATELY 20% OF THE TOWERS GROSS SURFACE AREA DEMONSTRATES THIS CONDITION. THE MORTAR JOINT DEPTH OF DETERIORATION VARIES FROM 1/8" DEEP TO 3/4" DEEP (SEE ILLUSTRATIONS I-3 & I-7). THE BREAKDOWN OF MORTAR STOPS AT 3/4" AND THE CONSISTENCY OF THE MORTAR FROM THAT DEPTH ON BECOMES STABLE. THEREFORE, UPON INSPECTION AND ANALYSIS OF THE MASONRY TOWER AND MORTAR SAMPLES, IT CAN BE CONCLUDED THAT THE BREAKDOWN IS CONFINED TO THE AREA AT THE FACE OF THE WALL ON BOTH INTERIOR AND EXTERIOR SURFACES.

EXISTING MORTAR
BREAKDOWN

BREAKDOWN VARIES
 $\frac{1}{8}$ " TO $\frac{3}{4}$ " IN DEPTH

1.) THE MORTAR JOINTS DEMONSTRATING FAILURE SHOULD BE REPOINTED. THE REMOVAL OF DETERIORATED MORTAR SHOULD BE CARRIED OUT BY TRAINED CRAFTSMEN FAMILIAR WITH REPOINTING TECHNIQUES FOR

REPOINTED JOINT

PREPARED JOINT
