SPERMACETI COVE LIFE-SAVING STATION

Fort Hancock, New Jersey
Sandy Hook Unit, Gateway National Recreation Area

HISTORIC STRUCTURE REPORT

**James J. Lee III
Architectural Conservator**

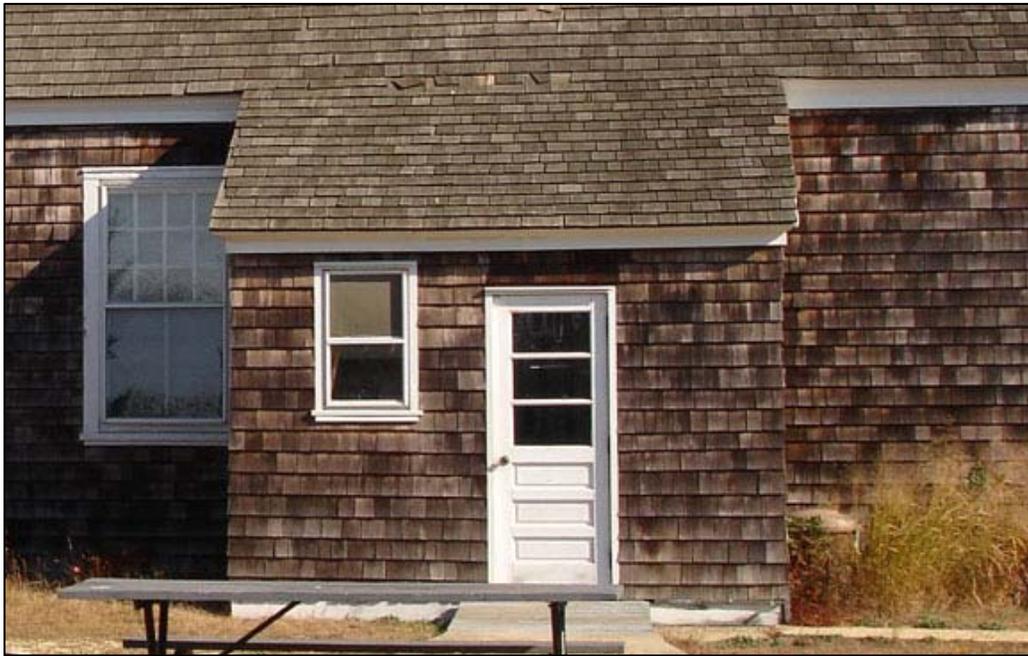
Figure 35. Spermaceti Cove Life-Saving Station, depicting west elevation exterior of enclosed back porch.

The back porch was an original feature of the Spermaceti Cove Life-Saving Station and sheltered the west elevation doorway (D103) to the building. It was originally an open porch that was enclosed when the building was occupied by the State Park (figs. 35 & 42). Presently the porch is enclosed and appears as a lean-to addition to the west elevation of the Main Block. In enclosing the porch certain original elements of the porch and some of the early

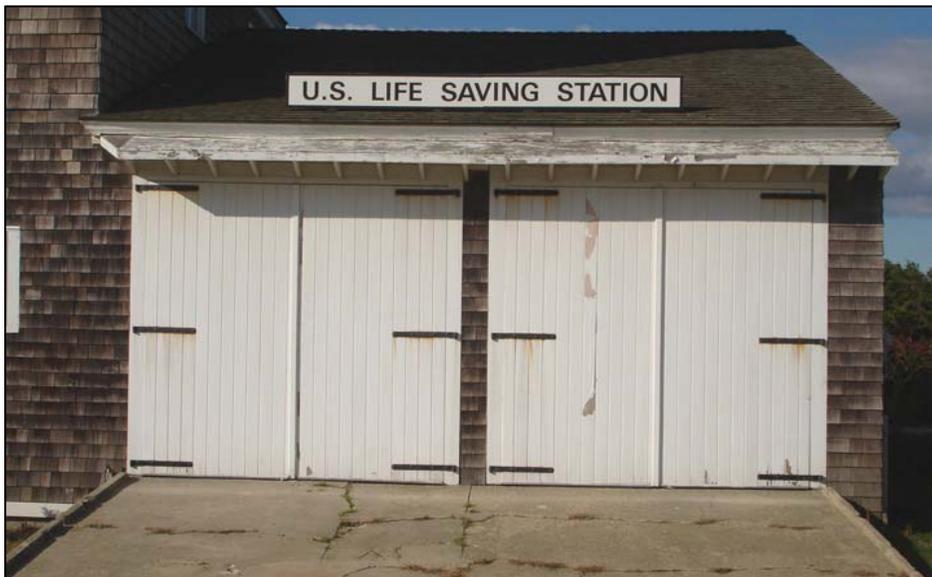
Figure 46. Spermaceti Cove Life-Saving Station, east elevation Boat Room doorways (D105 and D106).

The east elevation of the Boat Room is dominated by two wide doorways (D105 & D106) that served as access for the surf boats and boat carriages (fig. 46). Both of the doorways are 9 feet 9 inches wide and 9 feet 7 inches high. The doorways have plain board surrounds and wide lintel trim. A shed roof extends over both doorways and is an alteration from the original appearance (see the subsequent section “Roofs, Boat Room”).

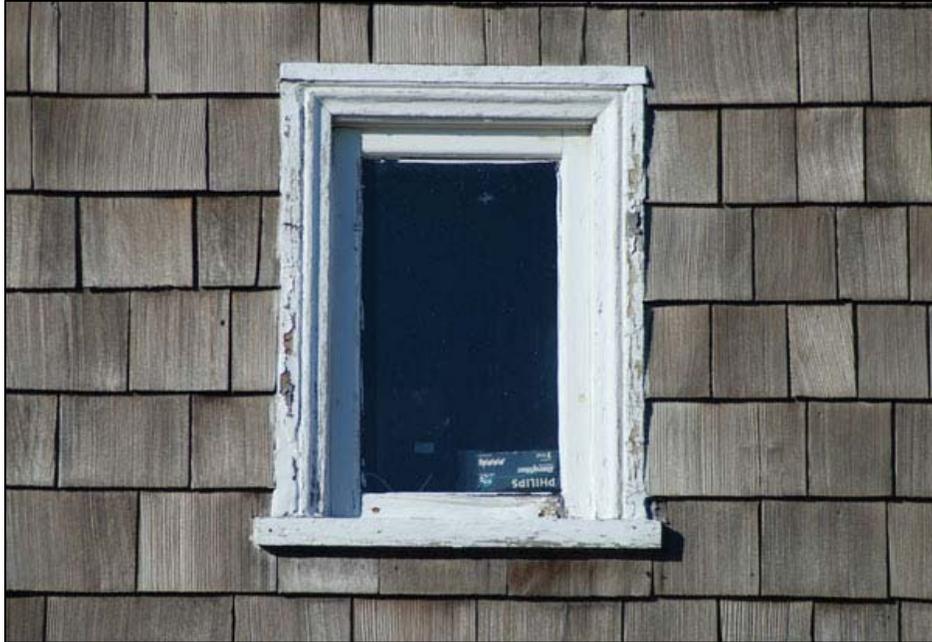
Figure 47. Spermaceti Cove Life-Saving Station, east elevation Tower window opening (W201) depicting historic molding.

Window Opening No. & Location	Window Description
W201, Tower, east elevation (fig. 47)	W201 is an original window opening on the east elevation of the Tower. Typical of the smaller window openings in the Tower it measures 1 foot 2¼ inches wide by 2 feet 1 inch high. Historic photographs and the plans for the Duluth-type station indicate that the window openings historically had casement sashes with six lights. Presently the W201 has a single fixed sash with one light. The exterior window surround was constructed with a molding that matches the historic elements on other windows (W113 – W115, etc.). Flashing is installed over the lintel trim of the window.
W202, Tower, south elevation	W202 is also an original window opening that historically had a six-light casement sash. The extant elements of W202 are similar to W201 including the one-light fixed sash. In addition W202 has an exterior wooden storm window.

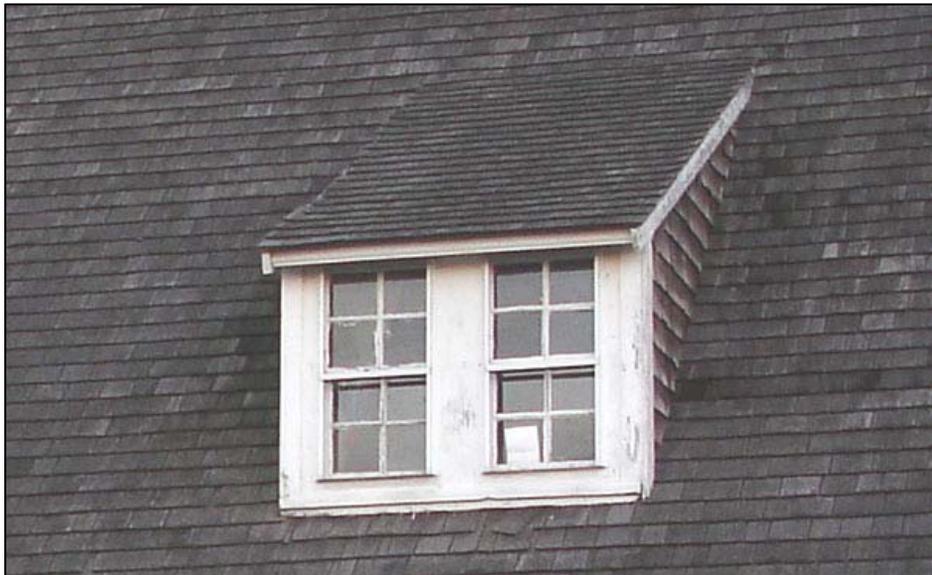
Figure 48. Spermaceti Cove Life-Saving Station, west elevation dormer window openings (W207 and W208).

W207 & W208, Main Block, west elevation dormer (fig. 48)	W207 and W208 form a double window in the west elevation dormer. Each window opening has double-hung, four-over-four sashes that appear to be the original sashes. The double window is trimmed with a plain board surround and a wide mullion separates the two window openings.
W209, Main Block, north elevation	W209 is located in the Main Block above the roof of the Boat Room. It is an original window opening that had a single sash with six lights. The window is currently closed off with plywood but retains what appears to be historic trim. The window surround is constructed with a cyma reversa molding that is similar to other original trim on the building. The lintel trim is flashed.
W210, Main Block, north elevation	W210 is located on the north elevation of the Main Block. It is not an original window opening and was probably installed when the second story restroom was added in 1930. Presently the window is blocked off with plywood. The window opening is trimmed with a plain board surround and the lintel trim is flashed.

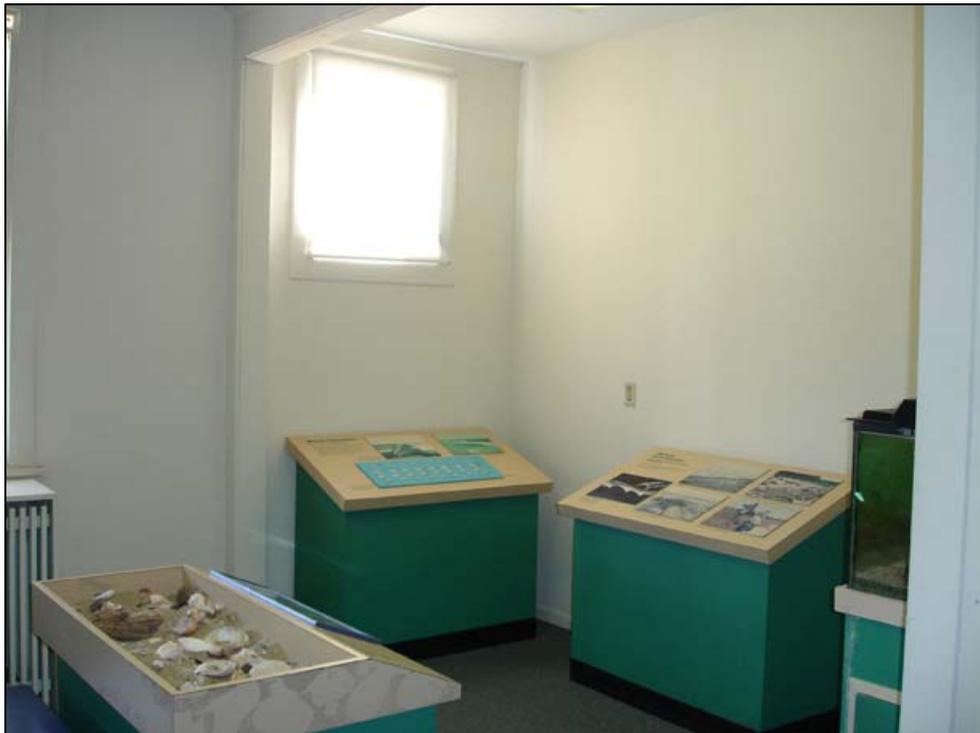
The original window opening for the Pantry (W108) is extant but the interior elements have been replaced (fig. 54). The interior of the window opening is surrounded on all sides with 4½-inch wide plain boards. W108 currently has a single-fixed sash held in place with interior quarter-round trim.

Figure 54. Spermaceti Cove Life-Saving Station, Room 105 looking south into former Pantry and W108.
