George Rogers Clark National Historical Park

*Cultural Landscape Report/
Environmental Assessment
January 2008*

George Rogers Clark National Historical Park
Vincennes, Indiana

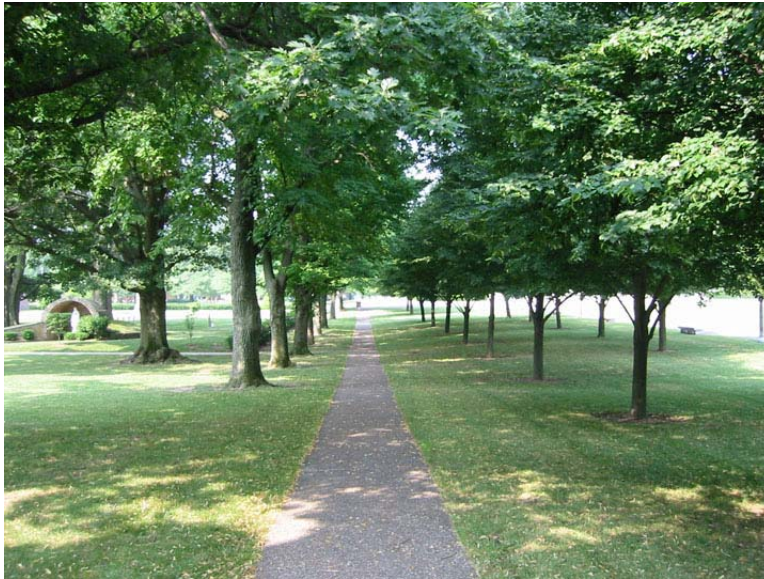
The double rows of little leaf linden trees flanking each side of the Mall were installed by NPS staff with concurrence from the Midwest office in 1989 (totaling forty-eight trees). At the time of the survey, five lindens were missing on the southeast side of the Mall and fourteen lindens were missing on the northeast side of the Mall. The remaining trees in this area are in fair condition (see Figure 3.3). Many of the trees are leaning and have exposed roots. The ground layer below these trees is lawn; however, it is in poor condition in shady areas where the tree canopy is dense (see Figure 3. 4). The lawn panel in the middle of the Mall is in good condition likely due to more sun exposure in this area.

Figure 3.3: View of linden allée (right side of photo) and sweet gums (left side of photo), Photo by The Jaeger Company, 2005.

Non-Historic Features	Figure No.	Condition	Deficiency
Ornamental Shrub Plantings in historic planting locations	Figure 3.13	Good	
Linden Allée	Figure 3.3	Poor	Missing specimens; some leaning trees.
Riverside Vegetation	Figure 3.12	Fair	Some areas of erosion continue.
George Rogers Clark Memorial Visitor Center		Good	
Visitor Center Courtyard	Figure 3.9	Good	Requires much maintenance to maintain good condition.
Maintenance Building Compound	Figure 3.10	Good	
Exposed Aggregate Benches & Trash Receptacles	Figure 3.43	Fair	Chips, scratching, and marring due to skateboards and bicycles.

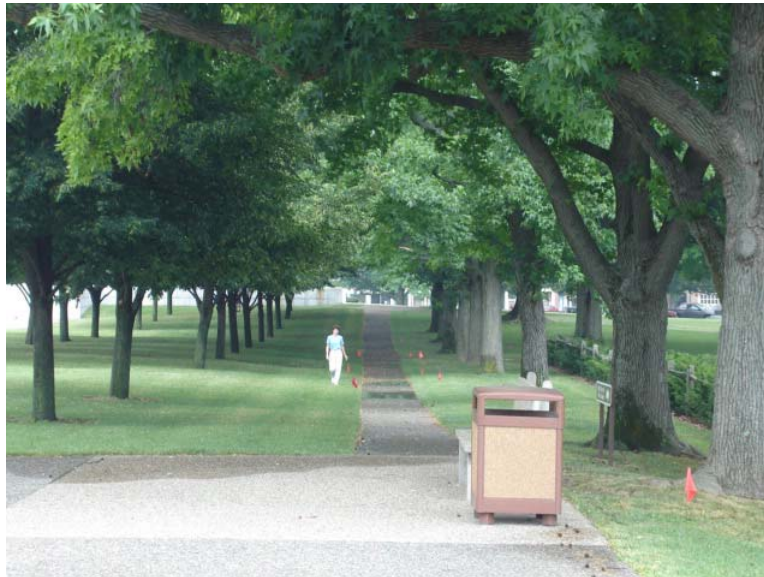
There is a row of sweet gum (*Liquidambar styraciflua*) trees lining the southeast side of the sidewalk running parallel to the Old French Cemetery (see Figure 3.5). These trees range in caliper size from fifteen inches to thirty inches. Twelve sweet gum were specified in the second version of Parsons' plan. Nine of these trees remain on the site and the condition of these trees is fair. However, the fruit of these trees causes a safety concern on the adjacent sidewalk. GERO staff members are concerned that visitors will slip on the fallen fruit from the trees. Additionally, GERO staff members complain that

the branches on these trees are weak and often break and fall to the ground. The ground layer below these trees is lawn. The lawn in this area is in fair condition due to the amount of shade cast by the trees.

Figure 3.5: Row of sweet gum trees along cemetery border, right side of photo, Photo by The Jaeger Company, 2005.

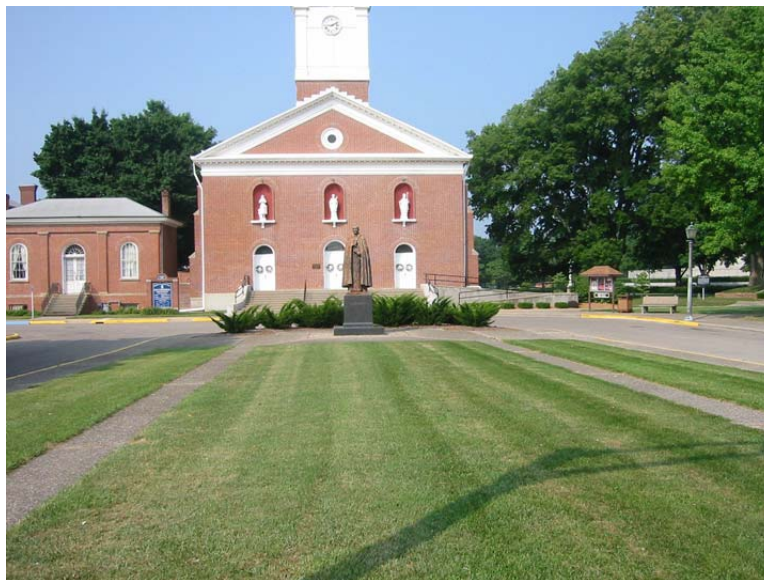
The Plaza is largely open lawn with small areas of shrub plantings (see Figure 3.6). The lawn in this area is in good condition. The shrub planting consists of a mass of junipers (*Juniperus pfitzeriana*). The junipers are in good condition. The shrub area reflects a revision to the original Parsons' plan for this area. The shrub area behind the Father Gibault Statue was added in his revised plan but was not present in the original rendition. It is not clear why these shrubs were added. Lawn currently occupies the two small beds on the outer perimeter of the Plaza. Both the original Parsons plan and his revised plan depict shrub plantings in this area.

Figure 3.6: Open lawn and shrub plantings in the Plaza area, Photo by The Jaeger Company, 2005.

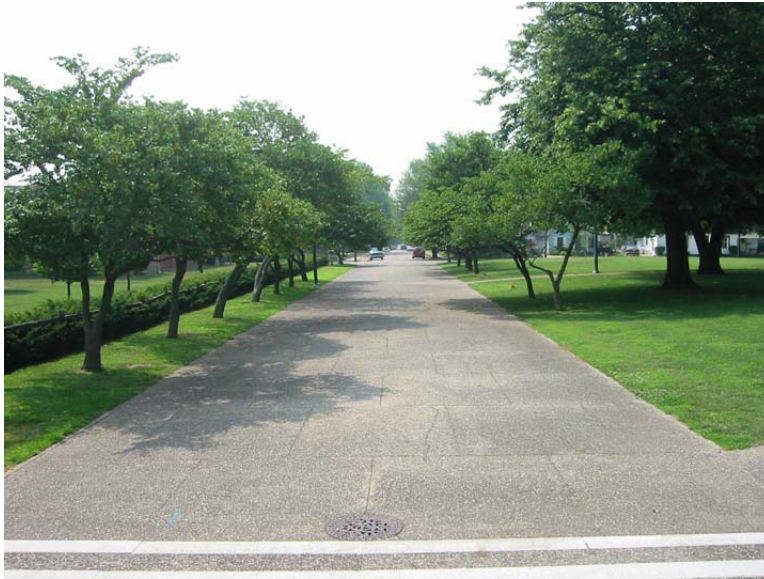
A major sidewalk to the Memorial is the extension of Barnett Street into the site. Due to the location of the Visitor Center, this sidewalk serves as a major access route for visitors to the Memorial Building. Although the original planting scheme shows crabapples (*Malus spp.*) lining the sidewalk, redbuds now line this route. There are sixteen redbuds in this area. The condition of these trees is poor as many have lost branches or have died and not been replaced (see Figure 3.7). The ground plane under these trees is lawn which is in good condition. There is a hedge of evergreen shrubs along the north side of the sidewalk along the Old French Cemetery border. These yews are in good condition.

Figure 3.7: Redbud allée along Barnett Street Sidewalk, Photo by The Jaeger Company, 2005.

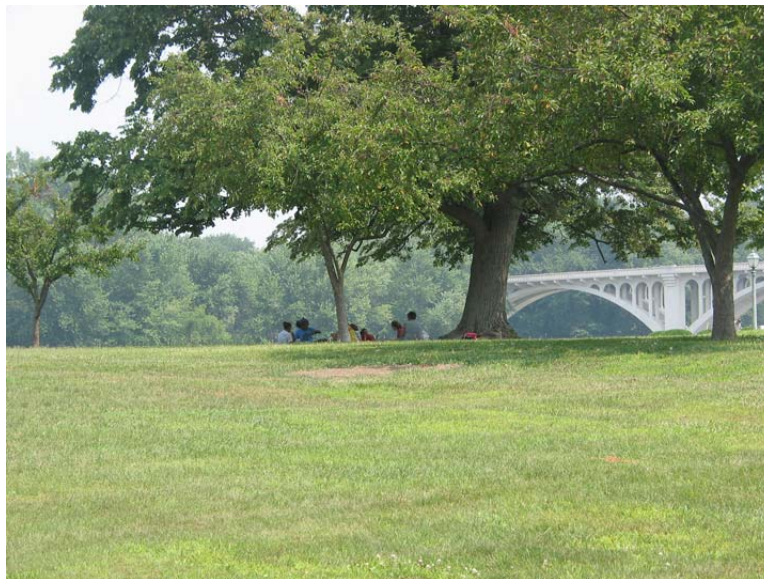
The area directly behind (southwest of) the Memorial Building contains a large open lawn area with a concentration of plantings close to the sidewalk. This group of trees contains the three large lindens (*Tilia vulgaris*) as well as eight crabapples, four northern red oaks, and a magnolia (*Magnolia grandifolia*). The trees in this area are in good condition (see Figure 3.8). The linden trees in this area likely date from the initial 1930's planting of trees. These are believed to be from the initial landscape installation of Parsons' plan at GERO. These lindens appear to be in good condition. The crabapples in this area range in condition from fair to poor due to a scab condition. The red oaks and magnolia are in good condition.

Figure 3.8: Group of children sitting under trees behind Memorial Building, Photo by The Jaeger Company, 2005.

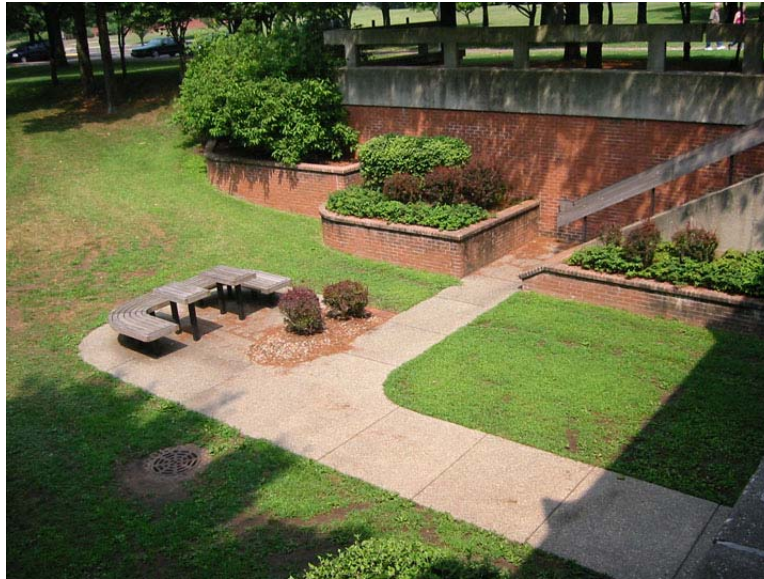
Plantings in the lower courtyard of the Visitor Center are dominated by shrubs and flowering trees shaded by the pines lining the retaining wall above (see Figure 3.9). Included in these plantings are Cornelian cherry dogwood (*Cornus mas*), smoketree (*Cotinus coggygia*), St. Johnswort (*Hypericum frondosum*), viburnum (*Viburnum carlesii*), and barberry (*Berberis thunbergii*). These shrubs and small trees are in good condition; however they require many maintenance hours annually for trimming. The lawn in the courtyard area is in fair condition with some vigorous areas interspersed with sections of that have "browned out" due to either high foot traffic or wet conditions.

Figure 3.9: View of Visitor Center courtyard from above, Photo by The Jaeger Company, 2005.

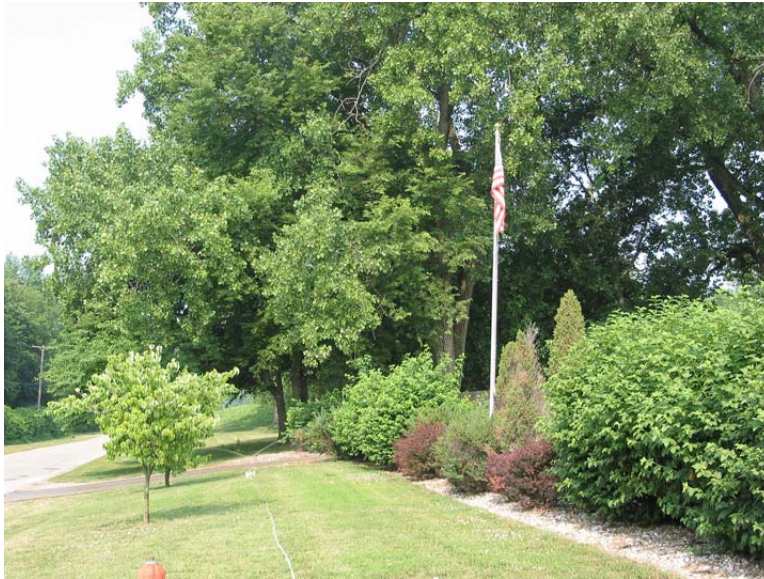
Plantings around the Maintenance Building include hackberry, redbud, and cottonwood, dogwood (*Cornus florida*), and sweet gum. These trees are in good condition. Two of the large cottonwood trees were present when the building was installed (see Figure 3.10). Shrubs around the Maintenance Area include viburnum, spirea (*Spiraea nipponica* "Snowmound"), barberry, and Chinese juniper. These shrubs are well maintained and are in good condition. The lawn in this area is in good condition.

Figure 3.10: Plantings Adjacent to the Maintenance Shed Area, Photo by The Jaeger Company, 2005.

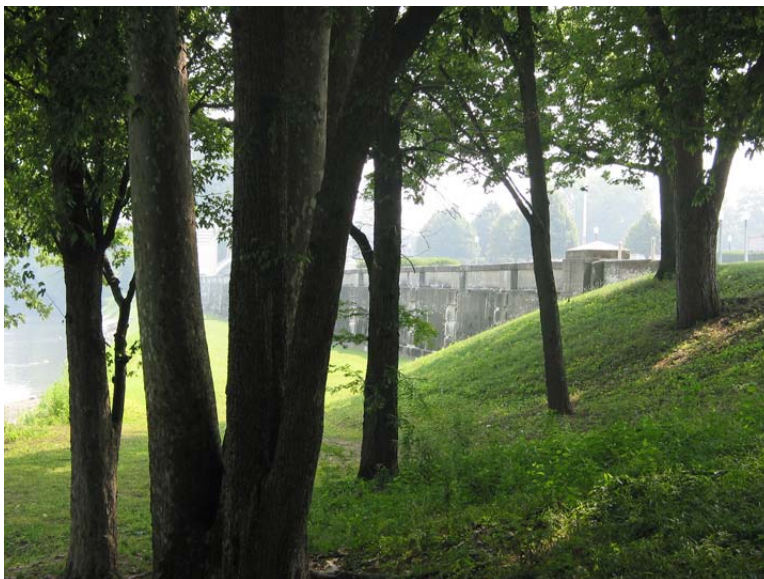
Trees outside the original boundary of the Memorial Grounds include a grouping of mixed sized trees adjacent to Willow Street between the Wabash River and the road. These trees include a picturesque grove of fifteen cottonwoods (*Populus deltoids*) ranging in size from twenty-nine to fifty-four inches in caliper. Interspersed among these cottonwoods are various sized maples (approximately twenty total), hackberries (three total), American elms (two total), black walnut (*Juglans nigra*) (two total), and locusts (*Gleditsia triancanthos*) (two total) (see Figure 3.11). These trees are in good condition. The ground layer below the trees is lawn and mixed weeds.

Figure 3.11: Group of trees near river on northwest side of the site, Photo by The Jaeger Company, 2005.

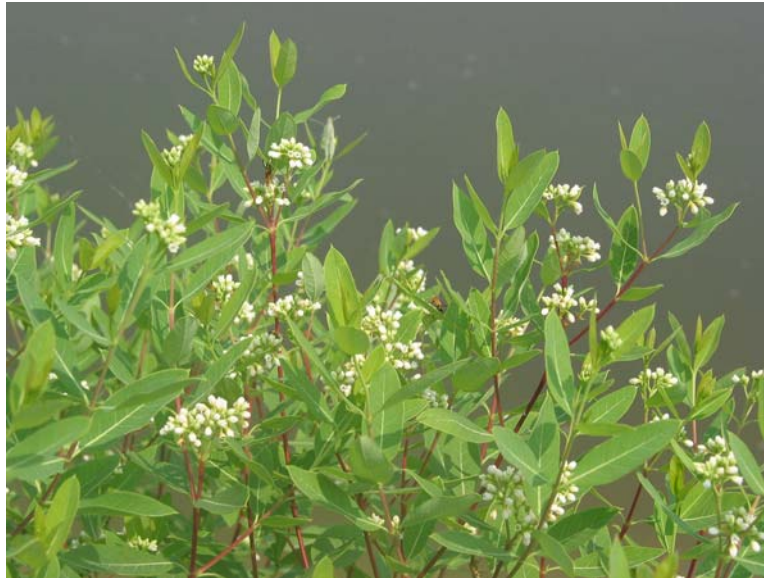
Area 30: Riverbank below Floodwall

Herbaceous vegetation along the riverbank is a mixture of native and non-native species including sheep sorrel (*Rumex spp.*), mustard family plants (*Brassicaceae*), dodder (*Cuscuta gronovii*), and other common wet-mesic perennials. This vegetation is likely a result of seeding associated with erosion control efforts (see Figure 3.12).

Figure 3.12: Riverbank vegetation, Photo by The Jaeger Company, 2005.

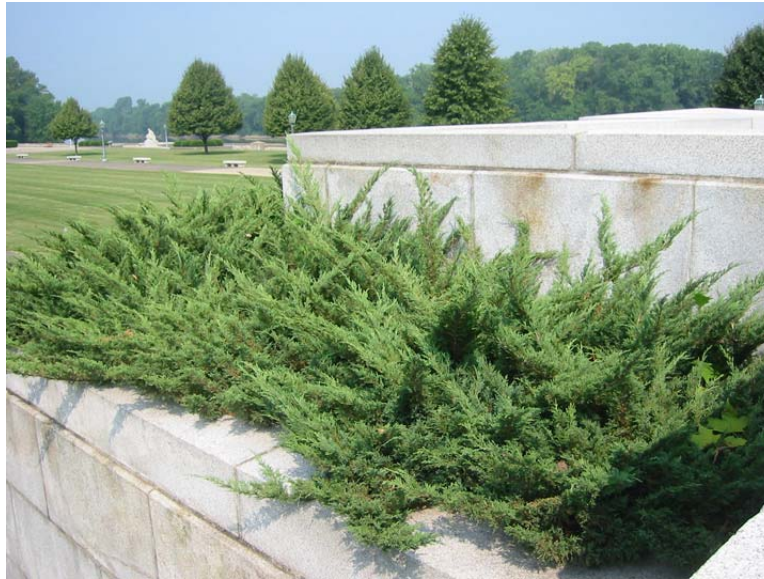
As with the Memorial Building base plantings, the plant installations at the base of the North and South Terraces of the Lincoln Memorial Bridge Approach were originally planned to be more diverse. "The original plantings were a mass of pyracantha [*Pyracantha coccinea*], juniper and small-leaf holly [*Ilex cornuta*]."¹³ The existing plantings include masses of junipers and large (six foot height) clipped yews. These plantings are in good condition.

Figure 3.13: Junipers in planters on the South Terrace of the Bridge Approach, Photo by The Jaeger Company, 2005.

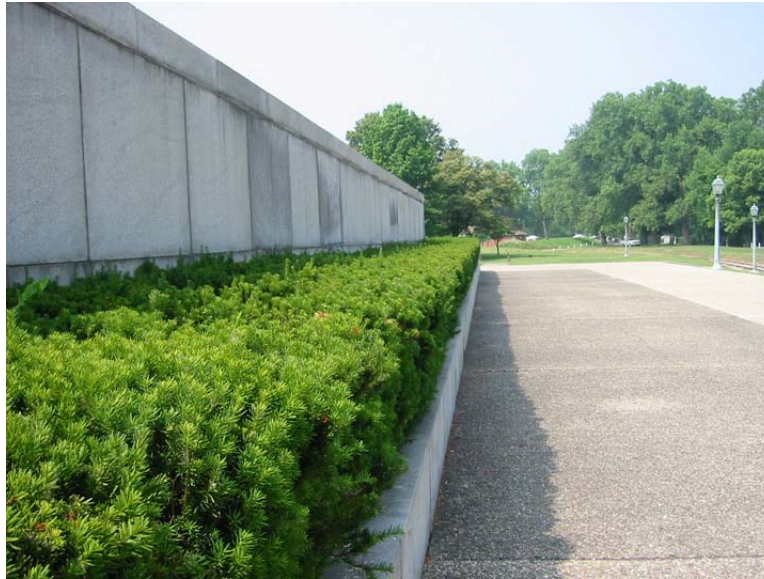
According to the 1995 CLR, “the foundation plantings at the base of the Memorial were originally planted with a mass of pyracantha (tree-form), pyramidal and spreading yew, and three species of juniper (*Juniperus spp.*) in each corner.” Junipers were to line the narrow planting beds connecting these corners.¹⁴ Existing plantings in this area consist of yews which are massed together and heavily maintained with clipping (see Figure 3.14). The yews are typically two and one-half to three feet tall. These yews are in fair condition due to some damaged specimens and overcrowding.

Figure 3.14: Yews at the base of the Memorial Building, Photo by The Jaeger Company, 2005.

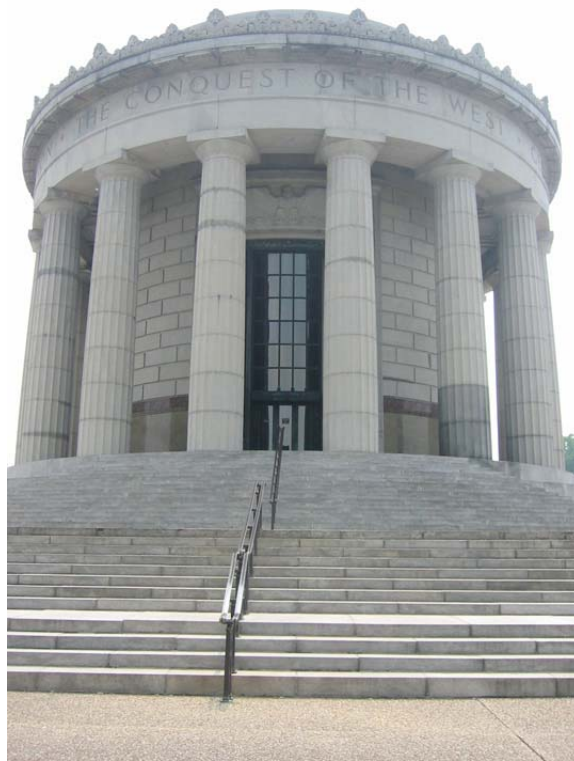
The Memorial Terrace, once finished with an exposed aggregate surface, is currently surfaced with concrete. Leaks in the terrace level into the basement level of the building have plagued the structure since its initial construction and these leaks continue to this day. A recent assessment of the terrace level determined that the following conditions exist on the Memorial Terrace:

- Spalling and corrosion of reinforcing steel in the bottom of concrete slabs
- Spalling and corrosion of reinforcing steel in the bottom of concrete beams
- Spalling and corrosion of reinforcing steel in the vertical sides of the concrete beams.
- Diagonal cracking in stepped concrete beams.”¹⁷
- Additional findings of this report include cracks and “exposed reinforcing steel with significant corrosion.”¹⁸

Figure 3.15: Memorial Building, Photo by The Jaeger Company, 2005.

There have been numerous studies conducted concerning the leaking of the Memorial Terrace. Existing conditions surveys and repair recommendations were prepared for the Memorial Terrace in 1995, 1998, 2002, and 2005. Funding has been approved for the 2005 plan. Because of the extensive leaking in the structure, the condition of this building is poor.

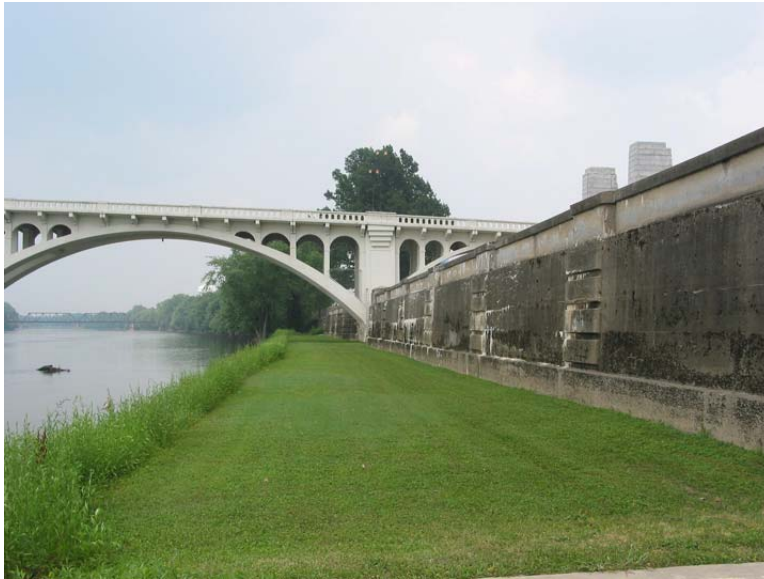
- Spalling is present on the cap and wall portions of the parapet and portions of the front and back face of the wall itself.
- Spalling on the face of the wall seems to be concentrated at the pilasters where there are joints in the wall.
- Many horizontal cracks in the face of the wall are susceptible to leakage when the river crests against the Floodwall.
- The predominant cause of the deterioration evidenced by both cracking and spalling is the freeze/thaw action of the concrete.
- Previous repairs, mostly cosmetic in nature, have not solved the deterioration problems of the Floodwall, and the deterioration appears to be progressing.²¹

Due to the severity of the spalling and cracking of the Wabash River Floodwall (see Figure 3.16 – Figure 3.19), the condition of this element is poor. Existing conditions reports and repair plans for the Floodwall were conducted in 1989 and in 2005. Funding has been proposed to implement the 2005 plan.

Figure 3.17: Wabash River Floodwall, view of northern portion, Photo by The Jaeger Company, 2005.

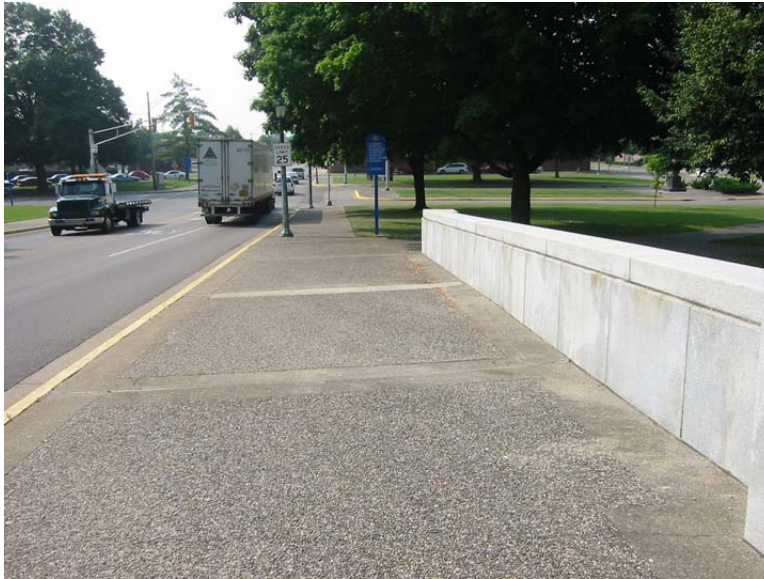
The Lincoln Memorial Bridge Approach and Plaza constitute a major visual feature of the park. This landscape component includes the poured concrete structures in the bridge approach as well as the granite-faced walls along the approach (see Figure 3.20 and Figure 3.21). The approach includes the two granite pylons at the entrance to the bridge (see Figure 3.22). These pylons depict two Native American figures (Tecumseh and The Prophet) in bas relief. The sidewalks along the bridge approach are exposed aggregate with smooth concrete borders. The road surfacing in this area is asphalt. Sidewalks in this area are approximately fifteen (15'-0") wide. The condition of the Bridge Approach and Plaza is fair due to structural deterioration caused by seepage of rust through the granite facing.

Figure 3.20: Granite wall on south side of Lincoln Memorial Bridge Approach, Photo by The Jaeger Company, 2005.

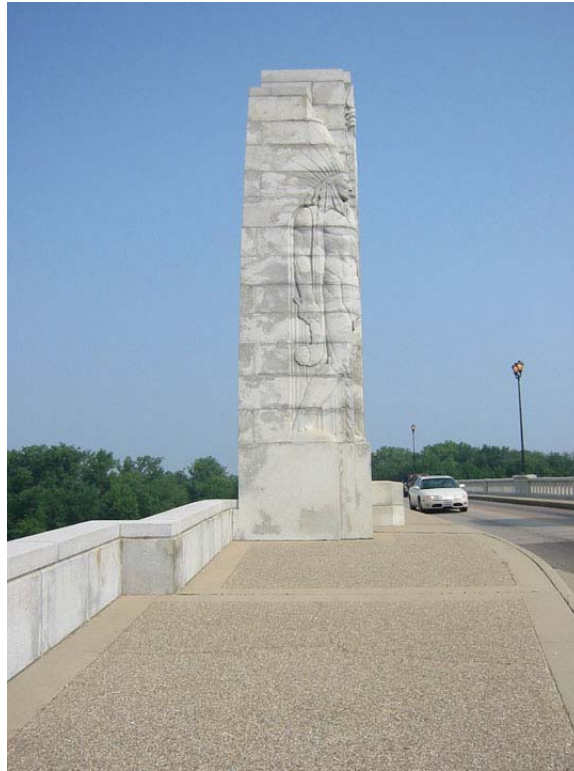
Figure 3.22: Detail of Pylon on Lincoln Memorial Bridge Approach, Photo by The Jaeger Company, 2005.

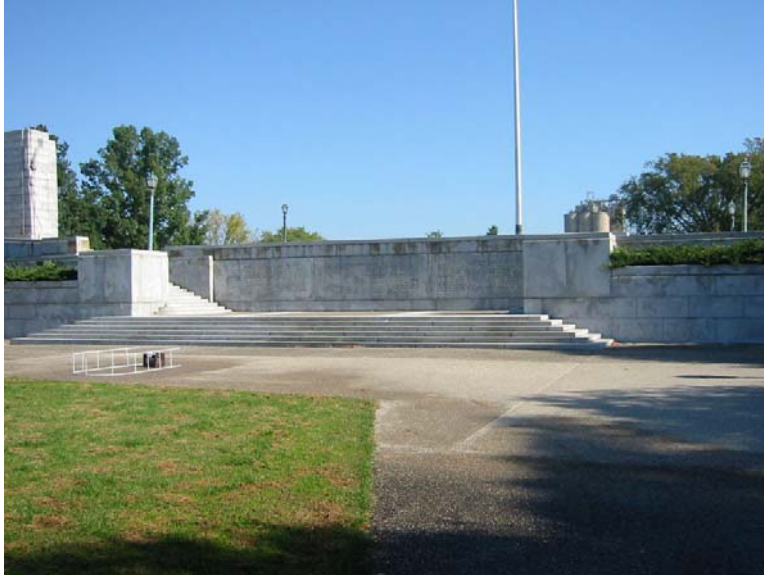
The South Terrace of the Lincoln Memorial Bridge is part of the “axial Beaux Arts design for the Memorial [G]rounds.”²² The South Terrace rests on a concrete substructure with large granite wall panels on all walls, platforms, piers, and coping (see Figure 3.23 – Figure 3.25). The wall facing south has three sections each with carved inscriptions about the “territorial road which crossed the river at Vincennes”. A set of six steps leads from the central Mall area of the Memorial Grounds to the elevated terrace. Additional stairs lead up on either side to the Lincoln Memorial Bridge Approach and Plaza. Large planters with granite facing flank the Terrace. Iron rust stains exist on the face of the granite panels of the Terrace. Some of the mortar joints show cracking. Due to the state of these materials, the condition of the South Terrace is fair.

Figure 3.23: View of South Terrace, Photo by The Jaeger Company, 2005.

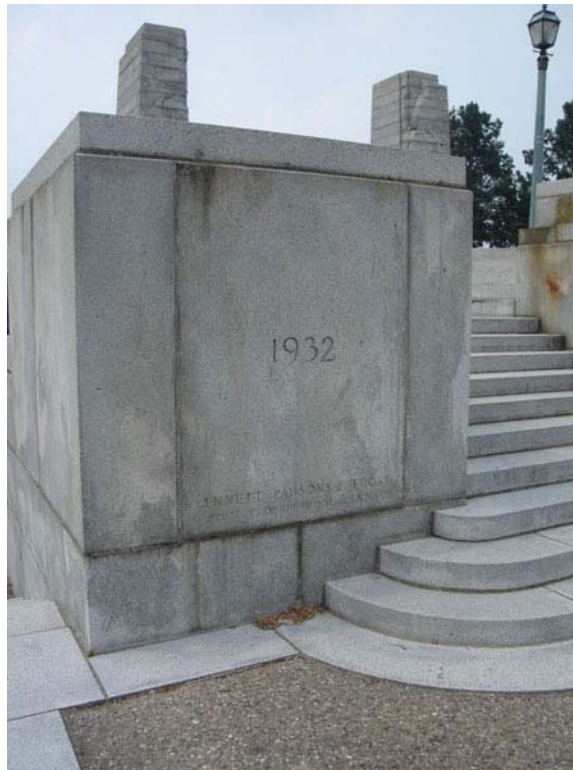
Figure 3.24: Detail view of South Terrace showing date inscription, Photo by The Jaeger Company, 2005.

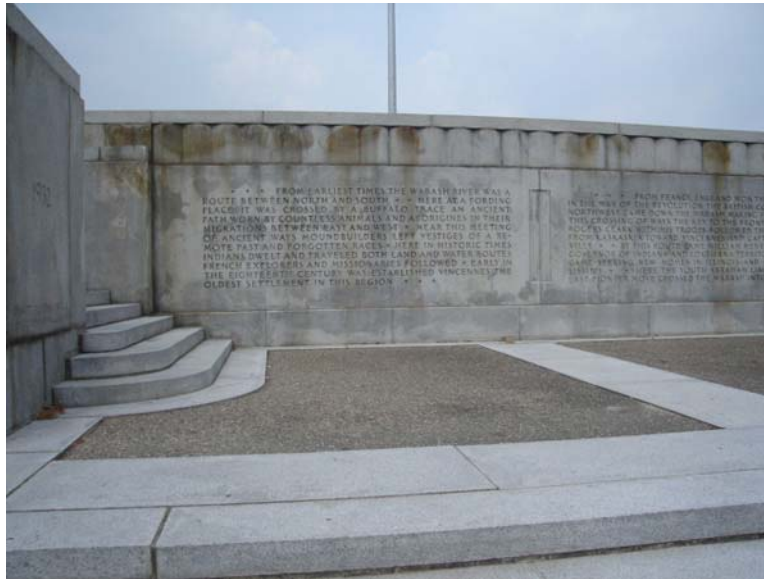
Figure 3.25: View of inscription panels at South Terrace, note discoloration, Photo by The Jaeger Company, 2005.

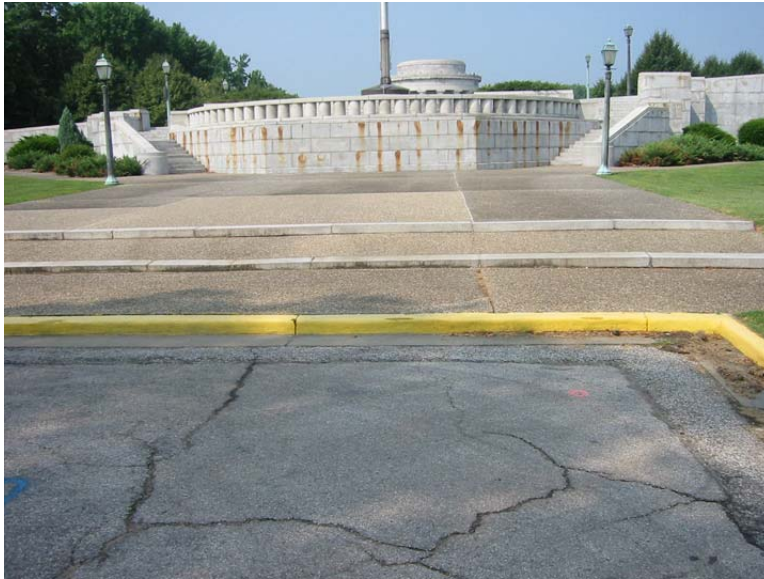
The North Terrace of the Lincoln Memorial Bridge contains a large parapet and a massive flagpole (see small-scale features). This terrace has a concrete substructure faced with granite panels which make up the large parapet and a circular platform with a granite balustrade (see Figure 3.26). The ground level of the Terrace serves as a public event area. Two sets of stairs lead up to the circular portion of the North Terrace from ground level at the northeast and northwest corners of the Terrace. Seven circular stairs then lead up to the flagpole level. The granite panels on the North Terrace also have iron rust stains and the mortar joints are cracked in several locations (see Figure 3.27). There is a room under the North Terrace which NPS employees use for storage. This room exhibits signs of leakage similar to the Memorial Terrace. Stalactites and water seepage are also visible in this room. Due to the state of these materials, the condition of the Lincoln Memorial Bridge North Terrace is poor. The leakage condition may indicate that there are similar problems both on the South Terrace and on the Bridge Approach.

Figure 3.26: View of Lincoln Memorial Bridge North Terrace and public assembly area, Photo by The Jaeger Company, 2005.

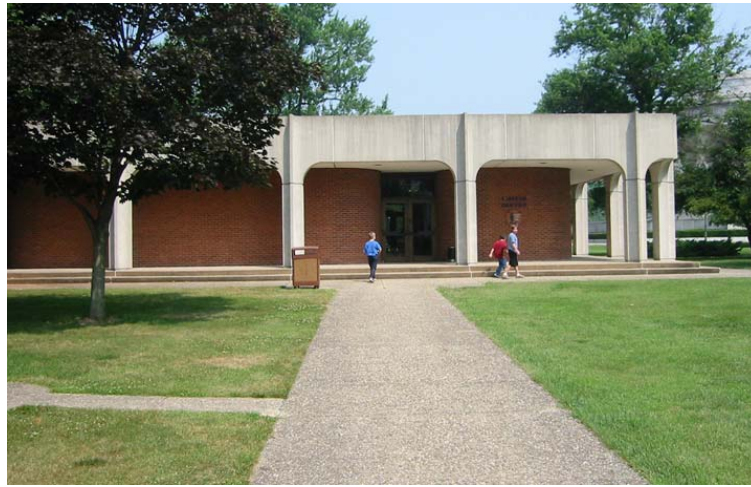
Built in 1975-1976, the Visitor Center is composed of brick and concrete with a low horizontal profile (see Figure 3. 28). A simple, unadorned colonnade surrounds the building. The main entrances to the Visitor Center are on axis with a central sidewalk which leads to the Memorial Grounds. A secondary lower entrance gives access to the GERO administrative offices. The overall condition of the Visitor Center is good. The Visitor Center is approximately 6300 square feet.

Figure 3. 28: Visitor Center, Photo by The Jaeger Company, 2005.

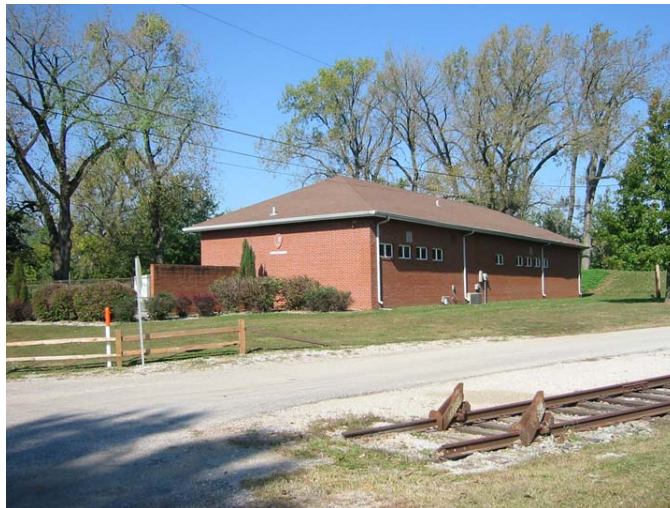
The Maintenance Building, constructed in 1992, is a low red brick building situated on the southwest corner of the Memorial Grounds across from the railroad tracks and Willow Street (see Figure 3.29). There are three small maintenance sheds outside the building itself. The condition of the Maintenance Building is good. The Maintenance Building is approximately 3,312 square feet.

Figure 3.29: Maintenance Building, Photo by The Jaeger Company, 2005.

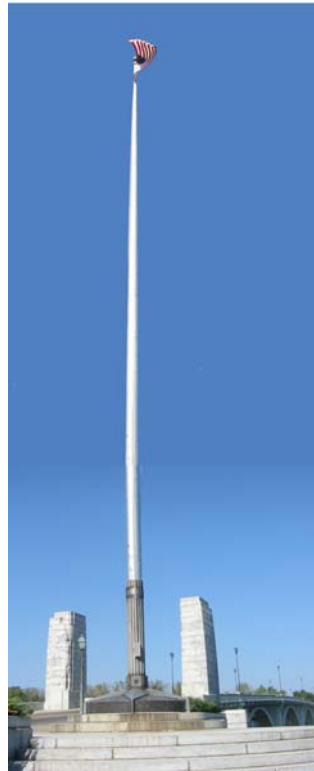
The large flagpole on the north terrace of the bridge approach “represents the five states formed from each of the Northwest Territory: Ohio, Indiana, Michigan, Wisconsin, and Illinois.”²³ The pole itself is approximately eighty feet high and is set into a “stepped circular granite base” and was installed between 1931 and 1933. A five-pointed aluminum star sits at the top step of the base with the “five state names inscribed in granite between [the] star points.”²⁴ The lower two steps of the base are grey and unpolished and the upper step is dark and polished. There is some discoloration of the lower granite steps caused by the metal from the post (see Figure 3.30); therefore, the condition of the flagpole is fair.

Figure 3.30: Lincoln Memorial Bridge – Flagpole, Photo by The Jaeger Company, 2005.

Lincoln Memorial Bridge – Flagpole	Figure 3.30	Fair	Discoloration of lower granite steps caused by metal from post.	70162
Vigo Statue	Figure 3.31	Fair	Past damage (some repaired).	06526
War Memorial	Figure 3.33	Good		06530
Headquarters Site Marker	Figure 3.34	Fair	Base is cracked.	06531
Fort Sackville Site Memorial	Figure 3.35	Fair	Vegetation impact; stains.	06532
Charles Gratiot Monument	Figure 3.36	Good		17023
Ferry Landing Plaque	Figure 3.37	Fair	Marks from vandalism; damage from over-cleaning.	70166
USS Vincennes Memorial	Figure 3.38	Good		70167
Vincennes in the American Revolution Marker	Figure 3.39	Good		70168
Name of Vincennes Marker	Figure 3.40	Good		70169
Granite Benches	Figure 3.41	Good		70164
Views and Vistas		Fair	Lack of historic vegetation to frame primary and secondary views.	
Street Lamps	Figure 3.62	Good		70163

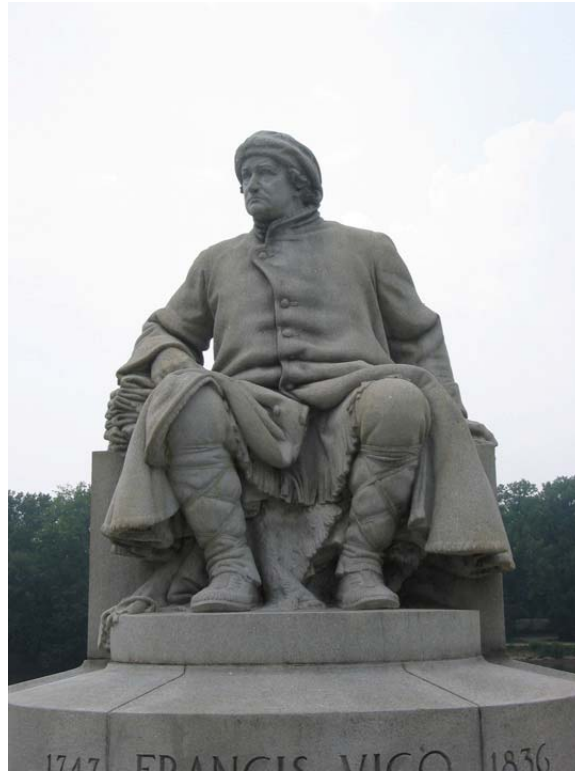
Vigo Statue (IDLCS 06526)

The Vigo Statue is located on the northwest edge of the site between the Memorial Building and the Floodwall and was installed in 1936. The granite statue rests in its original location (see Figure 3.31). As described in the LCS listing, this statue depicts Francis Vigo “seated with his arm resting on a bale of furs.” The statue “measures 4’x 9’x 11’ high” with “some staining” visible on the stones. As listed in the LCS system “Two fingers on [the] left hand [are] partially missing”; however these features have been repaired. The nose on the statue is not original and was repaired in 1943 and 1990. The figure “sits on [a] granite terrace with [a] course aggregate perimeter wall with granite coping.”²⁵ The condition of this statue is fair due to past damage.

Figure 3.31: Francis Vigo Statue, Photo by The Jaeger Company, 2005.

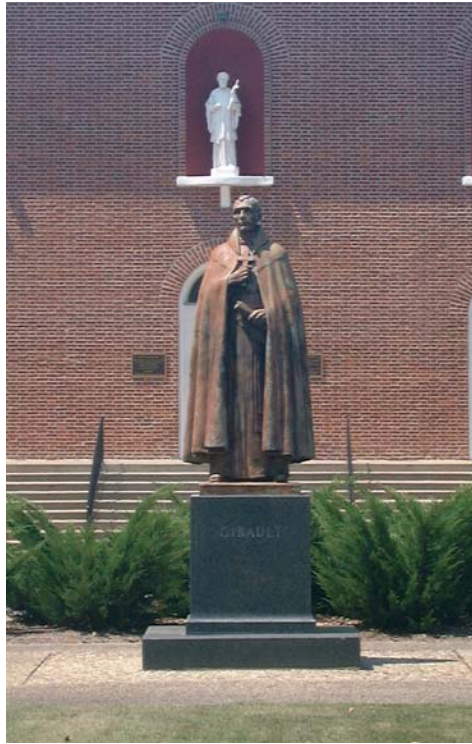
Gibault Statue (IDLCS: 06527)

The statue of Father Pierre Gibault rests in the plaza of the Second Street immediately in front of (northeast of) Saint Francis Xavier Catholic Church where it was installed in 1936 (see Figure 3.32). The statue rests in its original location. As described in its LCS listing, the bronze statue depicts an “8’ high robed priest holding a cross and parchment.” The statue rests on a dark green pedestal/base. The base inscription reads, “Pierre Gibault – 1737-1804 – Vicar-General of the Illinois Country-Who in 1778 gained the allegiance to the United States of the French Population of Vincennes.”²⁶ The condition of the Gibault statue is good. The statue is surrounded by exposed aggregate concrete which is bordered on the front by lawn and on the rear by a planting bed with junipers.

Figure 3.32: Gibault Statue, photo by The Jaeger Company, 2006.

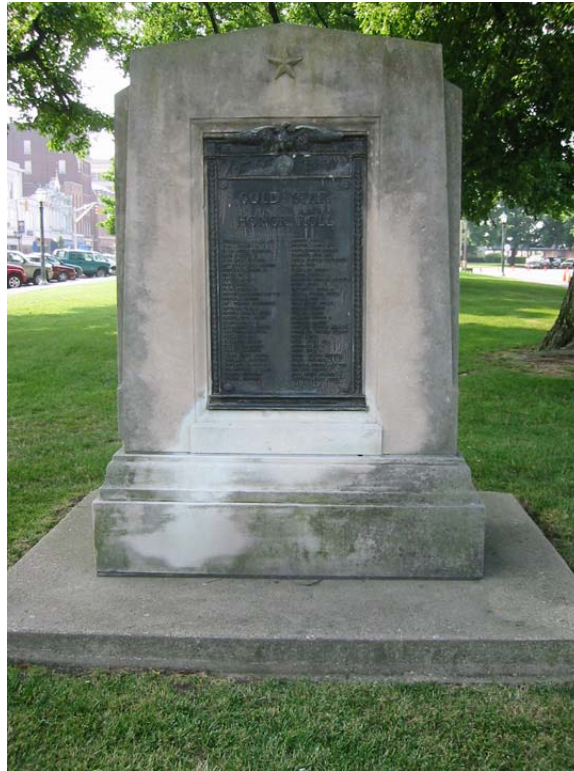
- The War Memorial (*IDLCS: 06530*) is located on the northwest side of the green between Main Street and Patrick Henry Drive (see Figure 3.33). This feature is a “limestone memorial on [a] rectangular concrete slab base” and was dedicated in 1937 to commemorate the residents of Knox County who lost their lives in World War I. This structure consists of three pieces: two pieces acting as a stepped base and a “massive top piece with [a] shallow double-pitched top.” There are bronze plaques on the front and back of the top piece. The “front plaque has [a] bas-relief of fighting soldiers and names of 60 [sixty] men.”²⁷ The condition of this memorial is good.

Figure 3.33: War Memorial, Photo by The Jaeger Company, 2005.

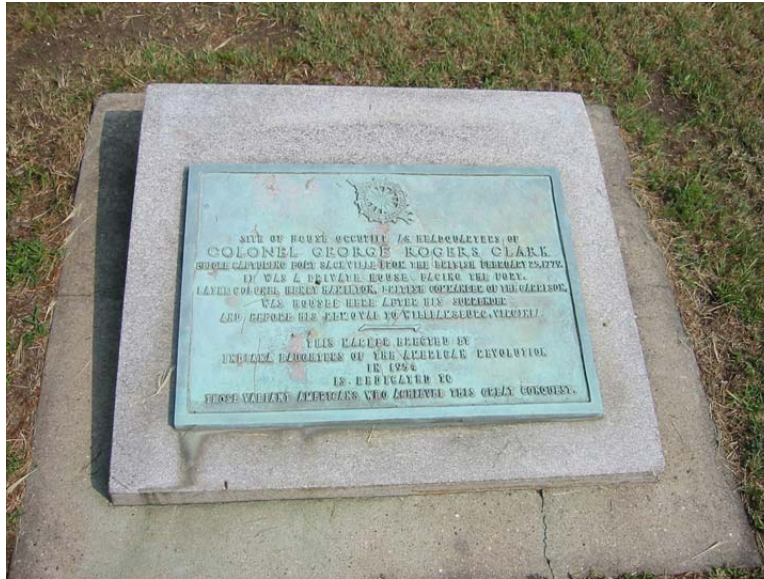
- The Headquarters Site Marker (*IDLCS 06531*) is located on the southeast corner of the green north of First Street (see Figure 3.34). This memorial consists of a “bronze plaque (2’-4” x 1’-8”) set into [an] angled granite base (3’ x 2’-9”)” which were erected in 1954. These structures are “sitting on [a] concrete pad (3’-9” x 3’-10”)” which is flush with grade. The plaque containing the inscription has a “raised border” and the symbol of the Daughters of the American Revolution above the text. The inscription identifies “the Clark Headquarter site during the attack on Fort Sackville in 1779.”²⁸ The base of this monument is cracked, therefore the marker is in fair condition.

Figure 3.34: Headquarters Site Marker, Photo by The Jaeger Company, 2005.

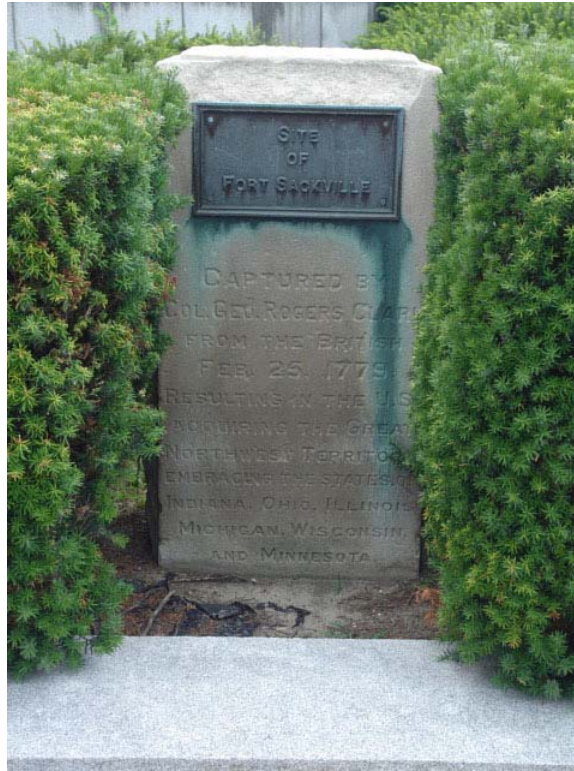
- The Fort Sackville Site Memorial (*IDLCS: 06532*) sits at the base of the Memorial Building on the northeast corner (see Figure 3.35). A bronze plaque measuring 1'-7" by 10" is set in a limestone base and reads "Site of Fort Sackville". An inscription in the limestone base reads "Captured by Col. George Rogers Clark from the British – February 25, 1779 – Resulting in the U.S. acquiring the Great Northwest Territory, embracing the States of Indiana, Ohio, Illinois, Michigan, Wisconsin, and Minnesota." According to the LCS listing, the original base was replaced in 1936 with the existing stone. "Bronze stains from water runoff [are] evident on [the] base."²⁹ The Memorial was originally installed on the GERO site in 1905, but it was moved to its current location in 1936. Due to damage and the impact of vegetation, the condition of the memorial is fair.

Figure 3.35: Fort Sackville Site Memorial, Photo by The Jaeger Company, 2005.

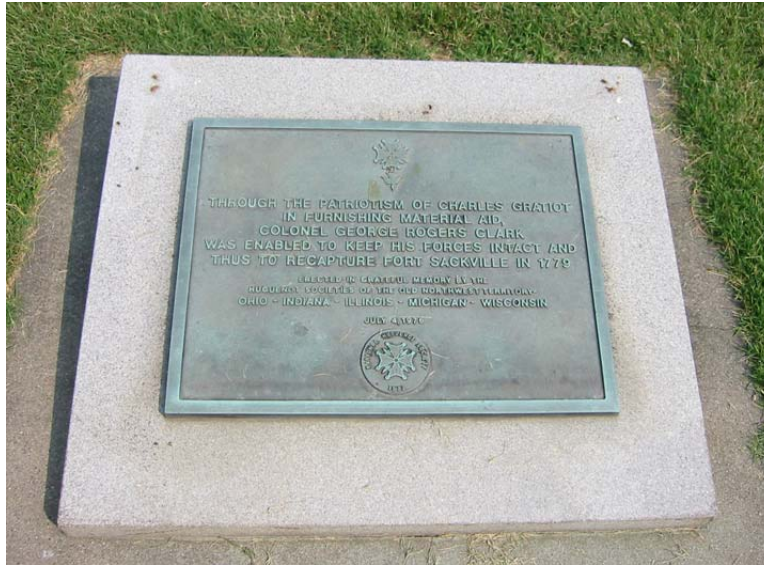
- The Charles Gratiot Monument (Listed as Gratiot, Charles, Monument in *IDLCS: 17023*) is located at the intersection of First Street and Patrick Henry Drive at the northwest side of the intersection (see Figure 3.36). According to GERO staff, this monument was installed on November 18, 1905 and replaced in 1936. This monument consists of a “bronze tablet (20” x 28”) mounted on [an] angled granite base (32.5” x 36”).” The tablet and base are mounted on a concrete footing which is mounted flush with existing grade.³⁰ The monument was dedicated by the Huguenot Societies of the Old Northwest Territory as part of Bicentennial celebrations at the site. The primary inscription on the plaque reads “Through the patriotism of Charles Gratiot in furnishing material aid, Colonel George Rogers Clark was enabled to keep his forces intact and thus to recapture Fort Sackville in 1779.” The condition of the monument is good.

Figure 3.36: Gratiot Monument, Photo by The Jaeger Company, 2005.

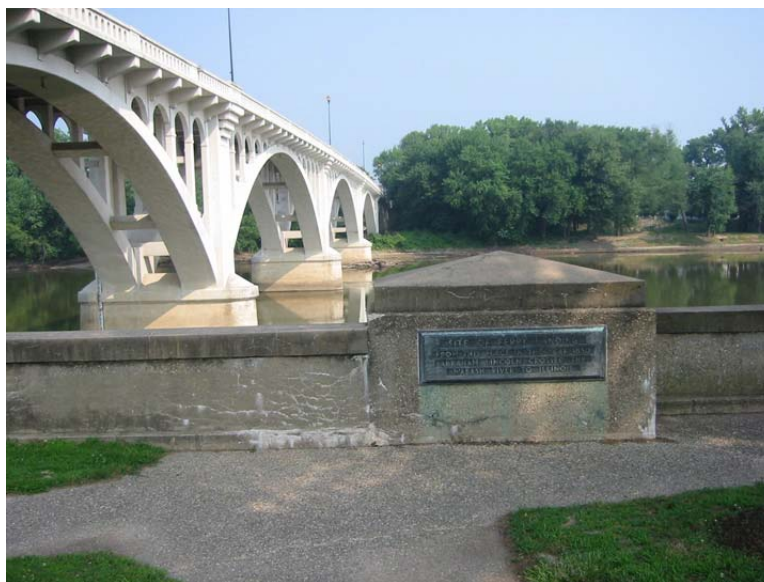
- The Ferry Landing Plaque (*IDLCS: 70166*) is located on the floodwall northwest of the bridge approach (see Figure 3.37). The plaque, which was installed in 1930, “commemorates Lincoln’s crossing of the Wabash” and reads, “Site of ferry landing, from this place in the year 1830 Abraham Lincoln crossed the Wabash River to Illinois.” The bronze plaque has been “marred from cleaning and vandals (inscribed names and initials).”³¹ Due to this damage the condition of the plaque is fair.

Figure 3.37: Ferry Landing Plaque, Photo by The Jaeger Company, 2005.

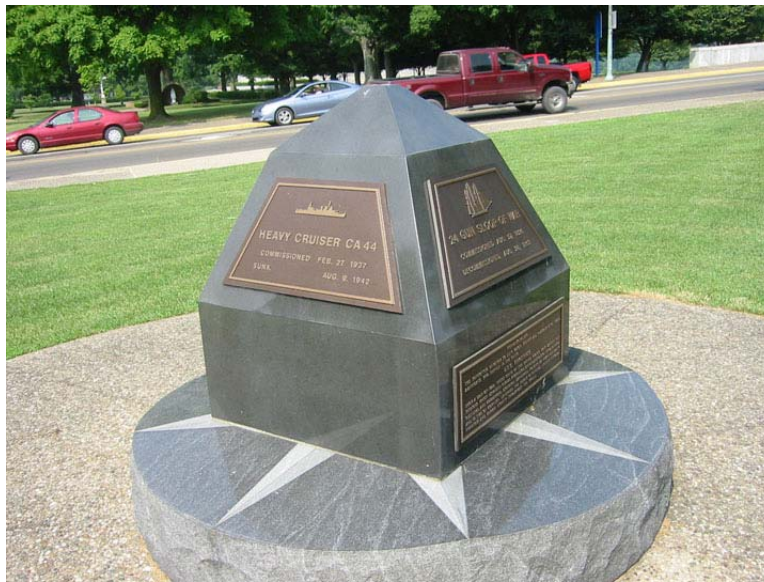
The memorial is situated on a spur off of the diagonal sidewalk running from the southeast corner of the green up to the bridge approach area. The memorial was “erected to commemorate the four U.S. Naval ships commissioned the USS Vincennes.” The construction of the memorial consists of a “circular grey granite base with [a] rough edge and 8 [eight] compass points on top. [The] memorial is polished black marble” which is square at the base with a “pyramidal, [beveled] and truncated” top half. There is a bronze plaque on each side of the memorial and a common “plaque on the north side of the base of the memorial.”³² The condition of the memorial is good.

Figure 3.38: USS Vincennes Memorial, Photo by The Jaeger Company, 2005.

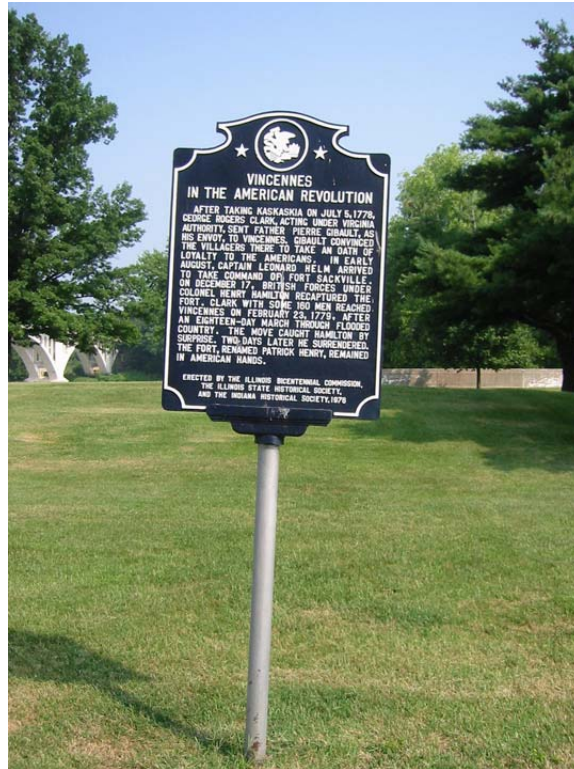
- The Vincennes in the American Revolution Marker (*IDLCS: 70168*) is located between the Gratiot Monument and the Headquarters Site Marker where it was installed in 1976 (see Figure 3.39). The plaque was erected by the Illinois Bicentennial Commission, Illinois State Historical Society and the Indiana Historical Society and is navy blue with raised white letters. The “plaque is secured to the pole with brackets at [the] middle and top” of a silver painted aluminum pole.³³ The condition of the plaque is good.

Figure 3.39: Vincennes in the American Revolution Marker, Photo by The Jaeger Company, 2005.

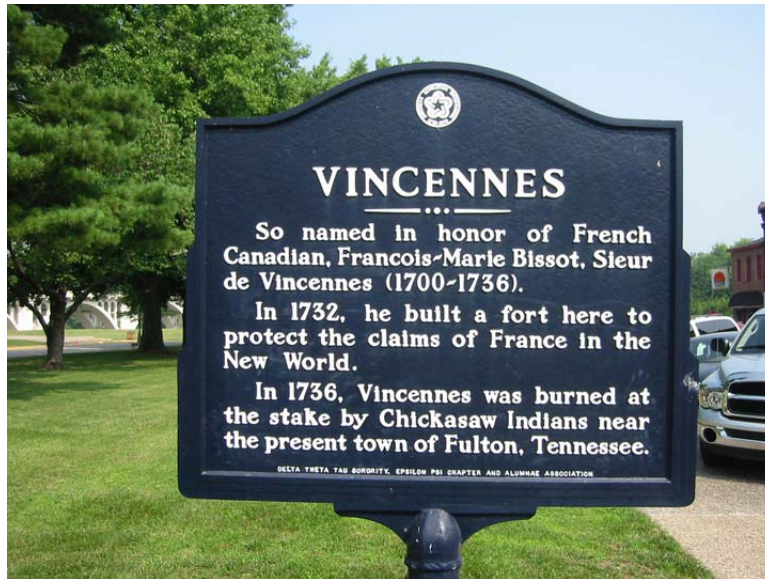
- The Name of Vincennes Marker (*IDLCS: 70169*) is located at the intersection of Main Street and Second Street where it was installed by Delta Theta Tau Sorority, Epsilon Psi Chapter and Alumni Association in 1976 (see Figure 3.40). This rectangular plaque is a traditional historical marker with the symbol of the American Revolution Bicentennial Commission above the text. The plaque is black with raised white letters. The plaque is posted on a concrete and metal post which is mounted into the ground. The condition of this plaque is good.

Figure 3.40: Name of Vincennes Marker, Photo by The Jaeger Company, 2005.

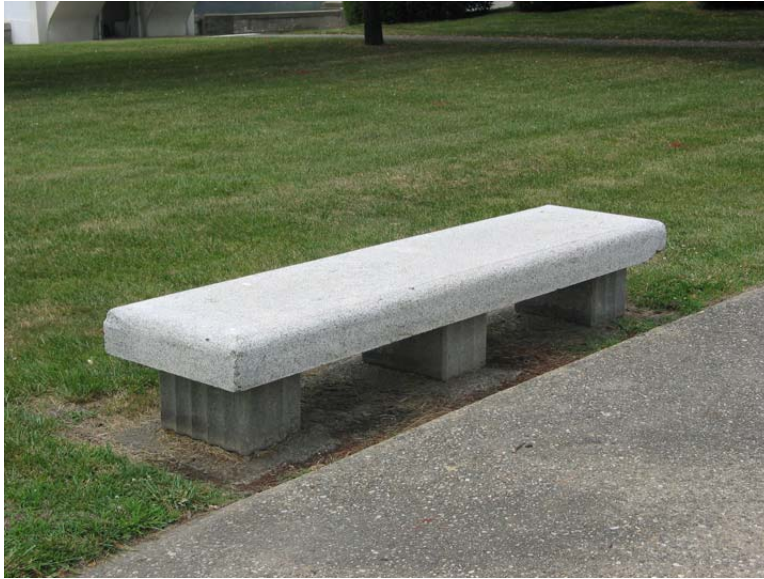
There are two types of benches located within the site. The benches are associated with the different development periods of the site. Historic granite benches dating from the Memorial Era period of significance are listed within the LCS system as IDLCS: 70164 (see Figure 3.41 and Figure 3.42). These “unpolished granite benches [are] supported by three fluted granite piers. The bench tops measure two feet by eight feet and are “rectangular with rounded edges on top.” There are twelve of these benches located along the approach to the Memorial Building sitting on exposed aggregate pads adjacent to the sidewalks. Additional granite bench locations include six benches located around the perimeter of the sidewalk surrounding the Memorial Building. The benches were installed in 1933. The condition of these benches is good. Nonhistoric benches associated with the Visitor Center construction period and not included on the LCS are exposed aggregate concrete. The benches are placed in several locations on the site near sidewalks (see Figure 3.43). Many of these benches have chips, scratches, and discolorations apparent on the surface which is a result of skateboard and bicycle abuse. Due to this damage, the condition of these benches is fair.

Figure 3.41: Granite Bench, Photo by The Jaeger Company, 2005.

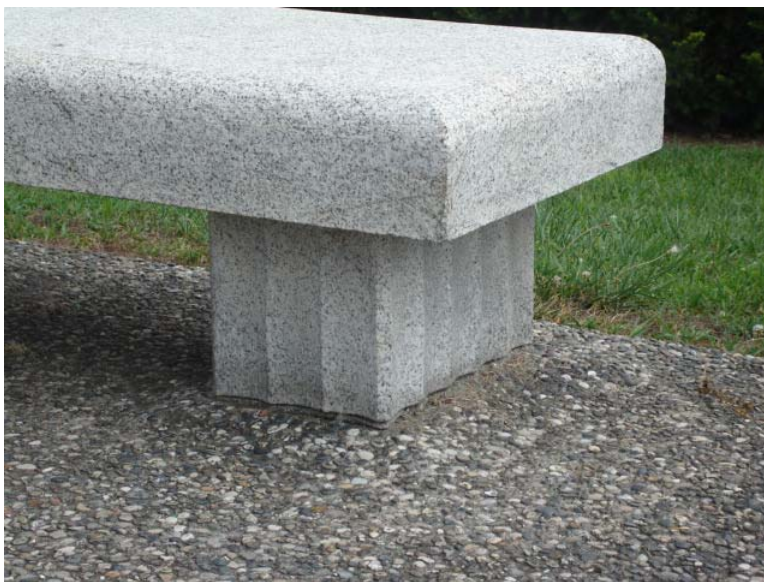
Figure 3.42: Detail of Granite Bench foot, Photo by The Jaeger Company, 2005.

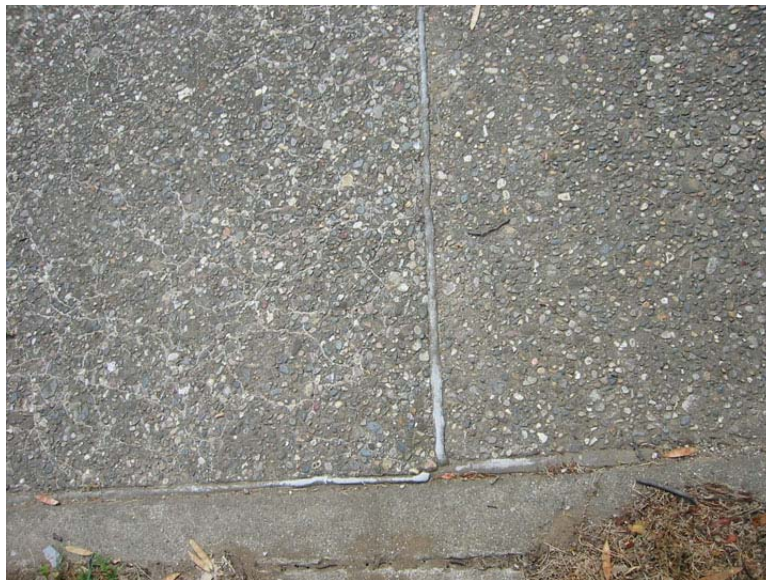
Figure 3.46: Typical exposed aggregate concrete sidewalk surface, Photo by The Jaeger Company, 2005.

Building Inholdings		Good		
Sidewalks	Figure 3.46	Fair	Areas of subsidence and cracking; Aggregate is inconsistent in size and color throughout park.	70165
Vehicular Circulation		Fair	Some areas of pavement cracking.	
Railroad Tracks	Figure 3.53
