George Rogers Clark National Historical Park

*Cultural Landscape Report/
Environmental Assessment
January 2008*

George Rogers Clark National Historical Park
Vincennes, Indiana

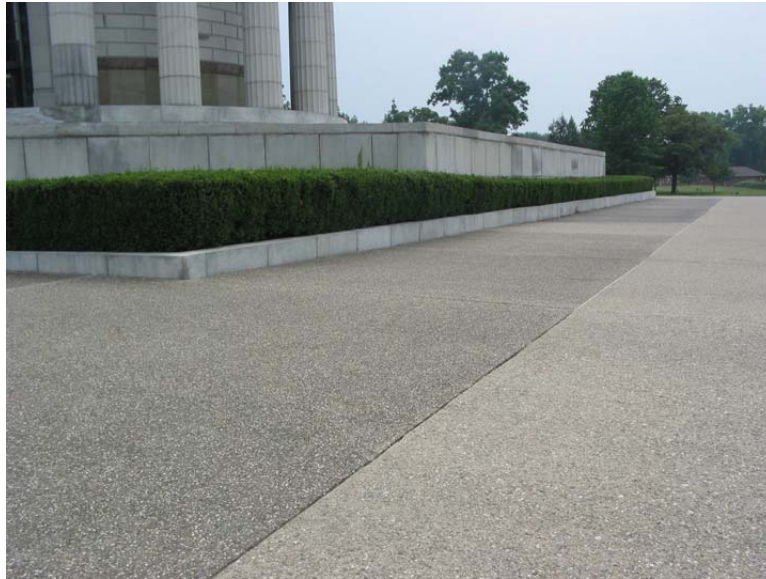
The sidewalks around the base of the Memorial Building are approximately fifty feet wide. The color of the aggregate closest to the Memorial Building is darker than that further away from the building (see Figure 3.47).

Figure 3.47: Contrast in aggregate colors adjacent to Memorial Building, Photo by The Jaeger Company, 2005.

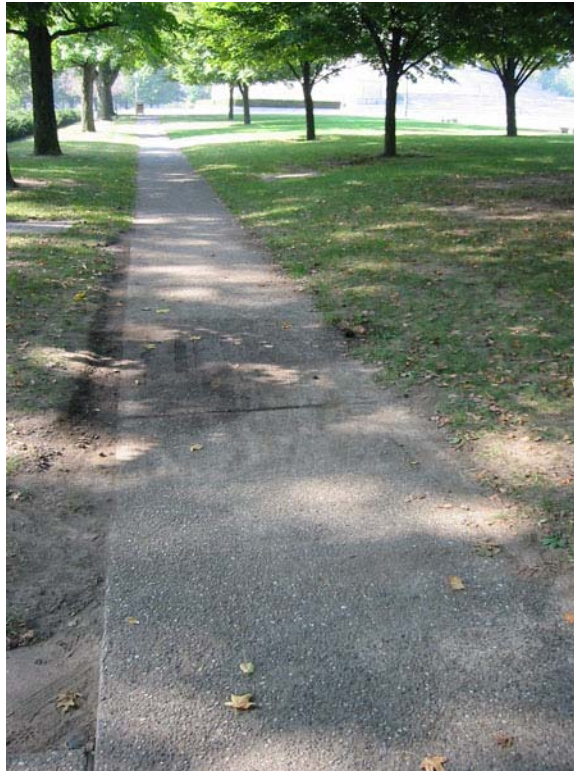
A five foot wide sidewalk serves as access from the east side of the Memorial Building to Vigo Street. This sidewalk runs north to south and parallels the property border with Saint Xavier Catholic Church. The pavement is lined by sweet gum and linden trees. This sidewalk intersects with a nearly eight-foot wide diagonal sidewalk which directs foot traffic from the South Terrace Area and Vigo Street to the entrance of the cathedral building. Sidewalks line the edges of the greenspace in this area. An almost mirror image of this sidewalk is present on the north side of Vigo Street leading from the North Terrace area down to the intersection of Patrick Henry Drive and Second Street. This greenspace is also bordered by sidewalks. All sidewalks in these areas are exposed aggregate concrete. The five foot wide sidewalk extending from the Memorial Building to Vigo Street is in poor condition at several locations and has subsided due to the settling of the underlying fill material (see Figure 3.48). In other locations the walkway is in good condition.

Figure 3.48: Area of concrete sidewalk subsidence, Photo by The Jaeger Company, 2005.

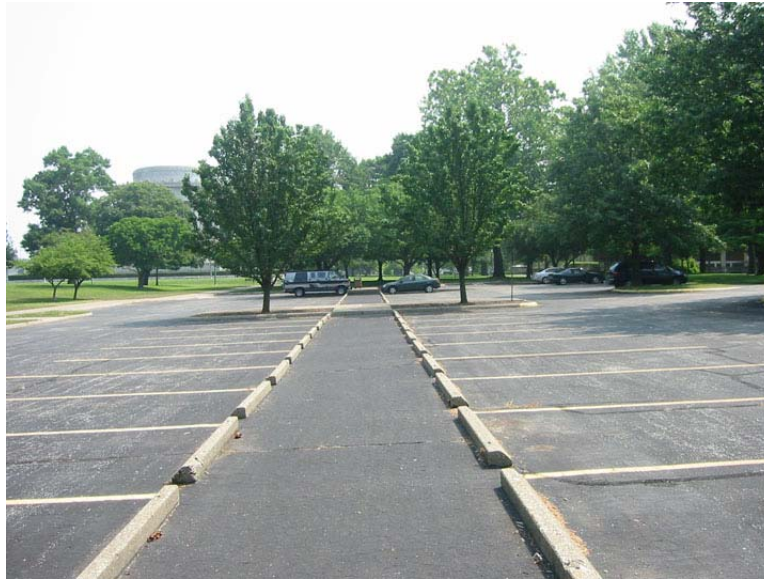
There is on-street parking both along Main Street and in front of the Visitor Center. However, most visitors to GERO who arrive via car typically park in the Visitor Center parking lot (see Figure 3.52). Although provisions for bus parking are made in the parking lot, conversations with park staff reveal that the turning radii for buses are inadequate and result in frequent visitor complaints. The parking lot is asphalt with painted striping and concrete curb stops. Several tree islands exist within the lot planted with Bradford pear trees. The southwest corner of the parking lot has sunken since original construction. Park staff speculates that the sinking has been caused by breakage of underground water lines. Because of this sinking and the fact that cracks and wearing are evident in some areas, the condition of the asphalt pavement in the parking area is fair.

Figure 3.52: View facing northeast in parking lot, Photo by The Jaeger Company, 2005.

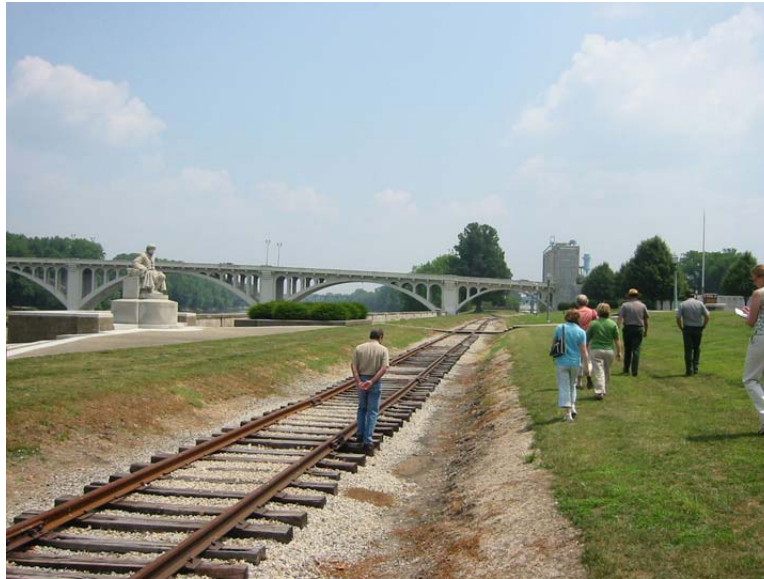
Although the original design for the Memorial Grounds called for a boulevard along the river, the retention of the railroad tracks in the proposed location has negated installation of this major design feature. Although the tracks predate the Memorial Era period of significance, they are not considered contributing to the design and are a barrier to universal access to the riverfront (see Figure 3.53). They currently receive very minimal use by cars reaching the grain elevator northeast of the site.

Figure 3.53: Railroad tracks with Vigo Statue and Lincoln Memorial Bridge in the background, Photo by The Jaeger Company, 2005.

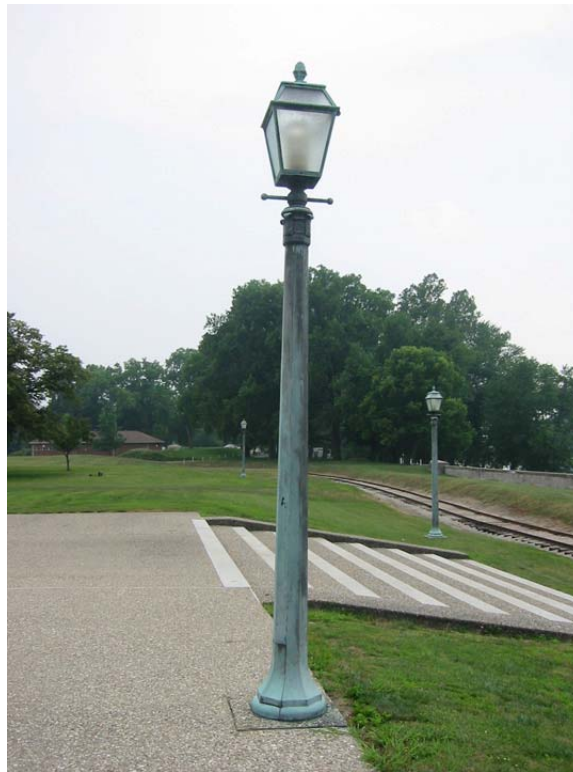
“topped with an ornamental ear of corn.”⁴⁴ There are two sizes of light standards. Ten foot standards are present in front of the Memorial Building and twelve foot standards are typical near street corners. The maintenance of these standards includes periodic cleaning and waxing.⁴⁵ In 2005 all of the wiring and bulbs in the fixtures were updated to meet contemporary electrical standards. The condition of the street lamps is good.

Figure 3.62: Typical street lamp, Photo by The Jaeger Company, 2005.

According to research conducted by GERO staff, replacement lamp posts are not commercially available for the historic street lamps. In the event that lamp posts are irreversibly damaged, NPS will have to make a decision on whether to copy and fabricate new posts based on the historic design or to replace with a post as similar to the original design as possible. A copy replacement is preferred, but this option may be cost prohibitive. The Indiana State Historic Preservation Office should be consulted in the event that replacement is needed.

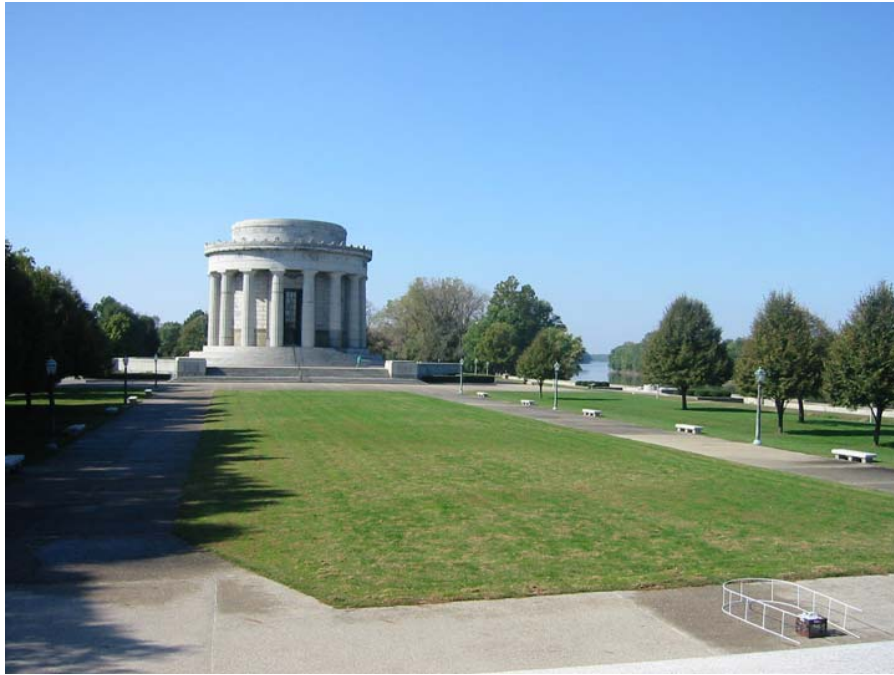
River are more open due to the missing trees within the Linden allée (see Figure 4.3 and Figure 4.4). The visual connection between the Memorial Grounds and the riverfront is interrupted by the railroad spur which parallels the Floodwall. These tracks disrupt the intended consistent lawn graded down toward the riverfront. The view down Second Street toward Saint Francis Xavier Cathedral is intact and still terminates at the Cathedral with the Gibault Statue in the foreground. However, in the original Parsons plan, this view would have been framed by the hardwood boundary trees.

Figure 4.4: View from Bridge Approach across Mall toward Wabash River, Photo by The Jaeger Company, 2005.
