SAN FRANCISCO  
PORT OF EMBARKATION  
HISTORIC STRUCTURE REPORT

Golden Gate National Recreation Area  
National Park Service

ARCHITECTURAL RESOURCES GROUP

February 1991

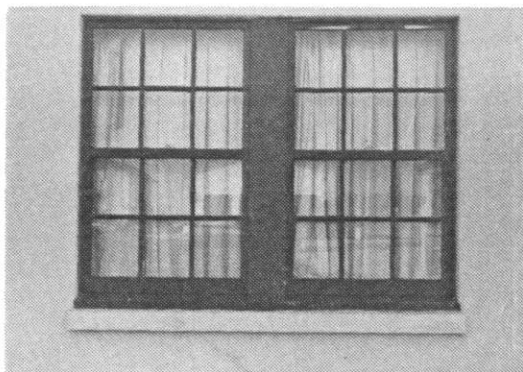
Factory sash in Pier Shed 3 with a bowed frame.

Missing muntins, sashes and frames should be replaced and matched to original.

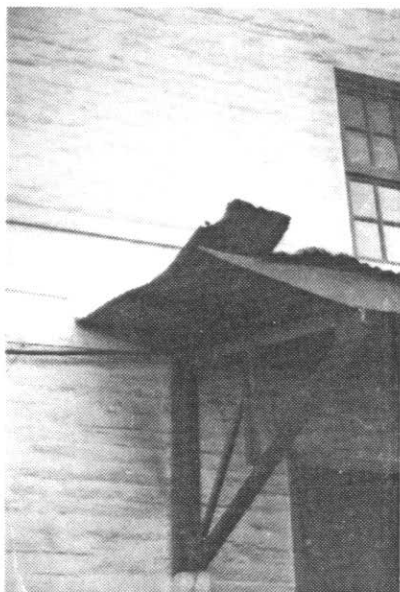
Both the siding and the soffit panels of the elevated passage have light to moderate corrosion.

Damaged awning on  
Building 314

1. Repair or replace deformed awning components.
2. Scrape loose or flaking paint and remove all corrosion from metal by wire brush.
3. Prime bare metal and paint all metal using appropriate coating of the same system for use on exterior ferrous metals. Finish coat color should match existing.
4. Check all metal biannually for any areas of corrosion. Remove corrosion and re-coated surface.
5. Areas where birds roost should be covered with specially manufactured bird netting sensitively installed.

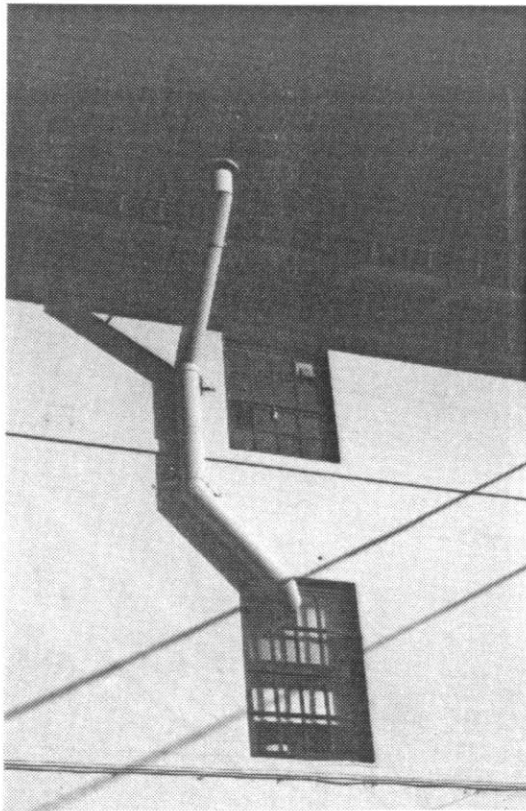
*Duct attached to exterior wall of Building 314.*

All non-functioning appendages should be removed from the buildings. The military orderliness should be replicated when appendages are added or re-configured. Standard designs should be adopted for conduit types, meters, vents, fire alarm boxes, etc.

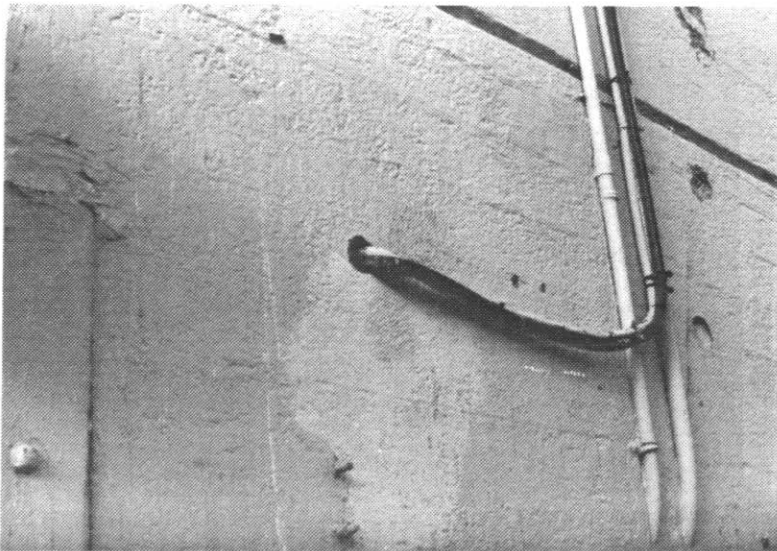
*right -- Rain gutters and leaders.*

*below -- Electrical conduit applied to and penetrating concrete wall.*

1. Repair and replace broken gutters and leaders. Broken joints should be re-soldered. Patching, if necessary, should be done with copper of same weight, configuration, and temper secured in place by soldering.
2. Check all drains and clear obstructed roof drains. Check monthly for obstruction, and more frequently during periods of heavy rains.

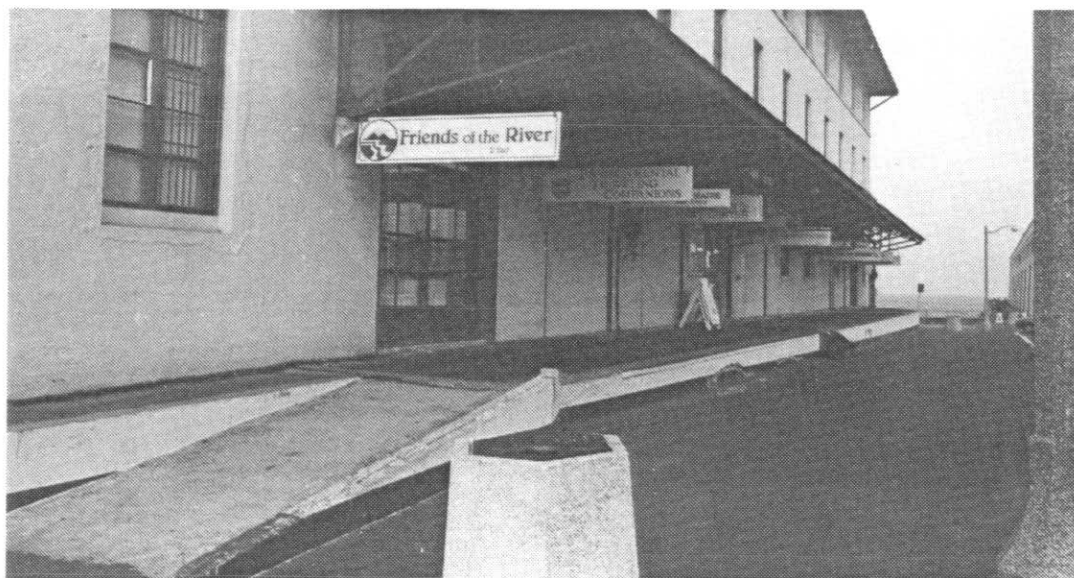
Large cracks with corresponding displacement of walls and sinking of decks were noted in the porch walls. This damage may have been caused or exacerbated by the October 1989 earthquake.

*Settling on a loading dock caused by the 1989 earthquake.*

The loading docks should be examined by a structural engineer to determine stability and feasibility of repair. Pedestrians should not be allowed on decks which are sunken or displaced.

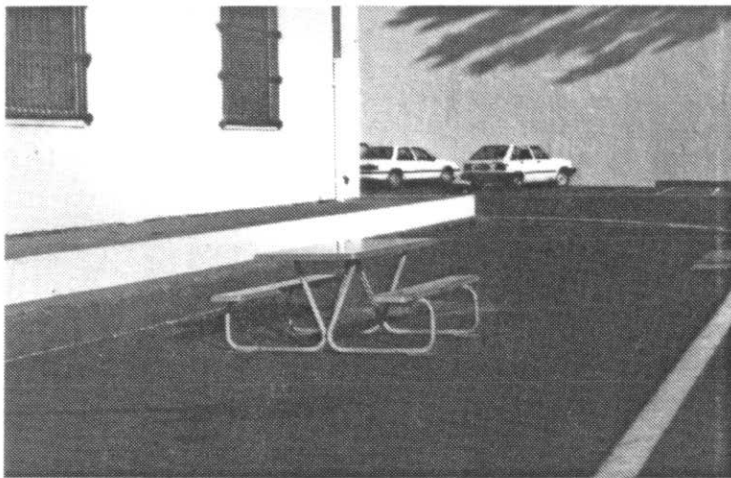
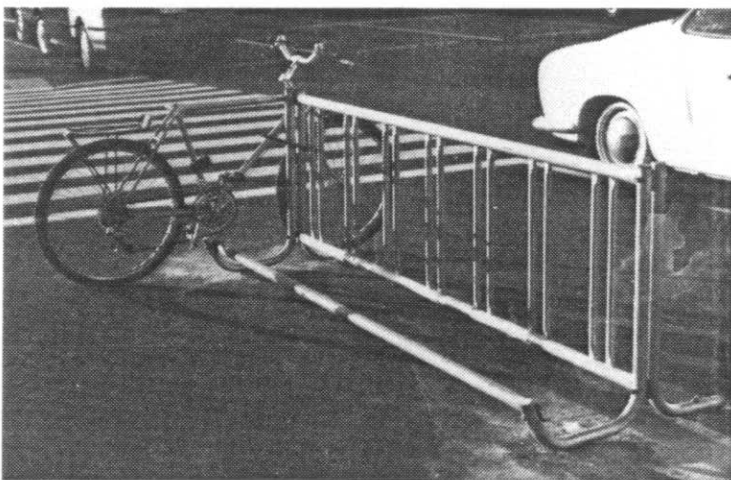
Photos above illustrate the inappropriate placement of picnic and bicycle facilities.

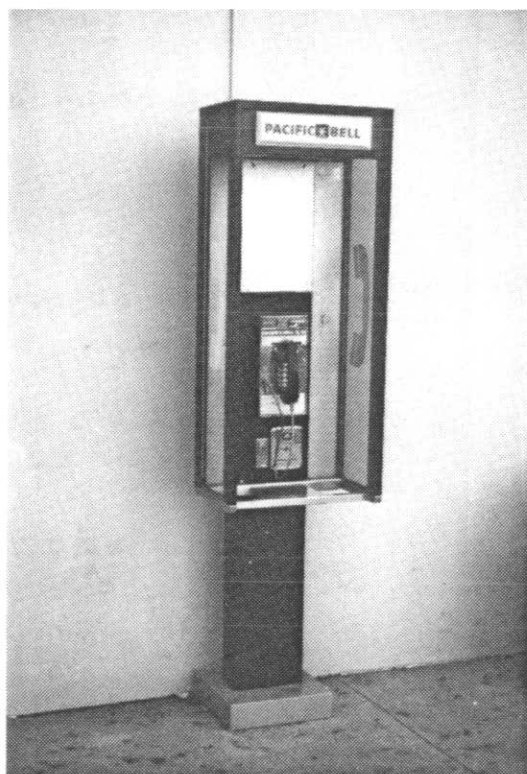
*left -- Public telephone  
and trash container of  
an inappropriate type.*

**Trash Containers.** Containers typically used in parks or public spaces are inappropriate as they detract from the character of the site. It is recommended that containers with an industrial character be used throughout the site.

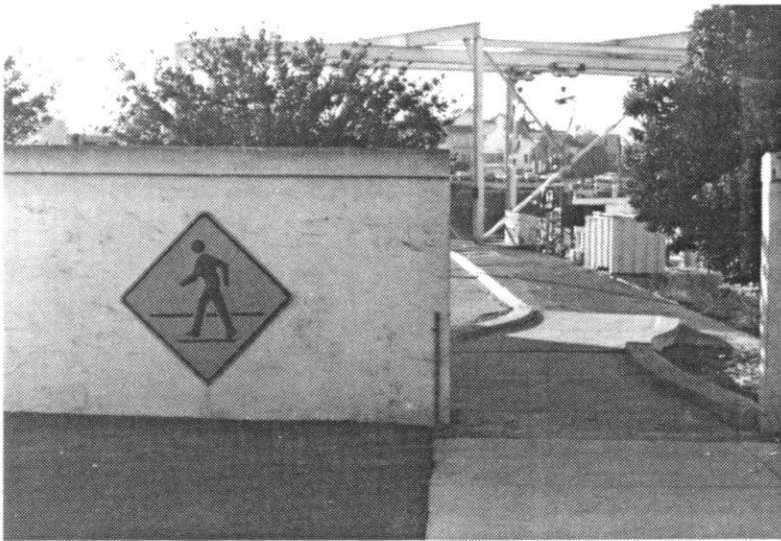
*above -- A sign that is too large. In many situations smaller signs should be considered.*

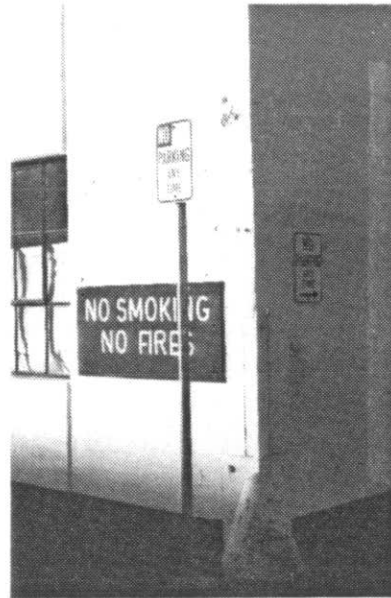
*right -- Sign clutter is an unsightly problem ameliorated by an organized sign system, part of an overall site plan.*
