Jean Lafitte National Historical Park and Preserve

Chalmette National Cemetery

Superintendent's Lodge

Historic Structure Report

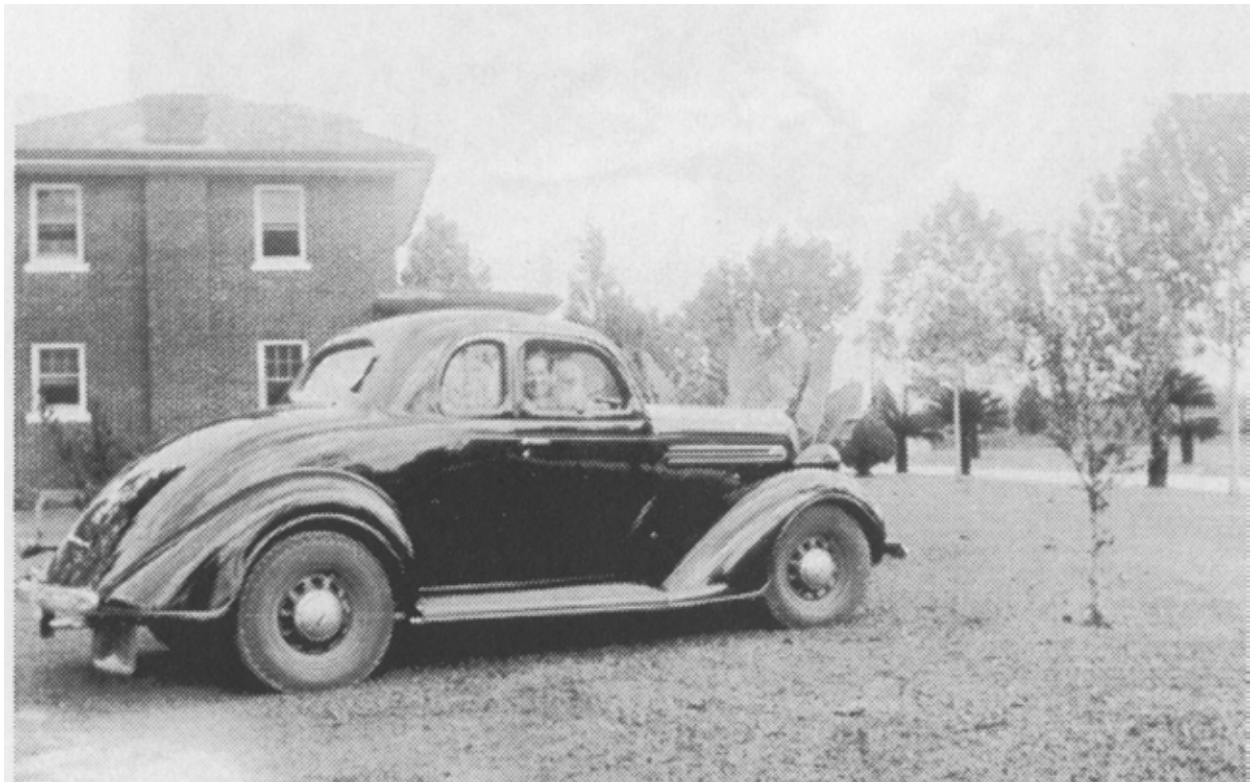
FIGURE 11. The earliest known image of the Chalmette Cemetery lodge, c. 1937. Note the chimney on the southeast side of the house, although it appears to have already lost part of its stack by the time this image was made. (From Risk's Cultural Landscape Report)

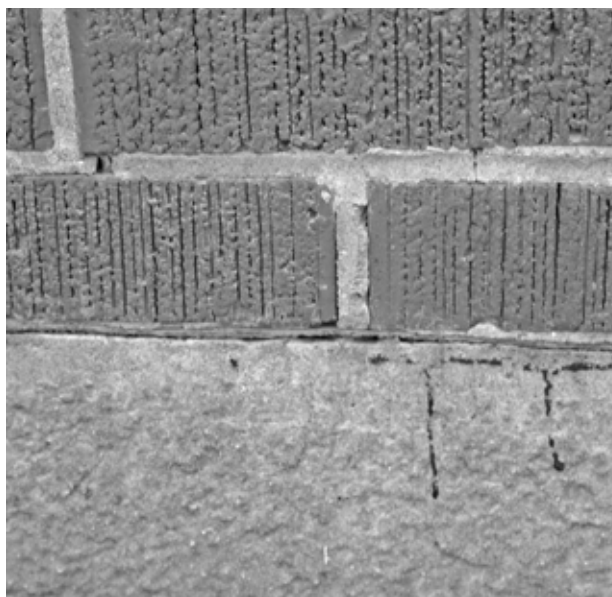
FIGURE 28. View of juncture of brick veneer wall and concrete foundation, with damp-proof course visible.

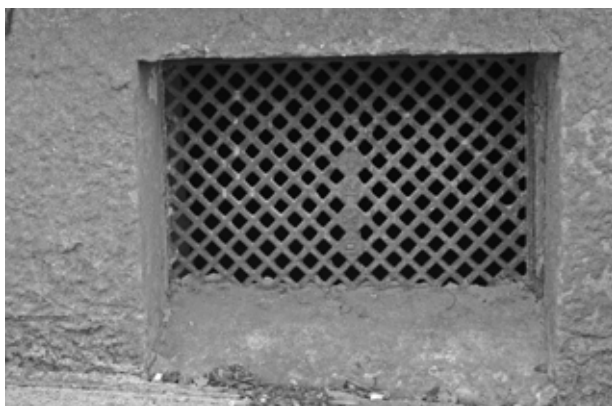
FIGURE 29. View of typical porch foundation vent.

Existing Condition. Although the foundation could not be directly observed below grade, the above-grade portions appear to be in excellent condition, with no cracking or other signs of differential settlement. One of the metal ventilation grills in the rear foundation is missing, and the remaining grills and the top-hinged crawl-space-access door are rusting.

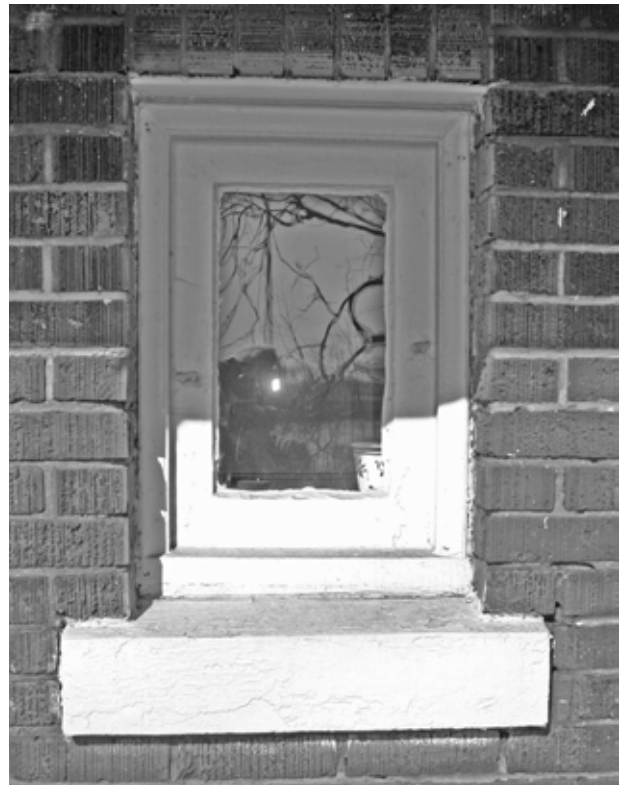
FIGURE 31. View of wood-framed window with typical cast-iron angle-iron lintel and cast-stone sill.

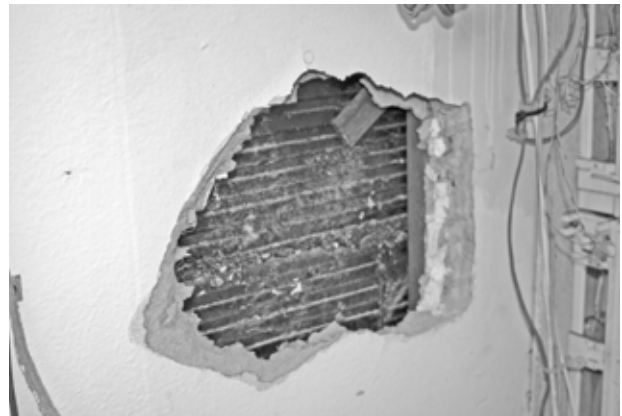
Existing Condition. As with the foundation, there are no signs of cracking or differential settlement in the exterior walls of the house. In the limited areas in which the clay tile could be observed, interior water-proofing appears to remain intact and in good condition. There has been some minor repointing of the brick veneer, and much of the dark-gray color of the mortar has been lost as lime has leached to the service.

FIGURE 32. View of water-proofed interior face of structural clay tile walls behind plaster-board walls.

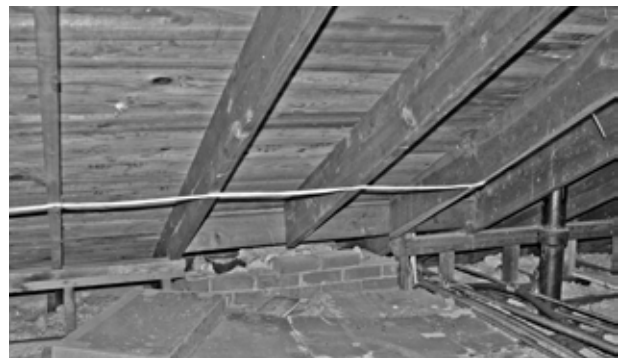
FIGURE 33. View of attic framing.

Existing Condition. Framing appears to be in mostly good condition. The exceptions are the additions on the back porch where the sole plate for the 1965 addition is almost completely rotted away and there is some termite damage in the northeast wall of the 1952 bathroom addition. There is also likely damage to the outer ends of the rafters for the sleeping porch roof. In addition, only a small fraction of the floor joists could be examined, and it is likely, given the framing's proximity to the ground, that other, probably minor damage, may be discovered.

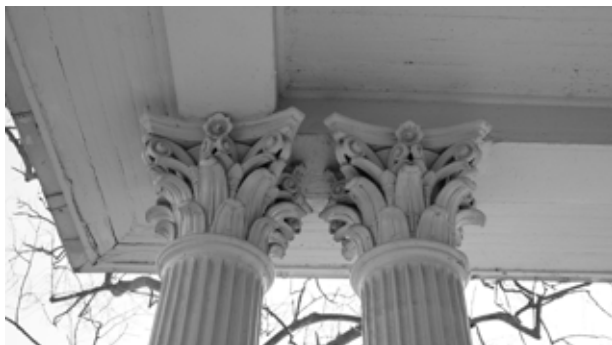
FIGURE 34. View of typical column capitals.

Existing Condition. Except for the alterations to the rear porch and damage to the rear porch's soffit, which will be discussed below, the porches remain in reasonably good condition. Some rusting of the columns is evident, but the floor slab and ceiling remain in good condition. The additions to the rear porch were constructed in a way that does not impact the columns or headers and appear to have done only minimal damage to the ceiling boards.

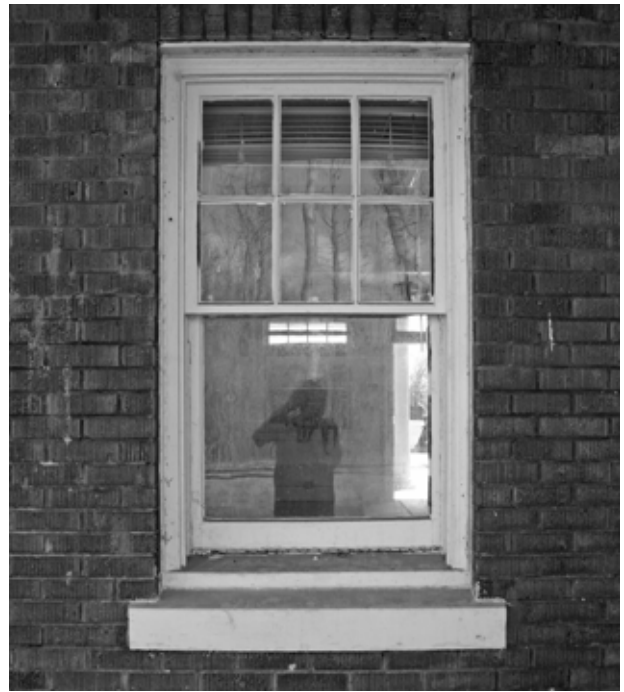
FIGURE 37. A typical 6/1 window.

Existing Condition. Windows and doors are in mostly good condition, although built-up paint and broken sash rope have rendered some sash inoperable, and a few panes of glass are broken.

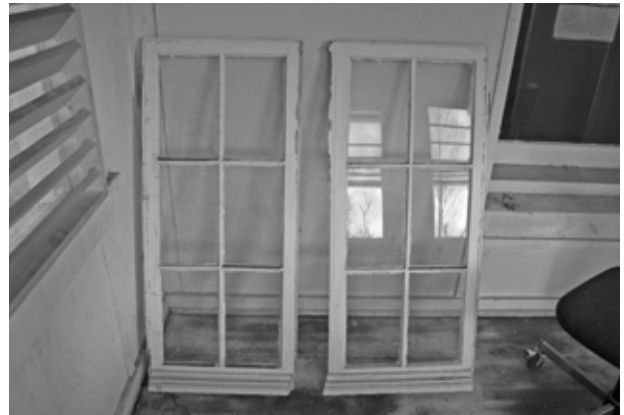
FIGURE 38. One of the surviving pairs of original sleeping porch windows.

The second-floor sleeping porch was originally constructed with ten pairs of six-light casement windows, 1'-9" by 4'-0" by 1-3/8", mounted on 3" butt hinges. The eight pairs of windows across the rear of the porch have since been replaced with 1/1 aluminum windows, but the original pair of windows at each end of the porch remain intact.

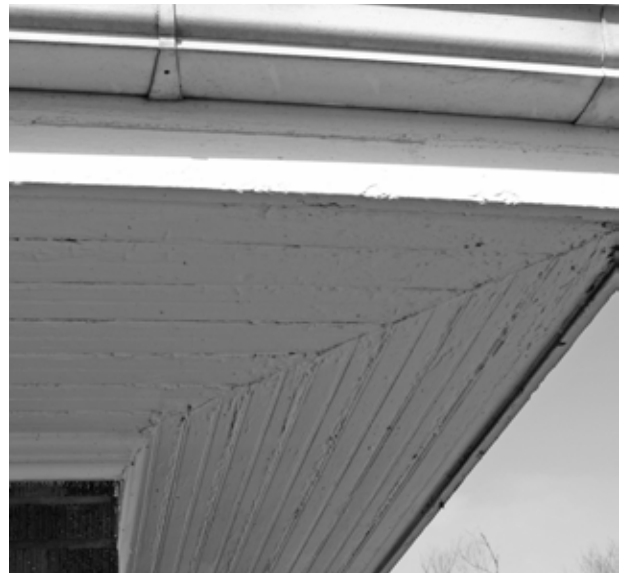
Existing Condition. Eaves are in good condition except on the back porch. There, an eight-foot section near the middle of the porch has been severely damaged by water penetration, probably through faulty flashing around a plumbing vent stack that penetrates the eaves at that location.

FIGURE 43. View of southeast corner of eaves on main block.

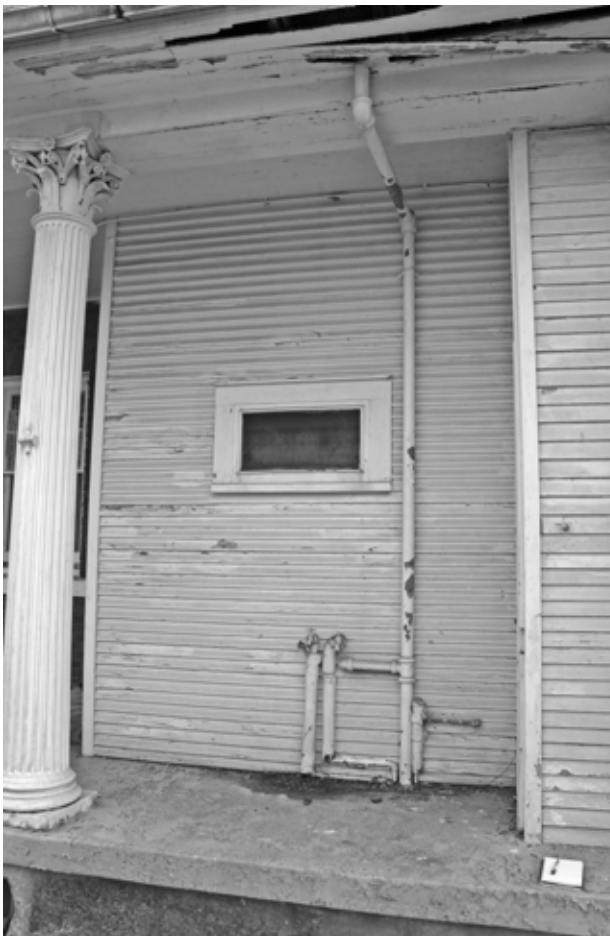
FIGURE 46. View of added bathroom.

Existing Condition. While the siding appears to be in good condition except for deteriorating paint, removal of a run of siding on the northeast side of the bathroom revealed significant termite damage between the sheathing and the siding. The 1965 siding remains in good condition, and because of its elevation, the sleeping porch may not have suffered damage.

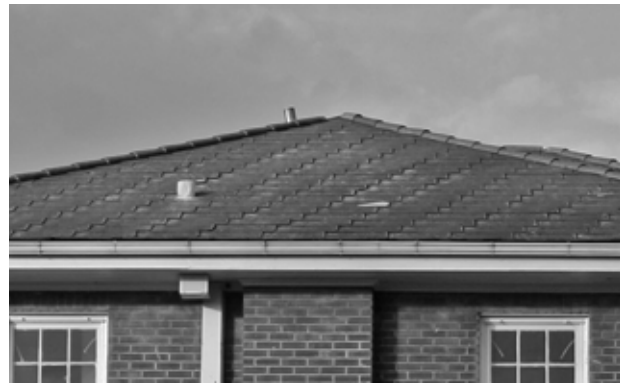
Existing Condition. The surviving cement- asbestos roof covering appears in good condition but significant damage was done to the northeast shed of the main roof when the chimney collapsed in the 2005 storm. All of the ridge cap is also missing from the north ridge of the roof. The other roofs appear to be functioning, although the pent roof at the rear porch is rusting. The condition of the tar- and- gravel roof of the sleeping porch was not examined. Gutters are in fair condition, but appear to be undersized. Along with temporary repairs to the roof in the fall of 2005, temporary extensions were added to the downspouts to keep run- off away from the house.

FIGURE 47. View of southwest shed of main roof.

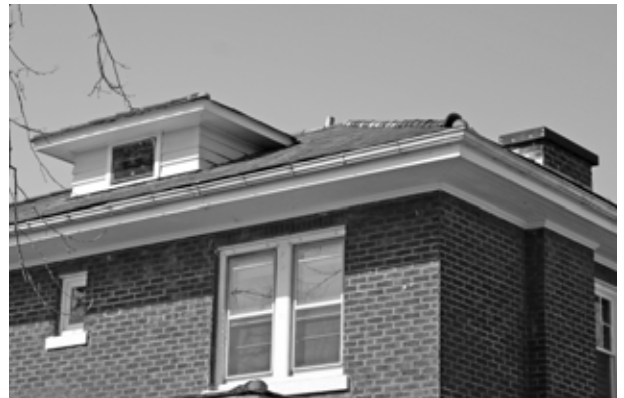
FIGURE 48. View of front dormer and capped chimney.

The house has three brick chimneys, but none of them is intact above the roofs. The principal chimney, located on the northeast side of the house, was destroyed during the recent hurricane. It has two flues which originally served the living room fireplace and a wood- burning stove in Room 201. Five feet wide at its base, this chimney corbels to about 44" at the height of the first floor window lintels before rising through the eaves and the roof. Originally rising some 7- 1/2' above the roof, the upper portion of this chimney was largely destroyed during the recent hurricane. The cast- stone coping which measures 4" by 21" by 46" and originally capped the chimney, is now leaning against the front porch. The chimney has been temporarily capped just above the roof line, and brick from the chimney are piled near the northeast end of the porch.

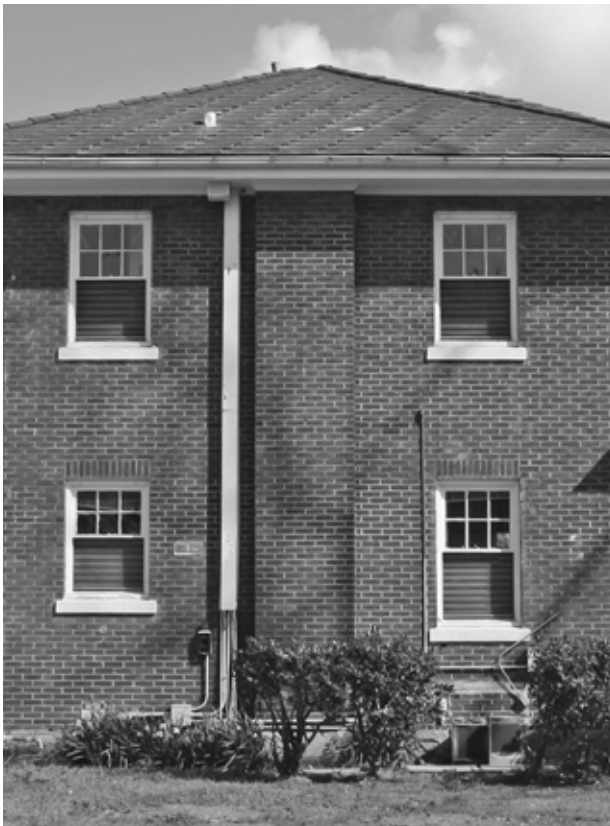
FIGURE 51. View of southwest chimney.

The chimney on the southwest side of the house is also an original chimney, but the stack above the roof was removed as early as the 1940s or early 1950s. Forty- two inches wide, this chimney also has two flues, which originally served wood- burning stoves in Rooms 102 and 103.

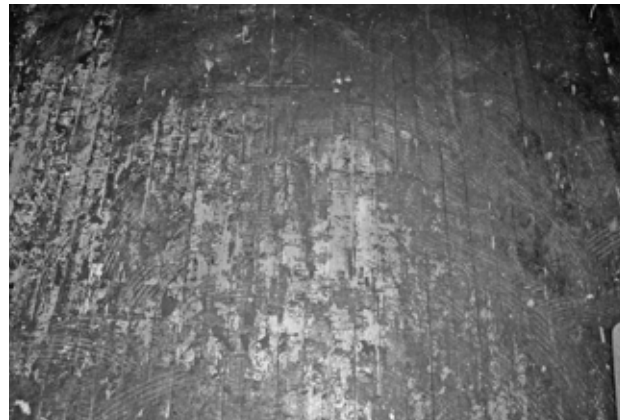
Existing Condition. In spite of flooding, the flooring remains in surprisingly good condition, with only minimal cupping and with buckled flooring only in one or two isolated locations. It is unclear, however, how much permanent discoloration has occurred due to water damage. Mastics from rubber or vinyl floor coverings cover much of the flooring in Rooms 103 and 206, although the vinyl floor covering itself has been removed. In room 203, sheet vinyl was installed over 9" by 9" vinyl tiles, much of which remains intact, although in poor condition. Remnants of carpet backing adhere to the flooring in Rooms 101, 102, and 104. The flooring in Rooms 201, 202, 204, and 205 remains in good condition.

FIGURE 53. Oak flooring in Room 103 with mastic from vinyl floor coverings.

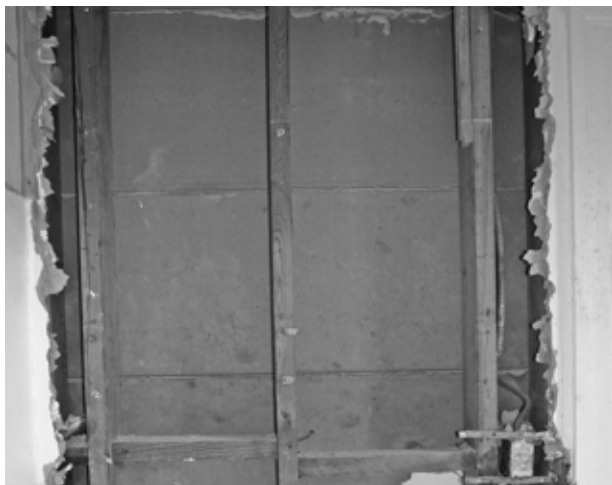
FIGURE 56. View of wall in Room 103 with rock lath in adjacent room exposed.

Existing Condition. In spite of flooding, most of the surviving interior plaster remains sound. Most plaster has been removed from the southeast wall of Room 103, and there is significant ceiling damage in Room 205. All of the fiberboard in Room 105 and all drywall in Room 106 were removed during stabilization after the flood. Fiberboard remains mostly intact in Room 206, except for some holes punched in the back wall and a panel of the ceiling which has been removed. Painted finishes on all surfaces are in fair to poor condition, with significant peeling and flaking in the kitchen and bathroom.

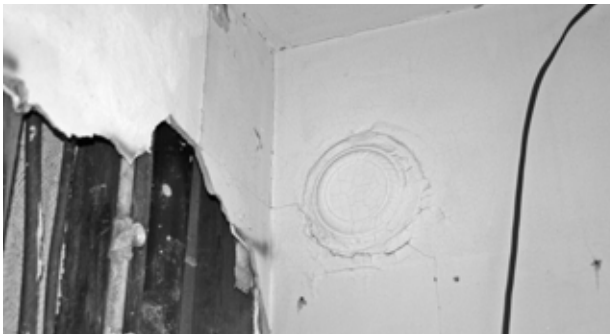
FIGURE 67. View of original stove flue in south corner of Room 103.

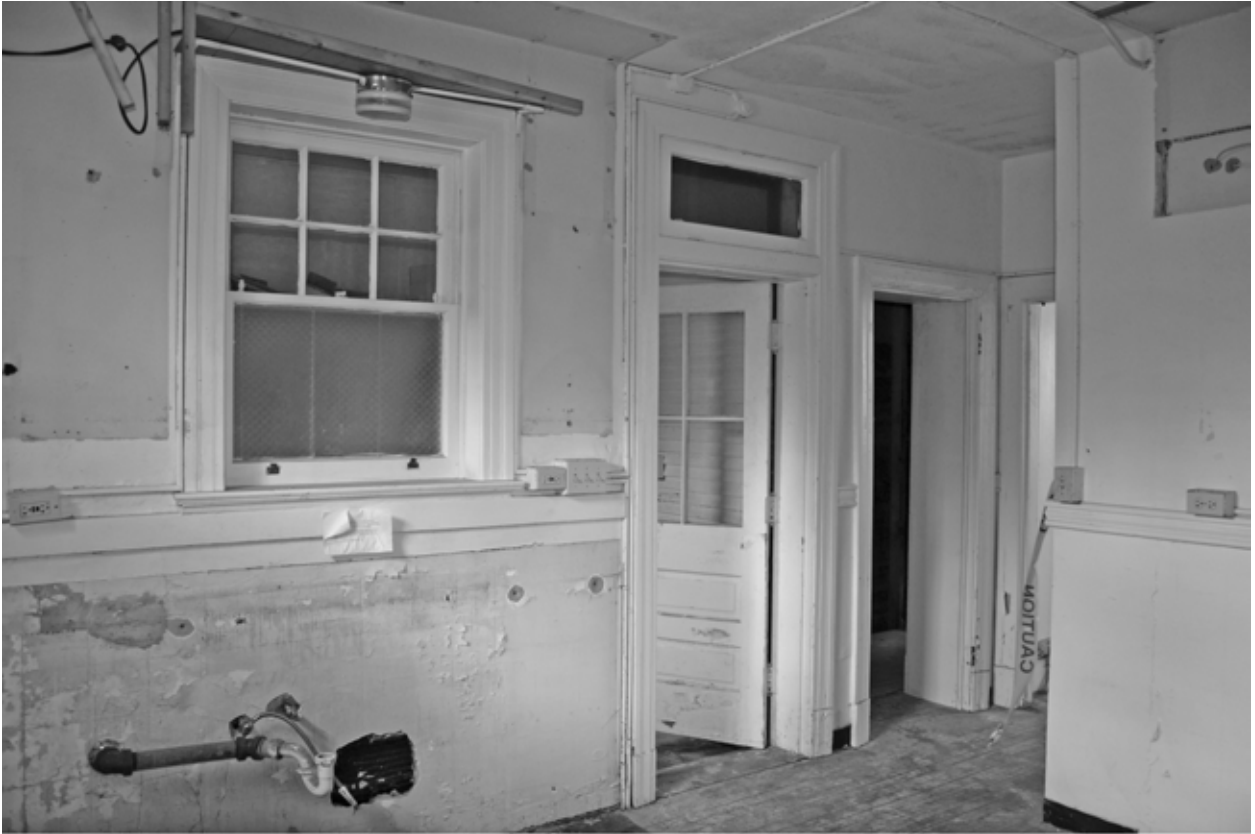
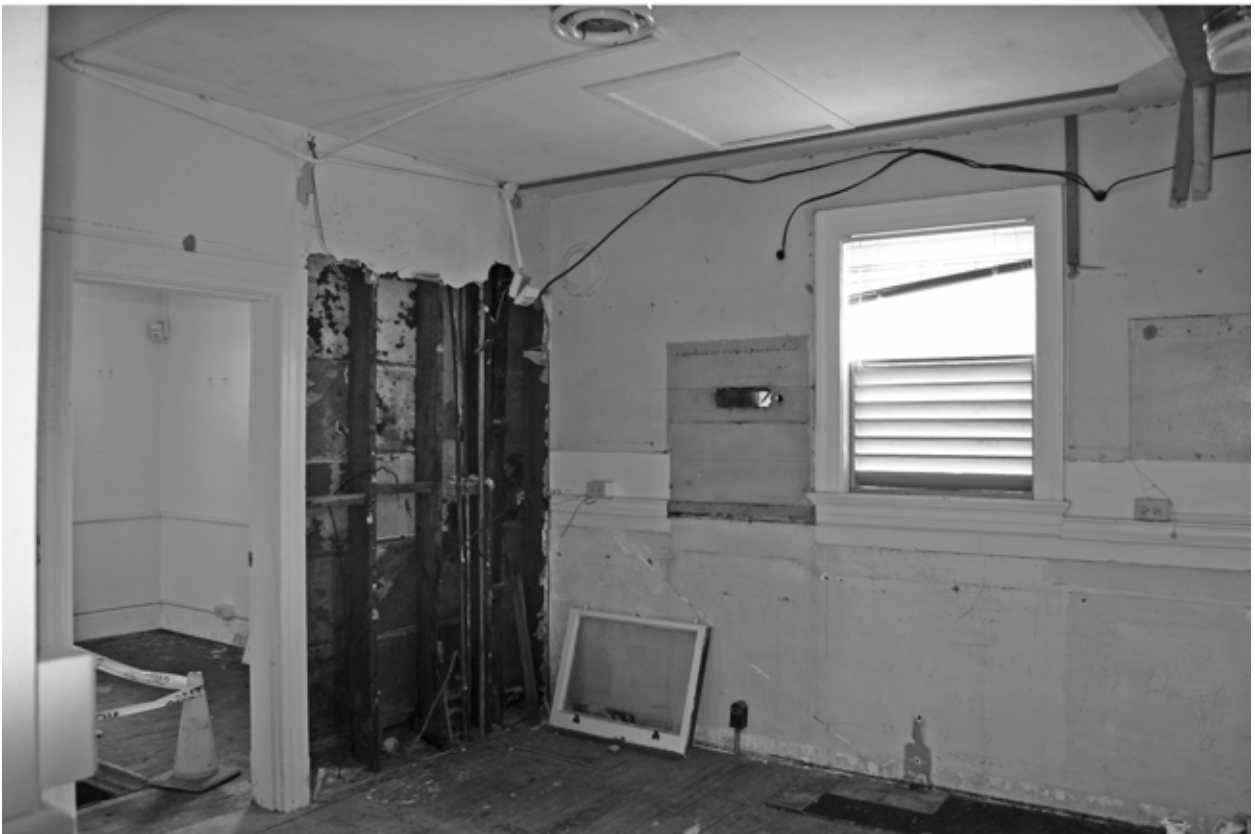
Kitchen (103)

FIGURE 70. View north (above) and south (below) in Room 103.

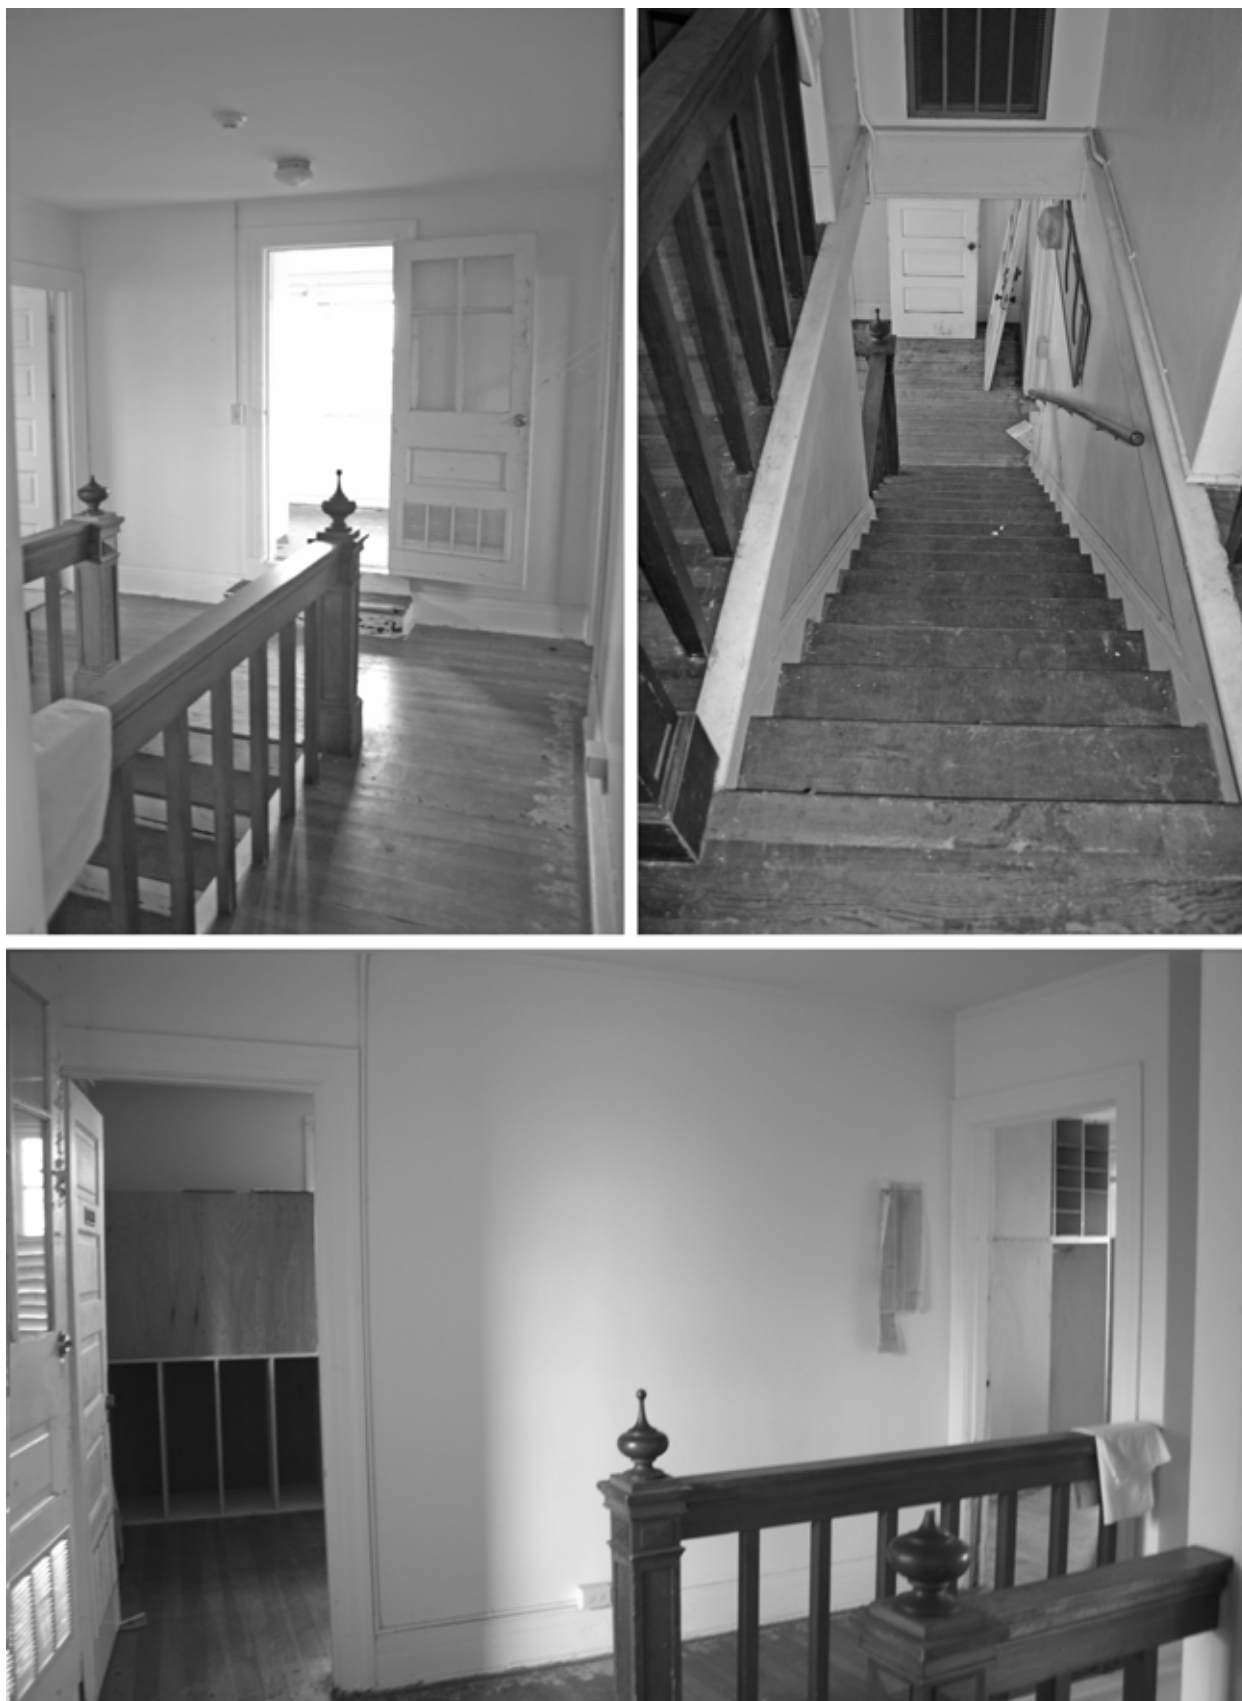
Stair Hall (204)

FIGURE 73. View west (upper left), southeast down staircase (upper right), and east (below).

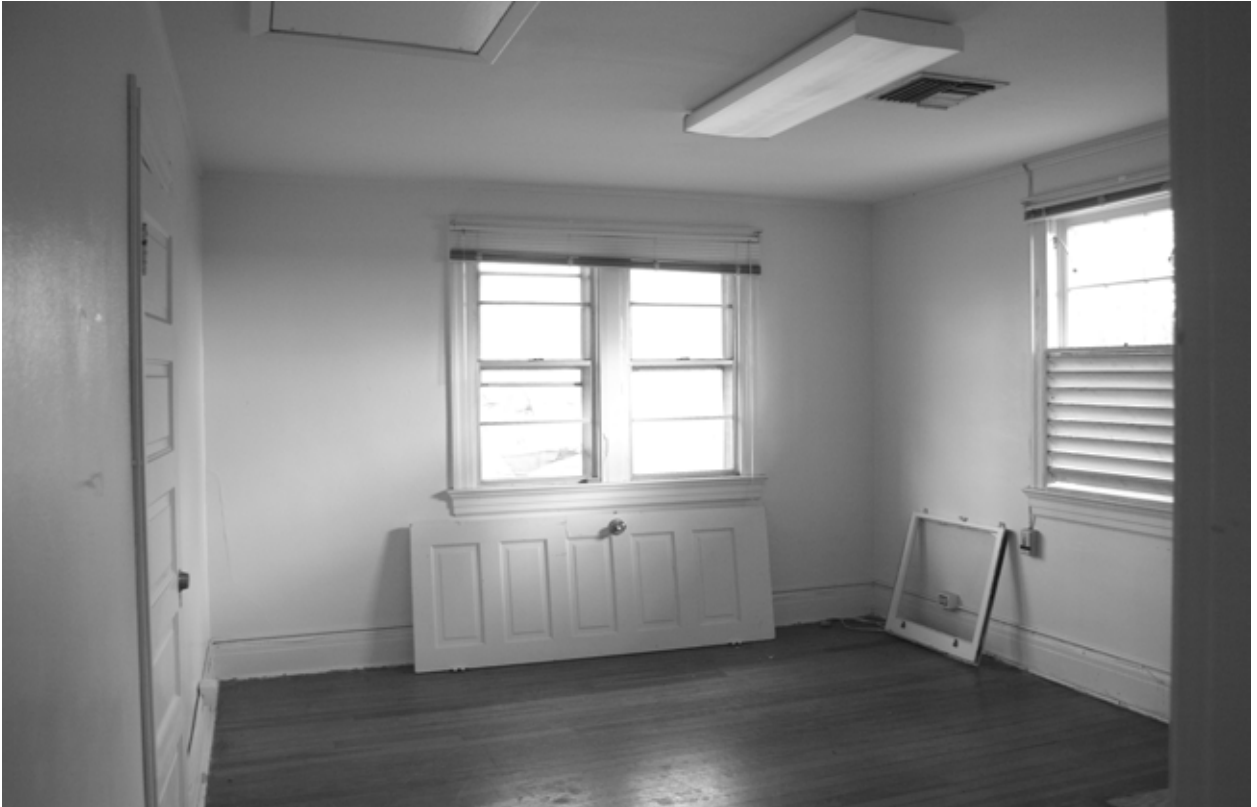
Master Bedroom (202)

FIGURE 74. View south in Room 202.

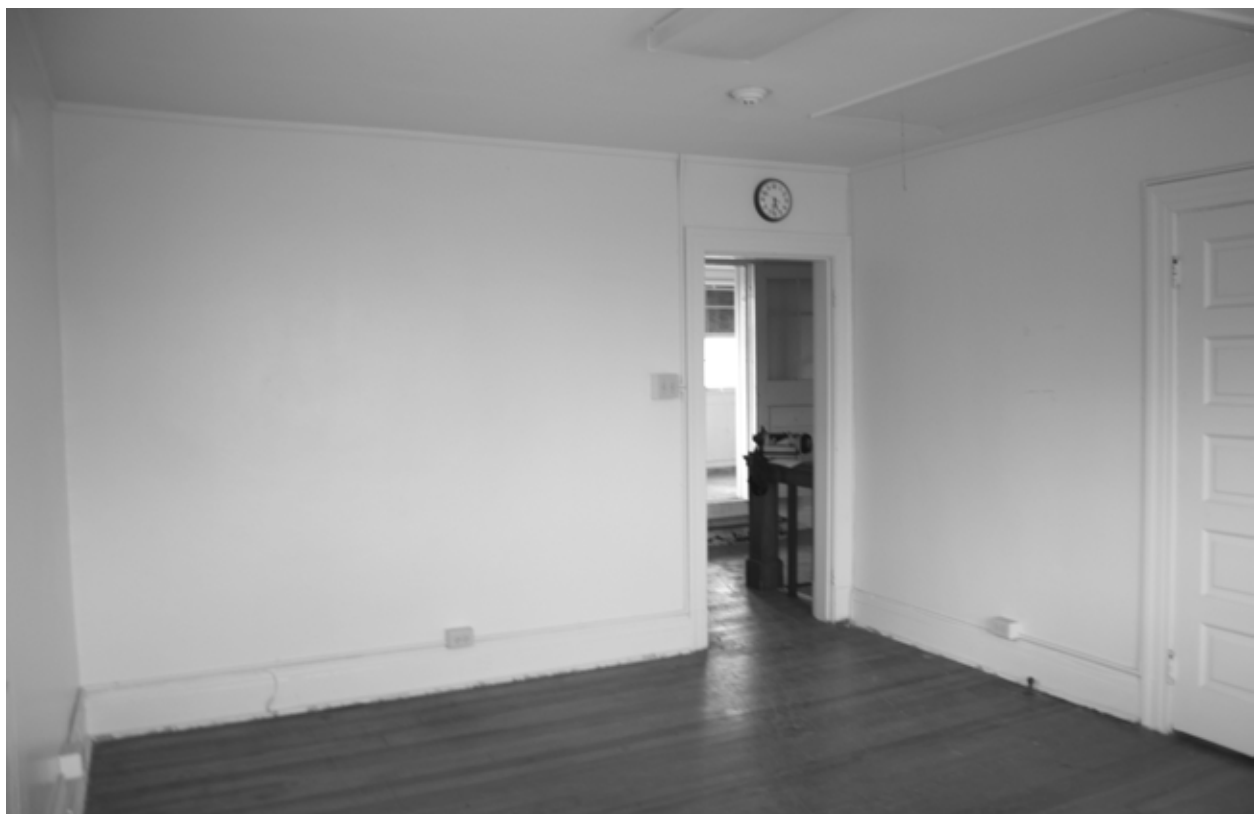
FIGURE 75. View north in Room 202.
