# KALAUPAPA

HISTORIC STRUCTURE REPORT

ST. PHILOMENA CATHOLIC CHURCH  
(FATHER DAMIEN'S CHURCH)

January 1985

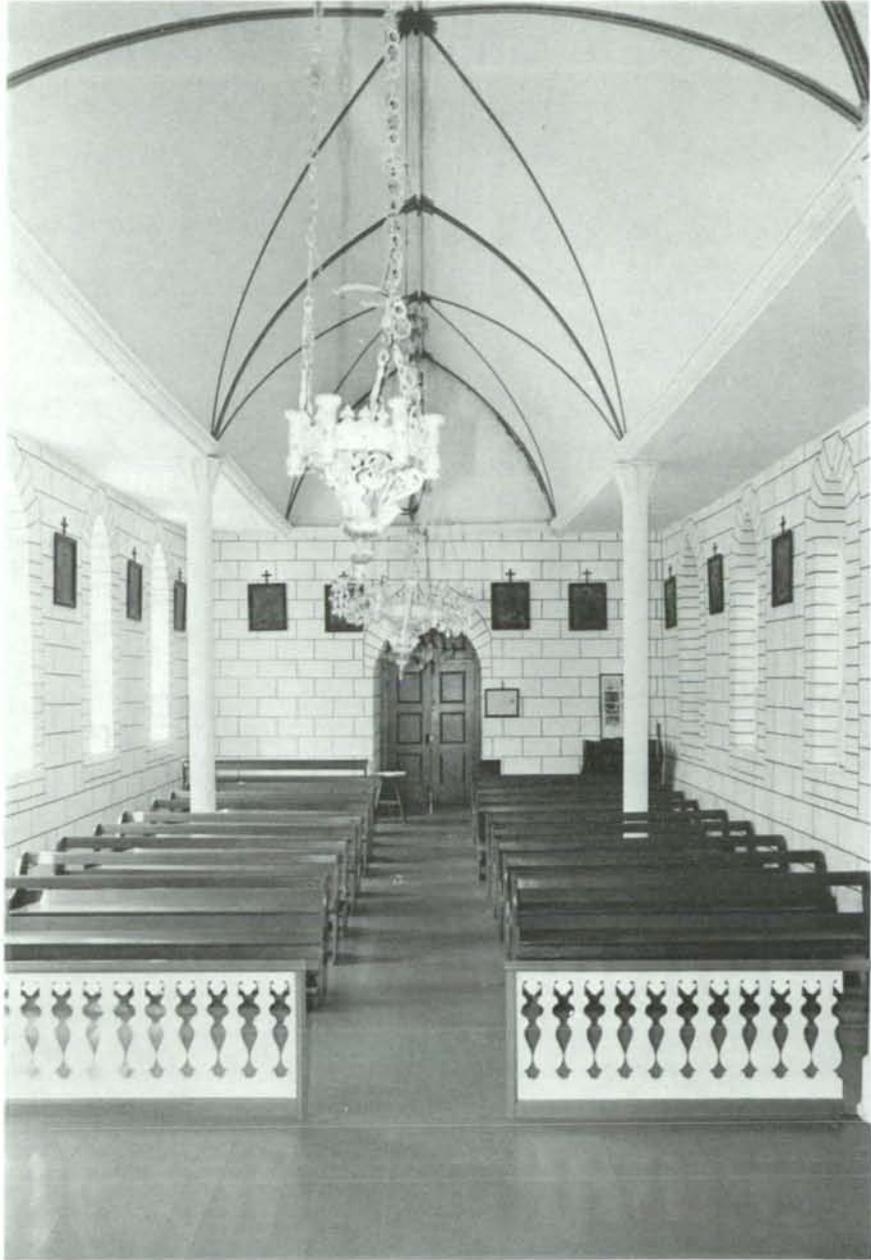
Illustration A6.

The poorly flashed junction of the main roof at the tower (Illustration A38) has allowed water to penetrate the building, causing deterioration of the anchoring of the wood cornice across the south nave wall and damage of two stations of the cross. The flashing at the intersection of the low roof ridge to the high roof is not secure and will become a major leakage point if not repaired (Illustrations A39 and A40). The roofing of the west portico is no longer secured due to extreme wood deterioration of the roof structure (Illustration A13).

The 1888 nave as viewed from the crossing. The plastered masonry walls are painted white with the stone block pattern painted on in red. The flat 'side-aisle' ceilings and vault are of wood boarding and painted light blue. Columns and cornices are white. Water and dirt stains at the junction of the vault and wall are due to leakage at the roof to tower flashing. This leakage has damaged the stations of the cross on the south wall. 8/84. P.C.C.

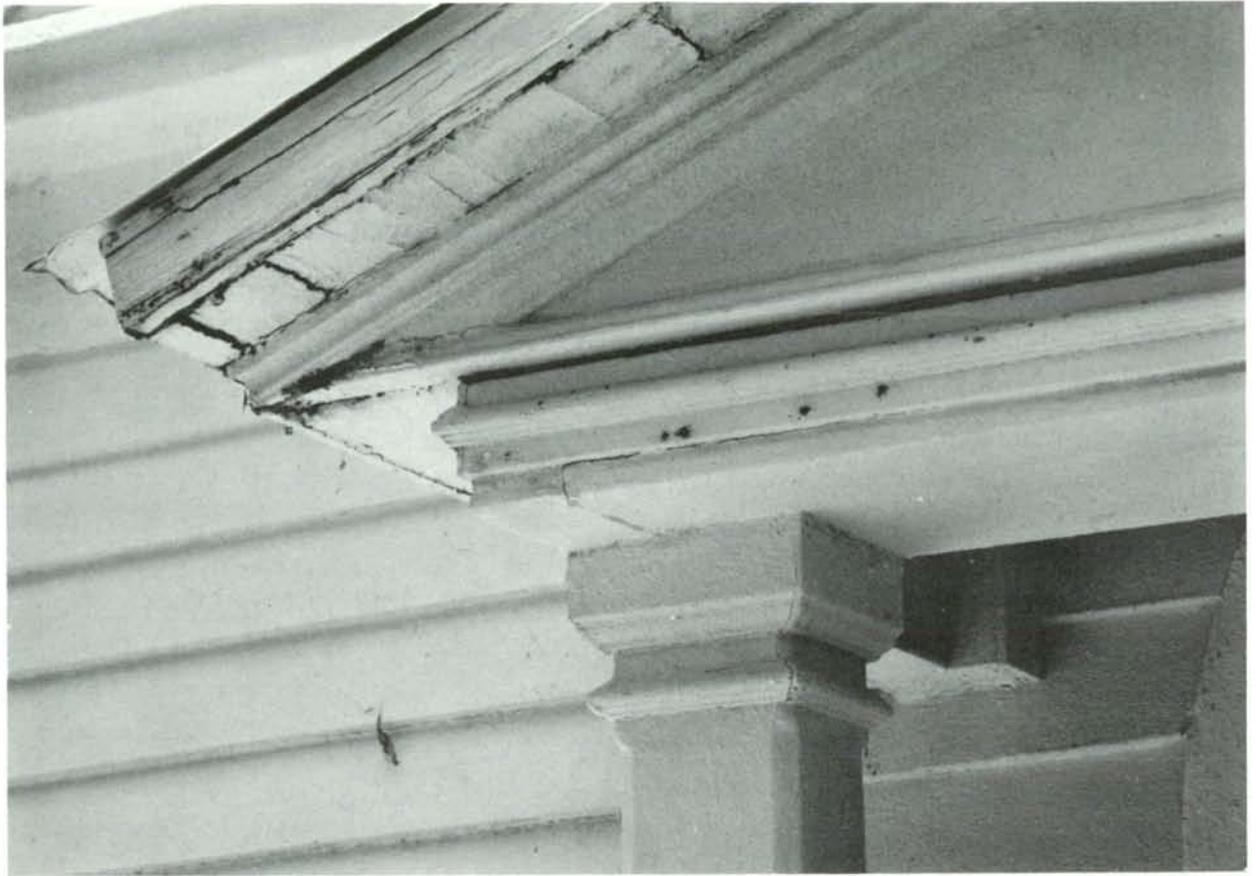
Illustration A14.

Detail at 'northwest' corner of 'west' portico roof, 1876 nave. Framing, sheathing, trims and moldings are extremely deteriorated due to air-borne termite damage and rot. Note the sand-textured paint. All of the wood sections of the building are finished in this manner. 6/84. R.L.C.

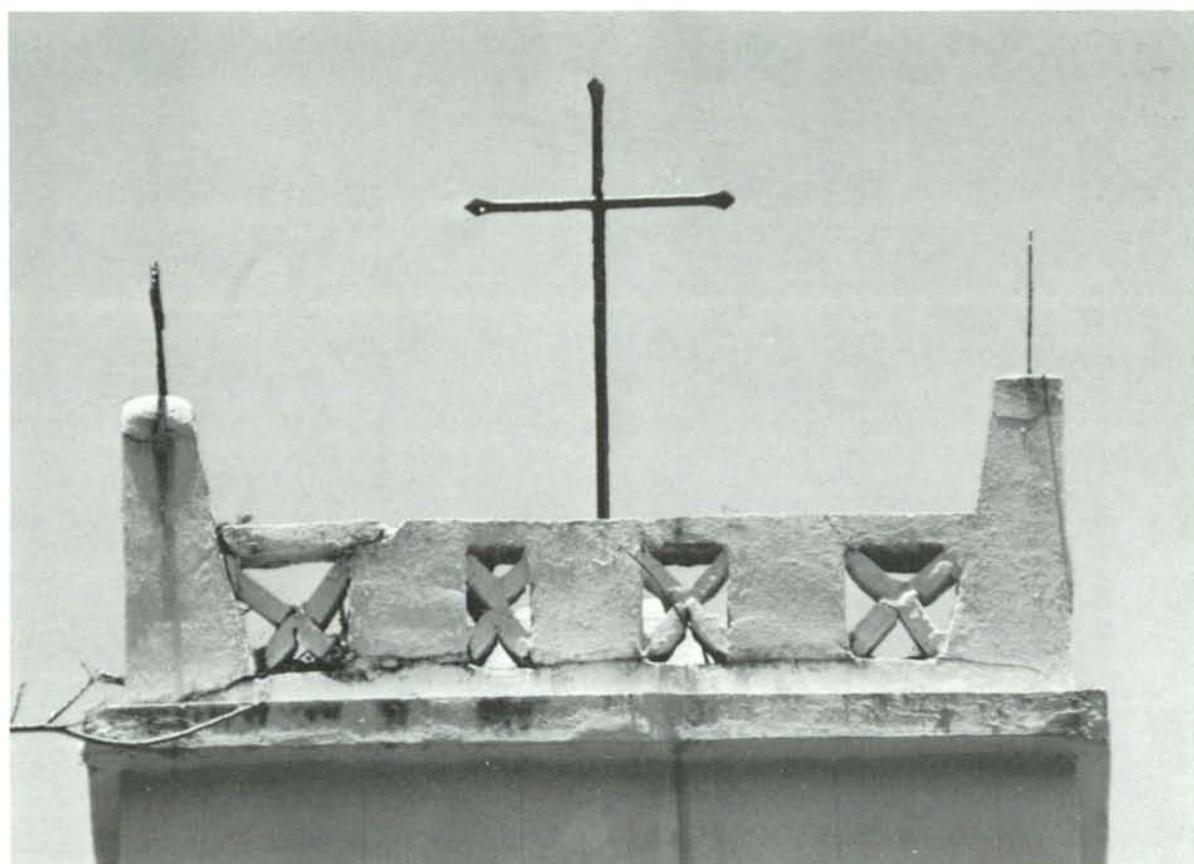
Illustration A22.

The parapet is in poor condition, with cracks being exacerbated by vegetation growth. A major horizontal crack is very visible along the base of the west and south parapets and through the two southerly pinnacles (Illustrations A22 and A25). This cracking might be of earthquake origin, but just as likely could be the result of root penetration from the vegetation. The southwest pinnacle is unstable, a possible hazard. Vegetation growth in these cracks and in exposed masonry joints of the back sides of the parapet is causing additional loosening of the masonry and allows considerable water penetration into the masonry (Illustration A26). A plastered drainage gutter between the parapet and the base of the pyramidal roof is in need of re-forming to achieve more positive drainage (Illustrations A27 and A28).

'South' parapet of bell tower. Note especially the crack along the base of the parapet and pinnacles. The 'southwest' pinnacle and cross (at left) appears to be the only original material and form of the four. 6/84. R.L.C.

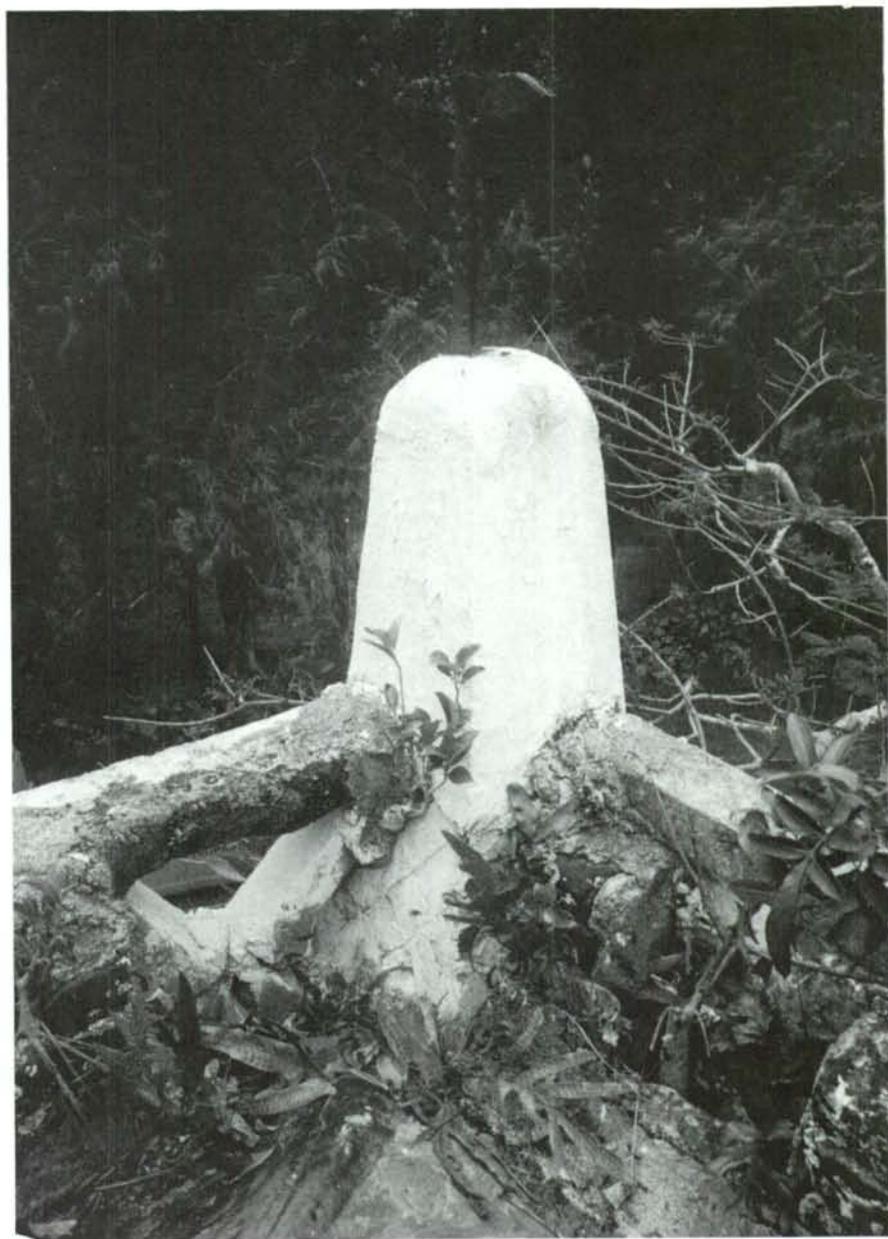
Illustration A26.

'Southwest' pinnalce showing vegetation growth in masonry which forces masonry work apart and allows water intrusion. 5/84. H.G.L.

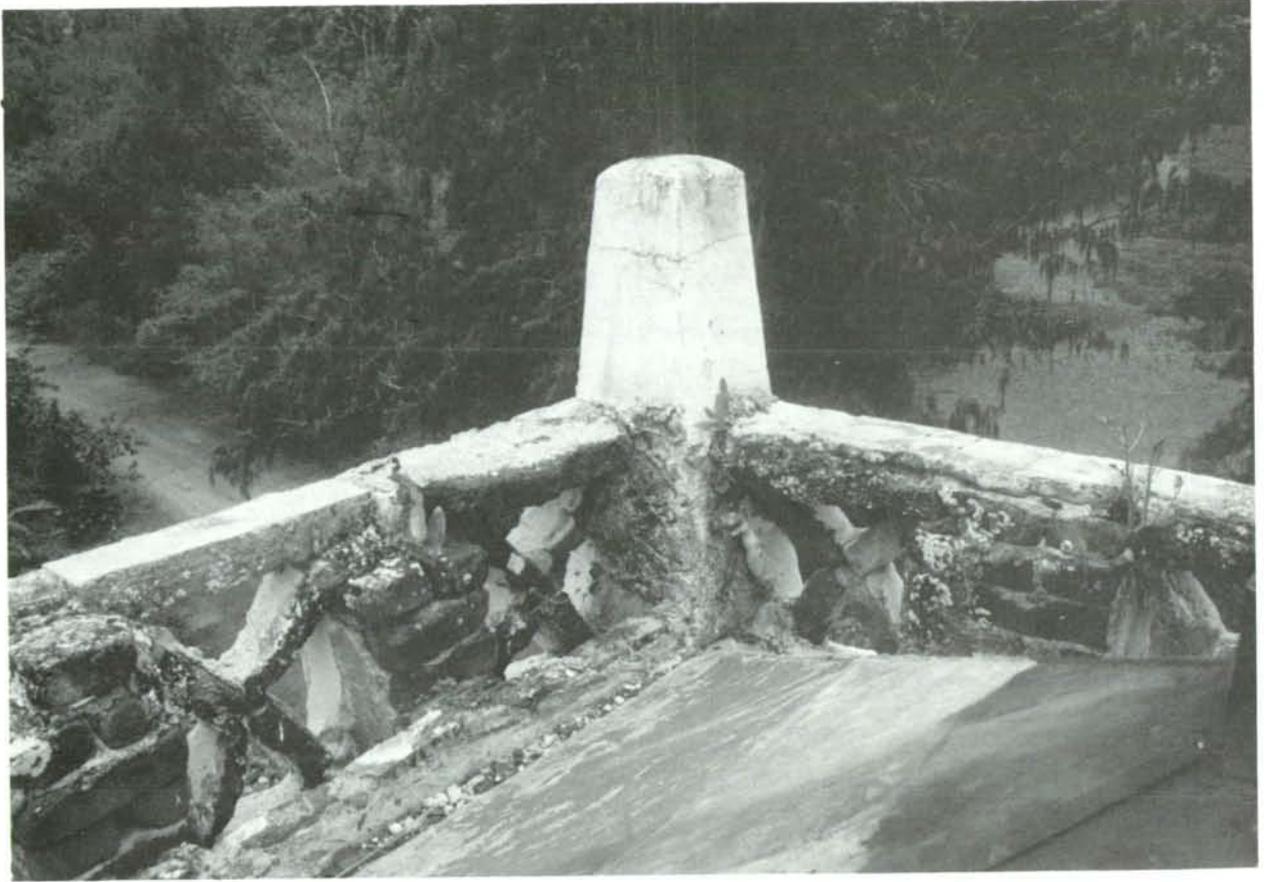
Illustration A28.

The top of the bell tower is enclosed with a square pyramidal roof, framed with 2 by 4s, covered with sheet copper. The framing appears to be from repairs accomplished in 1950 or ca. 1969. This roof system is in good condition except for rot of the base plate of the wood framing (Illustrations A66 and A67).

The metal crosses exhibit various degrees of deterioration, the major one being the most advanced with rust and exfoliation causing the loss of 30 to 50 percent of the material.

'East' parapet. Note concrete masonry units used for repairs. The copper roofing is in reasonably good condition but the drainage gutter around the base of this square pyramidal roof does not drain well and the base plate of the roof framing is rotted. All crosses are rusted and exfoliated. 5/84. H.G.L.

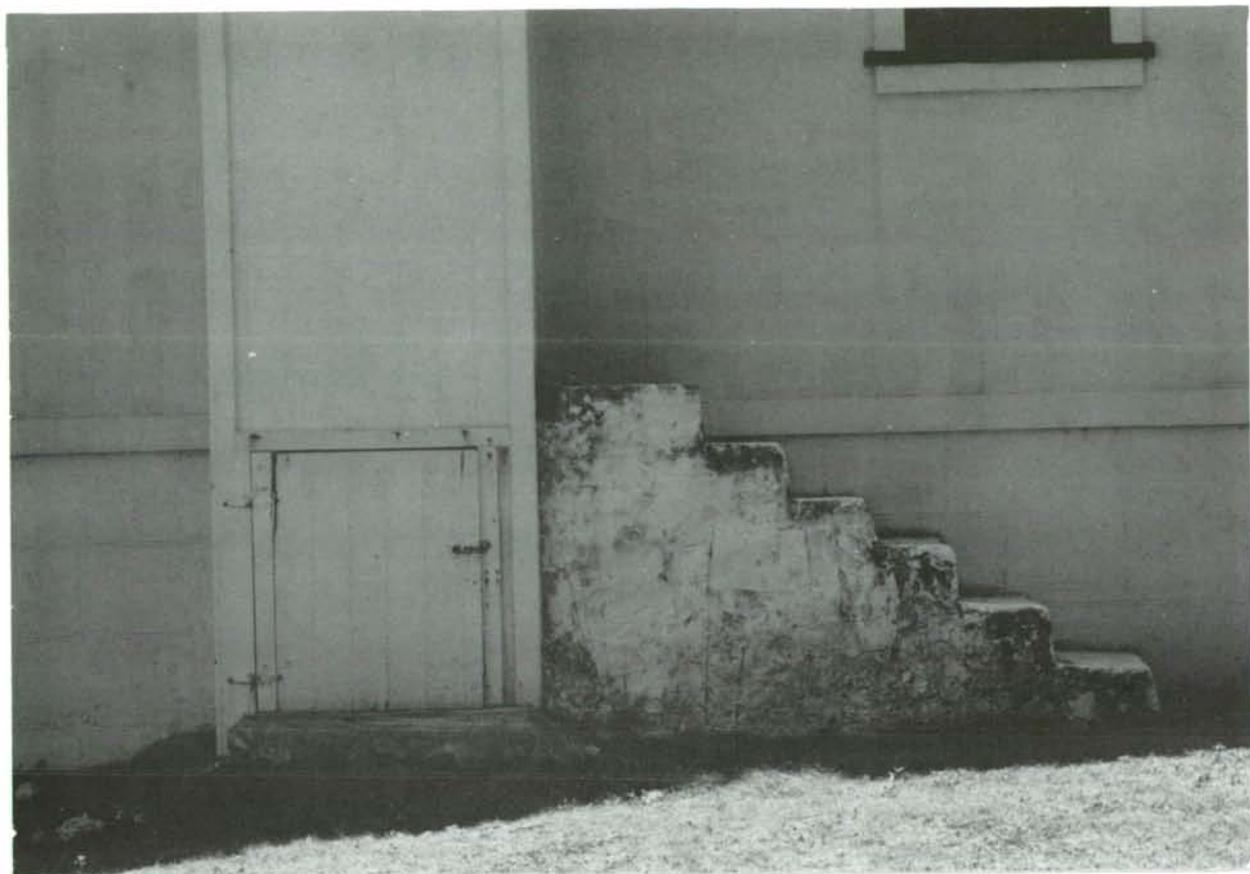
Illustration A32.

Rear ('north') elevation of 1888-89 portion of building. This wall was replaced after collapse during a storm. The sand density in the paint on this wall does not match that of the other siding of the building. 6/84. R.L.C.

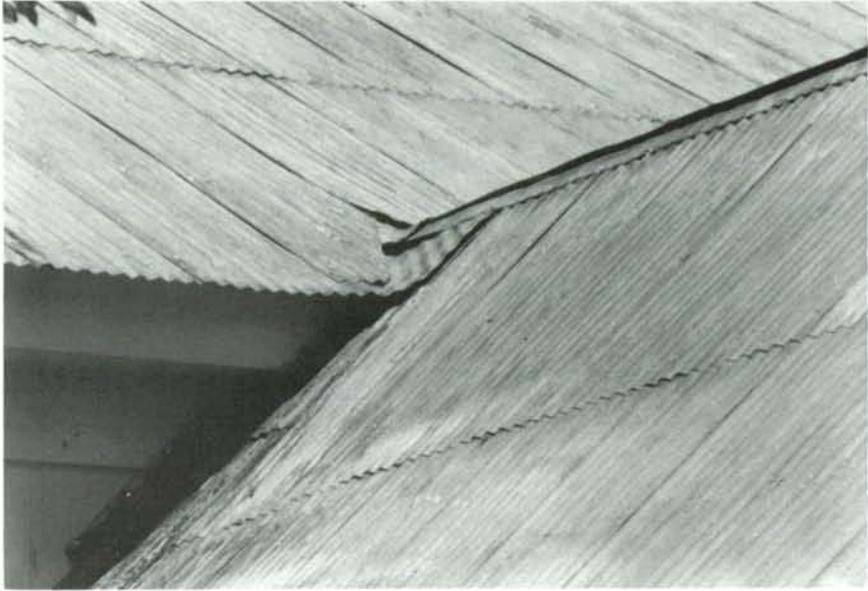
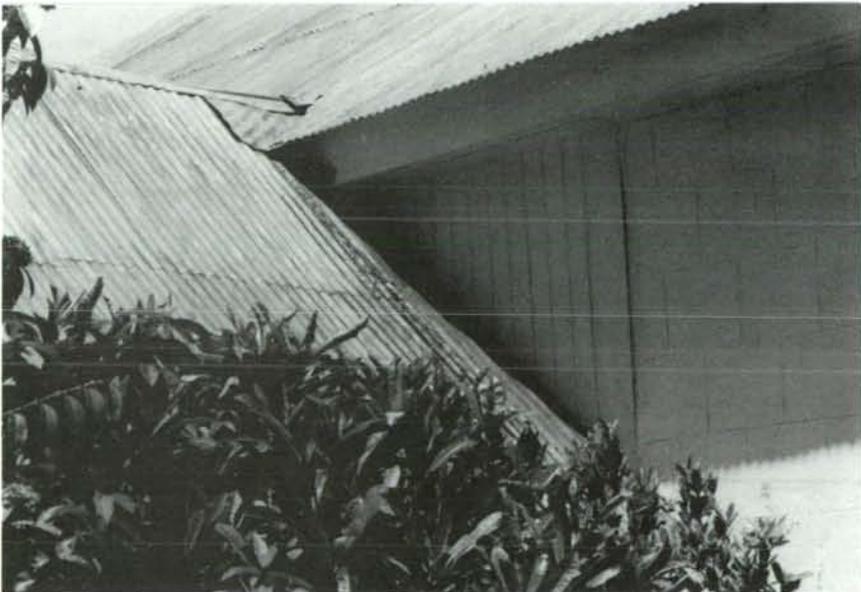
Illustrations A39 and A40.

Details of flashing at juncture of 1876 and 1889 roofs. Also note the vertical siding which is at both sides of the 1876 roof. 6/84. R.L.C.

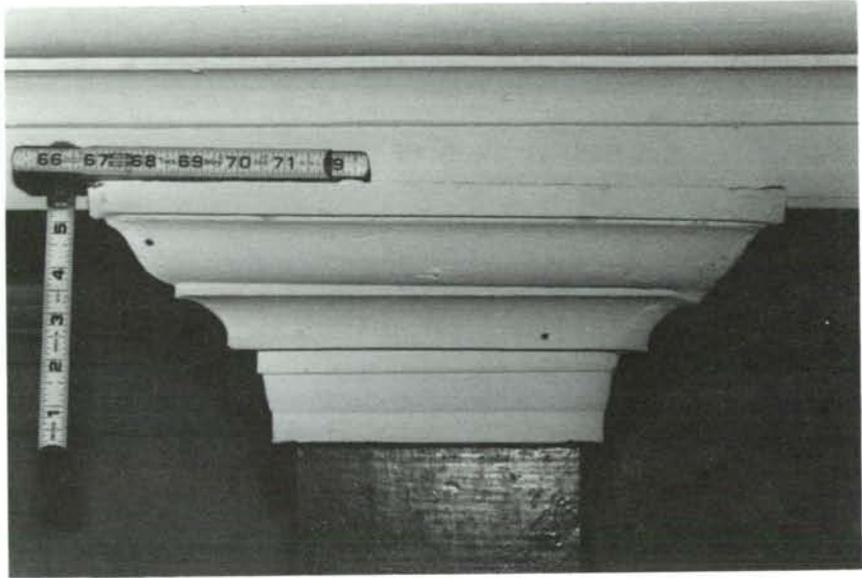
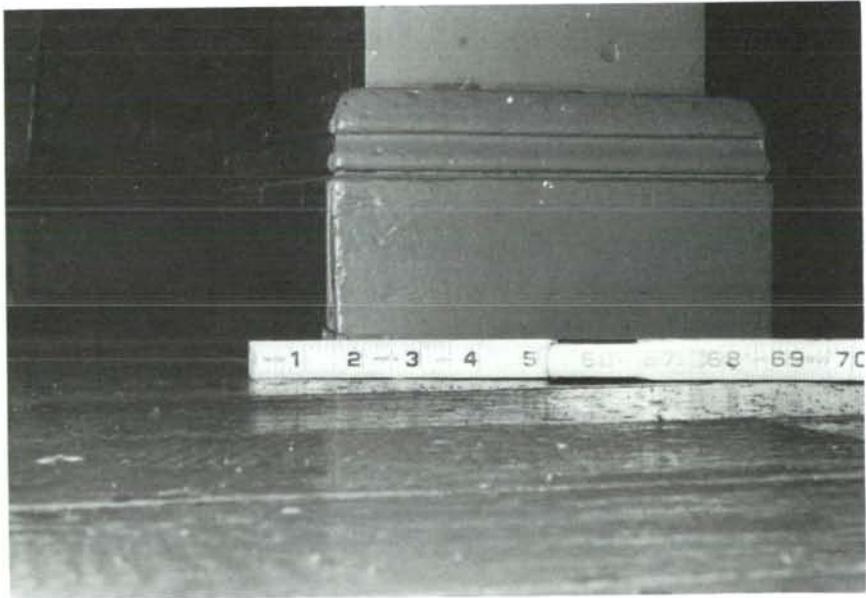
Illustrations A42 and A43.

Details of capital and base of one of two columns toward 'west' end of  
1876 nave. 8/84. P.C.C.

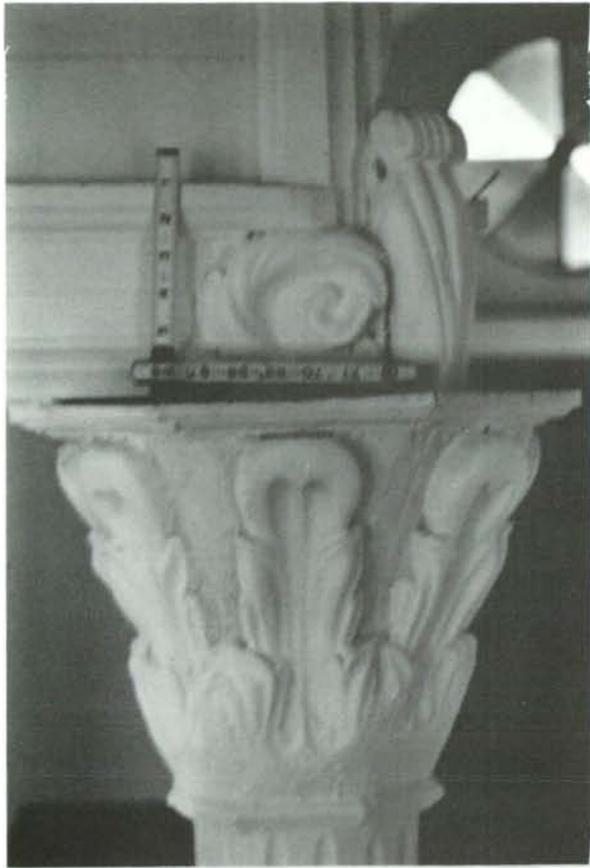
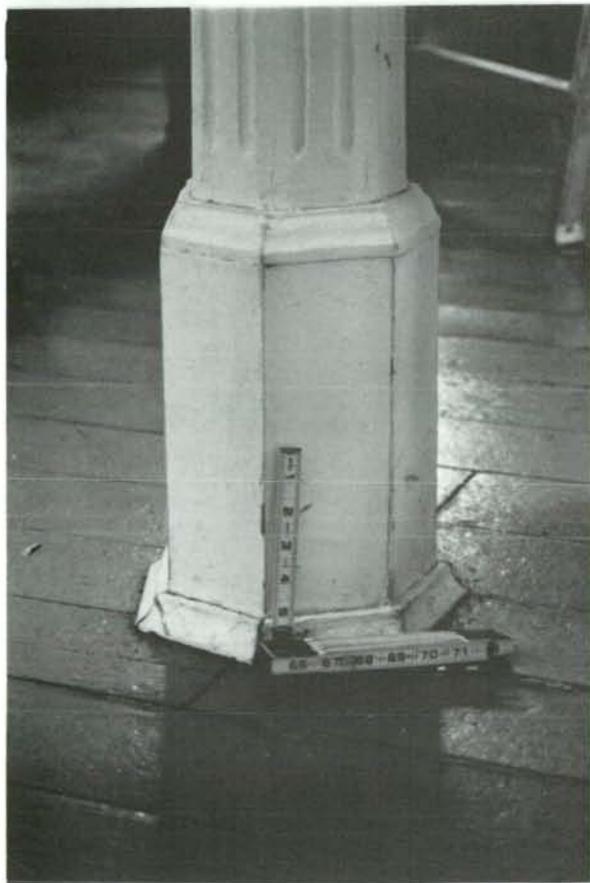
Illustrations A44 and A45.

Details of capital and base of column at intersection of 1876 nave with crossing. The two columns at this intersection are seven-sided, whereas the larger columns of the 1888 nave are octagonal. Some column capitols have been repaired with a fiberglass filler. 8/84. P.C.C.

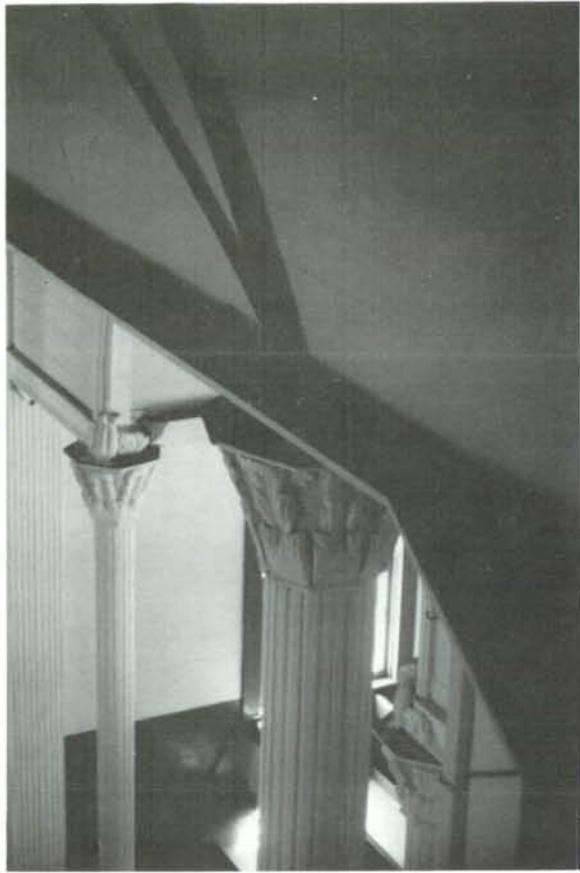
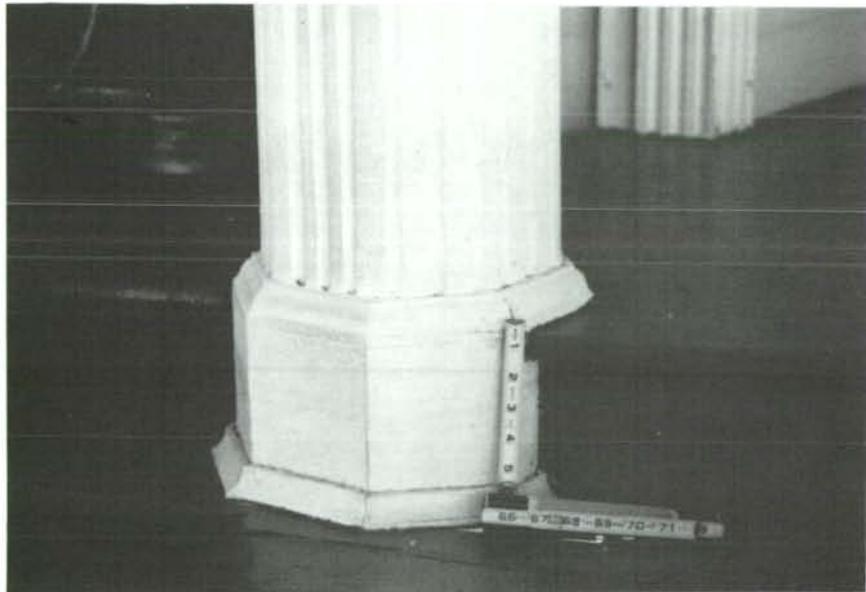
Illustrations A46 and A47.

Details of capital and base of column at 'northwest' corner of crossing.  
8/84. P.C.C.

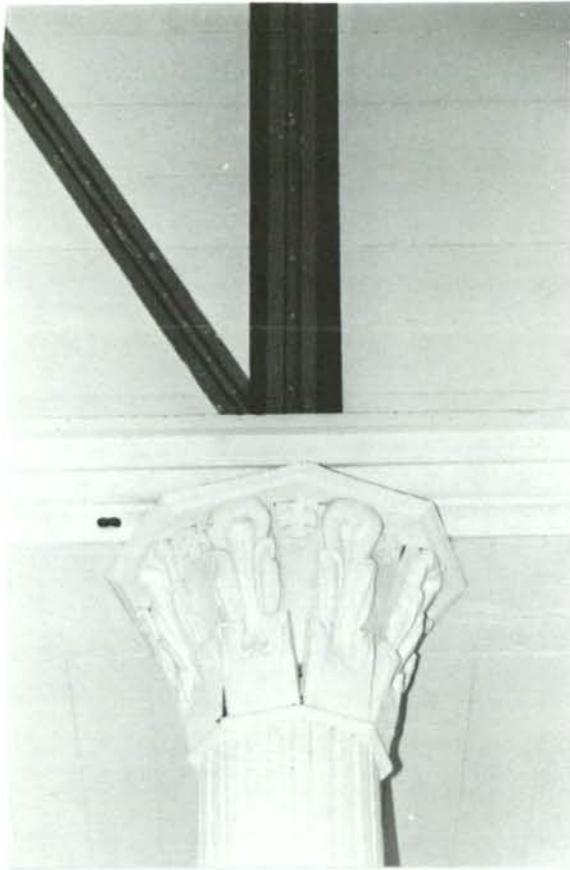
Illustration A48.

Capital of column at 'northwest' corner of crossing. The holes in the bottom of the cornice were for wiring decorative lighting. 8/84. P.C.C.

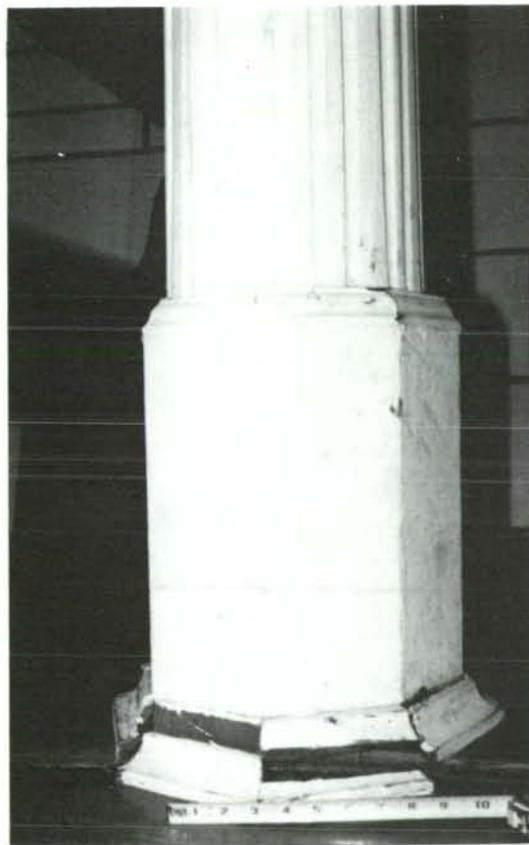
Illustration A49.

Base of 'southeast' column of 1888 nave showing subsidence of floor structure, which damaged base trim. 8/84. P.C.C.

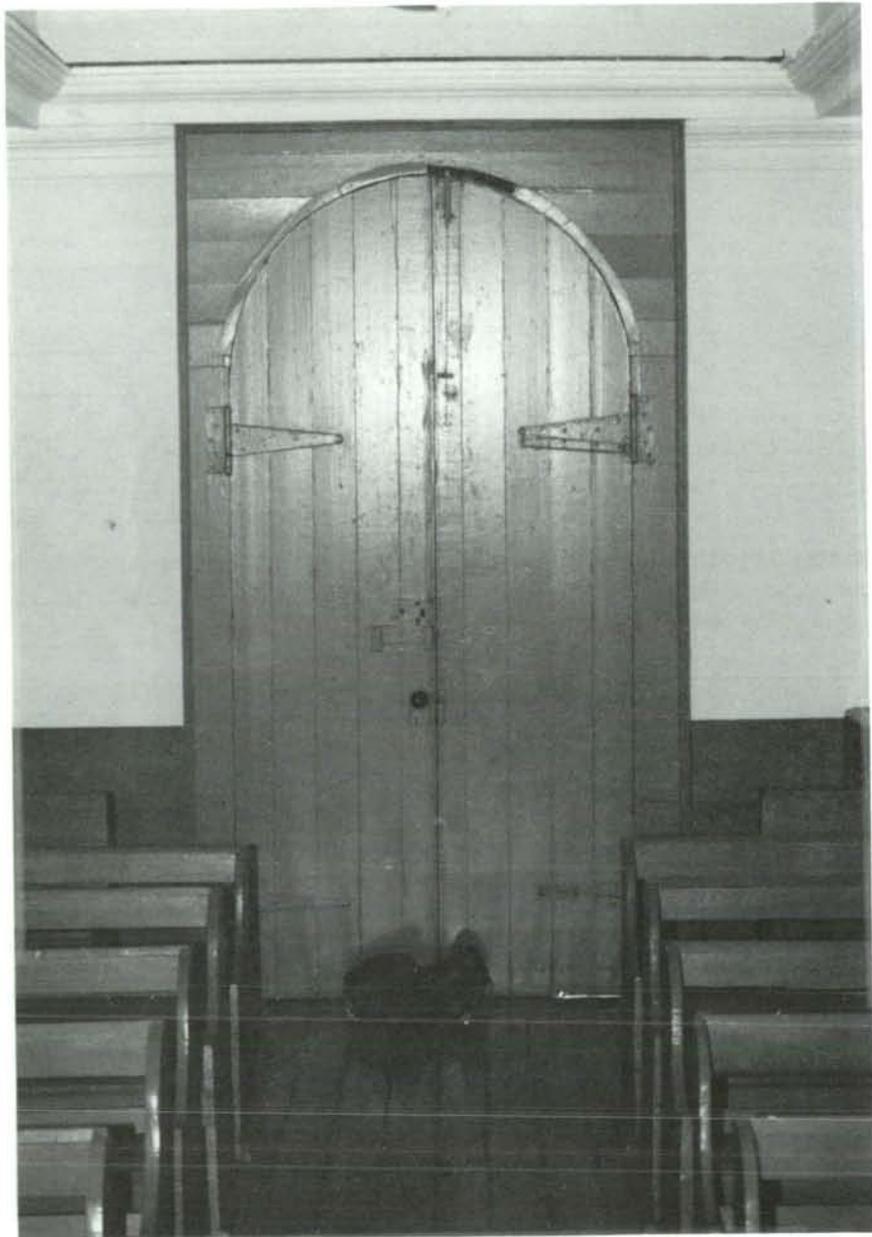
Illustration A56.

Interior of 'west' entry door, 1876 nave. The door is built-up of two layers of one-inch thick tongue-and-groove boarding. Note the repositioned and replacement hinges. 6/84. R.L.C.

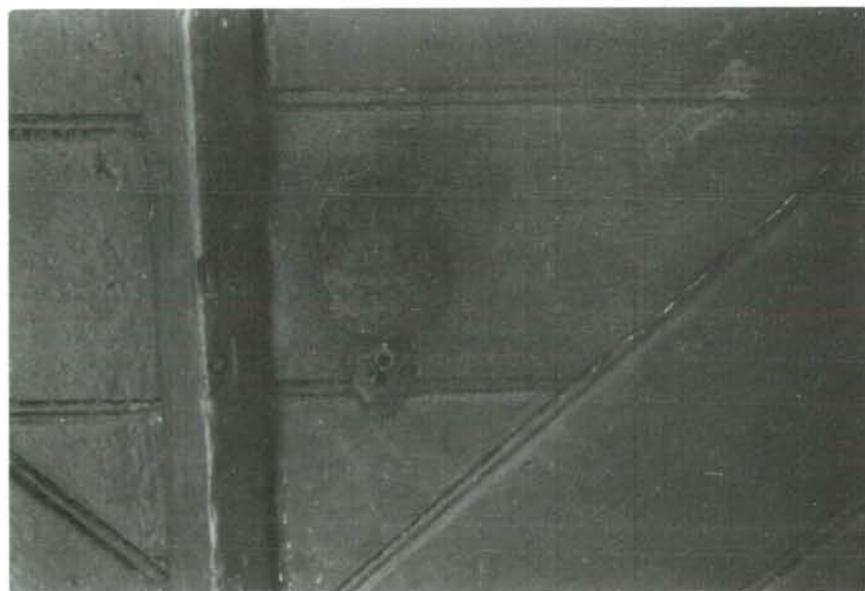
Illustration A58.

Hardware detail, exterior, 'west' entry door, 1876 nave. This lockset is inoperable. 8/84. P.C.C.

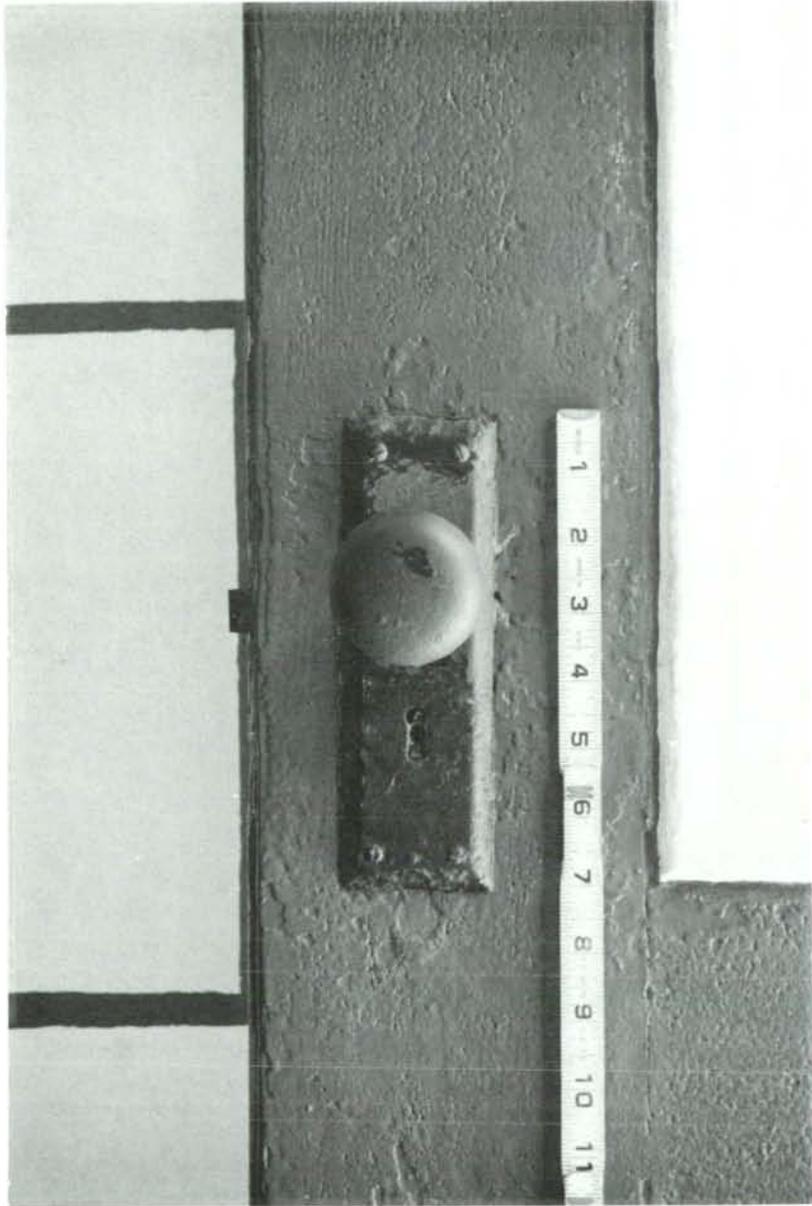
Illustration A59.

Hardware detail, 'south' entry, 1888 nave. This lockset is only partially operable. 8/84. P.C.C.

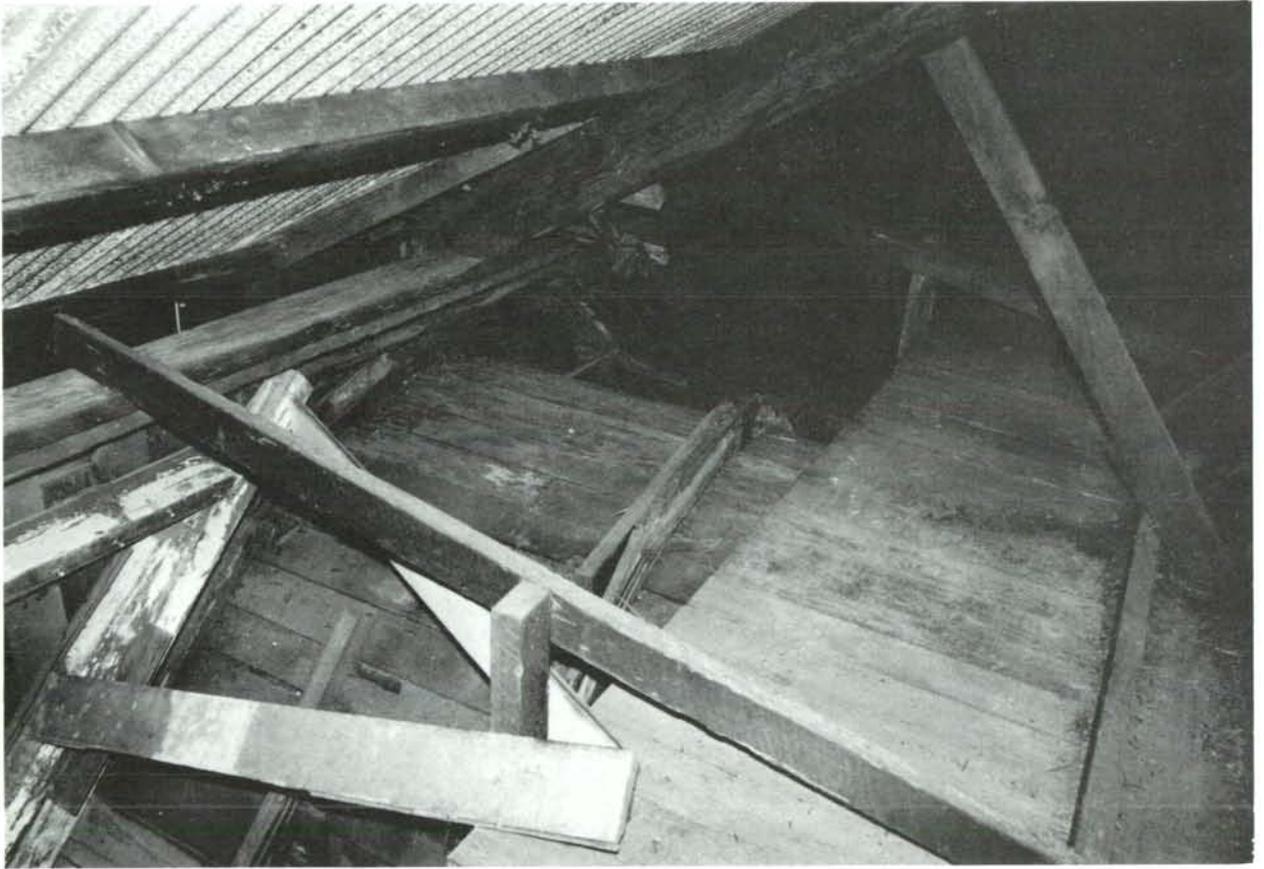
Illustration A60.

Attic at 'west' side of 1888 nave vault. The 'east' end of the 1876 nave vault is visible here. The flat 2x12 base plate of the 1888 vault is at the extreme lower right of the photo. 8/84. P.C.C.

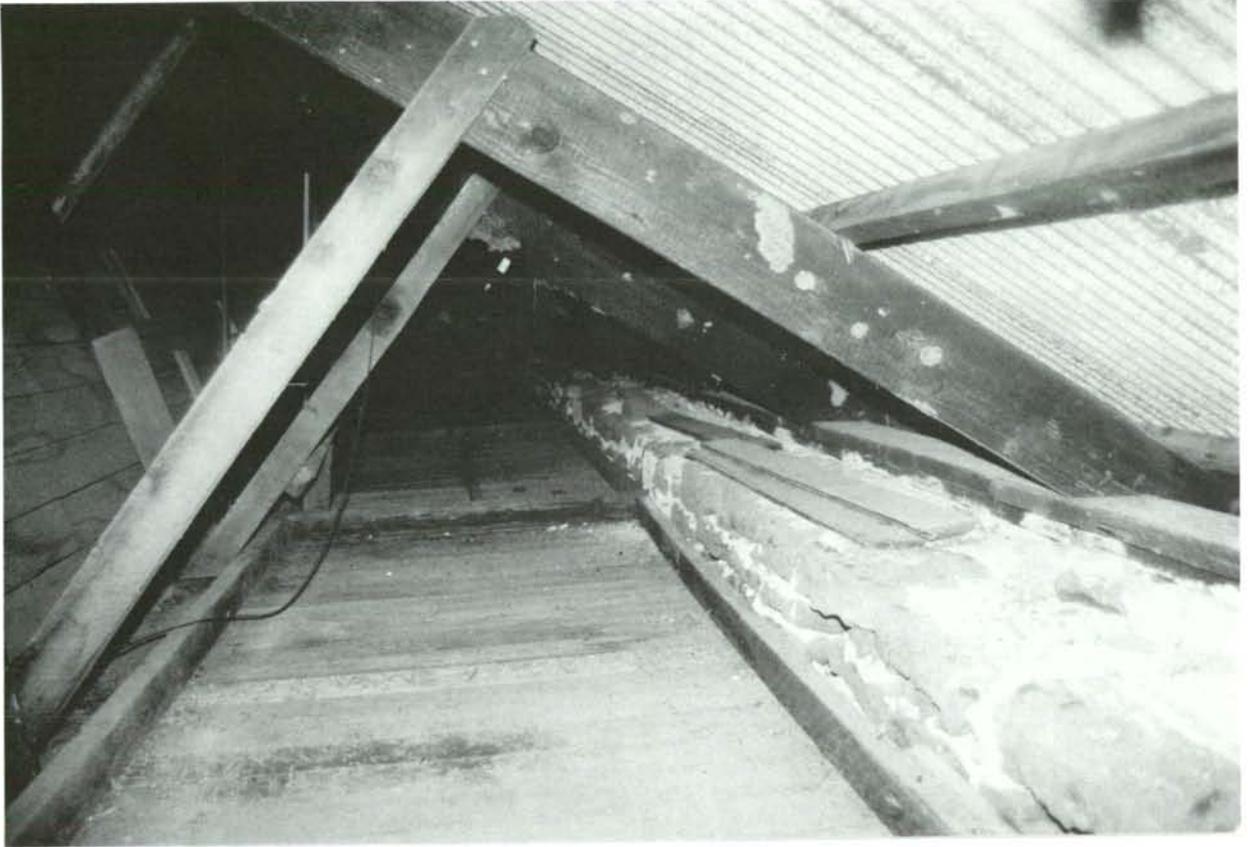
Illustration A61.

Attic along 'west' side of 1888 nave vault, view toward south. Part of the flat 'side-aisle' ceiling boarding has been replaced, probably ca. 1969. There are no visible anchors securing the double 2x8 rafter bearing plate to the stone wall. 8/84. P.C.C.

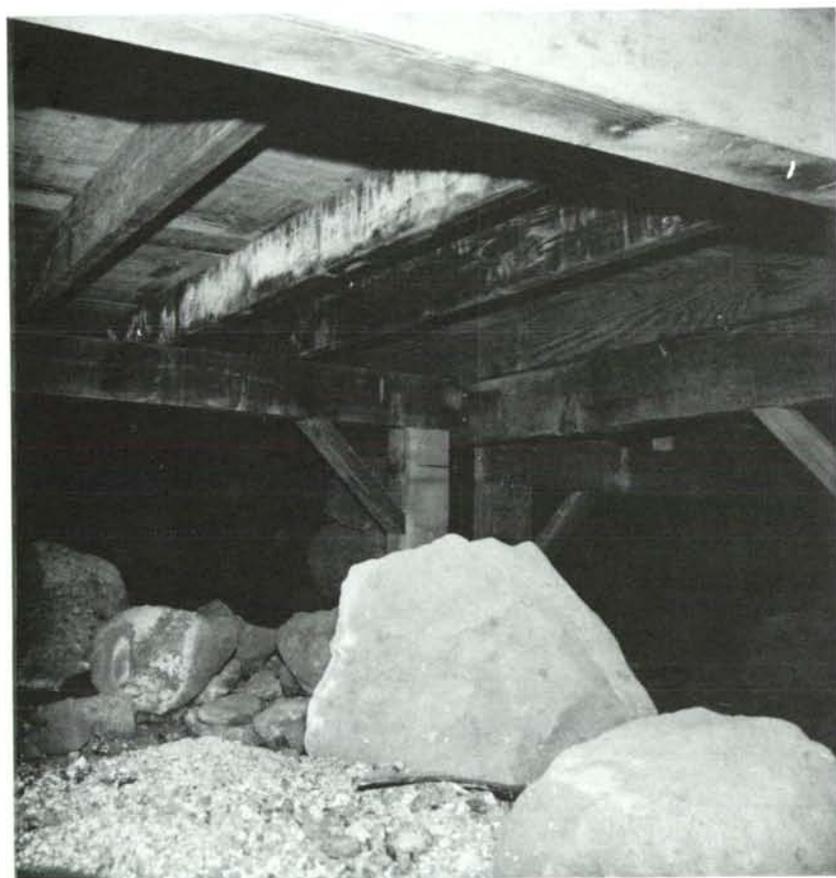
Illustration A65.

Crawl space beneath the crossing, view toward 'southeast'. 8/84.  
P.C.C.

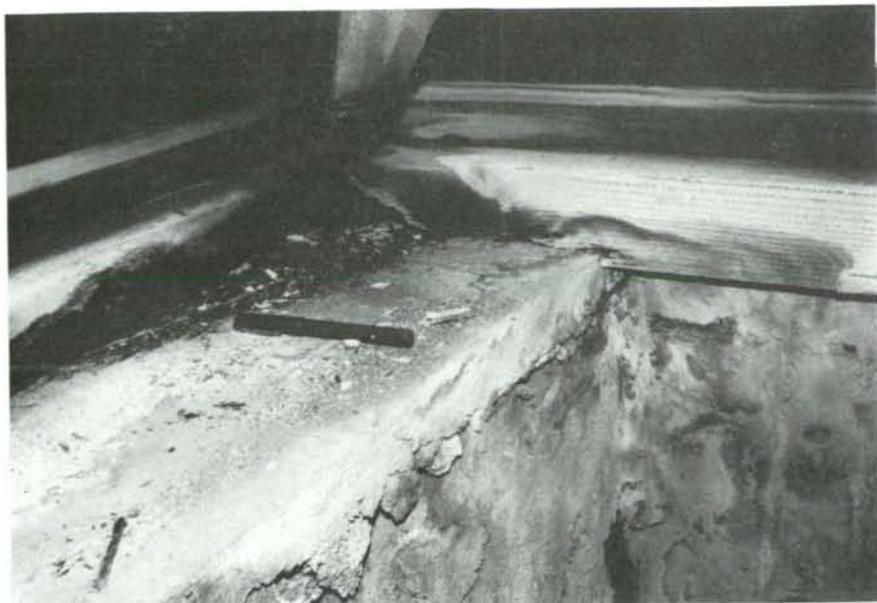
Illustration A66.

Detail of deteriorated base plate of bell tower roof at 'southeast' corner.  
8/84. P.C.C.

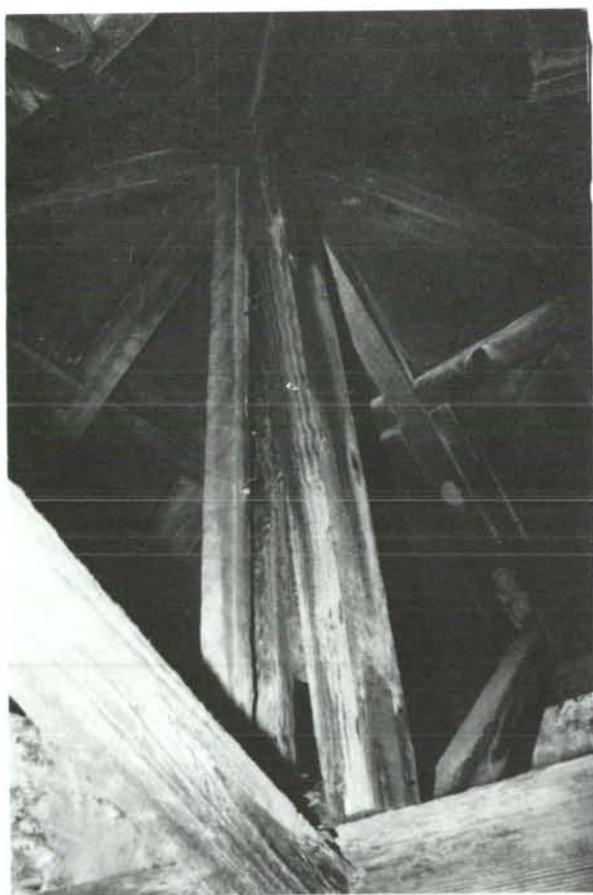
Illustration A67.

View from below of bell tower roof framing. The lower end of the main  
cross is within the vertical framing members. 8/84. P.C.C.

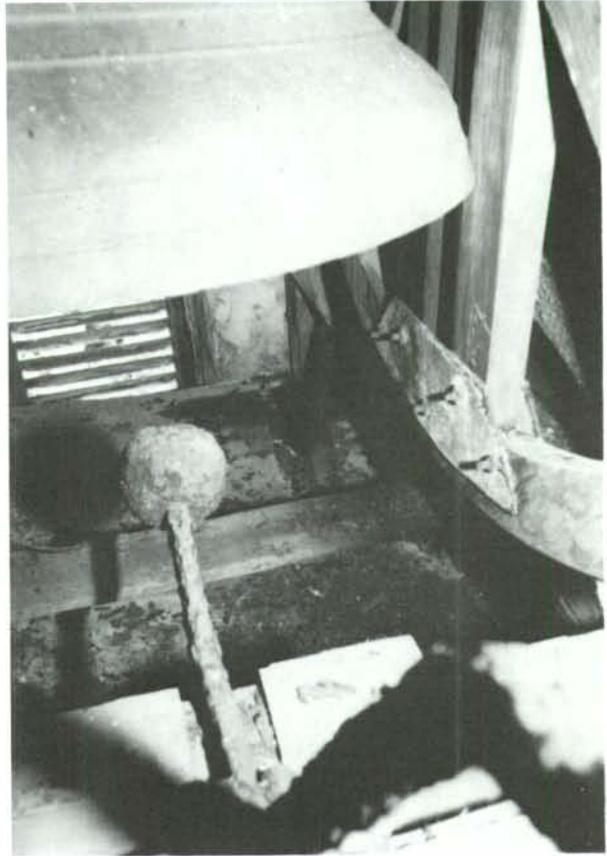
Illustration A69.

Secondary clapper and lower portion of  
rope wheel, which is not the original.  
The rope guide is visible in the far corner  
on a line halfway between the clapper ball  
and rope wheel. 6/84. R.L.C.

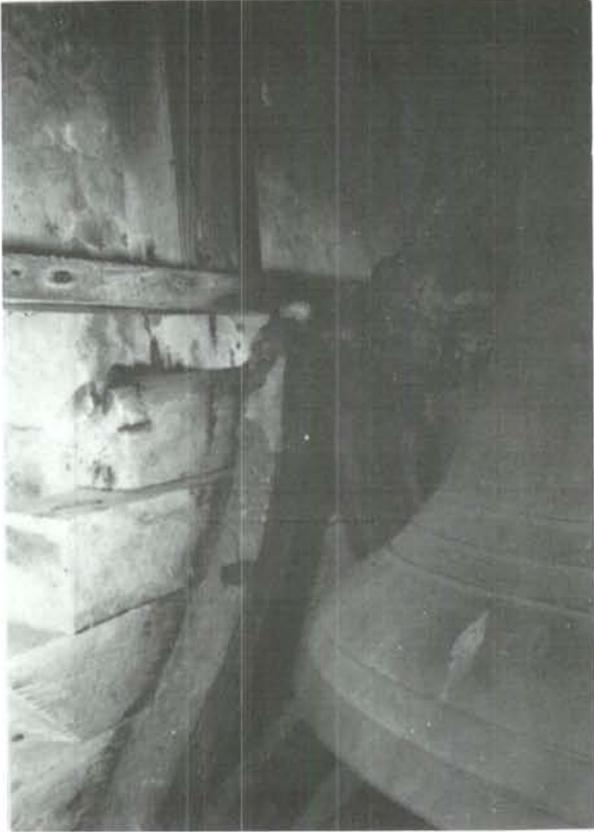
Illustrations A70 and A71.

Details of the deteriorated bell yoke. The bell is frozen because of the rust and exfoliation of the iron. 6/84. R.L.C.

13.Special construction							
Bell, yoke and bell cage; restore to operational condition	bell conservation, replace yoke, repair bell cage	1.00	lumpsum	25000.00	25000.00	3

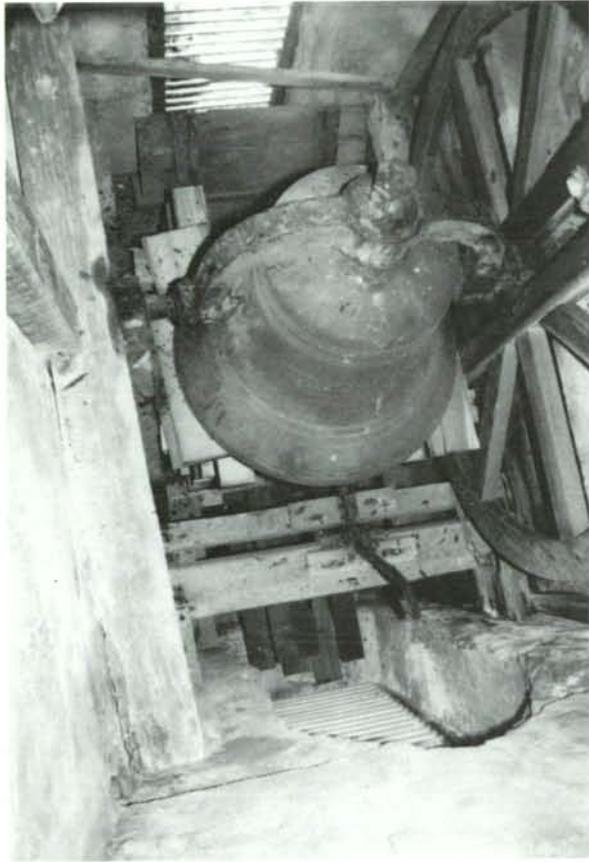
Illustration A73.

View of bell from above after temporary cribbing was installed. Cribbing is supported on sills of louvered openings. 8/84. P.C.C.

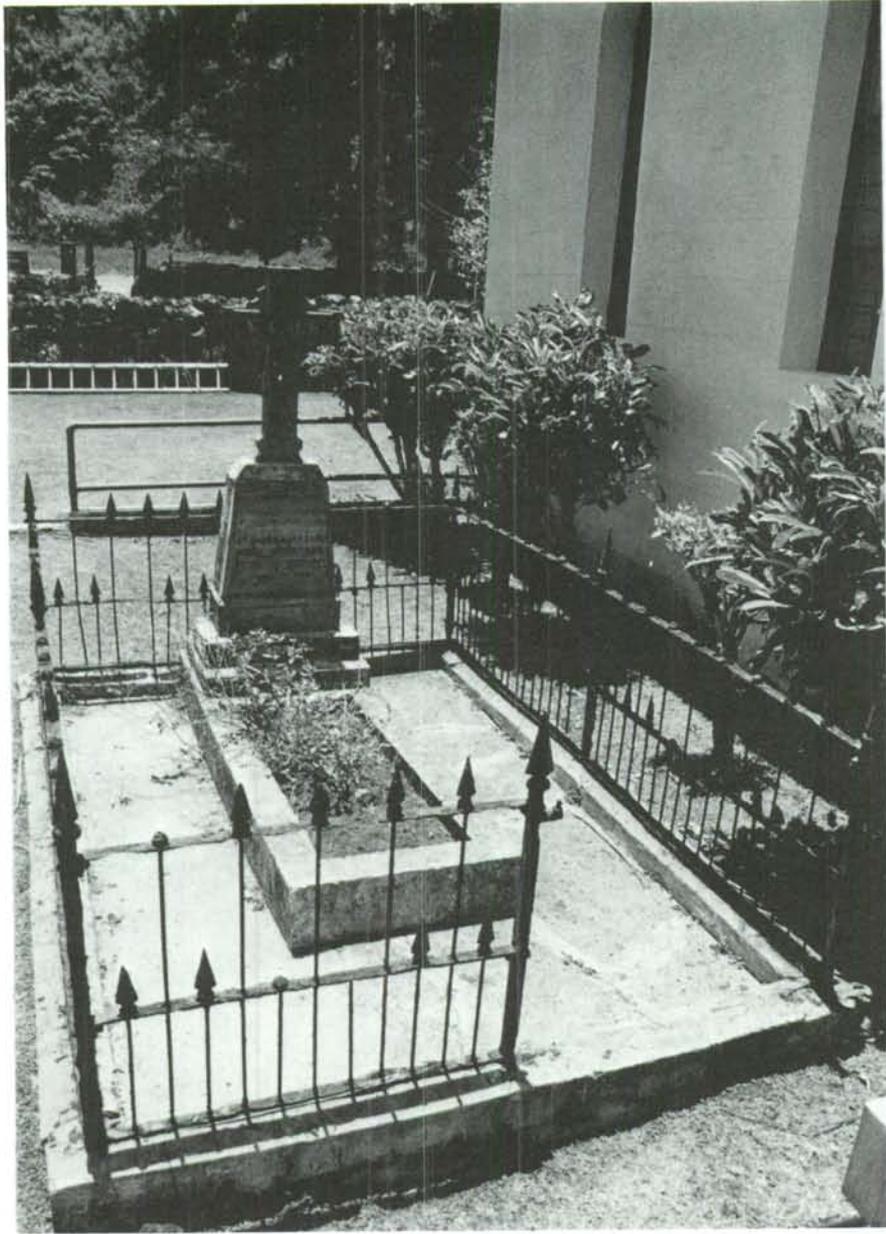
Illustration A111.

Fr. Damien's grave. Note deterioration of decorative railing and missing elements. Part of gate still exists. 8/84. P.C.C.
