# KALAUPAPA

HISTORIC STRUCTURE REPORT

ST. PHILOMENA CATHOLIC CHURCH  
(FATHER DAMIEN'S CHURCH)

January 1985

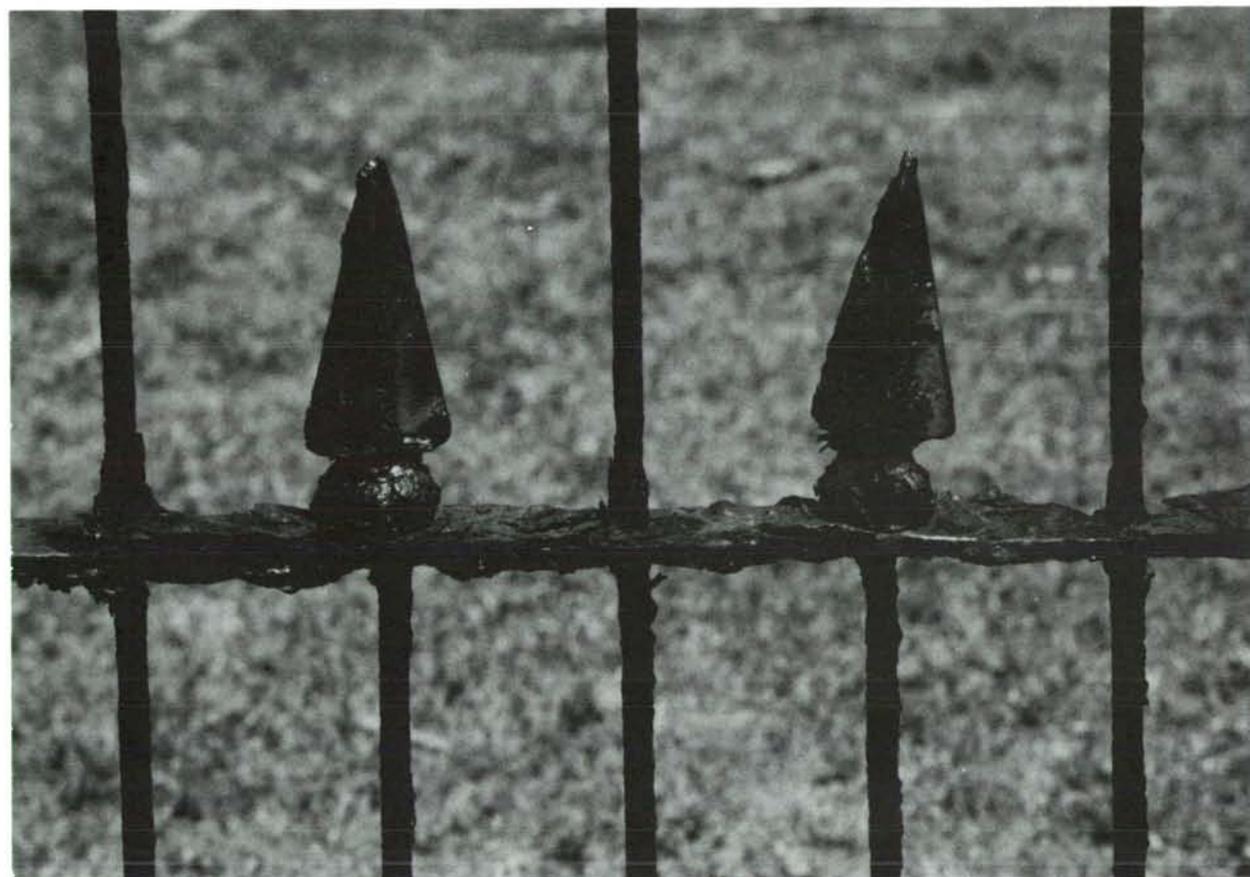
Illustration A114.

Detail at center rail, Fr. Damien's grave. 6/84. R.L.C.

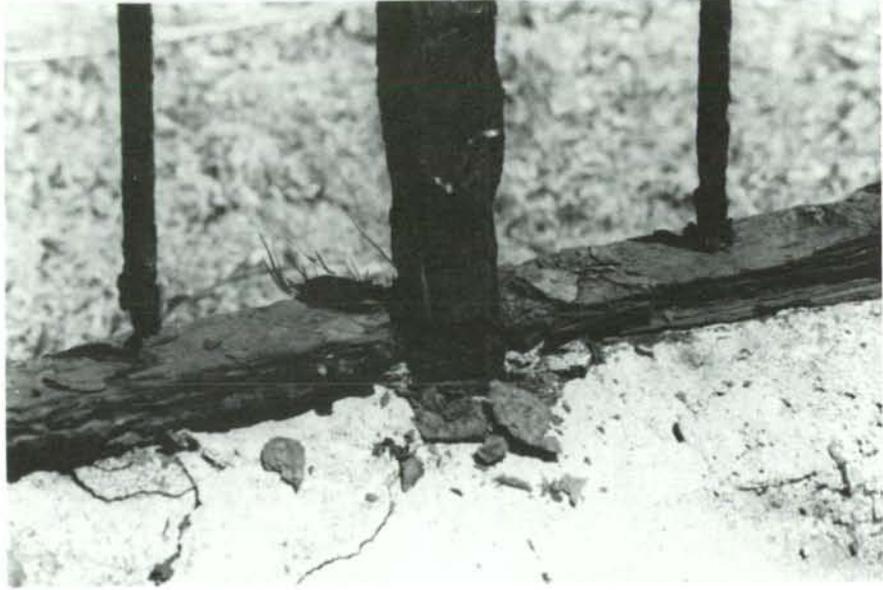
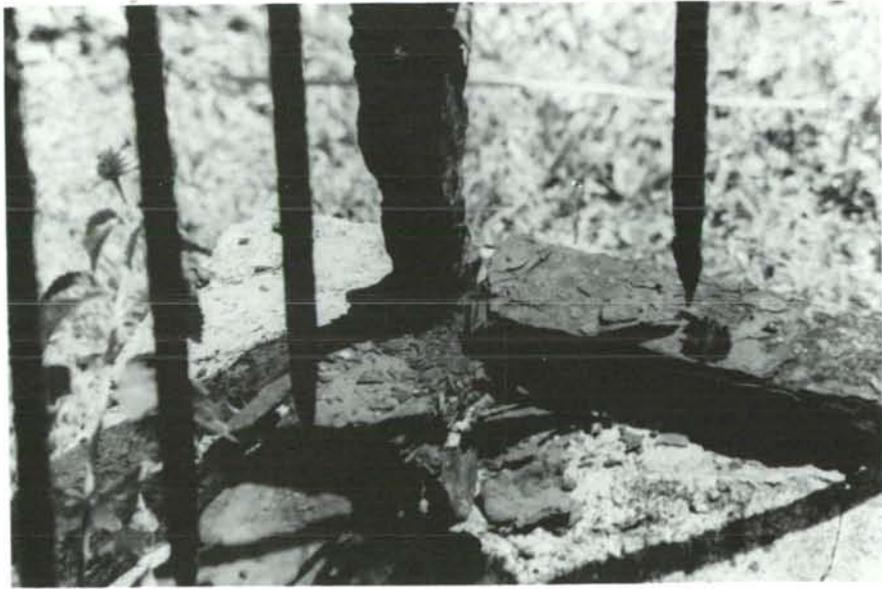
Illustrations A117 and A118.

Details of intermediate and corner post at bottom rail, Fr. Damien's grave. 6/84. R.L.C.

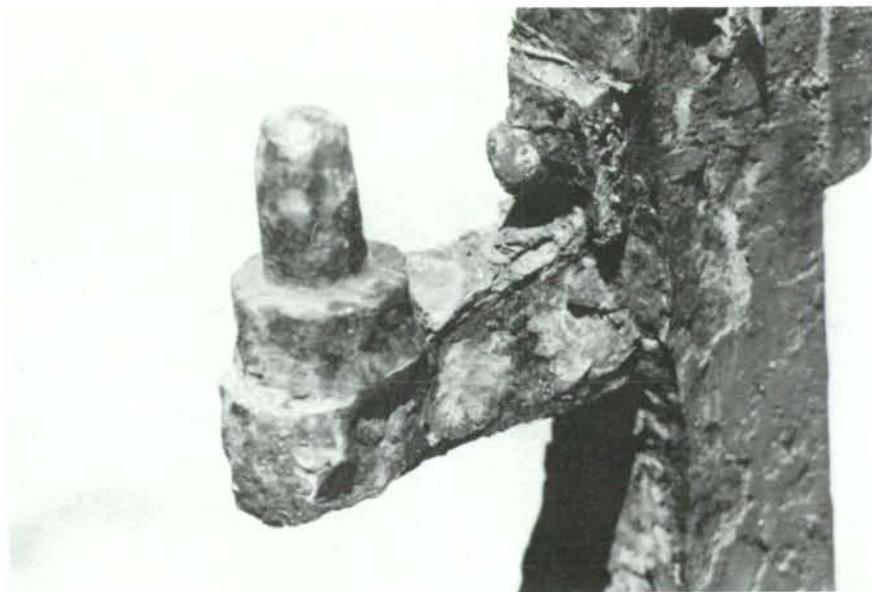
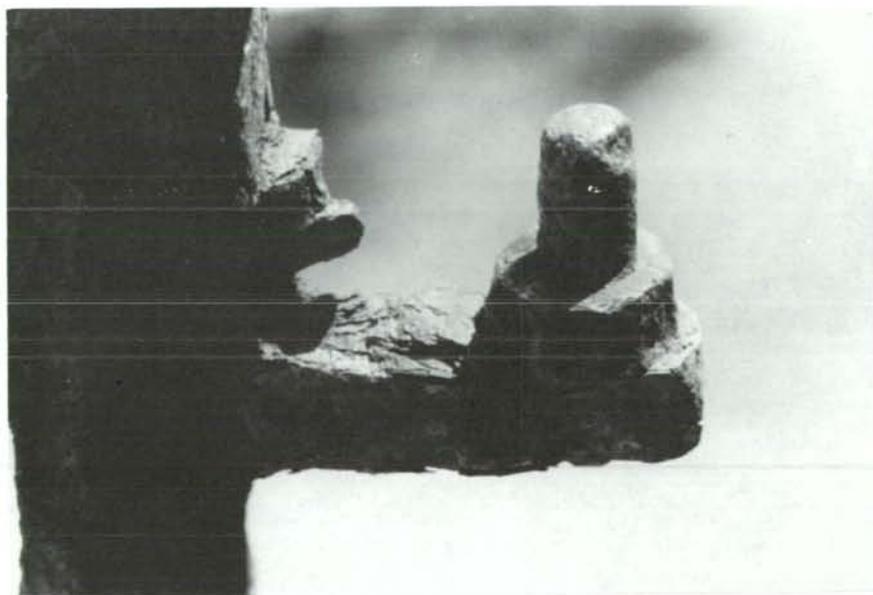
Illustrations A119 and A120.

Gate pintle details, railing of Fr. Damien's grave. 6/84. R.L.C.

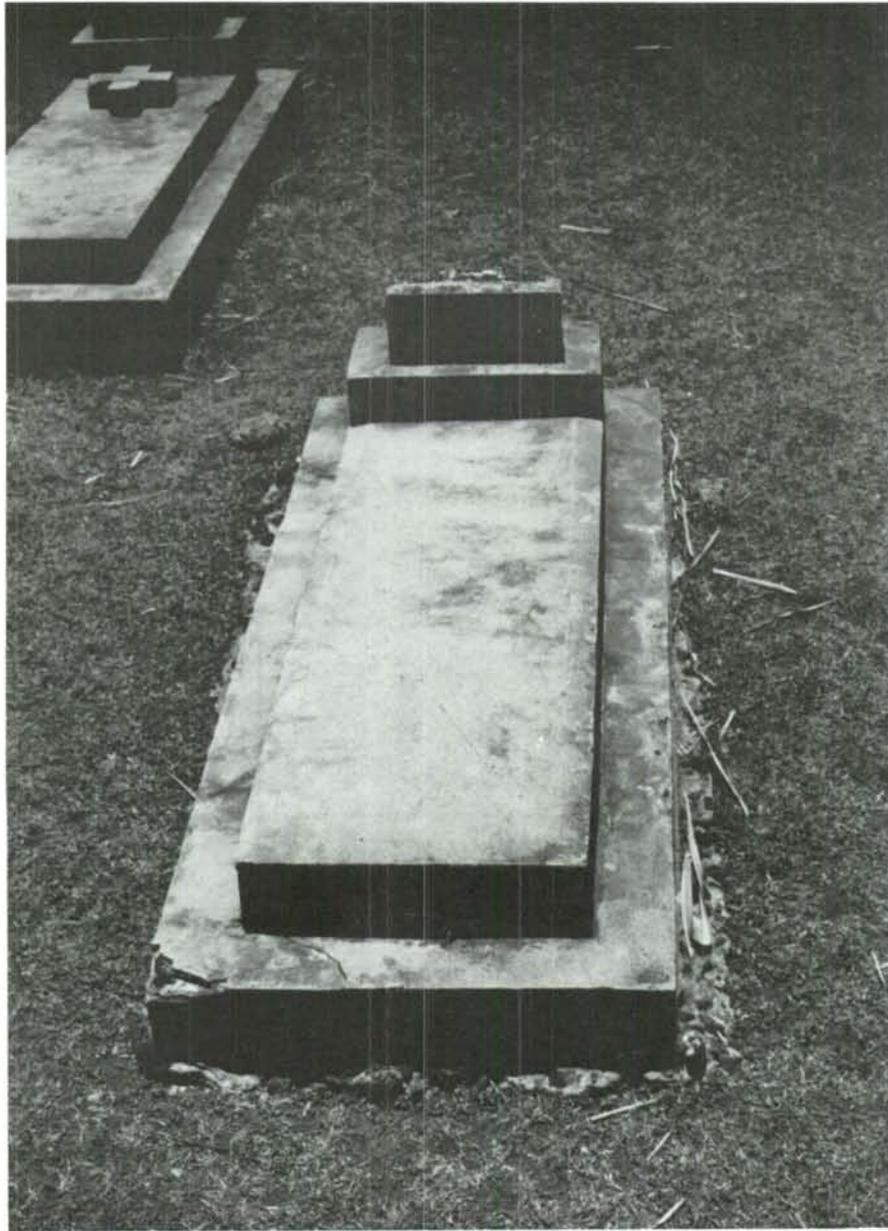
Illustration A132.

The person buried here was unidentified as the headstone is missing (grave No. 12 on Site Plan drawing). 8/84. P.C.C.

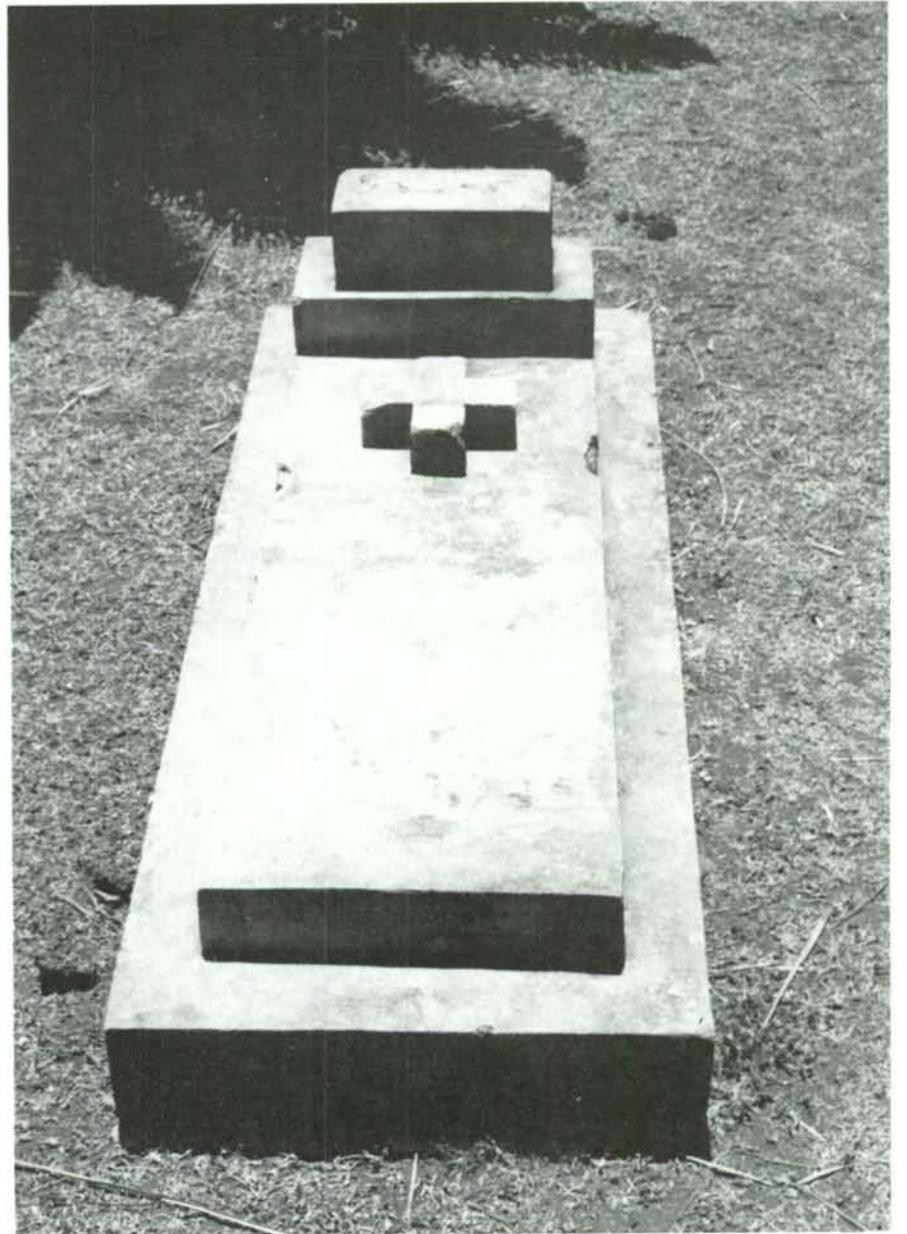
Illustration A133.

Also unidentified as headstone is broken (No. 13 on Site Plan drawing). 8/84. P.C.C.

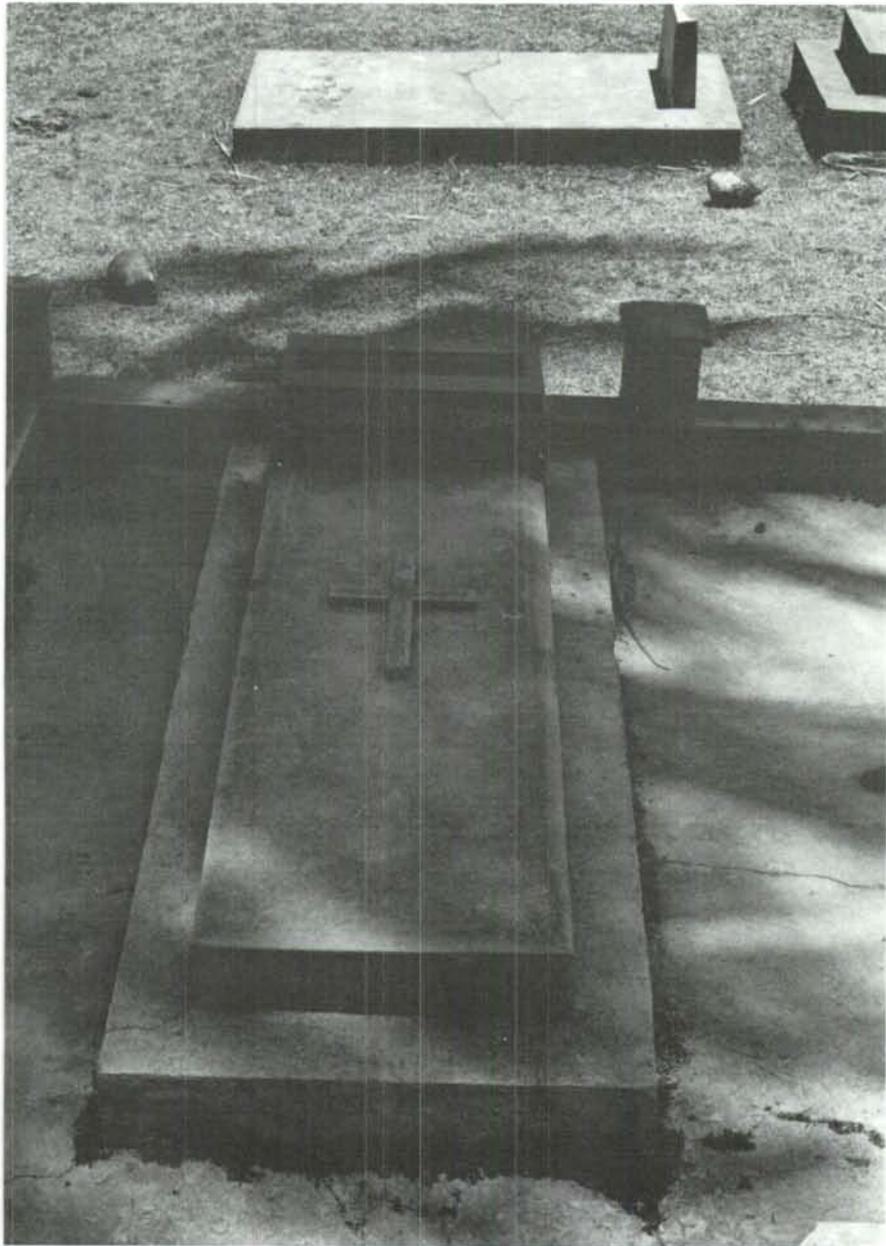
Illustration A136.

Grave of Br. Victor Schumpf, Feb. 20,  
1900 (No. 15B on Site Plan drawing).  
8/84. P.C.C.

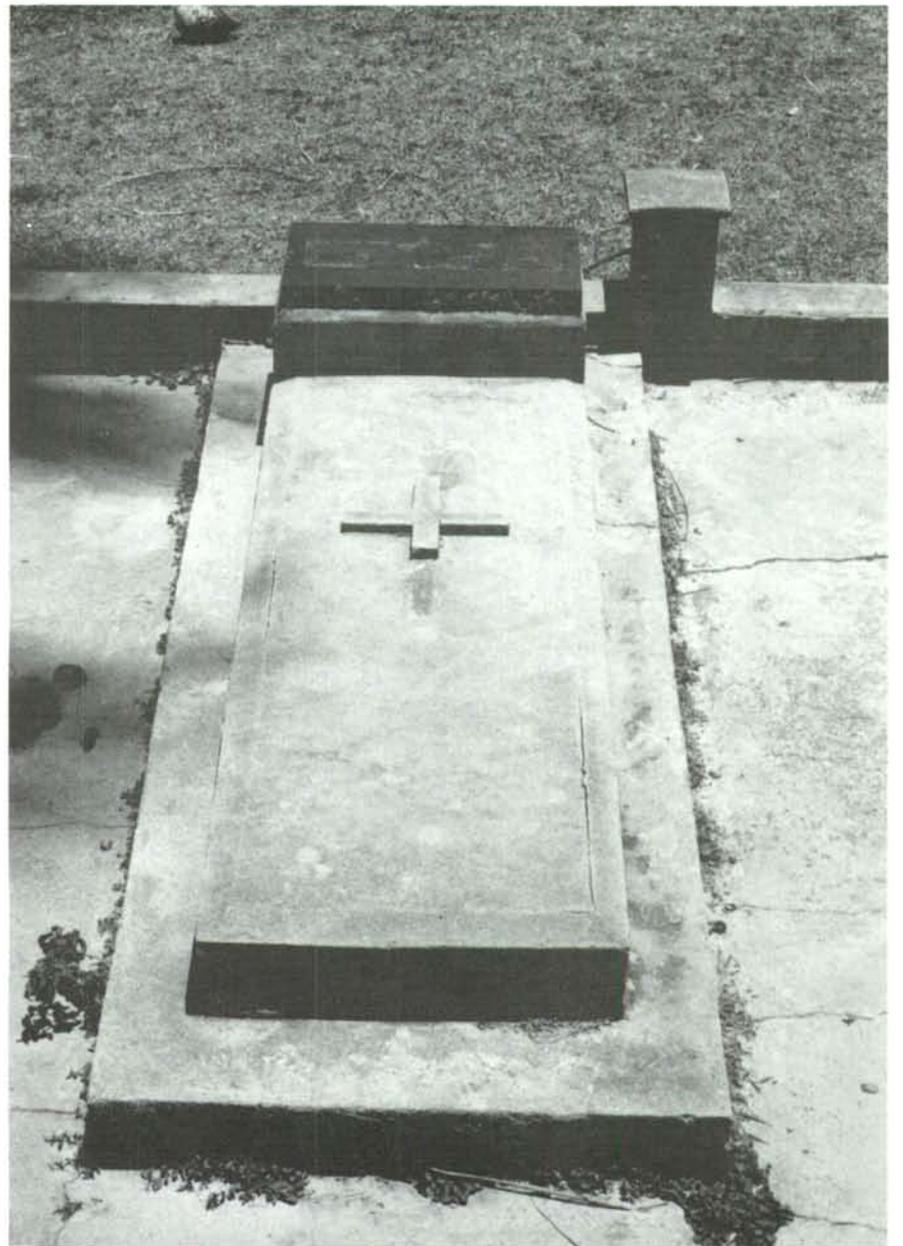
Illustration A137.

Br. Maria Serapion Van Hoof, May 12,  
1910 (No. 15C on Site Plan drawing).  
8/84. P.C.C.

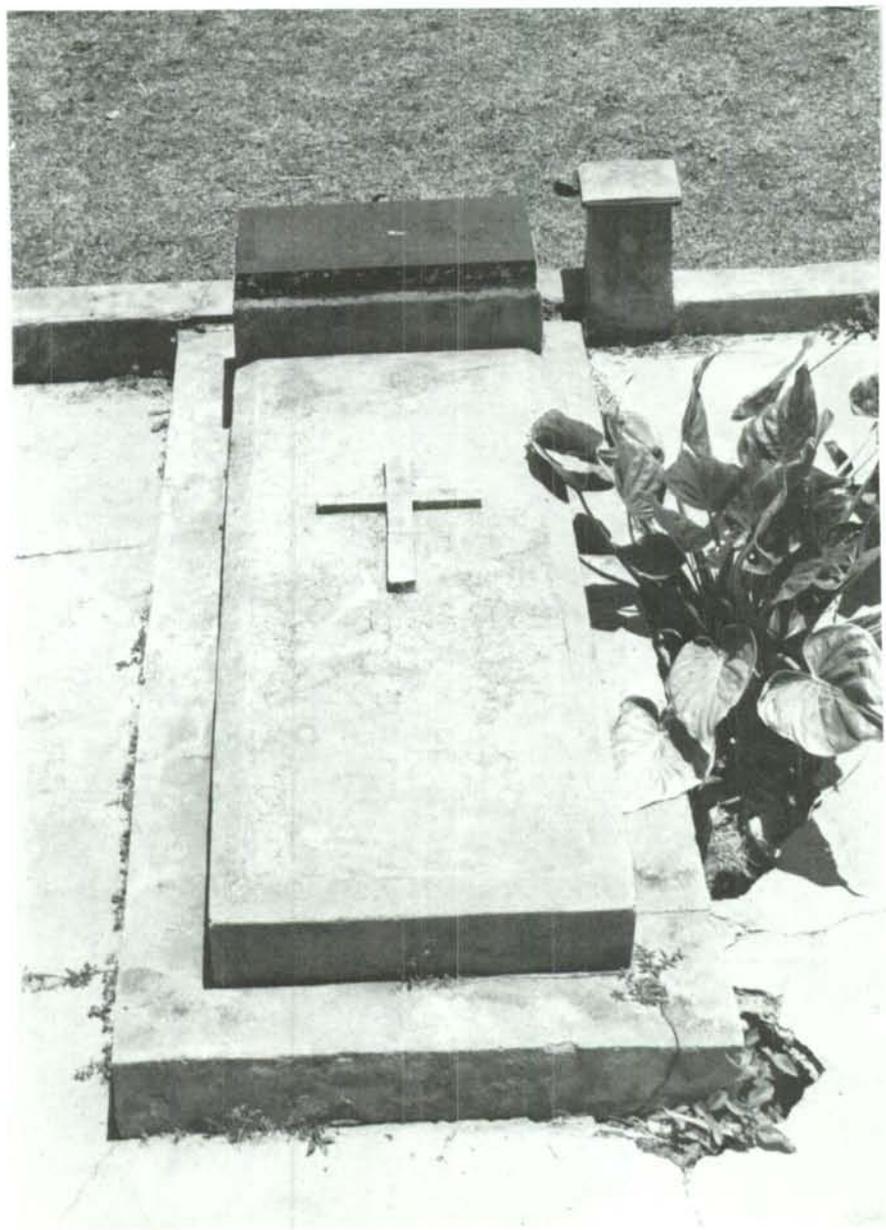
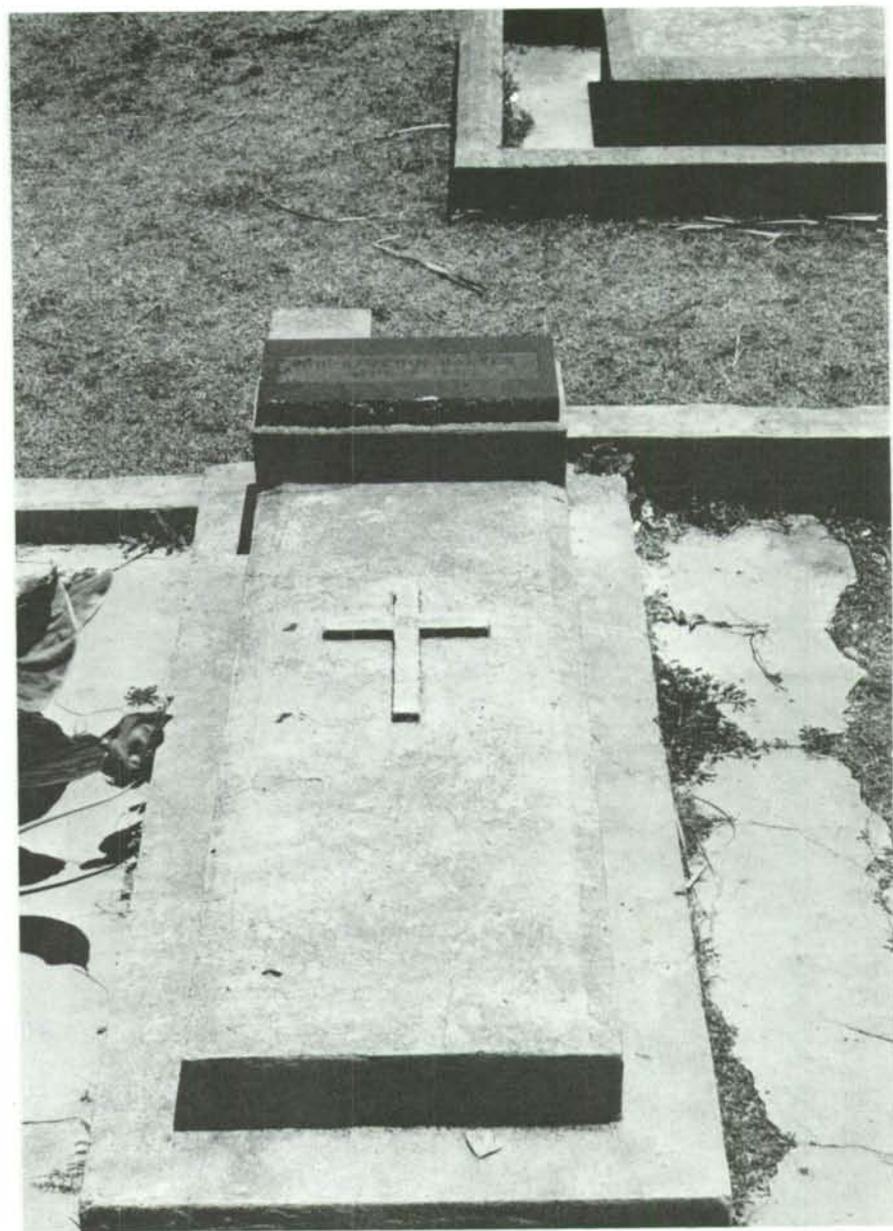
Illustration A138.

Grave of Br. Severin Baltes, Sept. 19,  
1921 (No. 15D on Site Plan drawing).  
8/84. P.C.C.

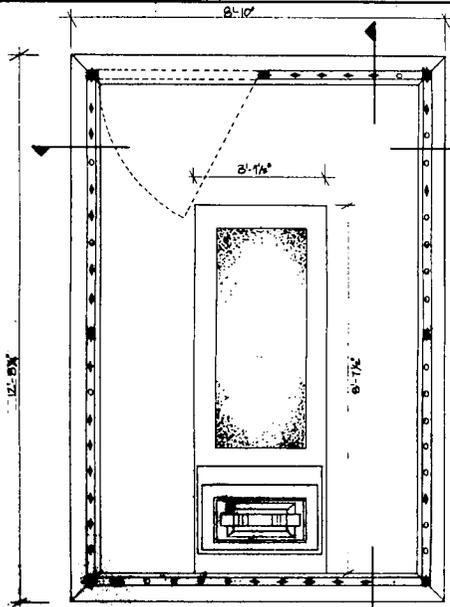
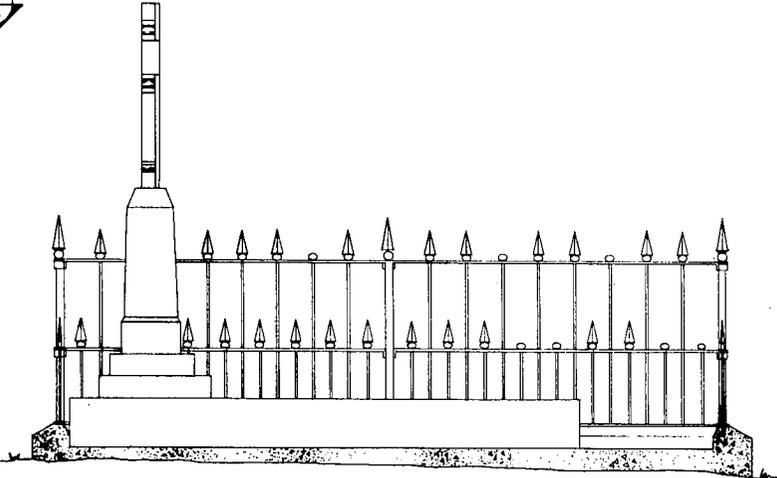
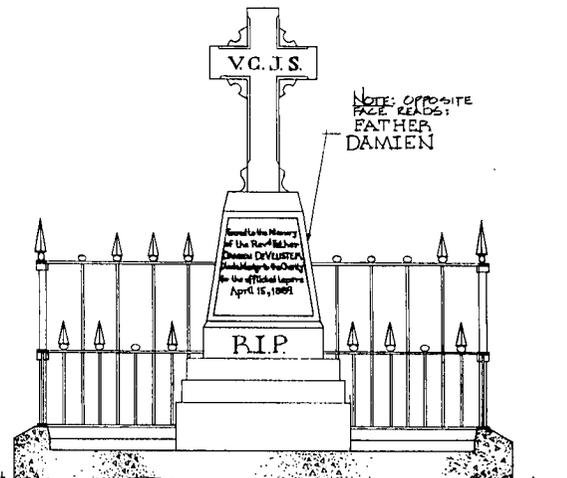
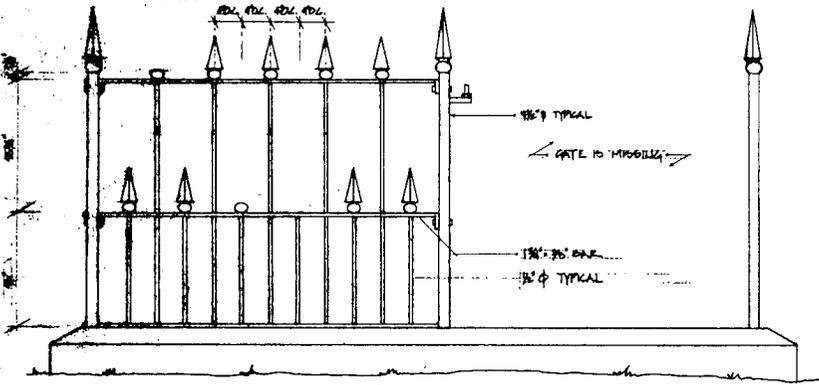
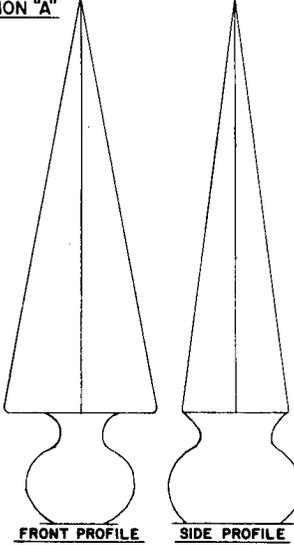
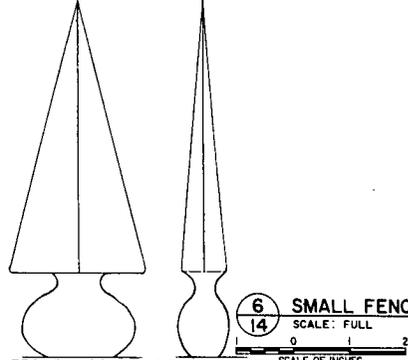
DESIGNED: EXISTING	SUB SHEET NO.	TITLE OF SHEET ST. PHILOMENA CATHOLIC CHURCH FATHER DAMIEN'S GRAVE DETAILS	DRAWING NO. 491
DRAWN: MC GRATH		EXISTING CONDITIONS HISTORIC STRUCTURE REPORT	25,000
FIELD REVIEW: DATE 8/28/84			PRG. NO. 118 SHEET 14 OF 28

Details of railing, Fr. Damien's grave, showing deterioration of metal. 6/84. R.L.C.

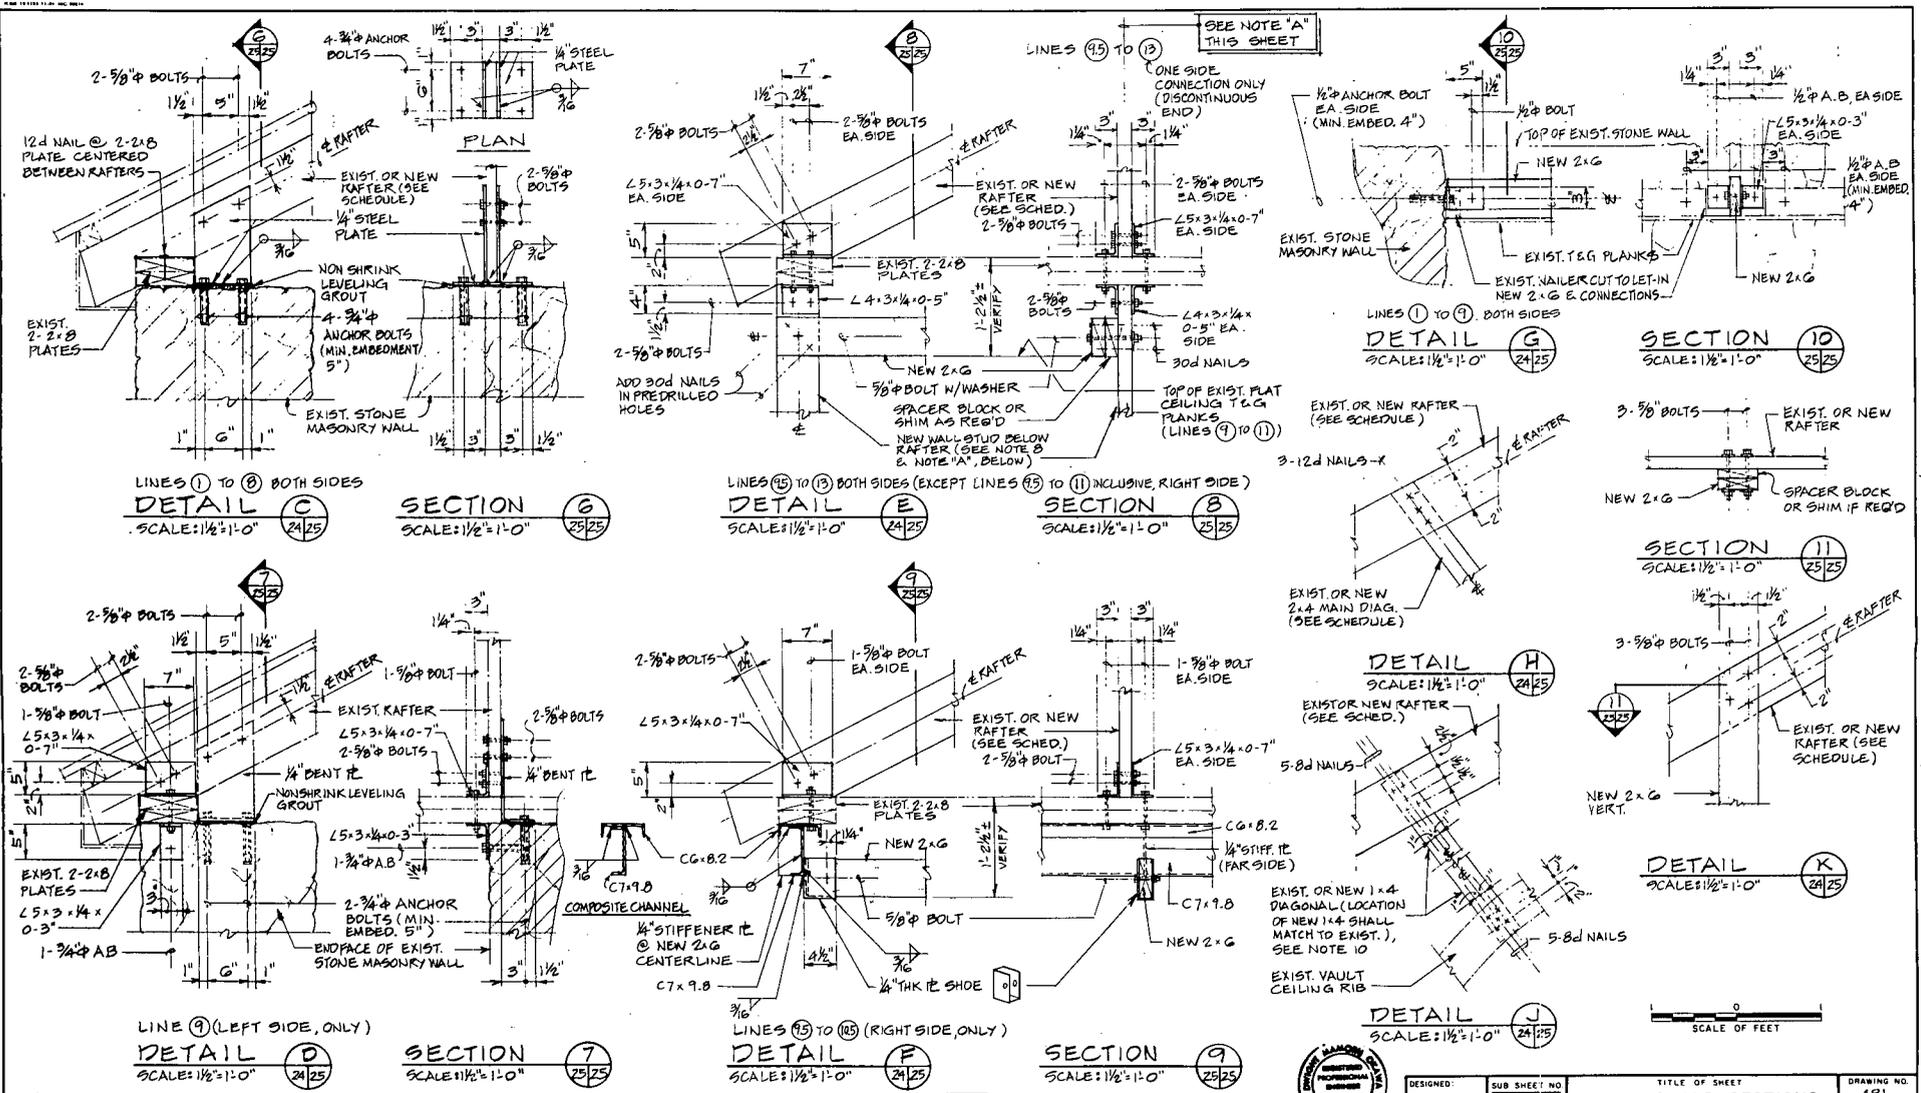
1. WALL STUDS MAY EXIST AT SOME LOCATIONS, VERIFY.
2. NEW STUD AT LINE (15) LEFT SIDE AND LINE (2) BOTH SIDES SHALL BE LOCATED SOUTH OF EXISTING WINDOW JAMB.
3. NEW STUD AT LINE (15) LEFT SIDE SHALL BE LOCATED NORTH OF EXIST. WINDOW JAMB.
4. INTERIOR WALL BOARDING EXISTS BETWEEN LINES (9) & (11). CONTRACTOR SHALL ARRANGE WITH THE CONTRACTING OFFICER THE PROCEDURE FOR INSTALLING THE NEW STUDS.

- PRIOR TO EXECUTION OF REPAIR AND/OR MODIFICATION WORK FOR THE ROOF AND VAULT CEILING FRAME, THE CONTRACTOR SHALL REPAIR THOSE PORTIONS OF THE VAULT BEARING PLATES AND 2X4 NAILERS WHICH ARE TERRITELY DAMAGED. REPAIR SHALL BE BY MEANS OF EPOXY INJECTION. (SEE SPECIFICATIONS.)

- PROCEDURES AND EXTENT OF EPOXY INJECTION SHALL BE AS RECOMMENDED BY THE PRODUCT MANUFACTURER EXPERIENCED IN THIS TYPE OF WORK IN ACCORDANCE WITH THE SPECIFICATION.

- REPLACE OR ADD NEW RAFTERS AND DIAGONALS AS NOTED IN THE SCHEDULE AND AS SHOWN ON THE DRAWINGS. EXISTING CONDITION MIGHT VARY FROM WHAT IS SHOWN ON THE DRAWING AND THEREFORE THE CONTRACTOR SHALL VERIFY AND ADJUST DETAILS SHOWN. THE CONTRACTOR SHALL PREPARE SHOP DRAWINGS FOR REVIEW BY THE CONTRACTING OFFICER SHOWING ALL CONNECTION DETAILS THAT ARE APPLICABLE TO THE WORK.

- EXISTING MEMBER JOINTS SHALL BE STRENGTHENED BY MEANS OF EPOXY INJECTION IN ACCORDANCE WITH MANUFACTURERS RECOMMENDATION.
- REPLACE TERRITELY DAMAGED PURLINS.

- NEW 2X6 SHALL BE ADDED AT EACH LINE OF RAFTER EXCEPT LINES 5, 9 AND 11. WHERE 2X4 OCCURS (SEE EXISTING PLAN). NO NEW 2X6 SHALL BE ADDED EXCEPT PROVIDED CONNECTION SIMILAR TO DETAIL D, E, F OR G WHERE APPLICABLE.

- ADD 1X4 DIAGONAL FOR NEW RAFTERS AS SHOWN ON DET. J TO PATCH EXISTING.
- WHEN INSTALLING THE NEW STEEL PIPE COLUMN, CONTRACTOR CAN REMOVE PORTION OF EXISTING TEG INTERIOR WALL SIDINGS NOT EXPOSED TO V.O.C. AND SHALL BE REINSTALLED UPON COMPLETION OF WORK. CARE SHALL BE TAKEN IN ORDER TO PREVENT DAMAGE TO EXISTING INTERIOR WALL FINISHES OF CHURCH HALL/SANCTUARY.
