THE HISTORY AND PRESERVATION
OF THE COMMUNITY AUDITORIUM-GYMNASIUM
Historic Structure Report

MANZANAR
NATIONAL HISTORIC SITE

HISTORIC STRUCTURE REPORT

December 1998

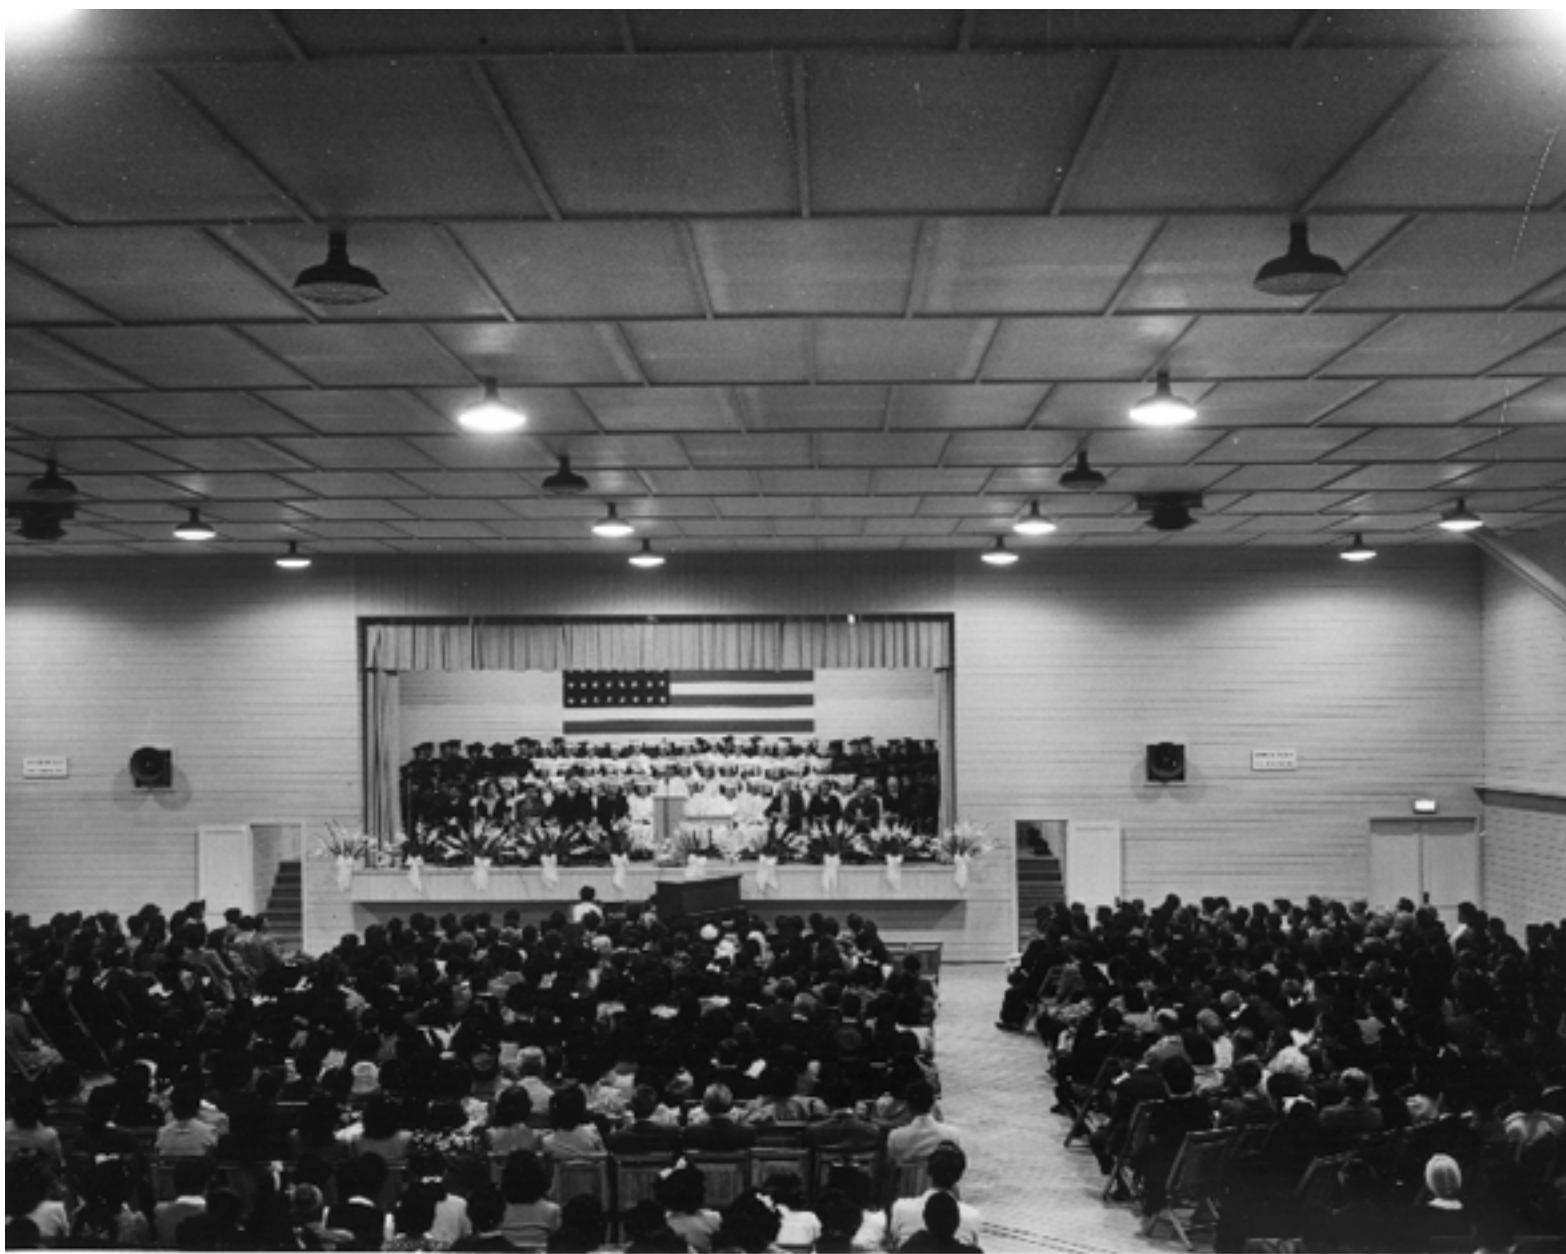
Photo 13. Auditorium interior, probably during the first high school graduation ceremony, held in 1944. The interior work had not yet been completed. The painting was incomplete – the wall wainscot paint colors are not yet finished and the doors and trim do not have their finish colors. Also the seating appears to be all folding wooden chairs, indicating that the wooden benches had not yet been built or completed. Although the stage backdrop curtains are not visible here, which could imply they were still being made, it is possible that they are pulled upward or aside because they do not appear in some later photos. Toyo Miyatake Collection, No. 691, courtesy Archie A. Miyatake, San Gabriel, California.

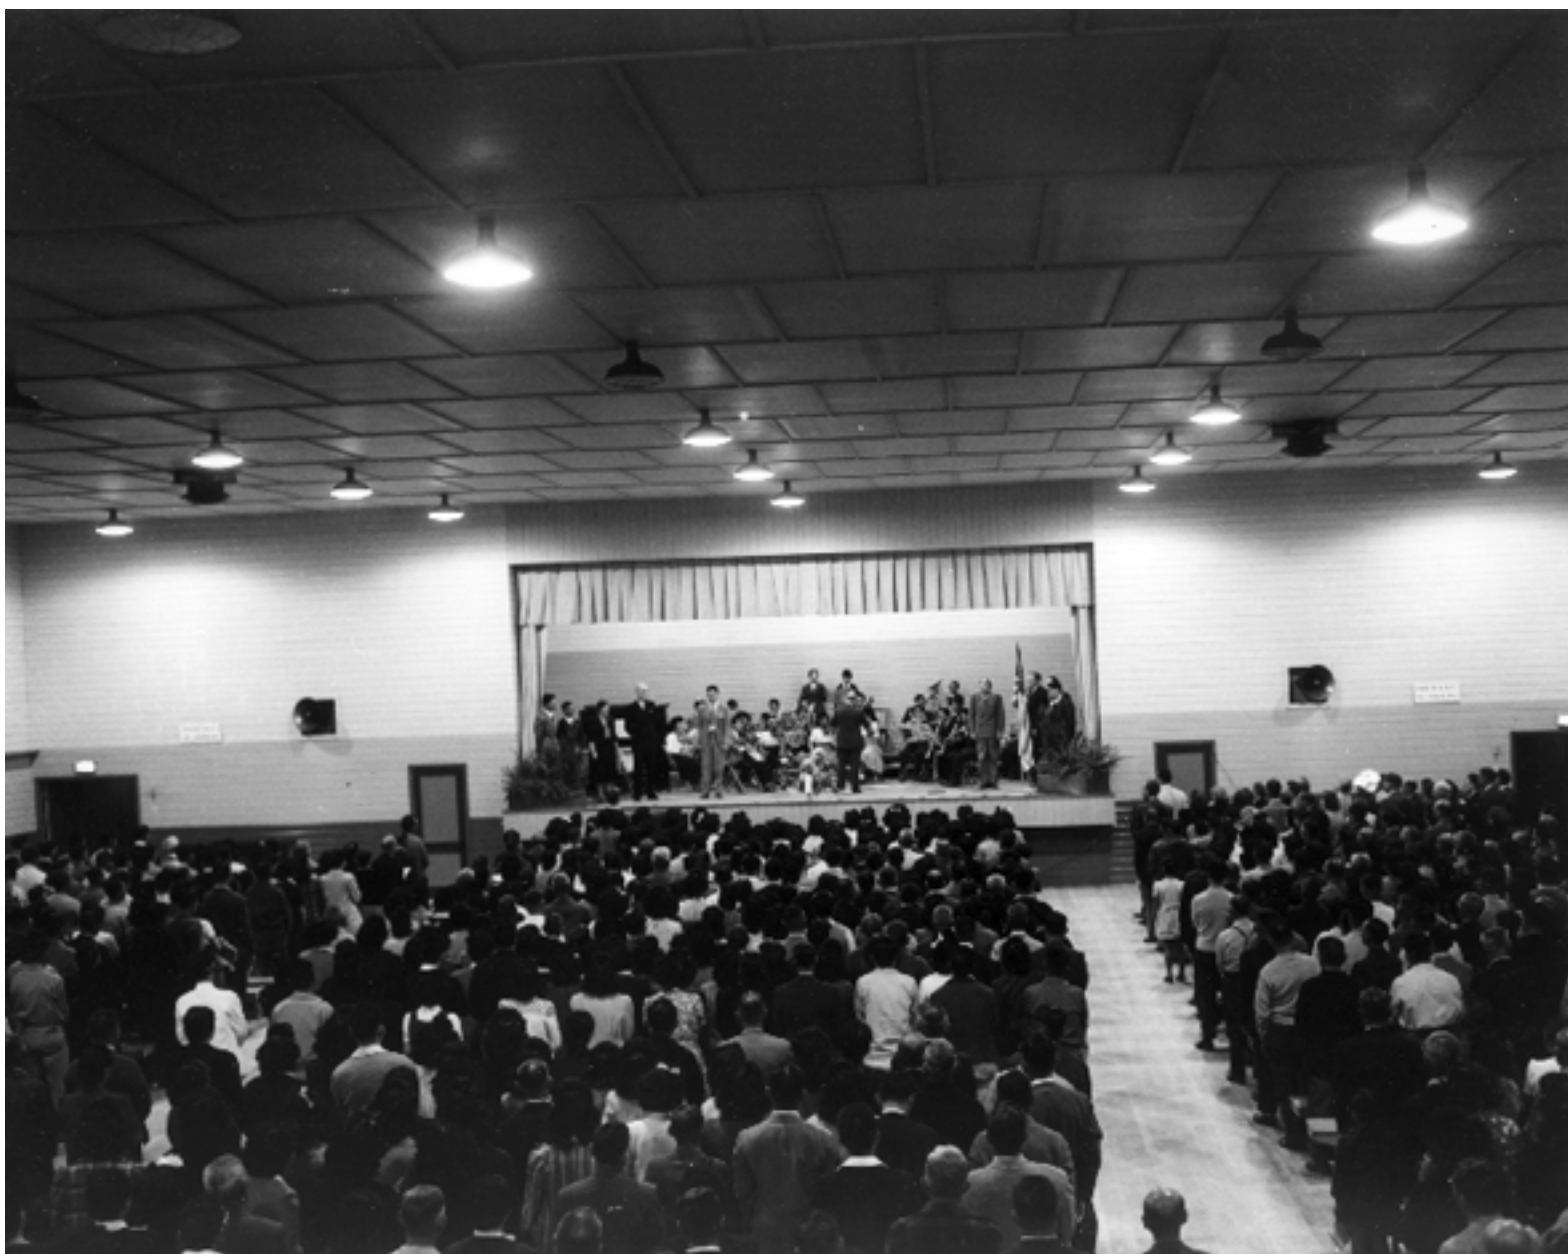
Photo 14. In this view later in 1944 or possibly in 1945 of the auditorium stage, it can be seen that the painting has been completed, with medium and darker brown used on the doors and trim and for the wainscoting delineation on the walls. The northeast and southeast exit doorways are also visible and the wooden benches are in use. The ceiling light fixtures and hot air circulation units are still in place. Toyo Miyatake Collection, No. 91, courtesy Archie A. Miyatake, San Gabriel, California.

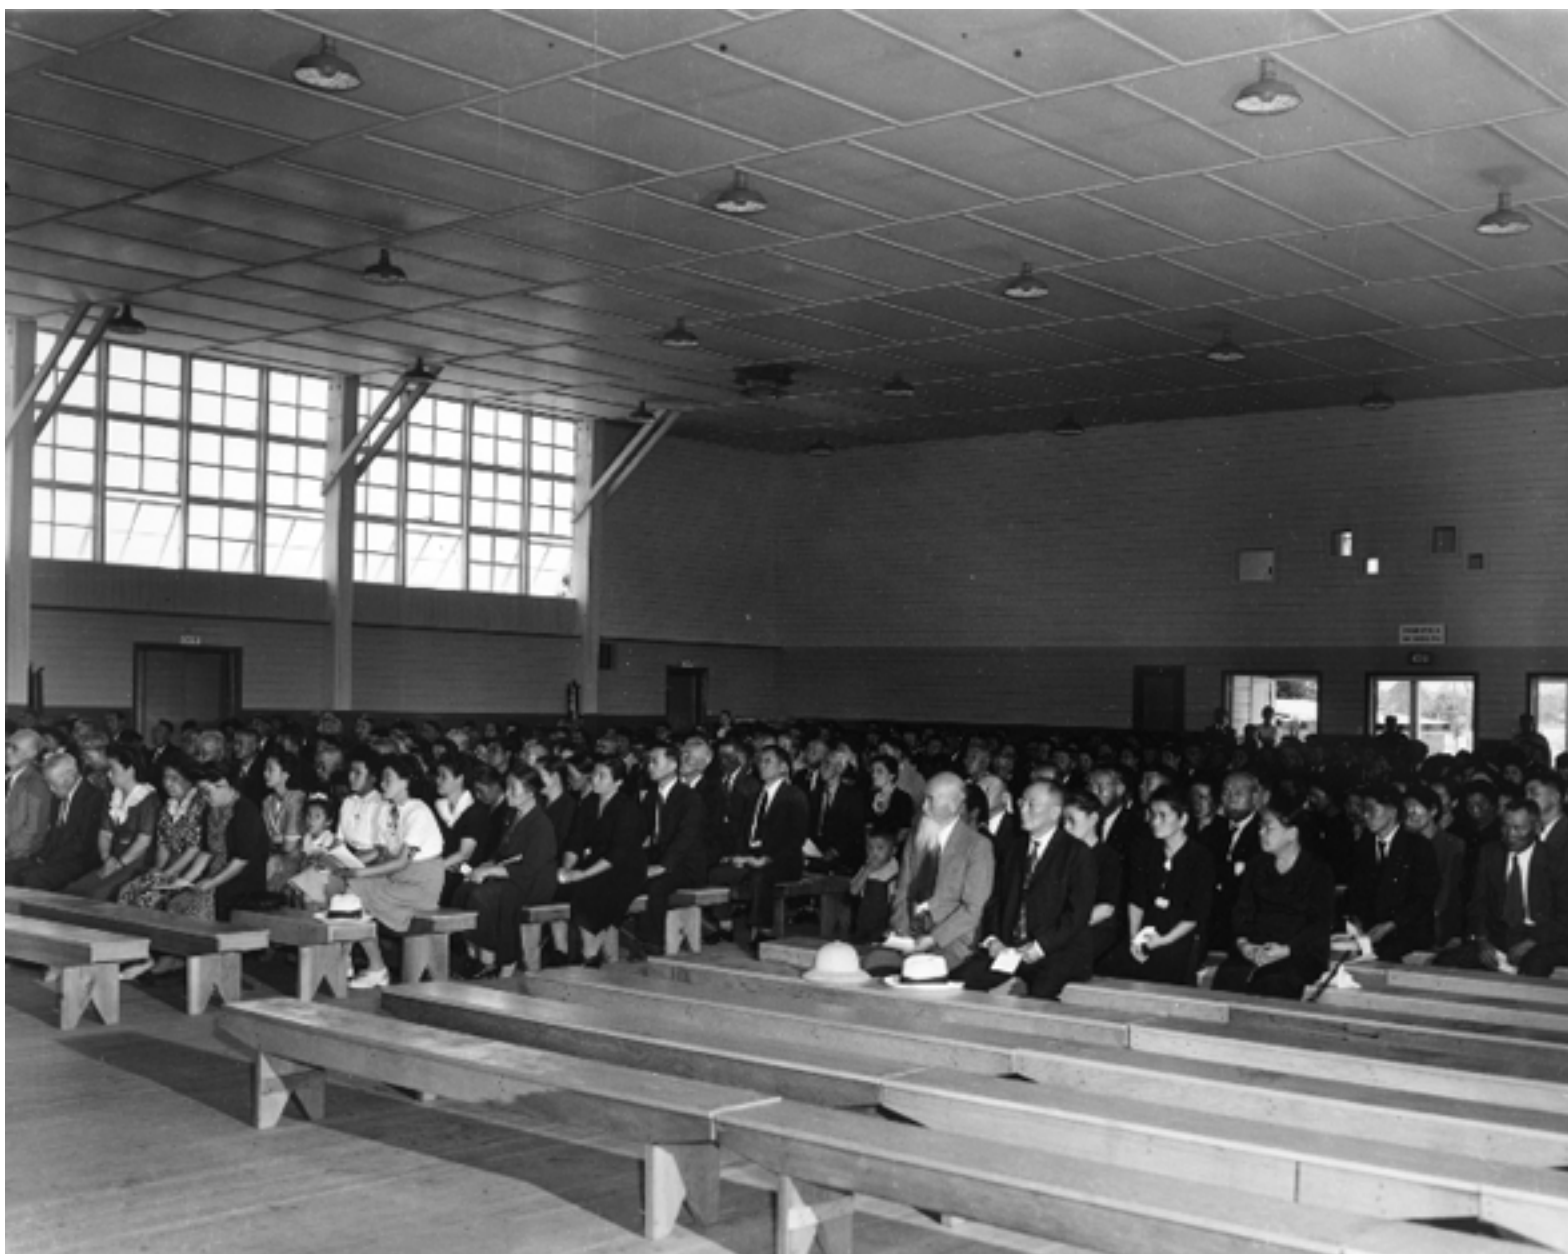
Photo 18. This view toward the southwest corner of the auditorium also provides a close-up view of the wooden benches. 1944 or 1945. The window curtains had not been installed at this time. Fire extinguishers are seen on two of the columns of the south wall. The hangers or evidence of their locations are extant. Toyo Miyatake Collection, No. 171-i(L), courtesy Archie A. Miyatake, San Gabriel, California.

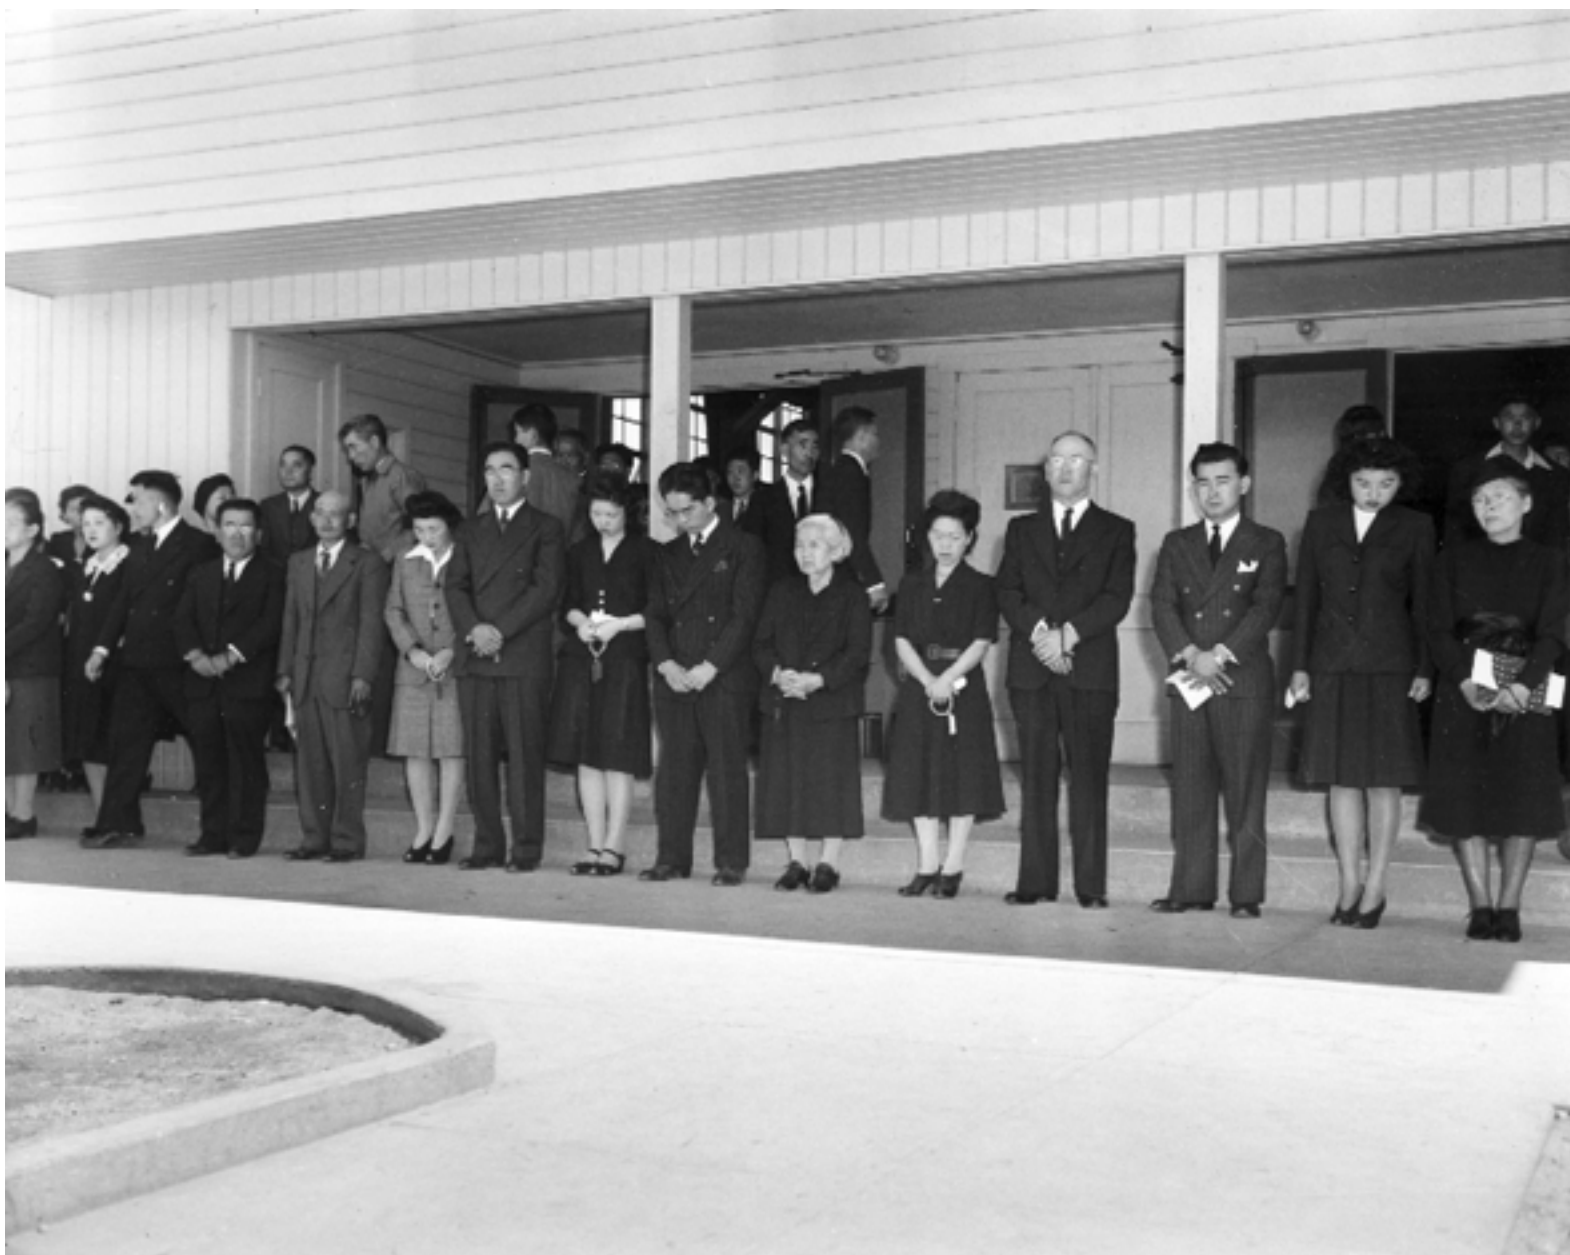
Photo 21. Another view at the west main entrance during the April 5, 1945 memorial service showing details at the doorways. The three double entry door sets and the closers are no longer in place but the light sockets are extant. Toyo Miyatake Collection, No. 170-A, courtesy Archie A. Miyatake, San Gabriel, California.

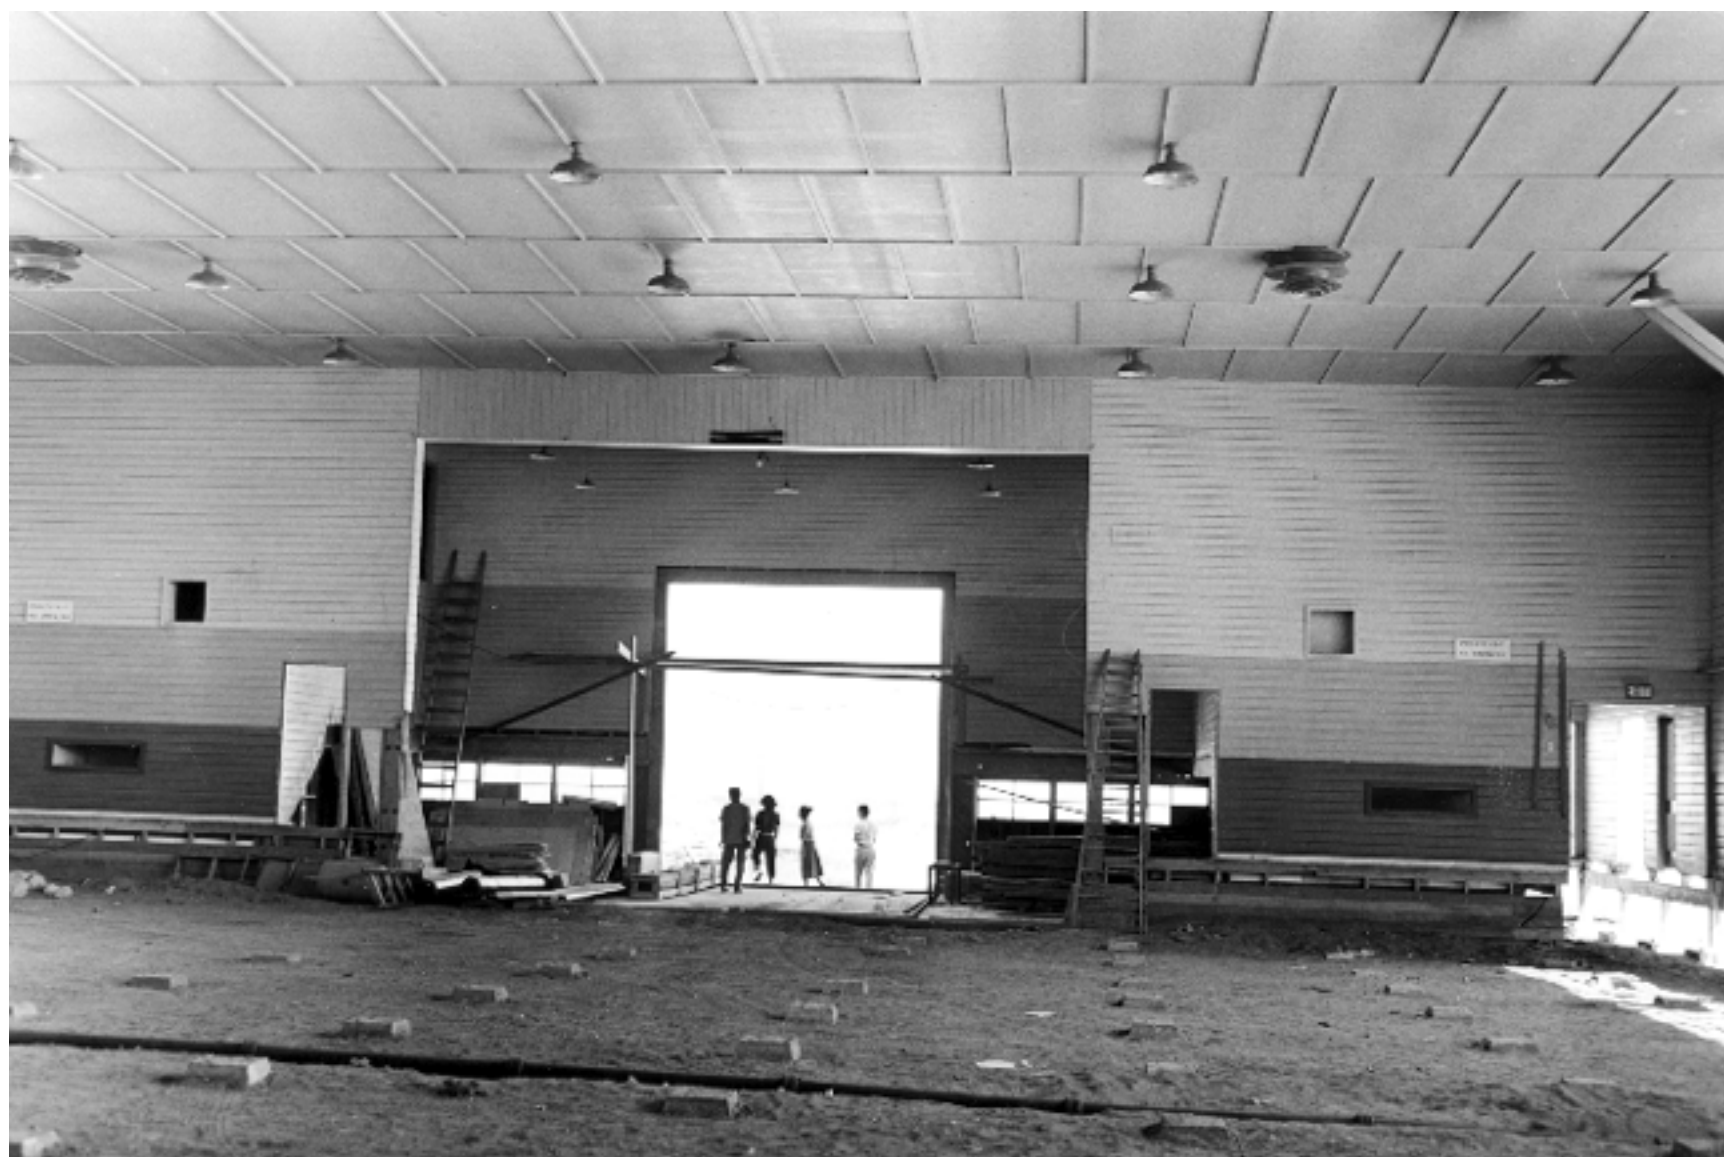
Photo 36. After removal of the south wing by the VFW, Inyo County modified the auditorium building for use as a maintenance facility. This view, probably mid- to late-1954, shows that the stage has been removed and a vehicle access opening constructed in the east exterior wall. The windows that were originally in the space beneath the stage had not yet been removed. The auditorium-gymnasium floor has also been removed. The concrete pads which had provided support for the floor framing were used to fill in spaces between framing and footings at the perimeter of this space before earth fill and a concrete slab were installed. This new floor level is lower than the original floor surface leaving the original floor level and base trim position still visible. Some of the original wood flooring was used on new walls in the former stage space. Toyo Miyatake Collection, No. 87-F, courtesy Archie A. Miyatake, San Gabriel, California.

The main floor of the auditorium is currently a concrete slab that was installed by the county (see historic photo 36) when they adapted the structure as a maintenance garage (ca. 1954). In order to satisfy this new

In addition to the removal of the original stage floor (historic photo 36), its two flanking stair wells were also razed. Paint ghosts of the stairs are visible in basement rooms 118 and 119. In this same historic photograph, the wood gym/auditorium floor has been removed along with flooring at the same elevation in Hall 121. The concrete footings are still in evidence in this photo, but current physical investigation indicates that many of them, if not all, were relocated and stacked with boulders to create a retaining wall for the slab fill around the perimeter of the gymnasium space. The entire gym/auditorium (123), the hall at the southeast corner (121), and a room of undetermined use at the west end of the north wing (106), were all back-filled and a concrete slab poured wall-to-wall.

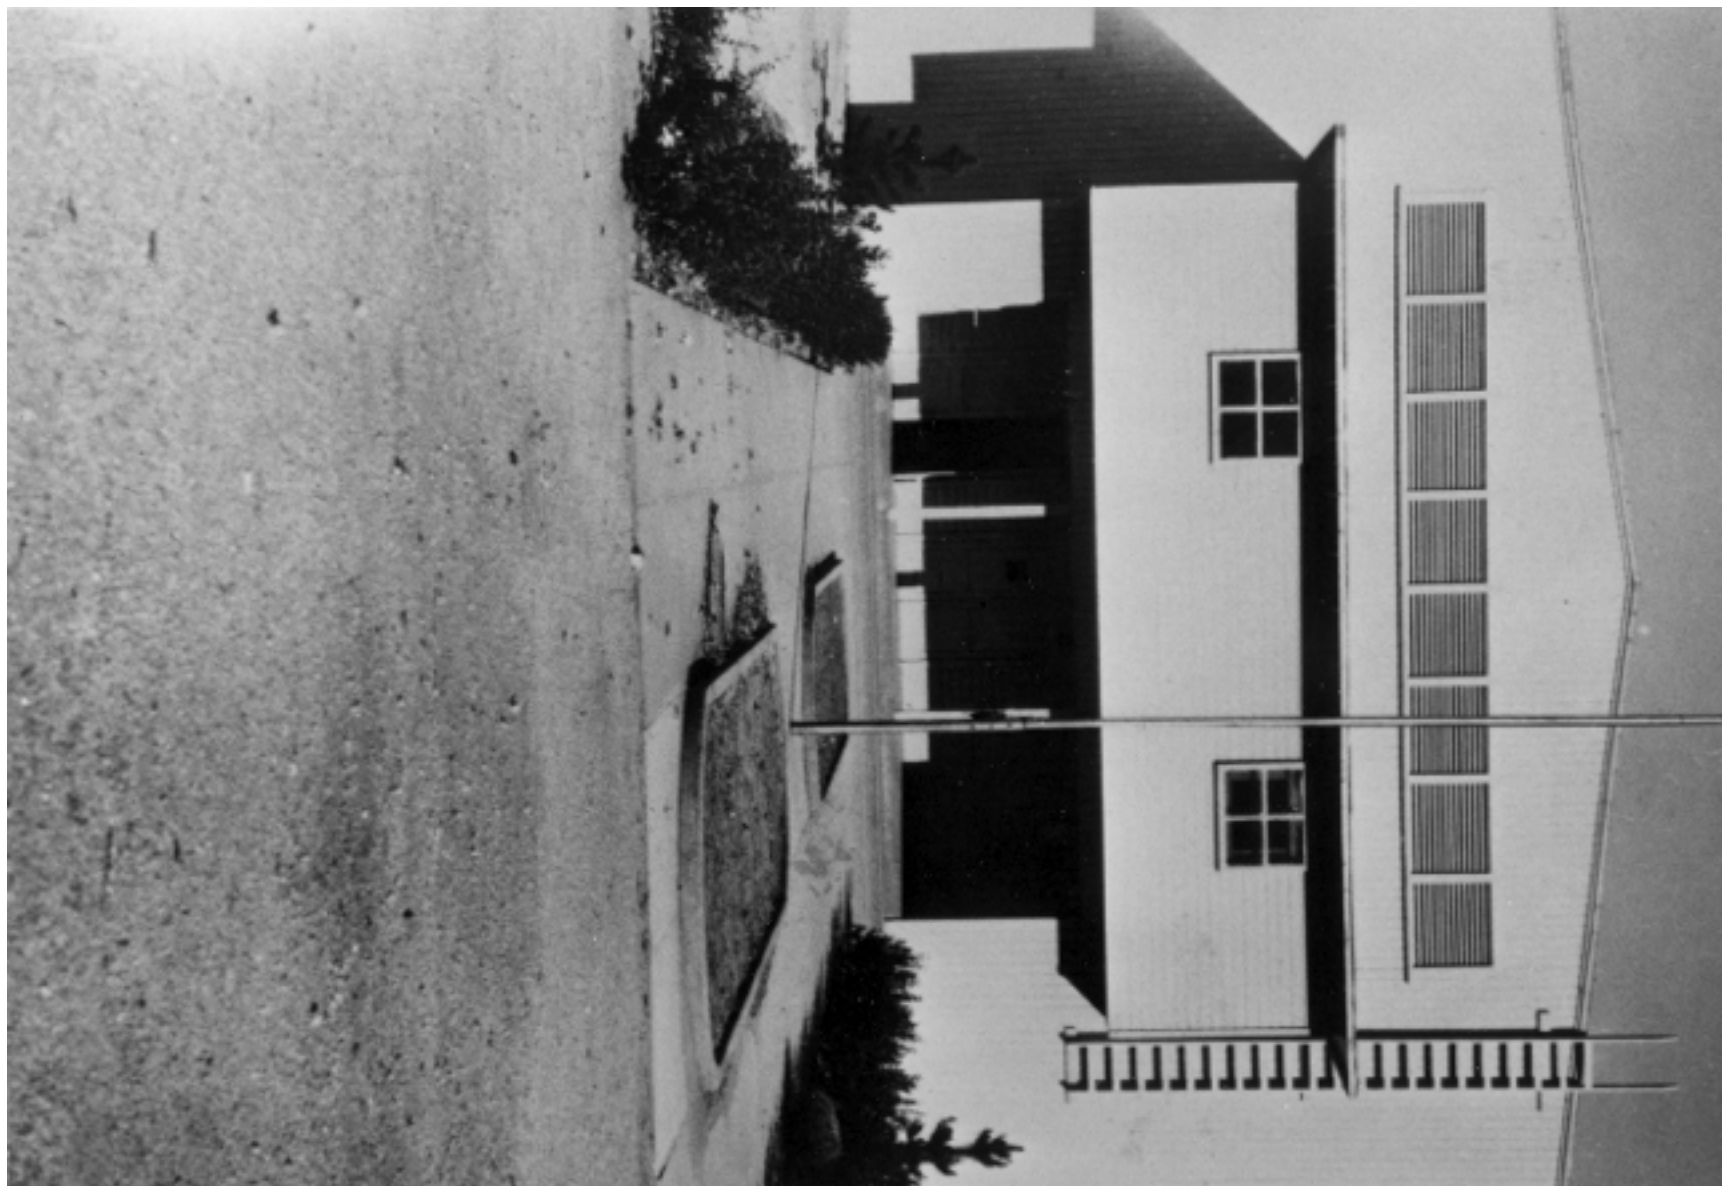
Photo 37. West (main) entrance of the auditorium. This view shows that a small pine tree had been planted on each side of the entrance walks, although they are still small so this photo may have been taken about the time the camp was closed, late 1945, or sometime later. The entryway had also not yet been enclosed. Eastern California Museum Collection, MERR 8.

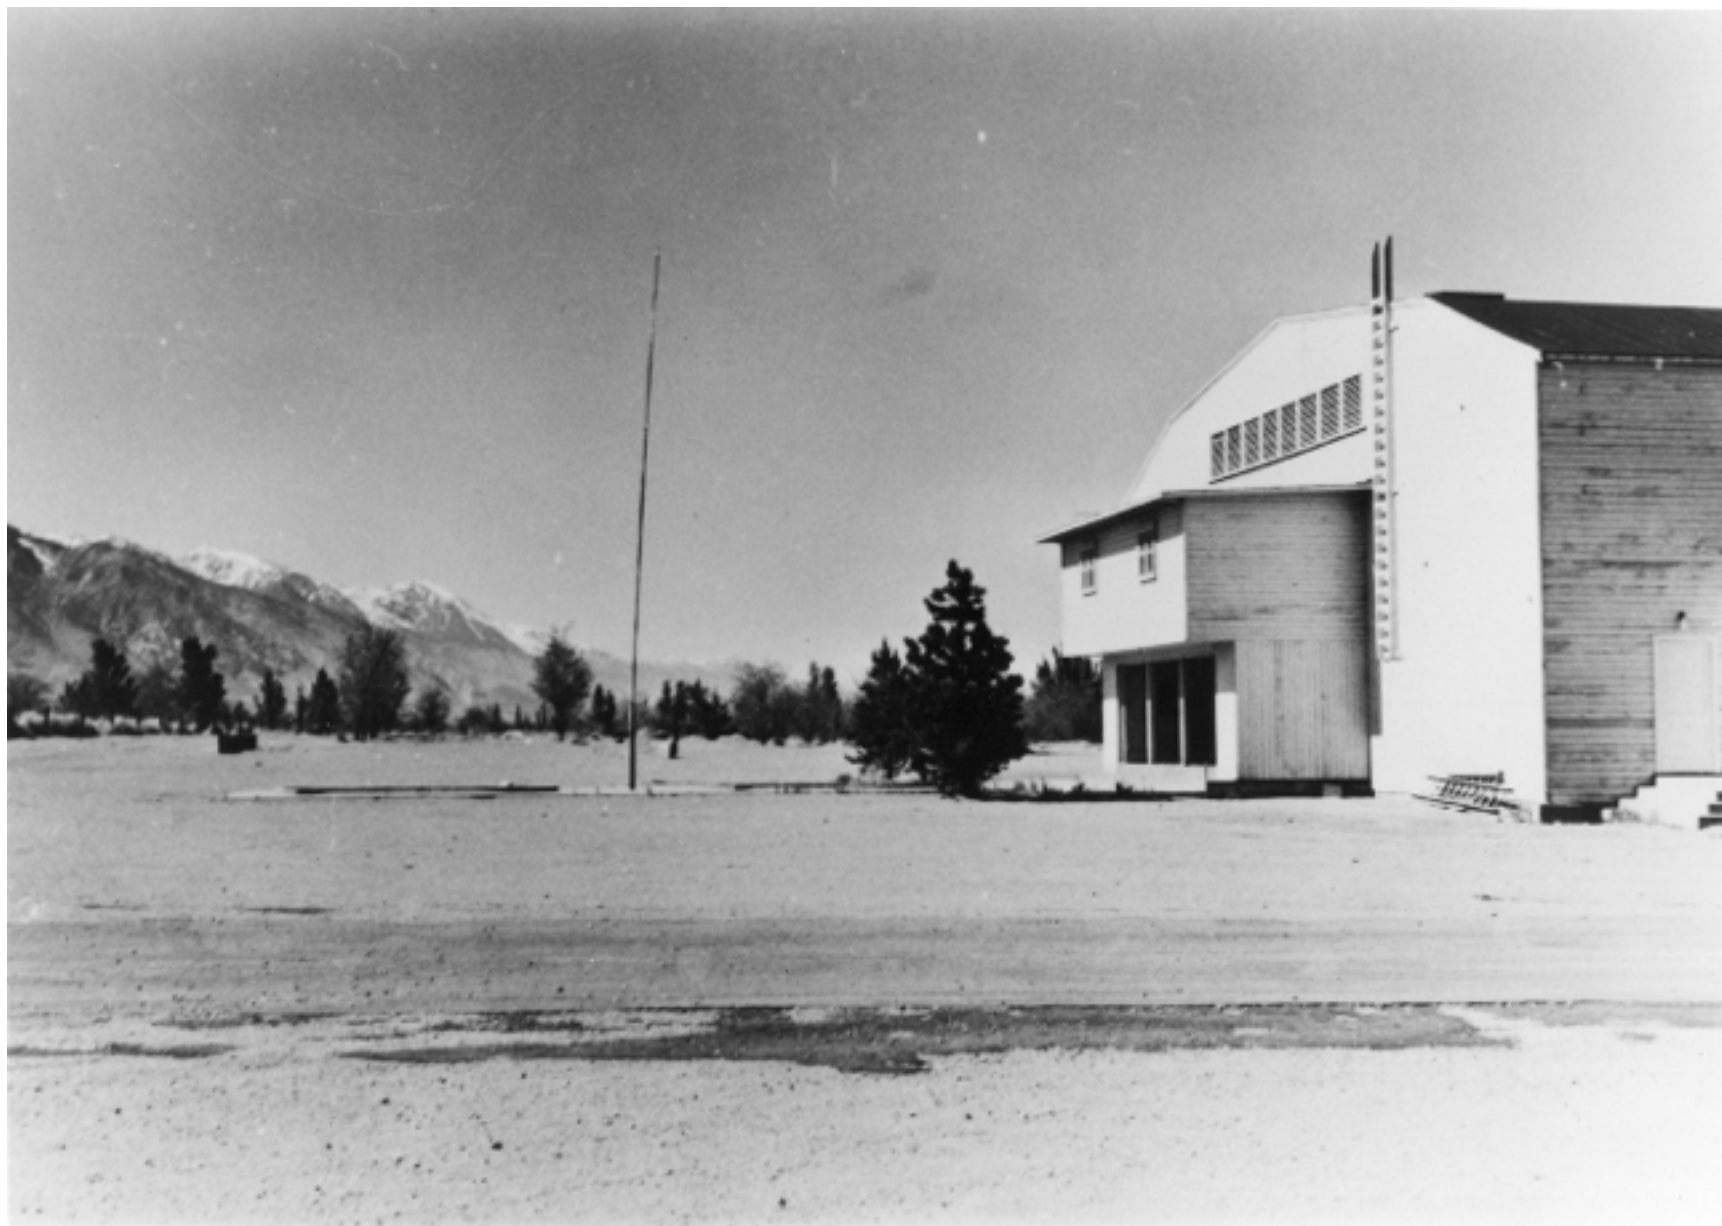
Photo 38. View to the north with the front entrance features and west end of the auditorium-gymnasium building. Barracks Block 13 is just north of the auditorium. The Sierra Nevada mountains are in the background. There are no other buildings visible but the steps at the southwest corner of the building are visible at the extreme right, so this photo was probably taken between 1947 and 1954, most likely in the later part of that period as evidenced by the growth of the two pine trees. The west entrance is unenclosed, indicating that the enclosure was possibly constructed after 1954. Eastern California Museum Collection, NOM 47, 94.80.10a.

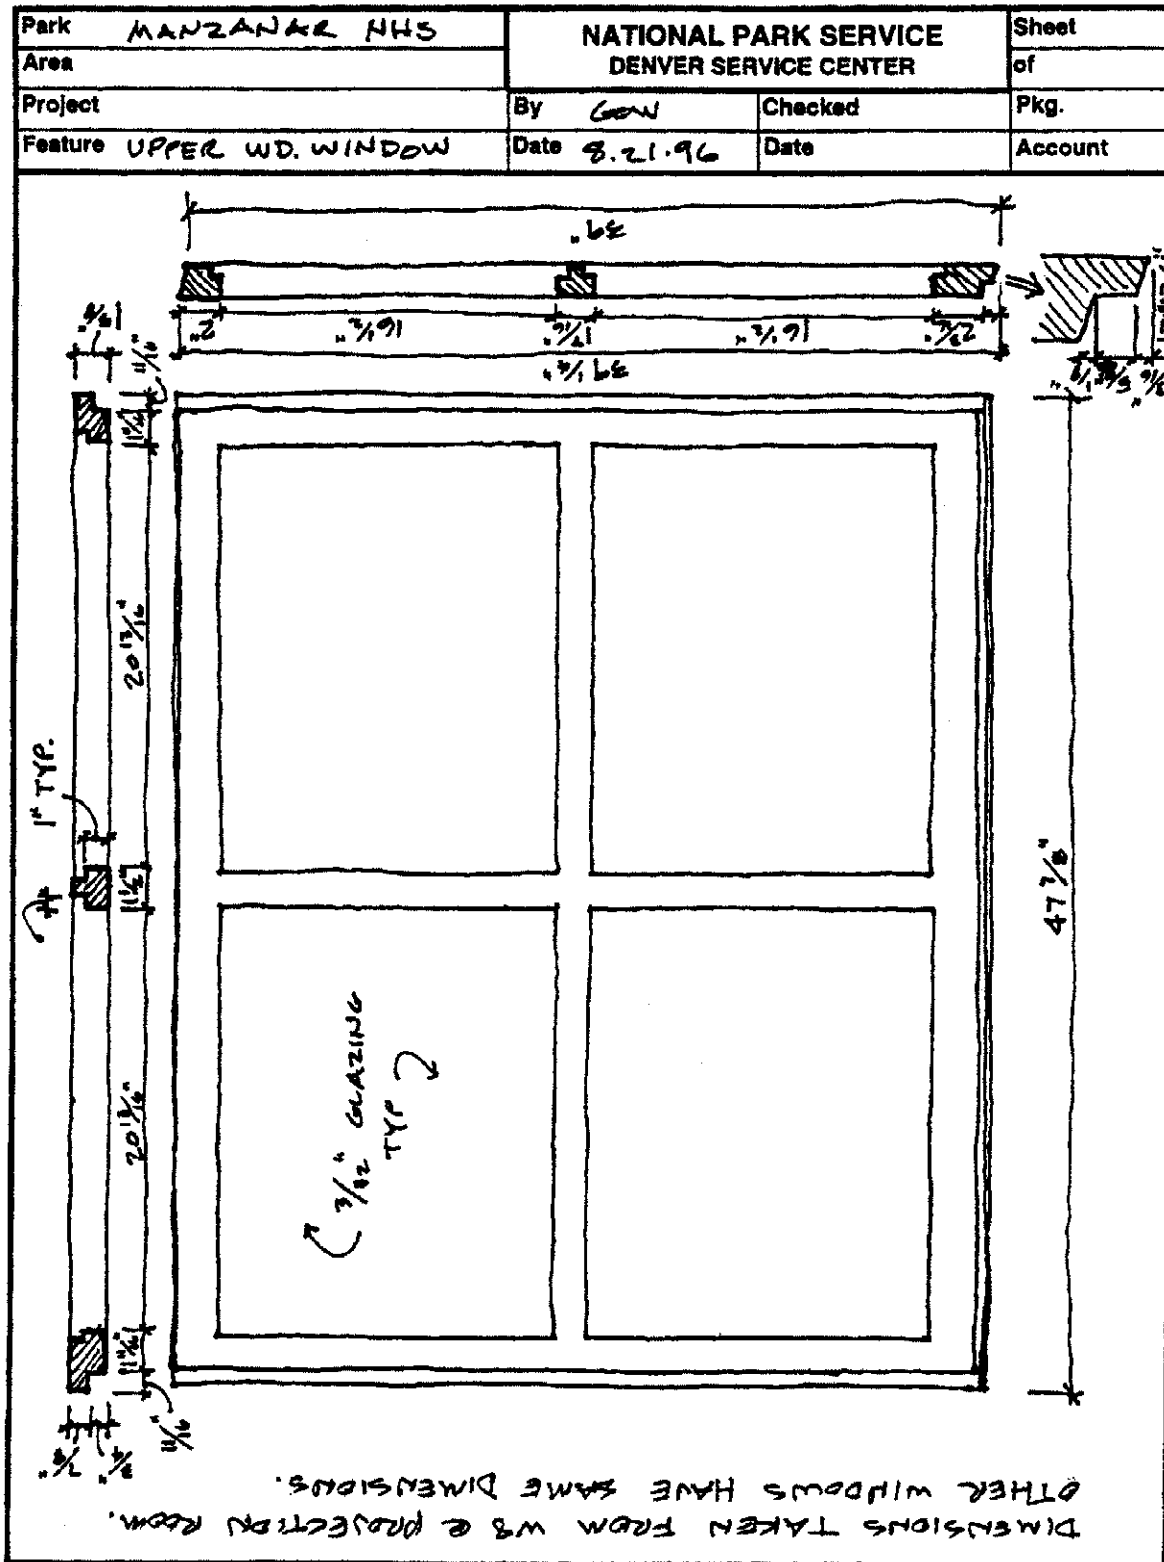
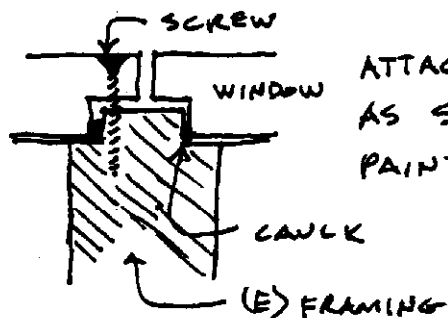
Park MANZANAR NHS	NATIONAL PARK SERVICE DENVER SERVICE CENTER		Sheet
Area			of
Project	By GOW	Checked	Pkg.
Feature UPPER WINDOWS	Date 8.22.76	Date	Account

The actual condition of the majority of the sash units on the north and south clerestories (where there are three courses of sash) is very poor, and in their current state they provide only limited protection from wind-driven rain. The rails and stiles are severely weathered and warped, and most of the glazing putty has broken down, the glass points rusted, the glass panes cracked, broken, and missing. A number of these sash units have been stockpiled inside the building.

- SET FIXED WINDOWS IN NON-ADHESIVE SILICONE CAULK, CONTINUOUS @ ALL FOUR EDGES:

ATTACH WINDOW w/ BRASS WD. SCREW AS SHOWN. COUNTERSINK, FILL $\frac{1}{2}$ PAINT OVER.

- REMOVE $\frac{1}{2}$ & REPLACE ALL UPPER WINDOWS ON SOUTH ELEVATION. (N) WINDOWS TO MATCH ORIGINALS. IN DIMENSION $\frac{1}{2}$ JOINERY. RETAIN UNBROKEN GLAZING FOR USE IN ~~REPLACEMENT~~ NORTH WINDOWS. $\frac{1}{2}$ STORAGE BY N.P.S.

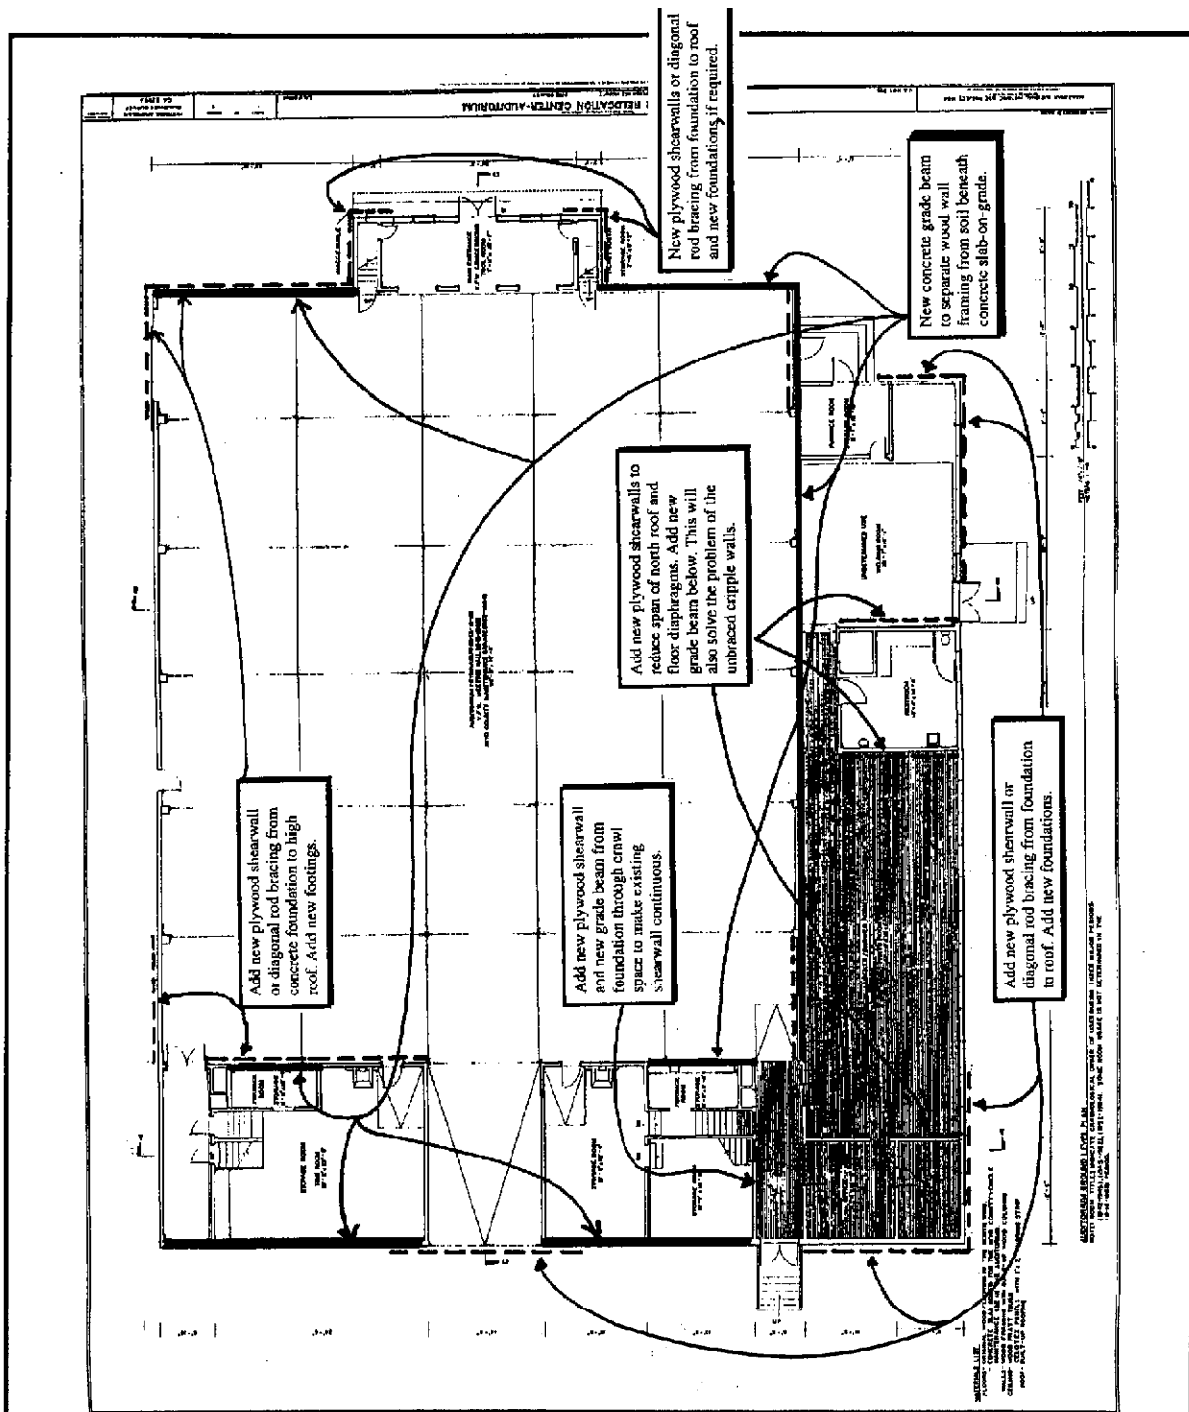
Figure 2 First Floor Plan Added Walls and Grade Beam

2. **Inadequate Shear Walls** - The lack of shear walls is a serious deficiency. The lack of adequate sheathing and the presence of large and numerous door and window openings render the existing walls severely overstressed. Certain portions of the walls should be designed as plywood shear walls or have new steel rod diagonal bracing installed. New concrete grade beams or enlarged footings will be required at the bases of these walls. The suggested locations for these shear walls are shown in Figures 2, 4, 5, 6, and 7, Appendix J.

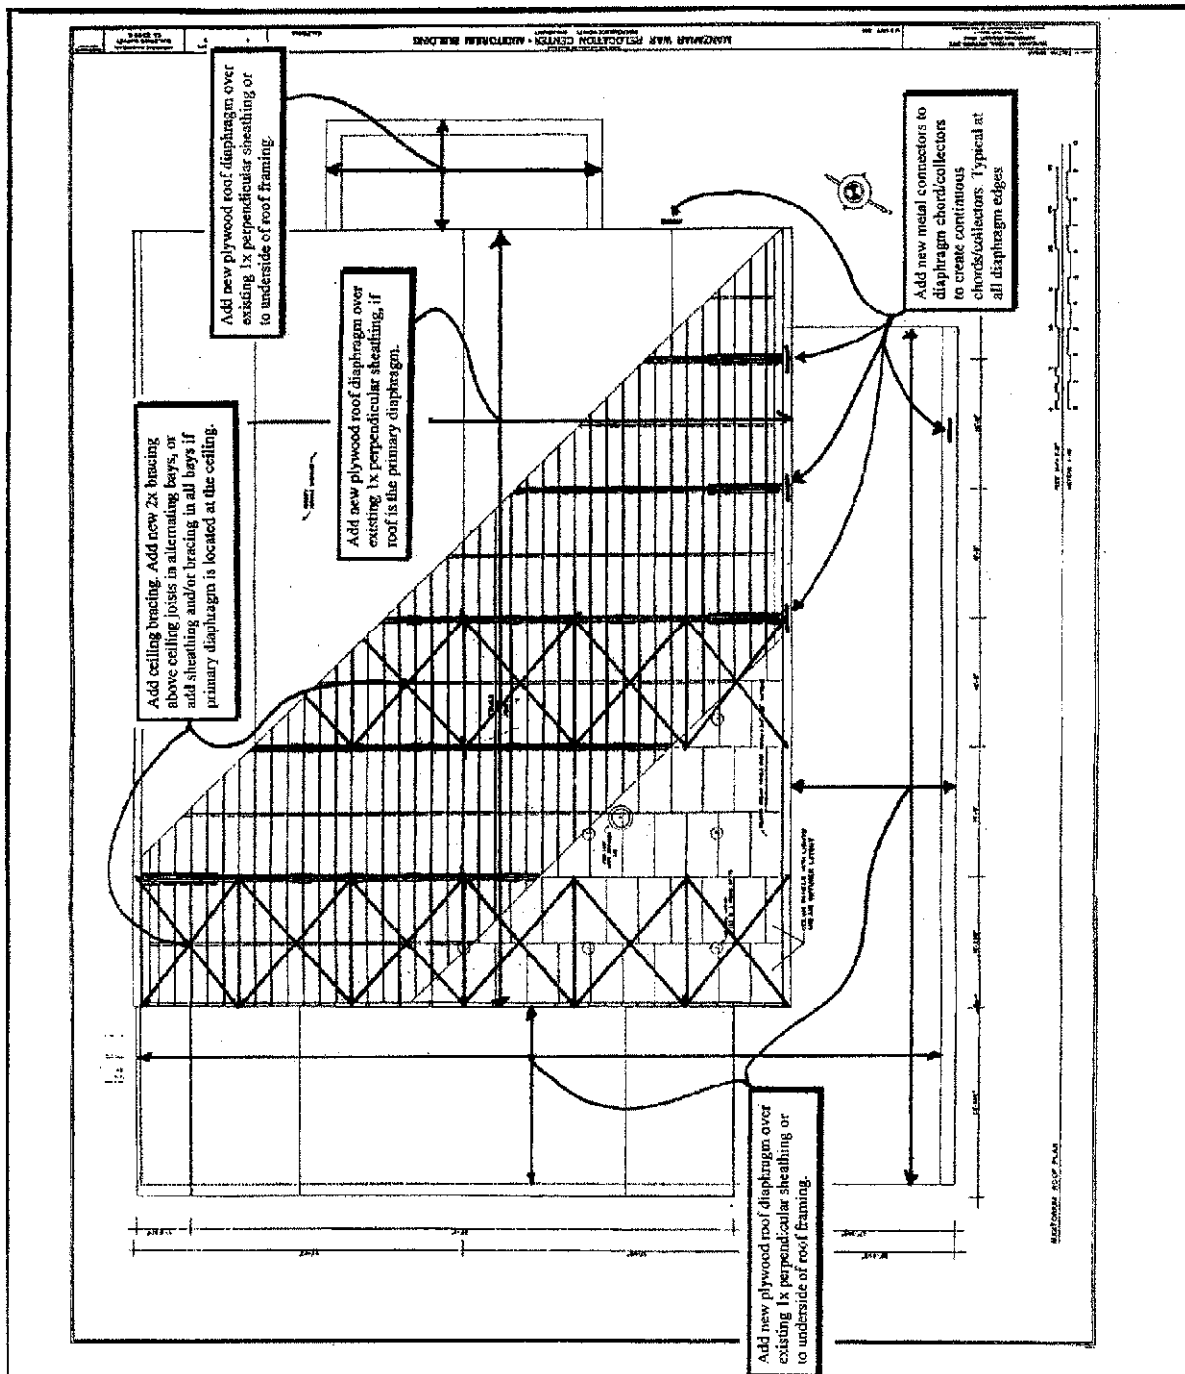
Figure 3 Roof / Ceiling Plan Added Roof Diaphragm

Replacing the existing Celotex ceiling with a gypsum board ceiling will improve the bracing but still does not satisfy the building code due to the 80 foot ceiling diaphragm span. Alternatively, 2x wood diagonals can be added in the horizontal plane of the ceiling, or plywood added in alternate bays to the top or bottom of the ceiling joists (Figure 3). This solution can also be designed to act as the primary building diaphragm as discussed in item 4.0.4.

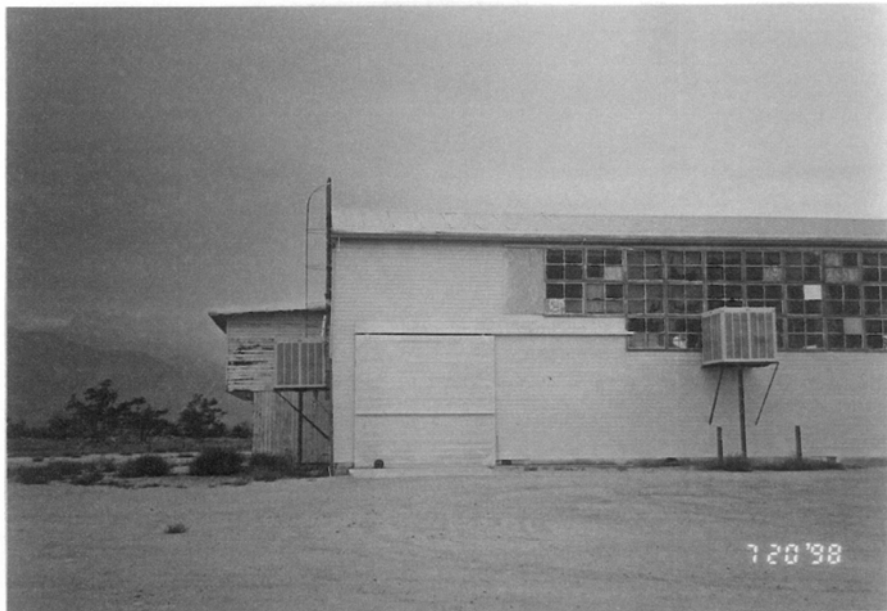
Photo No. 4
Large Added Door Opening in South Wall

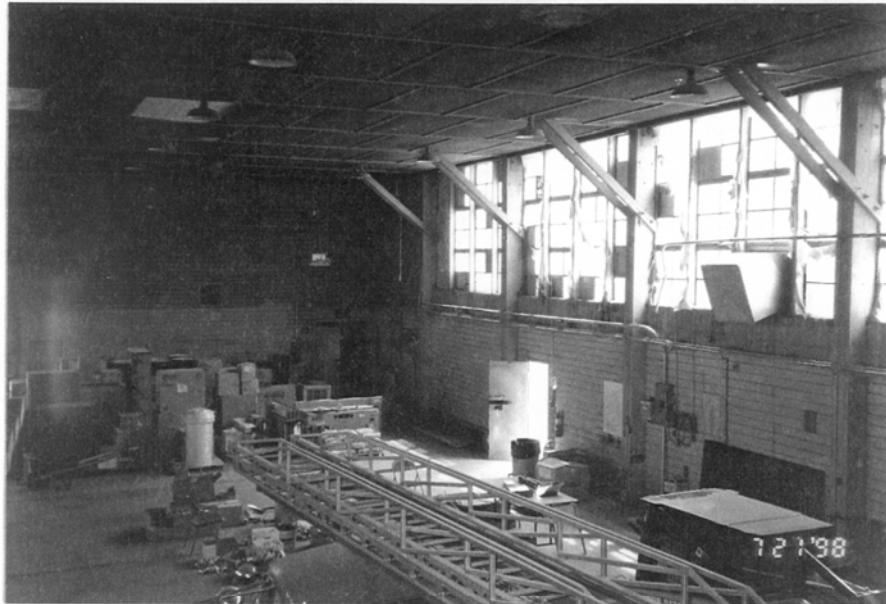
Photo No. 5
Knee Braces Attached to Wood Columns, South Wall

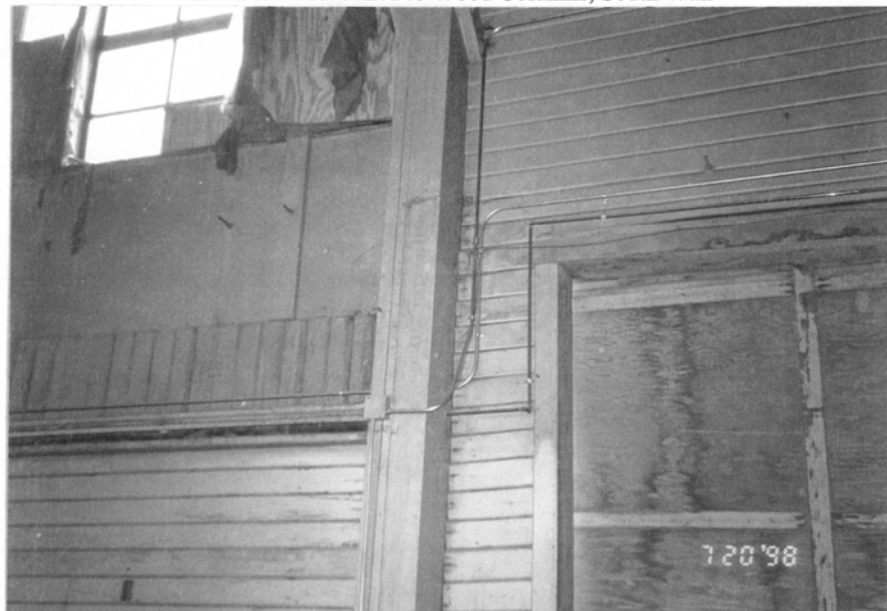
12). The interior wall covering is horizontal 1x lapped siding (Photo No. 6). Several walls which are now exterior were originally interior. These do not have diagonal redwood sheathing.

Photo No. 6
Wall Openings on Grid A at Grid 7
