THE HISTORY AND PRESERVATION
OF THE COMMUNITY AUDITORIUM-GYMNASIUM
Historic Structure Report

MANZANAR
NATIONAL HISTORIC SITE

HISTORIC STRUCTURE REPORT

December 1998

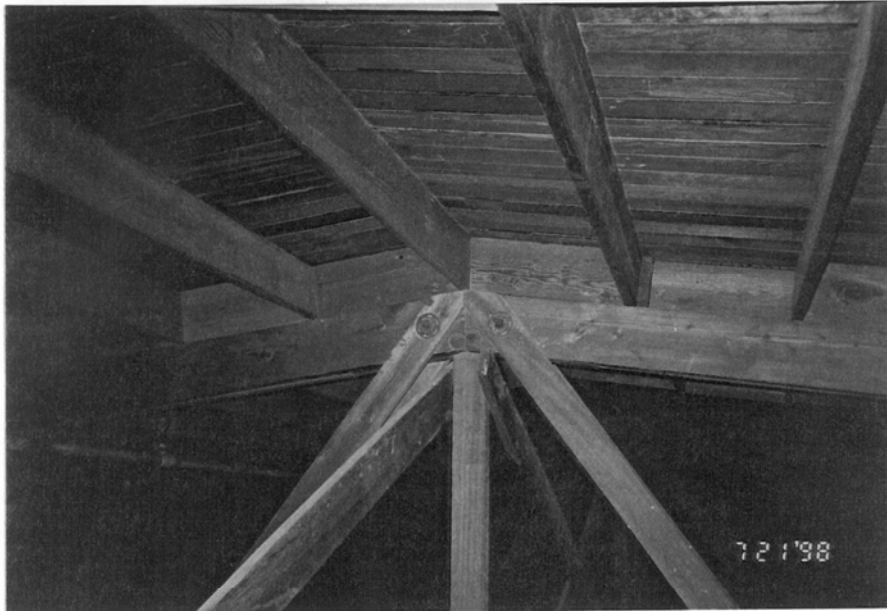
The roof of the auditorium consists of 1x wood sheathing on 2x10 joists spaced at 24 inches on center, spanning to wood trusses spaced at 16 feet on-center (Photo No. 7). The 1x sheathing is placed straight (i.e. perpendicular) to the joists. The trusses span approximately 80 feet and are supported by built-up wood columns along the north and south walls of the auditorium. The trusses and columns are knee braced (Photo No. 5 and Figure No. 8). The ceiling consists of Celotex panels supported by 2x6 ceiling joists spaced at 24 inches on center spanning to the truss bottom chord (Photo No. 8).

Photo No. 7
Wood Roof Framing in Auditorium

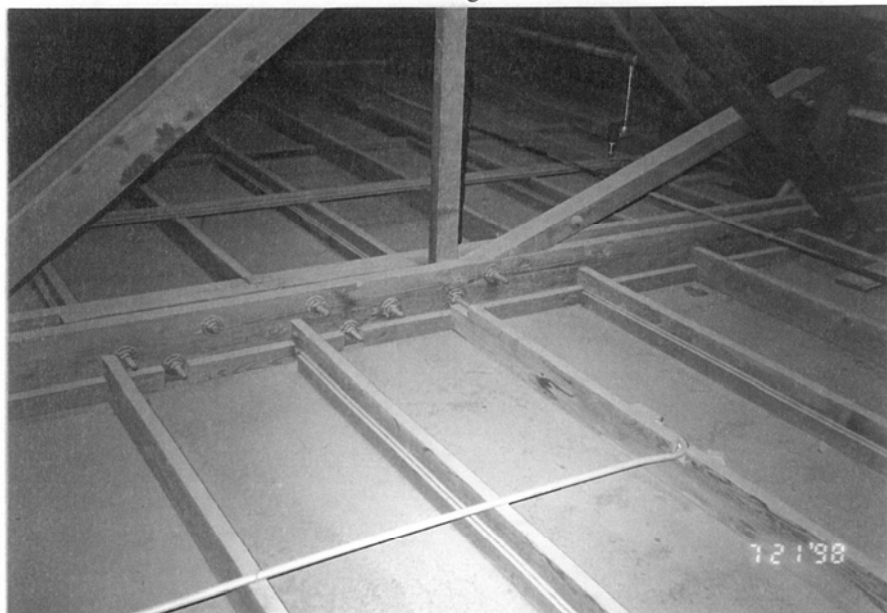
Photo No. 8
Auditorium Ceiling Framing

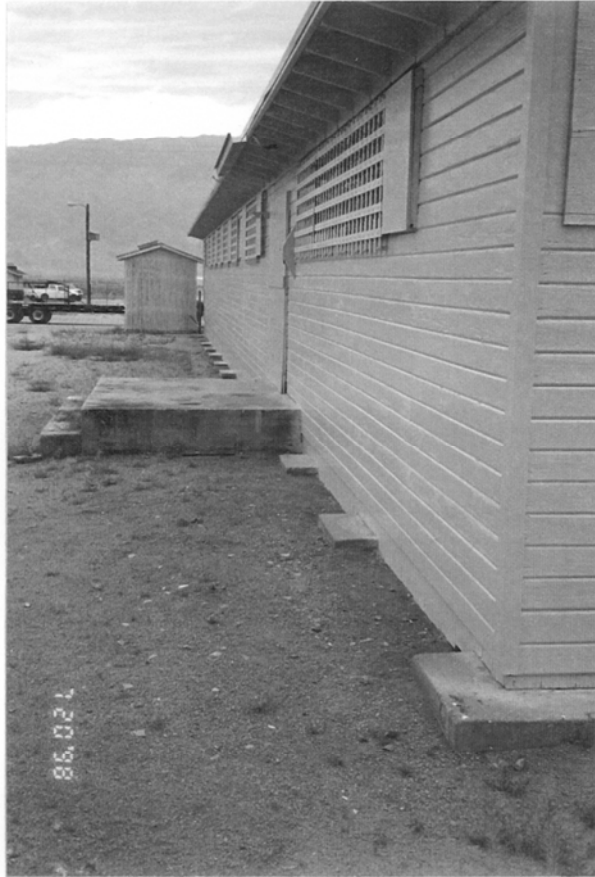
concrete footings (Photo No. 15). The north wing has a perimeter cripple wall which encloses the crawl space (Photo Nos. 15 and 17). The footings supporting the perimeter posts of the north wing are exposed on the exterior (Photo No. 9).

Photo No. 9
Exposed Footings on North Wall of North Wing

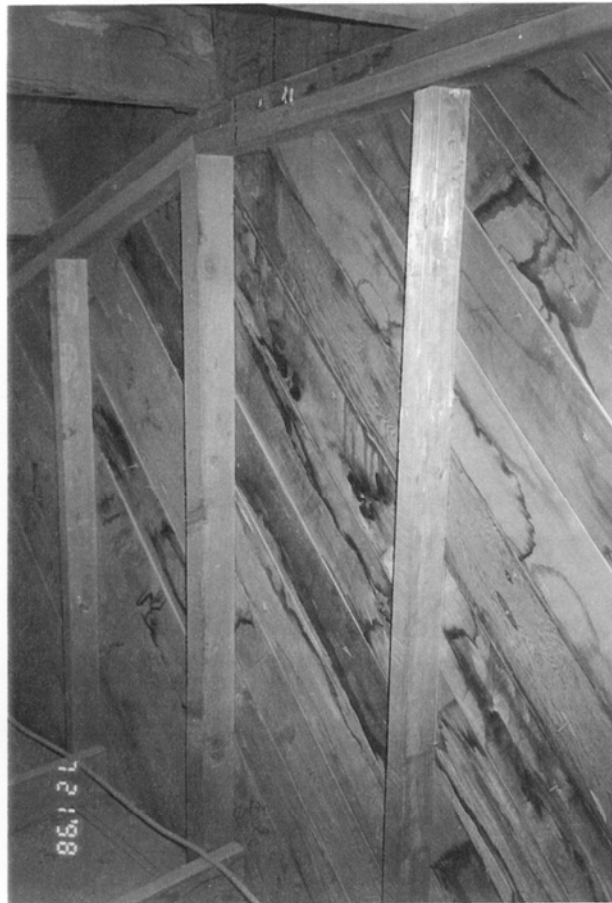
Photo No. 10
Typical exterior Wall Framing Showing Diagonal Wall Sheathing

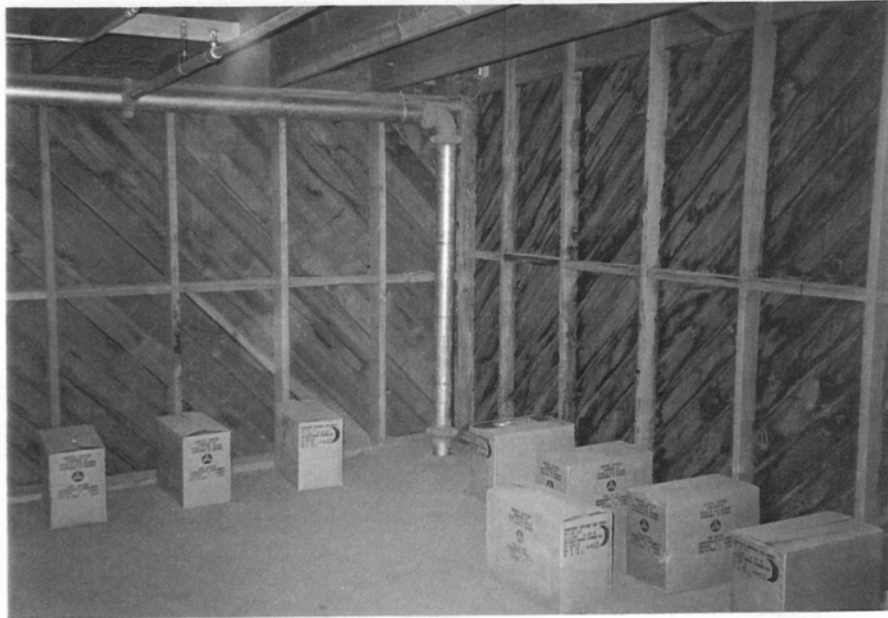
Photo No. 11
Typical Exterior Wall Framing

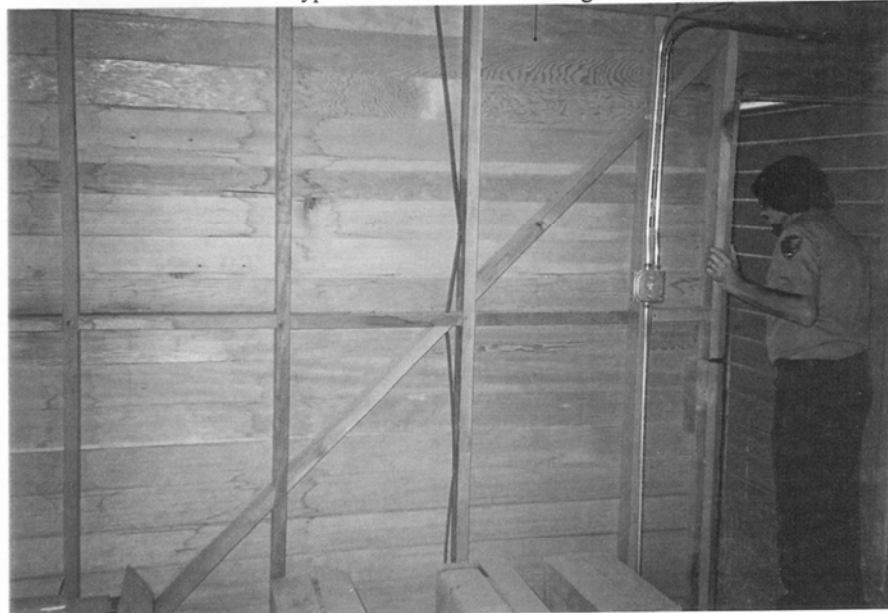
Photo No. 12
Interior Wall with Diagonal Wood Blocking

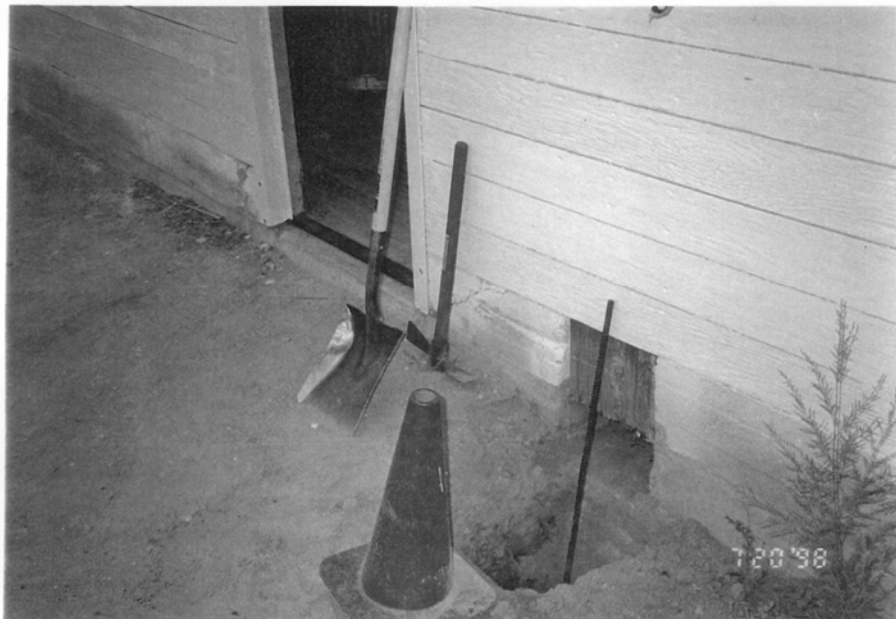
Photo No. 13
Bottom of South Column at Grids A-4

In three locations at the south wall of the auditorium/gymnasium, the bottoms of the columns were found to be considerably deteriorated from a combination of termite and rot damage (see photos 13 and 14, Appendix J), resulting in a lack of positive bearing between the column and the footing. In one case, there exists a 6" air gap between the bottom of the column and the top of the pier. In another case, the historic pier was capped with additional concrete, possibly by the county, to fill in the gap between the rotted column base and the pier. The column has continued to disintegrate, however. It should be noted that these columns were historically protected by the south wing that was removed ca. 1954. Once it was removed, they were exposed to the elements, and, in one case, the close proximity of a hose bib.

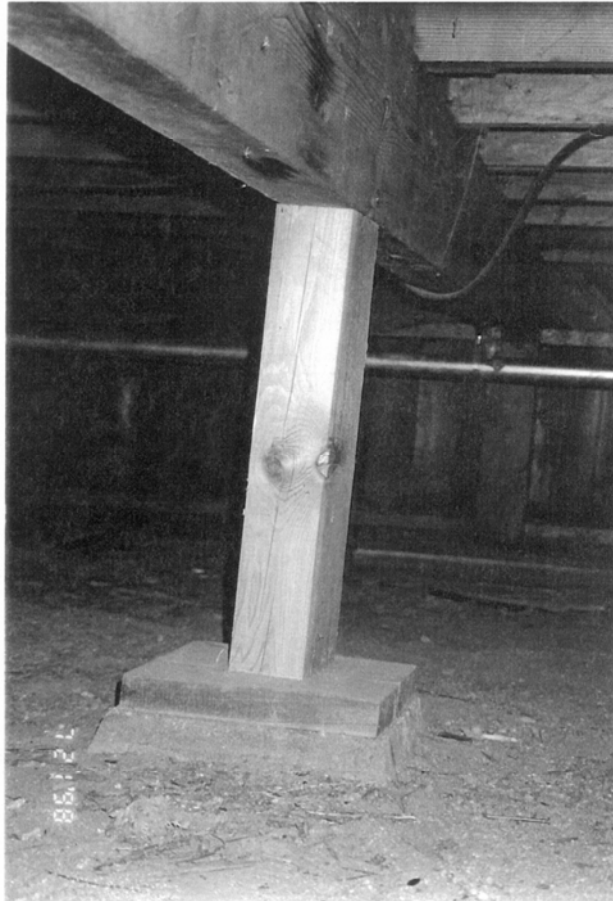
Sheet No. P8

Photo No. 15
Floor Beam, Post and Footing in Crawl Space of North Wing

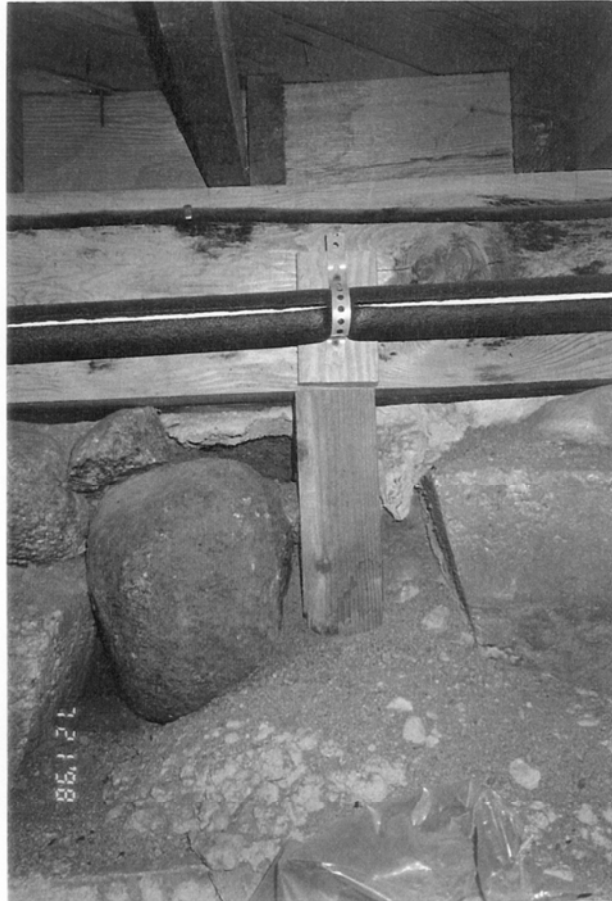
Sheet No. P9

Photo No. 16
Wood Framing on Grid H in Contact with Soil

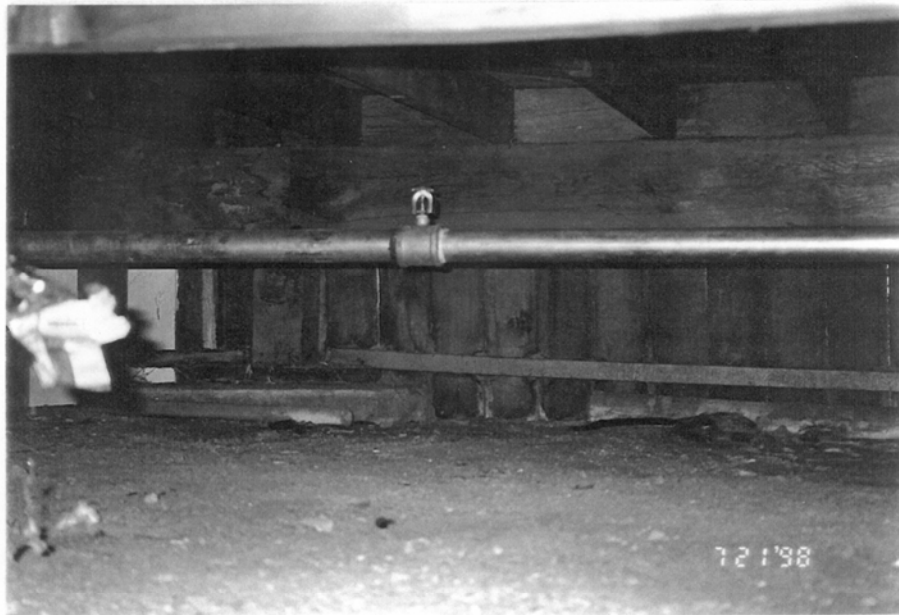
Photo No. 17
Unbraced Cripple Wall at North Wing

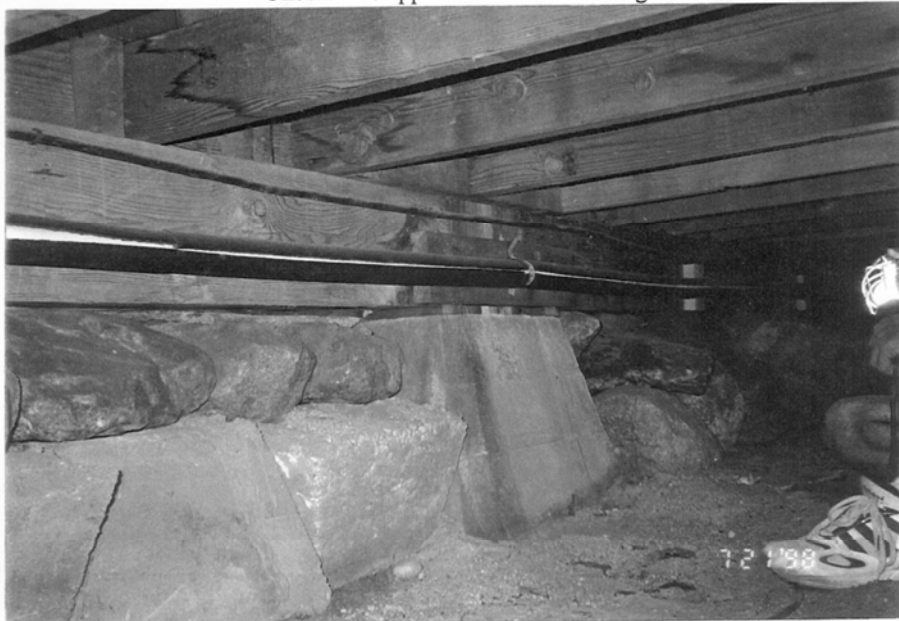
Photo No. 18
Tapered Footing Supporting Wood Column at Grids H-3

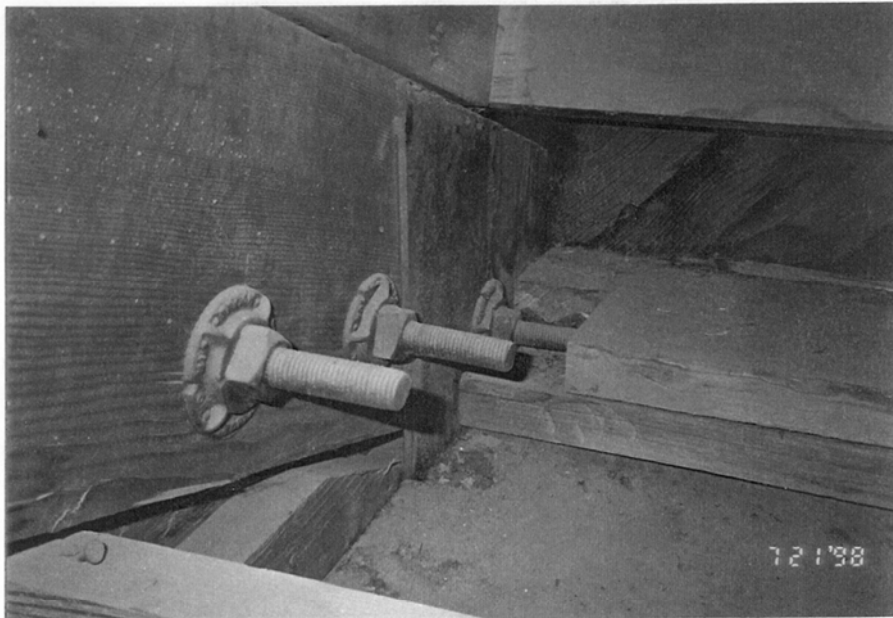
Sheet No. P11

Photo No. 19
Two 2x Top Wall Plate Discontinuous at Truss to Column Connections

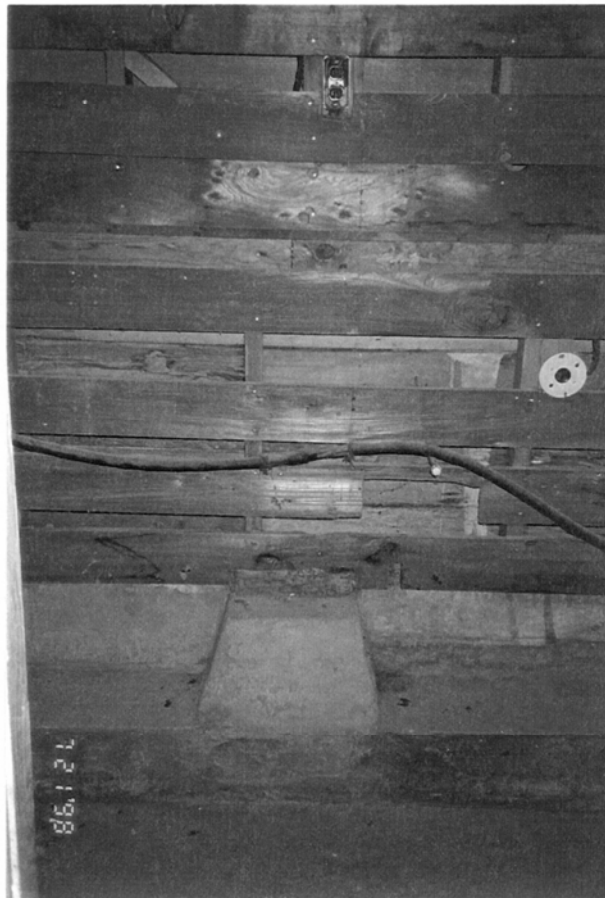
Sheet No. P12

Photo No. 21
Auditorium East Wall with Remnant of the Original Wood Floor
