historic structure report
architectural data section
volume 2: appendixes
june 1985

HISTORIC STRUCTURE REPORT

Architectural Data Section

MARTIN VAN BUREN NATIONAL HISTORIC SITE

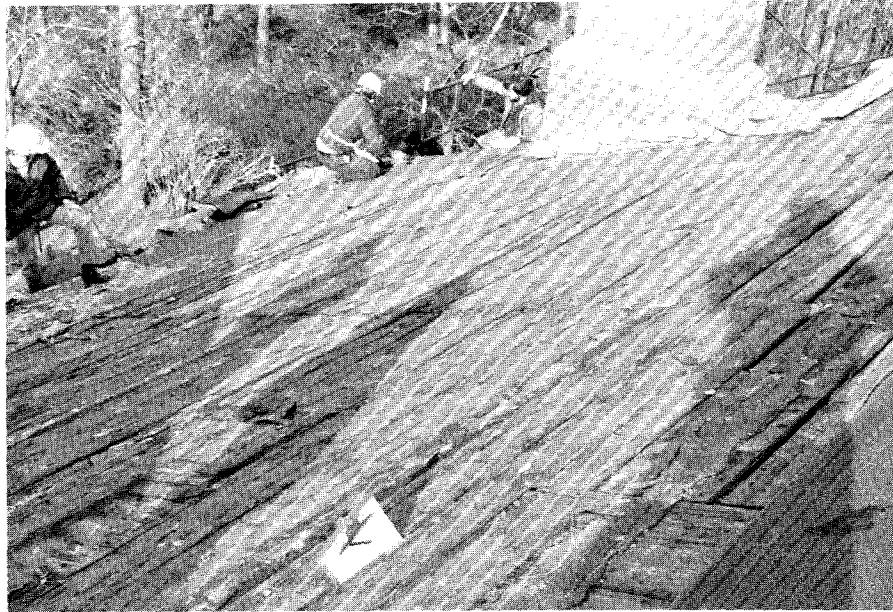
IP003, N039-01. Main roof, northwest corner looking northwest. Note hatch infill in foreground.

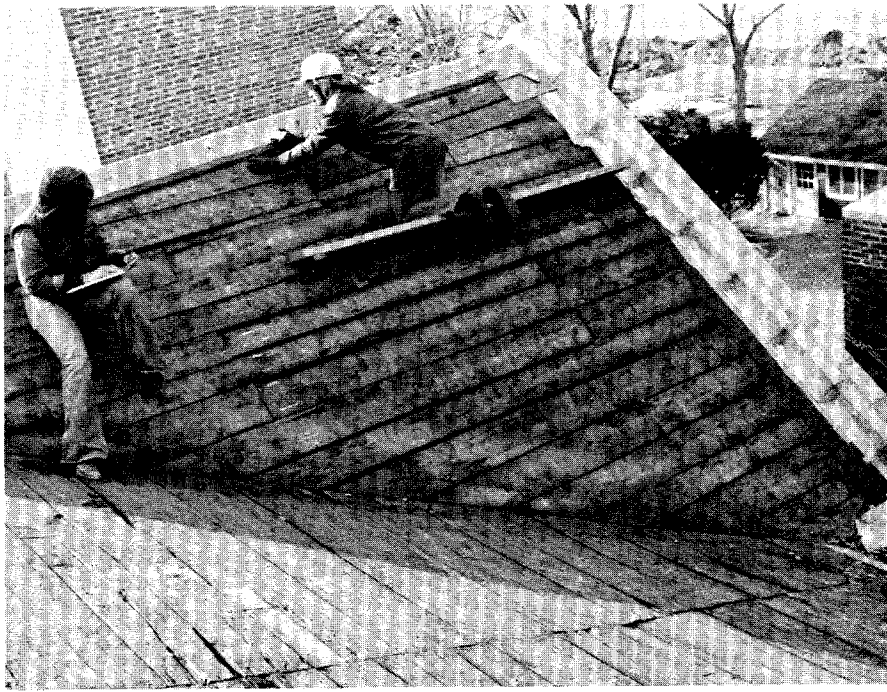
IP007, N039-14. Gable sheathing.

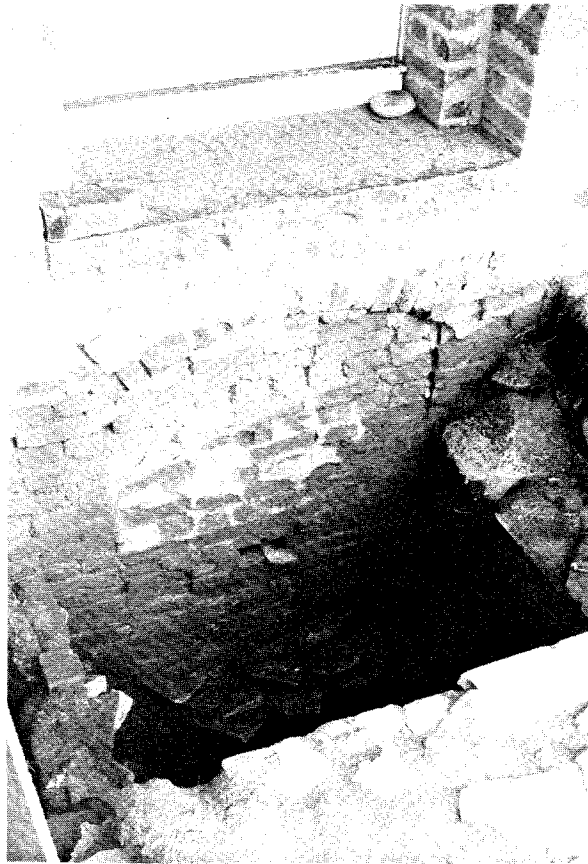
IP009, N004-19. Exterior view of door 010, probable entrance to cold storage area.

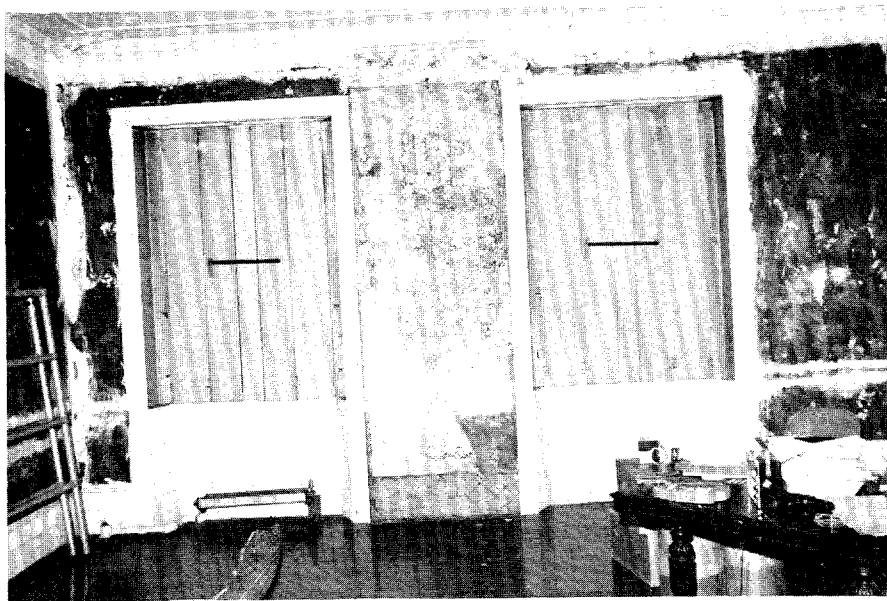
IP029, N022-12. Door 130 ca. 1849 alteration to room 105. Note patch in west wall about 8" above bracket.

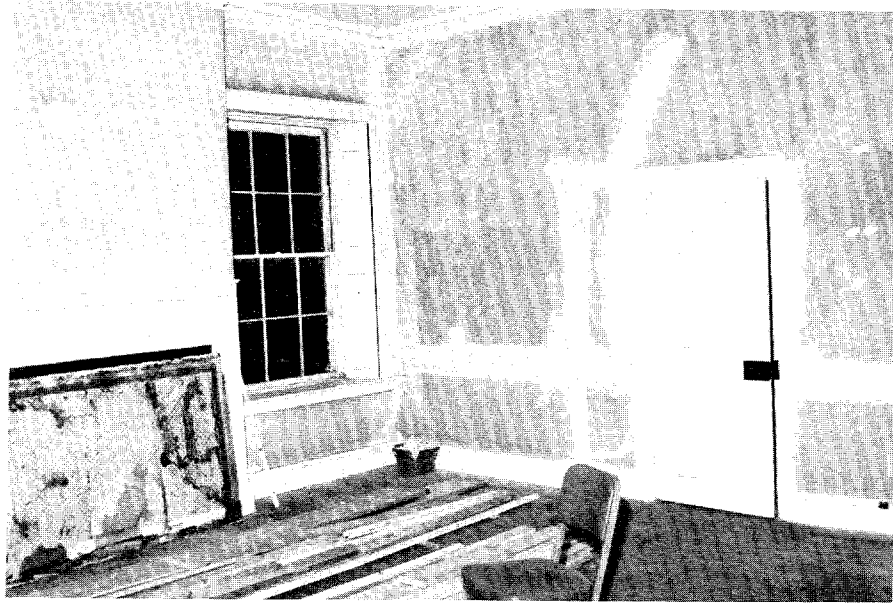
IP046, N030-03. Room 206, looking east into rooms 207 and 208 through doors 218 and 202. Note vertical line at former location of south wall near right edge.

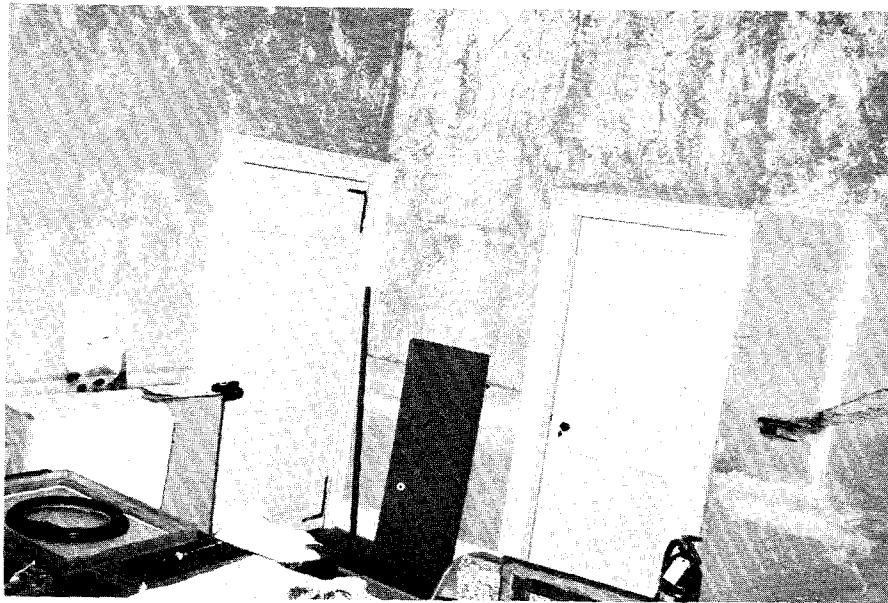
IP052, N030-11. Room 210 north and east walls, doors 215 and 216.

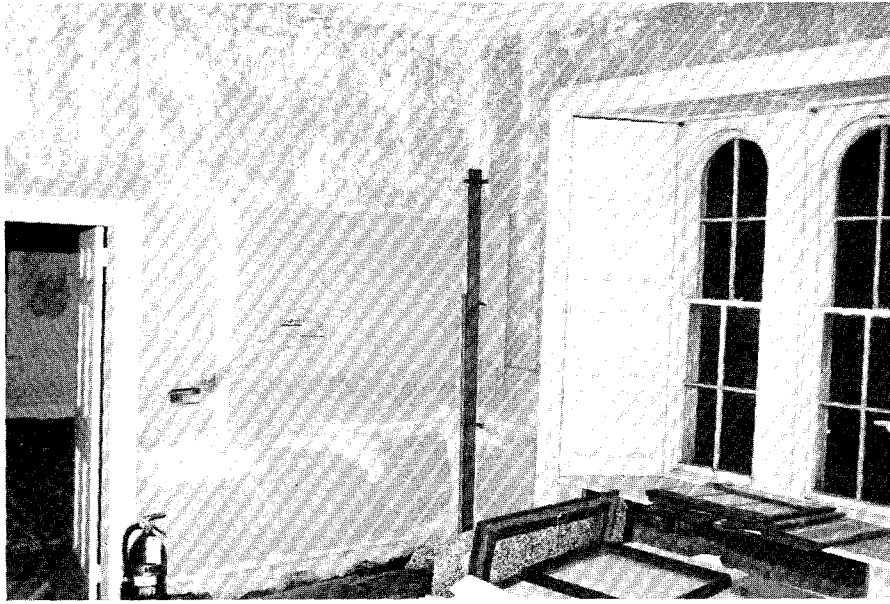
IP053, N030-10. Room 210, east and south walls, door 216, and windows 215 and 216.

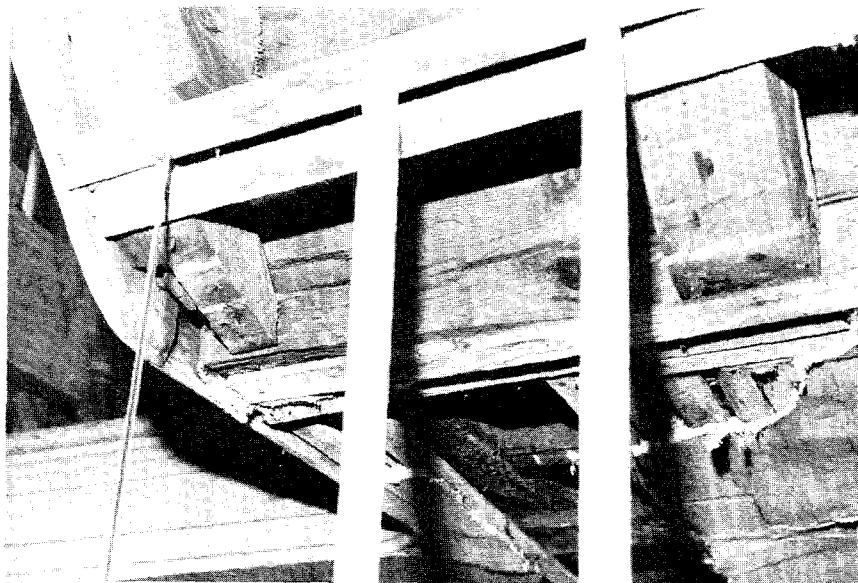
IP075, N041-06. Same area as IP069 (above), looking northwest and slightly up. Note stair stringers at top of picture. Horizontal joist is cantilevered from east wall. Tenon of previously mentioned stub joist appears at west end of cantilever above stair stringer.

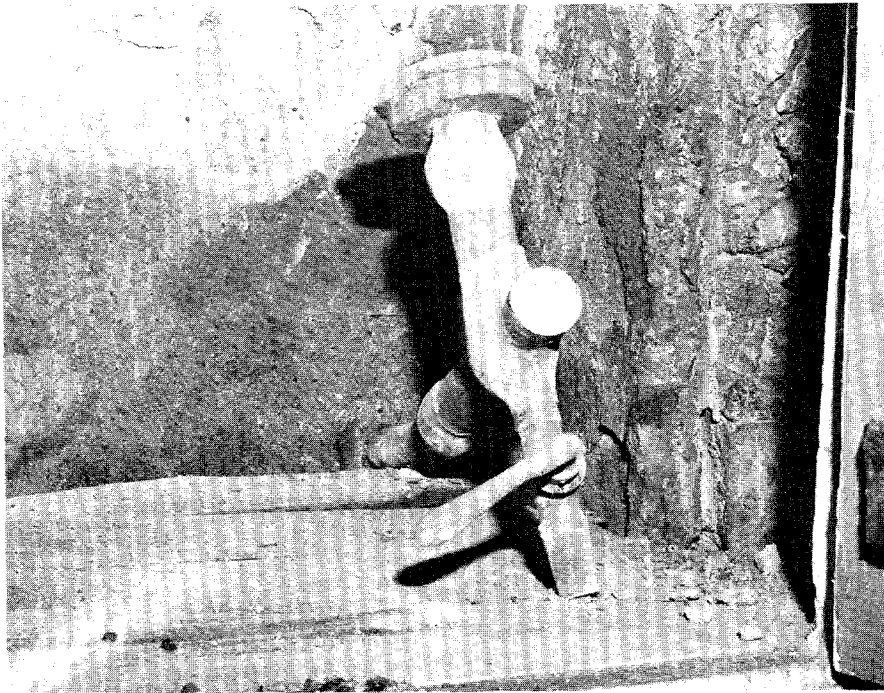
IP091, N038-01. Probable water supply to force pump, room 006, southwest corner at floor level.

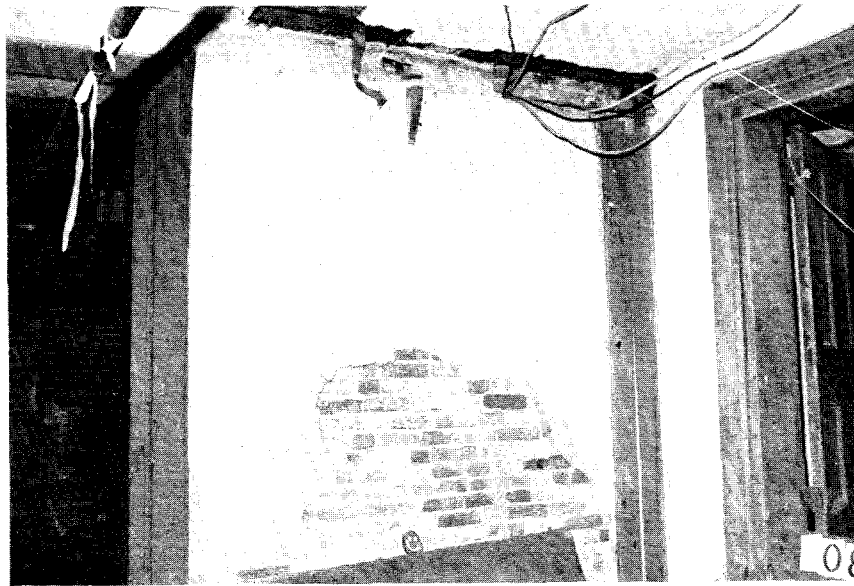
IP101, N009-20. Room 009, northeast corner. Note remains of wooden pipe chase.
