**THE BARN
AT THE FARWELL JONES HOUSE
STRUCTURAL ASSESSMENT REPORT**

**Minute Man National Historical Park
Concord, Massachusetts**

September 2004

Draft Historic Structure Report

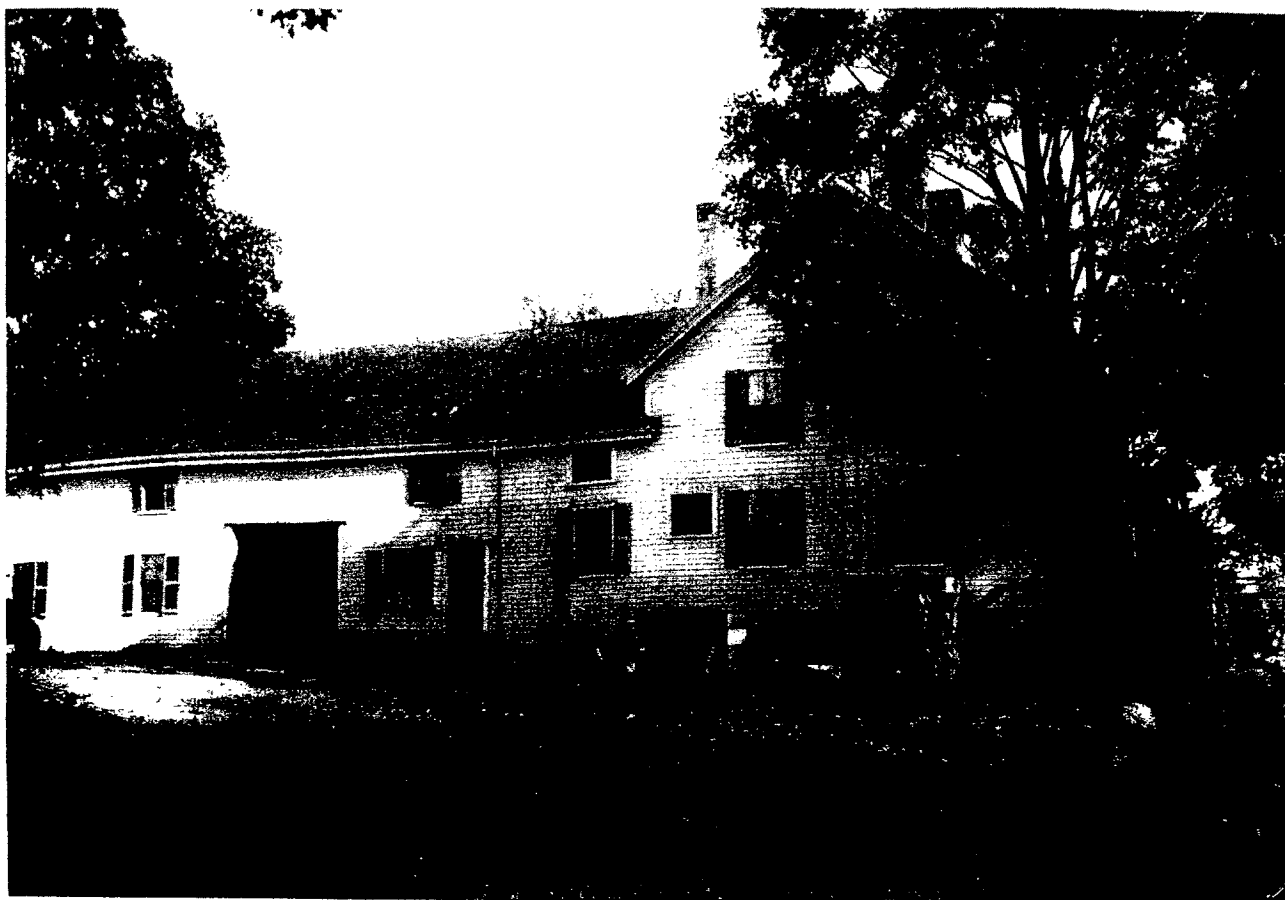
Figure 2. West elevation of the Farwell Jones House and rear barn connector, circa 1937.

No documentation has been found, such as written descriptions or photographs, of the original exterior paint color(s) of the barn. The earliest known photograph, a black-and-white view dated circa 1937, shows the barn connector that joined the house and barn, but not the barn itself (fig. 2, page 13). Both the house and connector were then painted a light shade, with the door, window sashes, and shutters a dark shade. The barn may have been finished in a similar manner. The connector had been removed by 1963 when a number of exterior photographs were taken of the barn for two separate appraisals of the property. One noted that the barn was then "in excellent condition being recently painted and repaired." The black-and-white photographs show a paint scheme similar to that of circa 1937, with light siding and dark doors and window sashes (figs. 4-10, pages 18-21). This same paint scheme is also shown in another set of black-and-white photographs taken in 1972 for a third appraisal of the property (figs 12 & 13, page 23).

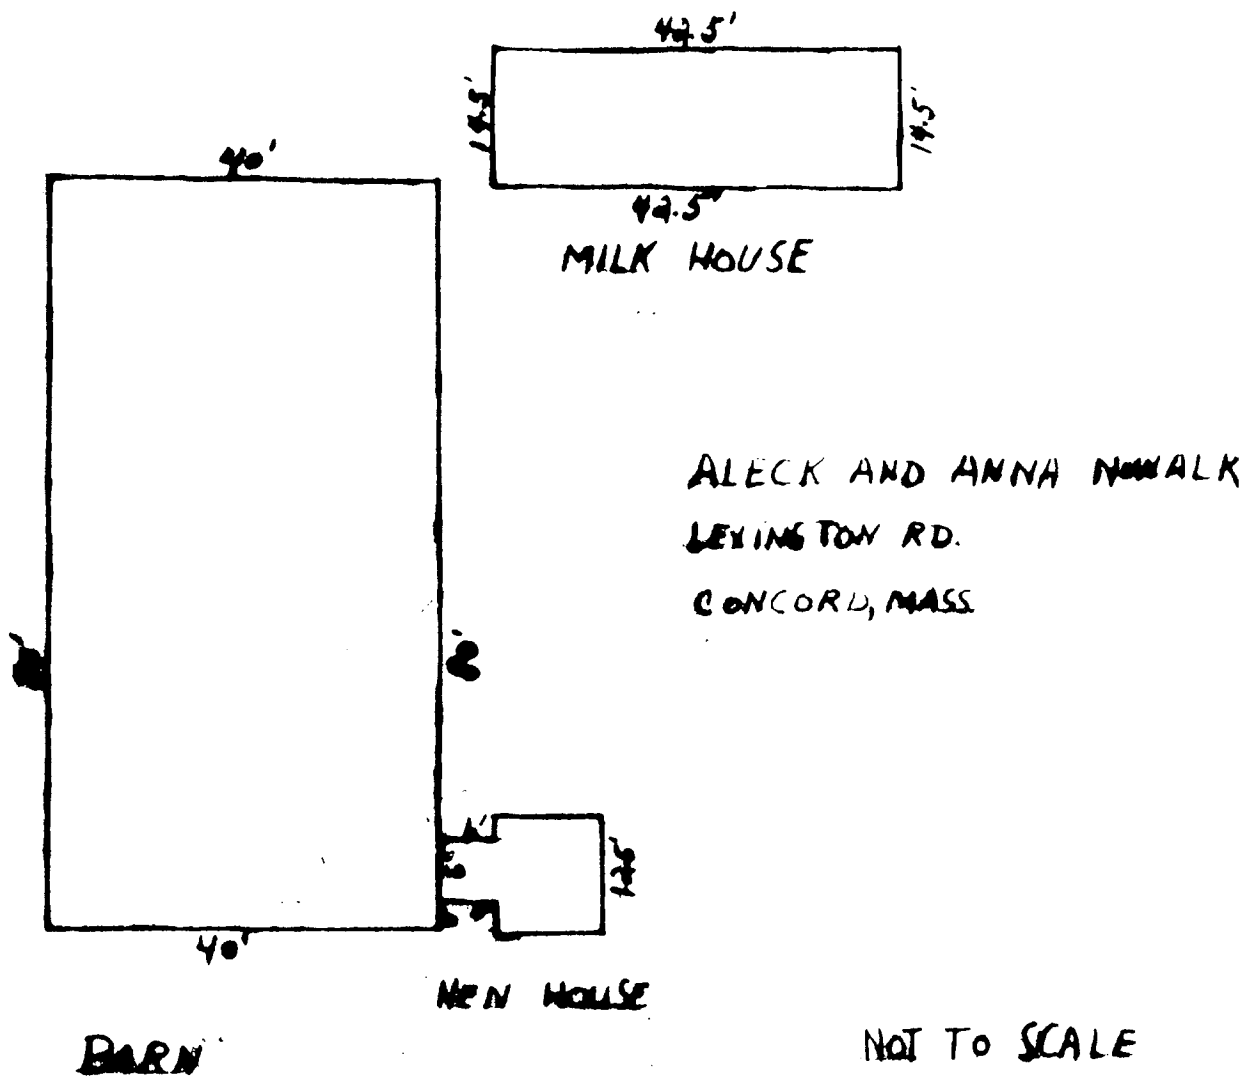
Figure 3. Plan of the Nowalk barn and hen house from an appraisal dated 1963. Note that the milk house is mistakenly labeled as the "Hen House," and the hen house as the "Milk House."

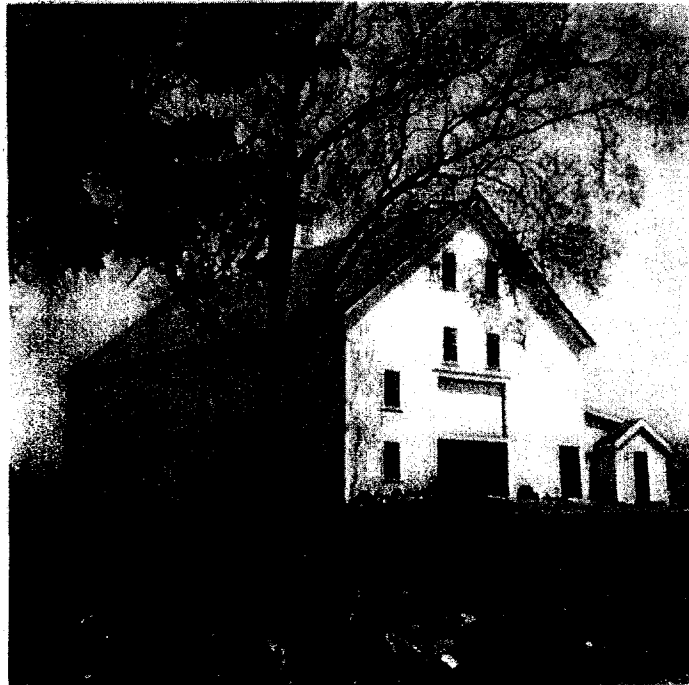
Figure 12. Front and west elevations of the Nowalk barn, May 1972.

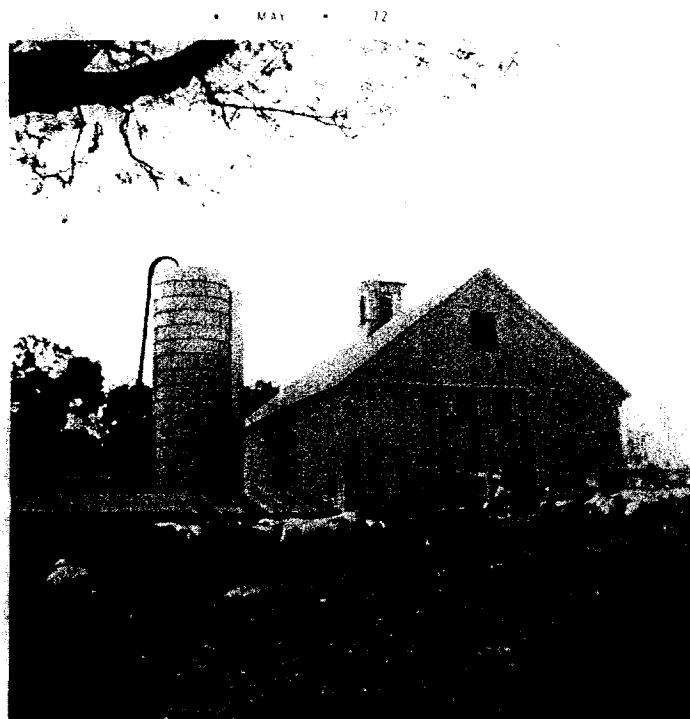
Figure 13. Rear and east elevations of the Nowalk barn and silo, May 1972.
