CAPTAIN WILLIAM SMITH HOUSE

Minute Man National Historical Park
Lincoln, Massachusetts

Historic Structure Report

December 2007

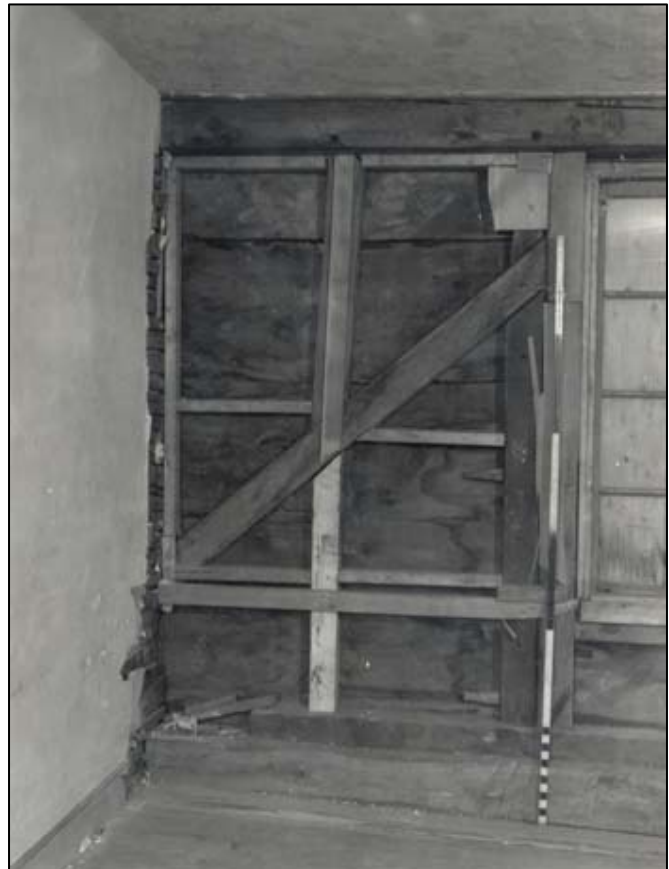
Figure 41. Ca.- 1900 Addition: Second- story west room, looking south at exposed framing of north (formerly exterior) wall of main house, showing oak framing members and West Chamber wall lath.

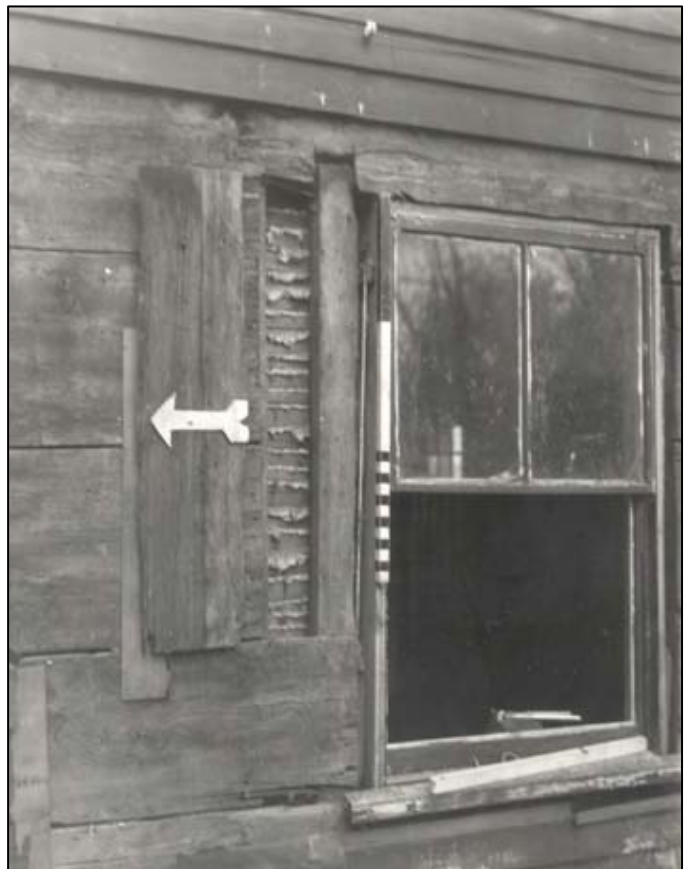
Figure 47. Main House:
West exterior wall, showing
West Parlor window; arrow,
which is attached to back
side of board reused to
narrow ca.- 1692 window
opening, points to molded
edge and red paint.

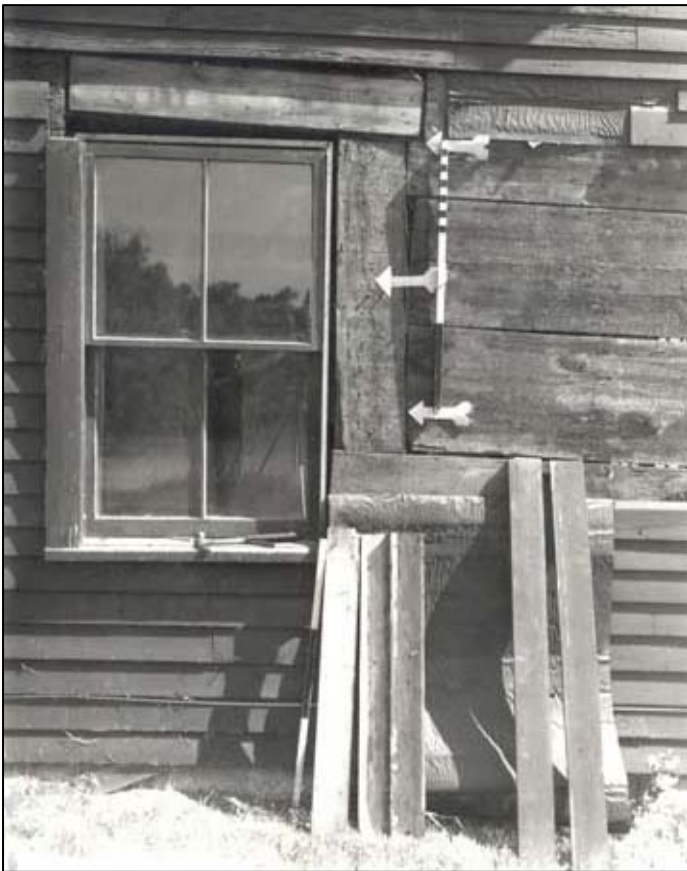
Figure 48. Main House:
South exterior wall,
showing East Parlor
window; arrows point to
head, sill locations of ca.-
1692 window opening.

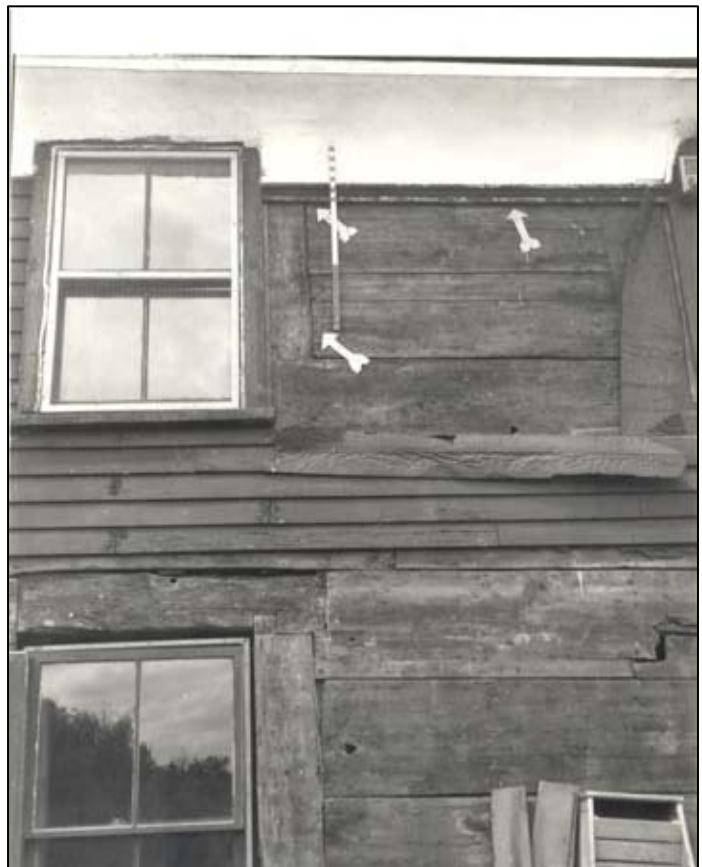
Figure 49. Main House:
South exterior wall,
showing East Chamber
window; arrows point to
head, sill locations of ca.-
1692 window opening.

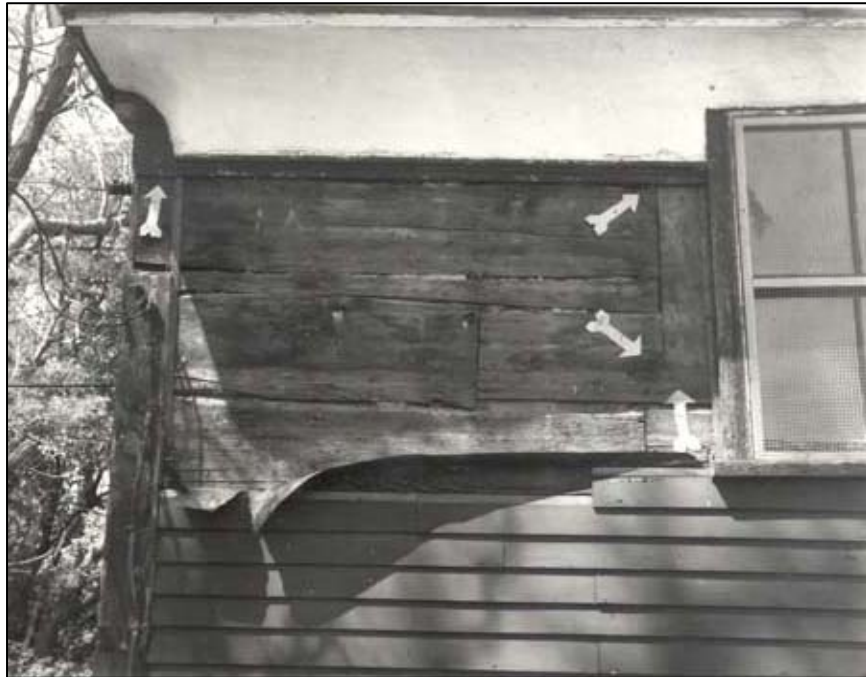
Figure 51. Main House: South exterior wall, west end, showing cove cornice and West Chamber window; left arrow points to former location of original bed molding; right arrows point to head, jamb, sill locations of ca.- 1692 window opening.

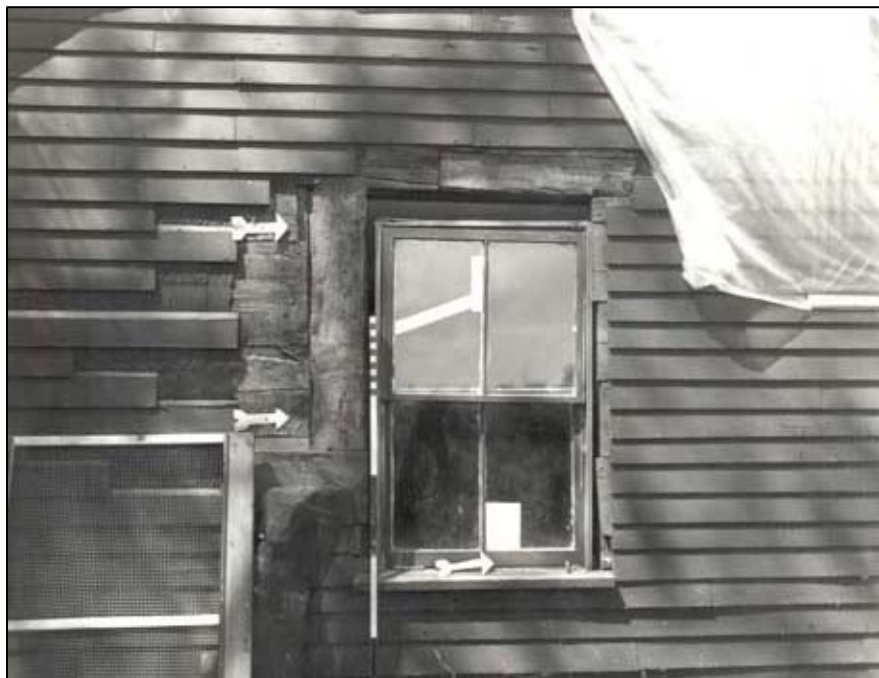
Figure 52. Main House: South exterior wall, showing West Parlor window; arrows point to head, sill locations of ca.- 1692 window opening.

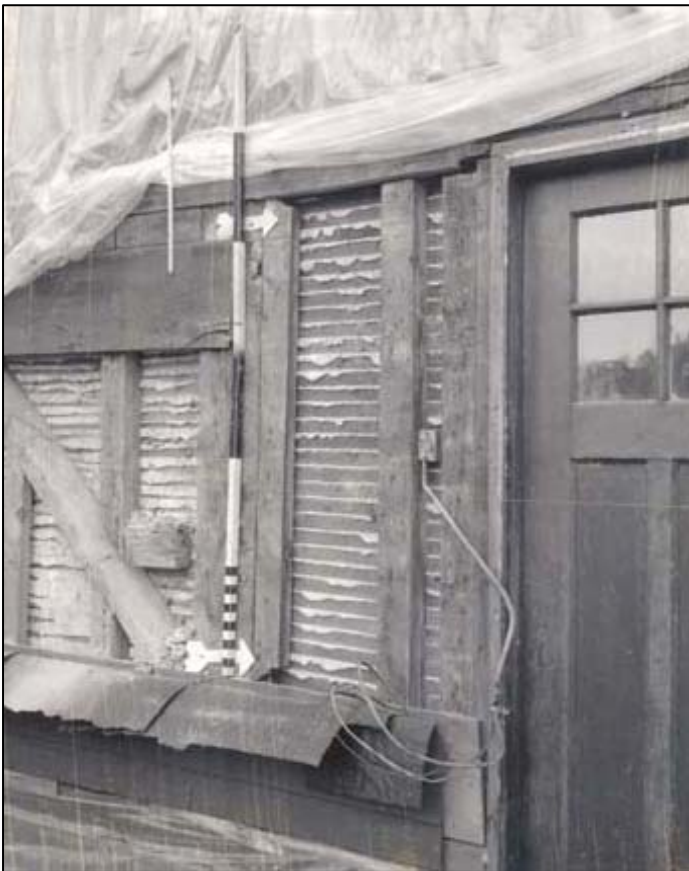
Figure 53. Main House: South exterior wall, west of doorway; arrows point to ends of ca.- 1692 window sill, reused in a vertical position.

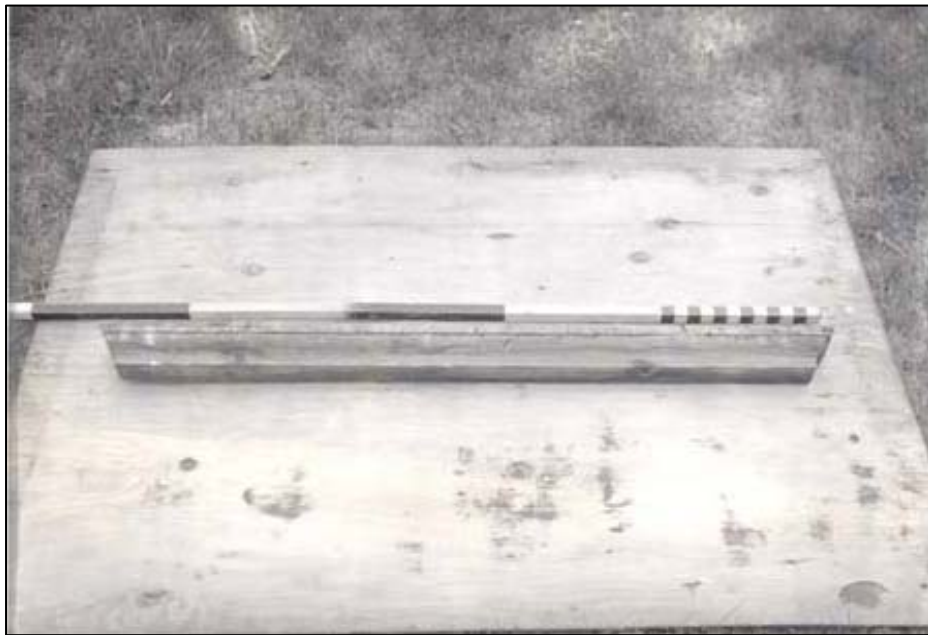
Figure 54. Ca.- 1692 window sill, after removal from south wall of main house.

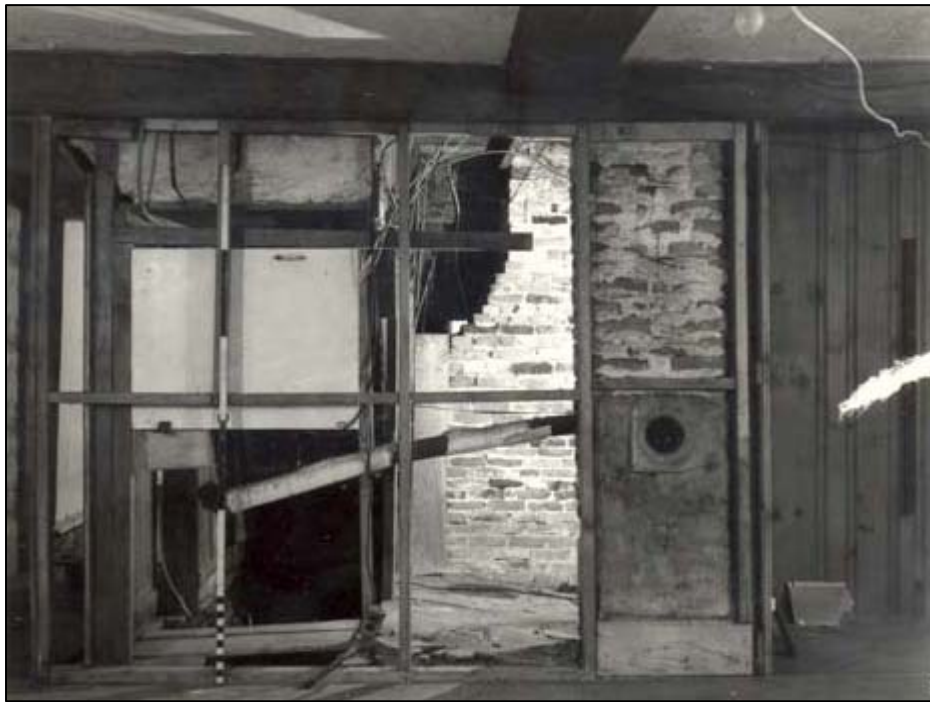
Figure 56. Main House: East Parlor, west wall after removal of ca.- 1956 paneling, showing space originally occupied by central chimney.

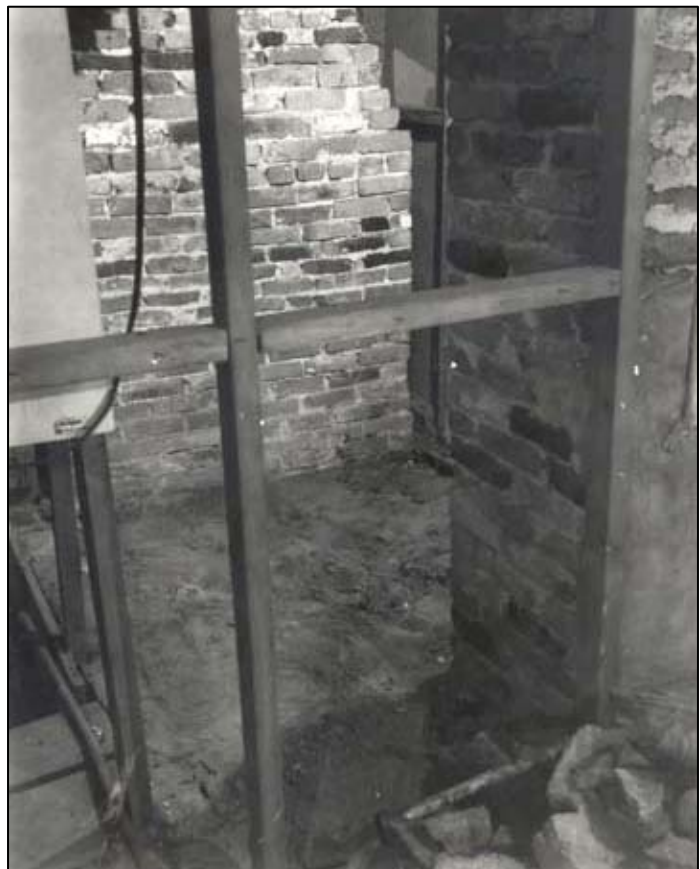
Figure 57. Main House: View of central chimney area, showing clay fill exposed when later concrete slab was removed; brick remains of ca.- 1692 and ca.- 1750 fireplaces lie beneath the fill.

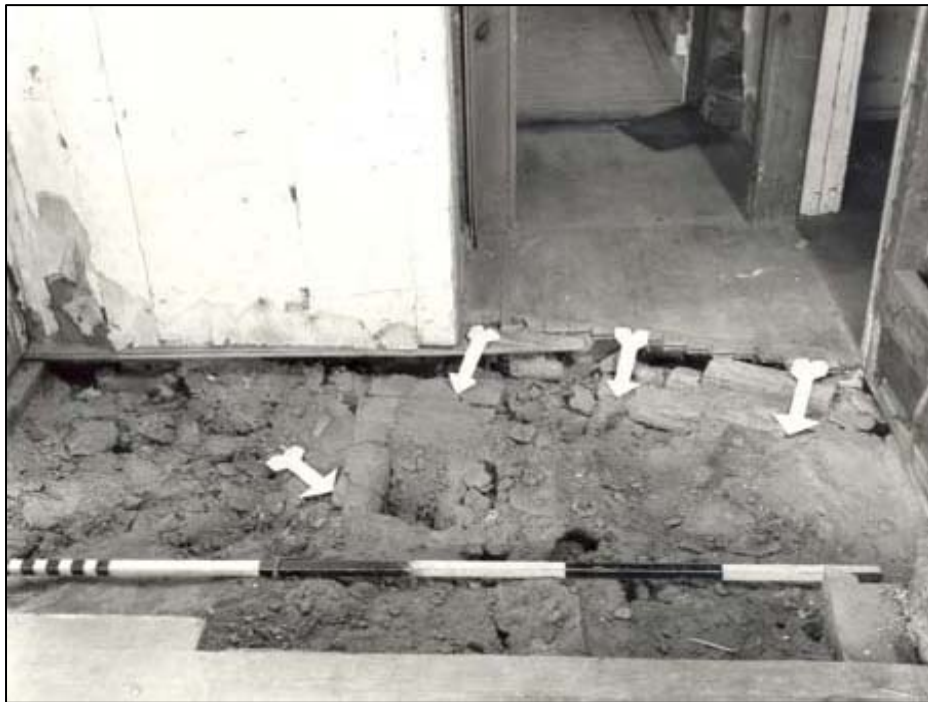
Figure 58. Main House: East Parlor, remains of north jamb of ca.- 1692 fireplace (left arrows), and of east side of ca.- 1750 fireplace in lean- to (right arrows).

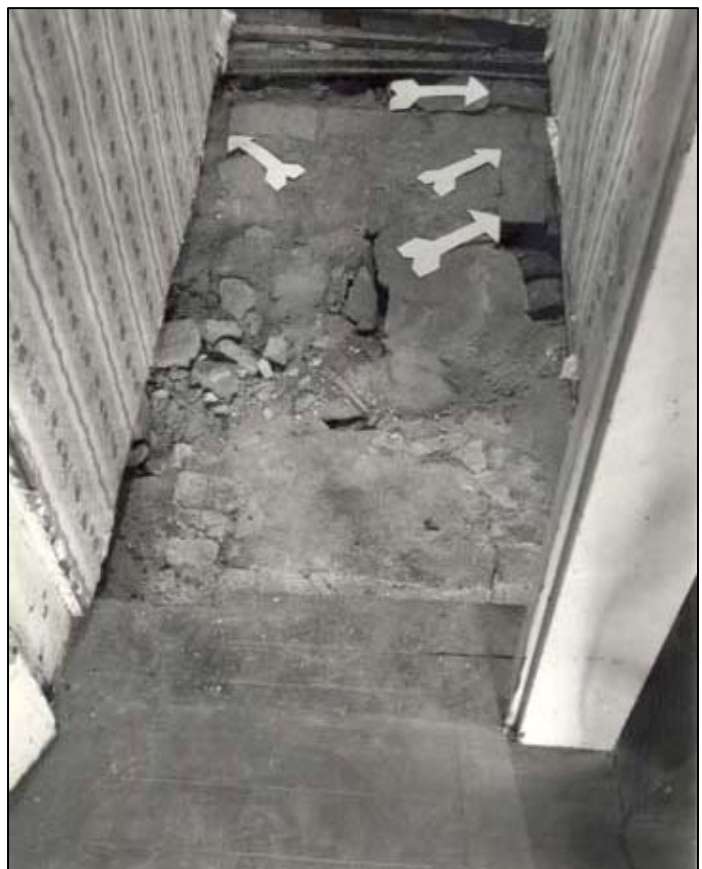
Figure 59. Main House: West Parlor, remains of ca.- 1692 fireplace in east-wall closet.

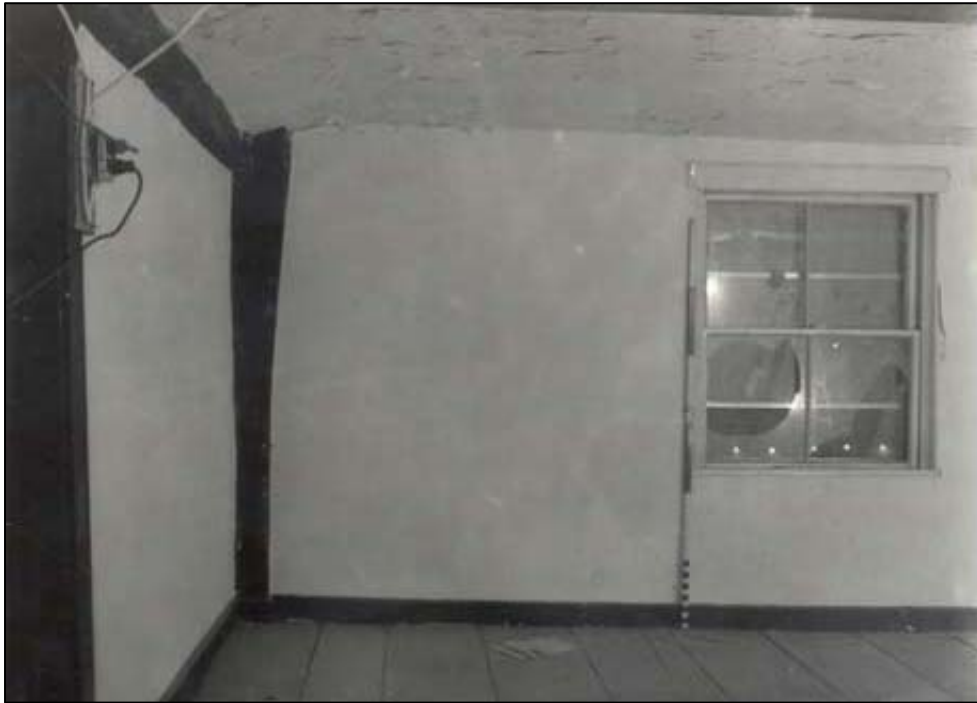
Figure 62. Main House: East Chamber, northeast corner, showing plaster cove ceiling.

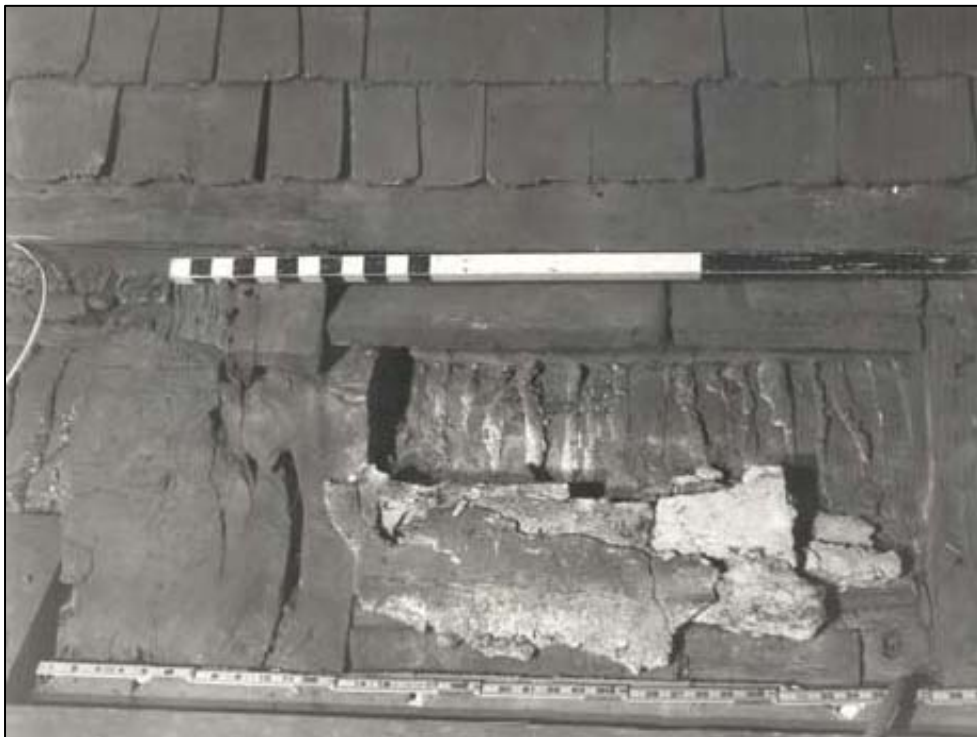
Figure 63. Ca.- 1900 Addition: Attic, looking south at backside of lath- and-plaster cove ceiling along north wall of West Chamber.

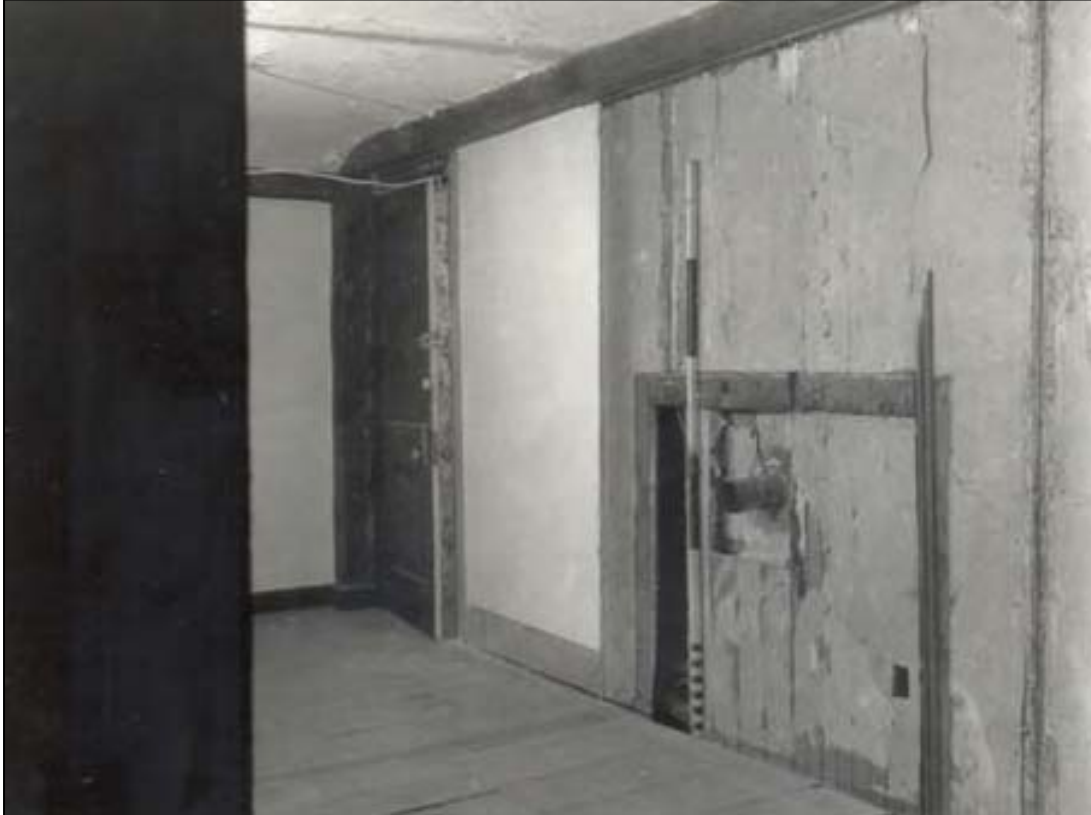
Figure 64. Main House: East Chamber, west wall, showing original wall boards being exposed as plasterboard is removed.

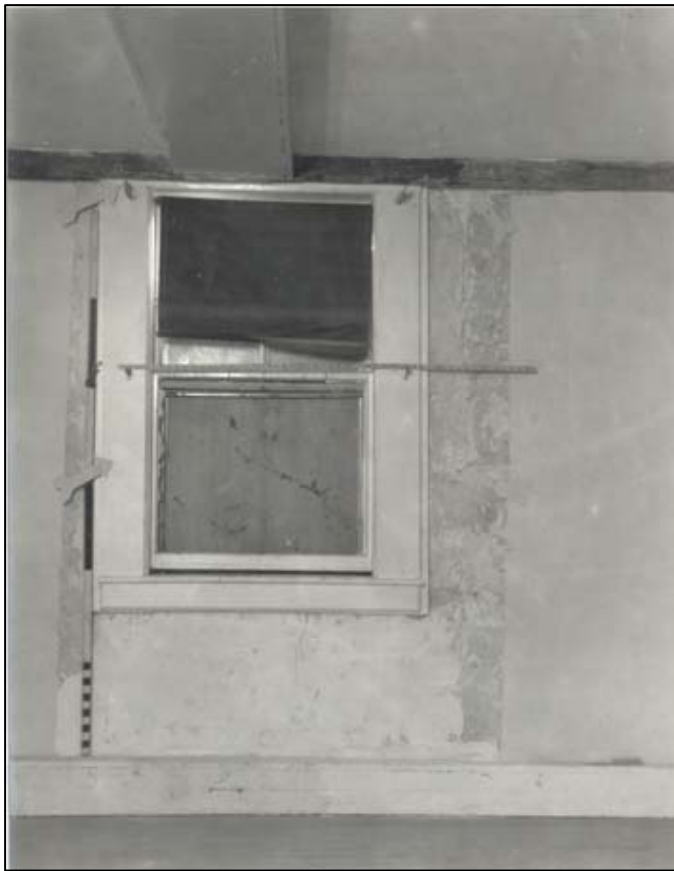
Figure 65. Main House:
West Parlor, west wall;
arrows indicate locations
of head, sill of ca.- 1692
window opening.

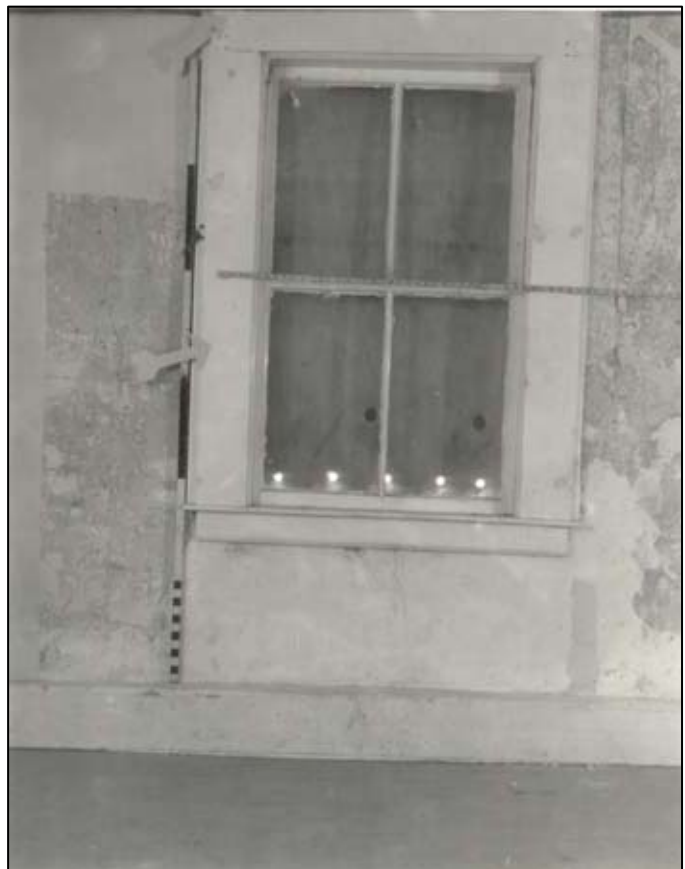
Figure 66. Main House:
West Parlor, south wall;
arrows indicate locations
of head, sill of ca.- 1692
window opening.

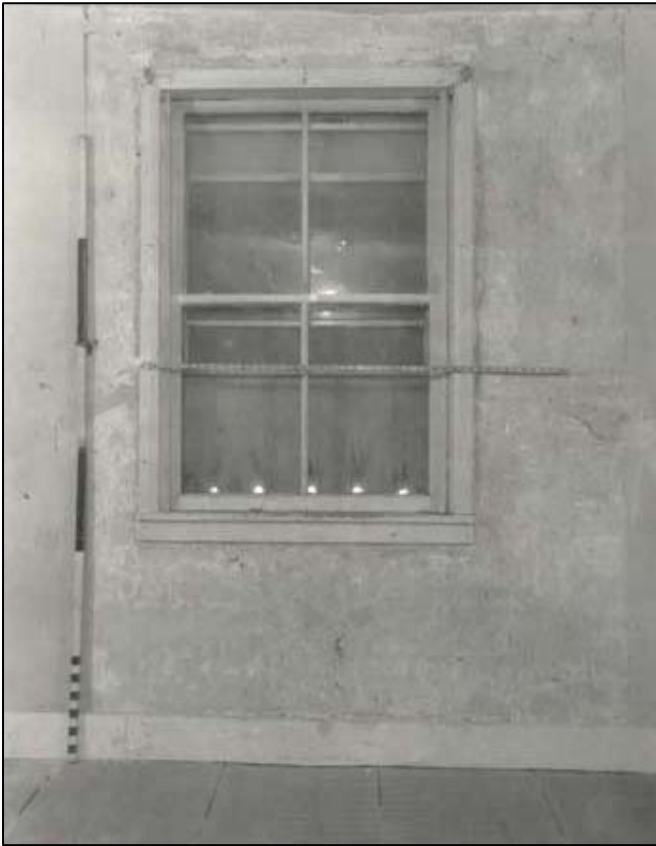
Figure 67. Main House:
West Chamber, west- wall
window, with wallpaper
peeled back to reveal
plaster patch from ca.-
1692 window opening.

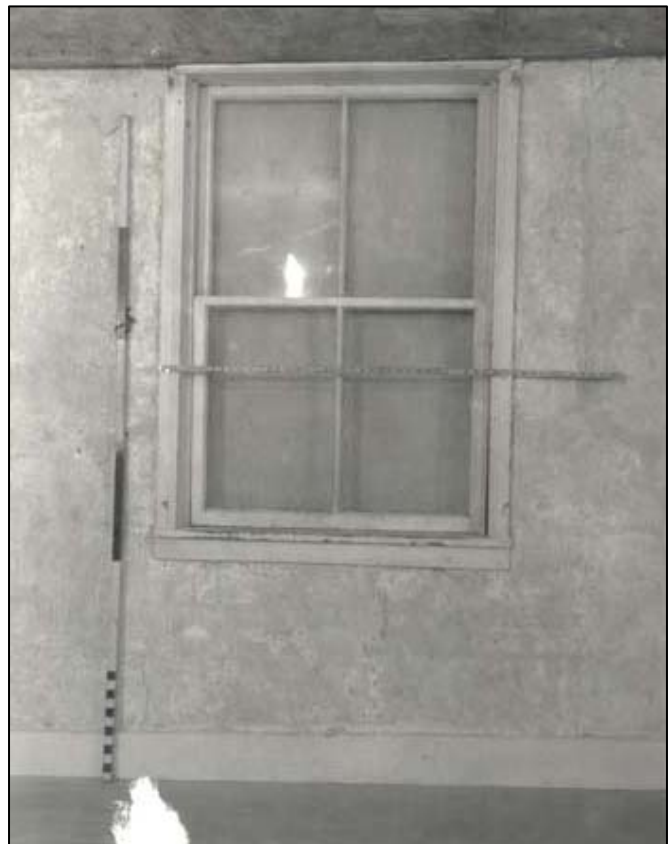
Figure 68. Main House:
West Chamber, south- wall
window, with plaster joint to
right indicating edge of ca.-
1692 window opening.

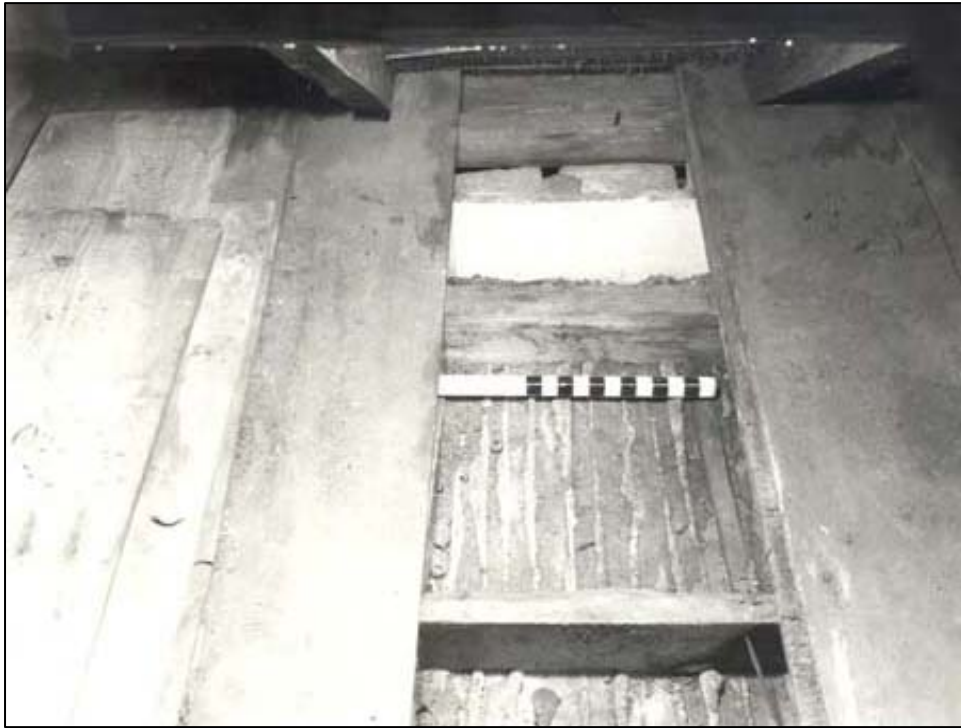
Figure 69. Main House: Attic, plaster over bricks between south plate and floorboards above West Chamber.

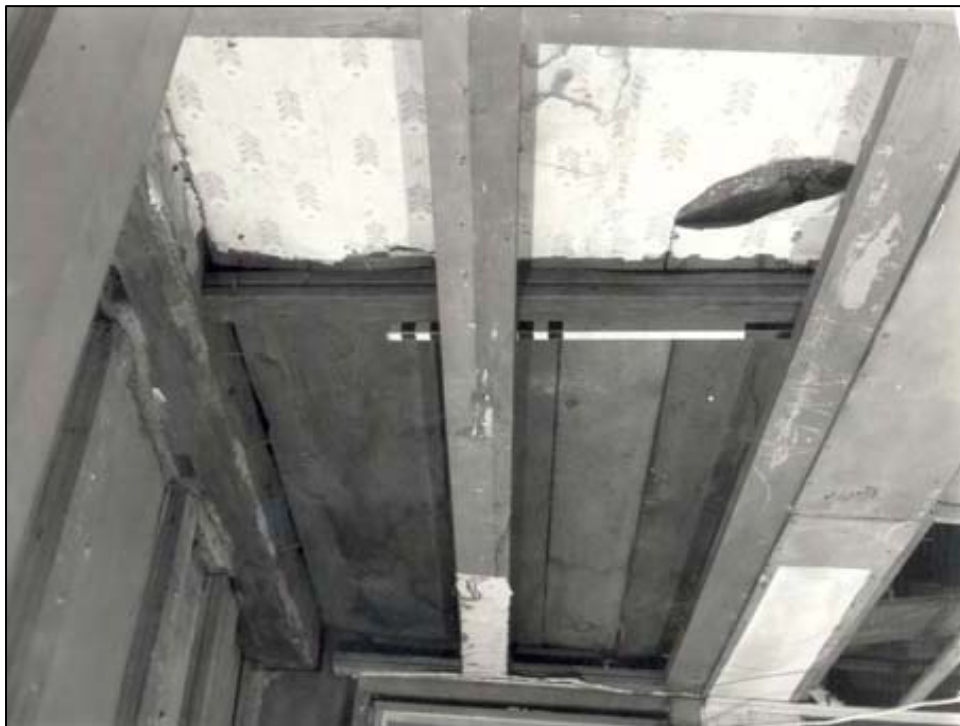
Figure 70. Main House: View of central chimney area, second story, looking east after removal of plasterboard walls and ceiling; scale stick rests on reused piece of ca.- 1692 handrail.

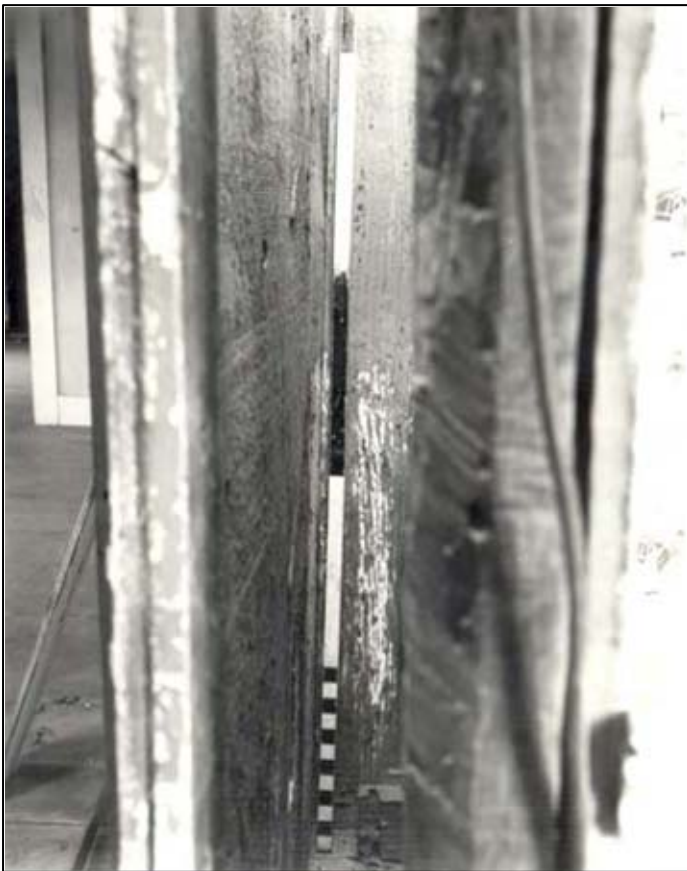
Figure 71. Main House:
Front Hall, looking northwest
into West Chamber, showing
cut- out for first step of
original attic stairway
(removed ca. 1750).

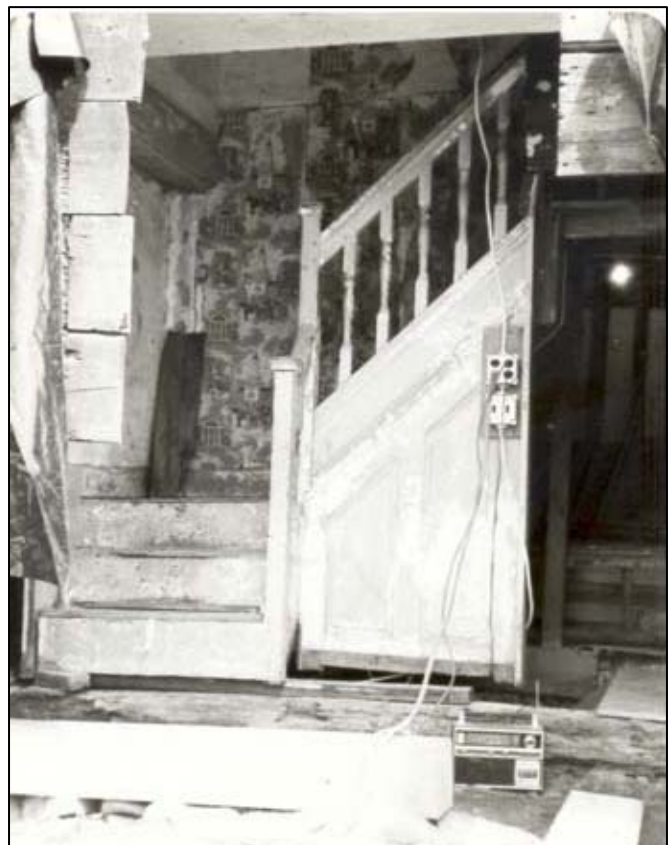
Figure 72. Main House:
Front Hall, looking north
into interior of partition wall
between hall and West
Chamber, showing
whitewash outlines of
original attic stairway
(removed ca. 1750).

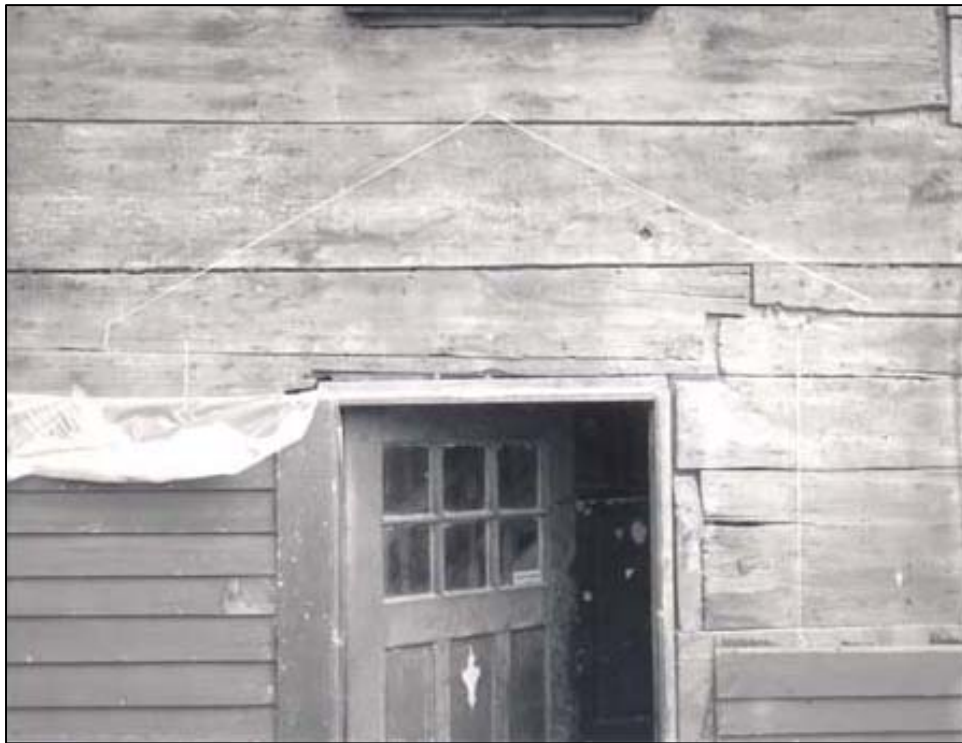
Figure 73. Main House: South exterior wall, outline of ca.- 1750 entrance pediment.

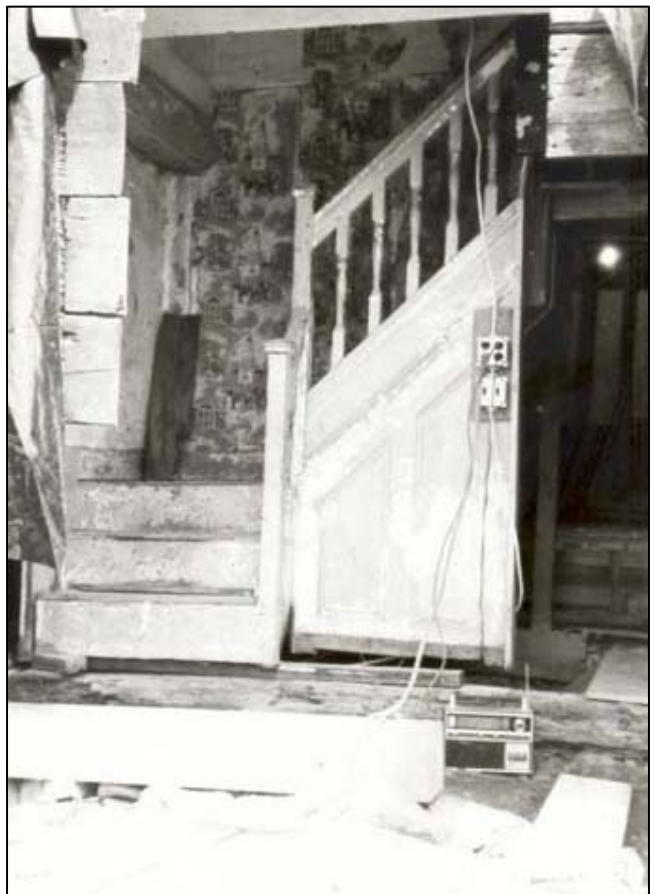
Significant changes also were made to the interior of the house. The ca.- 1692 front stairway was rebuilt into its present configuration (fig. 74- 75). It included an open balustrade and paneling below.¹¹² Figure 76 shows the back side of a section of the ca.- 1750 paneling; it was later hinged to serve as the present- day door to the cellar.

Figure 74. Main House: Entry Hall, stairway built ca. 1750.

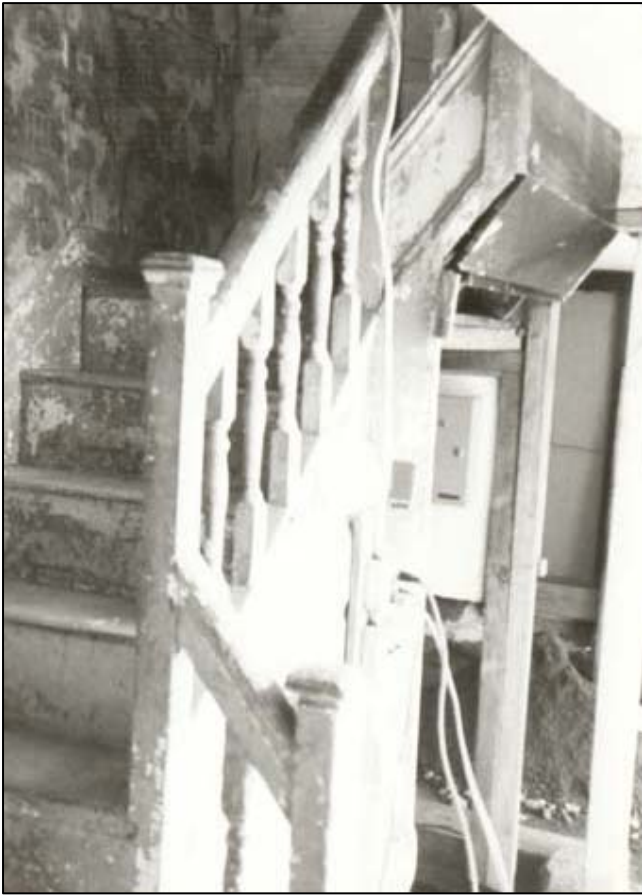
Figure 75. Main House:
Entry- Hall stairway.

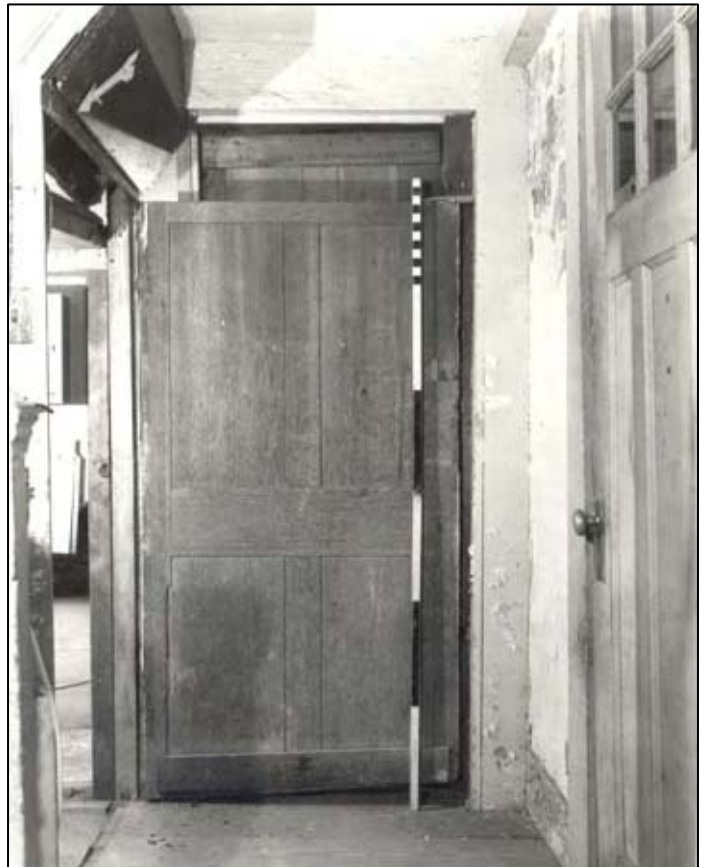
Figure 76. Main House:
Rear side of present- day
cellar door.

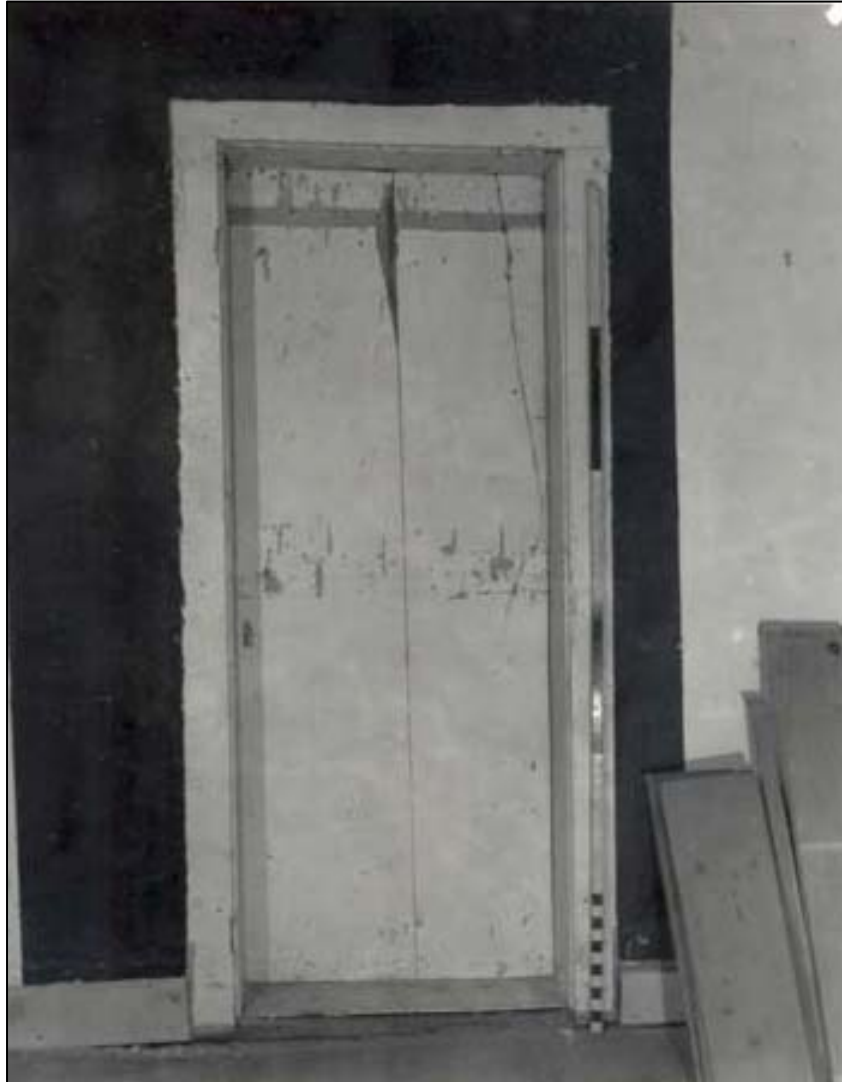
The north- wall doorway to the lean- to was widened by removing an original stud and reframing the rough opening with board studs nailed with hand- wrought nails, and heightened by cutting the sill to floor level (fig. 77). The east and south window openings were probably cased and retrimmed to make the new openings neat. It is not known if any work was done on the west (fireplace) wall at this time, since all evidence has since been removed.

Figure 77. Main House: East Parlor, north wall, ca.- 1810 doorway to ca.- 1730 lean- to (after removal of ca.- 1956 paneling and shelves).

The East Parlor underwent even more change when the central chimney was removed, along with the northwest corner cupboard that abutted it. No fireplace was rebuilt here, only a small brick flue with a thimble for a heating stove. A new west wall was built that extended from the Entry- Hall doorway just past the new brick flue. This wall consisted of studding covered with vertical, beaded, tongue- and- groove boards that were then wallpapered; it had a hole through which the heating stove's smoke pipe could pass, as seen in figure 56. The remaining walls of the East Parlor may have retained their finishes dating to ca. 1800 and ca. 1825. However, the old doorway in the center of the north wall was blocked off with two vertical beaded boards (fig. 77). The floors and ceiling do not appear to have been changed at this time.

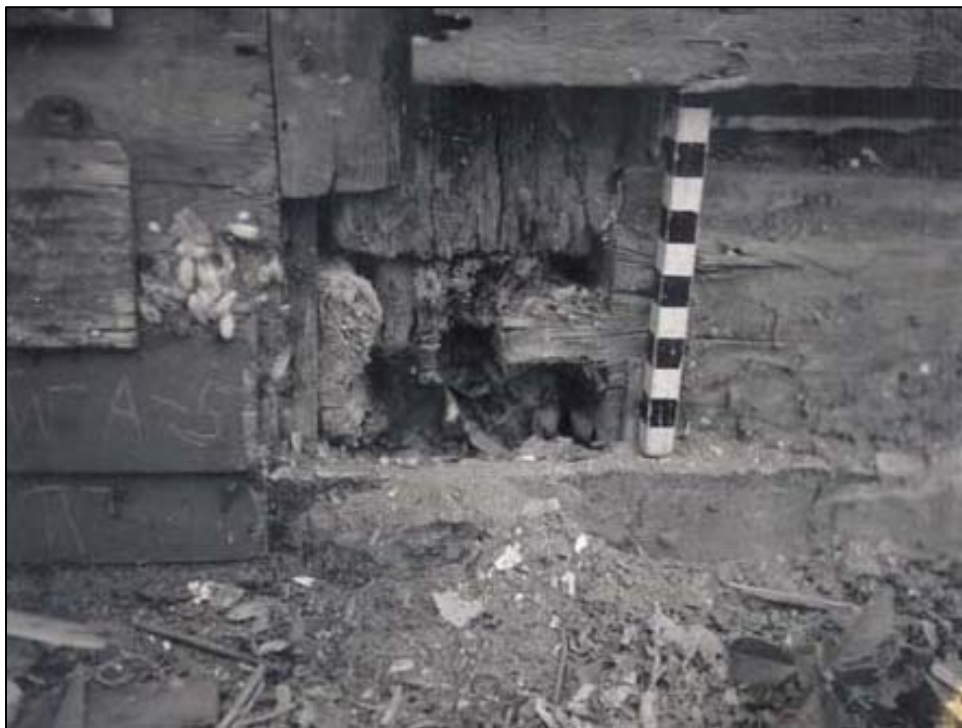
The 17th- century foundation sills were removed at the east and west ends, and new sills were installed (figs. 78- 79). The lower ends of studs were spliced, and rotted wall boards at sill level were replaced (see Appendix I, sheet no. 13). Cut granite stones were installed for underpinning along the south and east walls of the house. A cellar window was installed in the south foundation wall.

Figure 79. Main House: West wall, north corner, showing west sill tenoned into north sill.

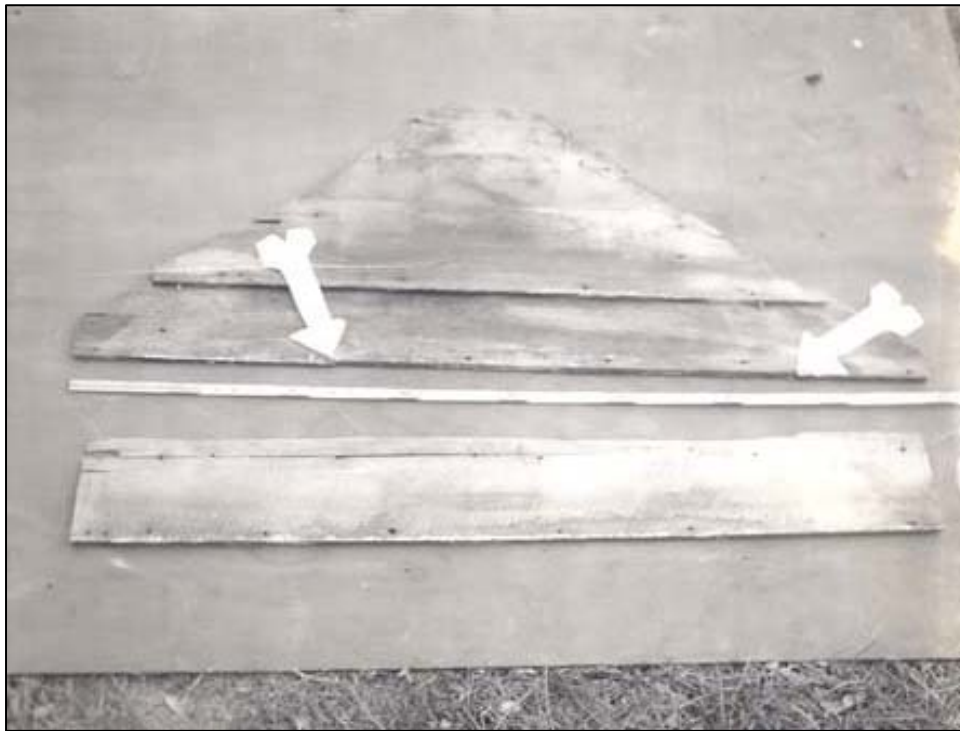
Four courses of clapboards remaining from the ca.- 1825 renovations were found in place in 1980 in the peak of the west gable (fig. 80). The boards were tapered and circular sawn¹¹⁸ (6 inches wide with one- half- inch thick butts that were smoothed off to one inch wide along the lower back side in order to fit more tightly against the clapboard below). They were laid 4 ½ inches to the weather, and were fastened with machine- cut nails similar to those used in fastening the corner boards, verge and soffit boards, and second- story window frames, also thought to date from ca. 1825.¹¹⁹ The majority of the existing rake boards, rake board trim, corner boards, and soffit boards covering the overhanging girt on the main house date from ca. 1825 and are plain, square- edge boards fastened (originally) with machine- cut nails. The rake board measures thirteen- sixteenths of an inch by 5 ¾ inches; the rake board trim measures three- quarters of an inch by 2 ¾ inches; the full- length soffit boards measure seven- eighths of an inch by 5 ½ inches (within a quarter of an inch). The corner boards, which are made of two sections, measure seven- eighths of an inch by 7 inches on the south wall and seven- eighths of an inch by 6 ⅛ inches on the end walls. In their original condition, the corner boards were full height. As done ca. 1692 and ca. 1750, a water table was omitted at sill level.

Figure 80. Clapboards from west wall of main house; ca.- 1825 boards from peak of west gable at top, ca.- 1900 board below.

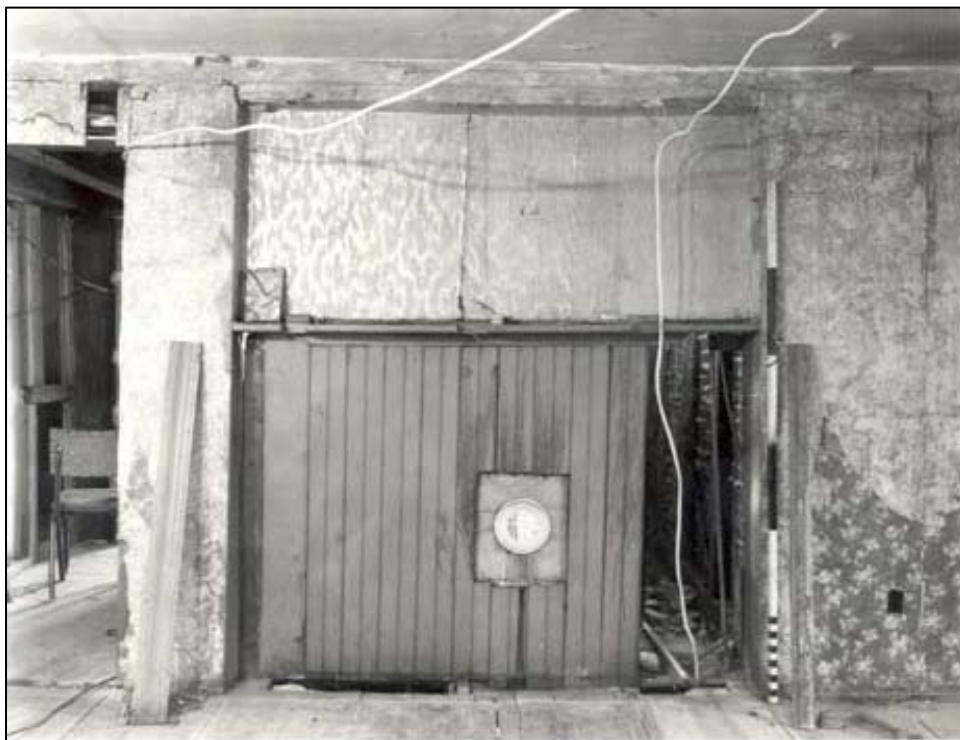
In the West Chamber, only the mantelshelf and the north fireplace jamb with its molding remain (fig. 81). The fireplace opening for this room was computed to be 3 feet 4 inches by 4 feet 2 inches. An opening of this proportion suggests that the fireplace of ca. 1692 may not have been altered in the 1750s.

The existing beaded stile measures 10 inches wide, while the top rail is $1\frac{3}{4}$ inches wide. Over this is a mantelshelf measuring $1\frac{3}{8}$ inches thick by 7 inches wide, and is 6 feet long. It is 4 feet 4 inches above the floor. Between the mantelshelf and the chimney girt is machine- cut lath and plaster.

Figure 81. Main House: West Chamber, east wall, showing ca.- 1825 mantel elements and ca.- 1910 wainscot infill and flue thimble.

In the second story, the fireplace openings in the East and West Chambers were closed off with vertical, beaded, tongue- and- groove boards, except for a rectangular opening large enough to accept a stovepipe (see figure 81).
