CAPTAIN WILLIAM SMITH HOUSE

Minute Man National Historical Park
Lincoln, Massachusetts

Historic Structure Report

December 2007

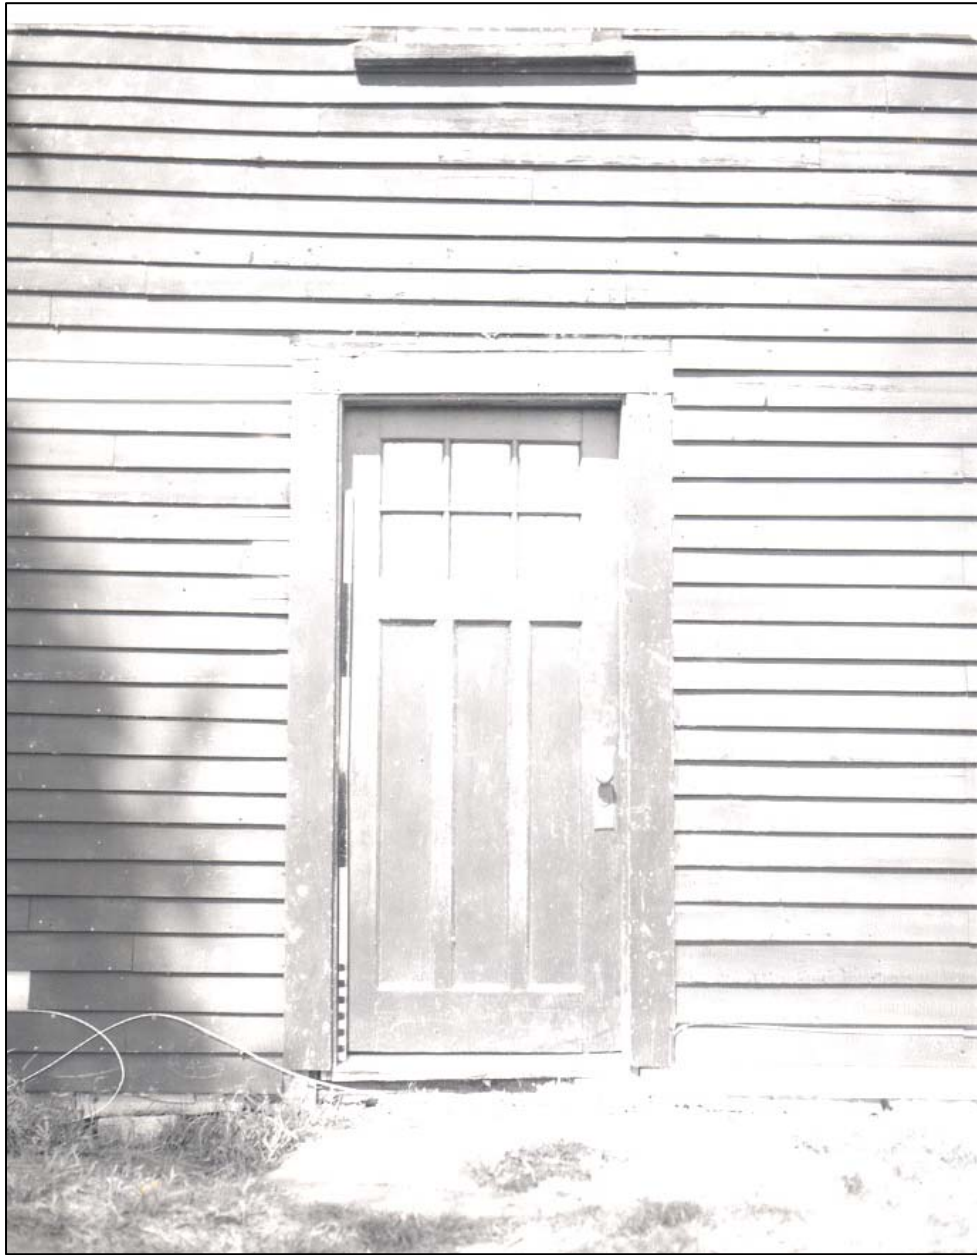
Sometime prior to ca. 1930, the Silva family removed the front door and the surrounding frontispiece of ca. 1825 and replaced it with a flat, square- edged architrave (fig. 19) and new door containing glass in its upper panel (fig. 84). The natural slope of the ground approaching the house and along the east wall was cut down approximately 3 feet and graded nearly level, as seen in figure 20. The interior walls of the hallway on each side of the new doorway were relathed, plastered, and wallpapered. Electricity was installed and lightning rods were mounted to the roof with aerial rods attached to the three chimneys, as seen in figure 21.

Figure 84. Main House: South exterior wall, door installed ca. 1956.

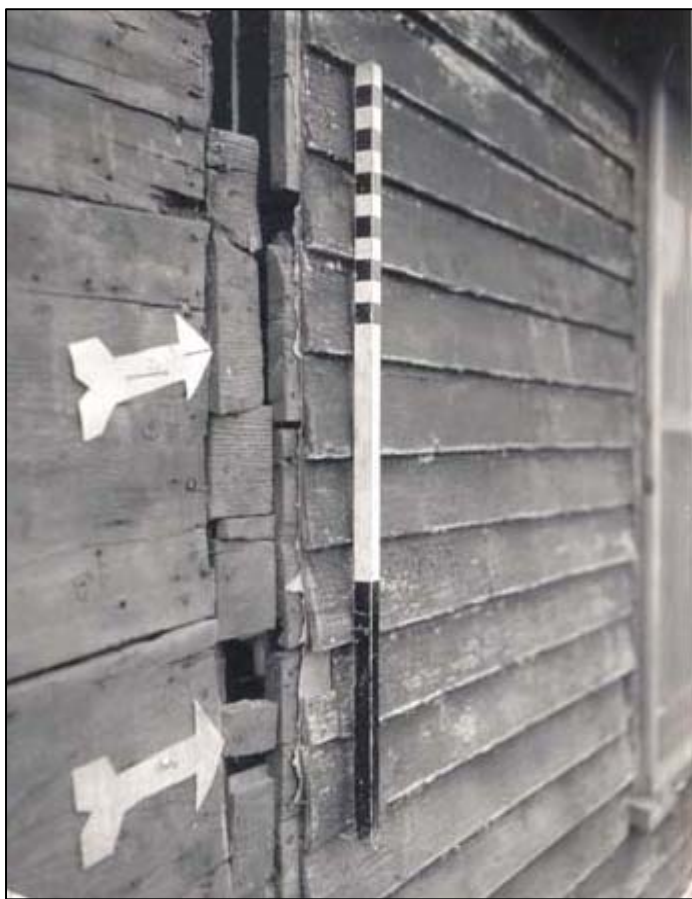
Figure 89. West- wall
junction of main (ca.- 1692)
house and ca.- 1900
addition.

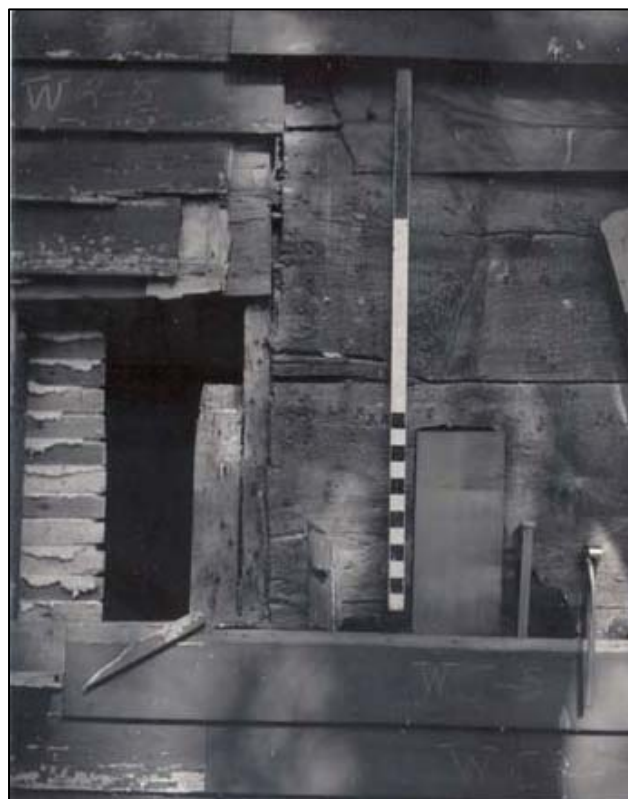
Figure 90. East- wall
junction of main (ca.- 1692)
house and ca.- 1900
addition.

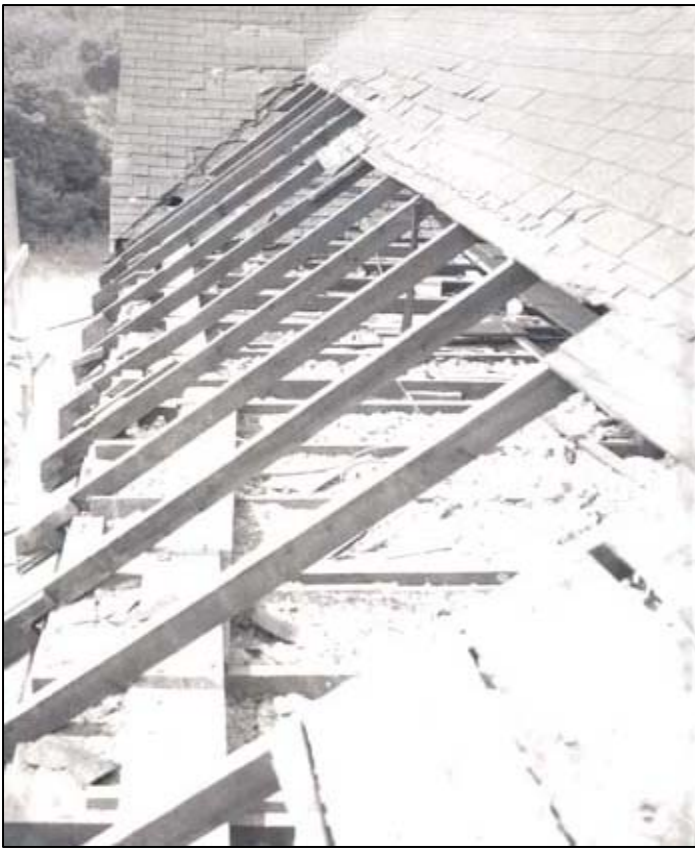
Figure 91. Ca.- 1900 Addition:
East roof slope, after removal of
reused ca.- 1692 wall boards.
