## Historic Structure Report

### Thurmond Commercial Buildings **NEW RIVER GORGE** National River • West Virginia

Historic Structure Report  
August 1992

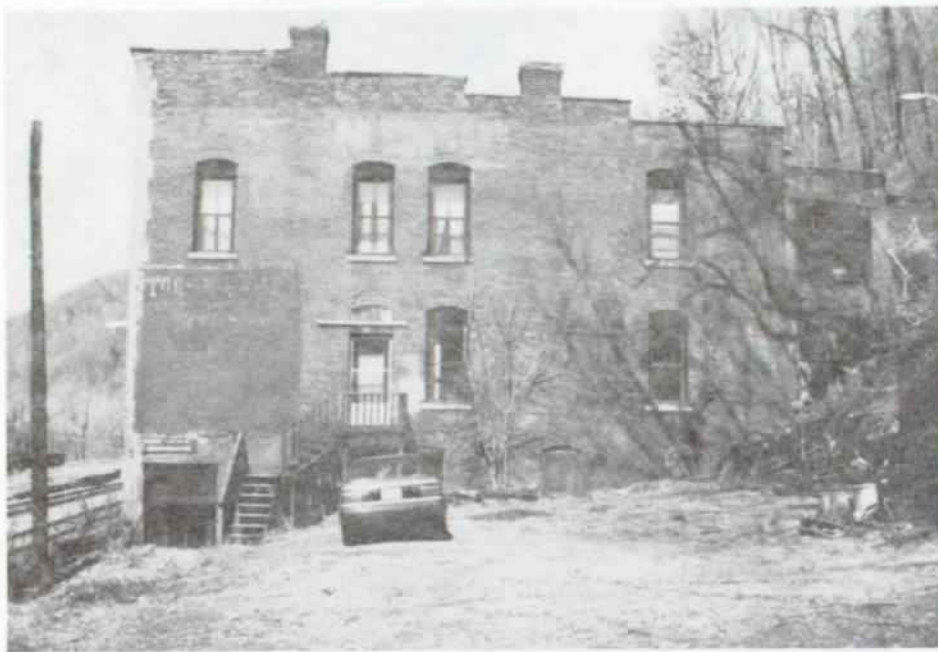
**Figure 13**  
South Elevation, Mankin-Cox Building, March 1990  
(NPS Photo)

The north, south, and east elevations are all of red brick, as is the addition to the southern rear corner of the building. The original portions of the north and south elevations are somewhat similar in composition (figure 13). Both elevations have four stepped parapet sections and two chimneys. Both elevations have three small, high windows at the first floor, three double-hung windows at the second floor, and four double-hung windows at the third floor. The third-floor windows are located directly over the second-floor windows, with the extra window to the east on the north elevation and to the west on the south elevation. Actually, the westernmost second-floor window on the south side of the building is now a door. The original window opening was modified to accommodate a door, probably for access to the second floor when the interior stair from the first floor was removed. What looks like a railing on the landing of the stair leading up to this door appears at the extreme right edge of a photograph taken about 1925 (figure 2). This stair was rebuilt late in 1990 (figure 14).

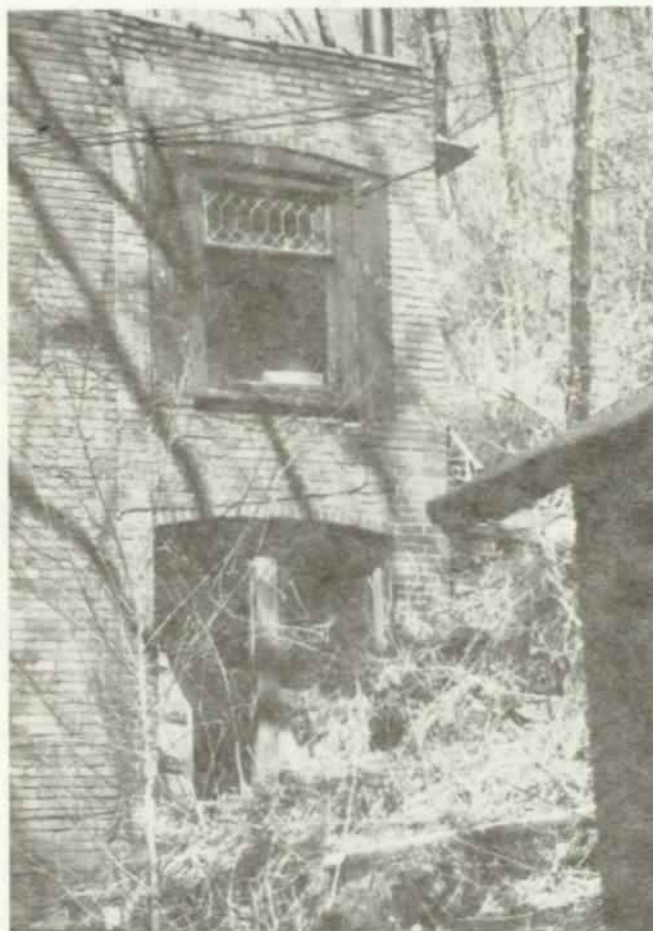
**Figure 16**  
South Elevation of Rear Addition, Mankin-Cox  
Building, March 1990  
(NPS Photo)

the second and third floors of this elevation. The third-floor door is headed by a transom and a brick arch. At the northern end of the second floor, a small arched window is also visible. An original third-floor arched window opening and an original second-floor door still exist inside the addition.

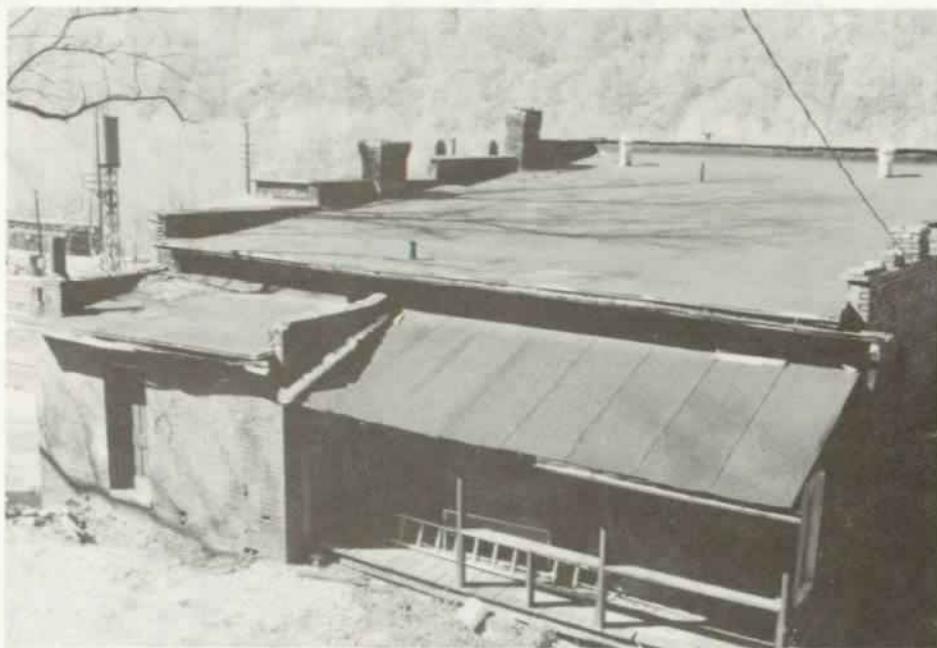
**Figure 17**  
East Elevation, Mankin-Cox Building, April 1991  
(NPS Photo)

The main roof of the Mankin-Cox Building is built up with a mopped asphalt finish (figure 17). The roof appears to be in good condition and is vented by two sheet metal turbine vents. The interior faces of the parapet walls are coated with asphalt or mastic. The parapets are in poor condition; almost every stepped section of wall at the north and south elevations is bowed inward. This bowing is especially severe at the northwest corner of the building. The parapets are capped with stone, which has been coated with asphalt.

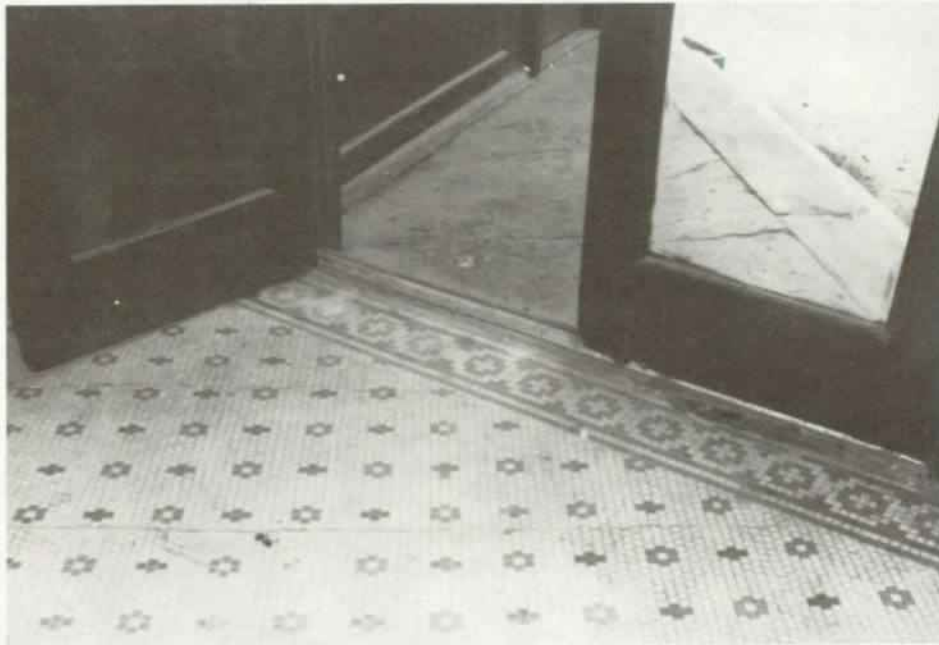
**Figure 24**  
Tile Floor, Room 101, Mankin-Cox Building, May 1990  
(NPS Photo)

The floor, except for the alcove created by the vault, was covered with Armstrong loose-laid sheet linoleum. During the investigation for this report, much of it was pulled up to reveal a mosaic tile floor of 1"-square tiles in white, blue, and dark red (figure 24). The park removed the remainder of the linoleum the winter of 1991. The mosaic tile evidently was only located in the public area of the banking hall, along the west wall and the west half of the south wall. The remainder of the original floor appears to have been tongue and groove. Most of this original floor has long since decayed and been replaced by plywood and other wood patches. A portion of plywood and masonite was removed at the west wall during the winter of 1991, revealing all that remains of the original tile. Only a few remnants of tongue-and-groove flooring remain along the north wall. Due to these floor repairs and the absence of a

tile border except along the walls, the exact extent of the original tile is impossible to determine. The tile floor is cracked along the line of the joists supporting it. The plywood floor in the eastern half of the room is painted grey and is deteriorating. At the eastern wall, the plywood is very soft and easily pushed through. A section of this soft flooring was removed for the structural investigation portion of this report.

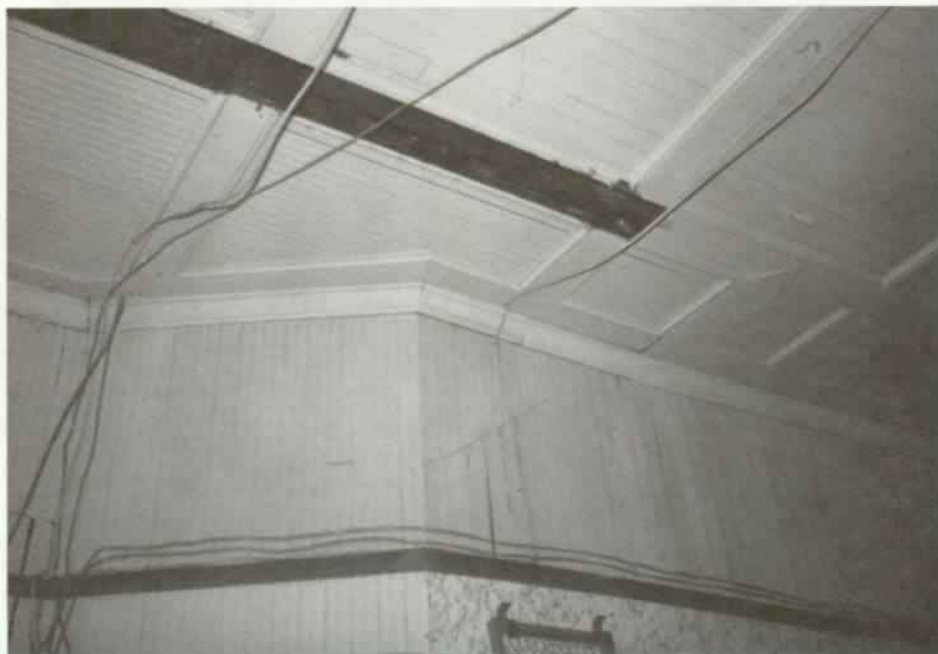
**Figure 25**  
Ceiling at Original Stair Location, Room 102  
Mankin-Cox Building, April 1991  
(NPS Photo)

unfinished boards outlining the approximate extent of the stair enclosure were removed during the investigation for the this report (figure 25). (It is unknown why these boards were unfinished, but they appear to be recently installed to replace missing earlier boards.) This ceiling extends to the east wall of the building and above the toilet rooms that were added later. The condition of this hidden portion of the ceiling is unknown, but in view of the general decay found in the eastern end of the building, it may be assumed that much of the ceiling is rotten.

The north wall is finished in vertical beaded tongue-and-groove boards, painted. Most are probably original, and the patched areas at the previous stair (figure 25) and double door to room 101 locations are obvious. In the middle of the north wall was a suspended canopy, constructed of wood framing and trim (figures 26 and 27) with an acoustical tile ceiling. The canopy was removed by the park in the summer of 1990. The wall finish below this canopy is plastic laminate panels in a gold-on-white abstract pattern. Generally, the wall is in good condition, although decay appears to be setting in along the bottom, especially at the east end of the room.

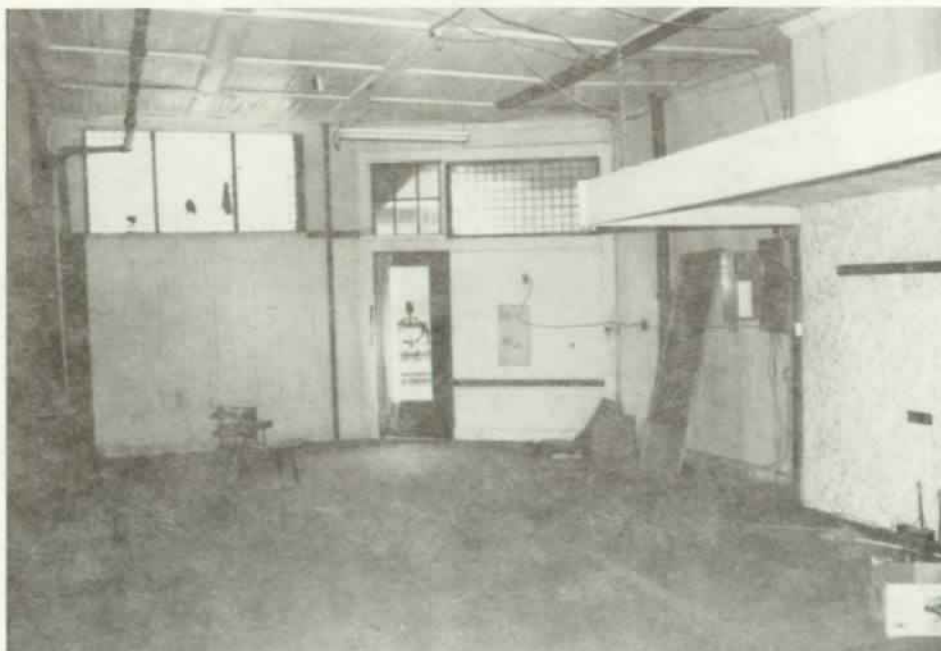
**Figure 27**  
West End of Room 102, Mankin-Cox Building, May 1990  
(NPS Photo)

The west wall of this room is finished in vertical beaded tongue-and-groove boards, painted yellow with black trim (figure 27). Gypsum board covers the original window opening to the north of the exterior door. While covered in tongue-and-groove boards, the wall to the south of the door had a patched area that may once have been an access to a window display.

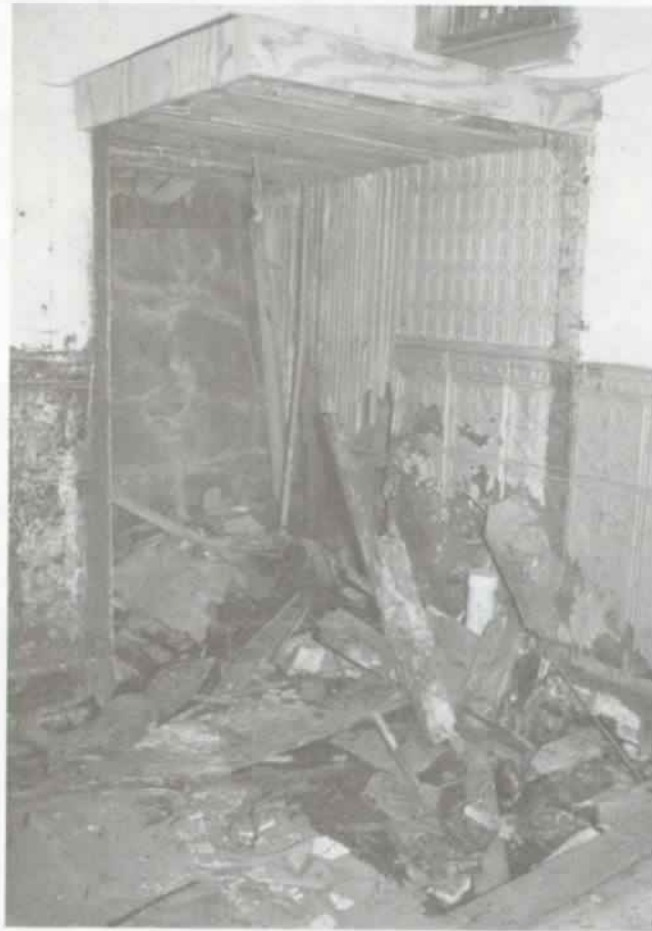
**Figure 29**  
Room 105, Mankin-Cox Building, April 1991  
(NPS Photo)

**Room 105.** This space apparently once served as a toilet room, although only a toilet paper holder affixed to the east wall remains. The south wall and the ceiling are finished in beaded tongue-and-groove boards, painted silver. The lower half of these walls is badly decayed if not completely deteriorated. The east wall, likewise, was of beaded tongue-and-groove boards, painted silver. Quite deteriorated, it was removed in the winter of 1991 to reveal the stone wall behind it (figure 29), which appears to be in good condition.

The remainder of the walls and the ceiling are in poor condition, with loose, decayed, and missing areas. The ceiling of this space is supported on a wood-frame canopy that extends into room 101. Ghosting on the walls of room 101 at the ends of the canopy suggests that walls once enclosed this space at those locations. The paint scheme of the pressed tin wall under the canopy also suggests this as it is the same silver paint. The north wall is a stud wall covered with horizontal tongue-and-groove boards at the top half. At the lower half of the wall, the studs are exposed to view. The floor has completely disintegrated.

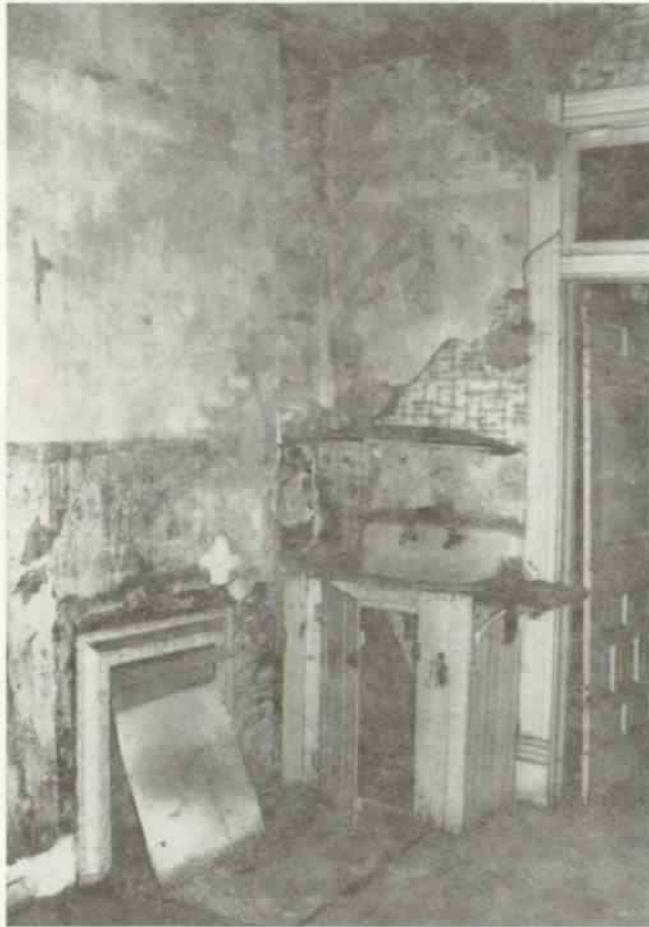
**Figure 30**  
Northeast Corner, Room 202, Mankin-Cox  
Building, May 1990  
(NPS Photo)

**Room 202.** This room was used as a kitchen, with sink, cabinet, and shelves located in the northeast corner (figure 30). While these do not appear to be original, they do appear to be an early addition. The tongue-and-groove flooring is in fair condition, with a wide orange brown painted border. Linoleum flooring was removed in May 1990 as part of a general building cleanup. The baseboard is in good condition, although a section of it is missing to

the west of the fireplace, and with the reduced ventilation in the sink cabinet, it is suspected the base there may be rotten. The walls and ceiling are plastered, with seven layers of wallpaper. The walls are in fair condition, although there is evidence of moisture damage in the corner around the sink, and the top several inches of the walls are cracked and loose. The wall area to the south of the door to room 203 is in particularly bad condition with large diagonal cracks and buckling, probably caused by the general settling of the building toward its center. During the winter of 1991, the park removed a section of plaster at the bottom of the wall to the south of door 203. The bottoms of the studs thus exposed are in good condition.

The ceiling has areas of loose and missing plaster along the south and east walls. The original mantle has been removed and the firebox boarded up, perhaps at the time of the sink installation. The decorative metal firebox surround and grate are still in place (figure 30). The firebox is filled with debris, including chunks of mortar from the chimney. The stone hearth has dropped to slightly below the surrounding floor surface.

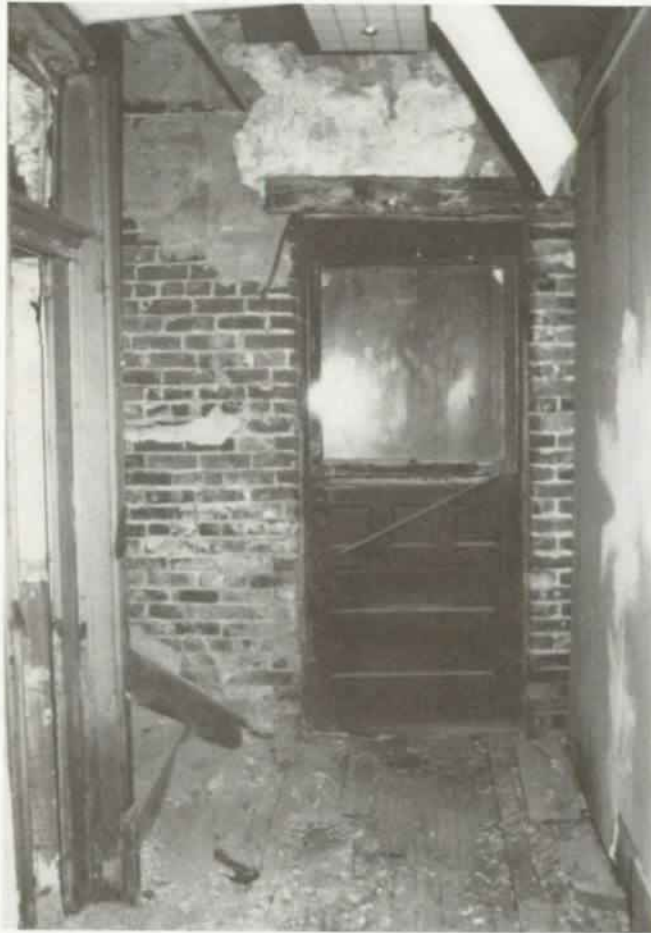
**Figure 32**  
East End of Hall 206, Mankin-Cox Building, May  
1990  
(NPS Photo)

**Room 206.** This hallway is in very poor condition at the eastern end. Paneling scraps have been applied to the ceiling in an attempt to prevent the plaster from falling further. At the east wall, nearly all of the plaster, baseboard, and door trim are gone; the door head trim and a small area of plaster above the door remain (figure 32) but are in visibly poor condition. The easternmost 10 feet or so of the south wall have been replaced with unfinished gypsum board. While it is likely that the original plaster finish was severely deteriorated, this portion of the wall may also have been redone to facilitate the installation of the modern bathtub in the adjoining bathroom. The baseboard at this stretch of wall is missing. The tongue-and-groove flooring at the east end of the hall, in a area extending west to door 202, is severely decayed. While the entire eastern end of the building is suffering from moisture-related deterioration, the deterioration of this section of flooring was exacerbated by a pile of debris that trapped moisture. The park removed the debris in May 1990.

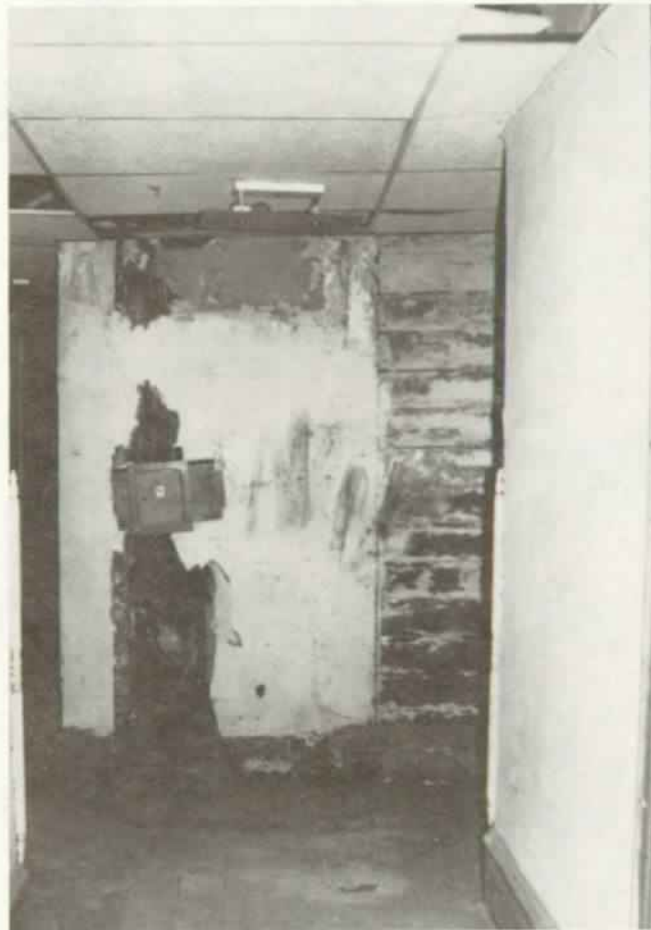
**Figure 33**  
West End of Hall 206, Mankin-Cox Building,  
May 1990  
(NPS Photo)

near doors 206 and 216. The plaster of the west wall is in fair condition, but the gypsum board door infill has large holes in it and is not all taped and painted (figure 33). The adjacent horizontal board wall is in fair condition with a great deal of peeling paint.

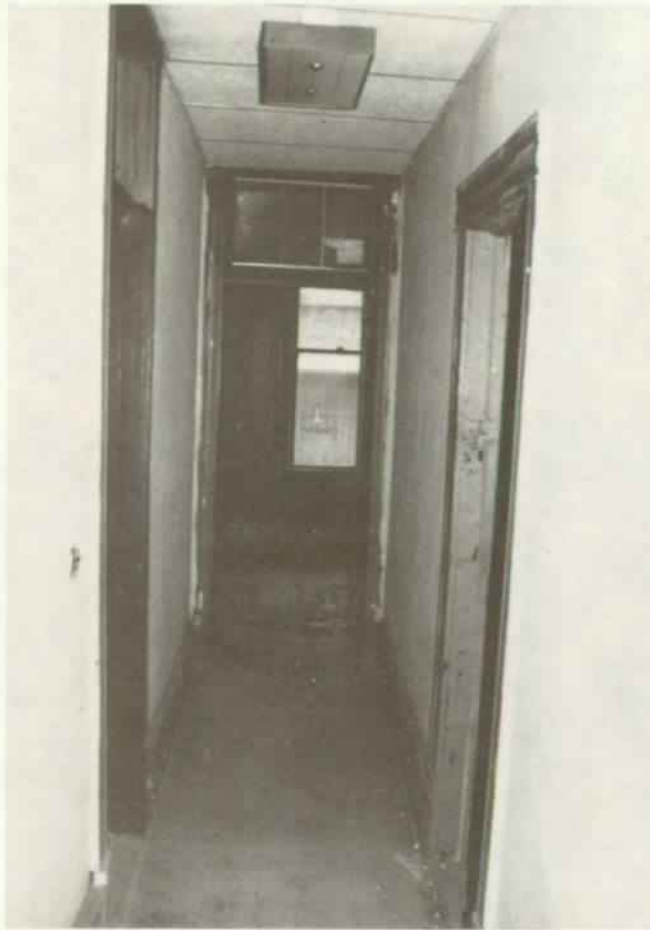
**Figure 34**  
Hall 207, Looking West, Mankin-Cox Building,  
May 1990  
(NPS Photo)

**Room 207.** This section of hall is in much better condition than the main hall, room 206 (figure 34). The tongue-and-groove flooring is completely covered with red linoleum, so its condition is unknown. The baseboard is painted salmon brown and is in good condition. The plaster walls, painted white, are also in good condition. The ceiling is finished with a 2' x 4' suspended acoustical panel ceiling in excellent condition. The condition of the plaster ceiling above is unknown. The corner guard (similar to that in figure 40) near door 209 is missing.

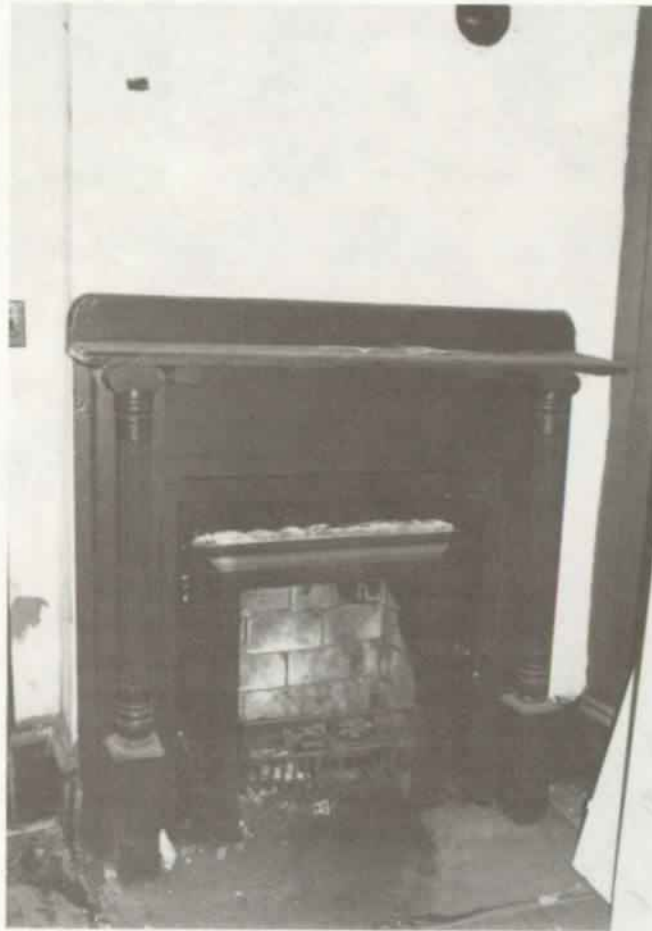
**Figure 36**  
Mantle, Room 211, Mankin-Cox Building, May  
1990  
(NPS Photo)

**Room 211.** The flooring in this room is tongue and groove, painted dark green. Carpeting was removed in May 1990. A section of baseboard is missing to the west of the mantle, and another section is loose at the east corner of the mantle. The remainder of the baseboard is fine. This room has paneled walls to the north, east, and west. The plaster at the south wall is painted white and displays a large old crack to the west of the fireplace flue. The ceiling is a 2' x 4' acoustical panel suspended ceiling. The condition of the original plaster ceiling above is unknown. The original wood mantle (figure 36) is in place, although its shelf is cracked lengthwise; the western column has shifted with the building; and various other elements are nicked and gouged. The metal grate is rusted and broken and contains bricks that have fallen from the chimney flue. Several firebox bricks are cracked and loose.

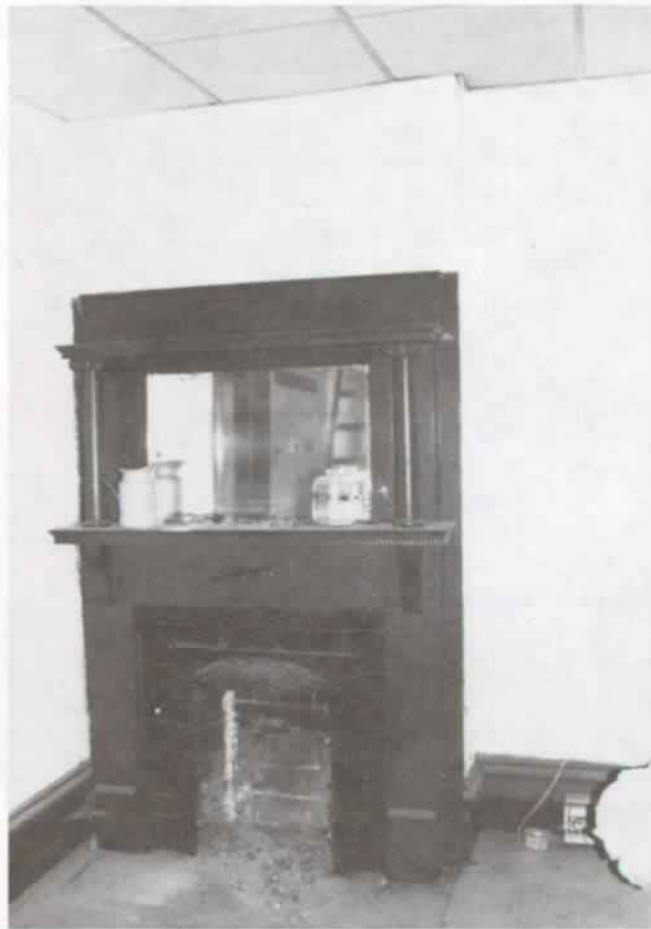
**Figure 37**  
Mantle, Room 212, Mankin-Cox Building, May  
1990  
(NPS Photo)

**Room 212.** The tongue-and-groove flooring of this room is painted dark green with a dark brown border. The floor is in fair condition and has a small, square sheet metal patch in the northwest corner. It is unknown whether the patch covers a hole and, if so, what kind. The baseboard is in generally good condition, although many of the tongue-and-groove joints are loose. The plaster walls are painted white; some areas have moisture damage, delamination, roughness, and cracking. On the east wall, a piece of board 1/8" thick evidently covers a hole

near the mantle. Several holes have been knocked in the plaster at the west wall. The ceiling is a 2' x 4' acoustical panel suspended ceiling. The condition of the original plaster ceiling above is unknown. The original mantle in this room is missing and has been replaced with another style of mantle. The current mantle (figure 37) is taller, with a mirror above the mantle shelf. The mirror is fastened in place with molding in a fashion that appears to be other than what was intended when the mantle was made. Several pieces of the mantle are cracked or otherwise broken. The decorative metal firebox surround is also of a different design than the others in the building, and a wythe of brick has been added to front of the fireplace as part of the firebox surround. Some of this brick is loose and misaligned. The hearthstone is original and is cracked.

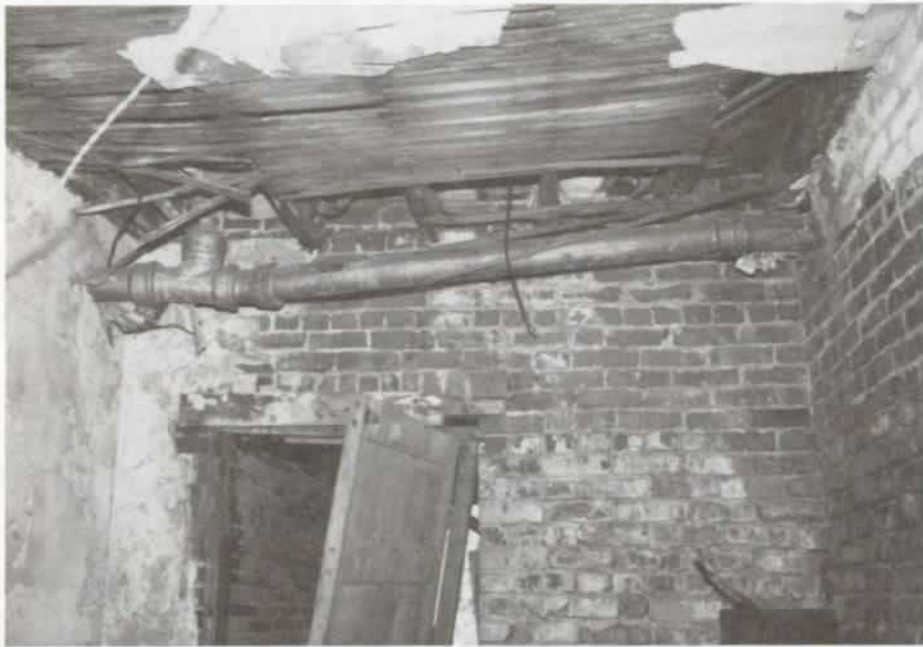
**Figure 38**  
North End of Room 217, Mankin-Cox Building, April 1991  
(NPS Photo)

**Room 217.** This room is the lower level of a two-story addition to the southeast corner of the original Mankin-Cox Building. The concrete floor is in good condition, the best of any element in the room. Most of the plaster on the walls and ceiling has disintegrated, leaving only the wood ceiling lath (figure 38). A ghost line indicates the room once had a baseboard, but it no longer exists. The doors and windows in this room were described under the exterior section above.

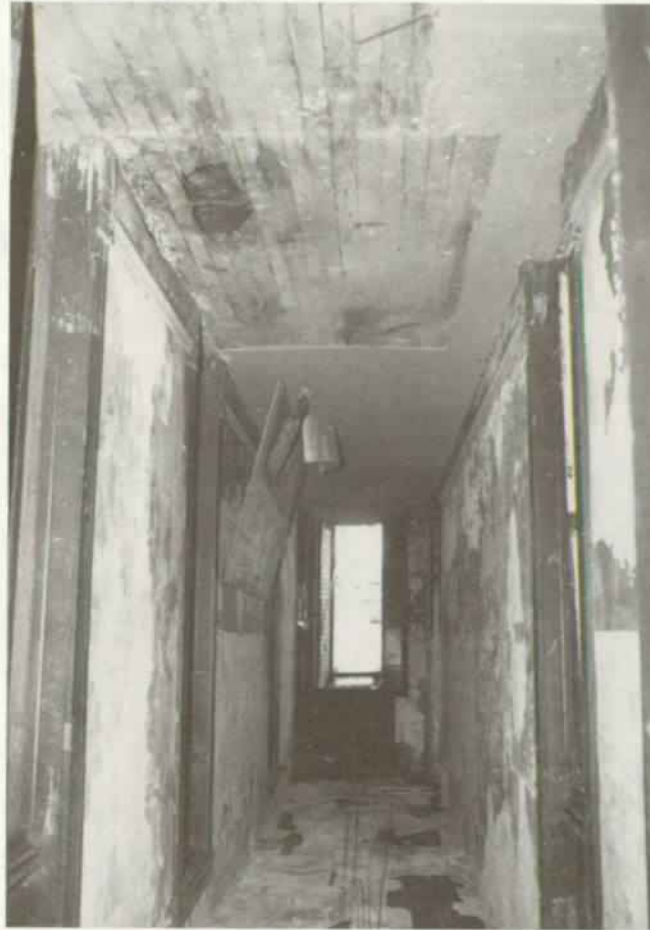
**Figure 39**  
Hall 303, Looking East, Mankin-Cox Building,  
April 1991  
(NPS Photo)

**Room 303.** The entire floor of this hallway is covered with plywood, presumably applied over the original tongue and groove because of the poor condition of the original floor. Between doors 311 and 312, this plywood flooring is very springy, as though nothing supports it. This section of plywood was removed during the winter of 1991, revealing a completely deteriorated section of flooring (figure 39). At the eastern end of the hall, the settlement of the original floor seems to be a factor in the installation of this plywood flooring. Indeed, at the intersection with hall 302, the plywood flooring is an inch or two above the level of the

original tongue and groove. The baseboard is painted a dark reddish brown, and some sections appear to be rotten at the bottom. Much of the paint has peeled.

As is typical throughout the building, the plaster at the east wall is severely deteriorated, and much of it is missing. The rest of the plaster is in fair condition, and the more cracked or otherwise deteriorated areas are at the eastern end of the hall. The walls are covered with two layers of wallpaper, painted cream, with a dark red painted wainscot. Turned wood corner guards (figure 40) protect the corners at the intersection of hall 202. The plaster ceiling is in poor condition with much plaster missing or loose. The ceiling was finished with cream paint on wallpaper, though most of the painted wallpaper has peeled.

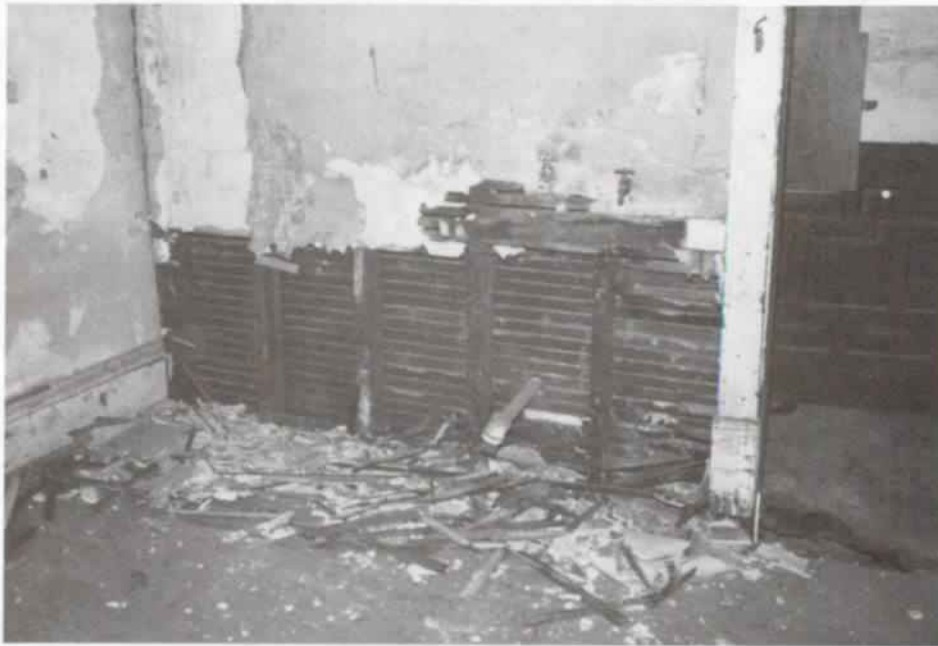
**Figure 41**  
East Wall of Room 304, Mankin-Cox Building, April 1991  
(NPS Photo)

**Room 304.** The floor of this room is in poor condition, with a totally decayed area that begins at the north half of door 303 and extends several feet along the east wall (figure 41). Another visibly rotten area of flooring is in the southeast corner of the room. Areas of the baseboard also exhibit rot, especially adjacent to the rotted areas of floor.

At the location of a sink, just north of door 303, several square feet of plaster were missing. More plaster and lath were removed (figure 41) in the winter of 1991 to expose the wall studs, which were found to be in poor condition. The sink is gone, but two faucets and a portion of the waste pipe remain at the wall.

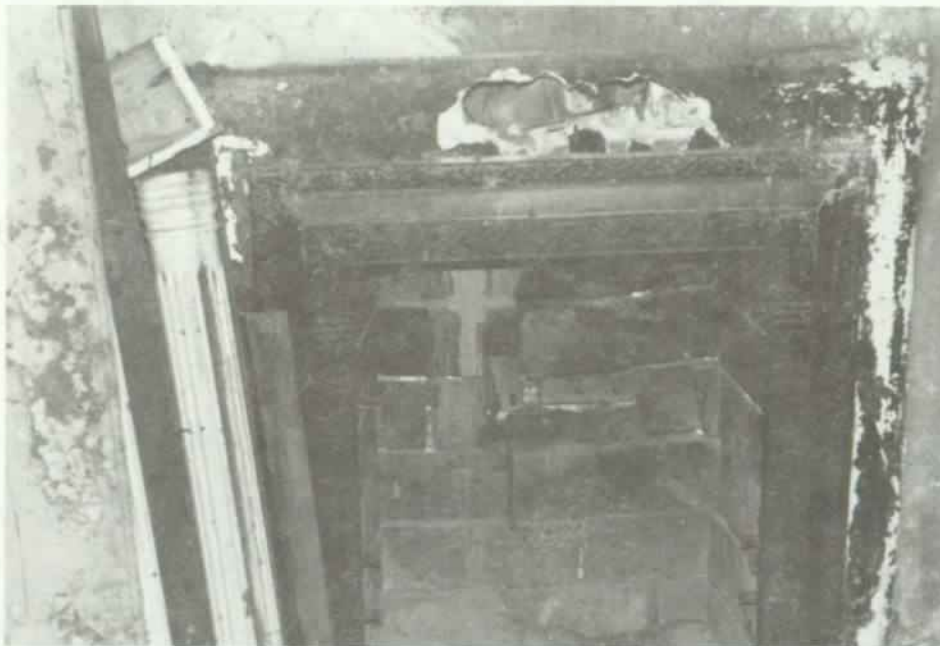
**Figure 42**  
Fireplace, Room 305, Mankin-Cox Building, May 1990  
(NPS Photo)

The mantelpiece is in pieces leaning against the wall. It appears that several pieces, including one column, are missing. The metal firebox surround is in place, but the grate is missing. The firebox bricks and bricks immediately above the firebox opening (figure 42) are cracked or missing.

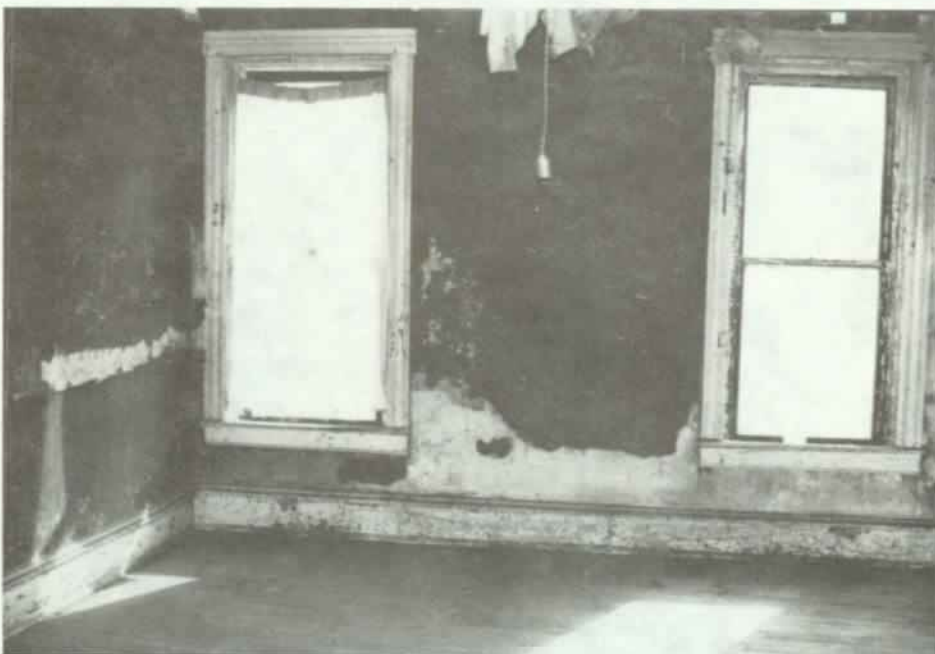
**Figure 43**  
West Wall of Room 306, Mankin-Cox Building, May 1990  
(NPS Photo)

**Room 306.** This room has an appearance similar to room 305, with wallpapered walls painted dark red (figure 43) and scratched by chickens. The plaster walls are in fair condition with some noticeable cracks at the west wall and to the south of doorway 306. Of special note is a crack 3/8" wide under window 304 and a vertical crack in the middle of the chimney at the north wall. A crack similar to and probably associated with the latter occurs at the chimney immediately below on the second floor.

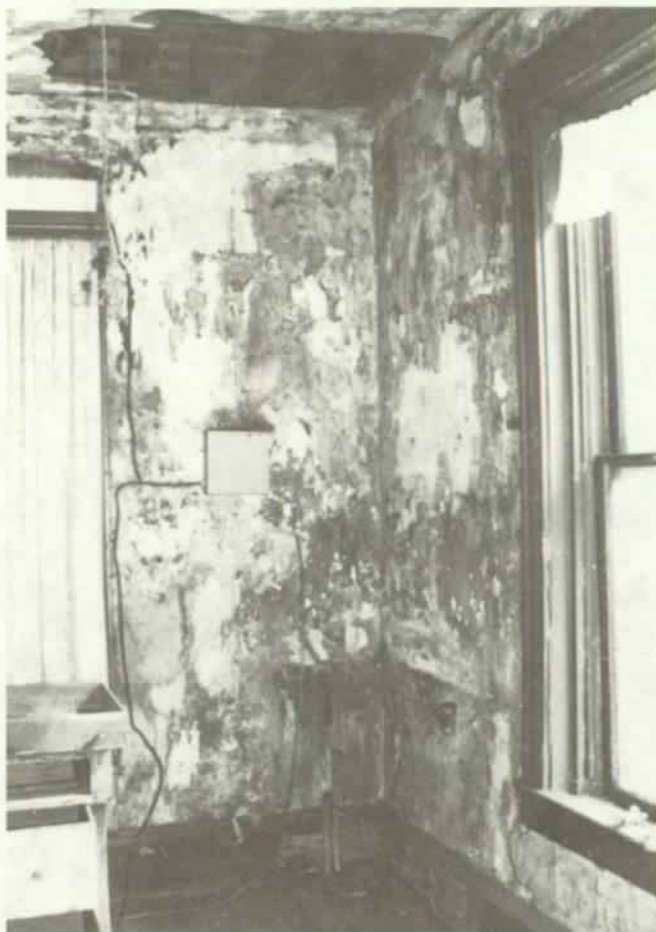
**Figure 44**  
Southwest Corner, Room 308, Mankin-Cox  
Building, May 1990  
(NPS Photo)

The plaster walls are wallpapered, although many of the seven layers of paper have peeled, especially in the southwest corner where there appears to have been a leak from the roof. The plaster ceiling is missing in this corner as well. The plaster walls are in fair condition, with areas of cracking and small areas of loose plaster concentrated in the northwest and southeast corners of the room, especially around the windows. A small area of rough and missing plaster also occurs at the area of the former cabinet. A large crack in the plaster has occurred in the northwest corner, where the interior wall has pulled away from the exterior wall as the building settled. The ceiling is wallpapered and, in addition to the missing area, has cracked and loose plaster. At the east wall, a ghost suggests that a wall cabinet, mirror, or other large object once hung here.

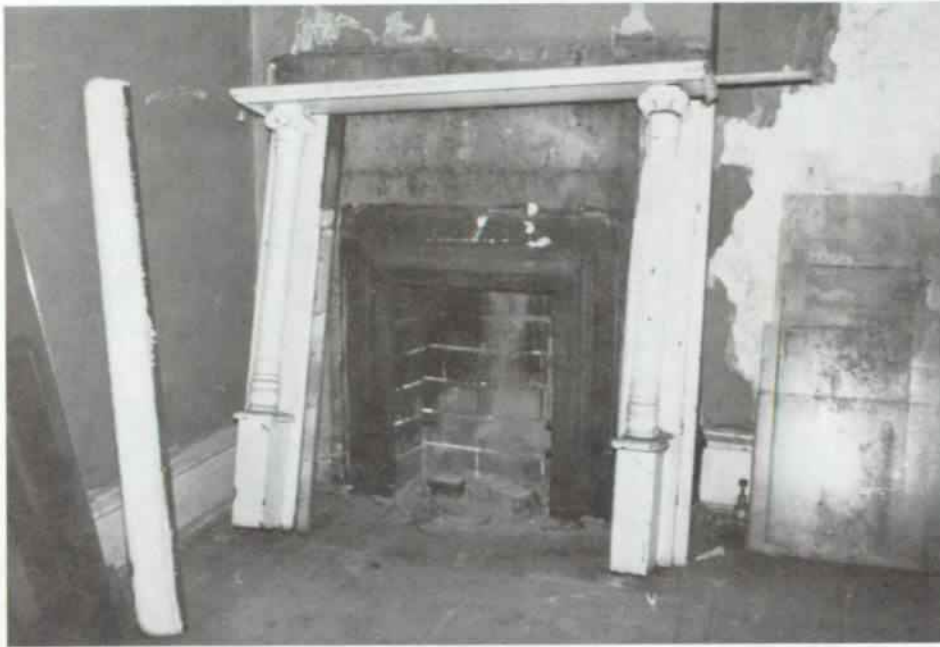
**Figure 46**  
Mantle, Room 310, Mankin-Cox Building, April 1991  
(NPS Photo)

The ceiling is in poor condition, with much loose plaster. The original wood mantle (figure 46) is not attached to the wall but is leaning against it at the proper location. Several pieces of the mantle are broken. The original metal firebox surround is in place, but the grate is missing.

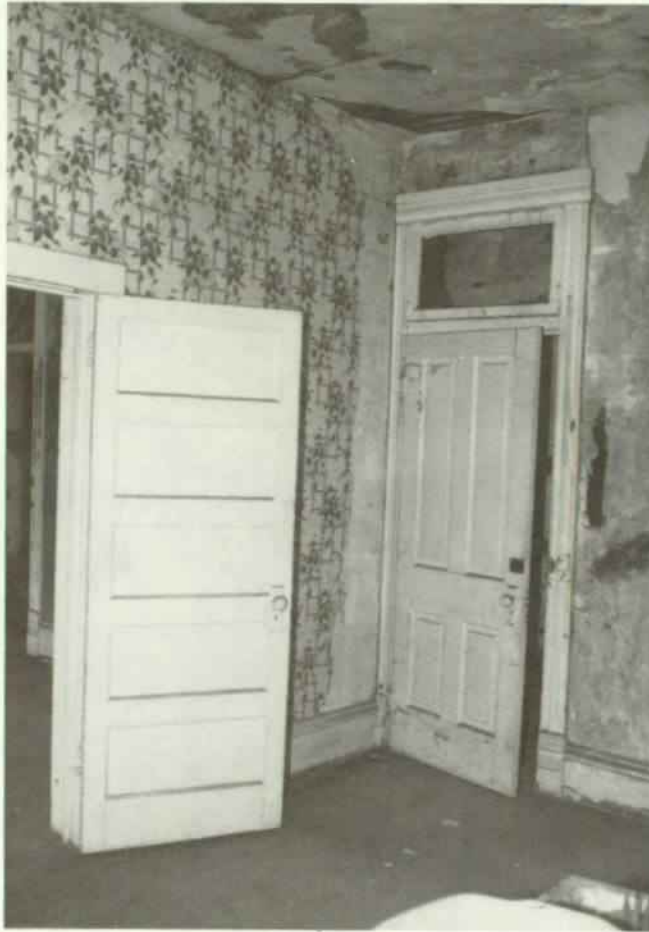
Figure 47  
Northwest Corner, Room 311, Mankin-Cox  
Building, April 1991  
(NPS Photo)

**Room 311.** This room appears to have been used as a kitchen (figures 47 and 48), based on the presence of a sink, kitchen-like wallpaper, and linoleum on the floor. All of the linoleum has been removed, exposing the original tongue-and-groove floor. The baseboard is painted white, although the paint is peeling, especially in the northeast corner. The plaster walls are papered with approximately eight layers of wallpaper. This paper is intact at the west, south, and southern half of the east walls but is peeling at the remainder of the space. The plaster is loose at the top half of the north wall and has moisture damage at the north half of the east wall and at the sink. The interior walls have separated from the exterior walls. The ceiling is wallpapered, with many areas of loose and missing plaster.

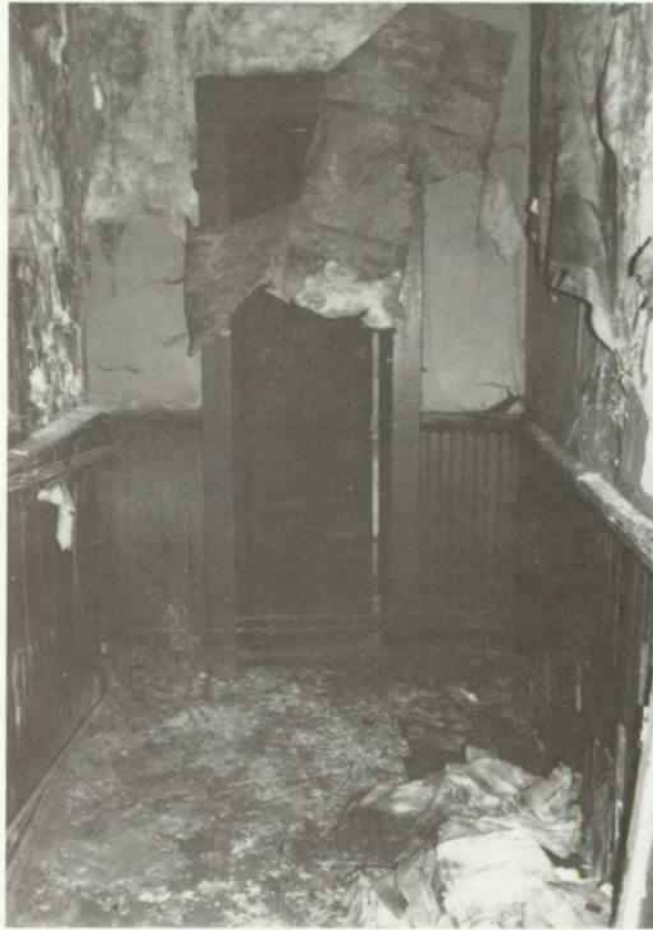
**Figure 49**  
South End of Room 312, Mankin-Cox Building,  
May 1990  
(NPS Photo)

**Room 312.** This bathroom is in poor condition. Much of the tongue-and-groove flooring is rotten and has caved in, especially in front of door 316 (figure 49). Vertical beaded tongue-and-groove wainscoting, painted dark brown, is on all four walls. It is largely rotten, especially from the bottom up, and has some buckled areas. The plaster above the wainscot is papered with wallpaper, painted aqua. Most of this wallpaper is peeling. At the north and east walls, the plaster itself has severely deteriorated. At the south and west walls, it is much less deteriorated, but there are still areas of moisture damage and delamination of the skim coat. Vertical beaded tongue-and-groove boards create a chase around a cast-iron soil stack at the north wall. This chase is falling apart. Most of the plaster ceiling is missing. The remaining portions are covered with wallpaper, painted aqua, and are in poor condition. All of the bath fixtures are missing.

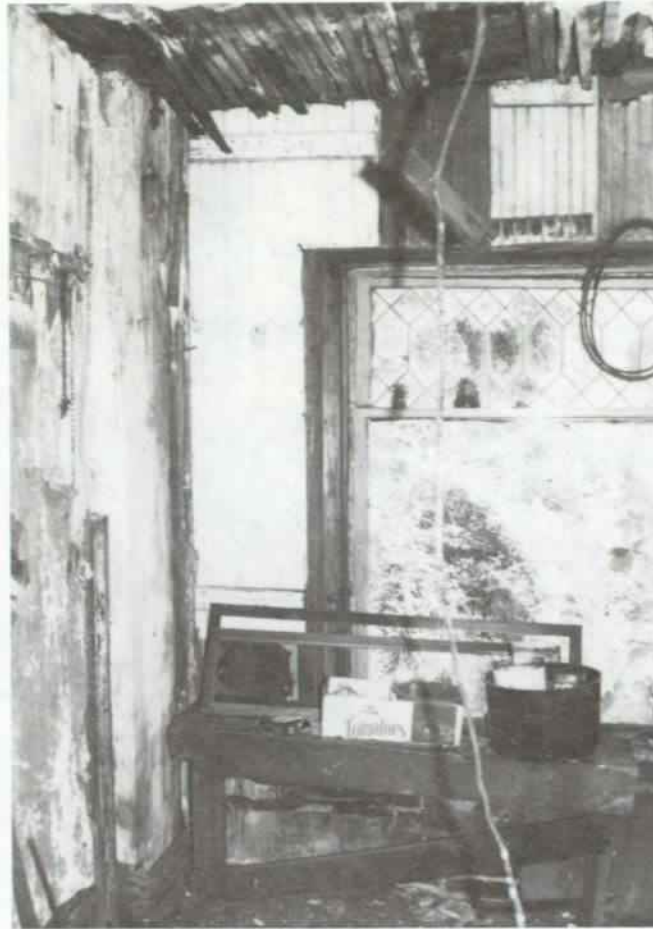
**Figure 50**  
Southeast Corner, Room 314, Mankin-Cox  
Building, May 1990  
(NPS Photo)

All of the walls are or were of plaster except the south wall of room 314, which was finished with various groupings of vertical beaded tongue and groove painted different colors (figure 50). The plaster walls in room 314 are papered and painted colonial blue. These walls are in good to fair condition except the east wall, which is cracked and shows signs of water damage, especially at the top. An original window opening in the west wall has been boarded over (figure 51). In room 315 the plaster walls are in poor condition. The plaster is mostly missing at the north and west walls, and is cracked and loose at the east wall. Much of the plaster at the ceilings of both rooms is gone. Remnants of wallpaper are found on the ceiling of room 314.

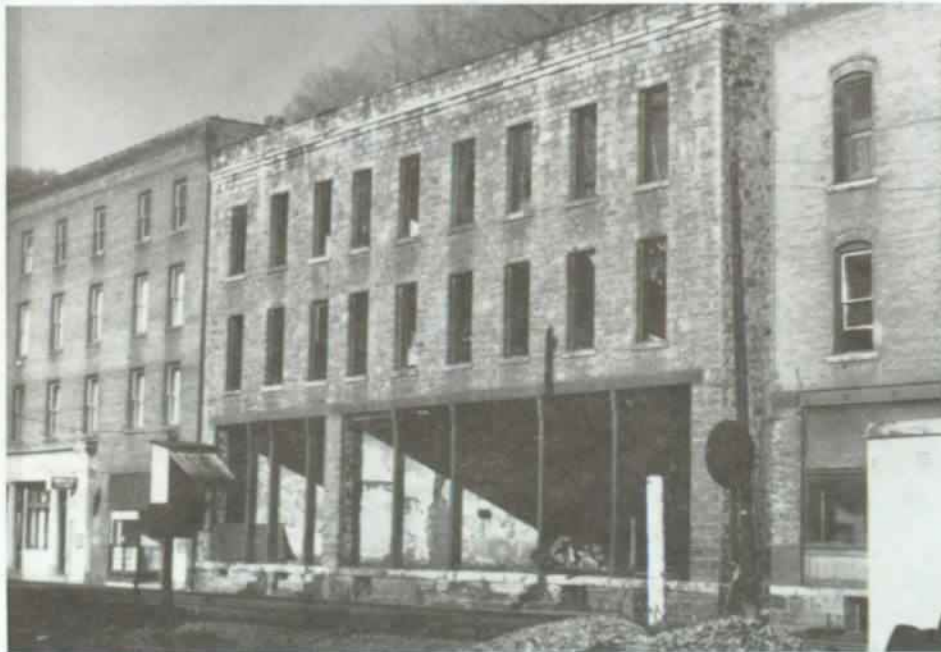
**Figure 53**  
Goodman-Kincaid Building, November 1975  
(NPS Photo)

The current storefronts and upper windows at the west elevation are not historic. Because of the humid climate and neglect, little was left of these elements by 1975 (figure 53). The current storefront at the northern end of the building was constructed in 1975 or shortly thereafter. The storefronts and upper windows at the southern end of the building were part of movie sets constructed for "Matewan," which was filmed in Thurmond in 1985. A wooden platform running the full length of the building was also built for the movie but was removed in July 1990.

In general, little original fabric remains in the interior of the Goodman-Kincaid Building, only scattered remnants of plaster and window frames. In the 1960s, the southern two-thirds of the building collapsed. The northern third of the building remained standing but was apparently in severe disrepair. Photographs from 1975 (figure 53) indicate the extent of the neglect from which the building was suffering.

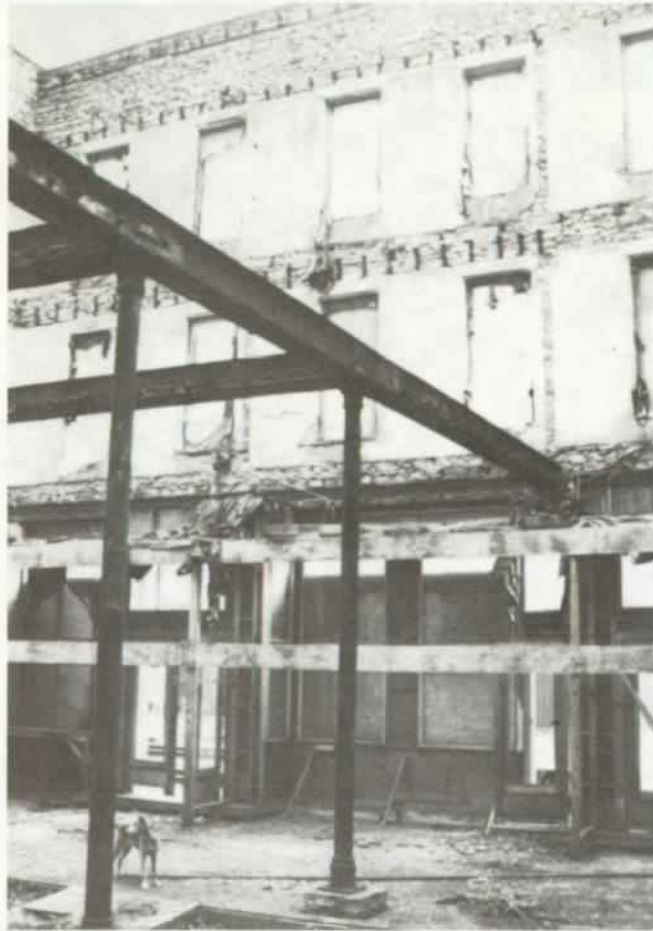
**Figure 61**  
West Wall, Room 102, Goodman-Kincaid  
Building, August 1990  
(NPS Photo)

**Room 102.** This "room" comprises approximately two-thirds of the building, all the space that collapsed in the 1960s, and is now open to the sky (figures 61 and 62). Enough plaster remains on the stone walls so that the locations of partition walls at the second and third walls can still be seen. The plywood floor at the western portion of the space, over the basement, was installed for the filming of "Matewan." The remainder of the "floor" is dirt. Wild raspberry bushes were growing in this eastern portion of the space, but they were removed in July 1990. A couple of trees were also growing in the northern and eastern walls at the second floor level. One tree in the east wall was approximately 12" in diameter before the trees were cut back in July 1990. At the first-floor level, four steel columns and three steel beams of the second-floor framing system remain in place, though severely rusted. As stated above, all of the windows and storefronts at the west wall were constructed for the filming of "Matewan."

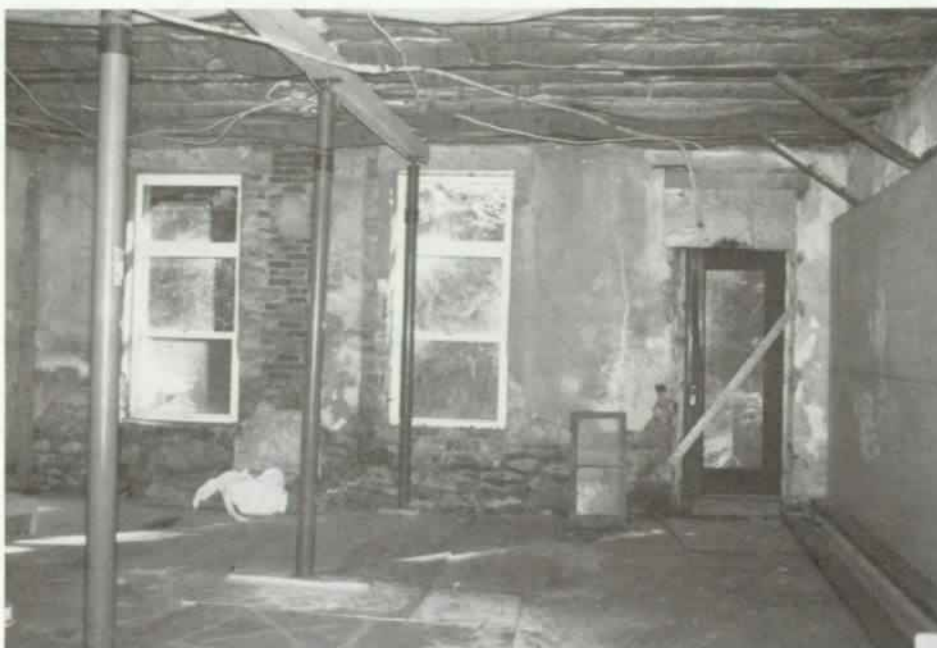
**Room 202.** This space is currently unfinished and unused. The floor is of plywood, and there is no baseboard (figure 63). Several areas of the floor are particularly springy, such as at the bottom of the stairs to the third floor and to the west of the door into the laundry room.

The walls are of stone with much of the original plaster intact, except at the east wall where a great deal of the plaster is missing. Some wallpaper remains on the wall in the southwest corner of the room. At the south wall, the original plaster is covered with unfinished gypsum board on 2 x 4 furring. At the western end of the south wall, where the wallpaper remains, only the 2 x 4 furring is in place. The gypsum board either has been removed or was never installed. Ghosts on the existing plaster indicate the location of the original walls. There is no finished ceiling in this room, and the third-floor framing, with fiberglass batt insulation between each joist, is exposed. The walls forming the laundry room (room 201) have not been finished out, so the framing is exposed (figure 64).

**Figure 63**  
East End of Room 202, Goodman-Kincaid Building, April 1991  
(NPS Photo)
