## Historic Structure Report

### Thurmond Commercial Buildings **NEW RIVER GORGE** National River • West Virginia

Historic Structure Report  
August 1992

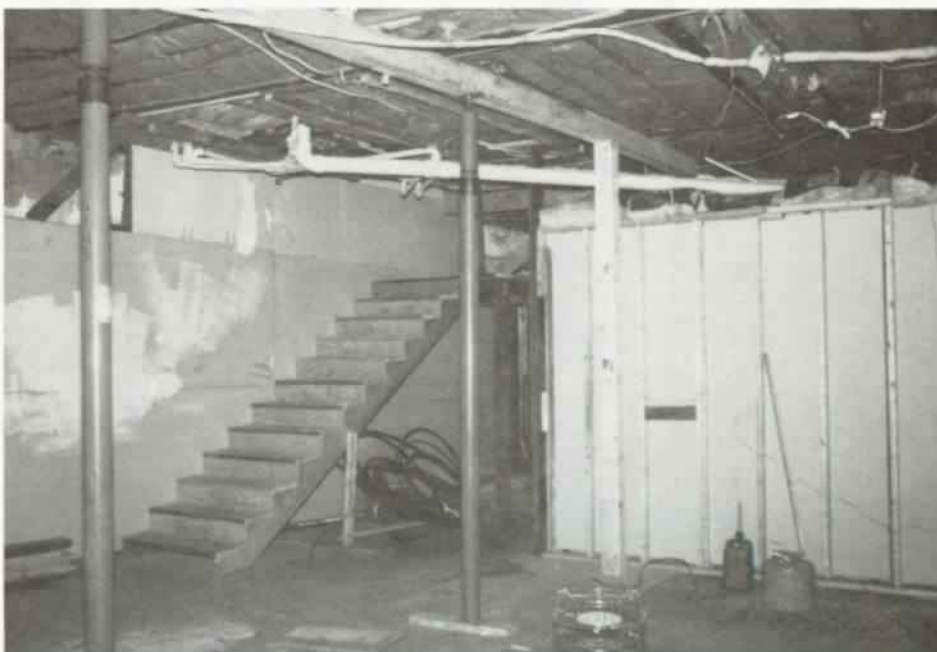
The walls are of stone with much of the original plaster intact, except at the east wall where a great deal of the plaster is missing. Some wallpaper remains on the wall in the southwest corner of the room. At the south wall, the original plaster is covered with unfinished gypsum board on 2 x 4 furring. At the western end of the south wall, where the wallpaper remains, only the 2 x 4 furring is in place. The gypsum board either has been removed or was never installed. Ghosts on the existing plaster indicate the location of the original walls. There is no finished ceiling in this room, and the third-floor framing, with fiberglass batt insulation between each joist, is exposed. The walls forming the laundry room (room 201) have not been finished out, so the framing is exposed (figure 64).

**Figure 64**  
Room 202, Looking Southwest, Goodman-Kincaid Building, April 1991  
(NPS Photo)

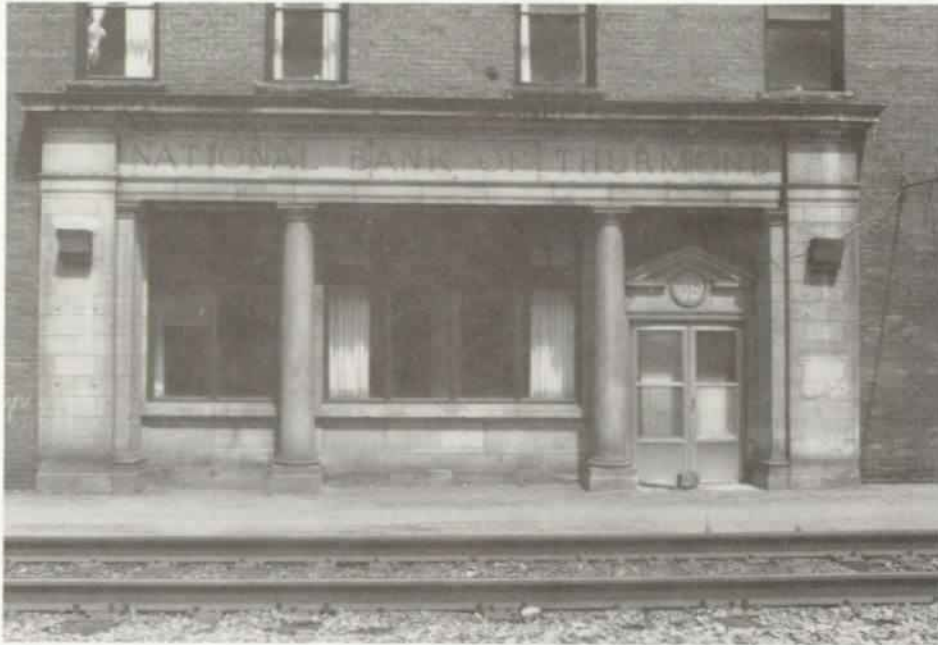
The National Bank of Thurmond is a four-story brick building constructed about 1917, with rubble stone foundation walls as the north, south, and east walls of the first story. Red brick is the only brick used in the building, and it is laid in a common bond pattern. A classical limestone facade was added at the first floor to the north end of the west elevation when the National Bank of Thurmond moved into the building in 1923 (figure 67).

**Figure 67**  
1923 Bank Facade, National Bank of Thurmond, April 1991  
(NPS Photo)

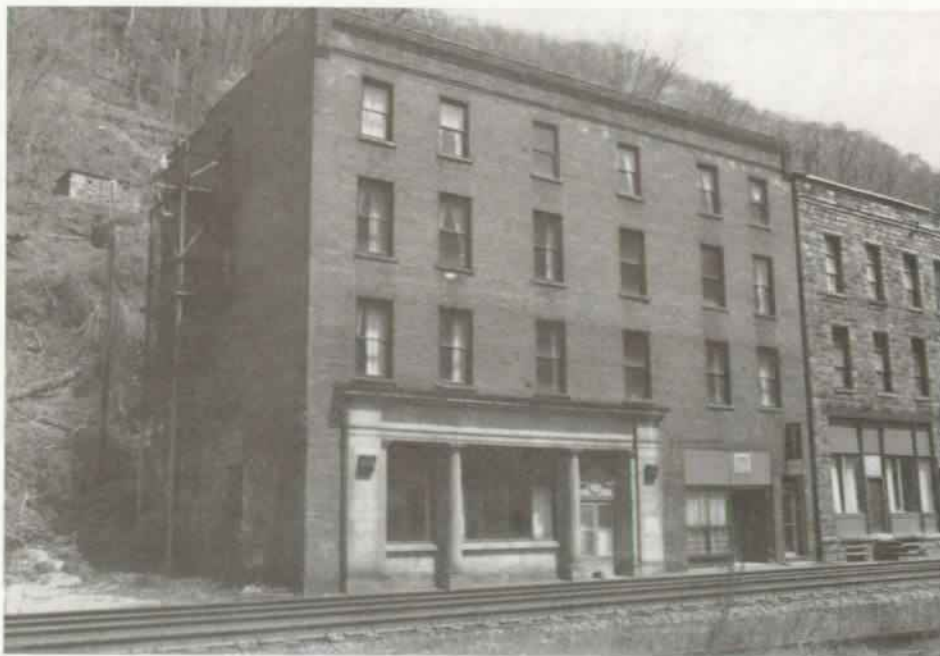
The track or west elevation (figure 68) of the building has an irregularly spaced six-bay fenestration pattern on the second, third, and fourth floors. The first floor is divided into two bays. The southern bay consists of a storefront, much of which may be original, and a modern metal door set into the original second-floor access doorway at the far south end of the building. This southern storefront consists of recessed double doors, with a small display window to the south and a large display window to the north of the doors. The masonry opening above the windows is currently infilled with masonite panels, but remains of horizontal wood siding over prism glass panels can be seen from the interior. The prism glass is probably original, but this cannot be confirmed from historic photographs because an awning was deployed at this storefront. The original storefront at the north end of the building is documented in only one photograph from 1920 (figure 4). This original storefront had a central recessed entry with large display windows to either side. In the photograph it is unclear what the area above the windows and door is made of, though it appears solid. It probably is an area of prism glass, as remains of prism glass can still be found behind the masonite panels above the southern storefront. This original storefront was replaced with the current neoclassical limestone facade in 1923 (figure 67). This facade is formed by rectangular end pilasters, a dentiled and carved frieze, and two semi-Doric columns dividing the storefront into three bays. The double-width center bay and the northern bay contain large fixed-pane windows, each topped by a square sash with eight muntins radiating outward

**Figure 68**  
West and North Elevations, National Bank of Thurmond, April 1991  
(NPS Photo)

The top of the west elevation consists of a corbelled parapet. Two courses below the very top of the wall, the corbelling extends outward a full brick width and is topped with a mortar wash. This mortar wash is in fair condition and is not adequately protecting the bricks. Several of the bricks have cracked, and moisture is entering the cracks and freezing, causing the face of the bricks to spall off.

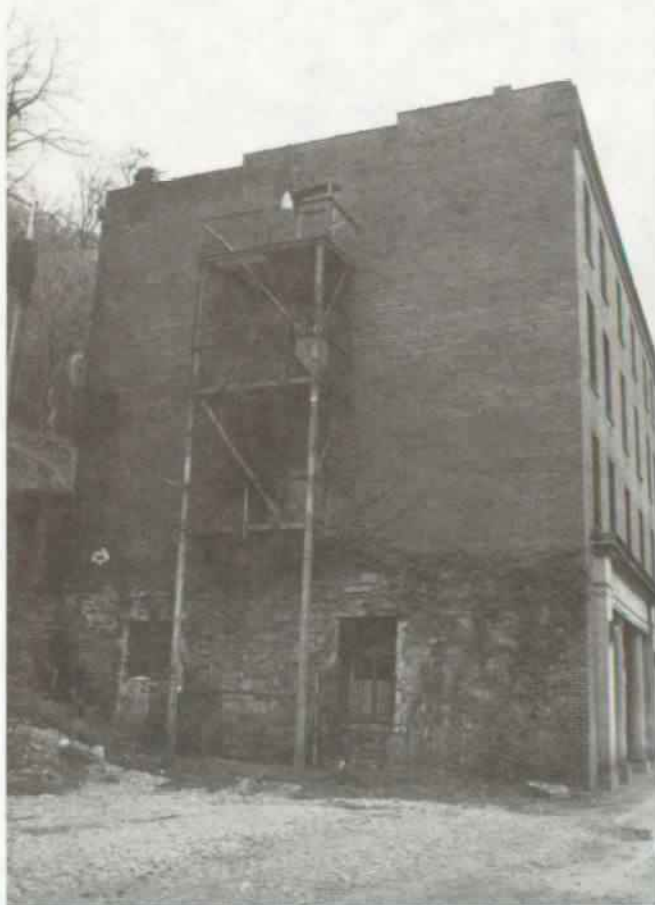
The north elevation (figure 69) of the building is very plain. At the second, third, and fourth floors, a single window is centered in the middle of the wall. These windows are metal with emergency exit doors. All three windows appear to be nonoriginal installations into original openings. The heads of the third and fourth are arched, while the second-floor window is spanned by a steel lintel. Two windows, both with iron security grills, are located at the first floor. The window to the east is a later sash installed in a larger, original masonry opening.

**Figure 69**  
North Elevation, National Bank of Thurmond,  
April 1991  
(NPS Photo)

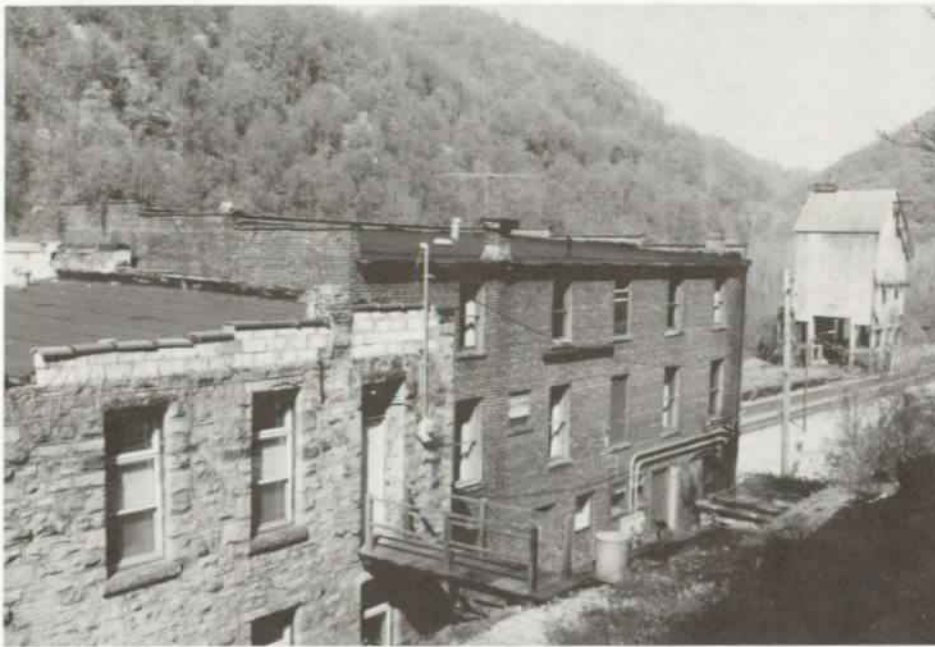
The east elevation (figure 70) is brick on the top three floors. The first floor is stone and is below grade on this side of the structure. At the far south end of the building are two original window openings at the landings of the interior stairs. The upper window is the original one-over-one double hung typical of the building, while the lower opening has been converted to a very short door. This door fits within the original, unmodified opening with room for a small fixed pane of glass above it. The door was evidently installed as an emergency exit, and it opens onto a deteriorating wooden bridge to grade. There are five double-hung windows on each of the third and fourth floors. An additional small, high window toward the southern end of the third floor is boarded over. Six double-hung windows are found at the second floor, with the two northernmost windows grouped together under a single brick arch. The remaining windows in this elevation are headed by steel lintels. Two small, high windows are located in the central portion of the second floor. Their tops are covered with masonite and have a bathroom vent at each masonite panel. On each floor, the third double-hung window from the north is boarded over to accommodate interior bathroom functions. The fourth-floor window is not completely boarded over and has a small window at the very top of the opening. A number of large electrical panels and meters are located at this elevation, with large conduits running between them. At the top of the east wall, roof-joist ends extend beyond the wall and are exposed to view. Wood blocking between the joists is located in the same plane as the masonry wall and is also exposed to view.

**Figure 70**  
East Elevation, National Bank of Thurmond, April 1991  
(NPS Photo)

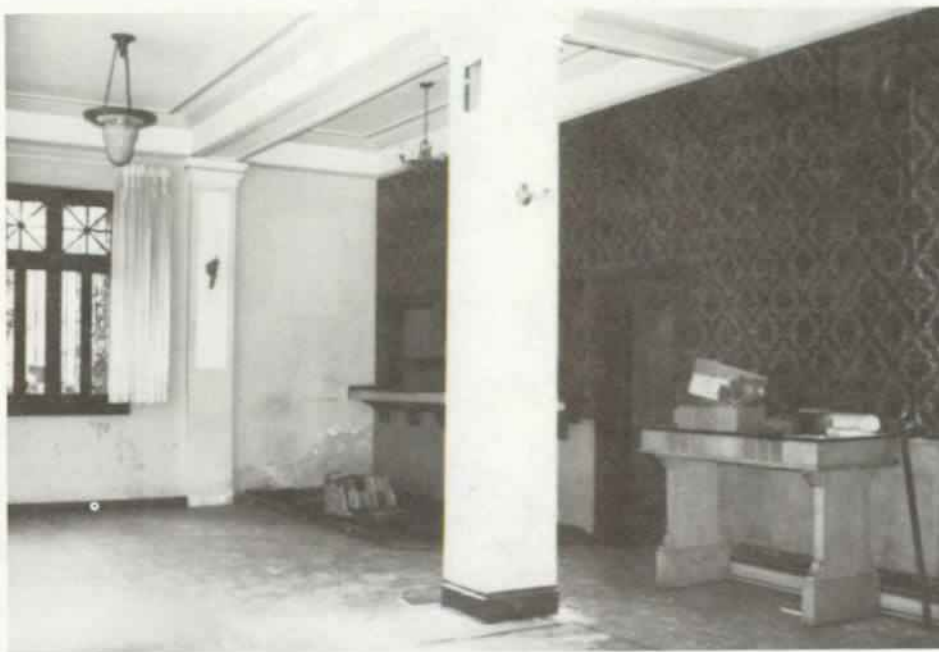
The marble check-writing stand now sits along the east wall (figure 71), just to the south of door 109. At some point, the tellers' area was moved from the banking hall to rooms 103 and 104. To accommodate this move, the existing tellers' windows were cut into the east wall of room 101. When the space was later converted for the Banker's Club, a padded edge was added to the counter at the tellers' windows, and a raised wooden platform covered in black shag carpeting was installed on the floor in front of the tellers' windows. The Banker's Club used this counter as a bar.

**Figure 71**  
 Northeast Corner, Room 101, National Bank of Thurmond, August  
 1990  
 (NPS Photo)

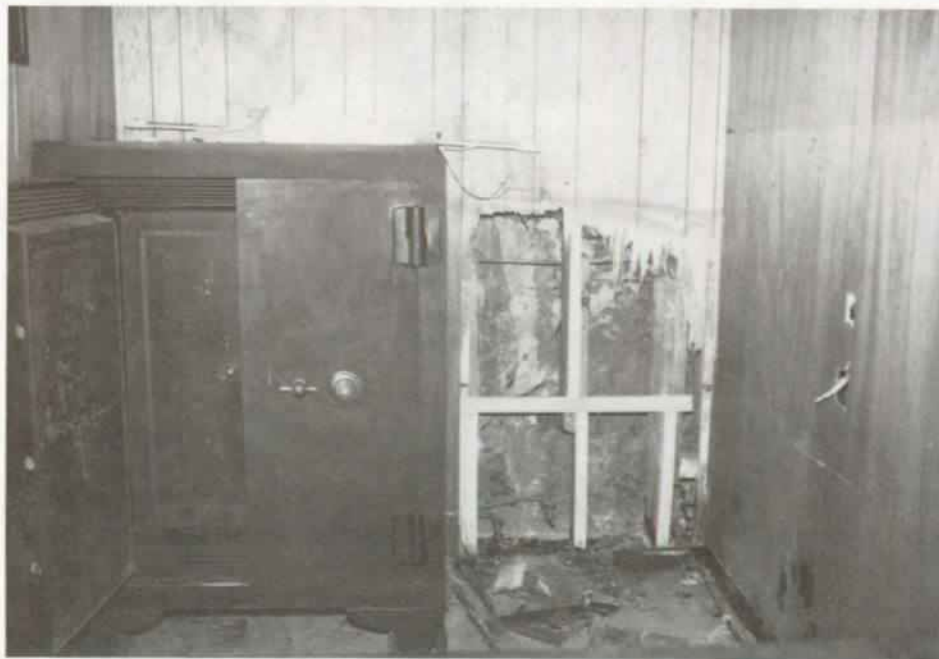
**Room 103.** Used as a teller's cage and office during the latter part of the National Bank of Thurmond's tenancy in the building, this room still contains a large safe from those days (figure 73). The safe is on wheels but is too large to be moved easily or to fit through doorways. The floor of the room is finished in 12" square linoleum tile. Much of the floor is stained, and some areas are scratched or gouged. There is no baseboard except for 4" vinyl cove at the south wall and about a third of the east wall. The walls are paneled, with water stains and possible decay along the bottom, especially at the north wall. In the southeast corner of the room, a section of paneling was removed during the winter of 1991 to expose the condition of the eastern stone wall, which is parged and in good condition.

**Figure 73**  
East End of Room 103, National Bank of Thurmond, April 1991  
(NPS Photo)

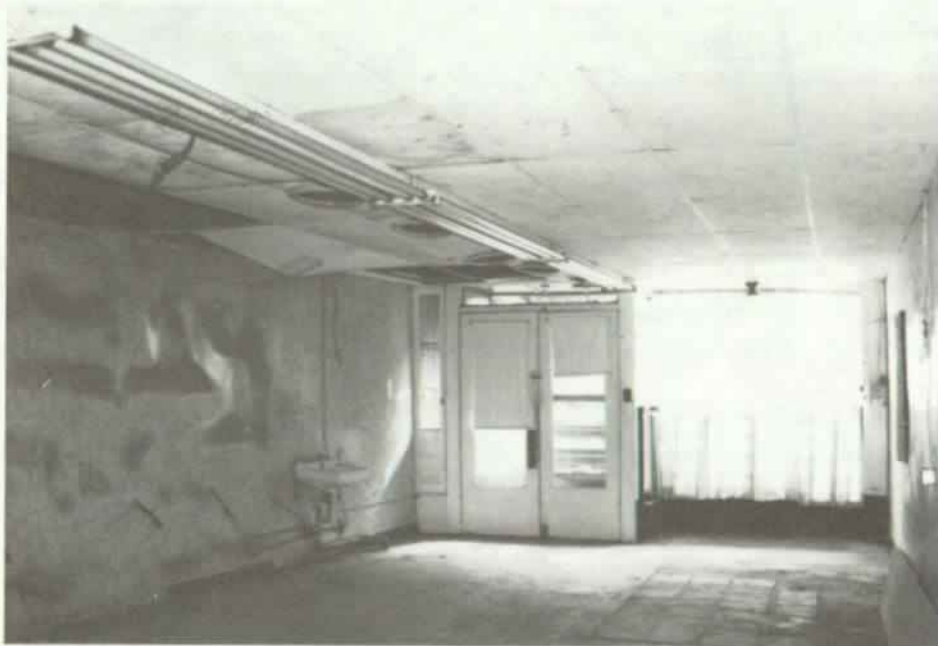
**Room 111.** This room served as the kitchen for the Banker's Club, and two sinks and some cabinets on the south wall remain (figure 74). The floor is of 1" white hexagonal tile with a blue Greek key border design in 3/4"-square tile around the perimeter of the room. Along the north wall, the border pattern turns into the room, outlining the location of an original counter from the days when this space had a mercantile function (figure 75). The border placement also suggests that a counter may have been located at the west window and perhaps used as a display surface. The tile is generally in good condition, although in a few areas tile is stained or missing. The floor at the display window and original counter is concrete. At the original counter, the floor is covered with 12"-square linoleum tile that is

**Figure 74**  
West End of Room 111, National Bank of Thurmond, August 1990  
(NPS Photo)

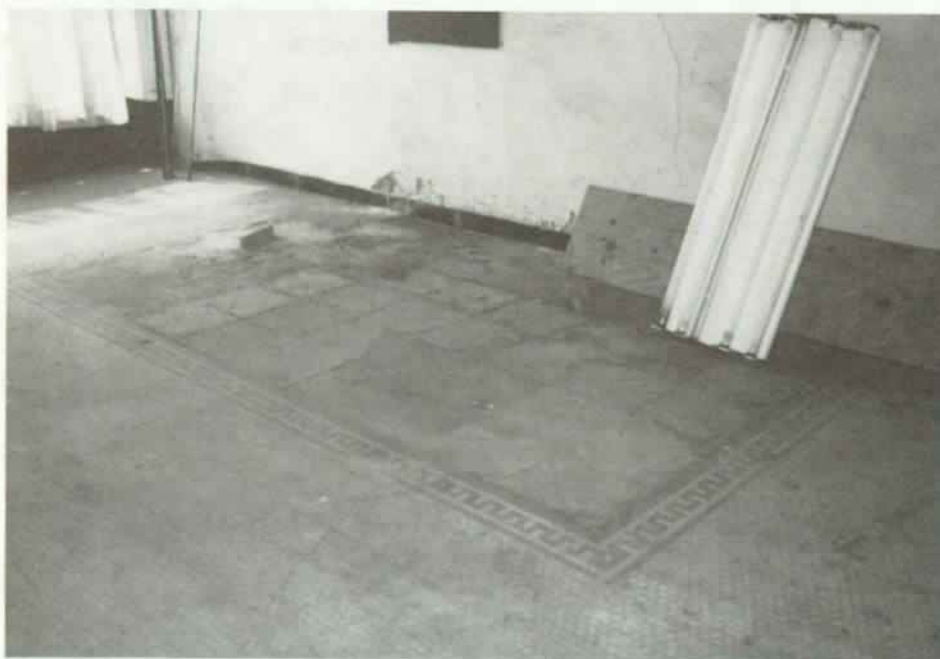
**Figure 75**  
Tile at North Wall, Room 111, National Bank of Thurmond, April 1991  
(NPS Photo)

loose, warped, and generally in poor condition. Four-inch vinyl cove molding serves as a base but much is loose, missing, or in poor condition.

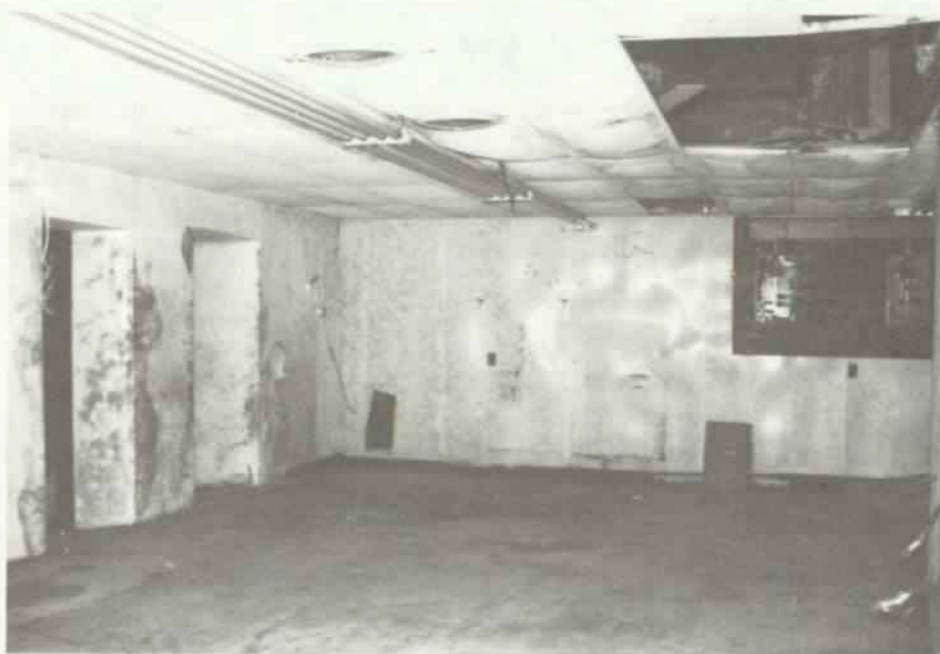
The north wall is finished in plaster. The plaster is rough in areas, with moisture damage along the bottom of the wall and significant amounts of mold growing on the eastern third of the wall (figure 76). The south and east walls are finished with plastic laminate on wood framing installed over the original wall surfaces. The laminate is white with a gold abstract pattern, is bucked from moisture, and has some areas of mold growth. In two areas where the studs behind the laminate can be seen, the bottoms of the studs are decayed. In the winter of 1991 some laminate was removed from the east wall. The studs were in poor condition, but the stone wall was in good condition. The west wall is formed by the entry doors and display windows (figure 74).

**Figure 76**  
East End of Room 111, National Bank of Thurmond, August 1990  
(NPS Photo)

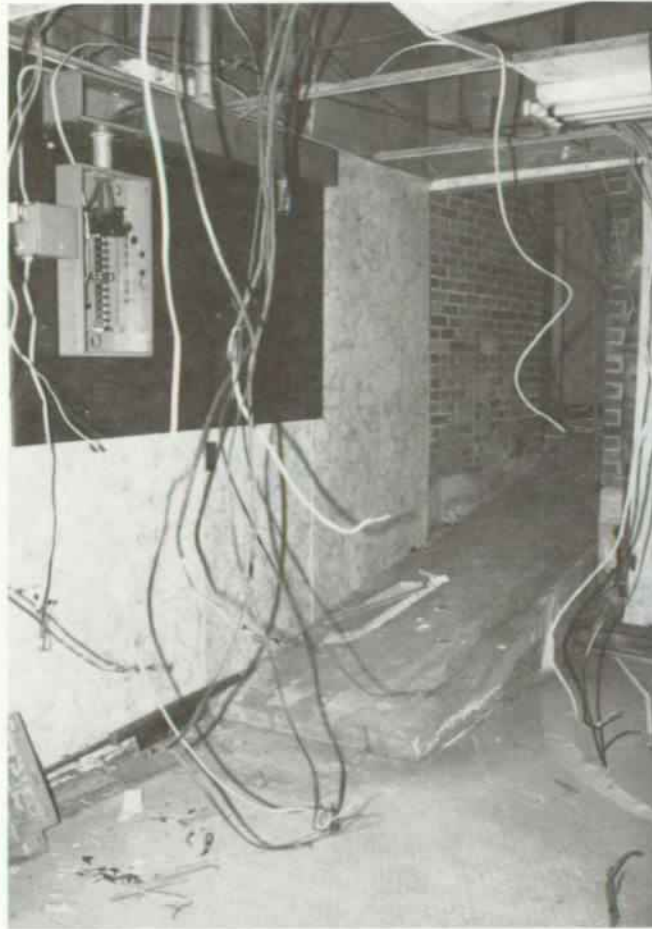
A concrete ramp up into the Goodman-Kincaid Building extends into the southeast corner of the room (figure 77). It was added after 1975, when the first floor of the Goodman-Kincaid Building was renovated for an additional Banker's Club dining room.

**Figure 77**  
Southeast Corner, Room 111, National Bank of  
Thurmond, April 1991  
(NPS Photo)

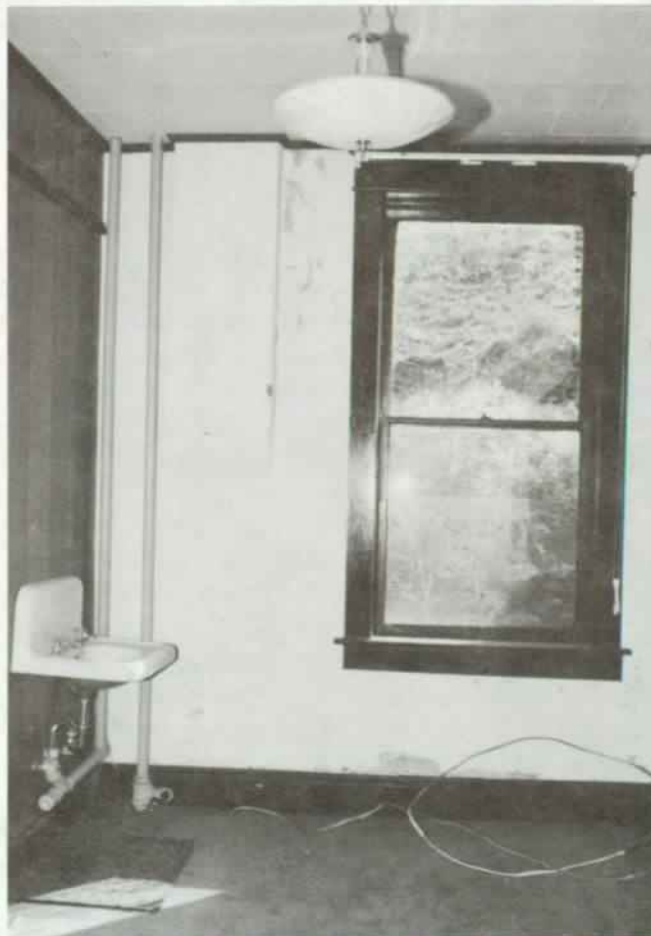
**Rooms 211 and 212.** While these rooms were included in the general description of the hotel rooms, they are worth mentioning again because they are the only upper floor rooms besides room 210 in which the original woodwork finish is not painted over. The original finish is a medium-tone grained finish, with a coat of dark varnish applied over it at a later date. Also, the sink in the northeast corner of room 211 (figure 79) is of an appropriate style to be original to the building.

**Figure 79**  
Northeast Corner, Room 211, National Bank of  
Thurmond, April 1991  
(NPS Photo)

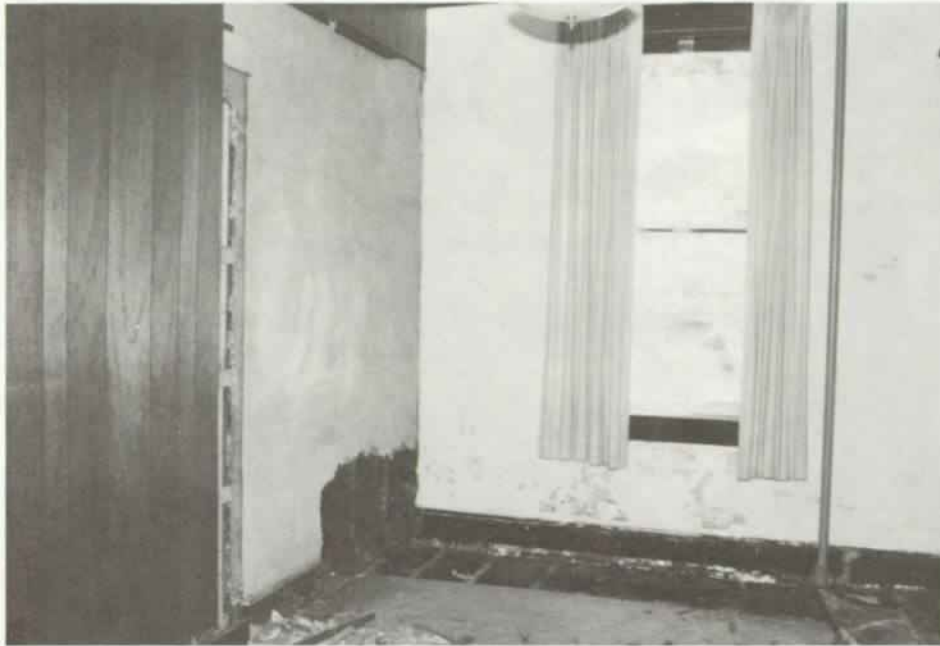
**Figure 80**

During the destructive investigation that took place in the winter of 1991, the carpet and flooring were removed from the east end of room 212 to expose the floor framing. Lath, plaster, and paneling at the bottoms of the interior walls in the northeast and southeast corners of the room were also removed. The studs thus exposed are in good condition. Removing the paneling also exposed the ghost of an original door opening on the north wall (figure 80).

Northeast Corner, Room 212, National Bank of Thurmond, April 1991  
(NPS Photo)

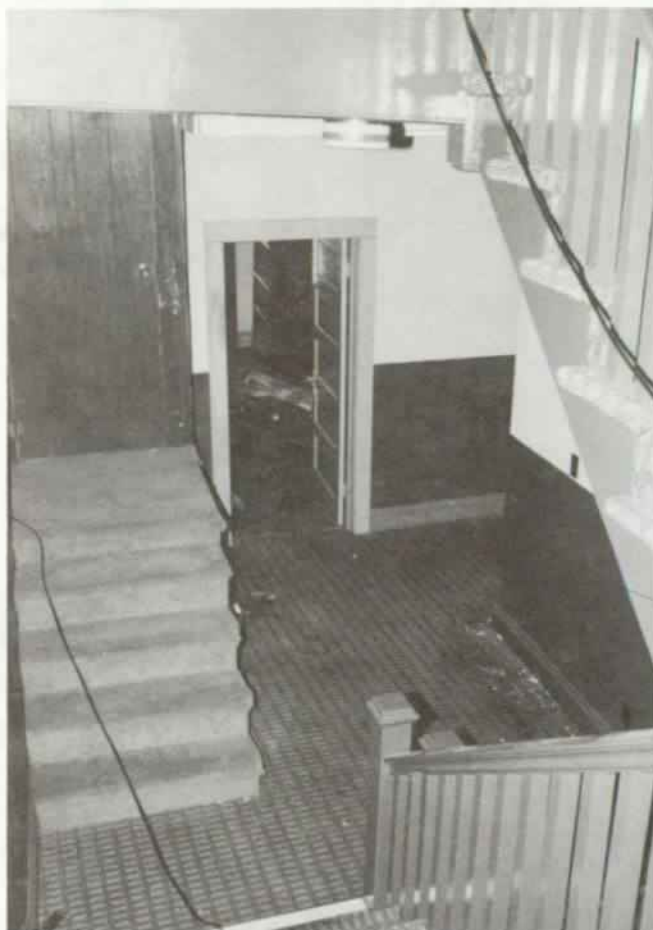
**Figure 82**  
South End of Hall 307, National Bank of  
Thurmond, April 1990  
(NPS Photo)

**Room 307.** Like that at the second floor, this hallway has plastered walls, painted white with a brown wainscot. However, the plaster here is textured in a brush-stroke pattern, not in a swirl pattern. It is not clear whether this texture is in the plaster or the paint. The vertical crack in the north wall of the building continues adjacent to the north window, and some other minor cracking occurs at the west wall. The plaster above door 310 is in poor condition. The floor is carpeted, and the baseboard is the typical wooden baseboard. The baseboard at the north wall is damaged. The ceiling at the main part of the hall is of 2' x 4' suspended acoustical panels, while the ceiling near the stairway is of plaster, painted white. At the south end of the hall is a set of steps and a platform that accesses a door into the third floor of the Goodman-Kincaid Building (figure 82). The steps and platform are carpeted, and a small closet is constructed on the west end of the platform. The closet exterior is of unfinished gypsum board. The platform is enclosed underneath with a set of cabinet doors, creating a storage area.

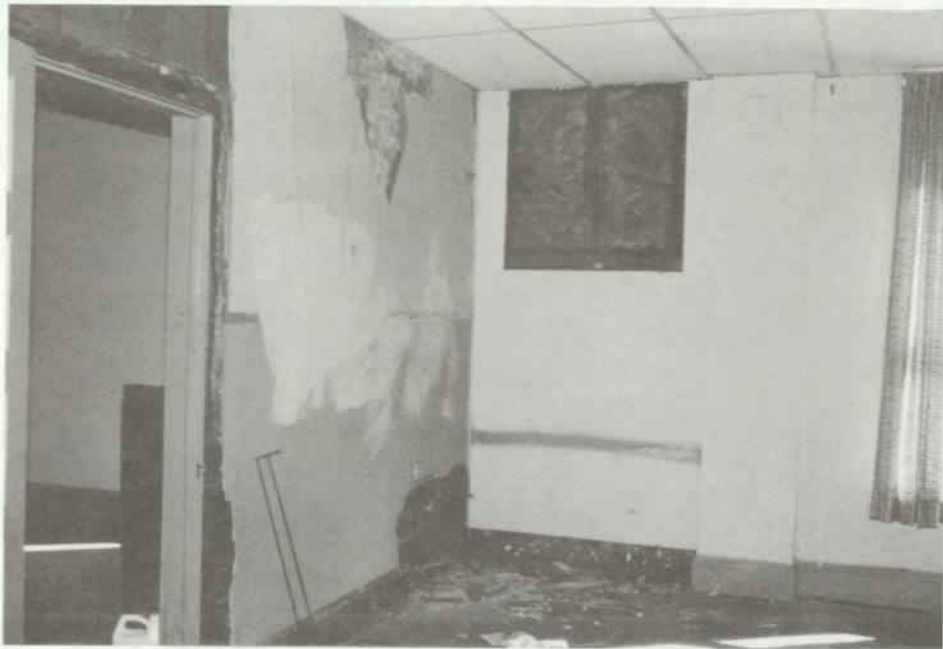
**Figure 83**  
Northeast Corner, Room 308, National Bank of Thurmond, April 1991  
(NPS Photo)

**Room 308.** During the winter of 1991, all carpeting was removed in this room. In the northeast corner, the flooring was removed to expose the floor framing, and lath and plaster were removed from the bottom of the interior wall to expose the wall framing. The studs were found to be in good condition. The wood panel covering the small window in the northeast corner was also removed (figure 83).

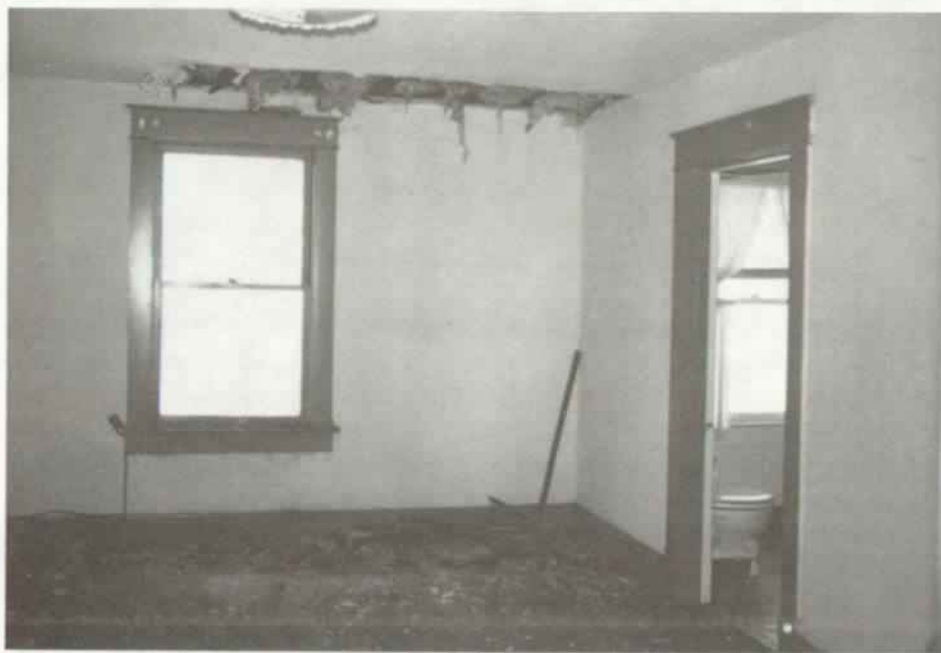
**Figure 85**  
Northwest Corner, Room 404, National Bank of Thurmond, April 1991  
(NPS Photo)

**Room 404.** This is perhaps the one hotel room that most closely retains its original finishes and character. The only changes that seem to have been made are the installation of carpeting, the painting of the woodwork, and the replacement of the original plaster ceiling with gypsum board. During the winter of 1991, a portion of the ceiling in the northwest corner of the room was removed to expose the ceiling joists (figure 85).

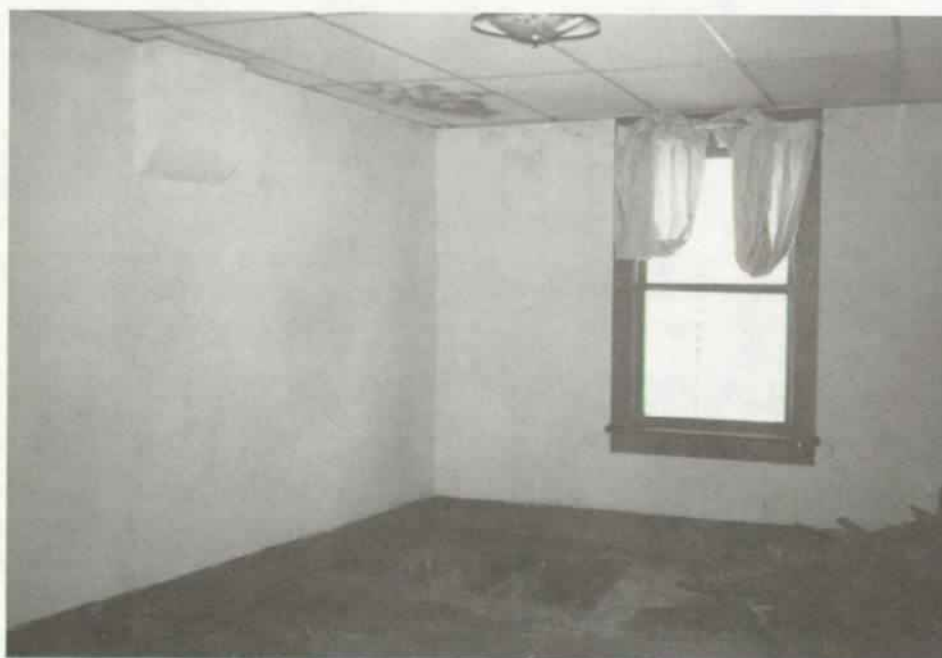
**Figure 86**  
Southwest Corner, Room 407, National Bank of Thurmond, April 1991  
(NPS Photo)

**Room 407.** The basic finishes of this room are described above. There is a 3' section of different baseboard to the south of door 408. Also, the floor slopes downward noticeably from the southeast corner toward the northwest. In the winter of 1991, a section of carpeting and flooring in the northwest corner of the room was removed to expose the floor framing (figure 86).

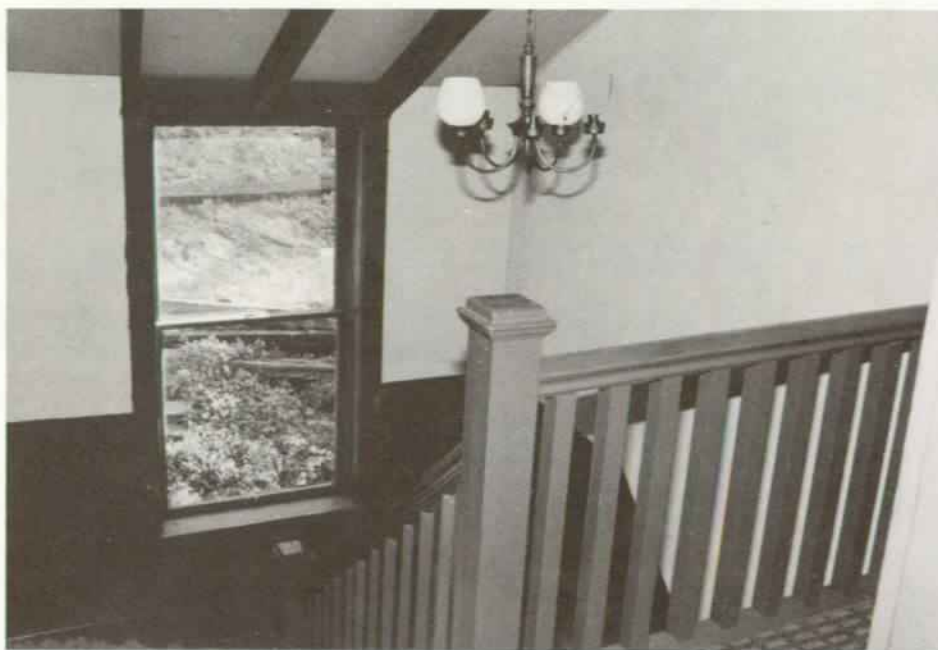
**Figure 88**  
Stair 410, National Bank of Thurmond, April 1991  
(NPS Photo)

**Room 410.** Much of this space is finished like the lower flights of stairs. The floor is carpeted, and the north, south, and east walls are plastered with a painted wainscot. The west wall is paneled, and at least the door portion of the wall was installed to comply with fire codes. The ceiling is finished with unfinished gypsum board between unfinished 3 x 6 beams, creating something of a Tudor look (figure 88). The flat ceiling at the upper landing is composed of 2 x 4 acoustical panels. The original plaster ceiling was undoubtedly flat.

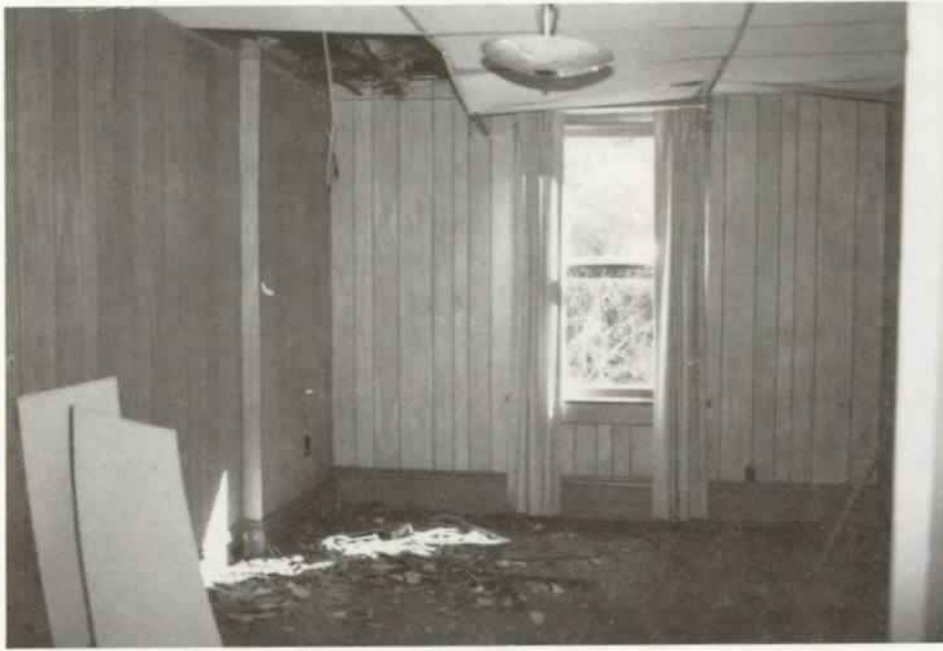
**Figure 89**  
Northeast Corner, Room 418, National Bank of Thurmond, April 1991  
(NPS Photo)

plain board covers the gap between the bottom of the higher base and the floor. All of the paneling in room 418 is light in color, quite unlike the paneling found throughout the rest of the building (figure 89).

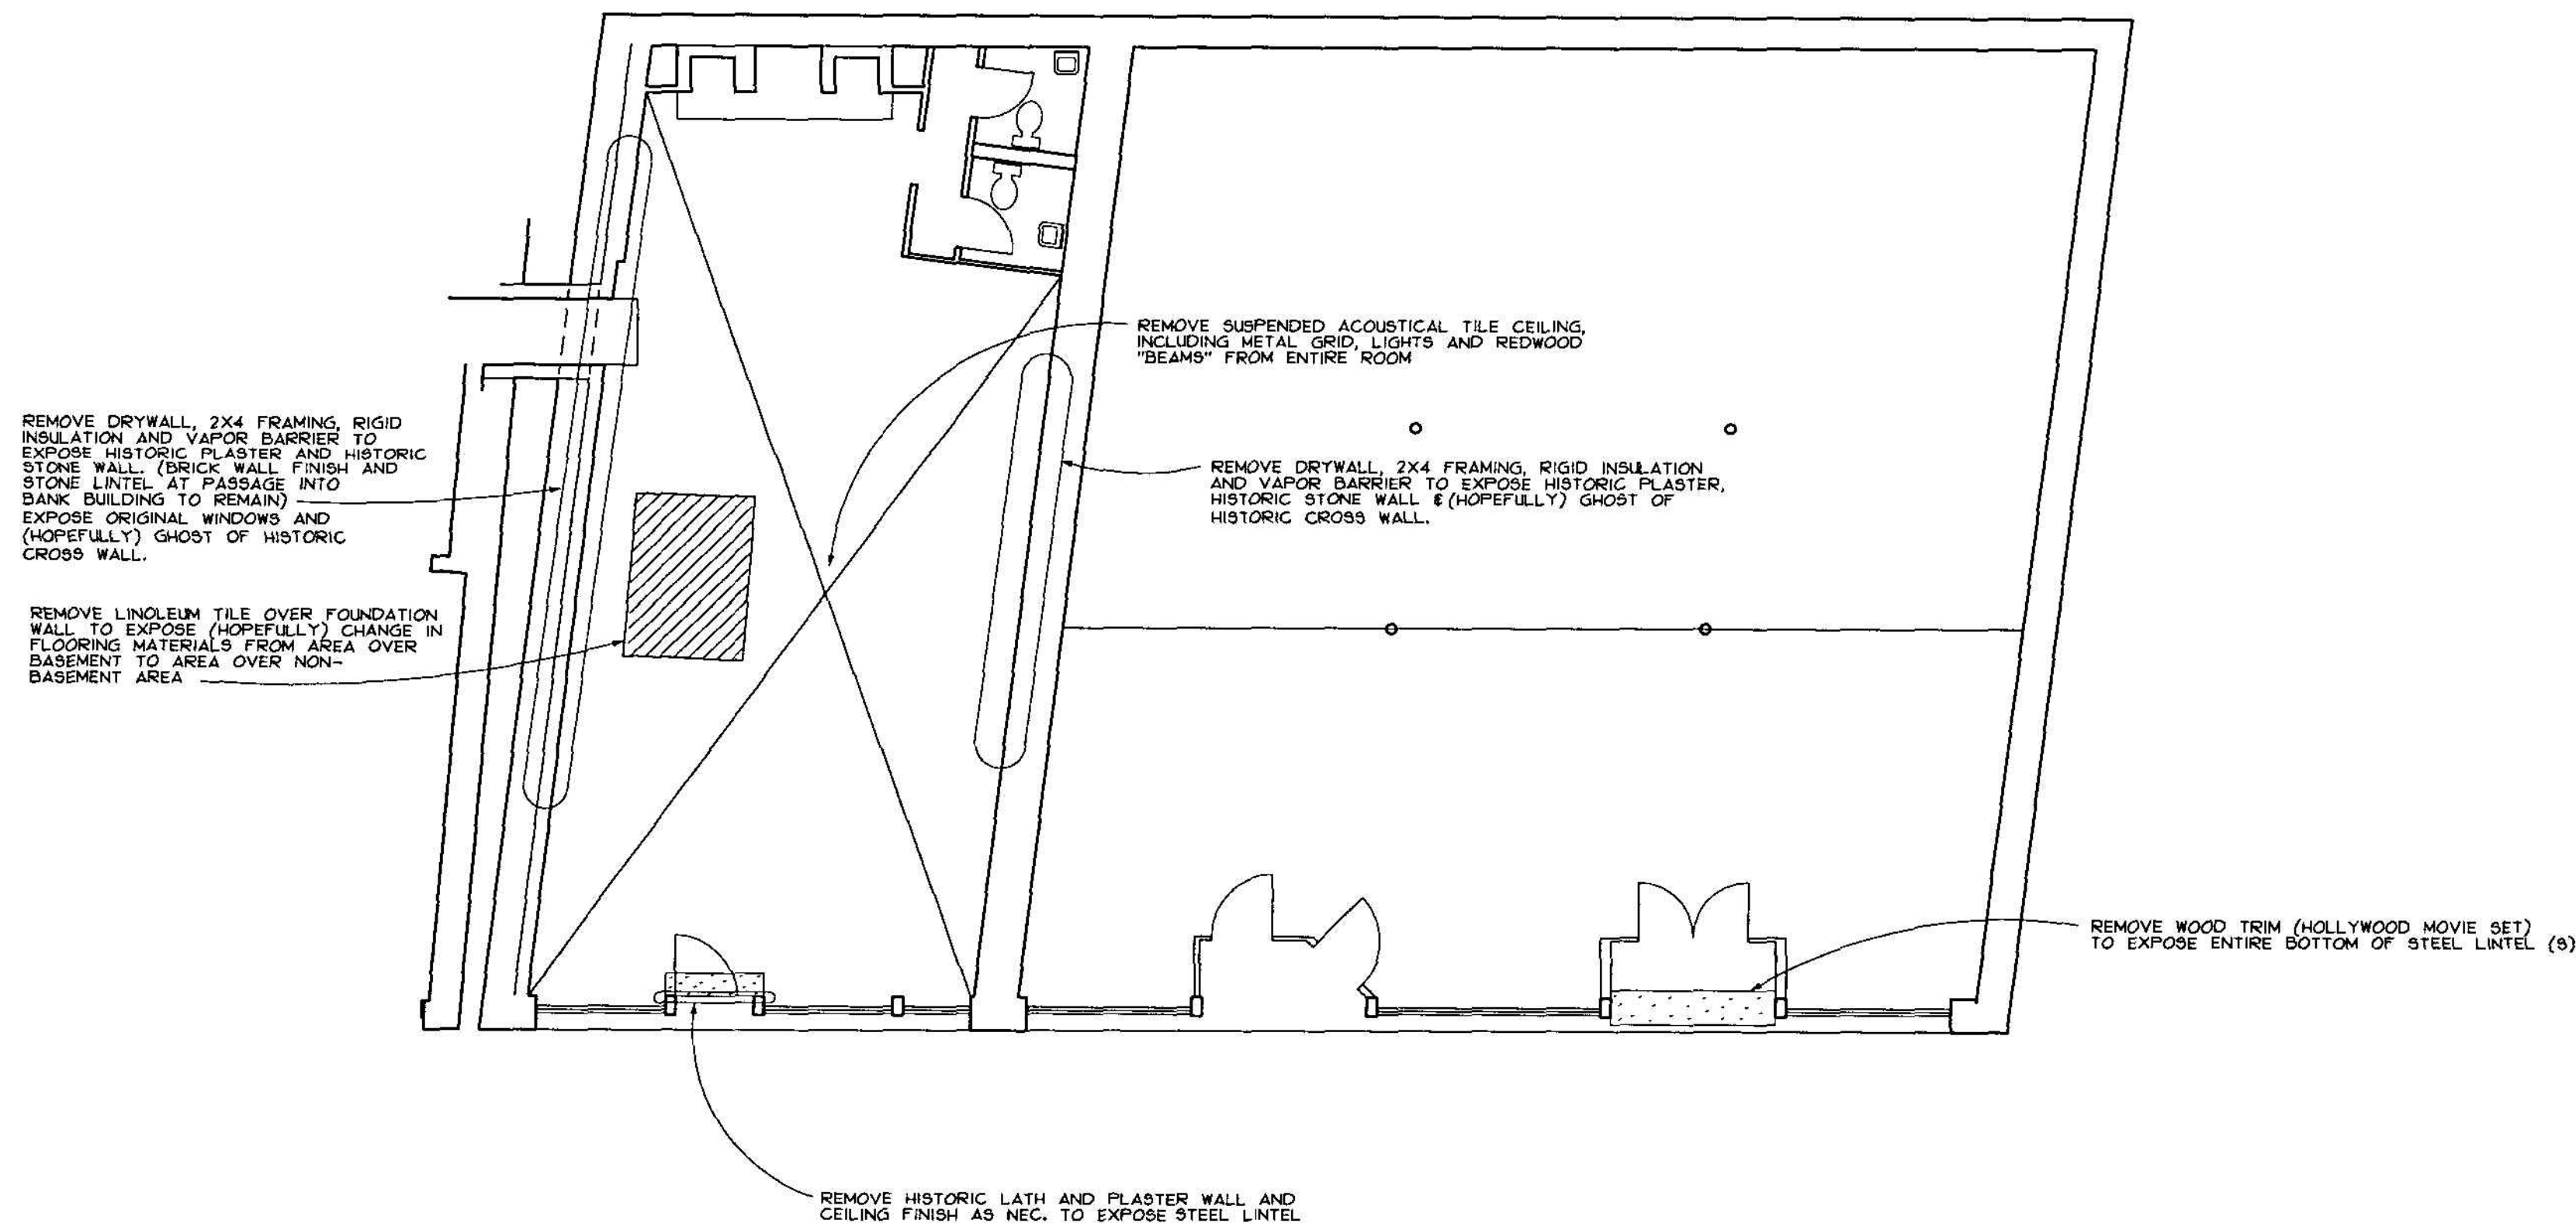
FIRST FLOOR PLAN - EXISTING CONDITIONS

REMOVE 2'-0" X 2'-0"  
SECTION OF PLYWOOD  
TO EXPOSE STEEL BEAM  
LOCATION
