**OREGON CAVES CHATEAU  
OREGON CAVES NATIONAL MONUMENT  
CAVE JUNCTION, OREGON**

**CHATEAU ACCESSIBILITY  
AND SAFETY STUDY**

**PREPARED BY  
ARCHITECTURAL RESOURCES GROUP**

**JUNE 2006**

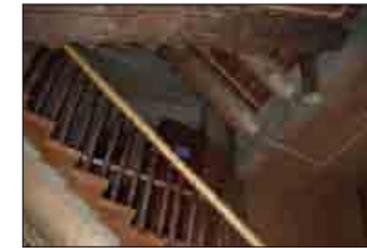
**Figure 4.7:** Open Main Stairway from First Basement to First Floor and First Floor to Second Floor

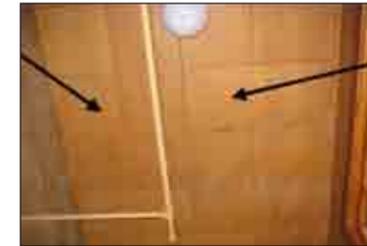
**Figure 4.8:** Gaps at Ceiling Fiberboard Panels (Typical Throughout at First Basement through Third Floor)

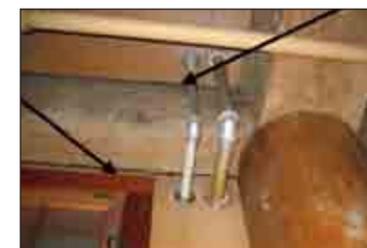
**Figure 4.11:** Ceiling and Wall Gaps (Typical) Throughout

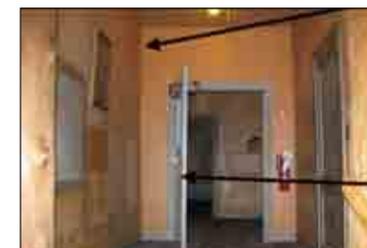
**Figure 4.12:** Fire Door to Guest Wing at First Floor held open, Non-fire rated wall

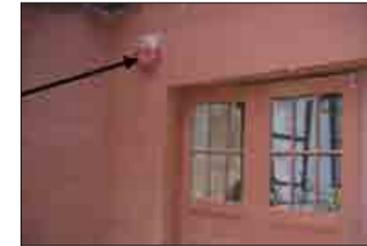
- The water level in the tank is not monitored and therefore the exact quantity of water at a given period may not be known. It is possible to estimate the depth of water in the tank by viewing the supply pressure gauge at the main sprinkler valve but this may not give an accurate reading.

**Figure 4.19:** Sprinkler Water Motor Gong (Note: This is the only sprinkler activation alarm.)

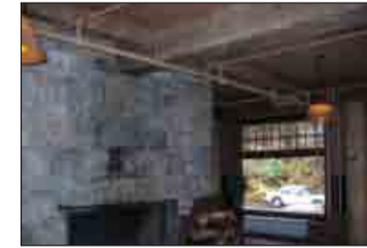
**Figure 5.2:** Exposed Sprinkler Piping in Main Lobby

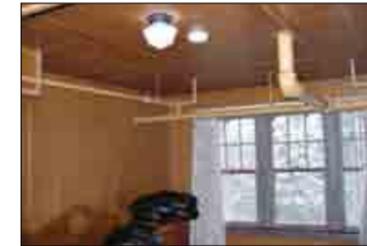
**Figure 5.3:** Exposed Sprinkler Piping in Guest Room

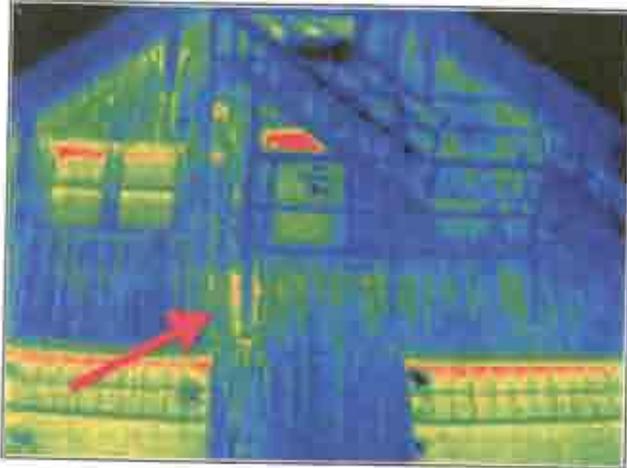
**IR Image File:** fncr0068.sit

<b>Inspection #</b> 1	<b>Problem #</b> 1
<b>Problem Date/Time:</b> 12/2/2004 10:18:30 AM	
<b>Indirect Temp. Measure:</b> No	
<b>Component Temp:</b> 30 @ N/A	
<b>Reference Temp:</b> 24 @ N/A	
<b>Temp Rise:</b> 6 @ N/A

**Component:** Small temp difference around north 2nd floor mounting bracket of fire escape, possible moisture problem or other anomaly.  
**Probable Cause:** Possible moisture or other anomaly

**Recommendation:** Investigate

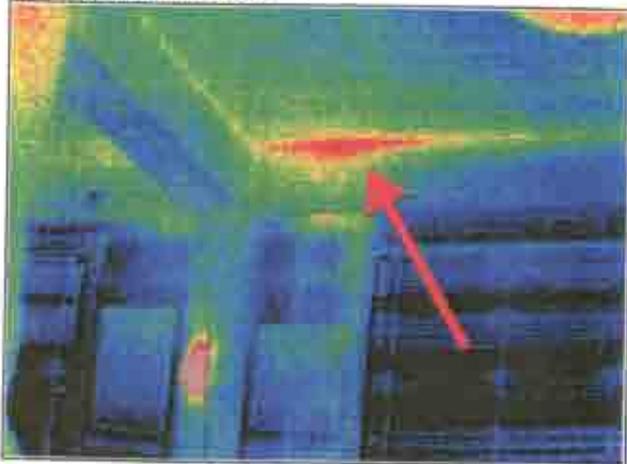
**IR Image File:** fhcr0076.sit

<b>Inspection #</b> 1	<b>Problem #</b> 2
<b>Problem Date/Time:</b> 12/2/2004 10:21:09 AM	
<b>Indirect Temp. Measurement:</b> No	
<b>Component Temp:</b> 20 @ N/A	
<b>Reference Temp:</b> 20 @ N/A	
<b>Temp Rise:</b> 0 @ N/A

**Probable Cause:** Possibly moisture or other anomalies

**Recommendation:** Investigate

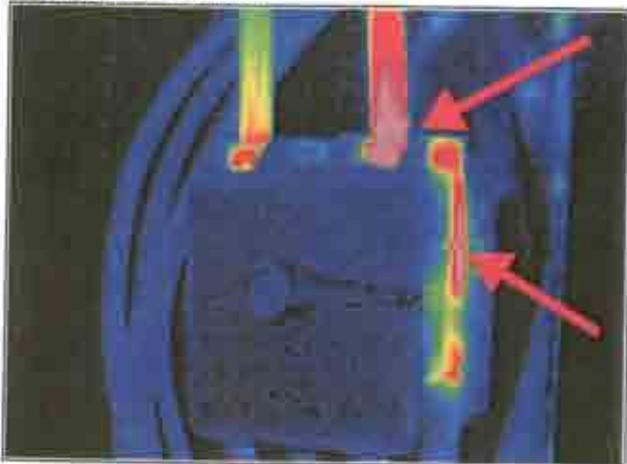
**IR Image File:** flcr0080.sit

<b>Inspection # 1</b>	<b>Problem # 3</b>
<b>Problem Date/Time:</b> 12/2/2004 11:11:49 AM	
<b>Indirect Temp. Measurement:</b> No	
<b>Component Temp:</b> 106 @ 44%	
<b>Reference Temp:</b> 70 @ 46%	
<b>Temp Rise:</b> 36 @ 44%

**Probable Cause:** Loose corroded or internal problem

**Recommendation:** Clean inspect retorque or replace breaker if needed.

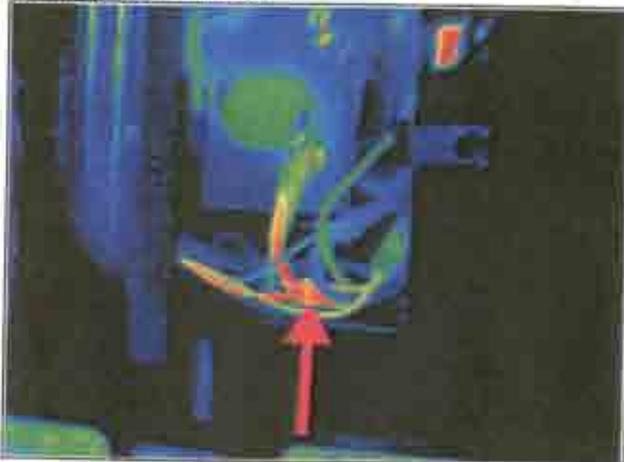
**IR Image File:** thr0083.bit

<b>Inspection #</b> 1	<b>Problem #</b> 4
<b>Problem Date/Time:</b> 12/2/2004 11:22:11 AM	
<b>Indirect Temp. Measureme:</b> No	
<b>Component Temp:</b> 89 @ N/A	
<b>Reference Temp:</b> 82 @ N/A	
<b>Temp Rise:</b> 7 @ N/A

**Probable Cause:** Loose or corroded wire nut

**Recommendation:** Clean inspect & replace wire nut.

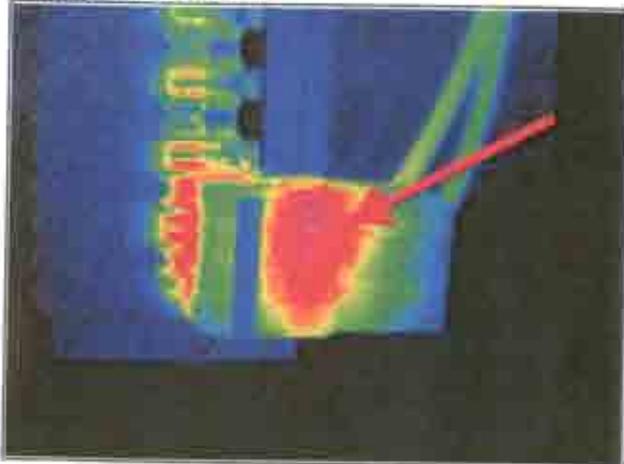
**IR Image File:** fhcr0090.sit

Inspection # 1	Problem # 5
Problem Date/Time 12/2/2004 11:45:53 AM	
Indirect Temp. Measureme Yes	
Component Temp: 97 @ 55%	
Reference Temp: 83 @ 54%	
Temp Rise: 14 @ 55%

**Probable Cause:** Internal problem

**Recommendation:** inspect, test breaker and replace if needed.

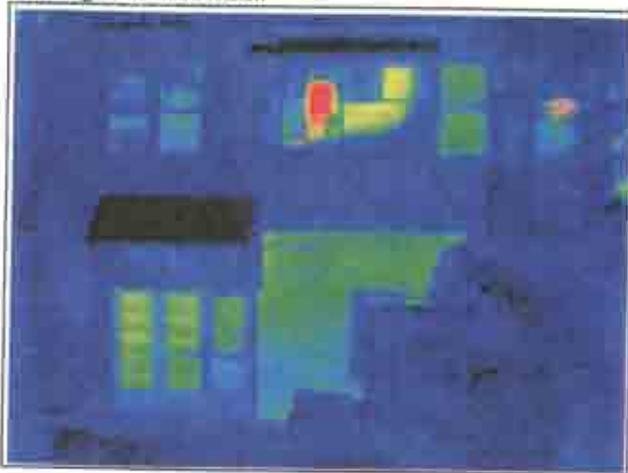
<b>Inspection #</b> 1	<b>Item #</b> 13
<b>Problem Date/Time:</b> 12/2/2004 10:04:37 AM	
<b>Indirect Temp. Measurement No:</b>	
<b>Component Temp:</b> 24 @ N/A	
<b>Reference Temp:</b> 24 @ N/A	
<b>Severity Code:</b> 0	
<b>Temp Rise:</b> 0 @ N/A

**Component:** South end lower shot

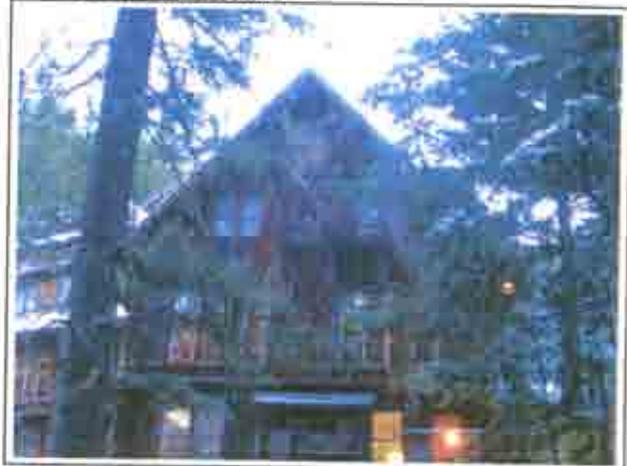
<b>Inspection #</b> 1	<b>Item #</b> 14
<b>Problem DateTime</b> 12/2/2004 10:04:37 AM	
<b>Indirect Temp. Measureme No.</b>	
<b>Component Temp:</b> 24 @ N/A	
<b>Reference Temp:</b> 24 @ N/A	
<b>Severity Code:</b> 0	
<b>Temp Rise:</b> 0 @ N/A

**Component:** South end upper shot

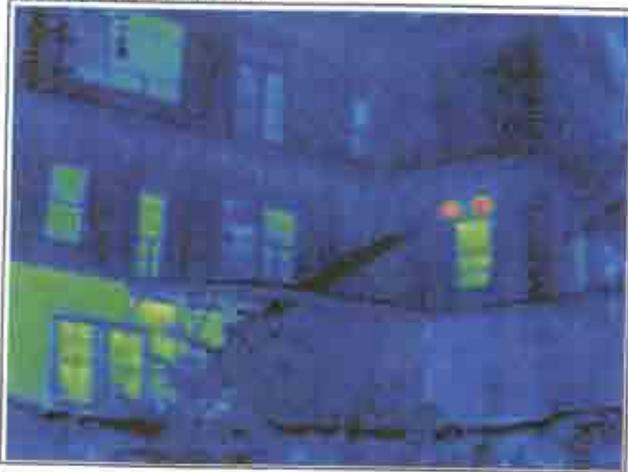
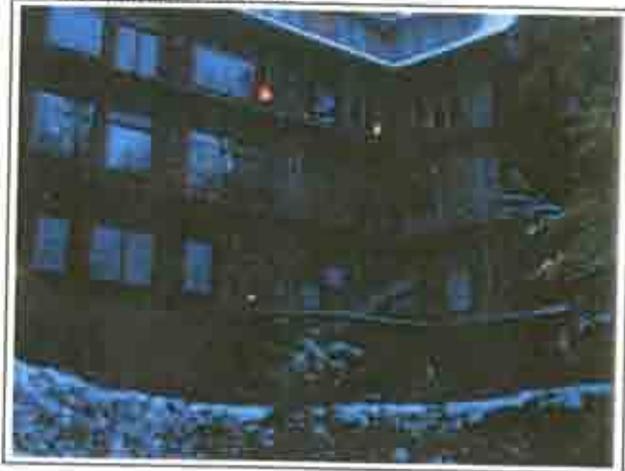
<b>Inspection #</b> 1	<b>Item #</b> 15
<b>Problem DateTime</b> 12/2/2004 10:04:38 AM	
<b>Indirect Temp. Measurement No</b>	
<b>Component Temp</b> 24 @ N/A	
<b>Reference Temp</b> 24 @ N/A	
<b>Severity Code</b> 0	
<b>Temp Rise</b> 0 @ N/A

**Component:** Center south lower shot

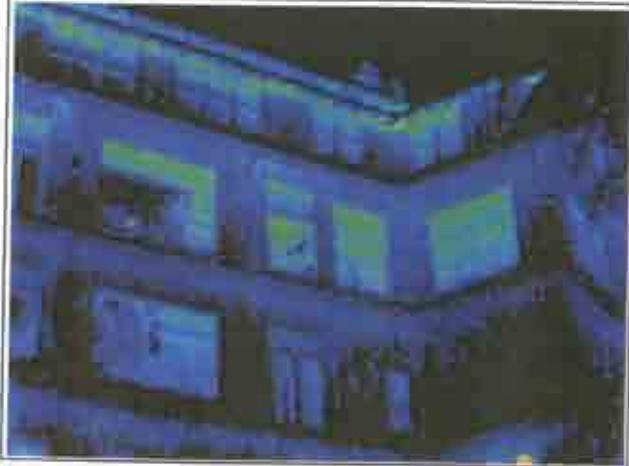
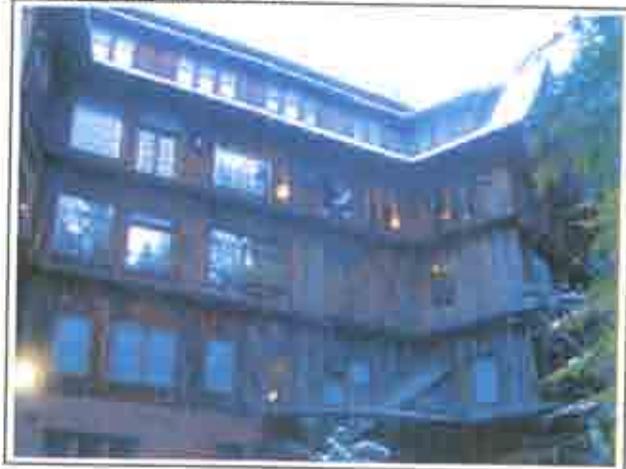
<b>Inspection #</b> 1	<b>Item #</b> 16
<b>Problem DateTime</b> 12/22/2004 10:04:39 AM	
<b>Indirect Temp. Measureme.</b> No	
<b>Component Temp</b> 24 @ N/A	
<b>Reference Temp</b> 24 @ N/A	
<b>Severity Code</b> 0	
<b>Temp Rise</b> 0 @ N/A

**Component:** Center south upper shot

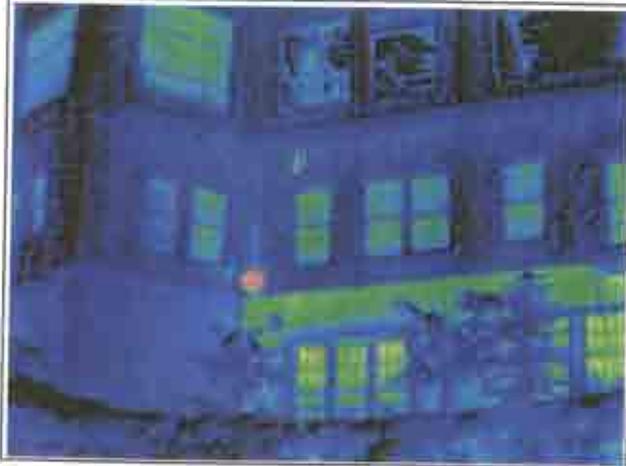
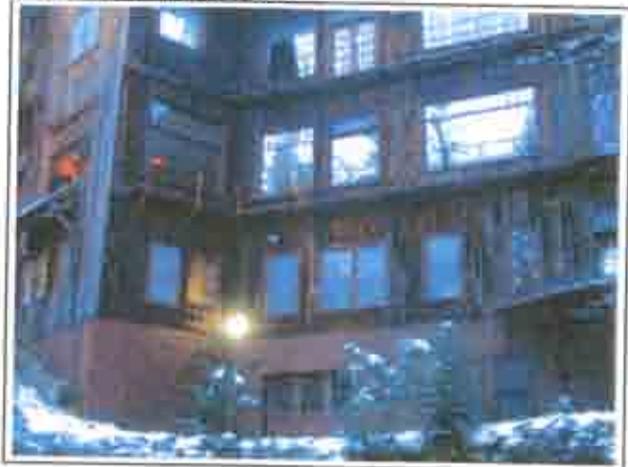
Inspection # 1	Item # 17
Problem Date/Time	12/2/2004 10:04:40 AM
Indirect Temp. Measurement	No
Component Temp	24 @ N/A
Reference Temp	24 @ N/A
Severity Code	0
<b>Temp Rise 0 @ N/A</b>

Component: Center north lower shot

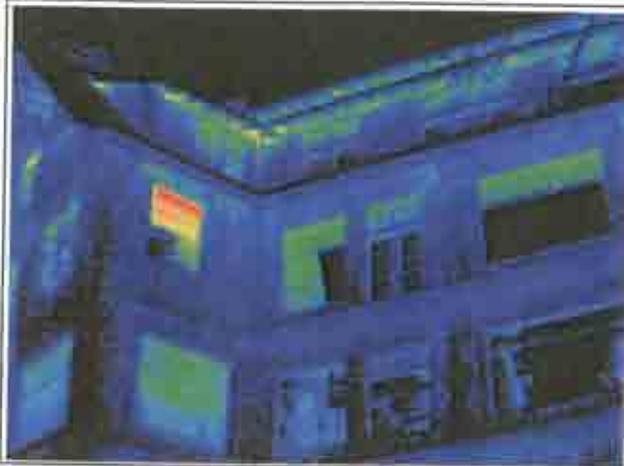
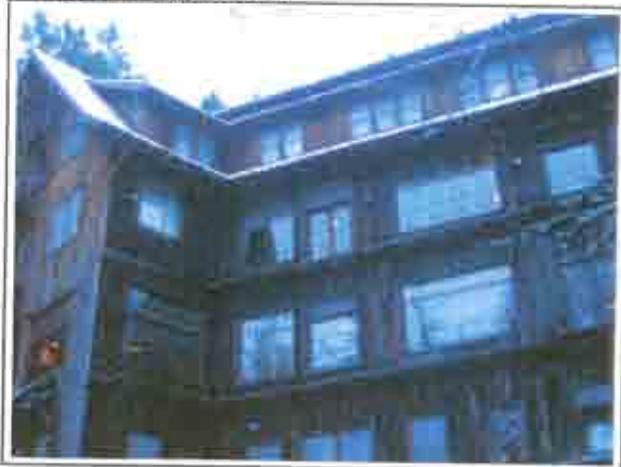
Inspection # 1	Item # 18
Problem DateTime	12/2/2004 10:04:42 AM
Indirect Temp. Measureme	No
Component Temp	24 @ N/A
Reference Temp	24 @ N/A
Severity Code	0
Temp Rise 0 @ N/A

Component: Center north upper shot.

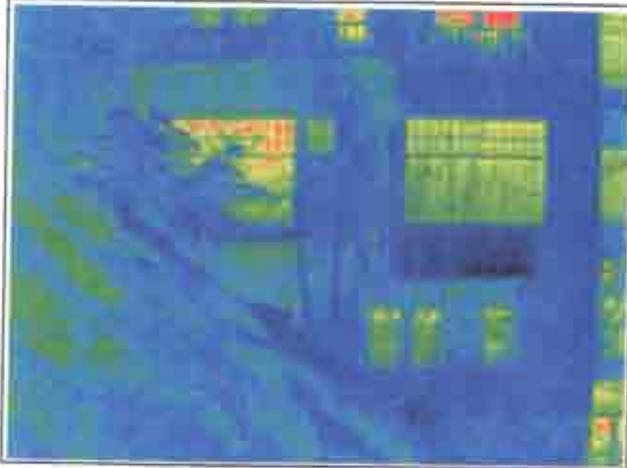
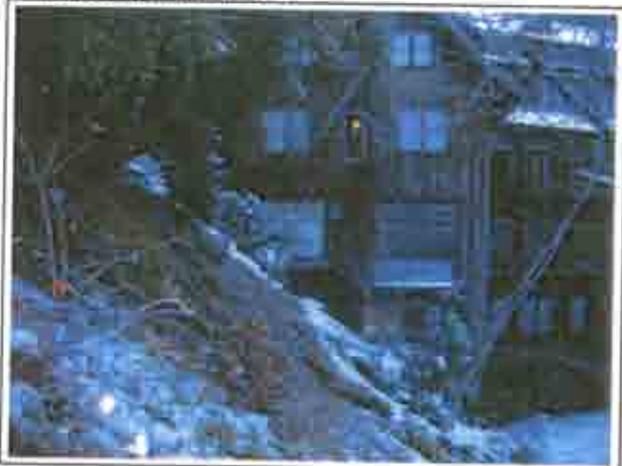
Inspection # 1	Item # 19
Problem Date/Time: 12/2/2004 10:08:30 AM	
Indirect Temp. Measurement No.	
Component Temp: 24 @ N/A	
Reference Temp: 24 @ N/A	
Severity Code 0	
Temp Rise 0 @ N/A

Component: North end lower shot

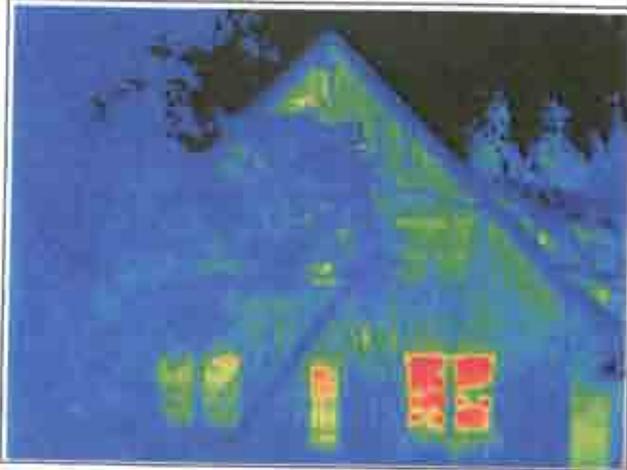
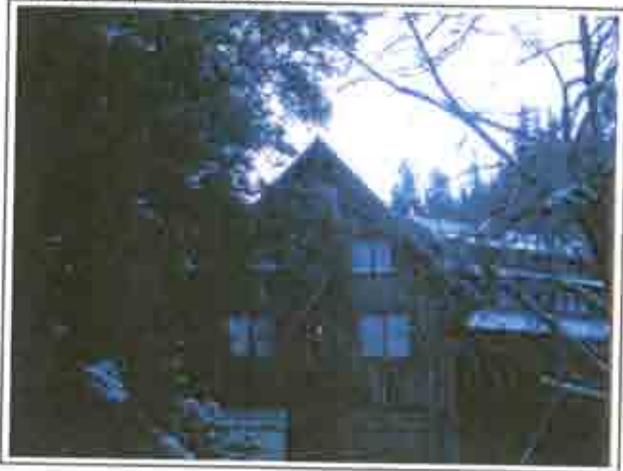
<b>Inspection #</b> 1	<b>Item #</b> 20
<b>Problem Date/Time</b> 12/2/2004 10:08:31 AM	
<b>Indirect Temp. Measurement</b> No	
<b>Component Temp</b> 24 @ N/A	
<b>Reference Temp</b> 24 @ N/A	
<b>Severity Code</b> 0	
<b>Temp Rise</b> 0 @ N/A

**Component:** North and upper shot

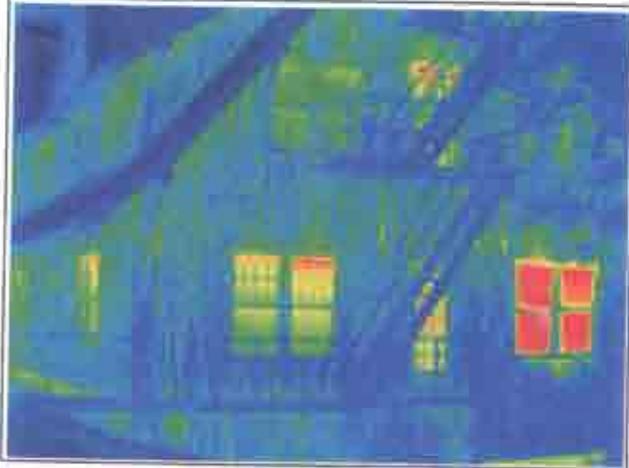
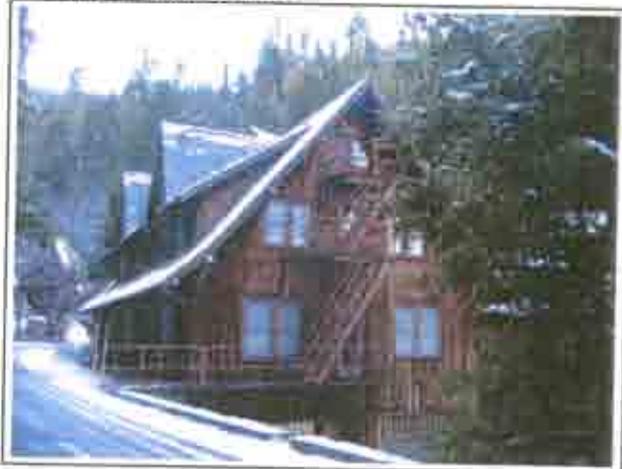
<b>Inspection #</b> 1	<b>Item #</b> 21
<b>Problem Date/Time</b> 12/2/2004 10:10:04 AM	
<b>Indirect Temp. Measurement No.</b>	
<b>Component Temp</b> 24 @ N/A	
<b>Reference Temp</b> 24 @ N/A	
<b>Severity Code</b> 0	
<b>Temp Rise</b> 0 @ N/A

**Component:** North end upper shot two

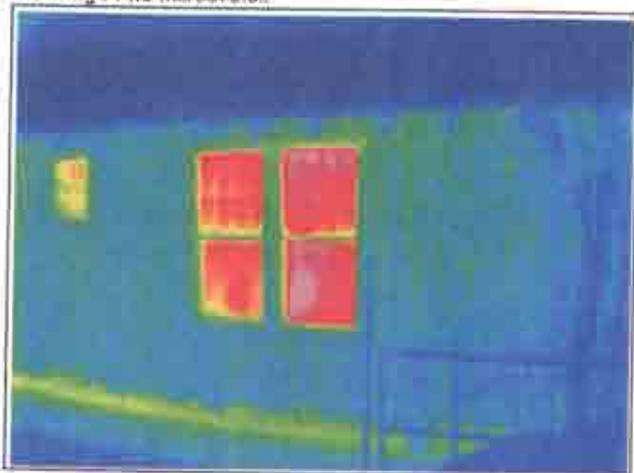
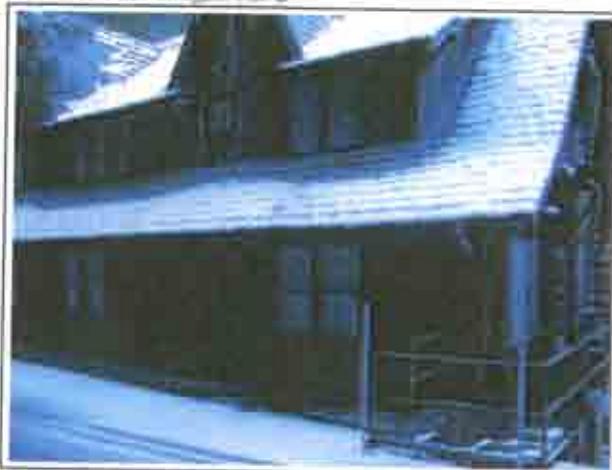
Inspection # 1	Item # 22
Problem Date/Time: 12/2/2004 10:10:57 AM	
Indirect Temp. Measurement: No	
Component Temp: 24 @ N/A	
Reference Temp: 24 @ N/A	
Severity Code: 0	
Temp Rise: 0 @ N/A

Component: West end lower shot (note west or north window)

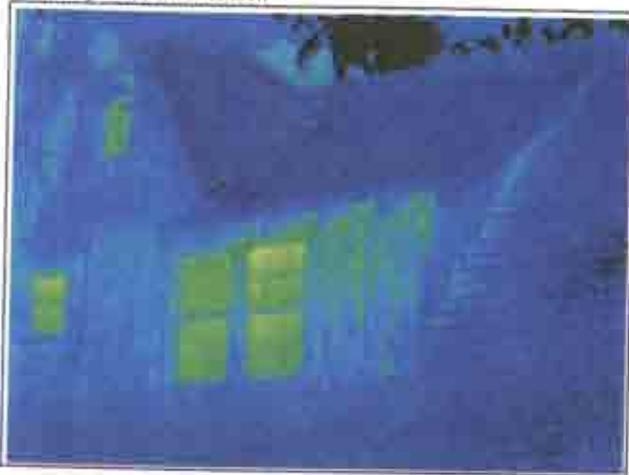
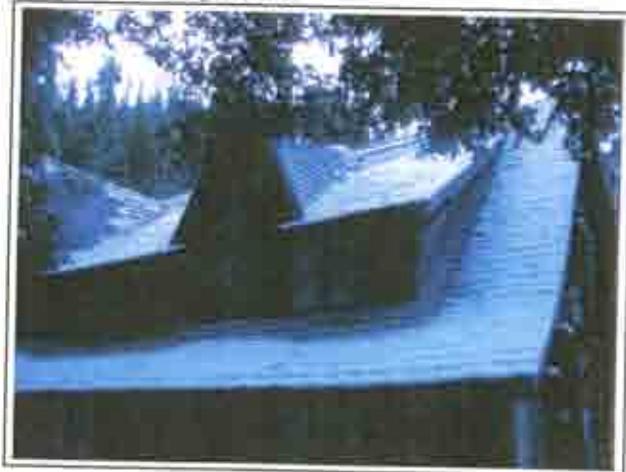
<b>Inspection #</b>	<b>Item #</b>
<b>Problem Date/Time</b>	12/2/2004 10:10:59 AM
<b>Indirect Temp. Measurement No.</b>	
<b>Component Temp</b>	24 @ N/A
<b>Reference Temp</b>	24 @ N/A
<b>Severity Code</b>	0
<b>Temp Rise</b> 0 @ N/A

**Component:** West end upper shot

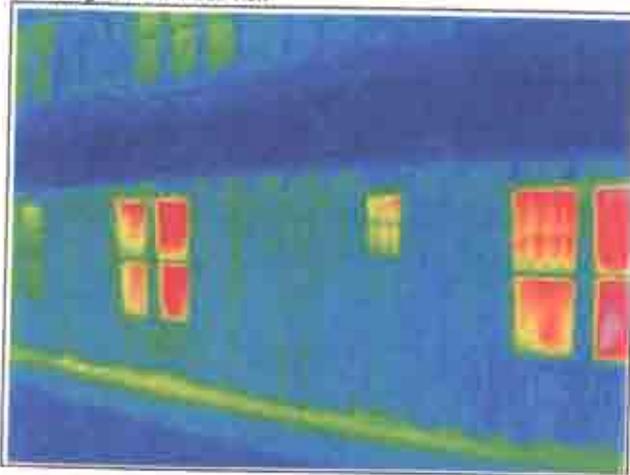
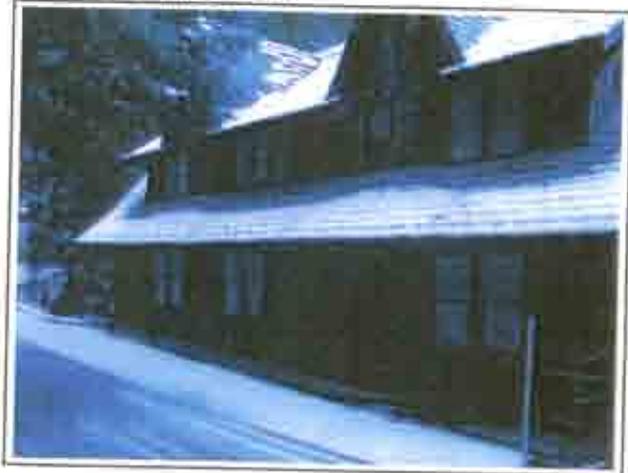
<b>Inspection #</b> 1	<b>Item #</b> 24
<b>Problem DateTime</b> 12/2/2004 10:11:00 AM	
<b>Indirect Temp. Measureme</b> No	
<b>Component Temp</b> 24 @ N/A	
<b>Reference Temp</b> 24 @ N/A	
<b>Severity Code</b> 0	
<b>Temp Rise</b> 0 @ N/A

**Component:** Center lower shot

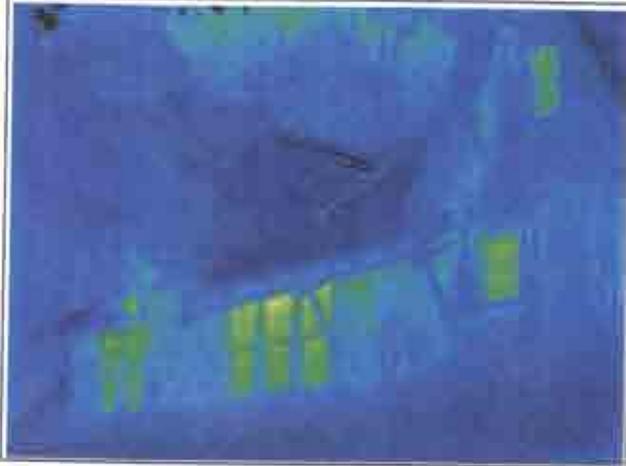
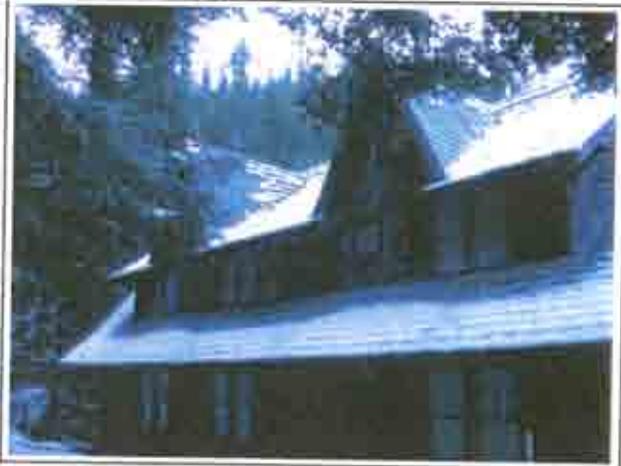
Inspection # 1	Item # 25
Problem Date/Time	12/22/2004 10:11:01 AM
Indirect Temp. Measurement	No
Component Temp	24 @ N/A
Reference Temp	24 @ N/A
Severity Code	0
Temp Rise 0 @ N/A

Component: Center upper shot

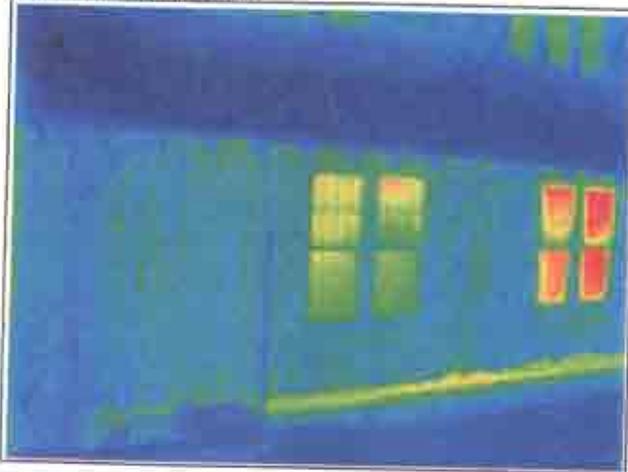
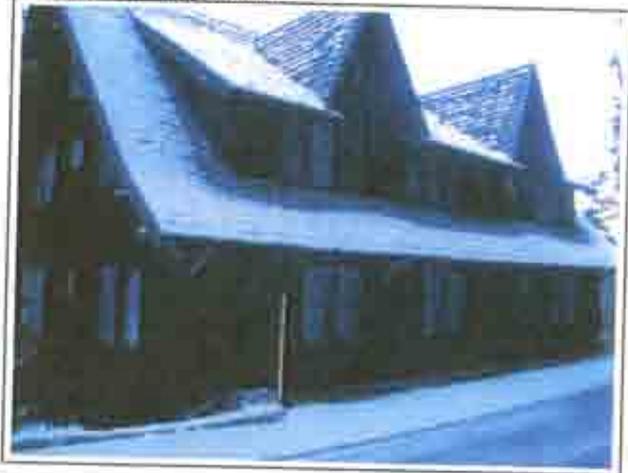
<b>Inspection #</b> 1	<b>Item #</b> 28
<b>Problem Date/Time</b>	12/22/2004 10:14:45 AM
<b>Indirect Temp. Measurement</b>	No
<b>Component Temp</b>	24 @ N/A
<b>Reference Temp</b>	24 @ N/A
<b>Severity Code</b>	0
<b>Temp Rise</b> 0 @ N/A

**Component:** East end lower shot

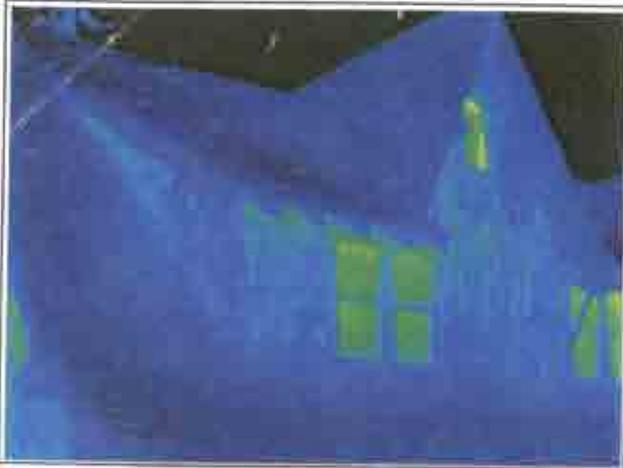
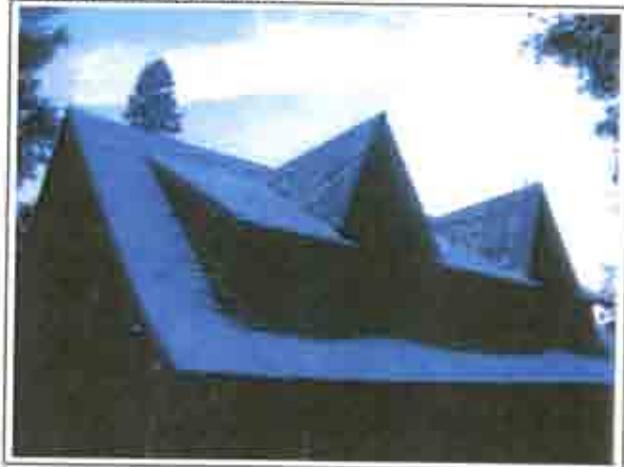
**IR Image File:** thcr0077.sit

<b>Inspection #</b> 1	<b>Item #</b> 27
<b>Problem Date/Time</b> 12/2/2004 10:14:46 AM	
<b>Indirect Temp. Measurement No.</b>	
<b>Component Temp</b> 24 @ N/A	
<b>Reference Temp</b> 24 @ N/A	
<b>Severity Code</b> 0	
<b>Temp Rise</b> 0 @ N/A

**Component:** East end upper shot
