**Appendix G. 1983 Stabilization Work.**

Images from Mac Watson, February 1983 report, prior to the collapse of the back wall,  
Courtesy Marc Simmons.

**D. Traylor, April 15, 1983, Field sketches and notes of foundation prior to work on new foundation and back wall. Original in Pigeon's Ranch File, SR-92, Historic Preservation Division, State of New Mexico, Santa Fe.**

**May 1983 repair work. Photos courtesy Marc Simmons**

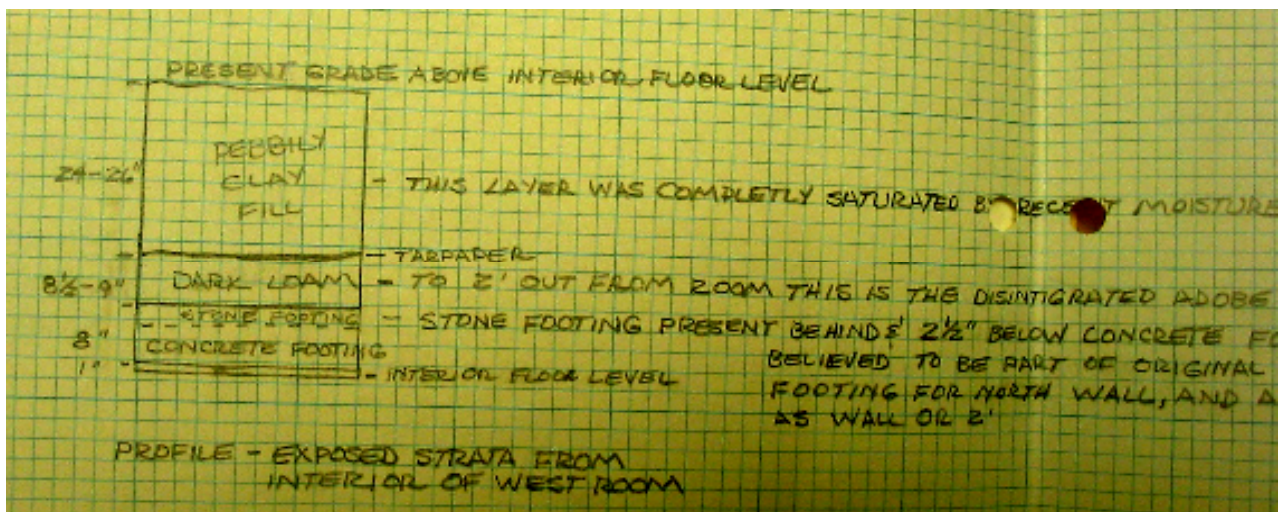
Left half of sheet.

The overall sheet above is reproduced and blown-up in the following pages. They note the poor condition of the back wall in 1983.
