CULTURAL LANDSCAPE REPORT MONTROSE PARK

Cultural Landscape Report

August 2004

Part I: Site History, Existing Conditions, and Analysis & Evaluation

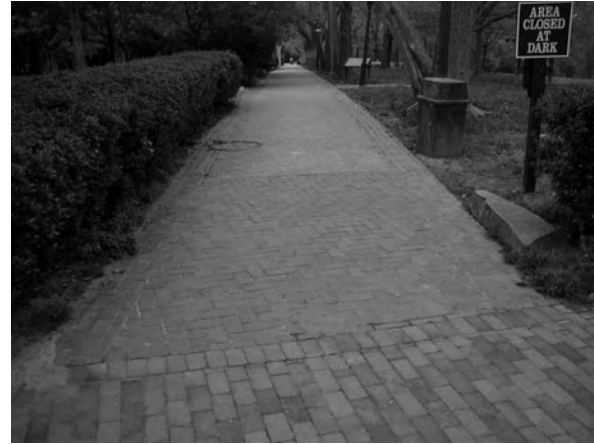
The Ropewalk forms a central axis beginning at R Street and extending northeast, terminating in a circular area at the playground. The Ropewalk is a ten foot wide path with a five foot central section of exposed aggregate concrete and thirty inch brick borders (Figure 61). The only place it varies from this typical paving is at its entrance at R Street where it is paved completely in brick for approximately twelve feet (Figure 62). At this location, a large piece of stone lies directly adjacent to the

Figure 62. Brick paved area at Ropewalk entrance. Stone lying on ground visible at right in image below sign may be one of curbstones visible in historic pictures (close up of stone in Fig. 63). (Rhodeside & Harwell, April 29, 2003).

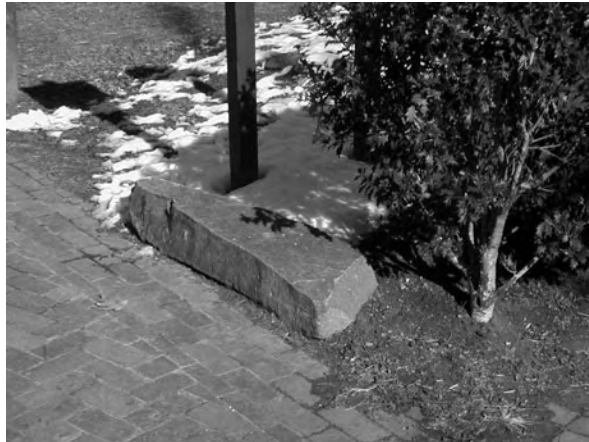
Figure 63. Stone at Ropewalk entrance. (Rhodeside & Harwell, February 12, 2003).

ropewalk to the east (Figure 63). This triangular shaped stone has a natural cleft finish and serves to accentuate this location as a gateway to the park and may be one of the curb-stones visible in historic photos. The circular section of paving at the end of the Ropewalk is also exposed aggregate concrete with a brick edge (Figure 64). A short curved walkway of similar type extends further to the northwest from the circle and ends abruptly near the edge of the playground and swings area (Figure 65).

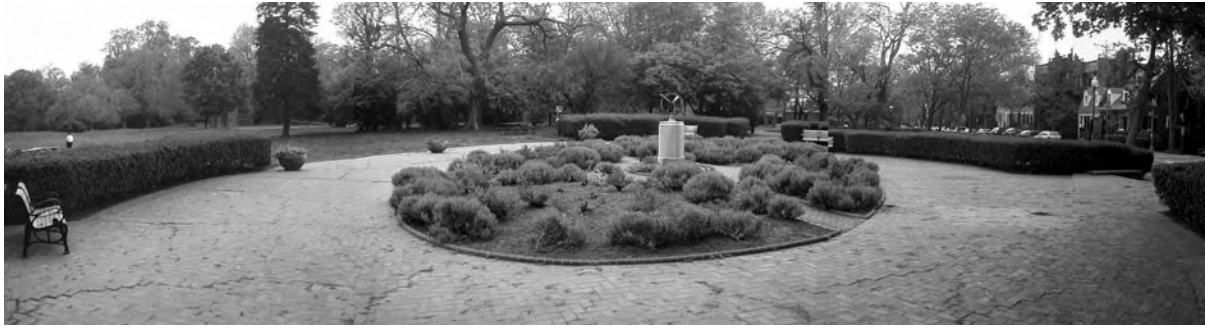
Figure 66. Deteriorated brick paving at the Entrance Ellipse. The four planting areas in the center of the ellipse were originally intended for roses but are currently planted with both roses and lavender. Note osmanthus hedge surrounding the Entrance Ellipse as designed by Peaslee in 1917 (see Figure 29). The opening in the hedge to the left is intended to focus the designed vista to the north across the Central Lawn. The trees that reinforced the direction of the vista are no longer present. (Rhodeside & Harwell, April 29, 2003).

The Entrance Ellipse is the largest paved area within the park consisting of brick paving and rounded brick edging defining the border of four planting beds (Figure 66). Four narrow brick pathways lead into the center of the ellipse to an armillary sphere (Figure 67). This paved area serves as a central gathering place and focal point in the park. Two smaller asphalt pathways extend out from the ellipse, one to the east and one to the west. The one to the east crosses the Ropewalk and continues eastward to the Lodge (Figure 68), while the one to the west proceeds westward to the tennis courts and then loops back to the north ending just before reaching the Circle. The western pathway from the Entrance Ellipse to the tennis courts and the Summerhouse is deteriorated asphalt with five sets of flagstone steps (Figure 69). North of the tennis courts, the path continues as deteriorated asphalt with a single row of brick edging along each side (Figure 70). The brick is stamped "Patton Pa. Paver." ¹ Just before reaching the Circle, this paving ends at a perpendicular row of brick edging (Figure 71). Two paths, each with flagstone steps descending to the tennis court level, extend west from the main path on either side of the Summerhouse leading to the two entrances to the tennis courts (Figure 72). Flagstones border the curved area of the pathway on the eastern side of the Summerhouse (Figure 73).

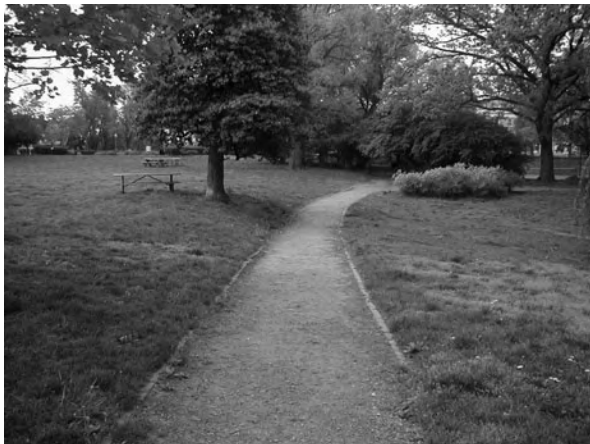
Figure 70. Path along western side of park is deteriorated asphalt with brick edging. (Rhodeside & Harwell, April 29, 2003).

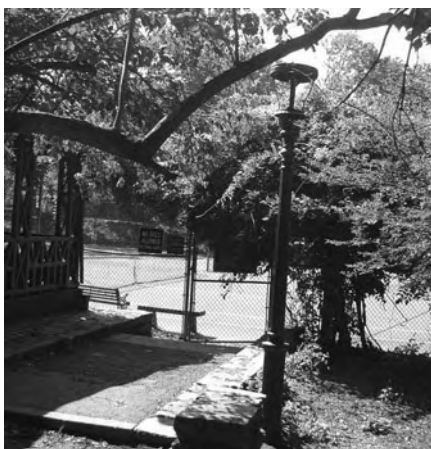
Figure 72. Walkway and steps leading to Summerhouse tennis courts at southwestern corner. The Newport gas light fixture visible at right is not functioning. (Rhodeside & Harwell, September 2002).

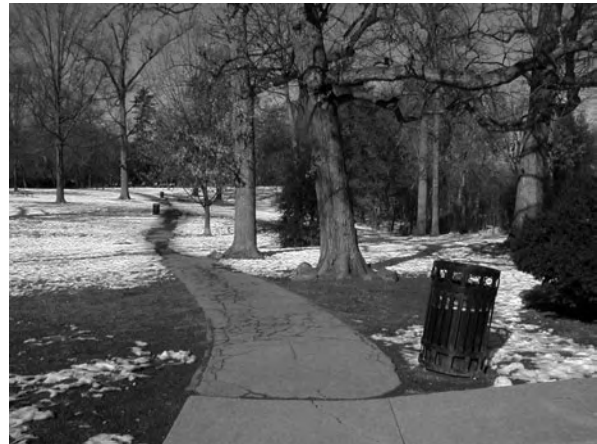
Figure 75. Asphalt path extending north from the Lodge, tilting decorative trash can in foreground. (Rhodeside & Harwell, February 12, 2003).

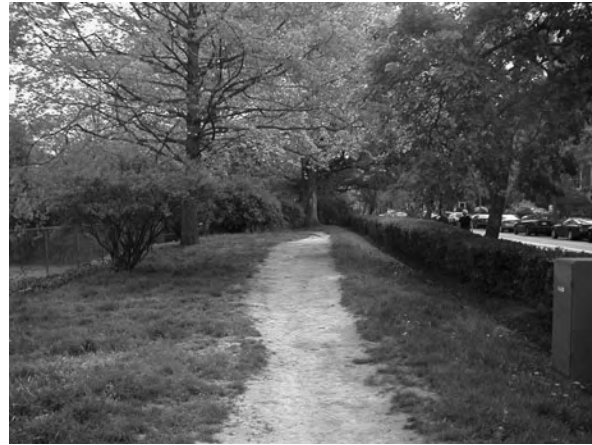
Entrance Ellipse and then eastward to the Lodge, where they exit the park and continue on R Street. This foot traffic pattern runs in both directions as many pedestrians choose to walk parallel to R Street inside the park on these pathways rather than using the sidewalk. Another informal path choice at the southwest corner is to head northward along the west side of the tennis courts eventually wrapping around to the east and connecting with the paved pathway (Figure 80). This path is heavily used by park visitors going to the northern parts of the site. Along the western edge of the park there are also several other smaller, less used paths connecting Lovers' Lane to the paved pathway. A few unpaved paths also extend westward from the Ropewalk. One begins south of the Ropewalk tennis courts and ends at the lawn area, and one begins north of these same tennis courts passing south of the Boxwood Gardens and ends at a lawn area (Figure 81). Two very narrow pathways extend north and south from the Pergola, one into each of the Boxwood Gardens (Figure 82). A wider pathway connects the end of Ropewalk with the paved pathway west of the Circle (Figure 83). Because this path connects these

Figure 79. Heavily used volunteer path at southwest corner, paralleling R Street. (Rhodeside & Harwell, April 29, 2003).

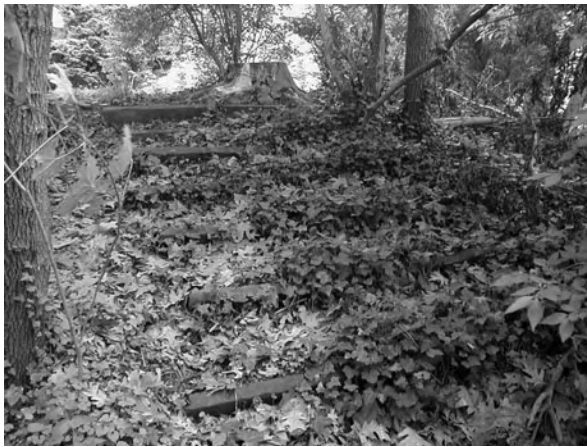
two other major circulation routes forming a loop, pedestrians use it very heavily. A small, barely visible path with a short set of partially buried flagstone steps (Figure 84) extends northward from the Circle.

Figure 84. Partially buried flagstone steps north of the Circle. (Rhodeside & Harwell, April 29, 2003).

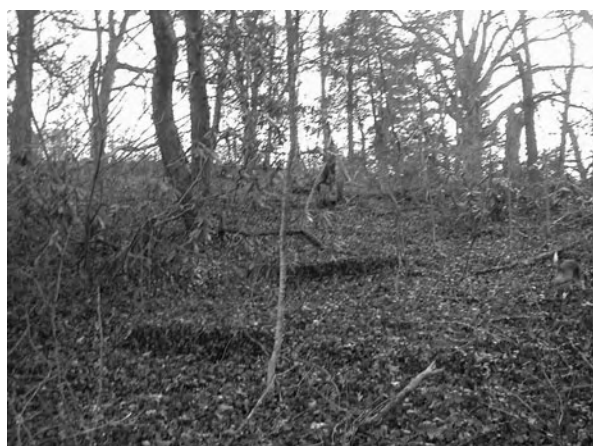
Figure 88. Partially buried flagstone steps in Northern Woodland. (Rhodeside & Harwell, December 22, 2003).

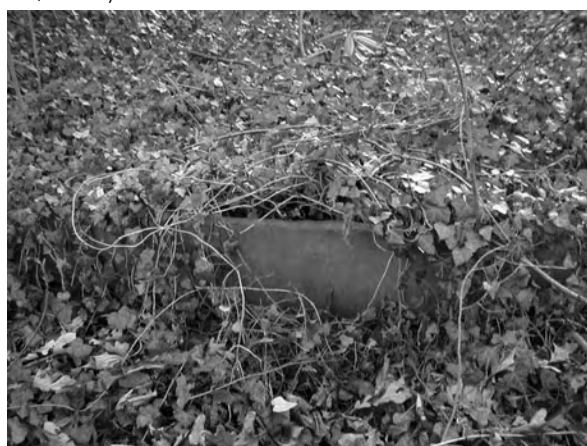
Figure 89. Detail of flagstone steps overgrown with English ivy in Northern Woodland. (Rhodeside & Harwell, December 22, 2003).

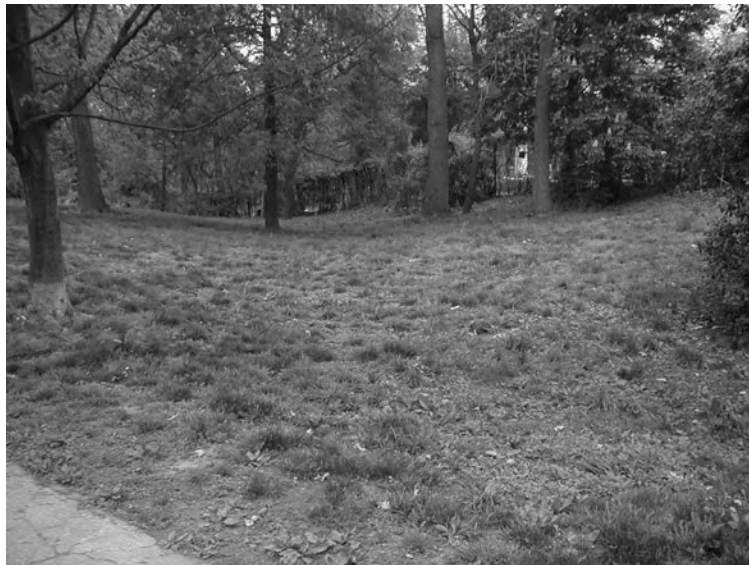
Figure 97. Gentle swale on east side of site. (Rhodeside & Harwell, April 29, 2003).

age, creating puddling and continuously wet conditions. One wet area is the major swale to the southeast along the series of drain inlets. Even though these drainage structures are in place, they do not appear to be functioning correctly, as this area is also often wet. Other wet areas on the site include a small area east of the swings, a depressed zone south of the Ropewalk tennis courts at two water spigots, and a section of lawn east of the Ropewalk.

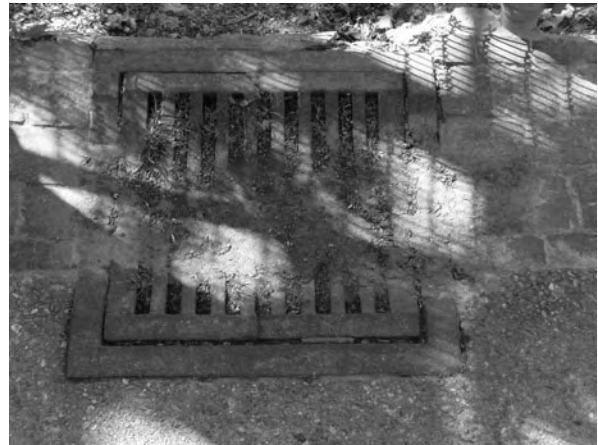
Most of the drainage on the site is via surface runoff or sheet flow into open stream channels rather than through built drainage structures. The only underground storm sewer pipes on the site connect the three drain inlets on the eastern side of the site (Figure 99). Otherwise, the only drainage structures are a series of catch basins of three different inlet designs along the Ropewalk. These catch basins are in the brick edging on the western side; one of these basins is completely silted in (Figures 100-104).

Figure 104. Clogged catch basin. (Architrave, 2003).

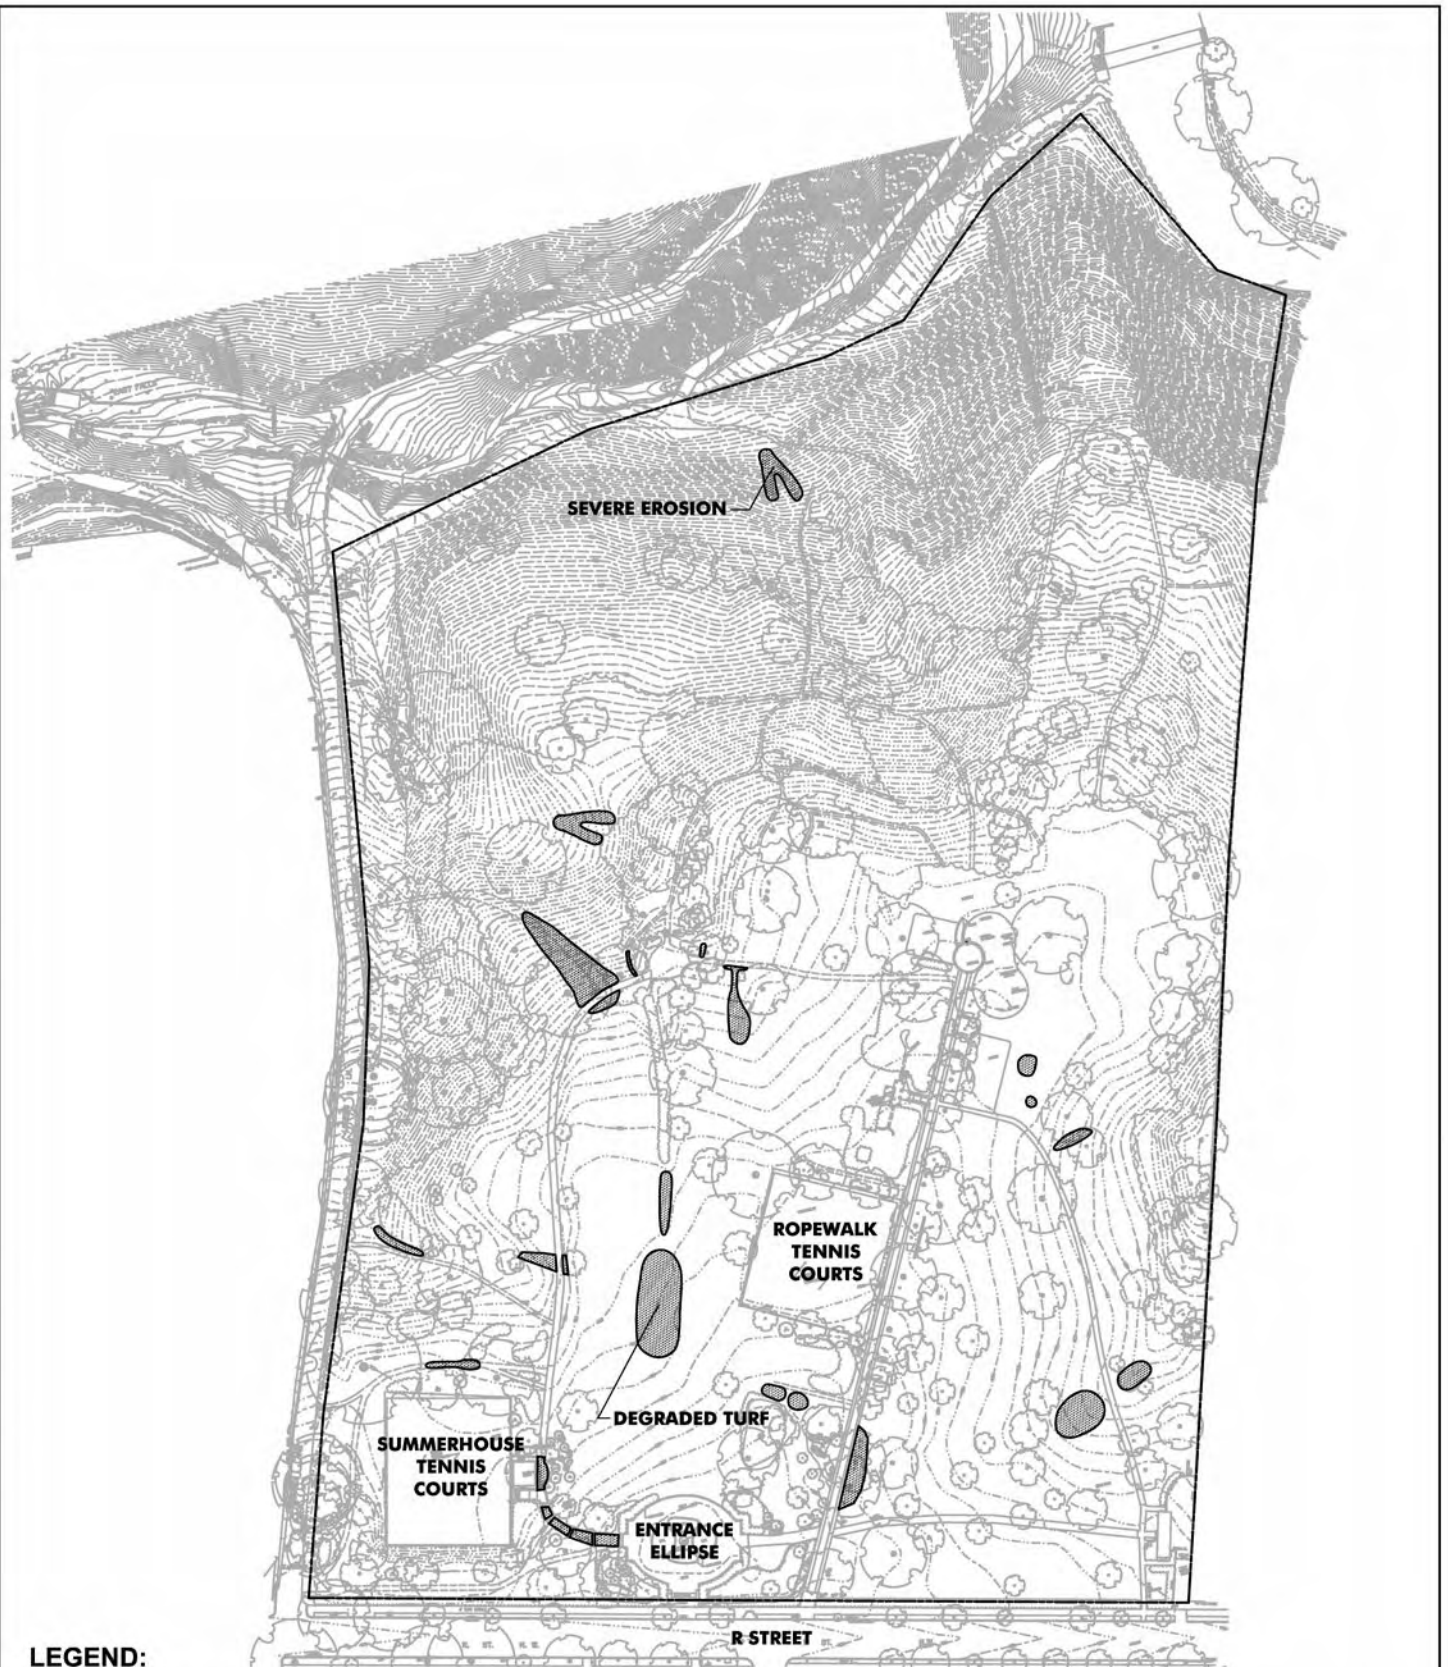
The other problem drainage areas shown on the plan have been caused by erosion. The most severe erosion is in the Northern Woodland where a small ravine has washed out (Figure 105). Water flows down or across paths at several other locations, such as at the path west from the Entrance Ellipse, causing erosion of the path surface. No turf grows on either side of the path in many of these instances (Figure 106). A large area of turf in the Central Lawn is degraded, but it is difficult to determine whether this is from poor drainage or heavy dog use (Figure 107).

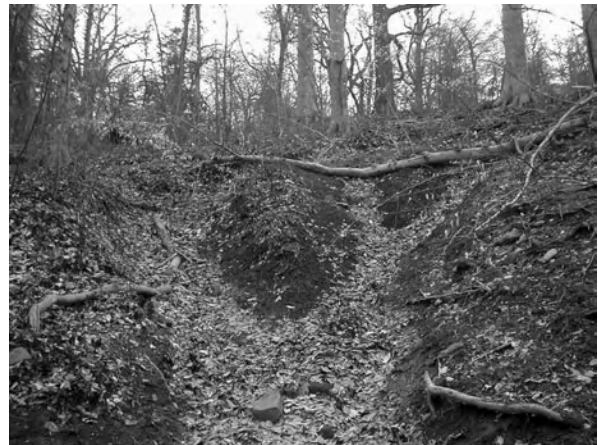
Figure 105. Area of severe erosion in the Northern Woodland. (Rhodeside & Harwell, March 12, 2003).

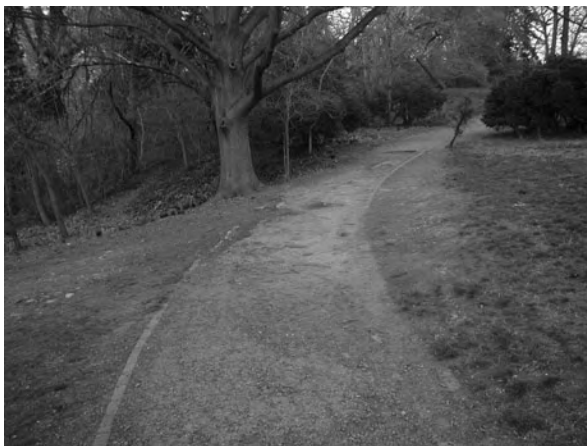
Figure 106. Example of water flow across path surface causing erosion and degradation of turf on either side. (Rhodeside & Harwell, April 3, 2003).

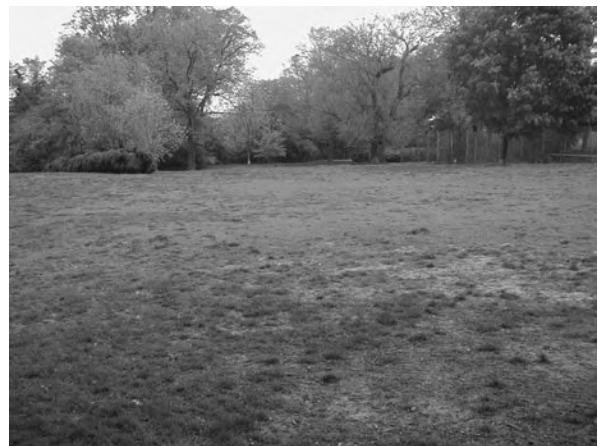
Figure 107. Degraded turf in Central Lawn area. (Rhodeside & Harwell, April 29, 2003).

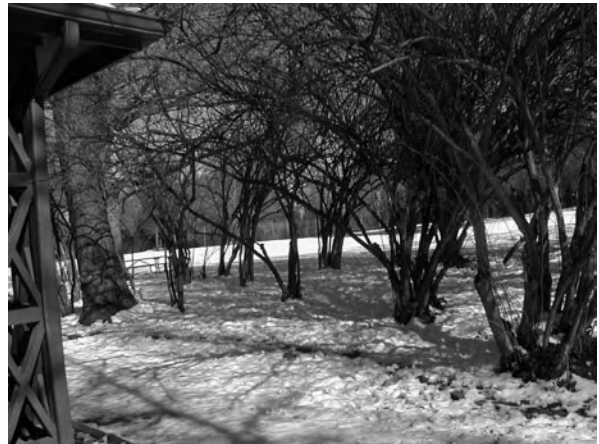
Figure 120. Large honeysuckles east of the Summerhouse. (Rhodeside & Harwell, February 12, 2003).

Quite a few individual honeysuckle (*Lonicera tatarica*) shrubs have become very large, especially east of the Summerhouse and in the planting areas southwest and northeast of the Entrance Ellipse (Figure 120).

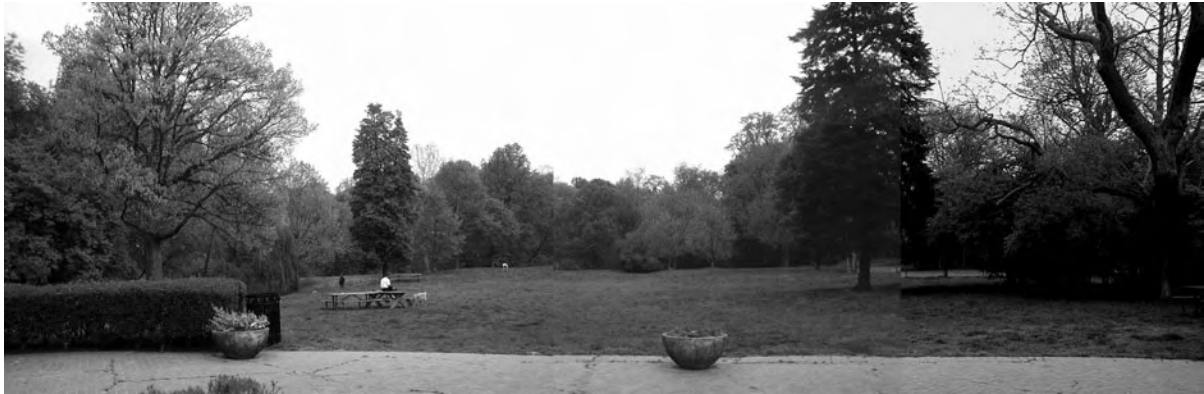
Figure 126. Designed Vista #1 from Entrance Ellipse looking north. Framing trees are no longer present. (Rhodeside & Harwell, April 29, 2003).

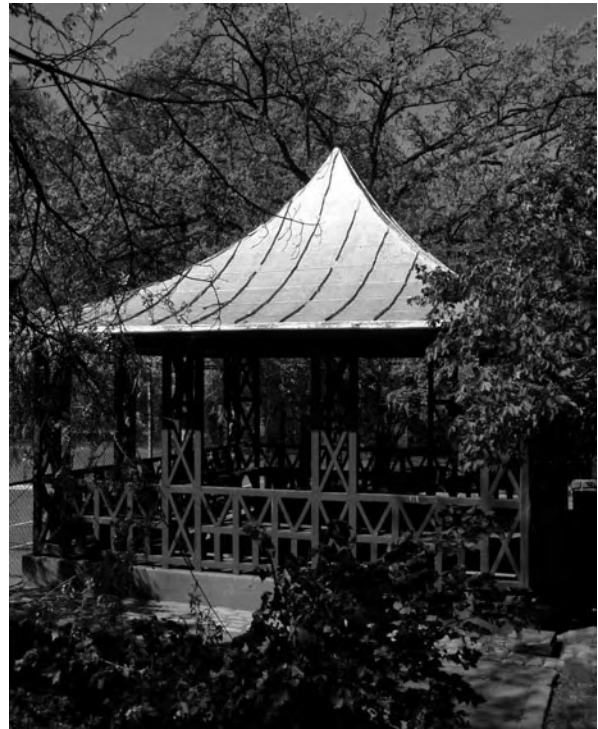
Figure 133. Overall view of the Summerhouse. (Architrave, 2003).

The scalloped ornament at the roofline visible in historic photos of the summerhouse (see Figure 8) is no longer present.

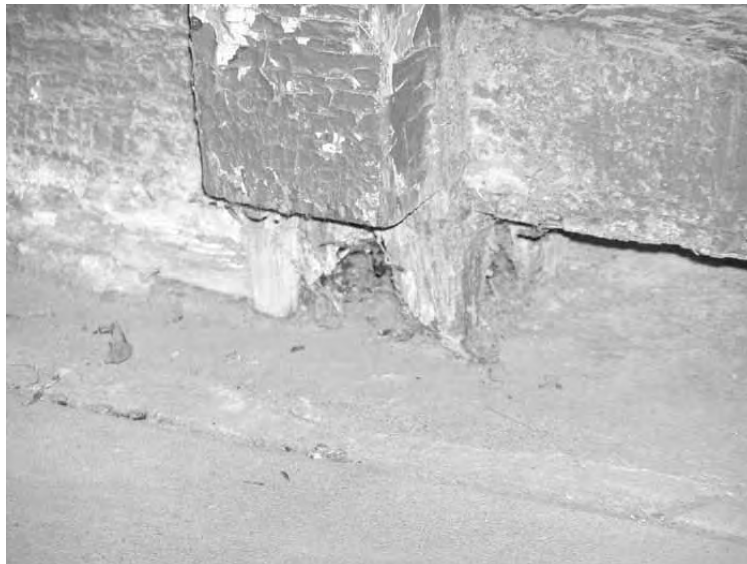
The “enclosure” of the Summerhouse consists of four floor-to-eave piers of two 3” by 3” members with x’s of 1 ½” x 2 5/8” between them. Railings fabricated of 1 ½” x 2 5/8” members in a pattern of y’s span between the piers (Figure 135). The main 3” by 3” vertical members sit directly on the concrete base and some of them suffer from rot at their bases (Figure 136).

Figure 136. The main members of Summerhouse sit directly on the concrete base. The one above has rotted. (Architrave, 2003).

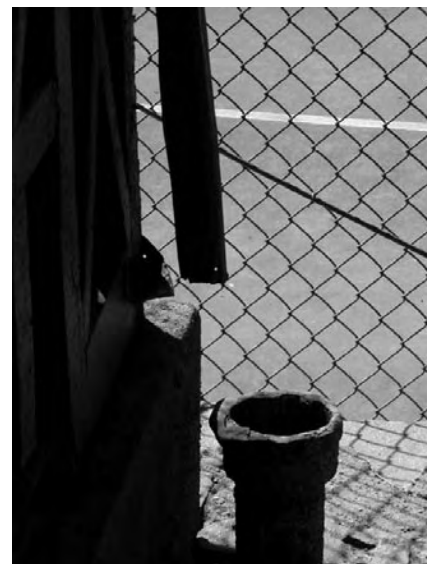
The standing seam ‘tin’ roof is painted with aluminized paint. The roof seams are at approximately 17” on center. The roofing panels themselves are very small, perhaps 15” by 12”, consistent with panel sizes from the late-nineteenth-century. We can’t determine if these panels date to the 1915 roof replacement or, indeed, if the roof was replaced in 1915. The gutters are green painted ogee with downspouts at the northwest and southeast corners, with a cast concrete splash block at the southeast corner and a cast iron hub, presumably into the storm drainage system, at the northwest corner. The downspout at the northwest corner of the Summerhouse stops about a foot above the hub (Figure 137).

Figure 137. Downspout at Summerhouse. (Architrave, 2003).

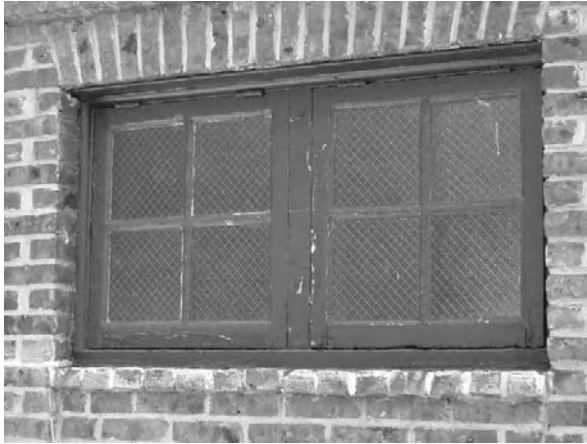
Figure 148. Typical window sash and frames at Lodge. Sash with muntins appears to be original although the wire glass is probably not. (Architrave, 2003).

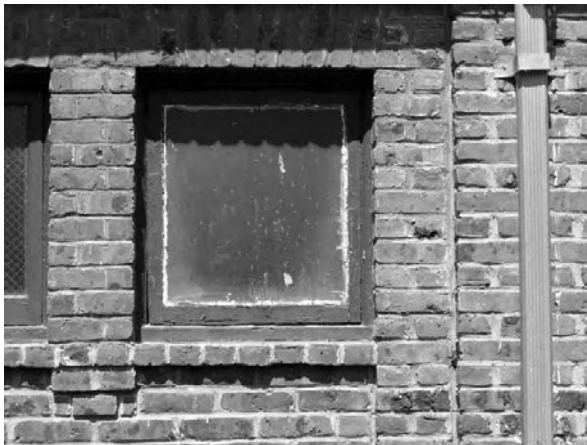
masonry openings with flat brick arches, steel lintels, and projecting brick sills (Figure 148). Some of the sash have been reglazed with glass different from the predominating obscure wire glass or have lost their muntins (Figure 149). One opening on the west façade is infilled with plywood (Figure 150).

Figure 149. Different type of window at Lodge without muntins. (Architrave, 2003).

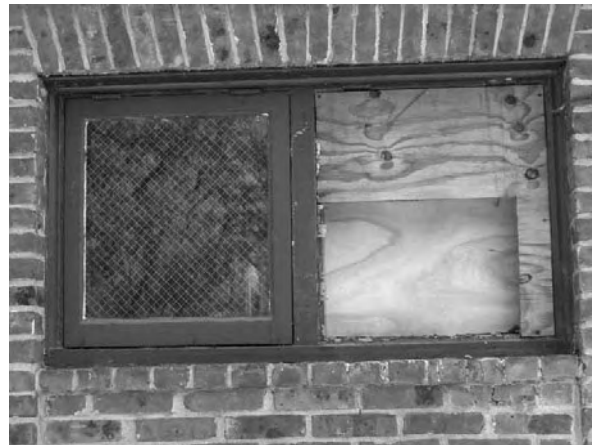
Figure 150. One window opening at Lodge is filled with plywood. (Architrave, 2003).

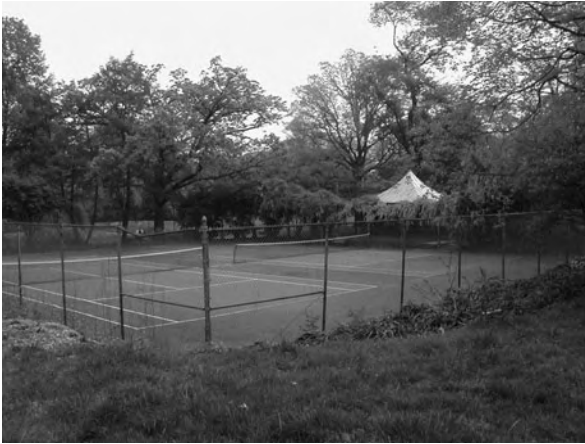
Figure 151. Tennis courts at southwestern corner of site (Summerhouse courts). The Summerhouse roof is visible beyond. (Rhodeside & Harwell, April 29, 2003).

appears to be old and is rusted, but still functions (Figure 153). This set of courts has several areas of surface cracking, making them less desirable for serious play (Figure 154). The other set of courts, near the Summerhouse, appears to be in better condition, but the fence surrounding it shows signs of wear. Neither of the two areas is equipped with court lighting, but the southwestern set of courts are oriented generally north-south, the preferred orientation. The courts west of the Ropewalk, however, are oriented east-west, a less desirable orientation.

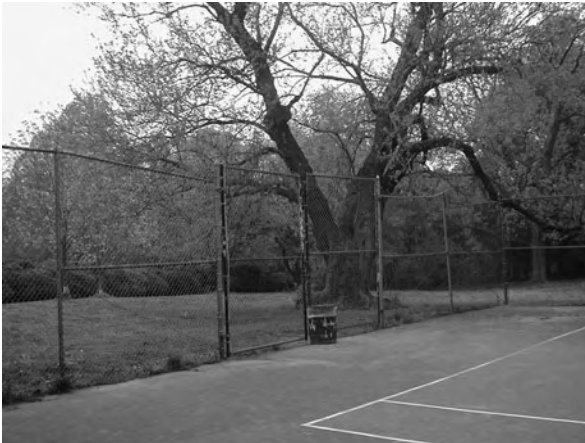
Figure 153. Rusty fencing at Ropewalk tennis courts. (Rhodeside & Harwell, April 29, 2003).

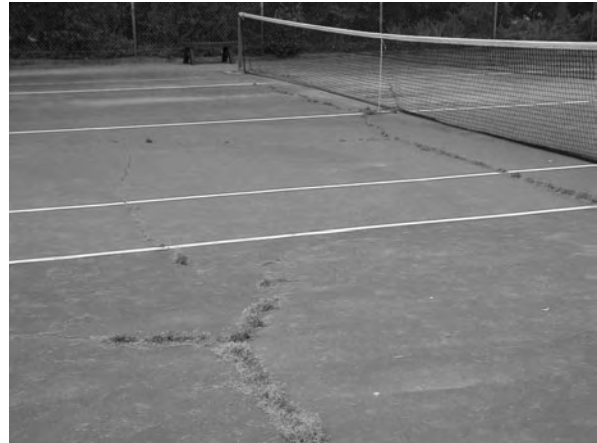
Figure 154. Surface cracking and turf growth in Ropewalk tennis courts. (Rhodeside & Harwell, April 29, 2003).

The existing tennis courts are in fair condition. They are usable for tennis play, but the surfaces, particularly that of the courts west of the Ropewalk, are cracked and worn (see Figure 154). The Croquet Court is gone, but a small area of lawn is still present in the general vicinity of the court's location. Features added since 1919 include the new children's playground area and the backstop/ball field. All of the play equipment appears to be new and in excellent condition. Several sections of the backstop are overgrown with vines, and the fencing itself does not appear to be in good condition.

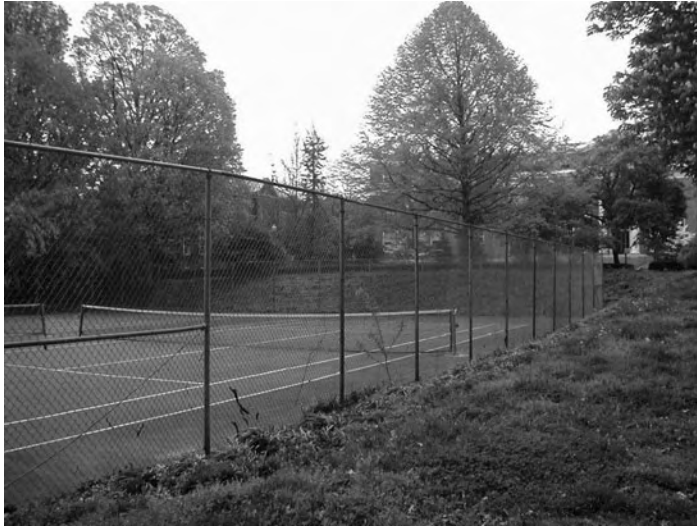
Figure 162. Chain link fence at Summerhouse tennis courts. Note slopes beyond and to the side of the courts. Historically these slopes were heavily planted per Burnap's planting plan of 1915 (see Figure 22) but none of the historic planting materials remain on these slopes. This image also illustrates the grading changes Burnap made to accommodate the tennis courts here. (Rhodeside & Harwell, April 29, 2003).

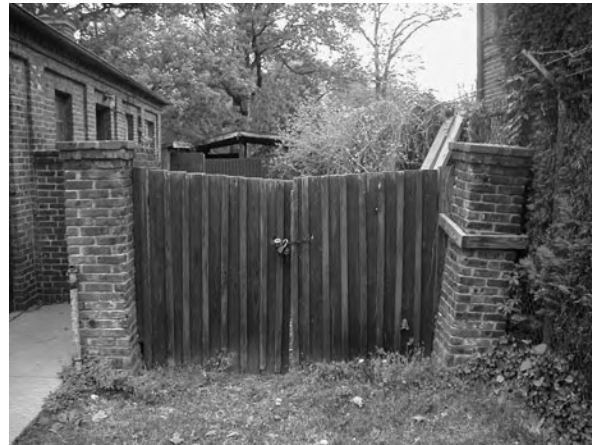
Figure 172. Locked wood gate east of Lodge. Note leaning brick pier to right. (Rhodeside & Harwell, April 29, 2003).

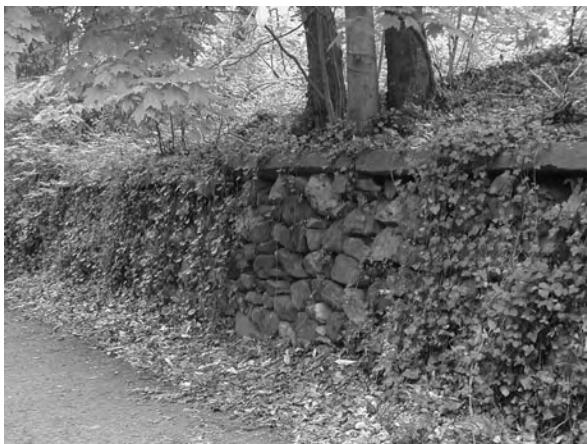
Figure 181. Stone retaining wall on east side of Lovers' Lane. The wall is lower and discontinuous at some locations along this edge of the park. (Rhodeside & Harwell, April 29, 2003).

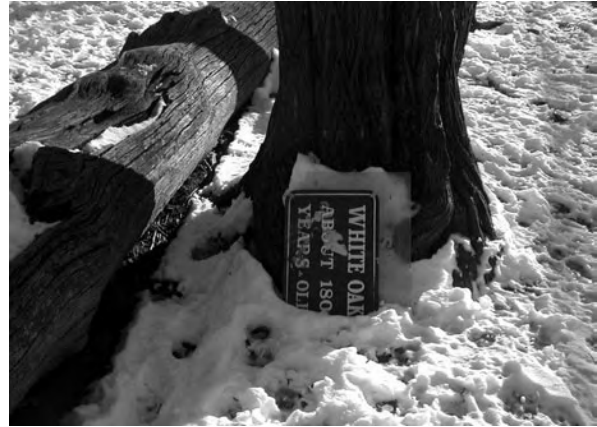
Figure 192. "White Oak - about 180 years old" sign located on the ground east of the Ropewalk, near large tree trunk. (Rhodeside & Harwell, February 13, 2003).

near a tree trunk on the ground along the Ropewalk (Figure 192). Overall, a wide variety of sign types are found in the park, some seemingly planned as part of a cohesive system and others seemingly added over time.

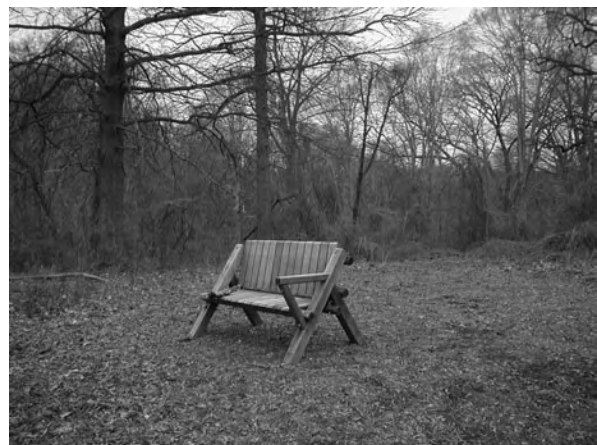
The park's benches are of five types ranging from rustic to contemporary. The most rustic bench is the wooden NPS "Washington Bench" constructed in the Adirondack style with wide vertical wooden slats (Figure 193). This bench was designed in the 1930s and used since then in both Rock Creek Park and along the Mt. Vernon Memorial Highway according to a ROCR Cultural Resources Manager, based on review of Federal Records from Suitland, Maryland. There are three of these benches, one in the western clearing of the Northern Woodland, one in the open area east of the playground, and one near the grove of beeches northeast of the Circle. A small wooden backless bench with black arched legs and a seat made of horizontal wood members painted red is another simple bench type found only in the tennis court areas (Figure 194). The park has several typical park benches with black painted

Figure 193. The rustic "Washington Bench" (with broken arm) located in clearing in northwestern section of park. (Rhodeside & Harwell, March 2003).

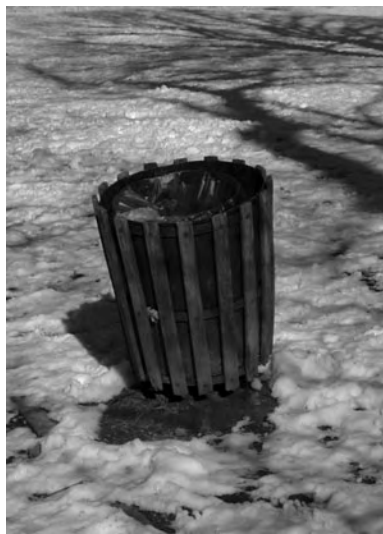
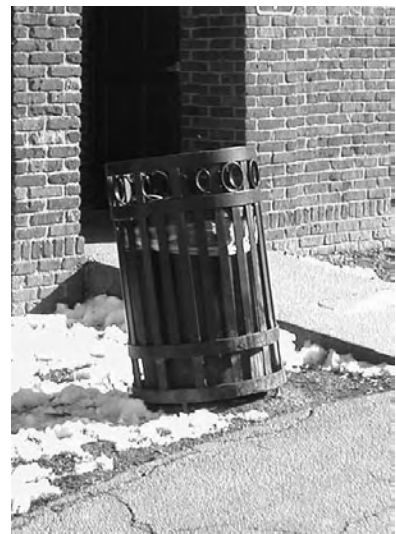
Figure 199. Small uncovered trash receptacle with vertical wood slats. NPS standard “Tulip” type. (Rhodeside & Harwell, February 12, 2003).

Figure 200. Ornamental black metal trash receptacle. (Rhodeside & Harwell, February 12, 2003).

We have found no record of the first installation of trash receptacles in the park. The 1925 inventory form for Montrose Park listed six trash cans within the park’s boundaries. Now there are many trash receptacles on the site, of varying size and type. Most are in good to excellent condition, except for two tilting receptacles (see Figures 199, 200). A number of the decorative steel trash can enclosures have areas of rust.

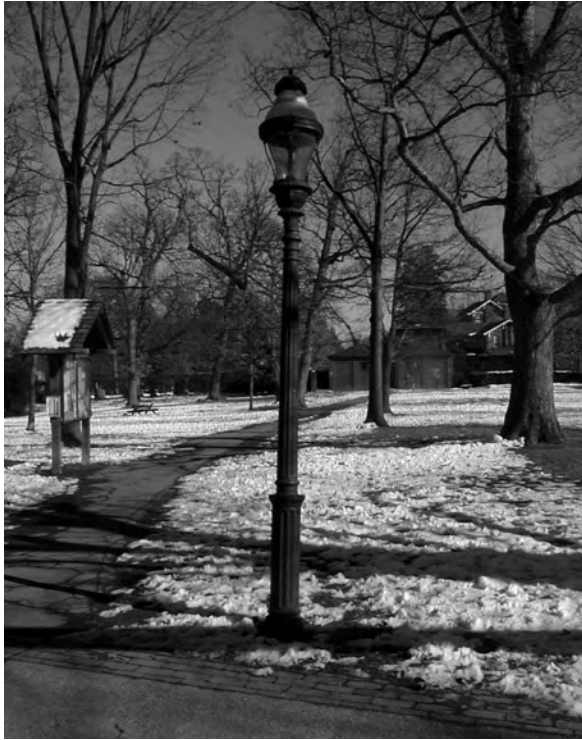
The park has a total of ten gas lights with nine of these staggered on either side of the Ropewalk, extending from the entrance to the playground. One other gas light is located near the Summerhouse tennis court, but it is not functional at this time. All of these lights are of the same, very ornamental “Newport” design with fluted poles painted black (Figure 209, 210).

Figure 209. Typical "Newport" gas light found within the park. (Rhodeside & Harwell, February 12, 2003).

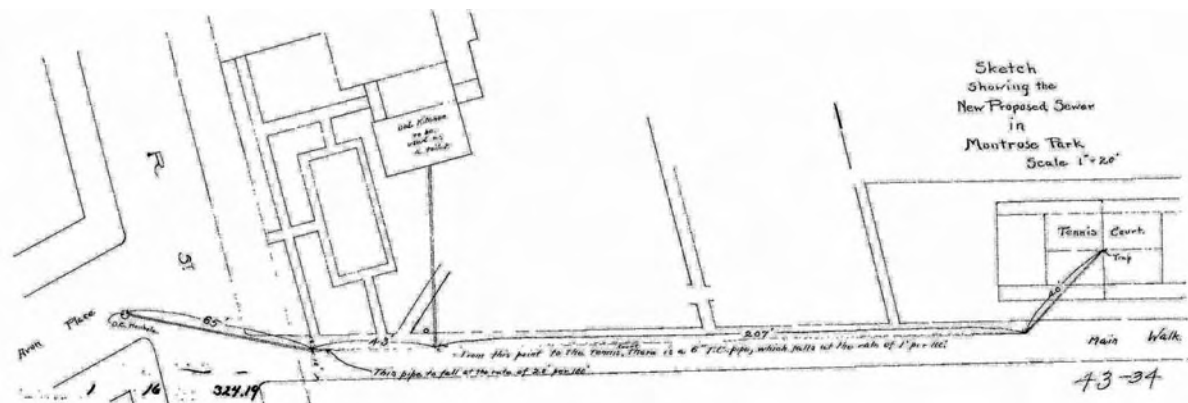
Figure 215. "Sketch showing the new proposed sewer in Montrose Park", circa 1914. Notes on the drawing identify the line from where the apparent waste line from the toilets in the old kitchen wing joins the main line to the tennis court as 6" T.C. (terra cotta). Three of the four existing drain inlets along the Ropewalk are located above the line. We have found no records suggesting this sewer has been replaced since 1914, so assume it continues in use. (NCR, Plans and Drawings Collection #891/80017. Titled "Sketch," no delineator or date. We have dated it circa 1914 since the old kitchen is still present. Text reads, "From this point to the tennis court, there is a 6" T.C. pipe, which falls at the rate of 1' per 100'." Another arrow points to a different pipe and reads, "This pipe to fall at the rate of 2.0' per 100'.")

62 feet of drain tile in 1915. The 1935 plan of the park completed by the National Park Service depicted an existing brick drain basin against the cemetery fence just south of the play area, and showed the spring, located in the northwestern part of the park, which ran to The Branch, a tributary of Rock Creek north of the park. The amount of drain pipe and drain tile listed above is very little for a park this size and may just be the piping shown on the "Sketch showing the new proposed sewer in Montrose Park" (see Figure 215), the piping in which appears to have total numbers not unlike those above.

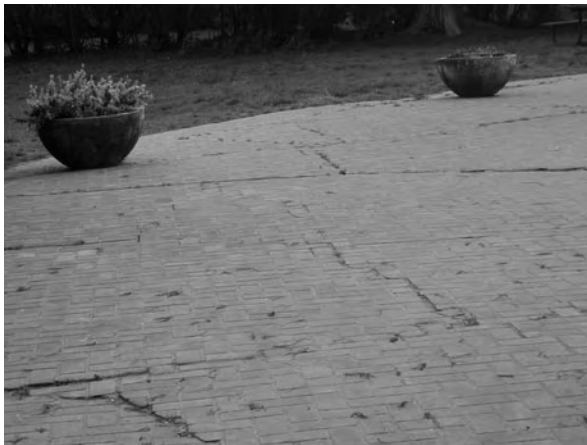
The Entrance Ellipse is another important circulation area still present. This entrance feature designed by Peaslee remains very similar to its original design with the exception of the layout of the small pathways and planting beds in the center of the ellipse. The current brick paving dates to 1956, but the fact that the material is still brick and retains its historic herringbone pattern adds to its integrity. Unfortunately, the condition of the present paving is only fair since it is cracked and shows signs of heaving (Figure 216). The alignments of the pathways extending east and west from the ellipse are also still present. The path to the east is now asphalt instead of gravel and is in good condition. The path to the west was originally a gravel walk with flagstone steps. Now this path is severely deteriorated asphalt, but has retained the flagstone steps (Figure 217). We do not know for certain, but it is possible that these flagstone steps date to 1919 when Peaslee's design was first implemented. They still exist in the same locations they did historically and are in fair condition, being mostly intact but with some losses due to

Figure 216. Cracked and heaved brick paving at Entrance Ellipse. (Rhodeside & Harwell, April 29, 2003).

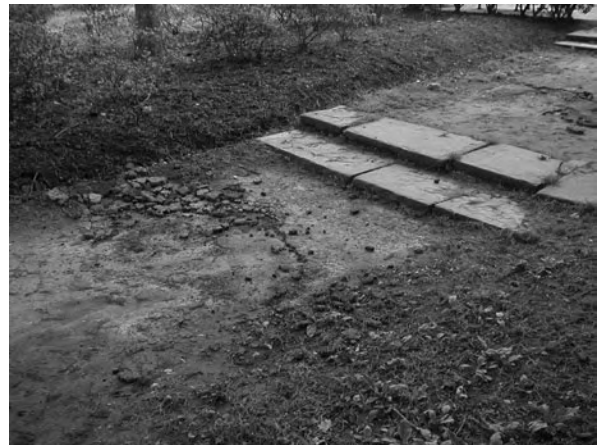
Figure 217. Deteriorated asphalt at path leading west from the Entrance Ellipse. (Rhodeside & Harwell, April 29, 2003).

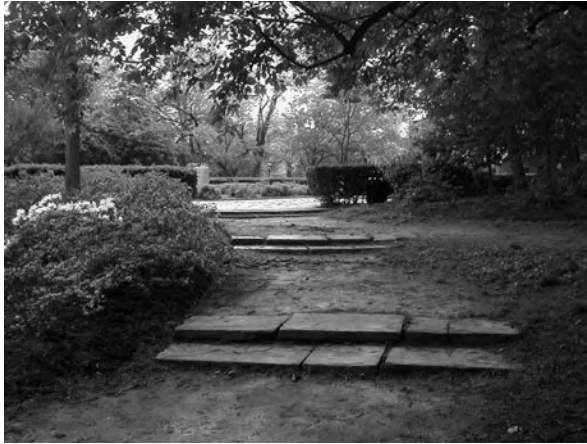
cracking and wear (Figure 218). The paths on either side of the Summerhouse remain as well, but are now also deteriorated asphalt instead of gravel. Once again the flagstone steps leading down to the tennis courts remain intact (Figure 219). The area east of the Summerhouse does not appear to have ever been paved. Historically this area was also gravel with flagstone edging defining the east side. This flagstone edging remains and is in good condition, while the walkway area itself suffers from lack of drainage and any kind of surface treatment (Figure 220). A section of pathway also still continues north into the park from the Summerhouse area, but its alignment is no longer the same as it

Figure 218. Flagstone steps leading west from Entrance Ellipse. (Rhodeside & Harwell, April 29, 2003).

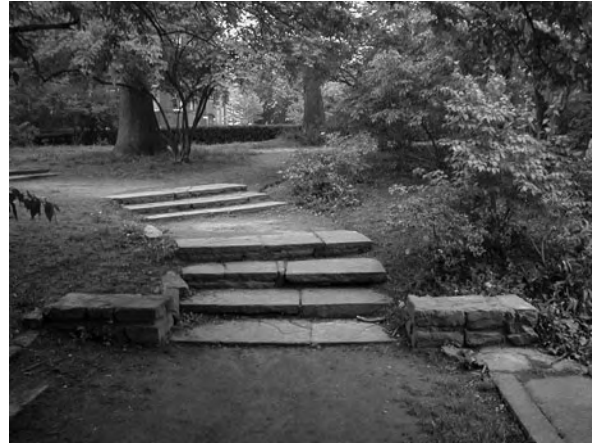
Figure 219. Flagstone steps leading down to the Summerhouse tennis courts. (Rhodeside & Harwell, April 29, 2003).

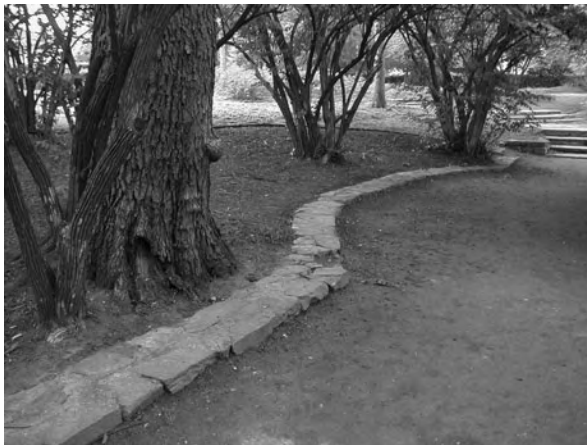
Figure 220. Flagstone edging and compacted soil area east of the Summerhouse. (Rhodeside & Harwell, April 29, 2003).

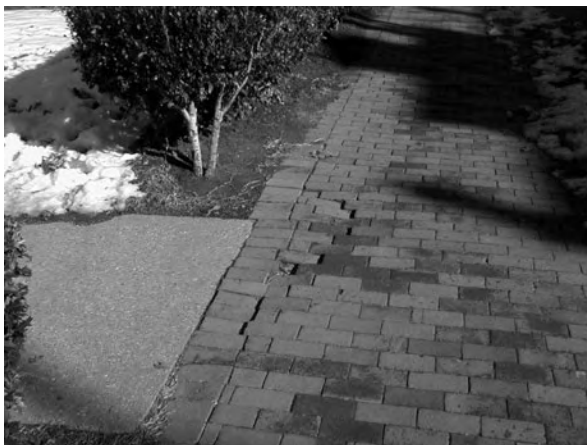
Figure 221. Heaving of bricks on sidewalk along R Street, causing a trip hazard. (Rhodeside & Harwell, February 12, 2003).

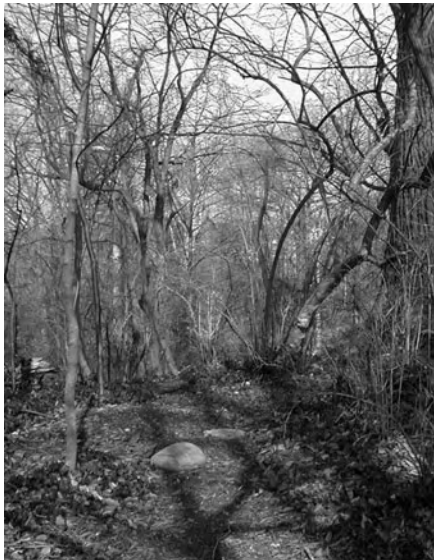
The Northern Woodland has only a few remnants of historic circulation. One of these is another section of the major loop trail that historically extended from the Circle to the end of the Ropewalk. This piece of trail is now isolated, not connected to any historic circulation to the east or the west. It is also a very narrow trail in fair condition, overgrown with vegetation in areas (Figure 223). Another fragment of historic circulation is on the northwestern corner of the site. What is today a wide gravel and dirt path was historically a small road, shown on the 1916 contour plan as connecting to Rock Creek Drive. This path is no longer used by vehicles, but has retained the historical alignment of the road, paralleling the Branch (Figure 224).

Figure 223. Remnant of historic trail in the Northern Woodland. (Rhodeside & Harwell, March 12, 2003).

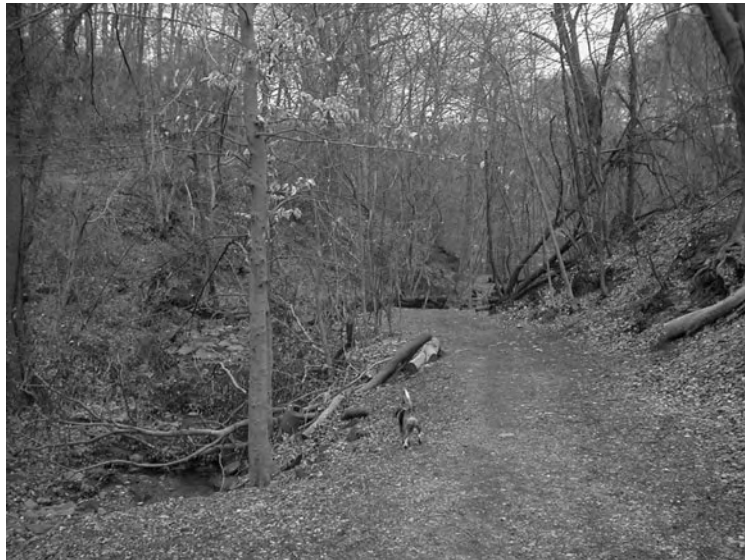
Figure 224. Wide gravel path that was historically a road, running along the Branch. (Rhodeside & Harwell, March 12, 2003).

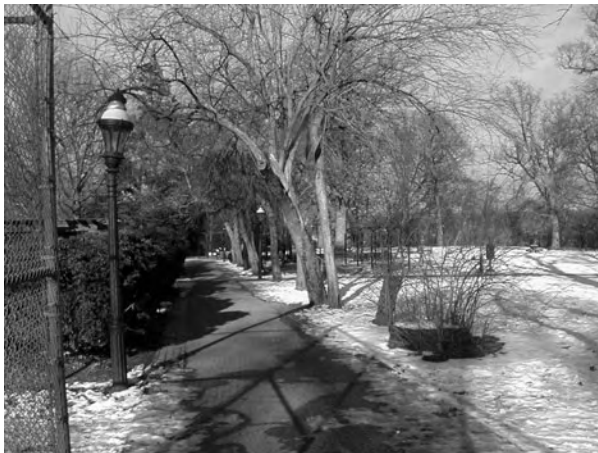
A number of specific vegetative features still exist in the park. The Osage orange hedge planted along the Ropewalk has now grown into individual trees forming an arching canopy over the length of the Ropewalk on the east side, as recommended by the CFA in 1916. Several of these trees have been removed with their stumps left in place. Many of these are now sprouting new growth, creating an unkempt look in certain areas along the Ropewalk (Figure 229). Several of the existing trees themselves also are in need of pruning and additional care. While the Osage oranges do retain a high degree of integrity because their location and design intent have re-

Figure 229. Osage orange stump with sprouts of new growth on east side of the Ropewalk. Rhodeside & Harwell, February 13, 2003).

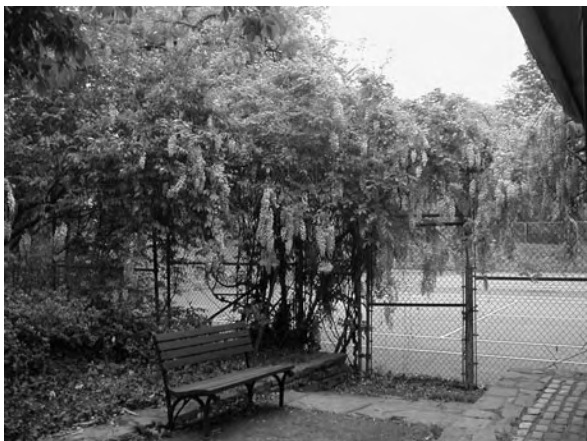
Figure 232. Wisteria on south side of Summerhouse, planted as part of Burnap's work. (Rhodeside & Harwell, April 29, 2003).

A few individual trees and vines in the park date to the historic period. There are two mature wisteria growing on the fence on either side of the Summerhouse (Figures 232, 233). These, as well as an existing Silverbell (Figure 234), were included on Burnap's 1915 planting plan for the tennis court area. Although it is difficult to know for certain, three individual white oak trees possibly date to the historic period. These become evident when overlaying the Existing Conditions Plan with the 1919 Historic Period Plan (see Map 11: 1919 Period Plan with Existing Conditions Overlay). One of these is located at the northwest corner of the Summerhouse tennis courts, one is just to the east of the fenced playground, and the other can be found just northwest of the backstop. Additional trees, especially in the Northern Woodland, could have existed before 1919. There are also a few groupings of mature rhododendrons in the Northern Woodland that could have been planted as part of Burnap's design.

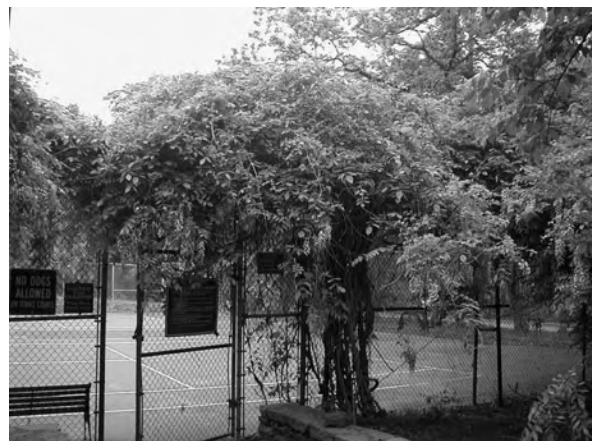
Figure 233. Wisteria on north side of Summerhouse, planted as part of Burnap's work. (Rhodeside & Harwell, April 29, 2003).
