CULTURAL LANDSCAPE REPORT MONTROSE PARK

Cultural Landscape Report

August 2004

Part I: Site History, Existing Conditions, and Analysis & Evaluation

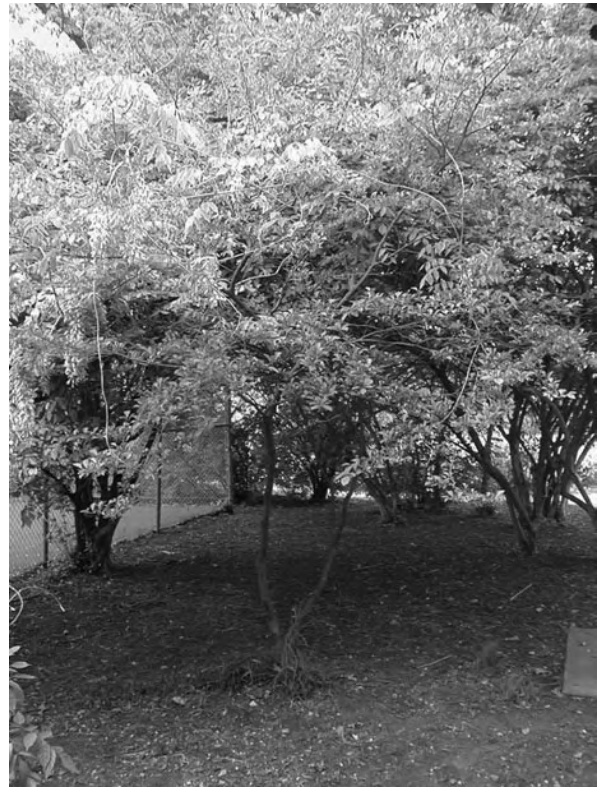
Figure 234. Silverbell tree on the north side of the Summerhouse, a remnant of Burnap's planting plan. (Rhodeside & Harwell, April 29, 2003).

A few individual trees and vines in the park date to the historic period. There are two mature wisteria growing on the fence on either side of the Summerhouse (Figures 232, 233). These, as well as an existing Silverbell (Figure 234), were included on Burnap's 1915 planting plan for the tennis court area. Although it is difficult to know for certain, three individual white oak trees possibly date to the historic period. These become evident when overlaying the Existing Conditions Plan with the 1919 Historic Period Plan (see Map 11: 1919 Period Plan with Existing Conditions Overlay). One of these is located at the northwest corner of the Summerhouse tennis courts, one is just to the east of the fenced playground, and the other can be found just northwest of the backstop. Additional trees, especially in the Northern Woodland, could have existed before 1919. There are also a few groupings of mature rhododendrons in the Northern Woodland that could have been planted as part of Burnap's design.

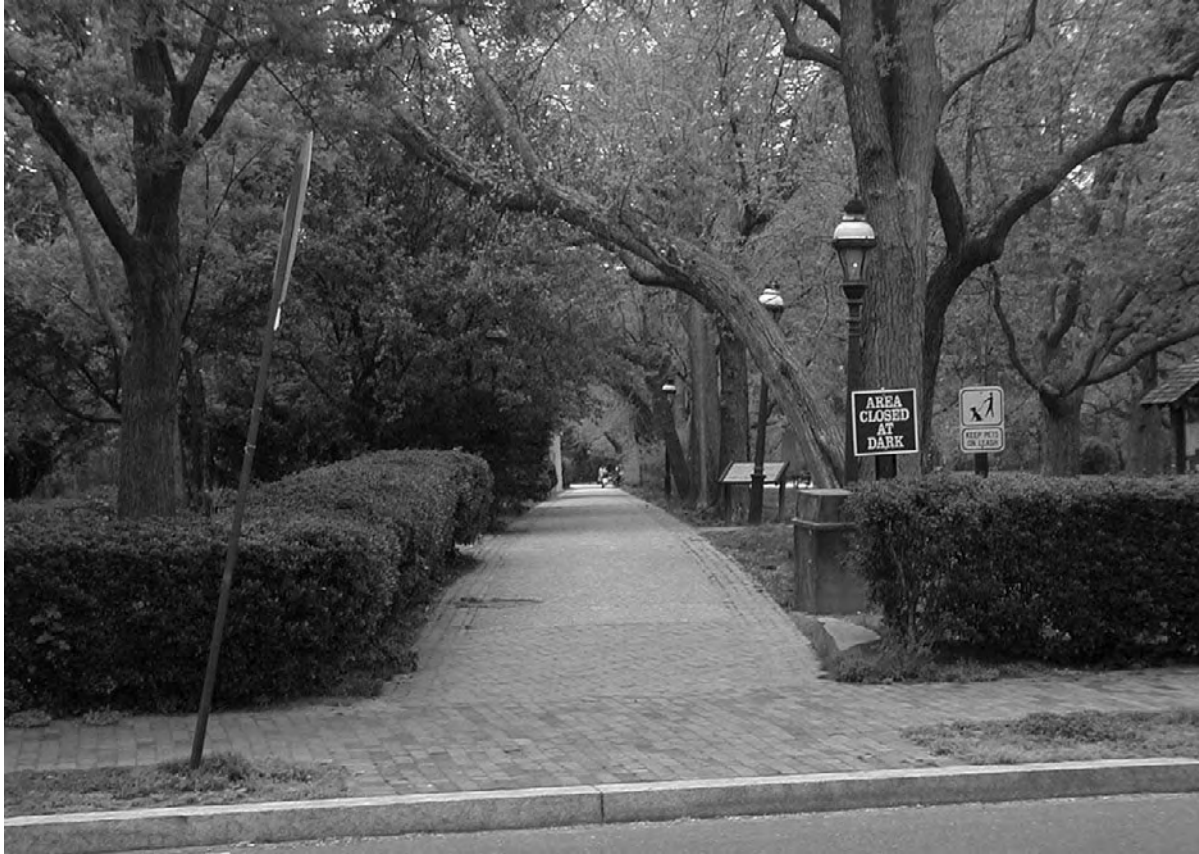
Figure 235. Axial view looking north down the Ropewalk. (Rhodeside & Harwell, April 29, 2003).

Both the view down the Ropewalk and the vista from the Entrance Ellipse continue to be present today (see Map 16: Contributing Views & Vistas). The Ropewalk continues to be a strong axis of the park with the mature Osage orange trees framing the view (Figure 235). This view from the entrance to the park draws pedestrians inside, and, once they're on the Ropewalk, several secondary views open into the park on either side. The vista from the Entrance Ellipse is the most prominent view in the park, looking from the high point at the ellipse down across the open lawn beyond (see Figure 126). This vista is no longer framed on either side by the two large oaks as Peaslee intended, but rather two staggered evergreen trees, one on either side, continue to serve this function to some degree. The Long Walk through the middle of the Central Lawn also no longer survives, but the boxwood hedge on the western side directs the viewer's eye northward.

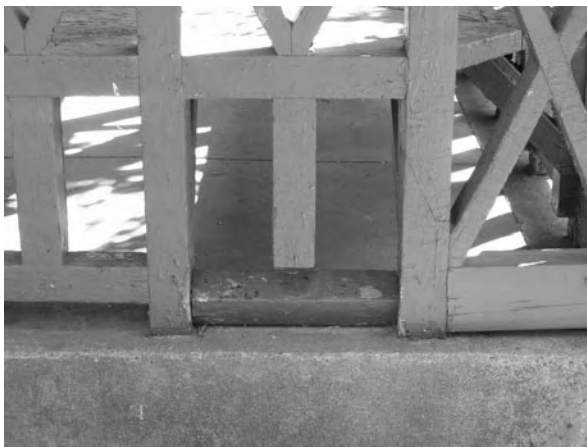
- Many of the wood members have relatively minor wood rot and deterioration.
- A number of the joints and connections between various wood members in the railings and piers have failed (Figures 237, 238)
- The paint film on much of the wood has failed.
- The concrete and stonework at the base of the building are in good condition.
- The downspout and gutter system of the Summerhouse is not in good condition.

Figure 237. An example of joint and connection failure of wood members at the Summerhouse. (Architrave, 2003).

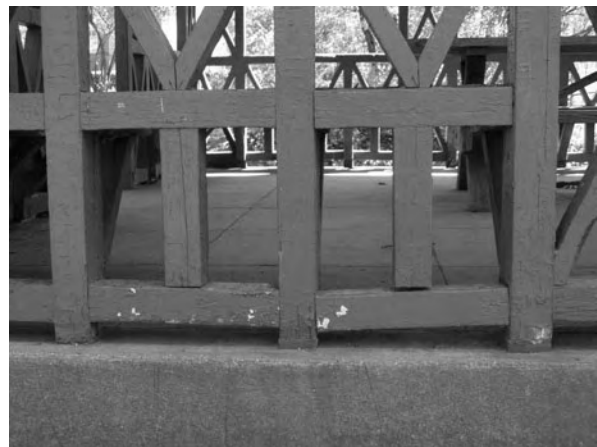
Figure 238. Another example of joint and connection failure of wood members at the Summerhouse. (Architrave, 2003).

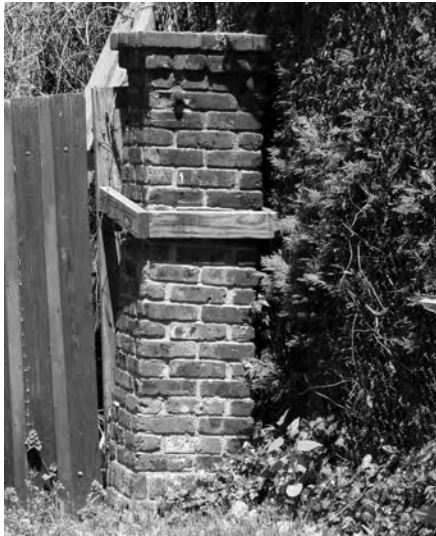
Figure 240. The east pier at the south gate to the service yard is tilting east. (Architrave, 2003).

- The brick and mortar on the building, including the chimneys and the site walls, appear to be in good condition, not requiring any work.
- The east pier at the south gate to the service yard is tilting east and looks as if some repair has been attempted (Figure 240).
- Both sets of wood gates to the service yard are deteriorated, out of plumb, showing signs of past repairs, with some deterioration of the wood.
- The joints at the junctions of both the women’s and men’s restroom screen walls where they join the main building walls are opened (Figure 241).

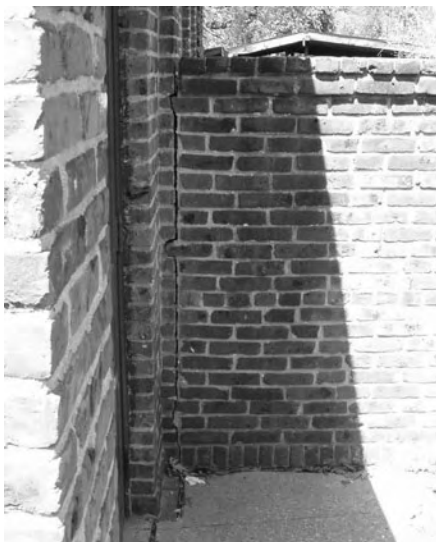
Figure 241. Open joint at wall connection at Lodge. Ad hoc roof in service area beyond. (Architrave, 2003).

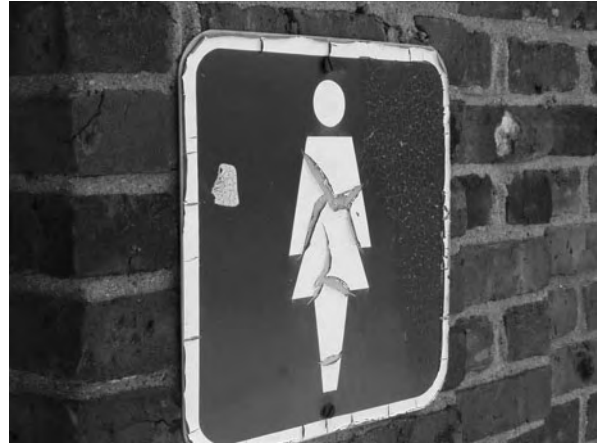
- The signs to the women's and men's restrooms are international pictographs but do not have the access symbol or any Braille identification. The paint on the women's sign is in very poor condition, lifting (Figure 242).

Figure 242. Paint lifting on women's restroom sign. (Architrave, 2003).

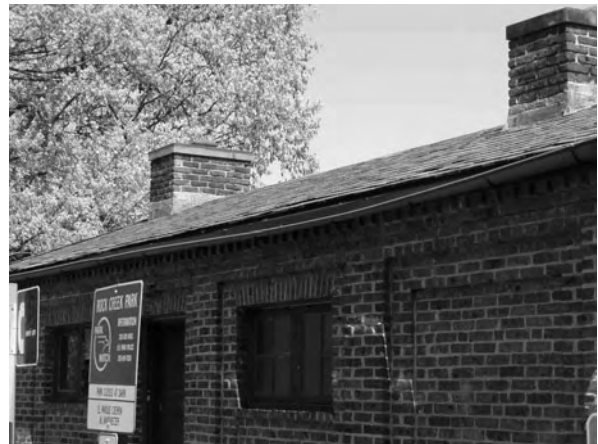
- The half round gutters appear to be in good condition.
- At the front, west, façade, of the Lodge, the gutter is bent downward (Figure 243).
- Deterioration of the slate shingles at this same approximate location is somewhat visible in this figure.

Figure 243. Gutter is bent on front side of Lodge. (Architrave, 2003).

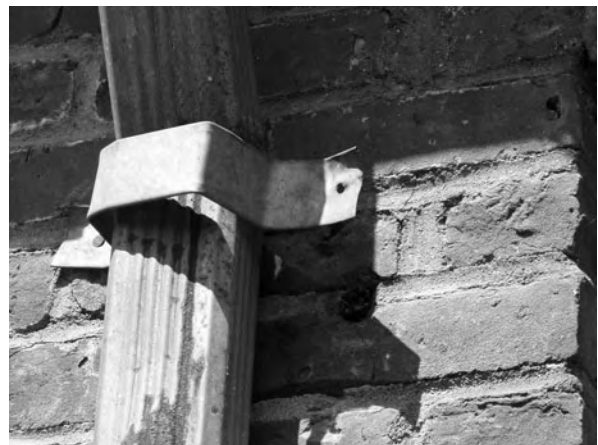
The four unpainted galvanized steel downspouts are all deteriorated. The straps securing them to the brick are, in some cases failing (Figure 244). In one instance, the bottom of the downspout is completely

Figure 244. Failing strap on galvanized steel downspout at the Lodge. (Architrave, 2003).

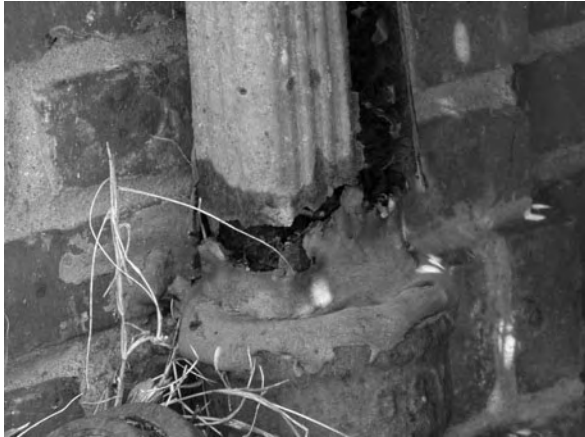
Figure 245. Rusty downspout at entrance to sewer hub at the Lodge. (Architrave, 2003).

rusting out just before it enters the hub to the sewer (Figure 245). The downspouts should be painted until they can all be replaced in round sections.

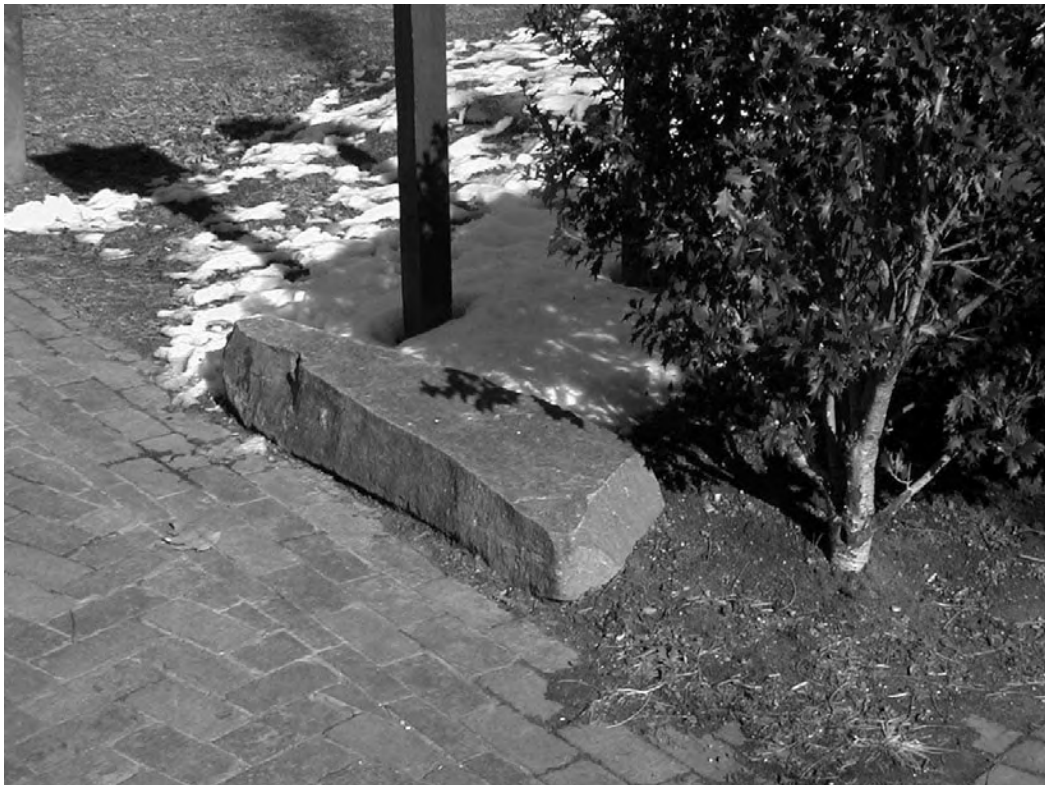
Figure 249. Possible remaining curb stone located on the east side of the Ropewalk entrance. See similarity in size and shape to historic stones shown in photo above. (Rhodeside & Harwell, February 12, 2003).

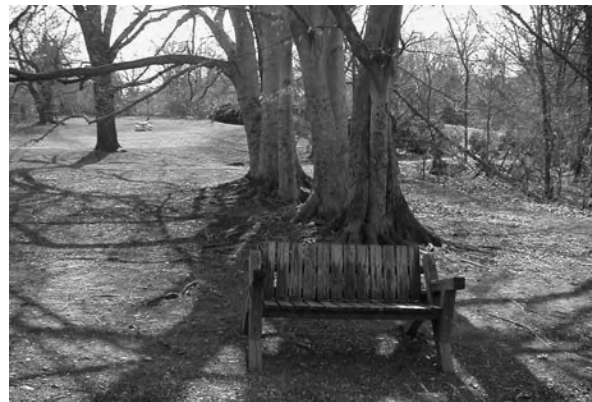
The park has many benches and picnic tables today, none of which are historic. Most of the benches are in good condition except for some of the rustic “Washington Benches,” missing arms or with rotted members (Figure 251). The picnic tables in the park range from fair to good condition, depending on their exposure to weathering and use. Visitors move some tables from place to place contributing to wear on the legs and support structure of the tables. This most often affects the most aesthetically pleasing wooden picnic tables, which are less durable than the tables with steel tube frames.

Figure 251. Washington Bench in the park showing signs of rot. (Rhodeside & Harwell, March 12, 2003).

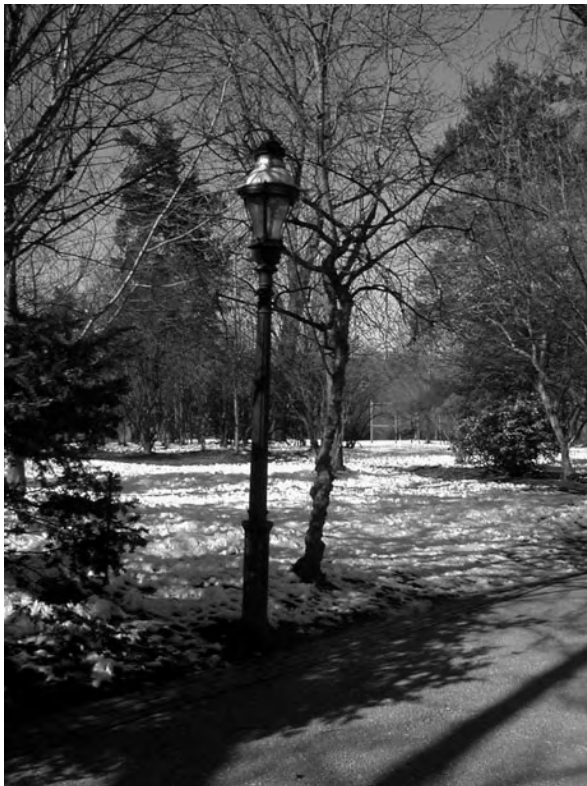
Figure 253. Tilting light pole on the west side of the Ropewalk. (Rhodeside & Harwell, March 12, 2003).
