THE FARM BUILDINGS at SAGAMORE HILL

Sagamore Hill National Historic Site
Oyster Bay, New York

Historic Structures Report

James J. Lee III
Architectural Conservator

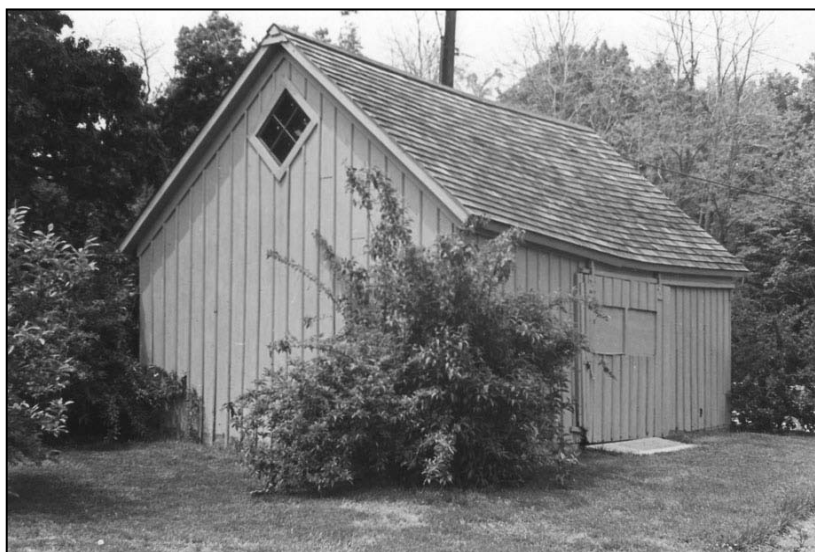
Figure 23. Gardener’s Shed: Looking northwest, ca. 1963.

Sagamore Hill was established as a National Historic Site in 1963. At that time the Gardener's Shed was apparently in good condition due to the 1957 renovations by the TRA. Photographs taken at that time depicted the building with a new roof and in good repair (fig. 23).

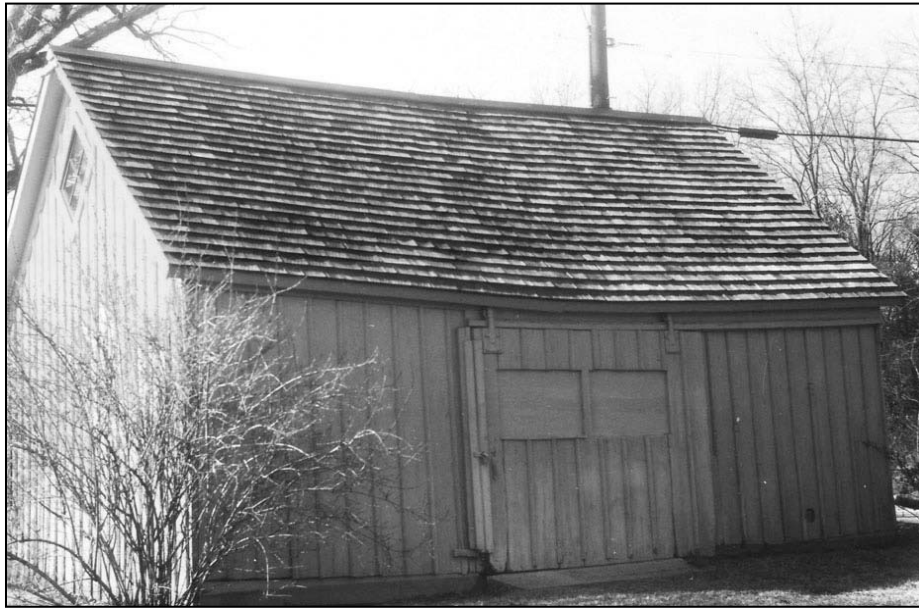
The NPS completed an *Individual Building Data* form for the "Gardener Shed; Bldg. No. 8" in January 1969. The form provided a description of the building and a brief evaluation of the conditions. At the time the Gardener's Shed was listed in good condition overall and good structural condition.⁶⁸ Photographs of the building taken at the same time recorded the existing conditions (fig. 24).

Figure 24. Gardener's Shed: Looking northwest, 1969.

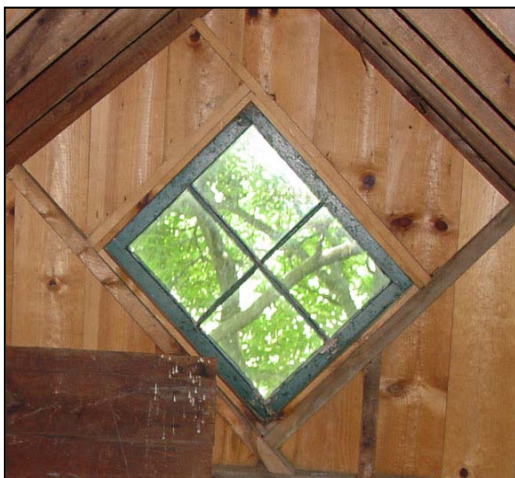
The Gardener's Shed has diamond shaped window openings in the gables of the north and south gable-ends. Both window openings have a single fixed sash with four lights and are cased with plain wood trim. They both also have a distinctive muntin style in which one muntin is wider than the other (figs. 29 & 30). A similar paint layering sequence was found on both window sashes. Based on these observations it appears that the windows are from the same period. In historic photographs the south window appears to be equal on all sides and the sash has square lights (figs. 19 & 20). However, the window currently on that elevation is rectangular (fig. 29). Examination of the extant north window, which is equal on all sides, indicates that it was not the original window in that opening. The framing of the north window opening was altered to accommodate the square sash and the earlier rectangular opening was filled in (fig. 30). It is not known whether the sashes were replaced or whether they were switched. However, the sashes do appear to be correct for the period of construction, which suggests that for some unknown reason they were switched during the TRA renovations.

Figure 29. Gardener's Shed: Interior of south gable window and sash, 2007.

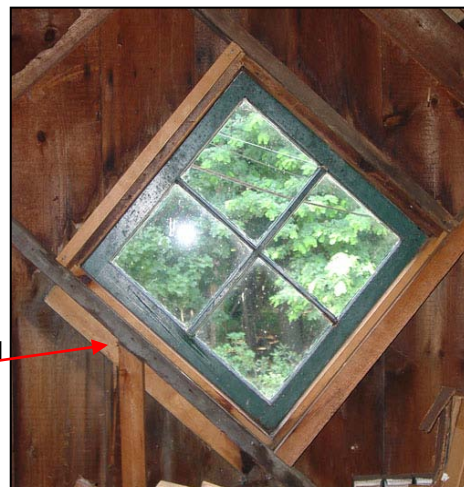
Figure 30. Gardener's Shed: Interior of north gable window and sash, 2007.

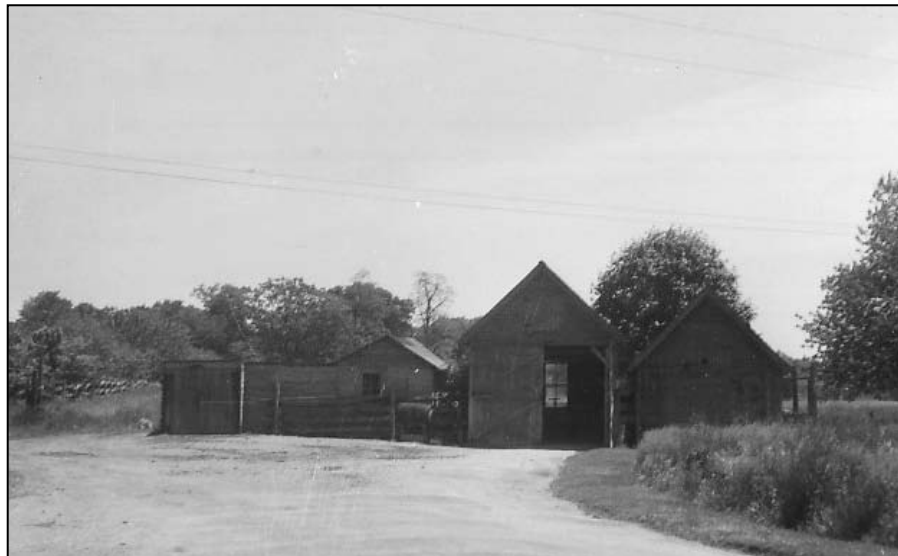
Figure 38. Farm Shed: Cow Shed to the north and Chicken House to the south, 1950.

Review of historic photographs of the Farm Shed suggested that the building was not significantly altered from the date of construction in circa 1900 through Edith Roosevelt's residency in 1948. A comparison of the earlier images (figs. 34 - 37) and the 1950 image (fig. 38) indicated that the building was largely unaltered during that time span.

The Farm Shed was listed as the “Caretaker’s Garage” in the insurance inspection and survey dated June 1950 (Appendix A). It was described as a frame building measuring 12 feet by 18 feet by 13 feet with one story and an attic, a shingle roof, and concrete floor. The survey also noted that there was no heat or light in the building.⁸² The insurance documents were accompanied with photographs (fig. 38) and provided information regarding the use and historic appearance of the building.

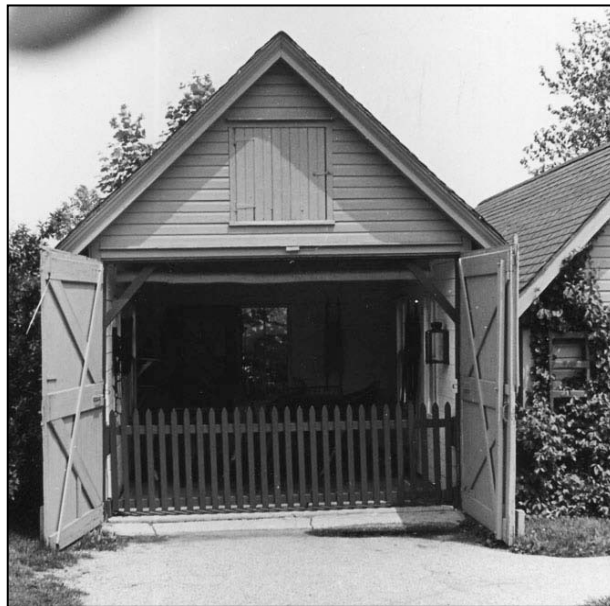
The maintenance of the Farm Shed by the TRA helped to preserve the building as an example of the farm buildings at Sagamore Hill. When the NPS took over the site, the Farm Shed appeared to be in good condition (fig. 40).

Figure 40. Farm Shed: West elevation, ca. 1963.

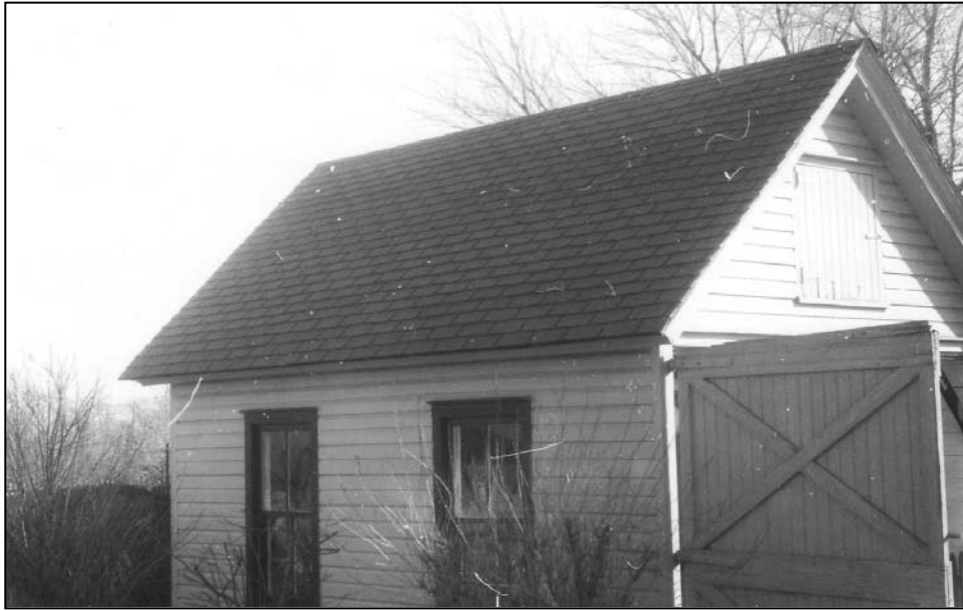
The *Individual Building Data* form for the “Carriage Shed; Bldg. No. 9” dated January 31, 1969 recorded that the structure was in good condition overall and good structural condition.⁸⁹ The survey of the building included photographs depicting the condition of the building at the time (fig. 41). The photographs indicated that the building remained in good condition and depicted that the siding of the building was painted a lighter color than the window trim and sashes (Appendix D).

Figure 41. Farm Shed: North elevation and west elevation gable, 1969.
Note lighter siding paint color and darker window trim and sashes.

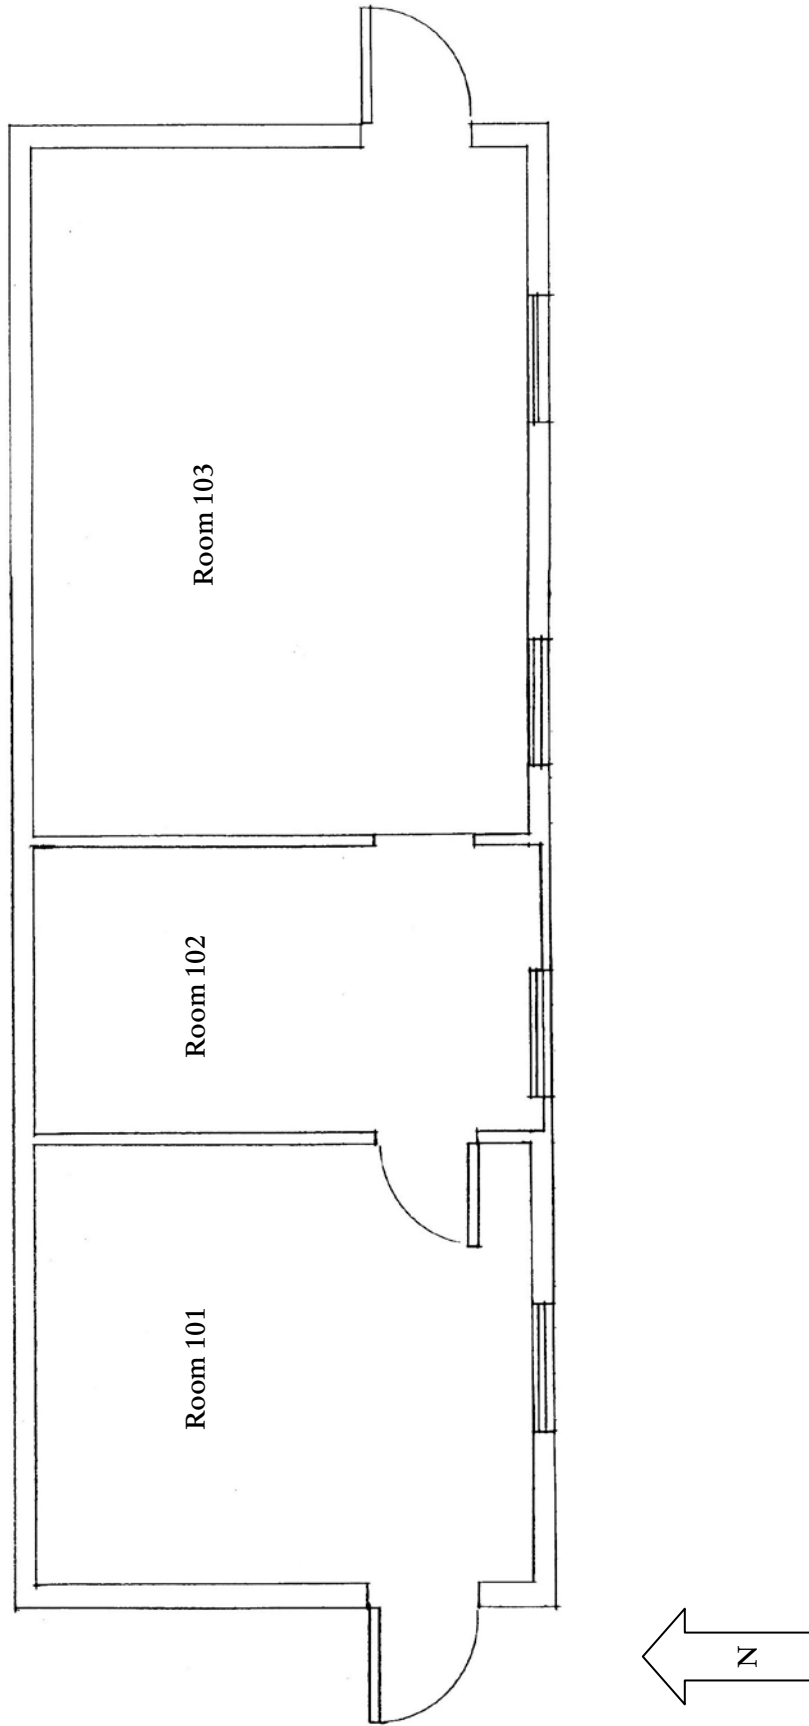
The Chicken House was a long rectangular building with a gable roof. It was a single story building with a loft and measured 12 feet 2¾ inches wide by 32 feet 2¼ inches long (fig. 50). The gable ends of the building faced east and west, and the west elevation was level with the west elevation of the Farm Shed.

The Chicken House was constructed with a first story and a second story loft. The first story of the building was divided into rooms by partitions that ran north-south (fig. 50). Each room had a doorway near the south end of the partition wall and/or the exterior wall. There were also openings on the south wall of each room, which were previously described. The area of the first story was approximately 384 square feet.

Figure 50. Chicken House: Existing first floor plan (not to scale), 2007.

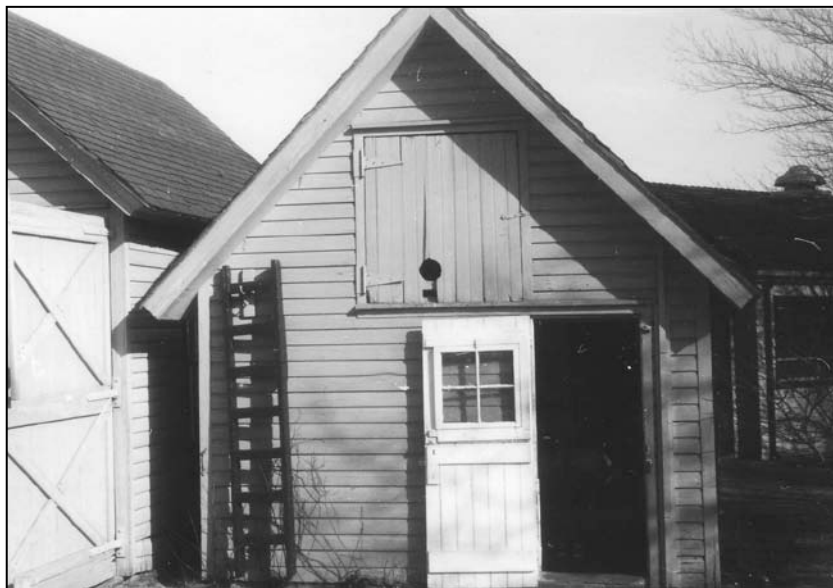
After the 1956 – 1957 alterations, the Chicken House was well maintained by the TRA and was in good condition when the NPS took over Sagamore Hill. The west elevation of the building retained its original elements, preserving some evidence of the former structure (fig. 53).

Figure 53. Chicken House: West elevation, ca. 1970.

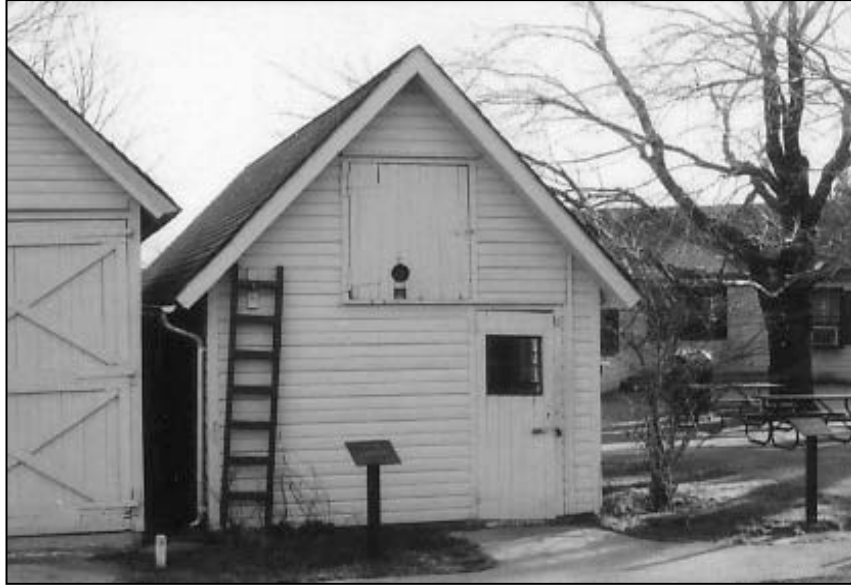
Figure 54. Chicken House: West elevation gable, ca. 1980. Note lighter siding paint color and darker window sash in door.

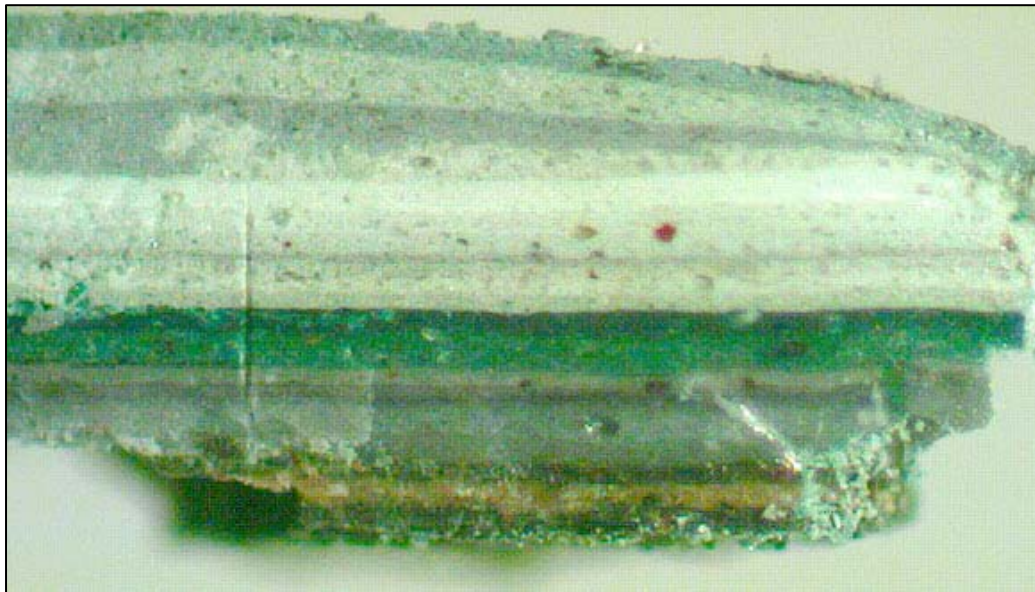
Figure 99. Gardener's Shed paint sample from vertical board siding (P004).

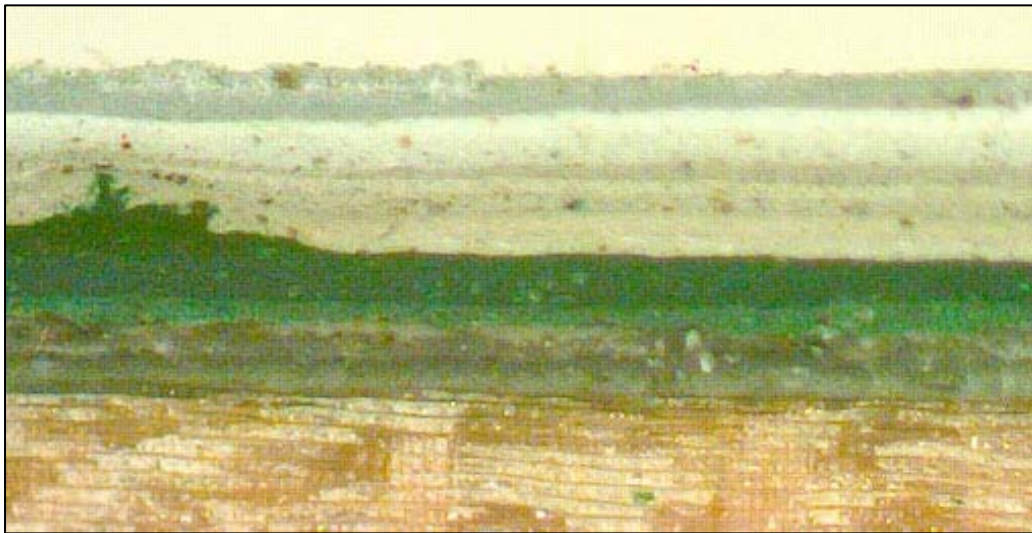
Figure 100. Farm Shed paint sample from horizontal drop siding (P011).

The current paint analysis determined that the exterior of the Farm Shed was finished with a gray paint color during the Roosevelt period. It is recommended that the rehabilitation of the exterior elements of the Farm Shed should include the application of the exterior gray paint color that is specified in Table IV.

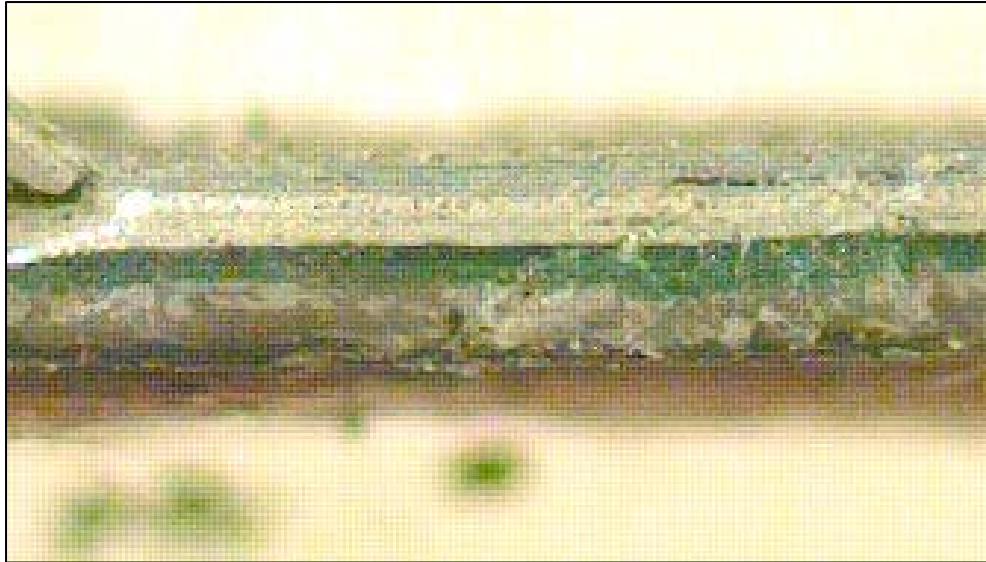
Figure 101. Chicken House horizontal drop siding (P014).

The current paint analysis determined that the exterior of the Chicken House was finished with a blue gray paint color during the Roosevelt period. It is recommended that the rehabilitation of the exterior elements of the Chicken House should include the application of the exterior gray paint color that is specified in Table VI.

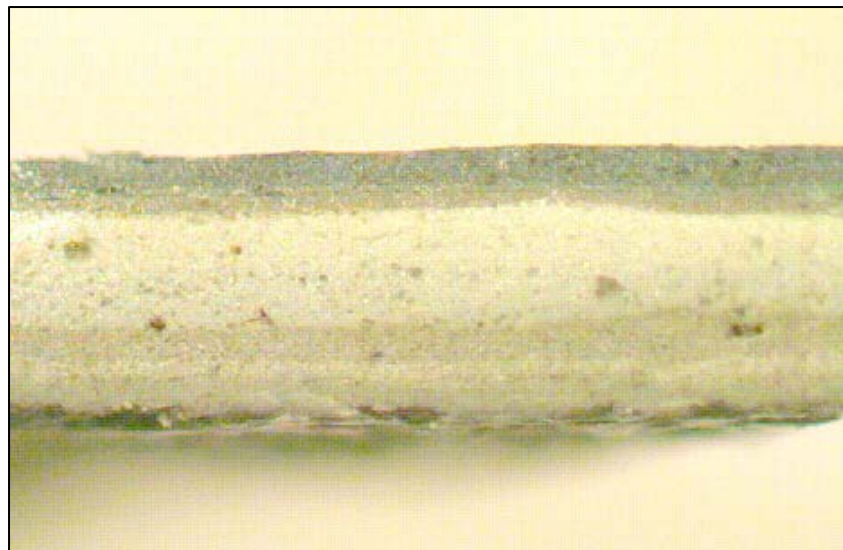
Figure 102. Chicken House replacement horizontal drop siding (P007).

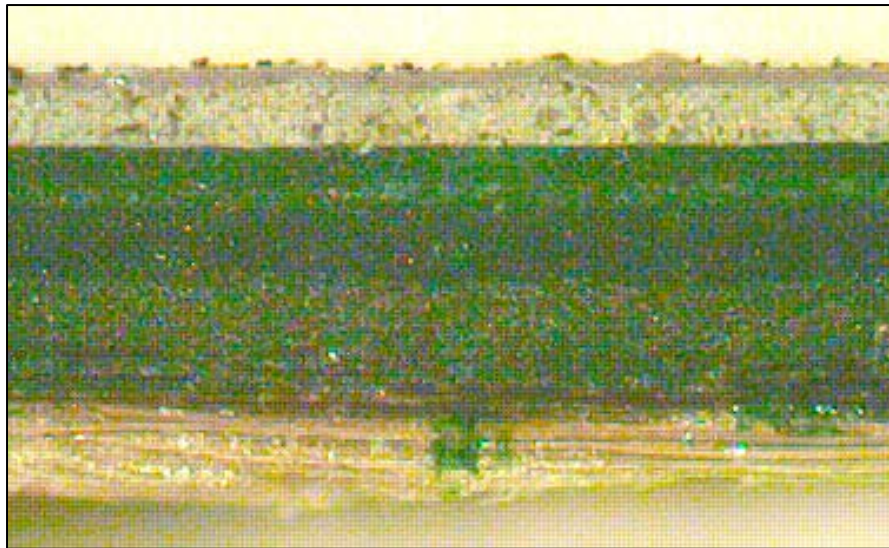
Figure 104. Ice House south entry doorway portico, pediment molding (P013).

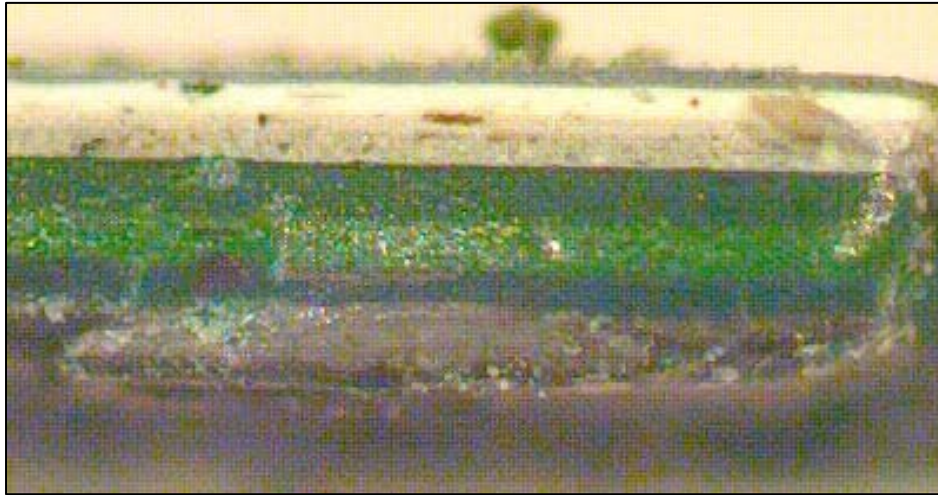
Figure 105. Pump House south gable-end rake (P001).

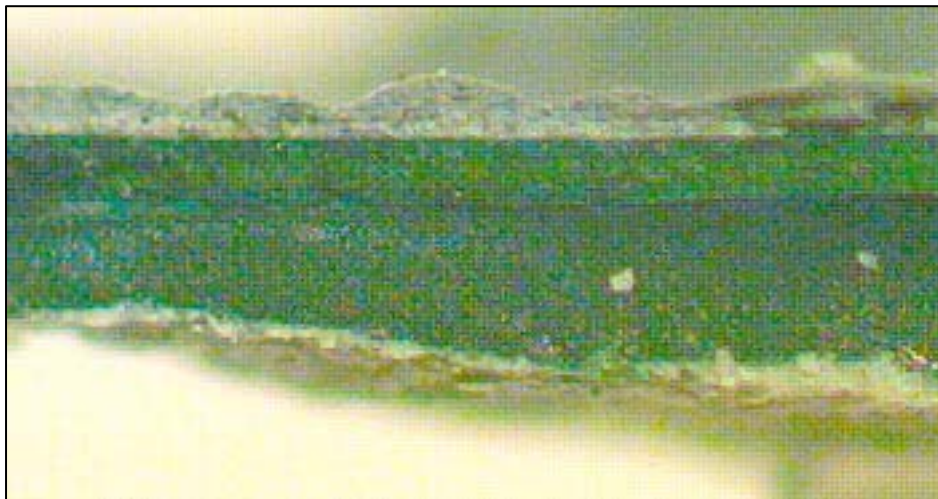
Figure 106. Hose Reel House at north end of Pump House,
north gable-end rake (P004).
