THE NEW BARN

HISTORIC STRUCTURE REPORT

Sagamore Hill National Historic Site
Oyster Bay, New York

2005

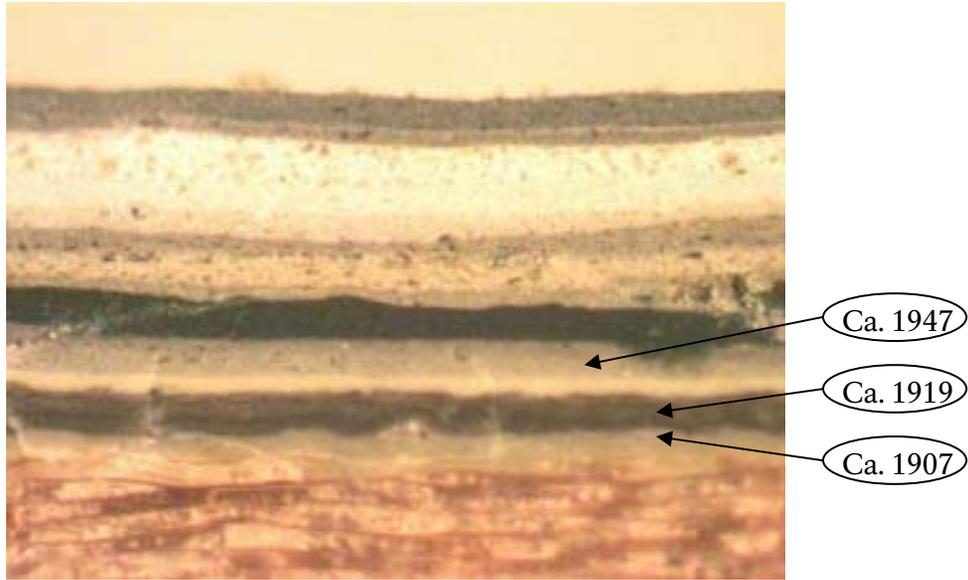
The New Barn was constructed ca. 1907, and a magazine article from that same year described that the barn was being painted gray (see Original Appearance). Samples from the original elements [cornice molding (P001), soffit (P006) and vertical siding (P011)] confirmed the presence of the earliest gray paint (fig. 44). As demonstrated in Table I., the exterior of the barn continued to be painted a gray color through the period that Theodore Roosevelt was associated with the site, and indeed throughout the entire Roosevelt family tenure. The samples from the vertical siding corroborated the evidence found on other original elements.²

Figure 44. Cornice molding paint sample (P001), 2005.

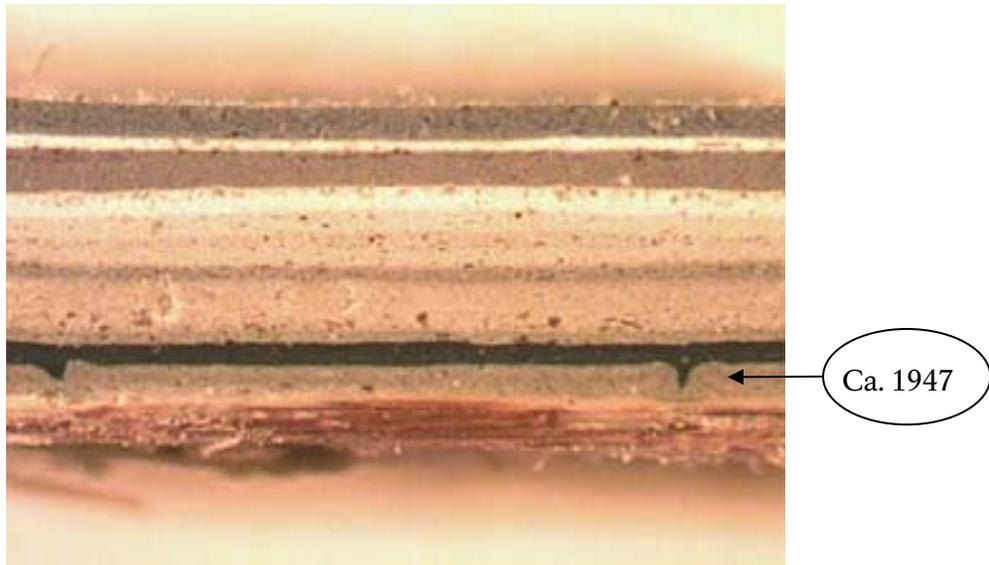
As previously discussed, the dates ascribed to particular paint layers are based on documentation and physical evidence. The paint color applied to the exterior after the barn was converted to a garage and residence ca. 1947 was apparent on the building materials applied during that conversion (fig. 45). During the stewardship of the TRA, records indicate that the building was painted ca. 1952 and ca. 1957. The paint evidence indicates that both of these exterior applications were a gray- colored paint. However, the dark green paint found on all elements sampled may date from the end of the TRA period or the beginning of the NPS period. As described in the section “Alterations,” it appears that the NPS painted the New Barn about every five years. Photographs and maintenance contracts were useful in determining some of the dates.

Figure 45. Horizontal clapboard siding paint sample (P004), 2005.
