THE FORTIFICATIONS OF SAN JUAN NATIONAL HISTORIC SITE

HISTORIC STRUCTURE REPORT

Summaries
Conditions Survey
Recommendations
Glossary
Bibliography
Selected Historic Drawings
Appendices

1991

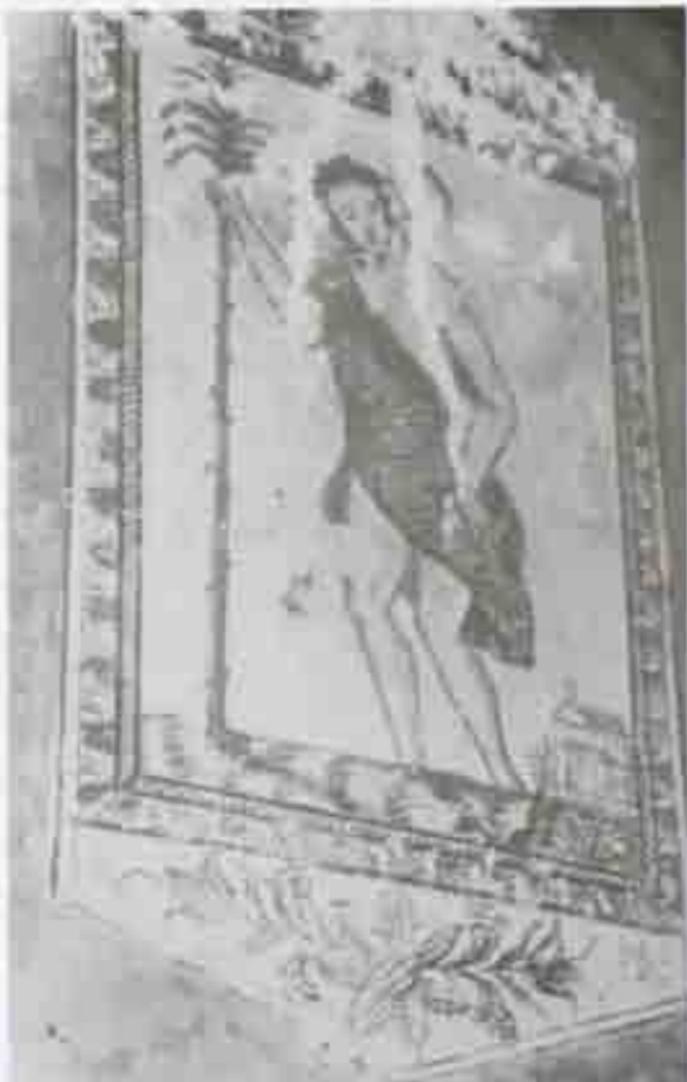
Figure 27. San Cristóbal, painted figure in cistern.
(Photo by T. T. Waterman, ca. 1919. SAN JUAN MHS
Archives.)

Illustrations executed with black paint on some interiors (eg. the San Cristóbal cisterns, the dungeon of San Cristóbal, and the tower room of el Morro) are in poor condition. Both the stucco substrate and paint are powdering and a great deal of loss has occurred. A photograph from ca. 1938 depicts the painting of St. Christopher in the cistern of San Cristóbal (fig. 27).¹⁴ Some deterioration is evident; today the image is nearly completely obliterated (fig. 28).

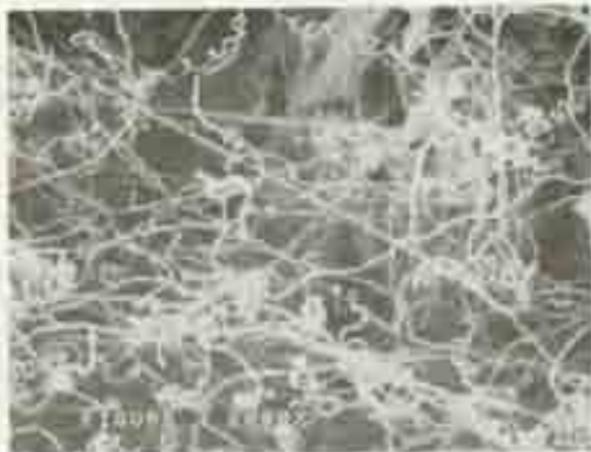
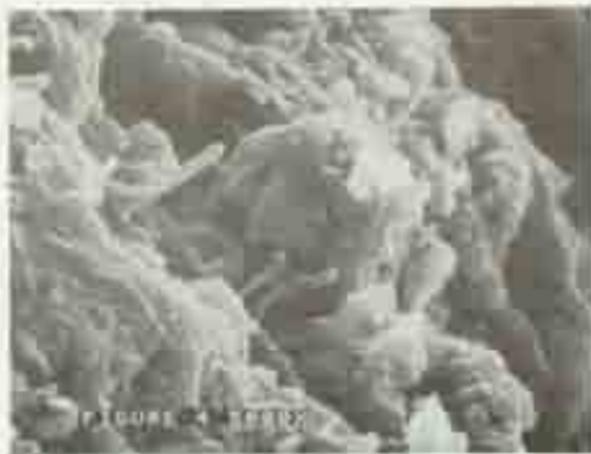
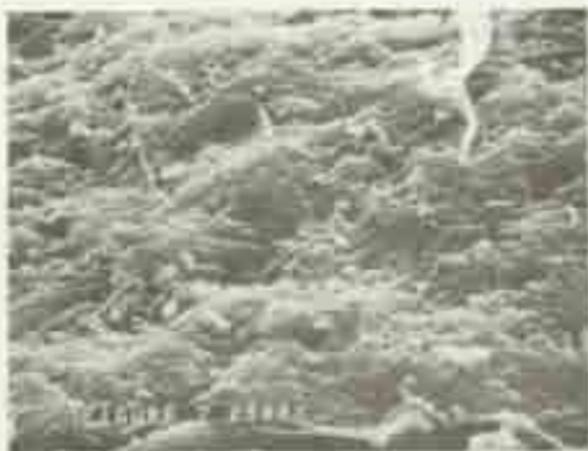
Scanning electron micrographs taken from samples of el Abanico are presented in figures 1 through 7. The surface of the stone was extensively covered with microbiological growths. Figures 1-3 show the extensive network of fungal hyphae that covers large parts of the samples. Even in apparently microbiologically-clear areas, at higher magnifications fungal hyphae and other microorganisms can be found, figs. 4 and 5. In other samples, the microorganisms had completely covered the surface of the stone with a biological "mat," figs. 6 and 7. Figure 6 shows an apparent layer of microbial exudate covering the upper half of the image. One long fungal hypha is visible in the center bottom, coming out of the layer. Figure 7 shows what look like rod-shaped bacteria in a layer of microbial exudate.

Figure 2. Scanning electron micrograph taken at 500x. Another sample of el Abanico stone showing extensive fungal-hyphal network.

Figure 3. Scanning electron micrograph taken at 2000x. Higher magnification view of fungal colony.

Figure 4. Scanning electron micrograph taken at 5000x. Relatively poorly colonized area of el Abanico stone. Note the presence though of some fungal growth tips.

Figure 6. Scanning electron micrograph taken at 2000x. Biological secretions or "mat" in upper half of the figure. Exudate probably from a mixture of algae, bacteria and fungal.

Figure 7. Scanning electron micrograph taken at 2500x. Biological "mat" on surface of stone. Rod-like bacteria are apparent as are fungal growth tips.

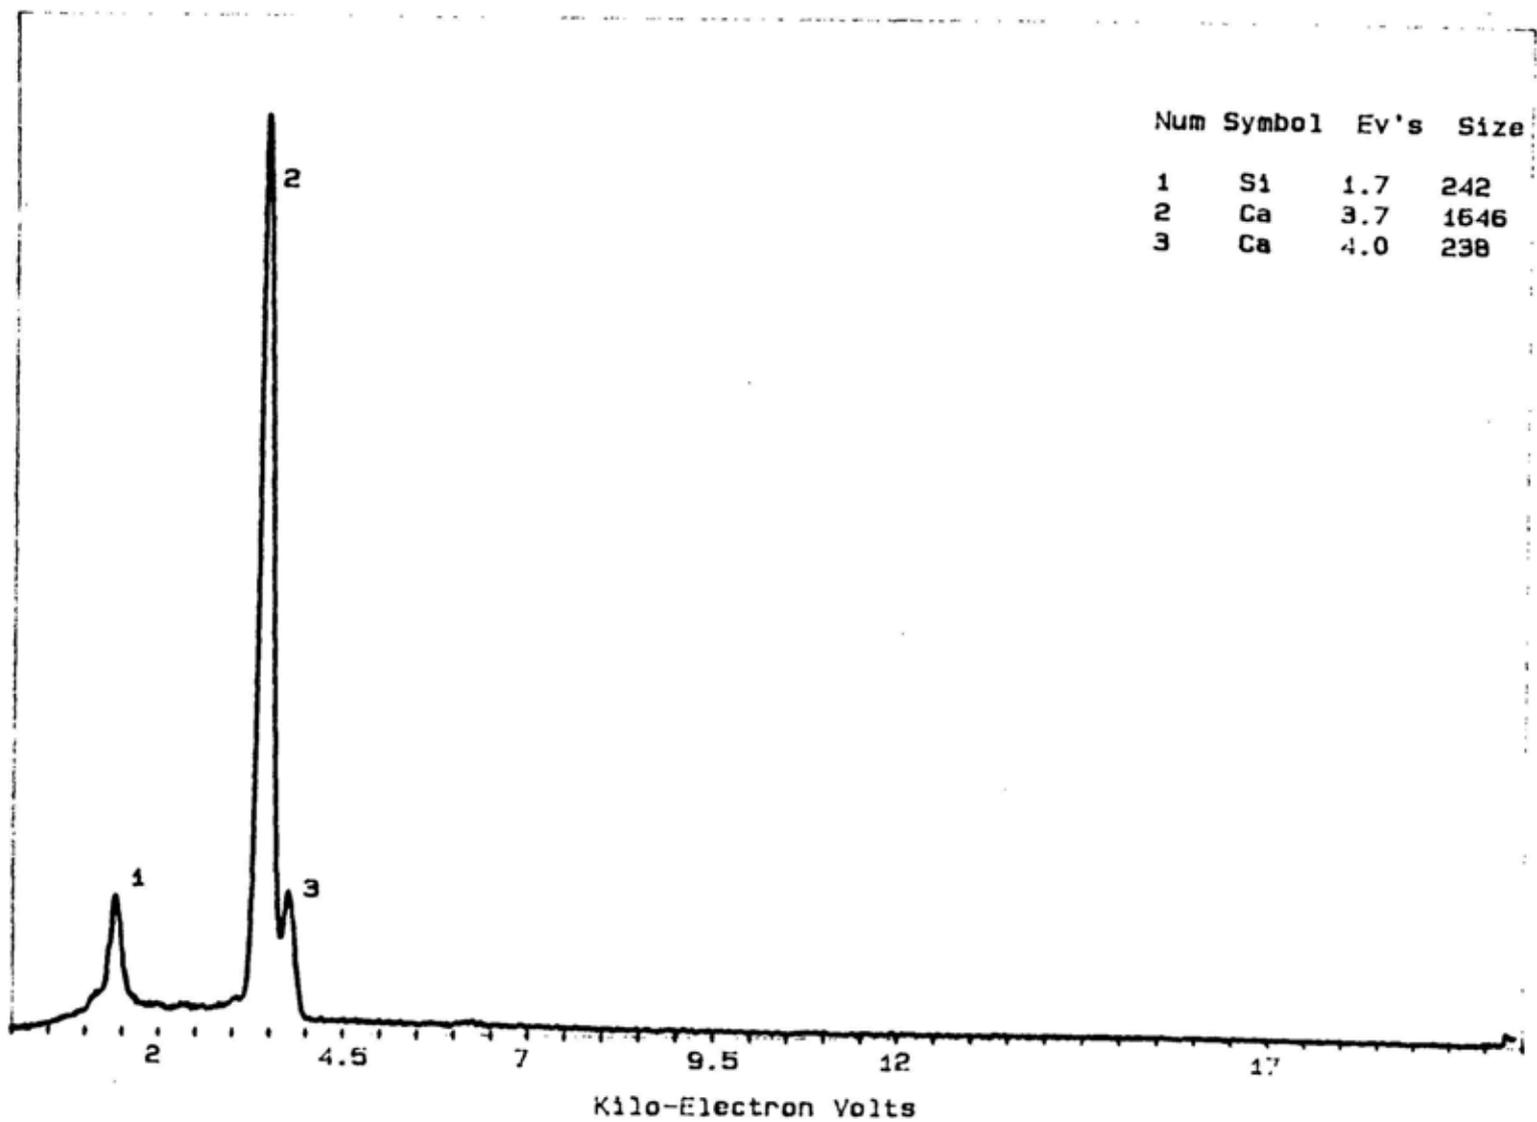
The X-ray spectrum from the clean interior (obtained by fracturing the sample) is in Figure 1. Silicon (Si) and Calcium (Ca) are the only elements (in addition to oxygen and other elements with low atomic numbers (less than 9), which are not detected by the energy dispersive X-ray technique utilized). In contrast, the spectrum in Figure 2 from a dirty area on the surface of a sample indicates the presence of many other elements and a much higher relative amount of Si, possibly from pickup of silicate (i.e., fine sand). In particular, there was a high concentration of sulfur (S), as you postulated in your letter.

Figure 1. X-ray Spectrum from the clean interior of a piece of stucco (obtained by fracturing a sample).

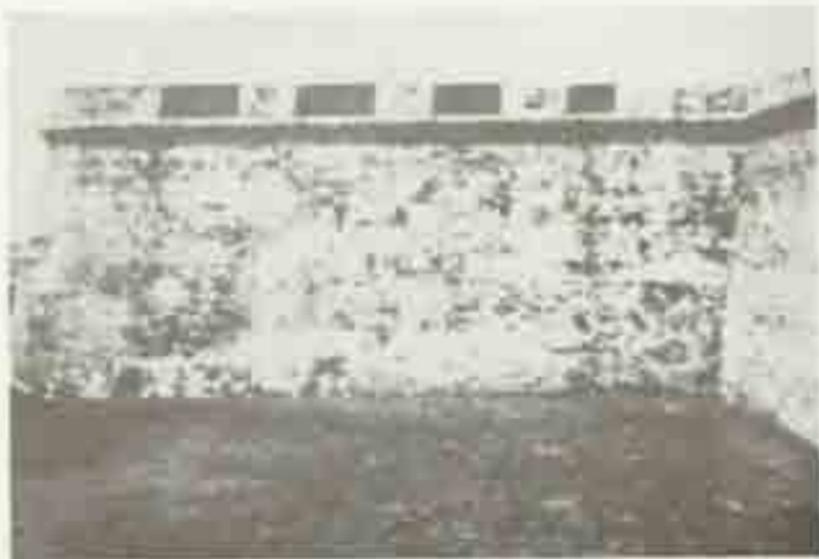
Figure 3. Photograph of the Study Area and the Flanking Battery Wall of Austria Bastion Prior to Excavation.

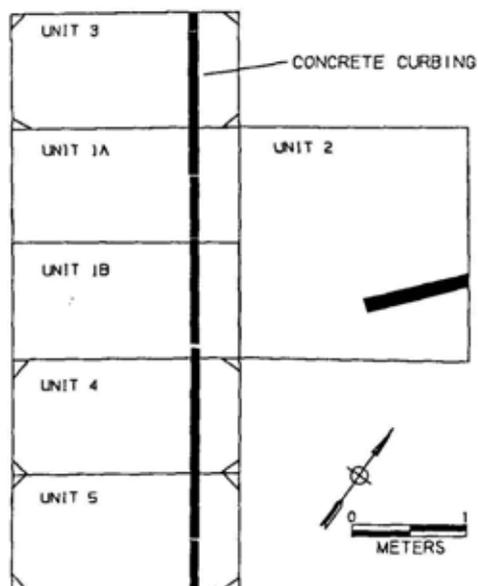
Figure 9. Location of Concrete Curbing in Units 1 through 5.

A sketch drawing of the fort made in the 1930s depicted a tennis court in the immediate vicinity of the excavation. During the 1961 investigations Smith found remains of this tennis court which he notes was of concrete and was present in the area in 1926. Evidence for the tennis court during the 1990 project was found in the form of concrete curbing underlaid with a red clay stratum. The red clay stratum was identified by Smith (1962) as the base for the tennis court. The curbing was found 1.4-1.5 meters out from the fort wall at 40-60 cmbs. The curbing runs parallel to the flanking battery wall. Four connecting sections of the curbing extended across units 3, 1, 4, and 5. A discarded section of the curbing was also removed from unit 2 (Figure 9). A footer was located adjacent to the curbing in unit 4 that initially was

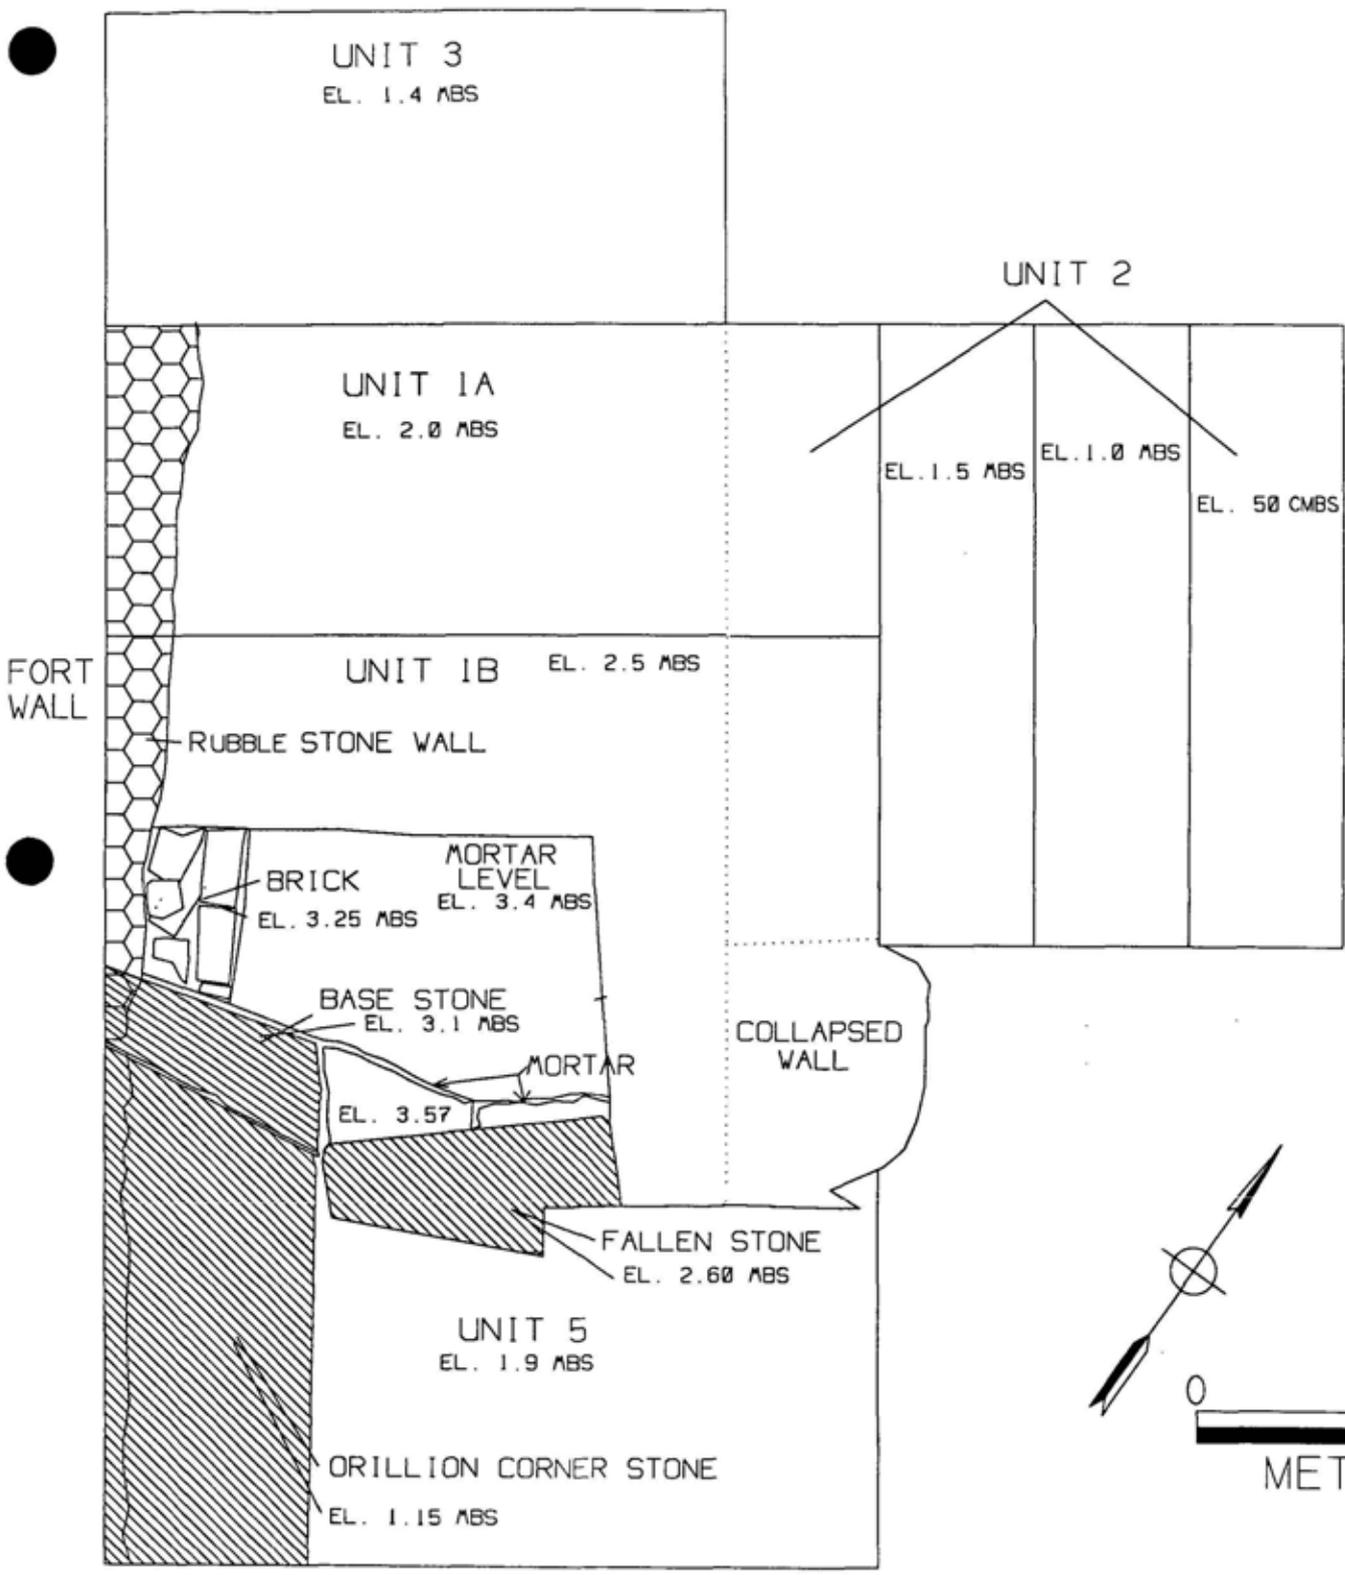
Figure 15. Plan View of Excavated Area.

Excavation reached the base of the rubble stone wall in the southeastern quarter of unit 1B at 3.25 meters below the surface (Figure 15). At the base of the wall two parallel courses of brick were located; the bricks were attached to the rubble stone wall and laid with their long axis to the wall (Figure 16). Three courses of the bricks were recorded. Whole bricks measured 28 cm long, 10 cm wide and five cm thick. A prepared level of mortar and sandstone was also found in association with the courses of brick. This mortar and sandstone level sloped away from the brick to 3.36 meters below the surface. The last 50 centimeters of soils atop this mortar floor were divided into three zones (A, B, and C) according to color and texture (Figure 16). Within zone C 11 pottery sherds identified as refilled earthenware (Smith 1962) were recovered. No date for this type of ware has been determined; however, the recovery of brick fragments identical to those used along the base of the rubble wall indicated that these redfilled sherds were deposited during the later half of the 18th century. Smith (1962) had also located this prepared floor and brick courses at the base of his excavations along the flanking battery wall. He excavated a portion of the floor and found it to be approximately 12 centimeters thick.

The stones of the vertical wall are 70 cm wide and between 40 and 45 cm thick except for a base stone which is 30 cm thick. The base stone extends out 30 cm from beneath the upper stones to the northwest providing a footing. The length of the stones was not determined as they continued beyond the width of the excavation (Figure 15).

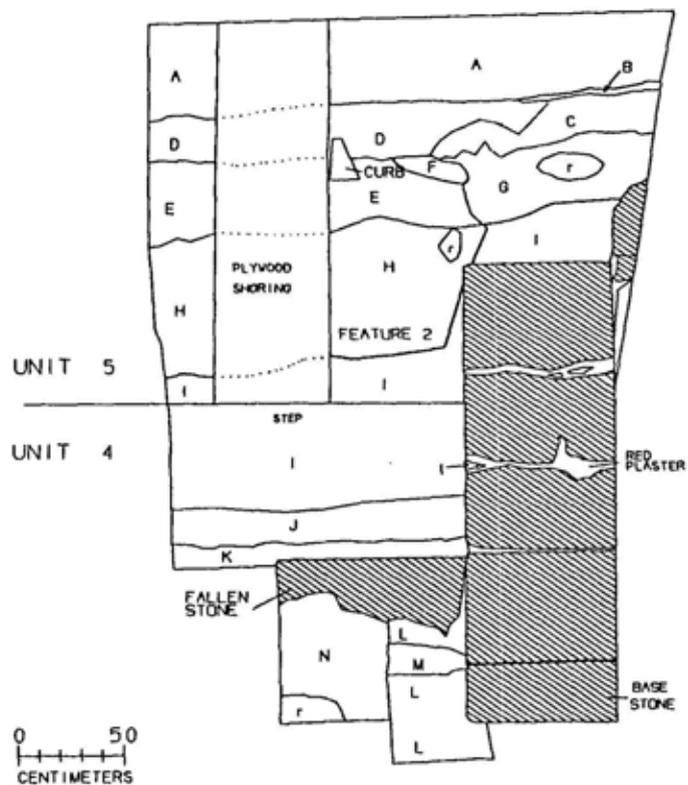
Figure 18. Units 4 and 5, Southeast Profile with Rubble Stone Wall and Mortar Level.

At 1.15 meters below the surface in unit 4 a large stone was encountered that altered the course of the investigations (Figure 11). After consultation with the Historic Architect it was decided that excavations be shifted in order that the deepest point reached in the excavation be located adjacent to this stone. The stones horizontal angle suggested that it was the corner of the orillon as it was identical to the angle depicted in the 1742 drawing of the fort (Figures 1, 15 and 17). Excavation down along the southeast edge of the stone revealed a vertical wall of solid construction consisting of five stones laid without batter or scarp on any exposed sides. It was obvious that this vertical stone wall had been constructed at a different date than the battered wall of dressed stone and the rubble stone wall (Figures 18 and 19).

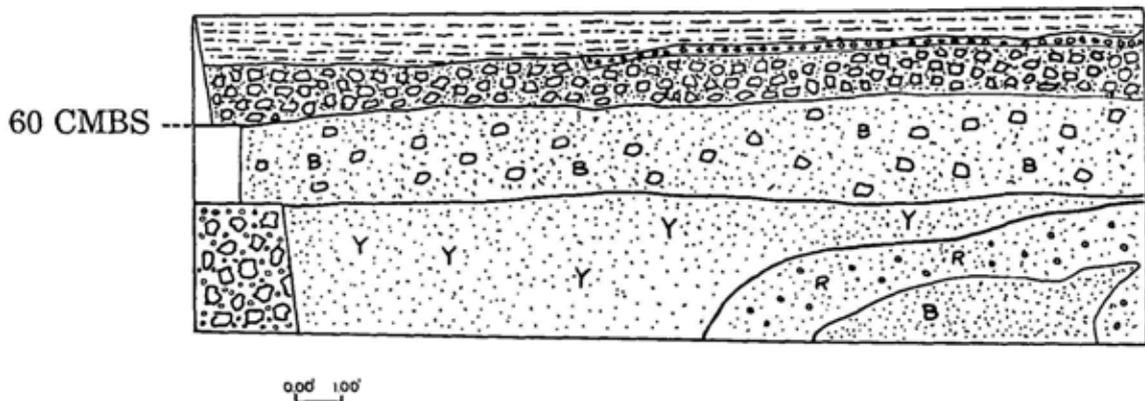
Figure 21. Northeast Profile of Trench A Located Along the Curtain Wall as Excavated in 1961 (Smith 1962).

Along the flanking battery wall, however, the ca. 1602 hornwork was used as foundation for the present battered wall. It occurred at the same depth (1.95 cms) as the rubble wall used to fill the orillon. The orillon was filled to the curtain wall as this rubble construction was located by Smith in 1960 at the juncture of the curtain wall and the flanking battery. In that the rubble wall, ca. 1773, was also used as foundation for the battered wall confirms that the walls presently in view above grade, within the moat area, were constructed in the late 18th century and constructed to a point at which the terreplein of the bastion is now 3.5 meters above the remains of the ca. 1602 level. Excavation of the soils adjacent to the rubble wall indicated that the moat was filled 2.8 meters during the ca. 1773 reconstruction and not after the reconstruction was completed as had been indicated in previous investigations. The lack of a surface finish to the face of the orillon fill indicates the likely intent of filling the moat from the onset of construction in ca. 1773. The brick courses and mortar level located at the base of the rubble wall were attached to the rubble wall and the mortar used was of the same materials as used in the rubble wall. These features, therefore, were determined to be the footing for the rubble wall and not the moat floor as had been suggested (Smith 1962). The footing course at the base of the orillon corner was assumed to be the level of the original orillon floor.
