# THE FORTIFICATIONS OF SAN JUAN NATIONAL HISTORIC SITE

## HISTORIC STRUCTURE REPORT

El Fuerte de San Cristóbal

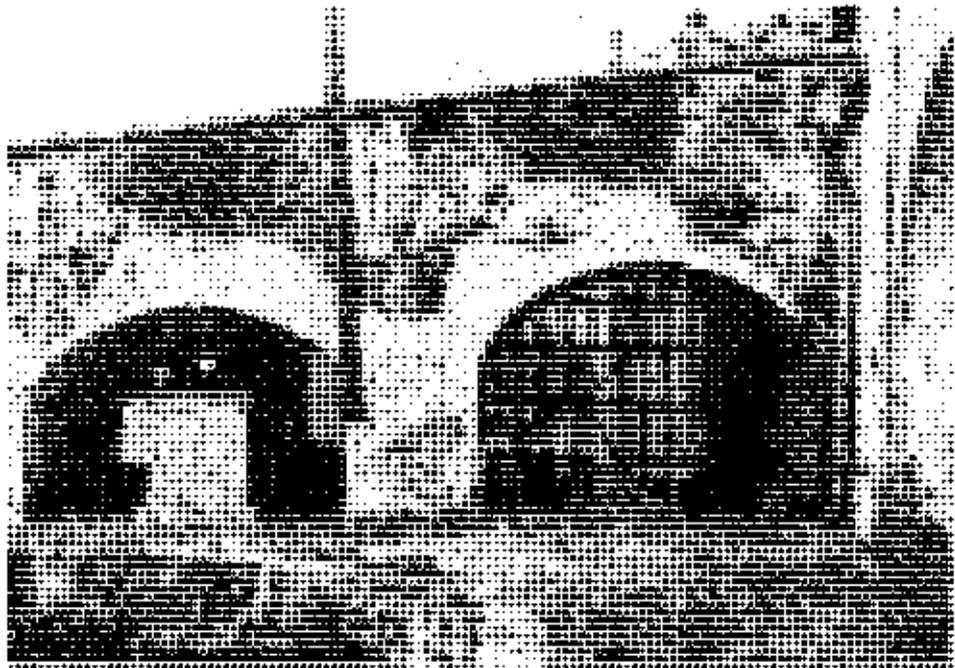
of the ramp are two elliptical brick barrel vaults (Nos. 1 and 2). The western vault (No. 2) is now infilled on the north face (fig. 1.3). This rubble infill has in turn been punctured by a large rectangular opening and two smaller openings to the west. The east vault (No. 1) is larger and only

FIGURE 1.3. Two elliptical barrel vaults partially infilled and of masonry ramp. (Photo by Mrs. L. H. L.)

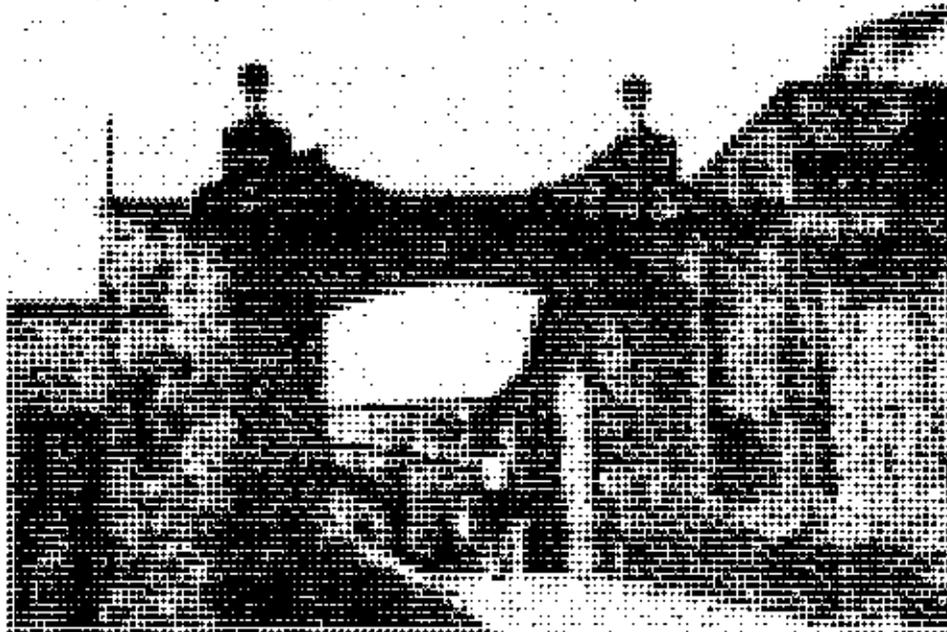
Figure 1.4. East elevation of Main Gate to San Cristóbal. (Photo by CPR, 1986.)

The present condition of the Main Gate itself is relatively sound with problems primarily affecting surface materials. In general, the gate's frontispiece (western elevation) is in stable condition with open joints and minor missing elements observed at both pilasters. More serious deterioration is concentrated on the eastern (rear) elevation of the gate and its adjacent wall to the north. Because the gate itself is a freestanding open structure with all surfaces exposed to the elements, its fabric is particularly susceptible to deterioration. Long-term problems, such as excessive moisture absorption, may be related to poor maintenance and repair procedures.

The sandstone pilasters of the west elevation show widespread, but uniform, differential weathering. This weathering however, is much less discernible on the five lowest stone courses that were replaced during the 1968-70 period with a similar sandstone.<sup>15</sup>

There are minor areas of stone loss on the northern pilaster's capital and molding, as well as areas of severe erosion. Both conditions were documented in photographs taken during the early 1960s. Missing fabric of the segmental arch and capital of the southern pilaster have been patched with repairs that are easily discerned. The ornamental stone finials are in good condition, although both show weathered and rounded profiles. Leaching deposits can also be seen on the thin necks of each finial.

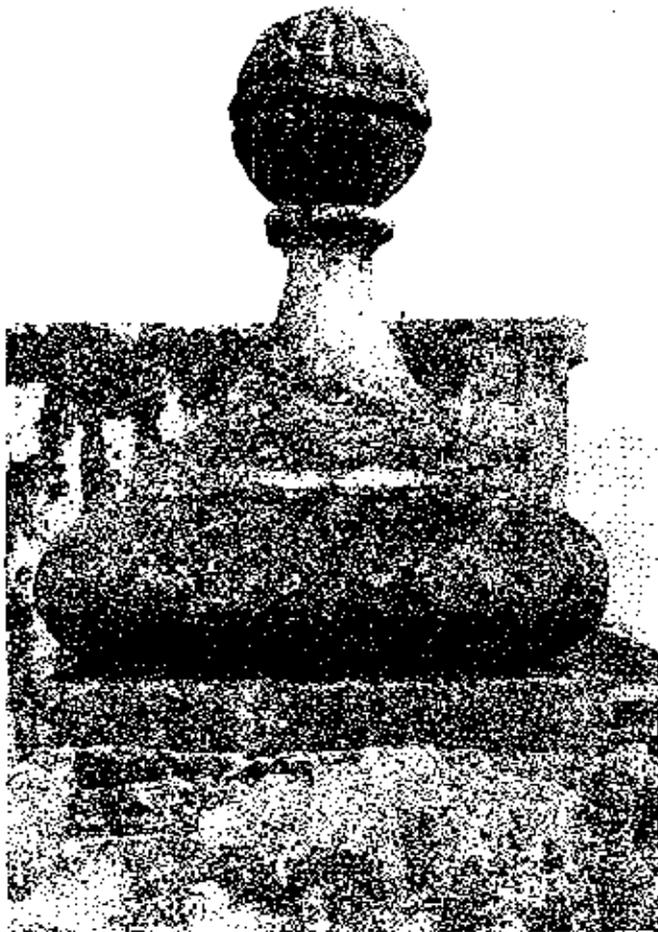
Figure 1.6. Carved finial on Main Gate's post. (Photo by CFR, 1986.)

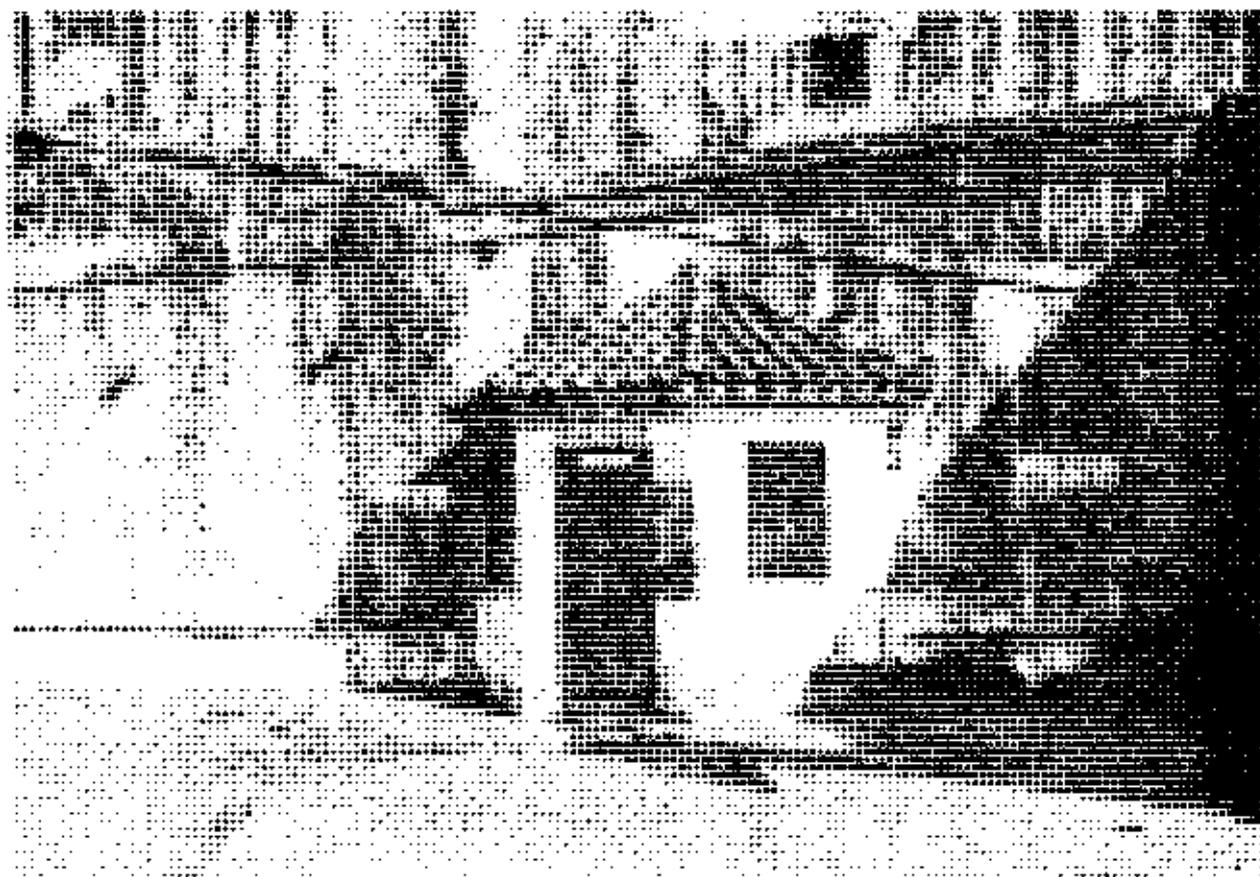
Figure 5.14. View of modern paint shop at base of ramp to el Caballero. HABS photo by Jack Boucher, 1960.

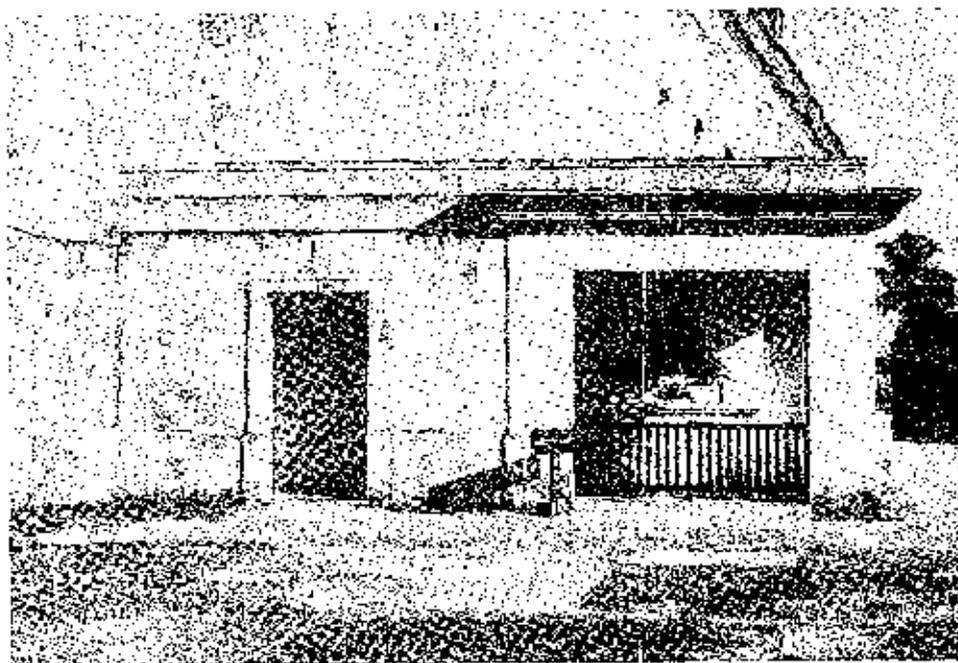
Figure 6.2. North elevation of the Chapel. Photo by Richard Crisson, 1986.

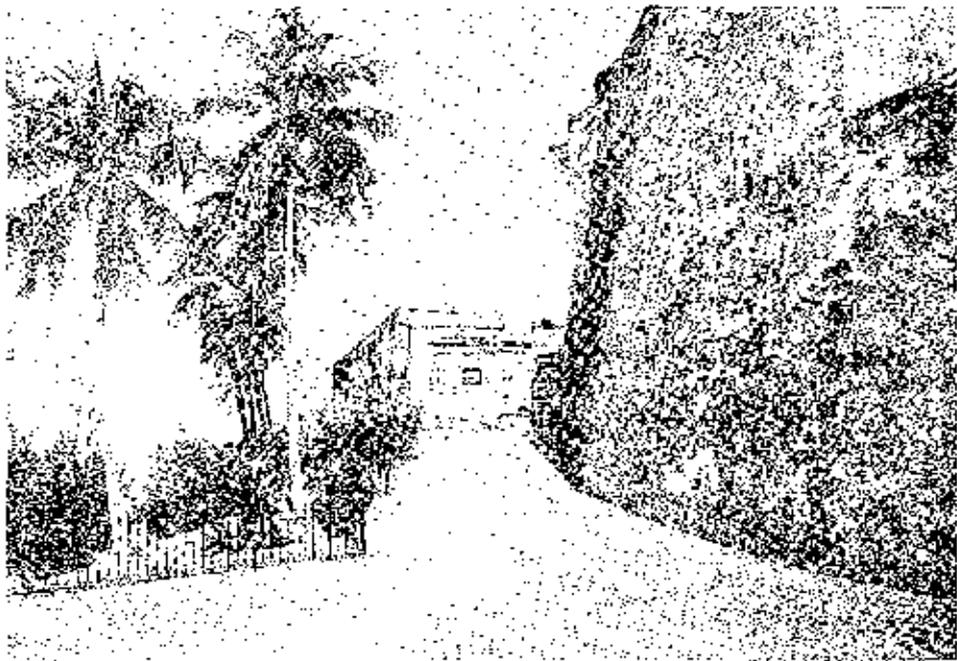
Figure 8.1. View of the South Gate looking north into the Plaza de Armas. Photo by CPR, 1986.

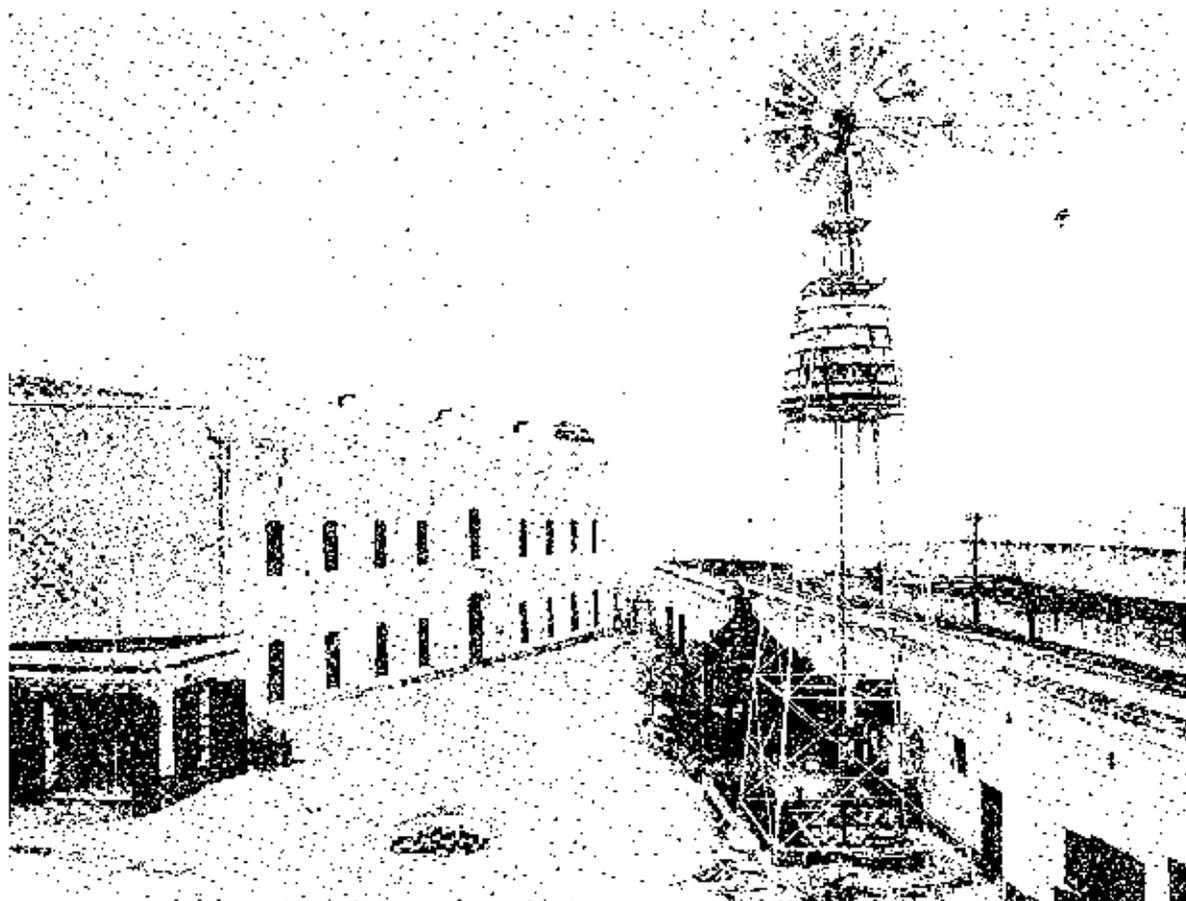
Whether or not the exterior was restuccoed within the next few years is not recorded, although a photograph (fig. 9.14) of the northwest facade dated ca. 1905 seems to show it in good repair except for a crack at the upper north corner, west facade.<sup>21</sup> In fact, the west facade was virtually unchanged from the elevations of 1861. Coloration, although shaded in black and white, appears to have been similar. Louvered shutters, which differed only slightly by having a panel in their lower sections, were still in place in the windows. The flagpole formerly located at the northwest corner of the roof was missing. The base support was shown in place, but the pole itself was most likely taken down in 1902 when a new 75 foot flagpole was installed elsewhere on el Caballero.<sup>22</sup> The four artillery pieces emplaced sometime after 1861 on the roof were still extant in the ca. 1905 photograph.

Figure 9.14. View dated ca. 1905 showing west and north elevations of the Troops' Quarters. (HABS negative 181.25.)

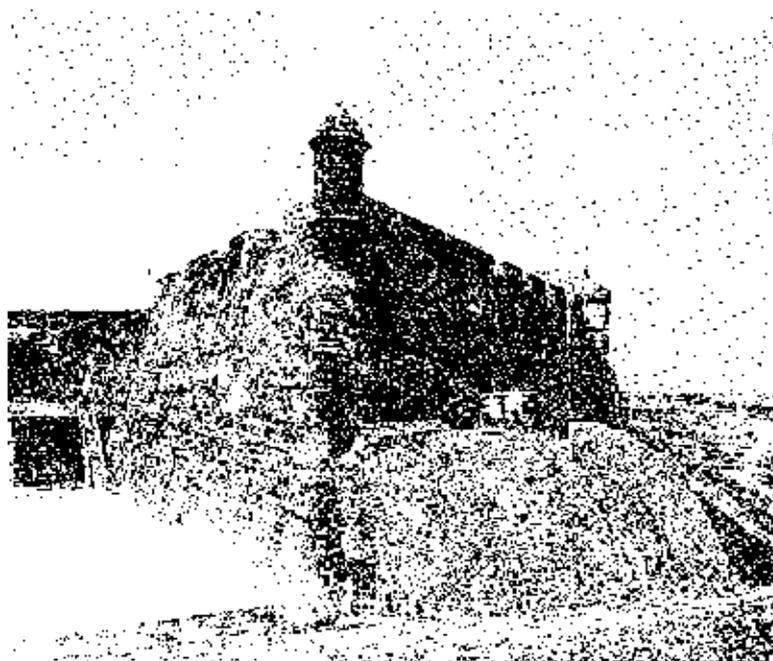
Figure 10.4. North and east walls of the North Bastion with sentry box. Photo by CPR, 1986.

The masonry of the North Bastion appears to exhibit two distinct systems that may relate to the raising of the earlier bastion in 1765. The sentry box (fig. 10.4) located at the northwest salient angle of the bastion is one of the few early echaugettes (sentry boxes) to survive. It is bonded to the upper wall. Like the salient angle, it is constructed of finely cut ashlar block set with brick spacers.

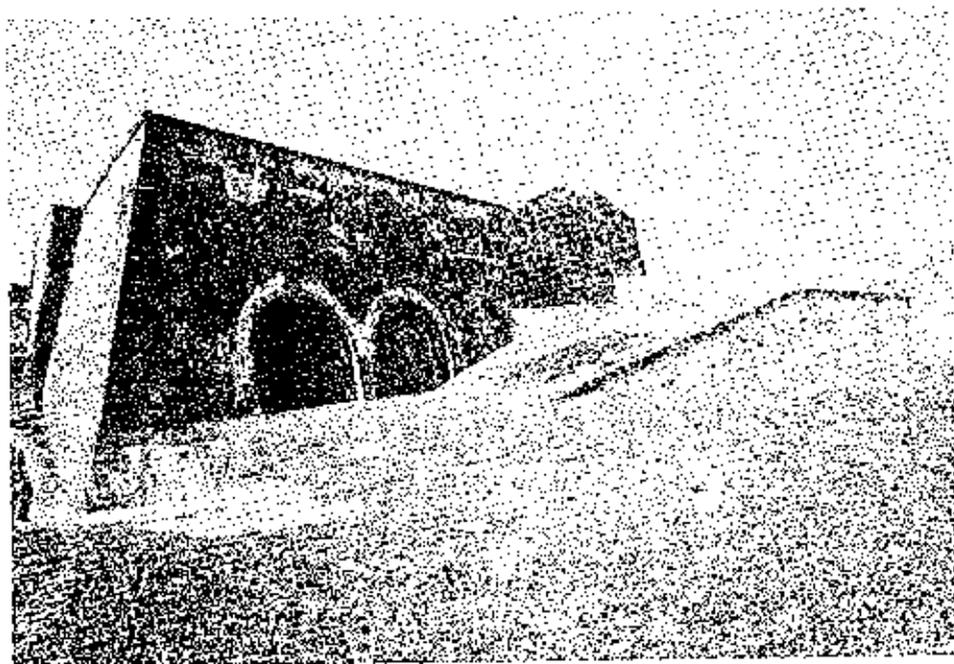
Figure 14.6. Arched openings to casemates extending beneath terreplein of upper level. Photo by CPR, 1986.

On the lower level to the north of the ramp lie the openings to casemates that extend beneath the terreplein of the upper level (fig. 14.6). The two eastern casemates measure about 12 feet by 27 feet. The western casemate about 12 feet square. All three are barrel vaulted chambers. The western and center casemates are linked by a small arched passage.
