## historic structure report

TUSKEGEE INSTITUTE  
THE OAKS

NATIONAL HISTORIC SITE / ALABAMA

HISTORIC STRUCTURE REPORT

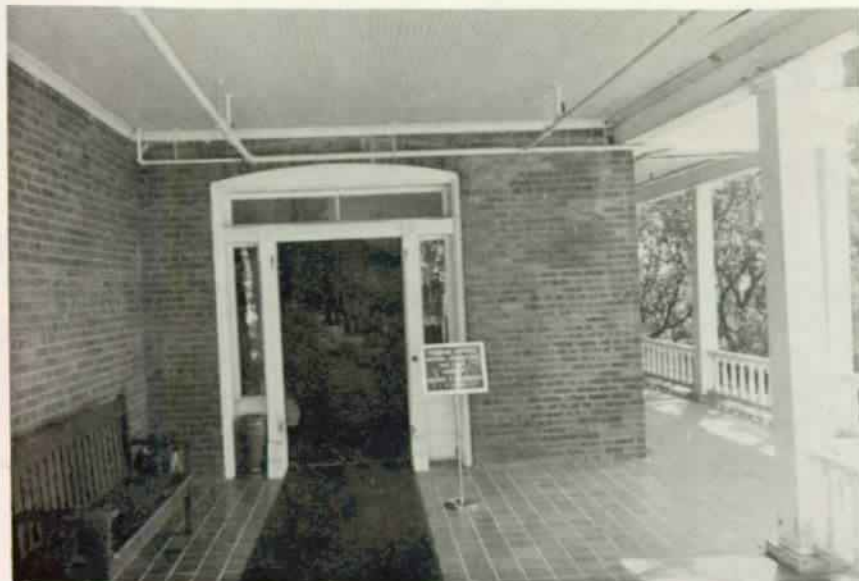
P2 — Porch Two — Looking South

PORCH TWO (cont.)						RECOMMENDATIONS						
EXISTING CONDITIONS					HISTORICAL DESCRIPTIONS		PRESERVE	REPAIR	REPLACE IN KIND	REMOVE	INSTALL	COMMENTS
ELEMENT	MATERIAL	CONDITION	PERIOD	COMMENTS	MATERIAL	COMMENTS						
Parlor Window	Masonry opening	Good	1899		Same		x					Store in attic Repaint
	Frame	Good	1899	Plain wood	Same		x					
	1/1 d.h. sash	Good	1899	Cylinder glass	Same		x					
	Screen sash	Good	1925	Two panels	None					x		
	White paint	Good	Inst.	Munsell N 9.5/	Brown paint	Munsell 2.5YR 3/4					x	
Ceiling Light	Metal, glass	Fair	1910	Incandescent	Same			x				
Electric	Mechanism	Poor	1910	In northwest corner	Same			x				
Floodlight	Metal, glass	Good	Inst.	Incandescent	None					x		
Fire Exting.	Metal	Good	Inst.	Five nozzles	None					x		
	Green paint	Good	Inst.	Munsell 10GY 8/4	None					x

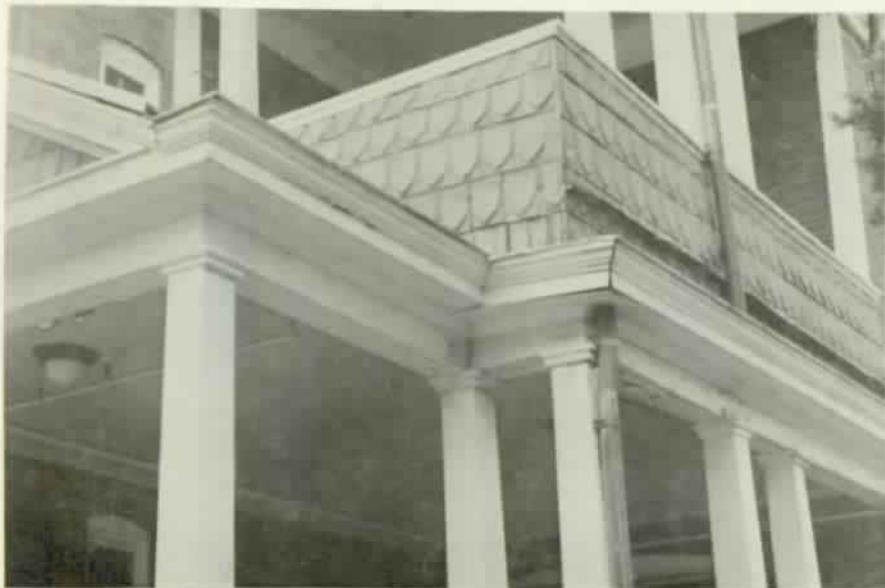
P7 — Porch Seven — Interior of Northwest Corner

Sheet metal	Good	Inst.	Pressed metal, outside wall	None					x	
	Shingles	Fair	1899		Same					x	Reshingle
	Brown paint	Fair	Inst.		Red paint	Munsell 8.5R 3.5/6				x	Paint new shingles
Woodwork	Posts (6)	Fair	1899	Including two pilasters	Same			x			
	Eaves	Fair	1899	Two different types	Same			x			
	White paint	Good	Inst.	Munsell N 9.5/	Brown paint	Munsell 2.5YR 3/4				x	Repaint
Doorway to Front Hall	Masonry opening	Fair	1899	Some mortar loss	Same			x			
	Frame	Good	1899	Plain wood	Same						Repoint as needed
	Transom	Good	1899	Single pane, cylinder glass	Same		x				
	Screen door	Good	1925	Munsell N 9.5/	None					x	Store in attic
	White paint	Good	Inst.		Brown paint	Munsell 2.5YR 3/4				x	Repaint
Front Hall Window	Masonry opening	Fair	1899	Some mortar loss	Same			x			
	Frame	Good	1899	Plain wood	Same						Repoint where needed
	2/2 d.h. sash	Good	1899	Cylinder glass	Same		x				
	Screen sash	Good	1925	Two panels	None					x	Store in attic

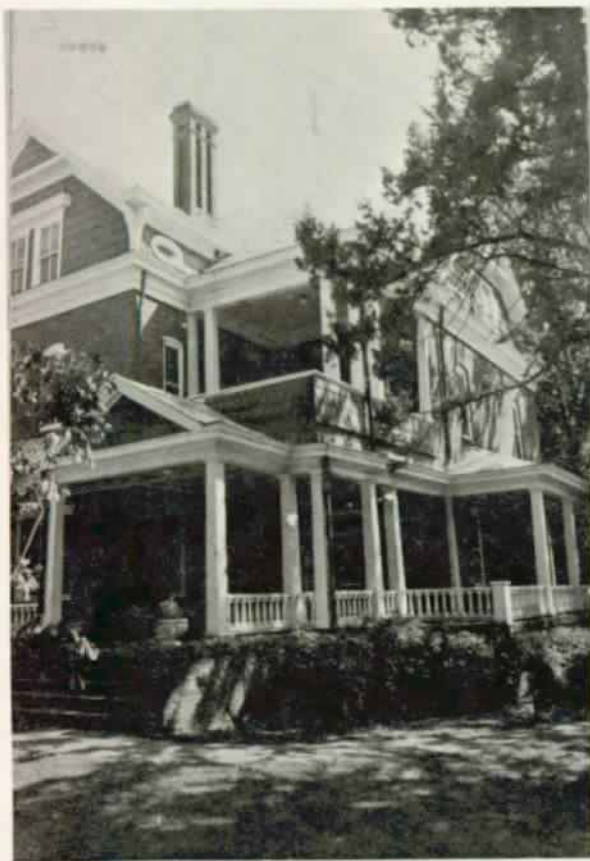
Northwest Corner

EXISTING CONDITIONS					HISTORICAL DESCRIPTIONS							COMMENTS
ELEMENT	MATERIAL	CONDITION	PERIOD	COMMENTS	MATERIAL	COMMENTS	PRESERVE	REPAIR	REPLACE IN KIND	REMOVE	INSTALL	
Lower Wall	Brick	Good	1899	Pink pointing mortar	Same		x					Repoint as needed
	Mortar	Fair	1899, Inst.		Same			x				
Third-floor Wall	Shingles	Fair	1899	Pressed sheet metal	Same	Munsell 8.5R 3.5/6				x	x	Reshingle Paint new shingles.
	Brown paint	Good	Inst.	Not sampled	Red paint					x		
Woodwork	Cornice	Fair	1899	Between 2nd and 3rd floors	Same	Munsell 2.5YR 3/4		x				Repaint
	Eaves	Fair	1899	At gable end	Same			x				
	White paint	Good	Inst.	Munsell N 9.5/	Brown paint						x	
Window, Boys' Bedroom	Masonry opening	Fair	1899	Plain wood Cylinder glass Two panels Munsell N 9.5/	Same	Munsell 2.5YR 3/4		x				Repoint as needed  Store in attic Repaint  Repaint as needed  Store in attic Repaint  Repaint
	Frame	Good	1899		Same		x					
	2/2 d.h. sash	Fair	1899		Same			x

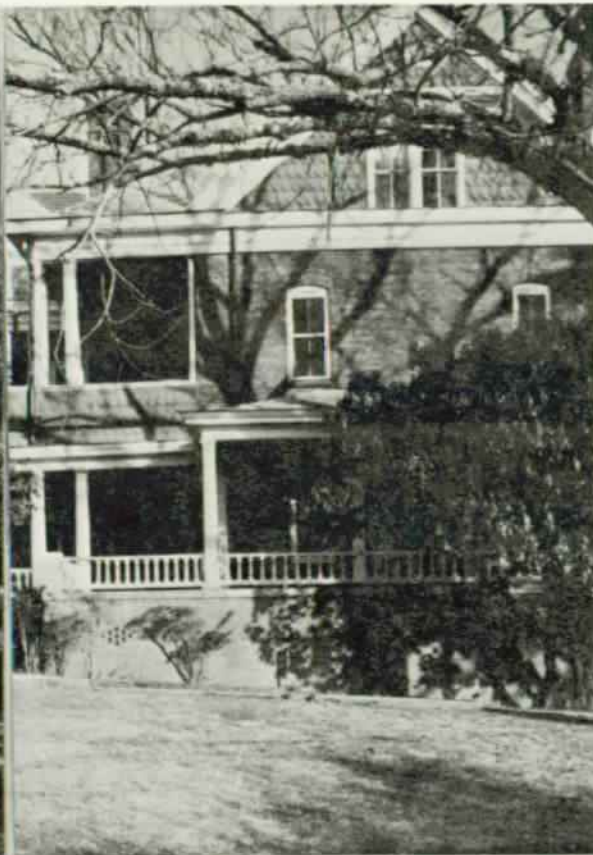
West Elevation

Screen sash	Good	1925		None					x		
	White paint	Good	Inst.		Brown paint						x	
Window, Front Hall	Masonry opening	Fair	1899	Plain wood Cylinder glass Two panels Munsell N 9.5/	Same	Munsell 2.5YR 3/4		x				Store in attic Repaint  Store in attic Repaint  Repaint
	Frame	Good	1899		Same		x					
	2/2 d.h. sash	Fair	1899		Same			x				
	Screen sash	Good	1925		None					x		
	White paint	Good	Inst.		Brown paint						x	
Windows, Third Floor (2)	Frame	Good	1899	Plain wood	Same	Munsell 2.5YR 3/4	x					Repaint
	2/2 d.h. sash	Fair	1899	Cylinder glass	Same			x				
	White paint	Good	Inst.	Munsell N 9.5/	Brown paint						x

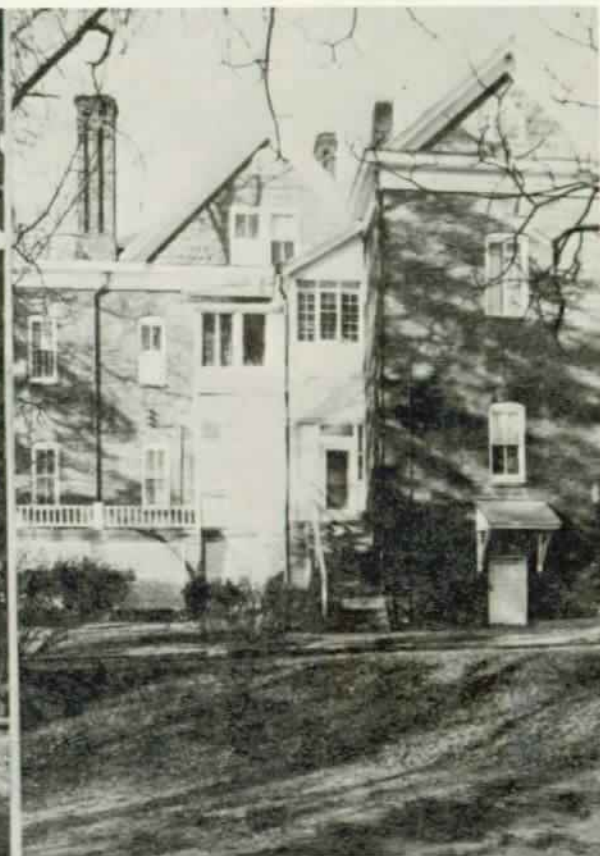
South Elevation

SOUTH ELEVATION						RECOMMENDATIONS						
EXISTING CONDITIONS					HISTORICAL DESCRIPTIONS		PRESERVE	REPAIR	REPLACE IN KIND	REMOVE	INSTALL	COMMENTS
ELEMENT	MATERIAL	CONDITION	PERIOD	COMMENTS	MATERIAL	COMMENTS						
Lower Wall	Brick Mortar	Good Fair	1899 1899, Inst.	Pink pointing mortar	Same Same		x	x				Repoint as needed
Third-floor Wall	Shingles Brown paint	Fair Good	1899 Inst.	Pressed sheet metal Not sampled	Same Red paint	Munsell 8.5R 3.5/6				x	x	Reshingle Paint new shingles
Woodwork	Cornice Eaves White paint	Fair Fair Good	1899 1899 Inst.	Between 2nd and 3rd floors At gable end Munsell N 9.5/	Same Same Brown paint	Munsell 2.5YR 3/4		x x			x	Repaint
Chimney	Brick Mortar Metal cap Iron tie rod	Fair Fair Missing Fair	1899 1899 Inst. 1899	Pink pointing mortar Tieing chimney to roof	Same Same None Same			x x x			x	Repoint as needed New cap
West Window, Guest Room	Masonry opening Frame 2/2 d.h. sash White paint	Fair Good Fair Good	1899 1899 1899 Inst.	Cylinder glass Munsell N 9.5/	Same Same Same Brown paint	Munsell 2.5YR 3/4	x	x x			x	Repoint as needed Repaint

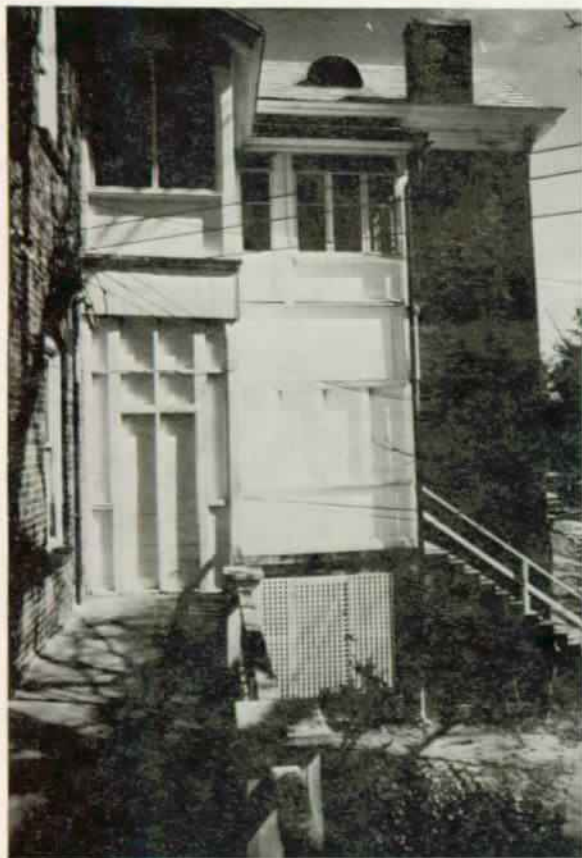
West Wing Elevation

WEST WING ELEVATION						RECOMMENDATIONS						
EXISTING CONDITIONS					HISTORICAL DESCRIPTIONS		PRESERVE	REPAIR	REPLACE IN KIND	REMOVE	INSTALL	COMMENTS
ELEMENT	MATERIAL	CONDITION	PERIOD	COMMENTS	MATERIAL	COMMENTS						
House Wall	Brick Mortar	Good	1899, 1910	Second floor added ca. 1910	Same		x					Minor repointing
		Fair	1899, 1910	Pink pointing mortar	Same			x				
Cornice	Molded wood White paint	Fair	1910	Munsell N 9.5/	Same				x			x Repaint
		Good	Inst.		Brown paint	Munsell 2.5YR 3/4						
Chimney	Brick	Fair	1910	Lowered by Institute	Similar				x			Restore to historic height Repoint as needed x New cap
	Mortar	Fair	1910	Pink pointing mortar	Same				x			
	Metal cap	Good	Inst		None							
Stair	Concrete steps	Good	1925	Hard brick Portland cement mortar Plain wood Munsell N 9.5/	Wood steps		x					x Repaint
	Brick wall	Good	1925		Brick piers		x					
	Mortar	Good	1925		Wood infill		x					
	Railing	Good	Inst.		Wood rail		x

White paint	Good	Inst.		Brown paint	Munsell 2.5YR 3/4

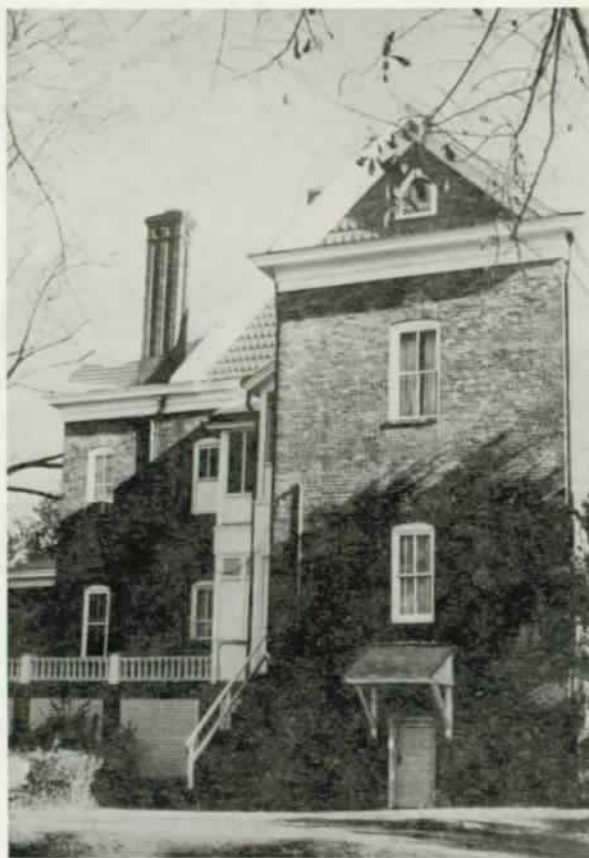
South Wing Elevation

EXISTING CONDITIONS					HISTORICAL DESCRIPTIONS		RECOMMENDATIONS					COMMENTS
ELEMENT	MATERIAL	CONDITION	PERIOD	COMMENTS	MATERIAL	COMMENTS	PRESERVE	REPAIR	REPLACE IN KIND	REMOVE	INSTALL	
Wall	Brick	Fair	1899, 1910	Second floor added ca. 1910	Same			x				Repoint as needed
	Mortar	Fair	1899, 1910	Pink pointing mortar	Same			x				
	Ironwork	Fair	1910	Misc. pieces set into wall	Same		x					
Gable End	Shingles	Fair	1910	Pressed sheet metal	Same					x	x	Reshingle Paint new shingles
	Brown paint	Good	Inst.	Not sampled	Red paint	Munsell 8.5R 3.5/6				x		
Woodwork	Cornice	Fair	1910	Between 2nd floor and gable	Same			x				Repaint
	Gable eaves	Fair	1910		Same			x				
	White paint	Good	Inst.	Munsell N 9.5/	Brown paint	Munsell 2.5YR 3/4					x	
Doorway to Basement	Masonry opening	Fair	1899		Same			x				Repoint as needed
	Frame	Good	1899	Plain wood	Same		x					
	Door	Fair	1899		Same			x				Repaint
	White paint	Good	Inst.	Munsell N 9.5/	Brown paint	Munsell 2.5YR 3/4					x

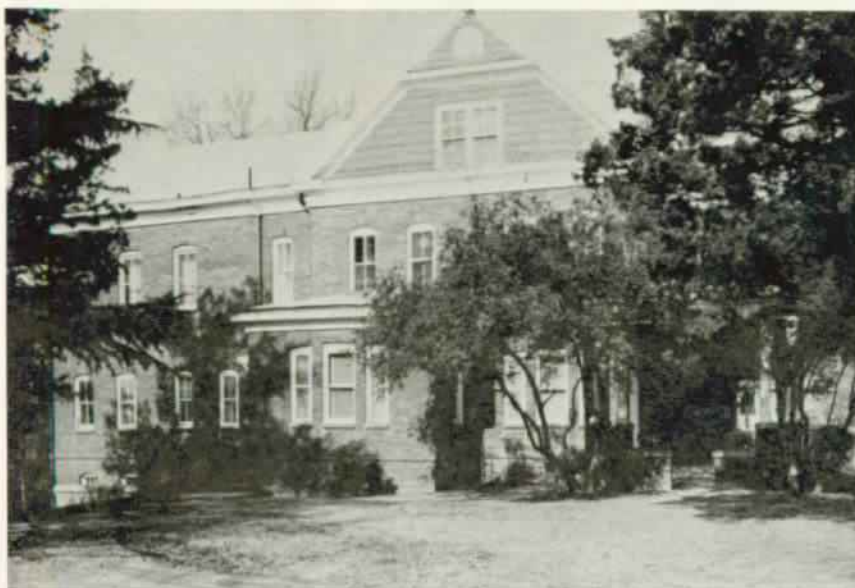
East Elevation

EXISTING CONDITIONS					HISTORICAL DESCRIPTIONS		RECOMMENDATIONS					COMMENTS
ELEMENT	MATERIAL	CONDITION	PERIOD	COMMENTS	MATERIAL	COMMENTS	PRESERVE	REPAIR	REPLACE IN KIND	REMOVE	INSTALL	
Lower Wall	Brick Mortar	Good Fair	1899 1899, Inst.	Pink pointing mortar	Same Same		x					Repoint as needed
Gable End Wall	Shingles Brown paint	Fair Good	1899 Inst.	Pressed sheet metal Not sampled	Same Red paint	Munsell 8.5R 3.5/6		x		x	x	Reshingle Paint new shingles
Woodwork	Cornice Eaves White paint	Fair Fair Good	1899 1899 Inst.	Between 2nd and 3rd floors At gable end Munsell N 9.5/	Same Same Brown paint	Munsell 2.5YR 3/4		x	x		x	Repaint
Chimney	Brick Mortar Metal cap	Fair Fair Good	1899 1899, Inst. Inst.	Pink pointing mortar	Same Same None		x	x				Repoint as needed
Windows (3), Study	Masonry opening Frames 1/1 d.h. sash Screen sash White paint	Fair Good Good Good Good	1899 1899 1899 1925 Inst.	Plain wood Cylinder glass Two-panel, over end windows Munsell N 9.5/	Same Same Same None Brown paint	Munsell 2.5YR 3/4	x	x			x	Store in attic Repaint

EXISTING CONDITIONS					HISTORICAL DESCRIPTIONS							COMMENTS
ELEMENT	MATERIAL	CONDITION	PERIOD	COMMENTS	MATERIAL	COMMENTS	PRESERVE	REPAIR	REPLACE IN KIND	REMOVE	INSTALL	
North Window, MOM's Bedroom	Masonry opening	Fair	1899		Same							Repoint as needed
	Frame	Good	1899	Plain wood	Same		x	x				
	2/2 d.h. sash	Fair	1899	Cylinder glass	Same			x				Repaint
	White paint	Good	Inst.	Munsell N 9.5/	Brown paint	Munsell 2.5YR 3/4					x	
Gable Windows (2)	Frame	Good	1899	Plain wood	Same		x					Repaint
	4/4 d.h. sash	Poor	1899	Cylinder glass	Same			x				
	White paint	Good	Inst.	Munsell N 9.5/	Brown paint	Munsell 2.5YR 3/4					x	
Attic Vent	Frame	Good	1899	Plain wood	Same		x					Repaint
	Louvers	Fair	1899		Same			x				
	White paint	Good	Inst.	Munsell N 9.5/	Brown paint	Munsell 2.5YR 3/4					x	
Crawlspace Vent	Masonry opening	Good	1925		None		x					
	Parging	Good	1925	Portland cement	None		x					
	Grille	Fair	1925	Cast iron, minor rusting	None			x

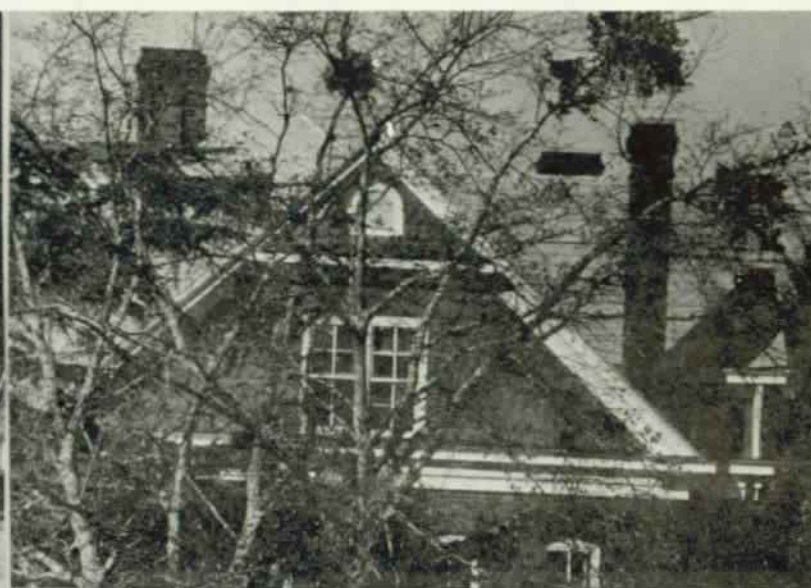
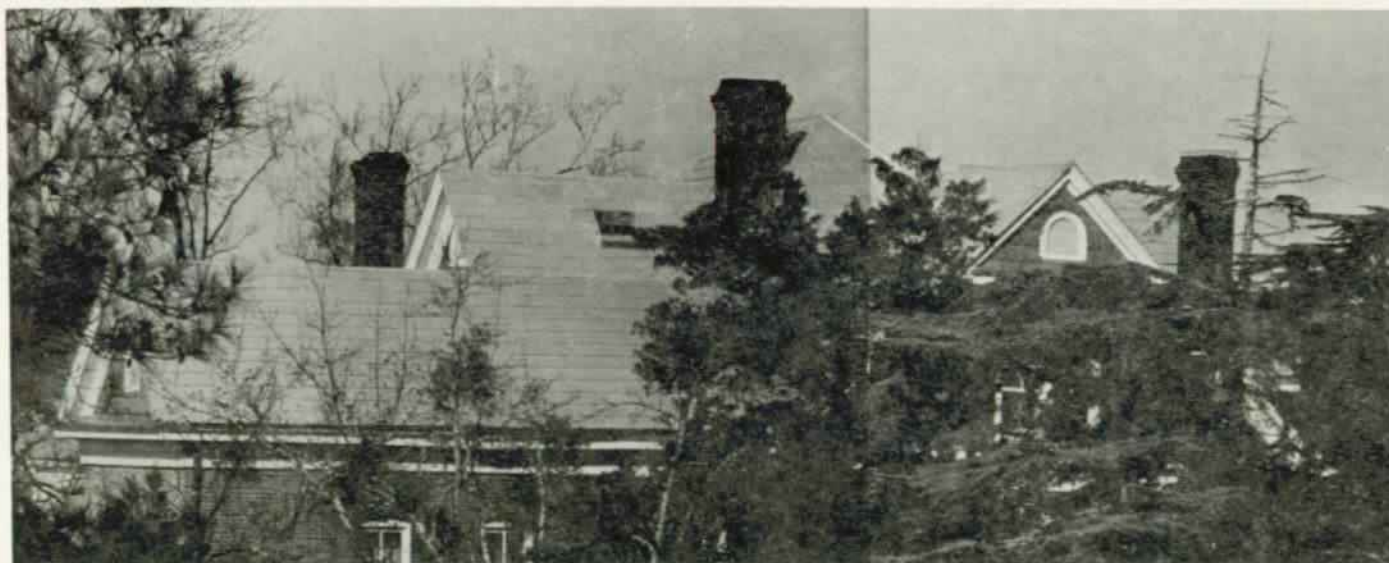
EXISTING CONDITIONS					HISTORICAL DESCRIPTIONS		PRESERVE	REPAIR	REPLACE IN	REMOVE	INSTALL	COMMENTS	
ELEMENT	MATERIAL	CONDITION	PERIOD	COMMENTS	MATERIAL	COMMENTS							
Main Roof	Shingles	Good	Inst.	Unpainted aluminum	Shingles	Pressed sheet metal, red paint				x	x	Reroof in future	
	Ridges	Good	Inst.	Unpainted aluminum	Ridges	Sheet metal, painted red				x	x	Reroof in future	
	Valleys	Good	Inst.	Unpainted aluminum	Ridge ends (2)	At top of roof, now missing			x				
	Hatch	Good	1899, Inst	On south gable	Valleys	Sheet metal, painted red				x	x	Reroof in future	
Den Roof					Similar	Covered with sheet metal				x	x	Recover in future	
	Shingles	Good	Inst.	Unpainted aluminum	Sheet metal	Standing seam, painted red					x	x	Reroof in future
	Ridge	Good	Inst.	Unpainted aluminum	Sheet metal	Simple seam					x	x	Reroof in future
	Dormer	Fair	1910	Sheet metal, louvers covered	Same			x					
Dining Room Addition Roof	Shingles	Good	Inst.	Unpainted aluminum	Sheet metal	Standing seam, painted red					x	x	Reroof in future

Ridges	Good	Inst.	Unpainted aluminum	Ridges	Sheet metal seams					x	x	Reroof in future
	Hatch	Good	1905, Inst	Covered with plain aluminum	Similar	Covered with sheet metal					x	x	Recover in future
Vent Pipes (2)	Cast iron	Fair	1900	Venting bathrooms	Same			x					
Gutters	Copper	Fair	Inst.	Clogged	Sheet metal						x	x	New gutters
Downspouts	Copper	Fair	Inst.	Clogged	Sheet metal						x	x	New downspouts
Lightning system	Conduit	Fair	Inst.	Inside downspouts, unusual	None			x					See engineering section

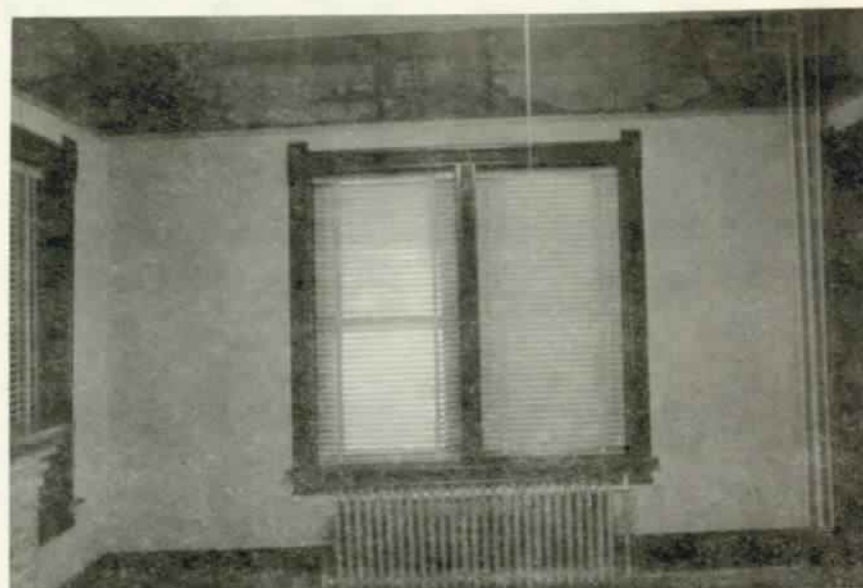
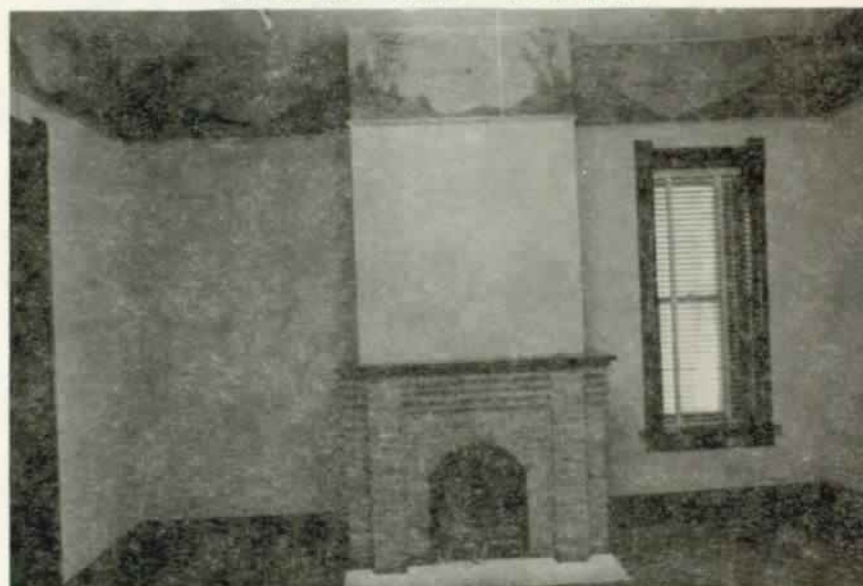
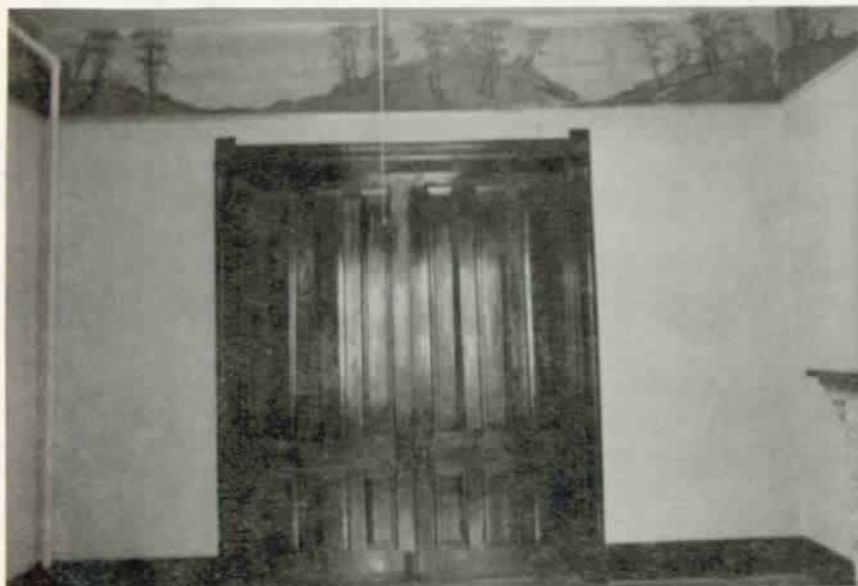
EXISTING CONDITIONS					HISTORICAL DESCRIPTIONS		RECOMMENDATIONS					COMMENTS
ELEMENT	MATERIAL	CONDITION	PERIOD	COMMENTS	MATERIAL	COMMENTS	PRESERVE	REPAIR	REPLACE IN KIND	REMOVE	INSTALL	
Walls	Sawn wood lath	Good	1899		Same		x					By art conservator Repaint
	Plaster	Fair	1899	Cracking	Same			x				
	Frieze mural	Fair	1908	Needs conservation	Same	Signed "A.W. Barman '06"		x				
	Green paint	Good	Inst.	Munsell 5GY 8/2	Dark red paint	Munsell 2.5R 2/8					x	
Picture Molding	Wood	Good	1899	Lowered with painting of mural	Same		x					Regild, rebuild base
	Nailing strip	Good	1899	Paint peeling, center of mural	Same		x					
	Silver paint	Fair	Inst.	Cracking and peeling	Gilded				x		x	
Ceiling	Sawn wood lath	Good	1899		Same		x					Repaint
	Plaster	Fair	1899	Cracking, esp. in corners	Same			x				
	White paint	Good	Inst.	Munsell 7.5Y 9/2	Cream paint	Munsell 2.5Y 7/4					x	
Floor	Subflooring	Good	1899	Laid diagonally	Same		x					Refinish, revarnish Fill, refinish

Top flooring	Fair	1910	Diagonal inside border, refinished, ground, gouged	Same			x				
	Varnish	Good	Inst.	Light color	Dark varnish						x x	
	Telephone hole	Good	Inst.	Center of floor, missing cover	None						x	
Fireplace	Brick masonry	Fair	1920	Settlement problems	Wood mantel	Moved to MMW's bedroom					x x	Replace original mantel
	Tilework	Good	1920	Large, white tiles	Tilework	Narrow, brown, mottled tiles					x x	Historical tilework
	Wood shelf	Good	1920	Plain wood	None						x	
	Firebox	Fair	1920	Beige brick masonry	Firebox	For coal grate, smaller					x x	Rebuild firebox
	Brass andirons	Good	1920	Tarnished, pipes with fittings	Grate and cover	For coal, cast iron, missing			x	x		
	Varnish	Good	1920	Dark, on shelf	Similar	On existing mantelpiece		x		x		Repair MMW's mantel varnish
Doorway to Foyer	Frame	Good	1899	Molded wood	Same		x					
	Varnish	Fair	1899	Dark, chipped	Same				x			
Doorway to Study	Frame	Fair	1899	Molded wood, corner broken	Same				x

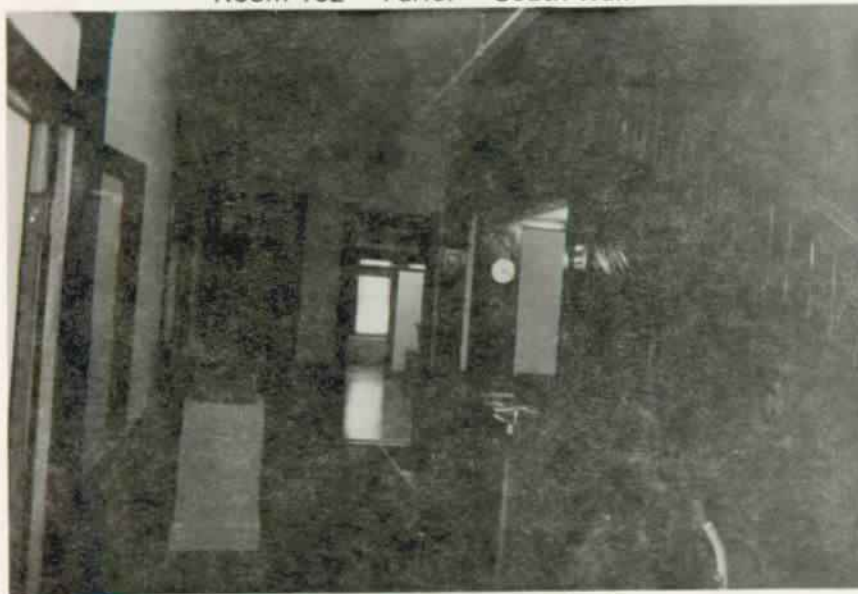
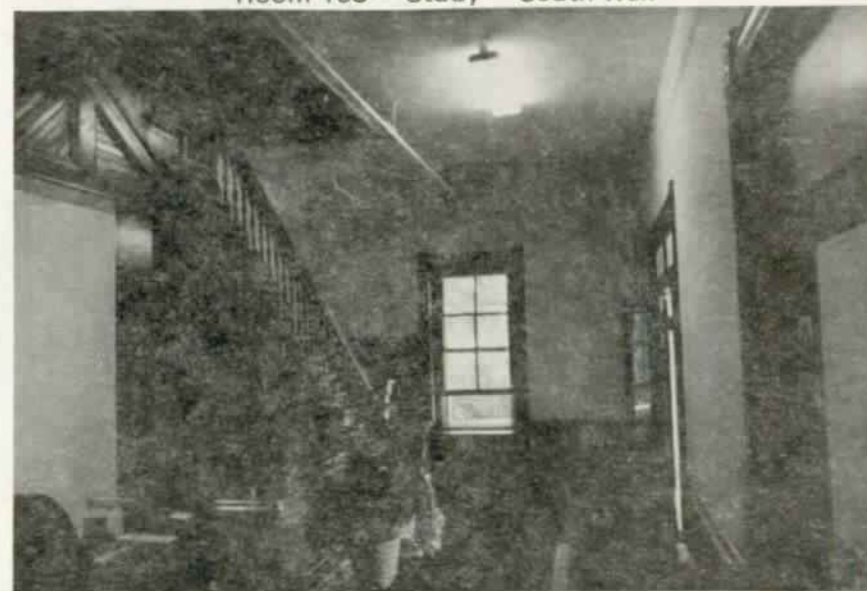
EXISTING CONDITIONS					HISTORICAL DESCRIPTIONS		RECOMMENDATIONS					COMMENTS
ELEMENT	MATERIAL	CONDITION	PERIOD	COMMENTS	MATERIAL	COMMENTS	PRESERVE	REPAIR	REPLACE IN KIND	REMOVE	INSTALL	
Walls	Sawn wood lath	Good	1899		Same		x					
	Plaster	Fair	1899	Minor cracking	Same			x				
	Green paint	Good	Inst.	Munsell 5GY 8/2, lower walls	Dark red paint	Munsell 2.5R 2/8					x	Repaint
	White paint	Good	Inst.	Munsell 7.5Y 9/2, frieze	Cream paint	Munsell 2.5Y 7/4					x	Repaint
	Wainscoting	Good	1899		Same		x					
	Varnish	Fair	1899	Dark, chipped	Same			x				
Picture Molding	Wood	Good	1899		Same		x					
	Green paint	Good	Inst.	Munsell 5GY 8/2	Gilding			x			x	Regild, rebuild base
Ceiling	Sawn wood lath	Good	1899		Same		x					
	Plaster	Fair	1899	Minor cracking	Same			x				
	White paint	Good	Inst.	Munsell 7.5Y 9/2	Cream paint	Munsell 2.5Y 7/4					x	Repaint
Floor	Subflooring	Good	1899	Laid diagonally	Same		x					
	Top flooring	Fair	1910	Diagonal inside border, refinished, ground, gouged	Same			x

Varnish	Fair	Inst.	Light color	Dark varnish					x	x	Refinish, revarnish
Stair	Wood wall	Fair	1899	E. end area removed by Institute	Same	Elaborate panelling	x		x			Replace east end
	Wainscoting	Fair	1899	E. end removed by Institute	Same		x		x			Replace east end
	Baseboard	Fair	1899	E. end removed by Institute	Same		x		x			Replace east end
	Treads (23)	Fair	1899	Refinished by Institute	Same			x				Refinish
	Risers (25)	Good	1899		Same		x					
	Railing	Good	1899	Some looseness	Same		x					
	Balusters (41)	Good	1899	Some looseness	Same		x					
	Newel post	Fair	1899	Small section missing	Same				x			
	Varnish	Fair	1899	Dark, chipped, exc. treads	Same			x				
Doorway to Parlor	Frame	Good	1899	Molded wood	Same		x					
	Infill	Good	Inst.		None						x	Reopen doors
	Varnish	Fair	1899	Dark, chipped	Same			x

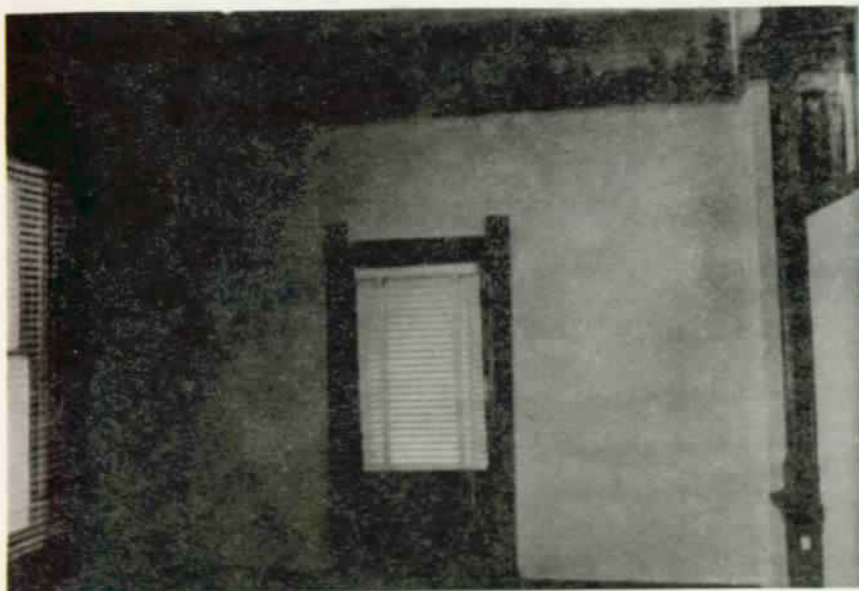
Room 106 — Dining Room Addition — South Wall

ROOM 106 - DINING ROOM ADDITION						RECOMMENDATIONS						
EXISTING CONDITIONS					HISTORICAL DESCRIPTIONS		PRESERVE	REPAIR	REPLACE IN KIND	REMOVE	INSTALL	COMMENTS
ELEMENT	MATERIAL	CONDITION	PERIOD	COMMENTS	MATERIAL	COMMENTS						
N., E., and S. Walls	Sawn wood lath	Good	1905		Same		x					
	Plaster	Fair	1905	Minor cracking	Same			x				
	Frieze mural	Fair	1905	Needs conservation	Same			x				By art conservator
	Yellow paint	Good	Inst.	Munsell 7.5Y 7/4	Dark red paint	Munsell 2.5R 2/8					x	Repaint
West Wall	Gypsum board	Good	Inst.		None					x		
	Yellow paint	Good	Inst.	Munsell 7.5Y 7/4	None					x		
Picture Molding	Wood	Good	1905	Lowered with painting of mural	Same		x					
	Nailing strip	Good	1905	Paint peeling, center of mural	Same		x					
	Silver paint	Fair	Inst.	Cracking and peeling	Gilded			x			x	Regild, rebuild base
Ceiling	Sawn wood lath	Good	1905		Same		x					
	Plaster	Fair	1905	Minor cracking	Same			x

White paint	Good	Inst.	Munsell 7.5Y 9/2	Cream paint	Munsell 2.5Y 7/4					x	Repaint
Floor	Subflooring	Good	1905	Laid diagonally	Same		x					
	Top flooring	Fair	1905	Diagonal inside border on N, E, & S sides; refinished	Same			x				Repair gouges
	Varnish	Fair	Inst.	Light color	Dark varnish					x	x	Refinish, revarnish
	Telephone hole	Good	Inst.	Missing cover	None						x	
Doorway to Dining Room	Frame	Good	Inst.	Plain wood	None						x	
	Varnish	Good	Inst.	Dark	None						x	
Doorway to Porch	Frame	Good	1905	Molded wood	Same		x					
	Transom	Good	1905	Single pane, cylinder glass	Same		x					
	Door	Fair	1905	With single, fixed pane	Same			x				Reopen
	Varnish	Fair	1905	Dark, chipped	Same			x				
	Venetian blinds	Good	Inst.		None						x	
East Windows (set of 3)	Frame	Good	1905	Molded wood	Same		x					
	1/1 d.h. sash	Good	1905	Upper pane, center window crack	Same		x					
	Shutters (12)	Missing	1905	Hinge sections filled	Same				x

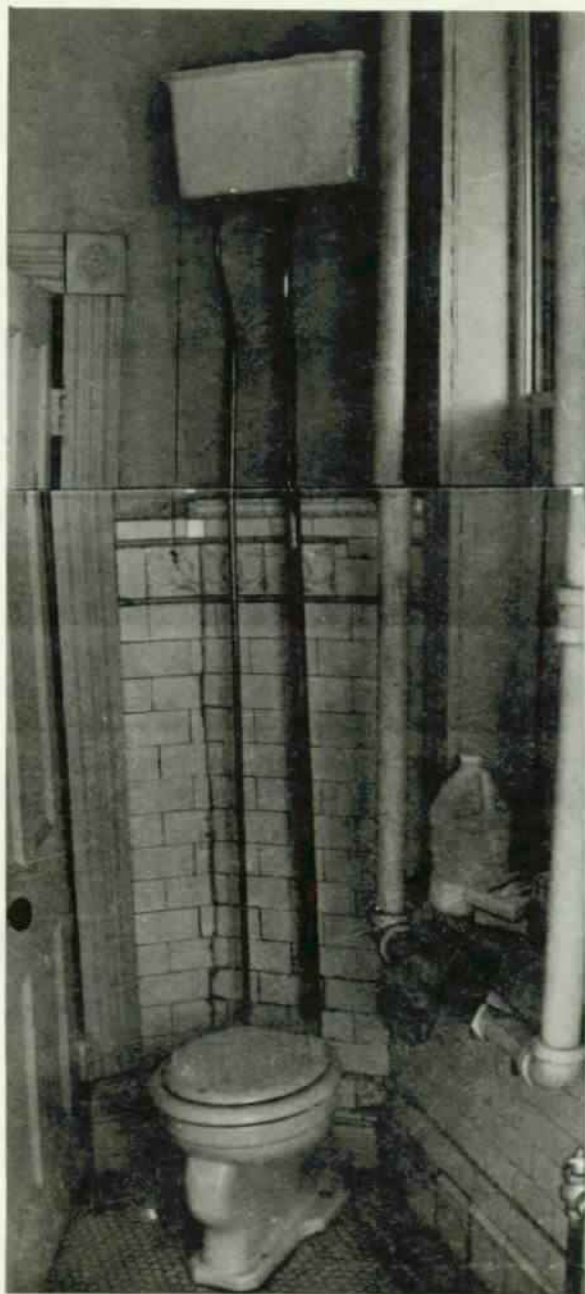
Room 210 — Boys' Bath — Toilet

EXISTING CONDITIONS					HISTORICAL DESCRIPTIONS		RECOMMENDATIONS					COMMENTS
ELEMENT	MATERIAL	CONDITION	PERIOD	COMMENTS	MATERIAL	COMMENTS	PRESERVE	REPAIR	REPLACE IN KIND	REMOVE	INSTALL	
Sink	Cast iron	Fair	1910		Same		x					
Toilet	Ceramic	Fair	1910	With upper tank	Same		x					
Towel Dispenser	Metal	Fair	Inst.		None					x		
Mirror	Glass	Good	1910		Same		x					
Radiator	Cast iron	Good	1920		None					x		
	Silver paint	Fair	Inst.		None					x		
Supply pipes	Metal	Good	1920	Two to radiator above	None					x		
	Blue paint	Good	Inst.	Munsell 1.BG 8/2	None					x		
Light	Metal	Good	Inst.	Incandescent	Plain fixture					x	x	Replica
Fire Exting.	Metal	Good	Inst.	Two nozzles	None					x	x	New fire system
	Off-white paint	Good	Inst.	Munsell 10Y 9/2	None					x

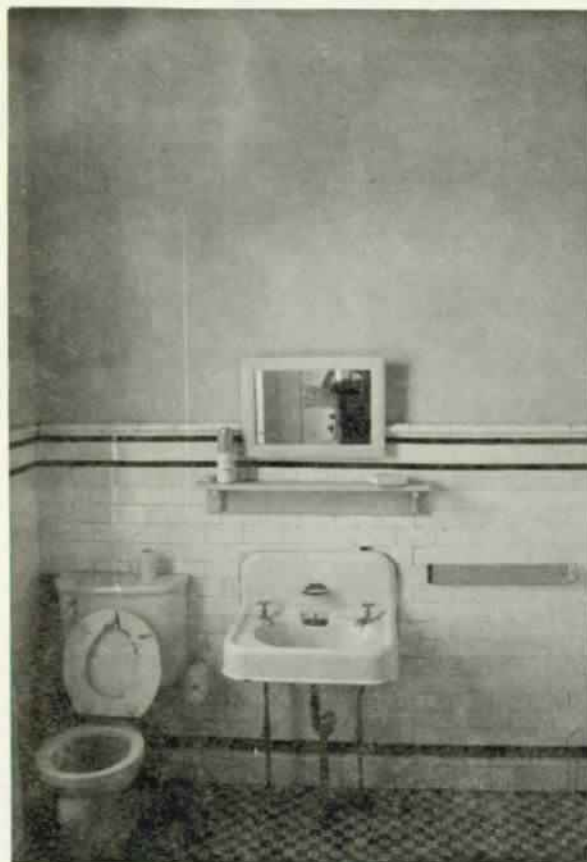
Room 212 — Booker T. Washington's Bath — South Wall

Off-white paint	Good	Inst.	Munsell 5Y 9/2	Off-white paint	Munsell 5Y 9/1	x					
Window	Frame	Good	1899	Molded wood	Same		x					
	1/2 d.h. sash	Fair	1899	North panes cracked	Same			x				
	Shutters (4)	Missing	1899	Hinge sections filled	Same				x			
	Off-white paint	Good	Inst.	Munsell 5Y 9/2	Off-white paint	Munsell 5Y 9/1	x					
Bathtub	Cast iron	Missing	1900	Pipe stubs in floor	Same		x					
Sink	Cast iron	Good	1900		Same		x					
Toilet	Porcelain	Good	1900		Same		x					
Mirror	Glass, wood	Good	1900		Same		x					
Shelf	Wood	Good	1900		Same		x

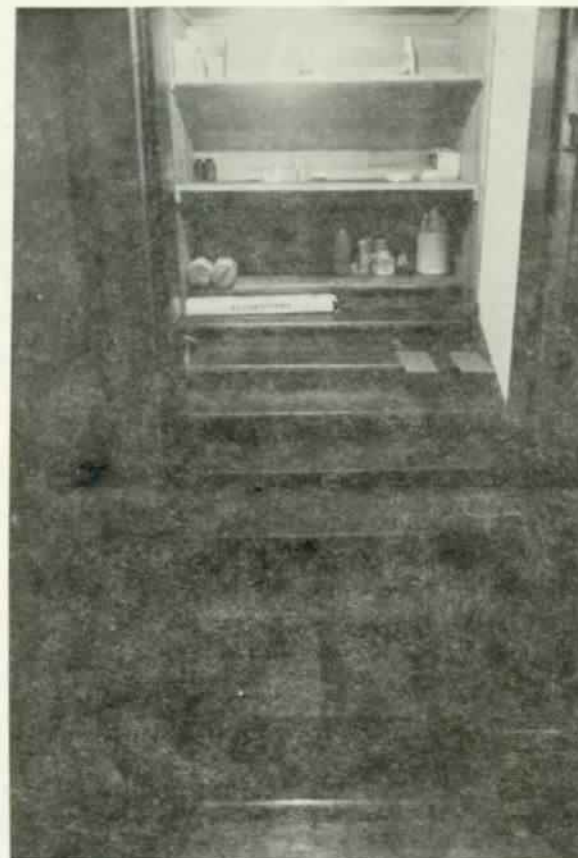
Room 213 — Hall Closet — From Rear Hall

EXISTING CONDITIONS						HISTORICAL DESCRIPTIONS						RECOMMENDATIONS	
ELEMENT	MATERIAL	CONDITION	PERIOD	COMMENTS		MATERIAL	COMMENTS	PRESERVE	REPAIR	REPLACE IN KIND	REMOVE	INSTALL	COMMENTS
N., W., and S. Walls	Sawn wood lath	Good	1899			Same		x					
	Plaster	Poor	1899	Cracking		Same		x					
	Orange paint	Good	Inst.	Munsell 7.5YR 7.5/4		None		x

E. Wall	Siding	Good	1905	Flush, horizontal boards		Same		x					
Ceiling	Sawn wood lath	Good	1899			Same		x					
	Plaster	Poor	1899	Cracking		Same		x					
	Orange paint	Good	Inst.	Munsell 7.5YR 7.5/4		None		x					
Floor (Former Stair)	Risers	Good	1899			Same		x					
	Treads	Good	1899			Same		x					
	Varnish	Good	1899	Dark		Same		x					
Baseboard	Wood	Good	1899	Plain wood		Same		x					
	Varnish	Good	1899			Same		x					
Shelf Unit	Wood	Good	1905	Plain wood, at east end		Same		x					
Doorway to Rear Hall	Frame	Good	1905	Plain wood		Same		x					
	Door	Fair	1905	Won't stay shut		Same		x					
	Varnish	Good	1905			Same		x	x				
Hookboards	Wood	Good	Inst.			Same		x					
Light	Metal	Fair	1905	Incandescent, shade missing		Same		x					
Fire Exting.	Metal	Good	Inst.	One nozzle		None		x					
													x x New fire system

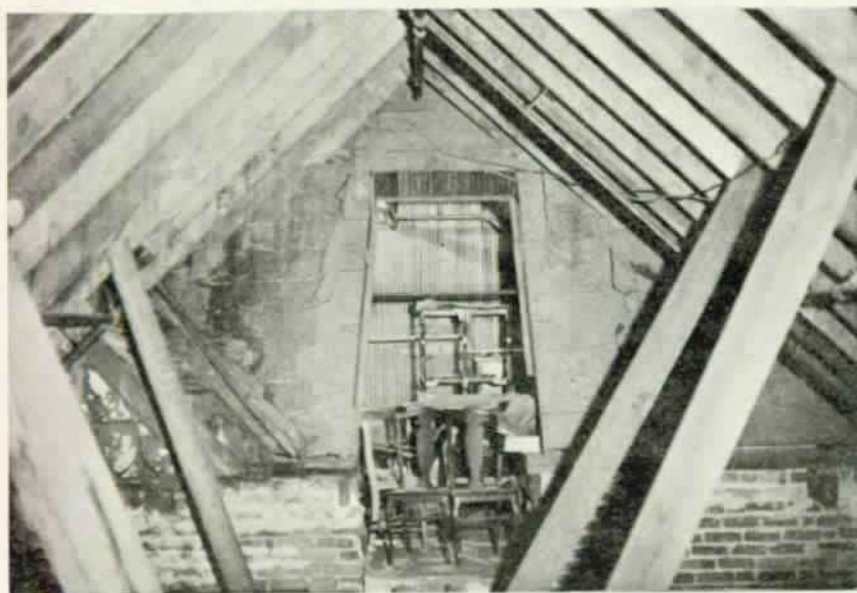
Room 307 — Den Attic — Looking North

ROOM 307 - DEN ATTIC						RECOMMENDATIONS							
EXISTING CONDITIONS					HISTORICAL DESCRIPTIONS		PRESERVE	REPAIR	REPLACE IN KIND	REMOVE	INSTALL	COMMENTS	
ELEMENT	MATERIAL	CONDITION	PERIOD	COMMENTS	MATERIAL	COMMENTS							
South Wall	Sheathing	Good	1910	1" x 6" boards	Same	Roof of original house	x						
	Studs	Good	1910	2" x 6" boards	Same		x						
	Sill plate	Good	1910	Two 2" x 8" boards	Same		x						
East and West Walls	Brick	Good	1910		Same			x					
	Mortar	Good	1910	White bedding mortar	Same			x					
	Sill plate	Good	1910	Two 2" x 8" boards	Same			x					
North Wall	Metal shingles	Good	1899	Painted red	Same			x					
Ceiling	Ridge beam	Good	1910	1" x 6" board, N-S	Same			x					
	Trusses (17)	Good	1910	2" x 6" boards, E-W, 24" o.c.	Same			x					
	Sheathing	Good	1910	1" x 6" boards, N-S	Same			x					
Floor	Joists	Good	1910	2" x 6" boards, E-W, 16" o.c.	Same			x					
	Sheathing	Good	1910	1" x 6" boards, N-S	Same			x

Doorway to Trunk Room	Opening	Fair	1899, 1910	Dormer removed ca. 1910, brick wall cut below sill	Same			x					
Vent	Frame	Fair	1910	Plain wood	Same			x					
	Louvers	Fair	1910	Plain wood	Same			x					
Fire Exting.	Metal	Good	Inst.	Twelve nozzles	None				x	x	New fire system

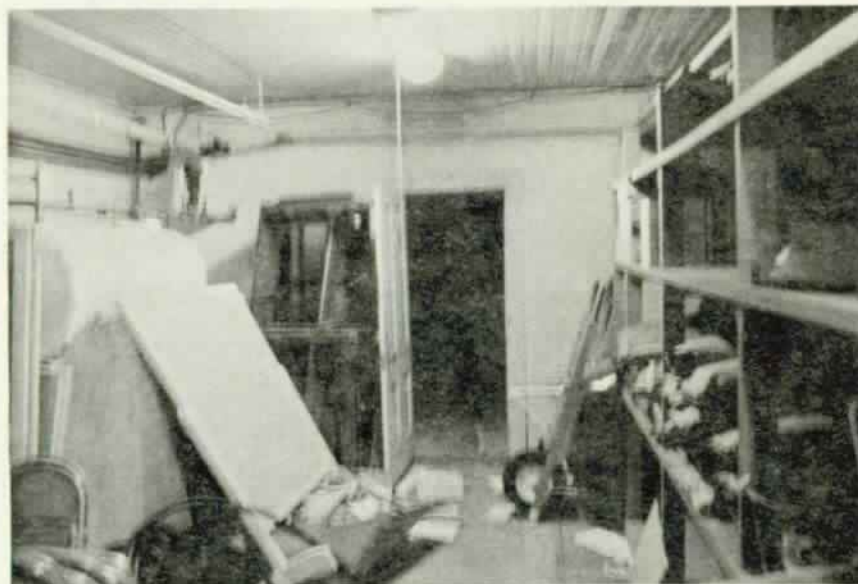
Room 002 — Wing Basement — Looking North

ROOM 002 - WING BASEMENT (cont.)						RECOMMENDATIONS							
EXISTING CONDITIONS					HISTORICAL DESCRIPTIONS		PRESERVE	REPAIR	REPLACE IN KIND	REMOVE	INSTALL	COMMENTS	
ELEMENT	MATERIAL	CONDITION	PERIOD	COMMENTS	MATERIAL	COMMENTS							
Center Window	Frame	Poor	1899		Same	Not sampled							
	6/6 d.h. sash	Poor	1899		Same								
	Paint	Fair	Inst.		Unknown		x						
South Window	Frame	Poor	1899		Same								
	6/6 d.h. sash	Poor	1899		Same								
	Paint	Fair	Inst.		Unknown		x						
Heating system	Metal	Good	Inst.	See engineering section	None						x	Forced air system	
Fire Exting.	Metal	Good	Inst.	Five nozzles	None							x x	New fire system
	Paint	Good	Inst.		None								
Light	Metal, glass	Good	Inst.	Flouresent	Incandescent		x						
Shelving	Wood	Good	Inst.		None		x

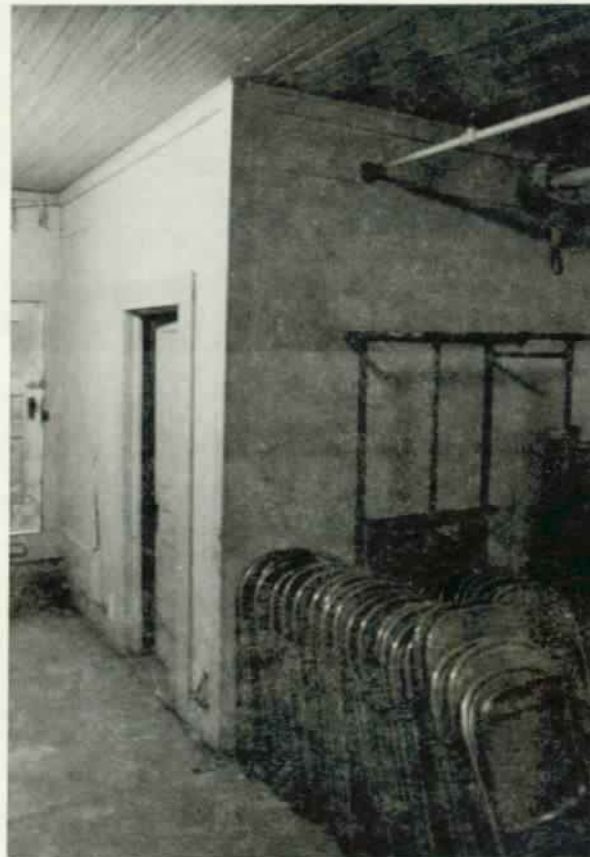
ROOM 003 - STORAGE ROOM

Room 003 — Storage — From Room 002

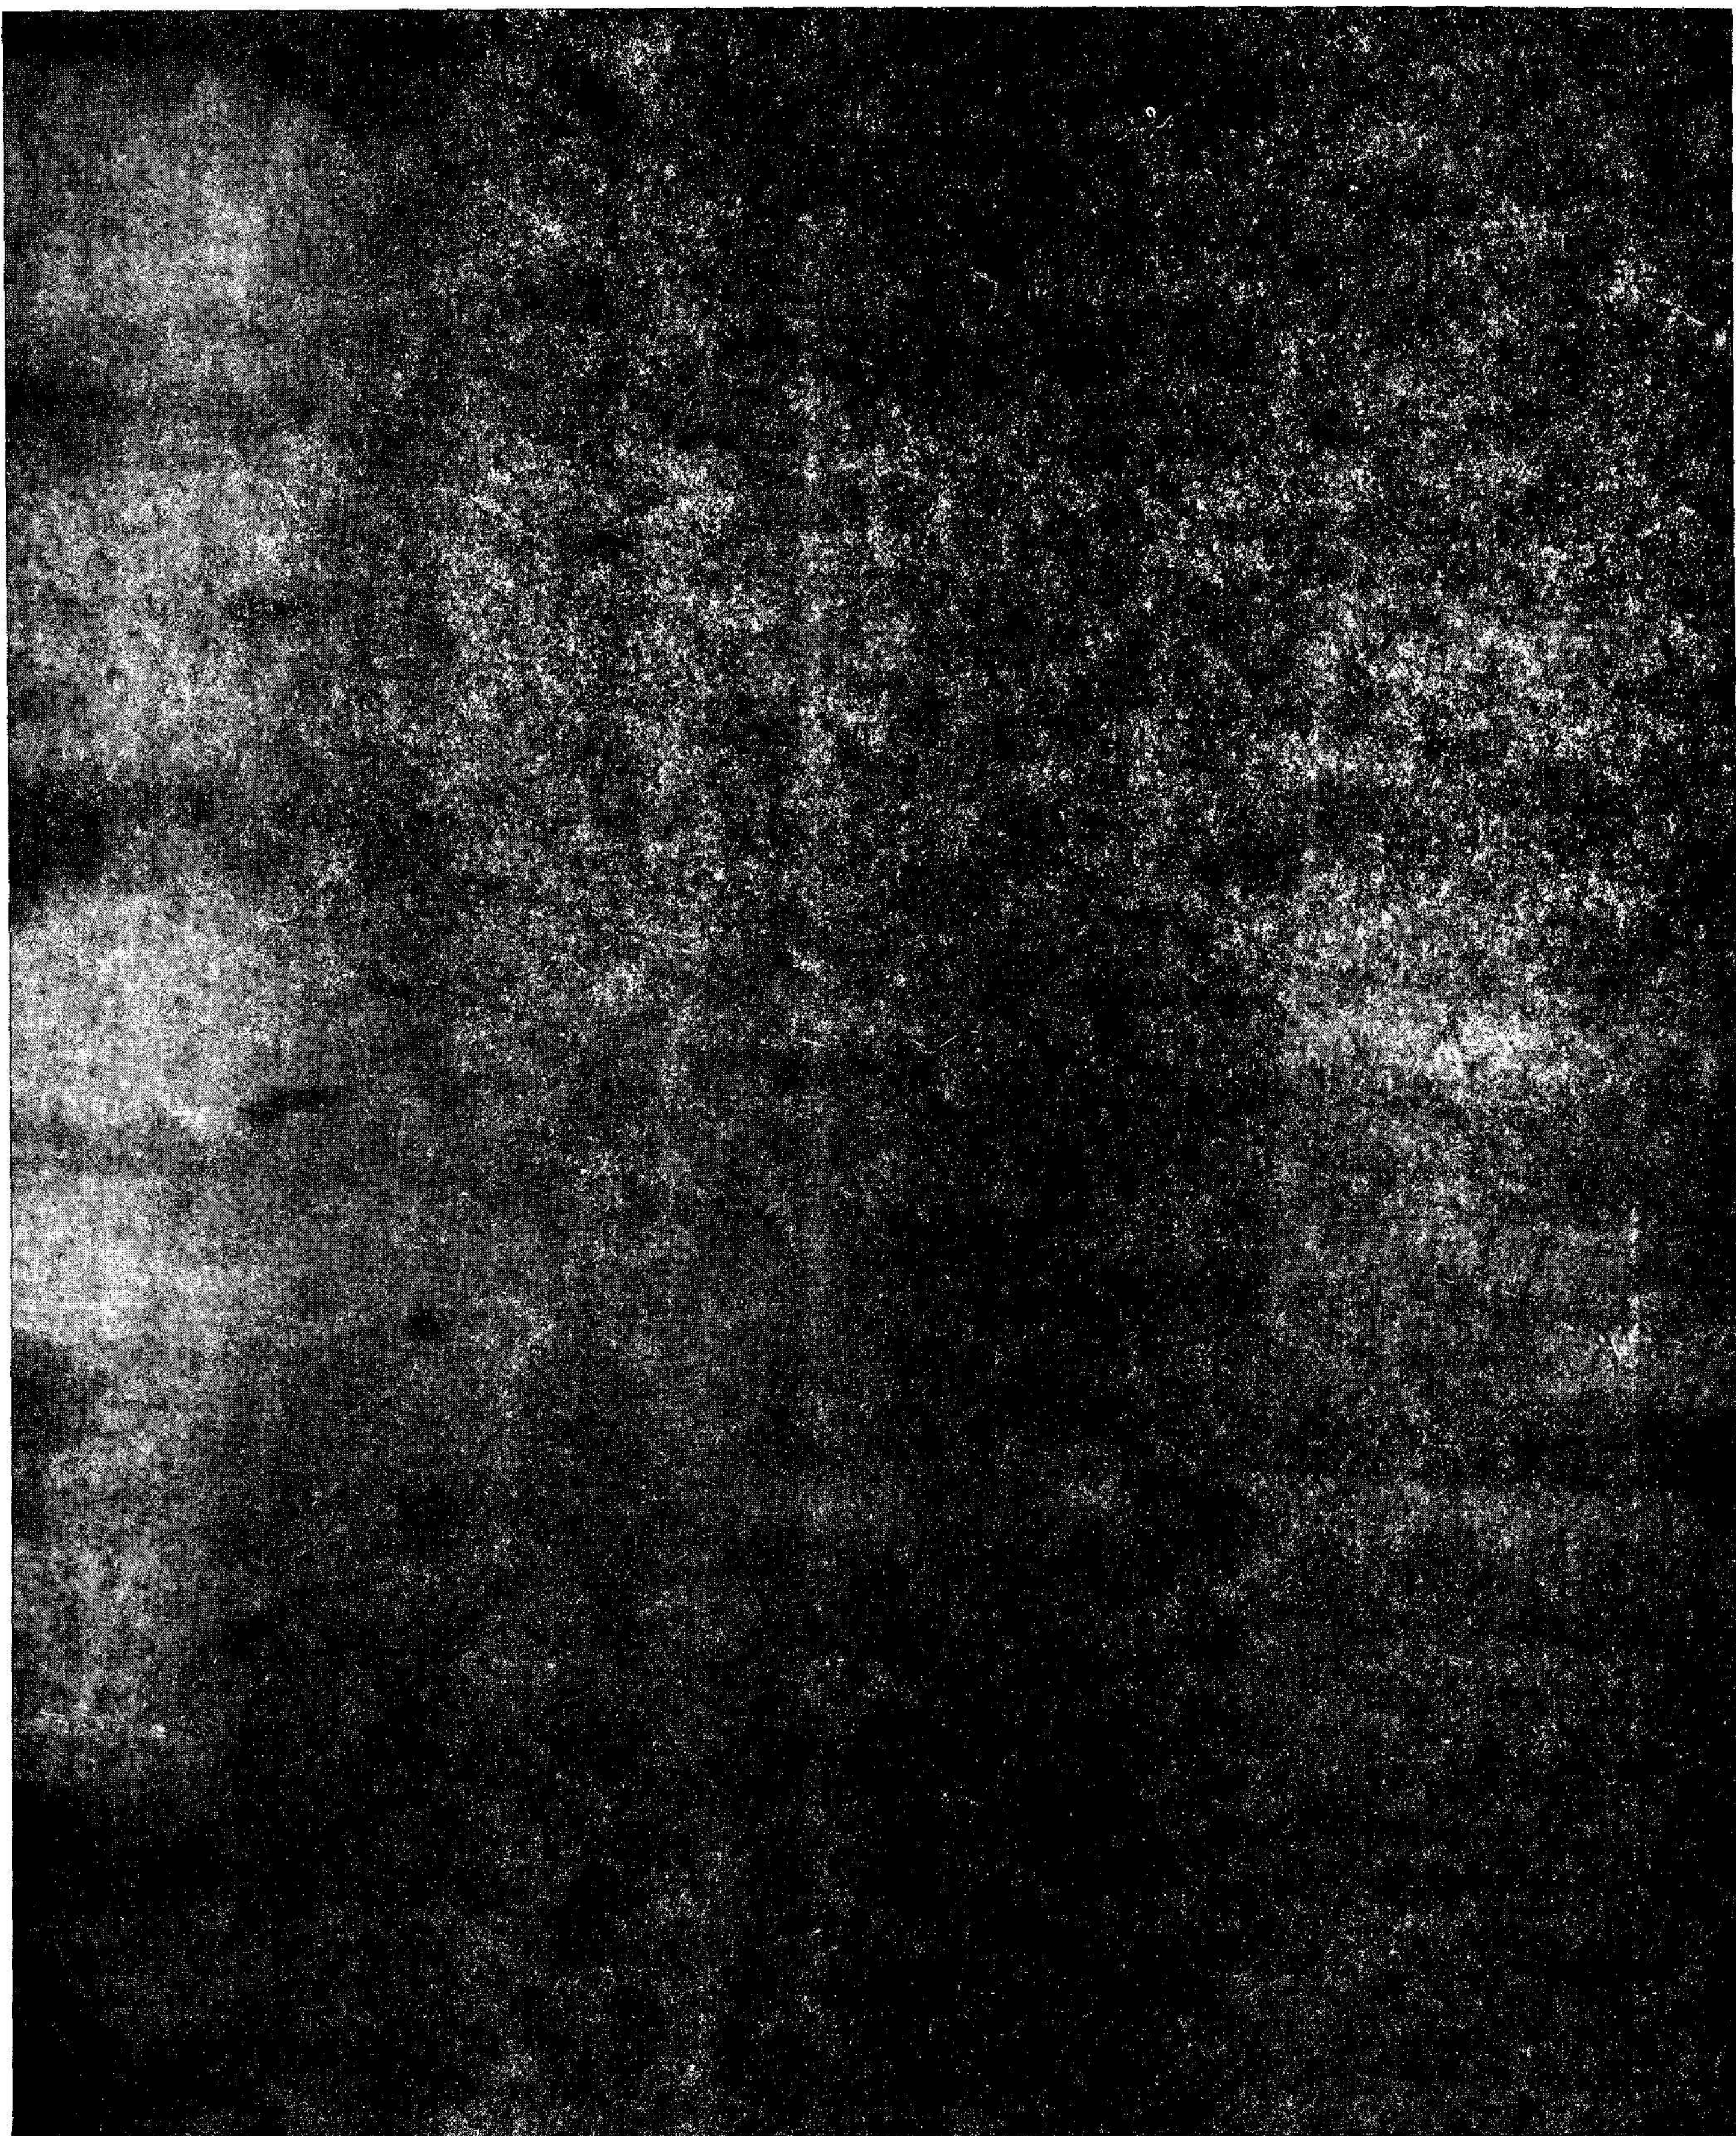
X-Ray 1. Taken through the jamb of the door which once was between the guest room (room 107) and its closet at a height of 3'-8" with thirty-five pulses used.

The later infill of the door is clearly seen in the expanded metal lath in contrast with the historic sawn wood lath of the adjoining wall. It is quite likely that the metal lath was installed by the Institute.
