## historic structure report

TUSKEGEE INSTITUTE  
THE OAKS

NATIONAL HISTORIC SITE / ALABAMA

HISTORIC STRUCTURE REPORT

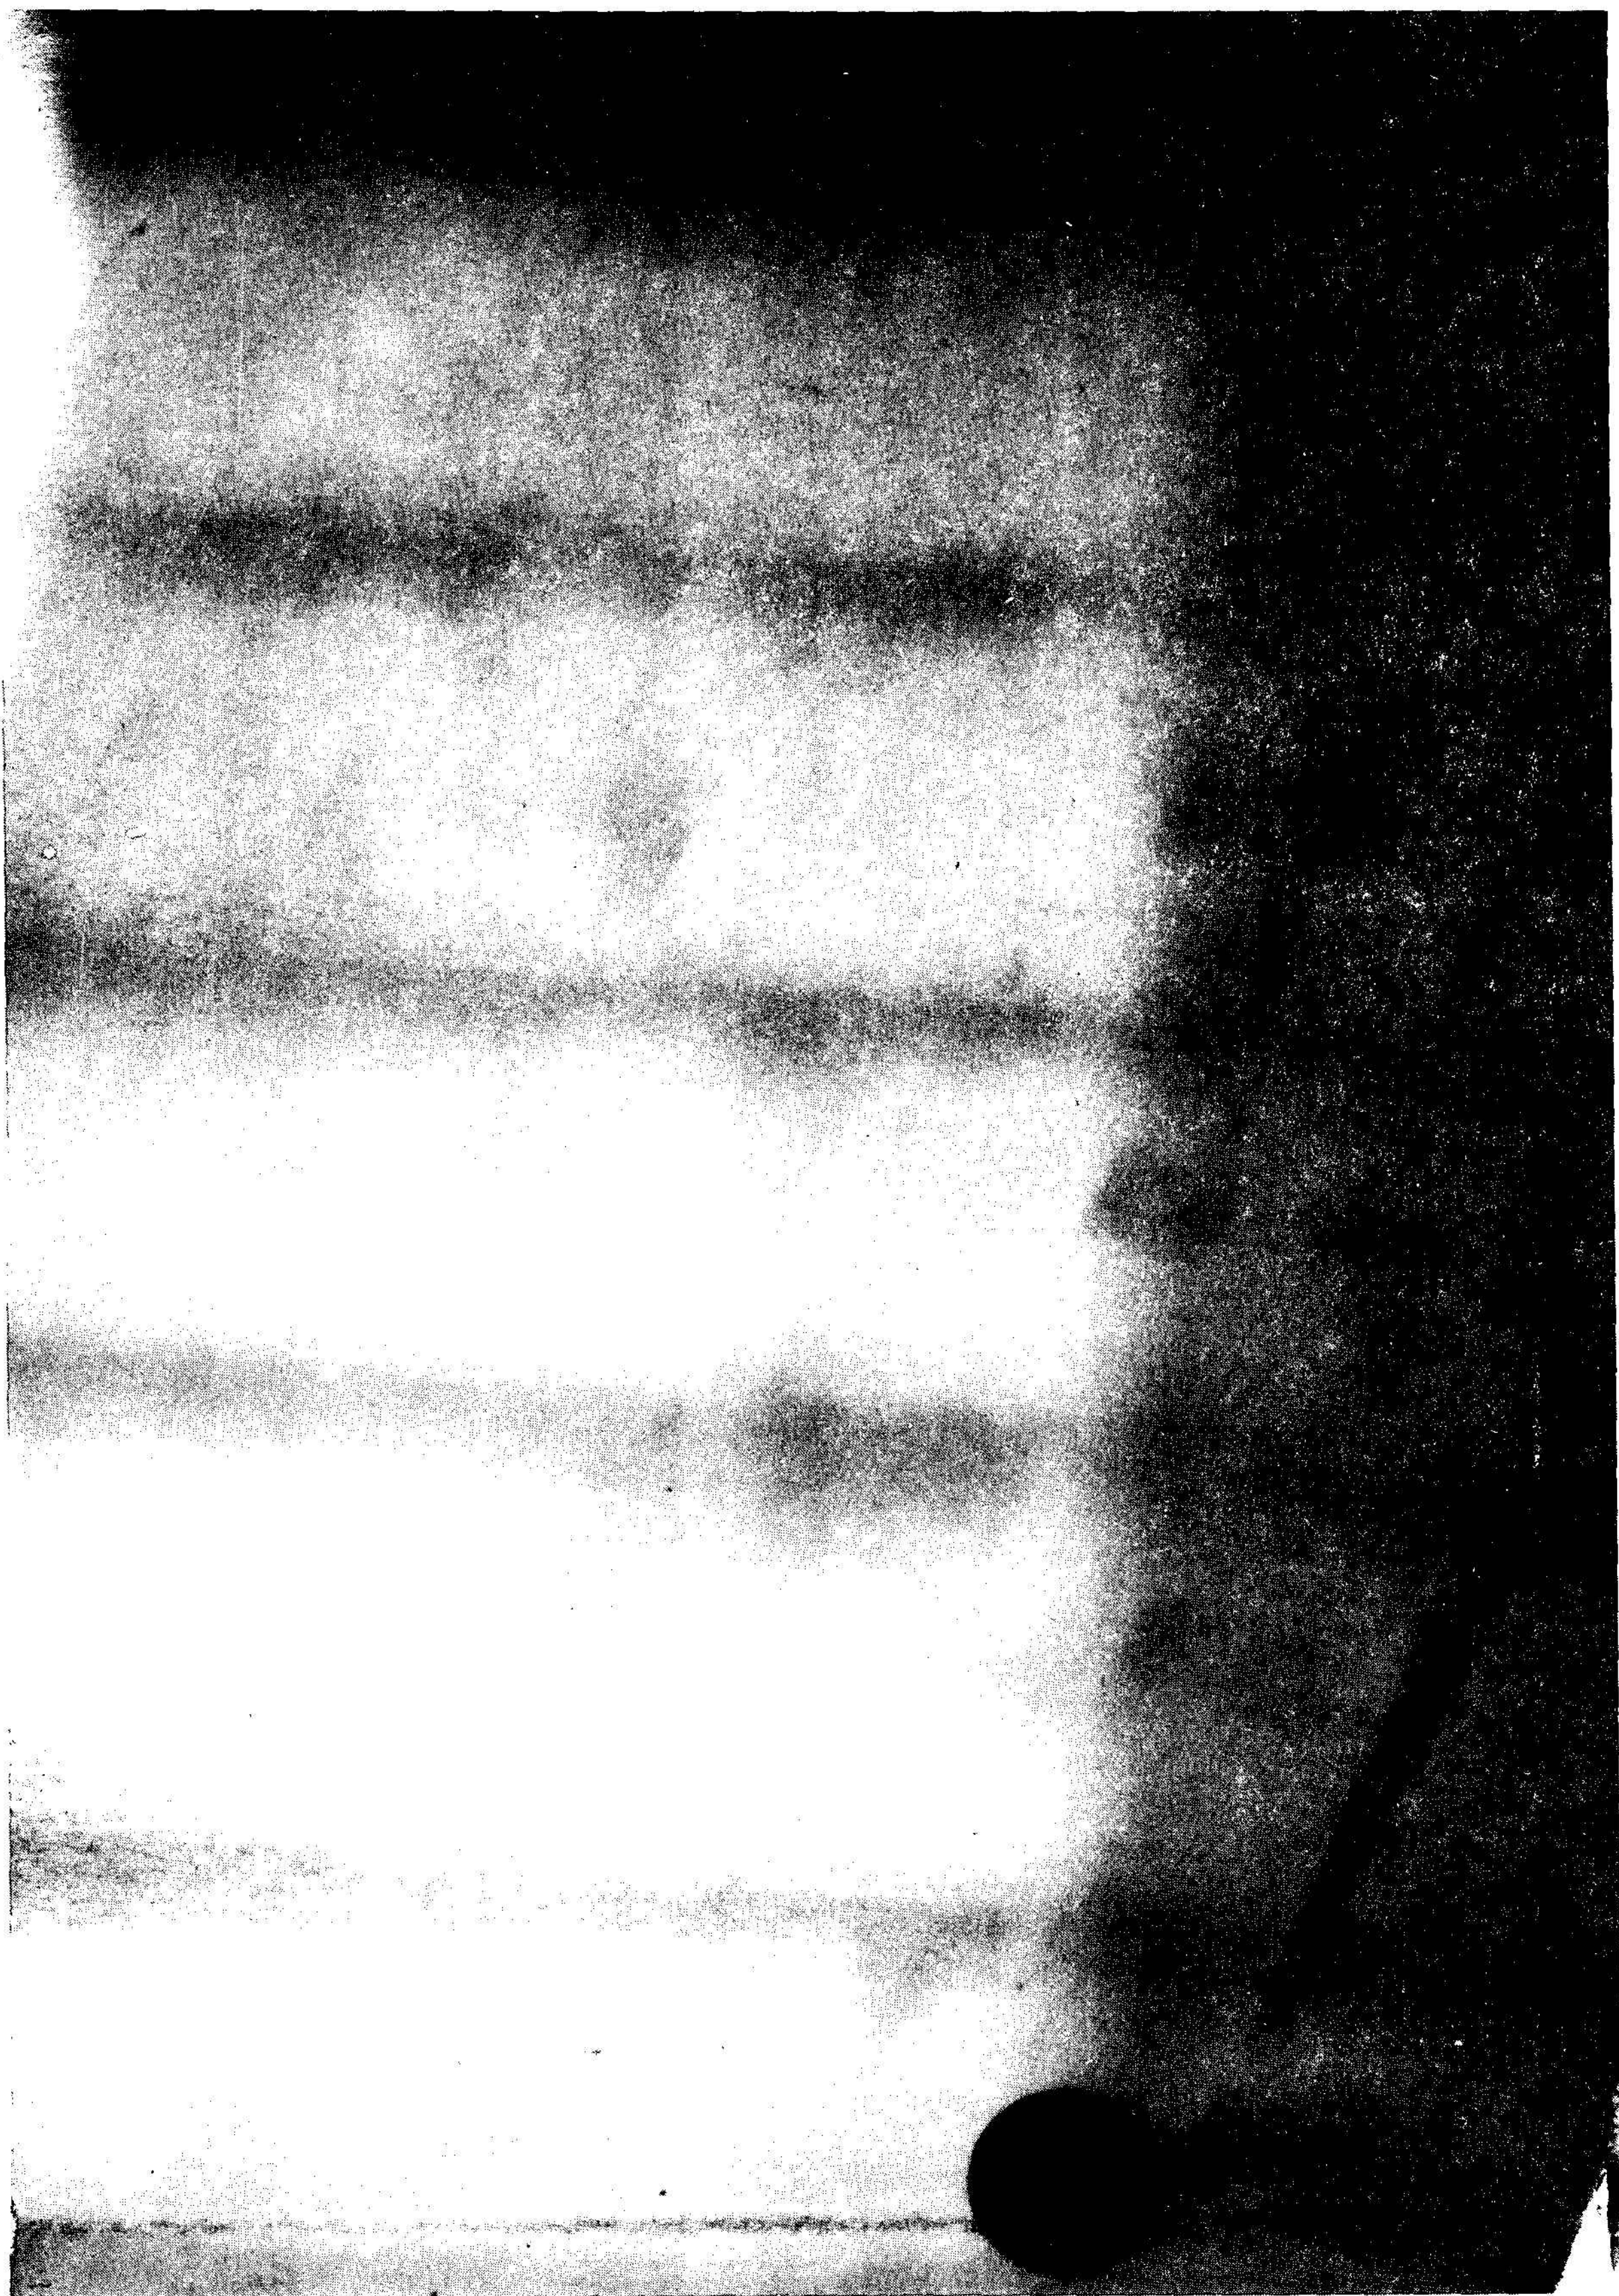
X-Ray 2. Taken through the east wall of the rear hall closet (room 213) at a level equal to the top step in the closet with forty pulses used.

The construction of the wall contains sawn wood lath and cut nails, typical of the period of the original construction of the house. The closet, therefore, was either a part of the original construction or a very early change.

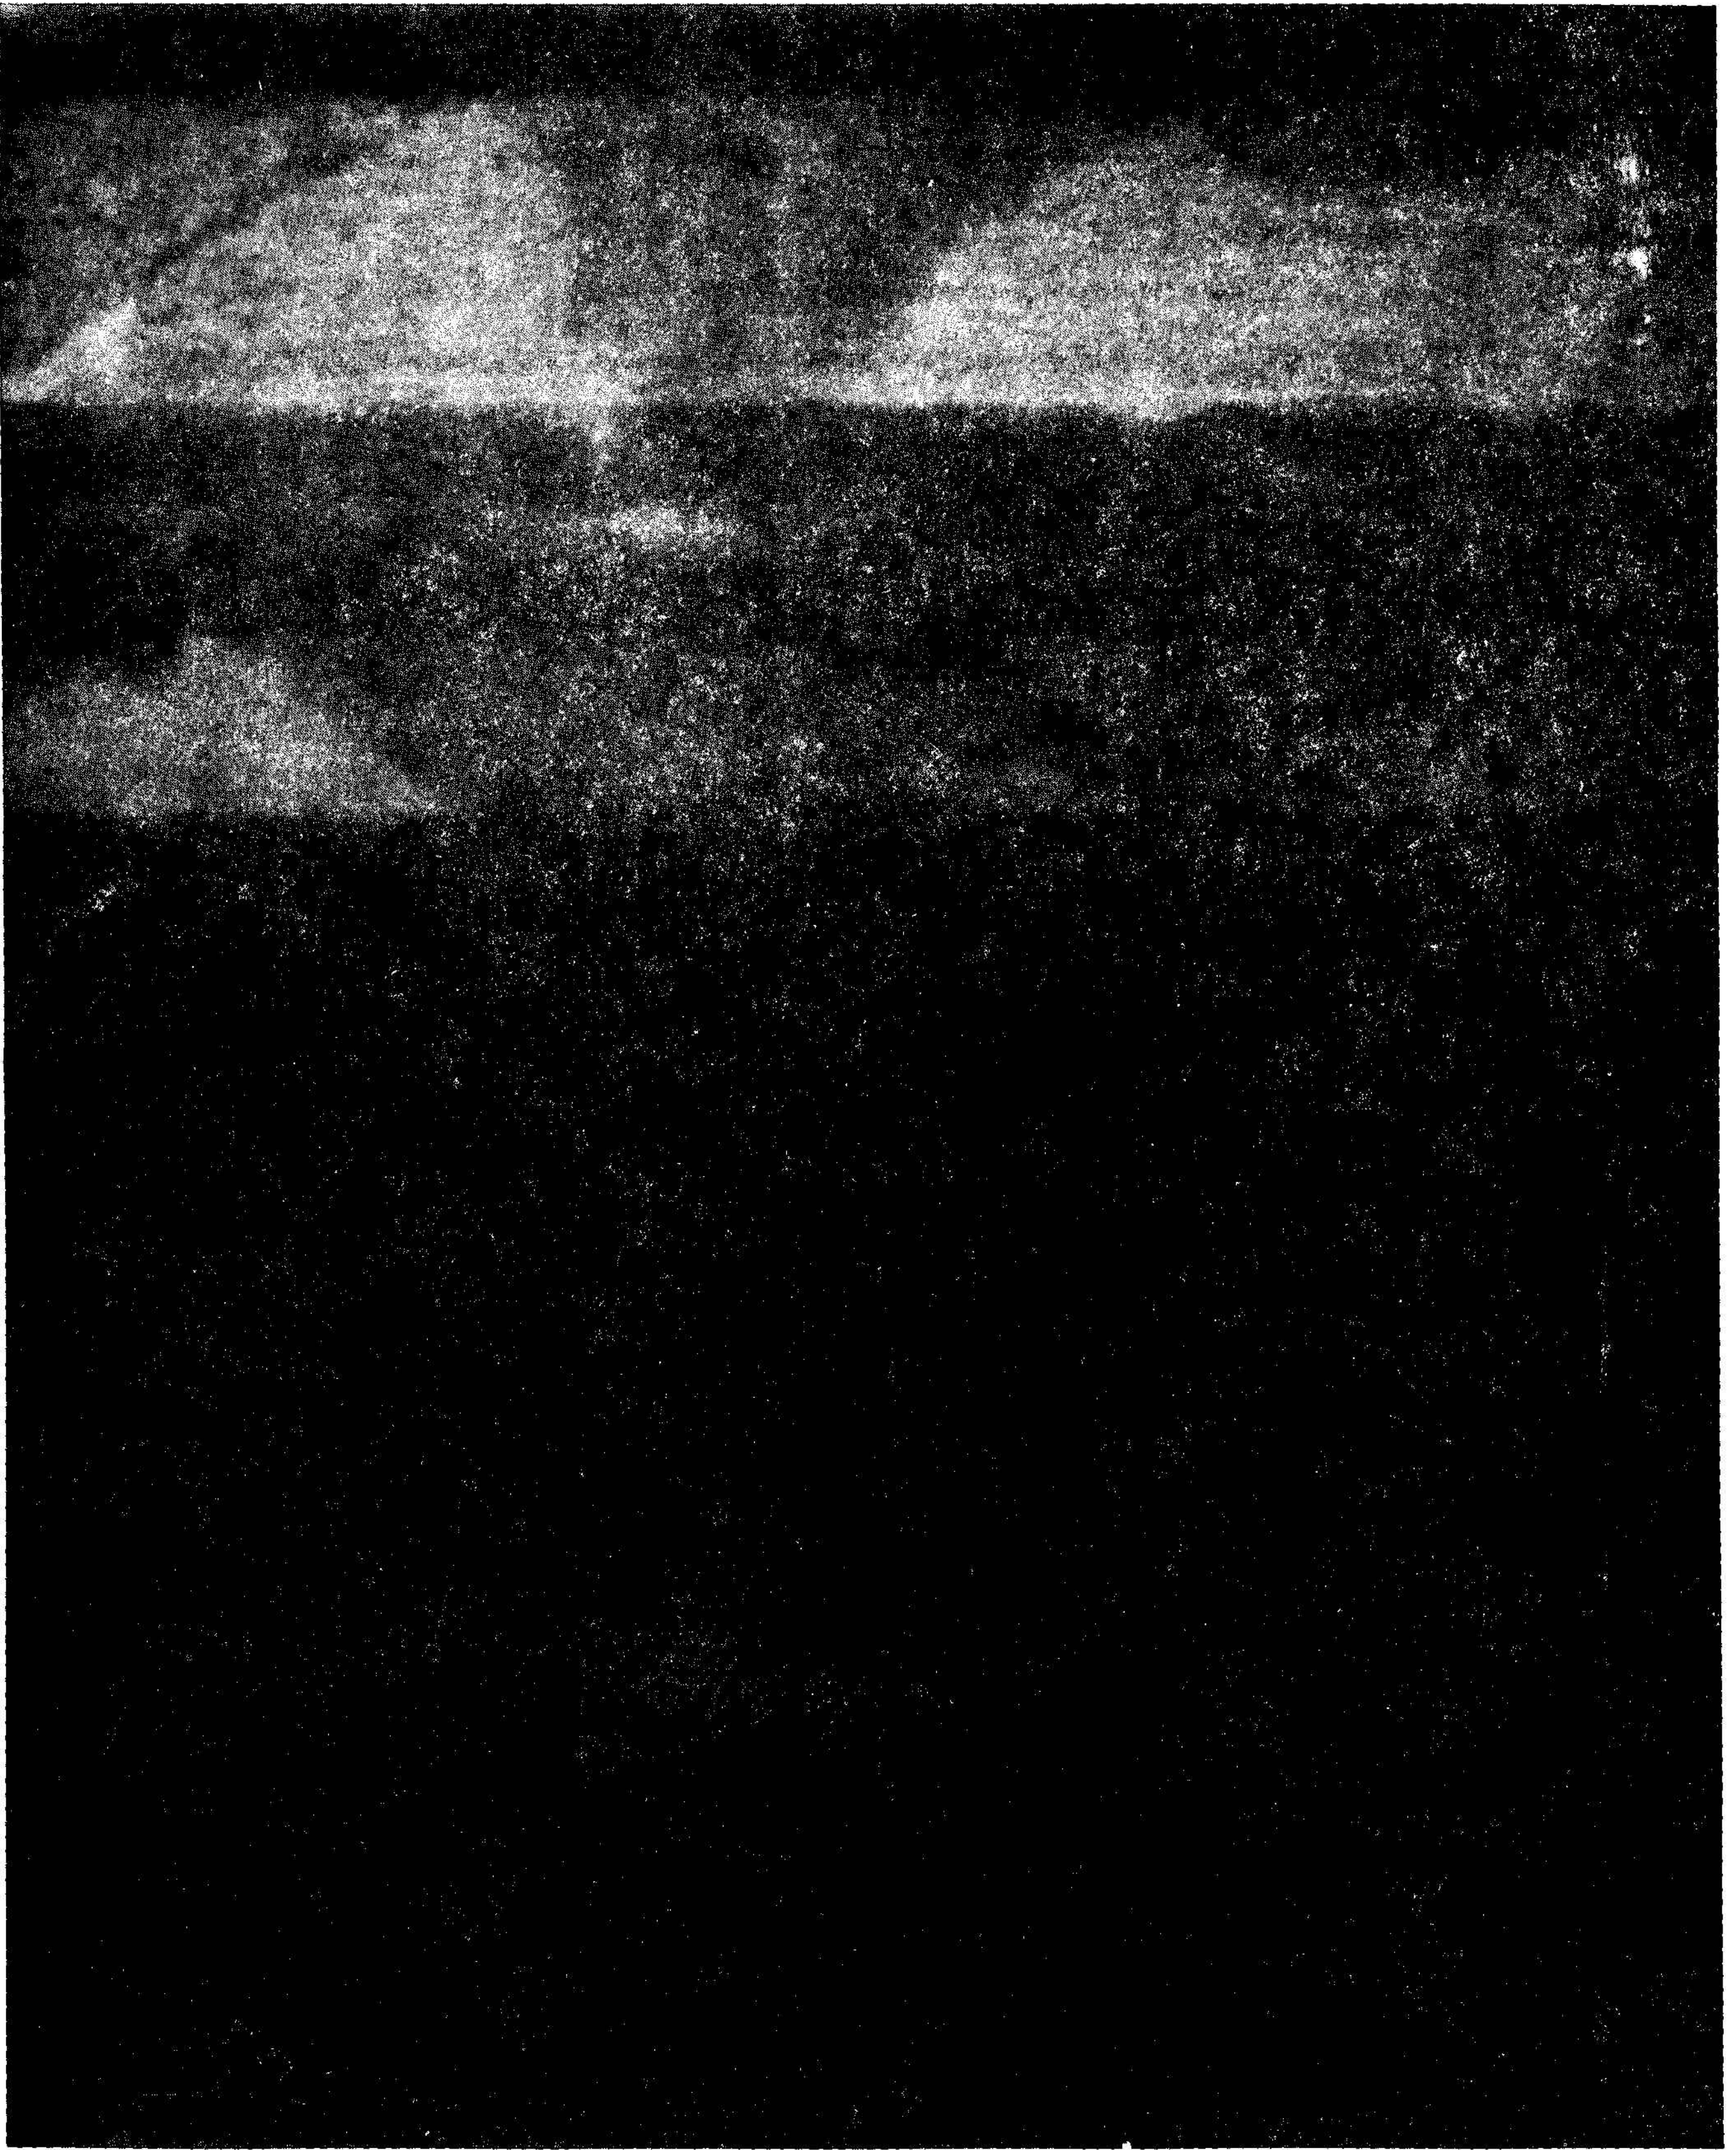
X-Ray 3. Taken through the north wall of the bathroom adjacent to Booker T. Washington's bedroom (room 211) at a height of 5'-0" with sixty pulses of energy used.

Taken through the top of the tile wainscoting, it is evident that the historic sawn wood lath extends behind the tilework, as well as the plaster, indicating that the tile is probably part of the original construction or a very early addition.

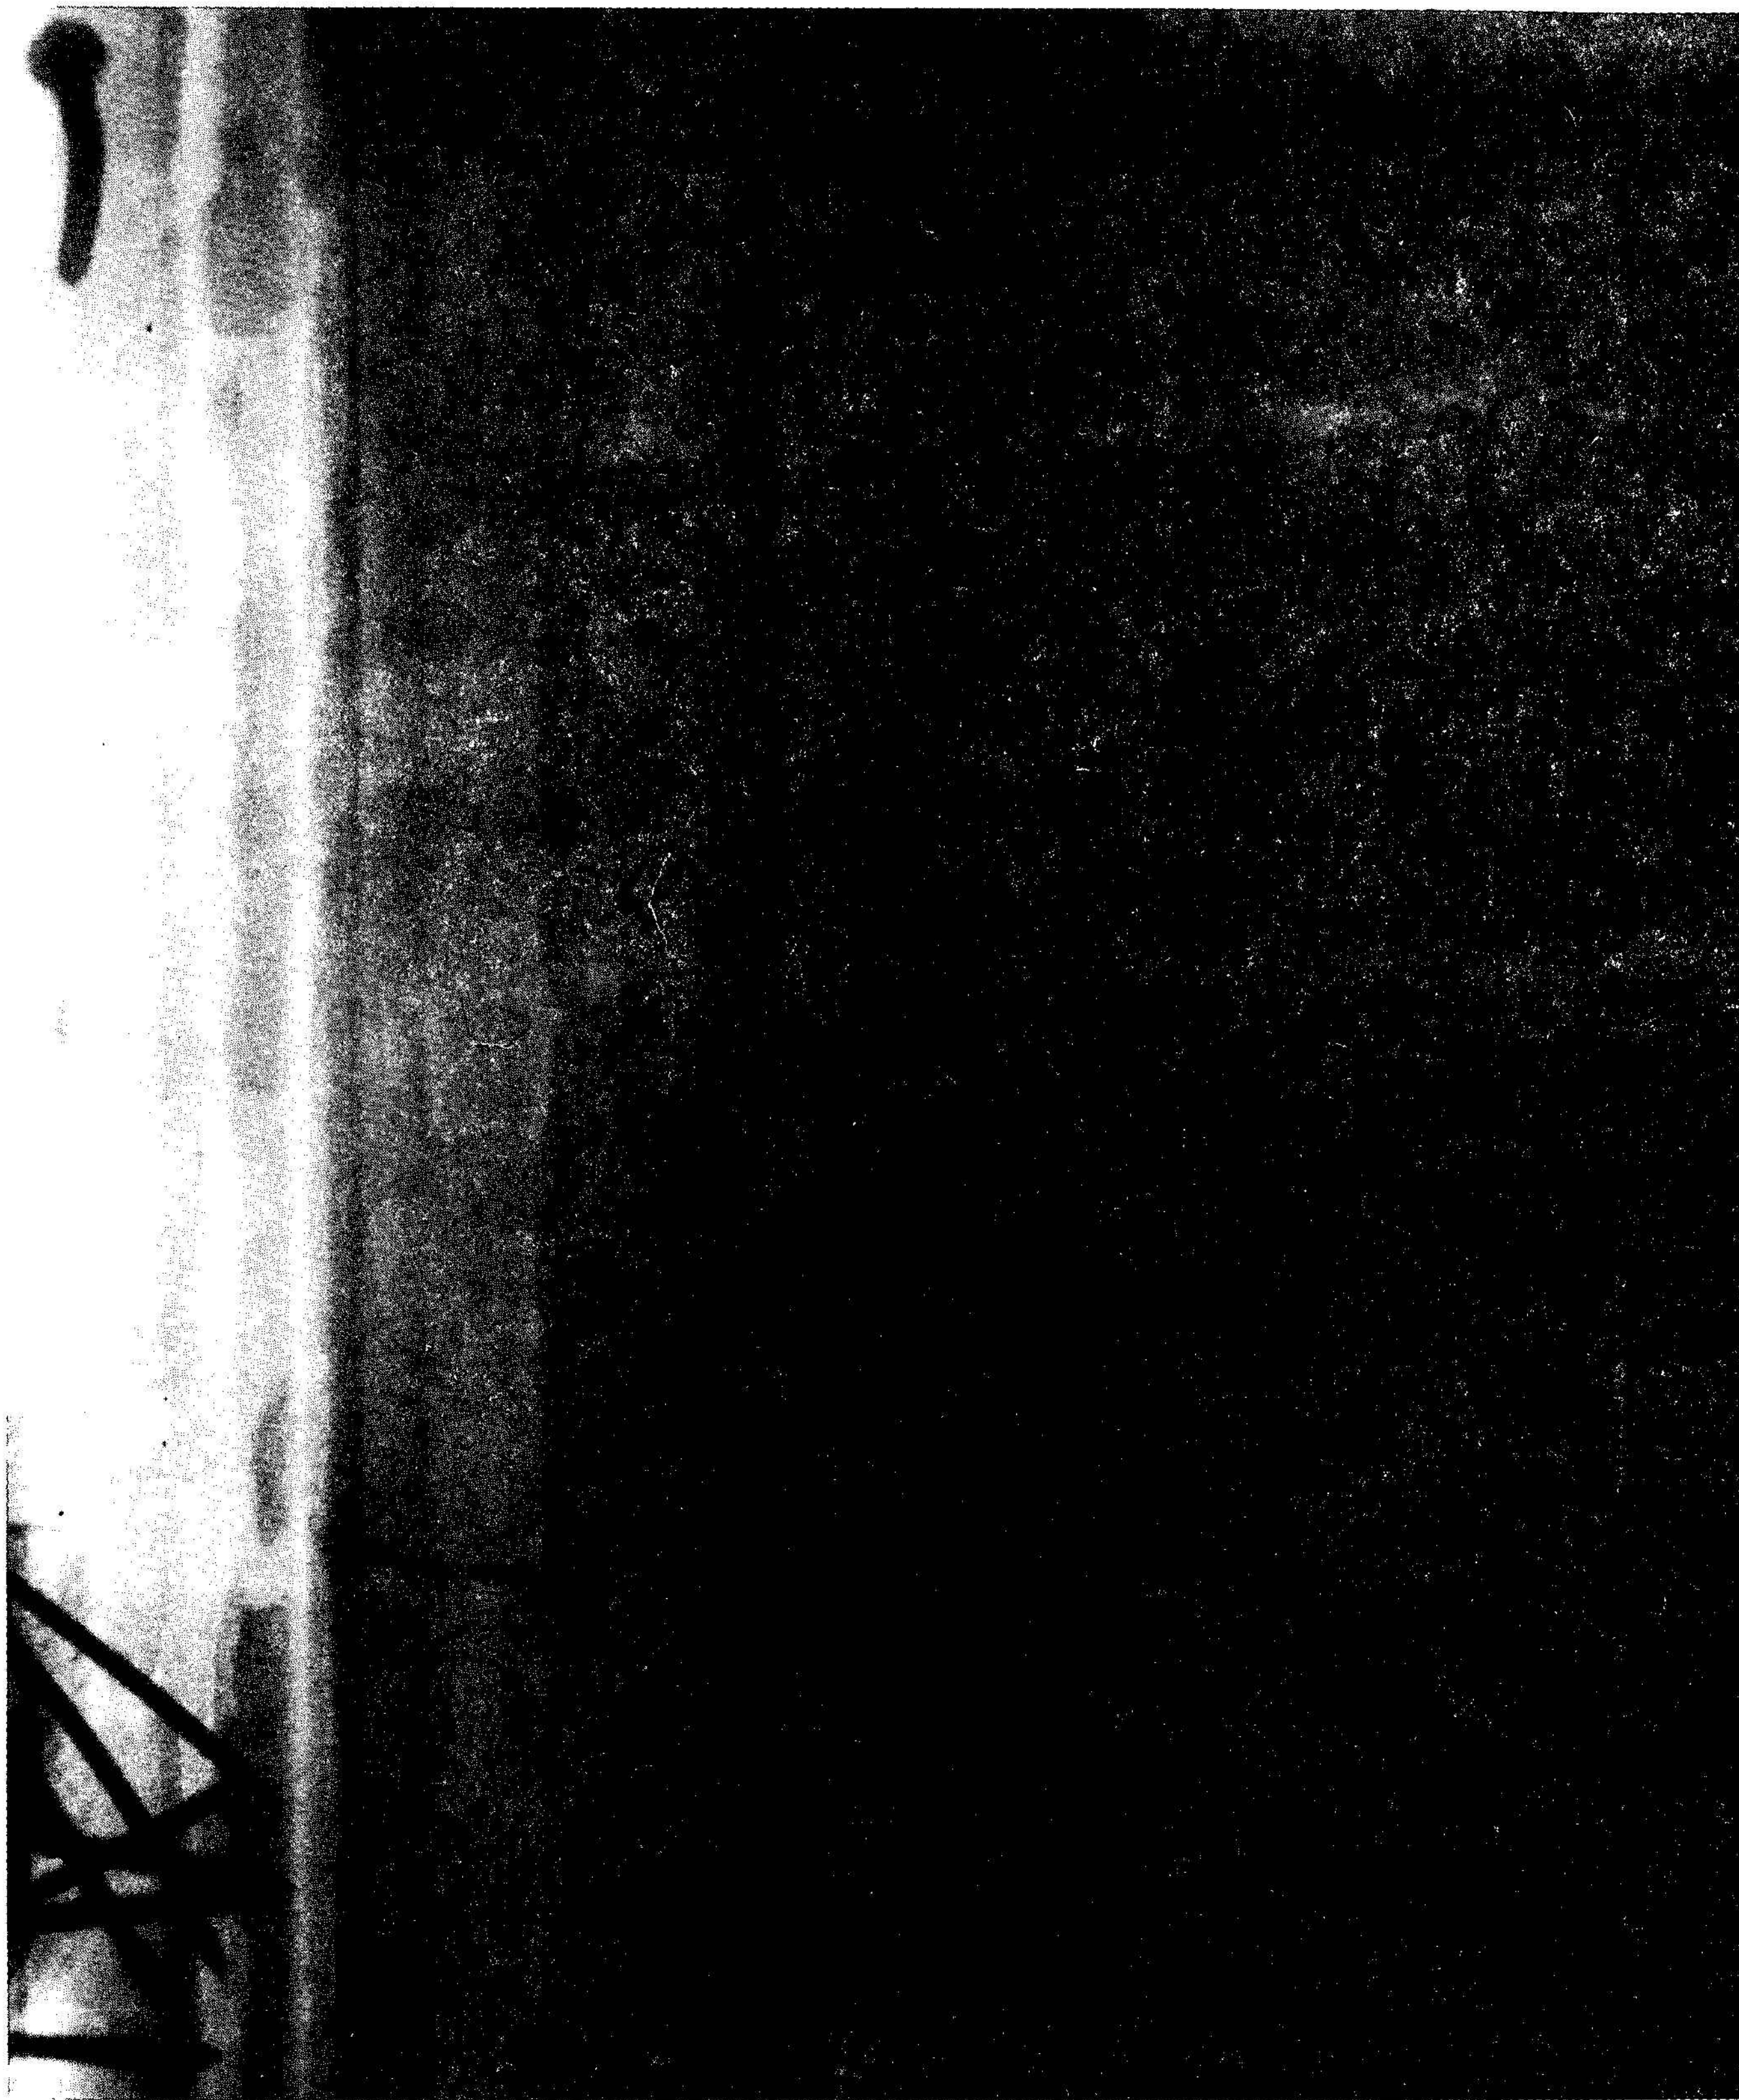
X-Ray 4. Taken through the east wall of the bathroom adjacent to the boys' bedroom (room 208) at a height of 5'-0" using ninety pulses.

Taken through the top of the tile wainscoting and the north jamb of the doorway, the wall is seen as being constructed of sawn wood lath and plaster and tilework with a profusion of wire nails used in the finished millwork. This is in contrast to the cut nails used in basic construction, as seen in x-ray 2.

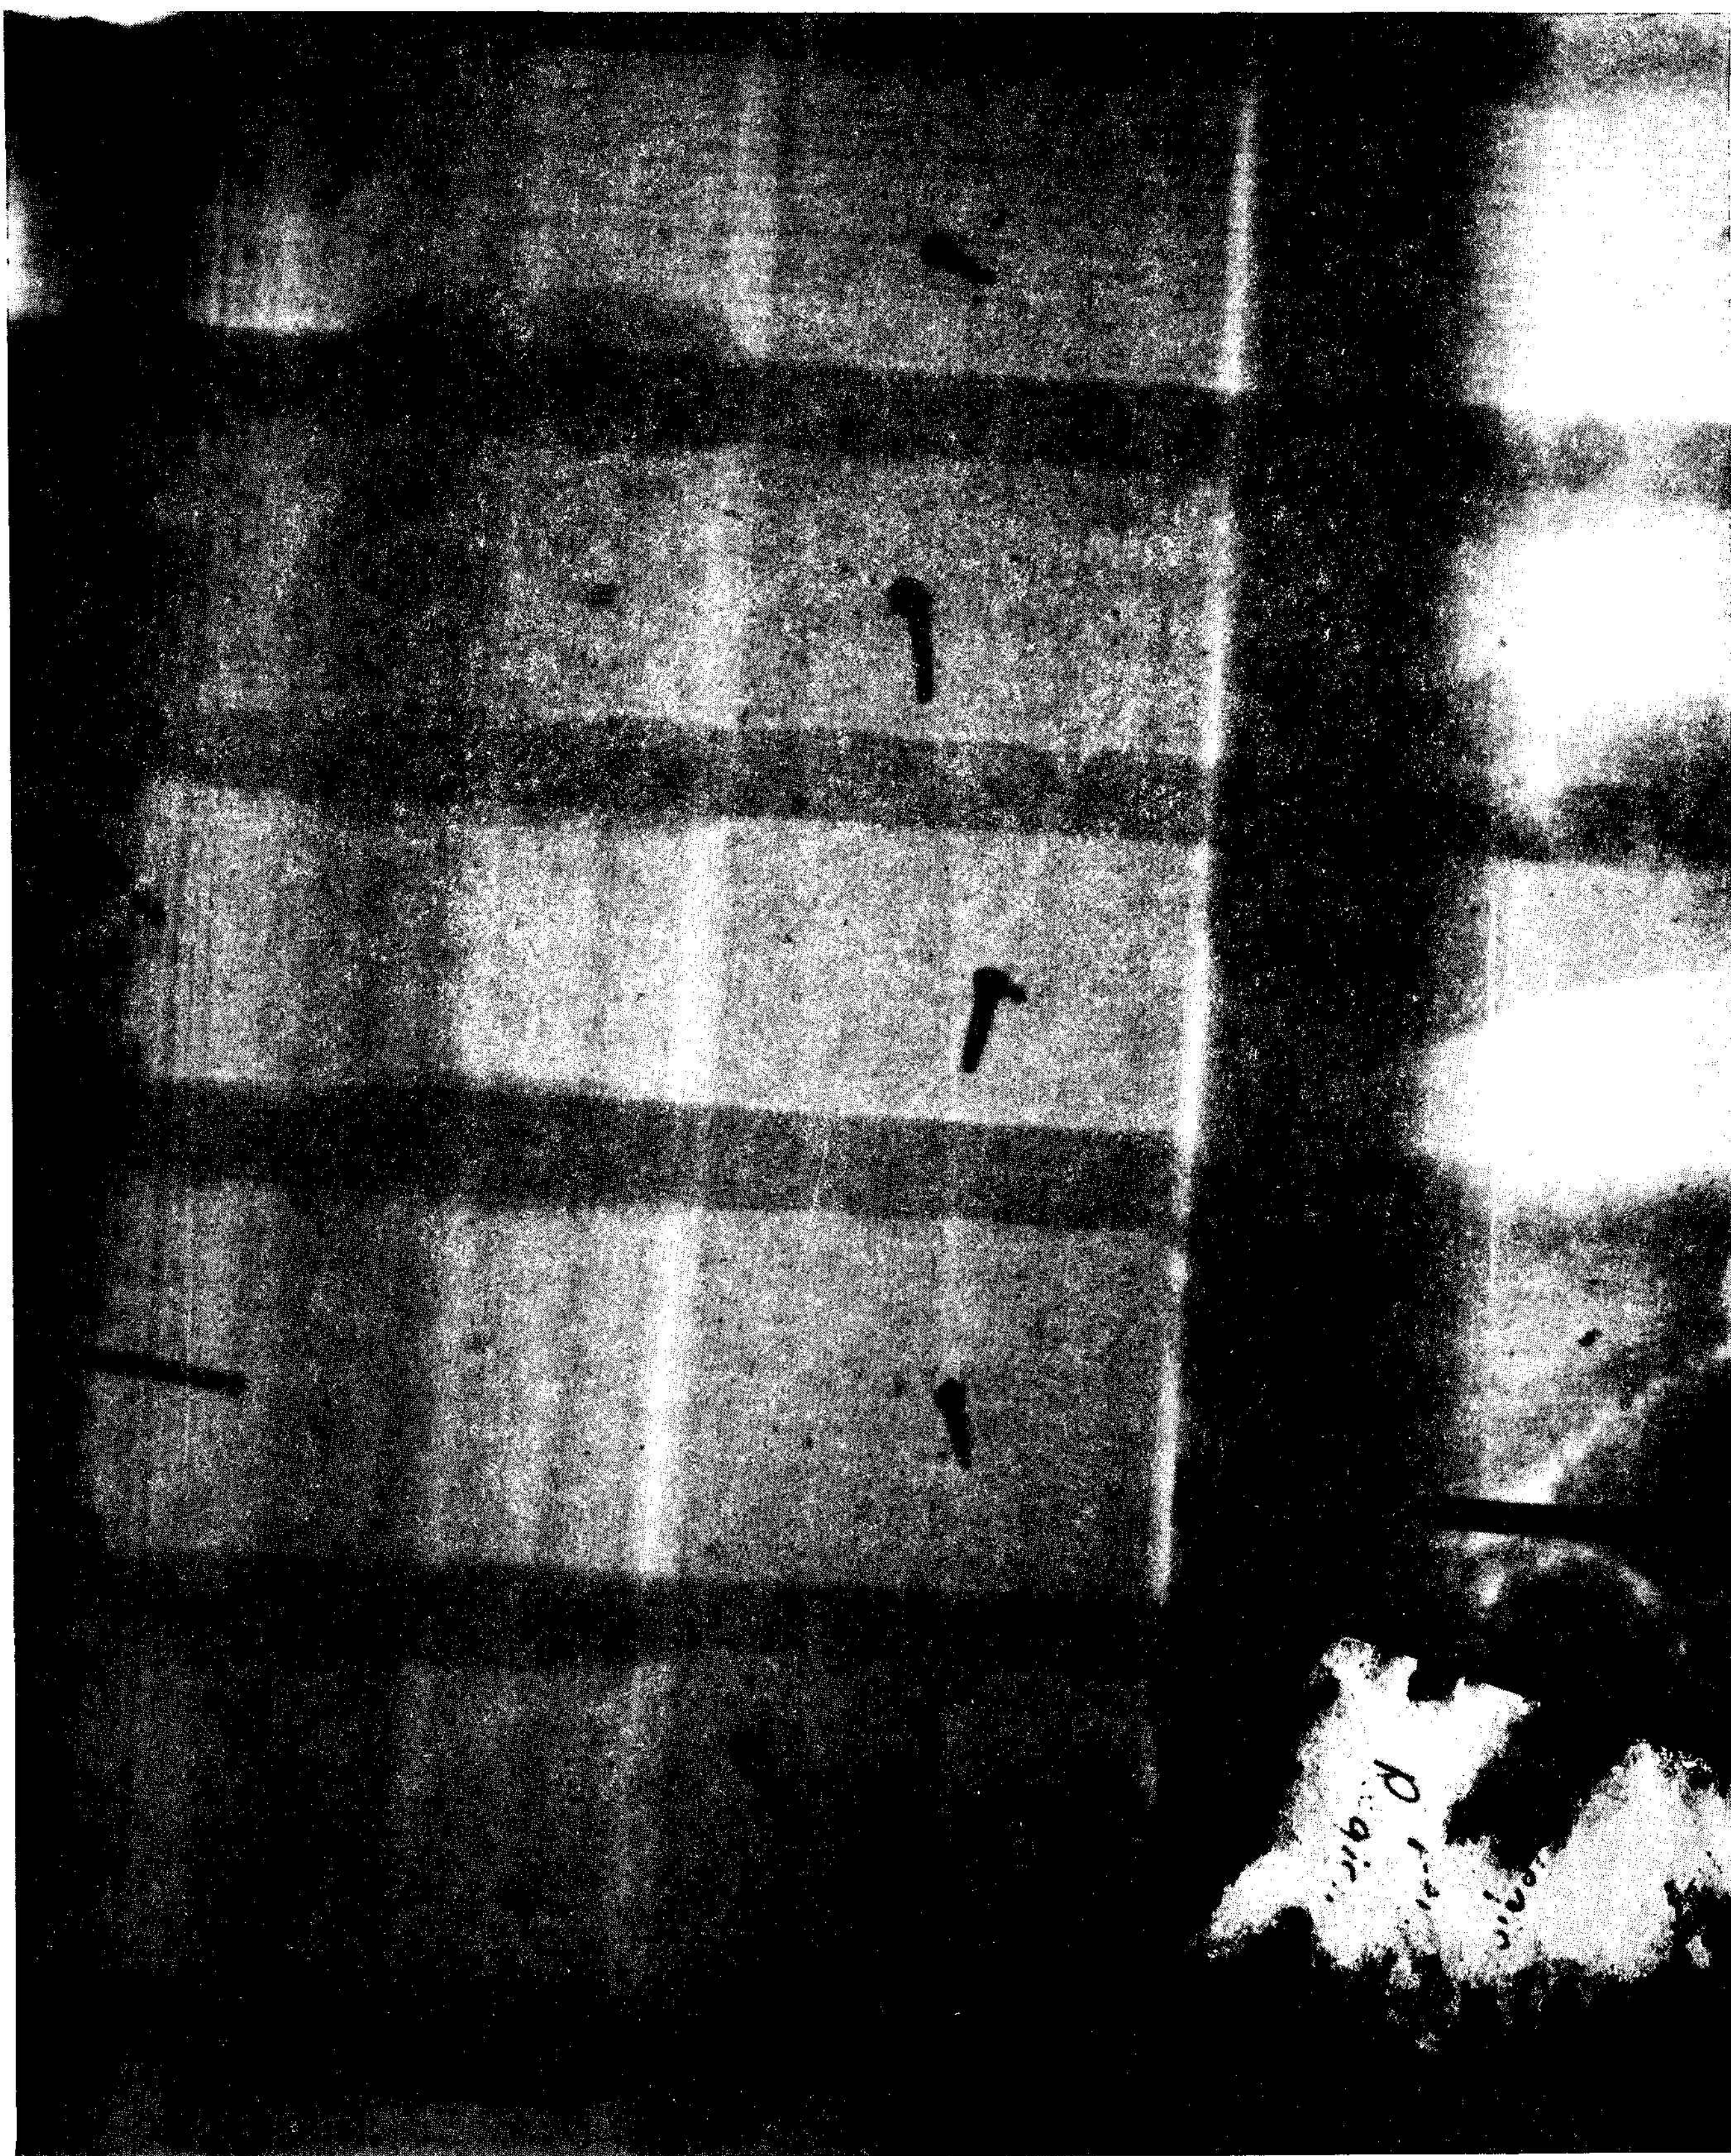
X-Ray 5. Taken through the small doorway near the fireplace in Booker T. Washington's bedroom (room 211) at a height of 4'-8" with thirty pulses used.

Seen in the x-ray is cracking in the plaster, sawn wood lath, small cut nails used with the lath, and large wire nails used in the door frame.

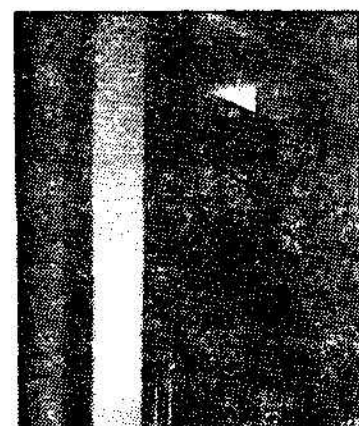
40. Transom opener

Lock	29	Inst.		x			x	G	"Yale" brand				x		
211/212	BTW's Bedroom/Bath	Hinges (2)	27	1899	x			x		G		x	x				Strip paint
		Lockware	17	1899	x				x	G		x					
		Hook	32	Inst.	x			x		F	Missing eye				x		
		Transom opener	24	1899	x			x		F			x				Strip paint
		Transom hinges (2)	28	1899	x			x		G		x	x				Strip paint
214/Ext.	Den Entry/Porch Eight	Hinges (2)	10	1899	x				x	G		x					
		Lockware	17	1899	x				x	G		x					
		Transom opener	24	1899	x				x	G		x					
		Transom hinges (2)	39	1899	x				x	G		x					
214/Ext.	Den Entry/Porch Nine	Hinges (2)	10	1899	x				x	G		x					
		Lockware	17	1899	x				x	G		x					
		Transom opener	40	1899	x				x	F			x				
		Transom hinges (2)	10	1899	x				x	G		x					
		Hasp	41	Inst.	x				x	G					x

Lock	18	Inst.		x			x	E	"Weiser" brand	x					
		Transom opener	24	1899	x			x		F		x					
		Transom hinges (2)	44	1899	x				x	F		x					
303/306	Hall/Trunk Room	Hinges (2)	27	1899	x				x	G		x					
		Lockware	17	1899	x				x	F	Missing one knob	x					
		Lock	29	Inst.		x			x	F	Missing keeper	x					
303/308	Hall/West Attic	Hinges (2)	27	1899	x				x	G		x					
		Lockware	17	1899	x				x	F	Missing knob	x					
		Lock	29	Inst.		x			x	P	Missing lockbox	x

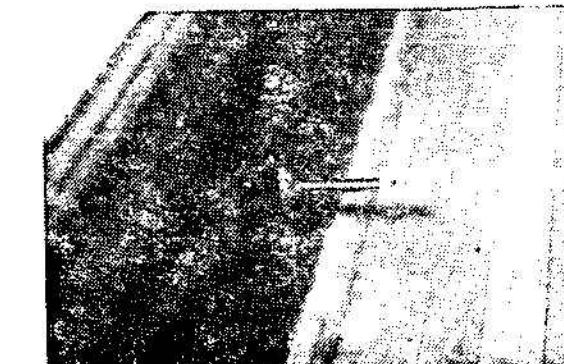
50. Door bumper

Room	Location	Element	Type	Period	Iron	Brass	Other Mater	Painted	Unpainted	Condition	Comments	Preserve	Repair	Replace	Remove	Install	Comments
103	South baseboard	Door bumper	50	Inst.		x	x		x	F	Missing rubber tip				x	x	Wood bumper
104	North wainscoting	Metal strap	51	Inst.	x				x	F					x		
105	North baseboard	Door bumper	52	1899			x		x	M						x	Wood bumper
106	South baseboard	Door bumper	52	1899			x		x	M						x	Wood bumper
107	North baseboard	Door bumper	53	1899	x		x	x	x	P	Wood		x				
110	West door	Towel rod	53	1899	x			x		P			x				
		Shelf	54	Inst.			x	x		F	Wood				x		
111	Cabinet	Upper hinges (8)	28	1899	x				x	G		x					
		Upper locks (2)	55	1905	x				x	G		x					
		Upper locks (2)	56	1899	x				x	M	Above existing locks	x					
		Lower hinges (8)	57	1899	x				x	G		x					
		Lower latches (4)	58	1899		x			x	F			x				
		Lower locks (2)	59	1910	x				x	P			x				
202	Hookboards	Coat hooks (5)	60	Inst.		x			x	P	One broken, two gone	x

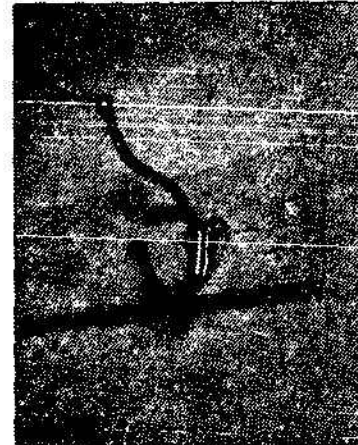
60. Coat hook

Room	Location	Element	Type	Period	Iron	Brass	Other Material	Painted	Unpainted	Condition	Comments	Preserve	Repair	Replace	Remove	Install	Comments
210	Door to Bedroom	Towel rod	62	1899	x			x		F		x					Strip paint
	Door to Rear Hall	Towel rod	63	Inst.			x	x		P	Porcelain, broken				x		
	East wall	Towel rod	64	1899	?				?	M				x			
	North wall	Sink shelf	65	1899	?				?	M				x			
		Towel rod	66	1899	?				?	M				x			
	South wall	Paper dispenser	67	1899	?				?	M				x			
211	South baseboard	Door bumper	52	1899			x	x		G						x	Wood bumper
212	Door	Towel rods (2)	62	1899	x			x		G		x	x				Strip paint
	South wall	Towel rod	68	Inst.			x	x		F	Wood	x					
	West wall	Towel rod	66	1899	?				?	M		x					
	Door	Hooks (3)	69	1899	x			x		F		x					
213	Hookboards	Coat hooks (14)	61	1899	x			x		F		x					
	Door lintel	Hook	66	1899		x		x		G		x					
301	South baseboard	Door bumper	52	1899			x		x	M						x	Wood bumper
302	Hookboards	Coat hooks (5)	60	1899	x			x		F	One missing	x

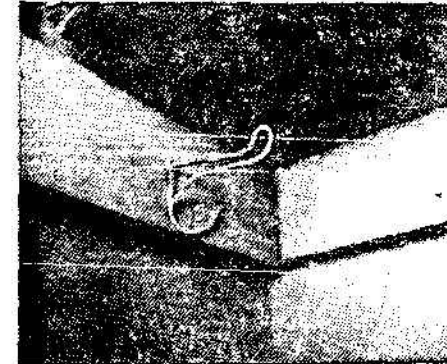
61. Coat hook -

Coat hooks (4)	61	1899	x			x		F	One broken	x					
203	West door	Towel rod	62	Inst.			x		x	G	Porcelain	x					
		Towel rod	63	Inst.			x		x	P	Plastic, missing rod	x					
		Shower rod	64	Inst.	x				x	M		x					
		Curtain hook	65	Inst.	x				x	G		x					
205	Fireplace cabinet	Hook	66	1899		x			x	G		x					
	West baseboard	Door bumpers (2)	52	1899			x		x	M						x	Wood bumpers
206	Hookboards	Coat hooks (6)	60	Inst.		x			x	P	One broken, two gone	x					
		Coat hooks (15)	61	1899	x			x		P	Thirteen missing	x					
207	North wainscoting	Metal strap	51	Inst.	x				x	F					x		
	North baseboard	Door bumper	52	1899			x		x	M						x	Wood bumper
208	North baseboard	Door bumper	52	1899			x		x	M						x	Wood bumper
	South baseboard	Door bumper	52	1899			x		x	M						x	Wood bumper
209	Hookboards	Coat hook	60	Inst.		x			x	G		x					
		Coat hooks (8)	61	1899	x				x	P	Six missing	x

303	East wainscoting	Metal strap	51	Inst.	x				x	F		x					
	Stair well	Door bell	70	1899	x				x	F		x					
304	West baseboard	Door bumper	52	1899			x		x	M		x					
305	Hookboards	Coat hook	60	Inst.		x			x	E		x					
		Coat hooks (10)	61	1899	x			x		P	Eight missing	x					
310	Wainscoting rail	Towel rods (2)	71	1905			x	x	x	F	Porcelain	x					
	East wall	Towel rod	72	1905			x	x	x	F	Porcelain	x					
		Soap dish	73	1905			x		x	F	Porcelain	x					
																x	Paper dispenser
																x	Towel dispenser
001	North baseboard	Door bumper	52	1899			x		x	M						x	Wood bumper
	Ceiling	Door stop	74	1899	x			x		G		x

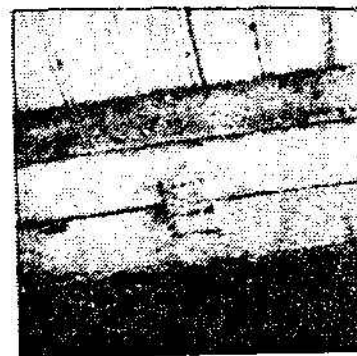
84. Hinge

Handle	75	1925	x			x		G					x		
		Spring	83	1925	x				x	G					x		
Porch Eight	South wall Northwest corner	Hinges (4)	84	1899	x			x		F			x				
		Eye	33	1899	x			x		F	No hook			x			Replace hook
South Den Elevation	Door hood Wall	Bolts (2)	85	1910	x			x		F	With square nuts	x					
		Miscellaneous iron	86	1910+	x				x	P		x

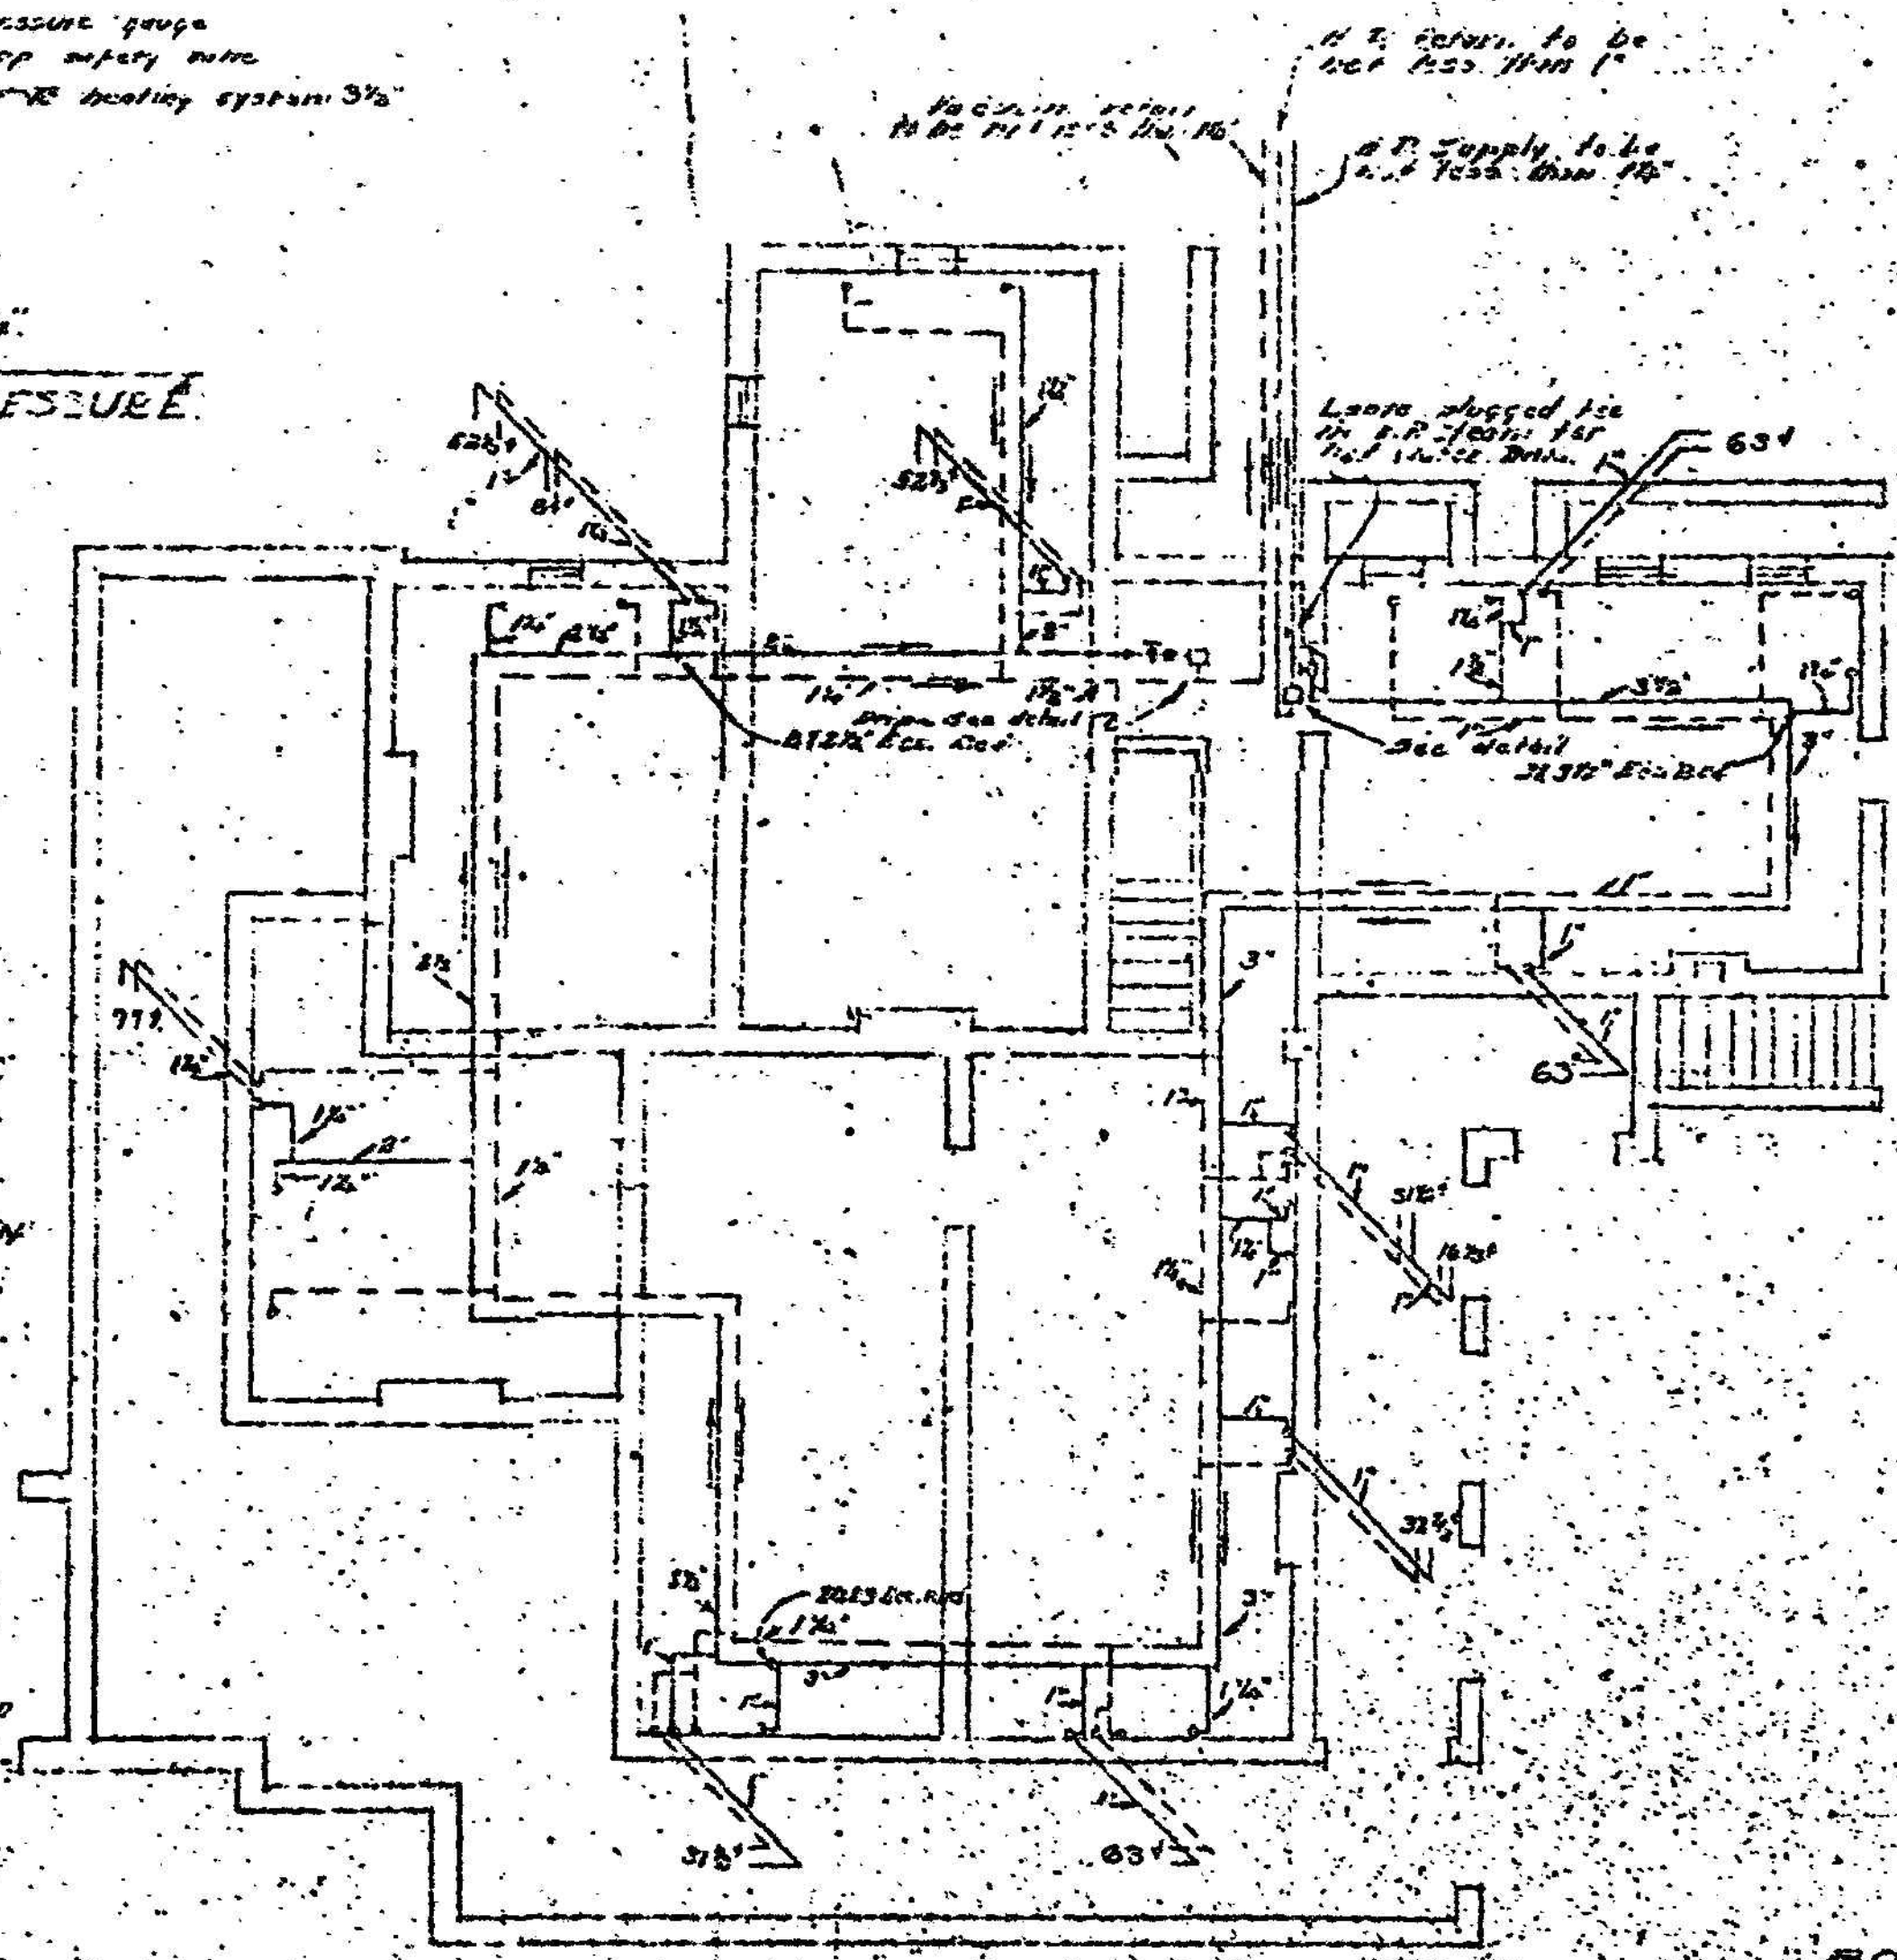
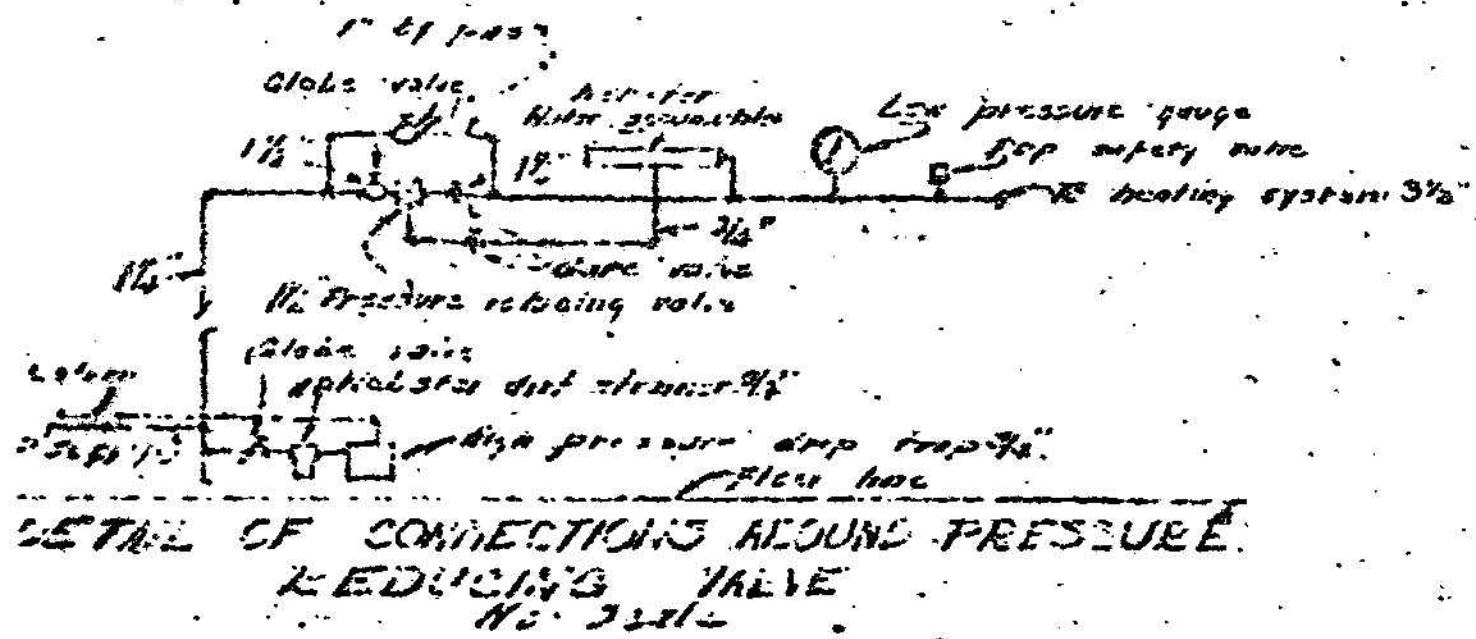
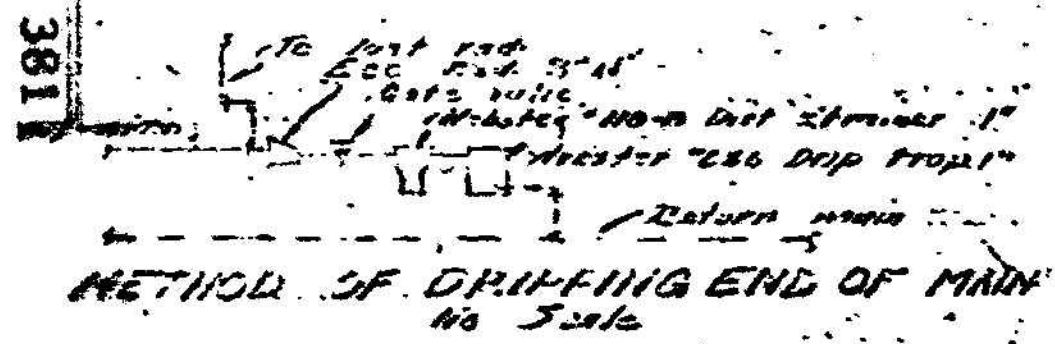
**BASEMENT PLAN**  
Scale 1/4" = 1'-0"

1. Basement Plan. Note that the base walls for the verandas and porches was depicted in its present configuration and not that of its original construction. Although portions of wall below the north and west of the study are shown this is probably a drafting error as these walls were never constructed. Note that the storage room (room 003) is not shown. It was probably constructed at a later date.
