## historic structure report

TUSKEGEE INSTITUTE  
THE OAKS

NATIONAL HISTORIC SITE / ALABAMA

HISTORIC STRUCTURE REPORT

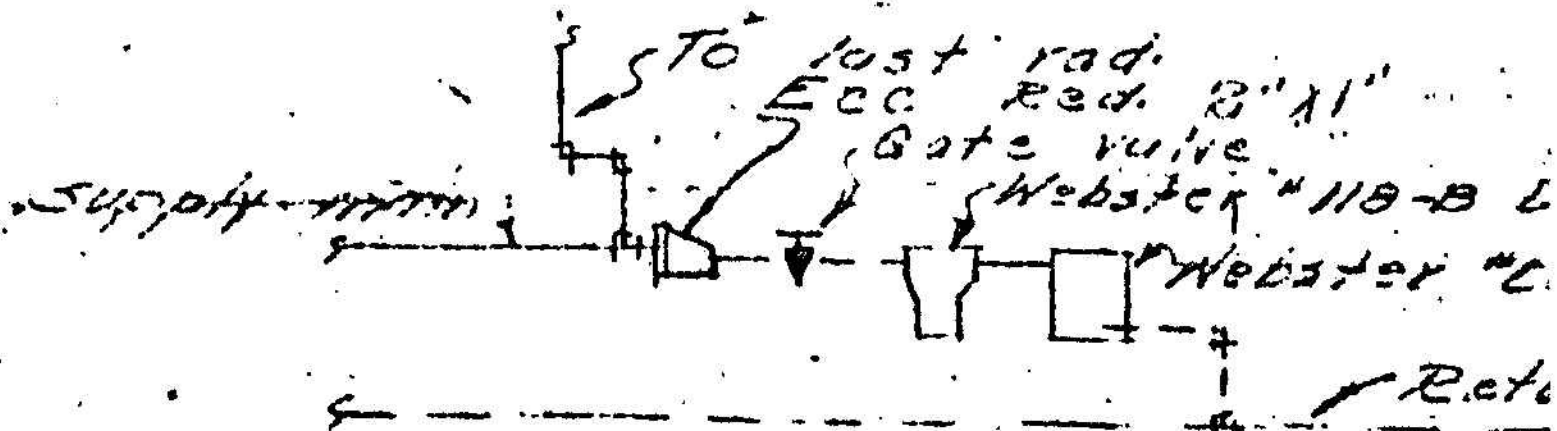
1a. Note on lower left margin of Basement Plan. The date, 6-26-29, appears only on this drawing, affirming the construction period of the radiator system as being undertaken by the Institute. The reference on the title to the "Booker Washington Memorial Residence" also substantiates that fact that the radiator system was installed after the house had ceased being used for active residential purposes.

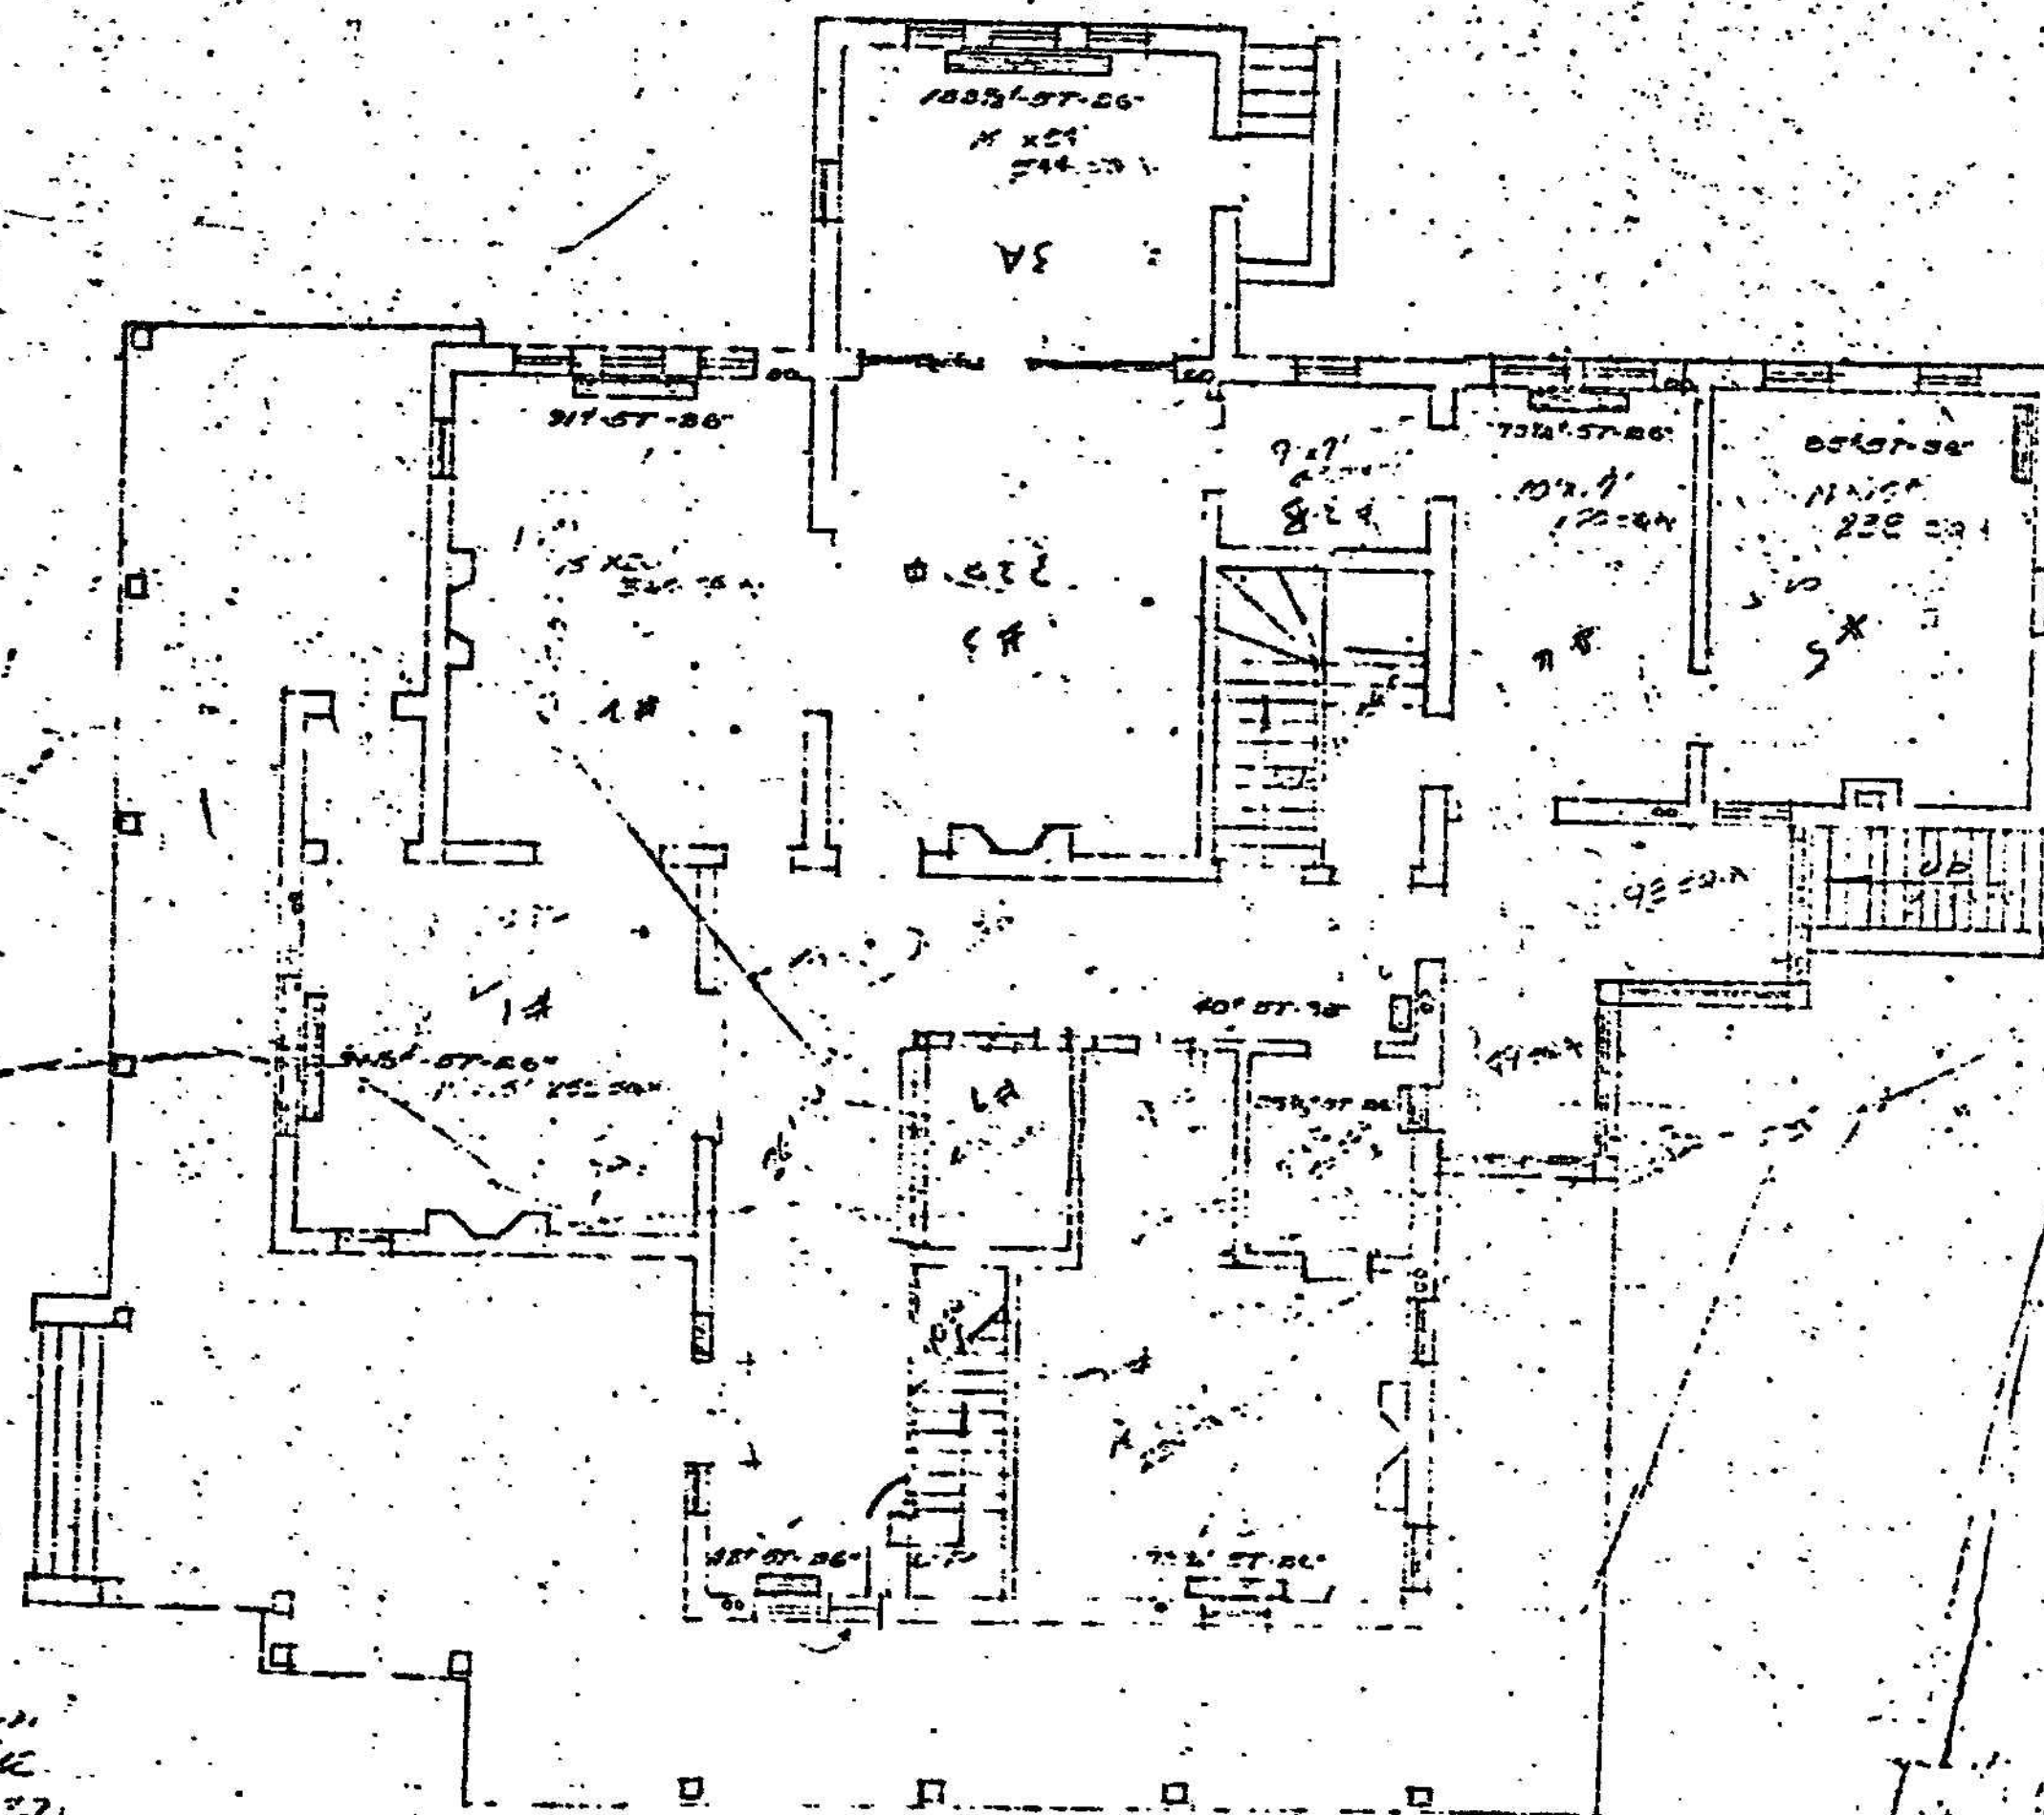
2. *First Floor Plan.* This plan can be assumed to be relatively accurate. The partition between the dining room and its addition was sketched in by a later hand. The guest room closet on the original print was drawn, having frame walls on its east and north sides and a doorway centered in its south wall. Note that the rear porch is L-shaped, without a dividing wall as at the present time.

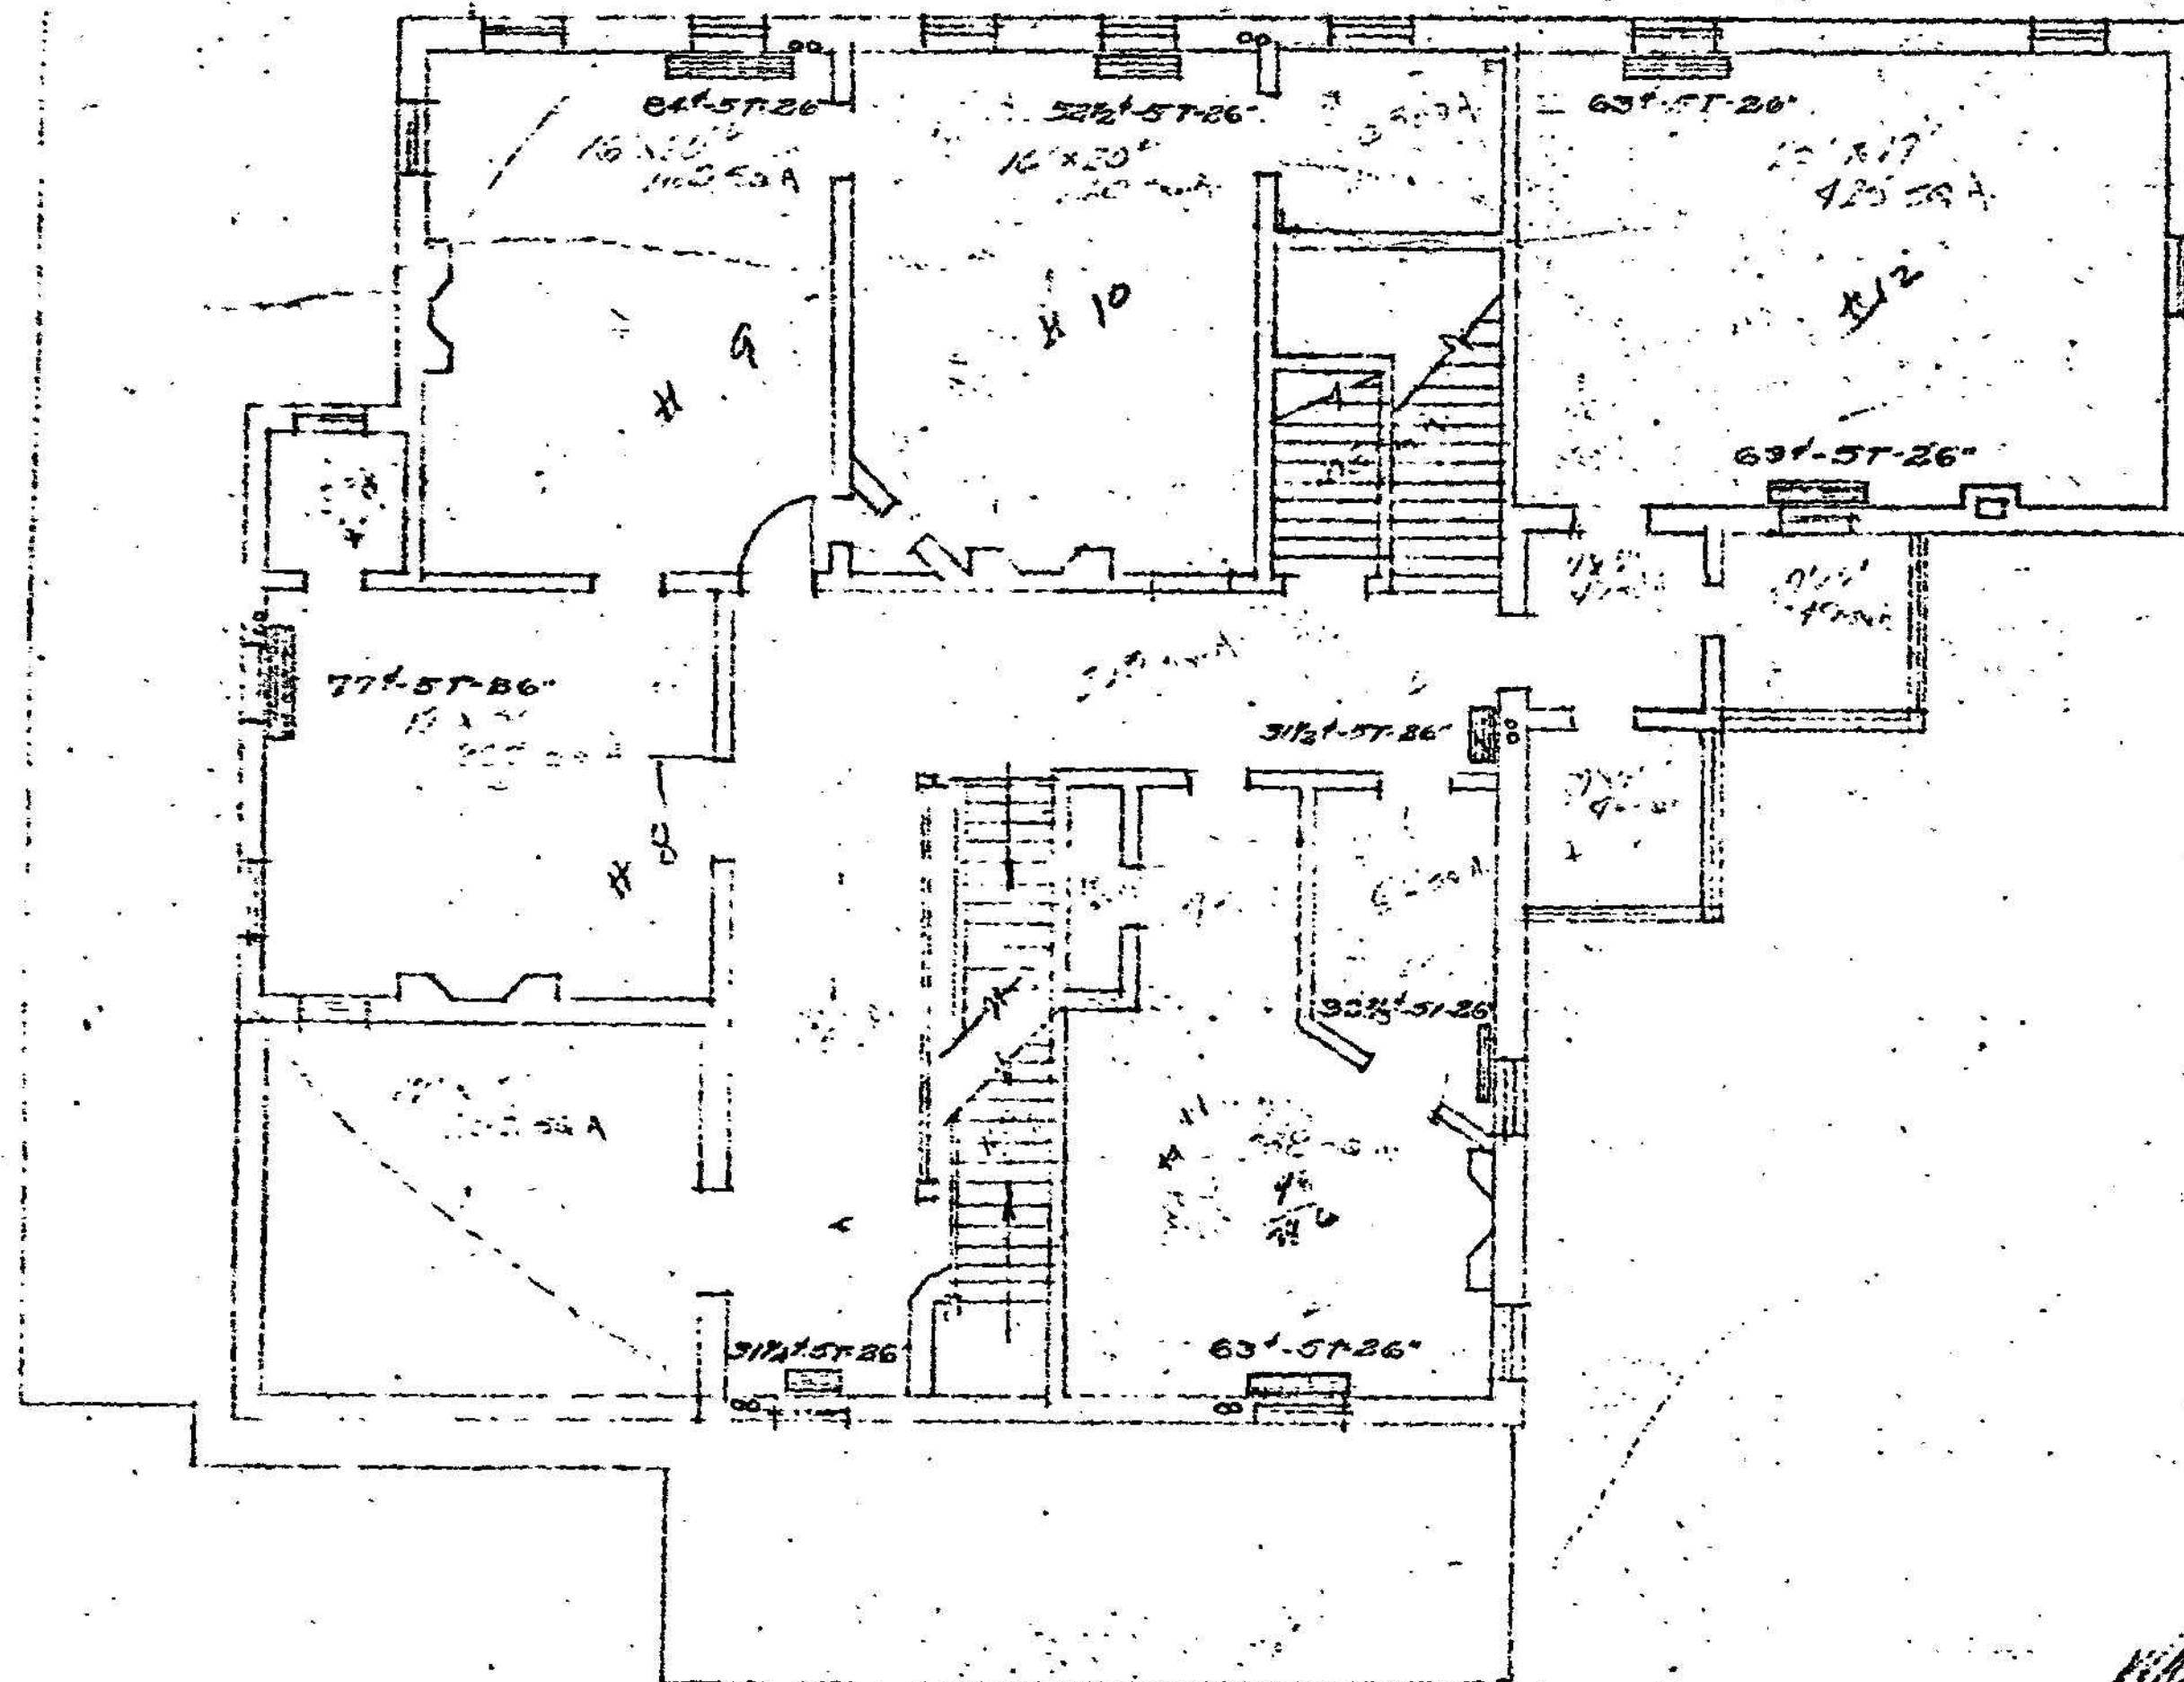
SECOND FLOOR PLAN  
Scale  $\frac{1}{8}" = 1'-0"$

3. Second Floor Plan. Aside from minor inaccuracies, this plan is relatively reliable. The closet in Portia's bedroom was overlooked, although it certainly existed at the time. The doorway between Margaret Murray Washington's bedroom closet and Booker Washington's bedroom was not as large as it is drawn. The south doorway to the den from the den porch is shown as a window, which it probably was at the time. Note also that the rear porches were screened, as were the porches below them.
