STIRLING'S QUARTERS AT VALLEY FORGE NATIONAL HISTORICAL PARK
HISTORIC STRUCTURE REPORT

PREPARED BY:
JOHN MILNER ARCHITECTS, INC.
104 LAKEVIEW DRIVE, CHADDS FORD, PA 19317

JANUARY 2006

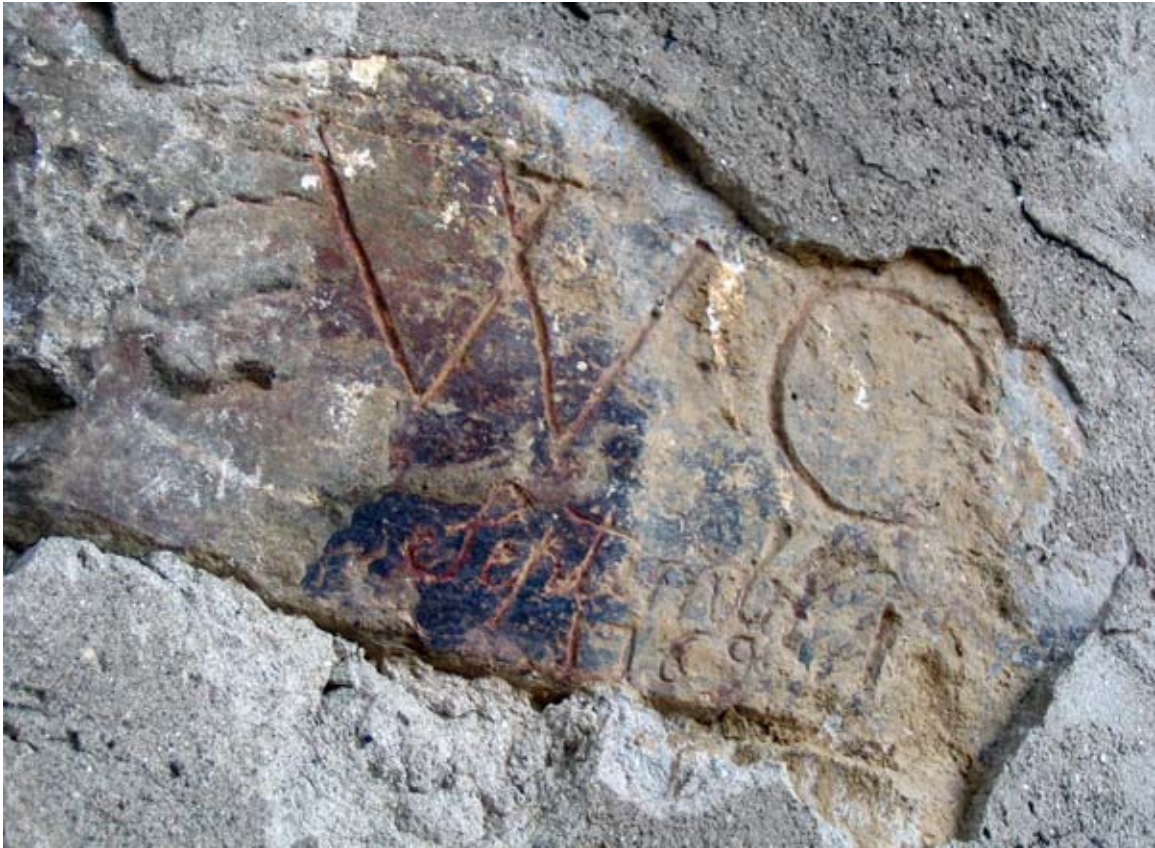
Figure 6: Detail view of one of the corner stones at the southwest corner of original kitchen block with the inscription, "W C September 1769."

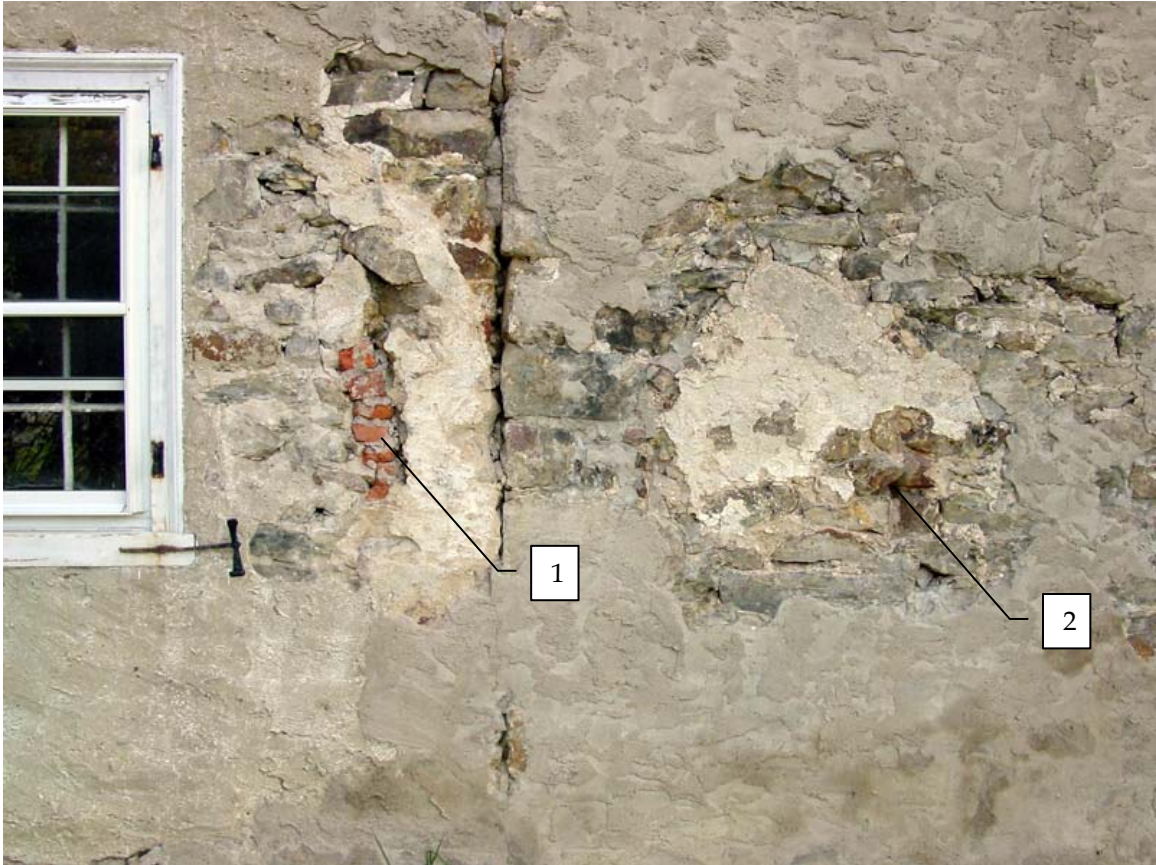
Photo WEf - Detail view of seam between original c. 1769 kitchen block (right) and c. 1810 addition to the north (left), looking east.

1. Brick infill at location of former bake oven.
2. Masonry infill at location of former bake oven.

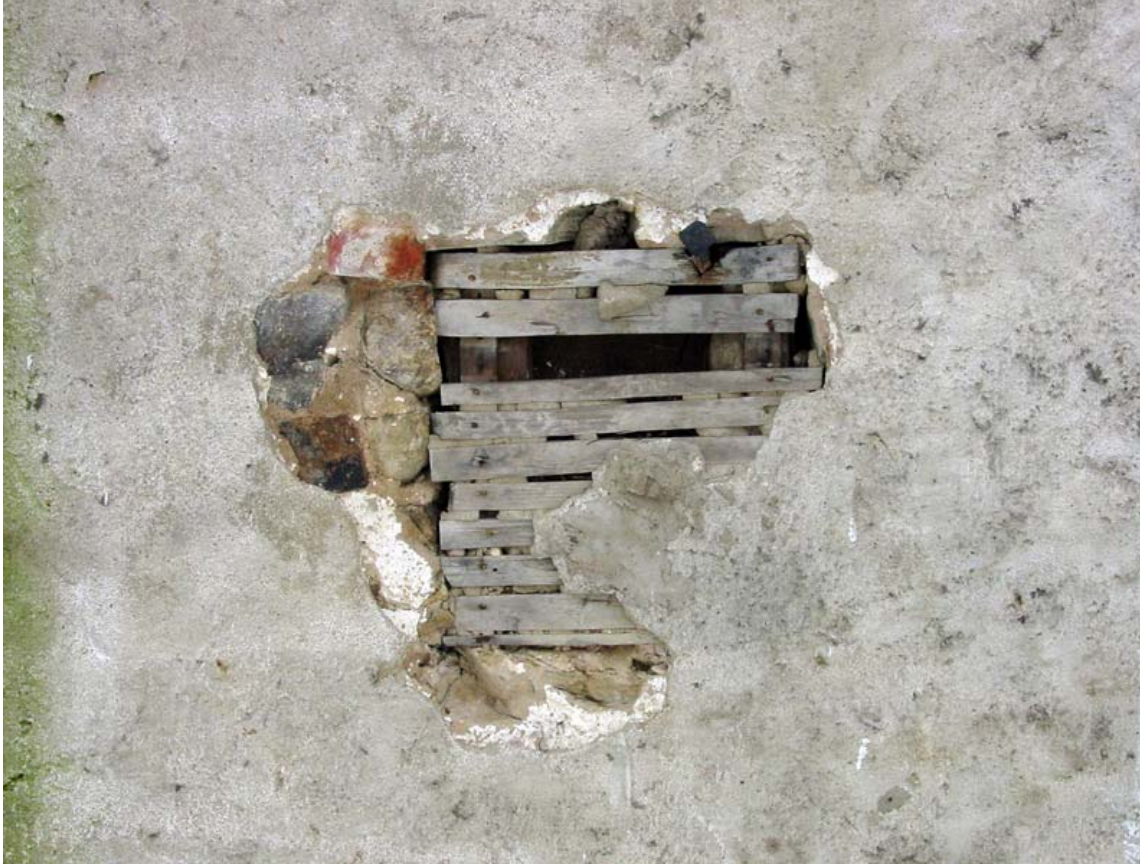
Photo NEb - Detail view of lath at lintel pocket, north façade of east addition, looking south.

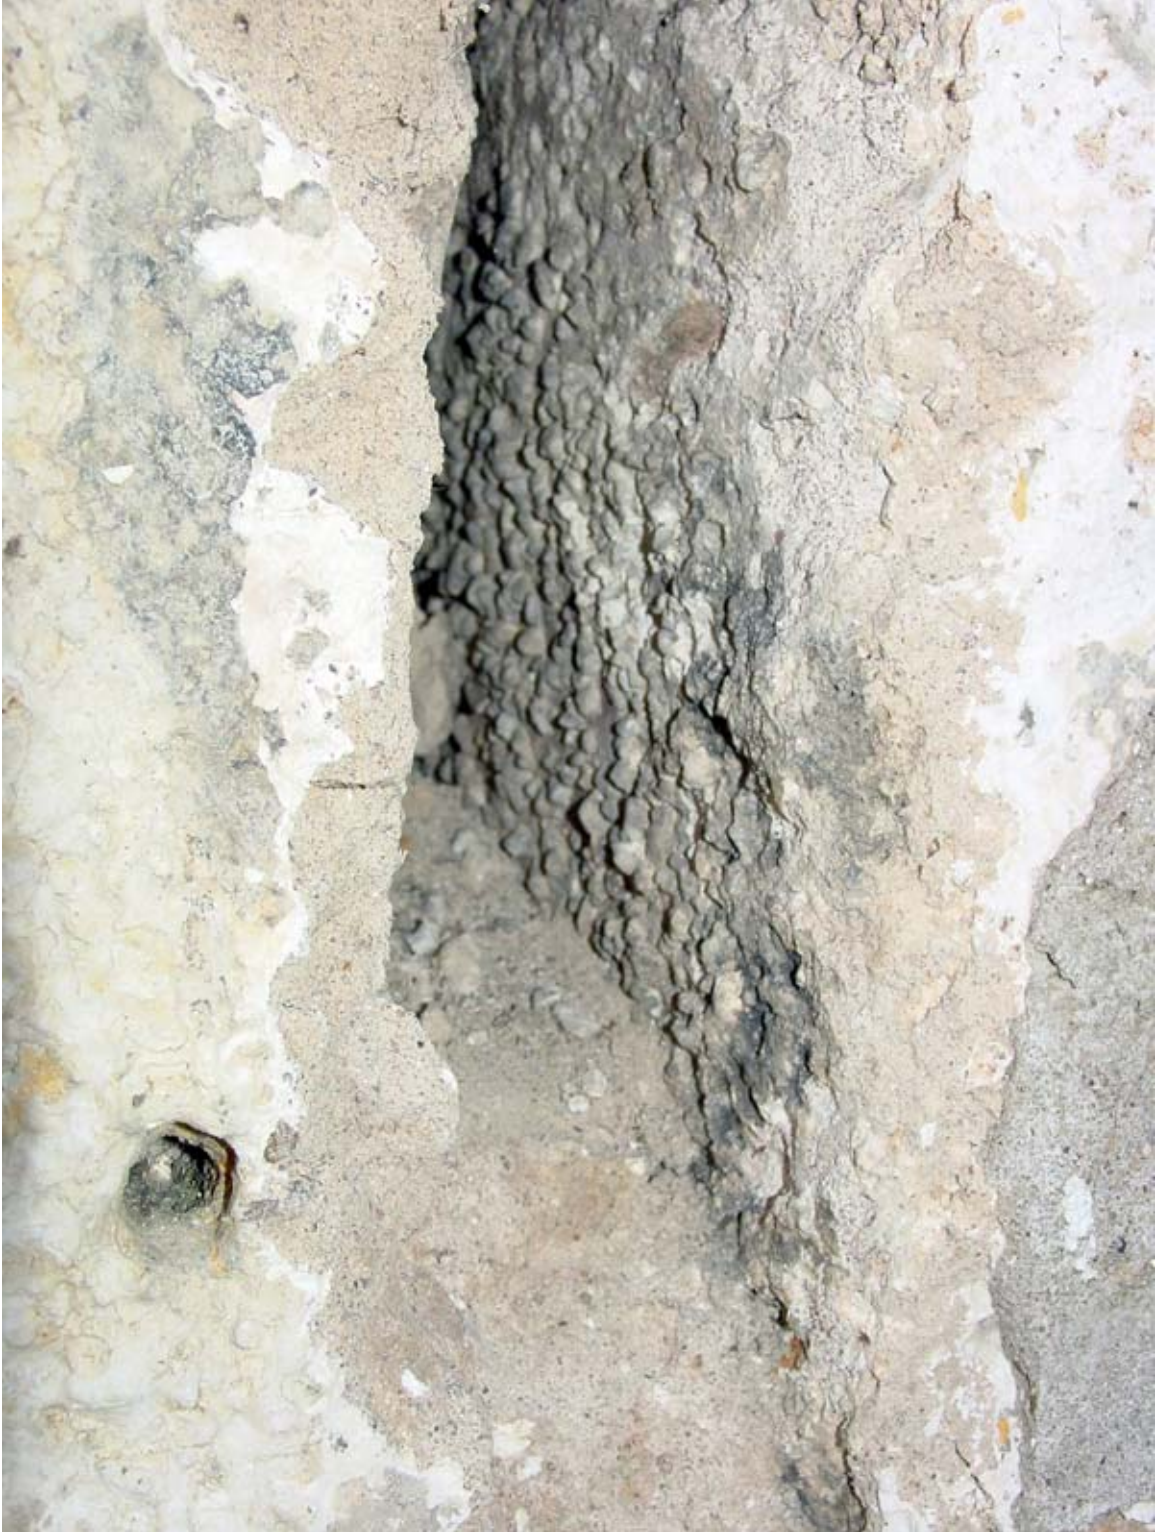
Photo NEd - Detail view of seam at north elevation between main block (right) and east addition (left), looking south. Note textured surface of stucco and that stucco wraps around east side of the main block. View represents the general location of Material Sample 26.

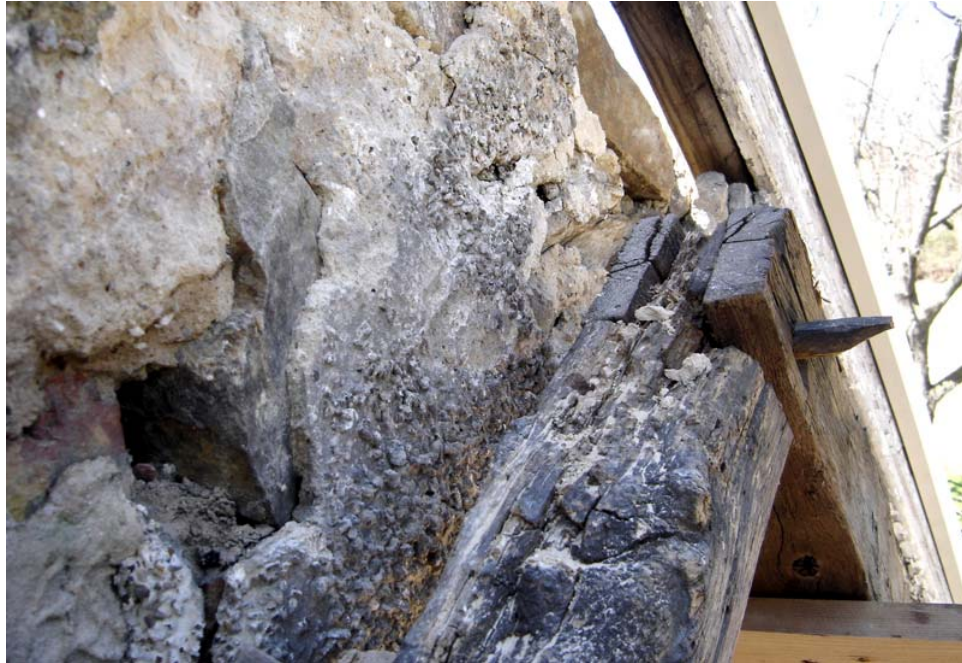
Photo EEb – Oblique view of east exterior wall of main block, looking northwest at location of east roof peak. Note that early lime-based stucco extends behind the east roof rafters. (East roof was removed at the time of this photo.) View represents the general location of Material Sample 14.

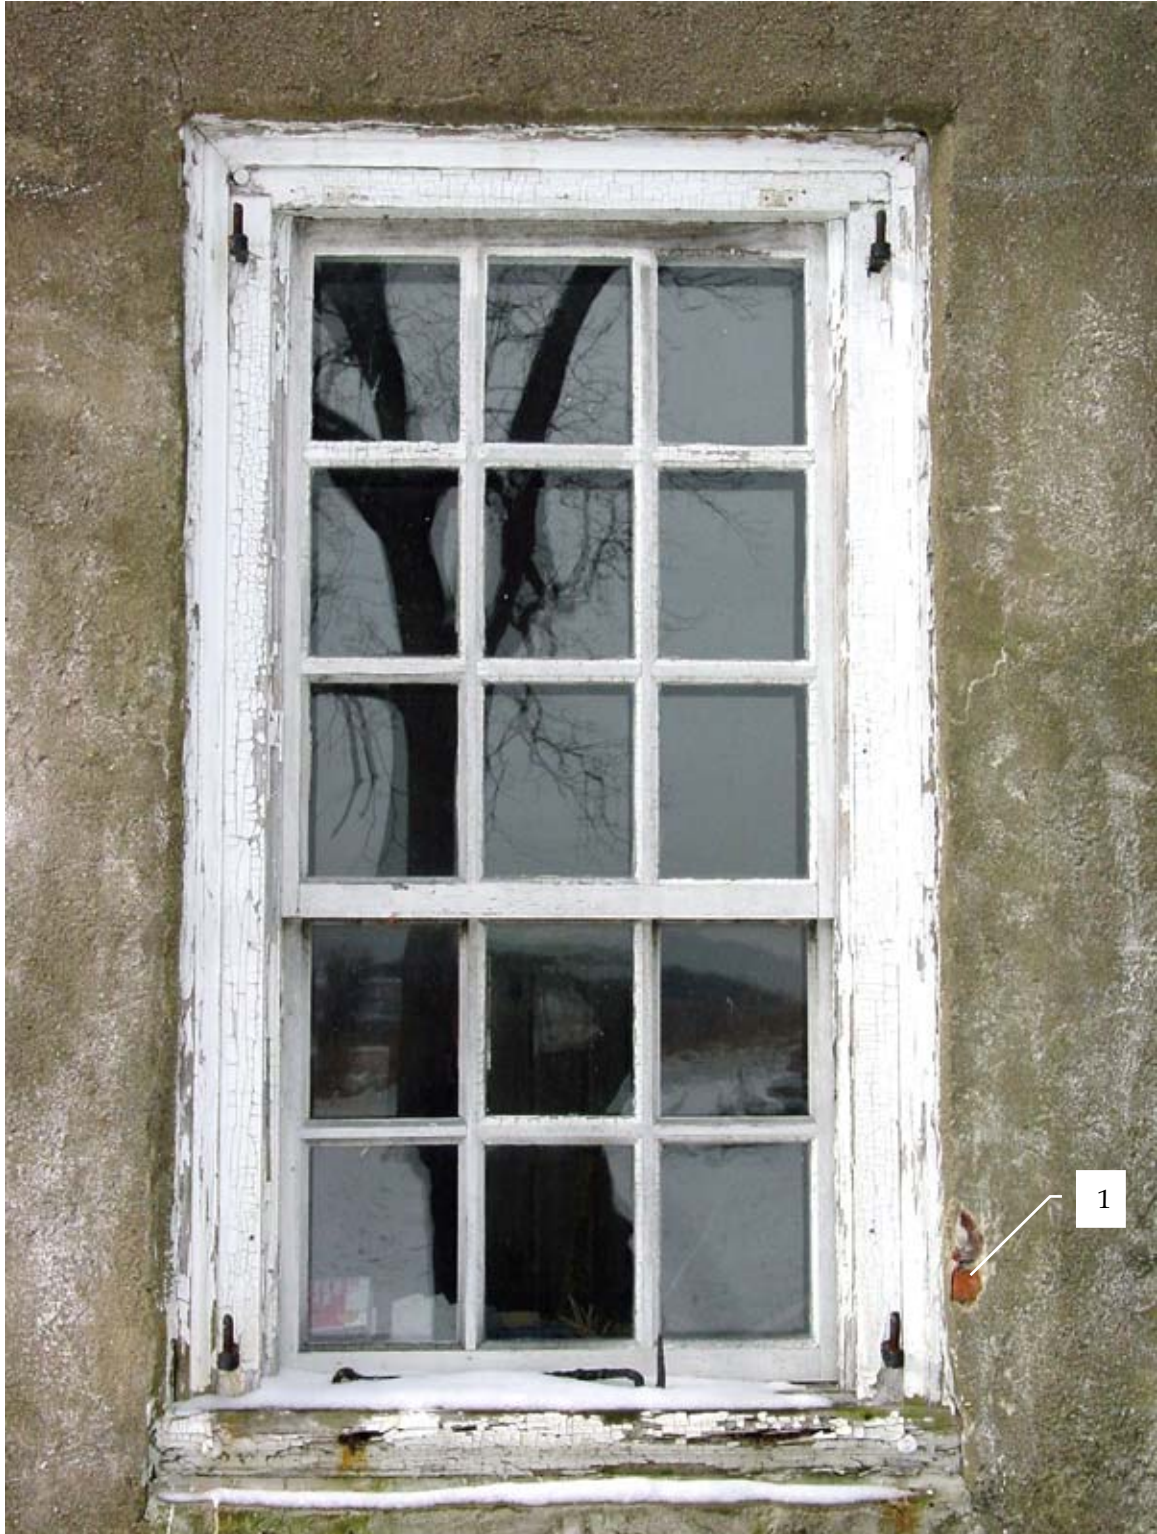
Photo EEd - Exterior view of Window 102, looking west.

- Window 102: 9/6 single-hung wood window. Based on the molding profiles and the construction of the window, Window 102 does not appear to be original to the main block. Archival photographs do not show a window at this location. Window 102 was likely added as part of the 1926 renovations to replicate the existing windows at the south façade of the main block (Windows 103 and 104). (Photo EEEd, Note 3/EE) (Archive Photos 2 & 4)
- Window 301: 4-light wood window. This window appears to be original to the east addition (c. 1830).

1. Brick infill at north jamb.

- Windows 103 & 104: Two windows on the south wall are 6/6 single-hung, wood windows. The detailing and profiles of the windows are consistent with 18th-century characteristics and are likely original.
- Window 102: Investigation at the east window exterior jamb revealed brick infill and indicates that this window opening is not original. Archive photographs show the east façade without the window which further corroborates that it is not original. The addition of this window is attributed to the Ligget family. There is also a seam in the chair rail cap and window sill where the sill for the new window would have been inserted. (Archive Photos 2 & 4)

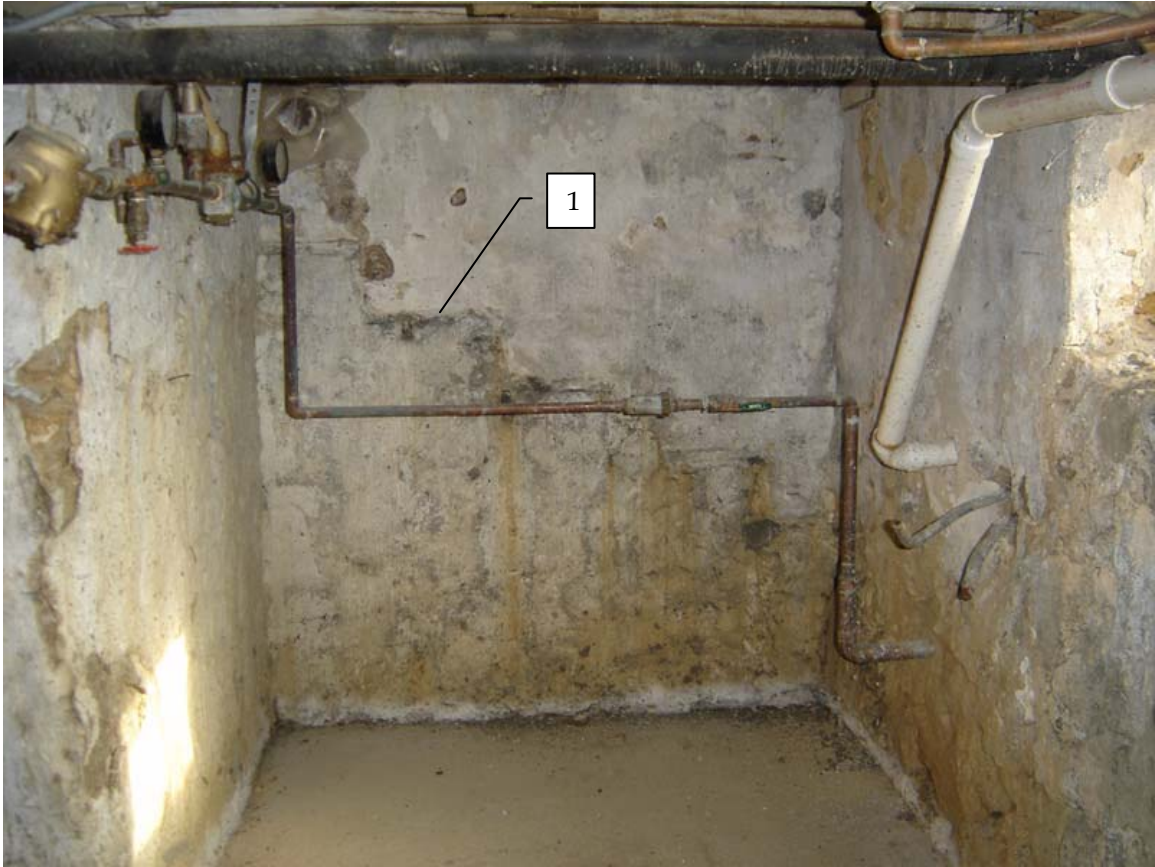
- The impression from the original winder stair to the first floor can be seen to the south of the fireplace vault and on the south wall of the vault. (Photo 001a, Note 1/001)
- There is a 20th-century concrete lintel to support the fireplace hearth. The original hearth support was most likely stone.

Photo 001a - View of segment of east wall to the south of the chimney vault, Room 001, looking east.

1. Evidence in plaster of former winder stair.

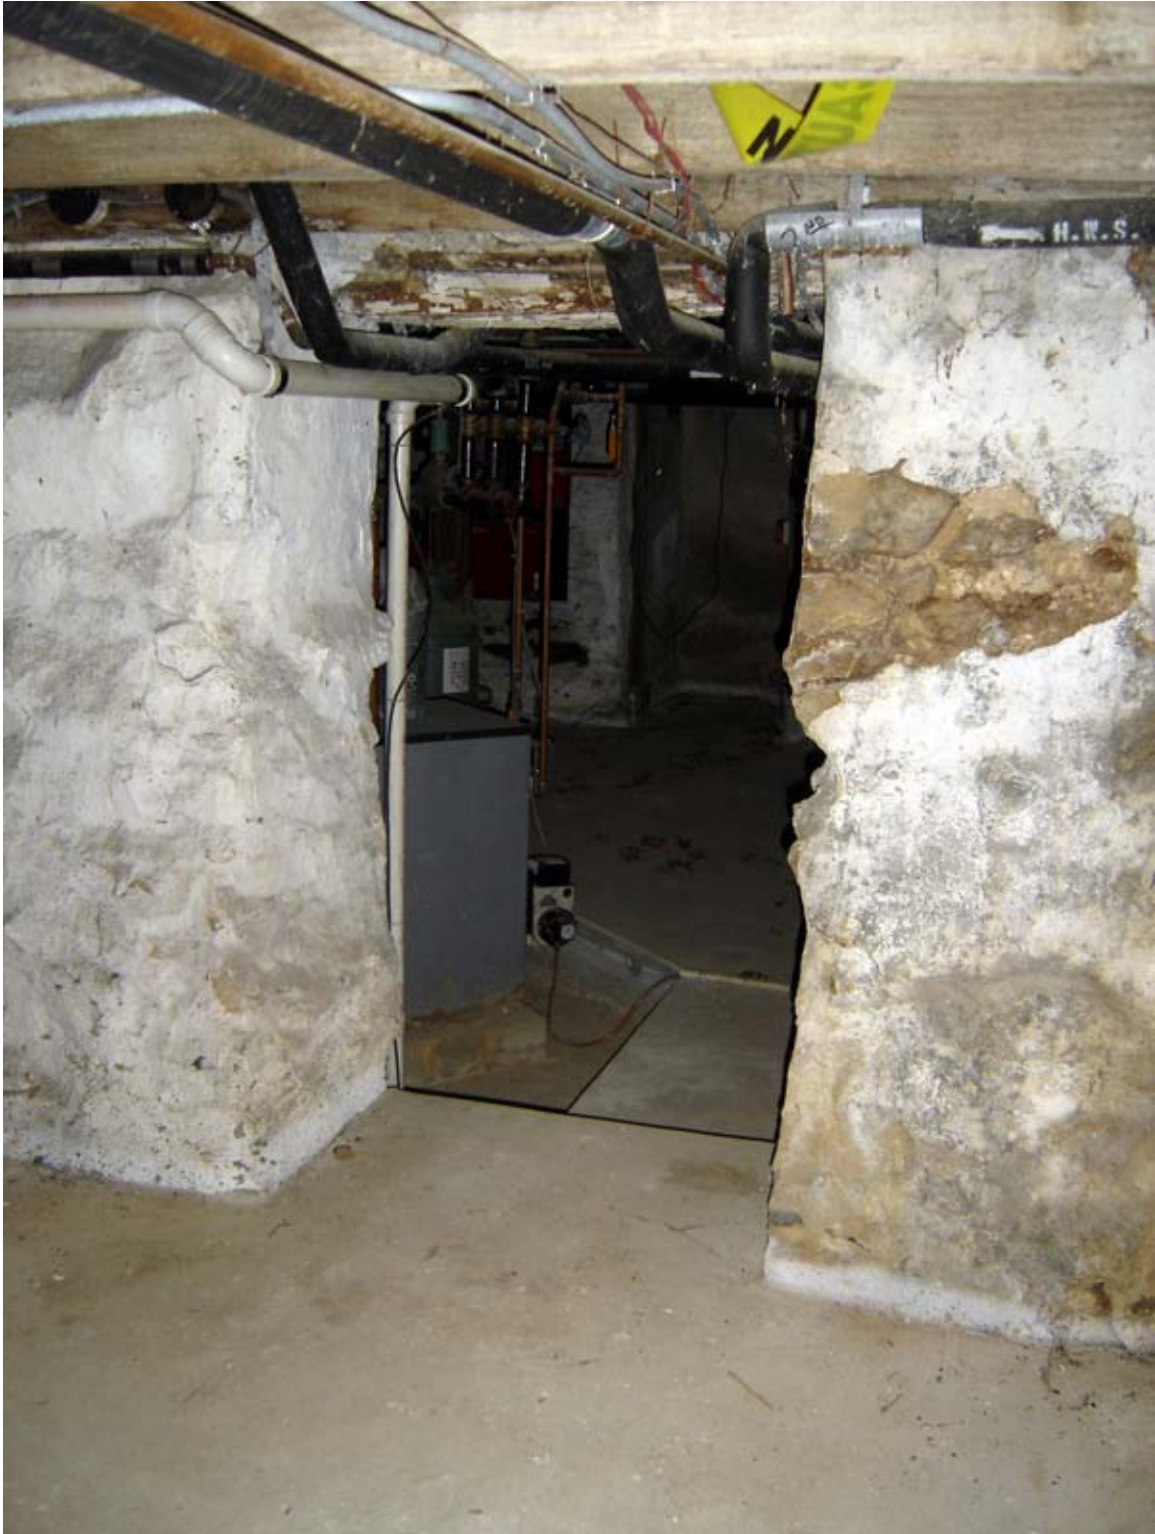
- Similar to what can be seen from the main block basement, the rough character of the stonework at the passageway to the basement of the main block suggests that the opening was introduced after the original foundation construction of 1769; most likely at the time of the c. 1830 addition. (Photo 001b, Note 3/001)

Photo 001b - Masonry opening between Rooms 001 and 002, looking west. Rough character of stonework suggests that the opening was added after original construction. This opening was likely formed at the time of the east addition, c.1830.

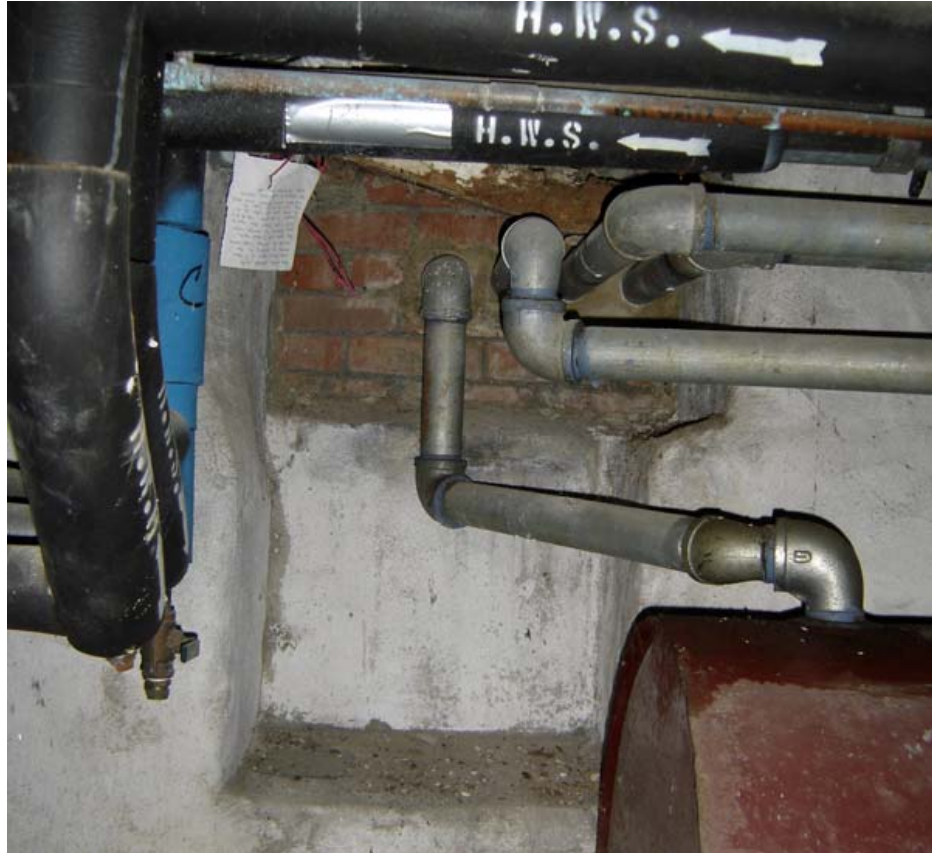
- An opening on the north wall has been infilled with brick around several mechanical pipes. The jagged edges of the opening suggest that it was not original to the building (c. 1769) but cut into the wall at a later date. The area below this infill appears to be an early wall niche and the ledge on the right and left may have supported a wood lintel. (Photo 002b, Note 2/002)

Photo 002b - Former masonry opening and niche at north wall, Room 002, looking north.

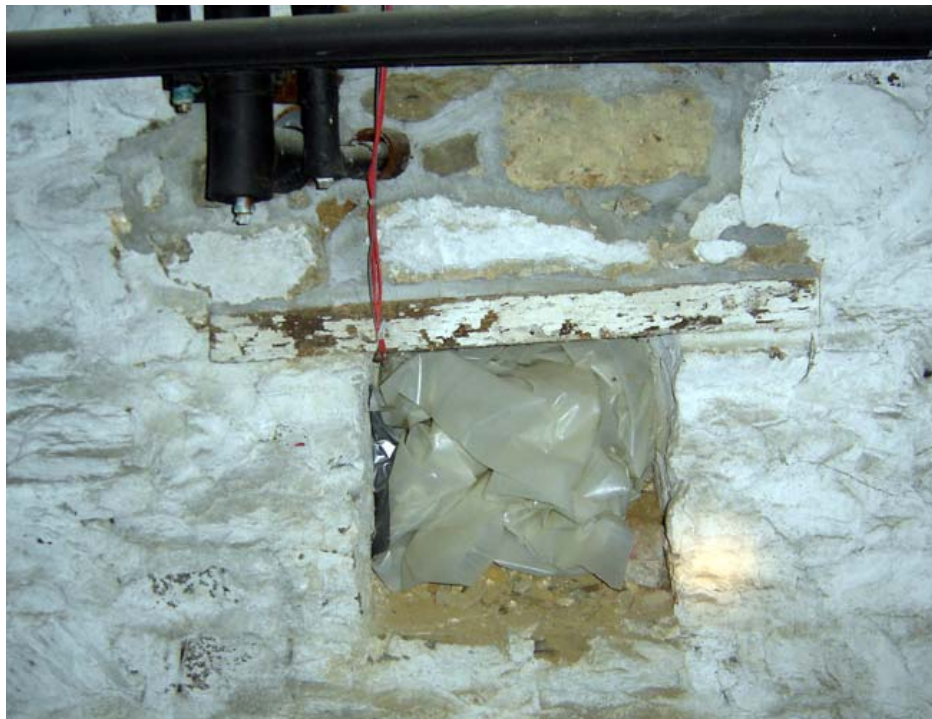
- The opening into the crawl space under the original kitchen may be an original wall niche that was altered to provide crawl space access. Pointing around the wood lintel is recent as well as the pointing in the stonework above. (Photo 002c, Note 3/002)
- The opening in the wall into a stone areaway was added in 1926 as access to a "new" winder stair up to Room 106 which was used as a kitchen by the Liggett family. Most likely they needed to add this stair since they were removing the two interior winder stairs and would not have otherwise had interior access to the basement. (Photo 002d, Note 4/002)

Photo 002c - Former masonry opening at west wall, Room 002, looking west.

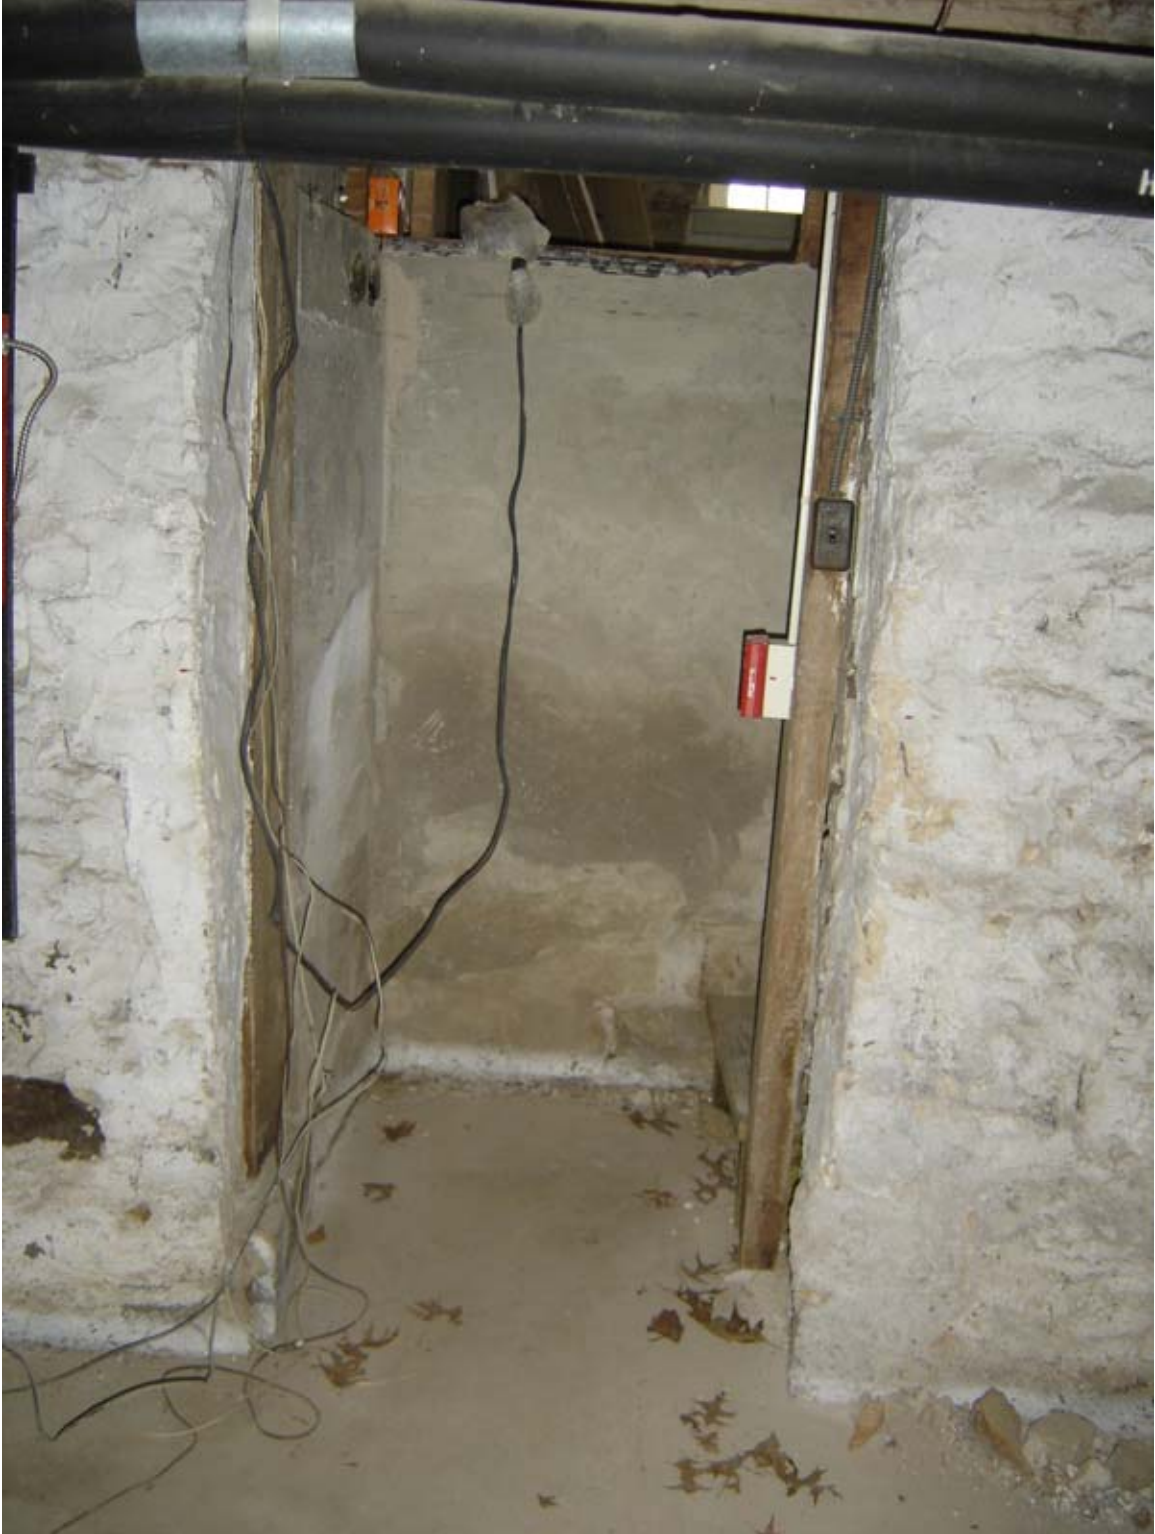
Photo 002d - Masonry opening at west wall, Room 002, looking west, into areaway for stair to Room 106. This opening was likely added as part of the c. 1926 alterations to the house to enable access to the basement from the first-floor kitchen.

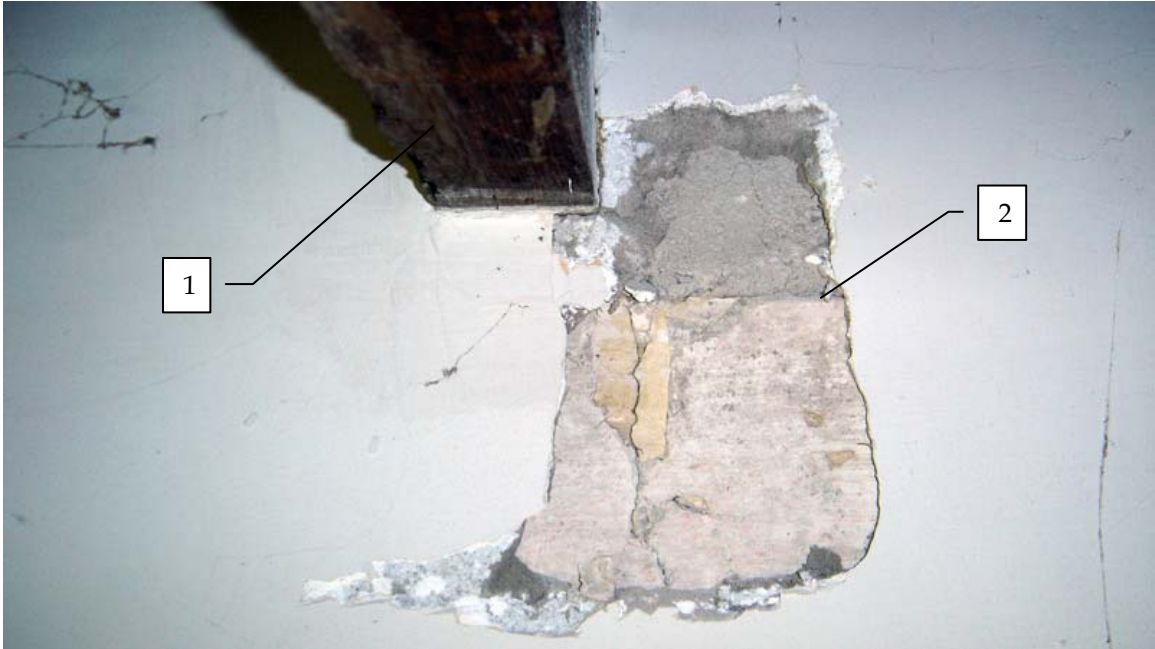
- All walls have two layers of plaster. The top layer is a thin finish coat; probably added in the 20th century.
- The c. 1830 plaster stops 1¼" below the ceiling joists and the top edge is slightly curved indicating that there was originally a plaster ceiling. (Photo 101a)
- Most of the wood baseboards on the north and south walls have been removed for the installation of baseboard radiators. The backing insulation for the radiators remains on the walls.
- The baseboard on the west wall has been applied over the second layer of plaster. In addition, the height of the present baseboard does not match the line in the original plaster indicating a 5¾" original c. 1830 baseboard height.

Photo 101a – Detail of plaster evidence below ceiling joist, south wall, Room 101, looking south.
1. Nail holes for lath at underside of joist.
2. Line of original c. 1830 plaster indicating intersection of wall and former ceiling plaster.

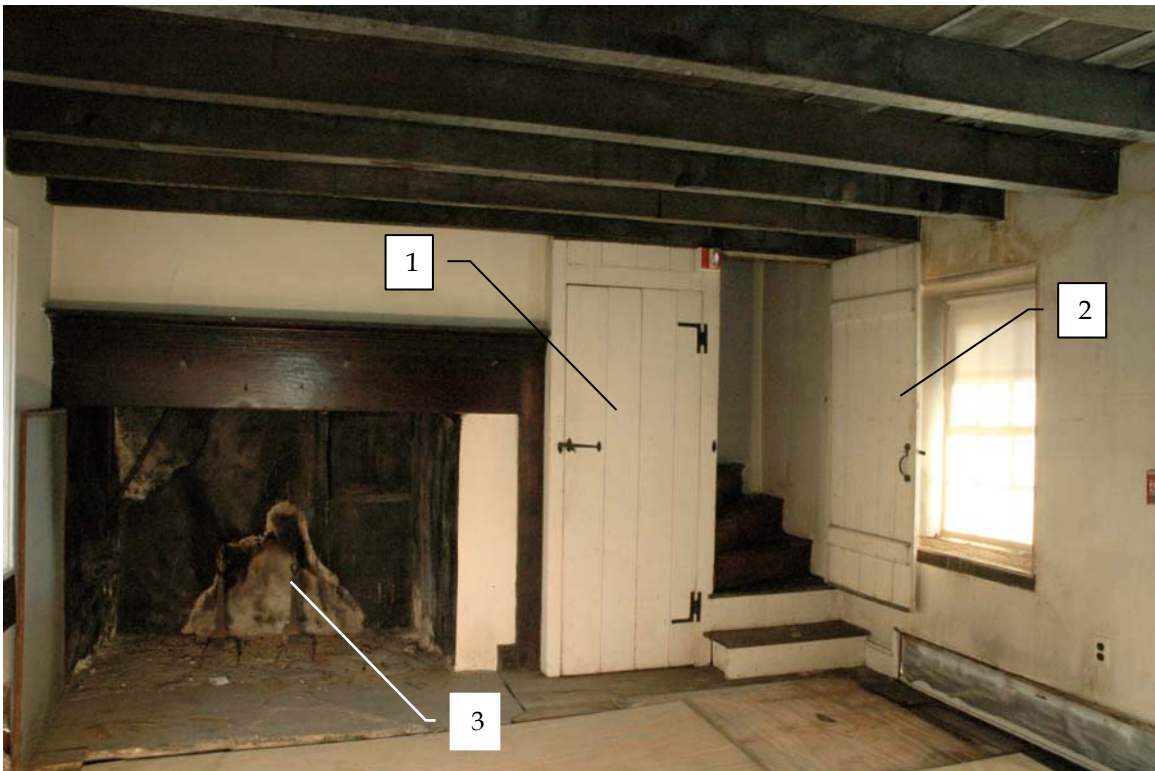
Photo 101b – Interior view of Room 101, looking east.
1. Original door to former winder stair to basement.
2. Original door to existing winder stair to 2nd floor.
3. Original cooking fireplace.

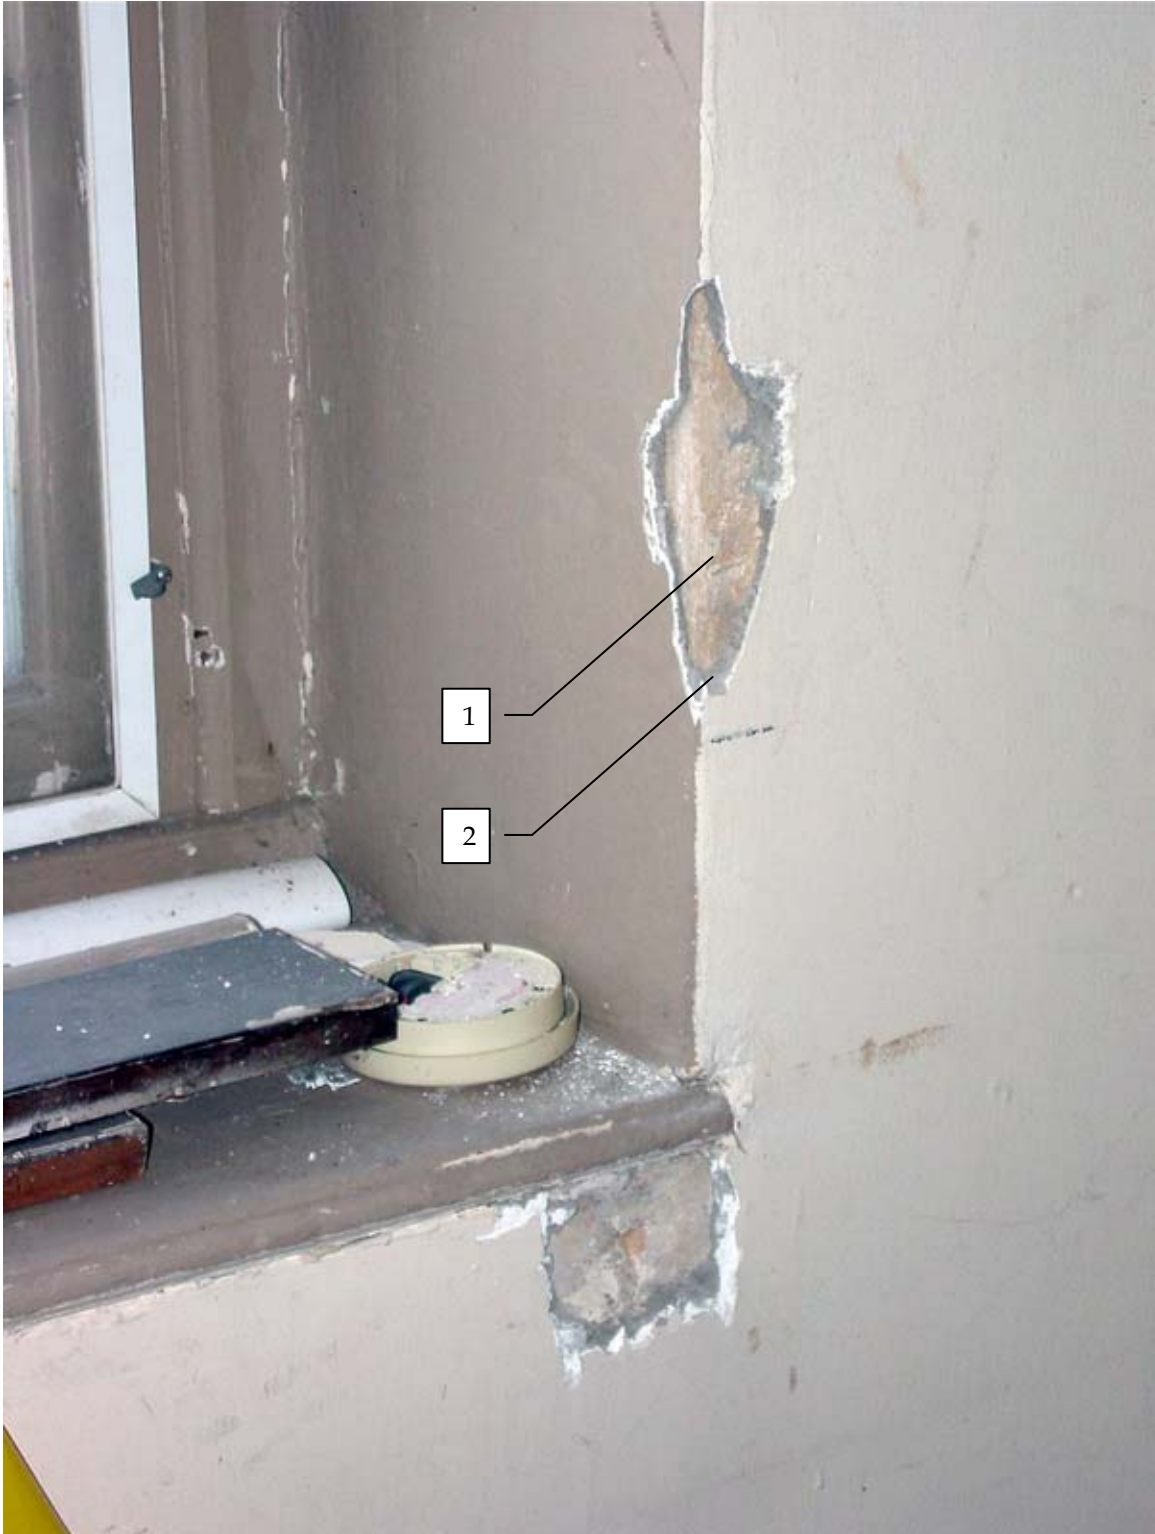
Photo 102c - Detail view of plaster at interior jamb, Window 118, looking northeast.

1. Original layer of plaster with curved jamb profile.
2. Cement-based, 20th-century plaster application.

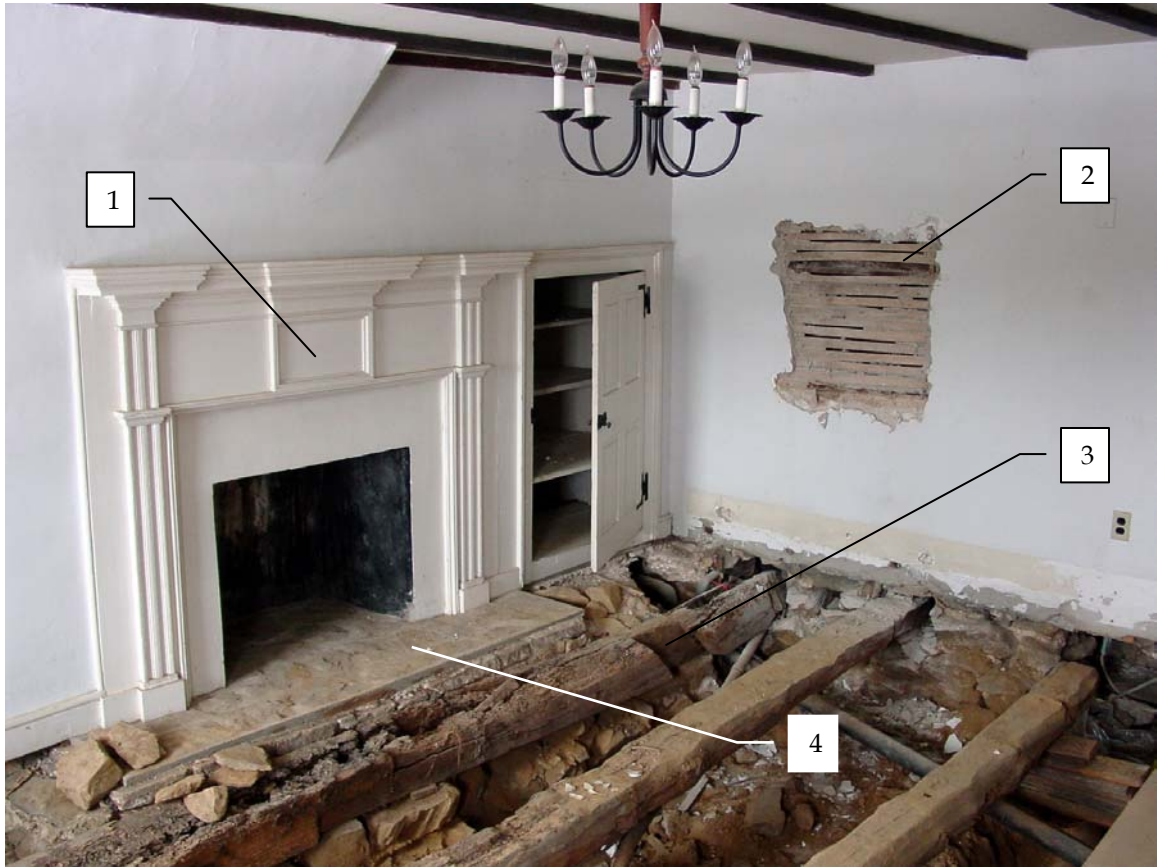
- Walls feature two layers of plaster on stone masonry.
- Plaster on wood lath at north wall covers an earlier window opening. A plaster on wire lath patch covers previous architectural investigations. (Photo 104a, Note 1/104)

- Window 105: 8/8 single-hung wood window. The interior molding and general detailing of the surround are very similar to the windows in the east addition. The lower sash appears to be a 20th-century replacement sash. The upper sash appears to be c. 1830. The original 1769 window opening may have been modified c. 1810 to increase light in this room at the time when the north kitchen addition was blocking the north window and door. However, the earliest plaster layer abuts both sides of the existing window trim. This either means that the window frame dates to 1769 or that the room was entirely re-plastered. (Note 8/104)
- Plaster removal on the north wall revealed an early window frame. The frame appears to be original to the kitchen (c. 1769), and shows signs of weathering on what was the exterior sill. (Photo 104a)

- The current fireplace mantel profiles and assembly with machine cut brads indicate that it dates to the 20th century. The 1979 "Inventory," in fact, states that it was the Ligget family who modified the fireplace. (Photo 104a)

Photo 104a – Interior view of Room 104, looking northwest.

1. Original cooking fireplace modified to current configuration as part of 1926 renovations. Mantel and cupboard added at that time.
2. Investigation at north wall revealed masonry opening for original kitchen window.
3. Wood flooring removed; joists appear to have been salvaged from earlier structures as evidenced by unused mortises and other cuts.
4. Original hearth has been modified to accommodate reconfigured fireplace.

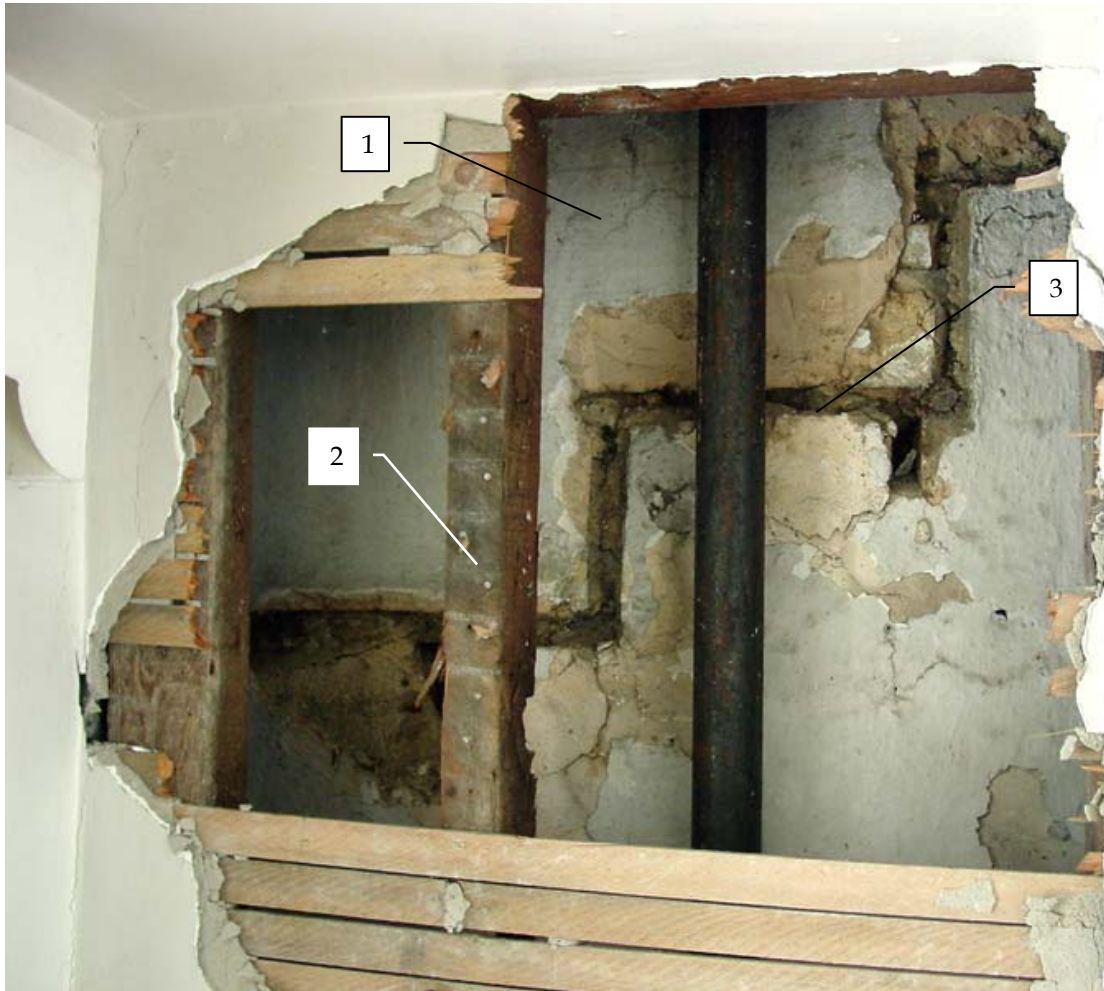
- Tile wainscot installed c. 1926.
- North wall, against chimney, has been furred out with 20th-century studs and drywall to form a plumbing chase. (Photo 105a)
- Traces of winder stair treads to second floor are evident behind 20th-century north wall and in earlier plaster layer. (Photo 105a, Note 1/105)
- East wall, door, and cabinet added c. 1926.

Photo 105a - Detail view of north wall, Room 105, looking north.

1. Original cooking fireplace cheek wall.
2. 20th-century stud wall furring with lath and plaster.
3. Evidence of winder stair in early plaster.

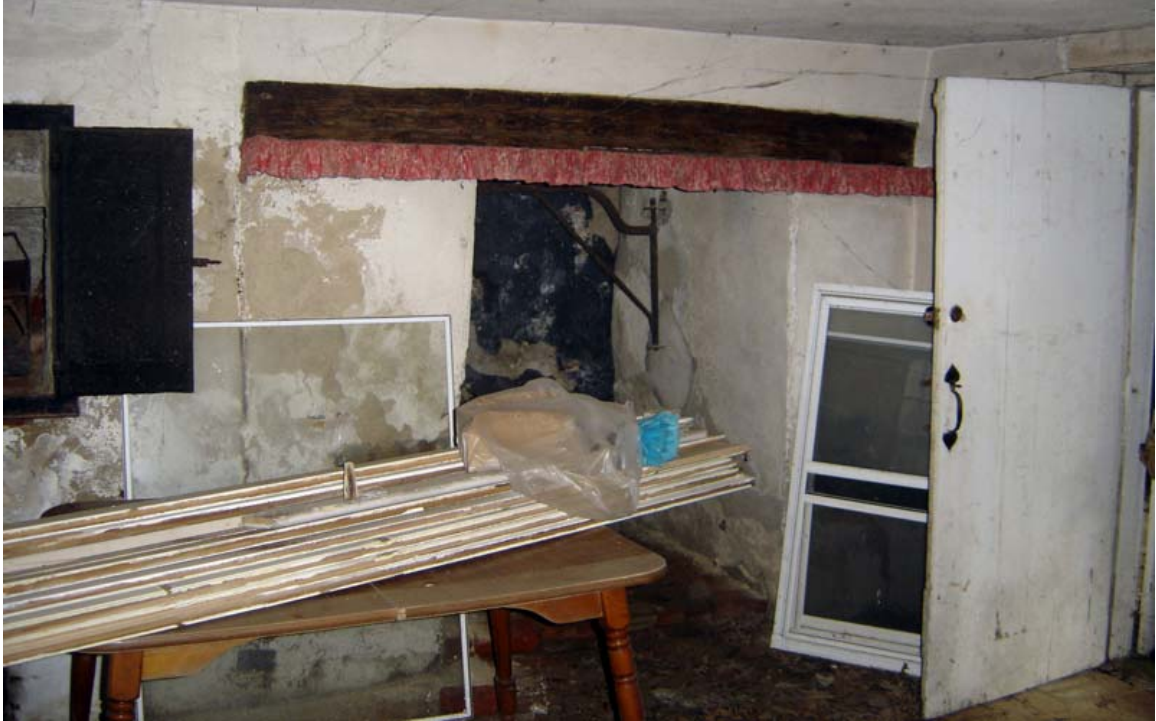
- The east wall consists of a moderate sized fireplace with a bake oven in the northeast corner. The fireplace has been modified at least two times. Based on the size of the chimney visible in archive photographs and the interior smoke chamber, the original fireplace was probably one large fireplace that spanned the entire width of the room. Such a large fireplace may have been used as a summer kitchen but could also have been used for laundry, candle-making, etc. (Photo 108a)
- The fireplace was reduced in width and a bake oven was added sometime before 1925. There are visible joints in the smoke chamber where the flue was modified.
- In 1926, the size of the fireplace opening was further reduced by the addition of a wing wall in the front and the top of the bake oven was broken by the new steps from the second floor. (Note 3/108)

Photo 108a - Segment of east wall of bakehouse, Room 108, looking east. Fireplace has been modified substantially from its original configuration.
