STIRLING'S QUARTERS AT VALLEY FORGE NATIONAL HISTORICAL PARK
HISTORIC STRUCTURE REPORT

PREPARED BY:
JOHN MILNER ARCHITECTS, INC.
104 LAKEVIEW DRIVE, CHADDS FORD, PA 19317

JANUARY 2006

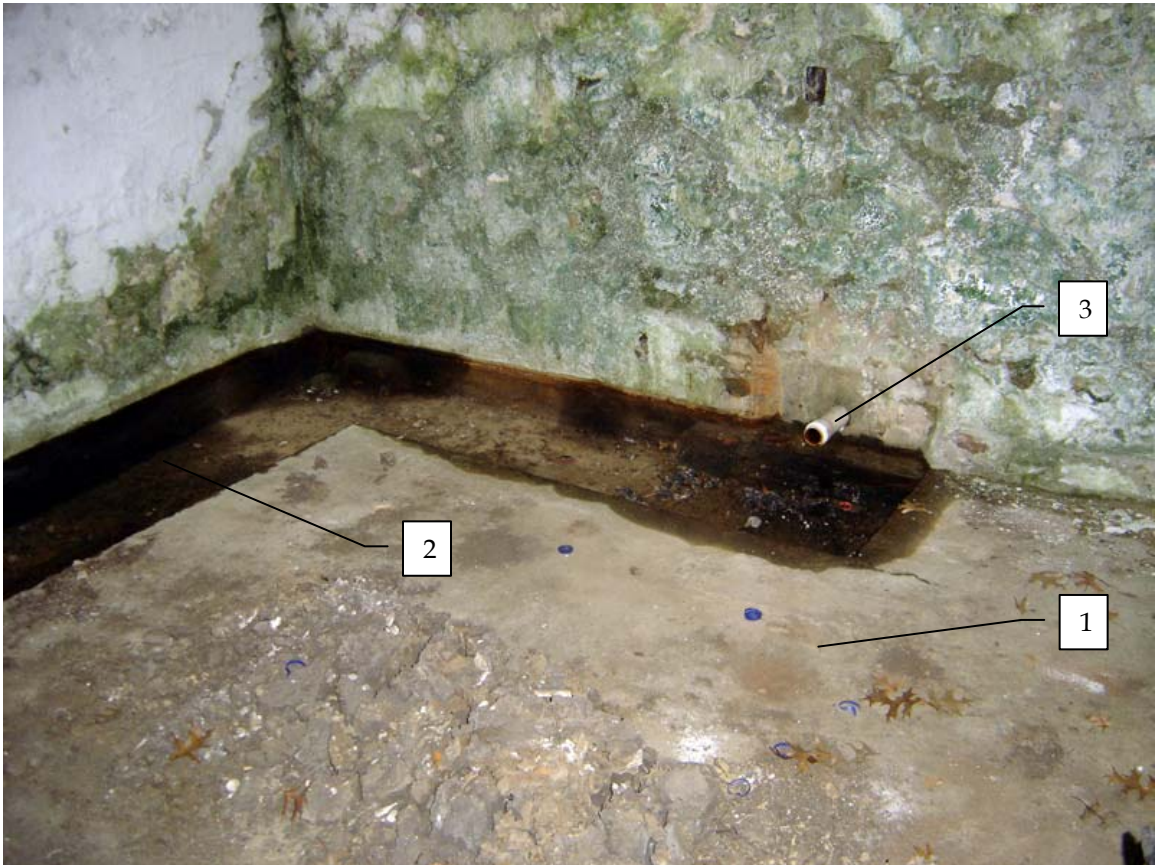
- Concrete floor with an inset trough for the spring water. The original floor was most likely brick. The precise date of the concrete floor installation is not known. (Photo 109a, Note 1/109)

- The north wall has a pipe penetrating the wall that brings the spring water to the springhouse from a holding cistern further up the hill. (Photo 109a, Note 8/109)

Photo 109a - Segment of springhouse interior, Room 109, looking northwest.

1. Concrete floor.
2. Perimeter trough.
3. Inlet pipe.

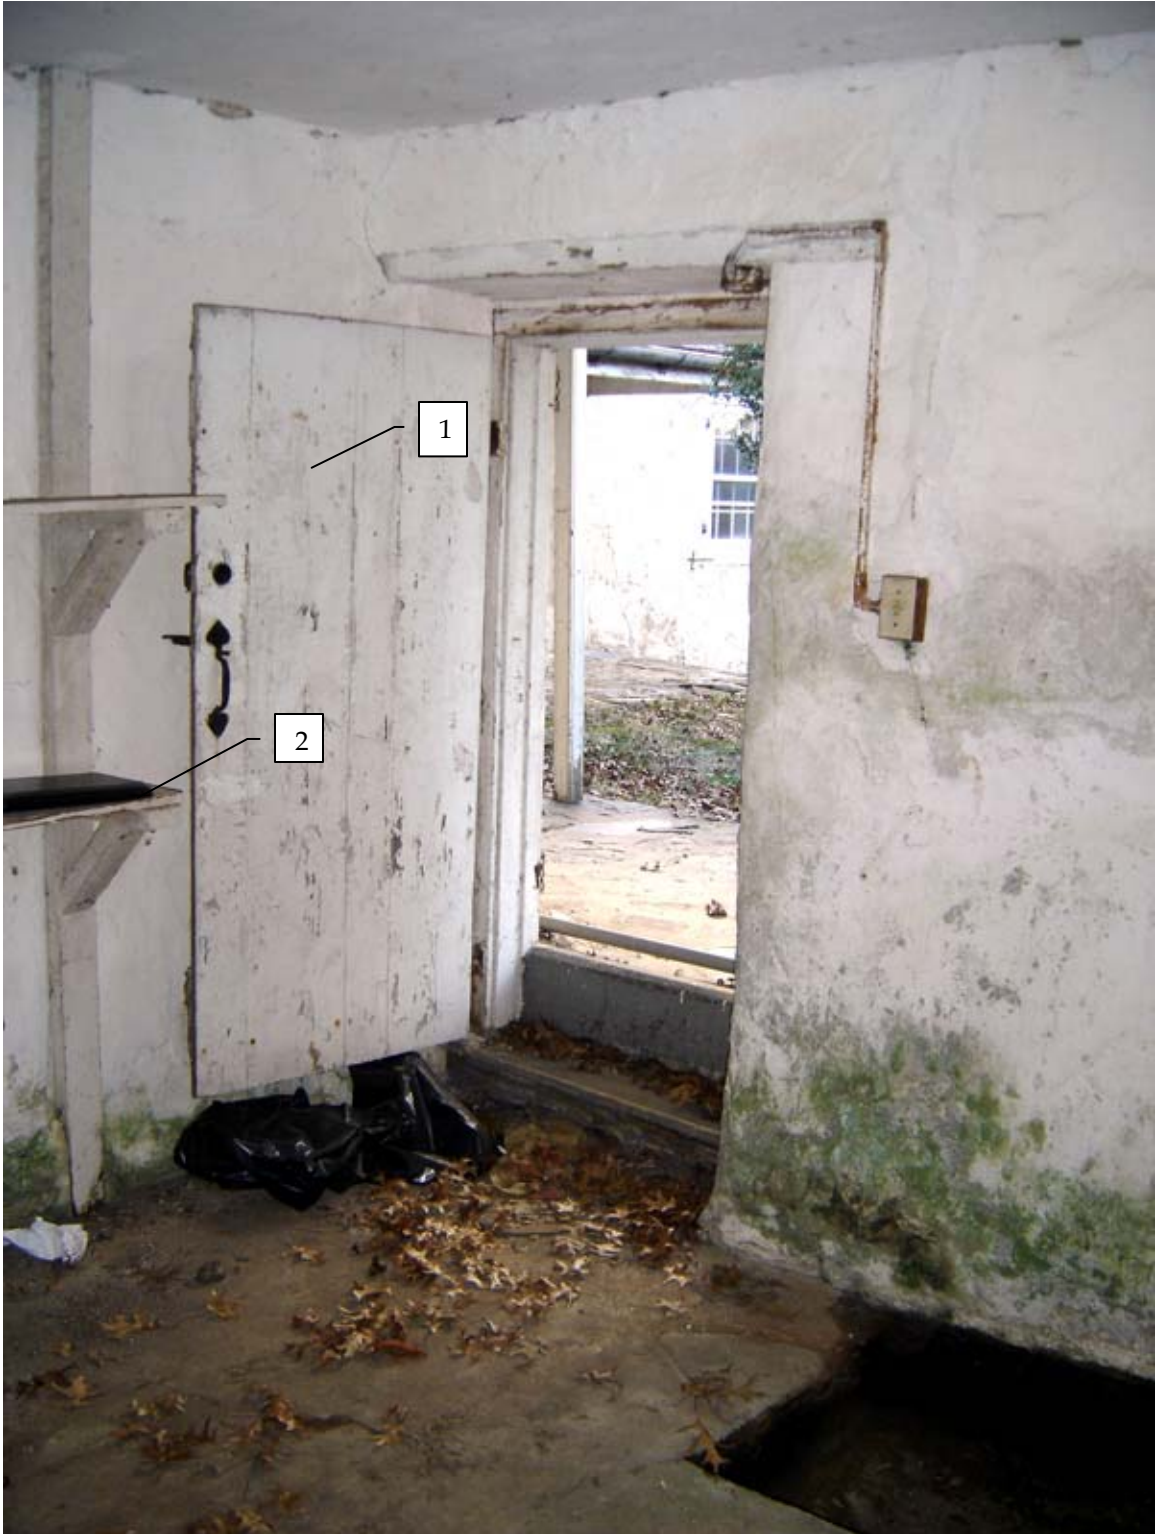
- The only door into the spring house is a vertical board and batten door. This door is a 20th-century replacement. The door frame is not as recent as the door but also appears to be a non-original frame. (Photo 109c, Note 4/109)

- Shelving on the east wall is not original. It consists of nominal 2x4 vertical supports and brackets and nominal 1x10 shelves. (Photo 109c, Note 7/109)

Photo 109c - Segment of springhouse interior, Room 109, looking southeast.

1. 20th-century board-and-batten door.
2. 20th-century shelving.

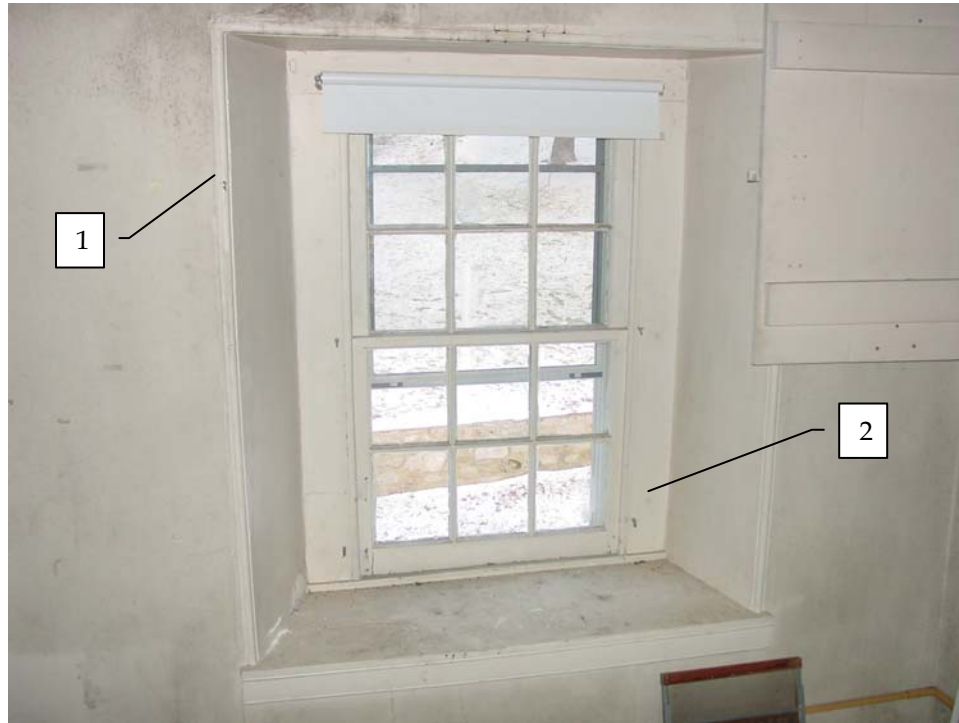
Photo 201c - Interior view of Window 223, looking north.

1. Splayed jamb with wood bead.
2. Original (c. 1830) wood sash and frame.

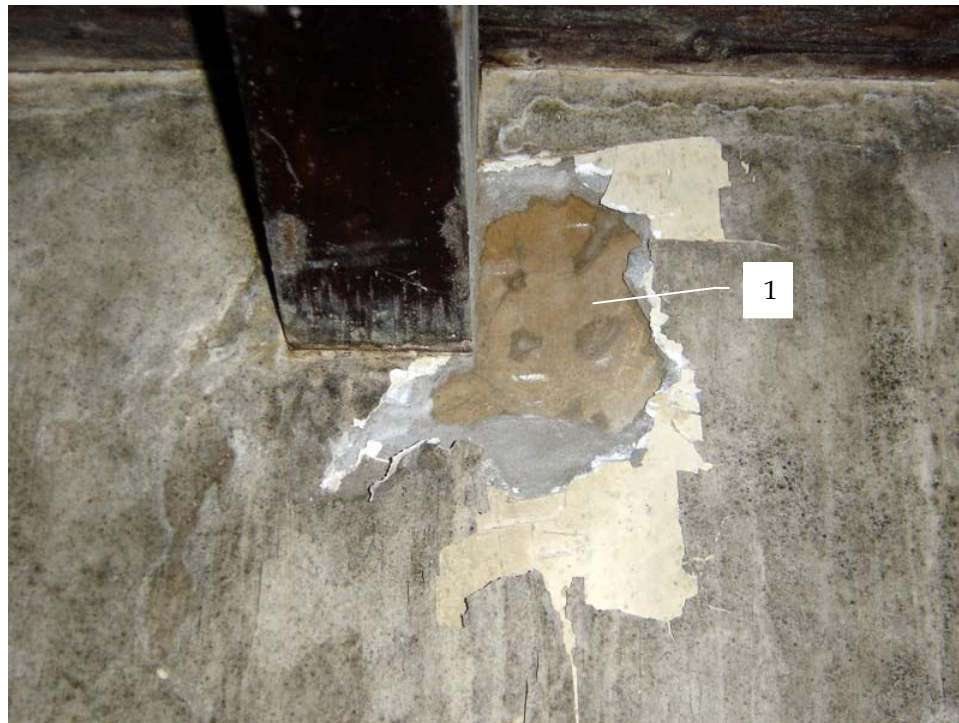
Photo 201d - Detail view of plaster at south wall, Room 201, looking south.

1. Original c. 1830 wall plaster runs between ceiling joists with no evidence of former plaster ceiling beneath joists.

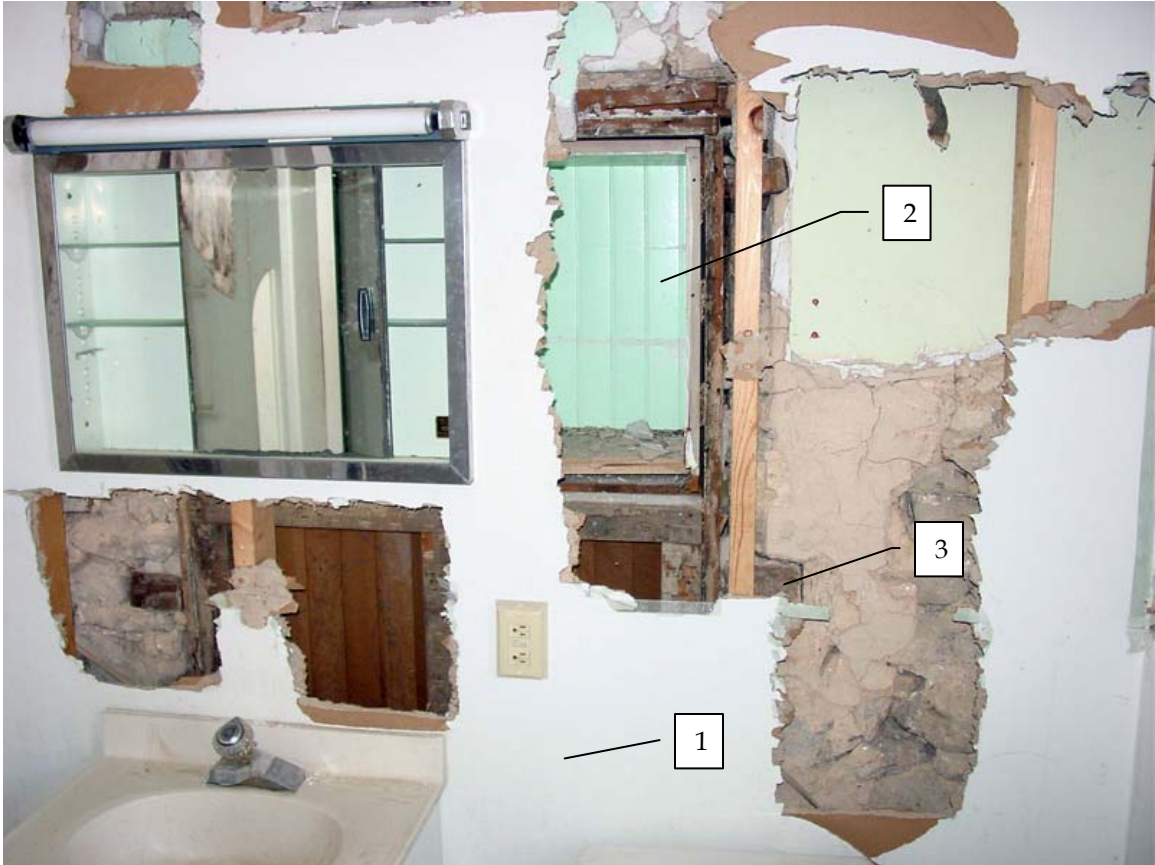
Photo 203a – View of west wall of Room 203, looking west. Former doorway between Rooms 203 & 207 located behind 20th-century renovations.

1. Late 20th-century stud wall with gypsum wallboard partially demolished.
2. Former 19th-century doorway infilled during 1926 renovations.
3. Wood nailer set in masonry to attach 19th-century (c. 1810) door frame.

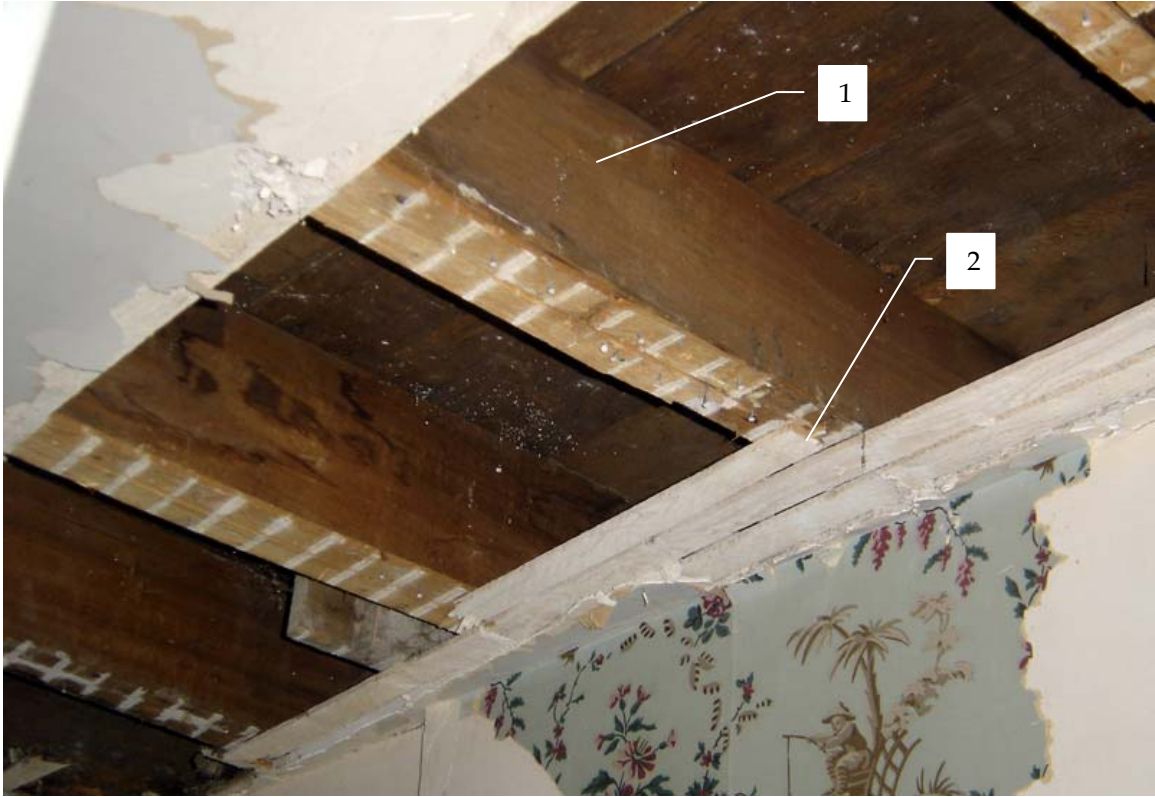
- Ceilings are thin plaster over sawn lath installed with 20th-century lath nails.
- Ceiling joists, spanning from the north wall to the central summer beam, appear sawn although saw marks are very faint.
- All but one ceiling joist have only one plaster and lath mark which further suggests that the joists are replacements, likely dating to the extensive Liggett-era renovations. The one joist with a second faint plaster line might be a salvaged joist from another location. (Photos 204b & 204c)

Photo 204b – View of exposed ceiling joists, Room 204A, looking southeast.

1. Typical replacement joist.
2. Existing plaster ceiling features sawn lath and 20th-century fasteners.

Photo 204c –
Detail view of atypical ceiling joist, Room 204A, looking up.

1. Stains on joist from most recent plaster installation.
2. Faint stains are from a previous plaster installation indicating that this one joist may have been recycled.

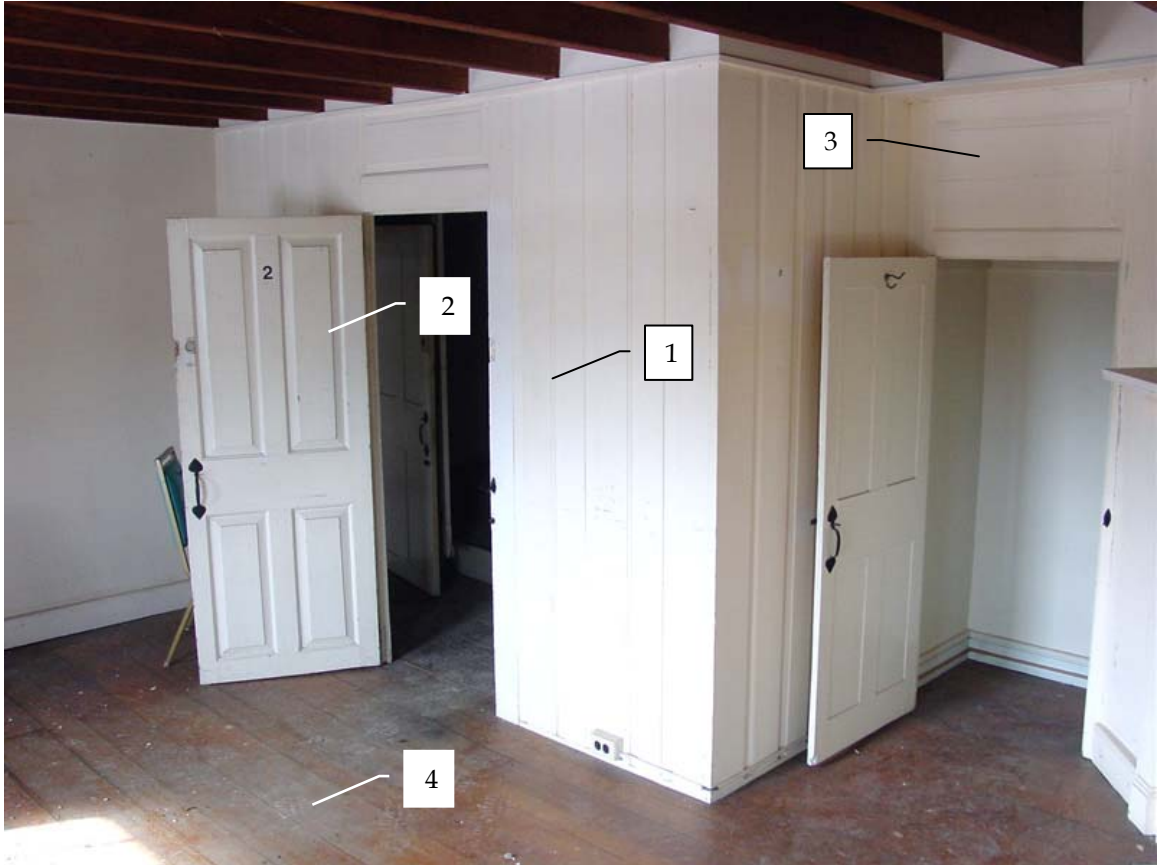
Photo 205a - View of north wall of Room 205, looking northwest.

1. Board partition wall was introduced sometime after original construction period. It is most likely a 20th-century modification made during the Liggett tenure.
2. Four-panel wood door was most likely added as part of the c. 1926 renovations, along with the board partition wall that separates the current hallway.
3. Segment of closet wall may be original.
4. Random-width wood flooring is not original, likely added as part of the c. 1926 renovations to the building.

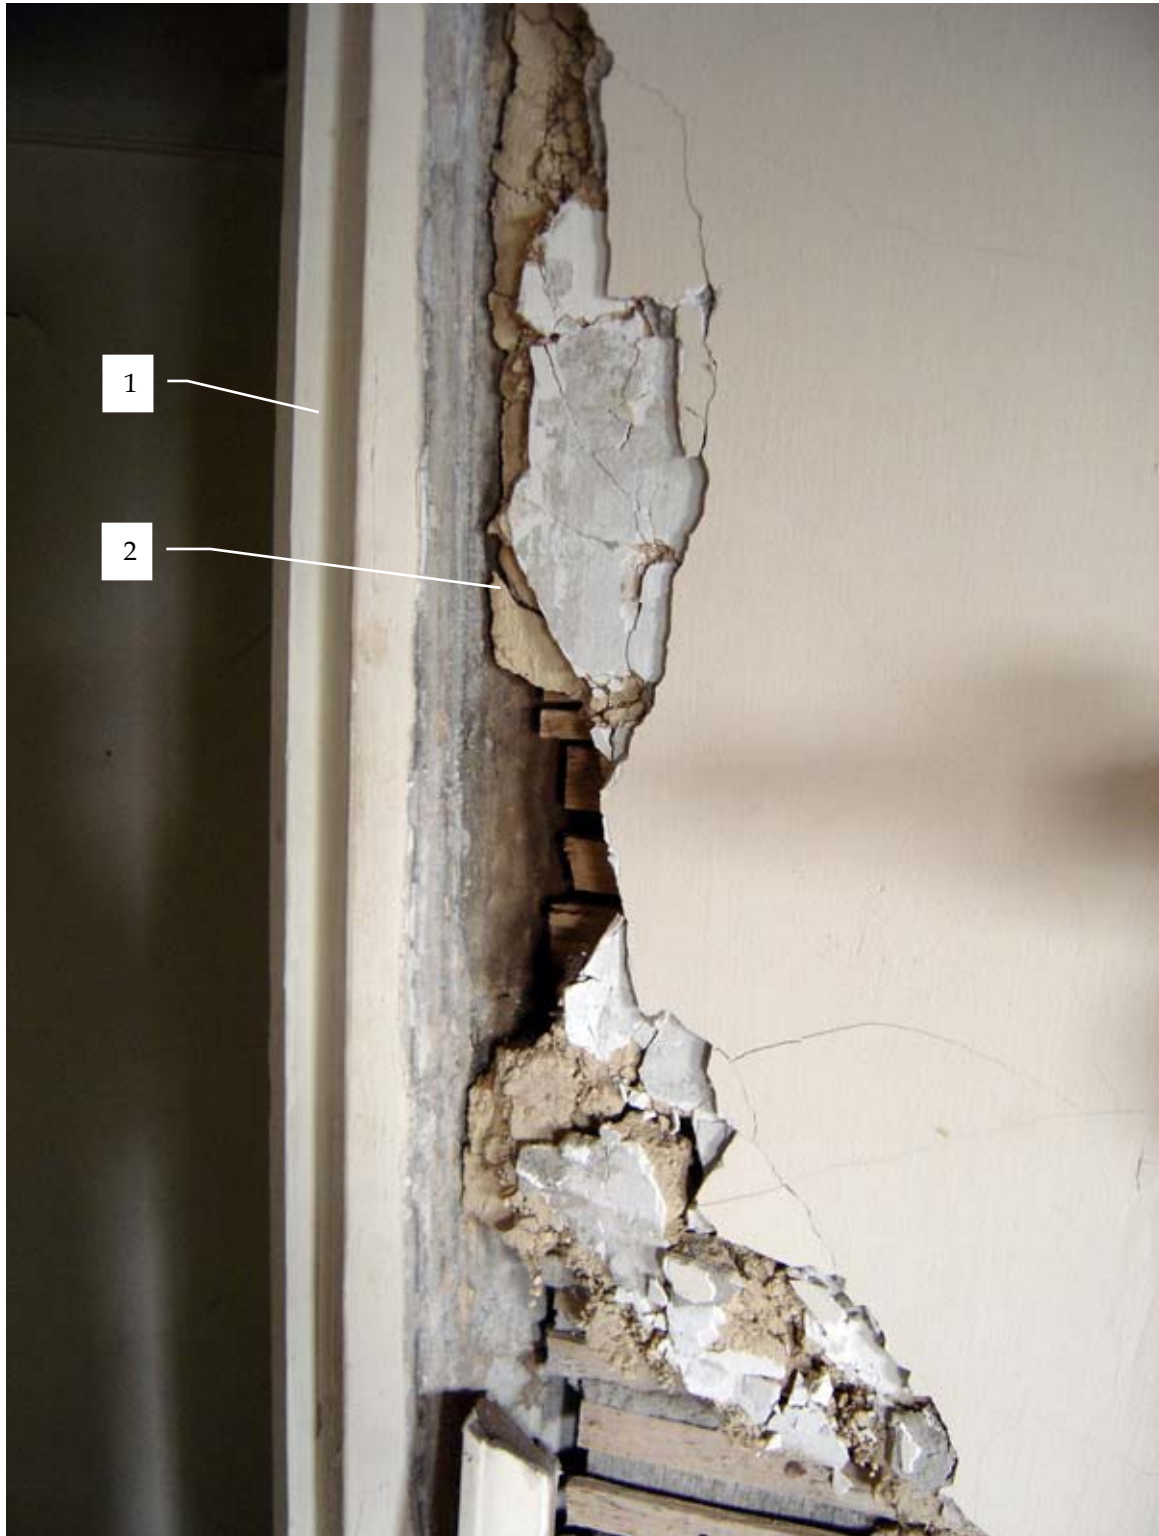
Photo 205b – Detail view of plaster at door jamb of closet, Room 205, looking northwest.

1. East jamb of closet door.
2. Original first-layer plaster abuts existing door jamb.

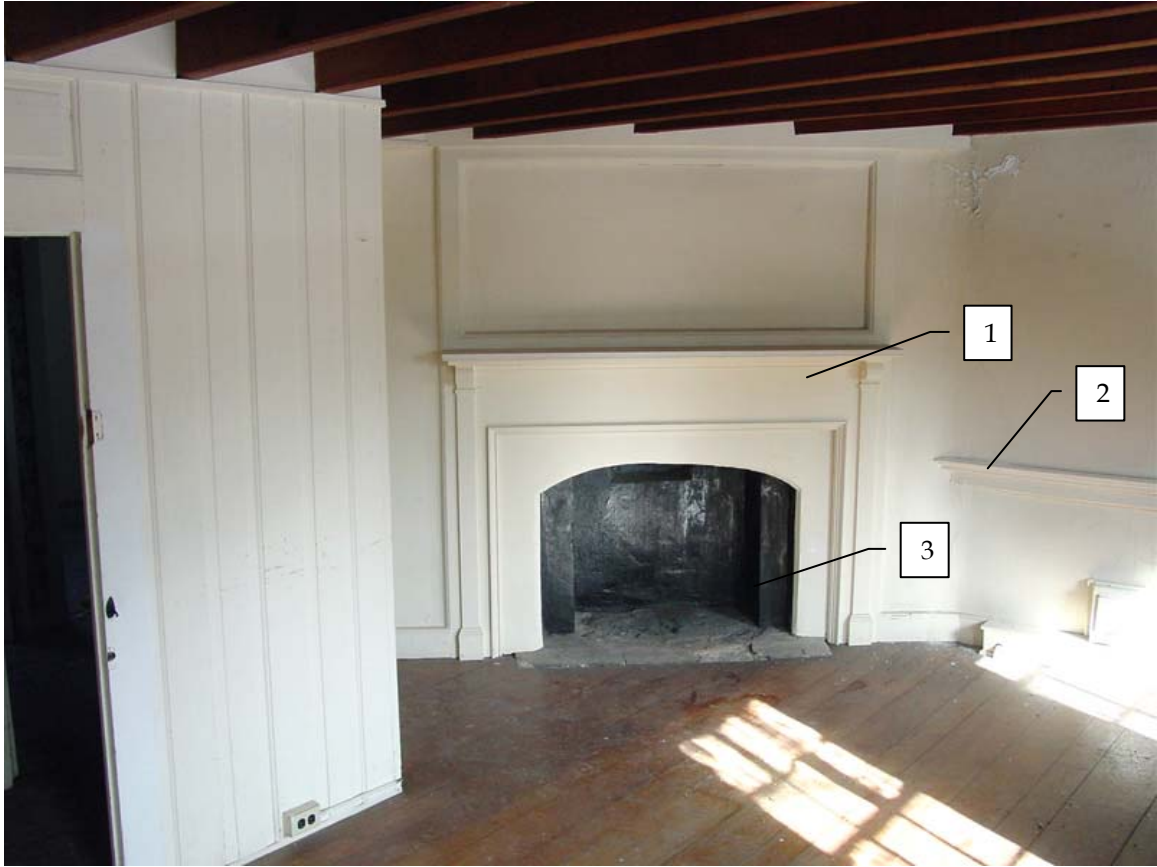
- Most of the original baseboard on the east and south walls has been removed to accommodate baseboard radiators and a pipe cover "box."
- Chair rails on south and east walls appear original. A section on the east wall is damaged by insects. (Photo 205c, Note 8/205)

Photo 205c – View of east wall of Room 205, looking northeast.

1. Wood mantel added as part of the c. 1926 renovations.
2. Chair rails at east and south walls appear to be original, c. 1769.
3. Corner fireplace is original, c. 1769.

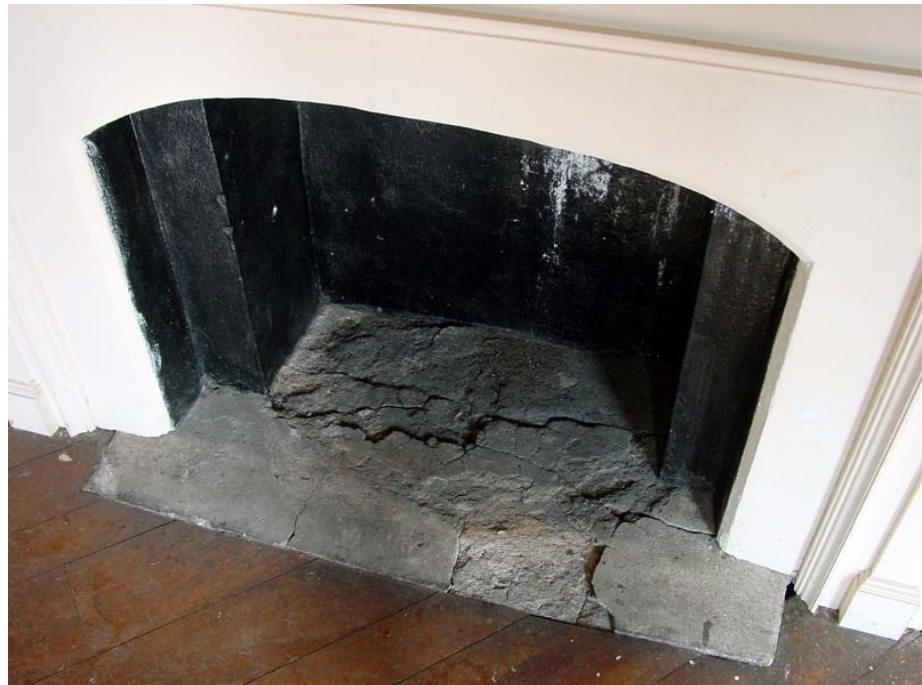
- Framing at both ceiling and floor confirm that corner fireplace is original to the structure.
- Mortar hearth appears to be from the 18th century. It is cracked and loose in several areas. (Photo 205d)
- The mantel is not original. The original layer of plaster continues behind the present mantel. Full removal of the mantel may reveal the outline of an earlier mantel or indicate that there was only a mantelshelf. (Photo 205c)
- Inside closet, there is a line in the original plaster layer relating to the original baseboard. The existence of an early plaster and a baseboard on the south and east closet walls indicates that these walls were always exposed and there was never a north corner fireplace on the second floor. (Photo 205e)

Photo 205d –
Detail view of
mortar hearth at
corner fireplace,
Room 205.
Hearth is cracked
and damaged.

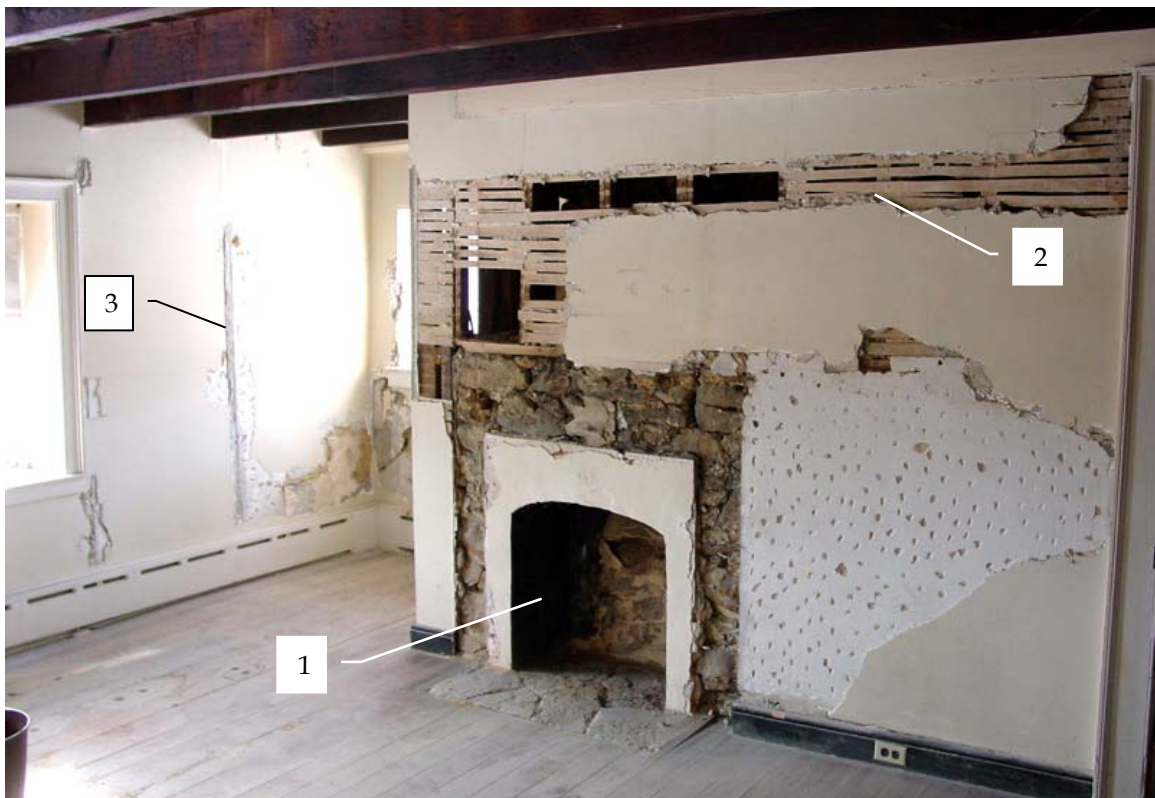
- Fireplace/chimney wall has been furred out. Before circa 1810, there was no fireplace since it was an unoccupied attic. The original (c. 1769) plastered chimney is visible behind the furring. (Photo 206a)

Photo 206a – Interior view of Room 206, looking southwest.

1. Fireplace was likely added when the west block was raised to 2 stories, c. 1810. It was later modified as part of the c. 1926 renovations to the house.
2. Wood framing, lath and plaster were added around fireplace and chimney mass subsequent to the original construction of the fireplace, c. 1810. Plastered chimney mass (c. 1769) is visible behind the furring.
3. Evidence in plaster of former winder stair and partition wall. See Photos 206b & 206c for details.

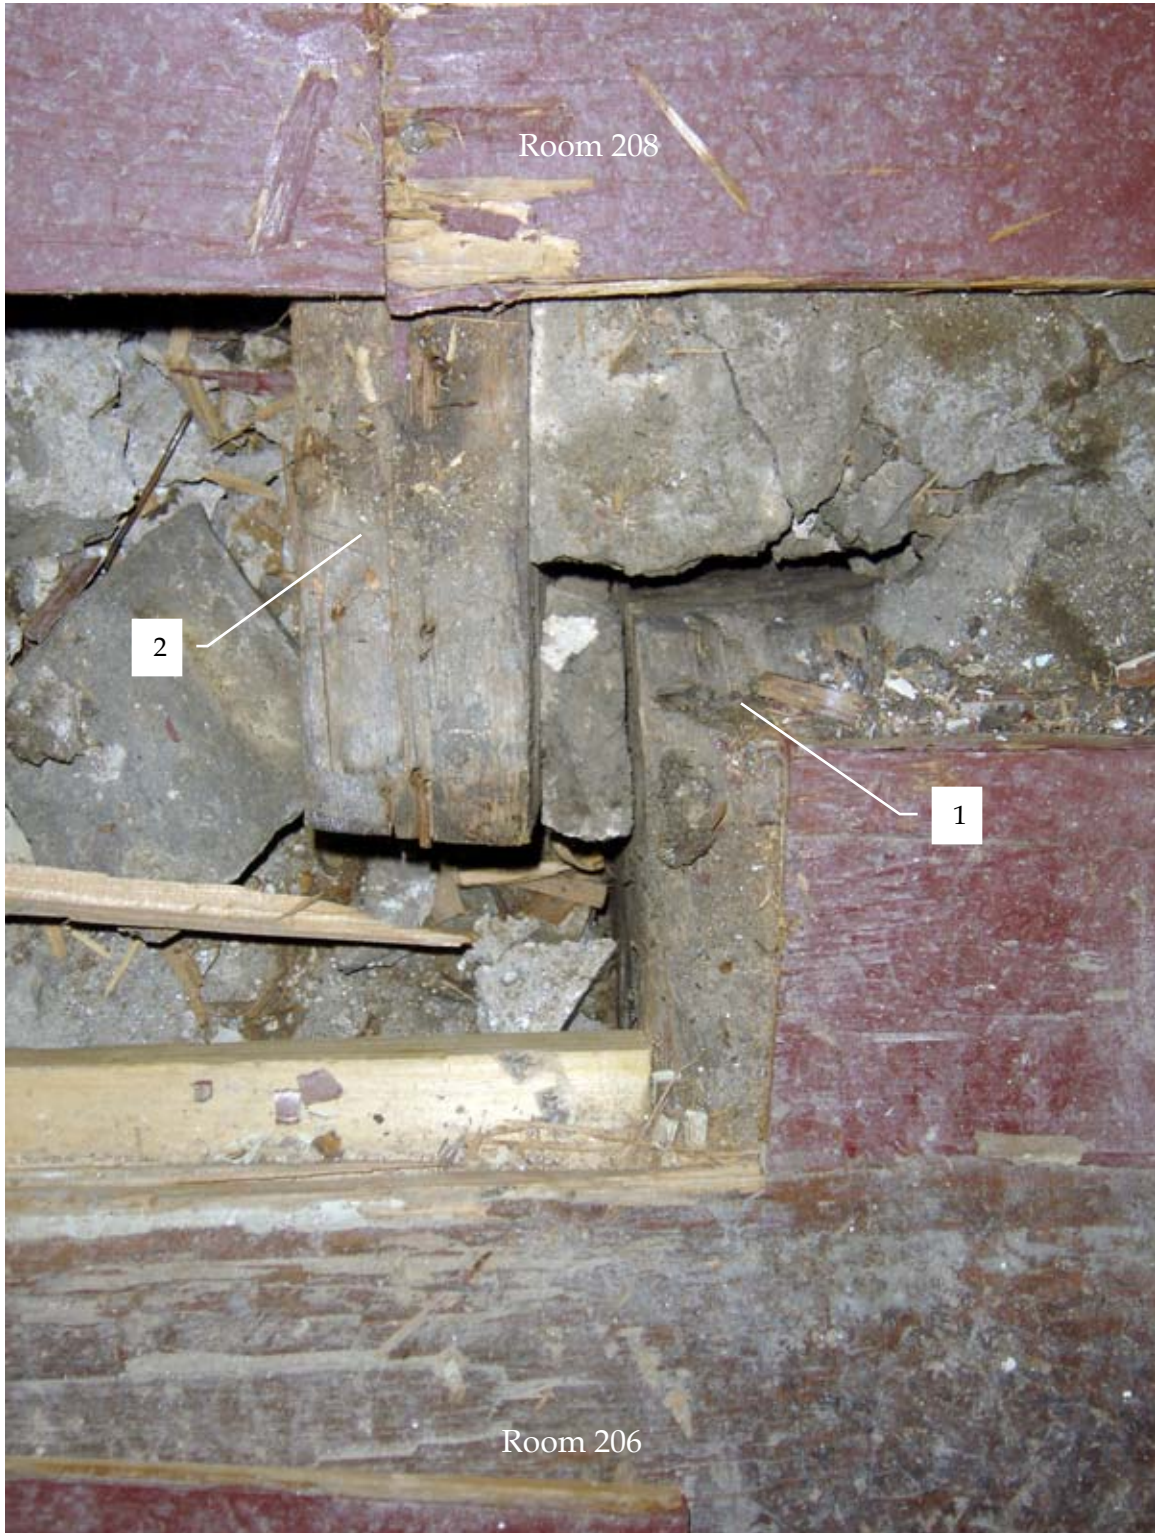
Photo 206d – Detail view of floor and framing (over masonry wall), between Room 206 (bottom) & Room 208 (top), looking down.

- Random-width floorboards installed in 1926 when the corner winder stair was removed.
- The floor joists between Room 206 and Room 208 appear to have been cut off in-situ. These floor joists originally projected beyond the face of the original north kitchen wall to support the rafter plate and rafters of the original roof of the 1-story kitchen. When the original kitchen was raised to 1½ stories, circa 1790, the roof and cornice were removed, the projecting joists were chiseled back behind the north face of the wall, and new stonework was constructed to elevate the wall by ½ story. The floor joists of Room 208 were inserted next to the existing joists circa 1810 when the kitchen wing was expanded to the north. This detail supports the idea that the original west kitchen wing was first (c. 1790) expanded in height and then later (c. 1810) was expanded to the north and up to the full two stories. (Photo 206d, Figure 206a)

1. Original joist over c. 1769 kitchen has been chiseled back to accommodate elevation of the walls by ½ story.
2. Adjacent floor joist for Room 208 added at the time of the c. 1810 expansion to the north.

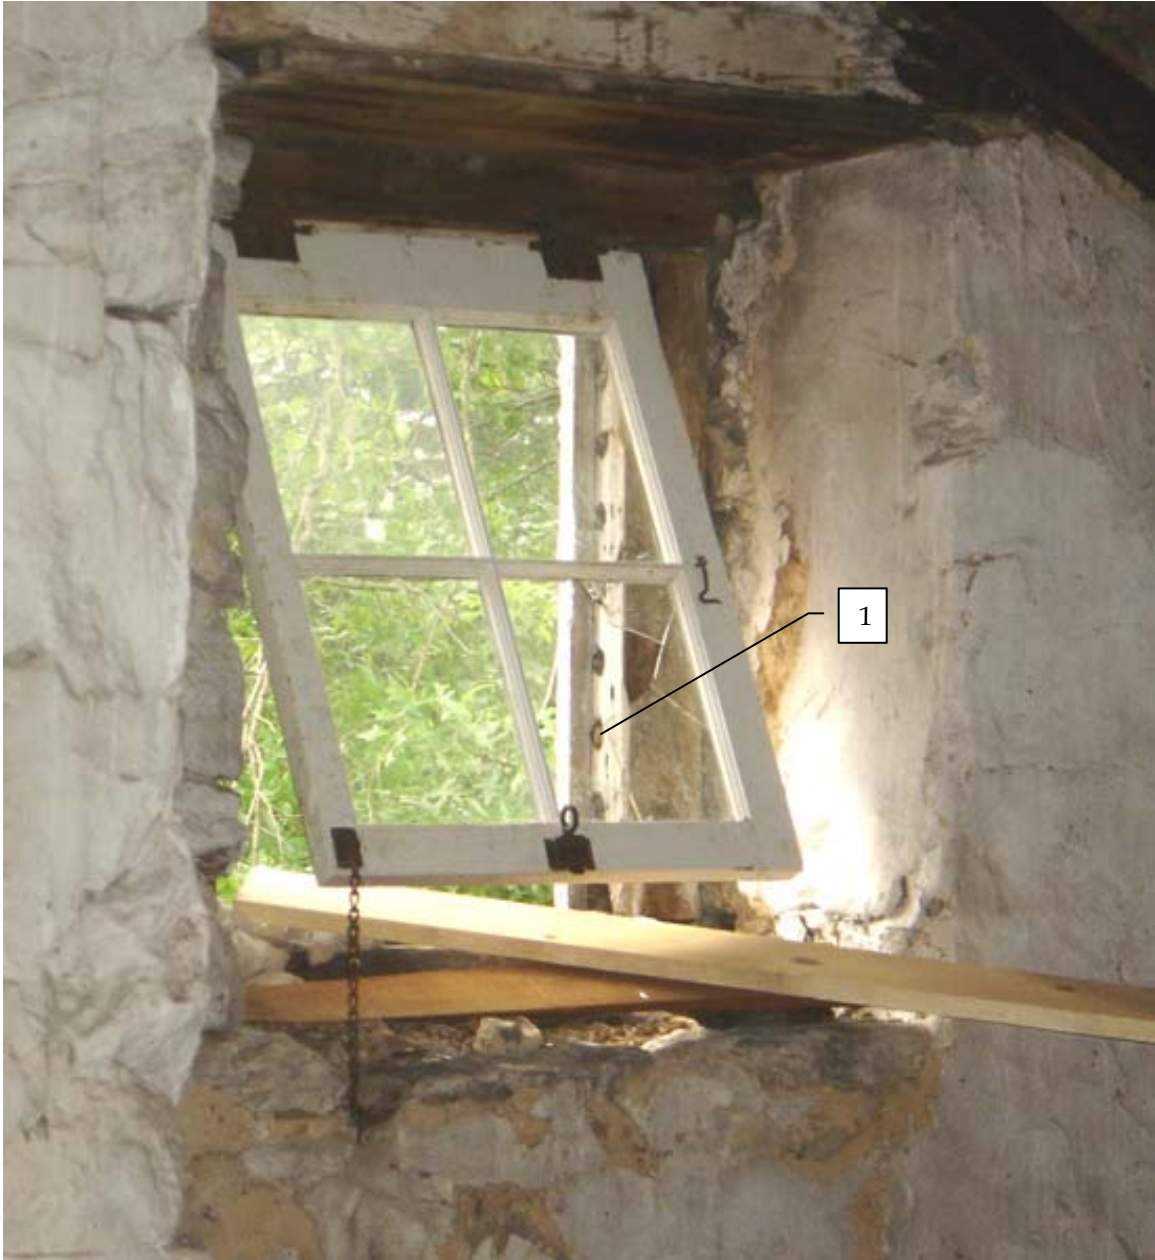
Photo 302a – Interior view of Window 302, looking southeast.

1. Indentations in wood jamb indicate the window opening formerly featured louver slats instead of glazed sashes.

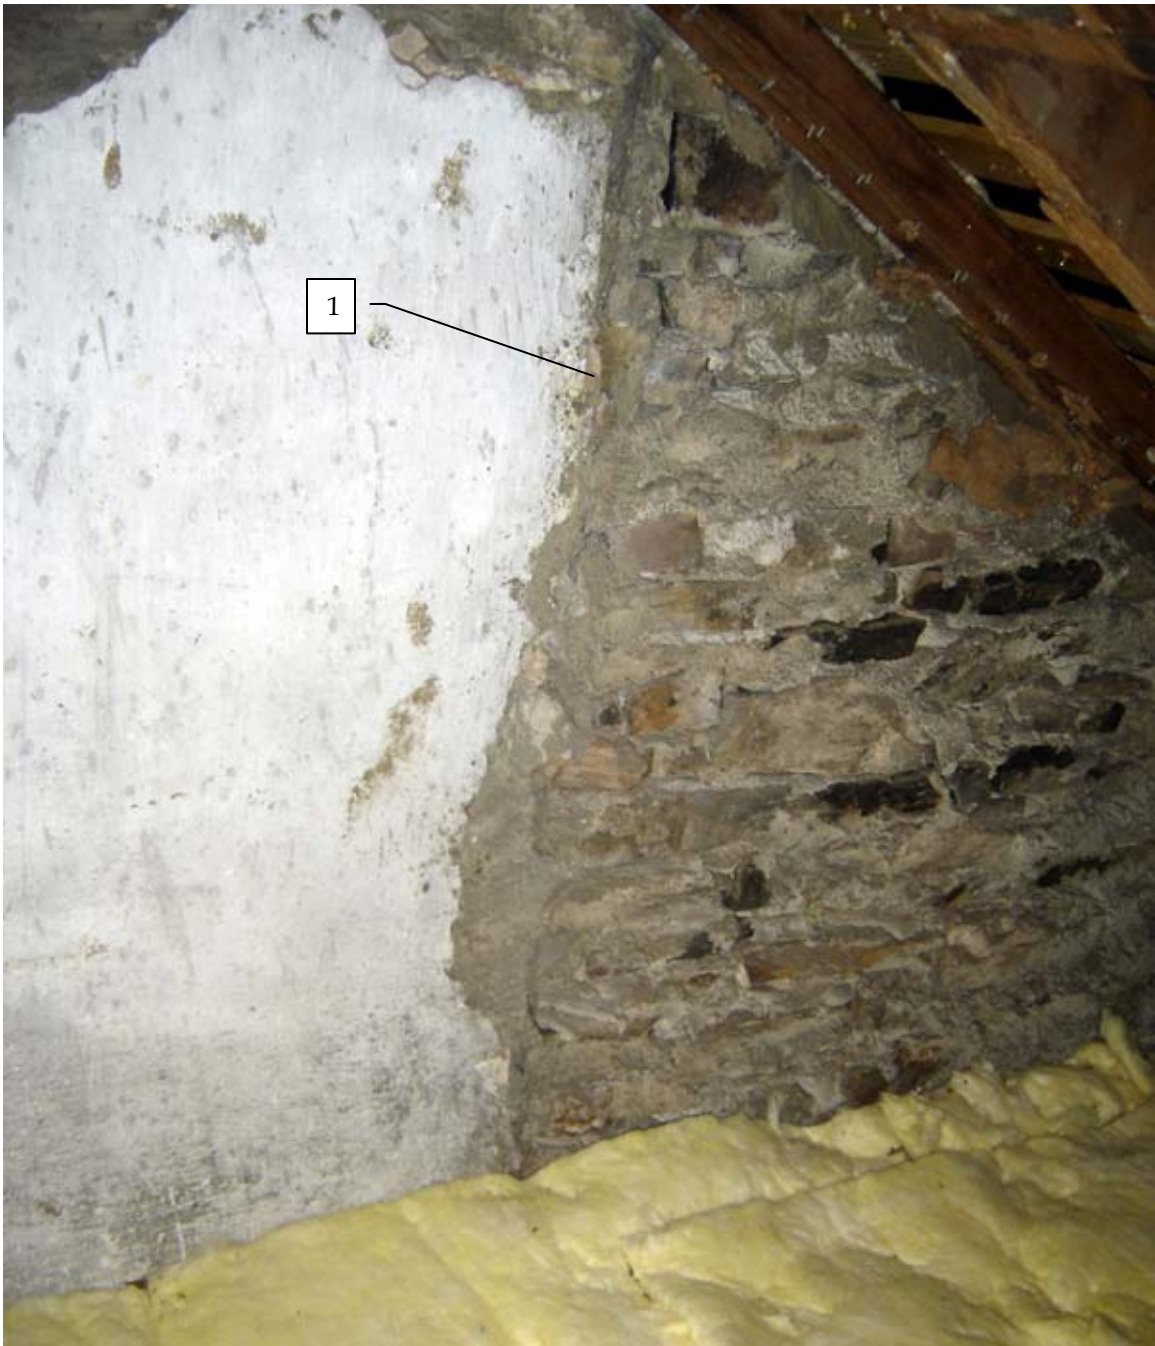
Photo 303a – West wall, north end, Room 303, looking west.

- Further north on the west wall is a crack and disturbed stone from the removal of the c. 1810 chimney. The chimney was removed in 1926. (Photo 303a, Note 7/303)

1. Masonry crack and disturbance in masonry where former chimney was removed c. 1926.

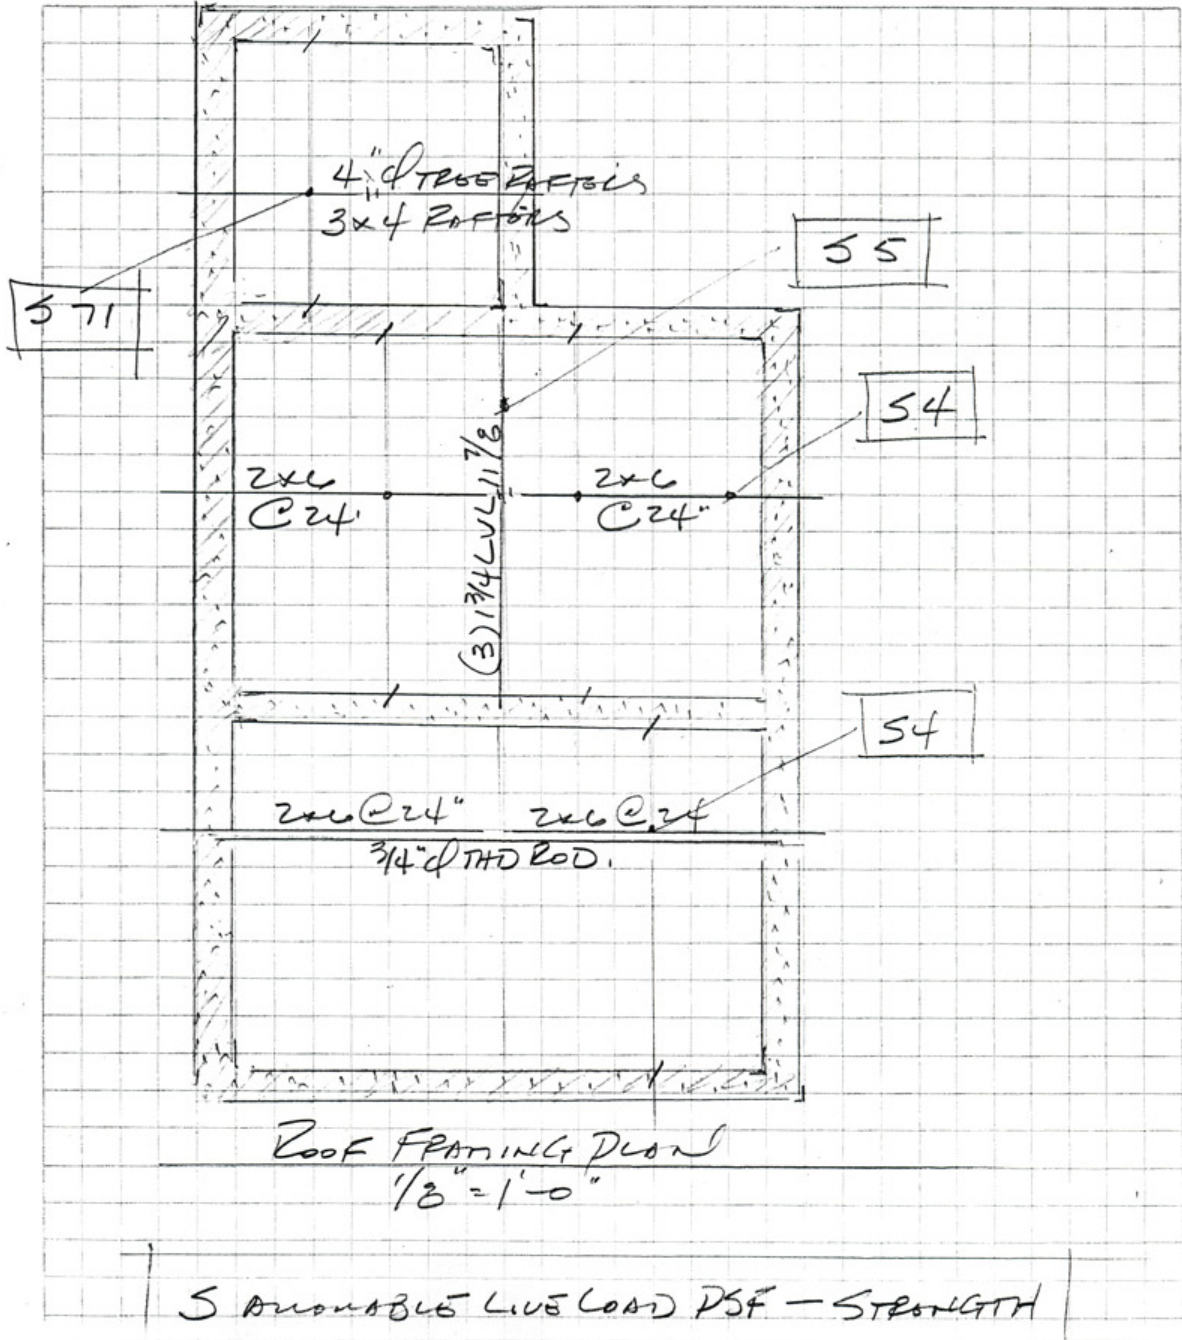
Figure S-4: Sketch of Roof Framing Plan. (Note: Image is not to scale).

The gable form roof structure of the main block has been reframed with 2x6 rafters set at 2' centers supported by collar members bearing on a manufactured timber beam (3) 1¾ LVL 11⅞ spanning east-west. The allowable uniformly distributed live loading on this reframed roof is only 5 PSF, which is considerably less than the minimum loading recommended by the building code of 15 PSF.

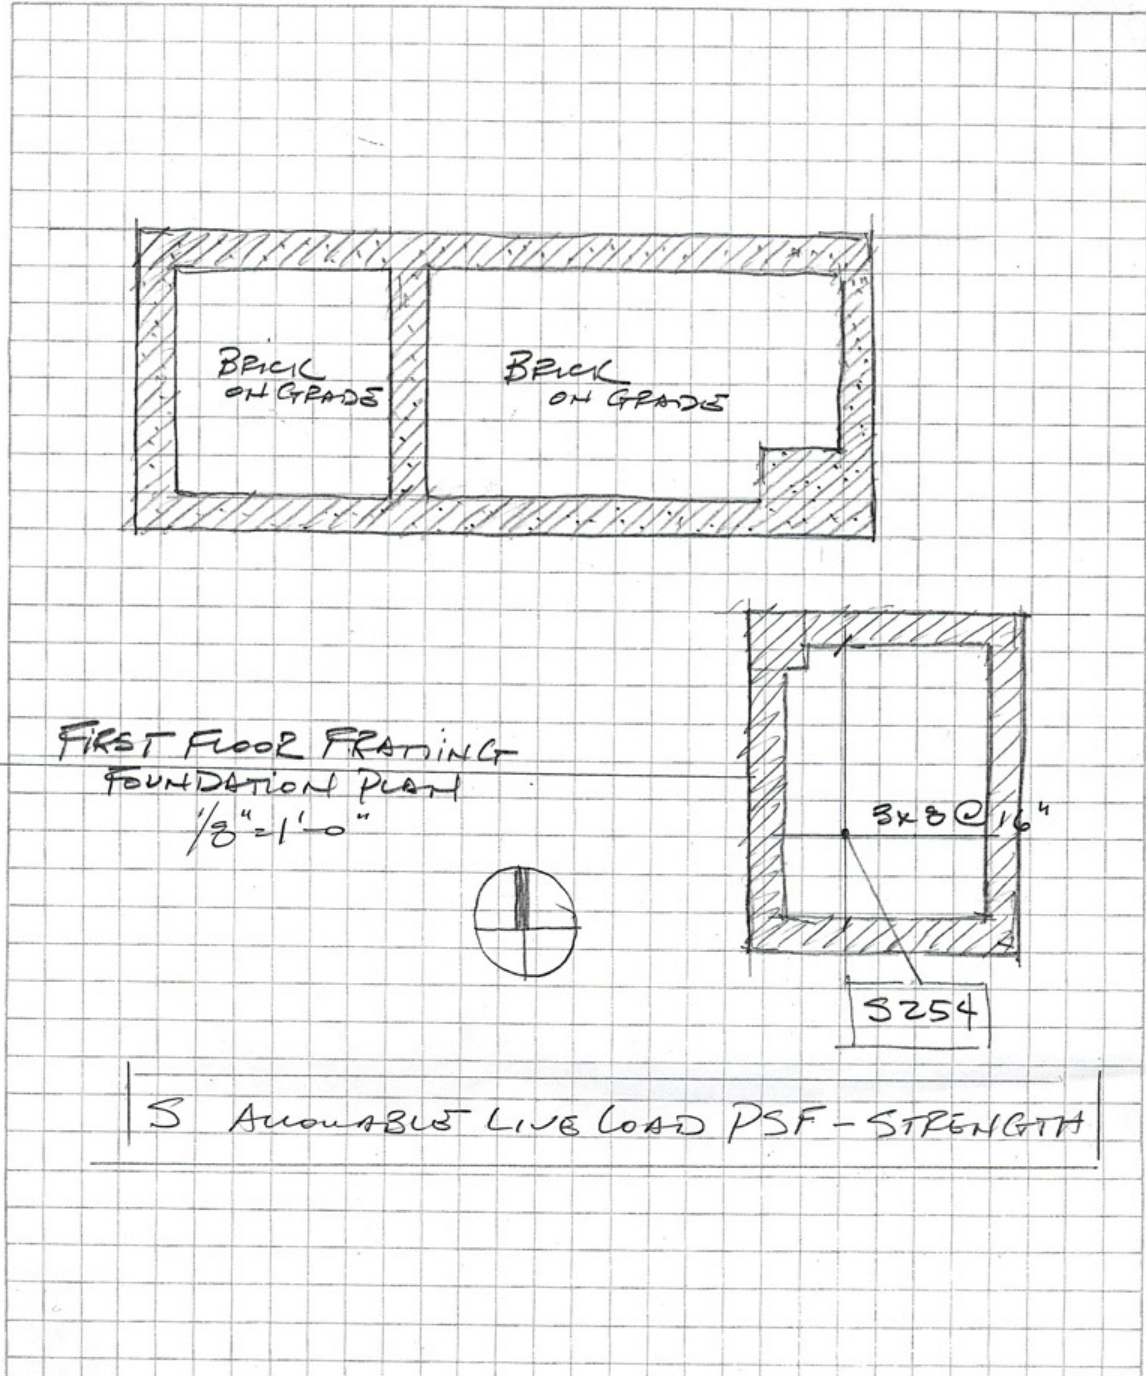
Figure S-5: Sketch of First Floor Framing Plan at 1926 northwest addition. (Note: Image is not to scale).

The first floor of the south block is framed with 3x8 joists set at 16" centers, spanning east-west over an earthen subgrade situated less than a foot below the bottom of the joists. The space below the framing is unventilated. Poor site drainage adjacent to the east wall of the south block has caused wet conditions in the stone masonry. Finding favorable environment, termite infestation has consumed the eastern ends of the joists.

Recommendations: Regrading the site to lower grade and provide positive drainage away from the building appears difficult to achieve. Accordingly, remove the timber joists at the first floor of the south block and replace with slab on grade construction. Excavate the subgrade inside the building; install vapor barrier and 4" of stone prior to casting a 4" thick concrete slab. Install pressure treated furring strips and marine plywood subfloor in preparation of the placement of the finish flooring. Coordinate the requirements of HVAC and piping.
